VOLUME TWO

GAZETTEER

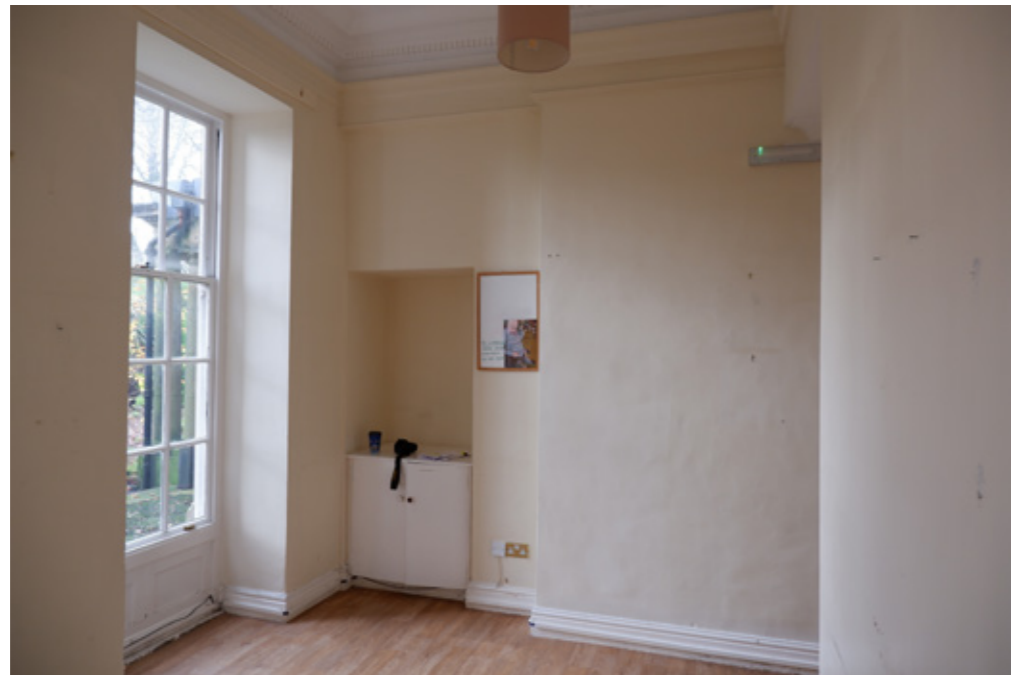
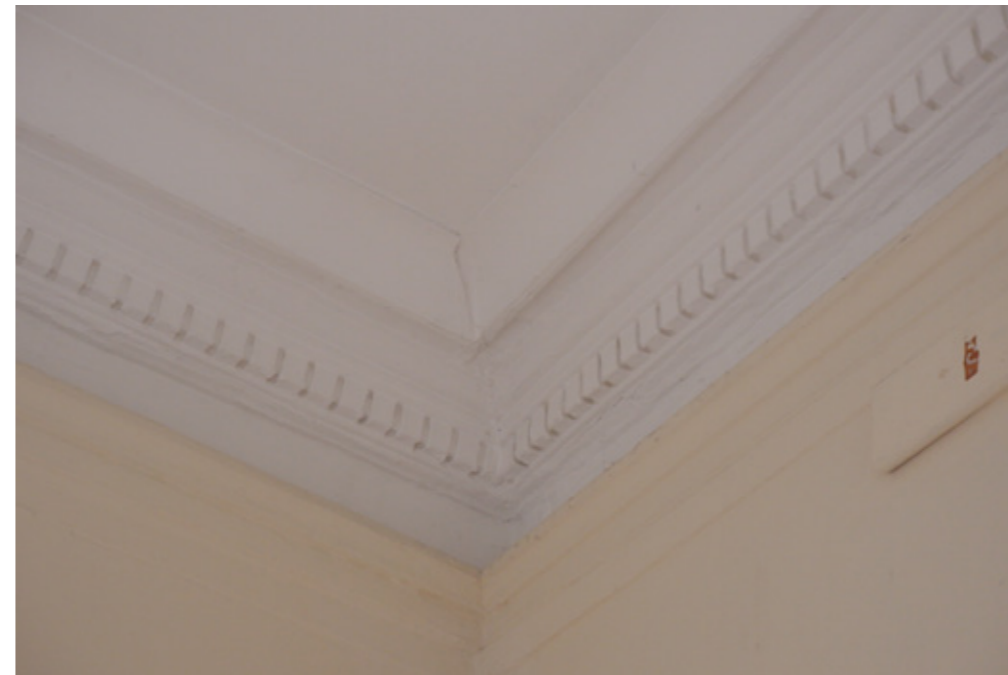
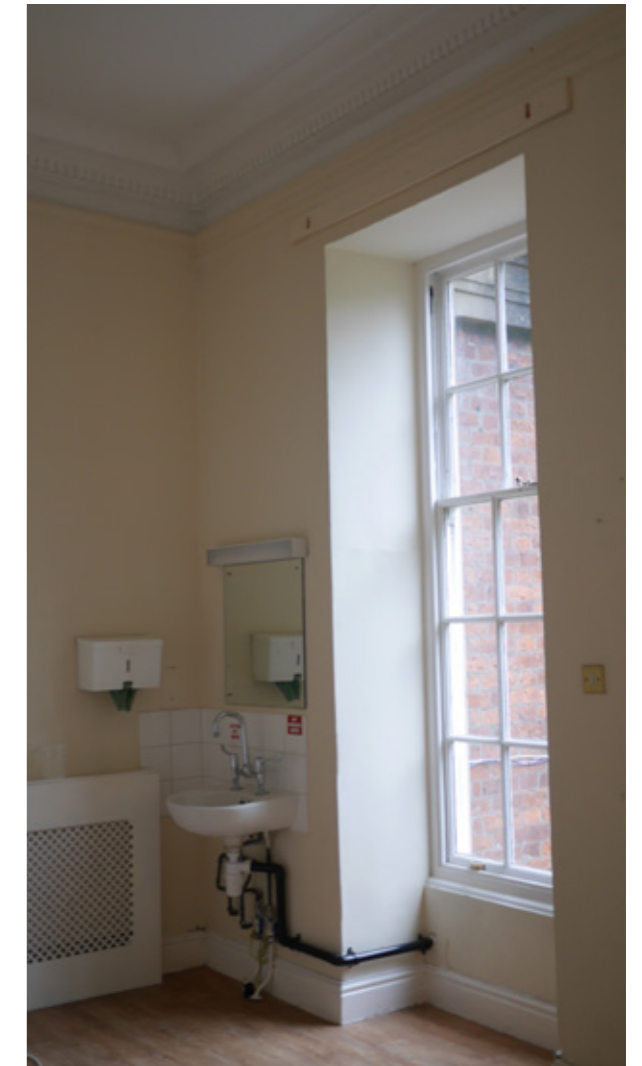
GROUND FLOOR: 1717 HOUSE – G2.10

Room Number:	G2.10
Current Room Use:	Bedroom
Historic Room Use:	Butler's Room
Date of Structure:	1717
Date of Fixtures / Fittings:	Late 20th century
Date of Decoration:	Late 20th century
Major Alterations:	Late 20th century subdivision of Butler's Room.

Overall Significance Level:	Medium
Key Historic Features:	Dentilled coricing, sash windows, and chimney breast
Detrimental Features:	Modern sanitaryware, floor, paint. Sub-division to form lift and blocked door to Butler's bedroom (G2.11/G.12).
Condition Level:	Fair
Condition Comments:	
Other Comments:

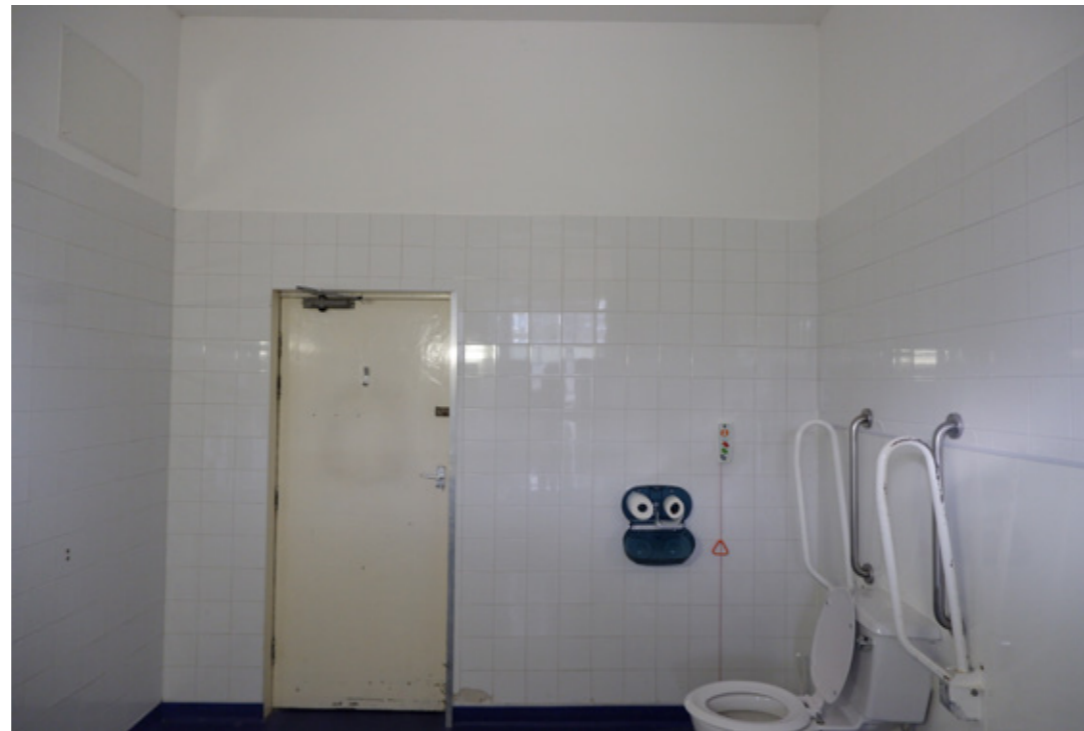
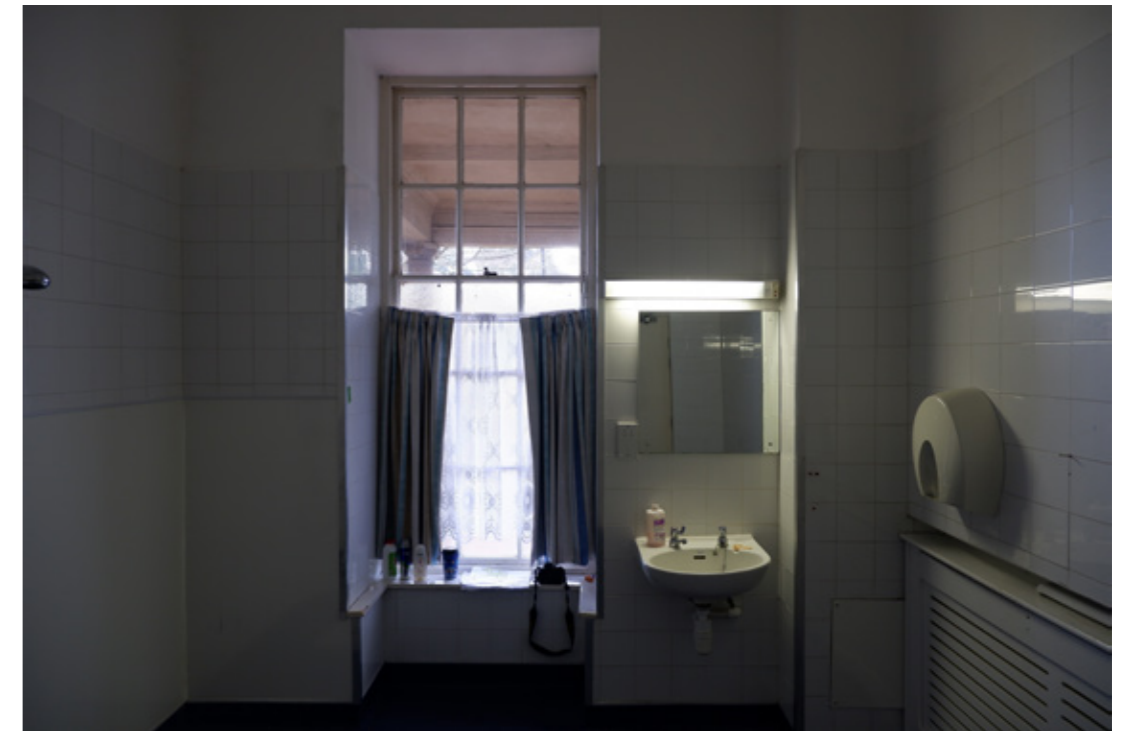
GROUND FLOOR: 1717 HOUSE – G2.12

Room Number:	G2.12
Current Room Use:	Bathroom
Historic Room Use:	Butler's Bedroom
Date of Structure:	1717
Date of Fixtures / Fittings:	20th century
Date of Decoration:	Late 20th century
Major Alterations:	Late 20th century subdivision of Butler's Room.

Overall Significance Level:	Medium
Key Historic Features:	Sash Window
Detrimental Features:	Modern door, radiators, M&E and sanitary ware. Floor, wall and ceiling finishes.
Condition Level:	
Condition Comments:	
Other Comments:

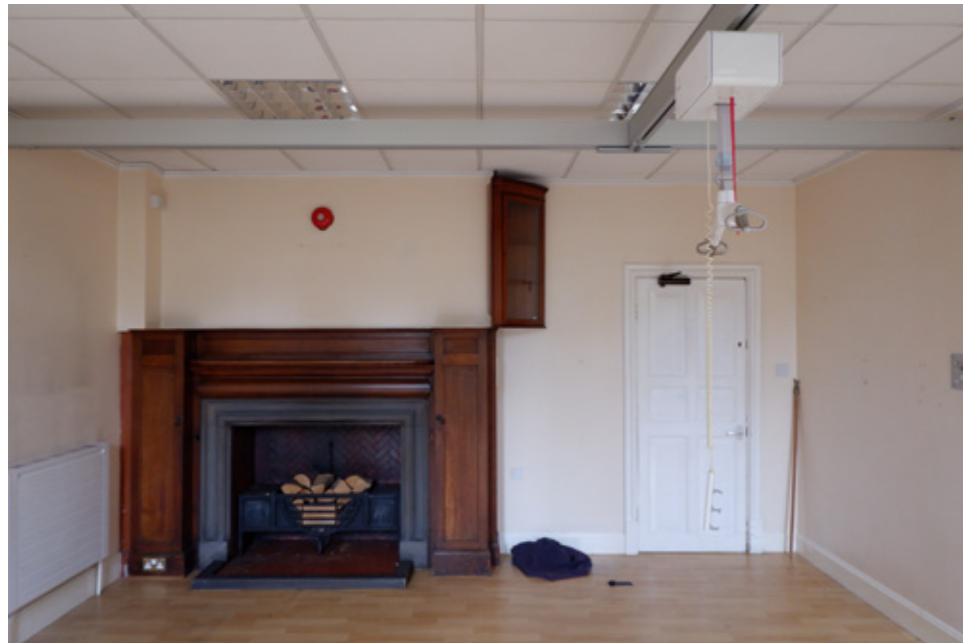
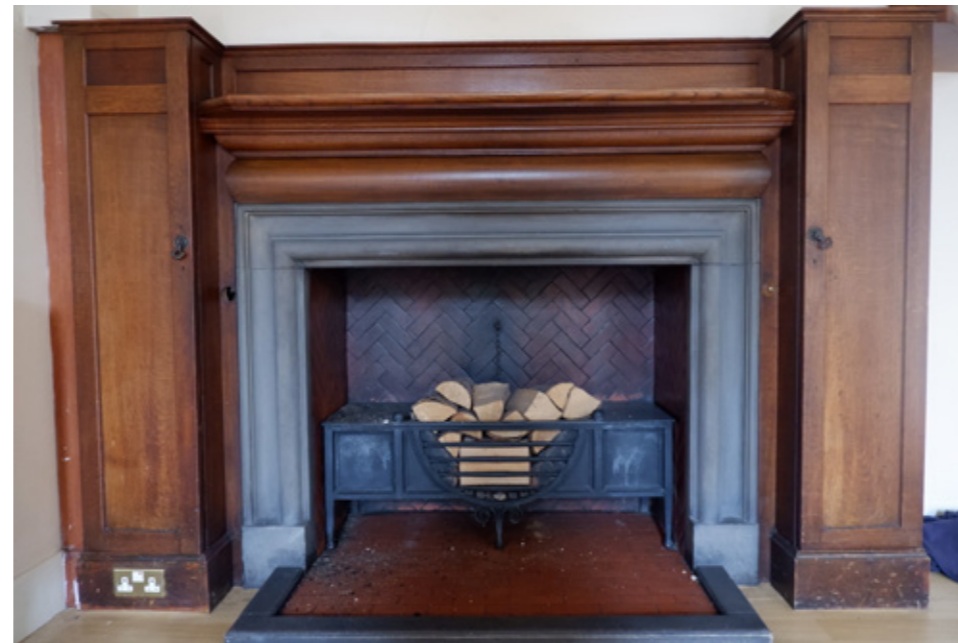
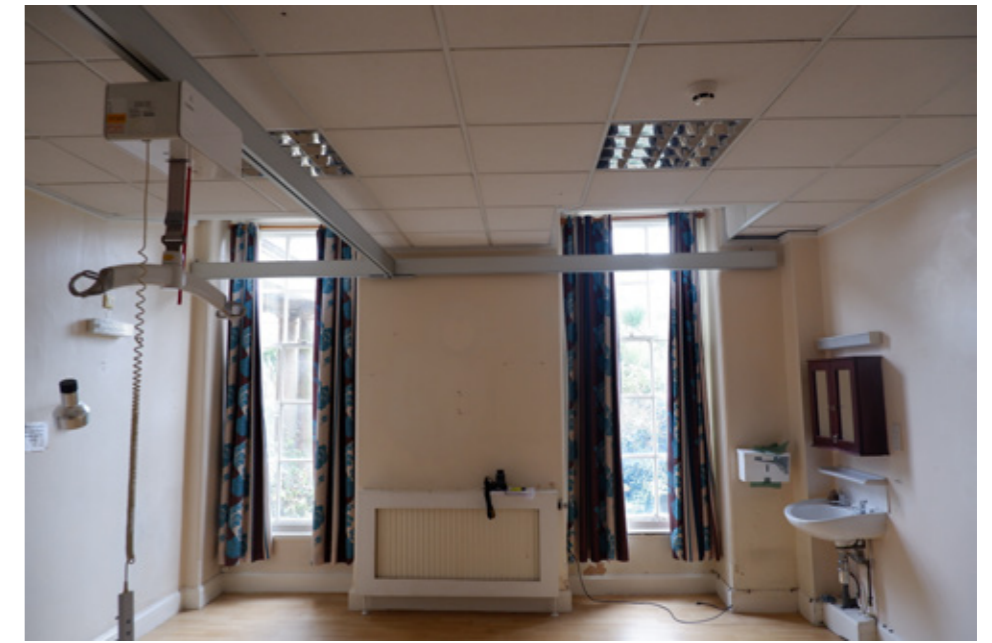
GROUND FLOOR: 1717 HOUSE – G2.13

Room Number:	G2.13
Current Room Use:	Bedroom
Historic Room Use:	Servant's Hall
Date of Structure:	1717
Date of Fixtures / Fittings:	
Date of Decoration:	Late 20th century
Major Alterations:	Subdivision of servant's hall
Overall Significance Level:	High

Key Historic Features:	Fireplace and hearth, timber cupboards 6 Panel door
Detrimental Features:	Inserted wall. Modern radiators, M&E, medical equipment and sanitary ware. Flooring, wall finishes and suspended ceiling Modern closer and door handles
Condition Level:	
Condition Comments:	
Other Comments:

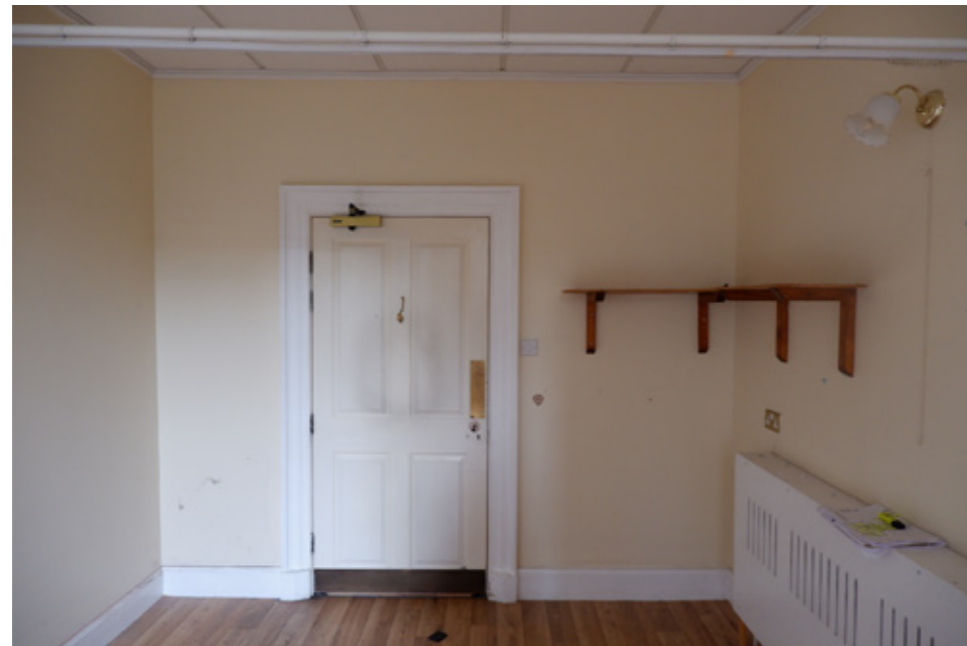
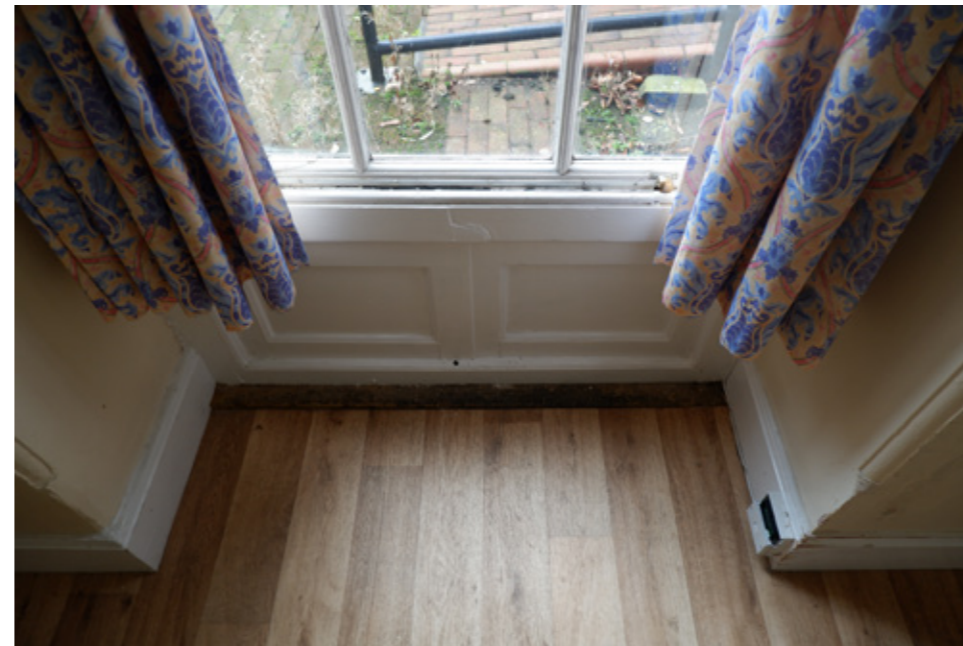
GROUND FLOOR: 1717 HOUSE – G2.14

Room Number:	G2.14
Current Room Use:	Bedroom
Historic Room Use:	Servant's Hall
Date of Structure:	1717
Date of Fixtures / Fittings:	
Date of Decoration:	Late 20th century
Major Alterations:	Subdivision of servant's hall

Overall Significance Level:	High
Key Historic Features:	Sash window with timber access doors below
Detrimental Features:	Inserted wall. Modern radiators, M&E and sanitary ware. Flooring, wall finishes and suspended ceiling
Condition Level:	
Condition Comments:	
Other Comments:	Window with panel under similar to G2.11

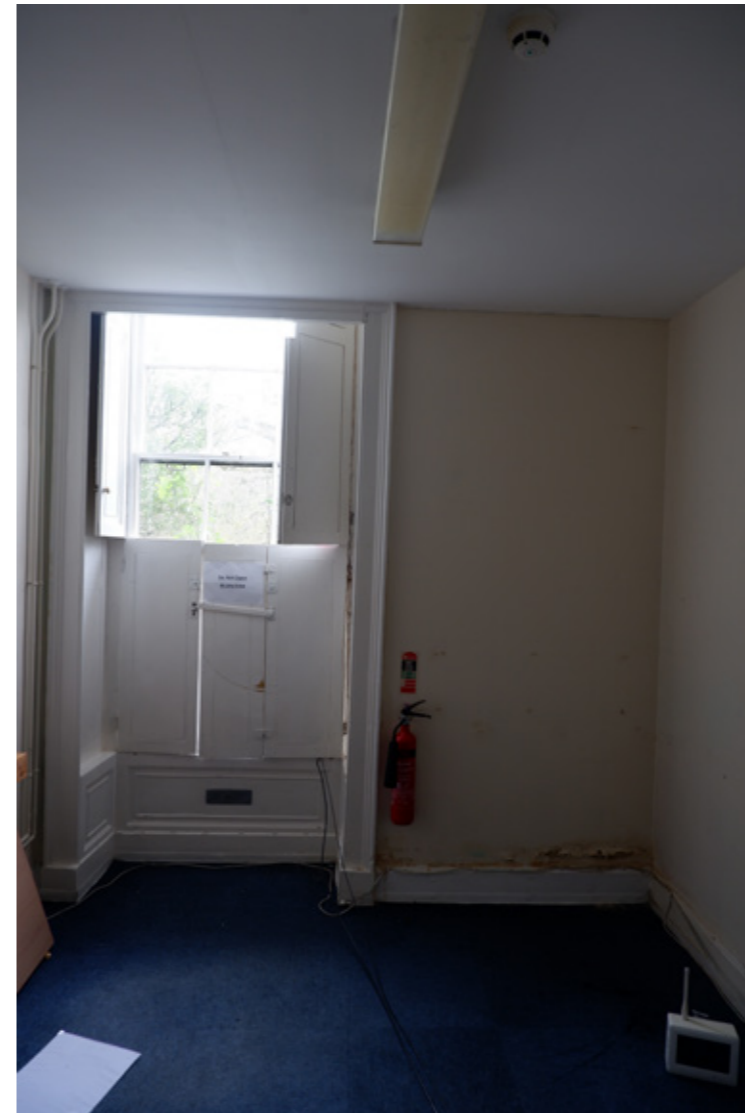
GROUND FLOOR: 1717 HOUSE – G2.16

Room Number:	G2.16
Current Room Use:	Office
Historic Room Use:	Still Room (Wyatt plan)
Date of Structure:	1717
Date of Fixtures / Fittings:	
Date of Decoration:	Late 20th century
Major Alterations:	Blocking of internal doorway, subdivision

Overall Significance Level:	tbc
Key Historic Features:	6 panel door Sash window and shutters
Detrimental Features:	M&E, flooring, modern radiators, lowered ceiling,
Condition Level:	
Condition Comments:	
Other Comments:	Shutters cut to fit dropped ceiling

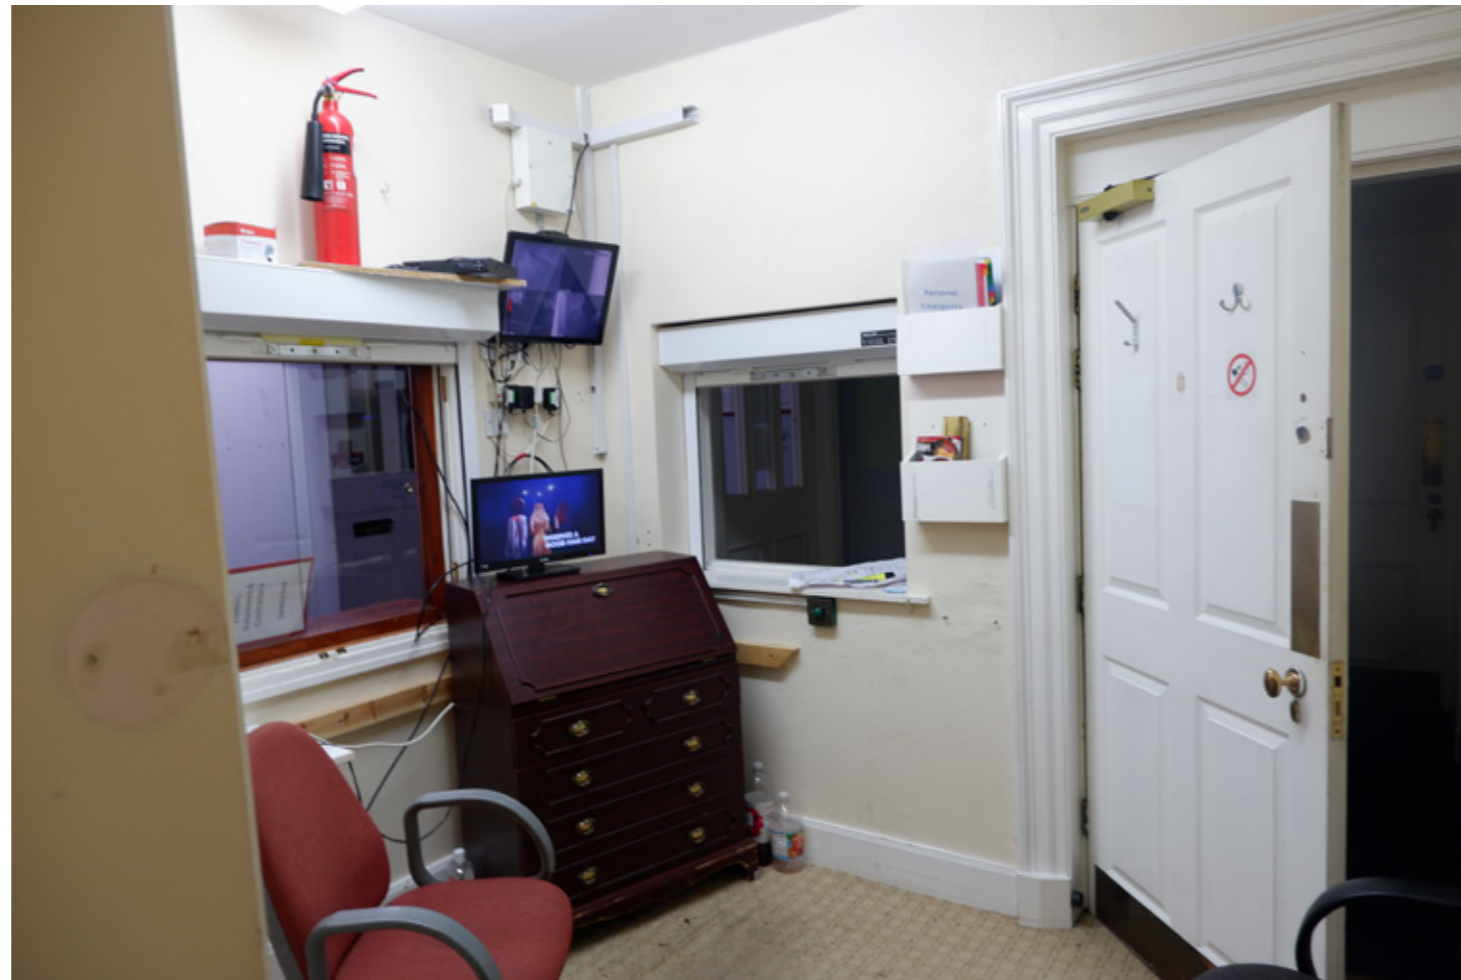
GROUND FLOOR: SERVICE WING – G3.01

Overall Significance Level:	Neutral
Key Historic Features:	Sash windows
Detrimental Features:	M&E, boxed in pipework, modern doors, modern radiators, flooring
Condition Level:	
Condition Comments:	
Other Comments:

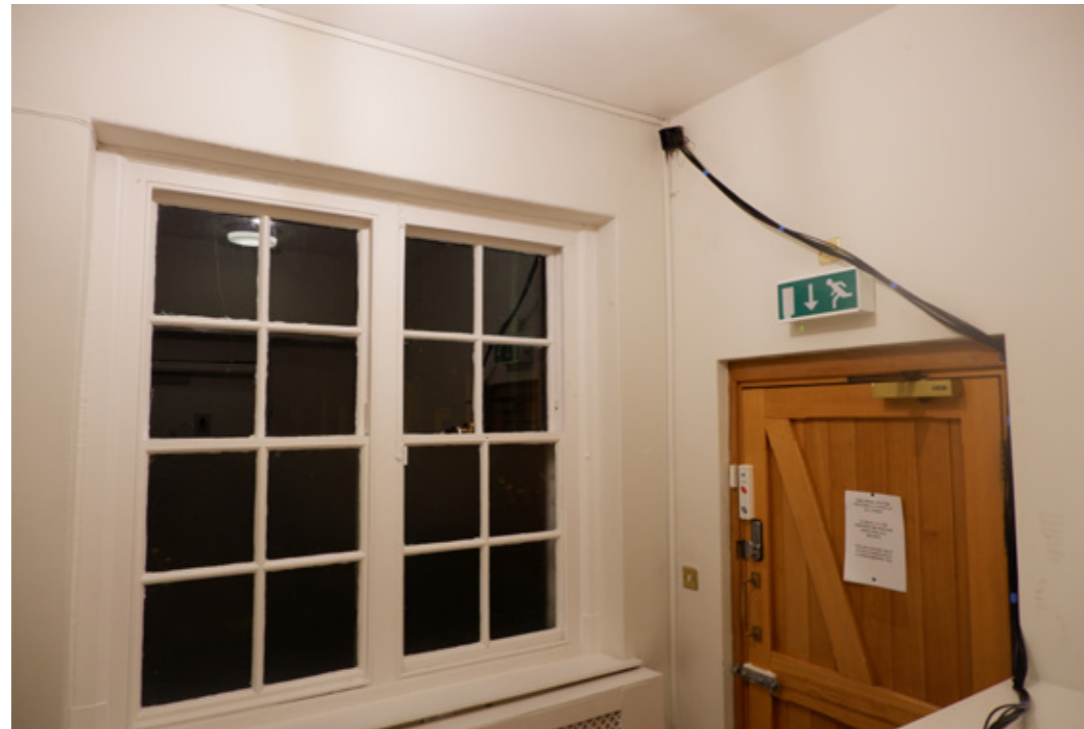
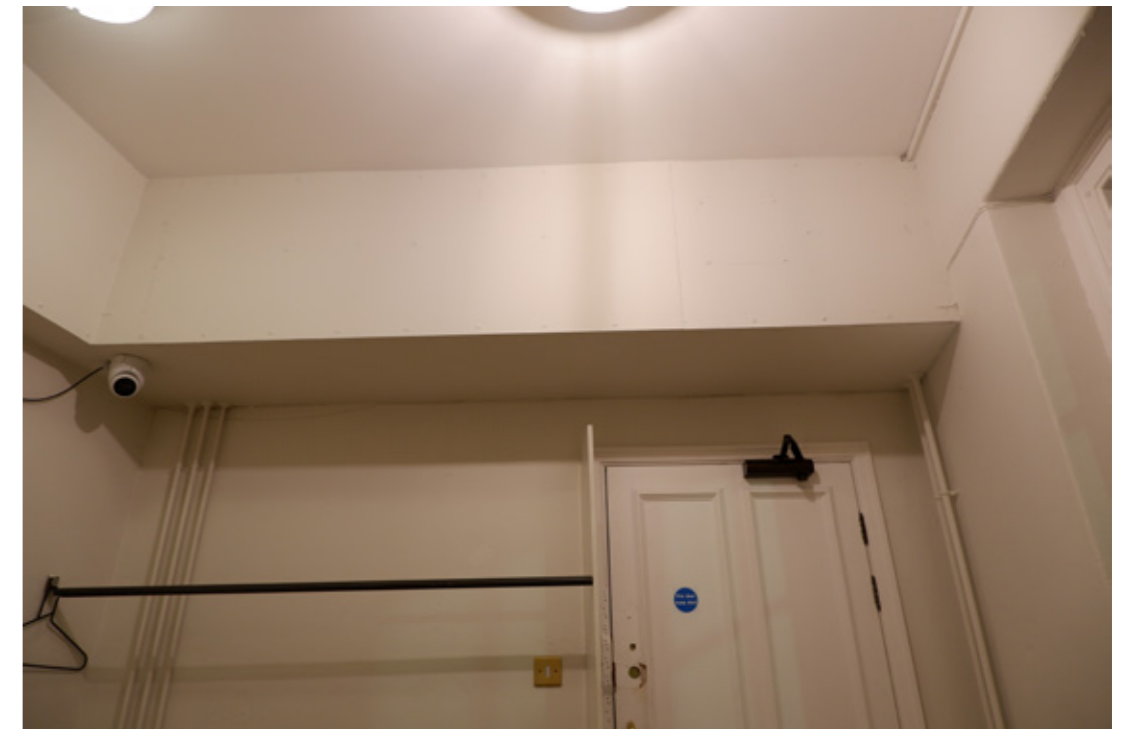
Room Number:	G3.01
Current Room Use:	Circulation/side entrance
Historic Room Use:	
Date of Structure:	1848-1893
Date of Fixtures / Fittings:	
Date of Decoration:	Late 20th century
Major Alterations:

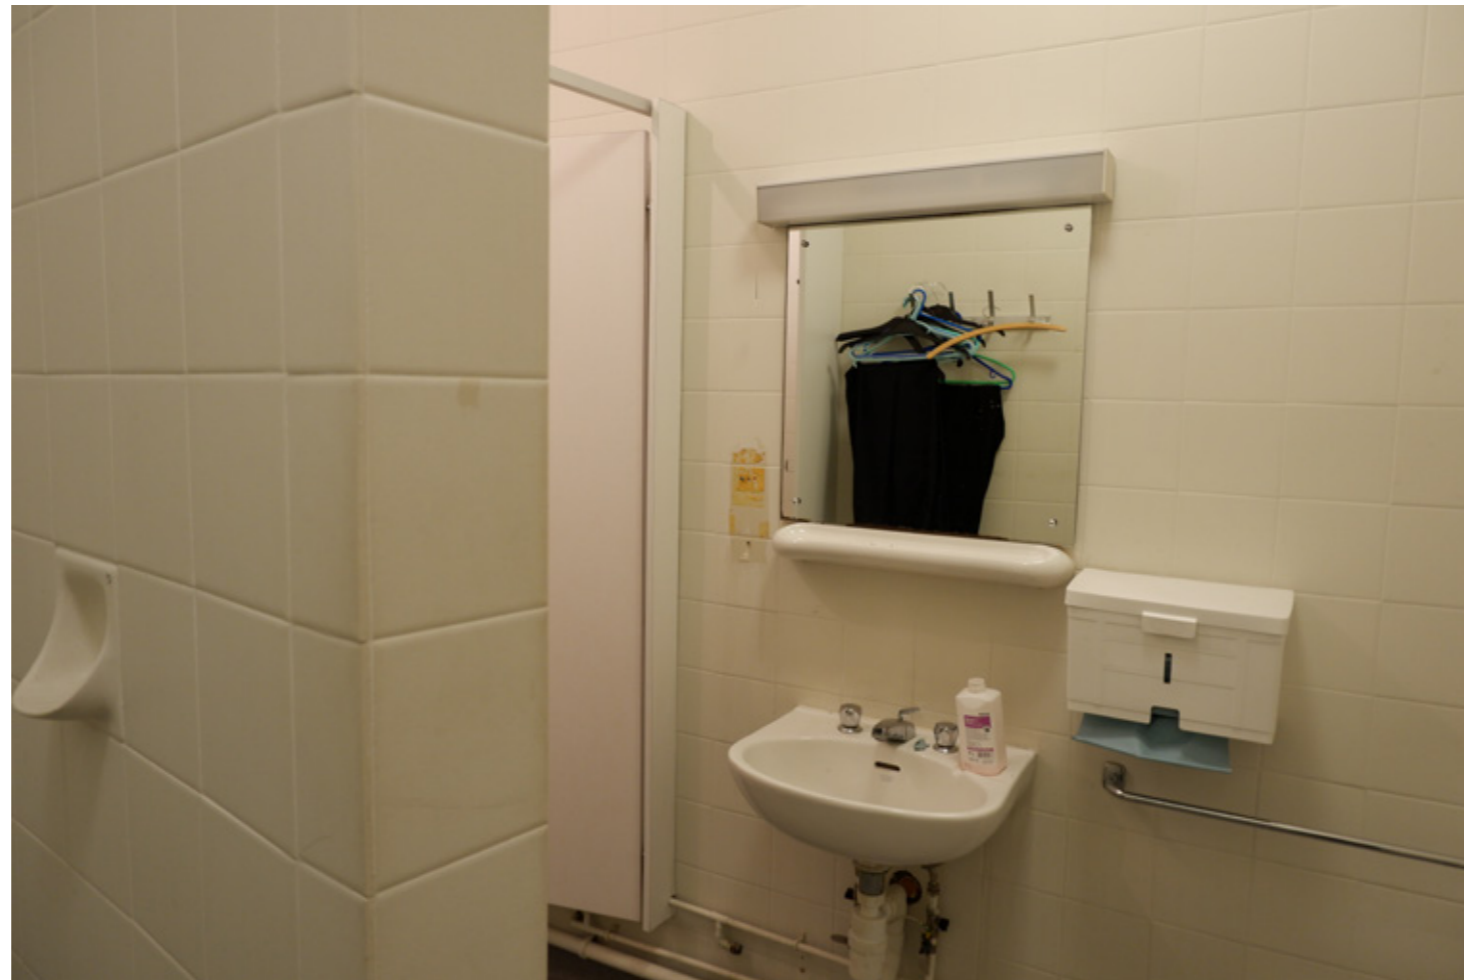
GROUND FLOOR: SERVICE WING – G3.02

Room Number:	G3.02
Current Room Use:	Bathroom
Historic Room Use:	
Date of Structure:	1848-1893
Date of Fixtures / Fittings:	
Date of Decoration:	Late 20th century
Major Alterations:

Overall Significance Level:	Neutral
Key Historic Features:	None
Detrimental Features:	M&E, sanitary ware, flooring, tiling
Condition Level:	
Condition Comments:	
Other Comments:

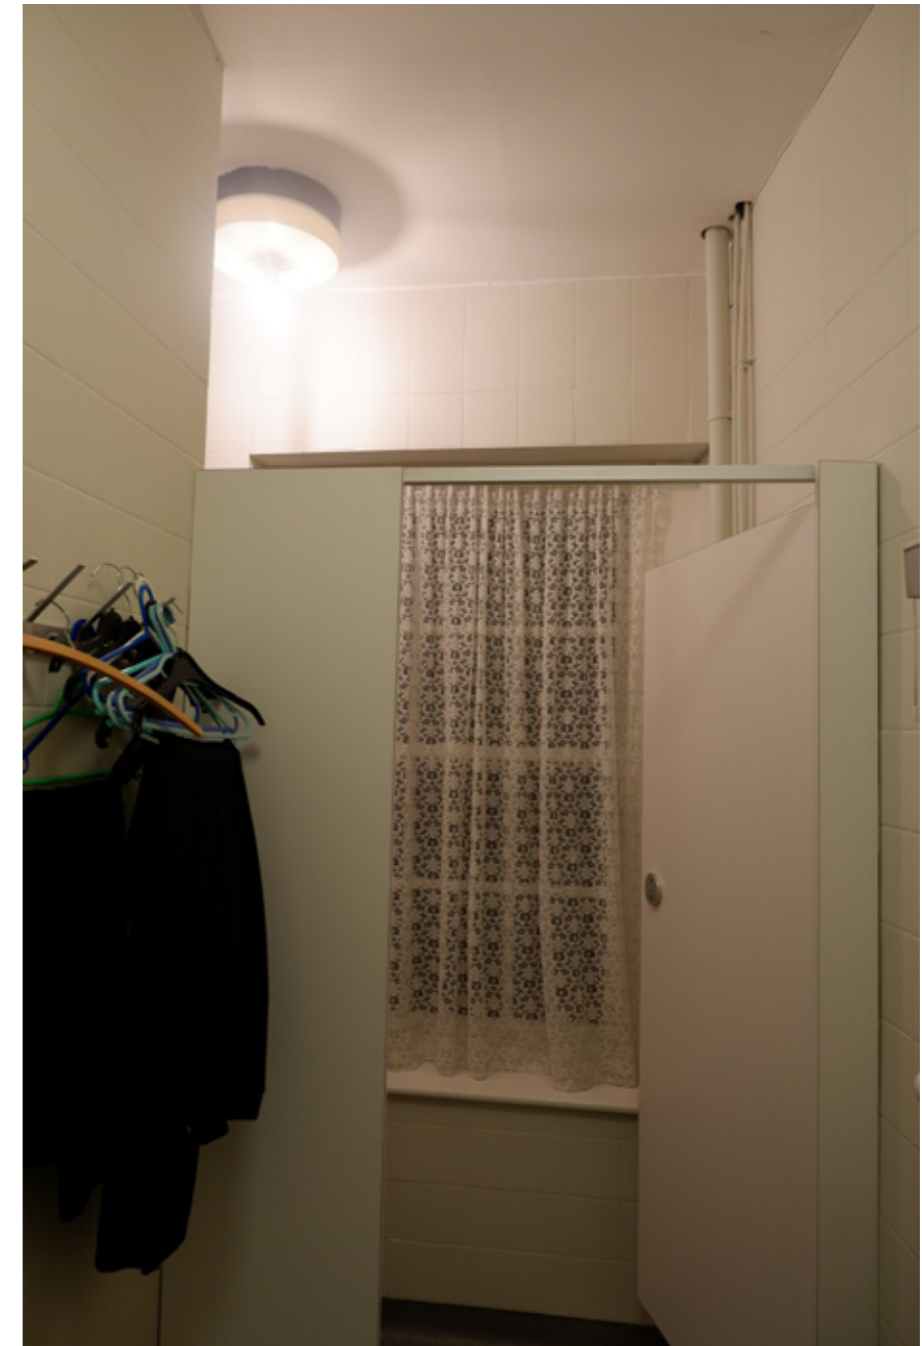
GROUND FLOOR: SERVICE WING – G3.04

Overall Significance Level:	Neutral
Key Historic Features:	Sash windows
Detrimental Features:	M&E, Modern Fitout, Suspended Ceiling
Condition Level:	
Condition Comments:	
Other Comments:

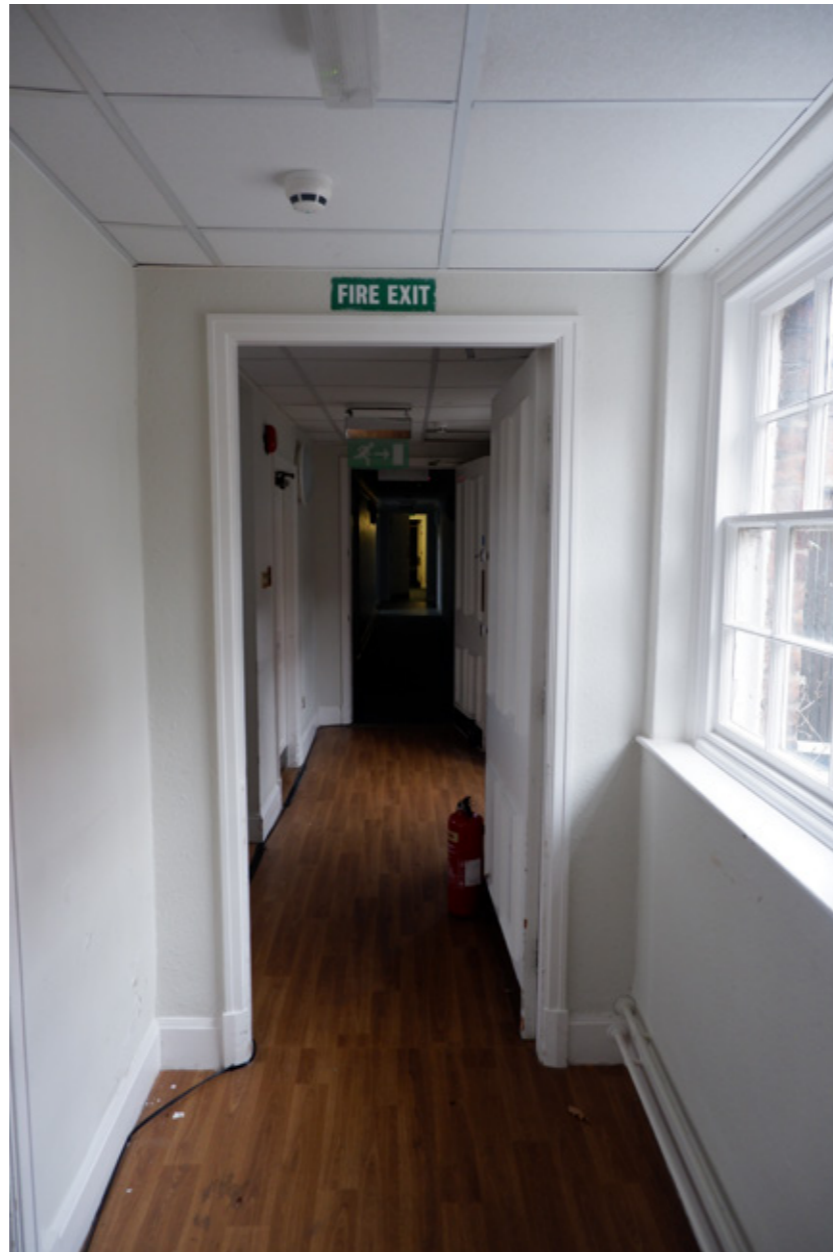
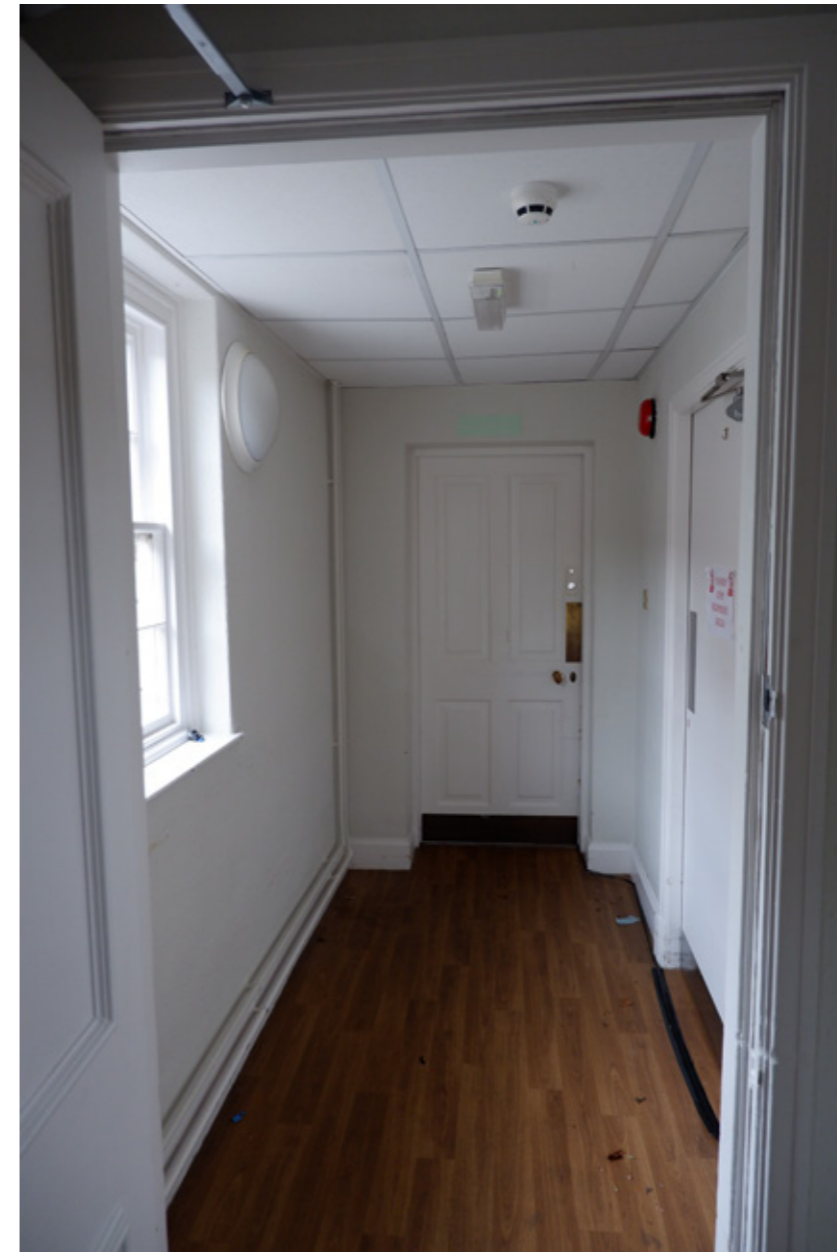
Room Number:	G3.04
Current Room Use:	Circulation
Historic Room Use:	
Date of Structure:	1848-1893
Date of Fixtures / Fittings:	
Date of Decoration:	Late 20th century
Major Alterations:

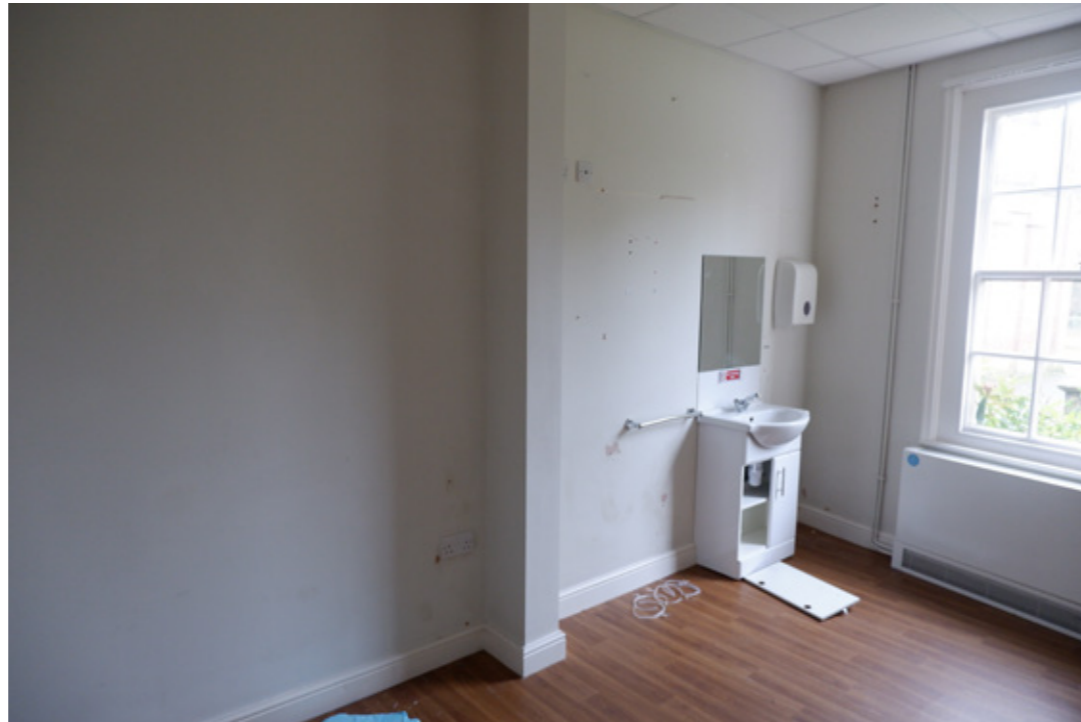
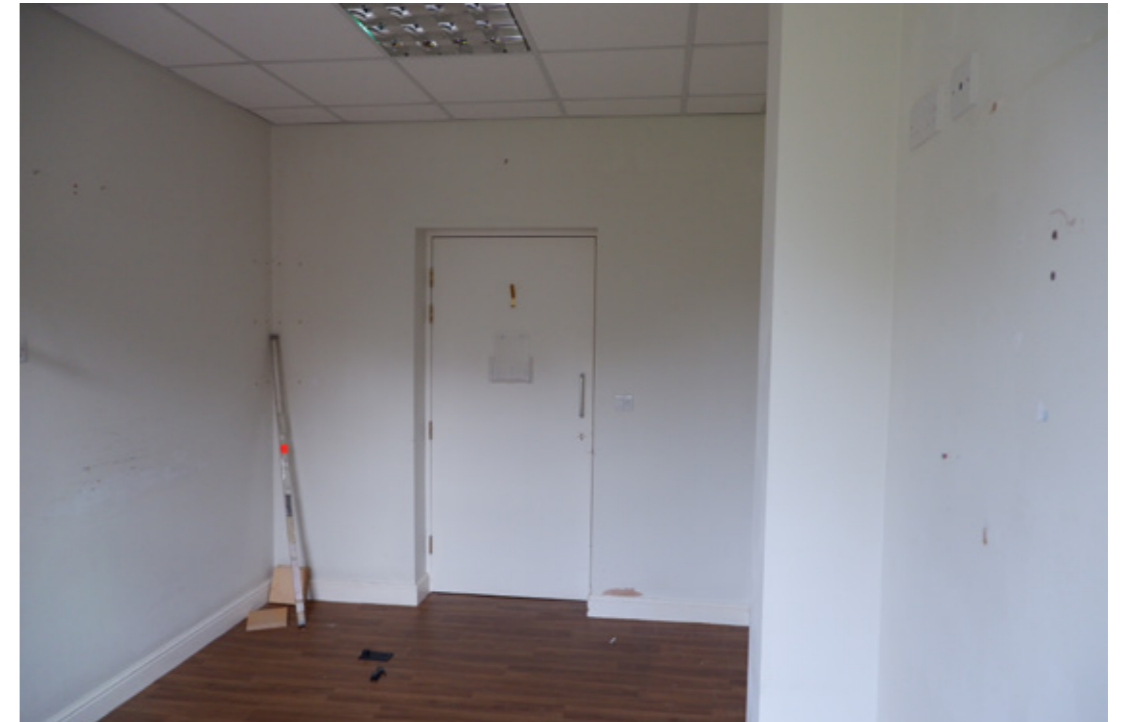
GROUND FLOOR: SERVICE WING – G3.05 / G3.06

Room Number:	G3.05 / G3.06
Current Room Use:	Bedroom
Historic Room Use:	
Date of Structure:	1848-1893
Date of Fixtures / Fittings:	
Date of Decoration:	Late 20th century
Major Alterations:

Overall Significance Level:	Neutral
Key Historic Features:	Sash window
Detrimental Features:	M&E, Modern Fitout, Suspended Ceiling
Condition Level:	
Condition Comments:	
Other Comments:

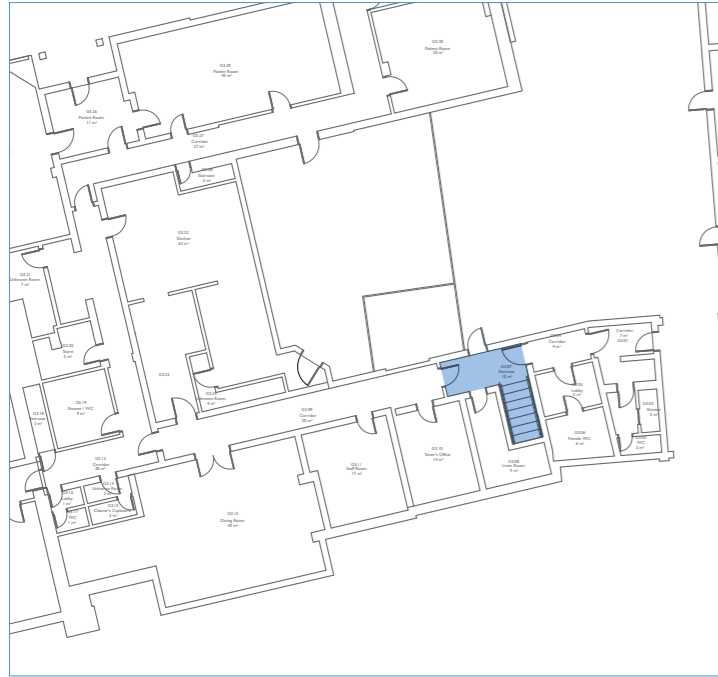
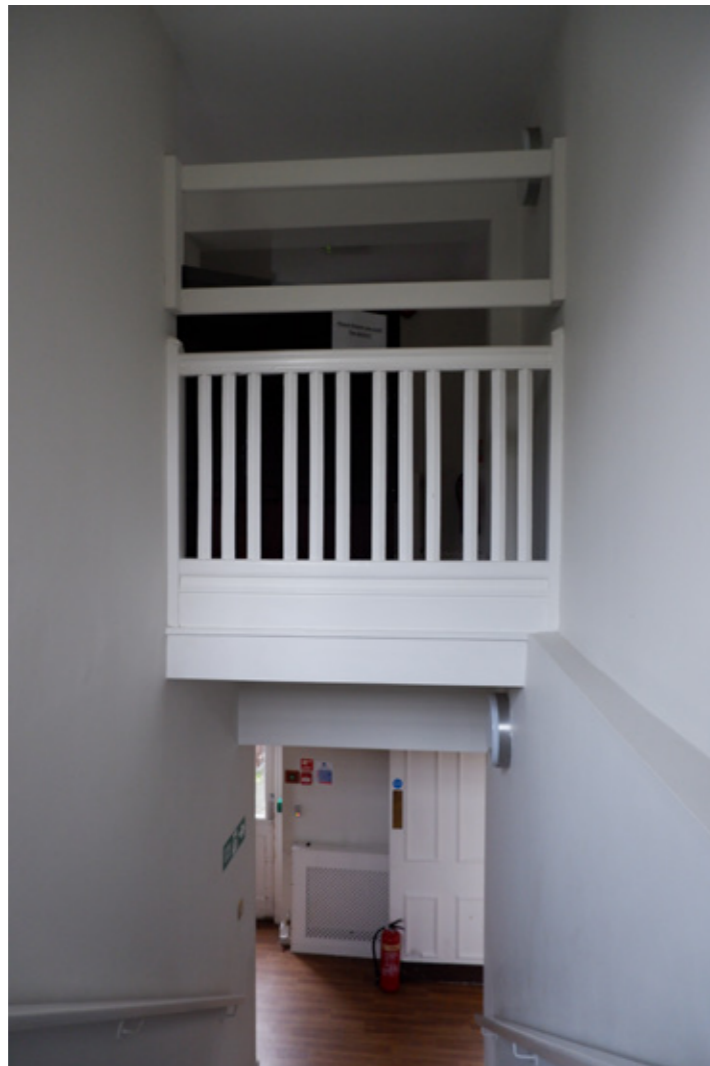
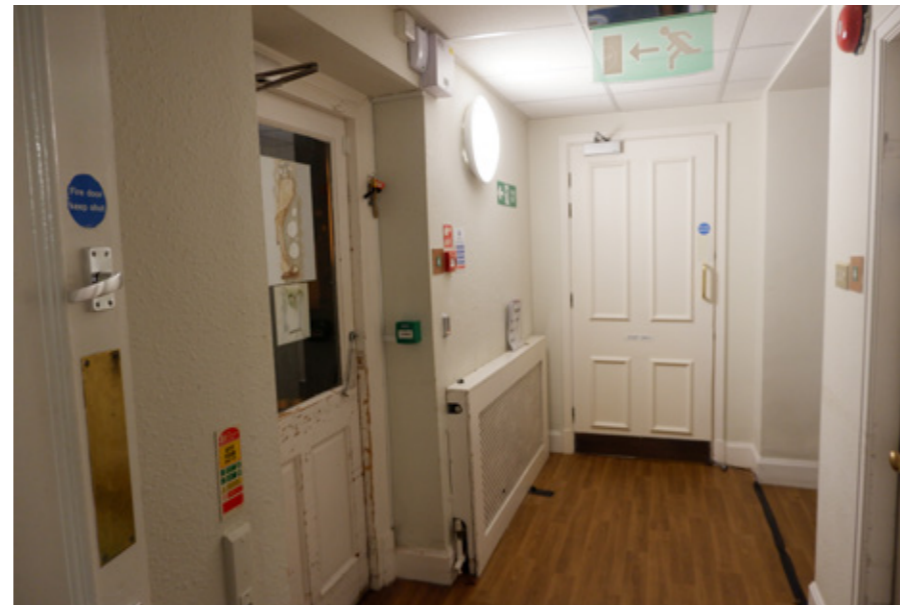
GROUND FLOOR: SERVICE WING – G3.07

Room Number:	G3.07
Current Room Use:	Stair
Historic Room Use:	
Date of Structure:	1848-1893
Date of Fixtures / Fittings:	
Date of Decoration:	Late 20th century
Major Alterations:	Insertation of modern stair

Overall Significance Level:	Neutral
Key Historic Features:	Sash window
Detrimental Features:	M&E, Modern Fitout, Suspended Ceiling
Condition Level:	
Condition Comments:	
Other Comments:

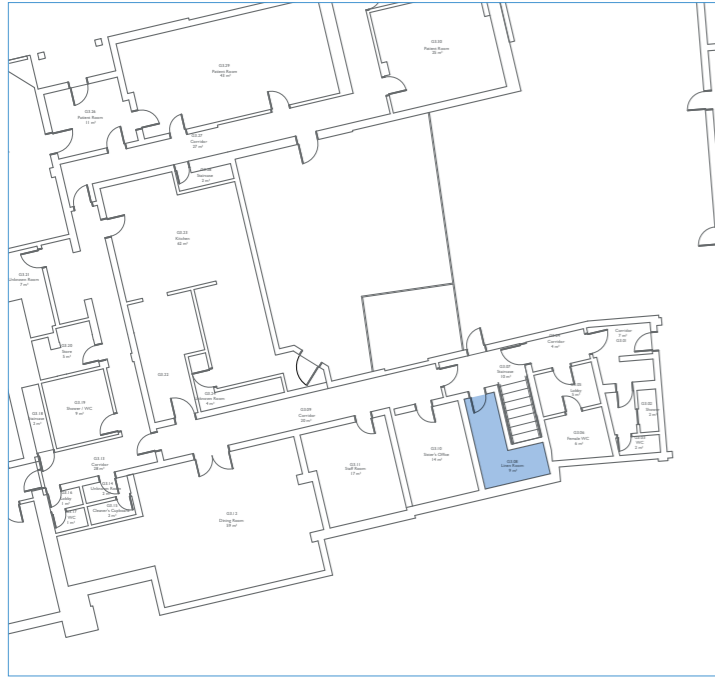
GROUND FLOOR: SERVICE WING – G3.08

Room Number:	G3.08
Current Room Use:	Storage/Plant
Historic Room Use:	Goods? (Wyatt plan)
Date of Structure:	1817
Date of Fixtures / Fittings:	
Date of Decoration:	Late 20th century
Major Alterations:	Insertation of modern stair

Overall Significance Level:	Neutral
Key Historic Features:	None
Detrimental Features:	None
Condition Level:	
Condition Comments:	
Other Comments:

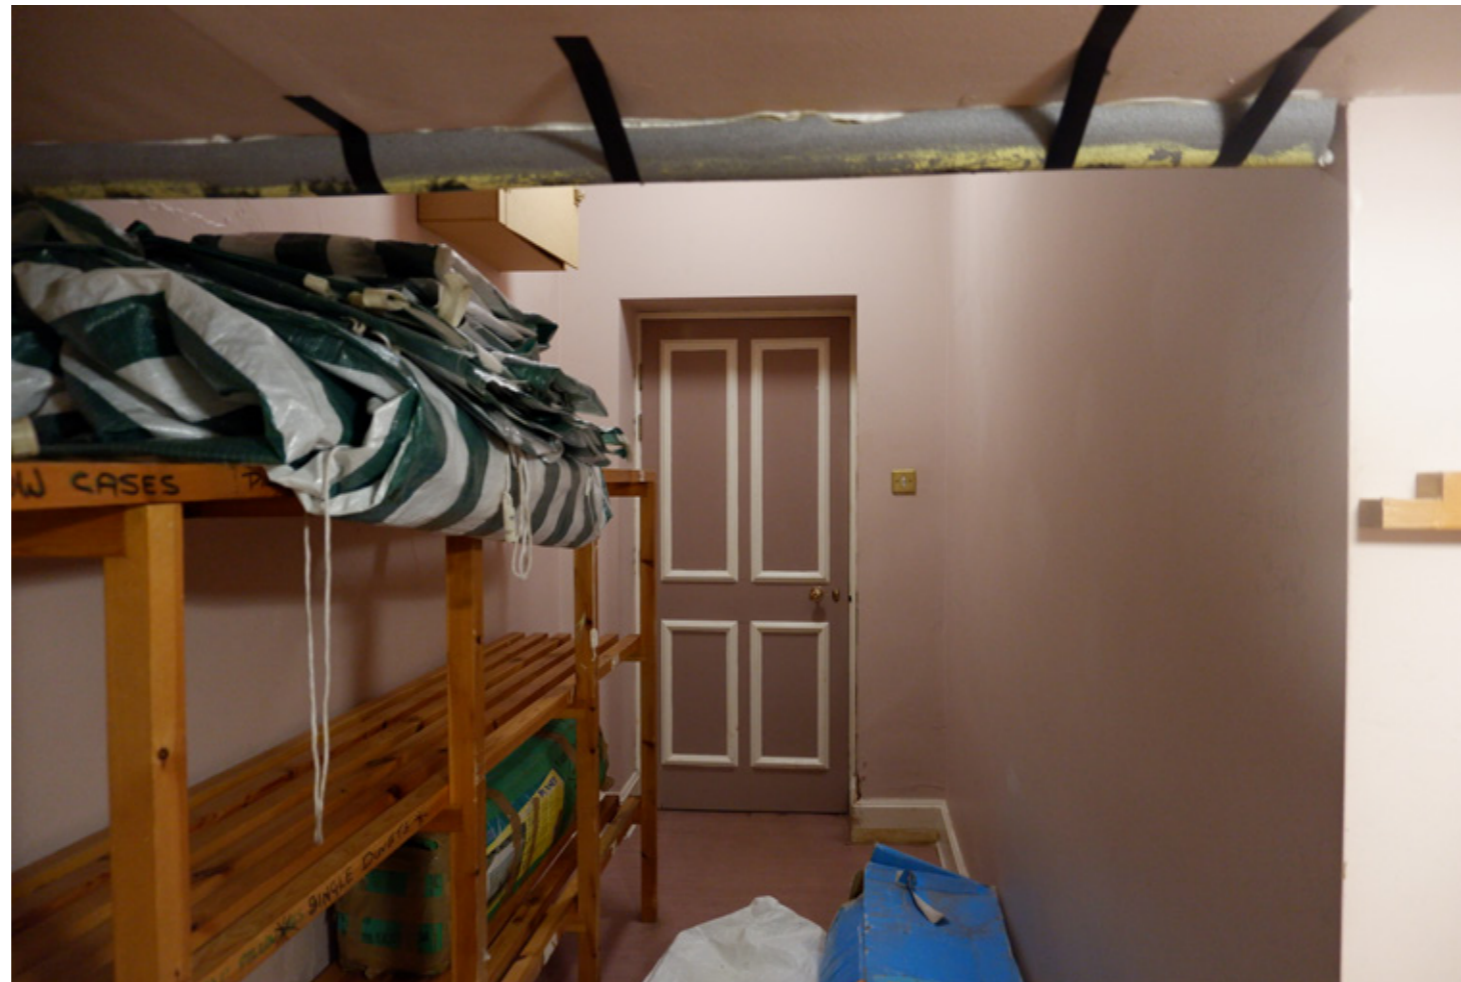
GROUND FLOOR: SERVICE WING – G3.09

Overall Significance Level:	Low
Key Historic Features:	None
Detrimental Features:	M&E, Modern Fitout
Condition Level:	
Condition Comments:	
Other Comments:
