VOLUME TWO

GAZETTEER

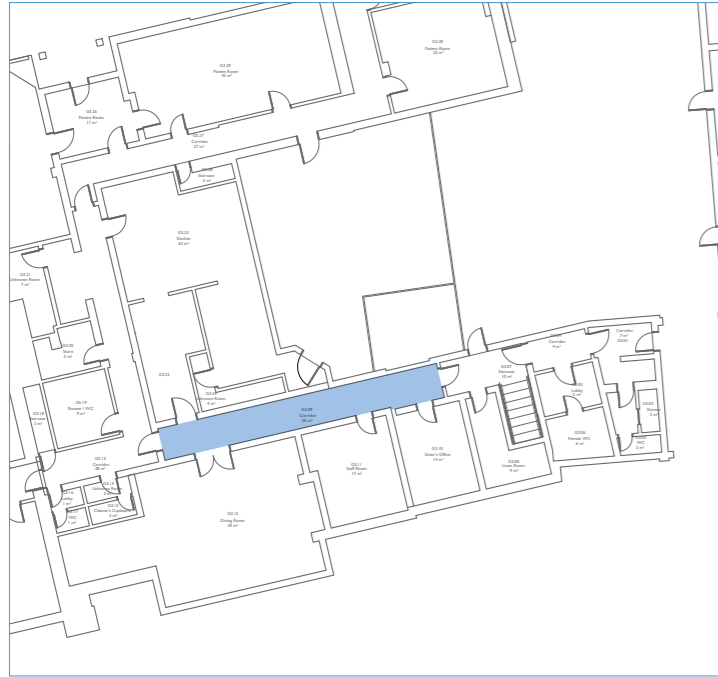
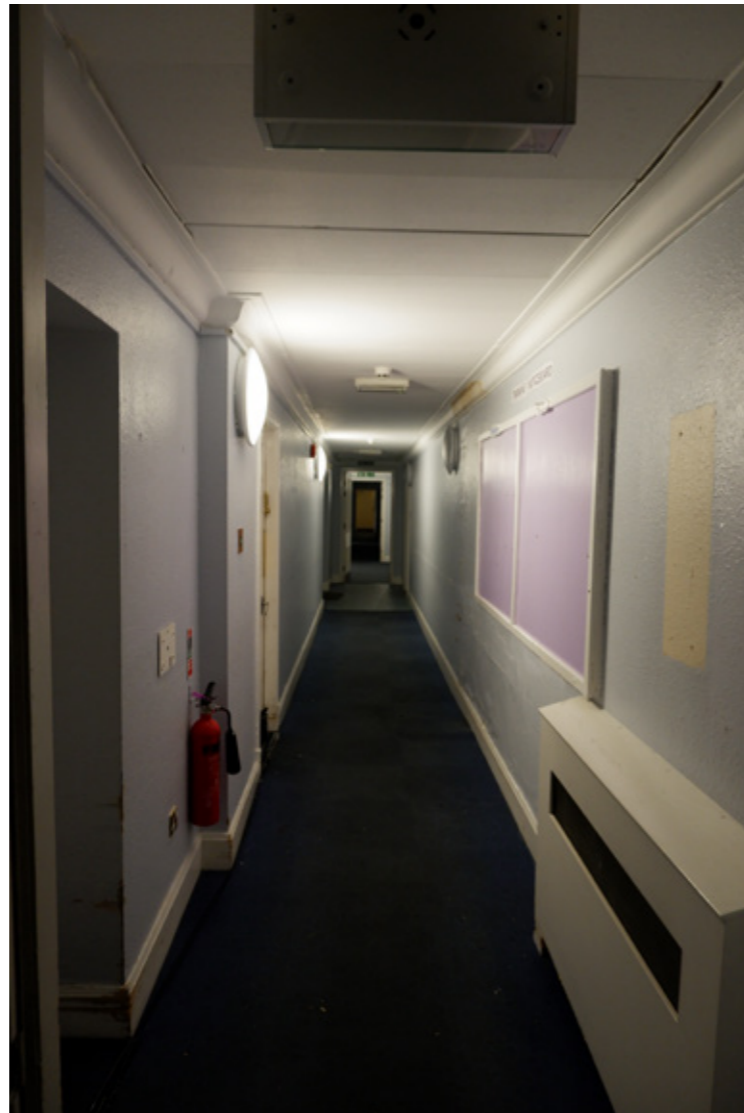
GROUND FLOOR: SERVICE WING – G3.09

Room Number:	G3.09
Current Room Use:	Corridor
Historic Room Use:	
Date of Structure:	1848-1893
Date of Fixtures / Fittings:	
Date of Decoration:	Late 20th century
Major Alterations:

Overall Significance Level:	Low
Key Historic Features:	None
Detrimental Features:	M&E, Modern Fitout
Condition Level:	
Condition Comments:	
Other Comments:

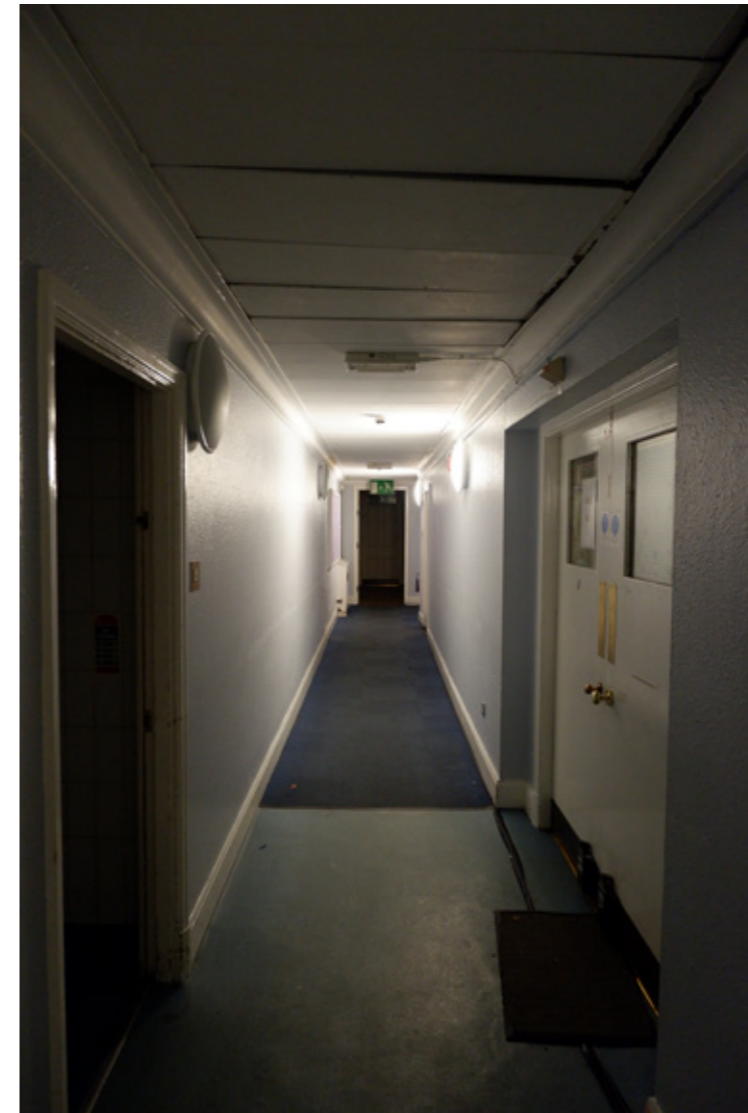
GROUND FLOOR: SERVICE WING – G3.10

Overall Significance Level:	Medium
Key Historic Features:	Sash window
Detrimental Features:	M&E, Modern Fitout
Condition Level:	
Condition Comments:	
Other Comments:

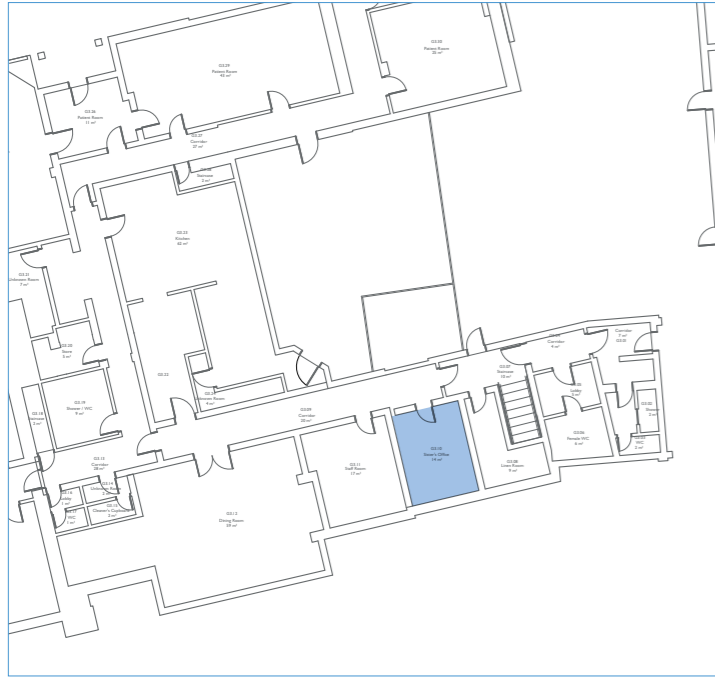
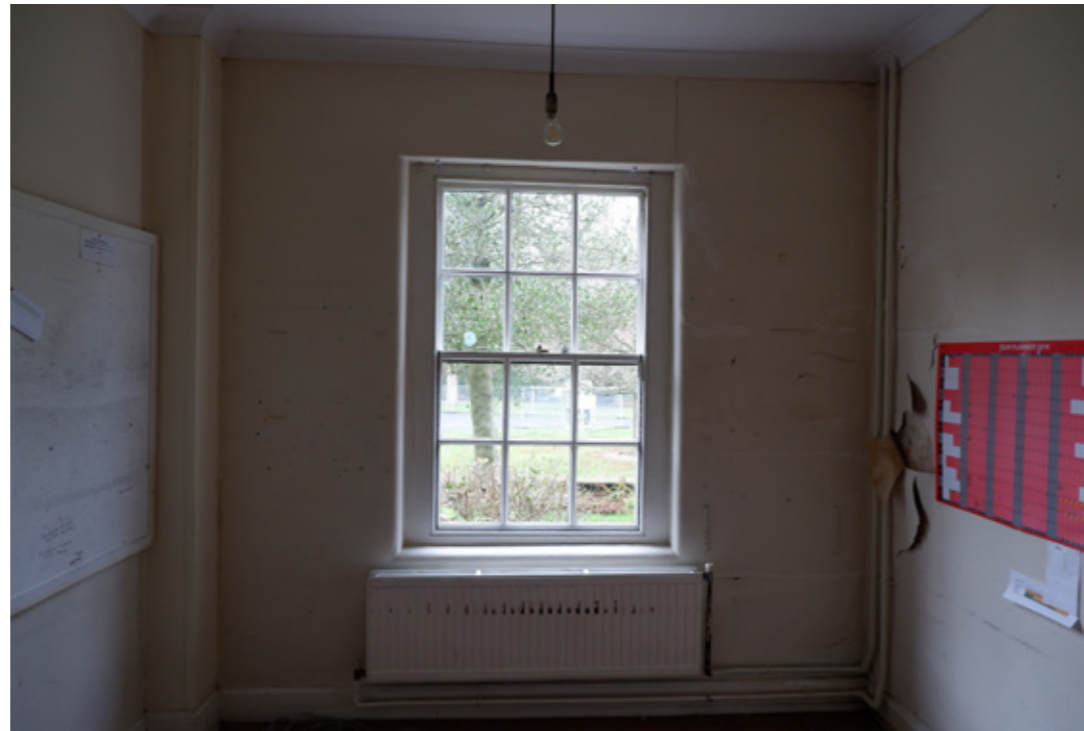
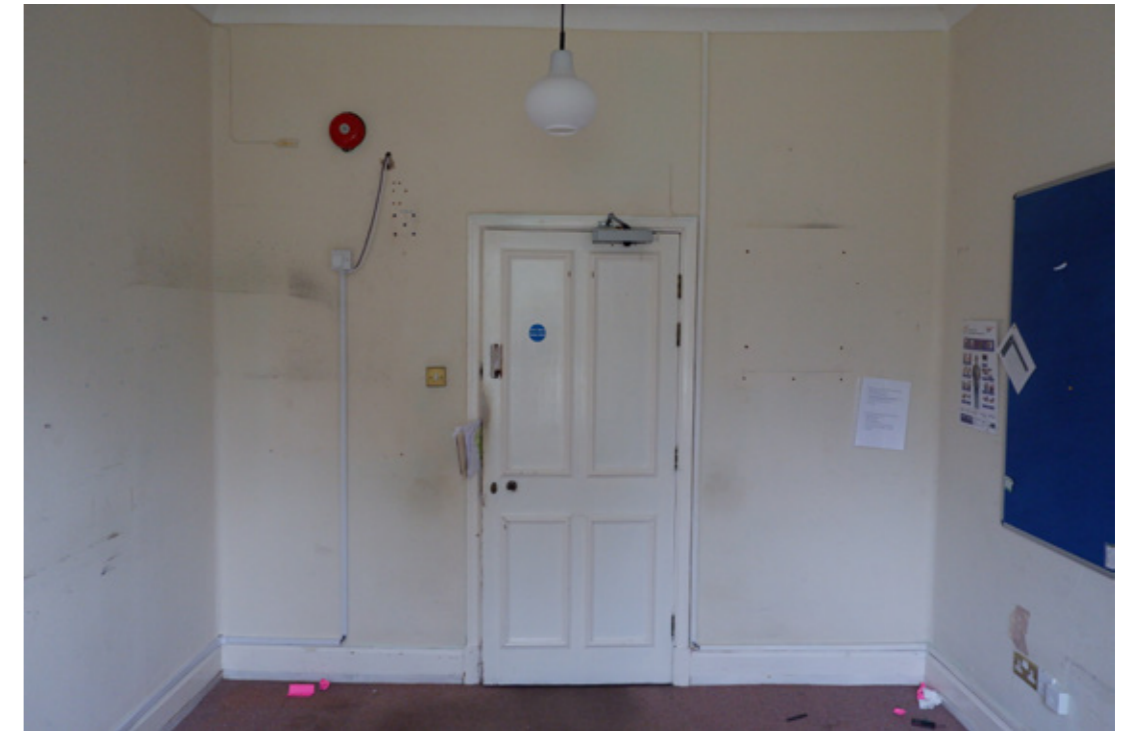
Room Number:	G3.10
Current Room Use:	Office
Historic Room Use:	Store (Wyatt plan)
Date of Structure:	1817
Date of Fixtures / Fittings:	
Date of Decoration:	Late 20th century
Major Alterations:

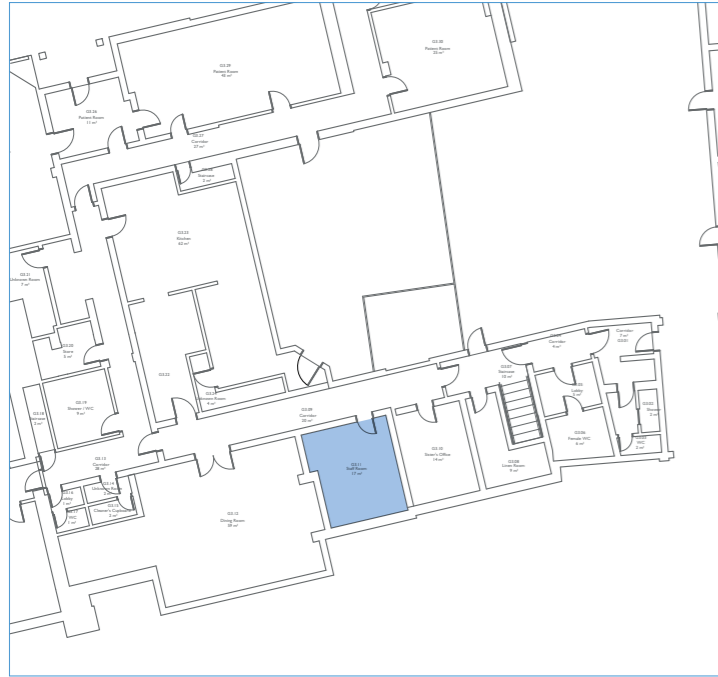
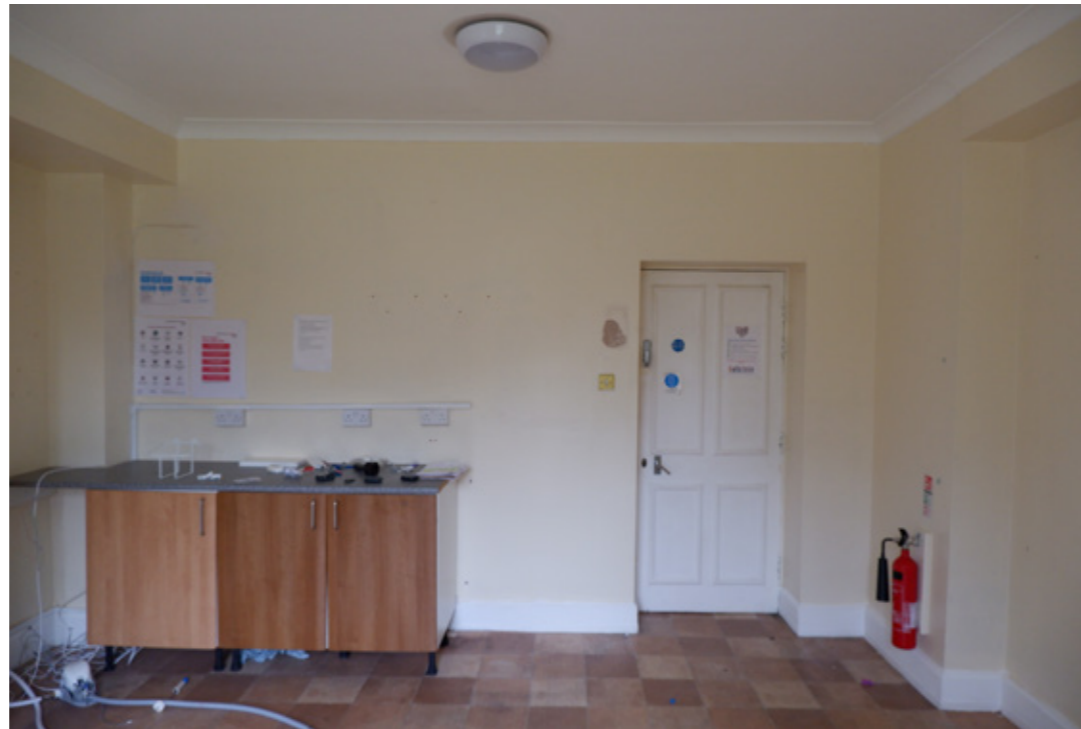
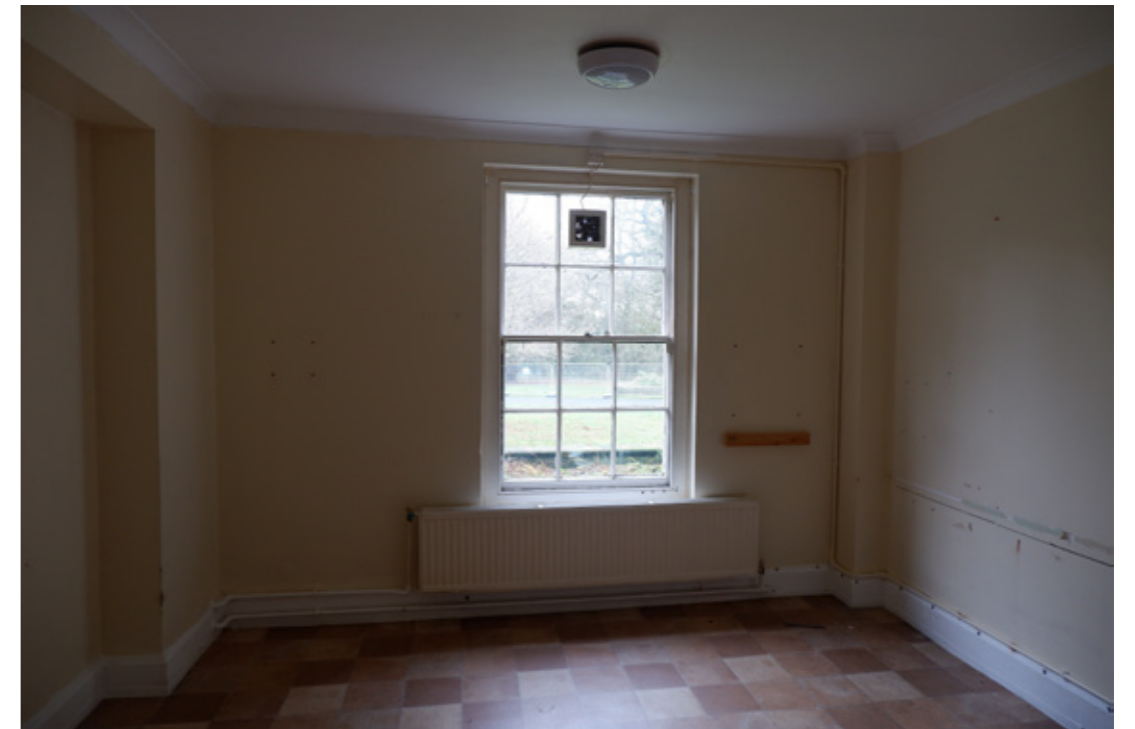
GROUND FLOOR: SERVICE WING – G3.II

Room Number:	G3.II
Current Room Use:	Welfare
Historic Room Use:	Scullery
Date of Structure:	1817
Date of Fixtures / Fittings:	
Date of Decoration:	Late 20th century
Major Alterations:

Overall Significance Level:	Medium
Key Historic Features:	Sash window, blocked up doorway
Detrimental Features:	Fitted units, M&E, Modern Fitout, Extractor fan on sash window
Condition Level:	
Condition Comments:	
Other Comments:

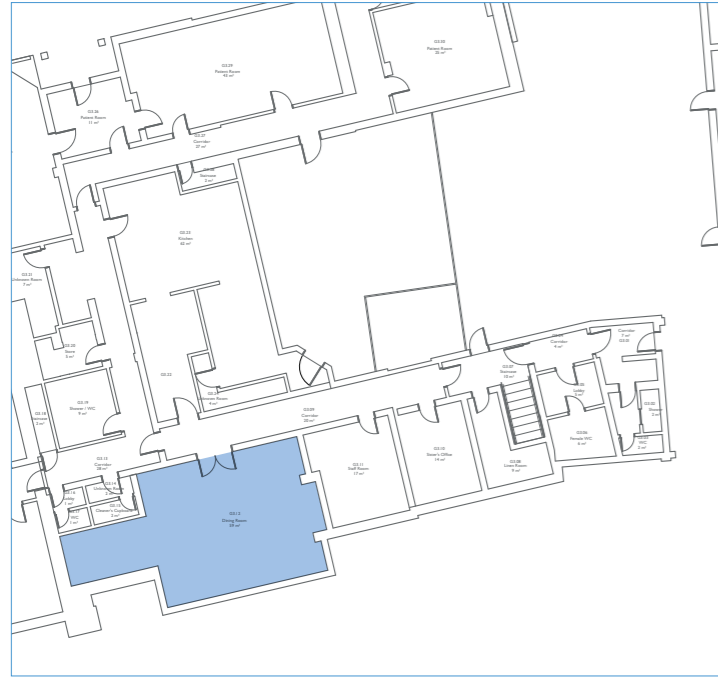
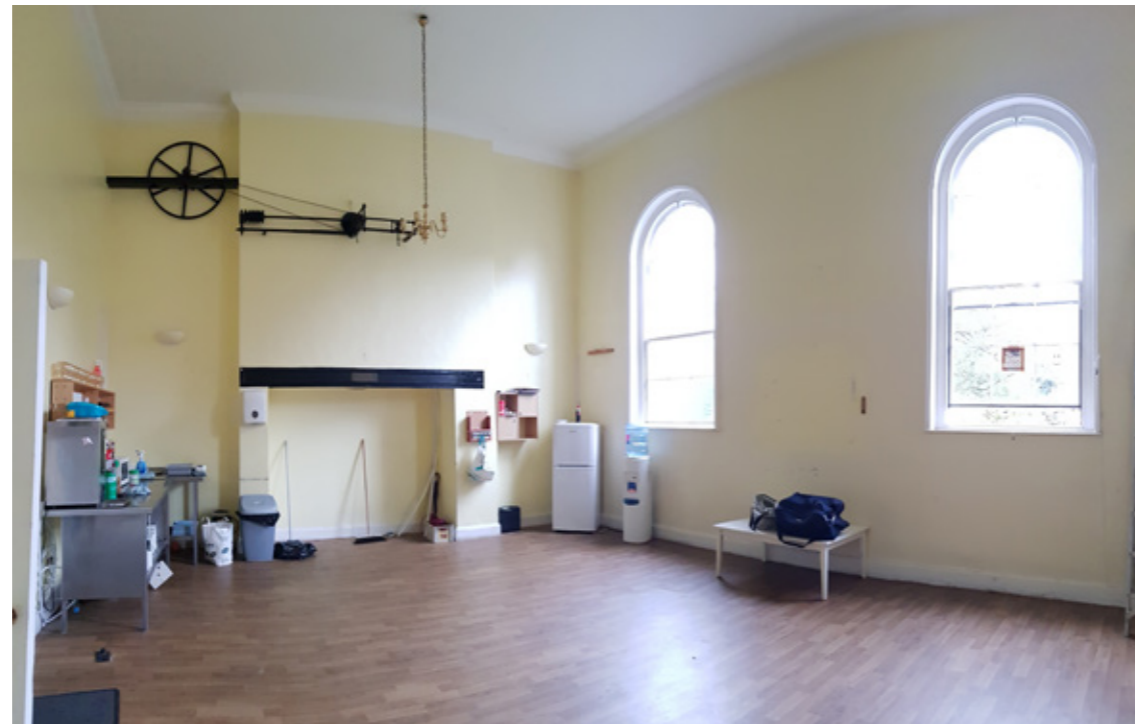
GROUND FLOOR: SERVICE WING – G3.12

Room Number:	G3.12
Current Room Use:	Welfare
Historic Room Use:	Kitchen/Pantry
Date of Structure:	1817
Date of Fixtures / Fittings:	
Date of Decoration:	Late 20th century
Major Alterations:

Overall Significance Level:	High
Key Historic Features:	Curved headed sash windows, fireplace with manufacturer's plaque, kitchen ironwork,
Detrimental Features:	M&E, Modern heaters, modern door in truncated opening, flooring
Condition Level:	
Condition Comments:	
Other Comments:

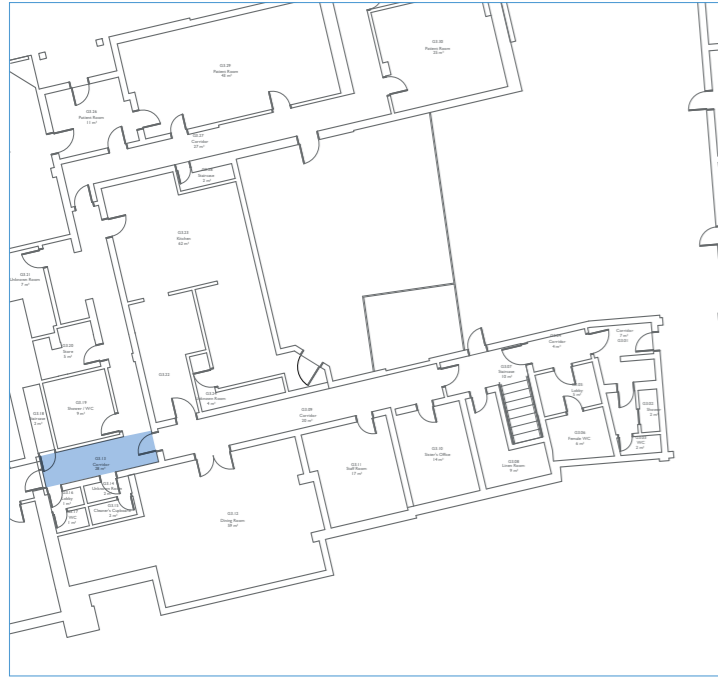
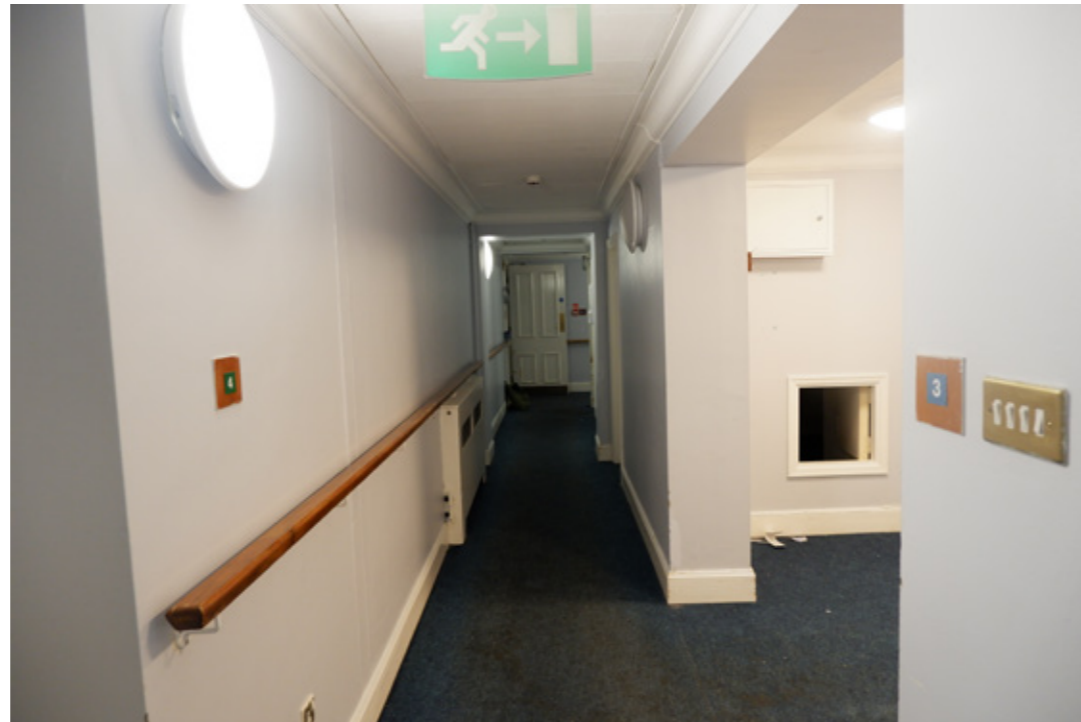
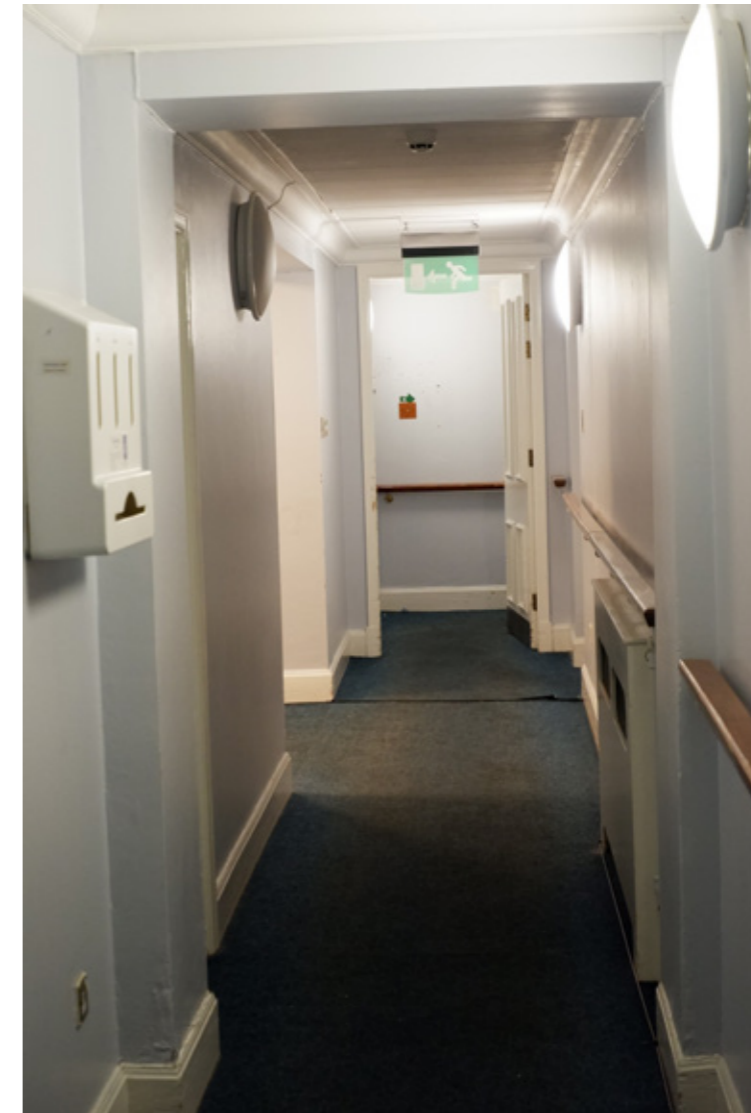
GROUND FLOOR: SERVICE WING – G3.13

Room Number:	G3.13
Current Room Use:	Corridor
Historic Room Use:	
Date of Structure:	1848-1893
Date of Fixtures / Fittings:	
Date of Decoration:	Late 20th century
Major Alterations:

Overall Significance Level:	Low
Key Historic Features:	None
Detrimental Features:	M&E, Modern Fitout, hatches for services, wall mounted hygiene dispensers
Condition Level:	
Condition Comments:	
Other Comments:

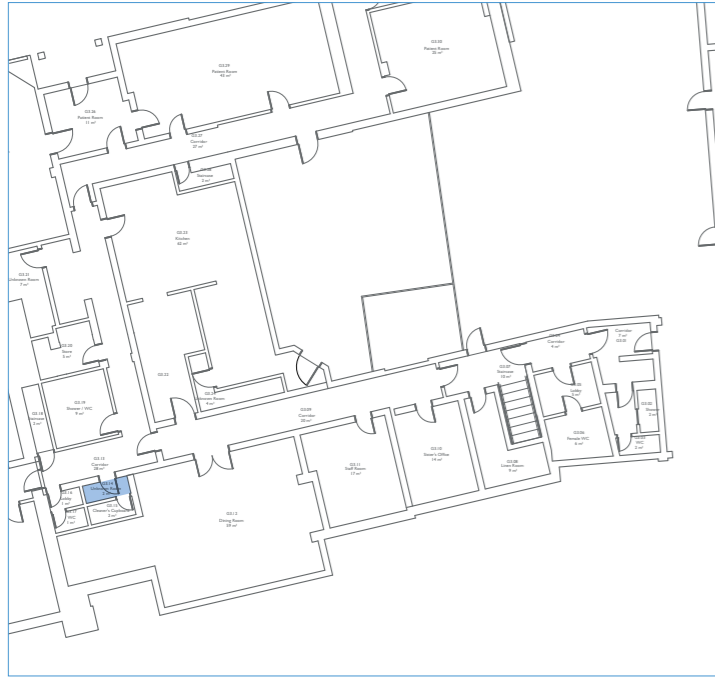
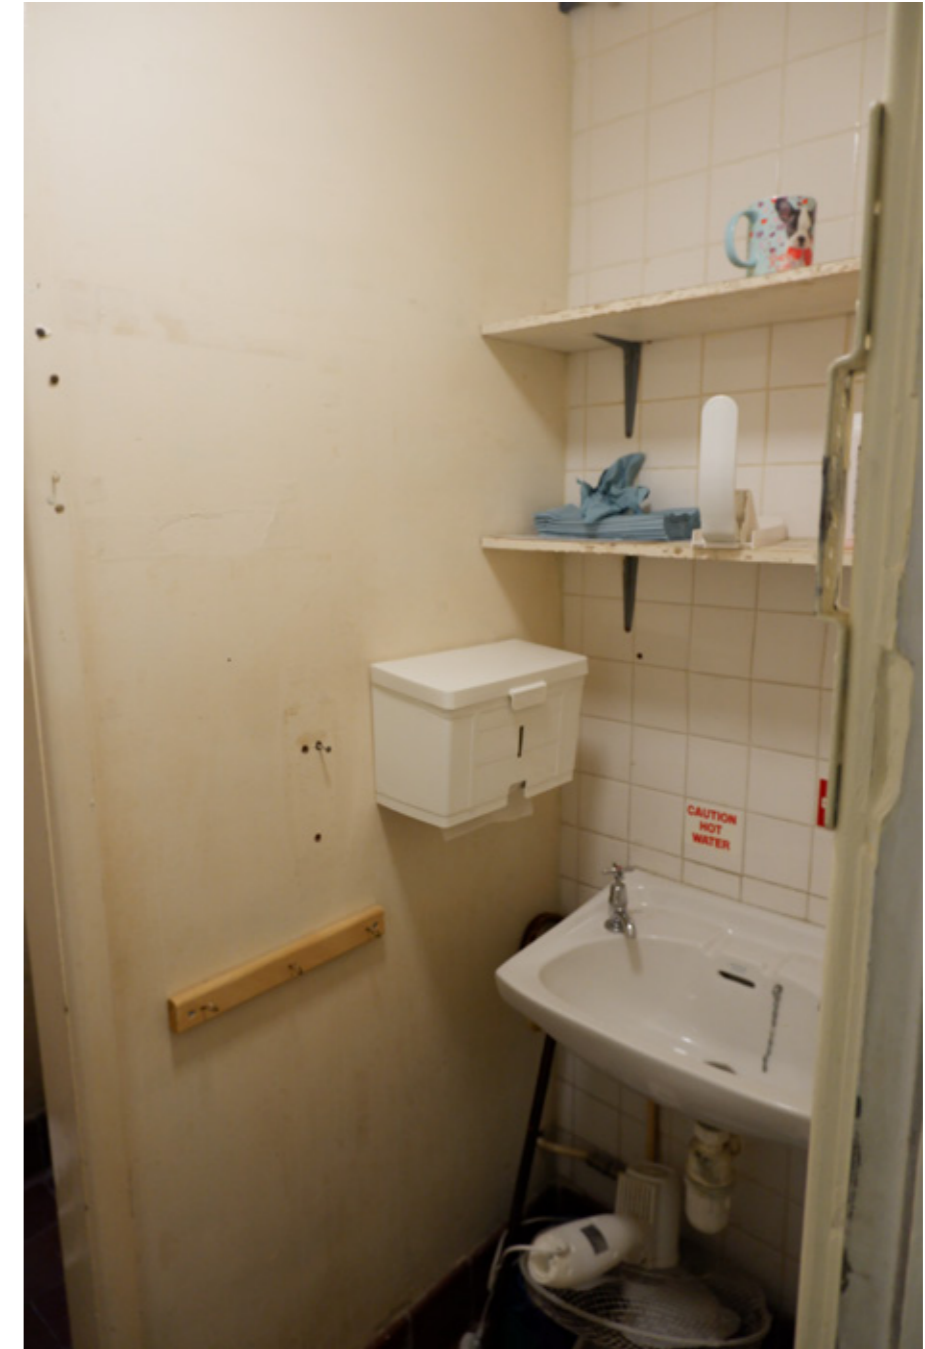
GROUND FLOOR: SERVICE WING – G3.14

Room Number:	G3.14
Current Room Use:	Storage/Plant
Historic Room Use:	Stair (Wyatt plan)
Date of Structure:	1817
Date of Fixtures / Fittings:	
Date of Decoration:	Late 20th century
Major Alterations:	Removal of stair, modern subdivision
Overall Significance Level:	Neutral
Key Historic Features:	None
Detrimental Features:	Modern sanitary ware
Condition Level:	
Condition Comments:	
Other Comments:

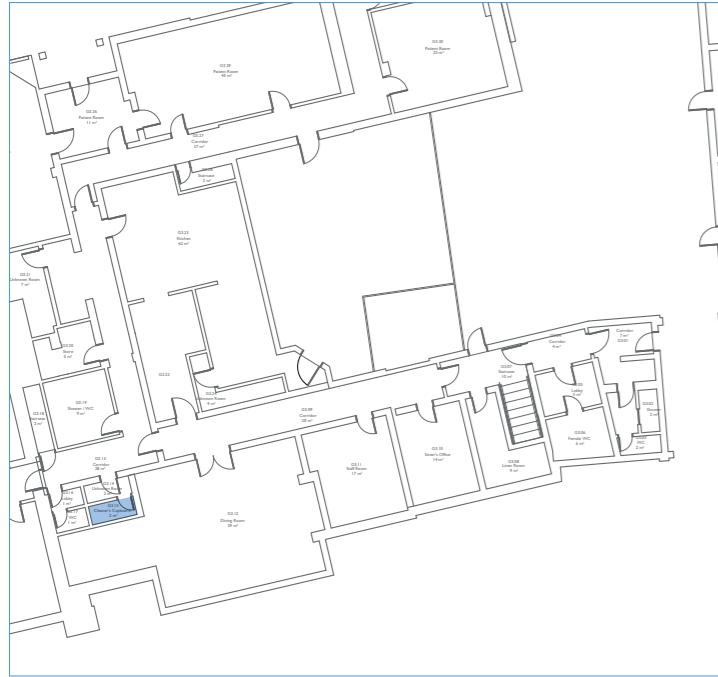
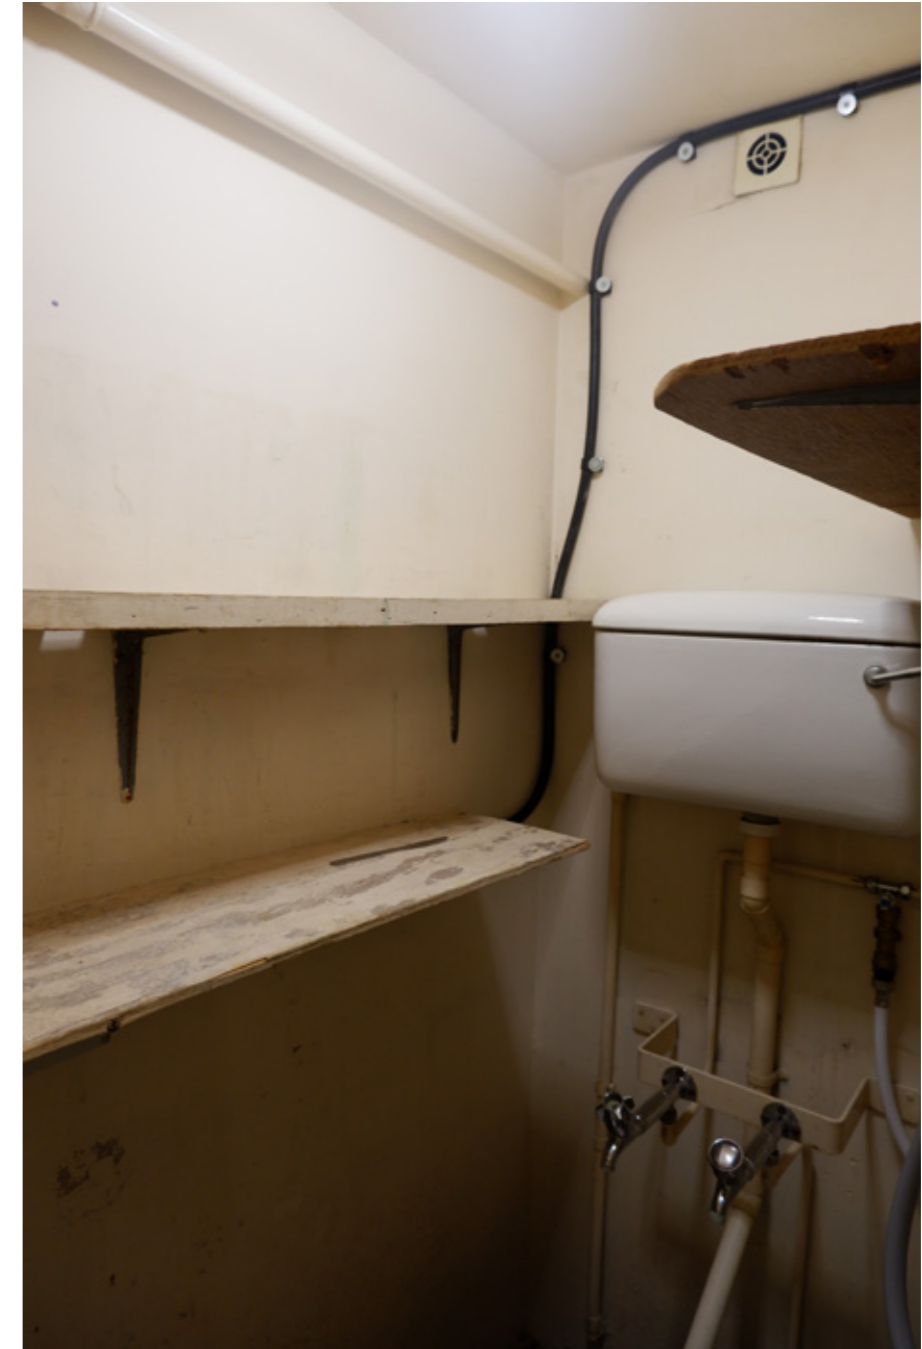
GROUND FLOOR: SERVICE WING – G3.15

Room Number:	G3.15
Current Room Use:	Storage/Plant
Historic Room Use:	Stair (Wyatt plan)
Date of Structure:	1817
Date of Fixtures / Fittings:	
Date of Decoration:	Late 20th century
Major Alterations:	Removal of stair, modern subdivision
Overall Significance Level:	Neutral
Key Historic Features:	None
Detrimental Features:	Modern sanitary ware
Condition Level:	
Condition Comments:	
Other Comments:

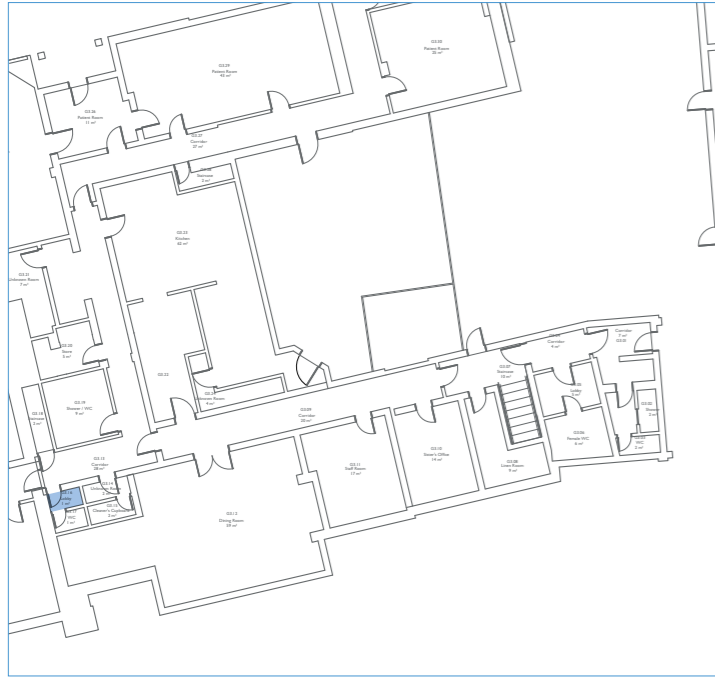
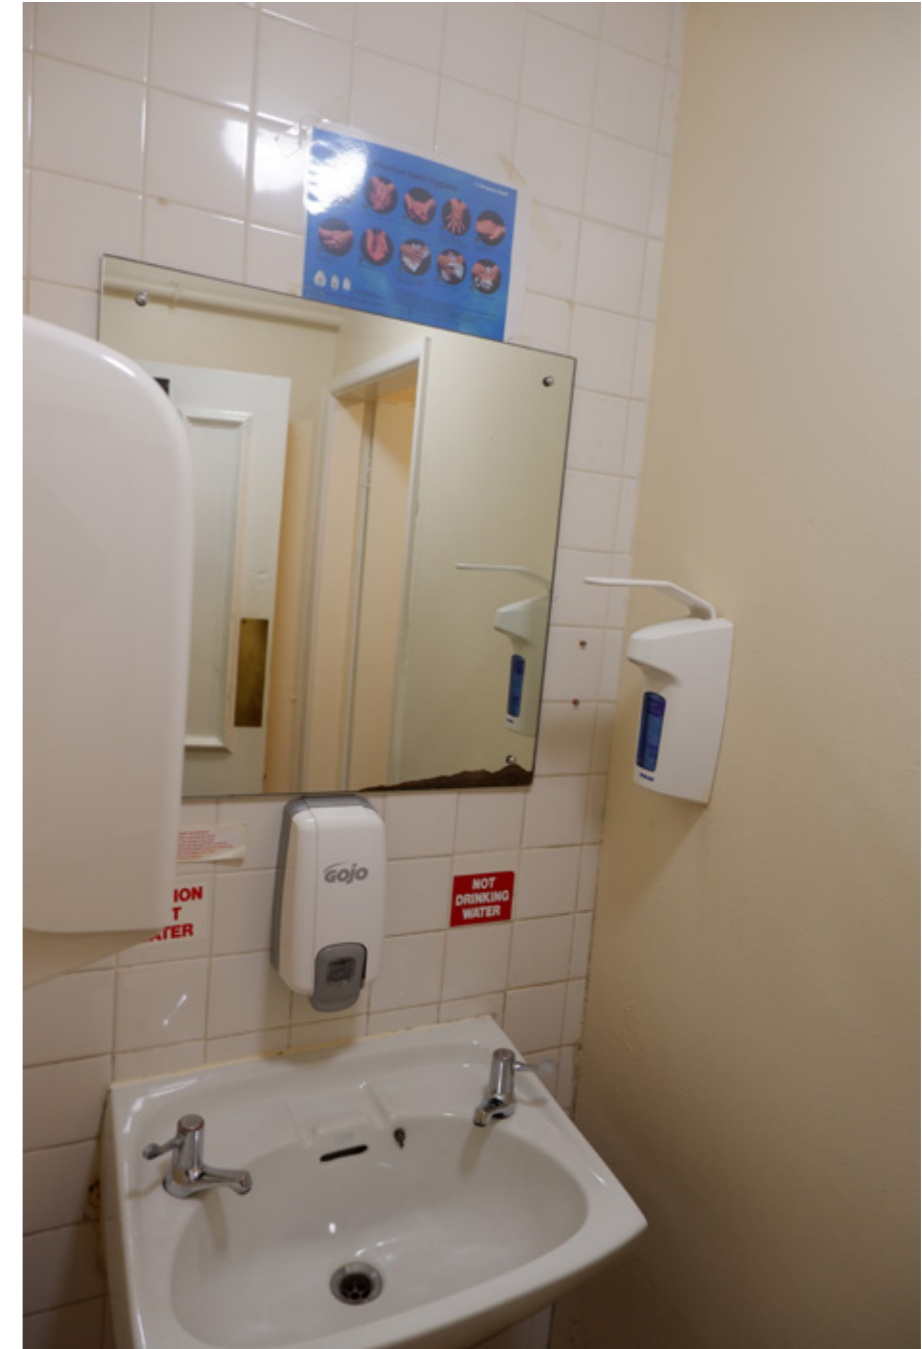
GROUND FLOOR: SERVICE WING – G3.16

Room Number:	G3.16
Current Room Use:	Circulation
Historic Room Use:	Stair (Wyatt plan)
Date of Structure:	1817
Date of Fixtures / Fittings:	
Date of Decoration:	Late 20th century
Major Alterations:	Removal of stair, modern subdivision
Overall Significance Level:	Neutral
Key Historic Features:	None
Detrimental Features:	Modern sanitary ware
Condition Level:	
Condition Comments:	
Other Comments:

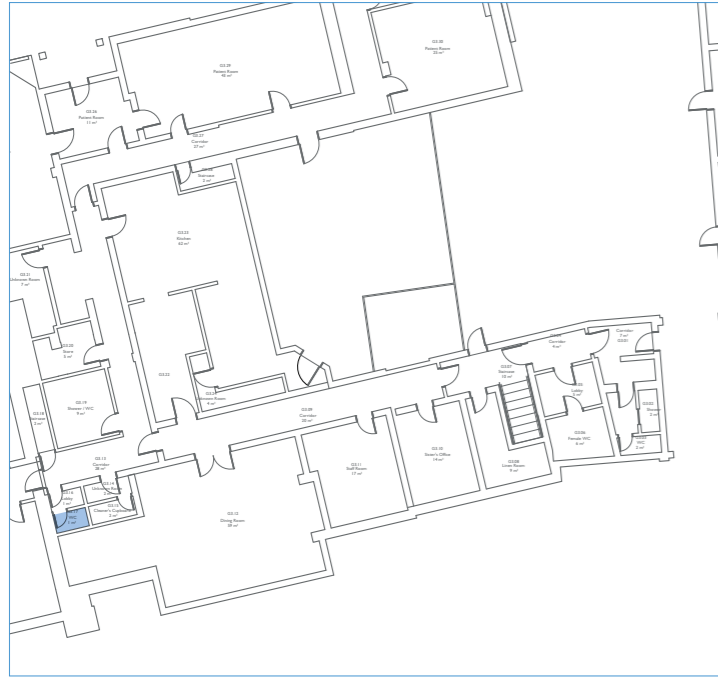
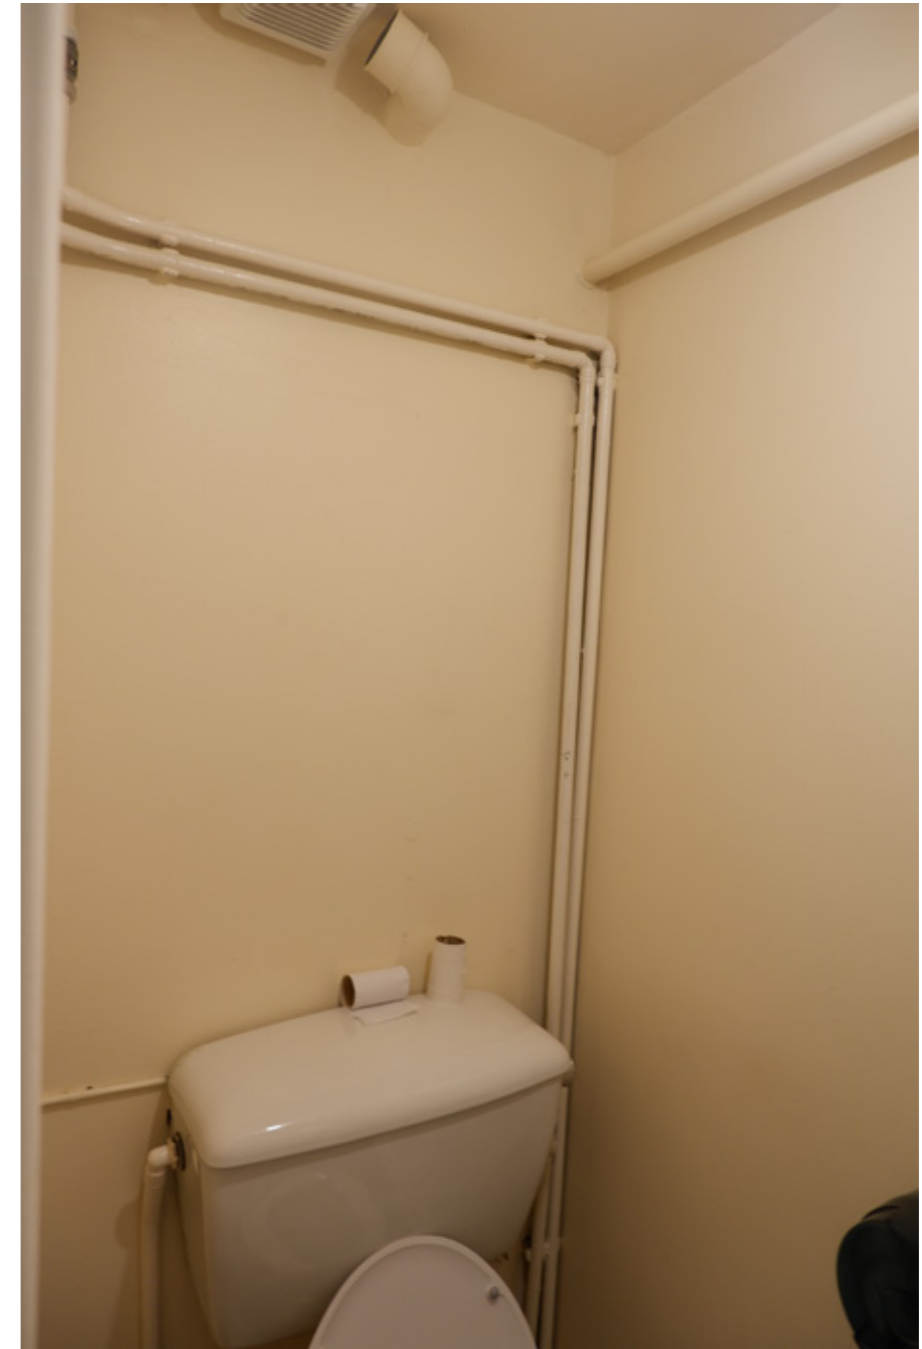
GROUND FLOOR: SERVICE WING – G3.17

Room Number:	G3.17
Current Room Use:	WC
Historic Room Use:	Stair (Wyatt plan)
Date of Structure:	1817
Date of Fixtures / Fittings:	
Date of Decoration:	Late 20th century
Major Alterations:	Removal of stair, modern subdivision
Overall Significance Level:	Neutral
Key Historic Features:	None
Detrimental Features:	Modern sanitary ware
Condition Level:	
Condition Comments:	
Other Comments:

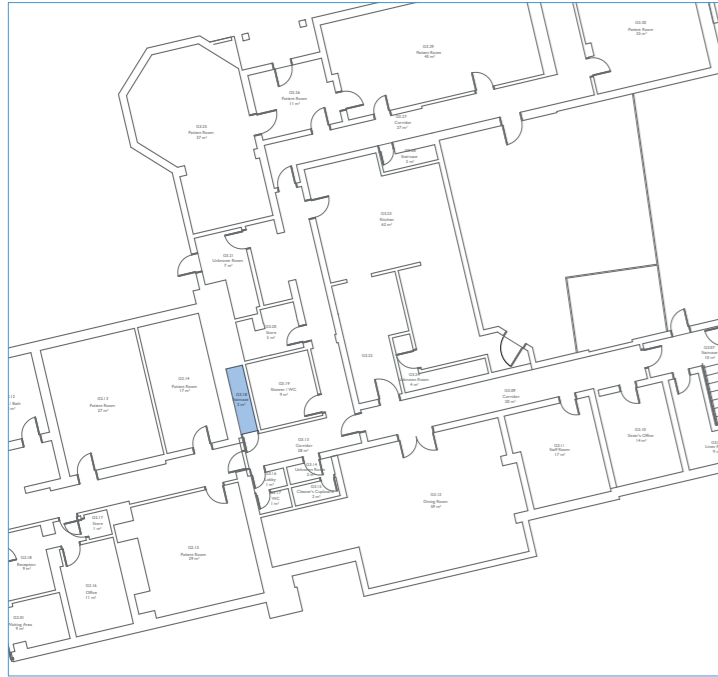
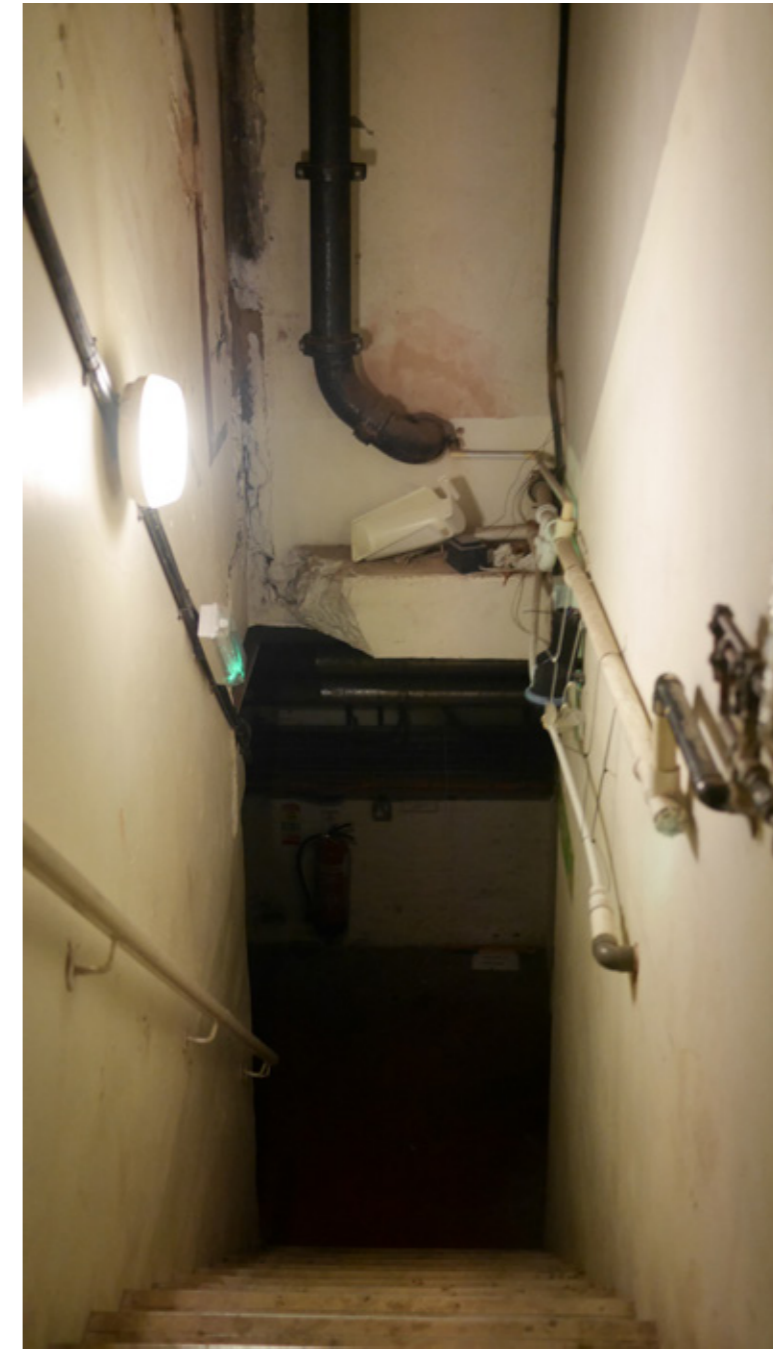
GROUND FLOOR: SERVICE WING – G3.18

Room Number:	G3.18
Current Room Use:	Basement Stair
Historic Room Use:	Circulation (Wyatt plan)
Date of Structure:	1817
Date of Fixtures / Fittings:	
Date of Decoration:	Late 20th century
Major Alterations:	Insertation of basement stair
Overall Significance Level:	Neutral
Key Historic Features:	None
Detrimental Features:	M&E
Condition Level:	
Condition Comments:	
Other Comments:

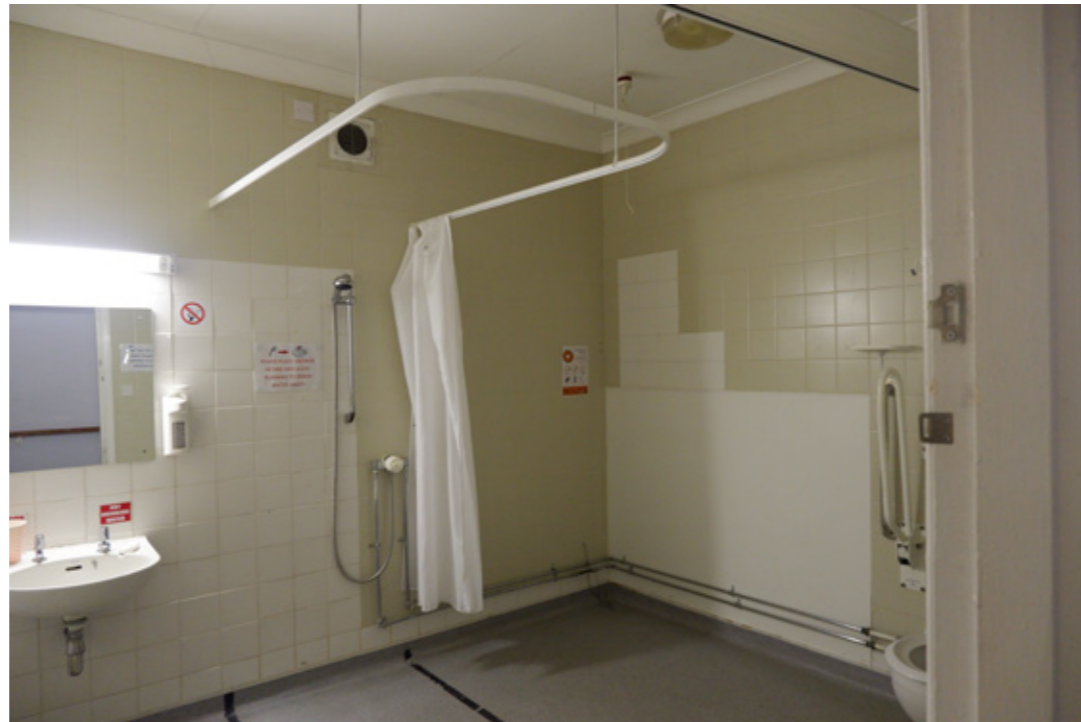
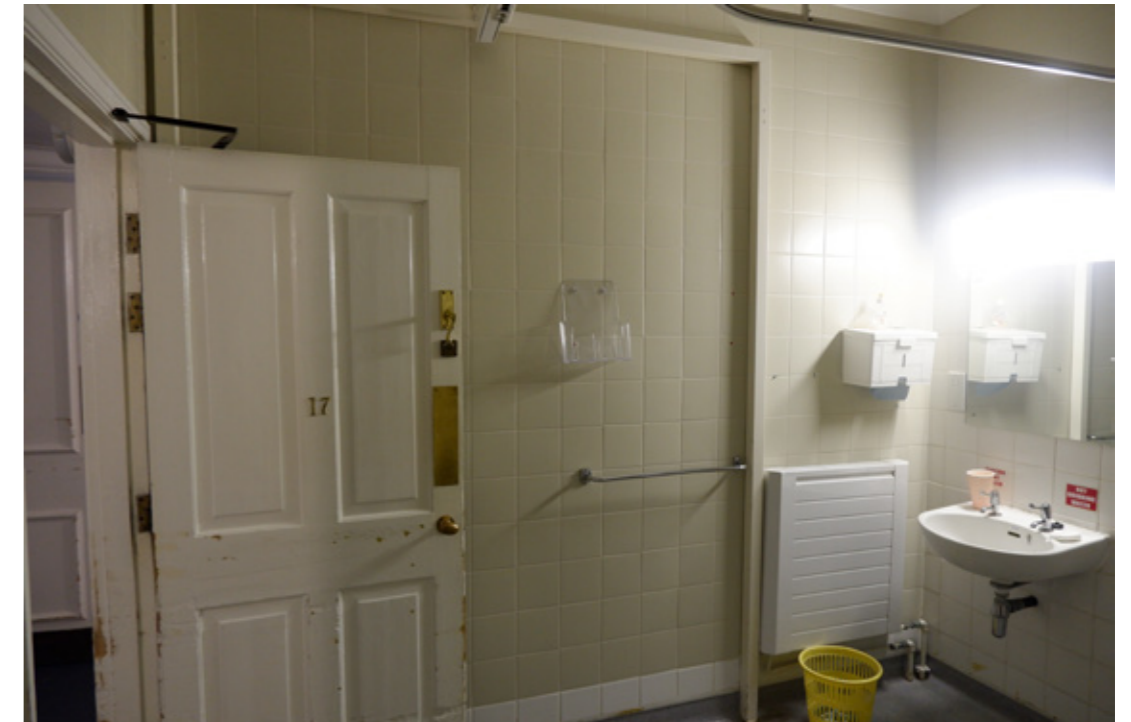
GROUND FLOOR: SERVICE WING – G3.19

Room Number:	G3.19
Current Room Use:	Bathroom
Historic Room Use:	on Wyatt plan
Date of Structure:	1817
Date of Fixtures / Fittings:	
Date of Decoration:	Late 20th century
Major Alterations:

Overall Significance Level:	tbc
Key Historic Features:	None
Detrimental Features:	M&E, Modern sanitary ware, wall and floor finishes
Condition Level:	
Condition Comments:	
Other Comments:

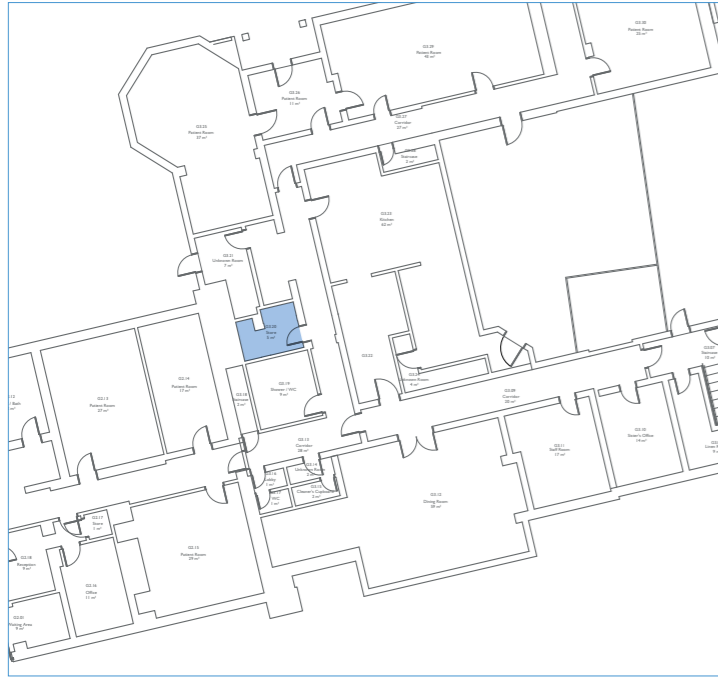
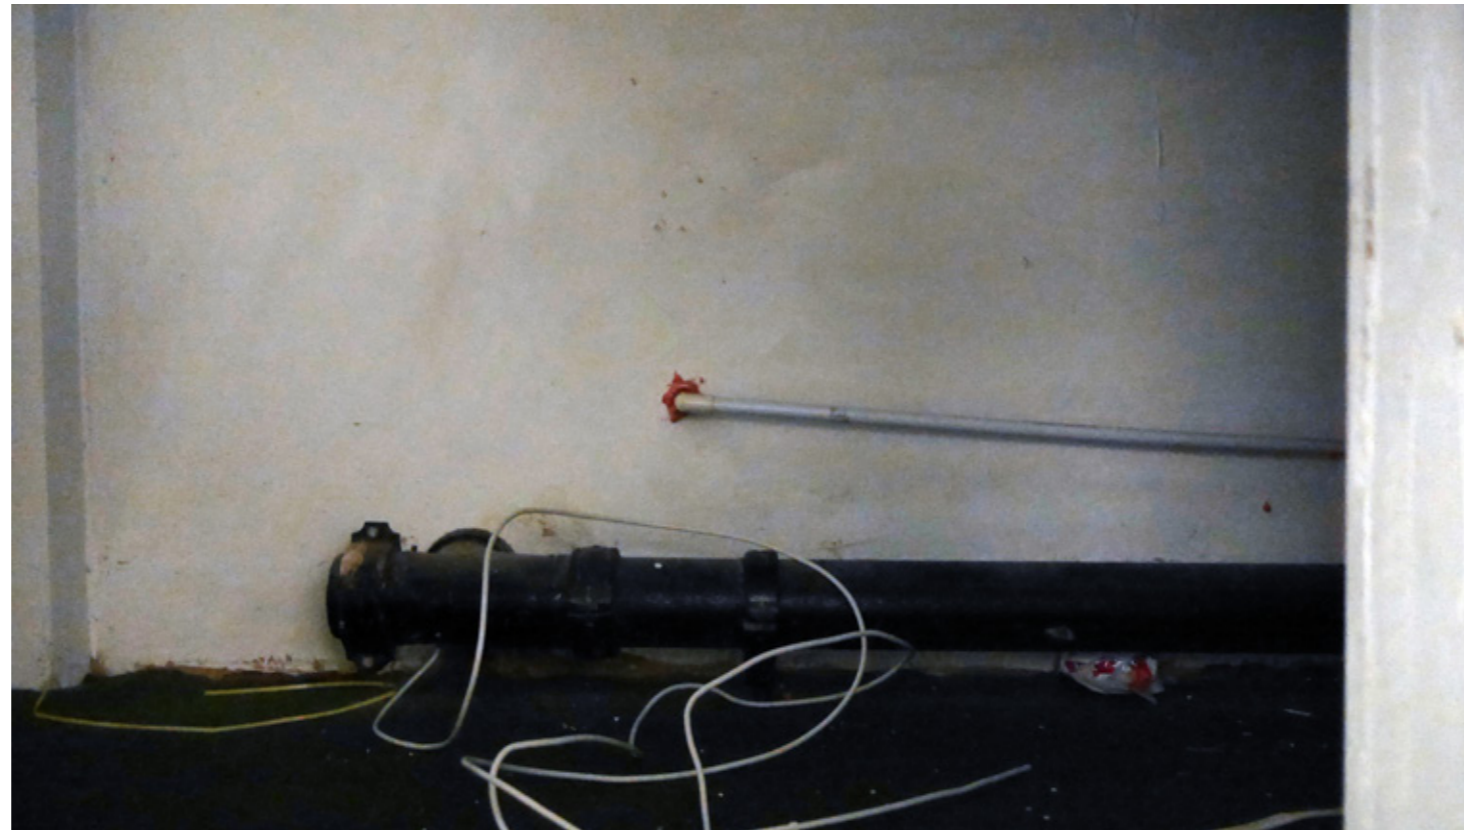
GROUND FLOOR: SERVICE WING – G3.20

Room Number:	G3.20
Current Room Use:	Storage/Plant
Historic Room Use:	Knife room?
Date of Structure:	1817
Date of Fixtures / Fittings:	
Date of Decoration:	Late 20th century
Major Alterations:	Removal of internal walls

Overall Significance Level:	tbc
Key Historic Features:	None
Detrimental Features:	M&E
Condition Level:	
Condition Comments:	
Other Comments:
