VOLUME TWO

GAZETTEER

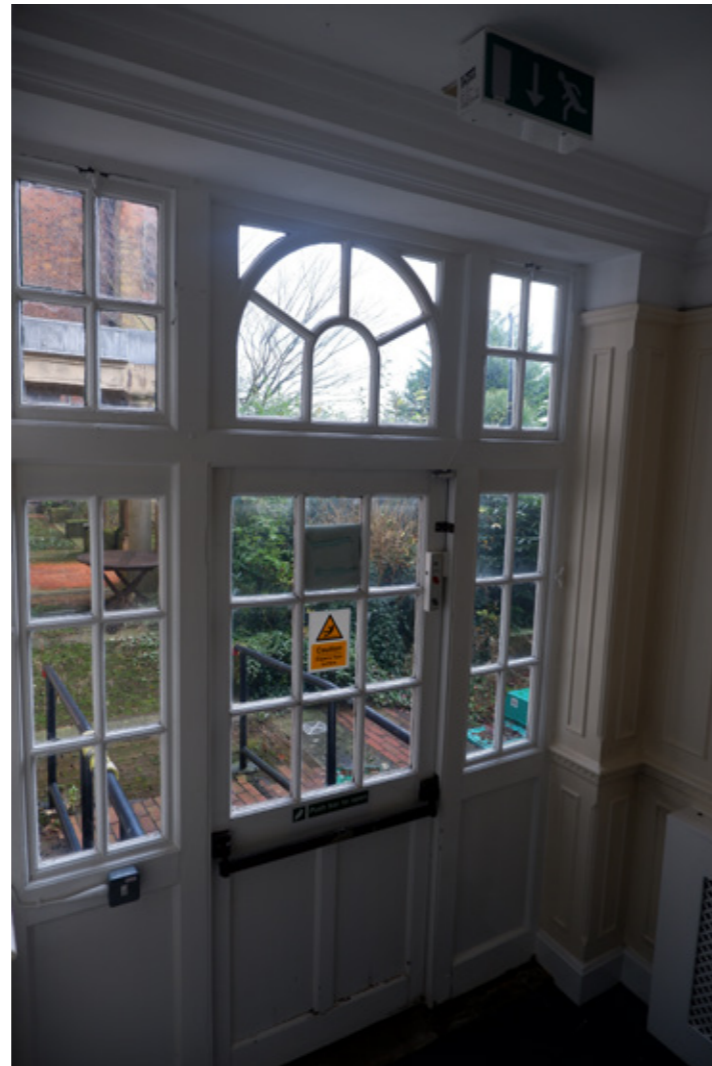
GROUND FLOOR: SERVICE WING – G3.21

Room Number:	G3.21
Current Room Use:	Stair/Side Entrance
Historic Room Use:	Wet Larder
Date of Structure:	1817
Date of Fixtures / Fittings:	
Date of Decoration:	Late 20th century
Major Alterations:	Modern subdivision and insertation of stair, insertation of external doorway and glazing

Overall Significance Level:	tbc
Key Historic Features:	Panelling, Cornice, part glazed door and surround
Detrimental Features:	M&E, radiator, stair
Condition Level:	
Condition Comments:	
Other Comments:

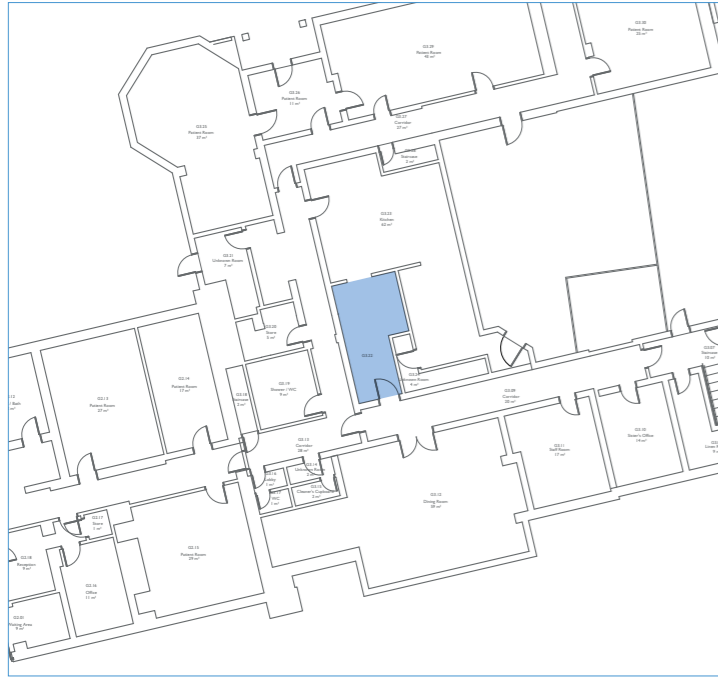
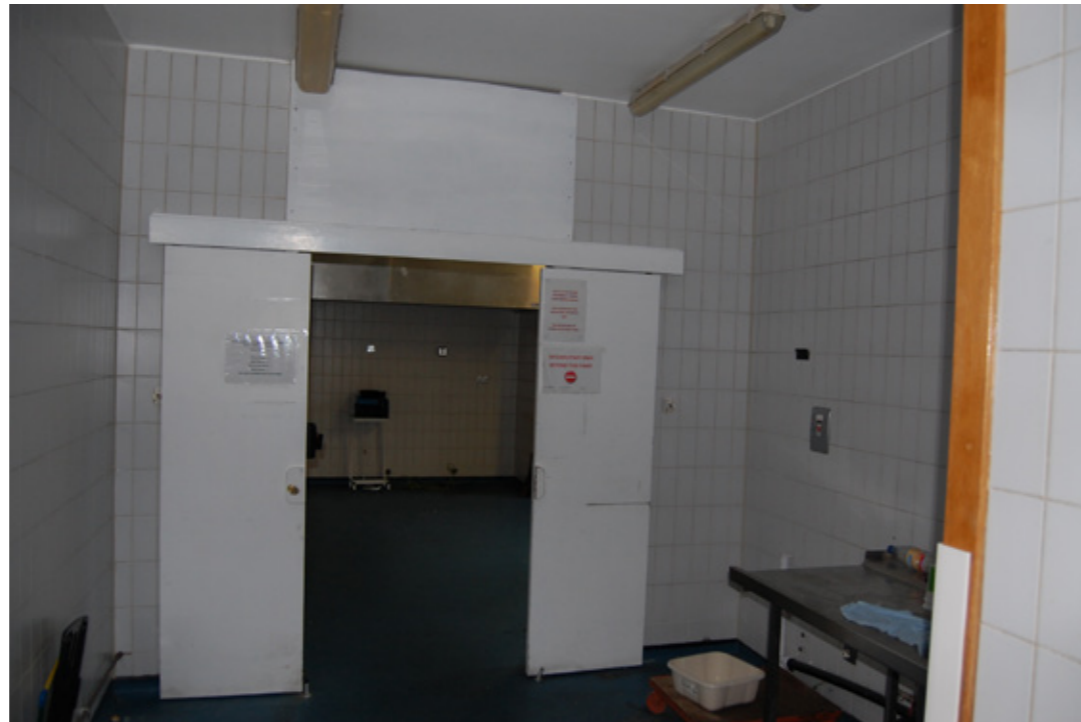
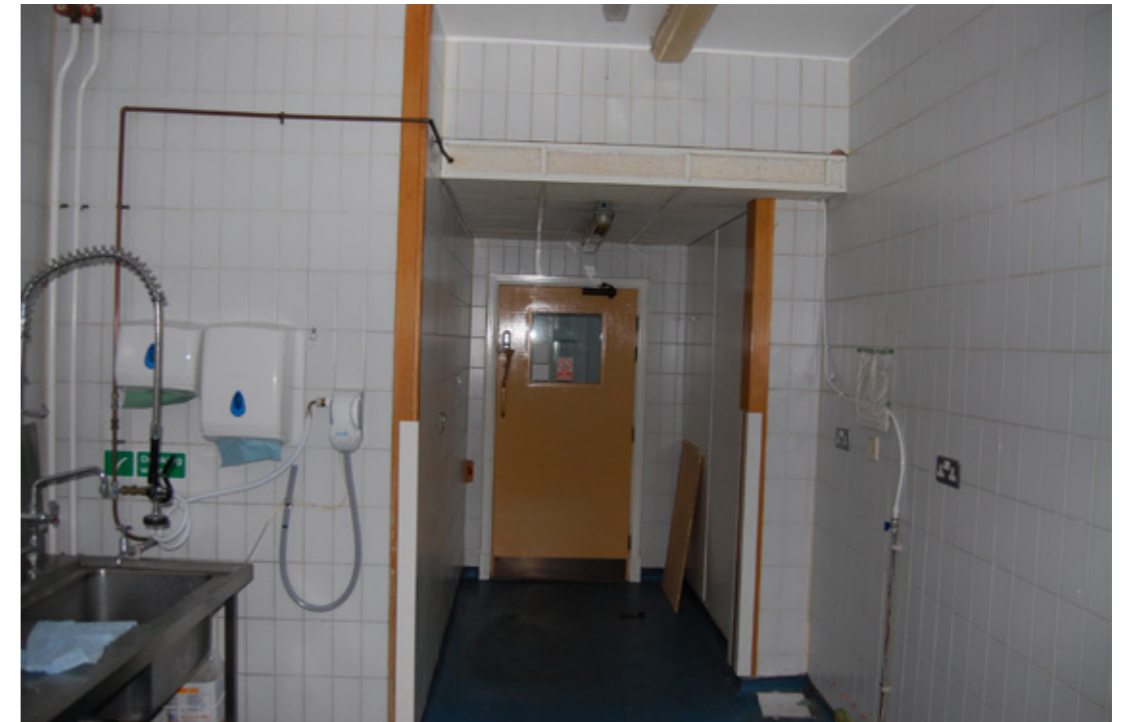
GROUND FLOOR: SERVICE WING – G3.22

Room Number:	G3.22
Current Room Use:	Circulation
Historic Room Use:	
Date of Structure:	1893-1911
Date of Fixtures / Fittings:	
Date of Decoration:	Late 20th century
Major Alterations:

Overall Significance Level:	Detrimental
Key Historic Features:	None
Detrimental Features:	M&E, modern kitchen fitout wall and floor coverings
Condition Level:	
Condition Comments:	
Other Comments:

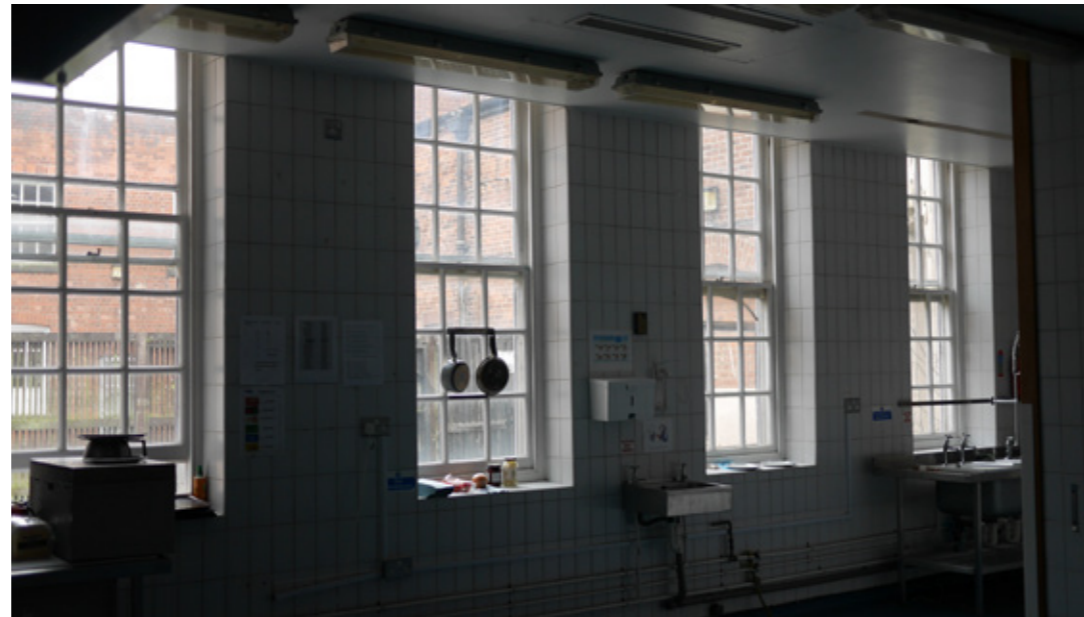
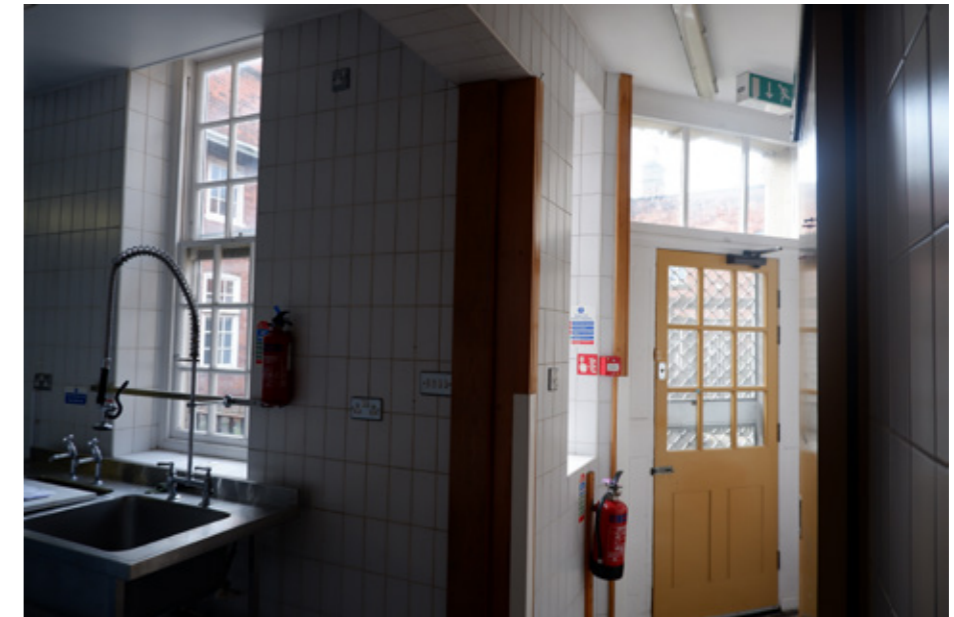
GROUND FLOOR: SERVICE WING – G3.23

Room Number:	G3.23
Current Room Use:	Kitchen
Historic Room Use:	
Date of Structure:	1893-1911
Date of Fixtures / Fittings:	
Date of Decoration:	Late 20th century
Major Alterations:

Overall Significance Level:	Detrimental
Key Historic Features:	Sash windows
Detrimental Features:	M&E, lowered ceiling, modern kitchen fitout, modern doors and glazing, wall and floor coverings
Condition Level:	
Condition Comments:	
Other Comments:

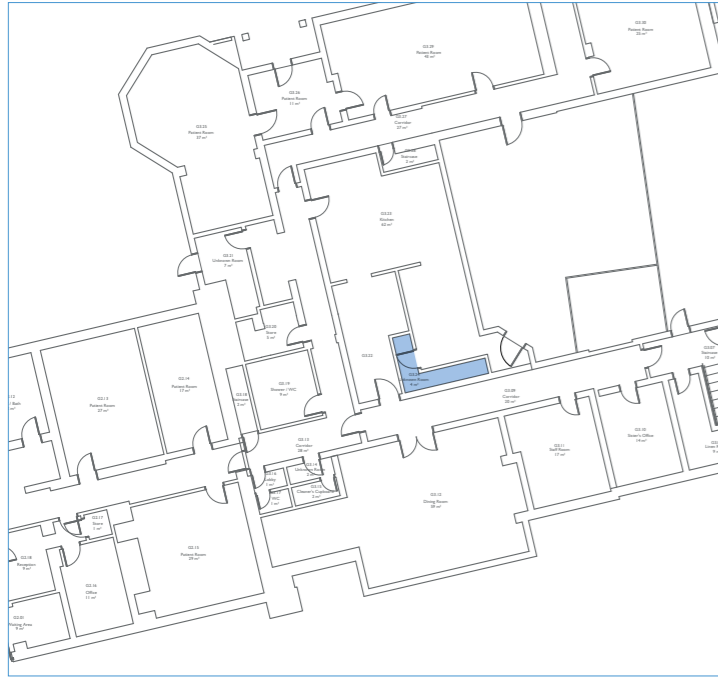
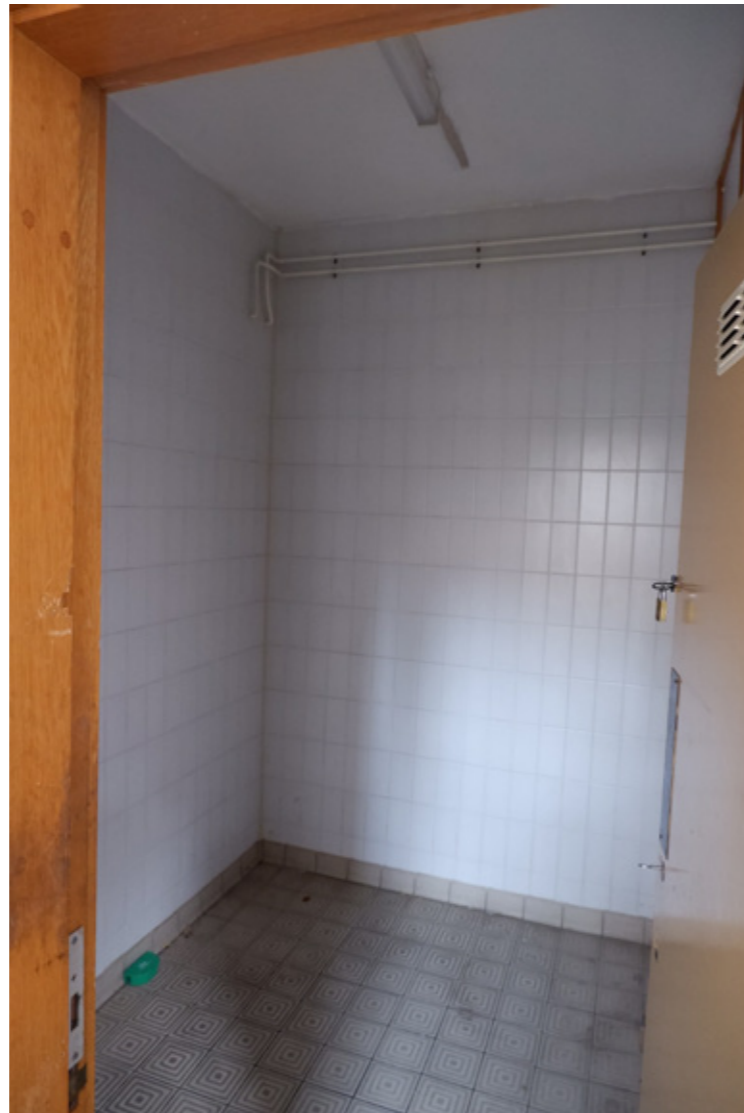
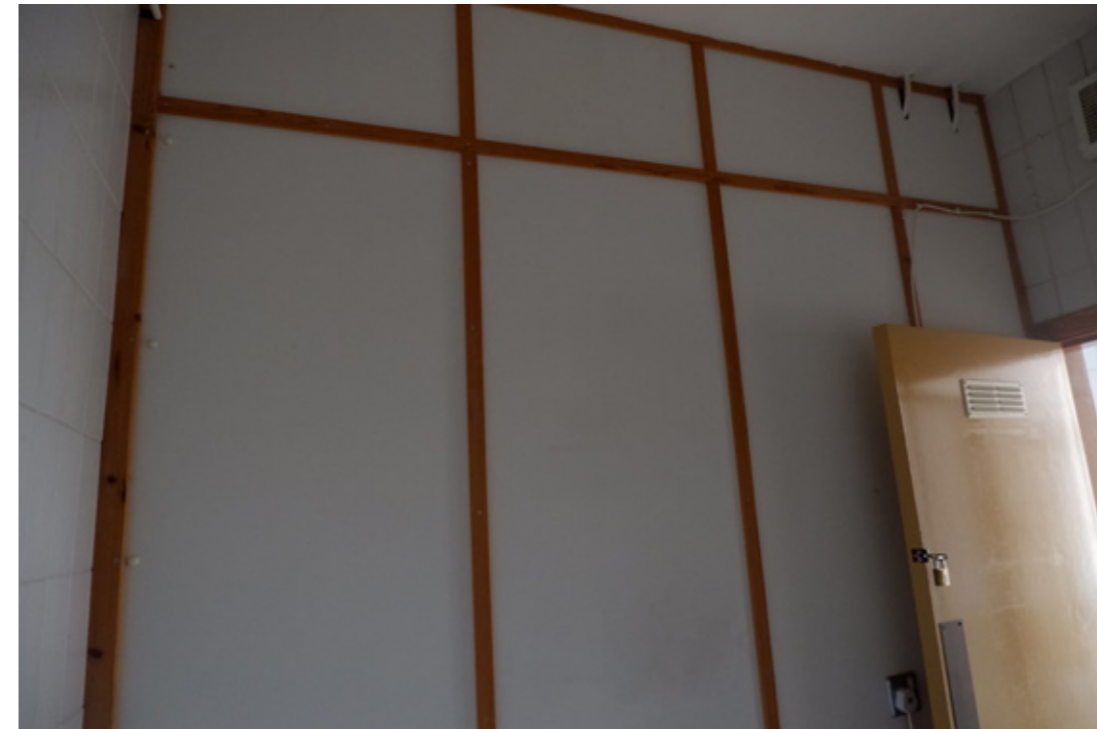
GROUND FLOOR: SERVICE WING – G3.24

Room Number:	G3.24
Current Room Use:	Storage/Plant
Historic Room Use:	
Date of Structure:	1893-1911
Date of Fixtures / Fittings:	
Date of Decoration:	Late 20th century
Major Alterations:

Overall Significance Level:	Detrimental
Key Historic Features:	None
Detrimental Features:	Wall and floor coverings, partition wall
Condition Level:	
Condition Comments:	
Other Comments:

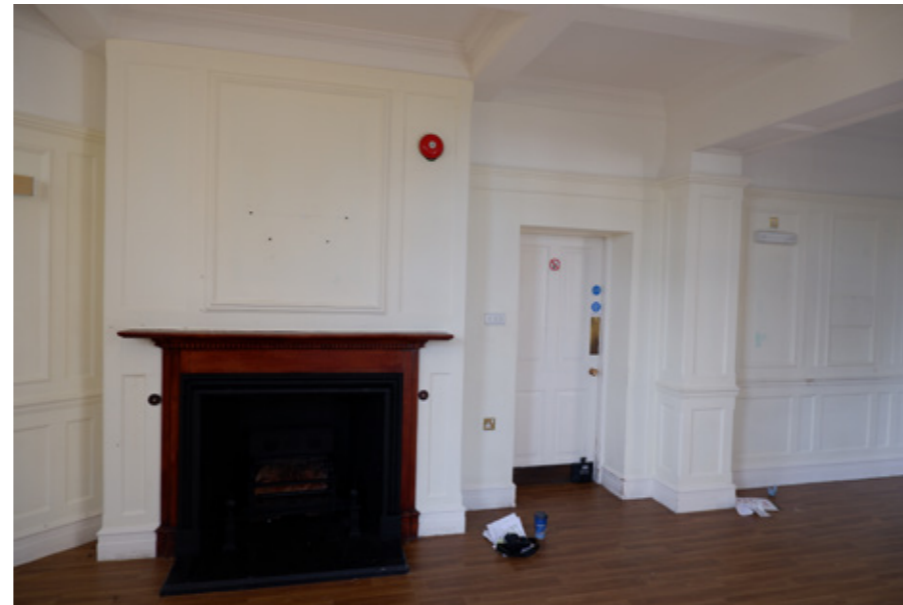
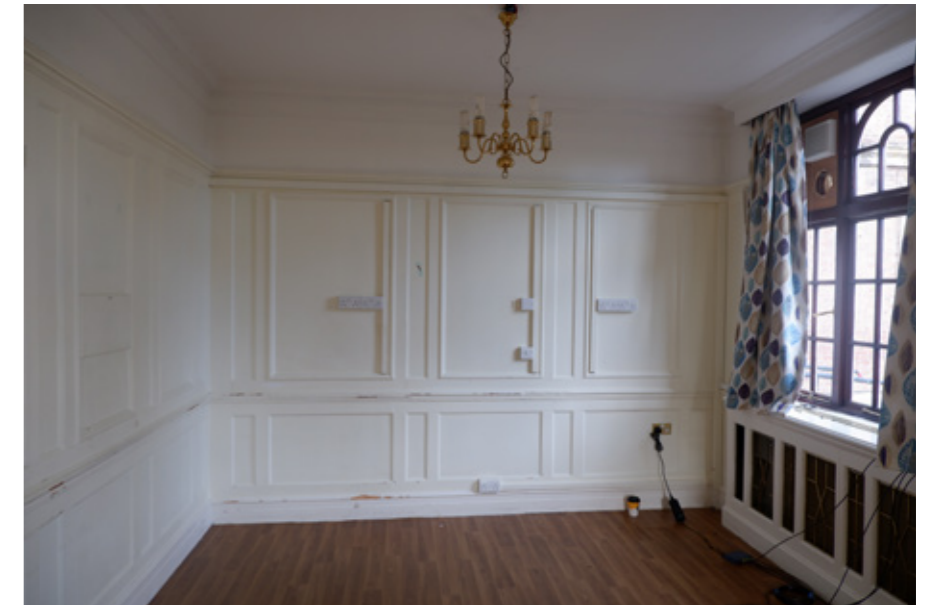
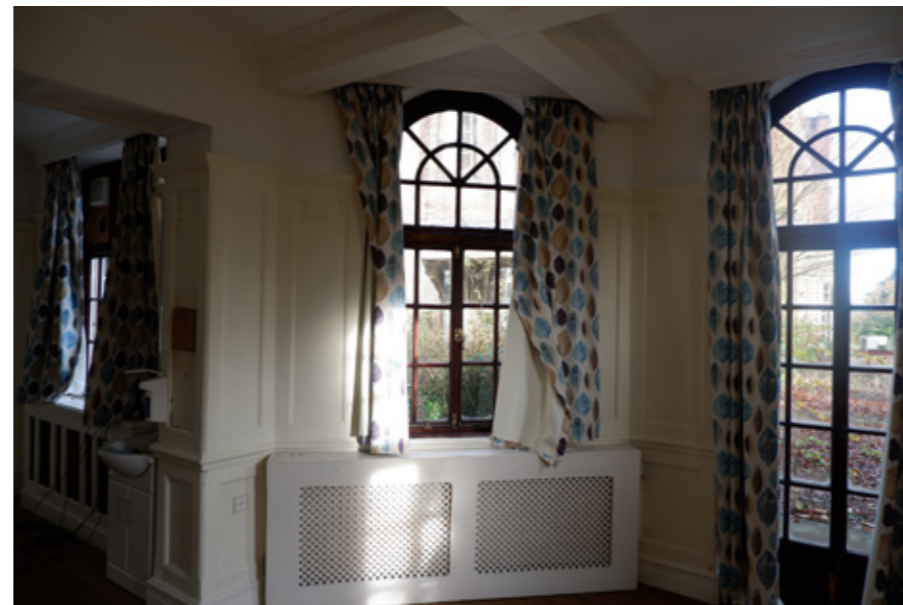
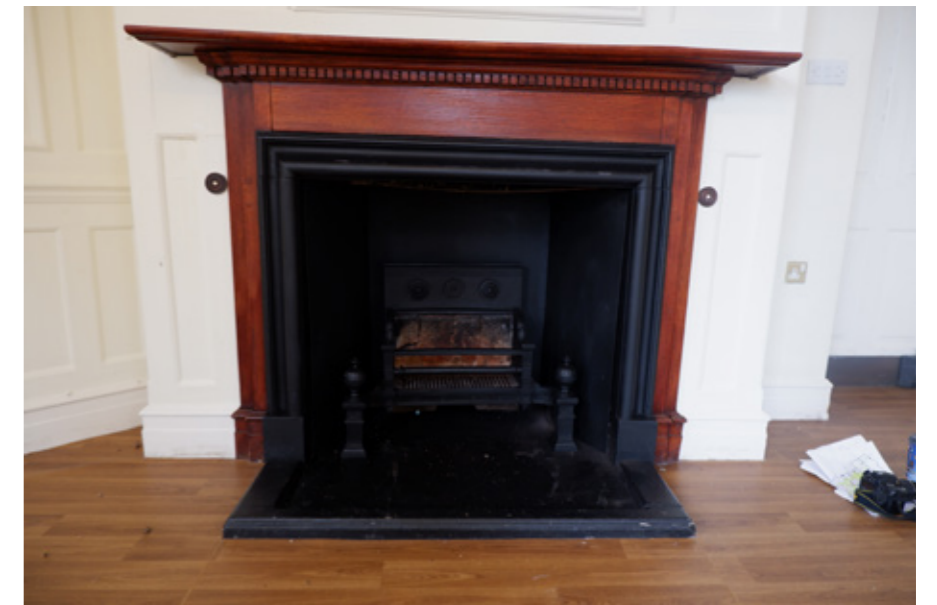
GROUND FLOOR: SERVICE WING – G3.25

Room Number:	G3.25
Current Room Use:	Bedroom
Historic Room Use:	Dairy/Steward's Room
Date of Structure:	1817
Date of Fixtures / Fittings:	
Date of Decoration:	Late 20th century
Major Alterations:	Removal of internal wall with Wyatt Larder
Overall Significance Level:	High
Key Historic Features:	Fireplace, mantelpiece and hearth, panelling, round headed timber casement windows/external doors
Detrimental Features:	M&E, Extractor fan through window, sanitaryware, modern flooring, paint finish to panelling, modern internal door
Condition Level:	
Condition Comments:	
Other Comments:

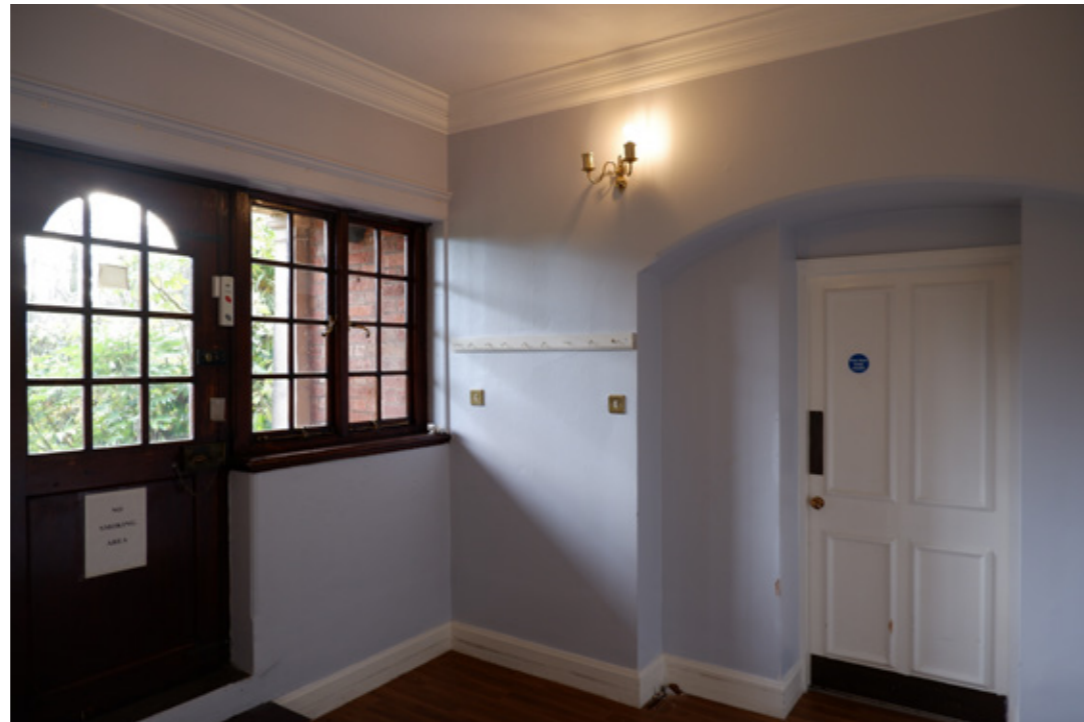
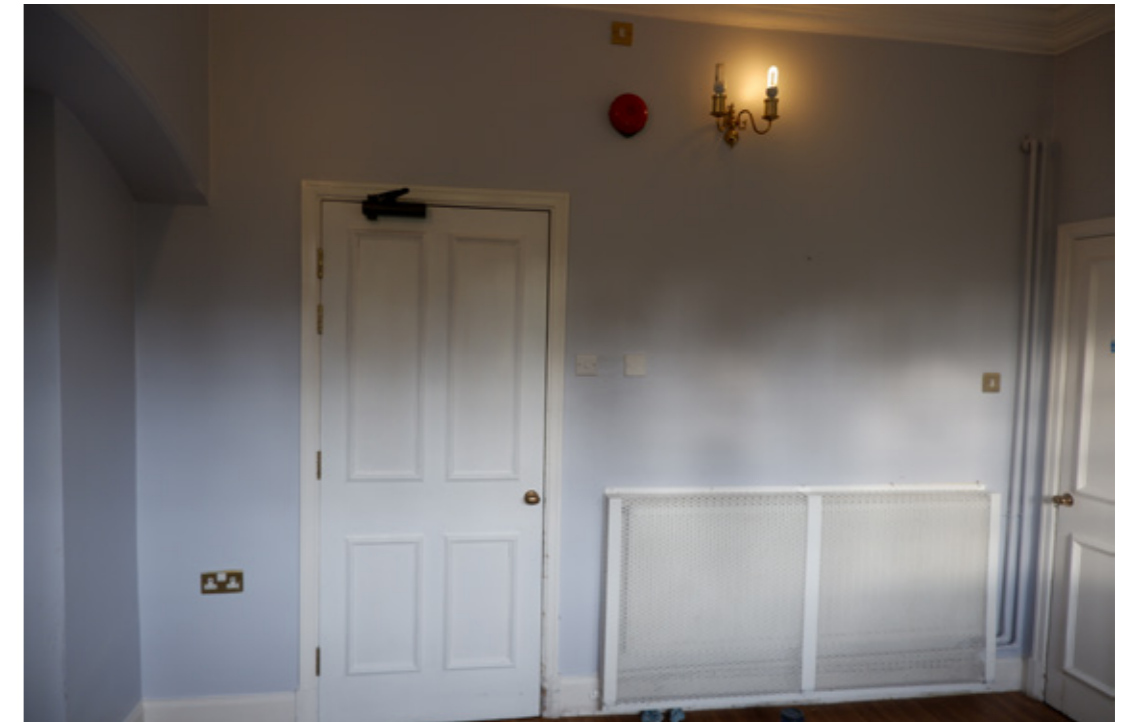
GROUND FLOOR: SERVICE WING – G3.26

Room Number:	G3.26
Current Room Use:	Bedroom/Side Entrance
Historic Room Use:	Circulation / Stewards? (Wyatt plan)
Date of Structure:	1817
Date of Fixtures / Fittings:	
Date of Decoration:	Late 20th century
Major Alterations:	Insertation of side entrance

Overall Significance Level:	Medium
Key Historic Features:	Timber casement windows and part glazed door, archway
Detrimental Features:	M&E, modern radiators and flooring, door closer
Condition Level:	
Condition Comments:	
Other Comments:

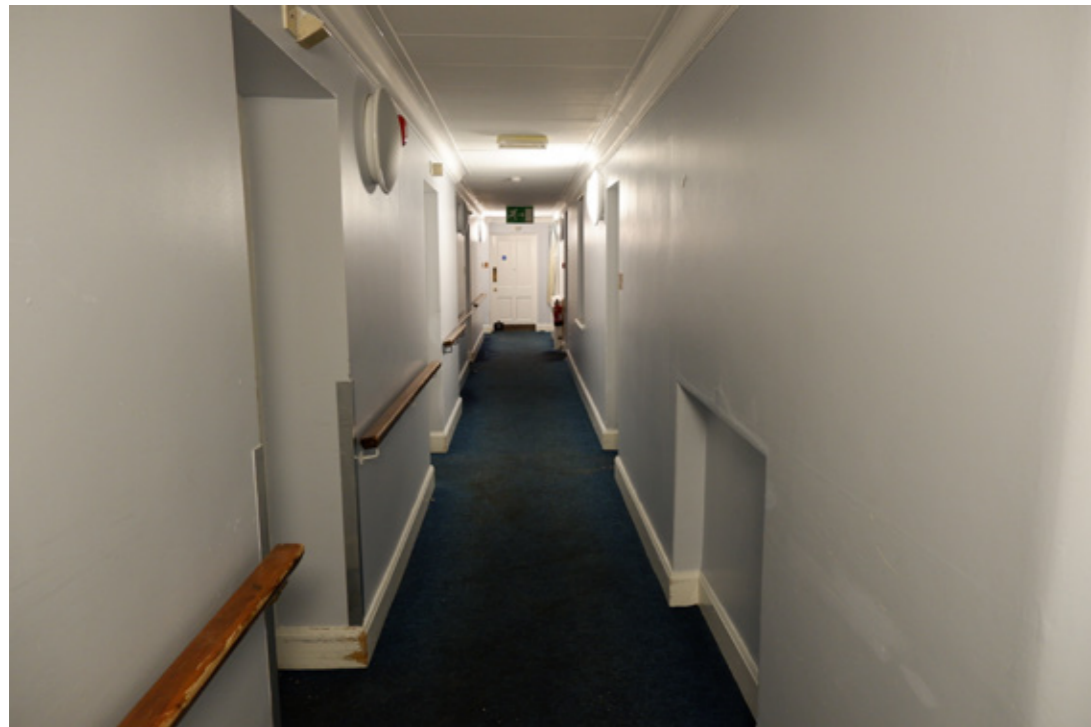
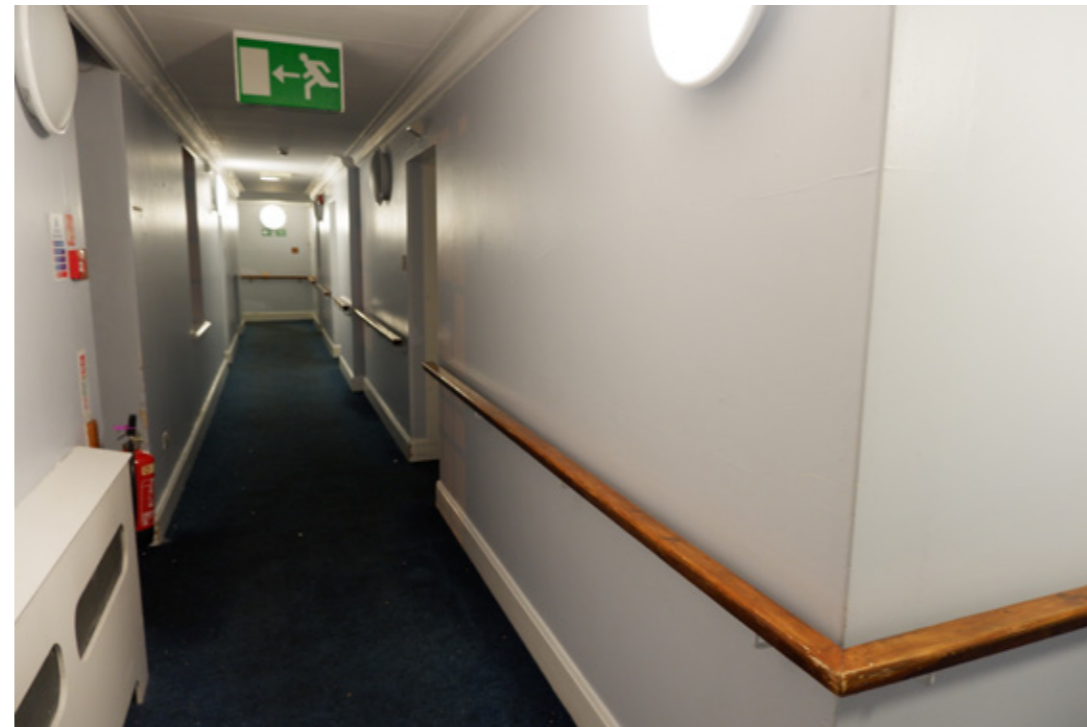
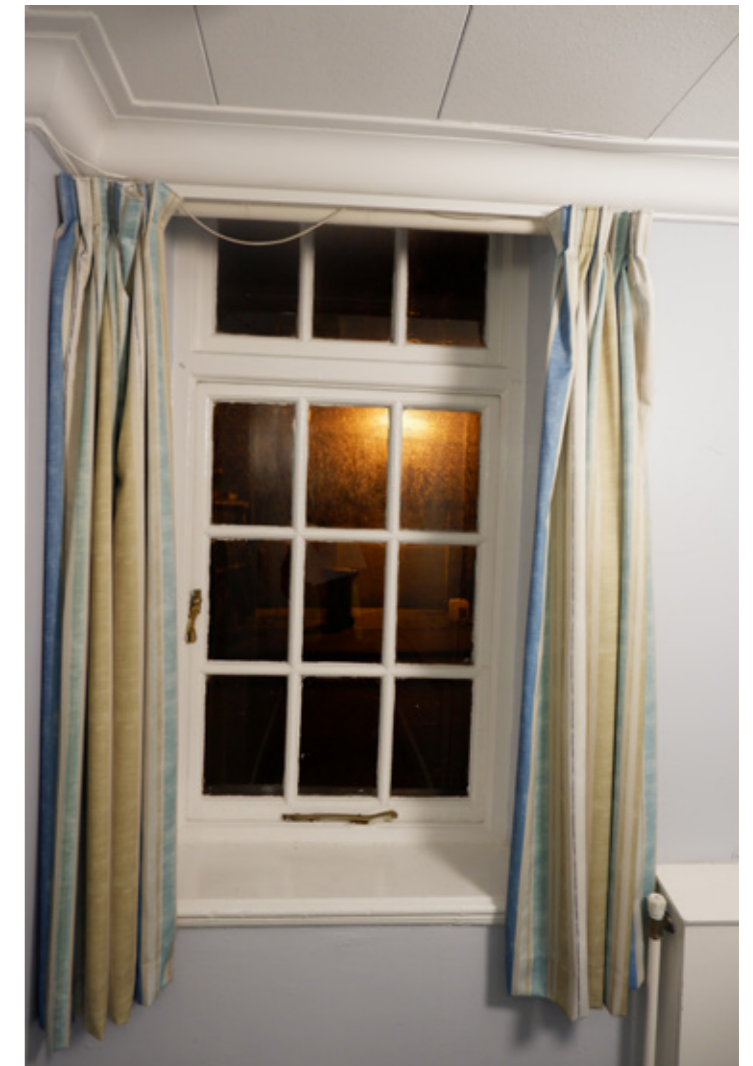
GROUND FLOOR: SERVICE WING – G3.27

Room Number:	G3.27
Current Room Use:	Corridor
Historic Room Use:	
Date of Structure:	1848-1893
Date of Fixtures / Fittings:	
Date of Decoration:	Late 20th century
Major Alterations:

Overall Significance Level:	Low
Key Historic Features:	Blocked opening, timber casement window
Detrimental Features:	Suspended ceiling, modern fitout, M&E, modern radiators
Condition Level:	
Condition Comments:	
Other Comments:	blocked opening use?

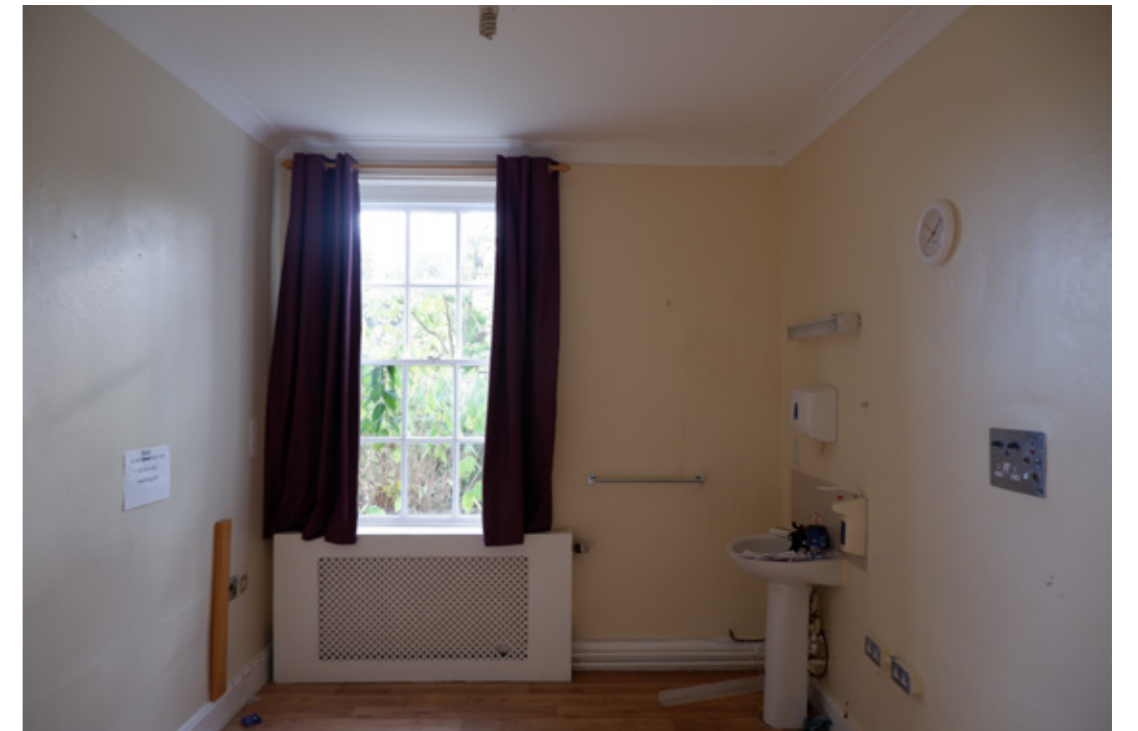
GROUND FLOOR: SERVICE WING – G3.29a

Room Number:	G3.29a
Current Room Use:	Bedroom
Historic Room Use:	Steward's office? (Wyatt Plan)
Date of Structure:	1817
Date of Fixtures / Fittings:	
Date of Decoration:	Late 20th century
Major Alterations:	Opening up to side entrance

Overall Significance Level:	Medium
Key Historic Features:	Sash window
Detrimental Features:	Modern fitout, sanitary ware, M&E, radiator
Condition Level:	
Condition Comments:	
Other Comments:

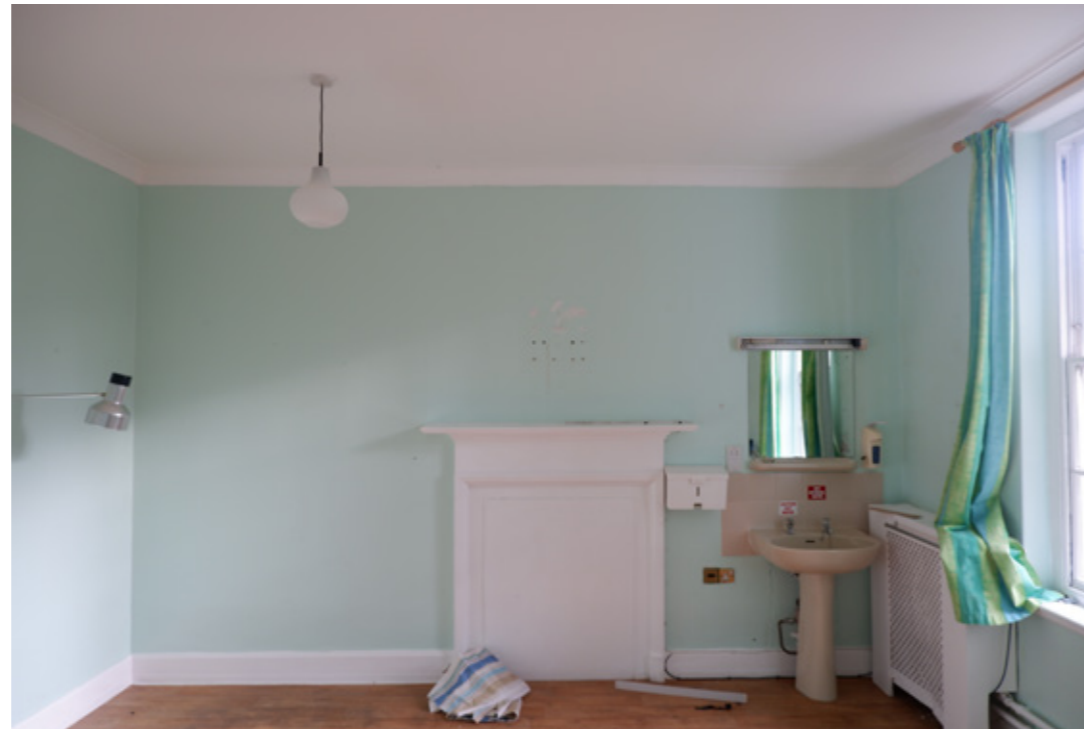
GROUND FLOOR: SERVICE WING – G3.29b

Room Number:	G3.29b
Current Room Use:	Bedroom
Historic Room Use:	Steward's office? (Wyatt Plan)
Date of Structure:	1817
Date of Fixtures / Fittings:	
Date of Decoration:	Late 20th century
Major Alterations:	Removal of internal walls from Wyatt plan

Overall Significance Level:	Medium
Key Historic Features:	Sash windows, blocked fireplace, fireplace and mantel
Detrimental Features:	Modern fitout, sanitary ware, M&E, radiators
Condition Level:	
Condition Comments:	
Other Comments:	Not on plan

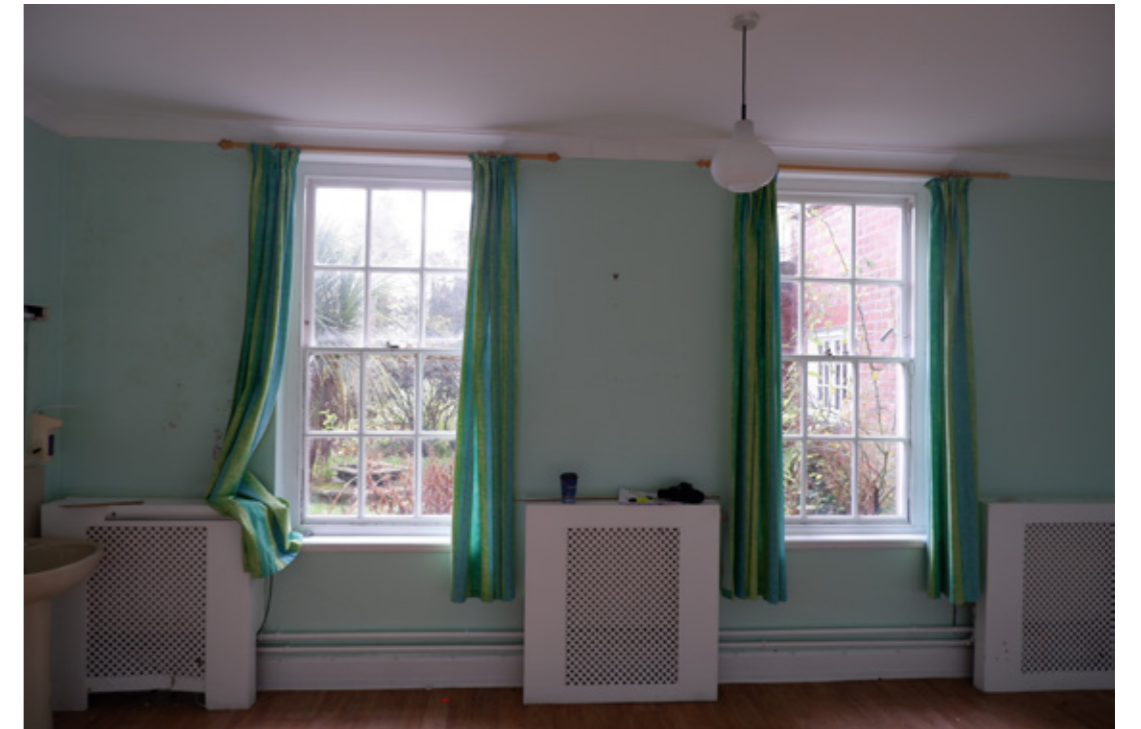
GROUND FLOOR: SERVICE WING – G3.30

Overall Significance Level:	Low
Key Historic Features:	Sash windows, timber casement windows
Detrimental Features:	Modern fitout, sanitary ware, M&E, radiators, fixtures attached to window frames
Condition Level:	
Condition Comments:	
Other Comments:

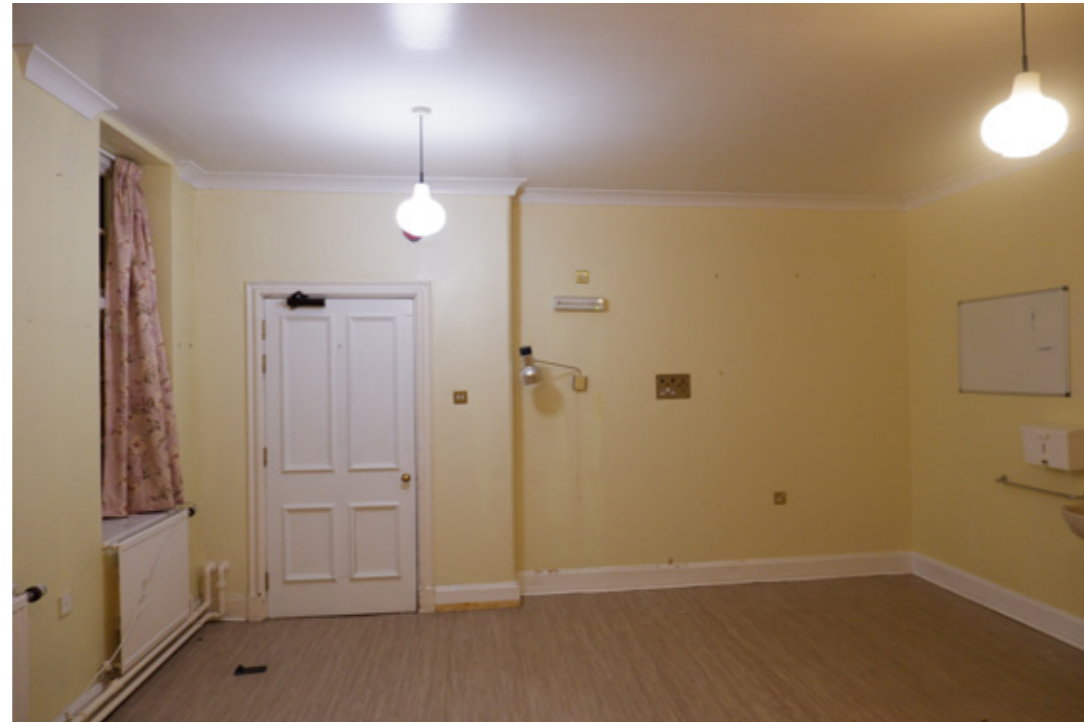
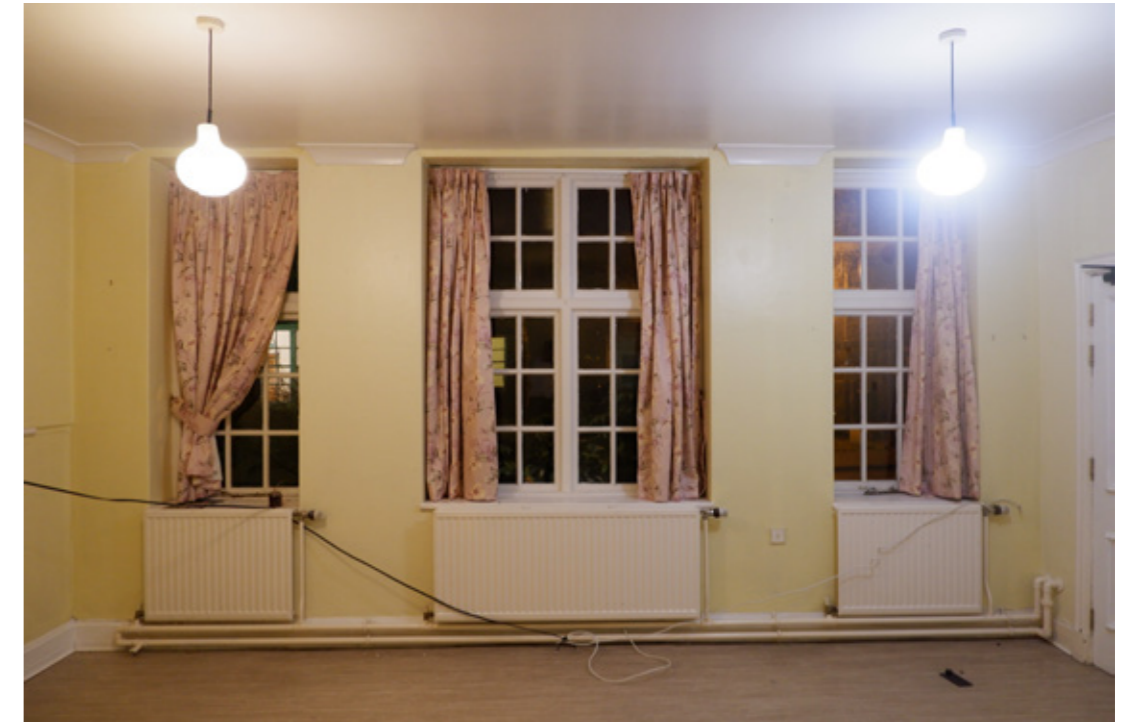
Room Number:	G3.30
Current Room Use:	Bedroom
Historic Room Use:	
Date of Structure:	1848-1893
Date of Fixtures / Fittings:	
Date of Decoration:	Late 20th century
Major Alterations:

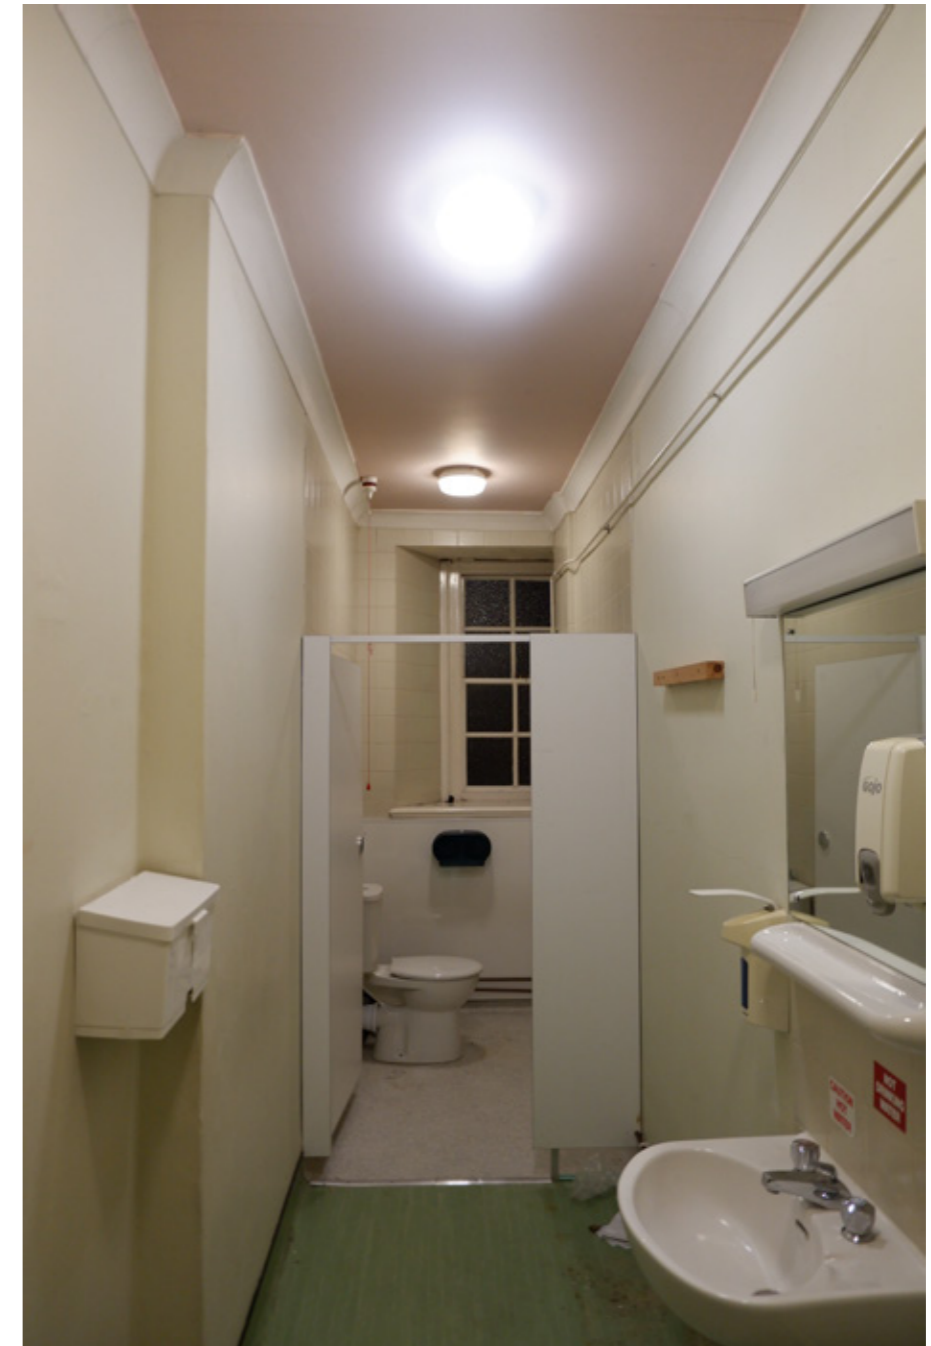
GROUND FLOOR: SERVICE WING – G3.31

Room Number:	G3.31
Current Room Use:	WC
Historic Room Use:	
Date of Structure:	1848-1893
Date of Fixtures / Fittings:	
Date of Decoration:	Late 20th century
Major Alterations:	
Overall Significance Level:	Low
Key Historic Features:	Sash window
Detrimental Features:	Modern fit out, sanitary ware
Condition Level:	
Condition Comments:	
Other Comments:

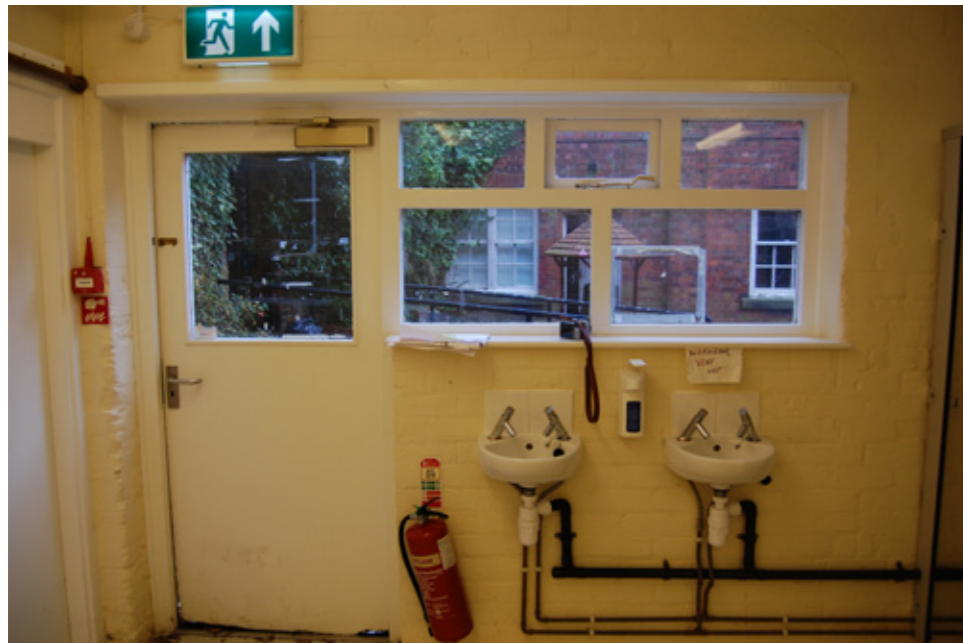
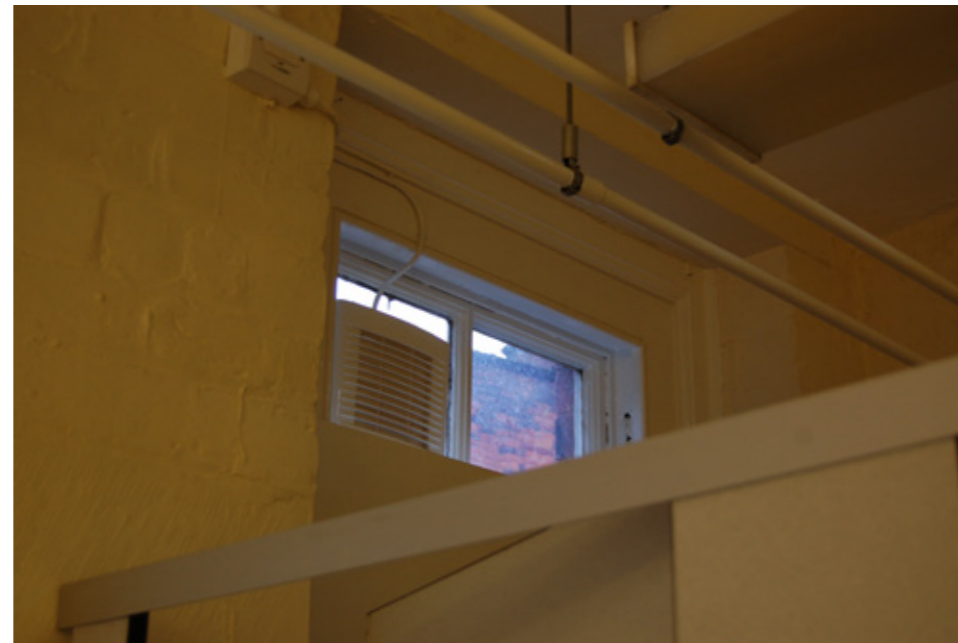
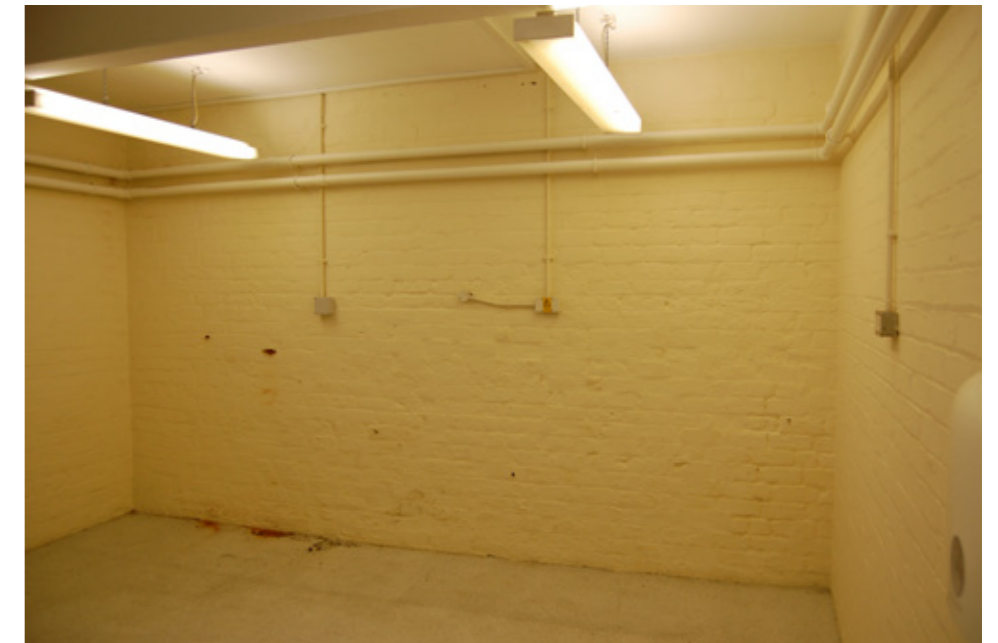
GROUND FLOOR: SERVICE WING – G3.32

Room Number:	G3.32
Current Room Use:	Office
Historic Room Use:	
Date of Structure:	1848-1893
Date of Fixtures / Fittings:	
Date of Decoration:	Late 20th century
Major Alterations:

Overall Significance Level:	Low
Key Historic Features:	Sash window
Detrimental Features:	Sash window part blocked, extractor fan on sash window, modern fit out, sanitary ware
Condition Level:	
Condition Comments:	
Other Comments:

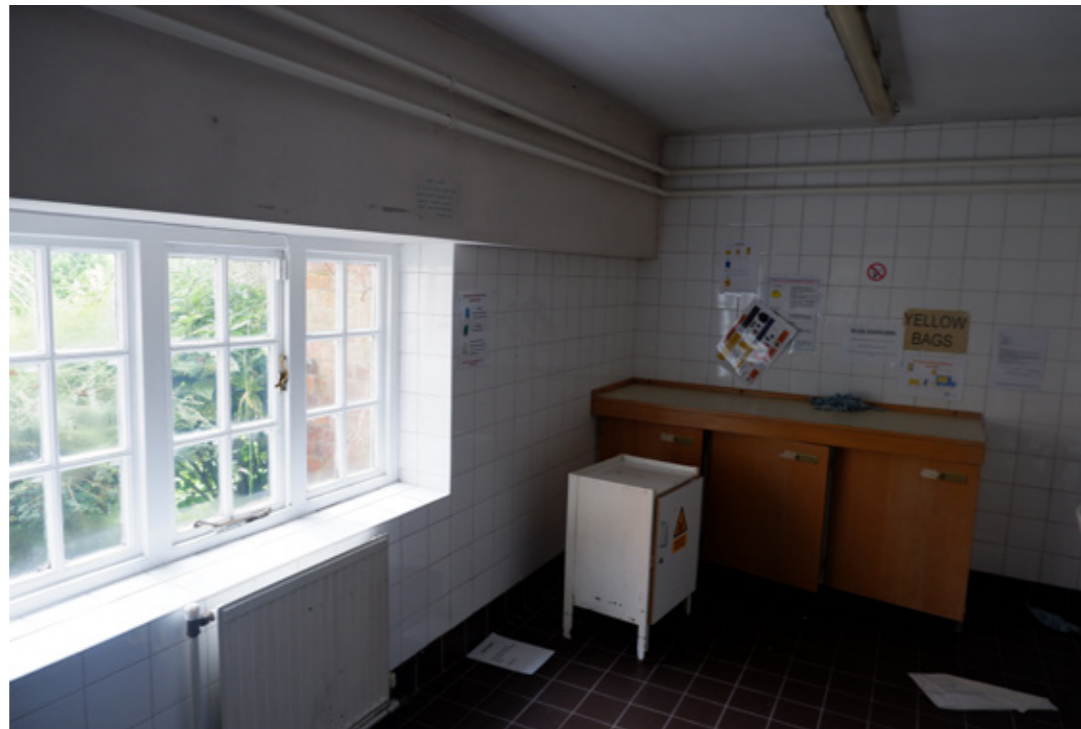
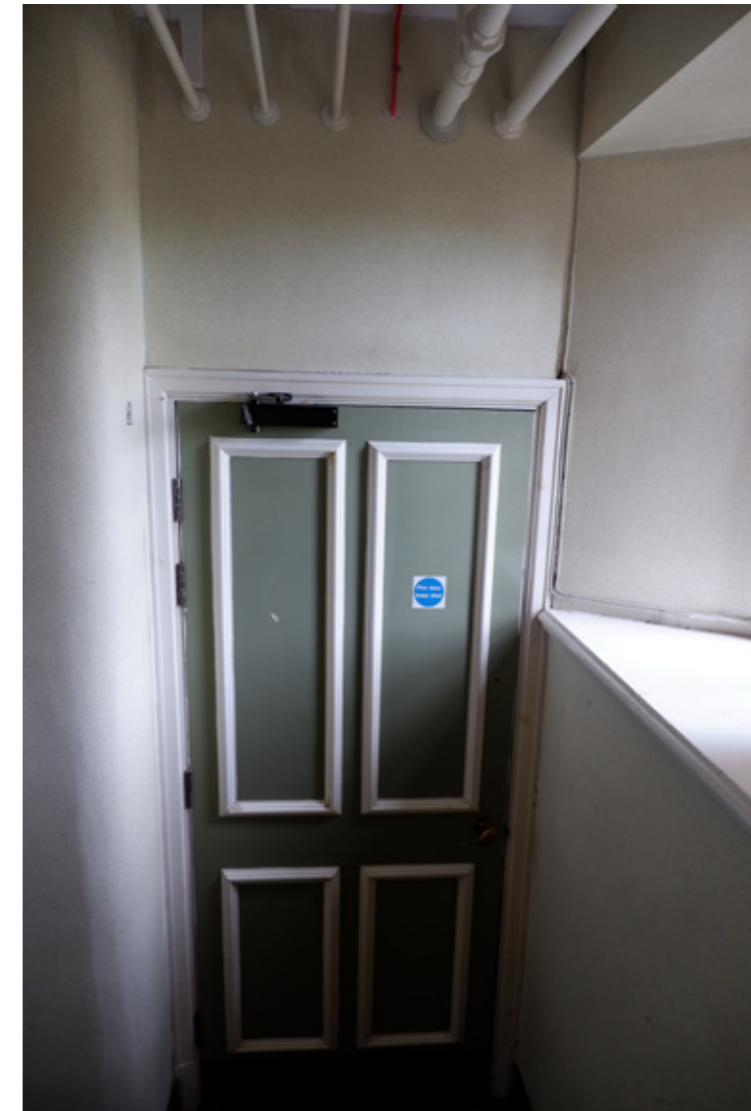
GROUND FLOOR: SERVICE WING – G3.33

Room Number:	G3.33
Current Room Use:	Welfare
Historic Room Use:	
Date of Structure:	1848-1893
Date of Fixtures / Fittings:	
Date of Decoration:	Late 20th century
Major Alterations:

Overall Significance Level:	Detrimental
Key Historic Features:	Timber casement windows
Detrimental Features:	M&E, floor and wall finishes, sanitary ware
Condition Level:	
Condition Comments:	
Other Comments:
