VOLUME TWO

GAZETTEER

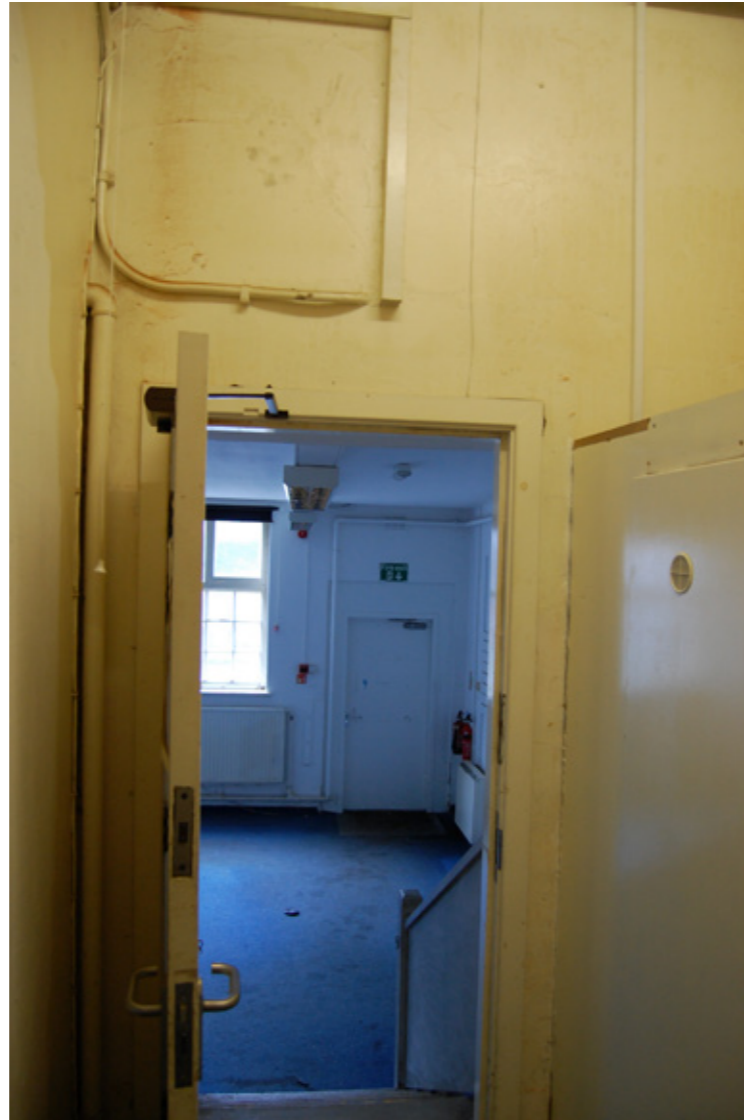
GROUND FLOOR: OFFICE RANGE - G4.03

Room Number:	G4.03
Current Room Use:	Storage/Plant
Historic Room Use:	
Date of Structure:	1848-1893
Date of Fixtures / Fittings:	
Date of Decoration:	Late 20th century
Major Alterations:

Overall Significance Level:	Detrimental
Key Historic Features:	None
Detrimental Features:	M&E
Condition Level:	
Condition Comments:	
Other Comments:

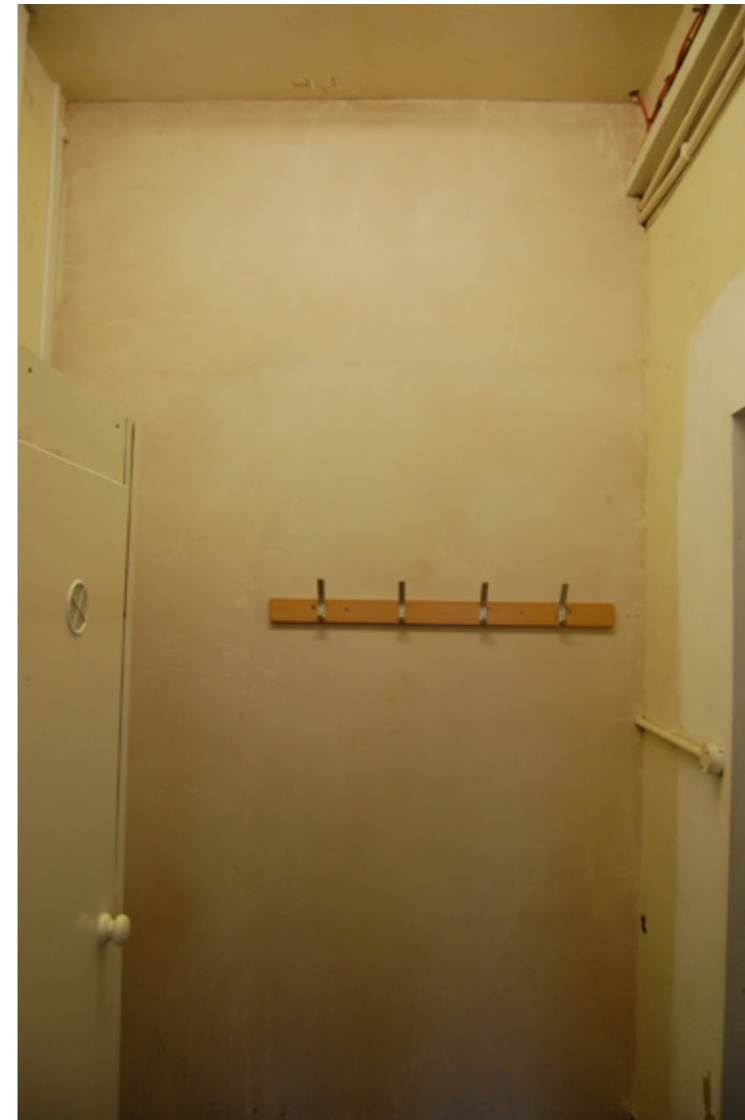
GROUND FLOOR: OFFICE RANGE - G4.04

Overall Significance Level:	Detrimental
Key Historic Features:	Sash window
Detrimental Features:	M&E, boiler, extraction ducting through sash window
Condition Level:	
Condition Comments:	
Other Comments:

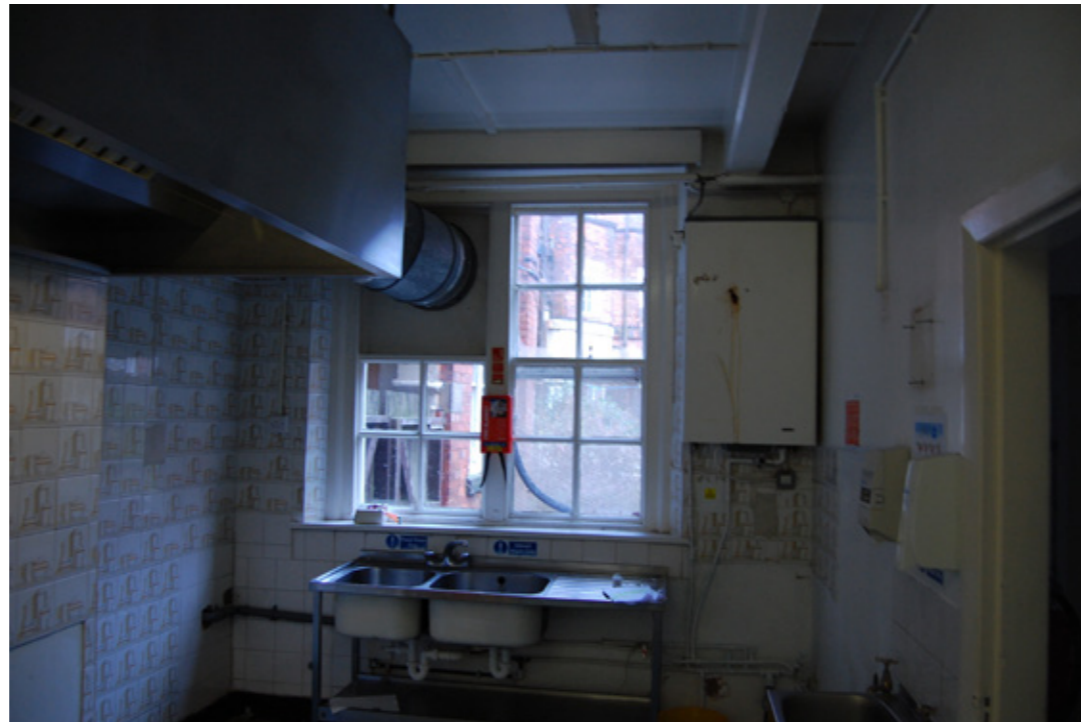
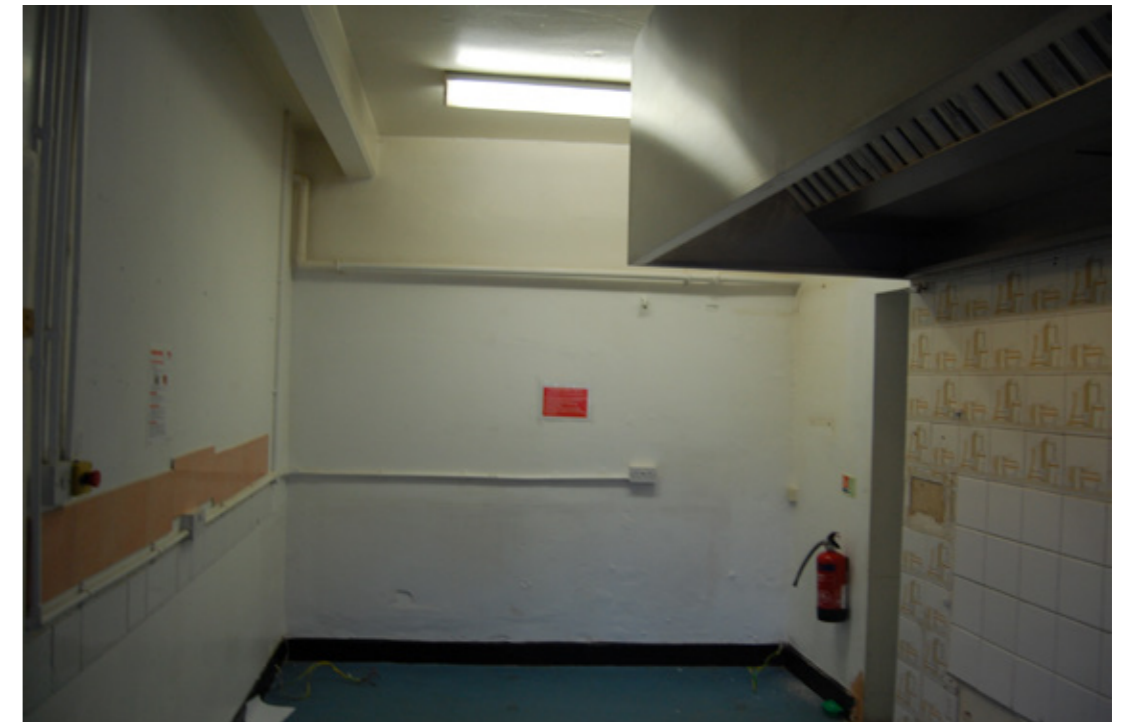
Room Number:	G4.04
Current Room Use:	Kitchen
Historic Room Use:	
Date of Structure:	1848-1893
Date of Fixtures / Fittings:	
Date of Decoration:	Late 20th century
Major Alterations:

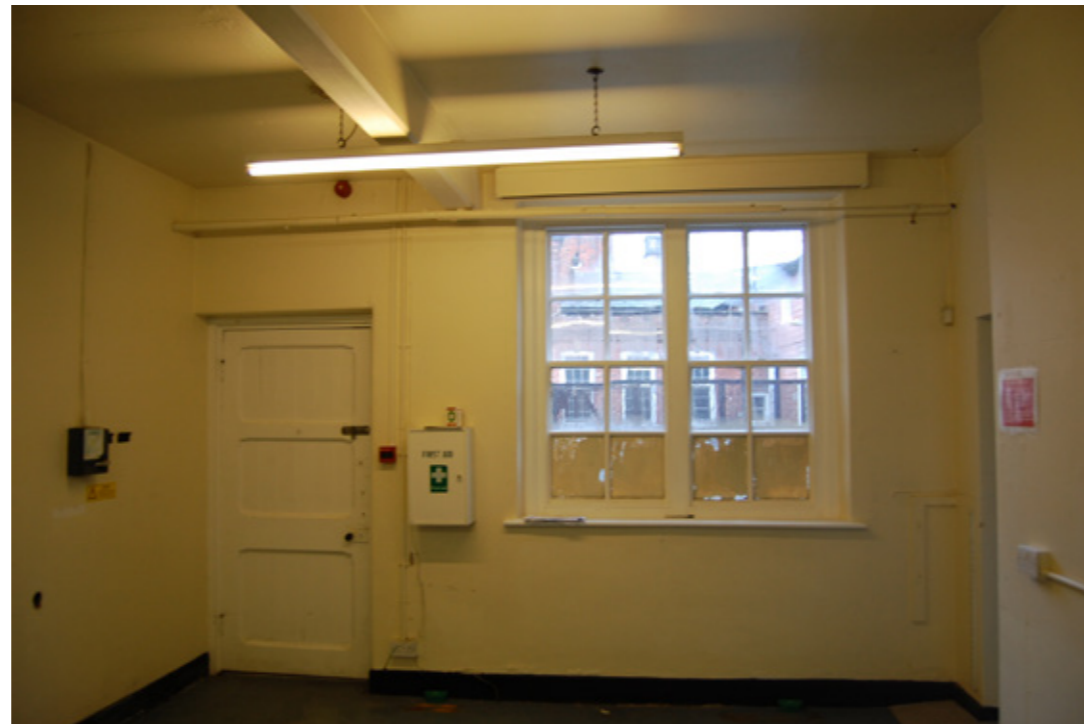
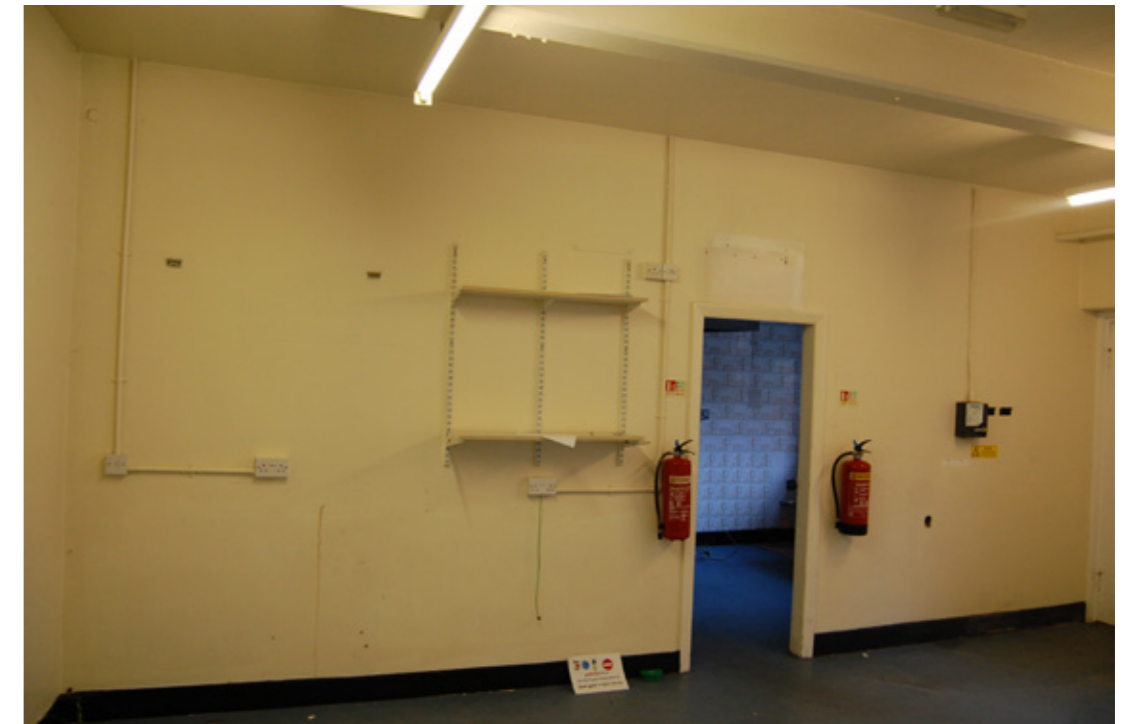
GROUND FLOOR: OFFICE RANGE - G4.05

Room Number:	G4.05
Current Room Use:	Office
Historic Room Use:	
Date of Structure:	1848-1893
Date of Fixtures / Fittings:	
Date of Decoration:	Late 20th century
Major Alterations:

Overall Significance Level:	Detrimental
Key Historic Features:	Sash window, timber door
Detrimental Features:	M&E, modern fitout, obscured panes
Condition Level:	
Condition Comments:	
Other Comments:

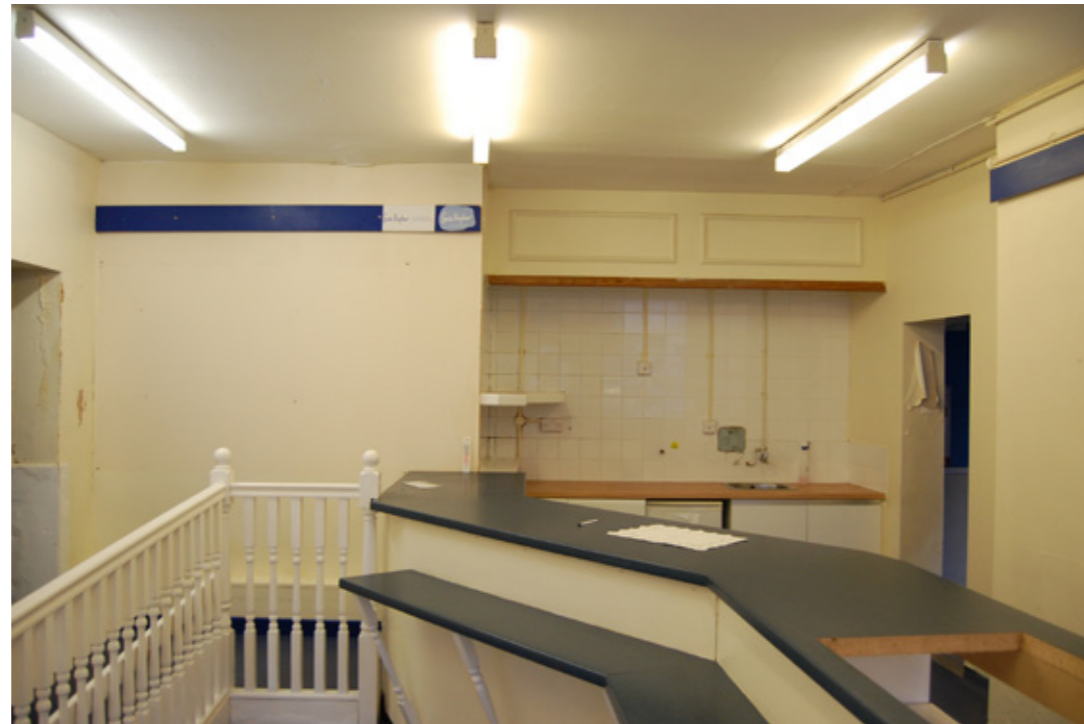
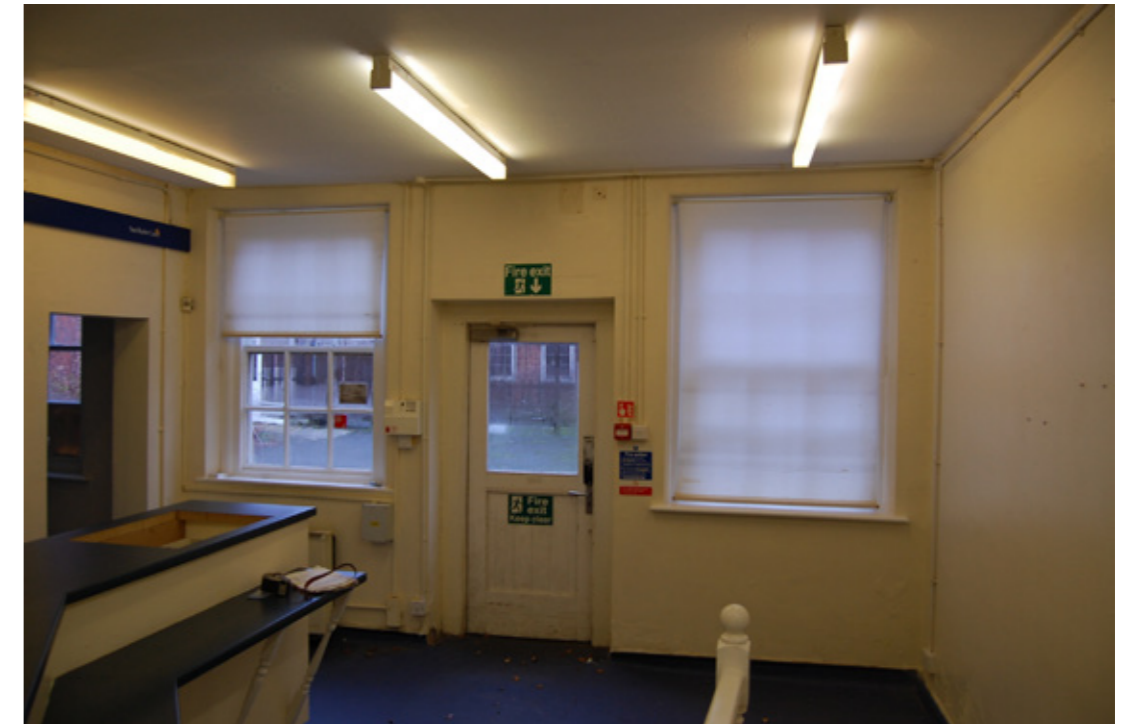
GROUND FLOOR: OFFICE RANGE - G4.06

Room Number:	G4.06
Current Room Use:	Office
Historic Room Use:	
Date of Structure:	1848-1893
Date of Fixtures / Fittings:	
Date of Decoration:	Late 20th century
Major Alterations:

Overall Significance Level:	Detrimental
Key Historic Features:	Sash windows
Detrimental Features:	M&E, Modern kitchen fitout
Condition Level:	
Condition Comments:	
Other Comments:

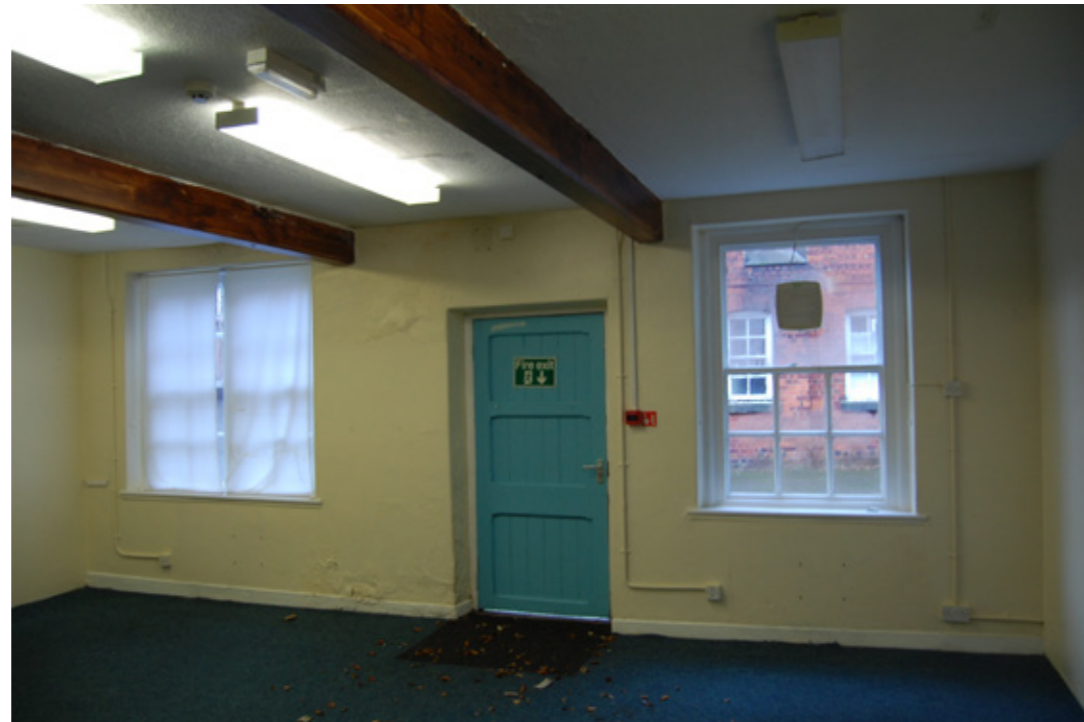
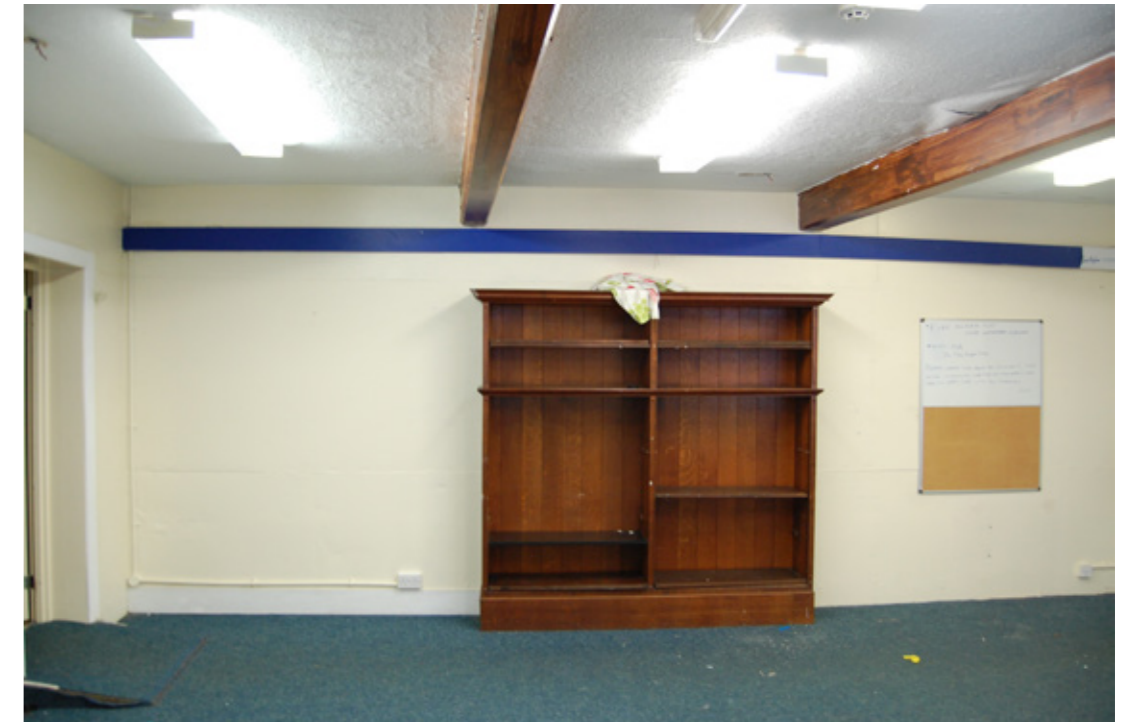
GROUND FLOOR: OFFICE RANGE - G4.07

Room Number:	G4.07
Current Room Use:	Bedroom
Historic Room Use:	
Date of Structure:	1848-1893
Date of Fixtures / Fittings:	
Date of Decoration:	Late 20th century
Major Alterations:

Overall Significance Level:	Detrimental
Key Historic Features:	Sash windows, timber door, exposed beams, timber bookcase
Detrimental Features:	M&E, extractor fan on sash window, modern fitout
Condition Level:	
Condition Comments:	
Other Comments:

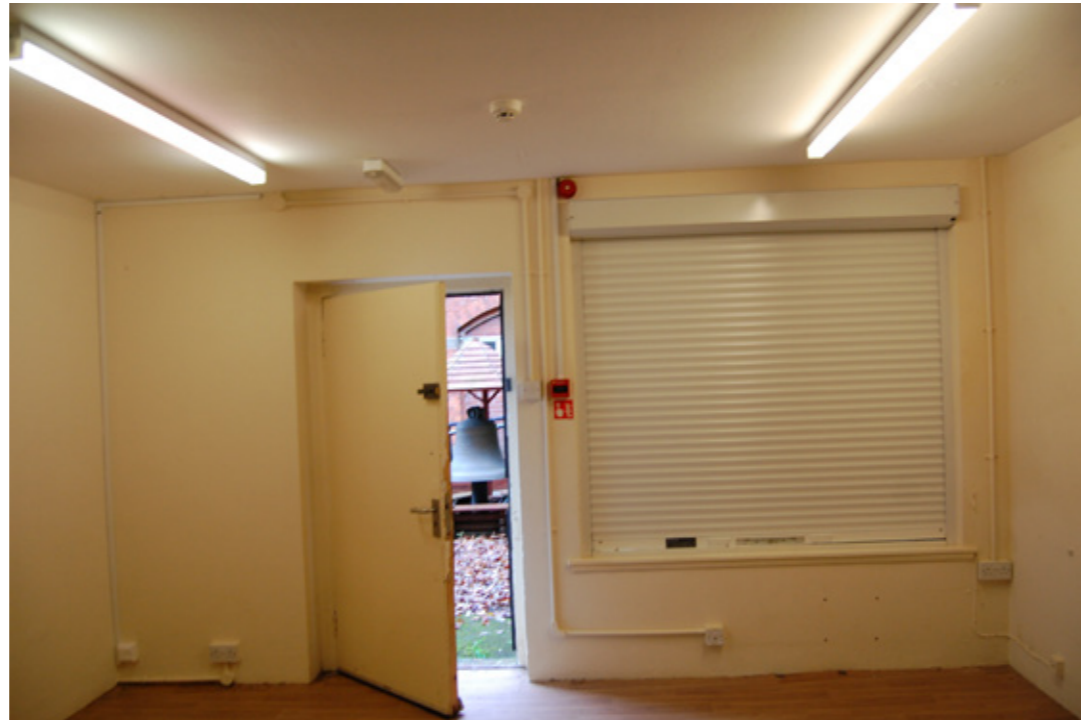
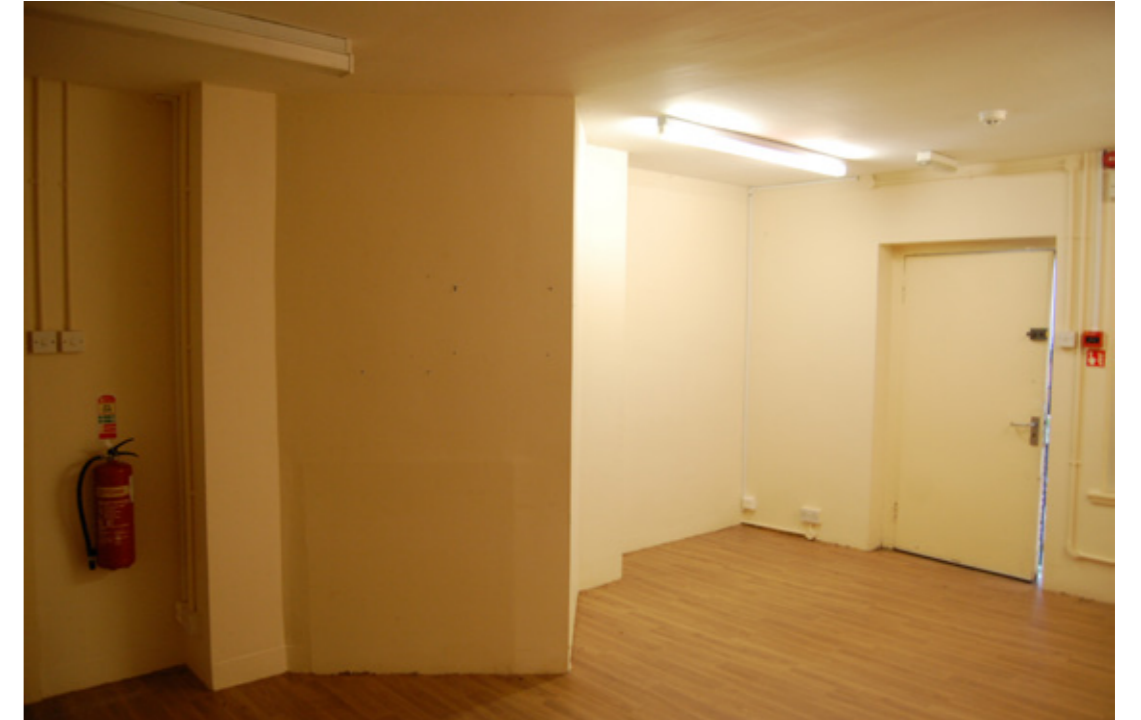
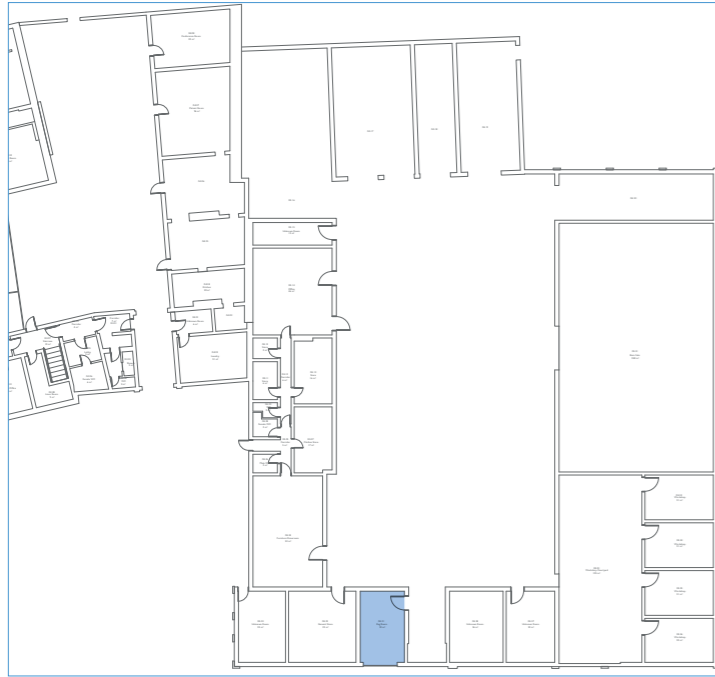
GROUND FLOOR: STABLEYARD - G5.01

Room Number:	G5.01
Current Room Use:	Stables/Store
Historic Room Use:	
Date of Structure:	1816-1848
Date of Fixtures / Fittings:	
Date of Decoration:	Late 20th century
Major Alterations:

Overall Significance Level:	Low
Key Historic Features:	Circular brickwork, timber window
Detrimental Features:	M&E
Condition Level:	
Condition Comments:	
Other Comments:

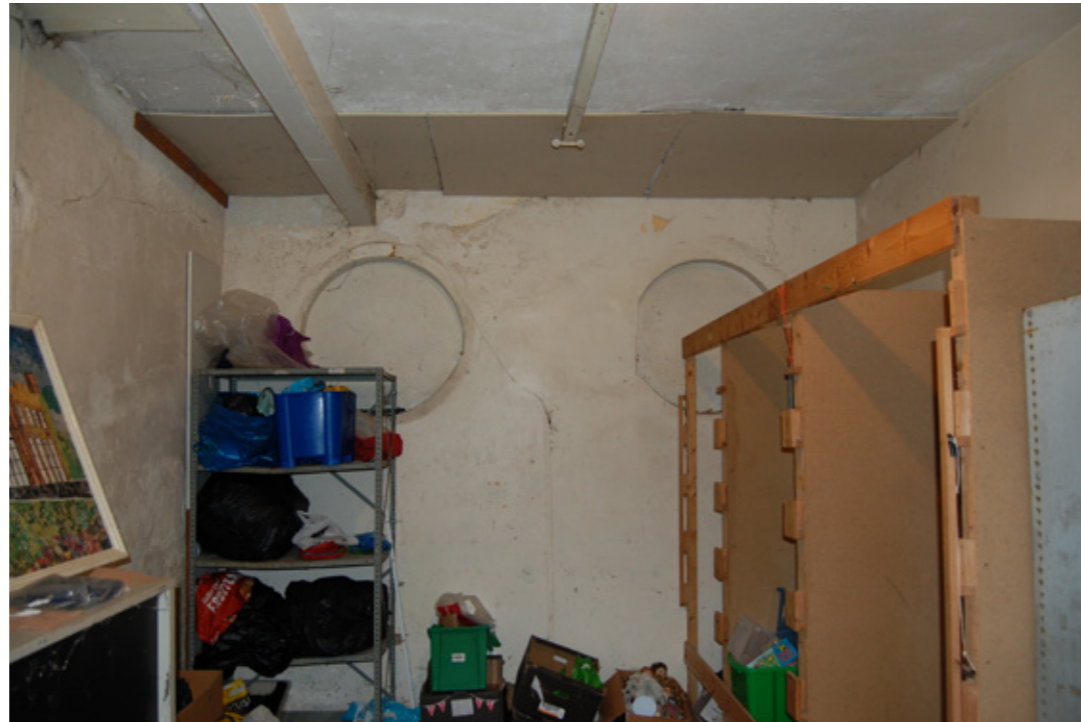
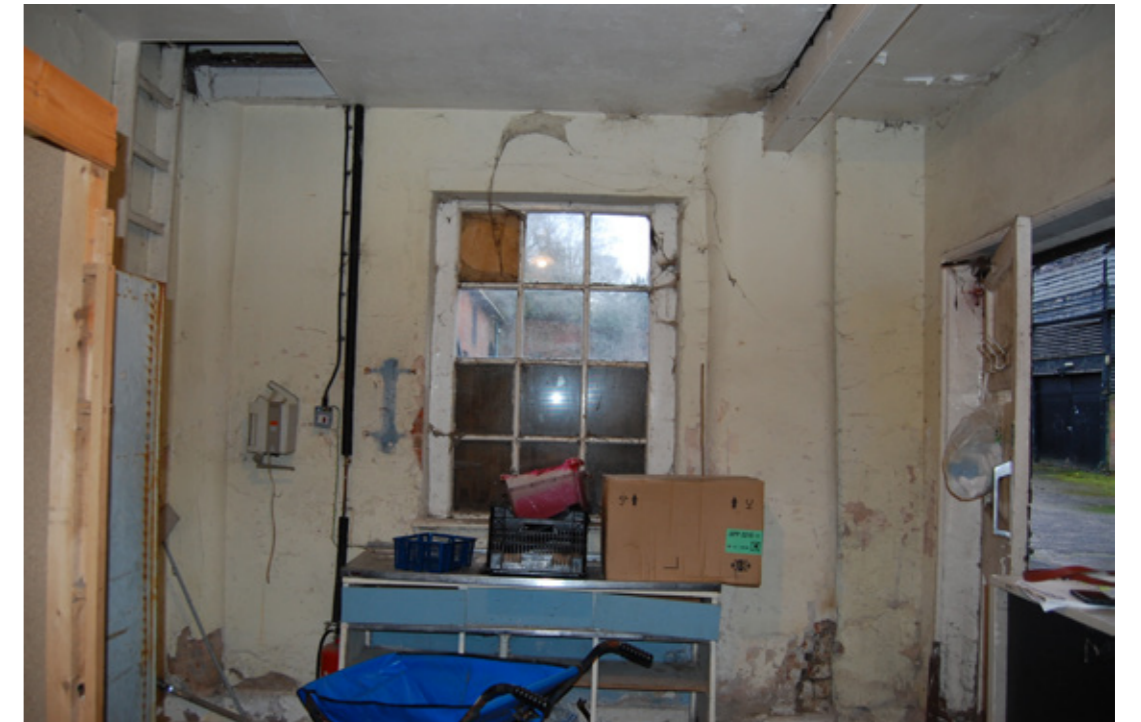
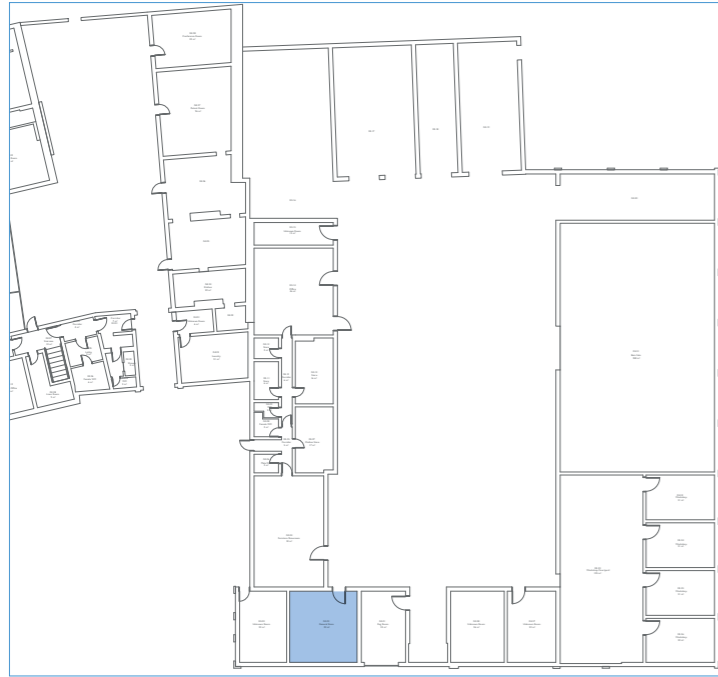
GROUND FLOOR: STABLEYARD - G5.02

Room Number:	G5.02
Current Room Use:	Stables/Stores
Historic Room Use:	
Date of Structure:	1816-1848
Date of Fixtures / Fittings:	
Date of Decoration:	Derelict / C20
Major Alterations:	Loss of first floor, modern subdivision

Overall Significance Level:	Low
Key Historic Features:	Exposed structure, evidence of lost first floor, timber windows
Detrimental Features:	M&E, modern doors and partitioning
Condition Level:	
Condition Comments:	
Other Comments:

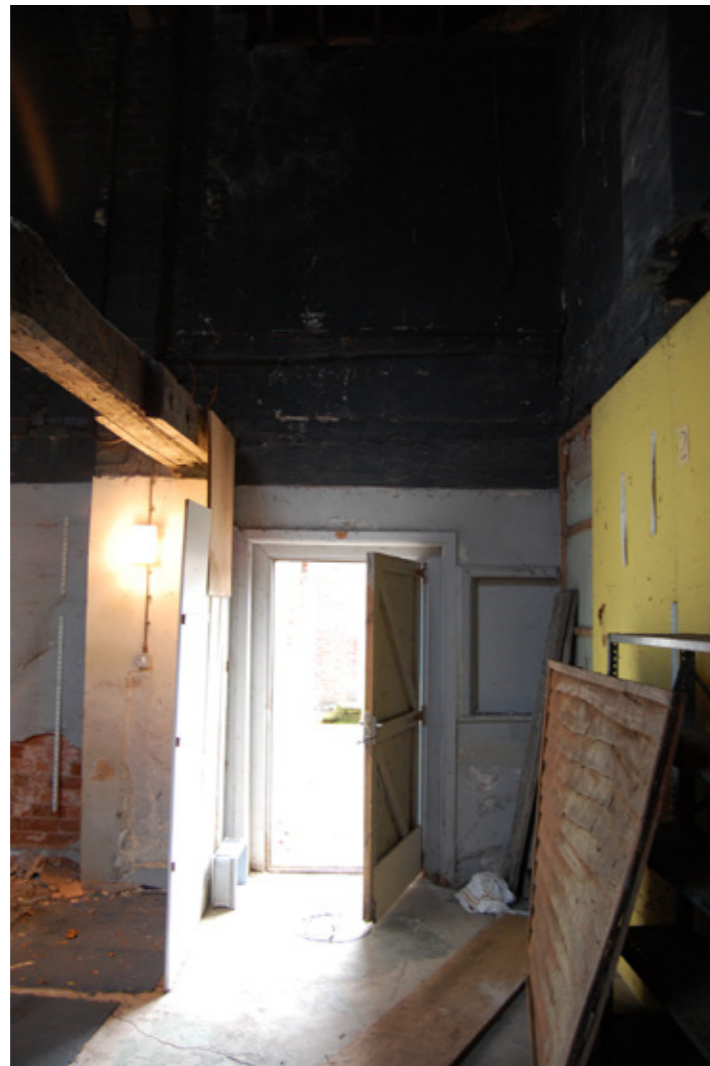
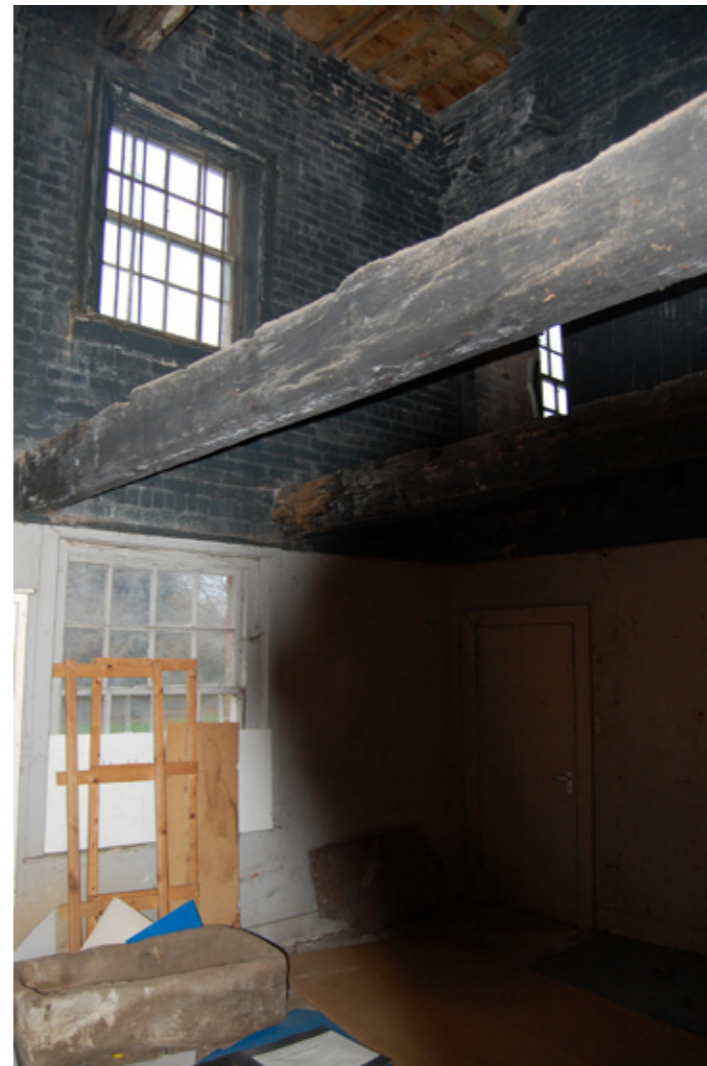
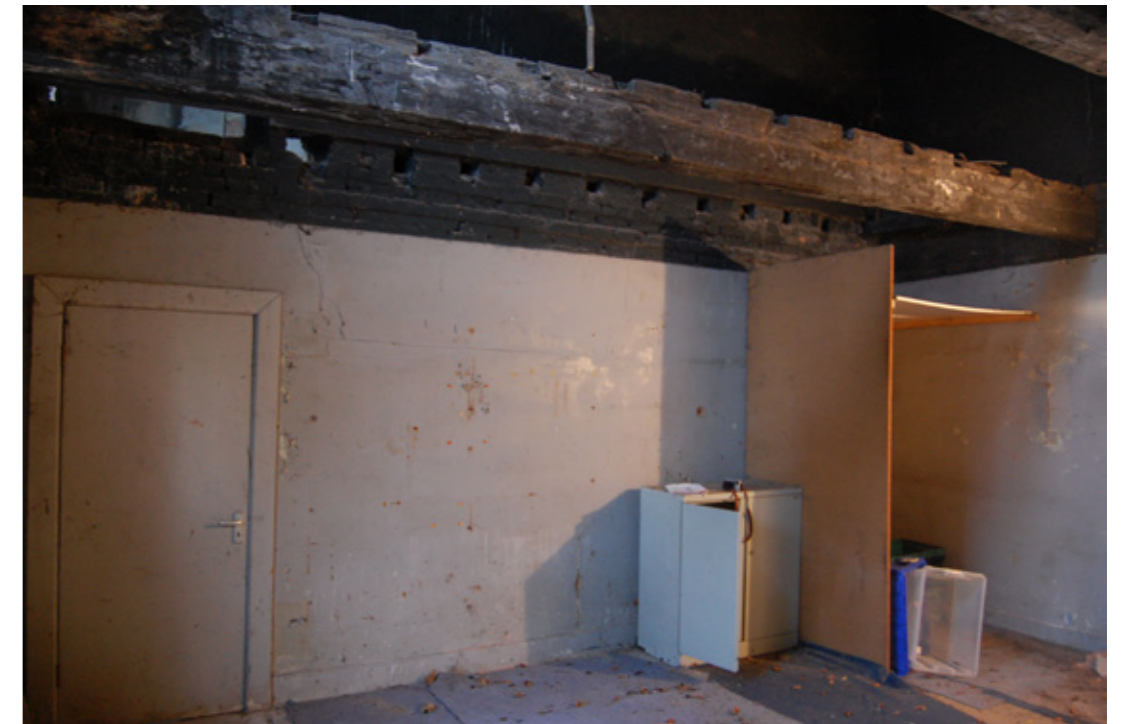
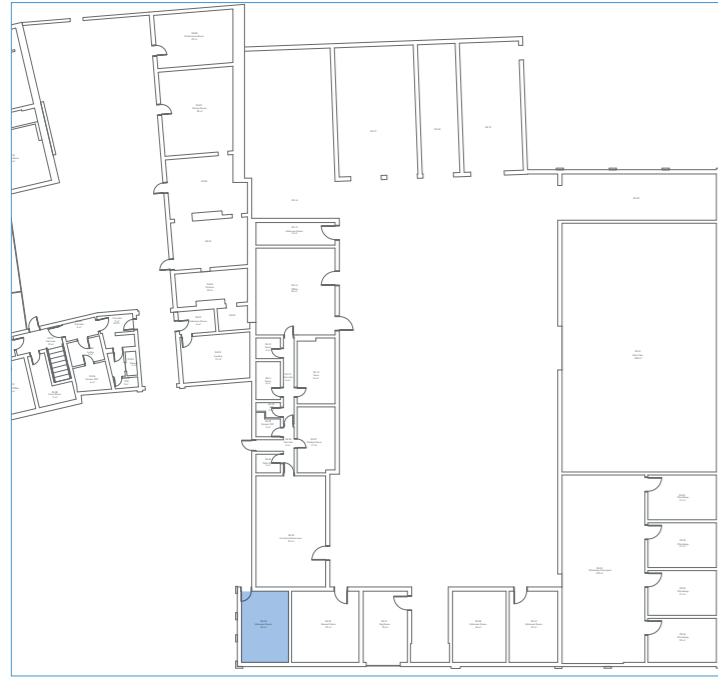
GROUND FLOOR: STABLEYARD - G5.03

Room Number:	G5.03
Current Room Use:	Stables/Stores
Historic Room Use:	
Date of Structure:	1816-1848
Date of Fixtures / Fittings:	
Date of Decoration:	Derelict / C20
Major Alterations:

Overall Significance Level:	Low
Key Historic Features:	Timber framed windows, evidence of previous stair
Detrimental Features:	Concrete block infill, structural repair
Condition Level:	
Condition Comments:	
Other Comments:

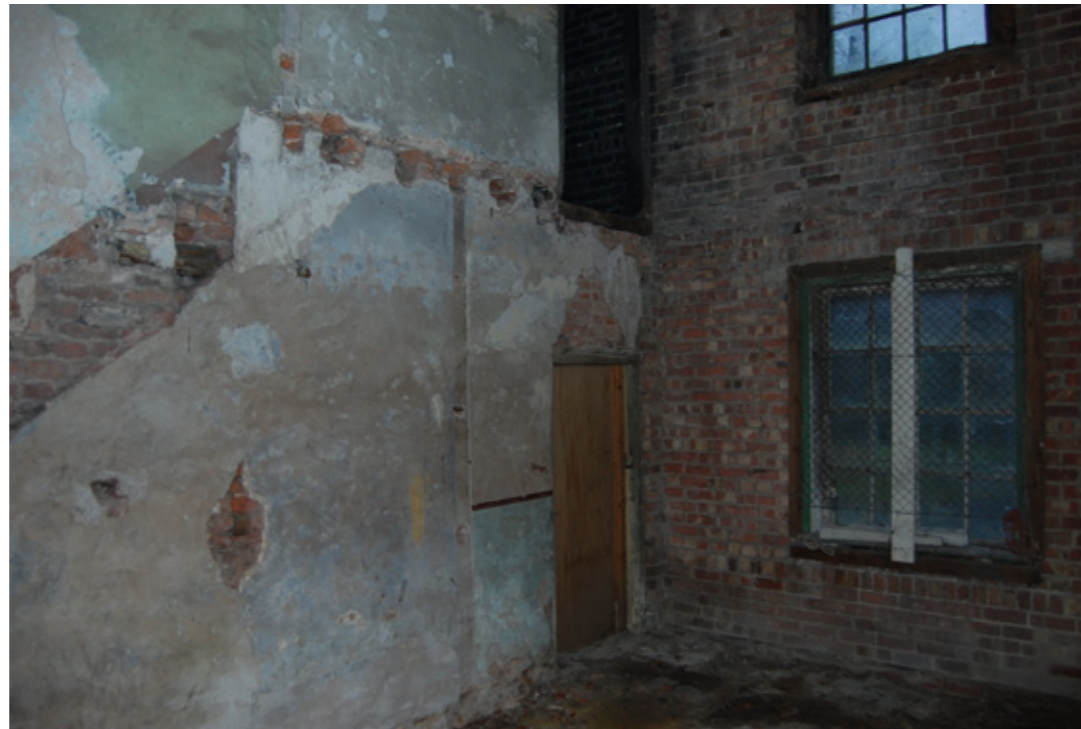
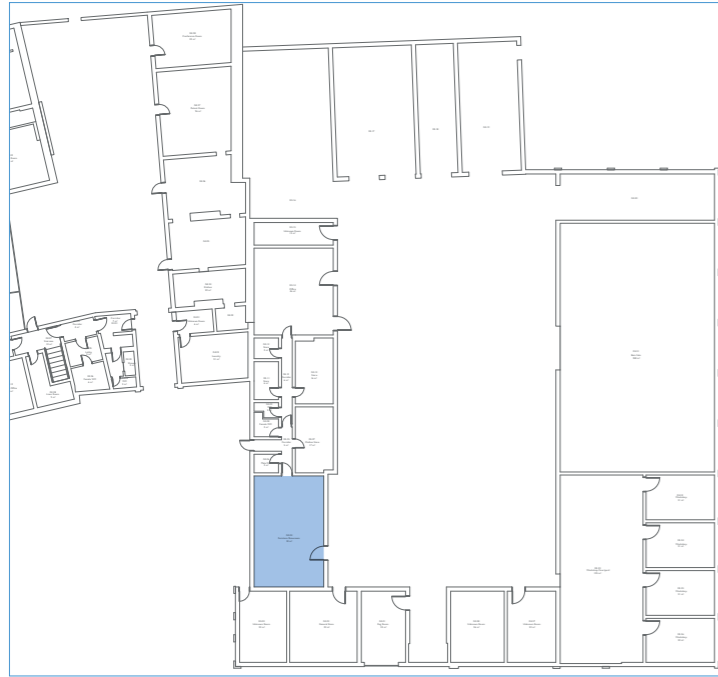
GROUND FLOOR: STABLEYARD - G5.04

Room Number:	G5.04
Current Room Use:	Stables/Store
Historic Room Use:	
Date of Structure:	1816-1848
Date of Fixtures / Fittings:	
Date of Decoration:	Late 20th century
Major Alterations:

Overall Significance Level:	Low
Key Historic Features:	Timber framed windows
Detrimental Features:	Modern fit out
Condition Level:	
Condition Comments:	
Other Comments:

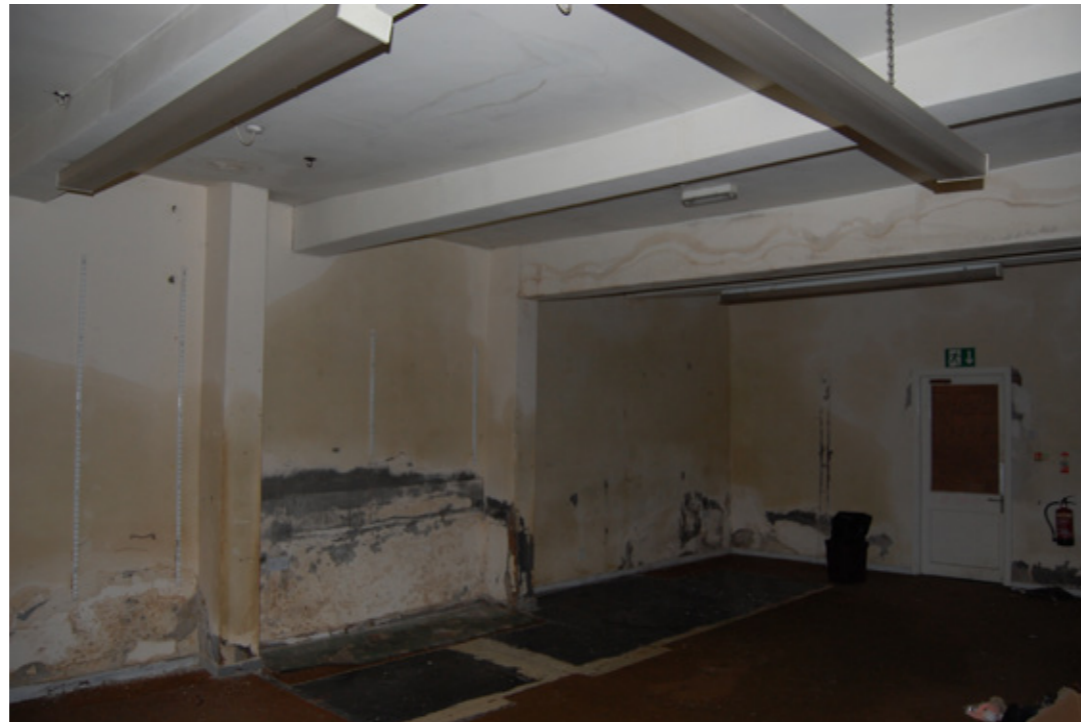
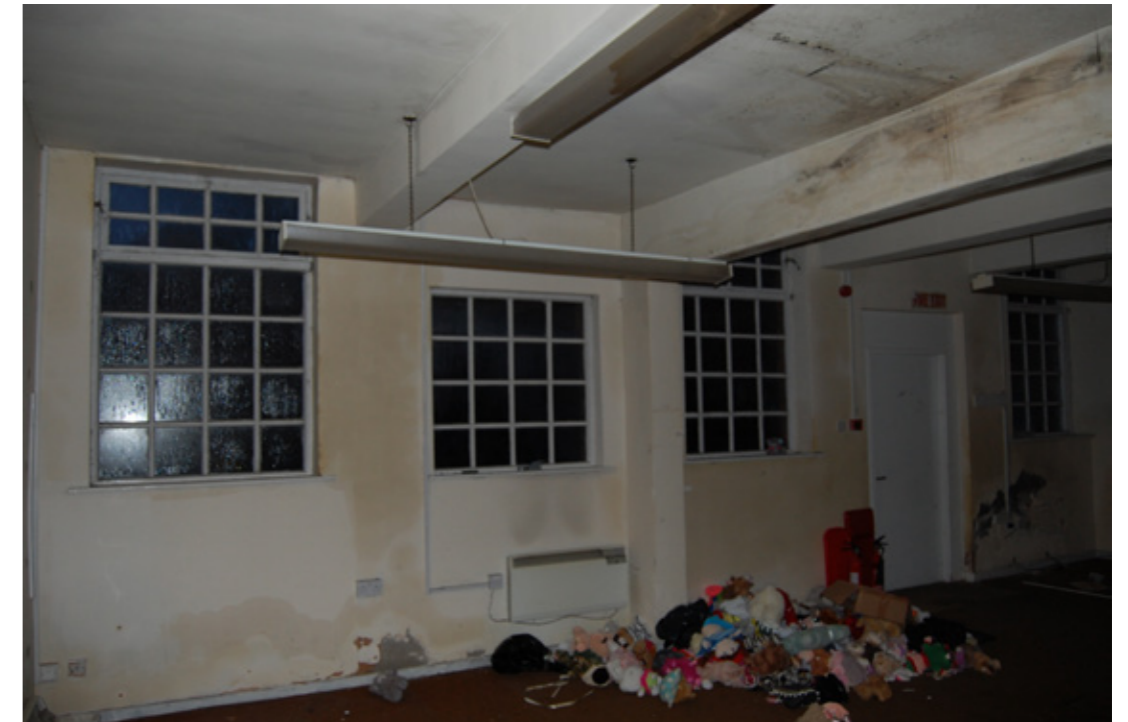
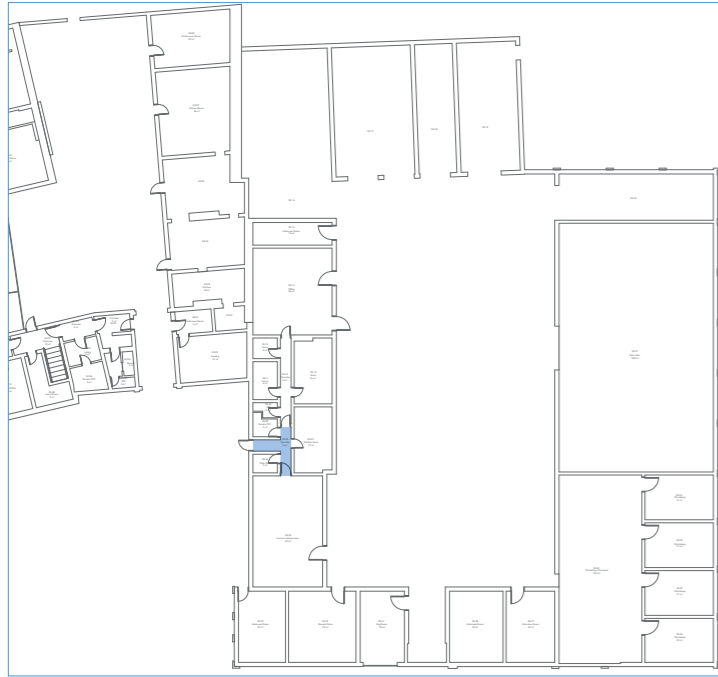
GROUND FLOOR: STABLEYARD - G5.05

Room Number:	G5.05
Current Room Use:	Corridor
Historic Room Use:	
Date of Structure:	1816-1848
Date of Fixtures / Fittings:	
Date of Decoration:	Late 20th century
Major Alterations:

Overall Significance Level:	Low
Key Historic Features:	None
Detrimental Features:	Modern fit out
Condition Level:	
Condition Comments:	
Other Comments:

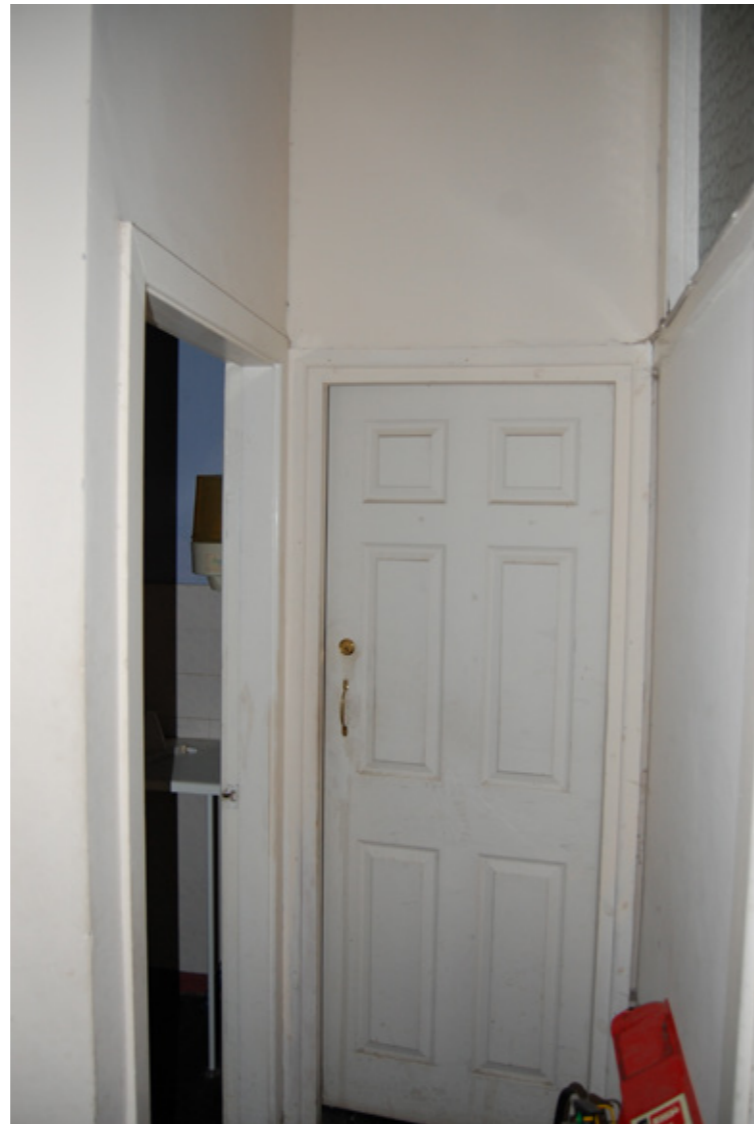
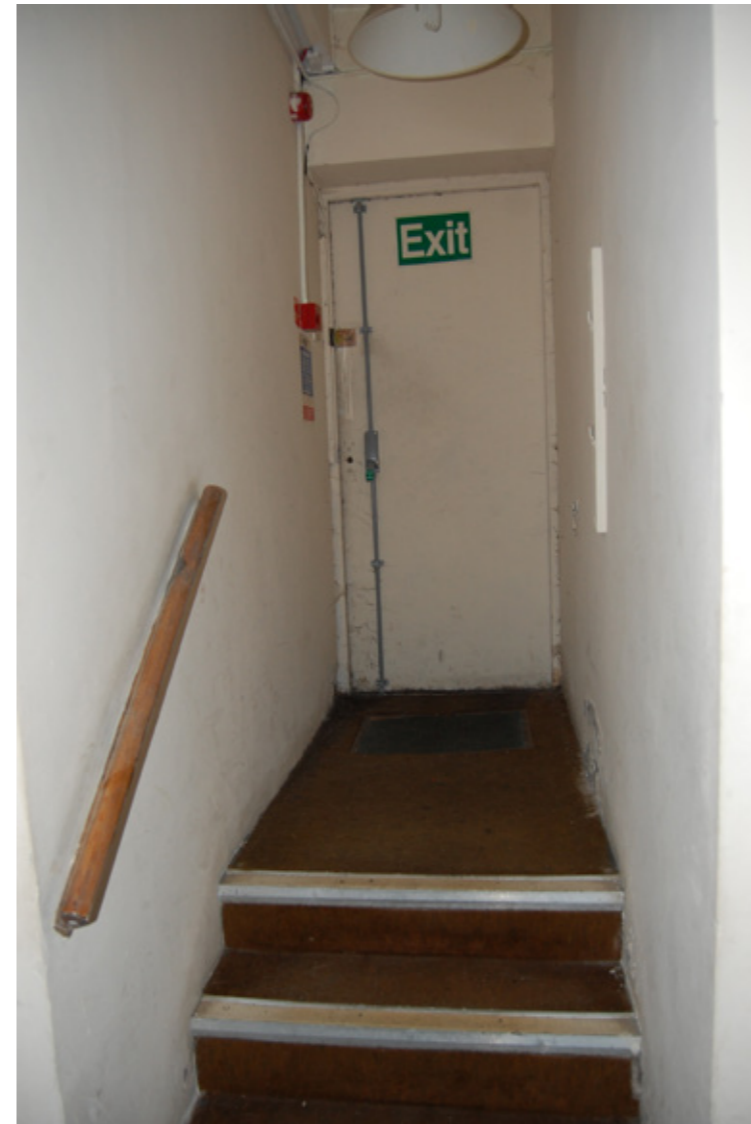
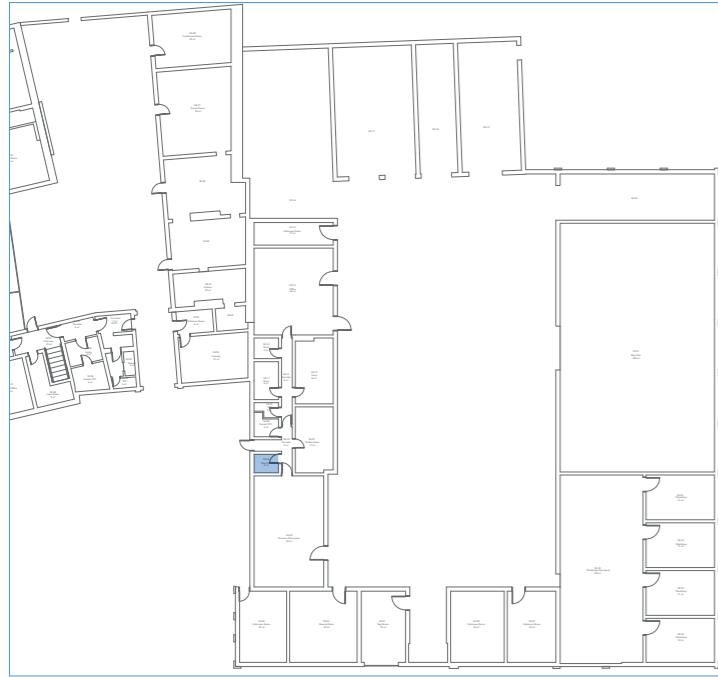
GROUND FLOOR: STABLEYARD - G5.06

Room Number:	G5.06
Current Room Use:	WC
Historic Room Use:	
Date of Structure:	1816-1848
Date of Fixtures / Fittings:	
Date of Decoration:	Late 20th century
Major Alterations:	
Overall Significance Level:	Low
Key Historic Features:	None
Detrimental Features:	M&E, modern fit out and sanitary ware
Condition Level:	
Condition Comments:	
Other Comments:

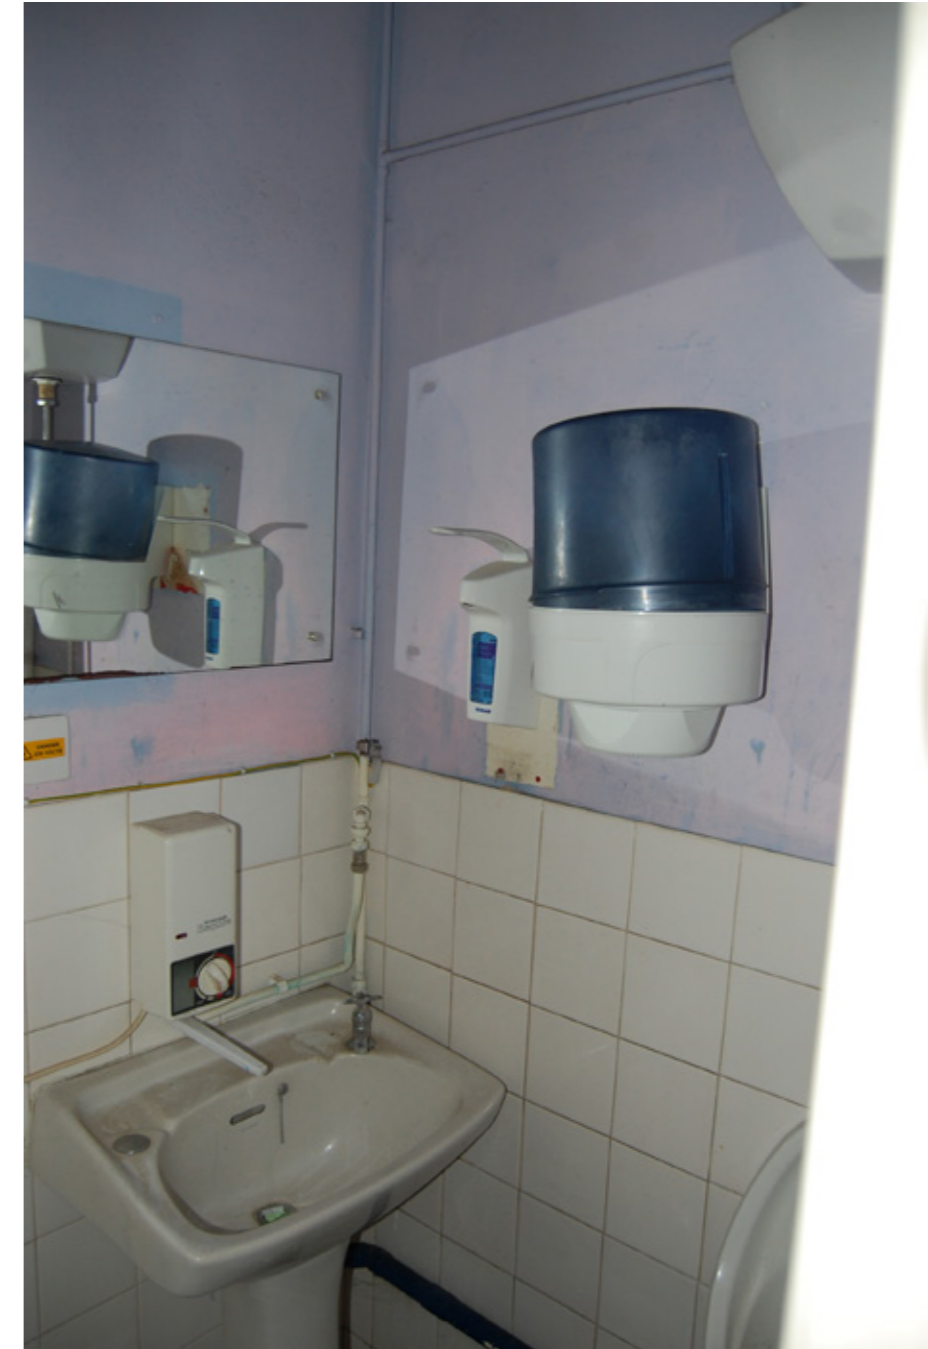
GROUND FLOOR: STABLEYARD - G5.07

Room Number:	G5.07
Current Room Use:	Stables/Store
Historic Room Use:	
Date of Structure:	1816-1848
Date of Fixtures / Fittings:	
Date of Decoration:	Late 20th century
Major Alterations:

Overall Significance Level:	Low
Key Historic Features:	Timber framed windows
Detrimental Features:	M&E, modern fit out
Condition Level:	
Condition Comments:	
Other Comments:
