VOLUME TWO

GAZETTEER

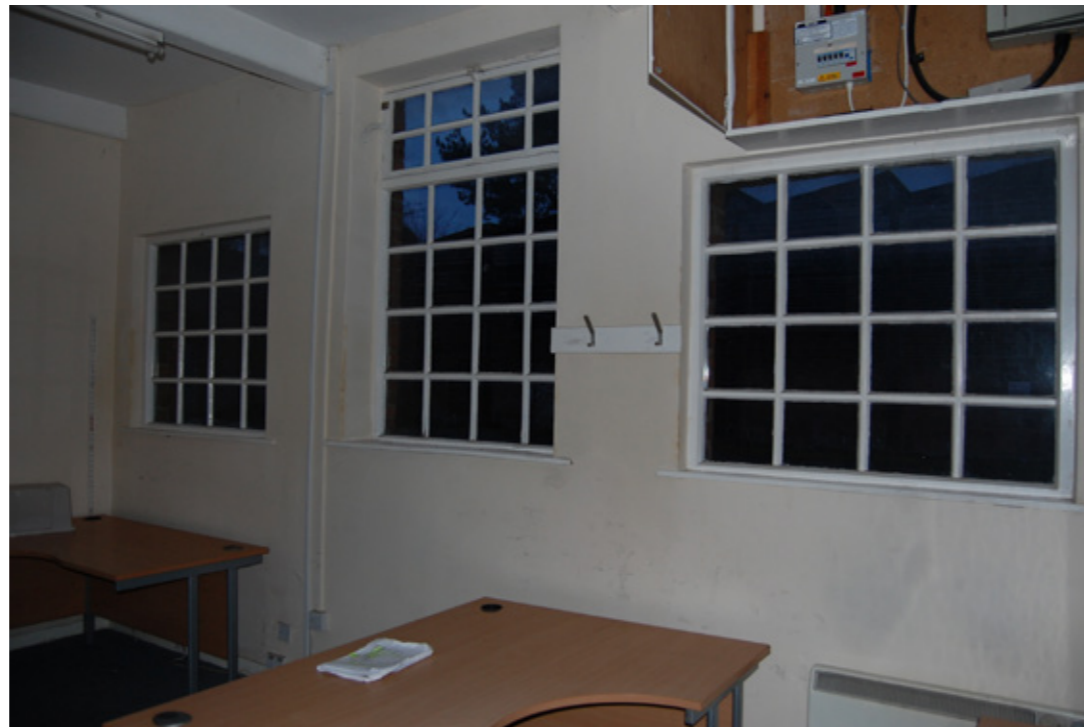
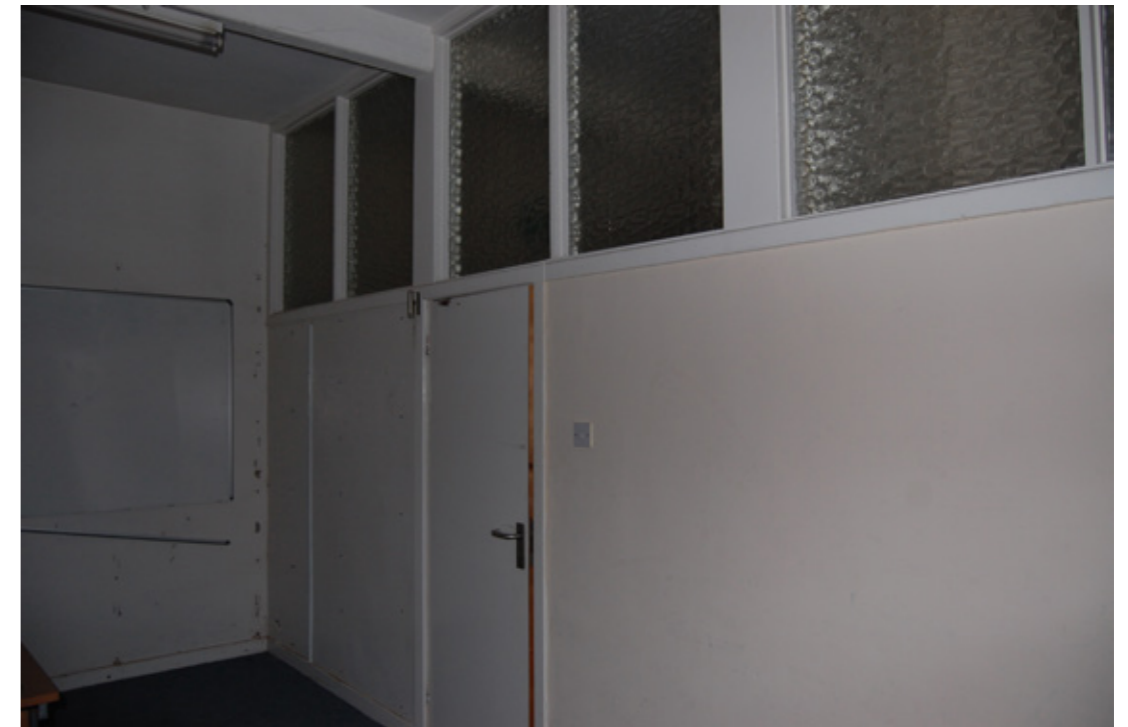
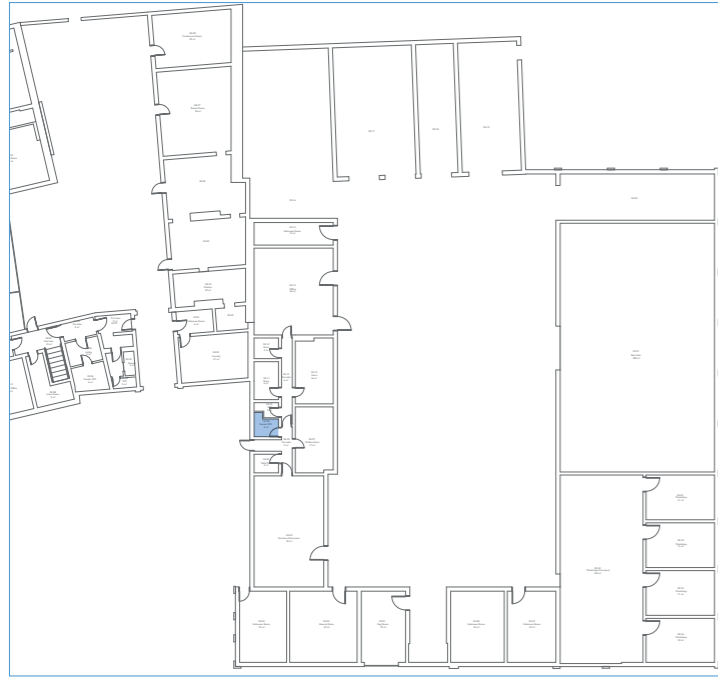
GROUND FLOOR: STABLEYARD - G5.08

Room Number:	G5.08
Current Room Use:	WC
Historic Room Use:	
Date of Structure:	1816-1848
Date of Fixtures / Fittings:	
Date of Decoration:	Late 20th century
Major Alterations:	
Overall Significance Level:	Low
Key Historic Features:	None
Detrimental Features:	M&E, modern fit out and sanitary ware
Condition Level:	
Condition Comments:	
Other Comments:

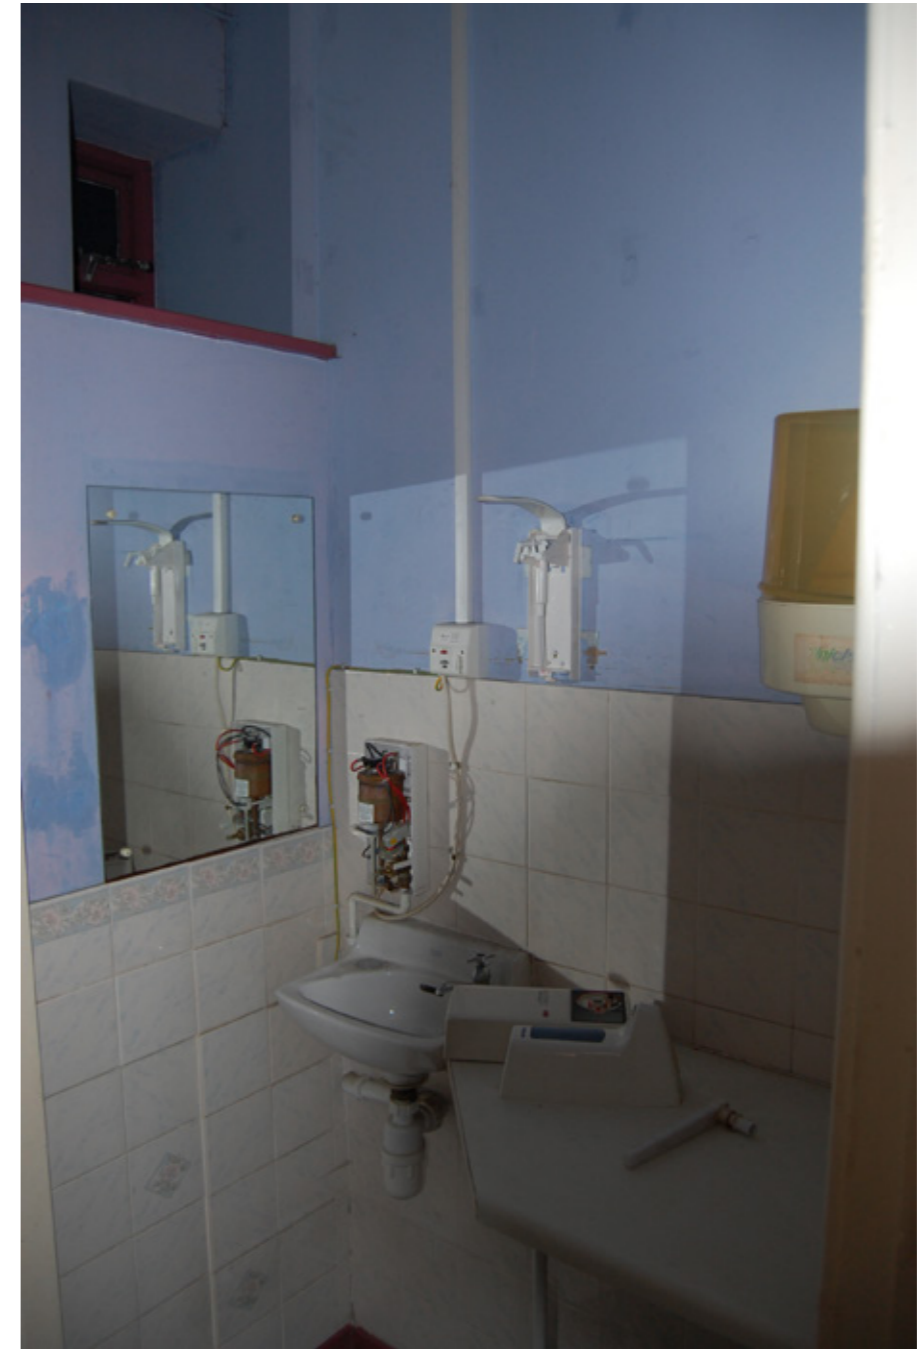
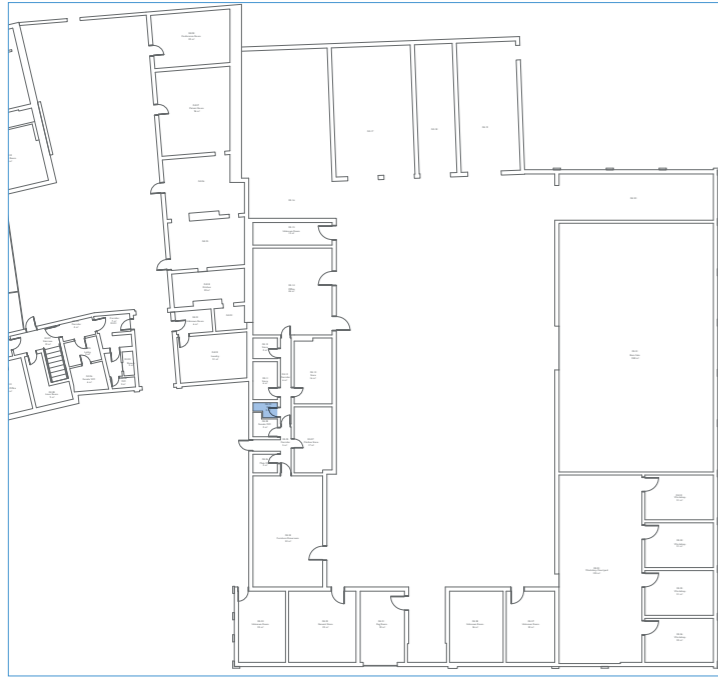
GROUND FLOOR: STABLEYARD - G5.09

Room Number:	G5.09
Current Room Use:	WC
Historic Room Use:	
Date of Structure:	1816-1848
Date of Fixtures / Fittings:	
Date of Decoration:	Late 20th century
Major Alterations:	
Overall Significance Level:	Low
Key Historic Features:	None
Detrimental Features:	M&E, modern fit out and sanitary ware
Condition Level:	
Condition Comments:	
Other Comments:

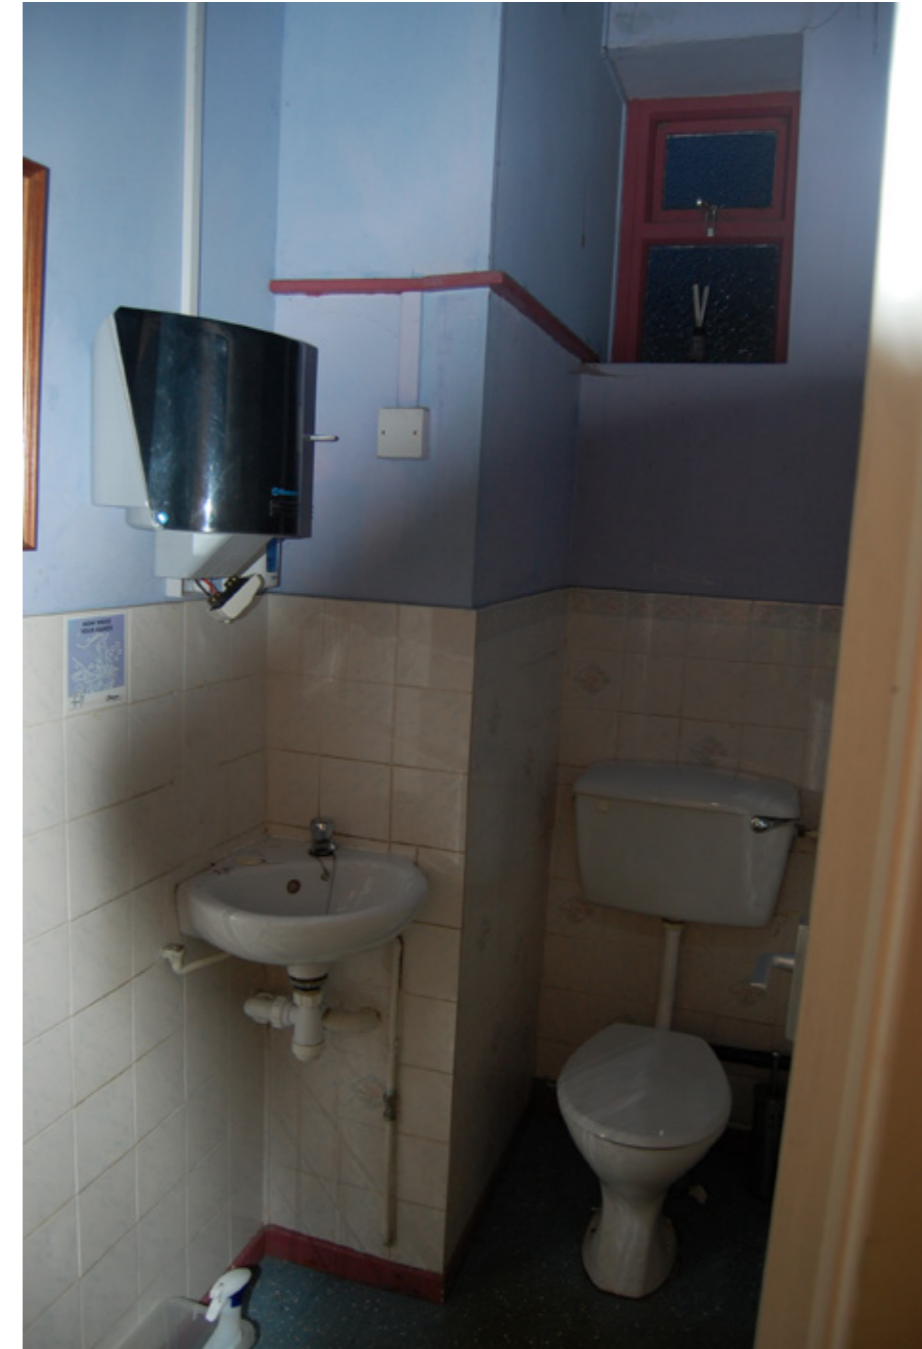
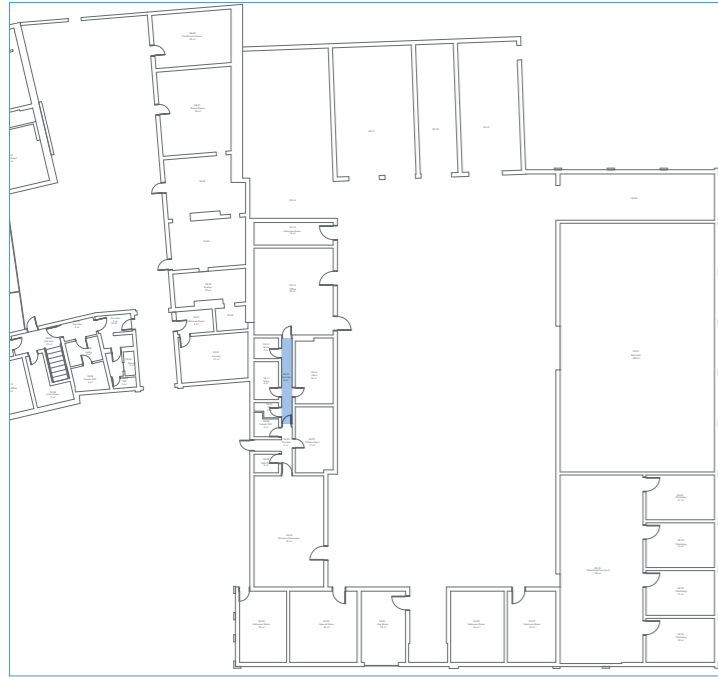
GROUND FLOOR: STABLEYARD - G5.10

Room Number:	G5.10
Current Room Use:	Corridor
Historic Room Use:	
Date of Structure:	1816-1848
Date of Fixtures / Fittings:	
Date of Decoration:	Late 20th century
Major Alterations:	
Overall Significance Level:	Low
Key Historic Features:	None
Detrimental Features:	Modern fit out
Condition Level:	
Condition Comments:	
Other Comments:

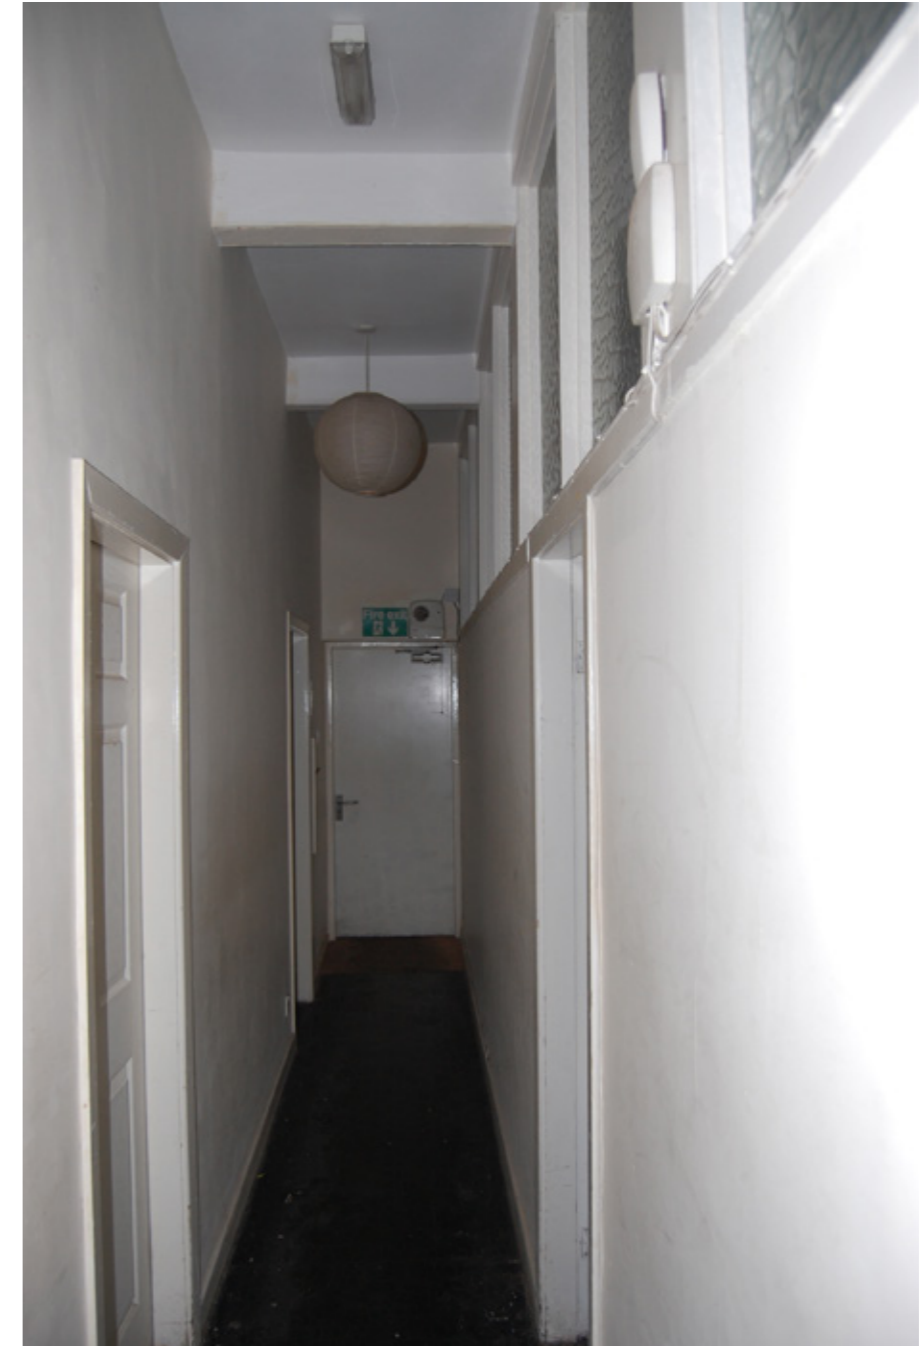
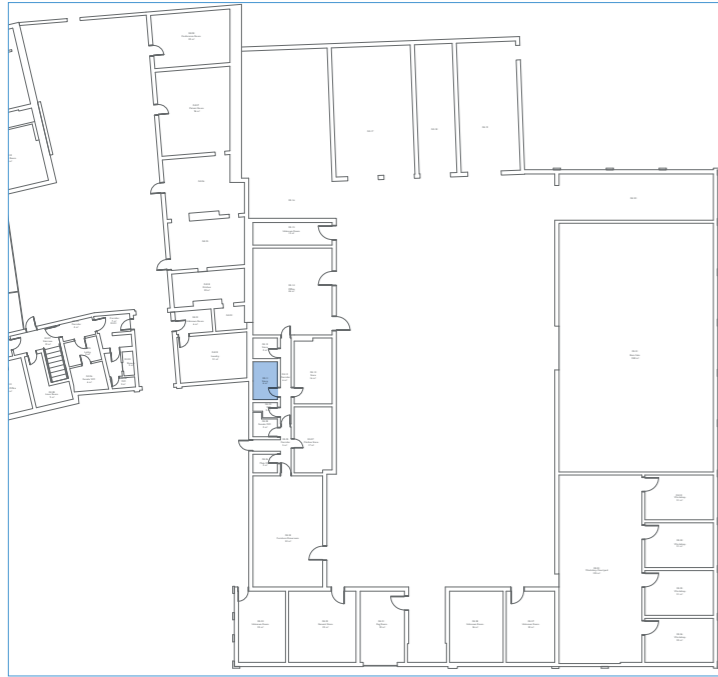
GROUND FLOOR: STABLEYARD - G5.II

Room Number:	G5.II
Current Room Use:	Stables/Store
Historic Room Use:	
Date of Structure:	1816-1848
Date of Fixtures / Fittings:	
Date of Decoration:	Late 20th century
Major Alterations:

Overall Significance Level:	Low
Key Historic Features:	Timber framed windows
Detrimental Features:	M&E
Condition Level:	
Condition Comments:	
Other Comments:

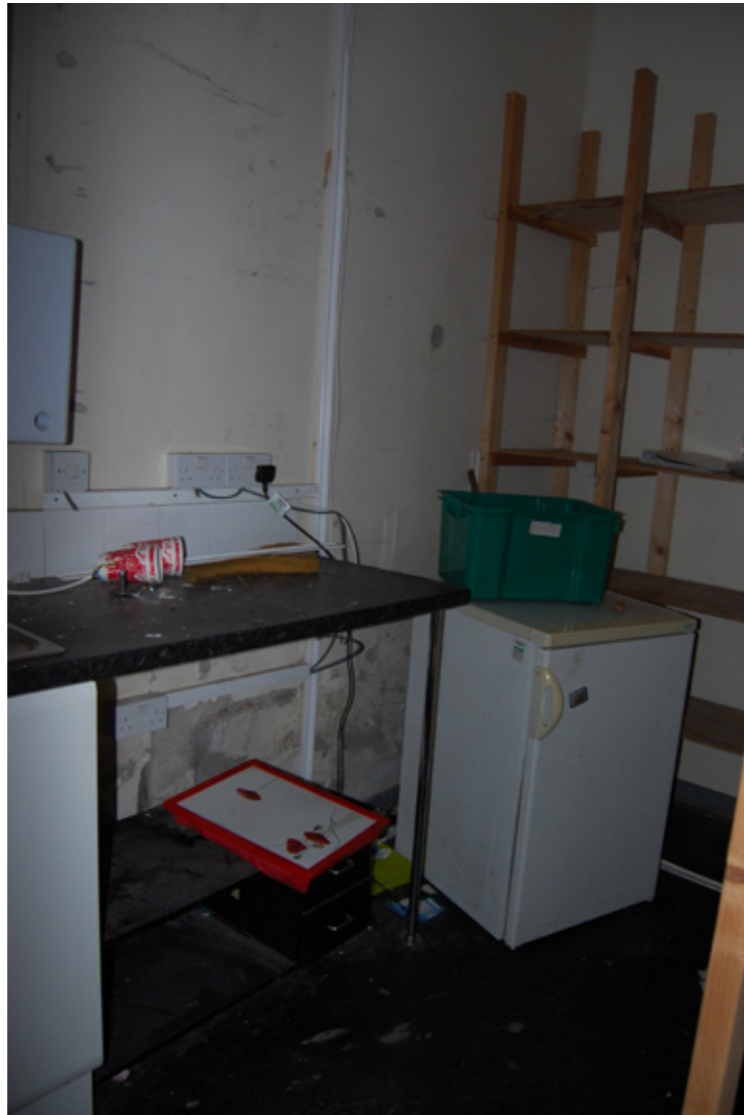
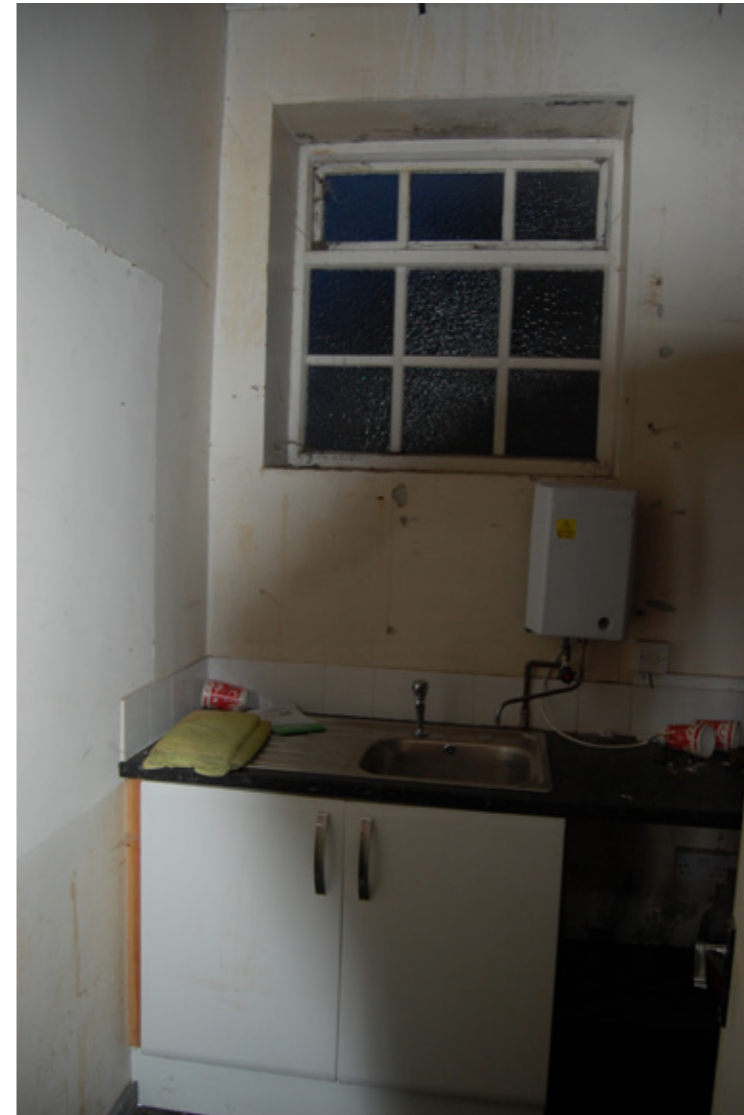
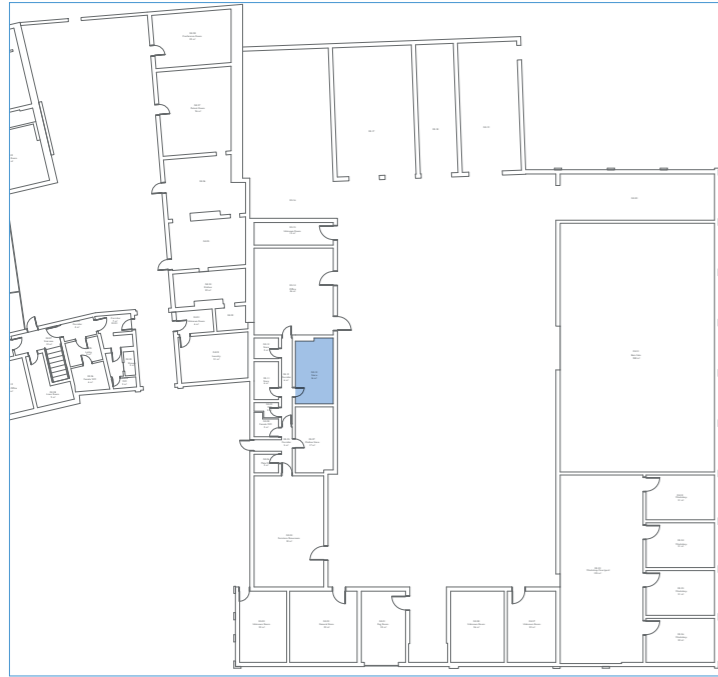
GROUND FLOOR: STABLEYARD - G5.12

Room Number:	G5.12
Current Room Use:	Stables/Store
Historic Room Use:	
Date of Structure:	1816-1848
Date of Fixtures / Fittings:	
Date of Decoration:	Late 20th century
Major Alterations:

Overall Significance Level:	Low
Key Historic Features:	Timber framed windows
Detrimental Features:	M&E, modern fit out
Condition Level:	
Condition Comments:	
Other Comments:

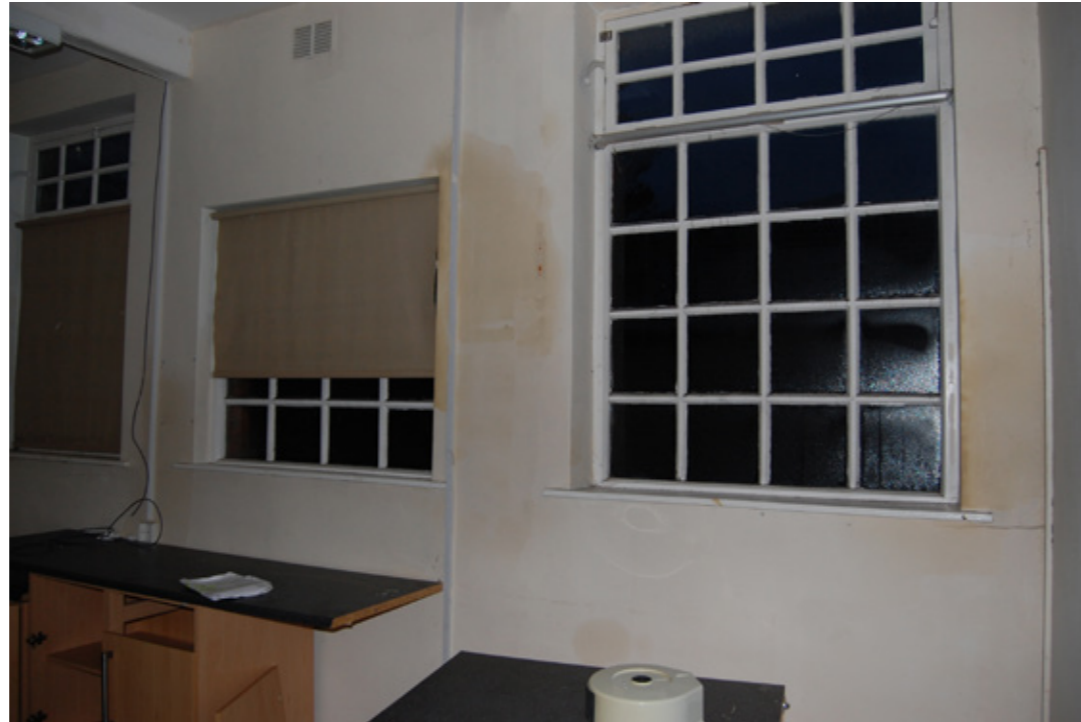
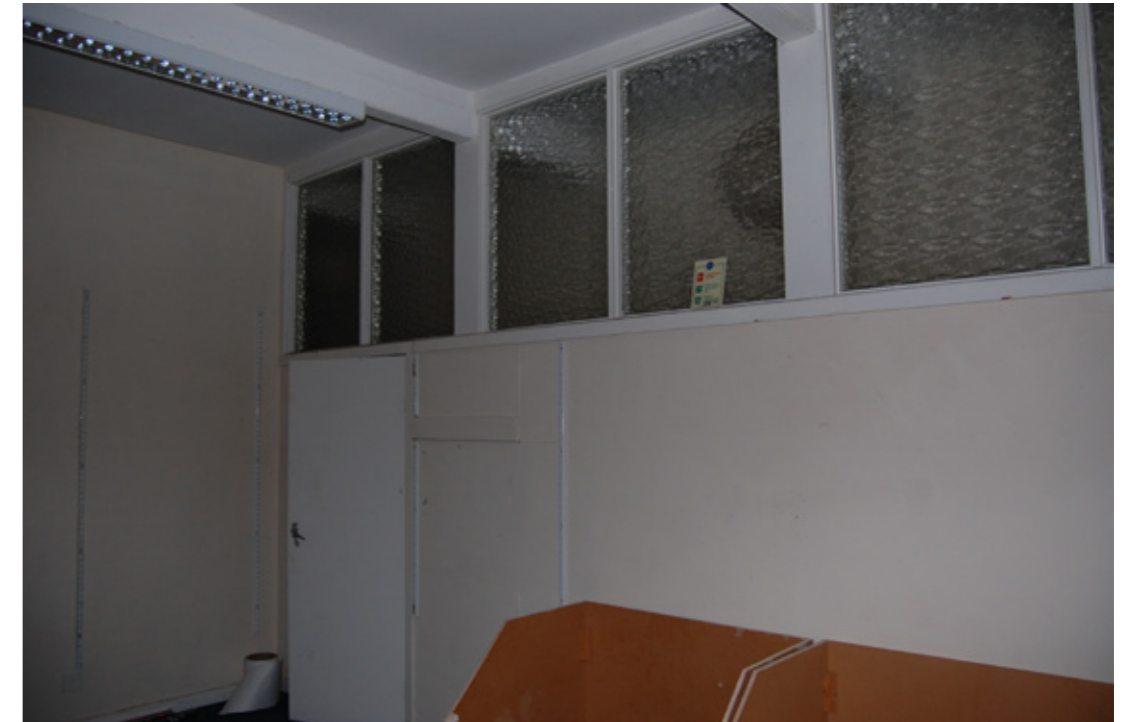
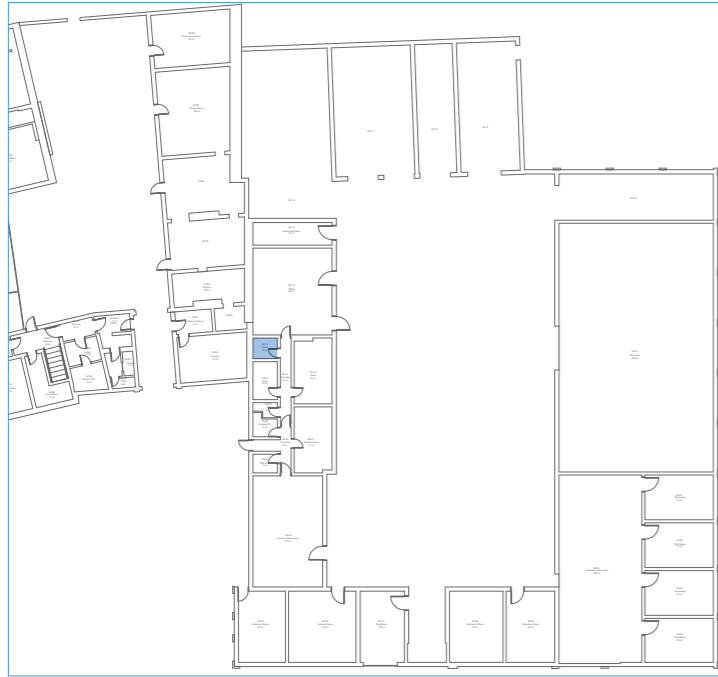
GROUND FLOOR: STABLEYARD - G5.13

Room Number:	G5.13
Current Room Use:	Stables/Store
Historic Room Use:	
Date of Structure:	1816-1848
Date of Fixtures / Fittings:	
Date of Decoration:	Late 20th century
Major Alterations:	
Overall Significance Level:	Low
Key Historic Features:	None
Detrimental Features:	Modern fit out
Condition Level:	
Condition Comments:	
Other Comments:

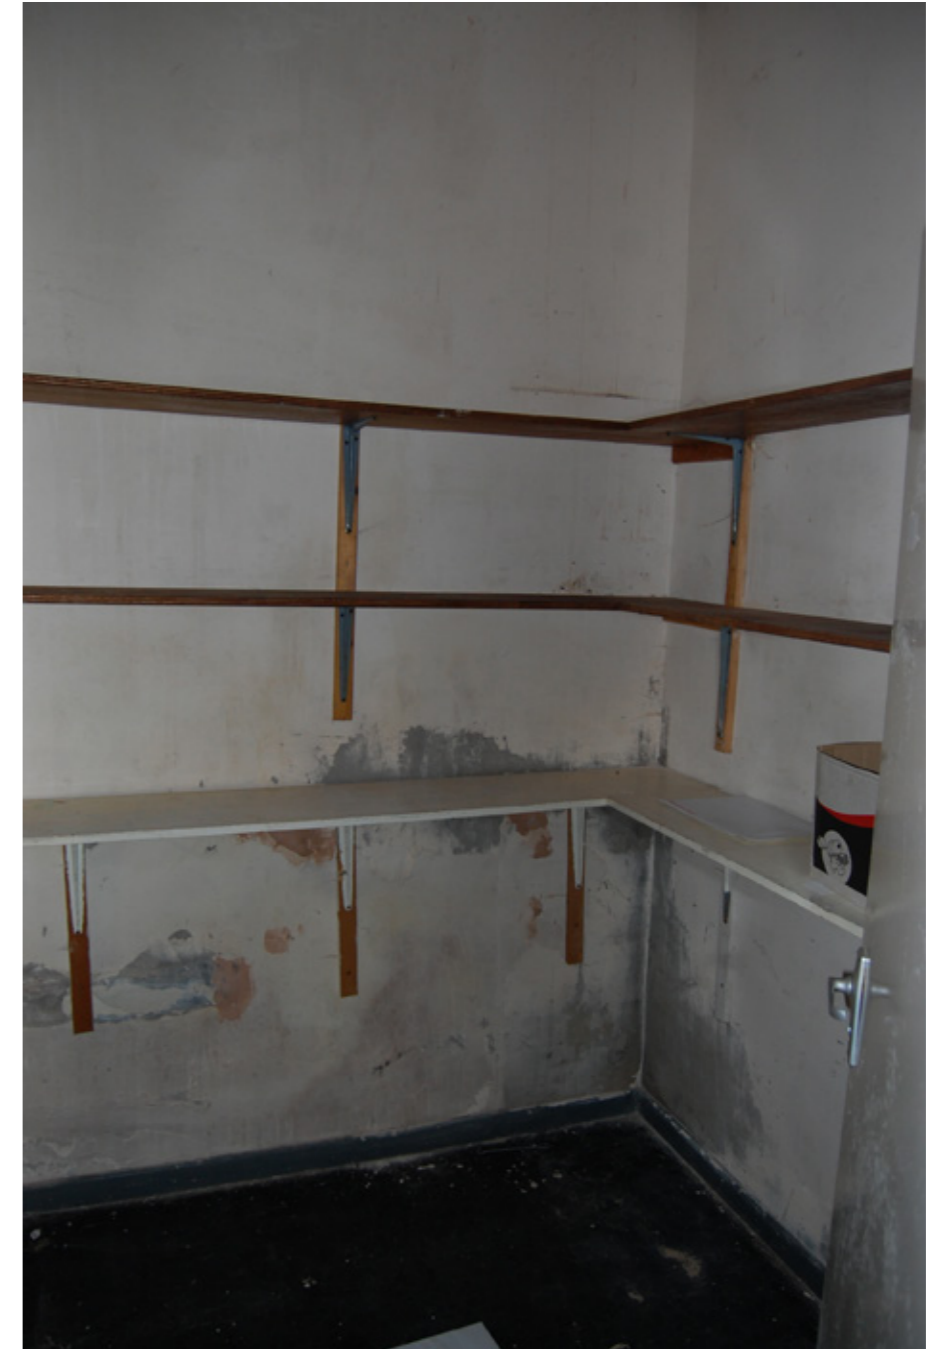
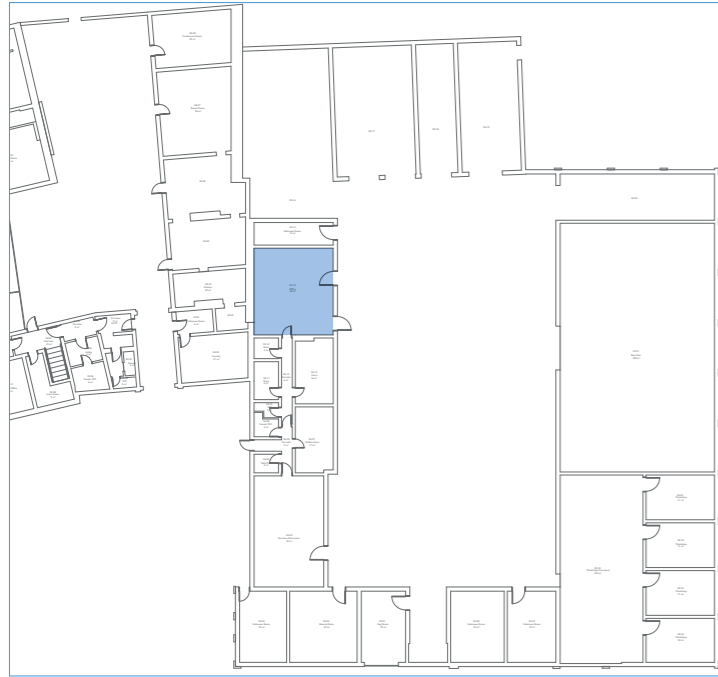
GROUND FLOOR: STABLEYARD - G5.14

Room Number:	G5.14
Current Room Use:	Office
Historic Room Use:	
Date of Structure:	1816-1848
Date of Fixtures / Fittings:	
Date of Decoration:	Late 20th century
Major Alterations:

Overall Significance Level:	Low
Key Historic Features:	Timber framed windows, door opening
Detrimental Features:	M&E, modern fit out, inserted stair
Condition Level:	
Condition Comments:	
Other Comments:

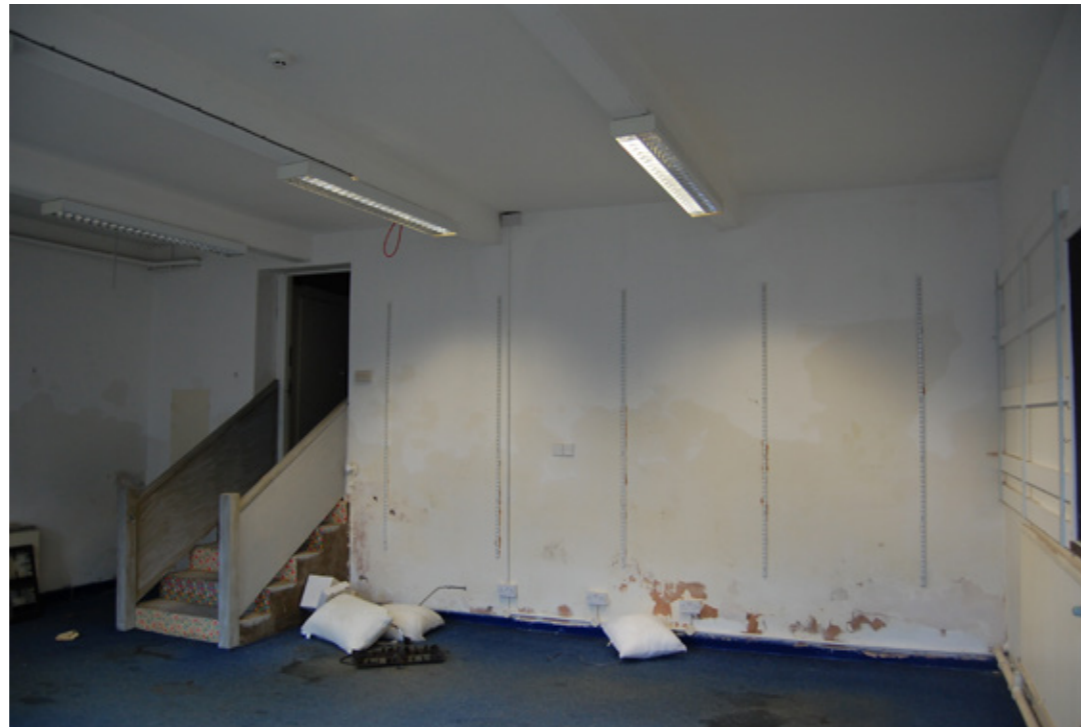
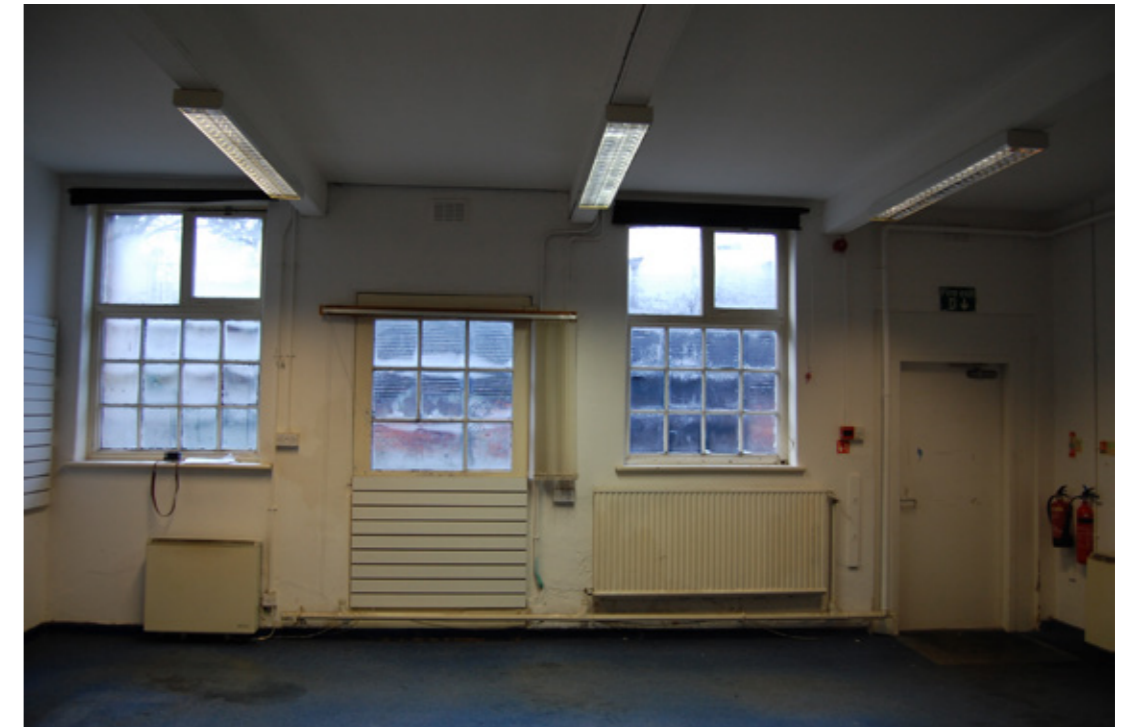
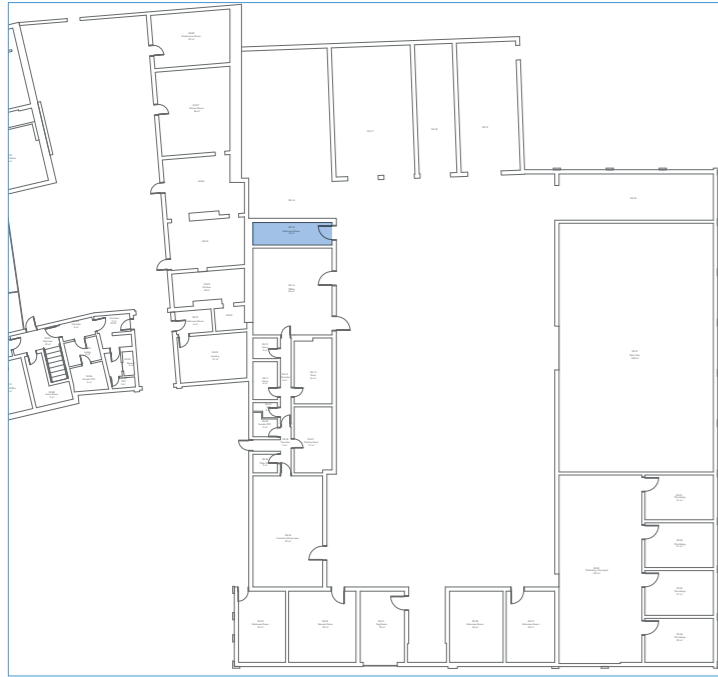
GROUND FLOOR: STABLEYARD - G5.15

Room Number:	G5.15
Current Room Use:	Stables/Store
Historic Room Use:	
Date of Structure:	1816-1848
Date of Fixtures / Fittings:	
Date of Decoration:	19th century
Major Alterations:

Overall Significance Level:	Low
Key Historic Features:	Timber framed window, lath and plaster wall/ceiling, stable kick boards
Detrimental Features:	Brick infill
Condition Level:	
Condition Comments:	
Other Comments:

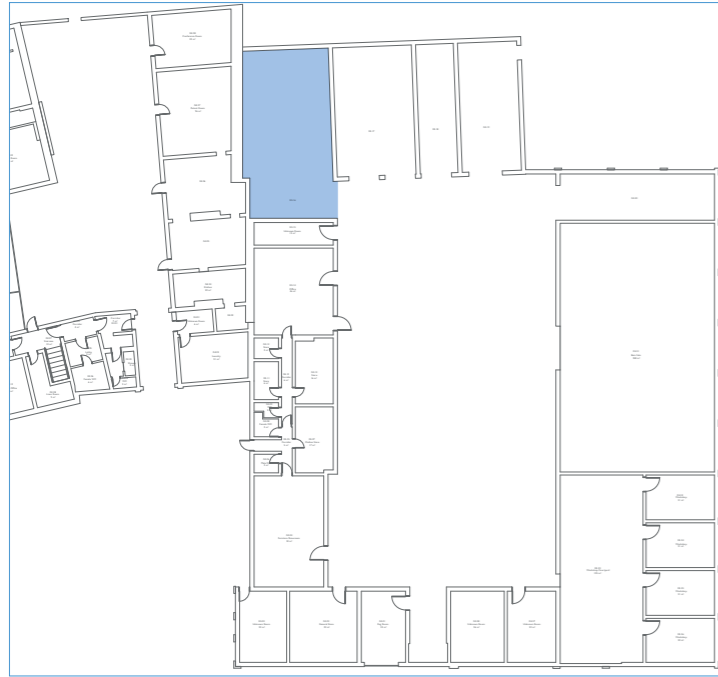
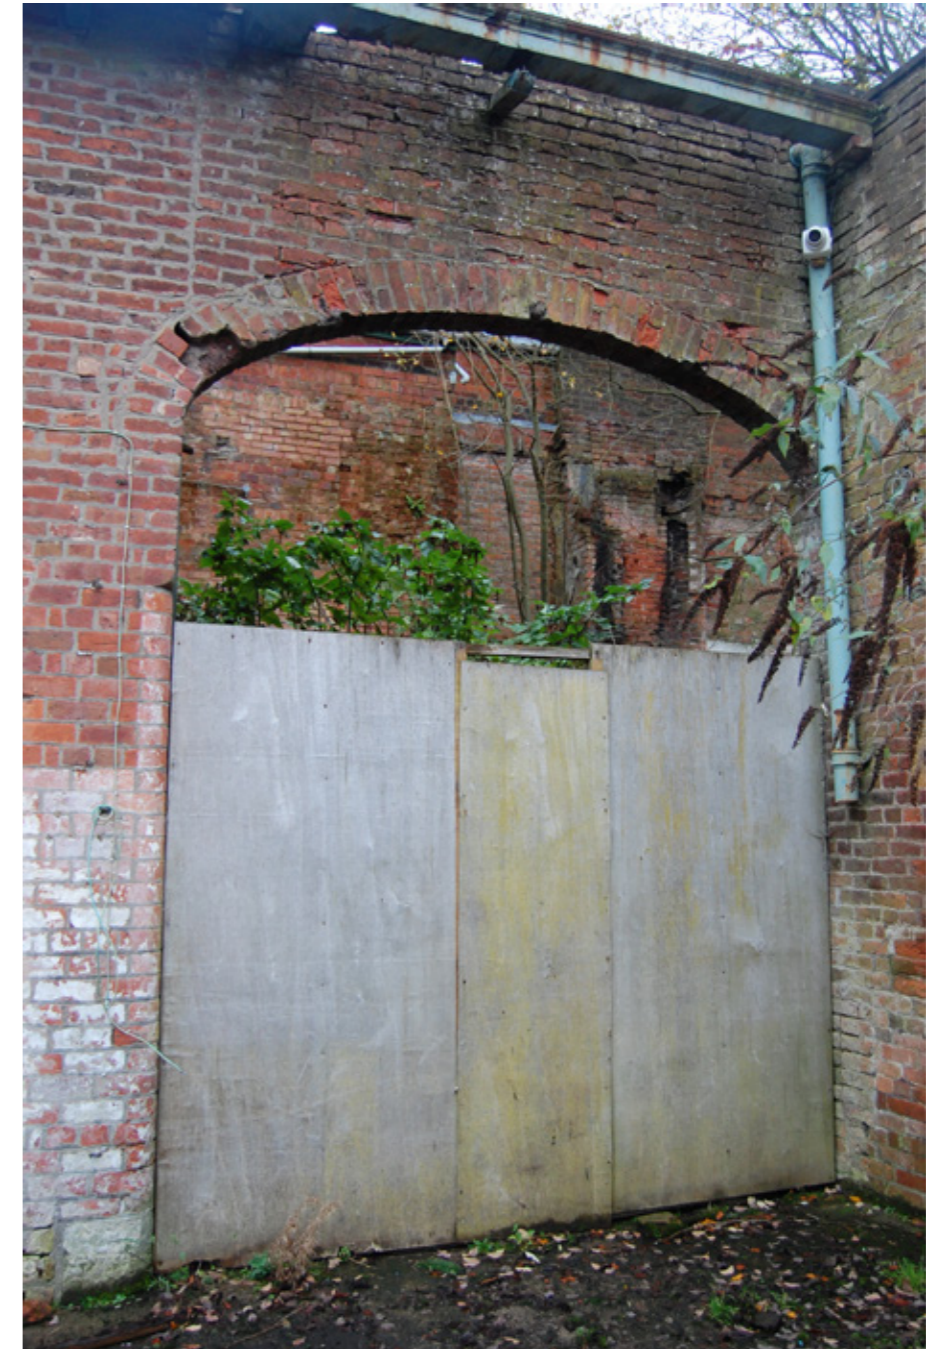
GROUND FLOOR: STABLEYARD - G5.16

Room Number:	G5.16
Current Room Use:	Ruined Structure
Historic Room Use:	
Date of Structure:	1816-1848
Date of Fixtures / Fittings:	
Date of Decoration:	n/a
Major Alterations:	
Overall Significance Level:	Detrimental
Key Historic Features:	Brick archways
Detrimental Features:	Ruin
Condition Level:	
Condition Comments:	
Other Comments:

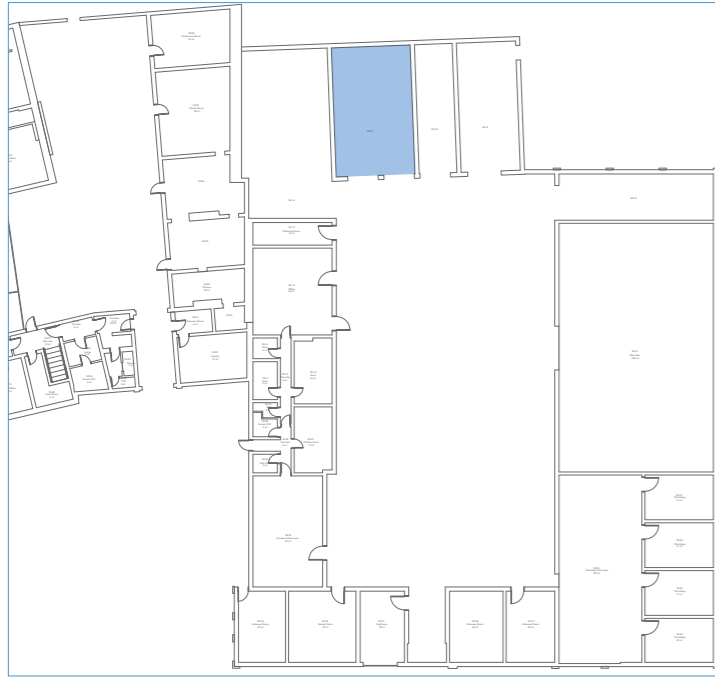
GROUND FLOOR: STABLEYARD - G5.17

Room Number:	G5.17
Current Room Use:	Ruined Structure
Historic Room Use:	
Date of Structure:	1816-1848
Date of Fixtures / Fittings:	
Date of Decoration:	n/a
Major Alterations:

Overall Significance Level:	Detrimental
Key Historic Features:	Brick archways
Detrimental Features:	Ruin
Condition Level:	
Condition Comments:	
Other Comments:

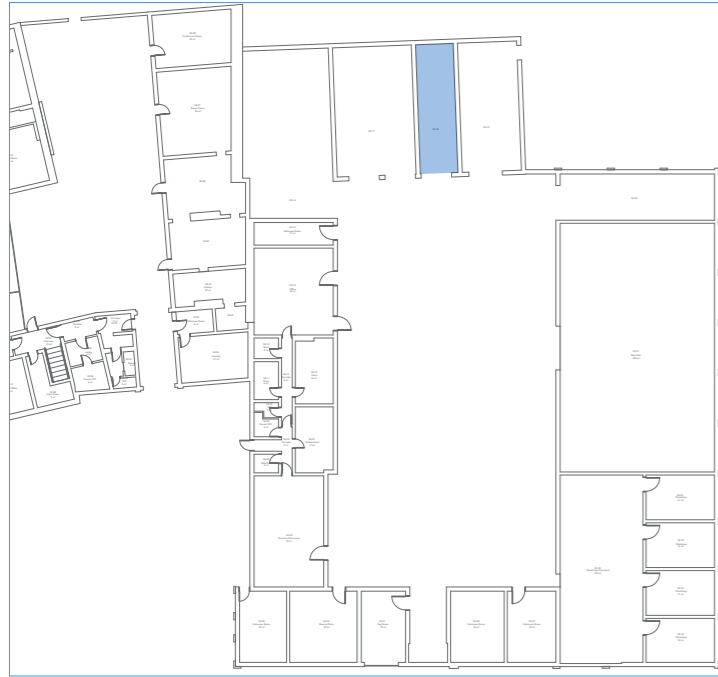
GROUND FLOOR: STABLEYARD - G5.18

Room Number:	G5.18
Current Room Use:	Ruined Structure
Historic Room Use:	
Date of Structure:	1816-1848
Date of Fixtures / Fittings:	
Date of Decoration:	n/a
Major Alterations:	
Overall Significance Level:	Detrimental
Key Historic Features:	Brick archways
Detrimental Features:	Ruin
Condition Level:	
Condition Comments:	
Other Comments:

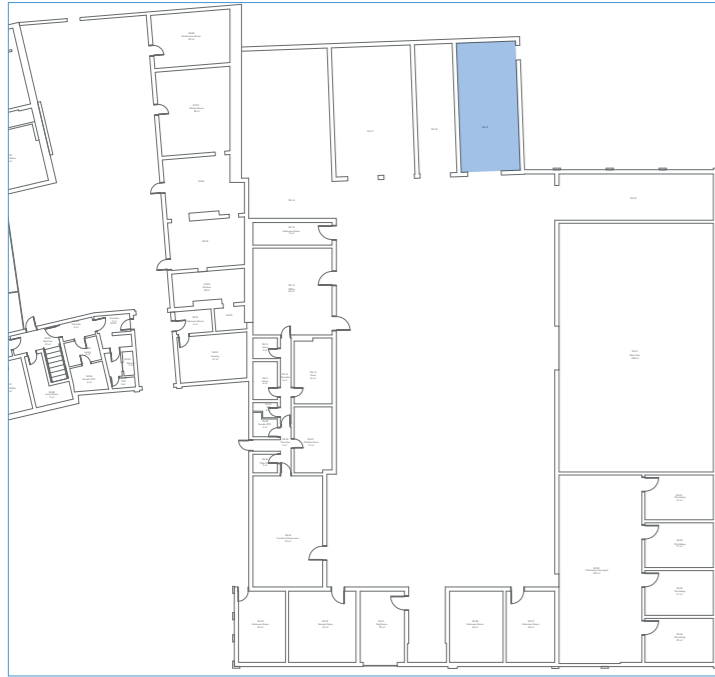
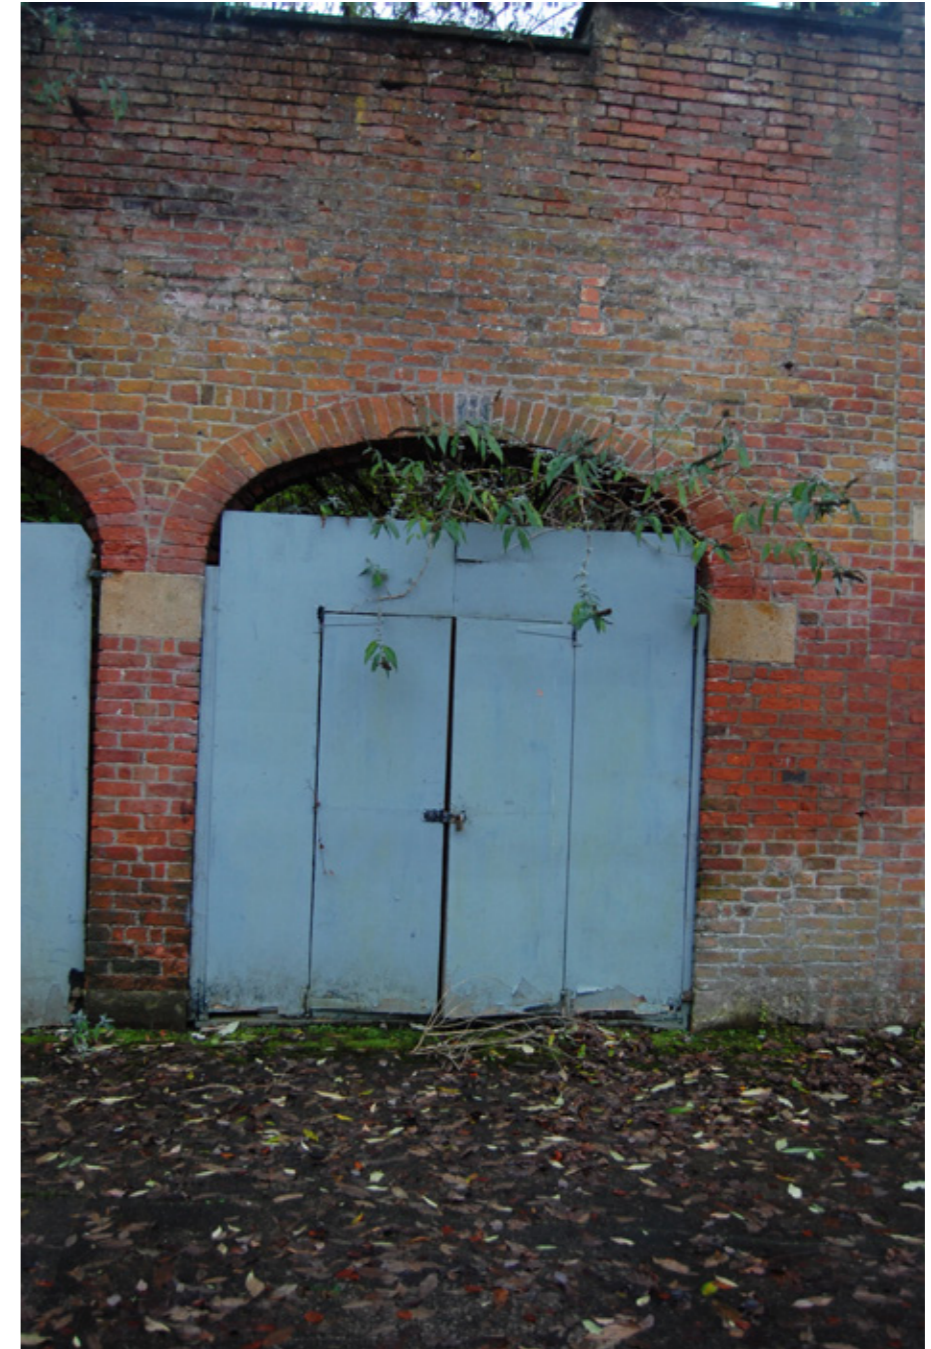
GROUND FLOOR: STABLEYARD - G5.19

Room Number:	G5.19
Current Room Use:	Ruined Structure
Historic Room Use:	
Date of Structure:	1816-1848
Date of Fixtures / Fittings:	
Date of Decoration:	n/a
Major Alterations:	
Overall Significance Level:	Detrimental
Key Historic Features:	Brick archways
Detrimental Features:	Ruin
Condition Level:	
Condition Comments:	
Other Comments:

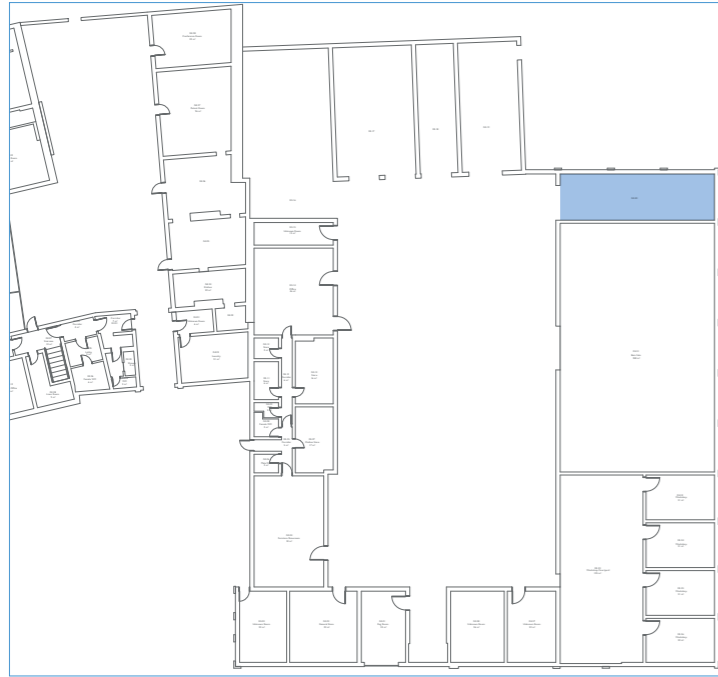
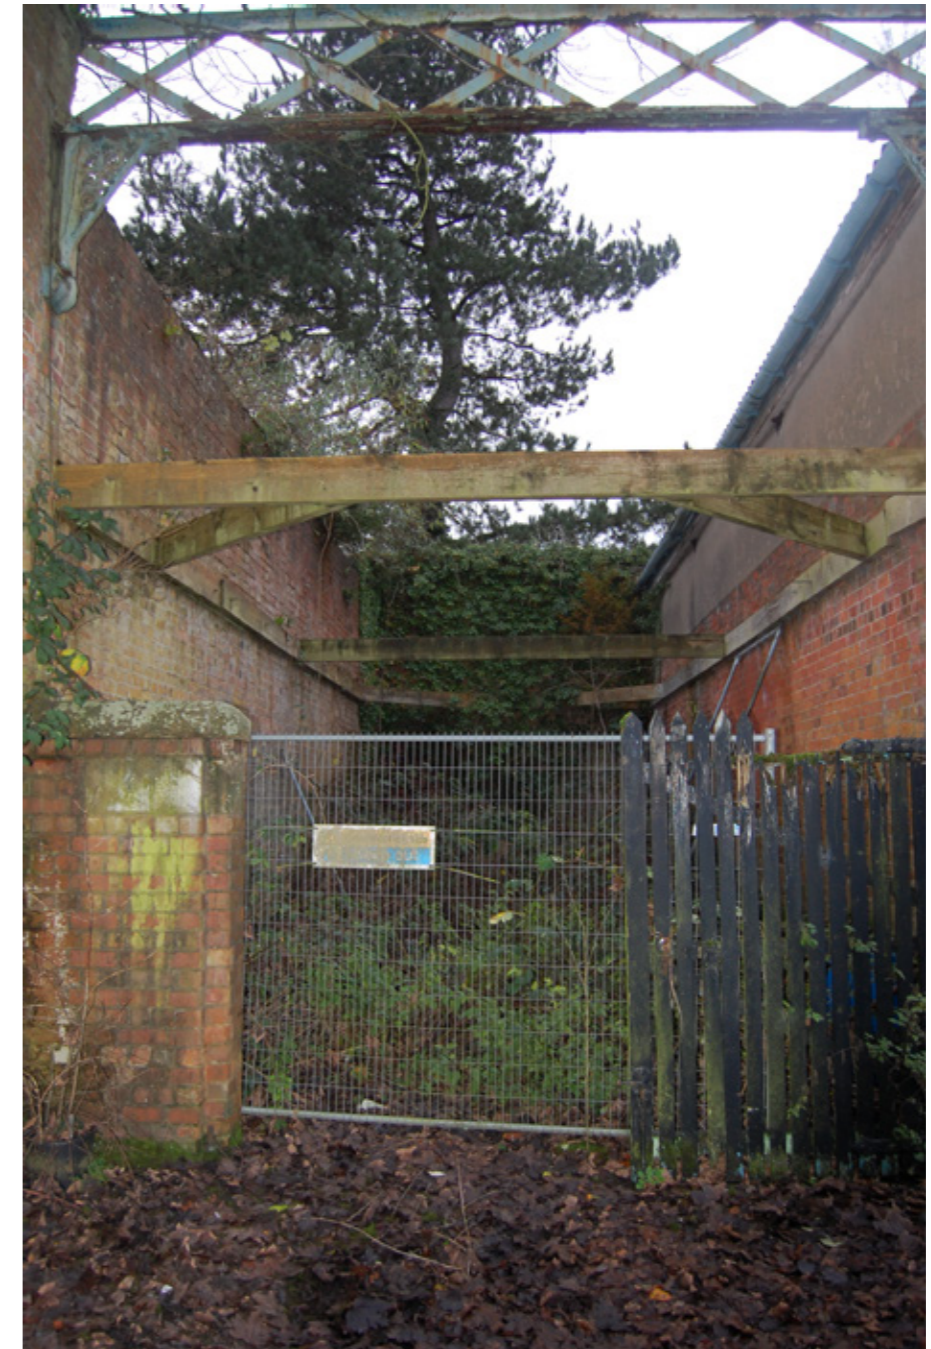
GROUND FLOOR: STABLEYARD - G5.20

Room Number:	G5.20
Current Room Use:	Ruined Structure
Historic Room Use:	
Date of Structure:	1848-1893
Date of Fixtures / Fittings:	
Date of Decoration:	n/a
Major Alterations:	
Overall Significance Level:	Detrimental
Key Historic Features:	Metalwork
Detrimental Features:	Ruin
Condition Level:	
Condition Comments:	
Other Comments:
