VOLUME TWO

GAZETTEER

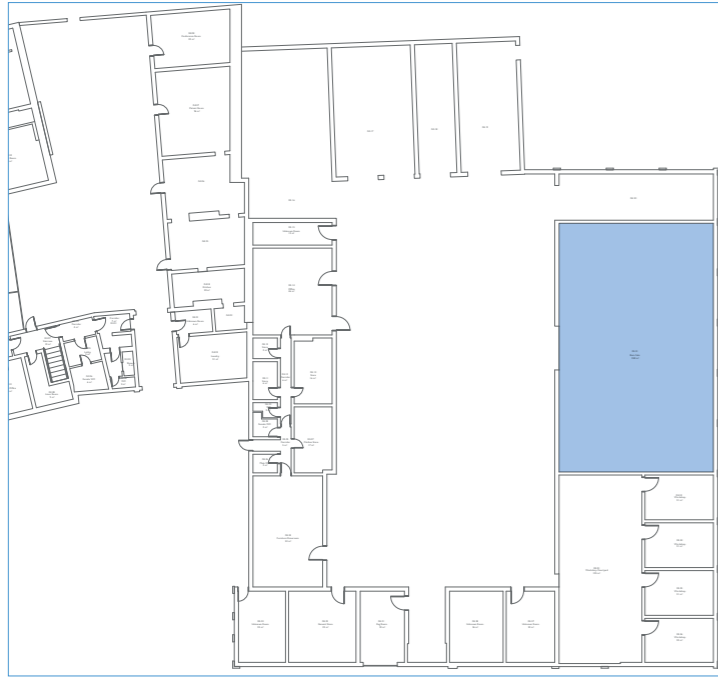
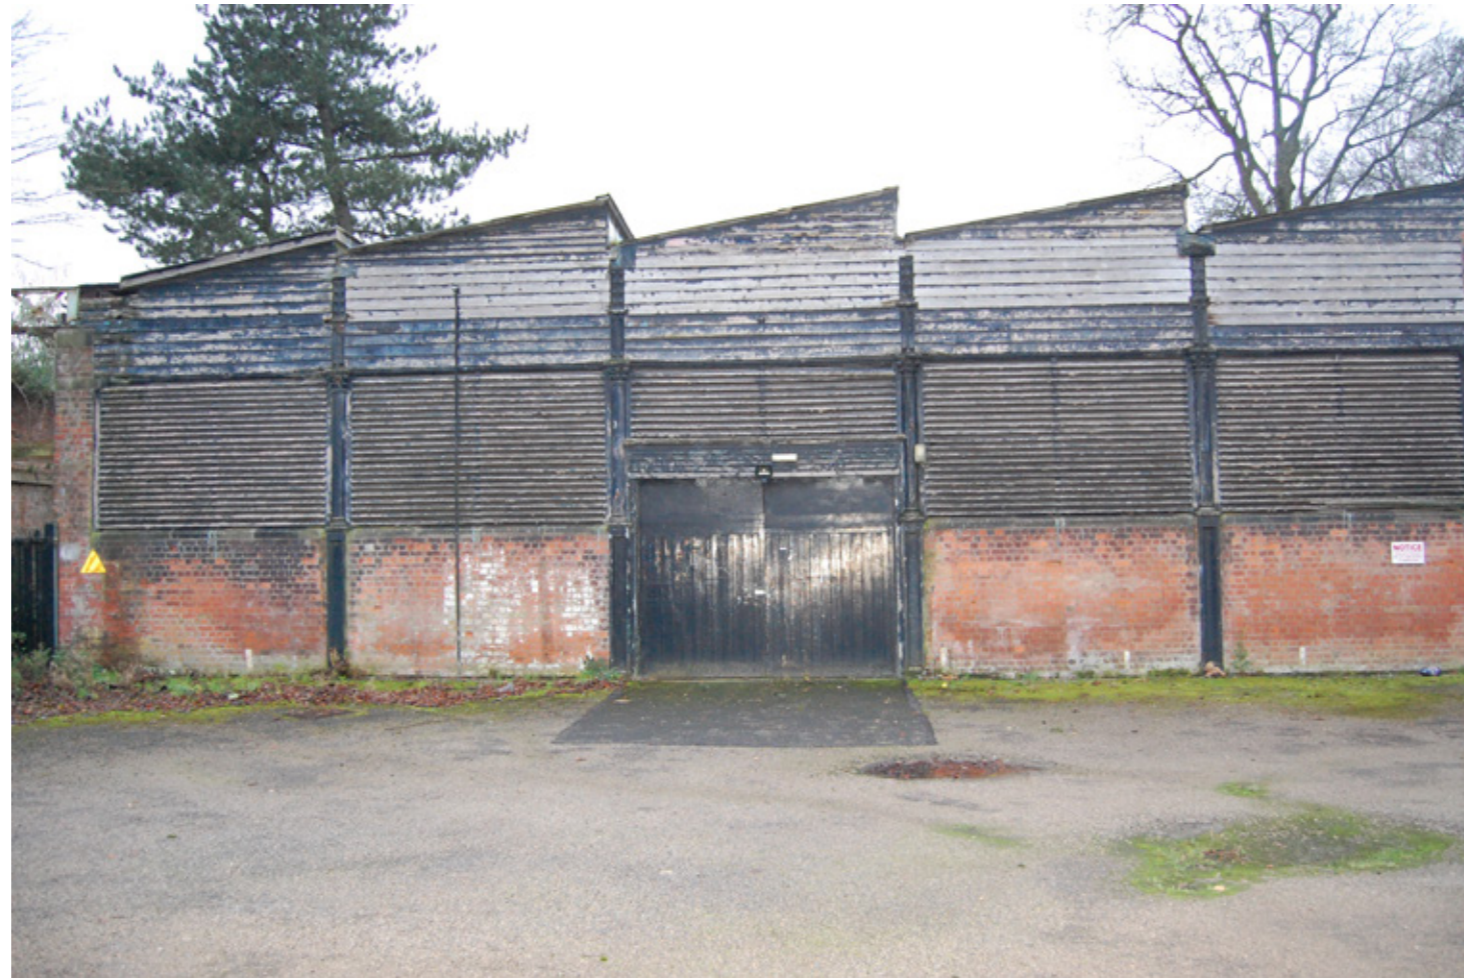
GROUND FLOOR: STABLEYARD - G5.2I

Room Number:	G5.2I
Current Room Use:	Garage
Historic Room Use:	
Date of Structure:	1848-1893
Date of Fixtures / Fittings:	
Date of Decoration:	No access
Major Alterations:

Overall Significance Level:	Neutral
Key Historic Features:	Roof profile, classical detailing on metal columns
Detrimental Features:	No access
Condition Level:	
Condition Comments:	
Other Comments:

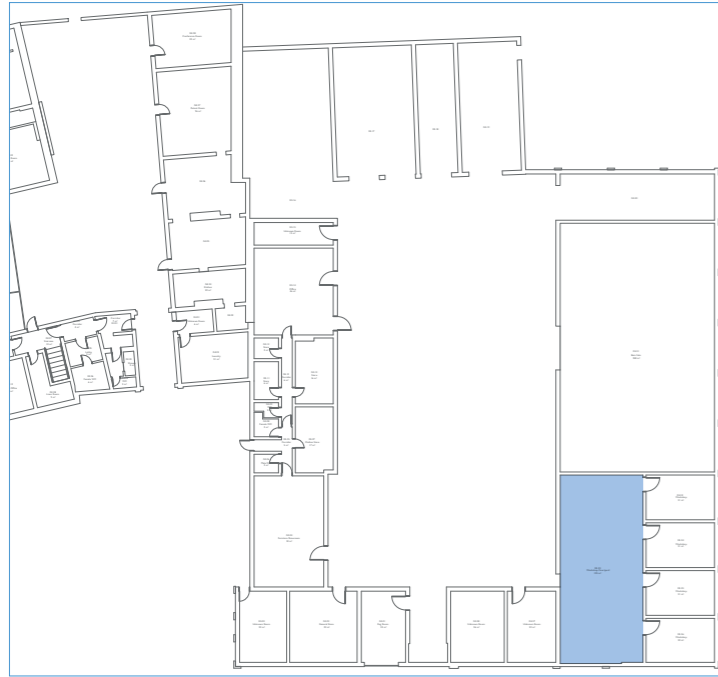
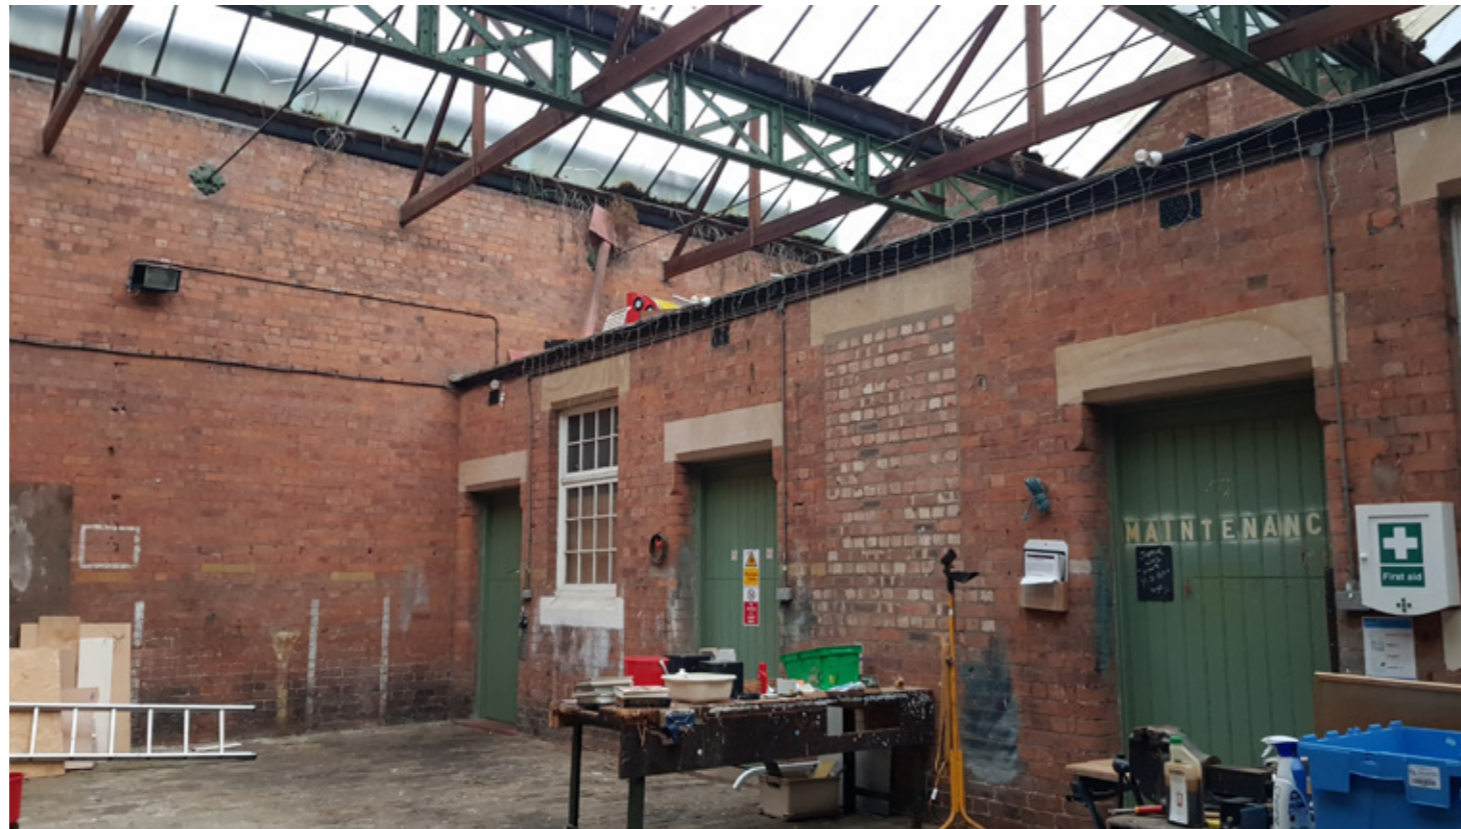
GROUND FLOOR: STABLEYARD - G5.22

Room Number:	G5.22
Current Room Use:	Workshop
Historic Room Use:	
Date of Structure:	1848-1893
Date of Fixtures / Fittings:	
Date of Decoration:	Late 19th / early 20th century
Major Alterations:

Overall Significance Level:	Low
Key Historic Features:	Glazed roof and metalwork, stable doors
Detrimental Features:	M&E
Condition Level:	
Condition Comments:	
Other Comments:

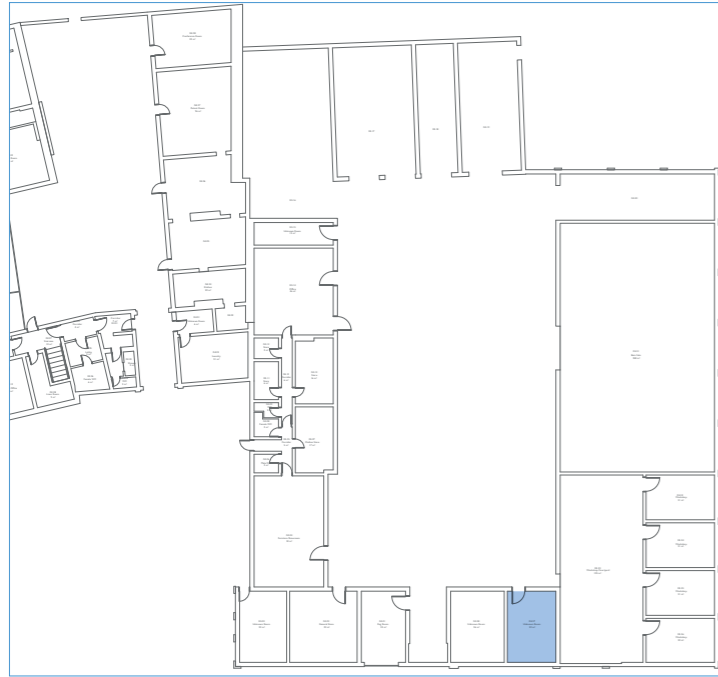
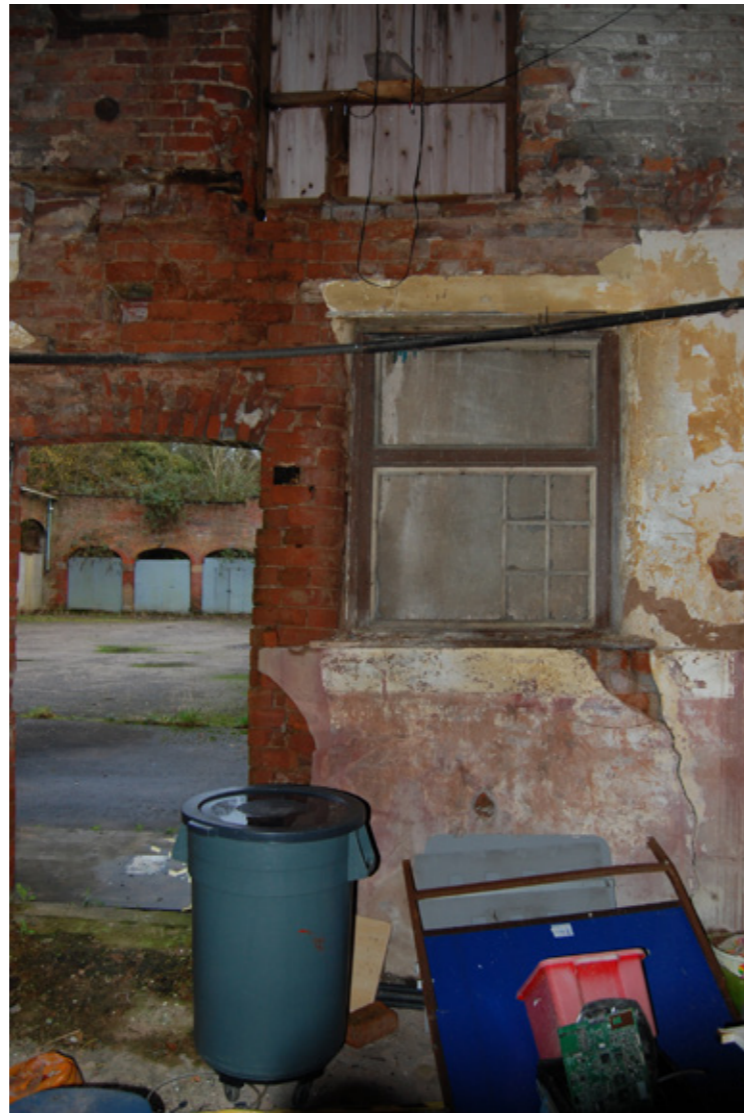
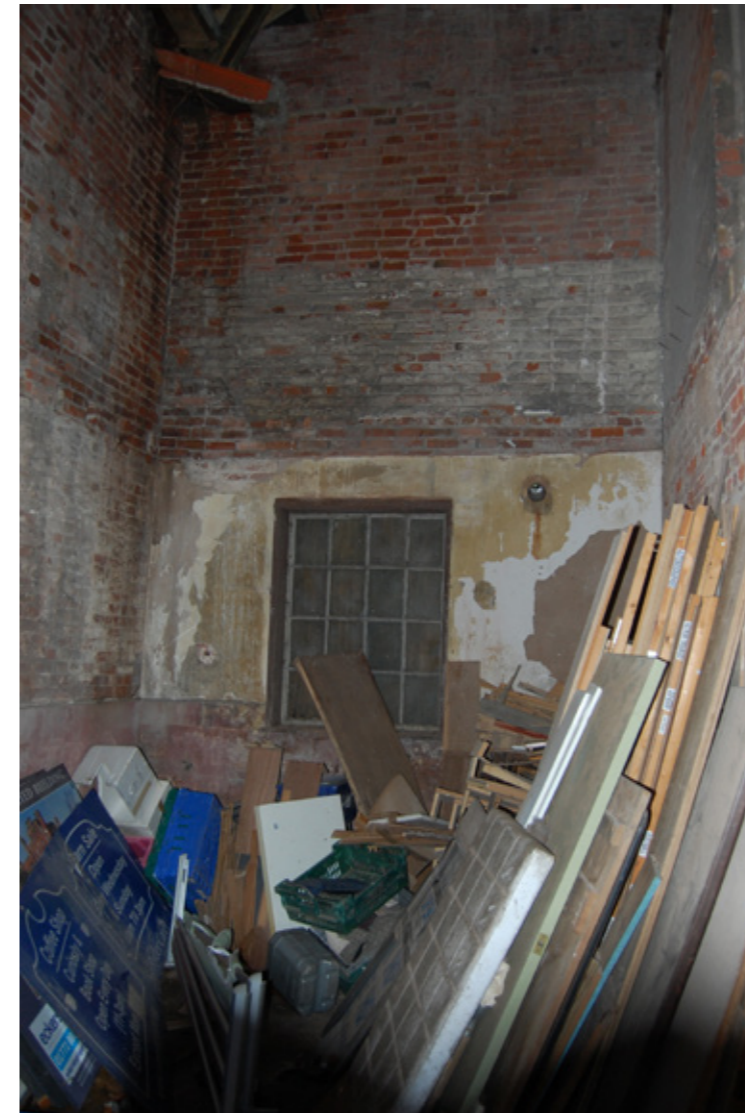
GROUND FLOOR: STABLEYARD - G5.27

Room Number:	G5.27
Current Room Use:	Stables/Store
Historic Room Use:	
Date of Structure:	1816-1848
Date of Fixtures / Fittings:	
Date of Decoration:	Derelict / 20th century
Major Alterations:

Overall Significance Level:	Low
Key Historic Features:	Timber framed windows
Detrimental Features:	M&E
Condition Level:	
Condition Comments:	
Other Comments:

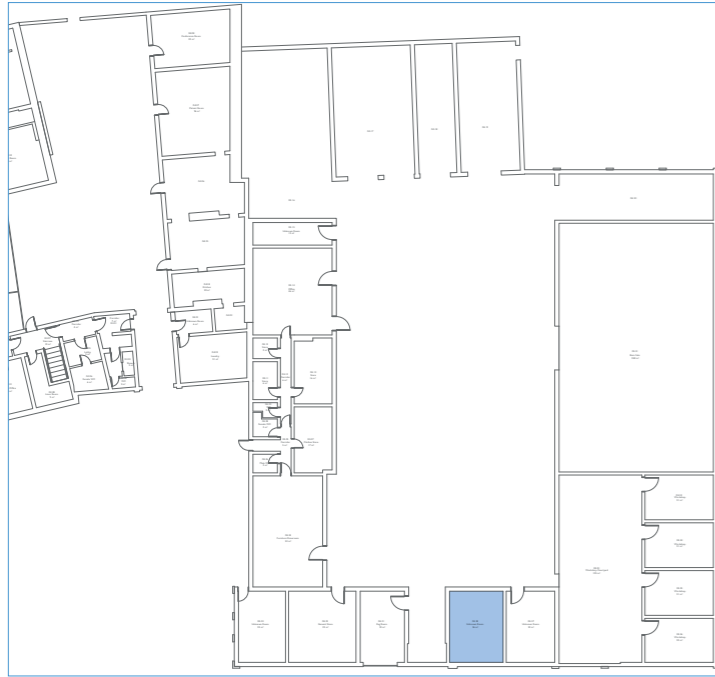
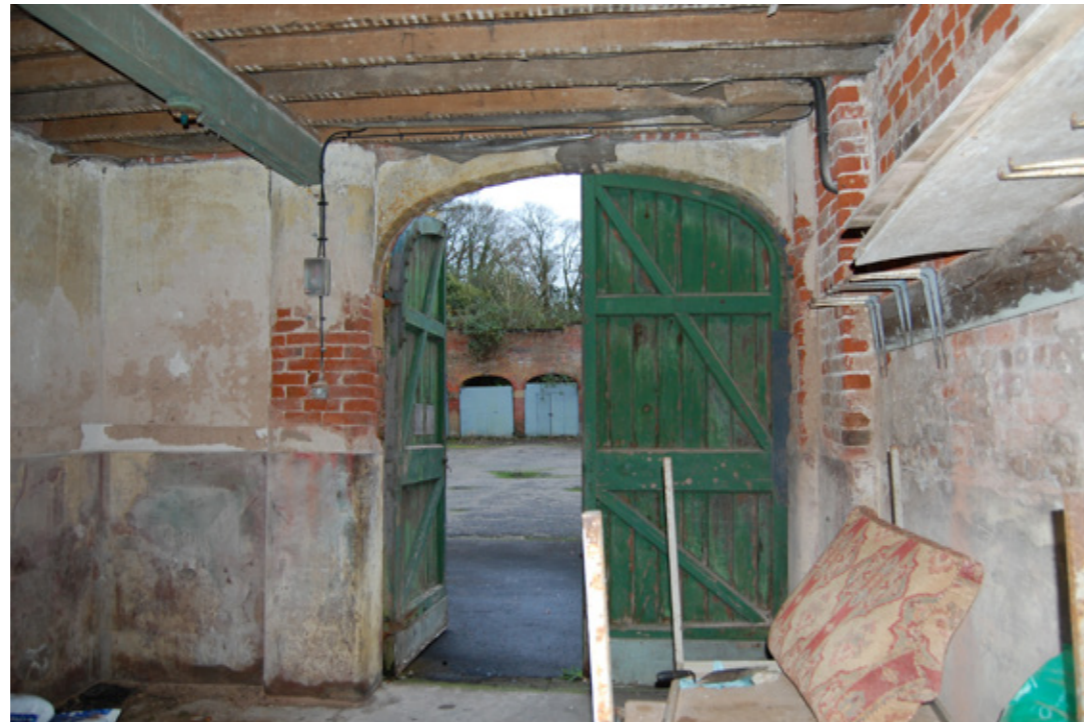
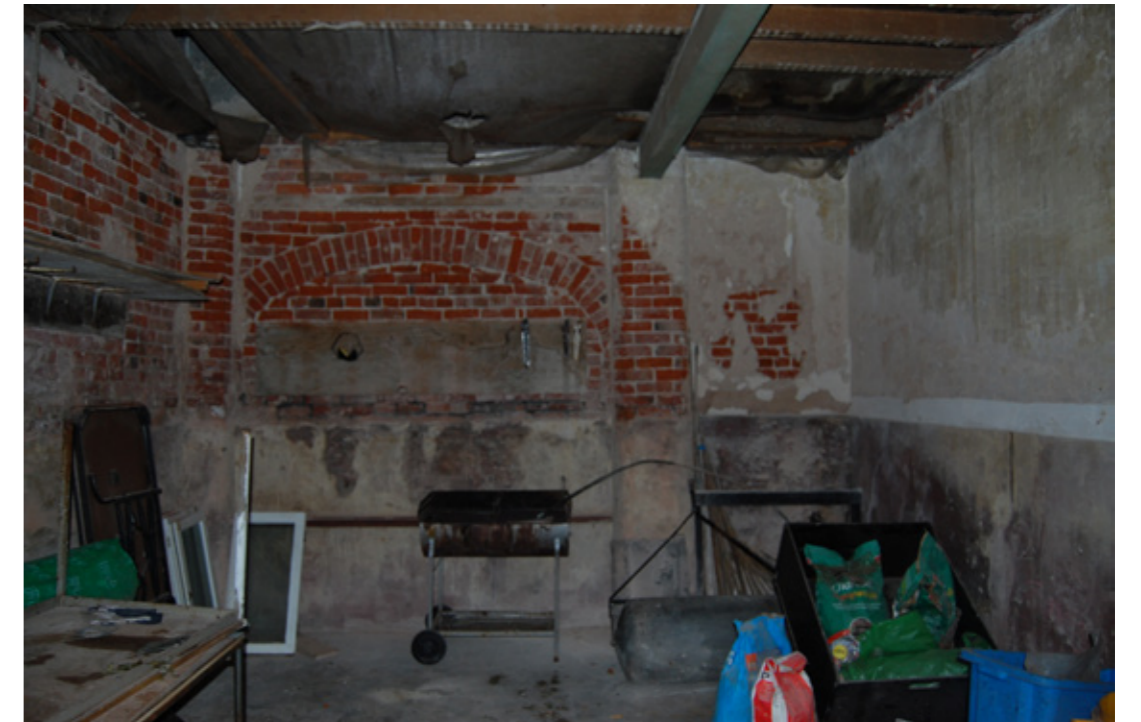
GROUND FLOOR: STABLEYARD - G5.28

Room Number:	G5.28
Current Room Use:	Stables/Store
Historic Room Use:	
Date of Structure:	1816-1848
Date of Fixtures / Fittings:	
Date of Decoration:	20th century
Major Alterations:

Overall Significance Level:	Low
Key Historic Features:	Timber doors
Detrimental Features:	M&E
Condition Level:	
Condition Comments:	
Other Comments:

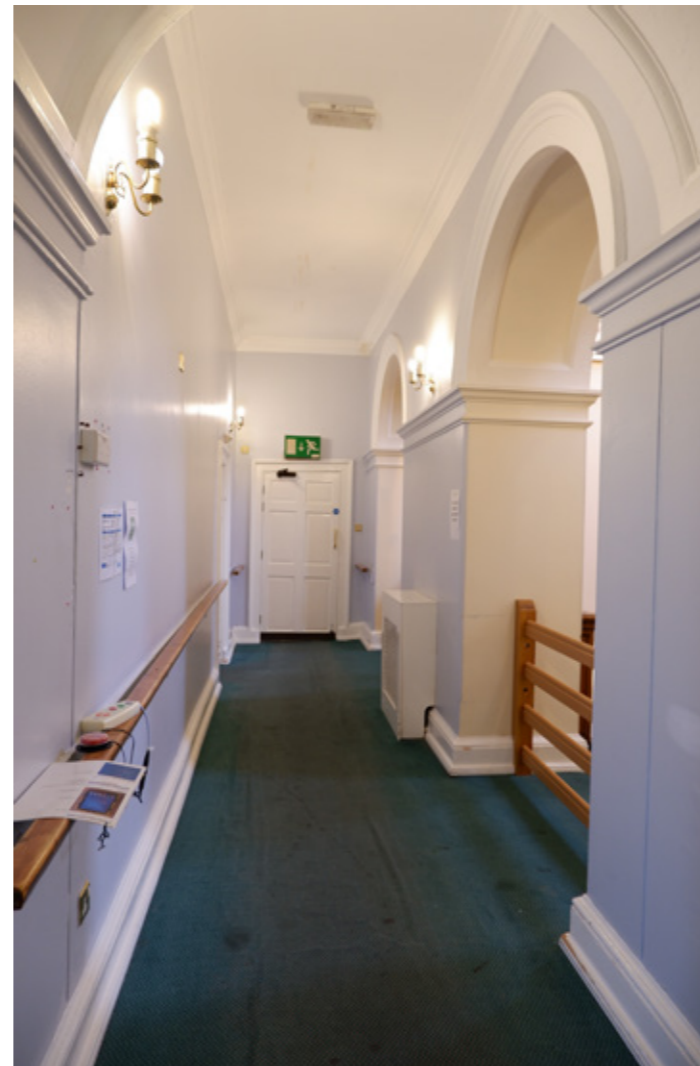
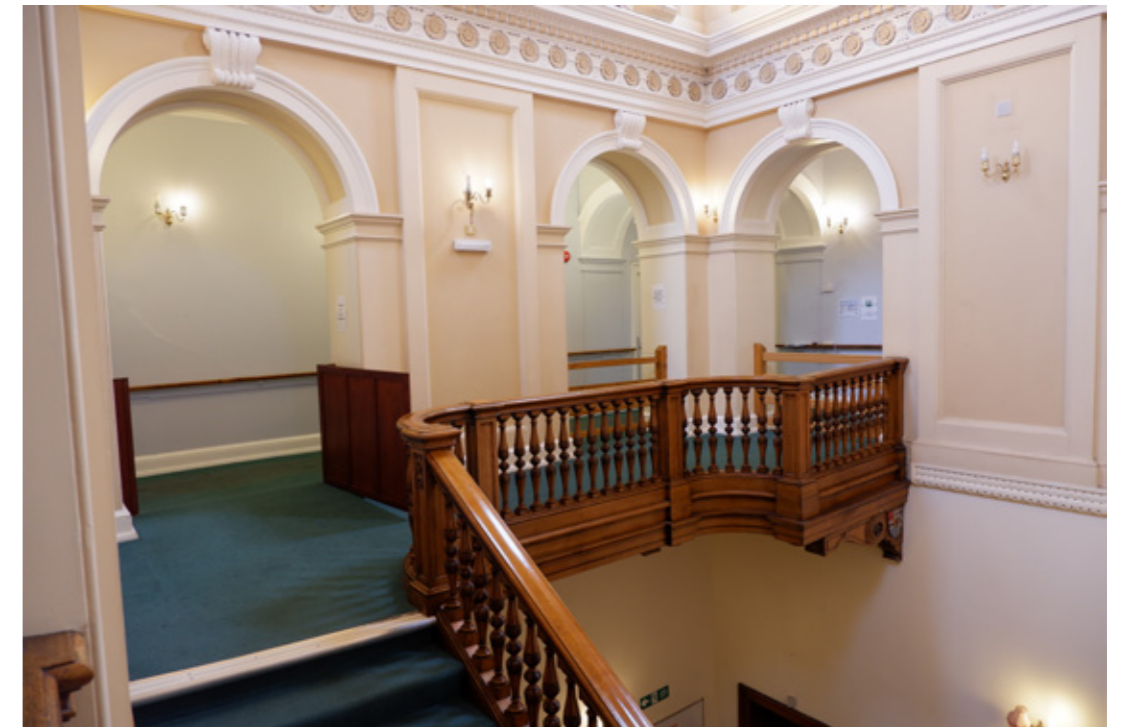
FIRST FLOOR: WYATT WING - FI.01

Room Number:	FI.01
Current Room Use:	Landing
Historic Room Use:	Landing
Date of Structure:	1817
Date of Fixtures / Fittings:	
Date of Decoration:	Late 20th century
Major Alterations:	Two doorways blocked since Wyatt plan
Overall Significance Level:	Very High

Key Historic Features:	Edward Wyatt turned bannister, decorative plaster walls/ ceiling, archways
Detrimental Features:	Modern carpet, paint and stair treads. Wall light pendants and emergency lighting. Safety doors and balustrade.
Condition Level:	
Condition Comments:	
Other Comments:

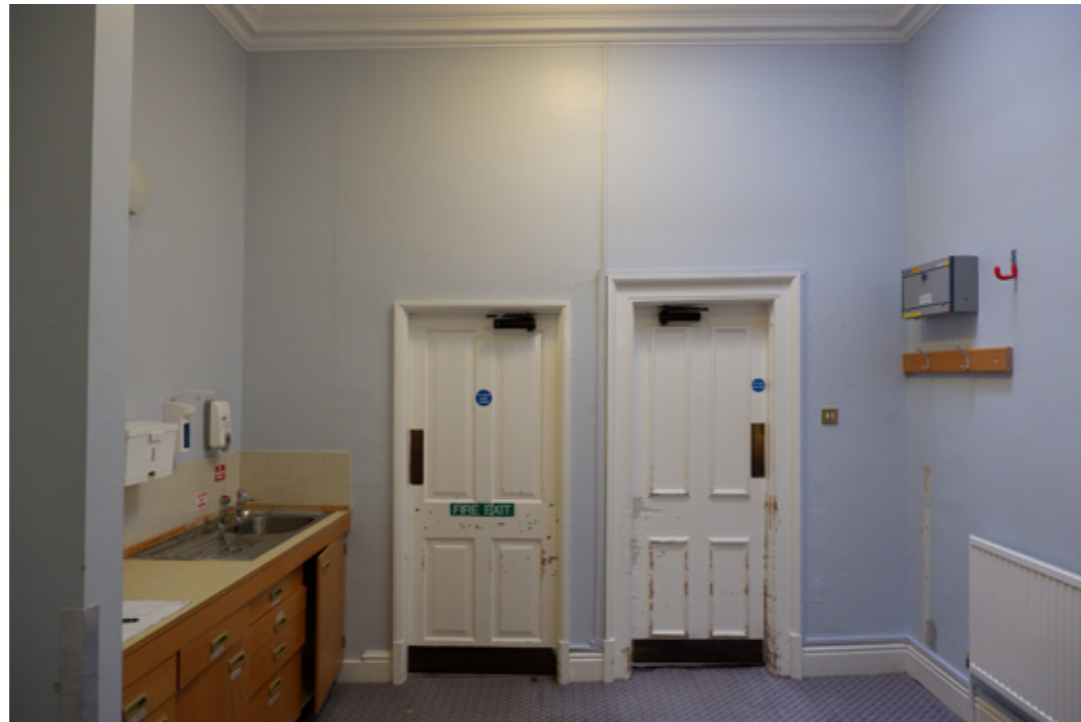
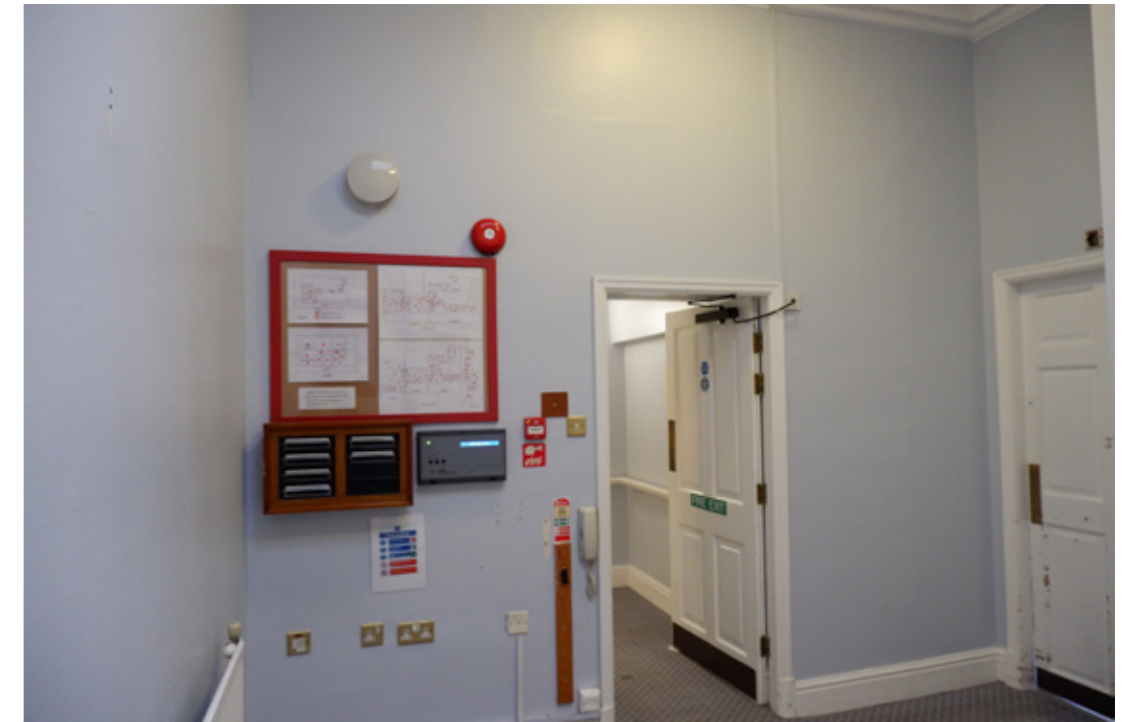
FIRST FLOOR: WYATT WING - FI.02

Room Number:	FI.02
Current Room Use:	Circulation
Historic Room Use:	Closet
Date of Structure:	1817
Date of Fixtures / Fittings:	
Date of Decoration:	Late 20th century
Major Alterations:	Removal of internal wall, Subdivision of original bedroom, inserted opening to 1717 house, inserted skylight

Overall Significance Level:	Low
Key Historic Features:	None
Detrimental Features:	M&E, modern carpet, radiator, modern sink and cabinet
Condition Level:	
Condition Comments:	
Other Comments:	Floorplan changes on two versions of Wyatt 1816 drawings

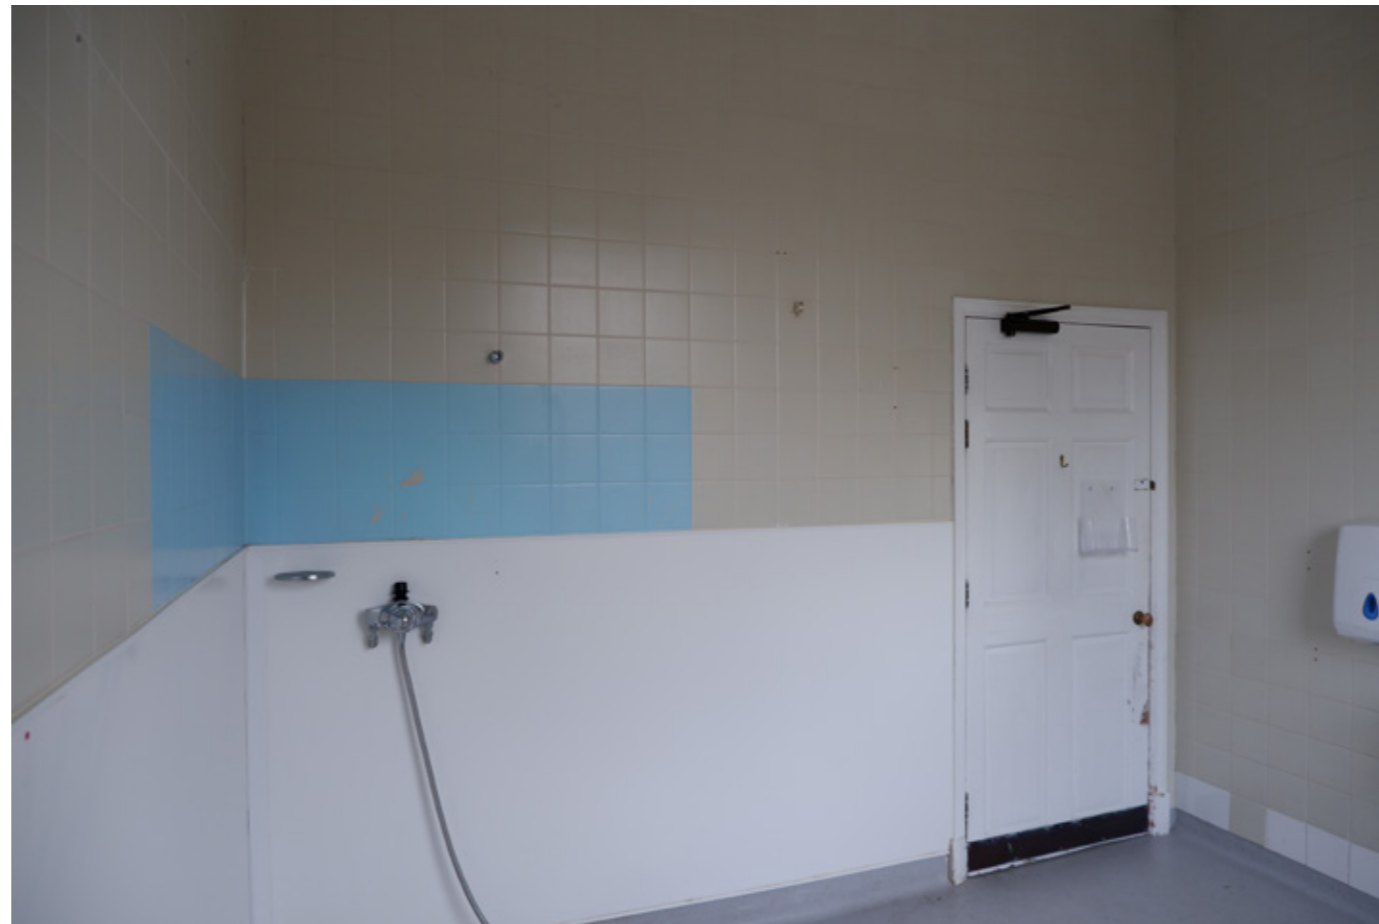
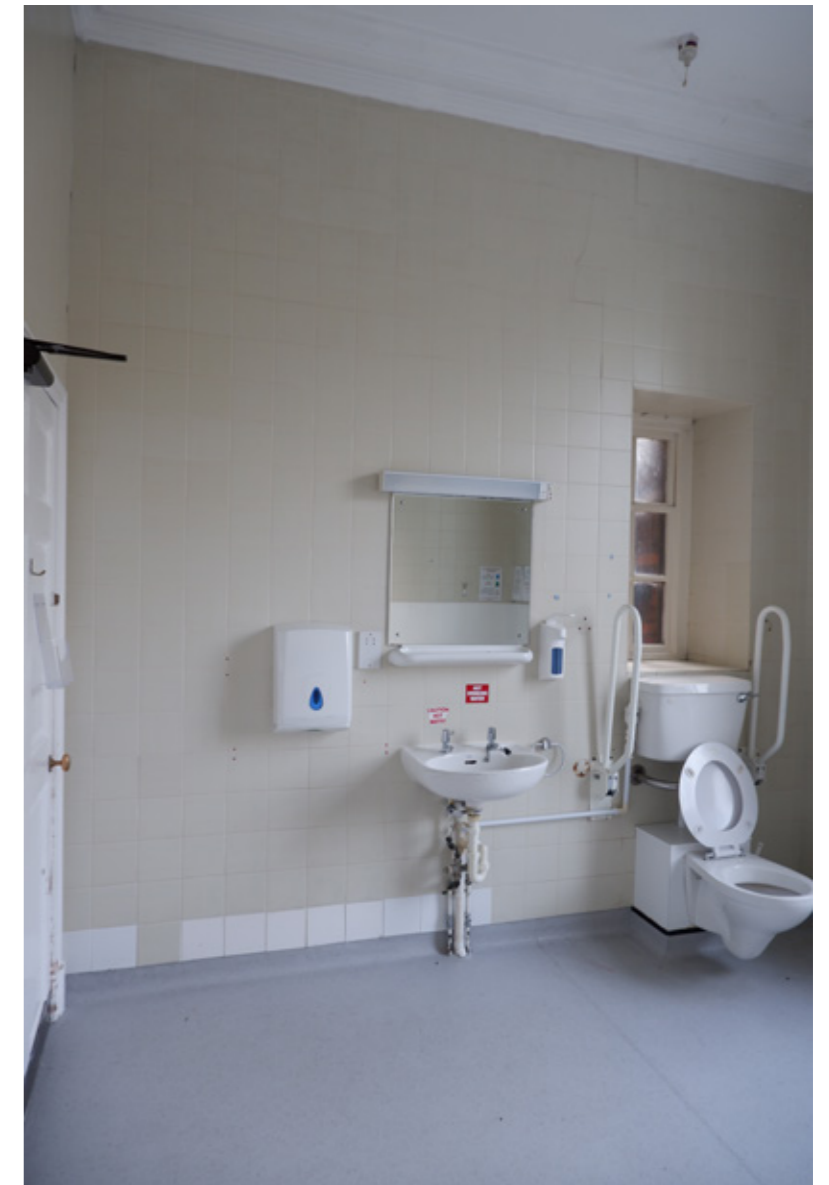
FIRST FLOOR: WYATT WING - FI.03

Room Number:	FI.03
Current Room Use:	WC
Historic Room Use:	Dressing Room
Date of Structure:	1817
Date of Fixtures / Fittings:	
Date of Decoration:	Late 20th century
Major Alterations:	Subdivision of bedroom, removal of fireplace

Overall Significance Level:	Low
Key Historic Features:	Sash window and shutters
Detrimental Features:	M&E, modern wall and floor covering, sanitary ware
Condition Level:	
Condition Comments:	
Other Comments:

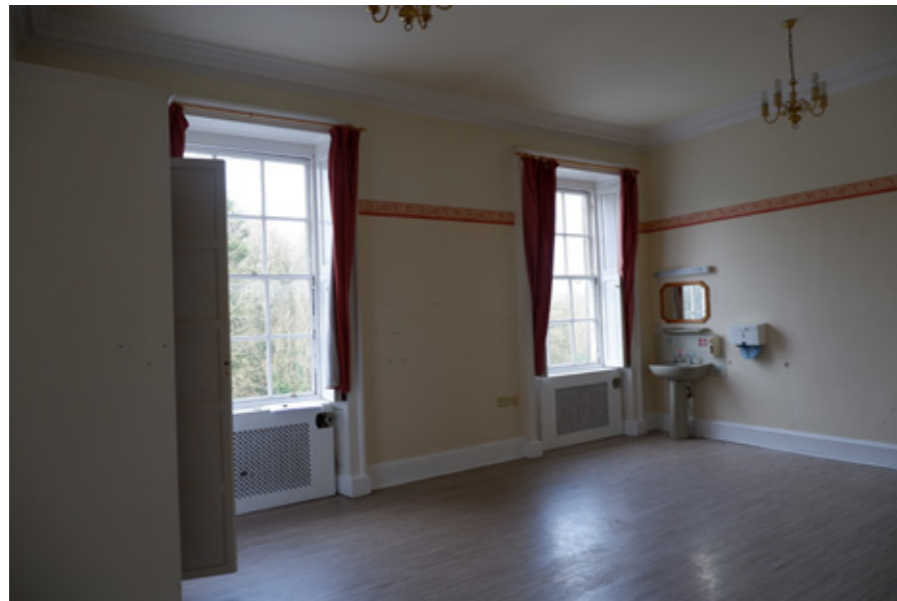
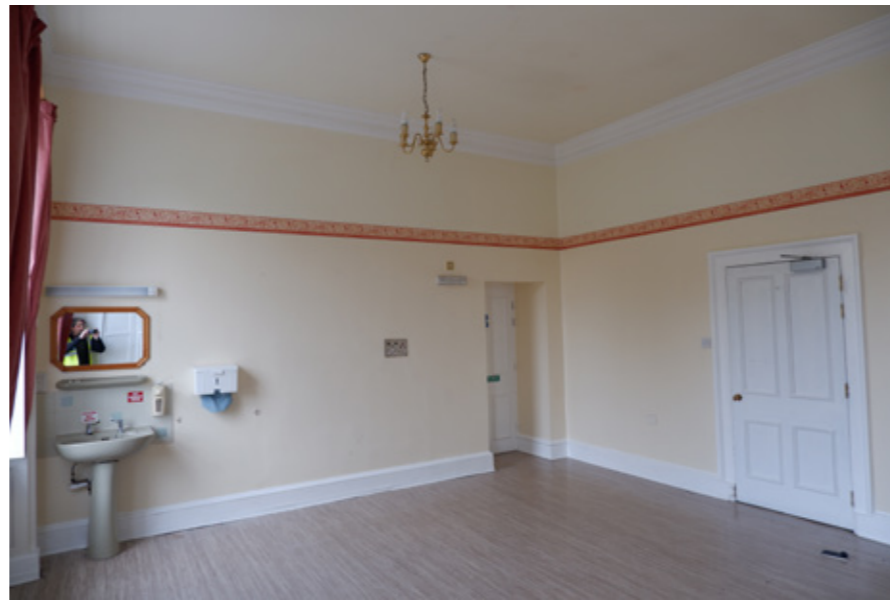
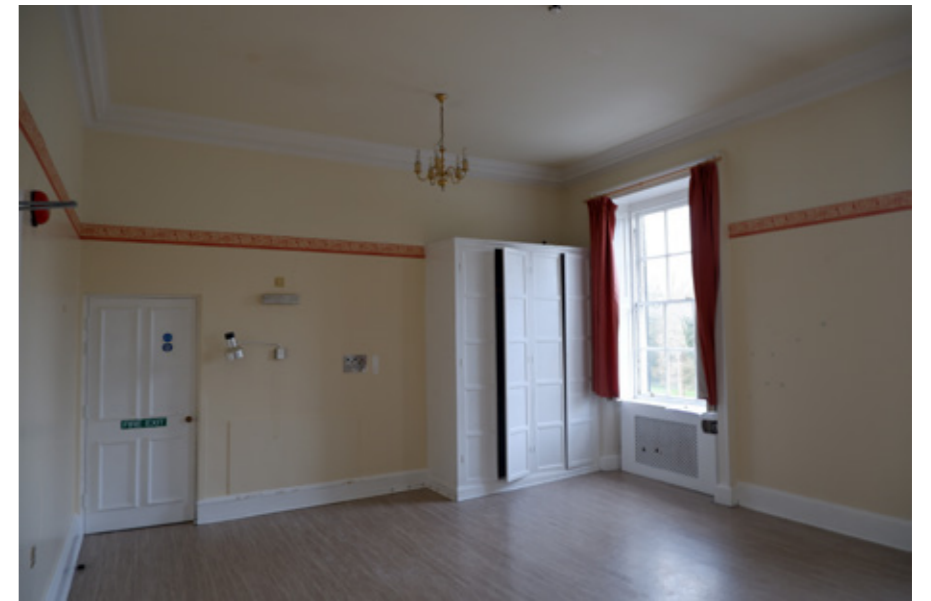
FIRST FLOOR: WYATT WING - FI.04

Room Number:	FI.04
Current Room Use:	Bedroom
Historic Room Use:	Bedroom
Date of Structure:	1817
Date of Fixtures / Fittings:	
Date of Decoration:	Late 20th century
Major Alterations:	Subdivision of bedroom, insertion of doorway to FI.05, removal of fireplace

Overall Significance Level:	Medium
Key Historic Features:	Sash window and shutters
Detrimental Features:	M&E, modern flooring, sanitary ware
Condition Level:	
Condition Comments:	
Other Comments:

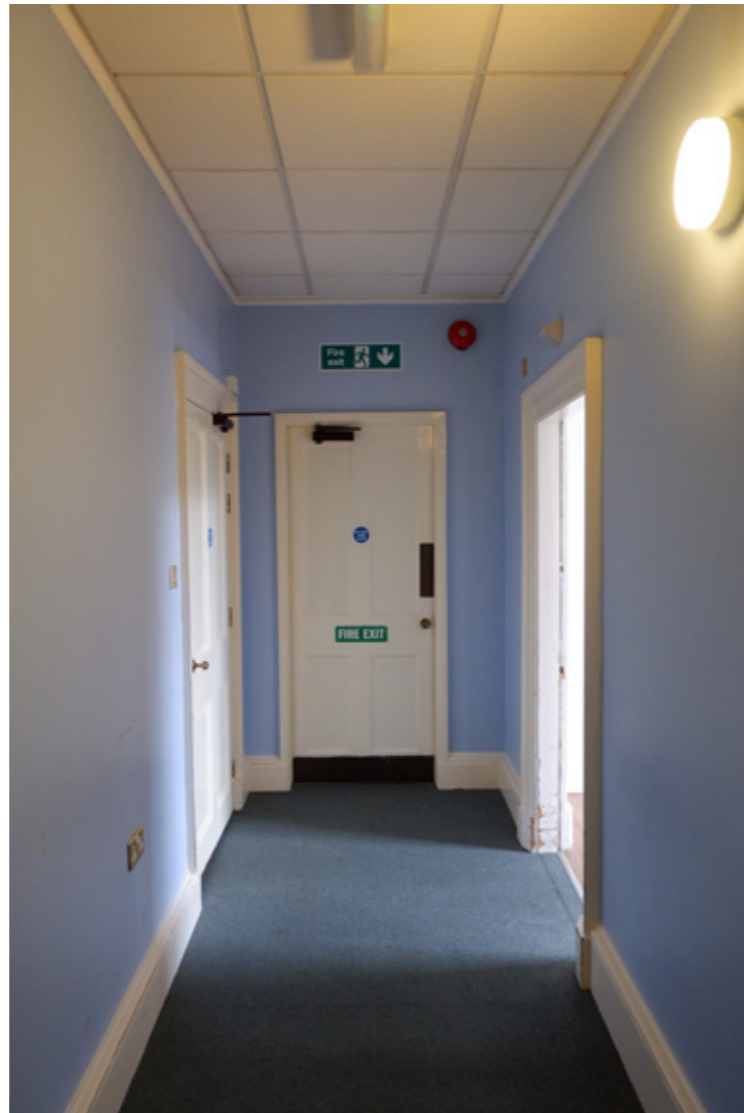
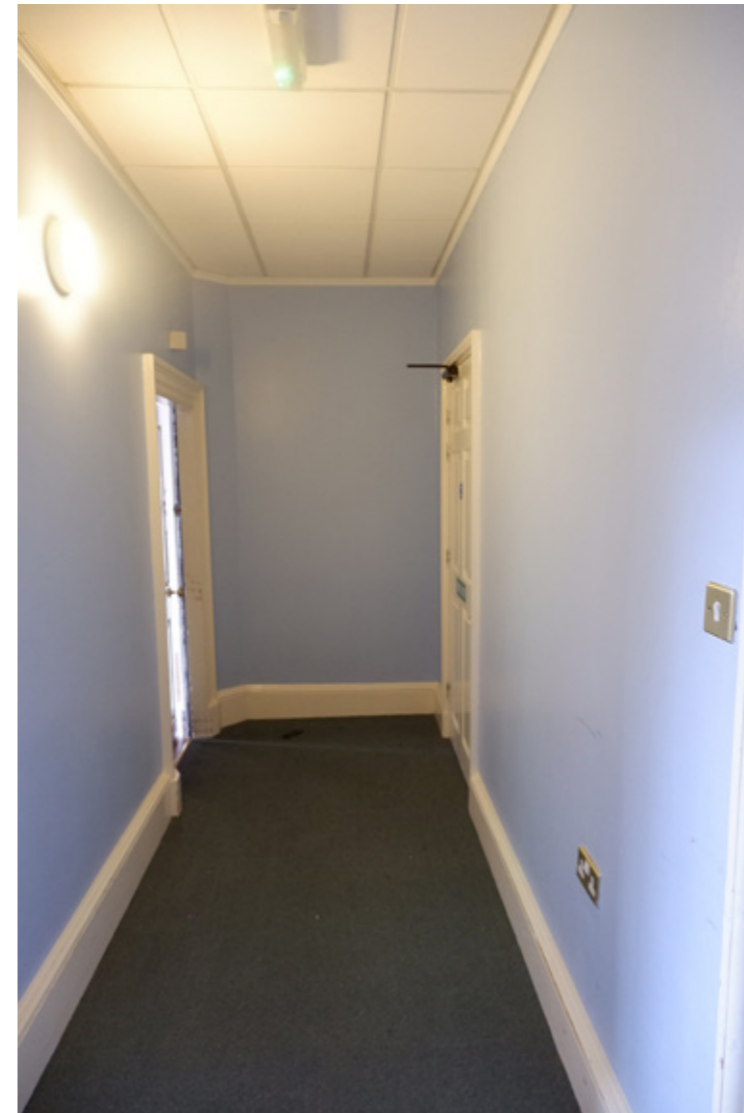
FIRST FLOOR: WYATT WING - FI.05

Room Number:	FI.05
Current Room Use:	Circulation
Historic Room Use:	Bedroom
Date of Structure:	1817
Date of Fixtures / Fittings:	
Date of Decoration:	Late 20th century
Major Alterations:	Subdivision of bedroom, insertion of doorway to F.108

Overall Significance Level:	Low
Key Historic Features:	None
Detrimental Features:	M&E, suspended ceiling, door closers, modern carpet
Condition Level:	
Condition Comments:	
Other Comments:

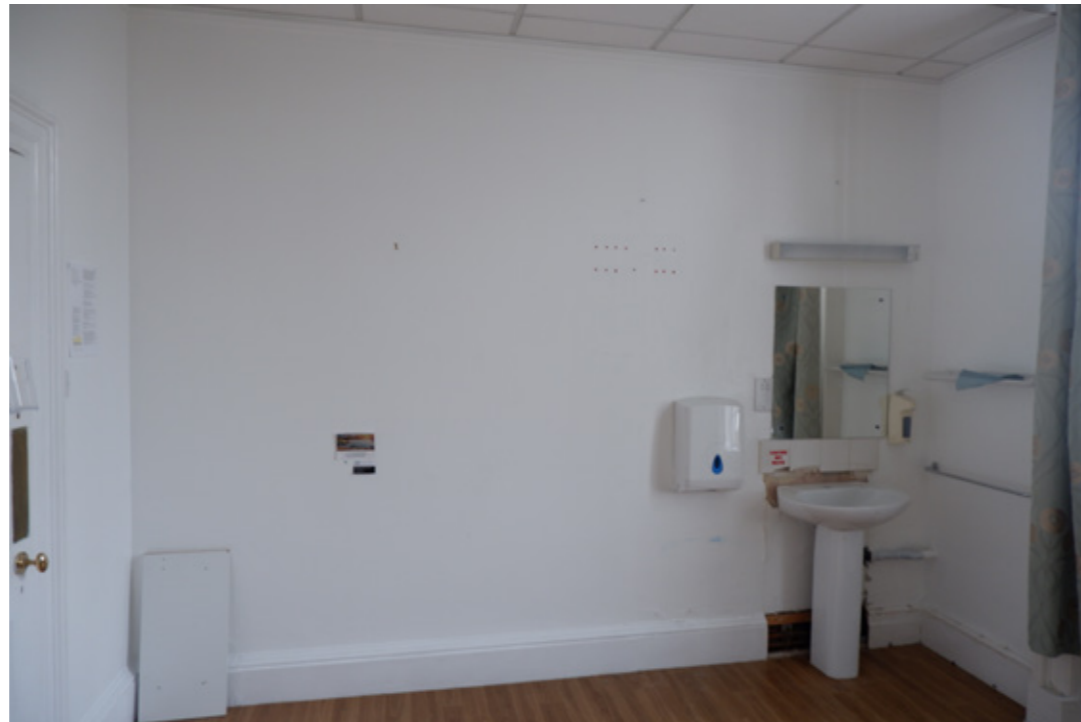
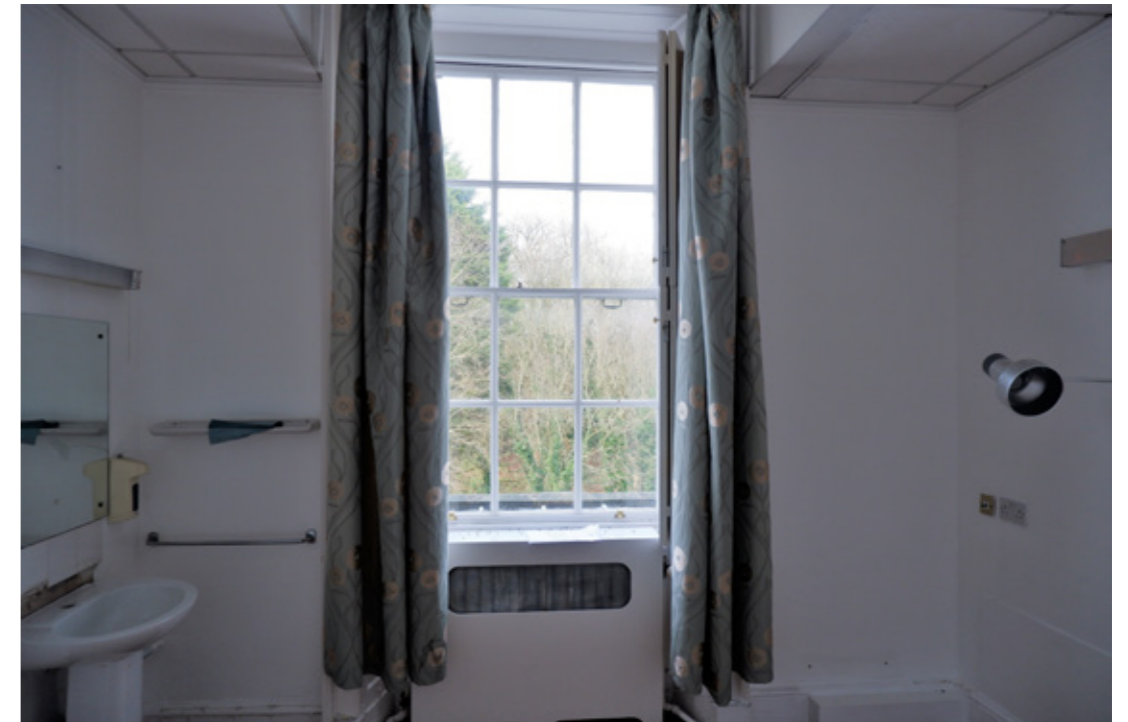
FIRST FLOOR: WYATT WING - FI.06

Room Number:	FI.06
Current Room Use:	Bedroom
Historic Room Use:	Bedroom
Date of Structure:	1817
Date of Fixtures / Fittings:	
Date of Decoration:	Late 20th century
Major Alterations:	Subdivision of bedroom

Overall Significance Level:	Low
Key Historic Features:	Sash window and shutters
Detrimental Features:	M&E, modern flooring, sanitaryware, radiator, suspended ceiling
Condition Level:	
Condition Comments:	
Other Comments:

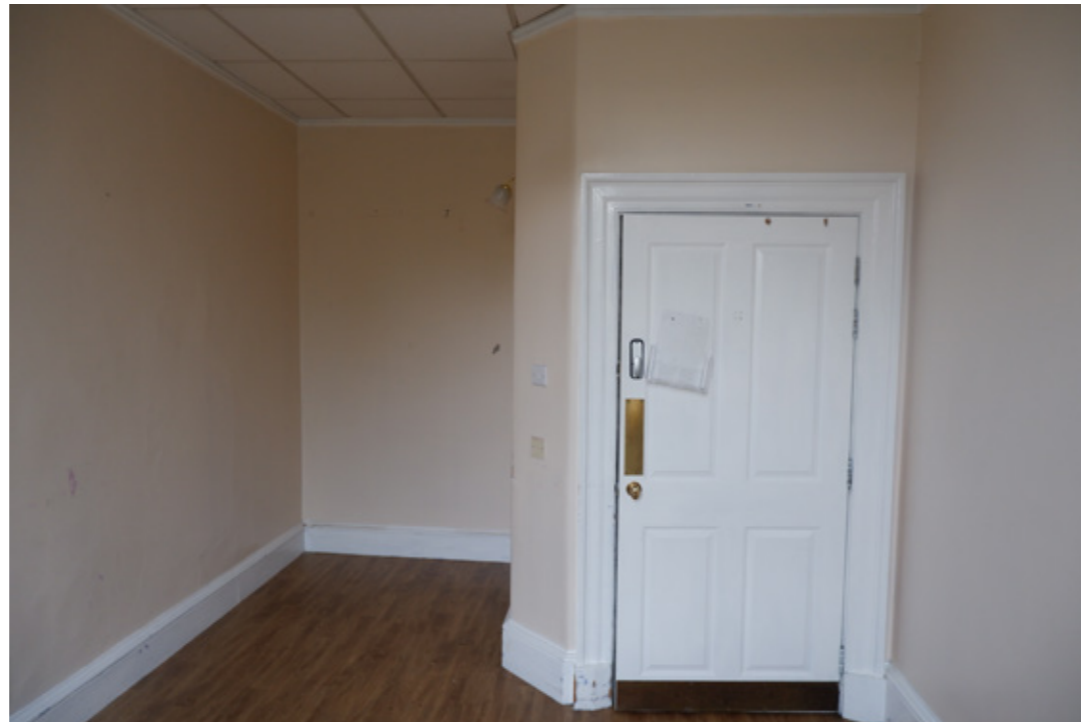
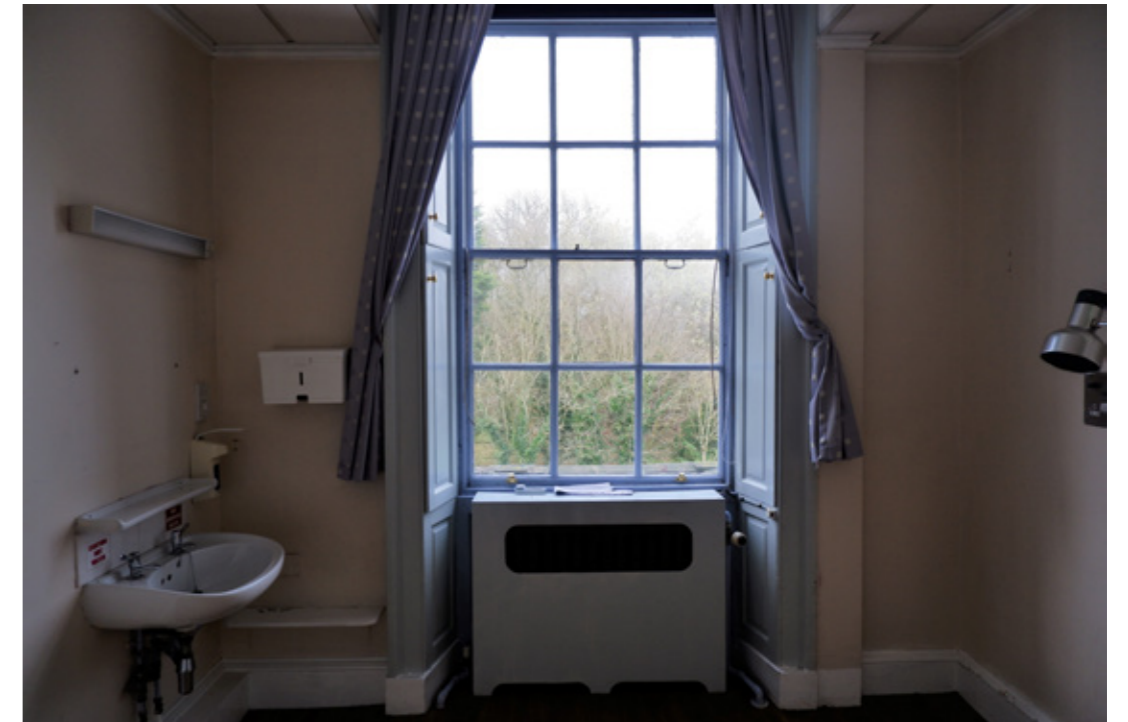
FIRST FLOOR: WYATT WING - FI.07

Room Number:	FI.07
Current Room Use:	Bedroom
Historic Room Use:	Bedroom
Date of Structure:	1817
Date of Fixtures / Fittings:	
Date of Decoration:	Late 20th century
Major Alterations:	Subdivision of bedroom, removal of fireplace

Overall Significance Level:	Low
Key Historic Features:	Sash window and shutters
Detrimental Features:	M&E, modern flooring, sanitaryware, radiator, suspended ceiling, modern paint finish on shutters
Condition Level:	
Condition Comments:	
Other Comments:

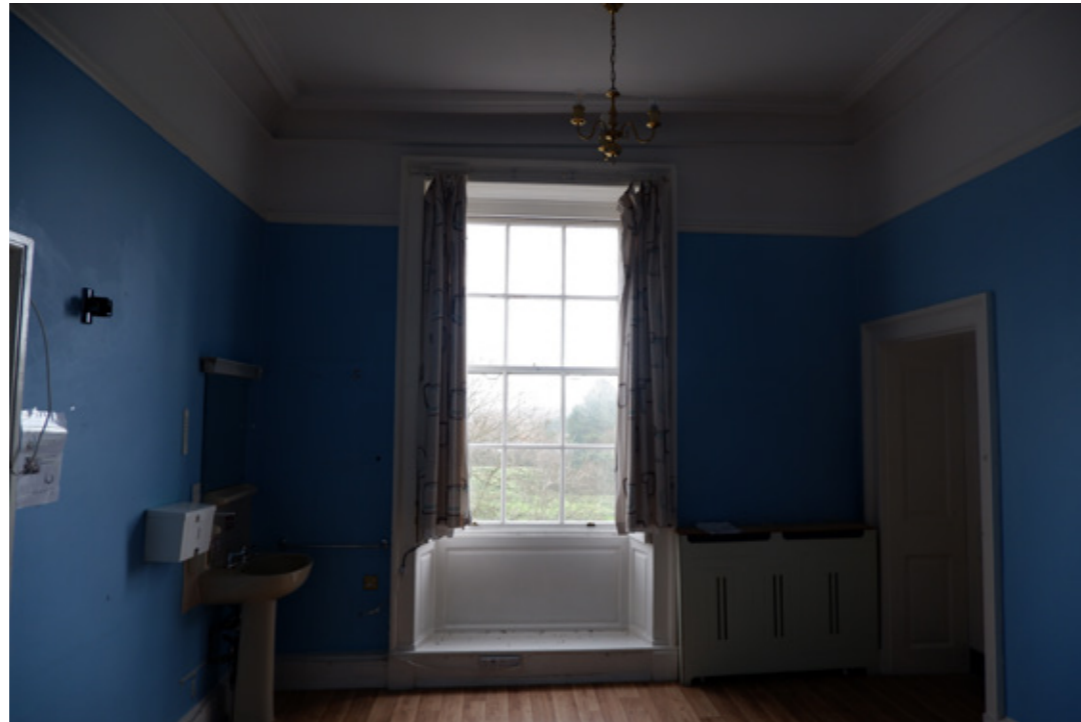
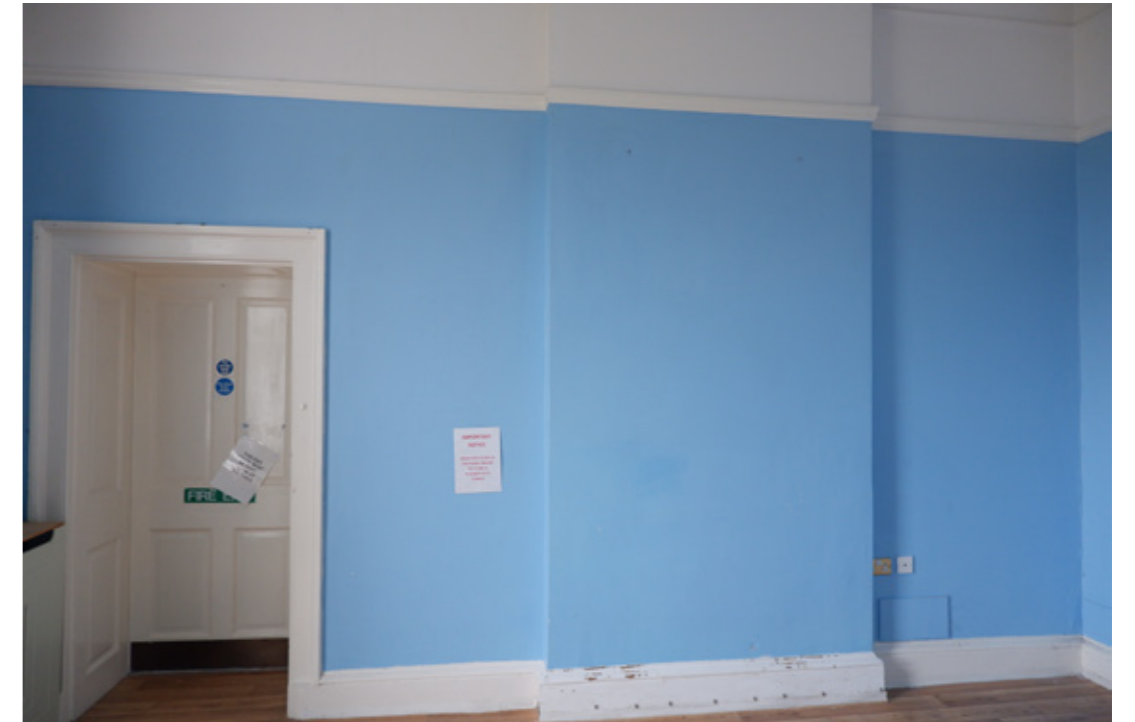
FIRST FLOOR: WYATT WING - FI.09

Room Number:	FI.09
Current Room Use:	Bedroom
Historic Room Use:	Bedroom
Date of Structure:	1817
Date of Fixtures / Fittings:	
Date of Decoration:	Late 20th century
Major Alterations:	Removal of fireplace, partitioning of bedroom

Overall Significance Level:	Low
Key Historic Features:	Sash window and shutters, chimney breast
Detrimental Features:	M&E, modern flooring, sanitaryware, radiator, suspended ceiling
Condition Level:	
Condition Comments:	
Other Comments:
