VOLUME TWO

GAZETTEER

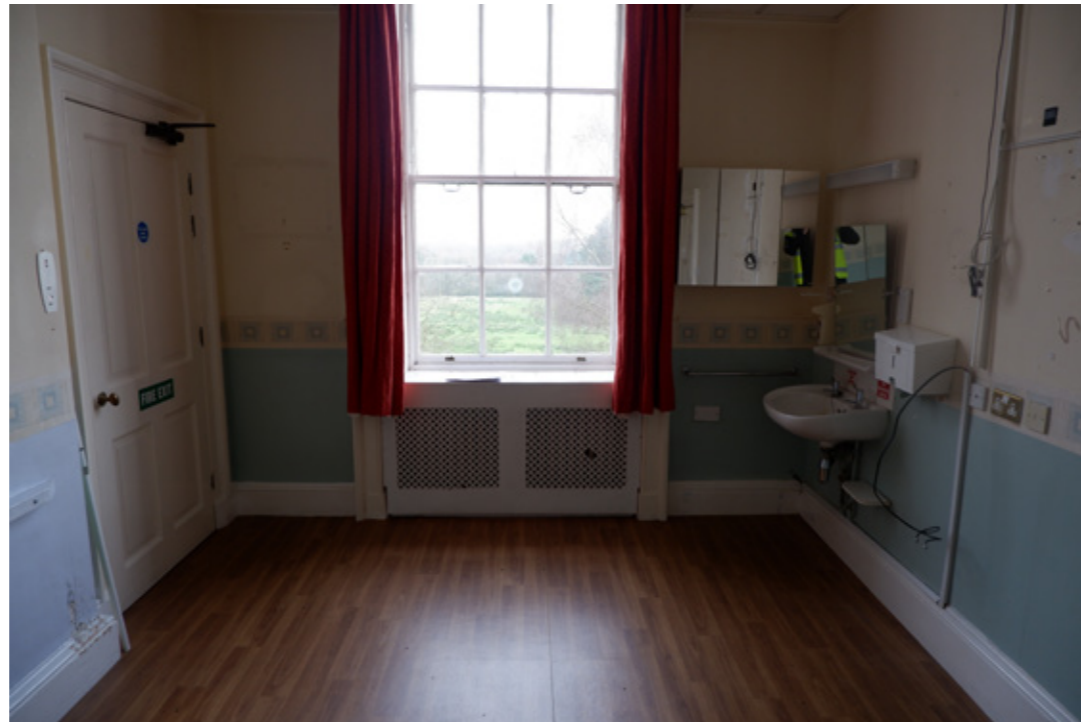
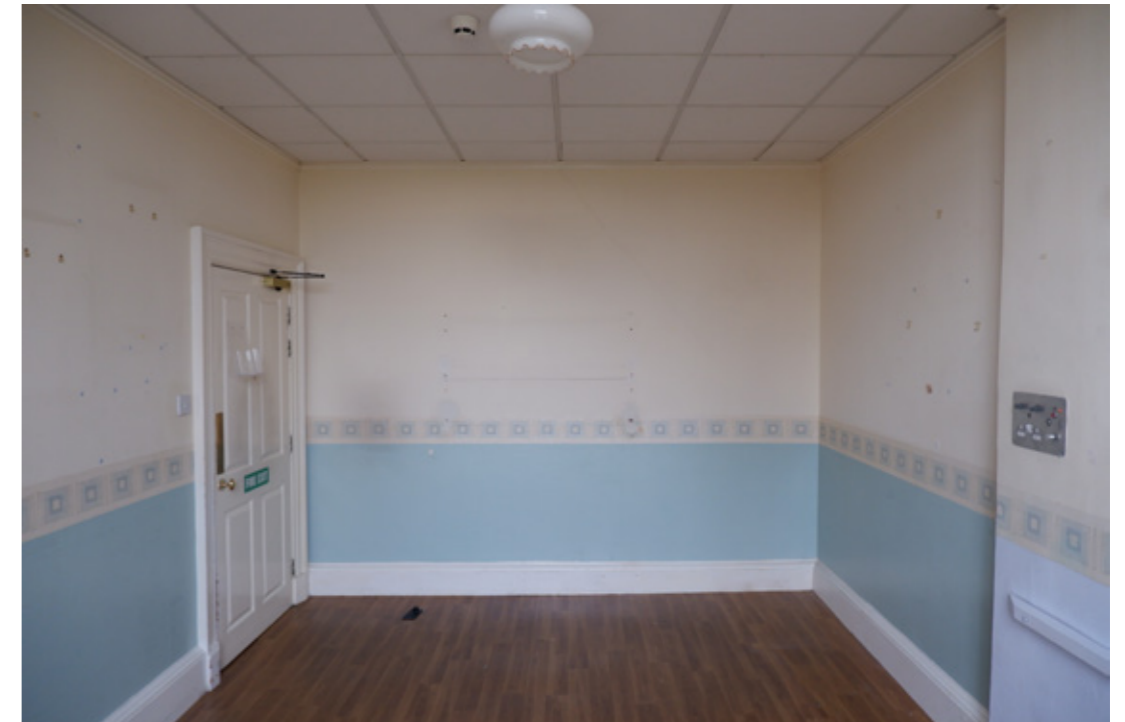
FIRST FLOOR: WYATT WING - FI.10

Room Number:	FI.10
Current Room Use:	Bedroom
Historic Room Use:	Bedroom
Date of Structure:	1817
Date of Fixtures / Fittings:	
Date of Decoration:	Late 20th century
Major Alterations:	Subdivision of bedroom, blocking of internal doorway

Overall Significance Level:	Low
Key Historic Features:	Sash window and shutters
Detrimental Features:	M&E, modern flooring, sanitaryware, radiator, suspended ceiling
Condition Level:	
Condition Comments:	
Other Comments:

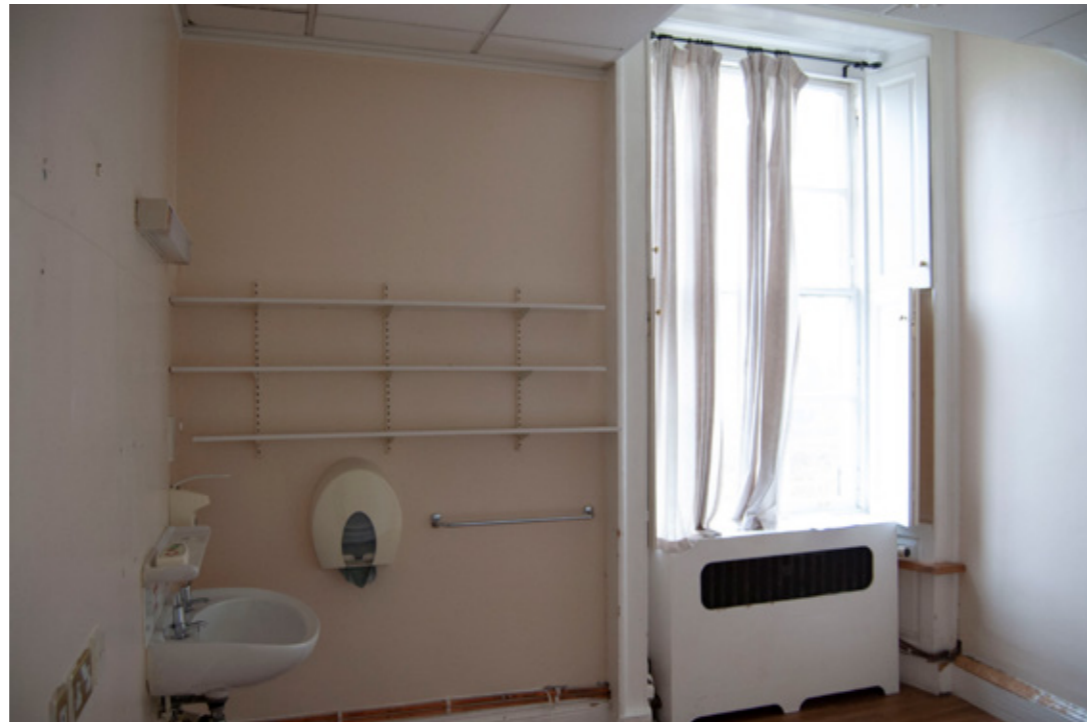
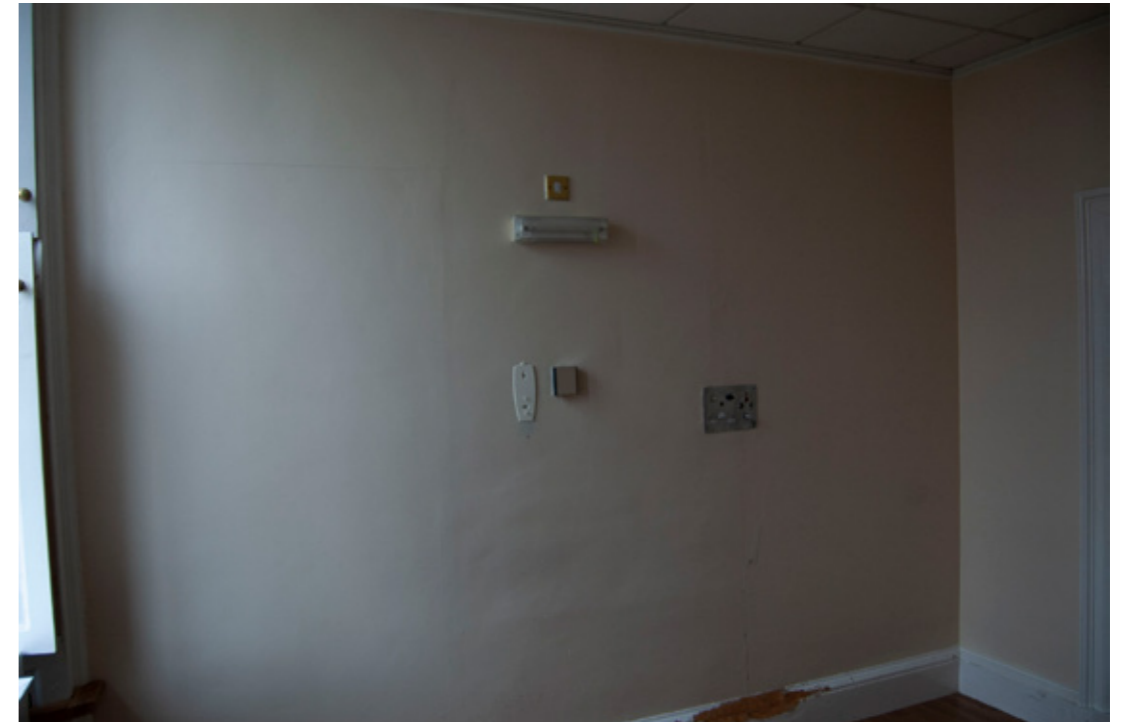
FIRST FLOOR: WYATT WING - FI.11

Room Number:	FI.11
Current Room Use:	Circulation
Historic Room Use:	Bedroom
Date of Structure:	1817
Date of Fixtures / Fittings:	
Date of Decoration:	Late 20th century
Major Alterations:	Subdivision of bedroom
Overall Significance Level:	Low
Key Historic Features:	None
Detrimental Features:	Suspended ceiling, door closers, modern carpet
Condition Level:	
Condition Comments:	
Other Comments:

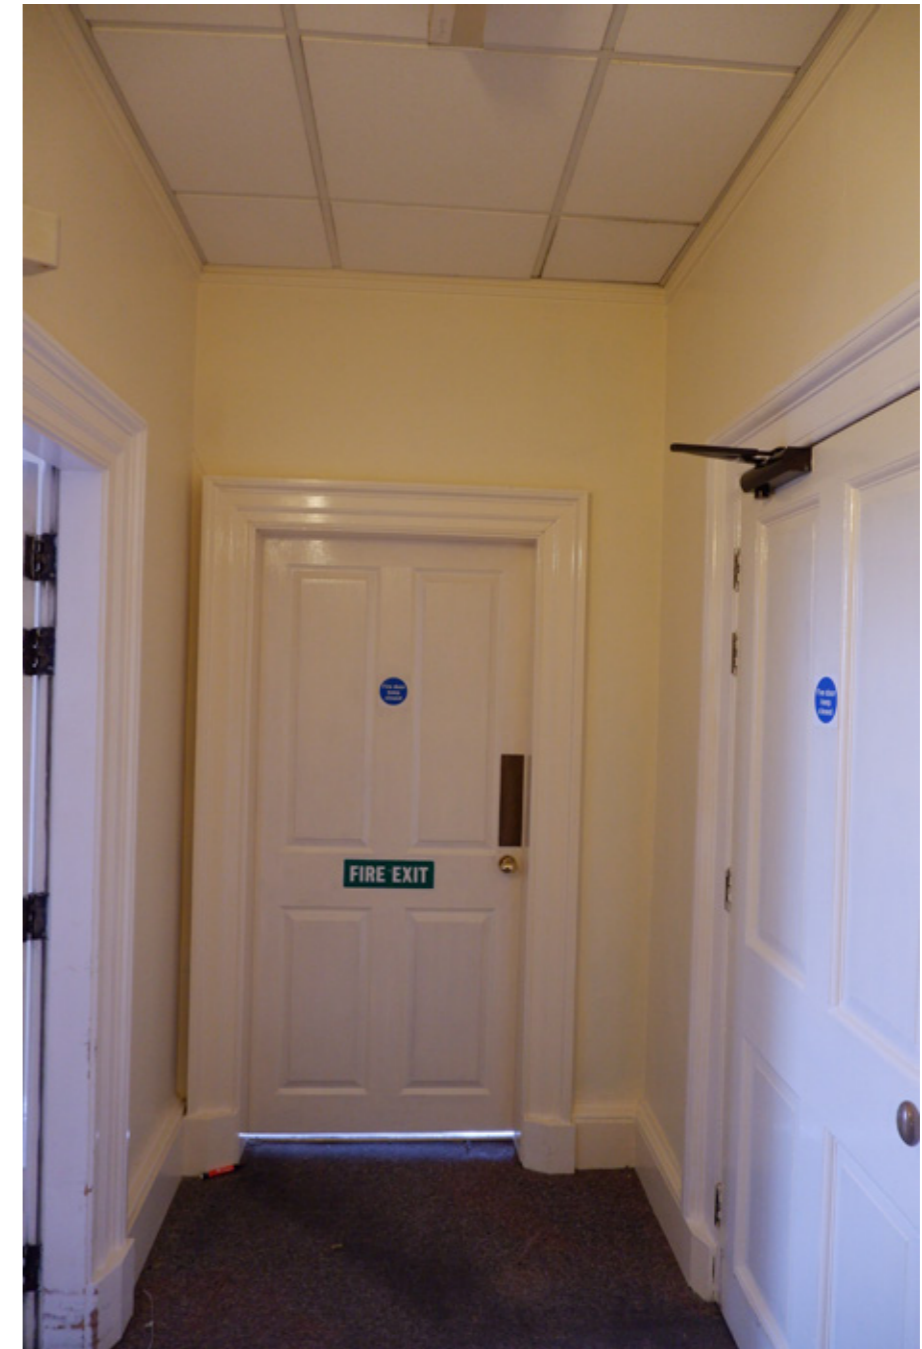
FIRST FLOOR: WYATT WING - FI.12

Room Number:	FI.12
Current Room Use:	Welfare
Historic Room Use:	Bedroom
Date of Structure:	1817
Date of Fixtures / Fittings:	
Date of Decoration:	Late 20th century
Major Alterations:	Blocking of doorway to FI.10, removal of fireplace, insertion of doorway to FI.11

Overall Significance Level:	Medium
Key Historic Features:	Sash windows and shutters
Detrimental Features:	M&E, modern flooring, sanitary ware
Condition Level:	
Condition Comments:	
Other Comments:

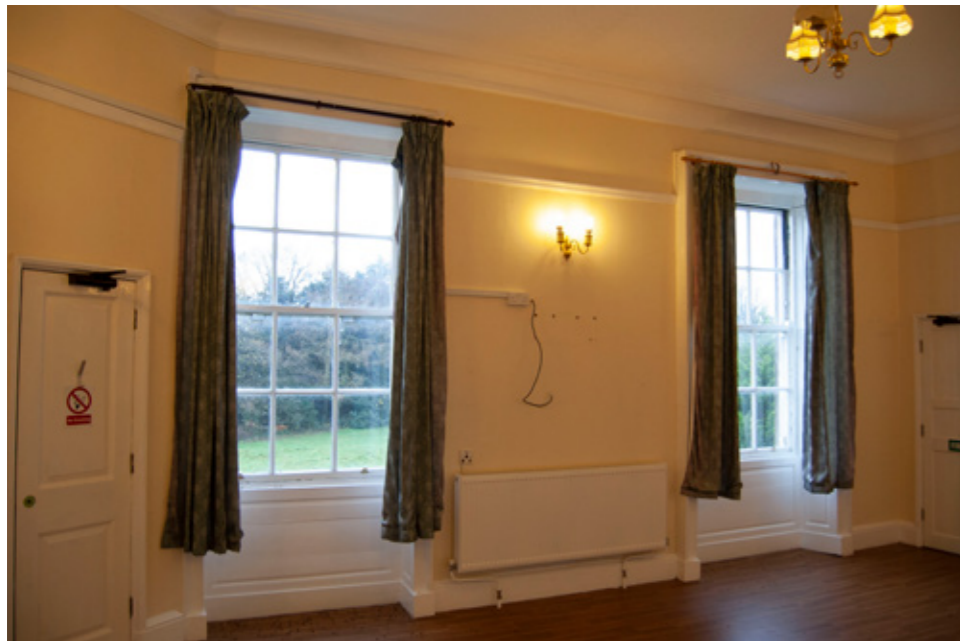
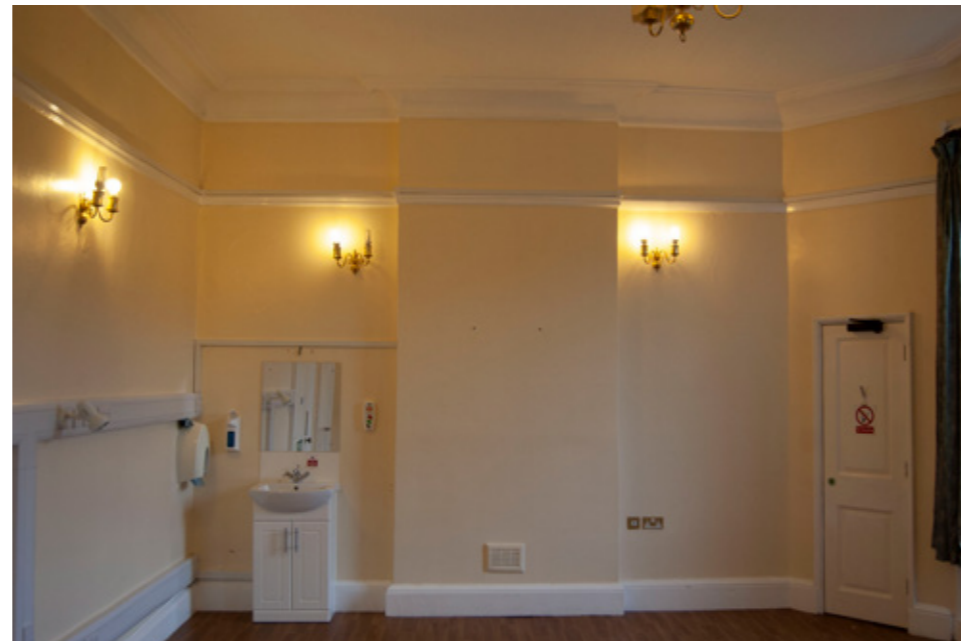
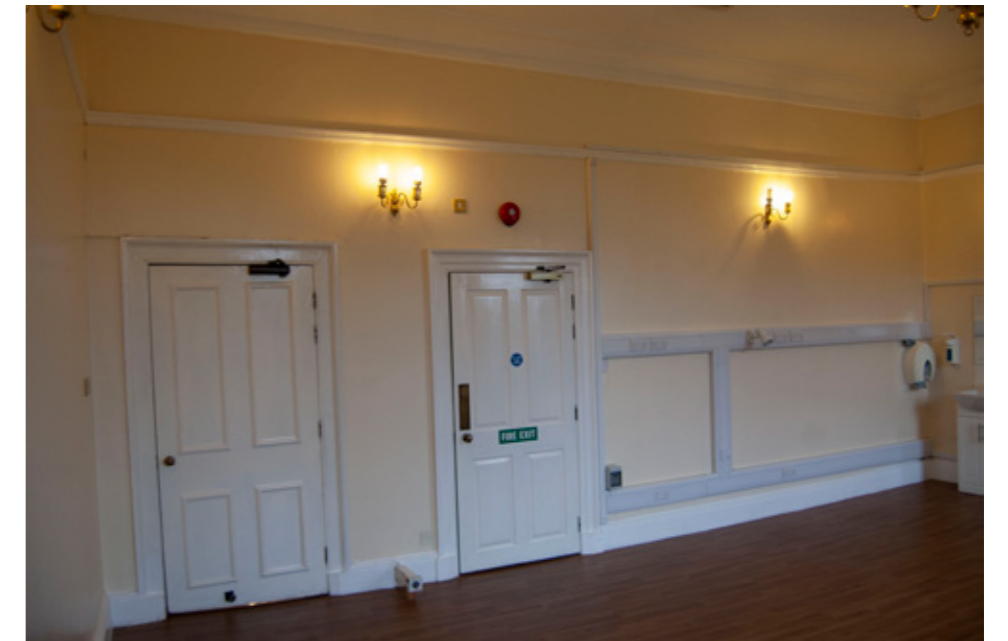
FIRST FLOOR: WYATT WING - FI.13

Room Number:	FI.13
Current Room Use:	Bedroom
Historic Room Use:	Dressing Room
Date of Structure:	1817
Date of Fixtures / Fittings:	
Date of Decoration:	Late 20th century
Major Alterations:	Subdivision of bedroom

Overall Significance Level:	Low
Key Historic Features:	Sash window and shutters
Detrimental Features:	M&E, modern flooring, sanitaryware, radiator, suspended ceiling
Condition Level:	
Condition Comments:	
Other Comments:	Floorplan changes on two versions of Wyatt 1816 drawings

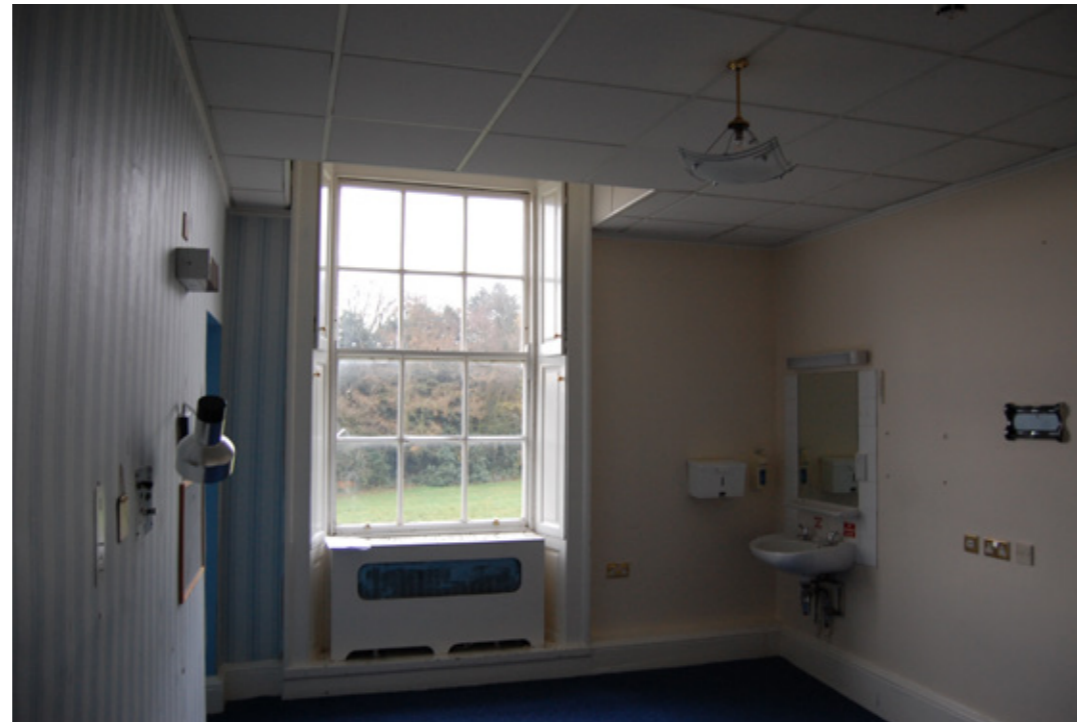
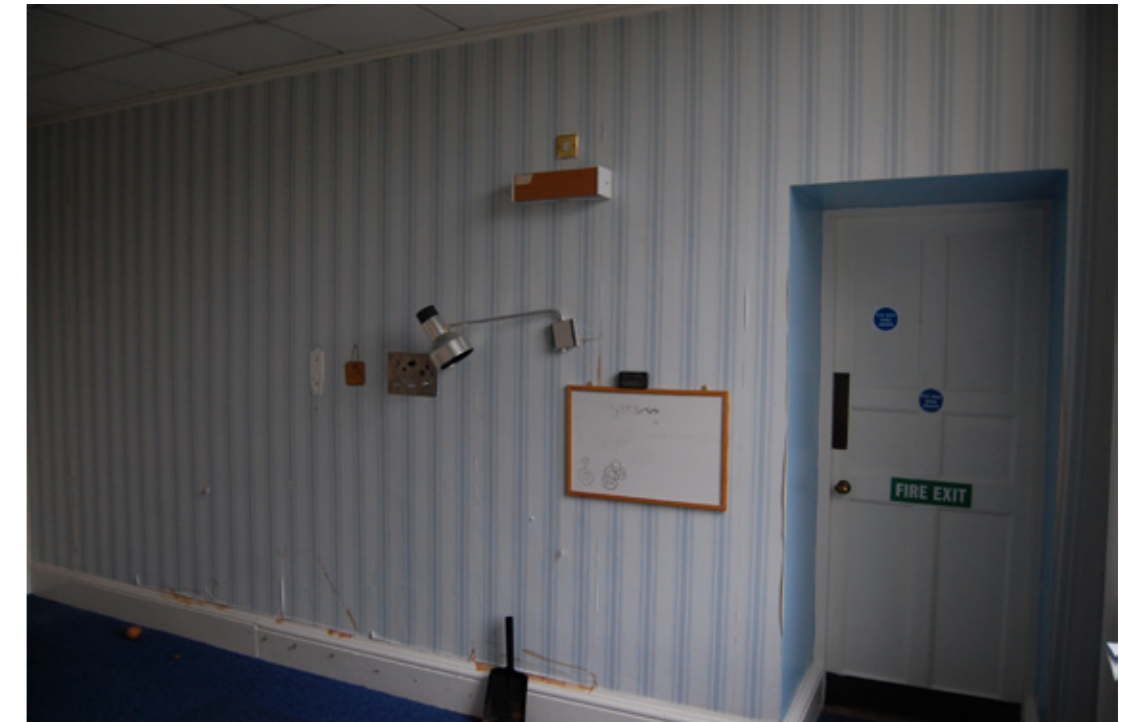
FIRST FLOOR: WYATT WING - FI.14

Room Number:	FI.14
Current Room Use:	Circulation
Historic Room Use:	Bedroom
Date of Structure:	1817
Date of Fixtures / Fittings:	
Date of Decoration:	Late 20th century
Major Alterations:	Subdivision of bedroom
Overall Significance Level:	Low
Key Historic Features:	None
Detrimental Features:	M&E, suspended ceiling, door closers, modern carpet
Condition Level:	
Condition Comments:	
Other Comments:

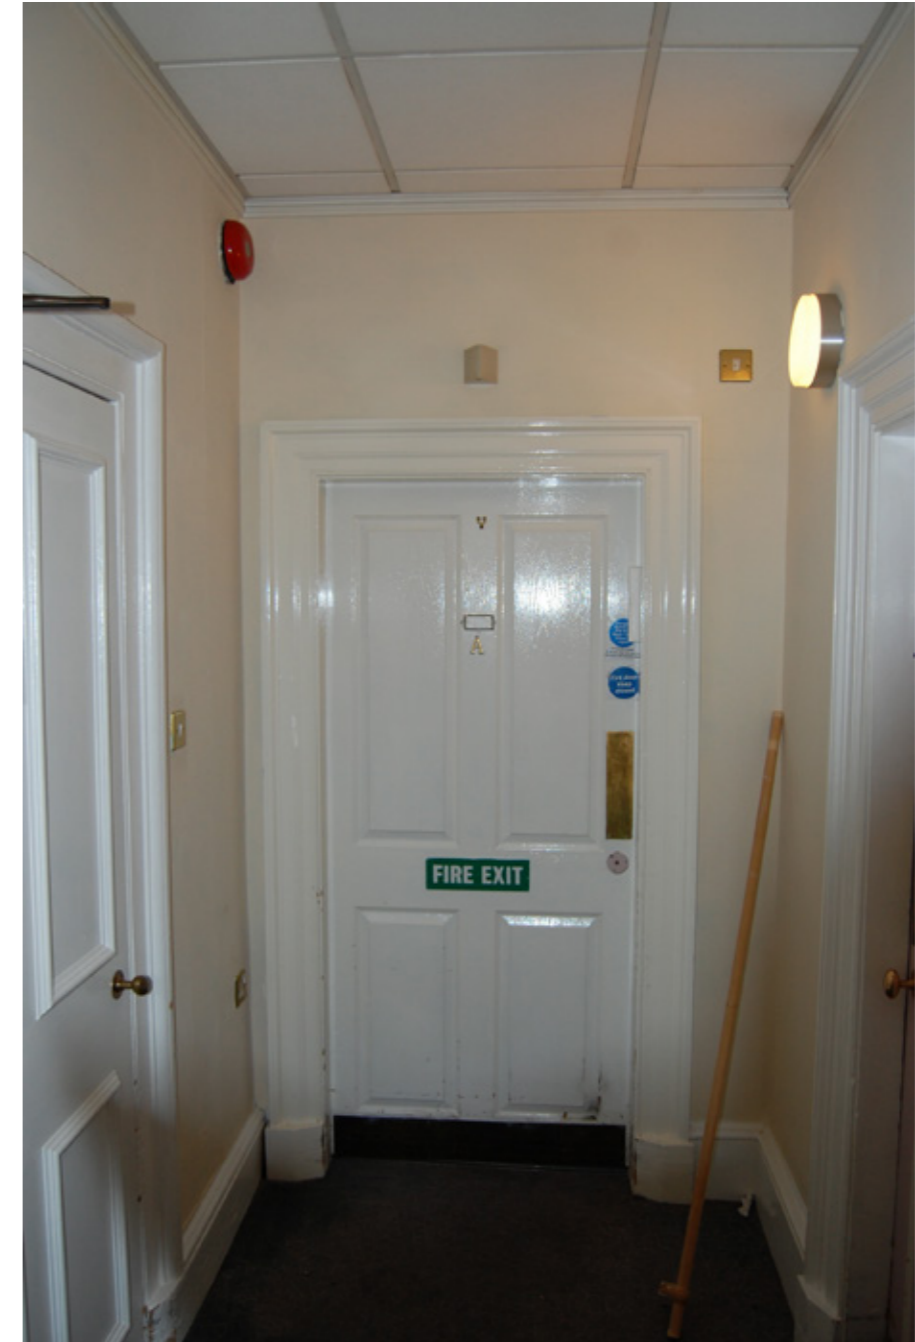
FIRST FLOOR: WYATT WING - FI.15

Room Number:	FI.15
Current Room Use:	Bedroom
Historic Room Use:	Bedroom
Date of Structure:	1817
Date of Fixtures / Fittings:	
Date of Decoration:	Late 20th century
Major Alterations:	Subdivision of bedroom

Overall Significance Level:	Low
Key Historic Features:	Sash window and shutters
Detrimental Features:	M&E, modern flooring, sanitaryware, radiator, suspended ceiling
Condition Level:	
Condition Comments:	
Other Comments:

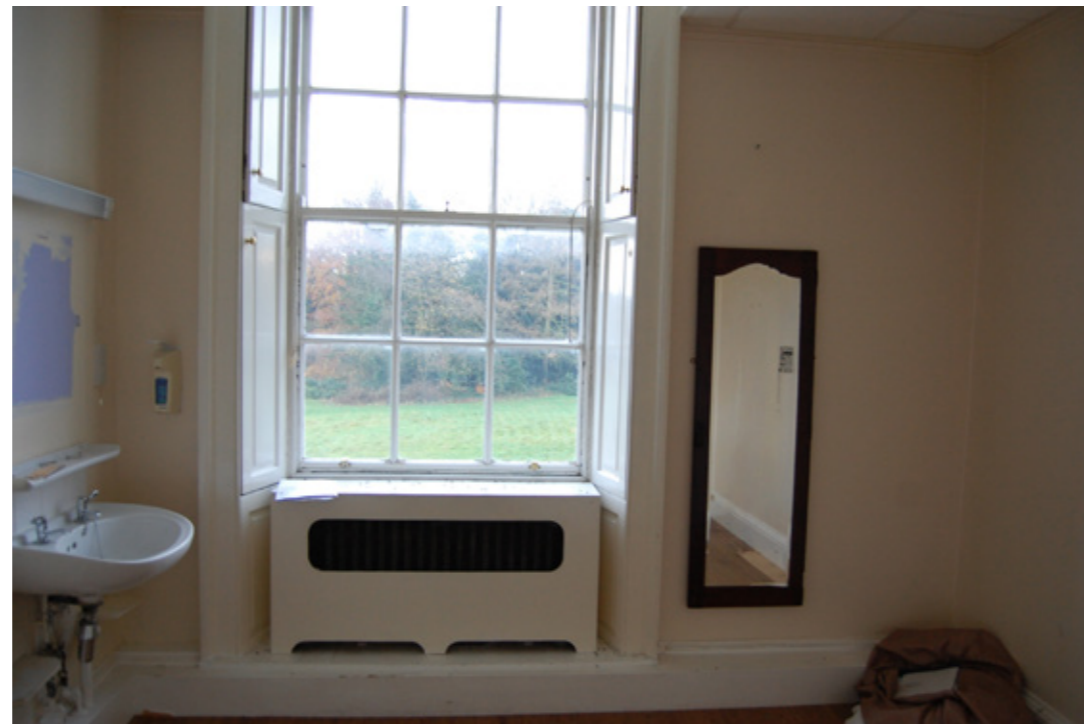
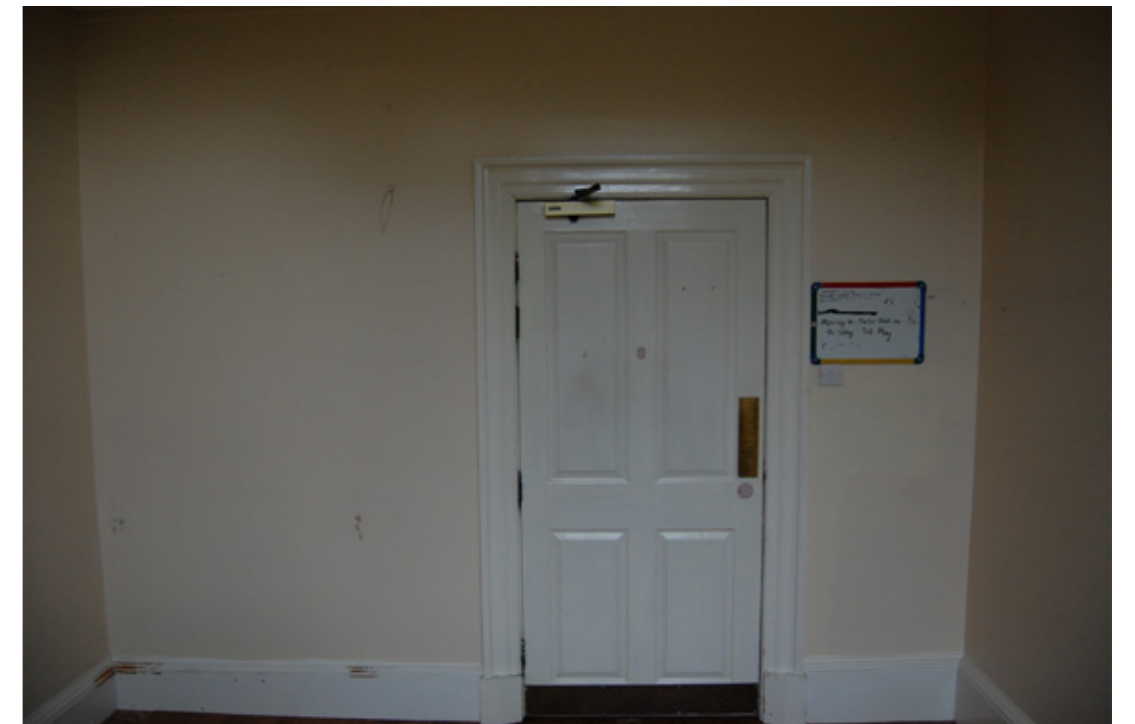
FIRST FLOOR: WYATT WING - FI.16

Room Number:	FI.16
Current Room Use:	Circulation
Historic Room Use:	Closet?
Date of Structure:	1817
Date of Fixtures / Fittings:	
Date of Decoration:	Late 20th century
Major Alterations:	Inseration of doorway to 1717 house
Overall Significance Level:	Low
Key Historic Features:	None
Detrimental Features:	Modern fit out
Condition Level:	
Condition Comments:	
Other Comments:

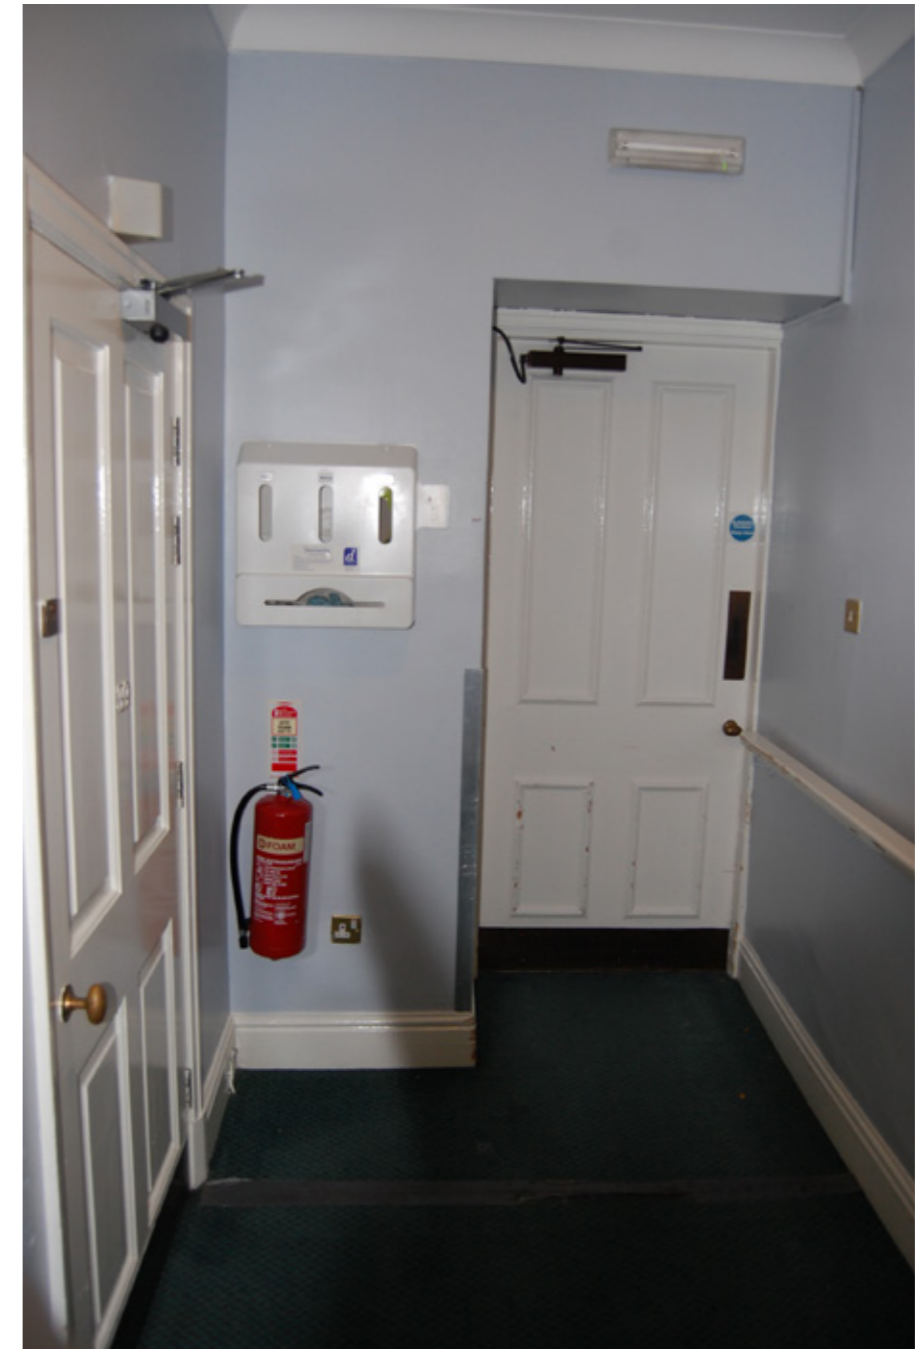
FIRST FLOOR: WYATT WING - FI.17

Room Number:	FI.17
Current Room Use:	WC
Historic Room Use:	Bedroom/Dressing Room
Date of Structure:	1817
Date of Fixtures / Fittings:	
Date of Decoration:	Late 20th century
Major Alterations:	Subdivision of bedroom

Overall Significance Level:	Low
Key Historic Features:	Sash window and shutters
Detrimental Features:	Modern floor and wall coverings, sanitary ware, M&E
Condition Level:	
Condition Comments:	
Other Comments:

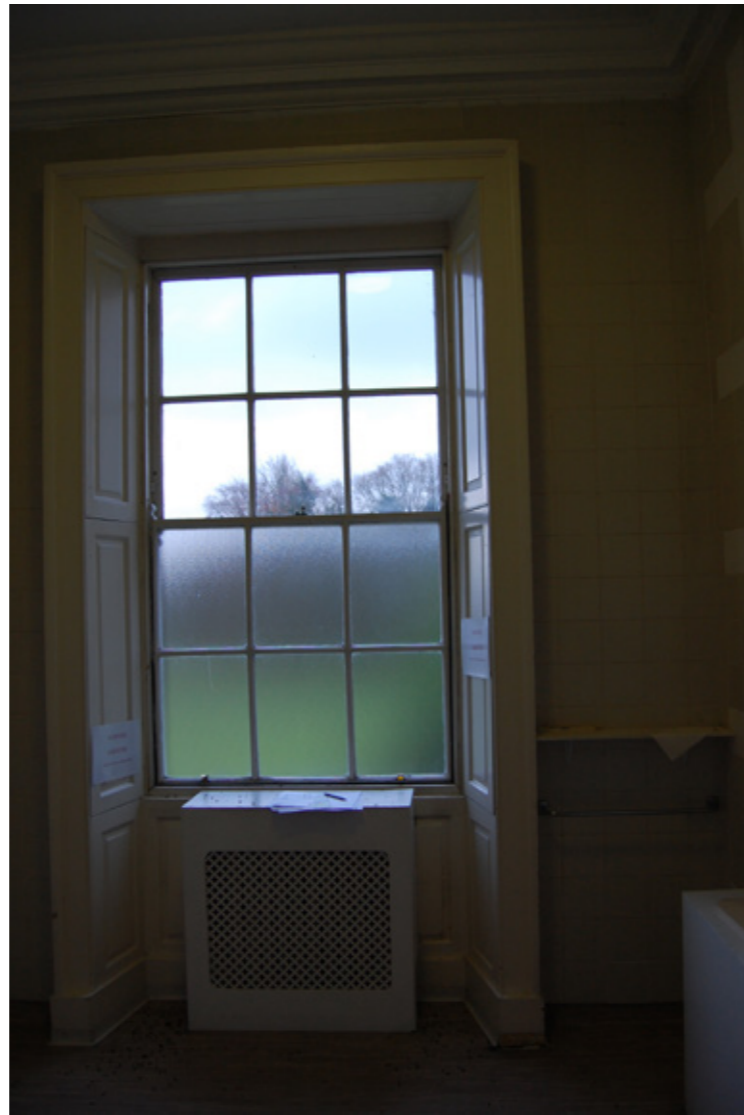
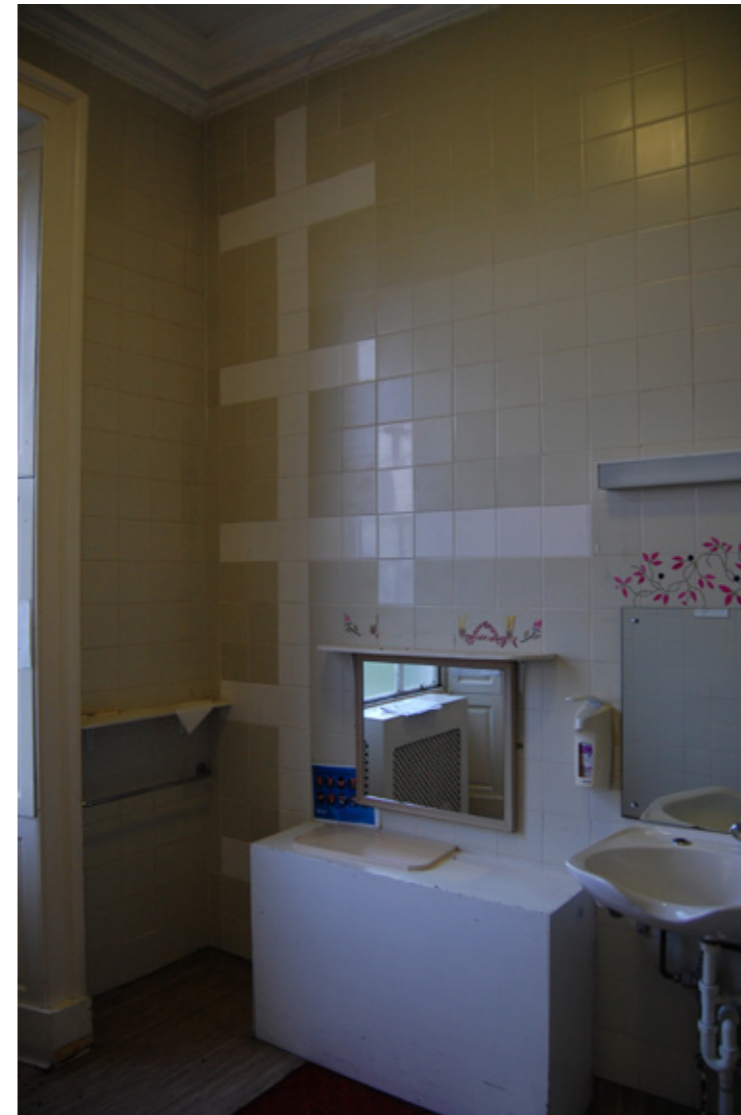
FIRST FLOOR: WYATT WING - FI.18

Room Number:	FI.18
Current Room Use:	Storage / Plant
Historic Room Use:	Bedroom/Dressing Room
Date of Structure:	1817
Date of Fixtures / Fittings:	
Date of Decoration:	Late 20th century
Major Alterations:	Subdivision of bedroom

Overall Significance Level:	Low
Key Historic Features:	None
Detrimental Features:	Modern floor and wall coverings, sanitary ware, M&E
Condition Level:	
Condition Comments:	
Other Comments:

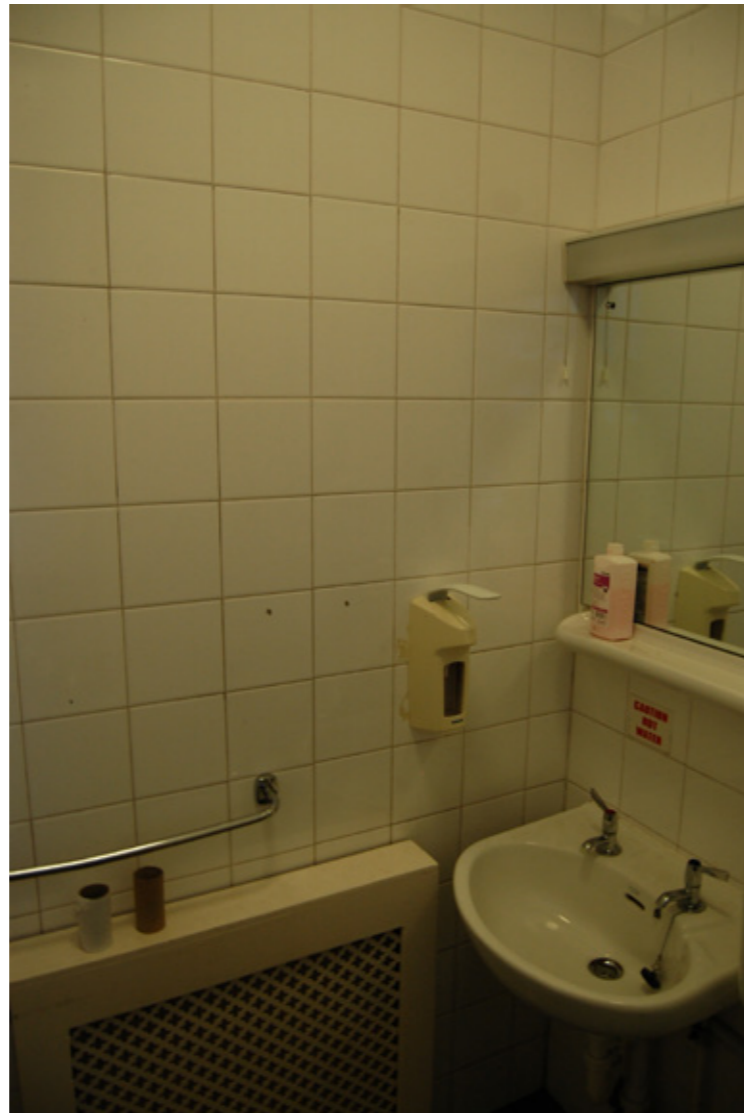
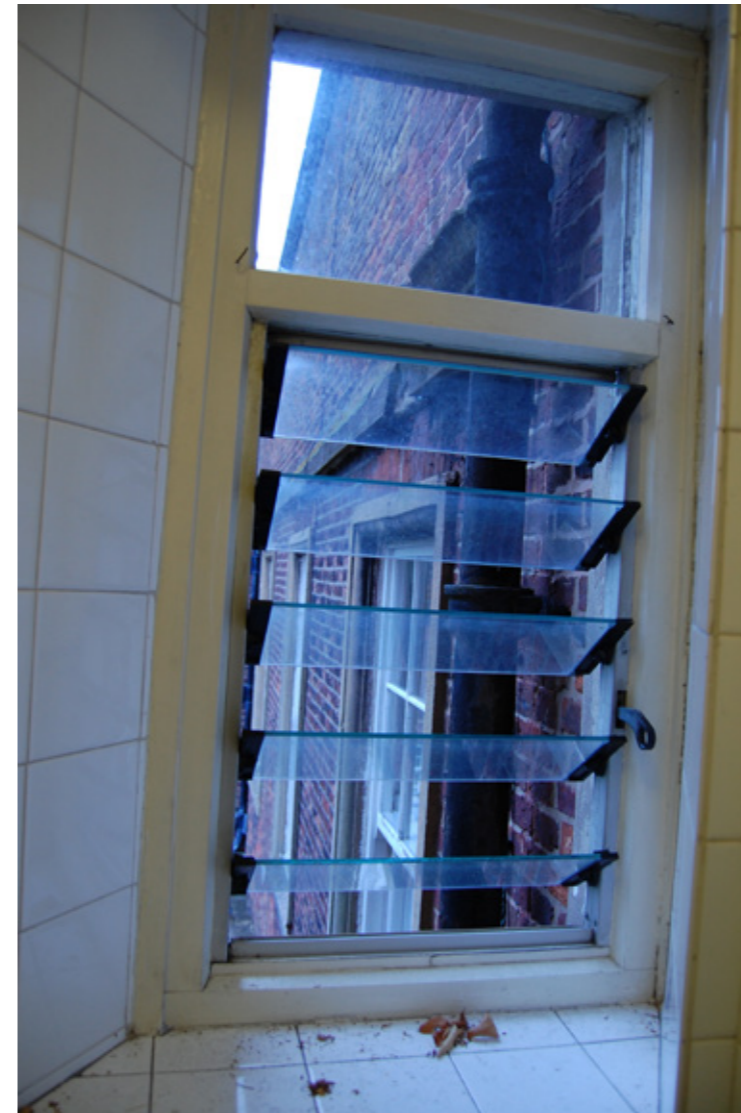
FIRST FLOOR: WYATT WING - FI.19

Room Number:	FI.19
Current Room Use:	Service Stair
Historic Room Use:	Service Stair
Date of Structure:	1817
Date of Fixtures / Fittings:	
Date of Decoration:	Late 20th century
Major Alterations:	Doorway inserted to landing

Overall Significance Level:	Very High
Key Historic Features:	Wyatt timber stair with lightwell above
Detrimental Features:	Lighting, modern carpet, paint and stair treads, modern joinery
Condition Level:	
Condition Comments:	
Other Comments:

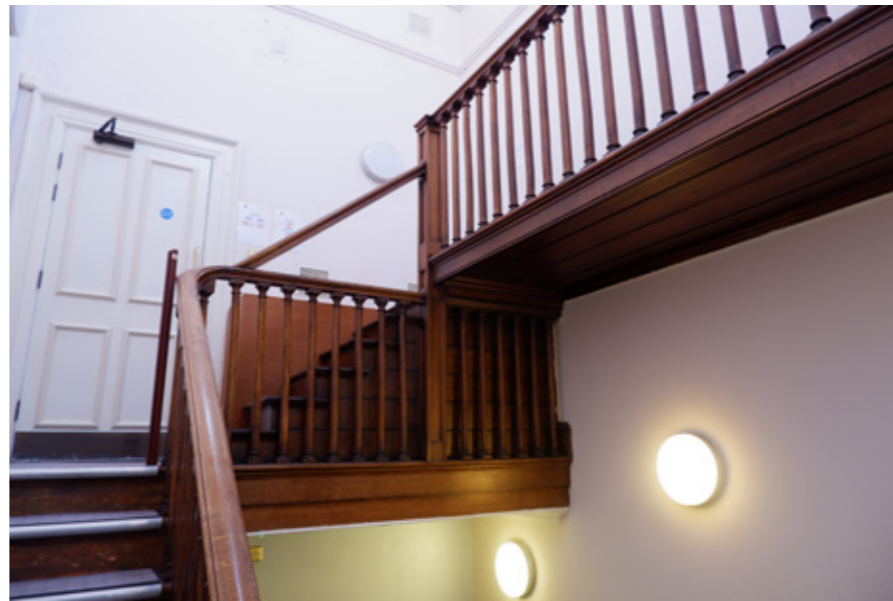
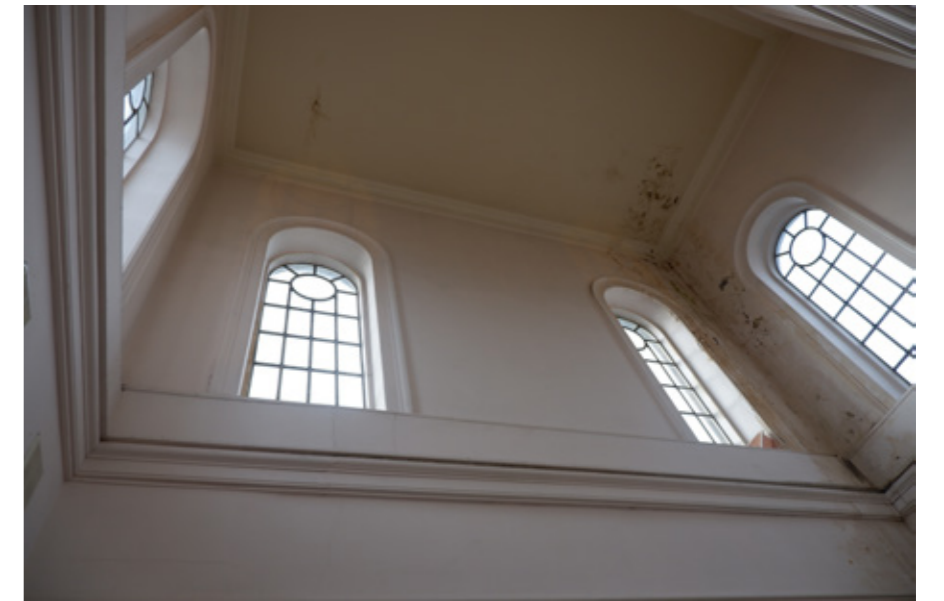
FIRST FLOOR: WYATT WING - FI.20

Room Number:	FI.20
Current Room Use:	Circulation
Historic Room Use:	Landing
Date of Structure:	1817
Date of Fixtures / Fittings:	
Date of Decoration:	Late 20th century
Major Alterations:	Subdivided from service stair
Overall Significance Level:	Very High
Key Historic Features:	Arched doorway
Detrimental Features:	Modern carpet and paint
Condition Level:	
Condition Comments:	
Other Comments:

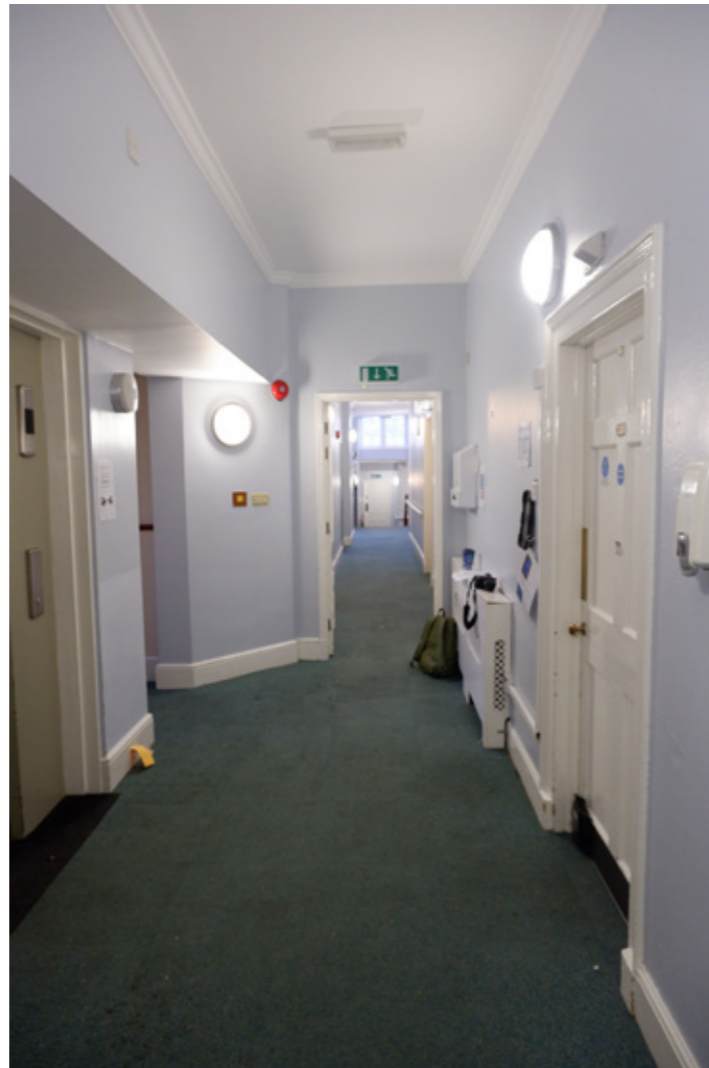
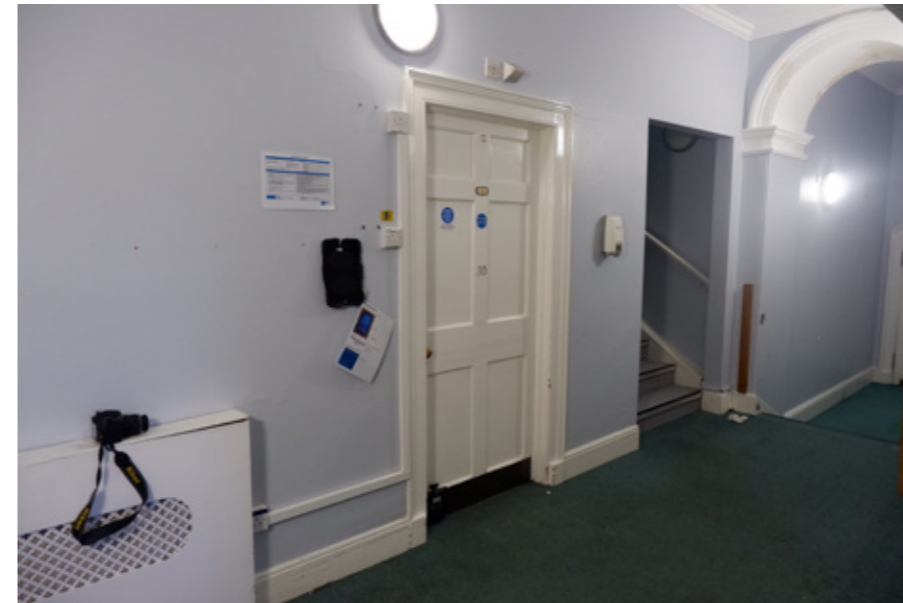
FIRST FLOOR: 1717 HOUSE - F2.01

Room Number:	F2.01
Current Room Use:	Bedrom
Historic Room Use:	Bedroom (Wyatt plan)
Date of Structure:	1717
Date of Fixtures / Fittings:	
Date of Decoration:	Late 20th century
Major Alterations:	Subdivision of bedroom

Overall Significance Level:	Medium
Key Historic Features:	Panelling, fluted timber pilasters, Sash Windows and shutters, blocked fireplace
Detrimental Features:	M&E, paint finish, flooring, radiators and door closer
Condition Level:	
Condition Comments:	
Other Comments:

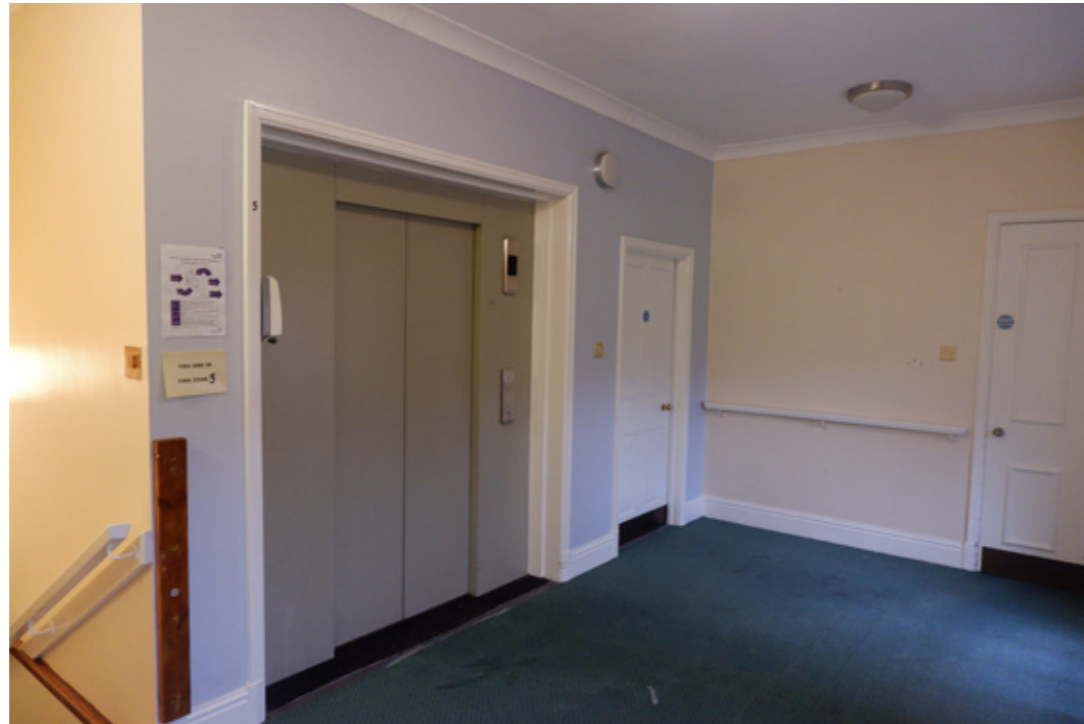
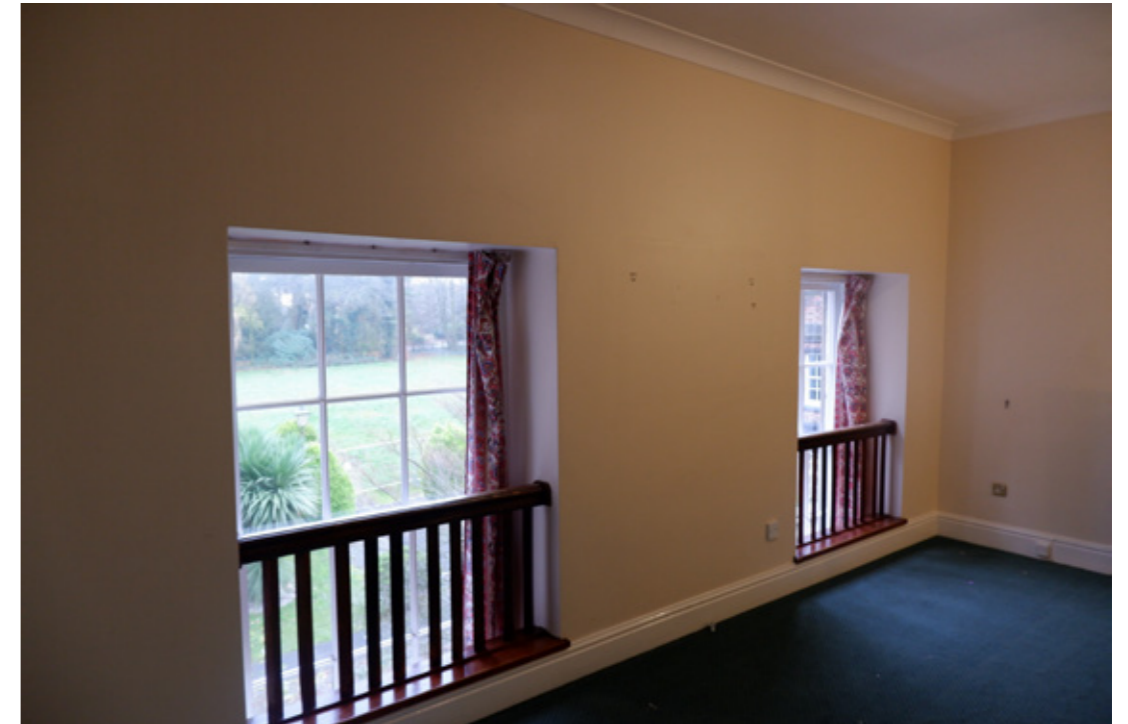
FIRST FLOOR: 1717 HOUSE - F2.03

Room Number:	F2.03
Current Room Use:	Circulation
Historic Room Use:	Bedroom (Wyatt plan)
Date of Structure:	1717
Date of Fixtures / Fittings:	
Date of Decoration:	Late 20th century
Major Alterations:	Late 20th century insertion of landing for lift, subdivision of bedroom

Overall Significance Level:	Detrimental
Key Historic Features:	Sash windows
Detrimental Features:	Inserted landing across windows, lift, M&E, modern carpet, landing gate
Condition Level:	
Condition Comments:	
Other Comments:

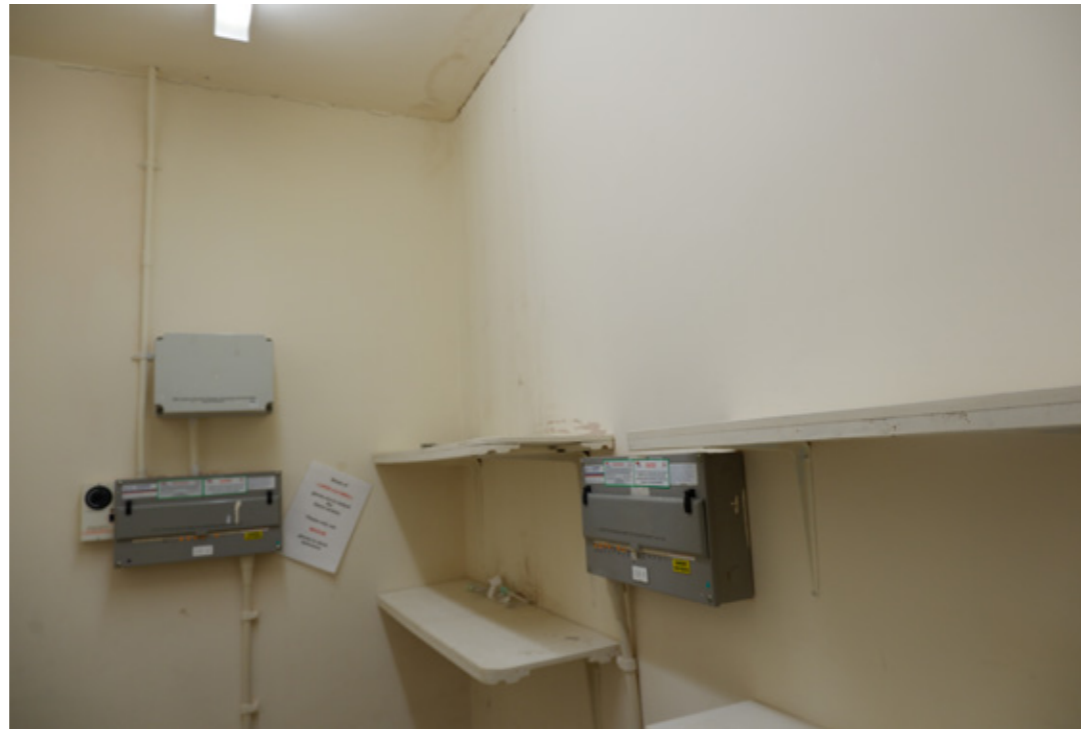
FIRST FLOOR: 1717 HOUSE - F2.04

Room Number:	F2.04
Current Room Use:	Storage / Plant
Historic Room Use:	Bedroom (Wyatt plan)
Date of Structure:	1717
Date of Fixtures / Fittings:	
Date of Decoration:	Late 20th century
Major Alterations:	Late 20th century insertation of lift plant, subdivision of bedroom

Overall Significance Level: Detrimental
