VOLUME TWO

GAZETTEER

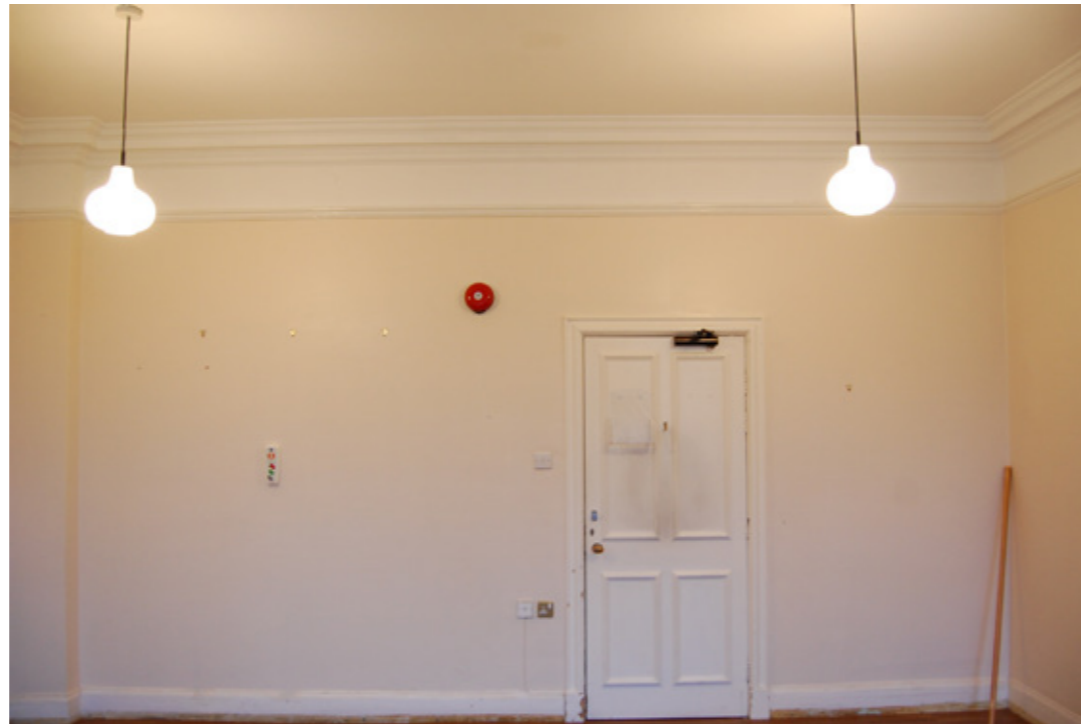
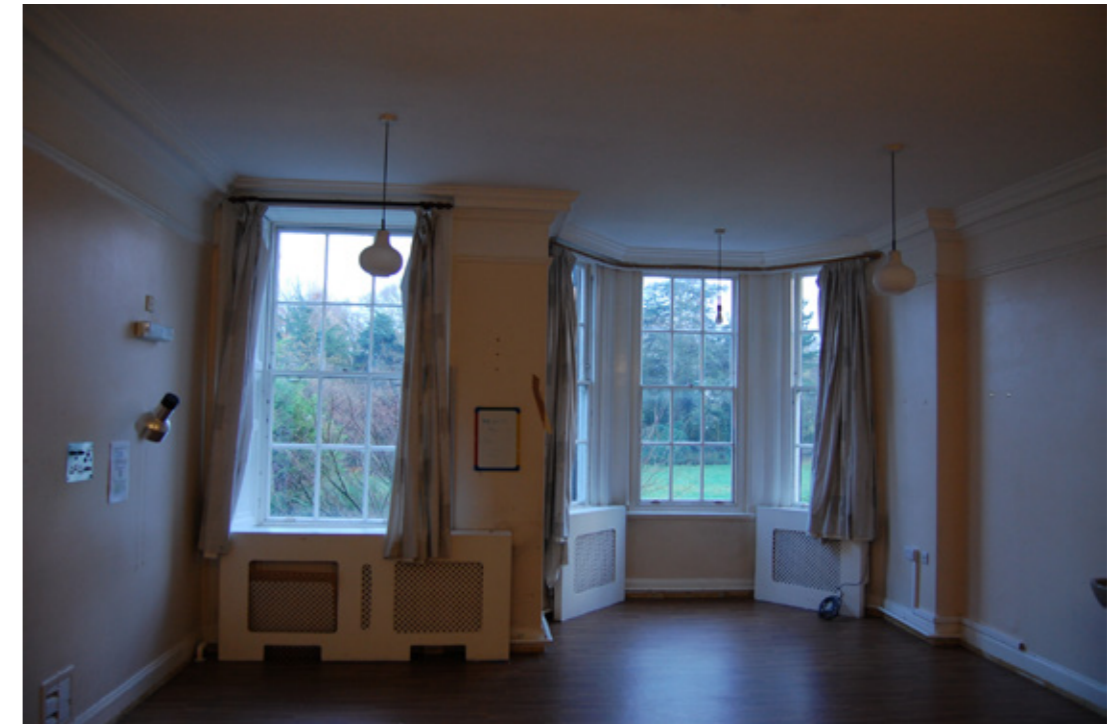
FIRST FLOOR: 1717 HOUSE - F2.05

Room Number:	F2.05
Current Room Use:	Bedroom
Historic Room Use:	Bedroom (Wyatt plan)
Date of Structure:	1717
Date of Fixtures / Fittings:	
Date of Decoration:	Late 20th century
Major Alterations:	Insertation of bay window

Overall Significance Level:	Low
Key Historic Features:	Bay window, sash windows and shutters
Detrimental Features:	M&E, modern radiators and flooring
Condition Level:	
Condition Comments:	
Other Comments:	Floorplan changes on two versions of Wyatt 1816 drawings

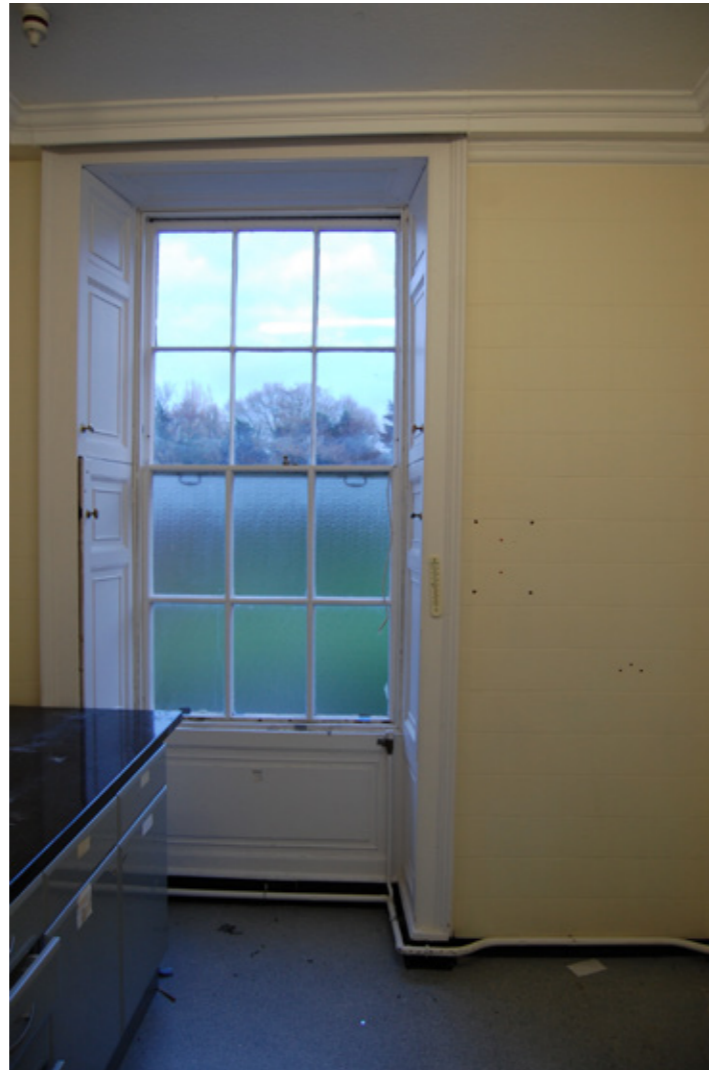
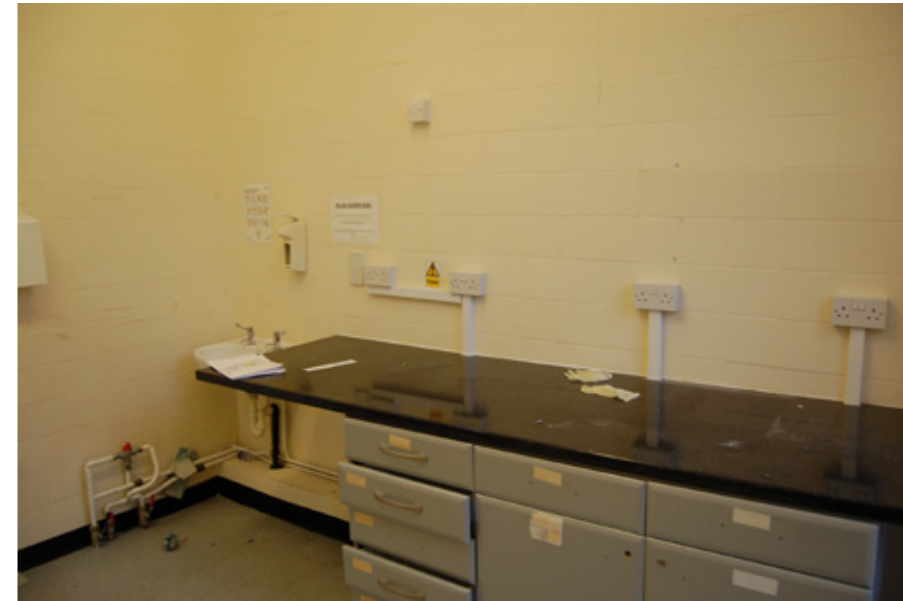
Room Number:	F2.06
Current Room Use:	Bathroom
Historic Room Use:	Bedroom (Wyatt plan)
Date of Structure:	1717
Date of Fixtures / Fittings:	
Date of Decoration:	Late 20th century
Major Alterations:	Subdivision of bedroom

Overall Significance Level:	Detrimental
Key Historic Features:	Sash window and shutters
Detrimental Features:	M&E, modern wall and floor coverings, modern cabinets
Condition Level:	
Condition Comments:	
Other Comments:	Floorplan changes otwo versions of Wyat 1816 drawings

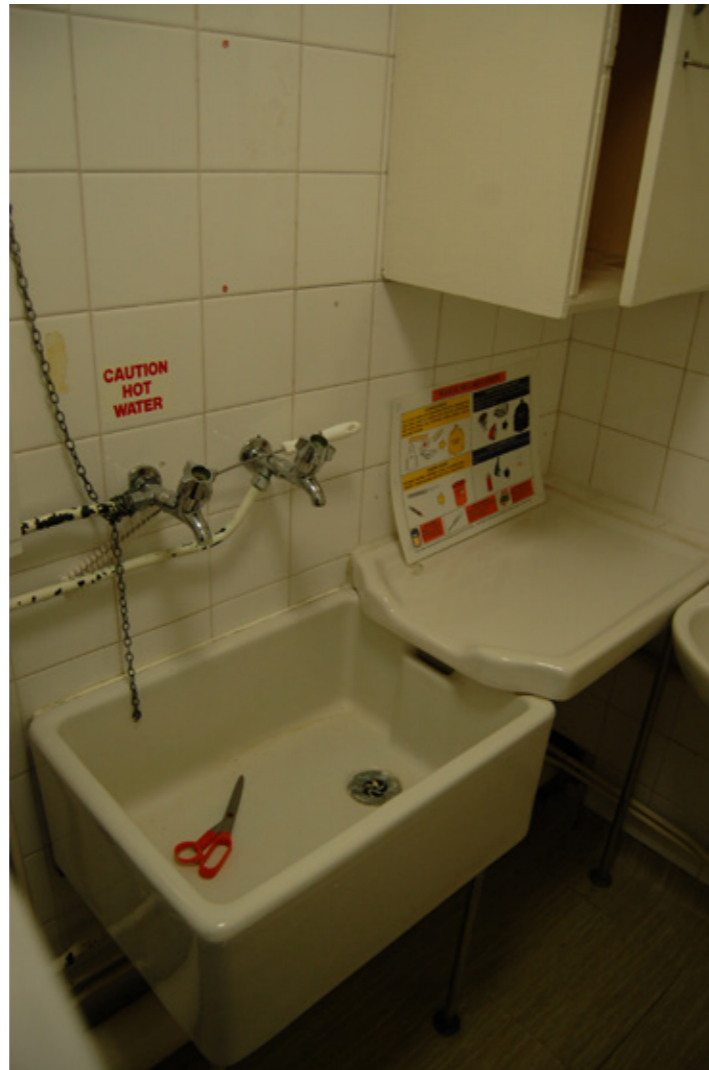
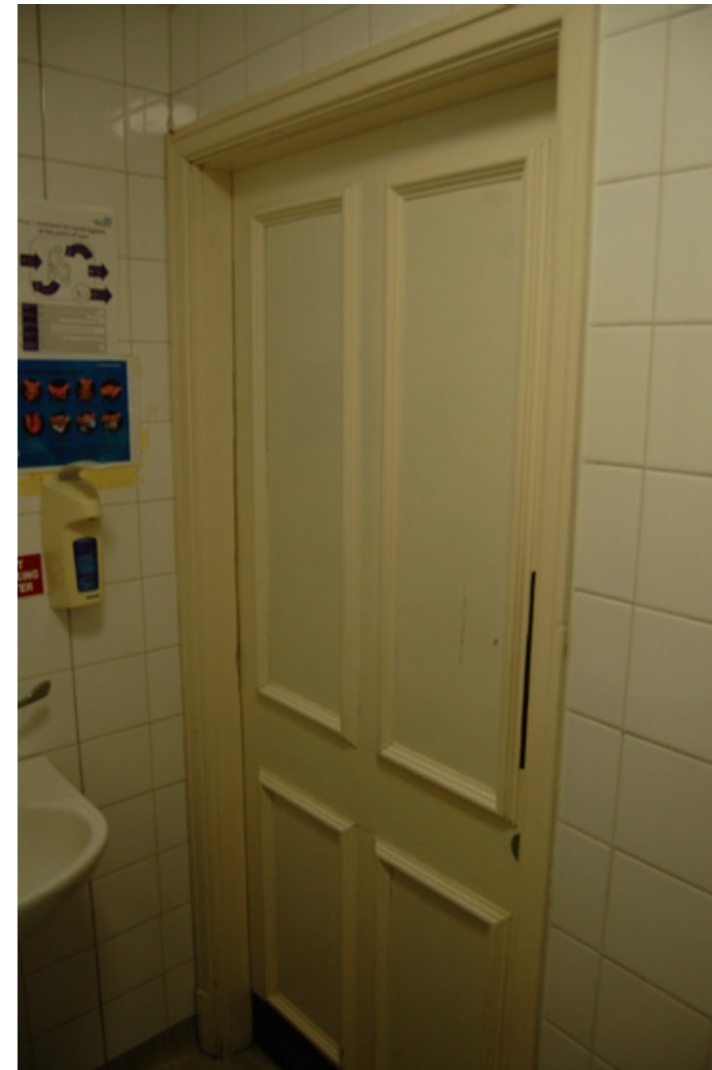
FIRST FLOOR: 1717 HOUSE - F2.07

Room Number:	F2.07
Current Room Use:	WC
Historic Room Use:	Bedroom (Wyatt plan)
Date of Structure:	1717
Date of Fixtures / Fittings:	
Date of Decoration:	Late 20th century
Major Alterations:	Subdivision of bedroom

Overall Significance Level:	Detrimental
Key Historic Features:	None
Detrimental Features:	M&E, floor and wall coverings, sanitaryware
Condition Level:	
Condition Comments:	
Other Comments:	Floorplan changes on two versions of Wyatt 1816 drawings

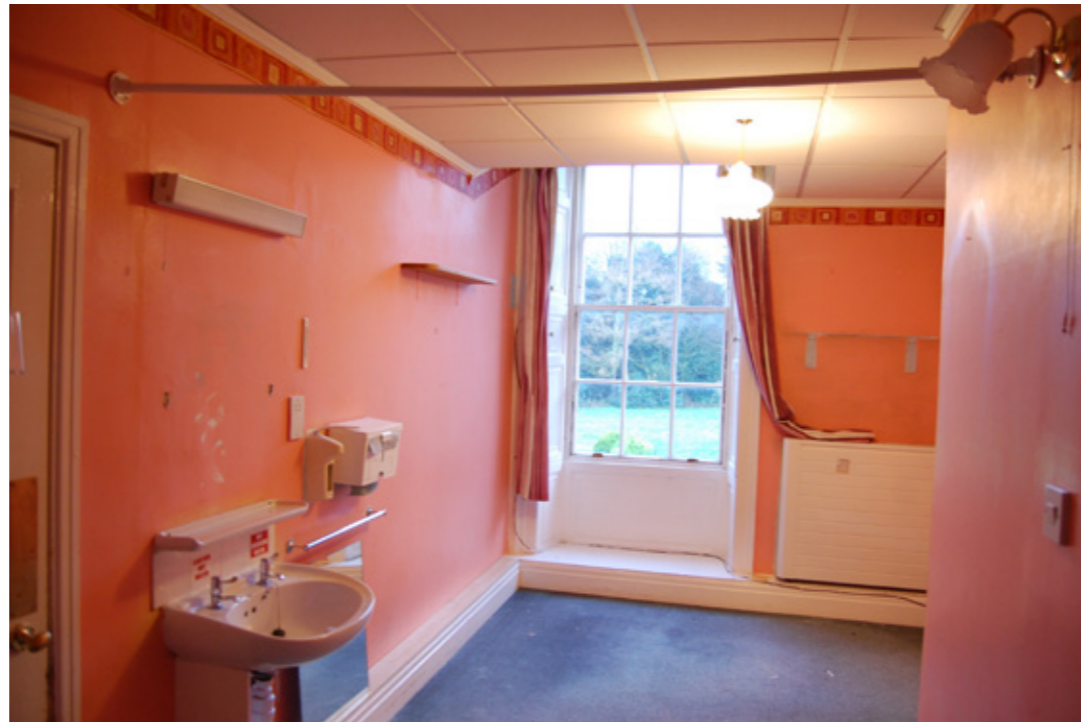
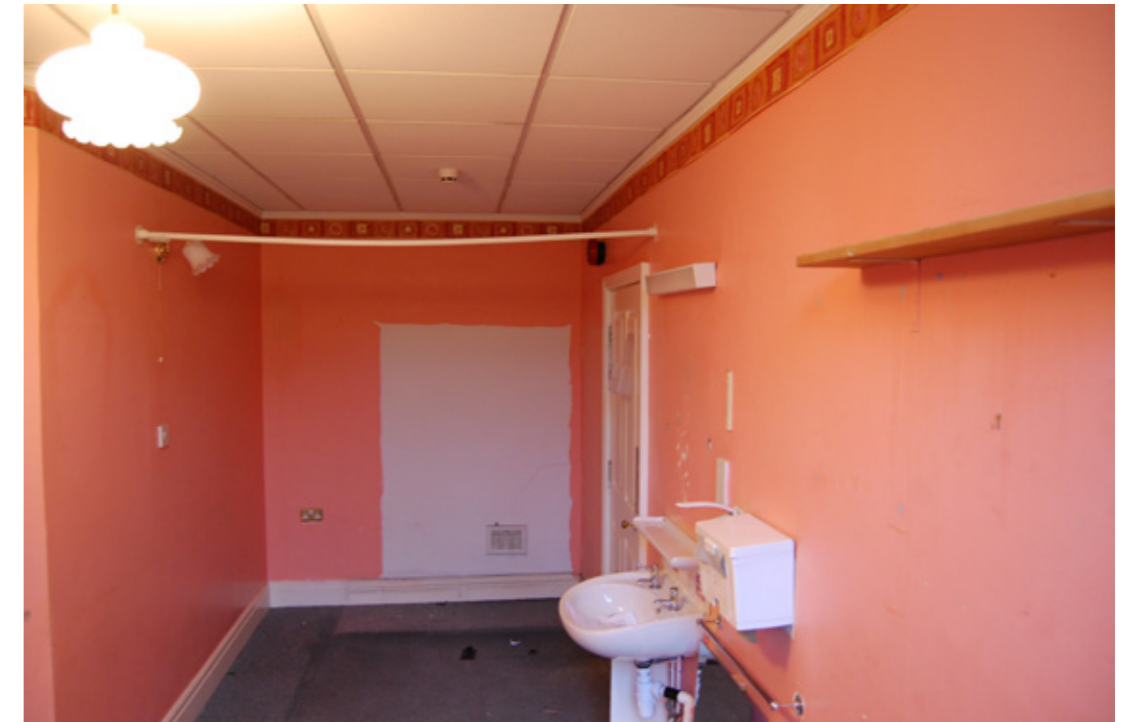
FIRST FLOOR: 1717 HOUSE - F2.08

Room Number:	F2.08
Current Room Use:	Bedroom
Historic Room Use:	Bedroom (Wyatt plan)
Date of Structure:	1717
Date of Fixtures / Fittings:	
Date of Decoration:	Late 20th century
Major Alterations:	Subdivision of bedroom

Overall Significance Level:	Detrimental
Key Historic Features:	Sash window and shutters
Detrimental Features:	Suspended ceiling, wall coverings, flooring, M&E, radiators
Condition Level:	
Condition Comments:	
Other Comments:	Floorplan changes on two versions of Wyatt 1816 drawings

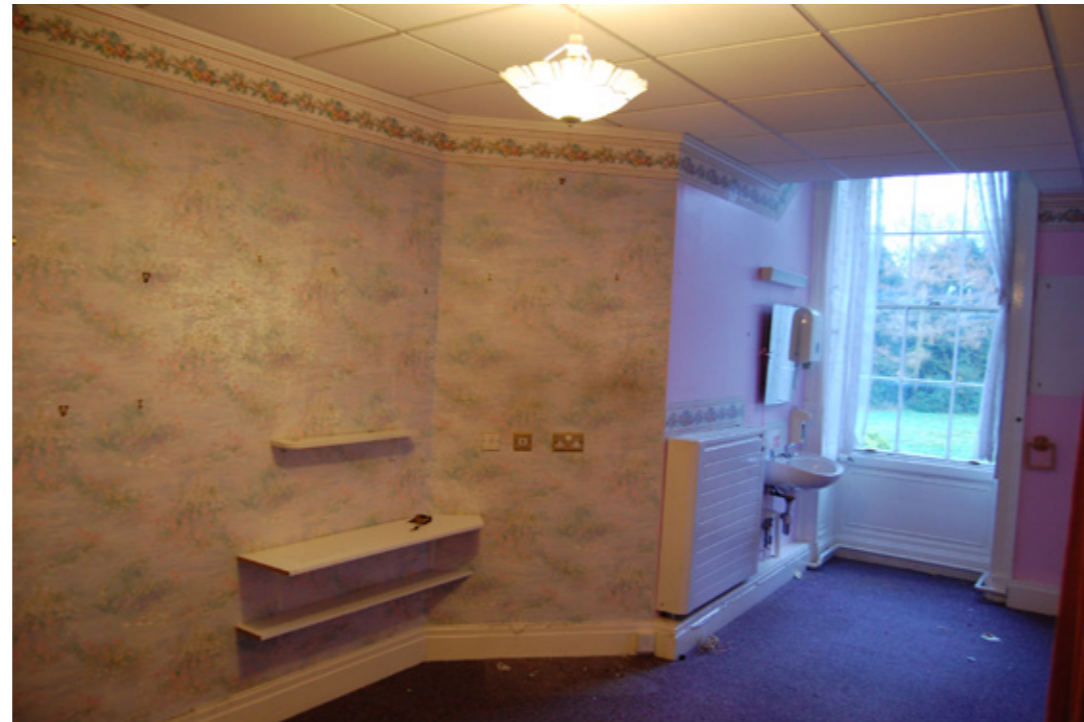
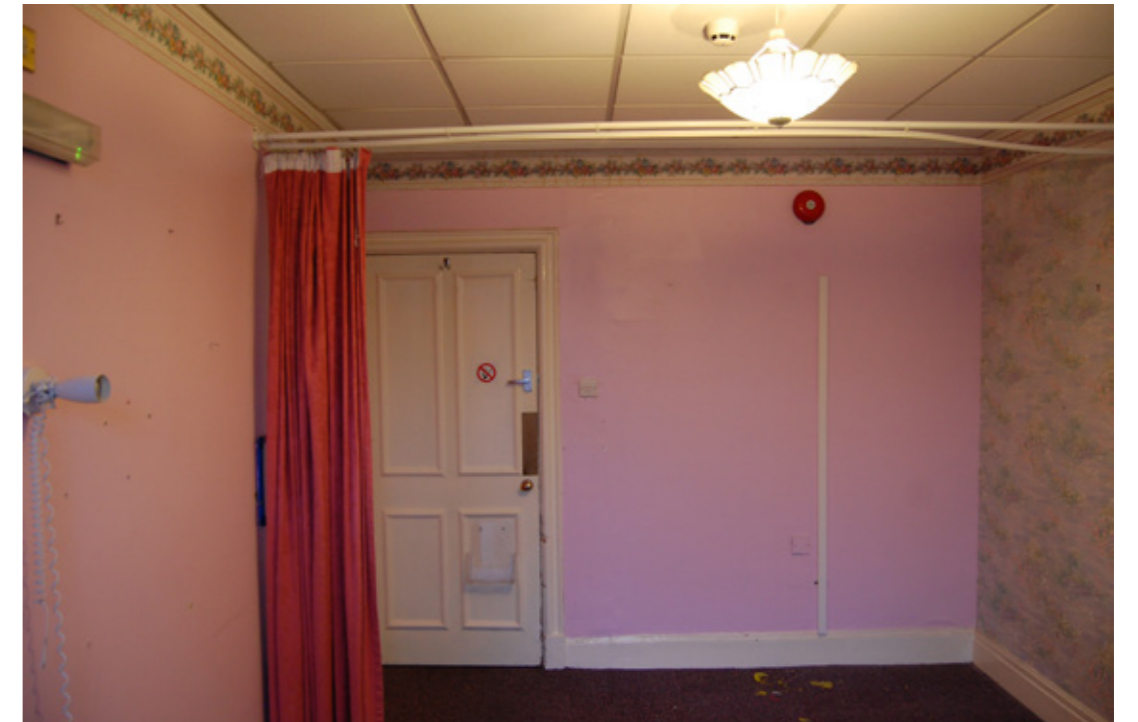
FIRST FLOOR: 1717 HOUSE - F2.09

Room Number:	F2.09
Current Room Use:	Bedroom
Historic Room Use:	Bedroom (Wyatt plan)
Date of Structure:	1717
Date of Fixtures / Fittings:	
Date of Decoration:	Late 20th century
Major Alterations:	Subdivision of bedroom, removal of Wyatt stair

Overall Significance Level:	Detrimental
Key Historic Features:	Sash window and shutters
Detrimental Features:	Suspended ceiling, wall coverings, flooring, M&E, radiators
Condition Level:	
Condition Comments:	
Other Comments:	Floorplan changes on two versions of Wyatt 1816 drawings

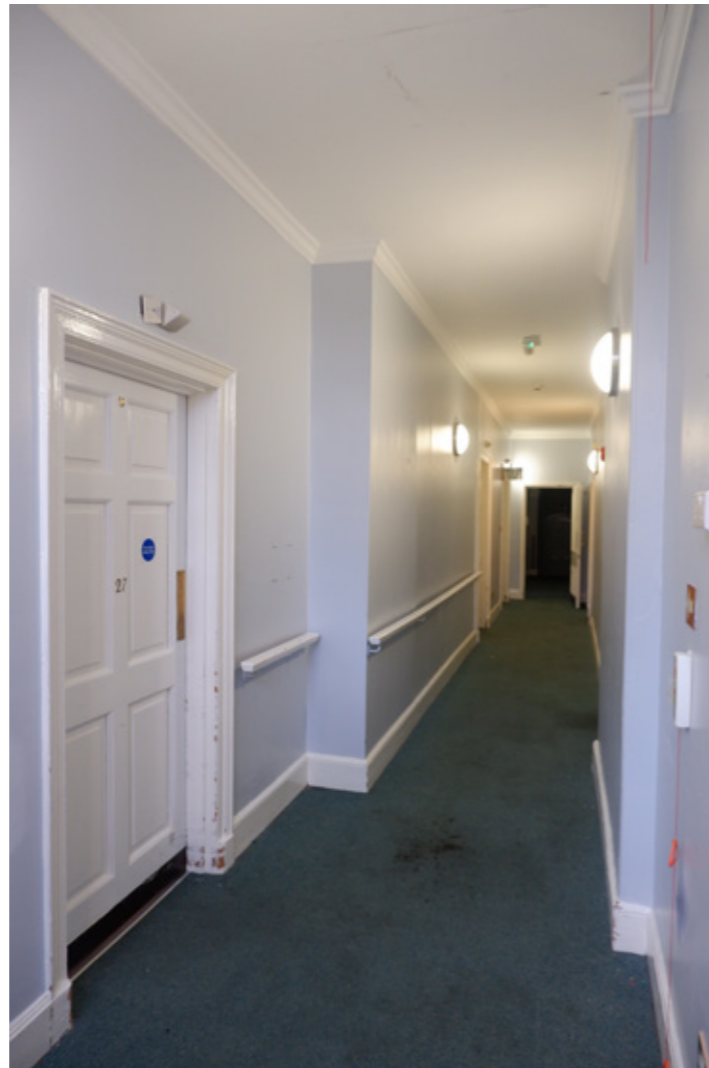
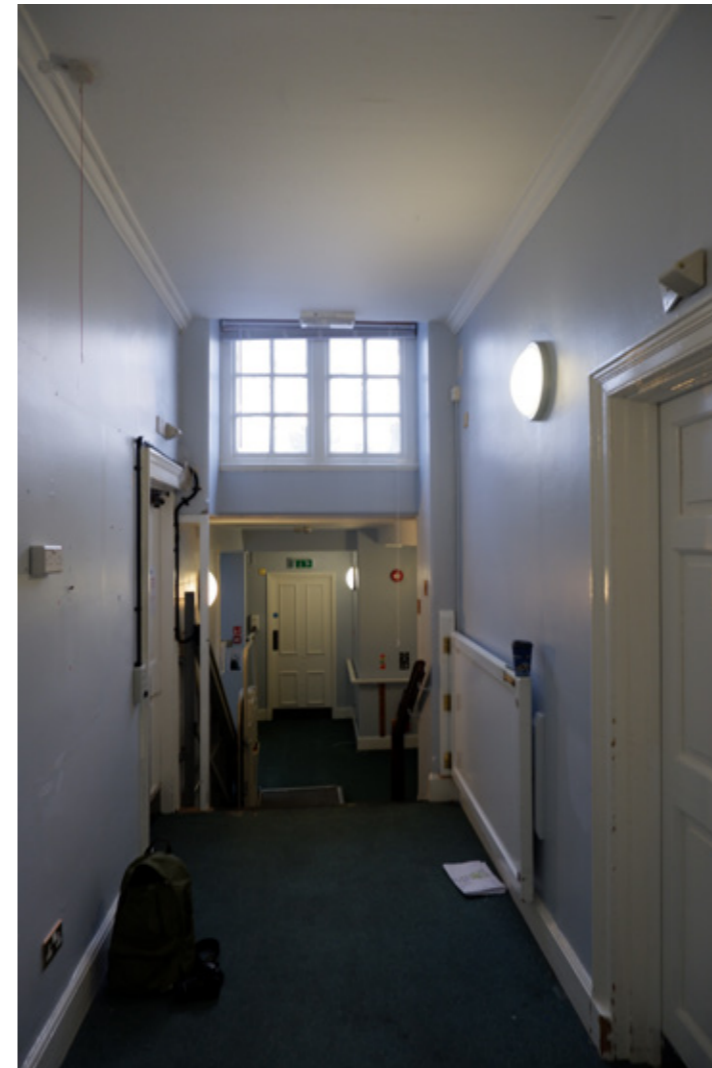
FIRST FLOOR: 1717 HOUSE - F2.10

Room Number:	F2.10
Current Room Use:	Corridor
Historic Room Use:	Corridor (Wyatt plan)
Date of Structure:	1717
Date of Fixtures / Fittings:	
Date of Decoration:	Late 20th century
Major Alterations:

Overall Significance Level:	Low
Key Historic Features:	Timber framed window
Detrimental Features:	M&E, modern carpet and wall finish
Condition Level:	
Condition Comments:	
Other Comments:

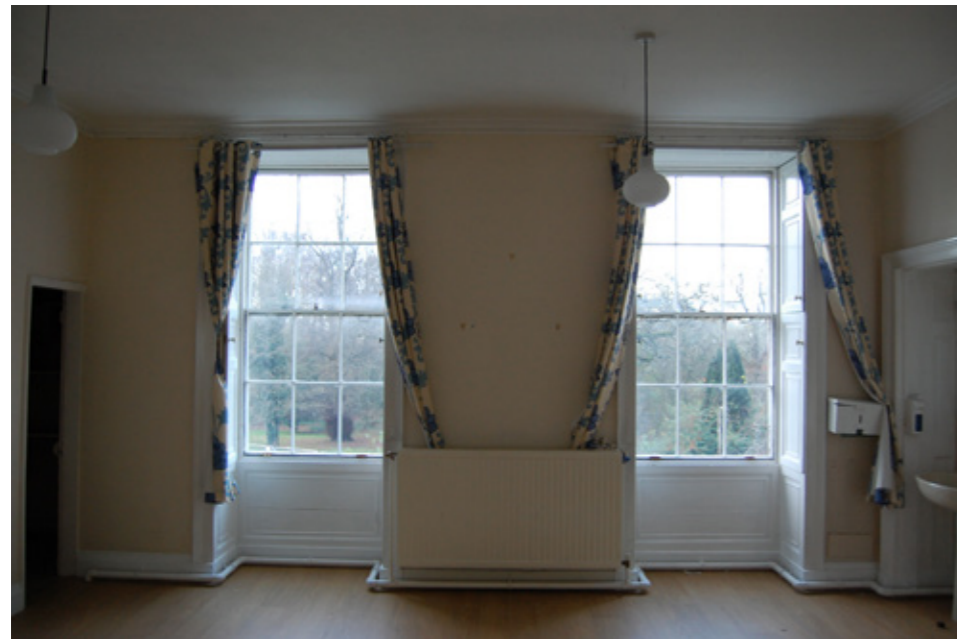
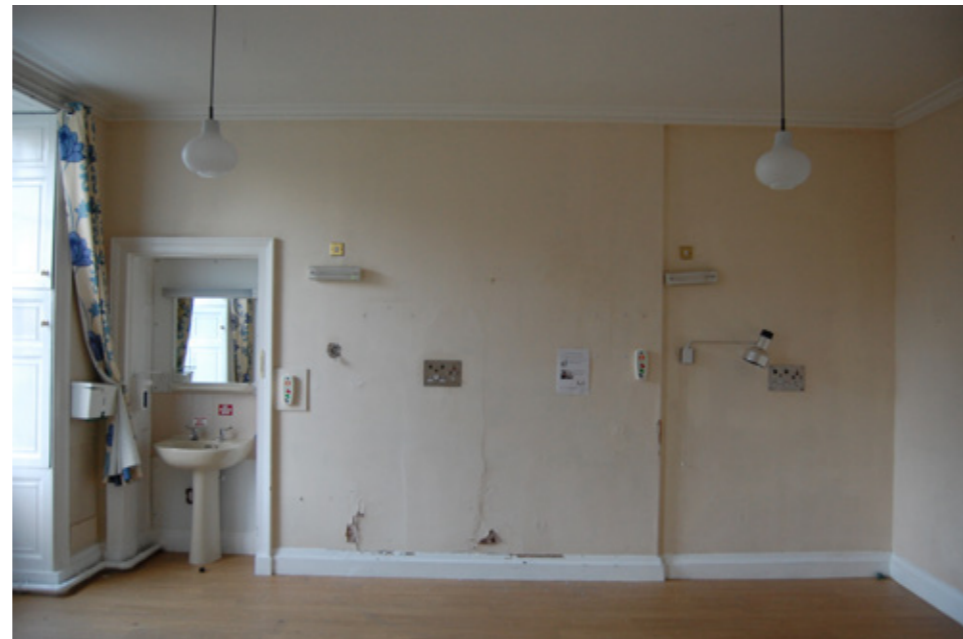
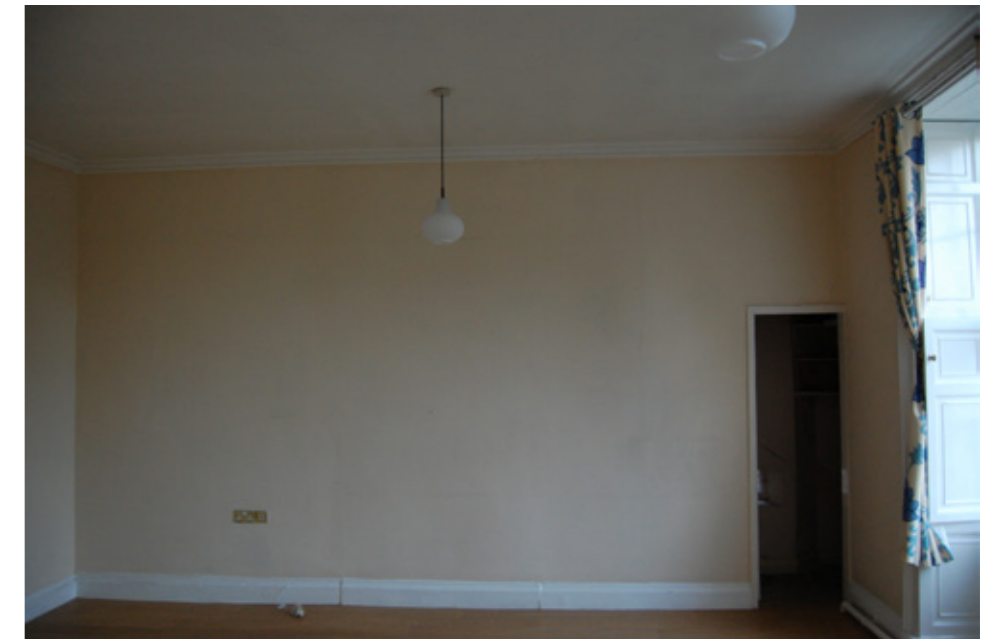
FIRST FLOOR: 1717 HOUSE - F2.II

Room Number:	F2.II
Current Room Use:	Bedroom
Historic Room Use:	Bedroom (Wyatt plan)
Date of Structure:	1717
Date of Fixtures / Fittings:	
Date of Decoration:	Late 20th century
Major Alterations:	Removal of fireplace

Overall Significance Level:	Medium
Key Historic Features:	Sash windows and shutters, panelling to blocked up doorway, Access to corner tower/closet
Detrimental Features:	M&E, modern flooring, sanitaryware, radiator
Condition Level:	
Condition Comments:	
Other Comments:	Floorplan changes on two versions of Wyatt 1816 drawings

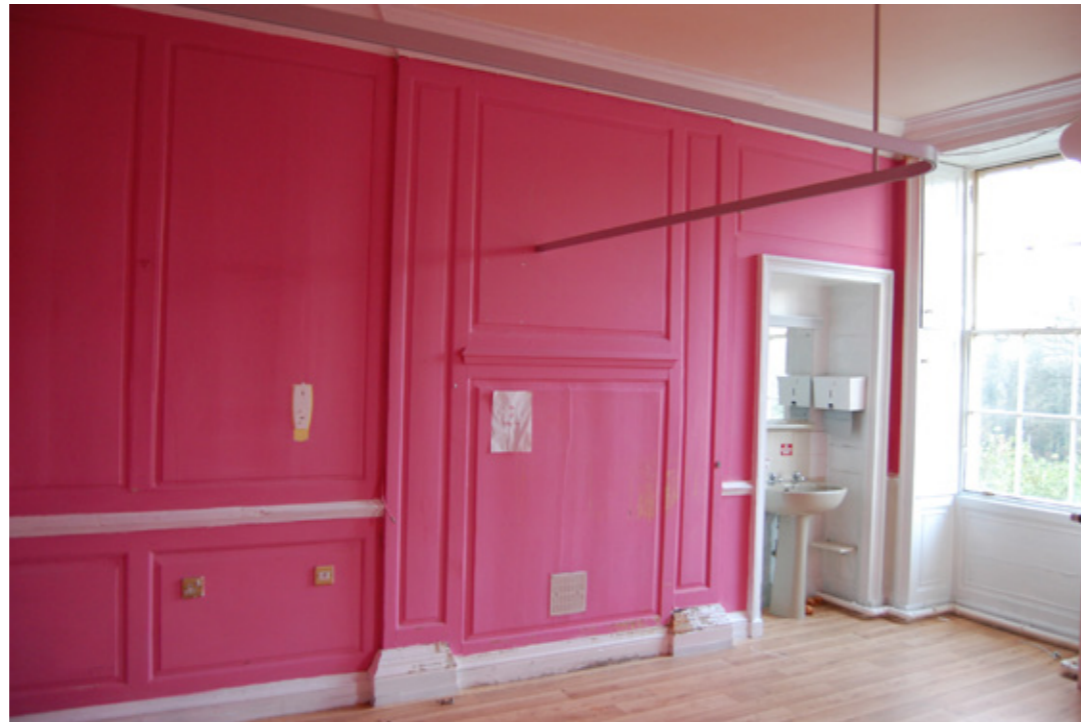
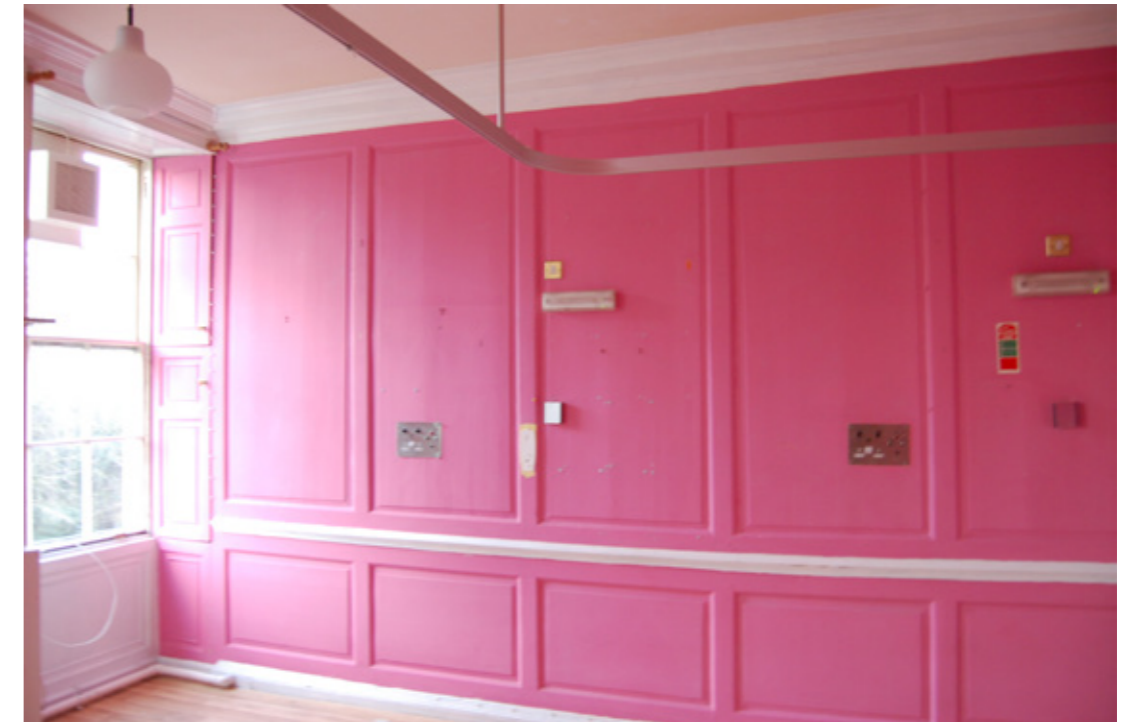
FIRST FLOOR: 1717 HOUSE - F2.12

Room Number:	F2.12
Current Room Use:	Bedroom
Historic Room Use:	Bedroom (Wyatt plan)
Date of Structure:	1717
Date of Fixtures / Fittings:	
Date of Decoration:	Late 20th century
Major Alterations:

Overall Significance Level:	Medium
Key Historic Features:	Sash windows and shutters, panelling, blocked fireplace
Detrimental Features:	M&E, modern flooring, paint finish, sanitary ware, extractor fan on sash window
Condition Level:	
Condition Comments:	
Other Comments:

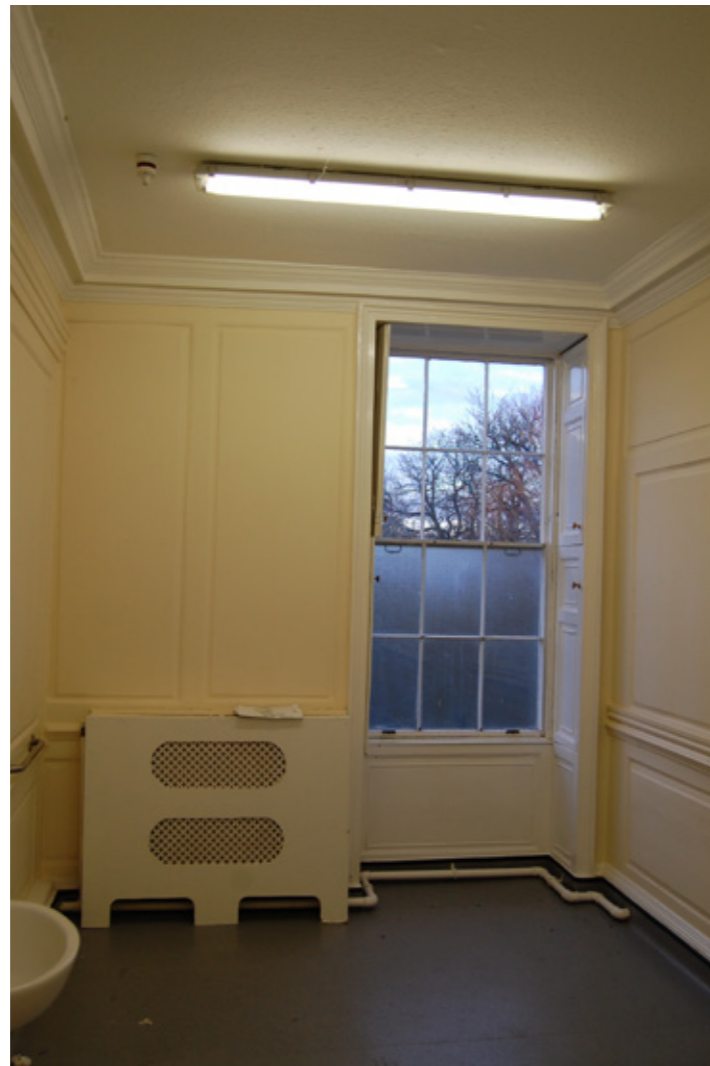
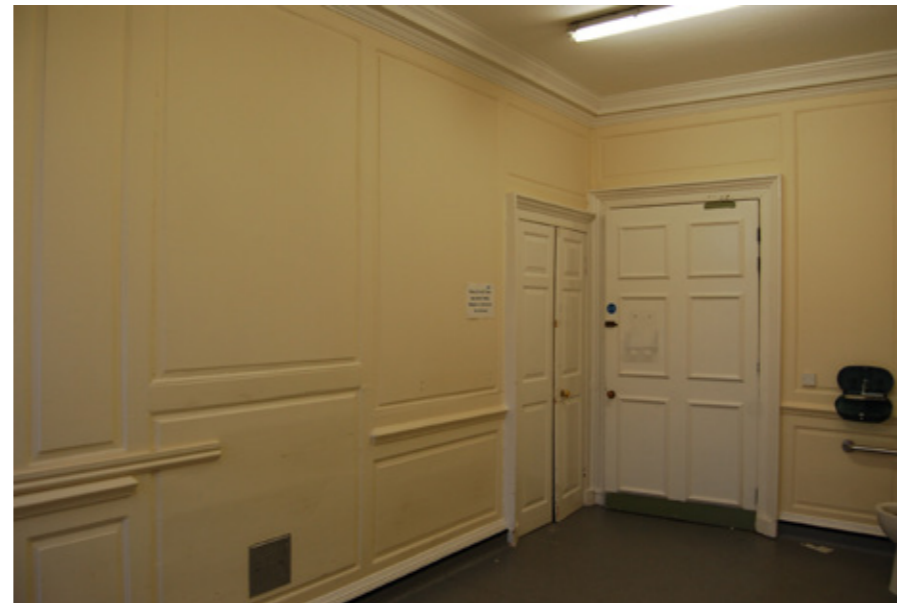
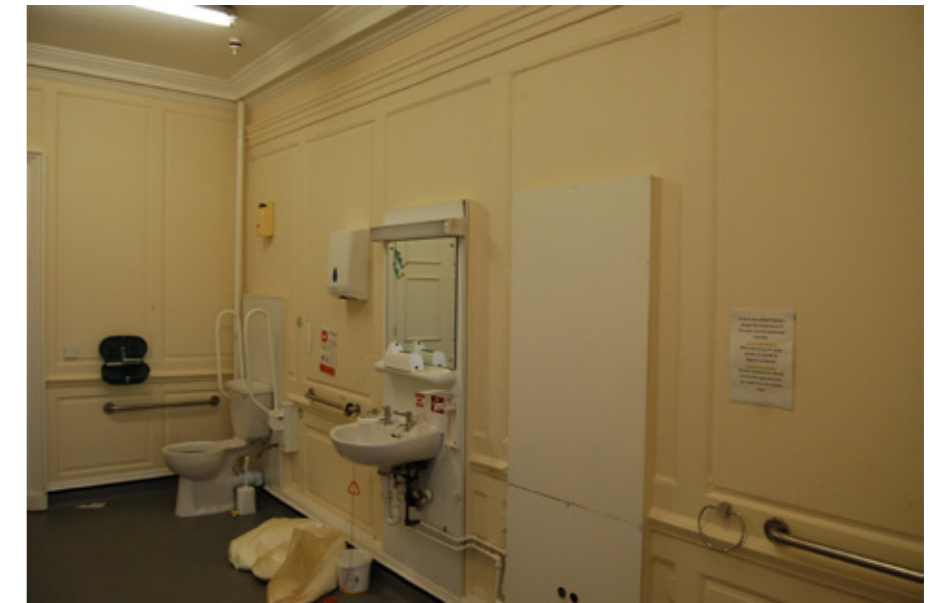
FIRST FLOOR: 1717 HOUSE - F2.13

Room Number:	F2.13
Current Room Use:	Bedroom
Historic Room Use:	Bedroom (Wyatt plan)
Date of Structure:	1717
Date of Fixtures / Fittings:	
Date of Decoration:	Late 20th century
Major Alterations:	Removal of fireplace

Overall Significance Level:	Medium
Key Historic Features:	Sash windows and shutters, panelling, blocked fireplace
Detrimental Features:	M&E, modern flooring, paint finish, sanitary ware
Condition Level:	
Condition Comments:	
Other Comments:	Floorplan changes on two versions of Wyatt 1816 drawings

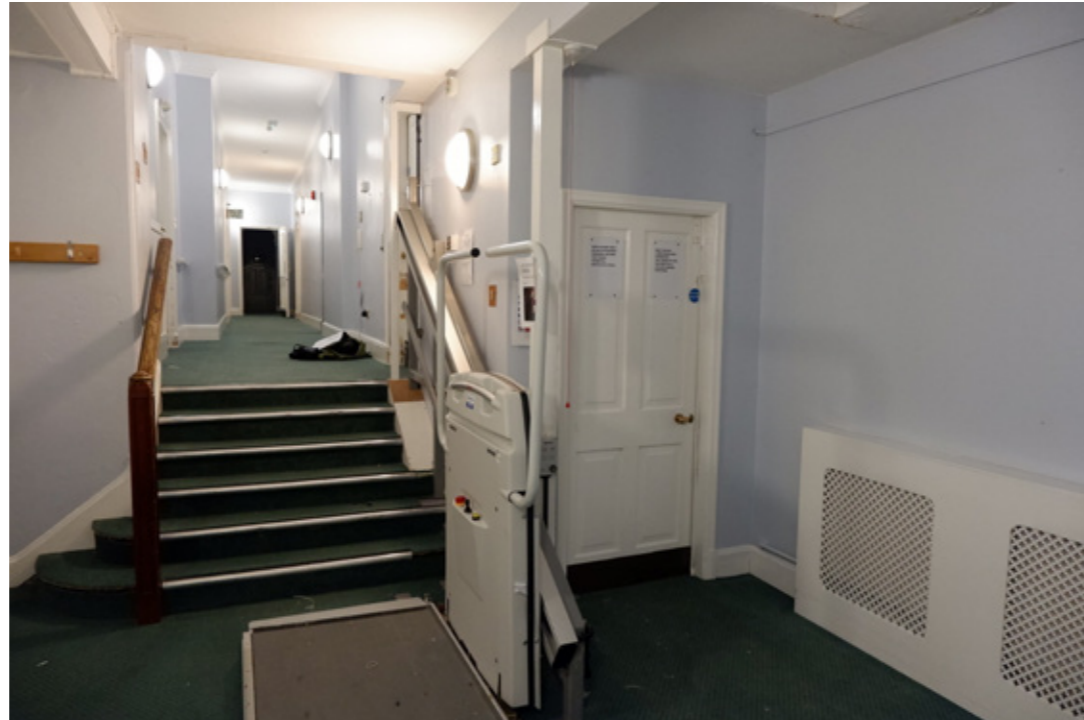
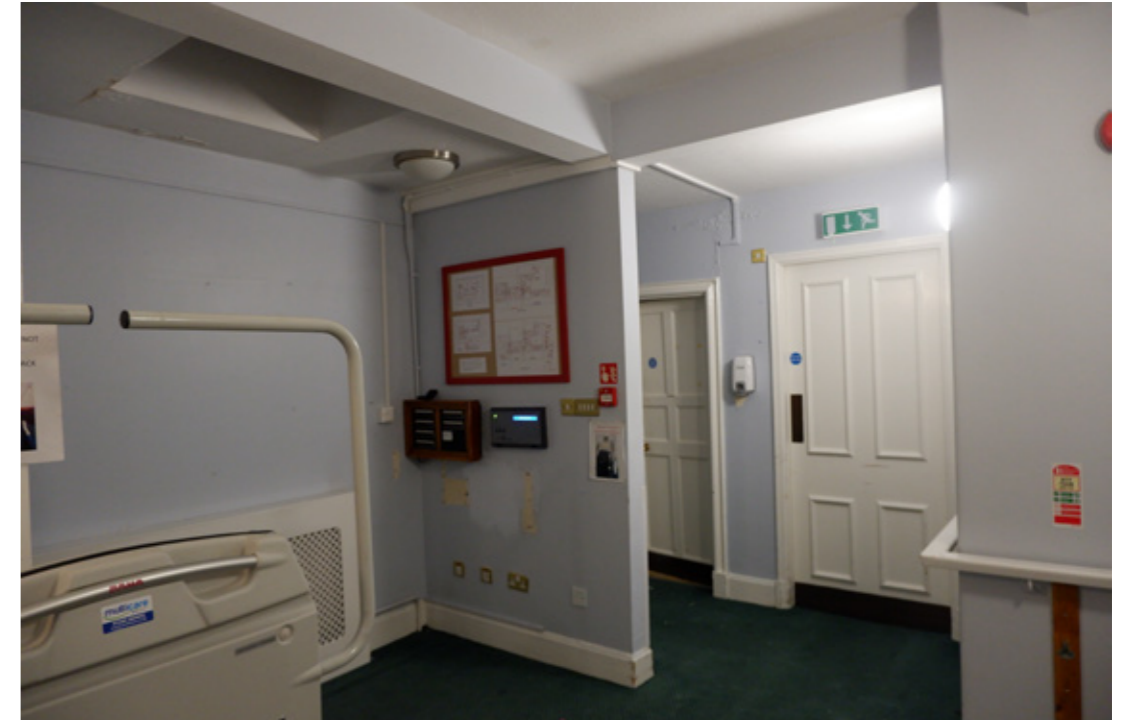
FIRST FLOOR: SERVICE WING - F3.01

Room Number:	F3.01
Current Room Use:	Circulation
Historic Room Use:	Stair (Wyatt plan)
Date of Structure:	1817
Date of Fixtures / Fittings:	
Date of Decoration:	Late 20th century
Major Alterations:	Removal of Wyatt Stair; reconfiguration as part of FF extension

Overall Significance Level:	Low
Key Historic Features:	None
Detrimental Features:	M&E, Modern carpet, stairlift
Condition Level:	
Condition Comments:	
Other Comments:	Floorplan changes on two versions of Wyat 1816 drawings

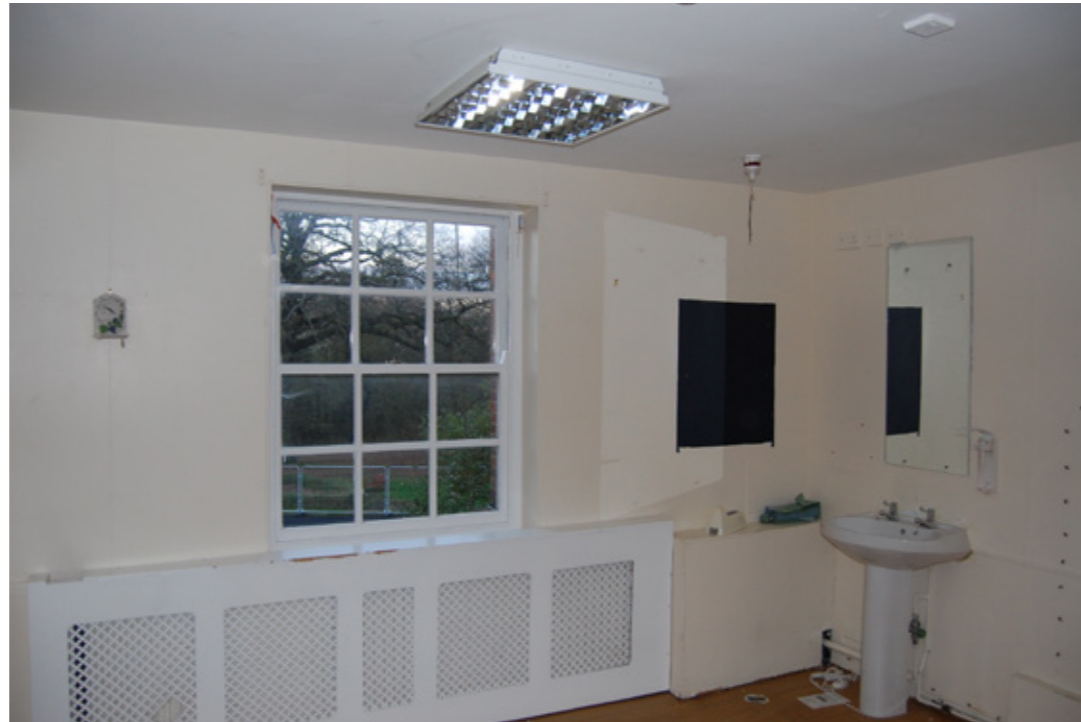
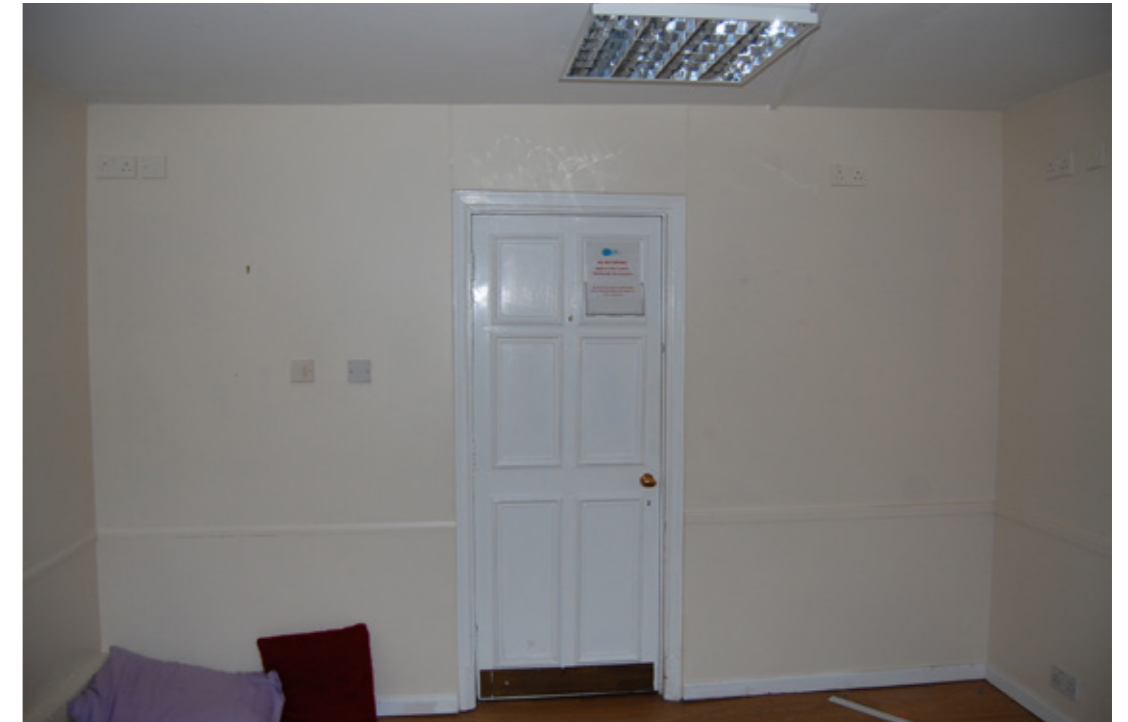
FIRST FLOOR: SERVICE WING - F3.02

Room Number:	F3.02
Current Room Use:	Bedroom
Historic Room Use:	Bedroom (Wyatt plan)
Date of Structure:	1817
Date of Fixtures / Fittings:	
Date of Decoration:	Late 20th century
Major Alterations:	Reorganisation of Wyatt FF

Overall Significance Level:	Medium
Key Historic Features:	Sash window
Detrimental Features:	M&E, light fittings, modern fit out and sanitary ware
Condition Level:	
Condition Comments:	
Other Comments:

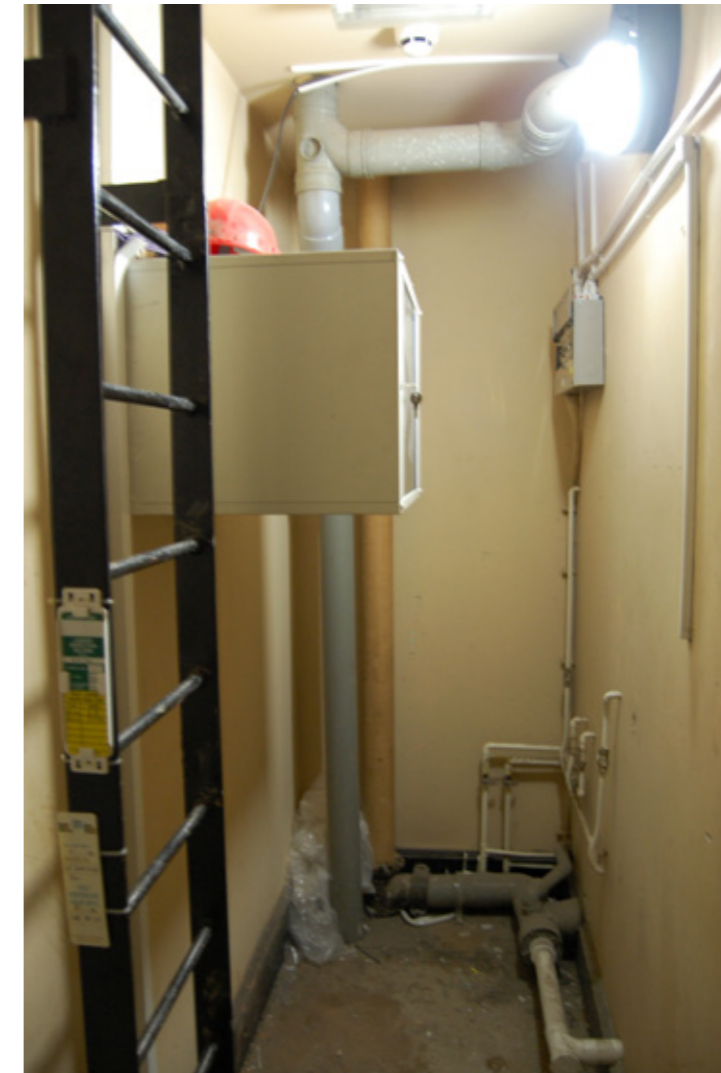
FIRST FLOOR: SERVICE WING - F3.03

Room Number:	F3.03
Current Room Use:	Access to Attic
Historic Room Use:	Bedroom (Wyatt plan)
Date of Structure:	1817
Date of Fixtures / Fittings:	
Date of Decoration:	Late 20th century
Major Alterations:	Reorganisation of Wyatt FF
Overall Significance Level:	Neutral
Key Historic Features:	None
Detrimental Features:	M&E, plant
Condition Level:	
Condition Comments:	
Other Comments:	Floorplan changes on two versions of Wyatt 1816 drawings

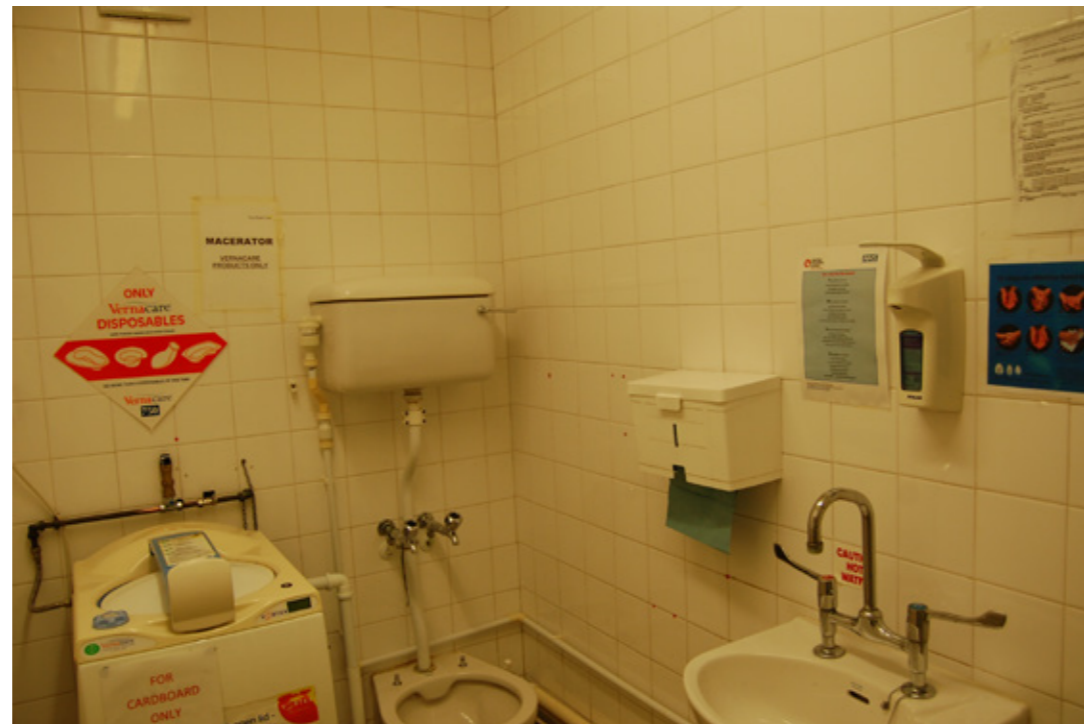
FIRST FLOOR: SERVICE WING - F3.04

Room Number:	F3.04
Current Room Use:	Storage / Plant
Historic Room Use:	Bedroom (Wyatt plan)
Date of Structure:	1817
Date of Fixtures / Fittings:	
Date of Decoration:	Late 20th century
Major Alterations:	Reorganisation of Wyatt FF

Overall Significance Level:	Neutral
Key Historic Features:	None
Detrimental Features:	M&E, plant, modern floor and wall covering, sanitary ware
Condition Level:	
Condition Comments:	
Other Comments:	Floorplan changes on two versions of Wyatt 1816 drawings

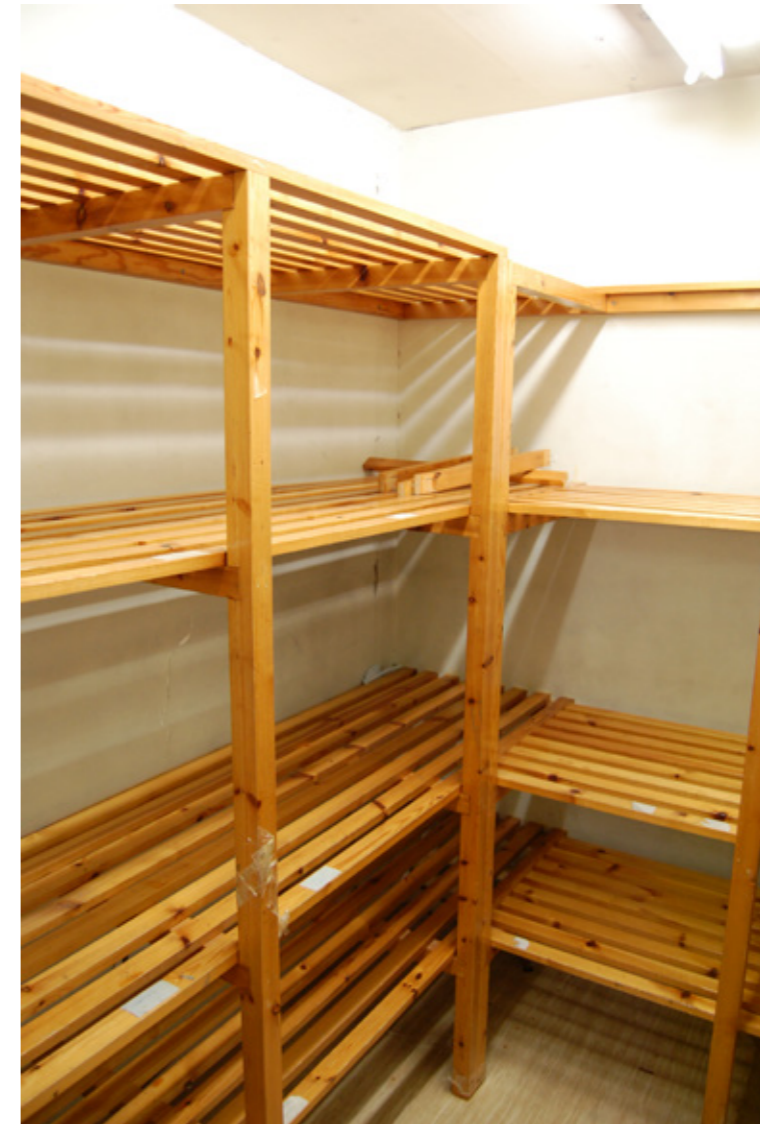
FIRST FLOOR: SERVICE WING - F3.05

Room Number:	F3.05
Current Room Use:	Storage / Plant
Historic Room Use:	
Date of Structure:	1893-1911
Date of Fixtures / Fittings:	
Date of Decoration:	Late 20th century
Major Alterations:	
Overall Significance Level:	Detrimental
Key Historic Features:	None
Detrimental Features:	Modern fit out
Condition Level:	
Condition Comments:	
Other Comments:

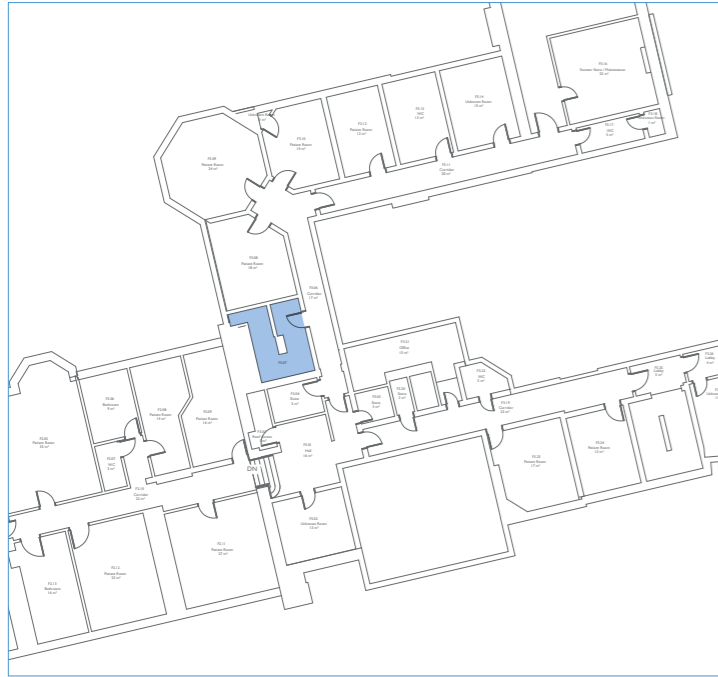
FIRST FLOOR: SERVICE WING - F3.07

Room Number:	F3.07
Current Room Use:	Stair
Historic Room Use:	Bedroom
Date of Structure:	1817
Date of Fixtures / Fittings:	
Date of Decoration:	Late 20th century
Major Alterations:	Insertion of modern stair

Overall Significance Level:	Neutral
Key Historic Features:	None
Detrimental Features:	Modern fit out
Condition Level:	
Condition Comments:	
Other Comments:
