VOLUME TWO

GAZETTEER

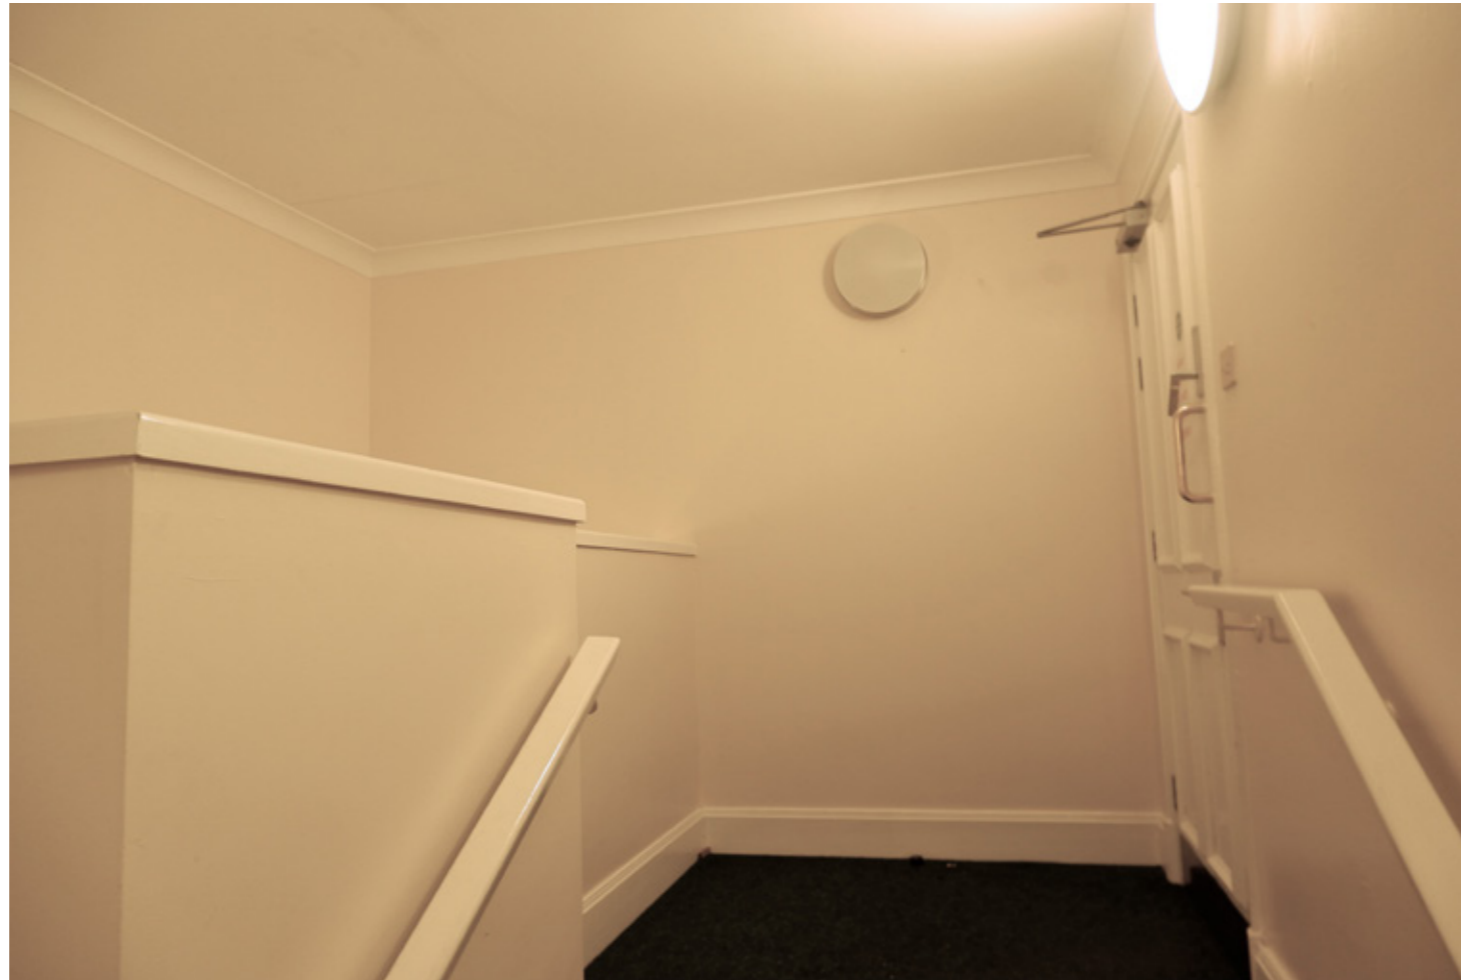
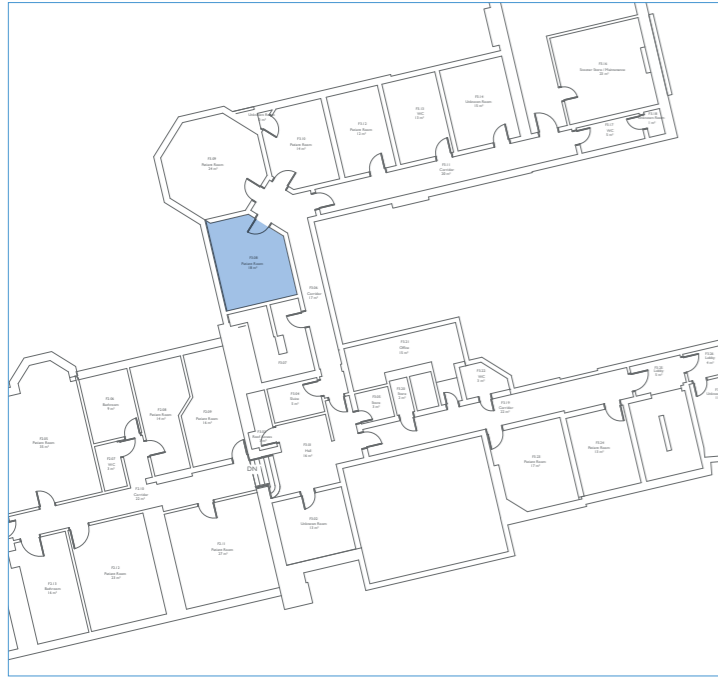
FIRST FLOOR: SERVICE WING - F3.08

Room Number:	F3.08
Current Room Use:	Bedroom
Historic Room Use:	School Room
Date of Structure:	1848-1893?
Date of Fixtures / Fittings:	
Date of Decoration:	Late 20th century
Major Alterations:

Overall Significance Level:	Neutral
Key Historic Features:	Sash window
Detrimental Features:	M&E, modern flooring, sanitary ware, radiator across window
Condition Level:	
Condition Comments:	
Other Comments:	Appears on one version of Wyatt plans?

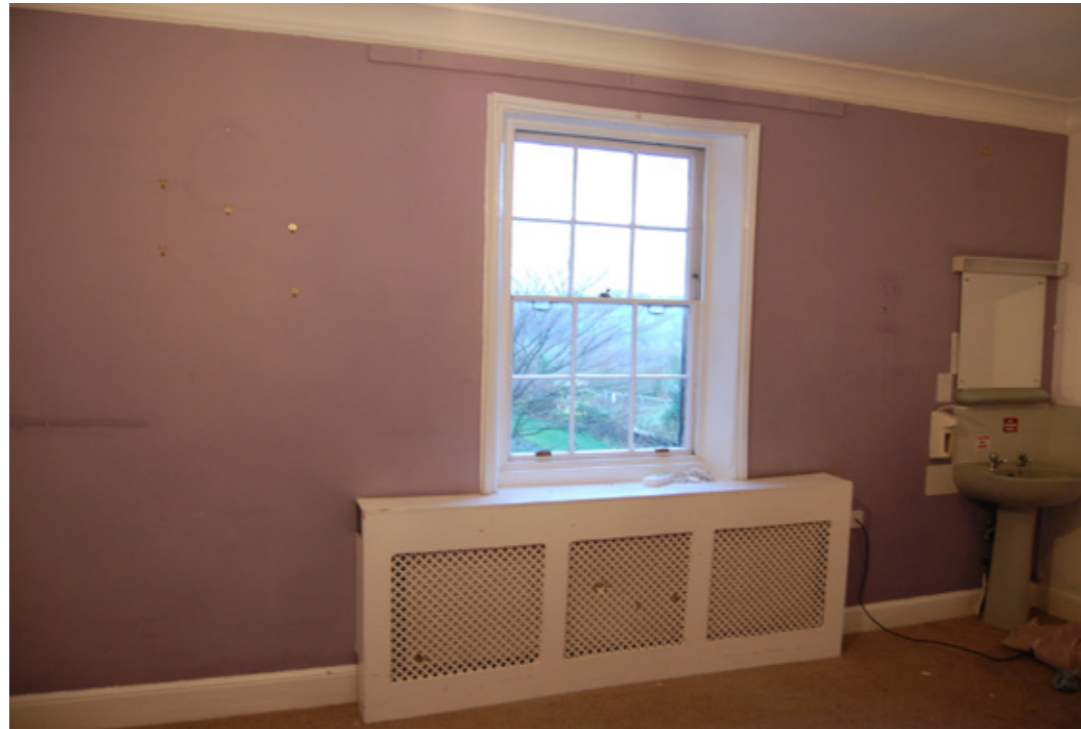
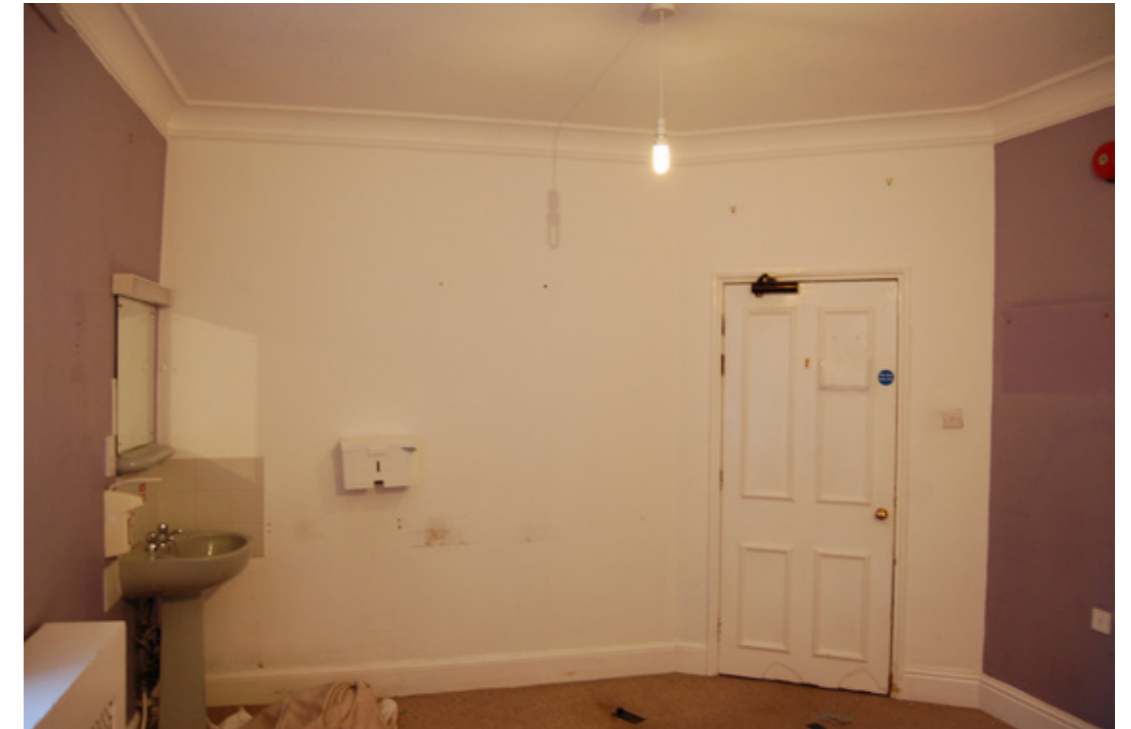
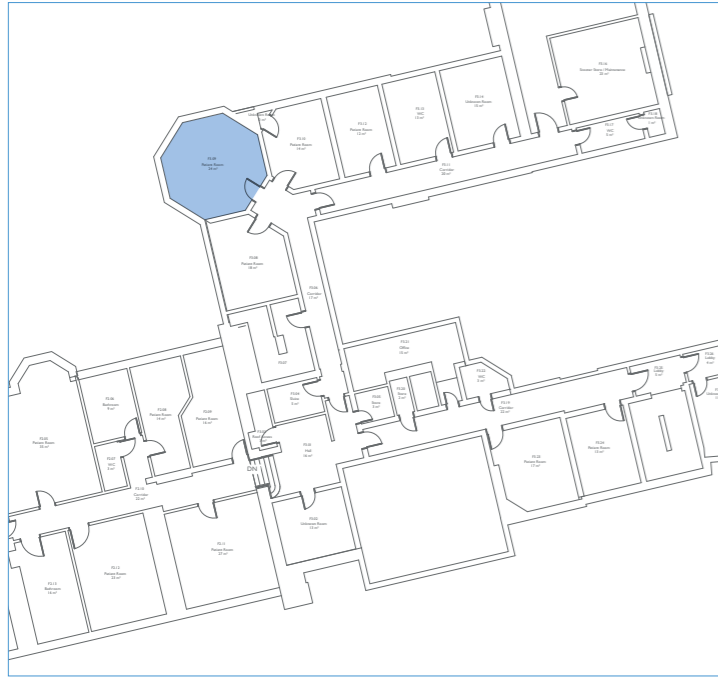
FIRST FLOOR: SERVICE WING - F3.09

Room Number:	F3.09
Current Room Use:	Bedroom
Historic Room Use:	Nursery
Date of Structure:	1848-1893?
Date of Fixtures / Fittings:	
Date of Decoration:	Late 20th century
Major Alterations:

Overall Significance Level:	Medium
Key Historic Features:	Panelling, cornice, octagonal ribbed ceiling, sash windows, blocked fireplace
Detrimental Features:	M&E, modern flooring, radiators
Condition Level:	
Condition Comments:	
Other Comments:	Appears on one version of Wyatt plans?

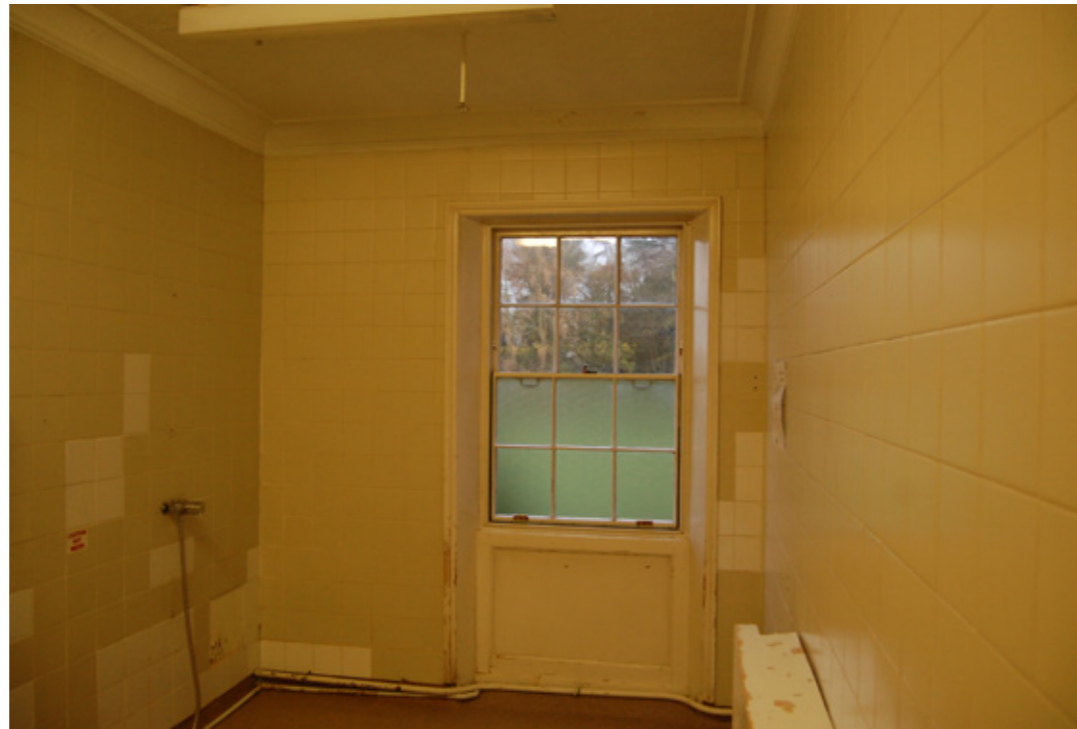
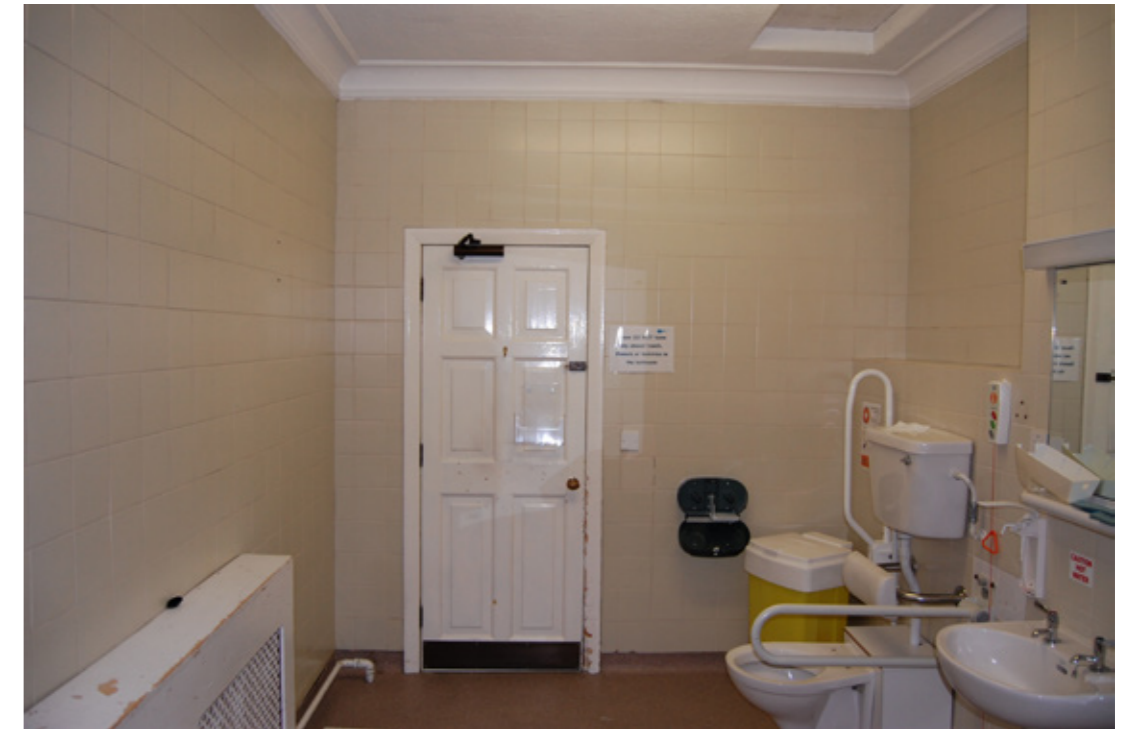
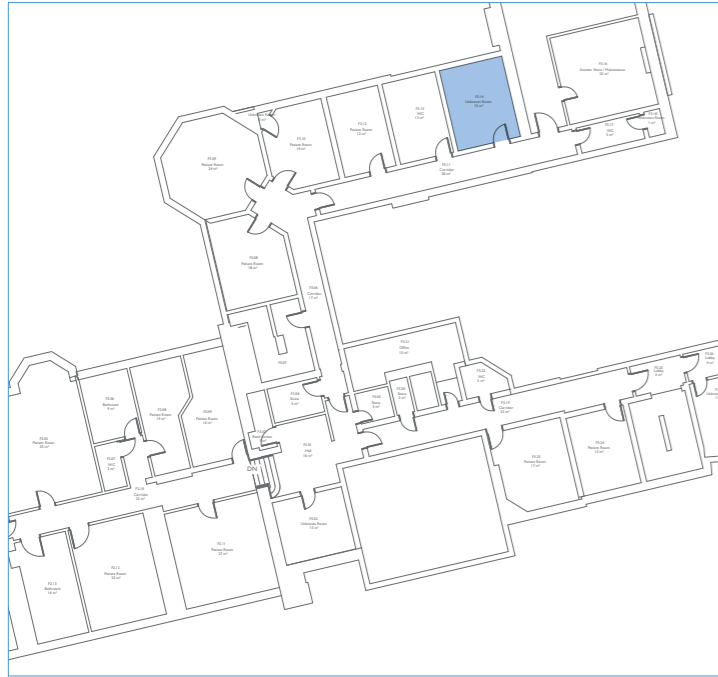
FIRST FLOOR: SERVICE WING - F3.14

Room Number:	F3.14
Current Room Use:	Bedroom
Historic Room Use:	
Date of Structure:	1848-1893
Date of Fixtures / Fittings:	
Date of Decoration:	Late 20th century
Major Alterations:

Overall Significance Level:	Low
Key Historic Features:	Sash window
Detrimental Features:	M&E, modern fit out
Condition Level:	
Condition Comments:	
Other Comments:

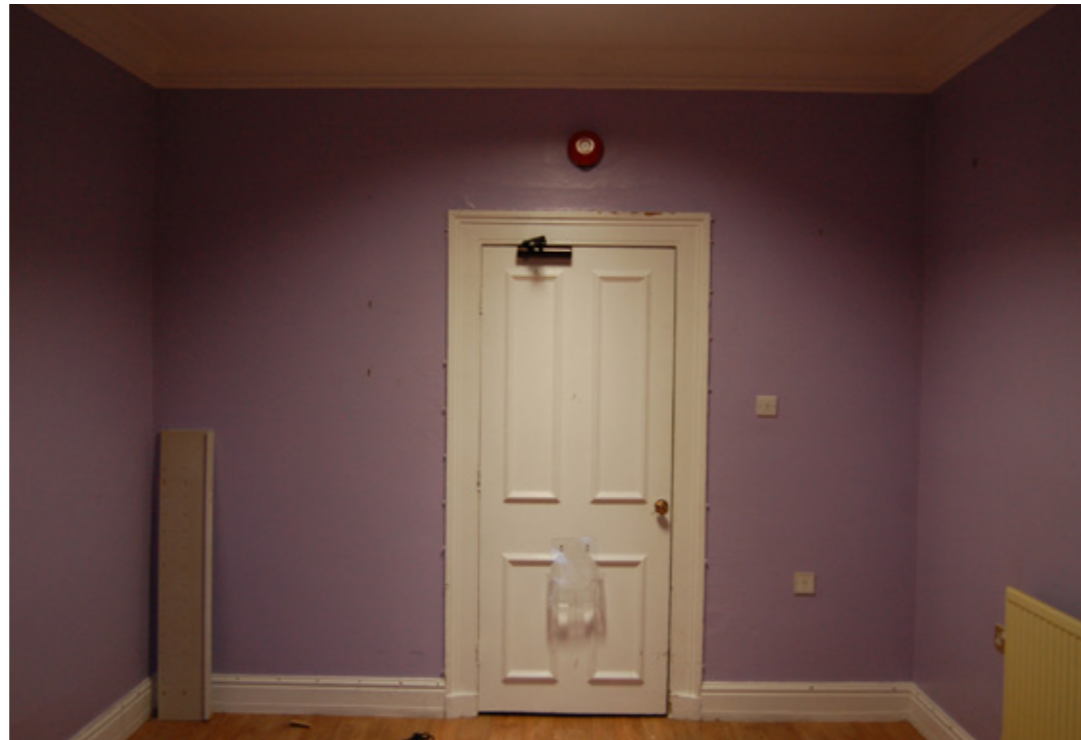
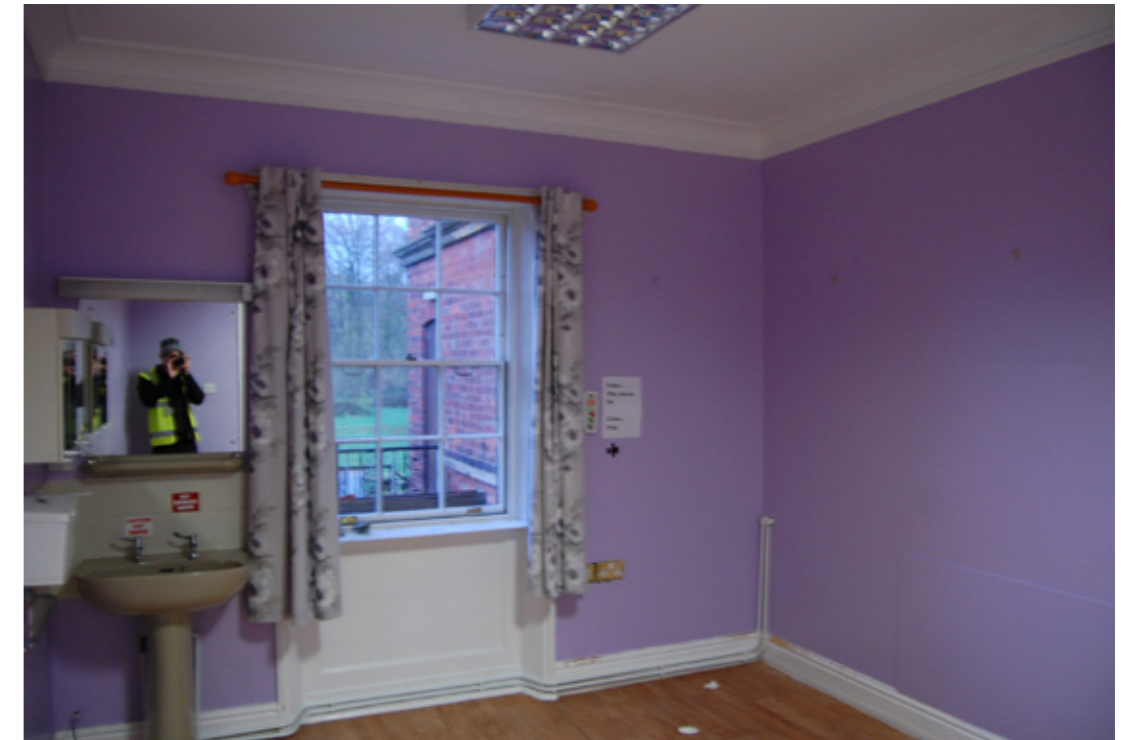
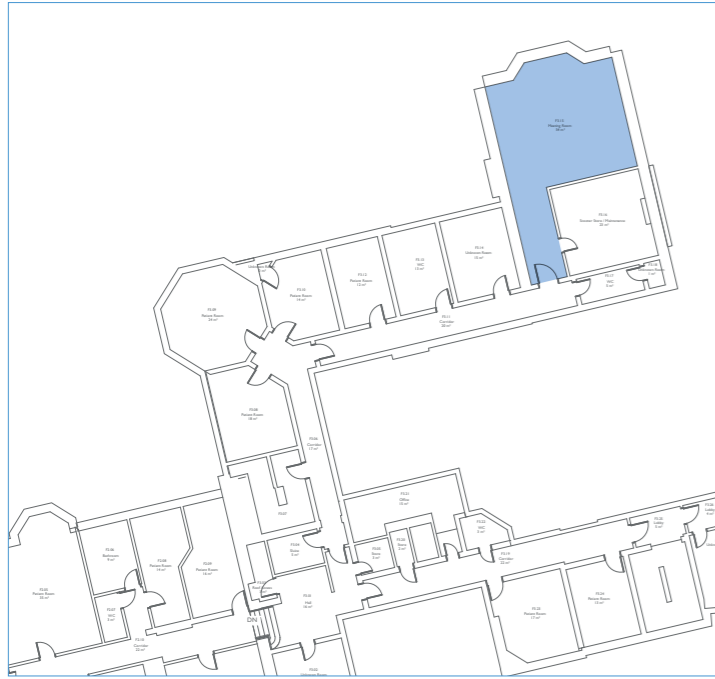
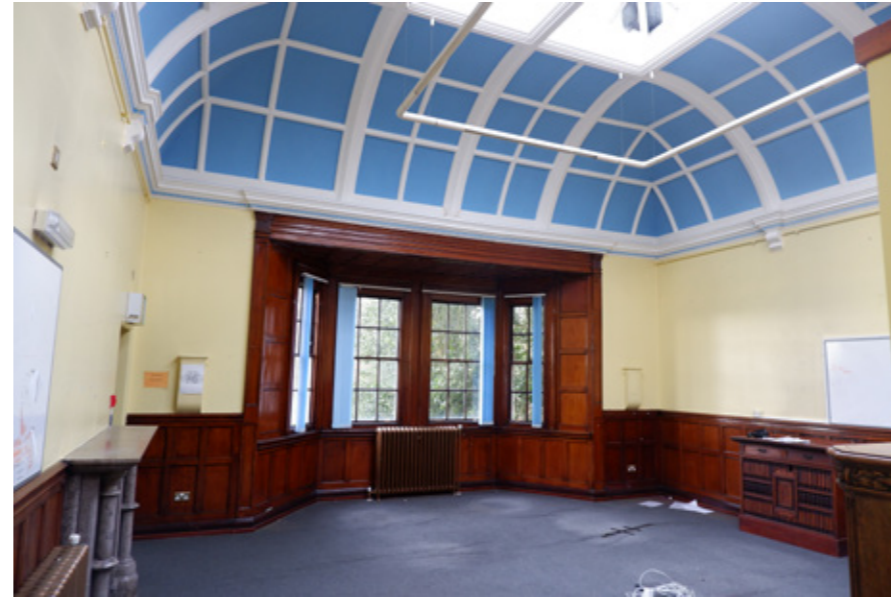
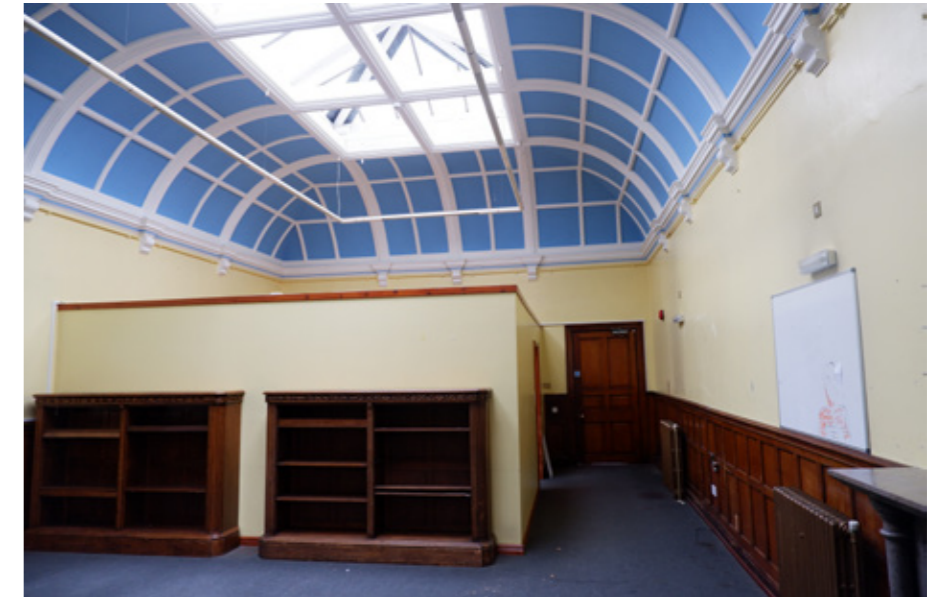
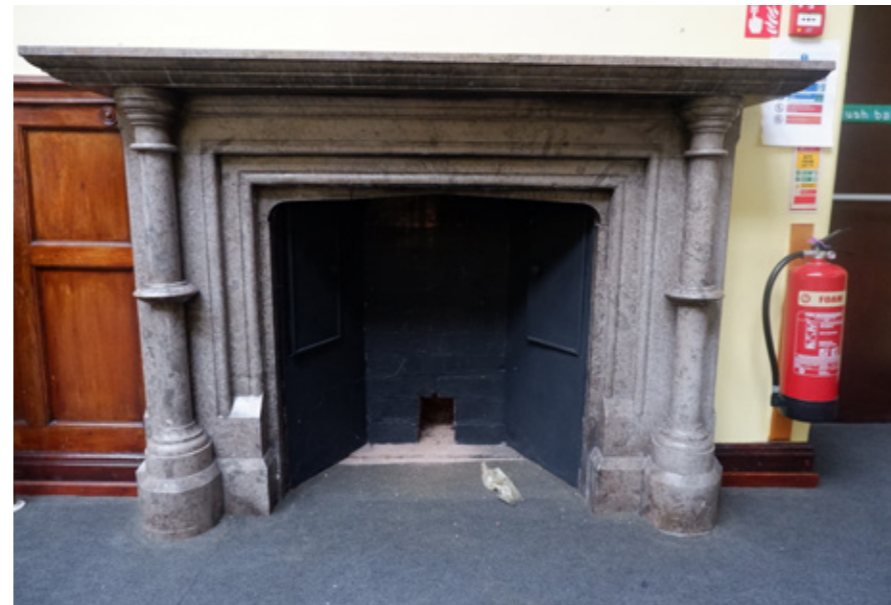
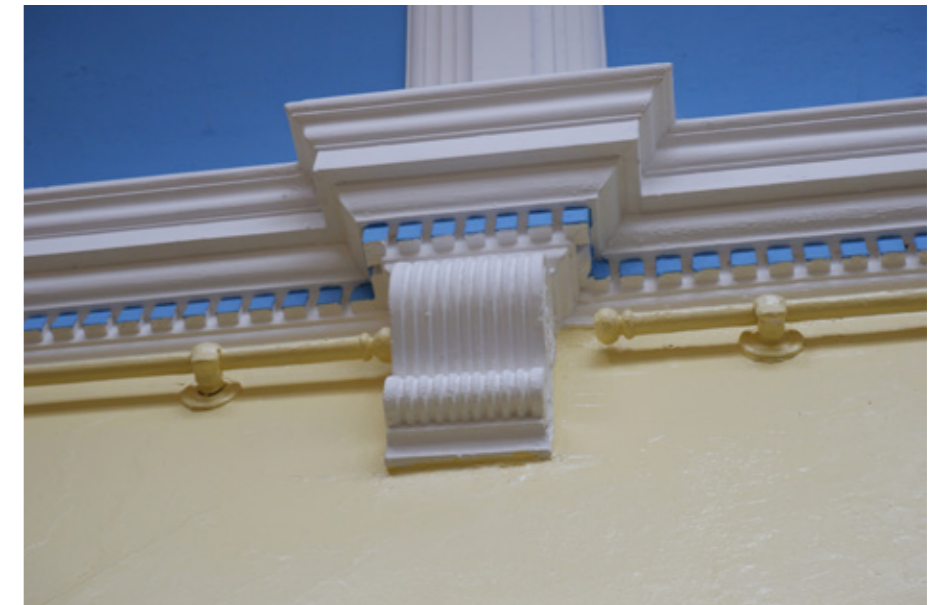
FIRST FLOOR: SERVICE WING - F3.I5

Room Number:	F3.I5
Current Room Use:	Office
Historic Room Use:	Billiards Room / Workshop / Museum
Date of Structure:	1848-1893
Date of Fixtures / Fittings:	
Date of Decoration:	Late 20th century
Major Alterations:	
Overall Significance Level:	Medium
Key Historic Features:	Decorated ribbed ceiling, wainscot panelling, dentilled cornicing, fireplace, canted bay window with panelling and sash windows, skylight relating to use as billiard room
Detrimental Features:	M&E, modern carpet and blinds, fire escape door, inserted partition walls
Condition Level:	
Condition Comments:	
Other Comments:

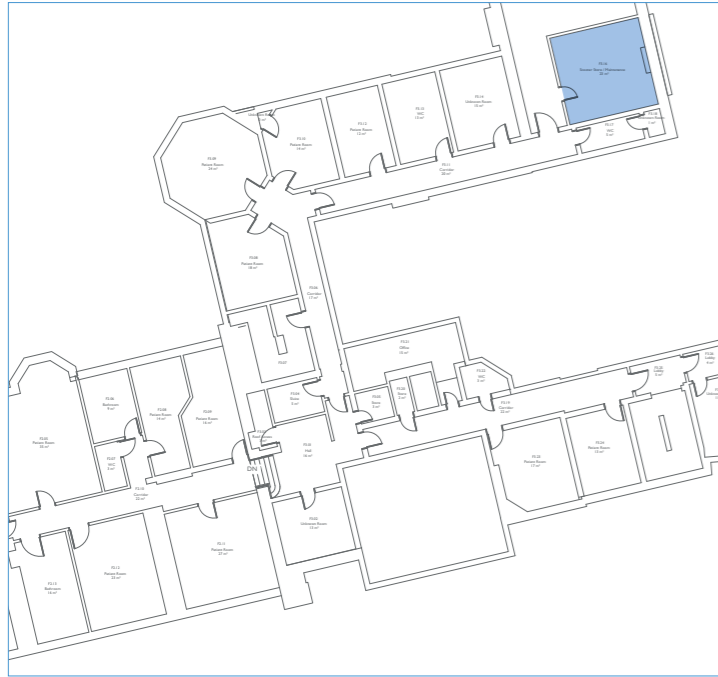
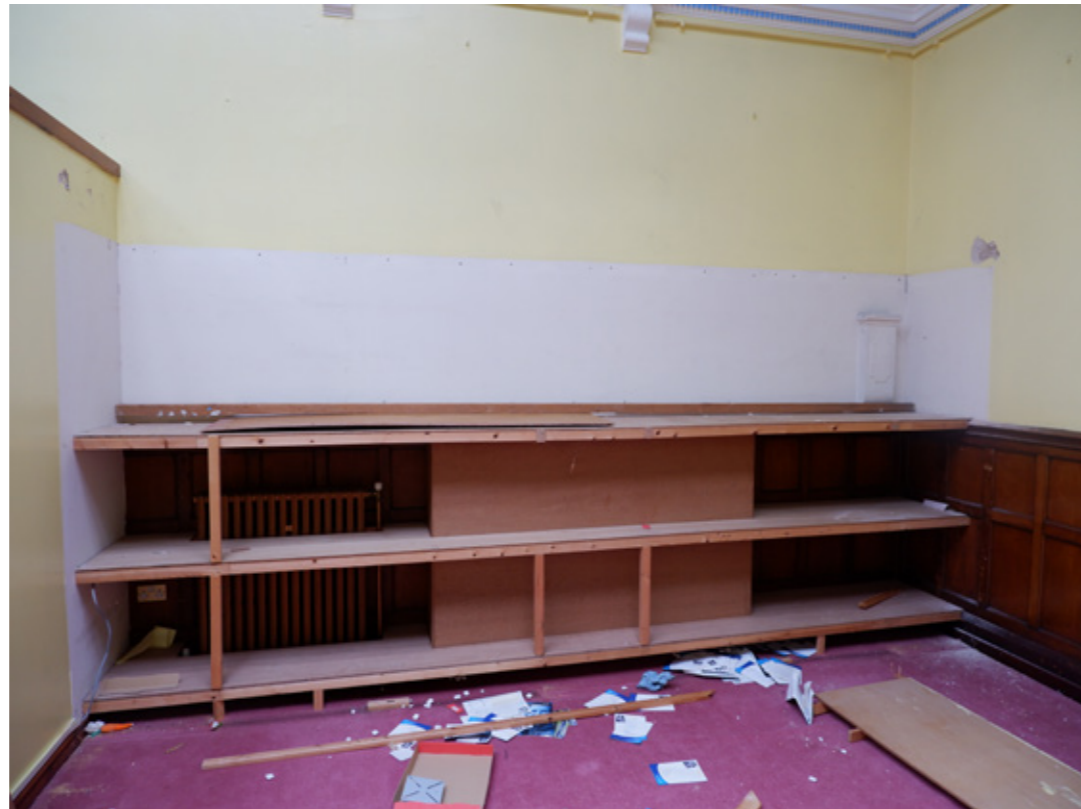
FIRST FLOOR: SERVICE WING - F3.16

Room Number:	F3.16
Current Room Use:	Workshop
Historic Room Use:	
Date of Structure:	1848-1893
Date of Fixtures / Fittings:	
Date of Decoration:	Late 20th century
Major Alterations:

Overall Significance Level:	Medium
Key Historic Features:	Panelling as part of F3.15
Detrimental Features:	Inserted partition walls, carpet, modern joinery
Condition Level:	
Condition Comments:	
Other Comments:

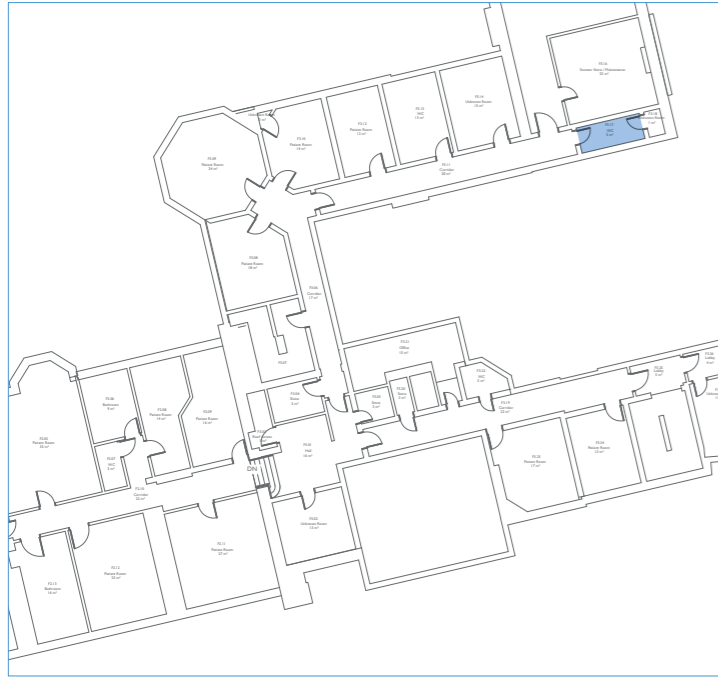
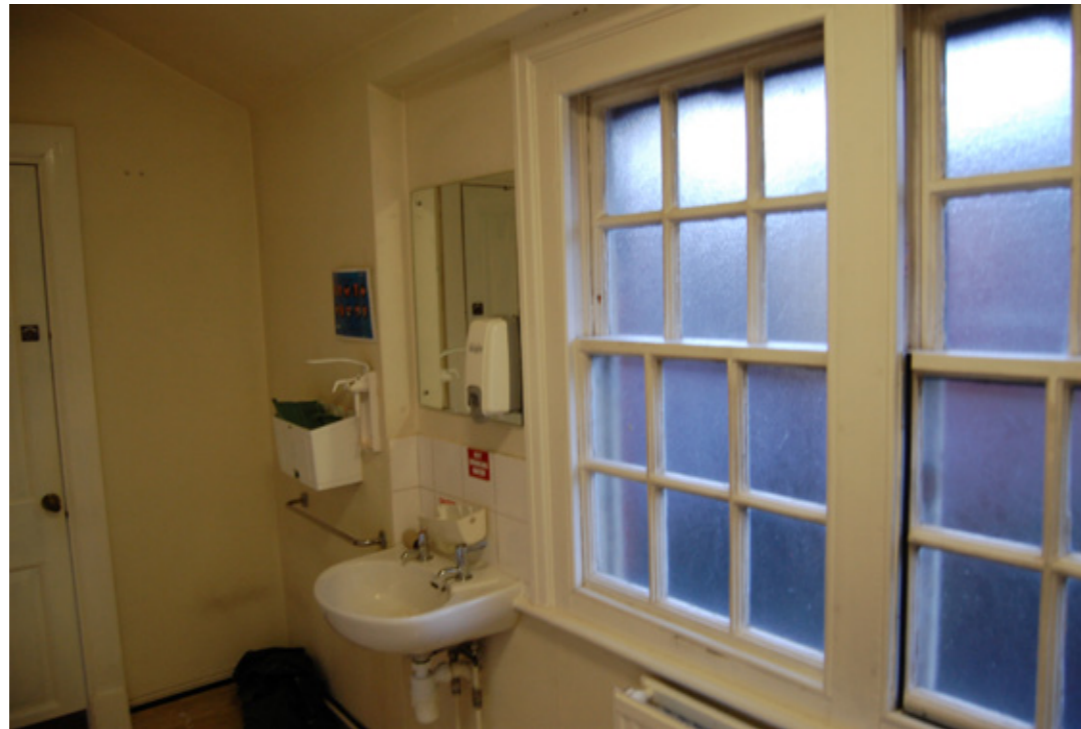
FIRST FLOOR: SERVICE WING - F3.17

Room Number:	F3.17
Current Room Use:	WC
Historic Room Use:	
Date of Structure:	1848-1893
Date of Fixtures / Fittings:	
Date of Decoration:	Late 20th century
Major Alterations:

Overall Significance Level:	Low
Key Historic Features:	Sash windows
Detrimental Features:	M&E, modern sanitary ware and flooring
Condition Level:	
Condition Comments:	
Other Comments:

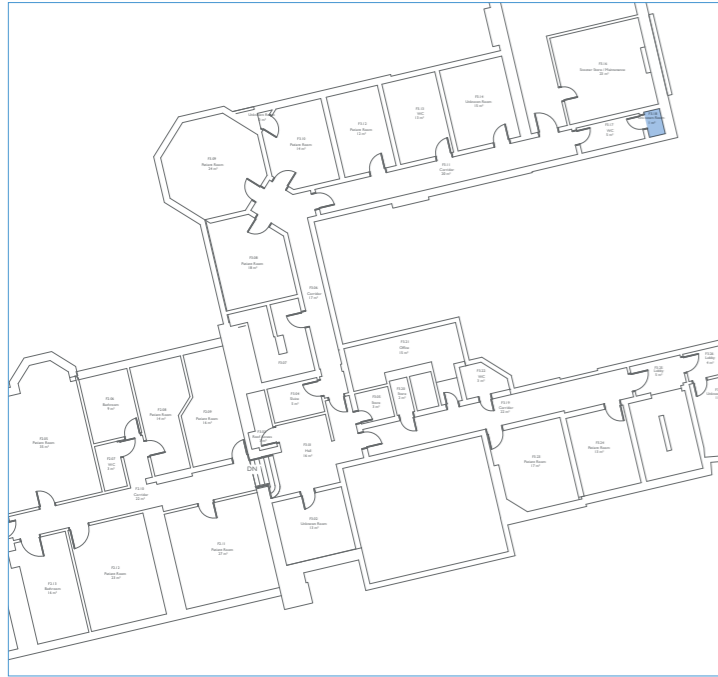
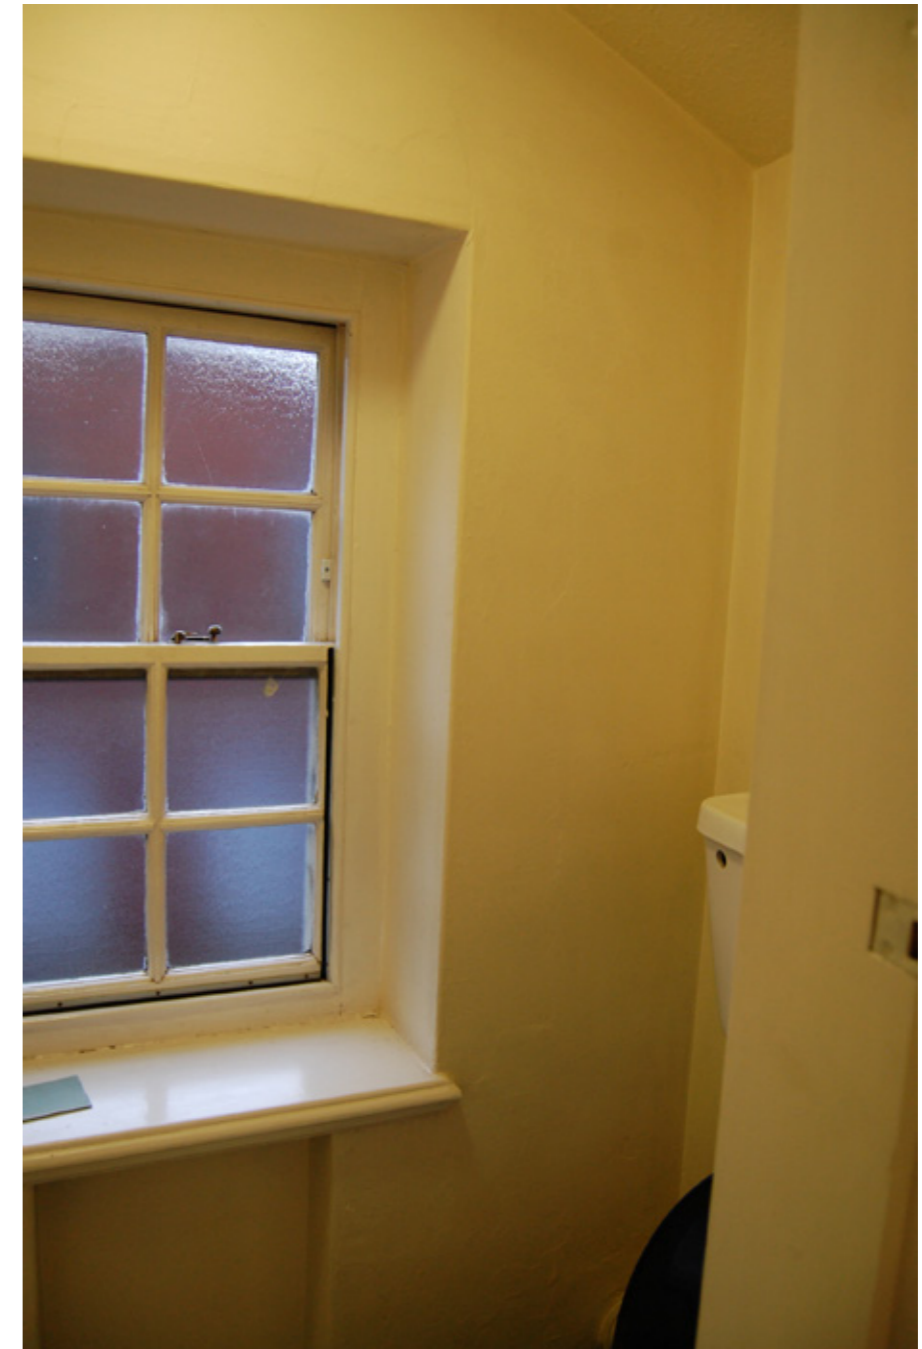
FIRST FLOOR: SERVICE WING - F3.18

Room Number:	F3.18
Current Room Use:	WC
Historic Room Use:	
Date of Structure:	1848-1893
Date of Fixtures / Fittings:	
Date of Decoration:	Late 20th century
Major Alterations:	
Overall Significance Level:	Low
Key Historic Features:	Sash window
Detrimental Features:	M&E, modern sanitary ware and flooring
Condition Level:	
Condition Comments:	
Other Comments:

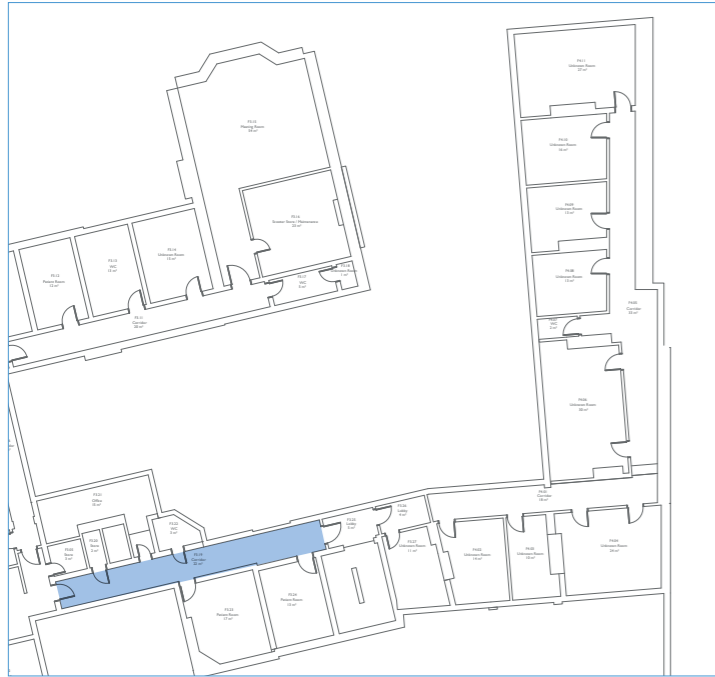
FIRST FLOOR: SERVICE WING - F3.19

Room Number:	F3.19
Current Room Use:	Corridor
Historic Room Use:	
Date of Structure:	1848-1893
Date of Fixtures / Fittings:	
Date of Decoration:	Late 20th century
Major Alterations:

Overall Significance Level:	Low
Key Historic Features:	Timber sash and casement windows
Detrimental Features:	M&E, modern fit out
Condition Level:	
Condition Comments:	
Other Comments:

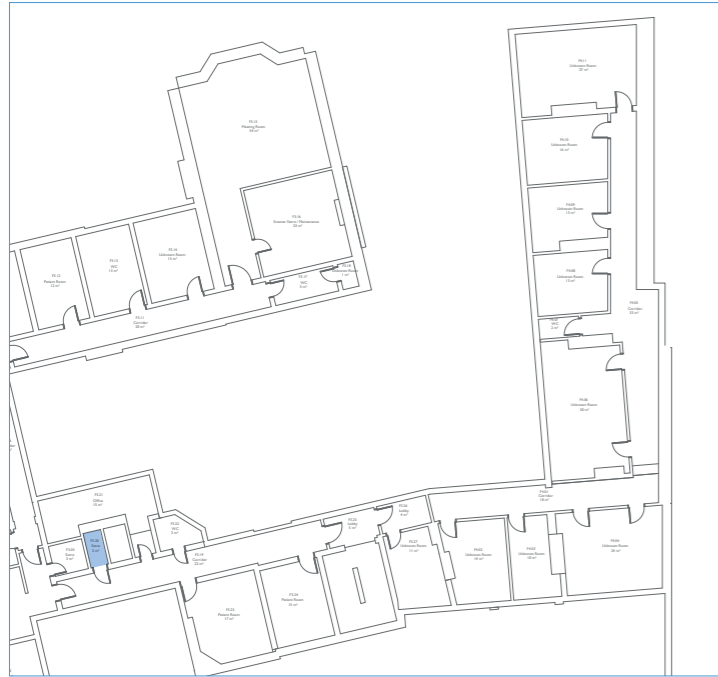
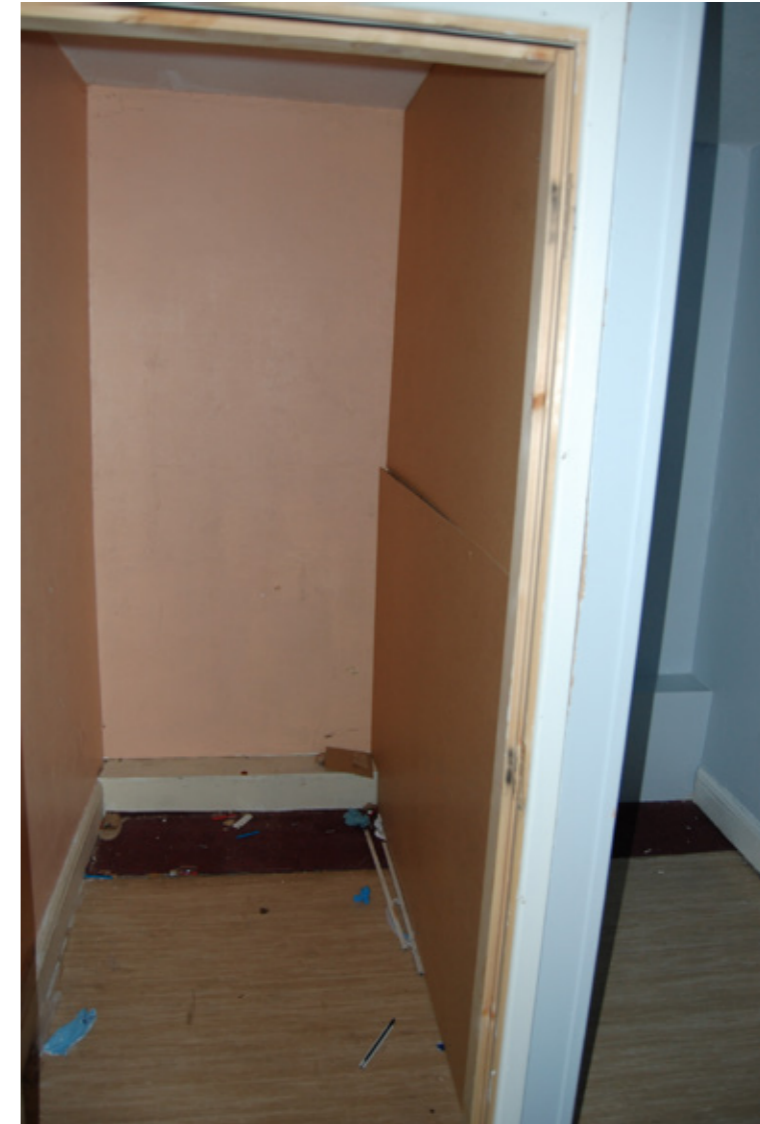
FIRST FLOOR: SERVICE WING - F3.20

Room Number:	F3.20
Current Room Use:	Storage/Plant
Historic Room Use:	
Date of Structure:	1893-1911
Date of Fixtures / Fittings:	
Date of Decoration:	Late 20th century
Major Alterations:	
Overall Significance Level:	Detrimental
Key Historic Features:	None
Detrimental Features:	Unfinished modern timber joinery
Condition Level:	
Condition Comments:	
Other Comments:

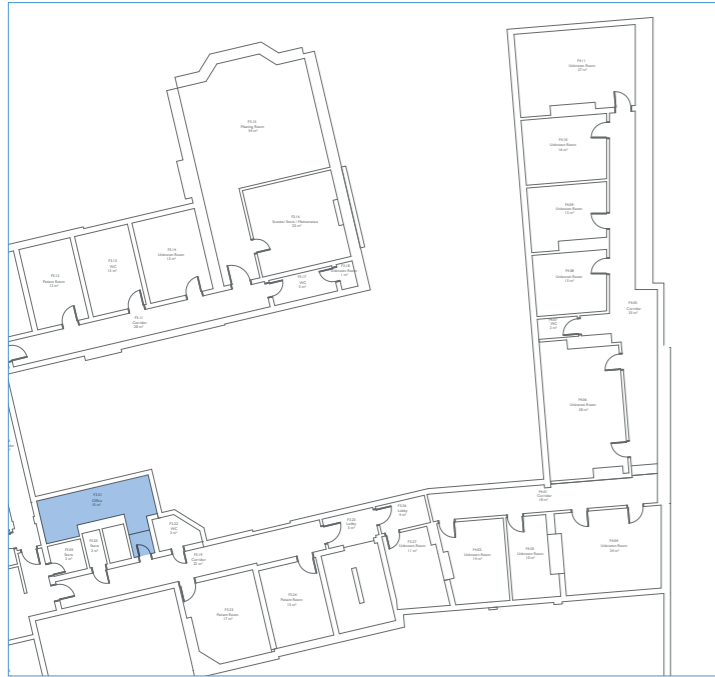
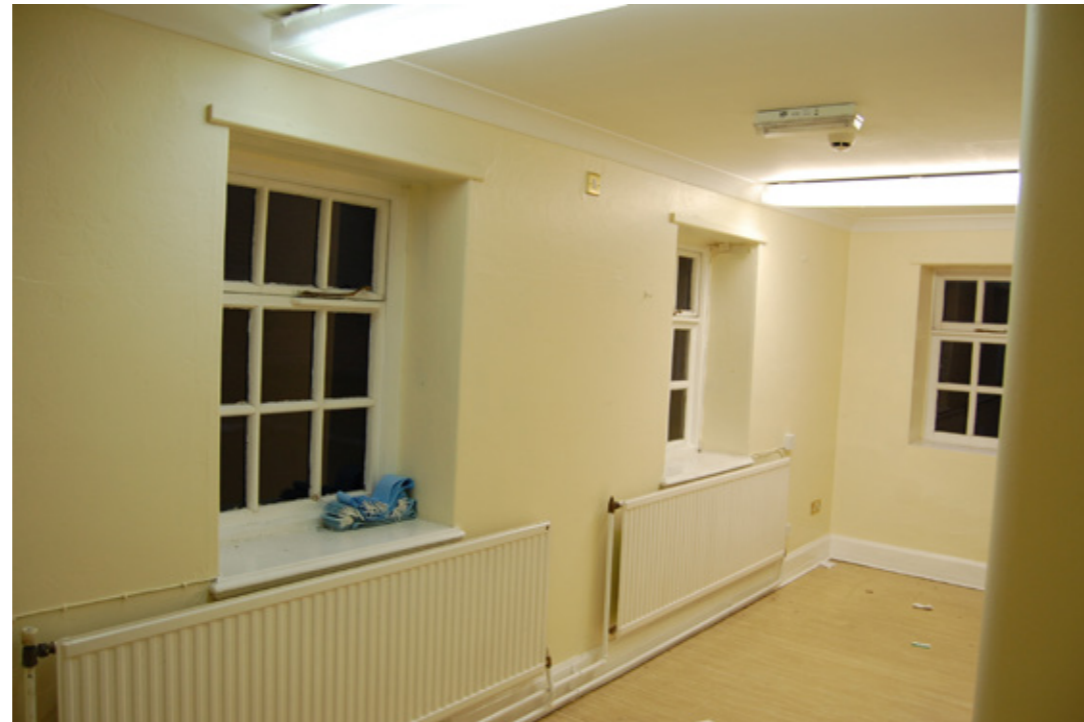
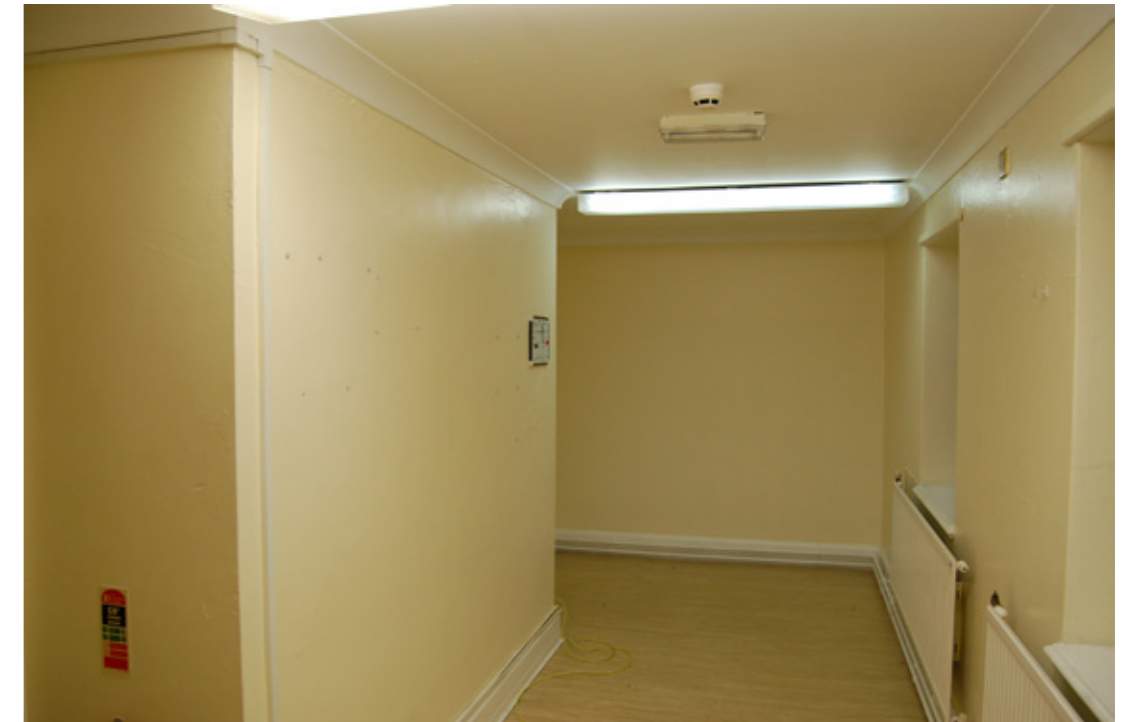
FIRST FLOOR: SERVICE WING - F3.21

Room Number:	F3.21
Current Room Use:	Office
Historic Room Use:	
Date of Structure:	1893-1911
Date of Fixtures / Fittings:	
Date of Decoration:	Late 20th century
Major Alterations:

Overall Significance Level:	Detrimental
Key Historic Features:	Timber casement window
Detrimental Features:	M&E, modern fit out
Condition Level:	
Condition Comments:	
Other Comments:

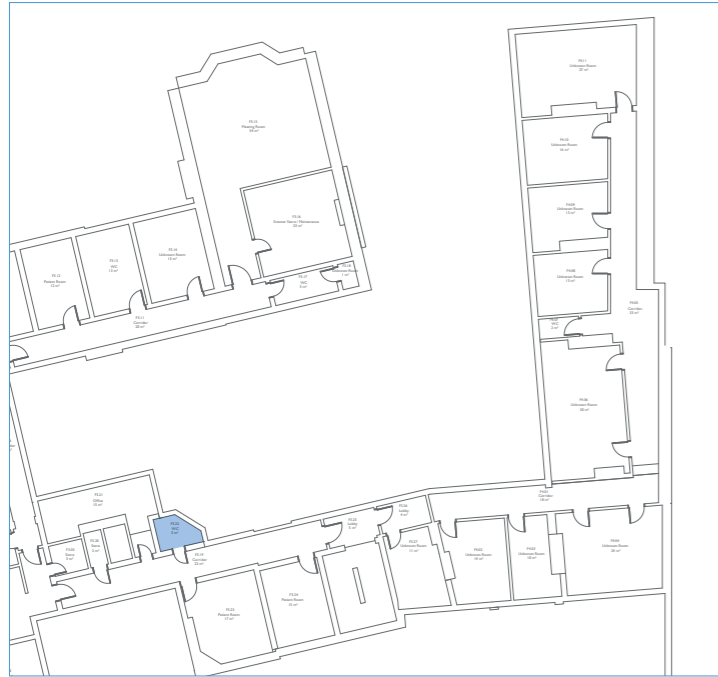
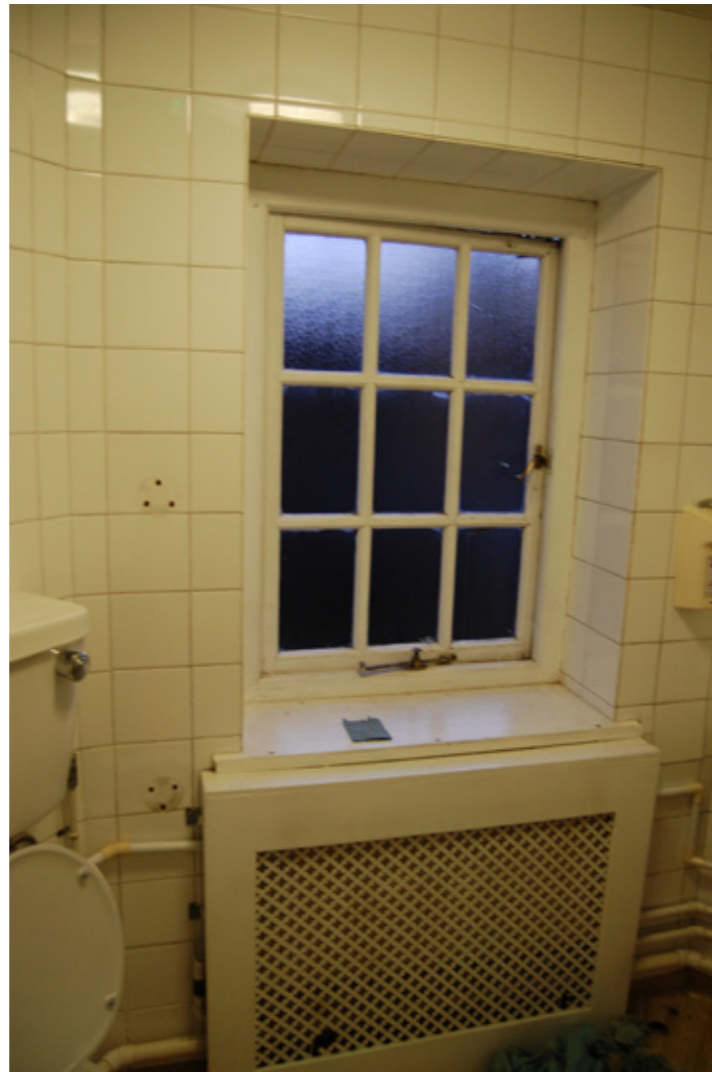
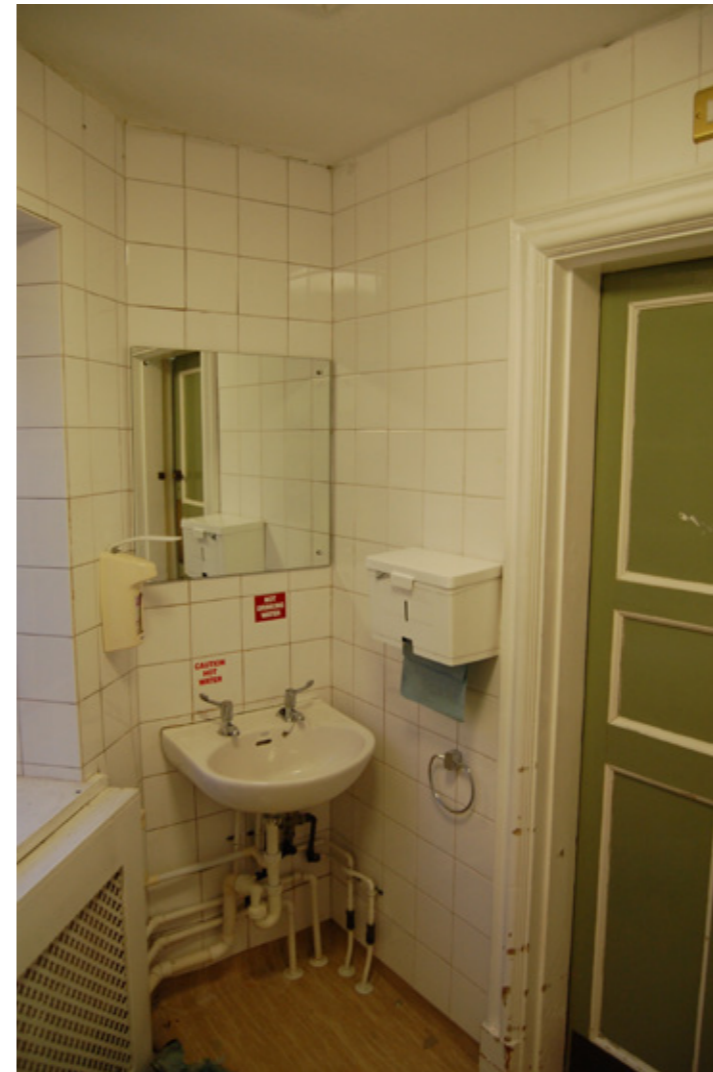
FIRST FLOOR: SERVICE WING - F3.22

Room Number:	F3.22
Current Room Use:	WC
Historic Room Use:	
Date of Structure:	1893-1911
Date of Fixtures / Fittings:	
Date of Decoration:	Late 20th century
Major Alterations:

Overall Significance Level:	Detrimental
Key Historic Features:	Timber casement window
Detrimental Features:	M&E, floor and wall coverings, modern sanitary ware
Condition Level:	
Condition Comments:	
Other Comments:
