VOLUME TWO

GAZETTEER

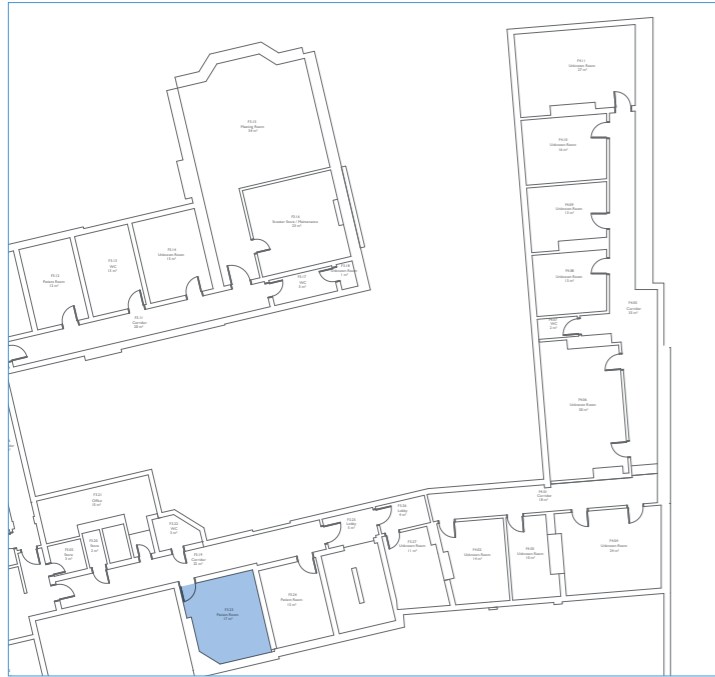
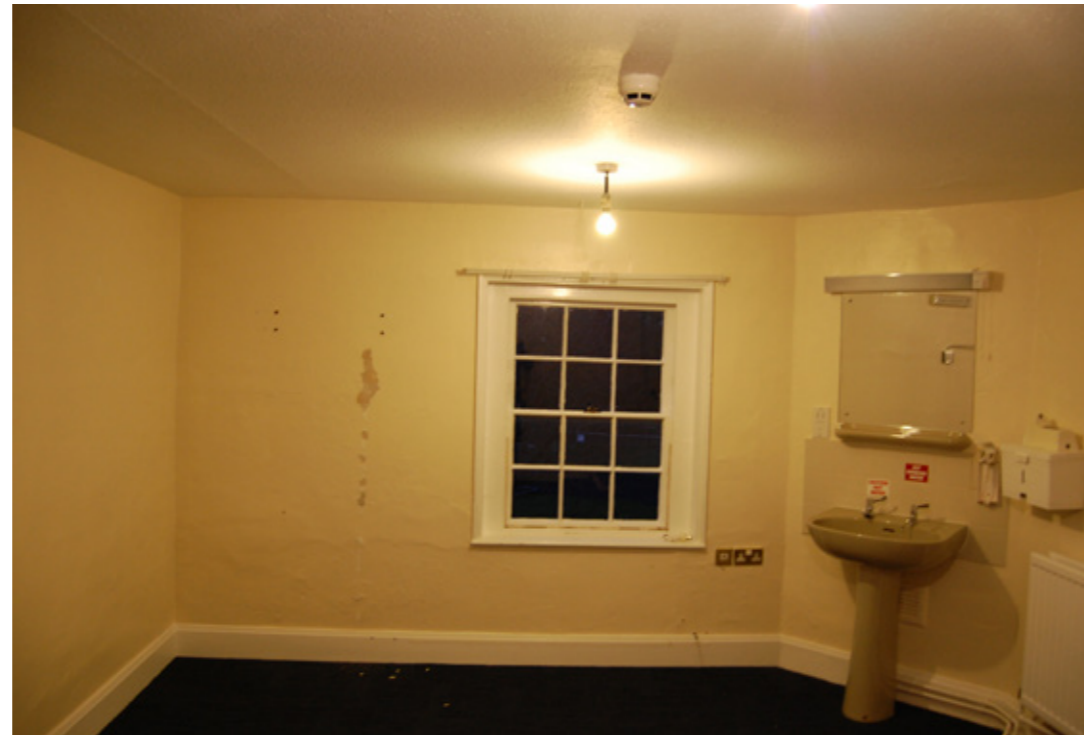
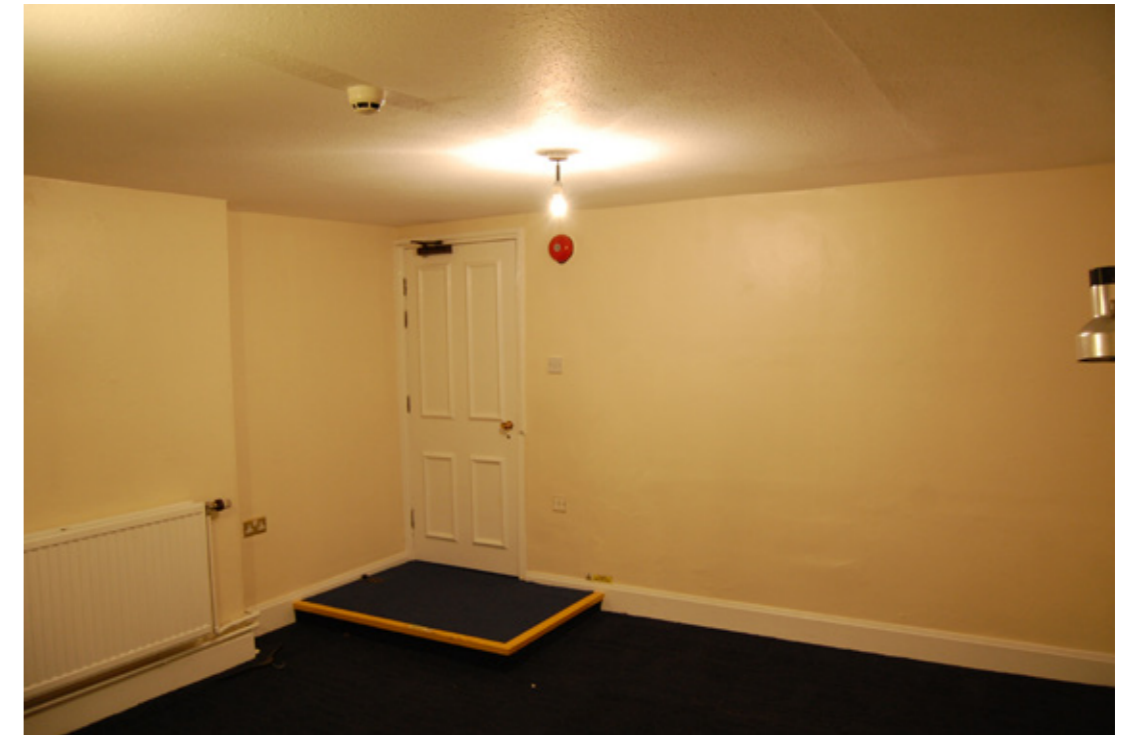
FIRST FLOOR: SERVICE WING - F3.23

Room Number:	F3.23
Current Room Use:	Bedroom
Historic Room Use:	Bedroom (Wyantt plan)
Date of Structure:	1817
Date of Fixtures / Fittings:	
Date of Decoration:	Late 20th century
Major Alterations:

Overall Significance Level:	Low
Key Historic Features:	Sash window
Detrimental Features:	Modern fit out and sanitary ware
Condition Level:	
Condition Comments:	
Other Comments:

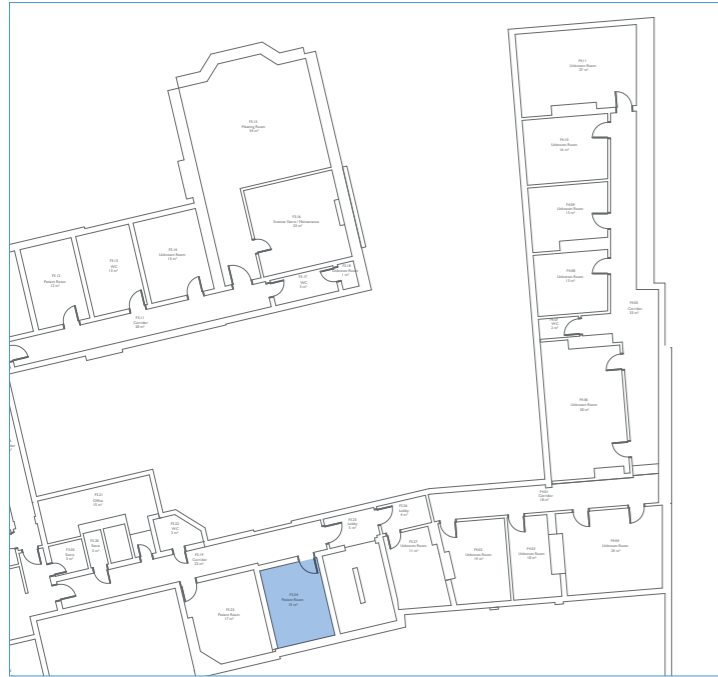
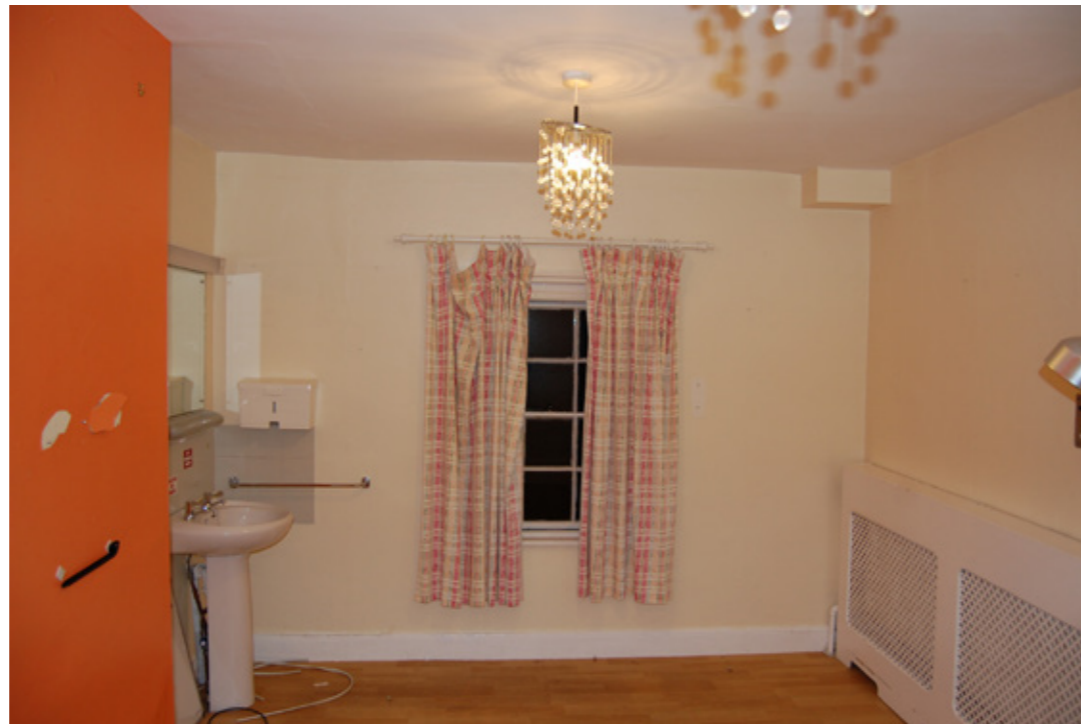
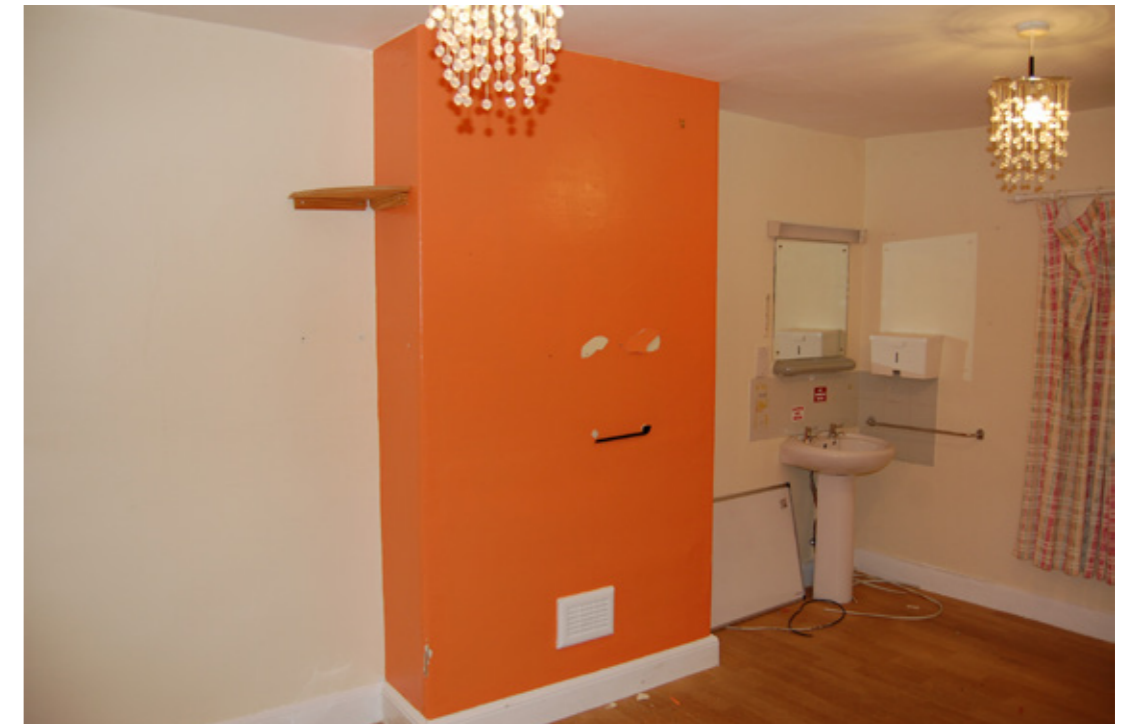
FIRST FLOOR: SERVICE WING - F3.24

Room Number:	F3.24
Current Room Use:	Bedroom
Historic Room Use:	
Date of Structure:	1848-1893
Date of Fixtures / Fittings:	
Date of Decoration:	Late 20th century
Major Alterations:

Overall Significance Level:	Low
Key Historic Features:	Sash window, chimney breast
Detrimental Features:	Modern fit out and sanitary ware
Condition Level:	
Condition Comments:	
Other Comments:

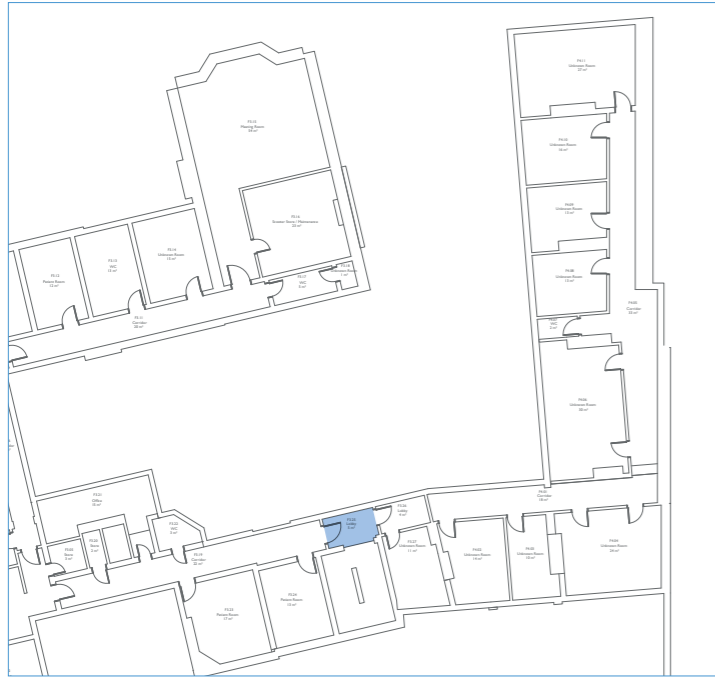
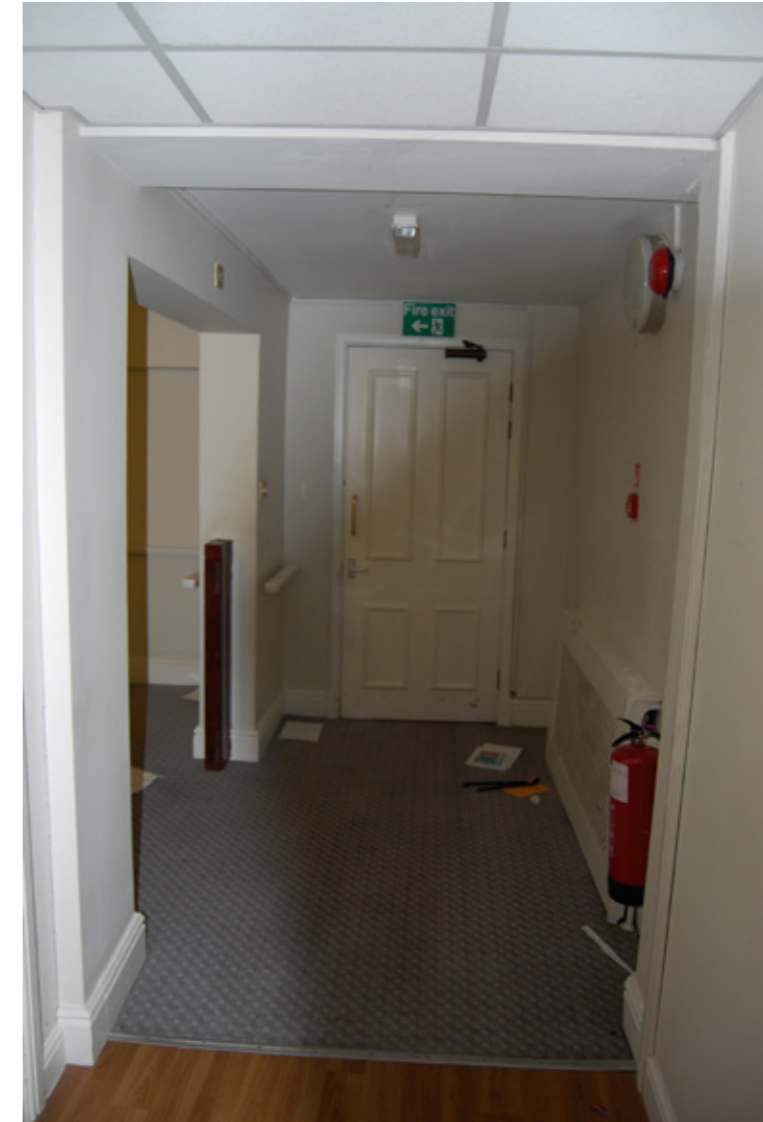
FIRST FLOOR: SERVICE WING - F3.25

Room Number:	F3.25
Current Room Use:	Circulation
Historic Room Use:	
Date of Structure:	1848-1893
Date of Fixtures / Fittings:	
Date of Decoration:	Late 20th century
Major Alterations:	
Overall Significance Level:	Low
Key Historic Features:	None
Detrimental Features:	Modern fit out
Condition Level:	
Condition Comments:	
Other Comments:

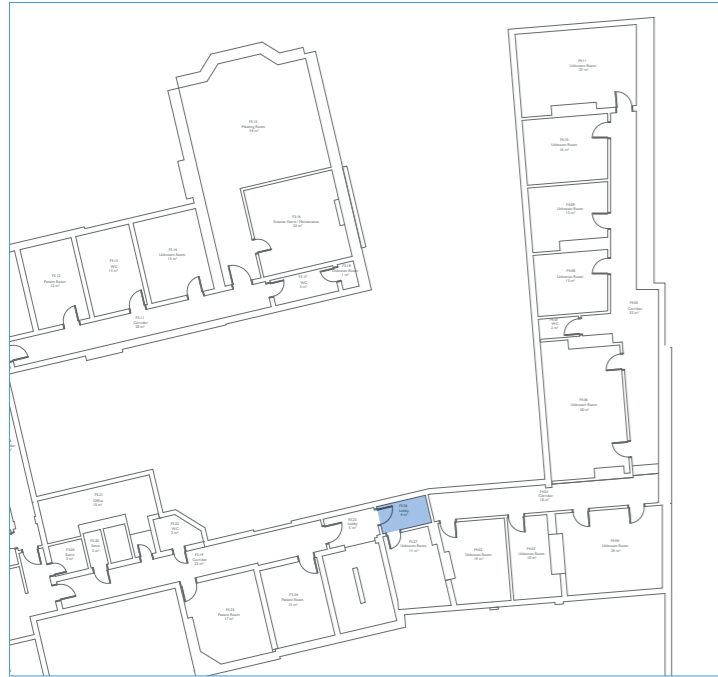
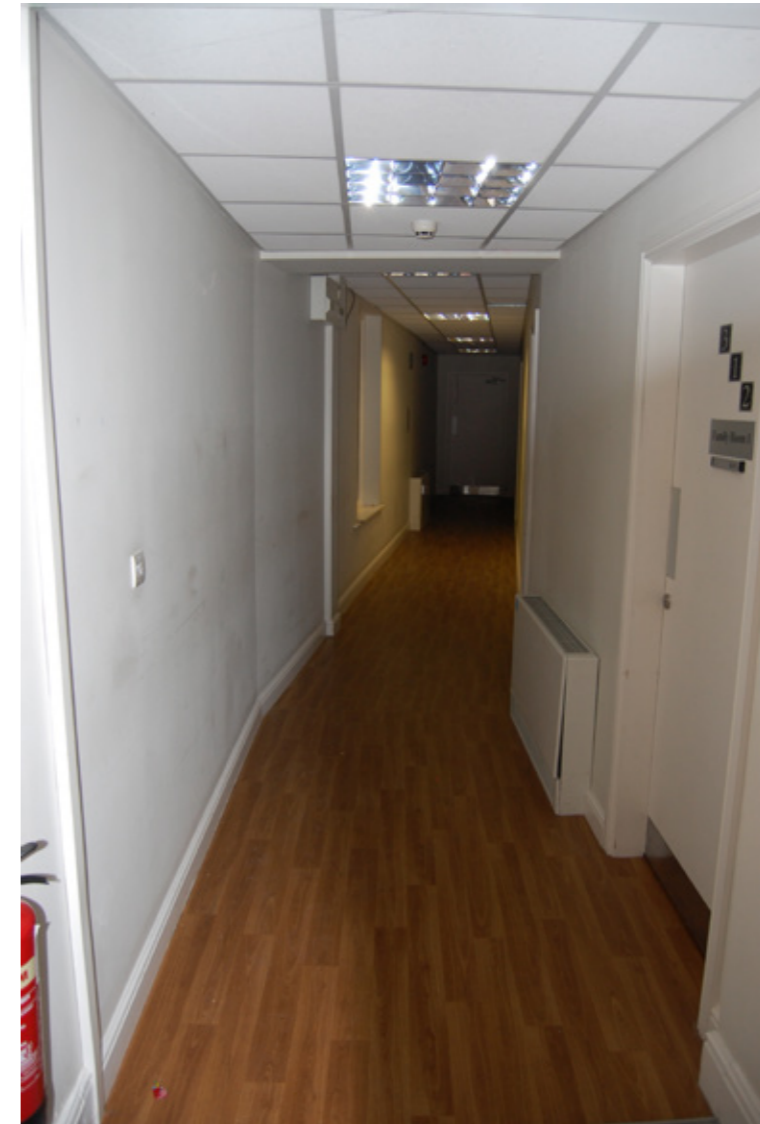
FIRST FLOOR: SERVICE WING - F3.26

Room Number:	F3.26
Current Room Use:	Circulation
Historic Room Use:	
Date of Structure:	1848-1893
Date of Fixtures / Fittings:	
Date of Decoration:	Late 20th century
Major Alterations:	
Overall Significance Level:	Low
Key Historic Features:	Non
Detrimental Features:	Modern fit out, suspended ceiling
Condition Level:	
Condition Comments:	
Other Comments:

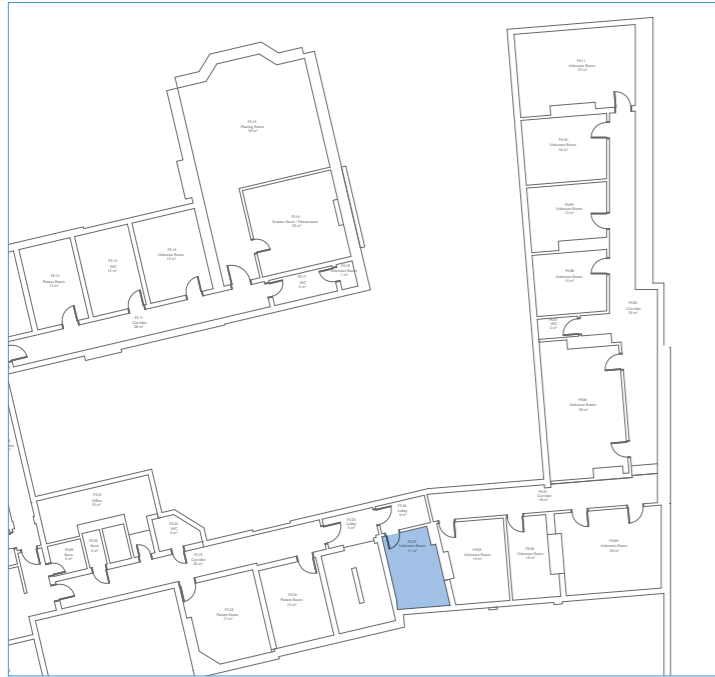
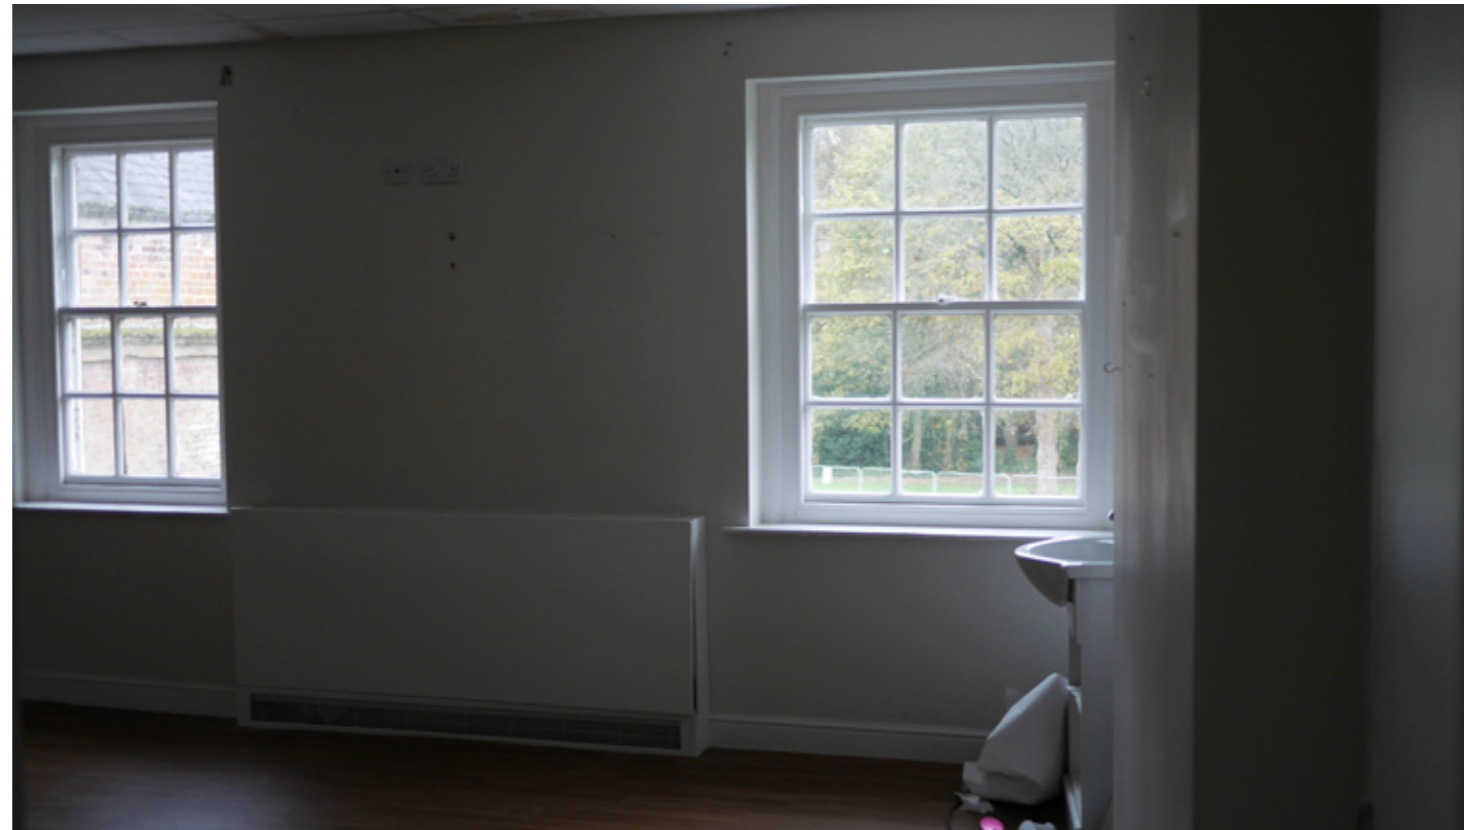
FIRST FLOOR: SERVICE WING - F3.27

Room Number:	F3.27
Current Room Use:	Bedroom
Historic Room Use:	
Date of Structure:	1848-1893
Date of Fixtures / Fittings:	
Date of Decoration:	Late 20th century
Major Alterations:

Overall Significance Level:	Low
Key Historic Features:	Sash windows
Detrimental Features:	Modern fit out
Condition Level:	
Condition Comments:	
Other Comments:

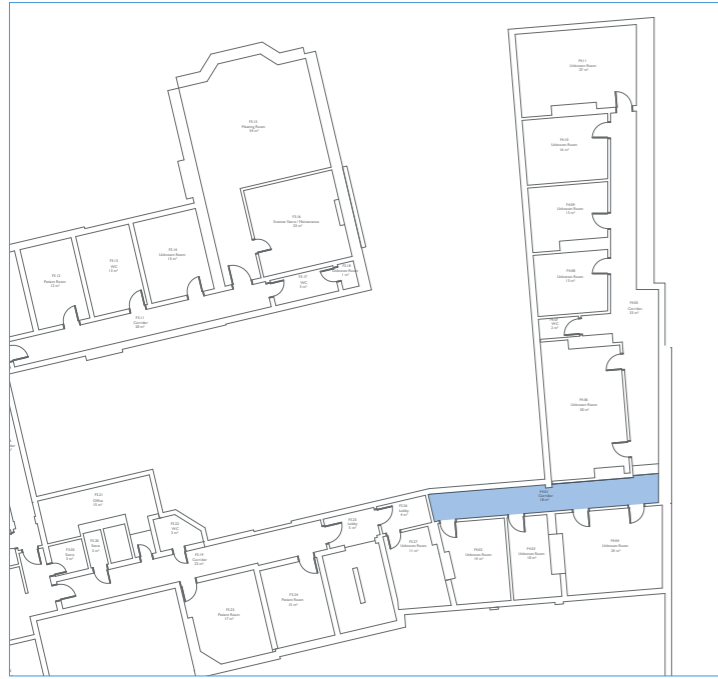
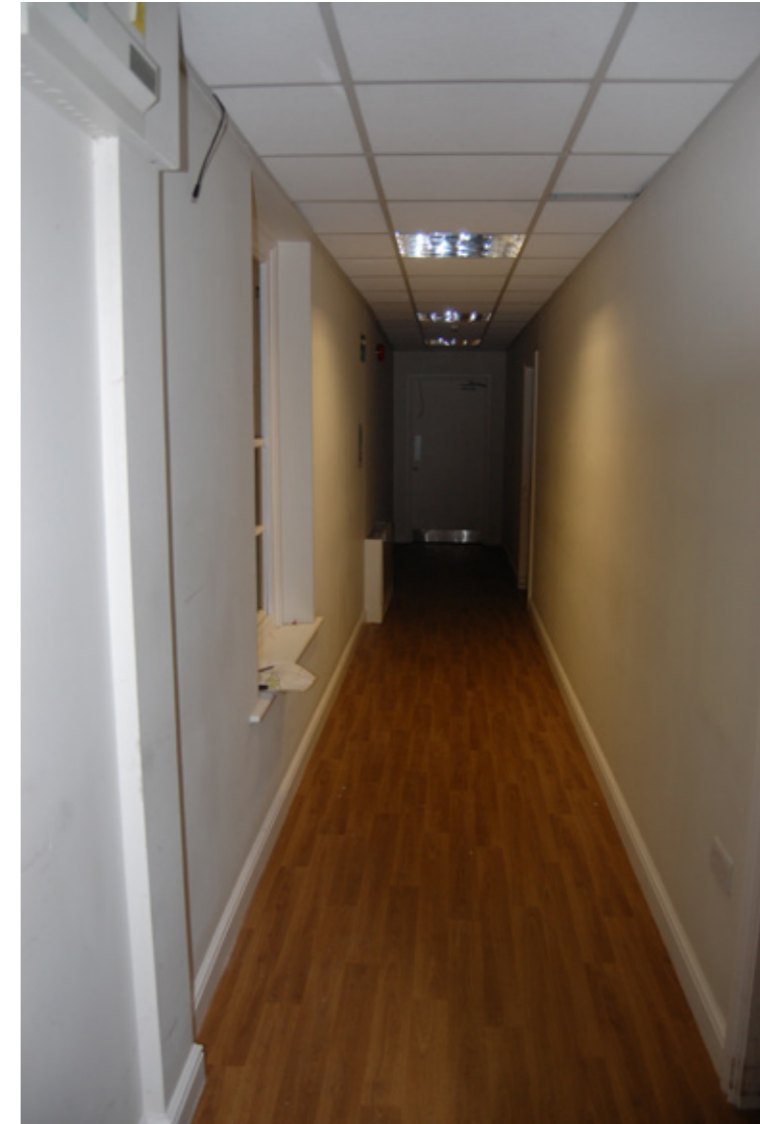
FIRST FLOOR: OFFICE RANGE - F4.01

Room Number:	F4.01
Current Room Use:	Corridor
Historic Room Use:	
Date of Structure:	1848-1893
Date of Fixtures / Fittings:	
Date of Decoration:	Late 20th century
Major Alterations:	
Overall Significance Level:	Low
Key Historic Features:	Sash window
Detrimental Features:	Modern fit out, suspended ceiling
Condition Level:	
Condition Comments:	
Other Comments:

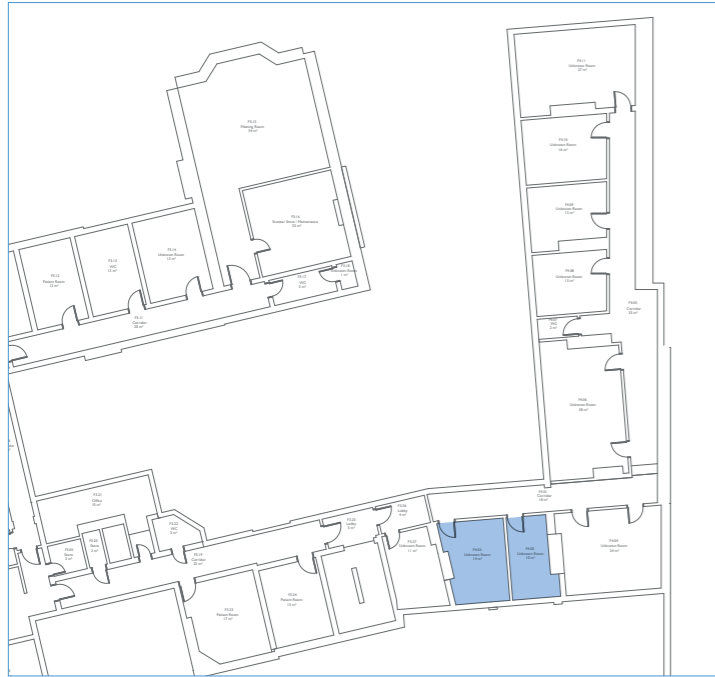
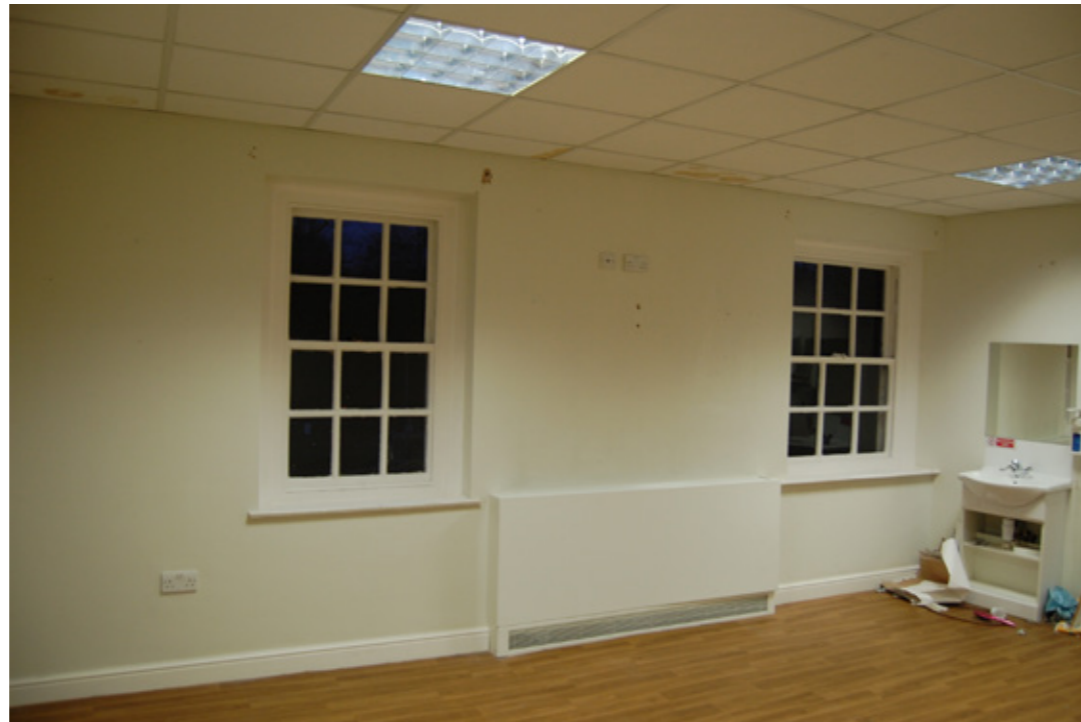
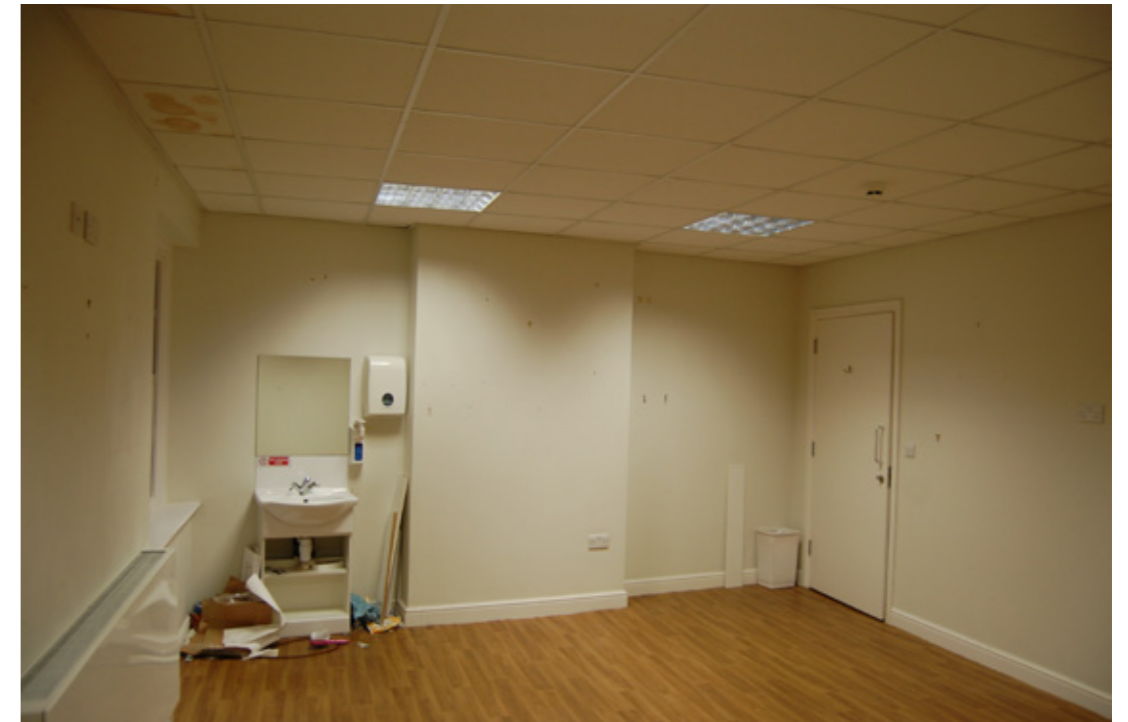
FIRST FLOOR: OFFICE RANGE - F4.02 AND F4.03

Room Number:	F4.02 and F4.03
Current Room Use:	Bedroom
Historic Room Use:	
Date of Structure:	1848-1893
Date of Fixtures / Fittings:	
Date of Decoration:	Early 21st century
Major Alterations:

Overall Significance Level:	Low
Key Historic Features:	Sash windows
Detrimental Features:	Modern fit out, suspended ceiling
Condition Level:	
Condition Comments:	
Other Comments:

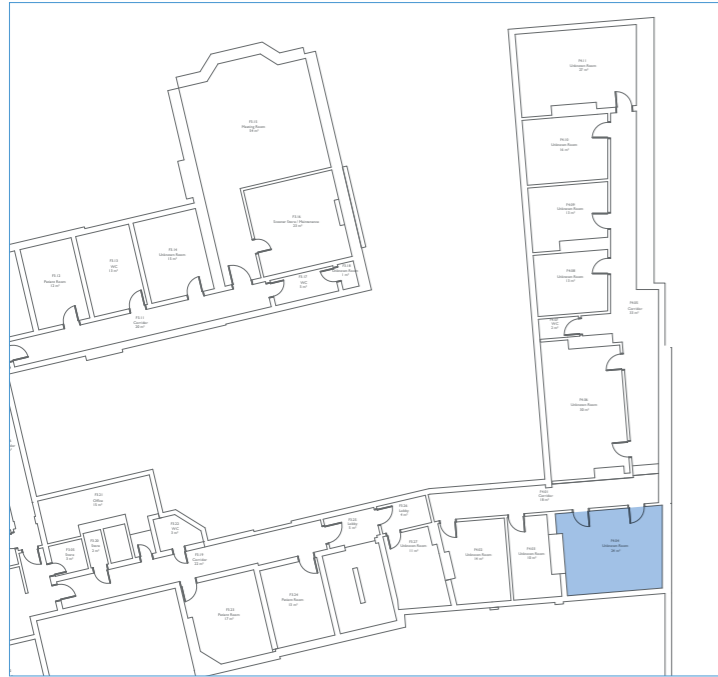
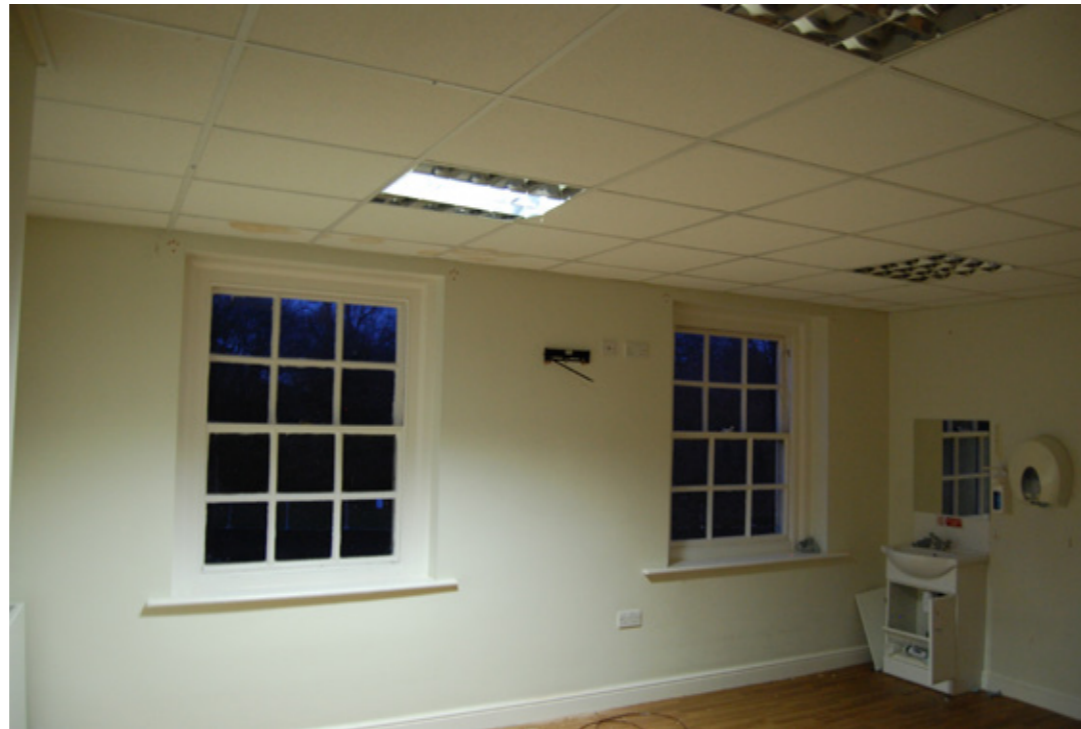
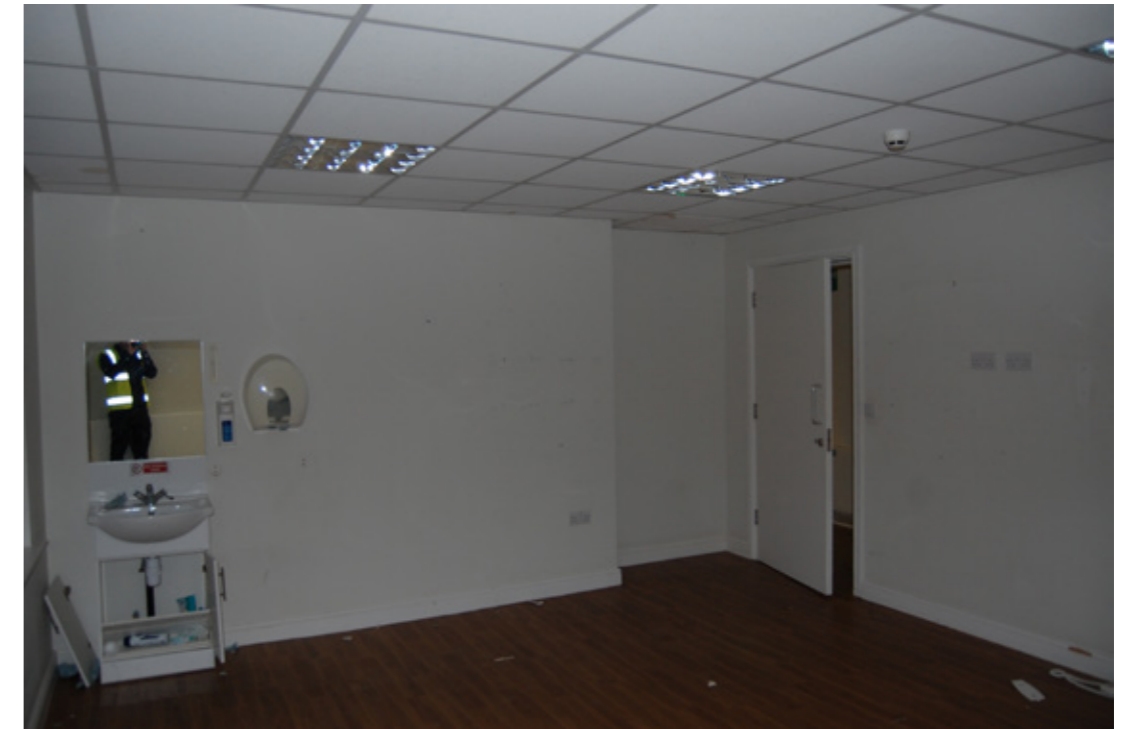
FIRST FLOOR: OFFICE RANGE - F4.04

Room Number:	F4.04
Current Room Use:	Bedroom
Historic Room Use:	Bedroom
Date of Structure:	1848-1893
Date of Fixtures / Fittings:	
Date of Decoration:	Early 21st century
Major Alterations:

Overall Significance Level:	Low
Key Historic Features:	Sash windows
Detrimental Features:	Modern fit out, suspended ceiling
Condition Level:	
Condition Comments:	
Other Comments:

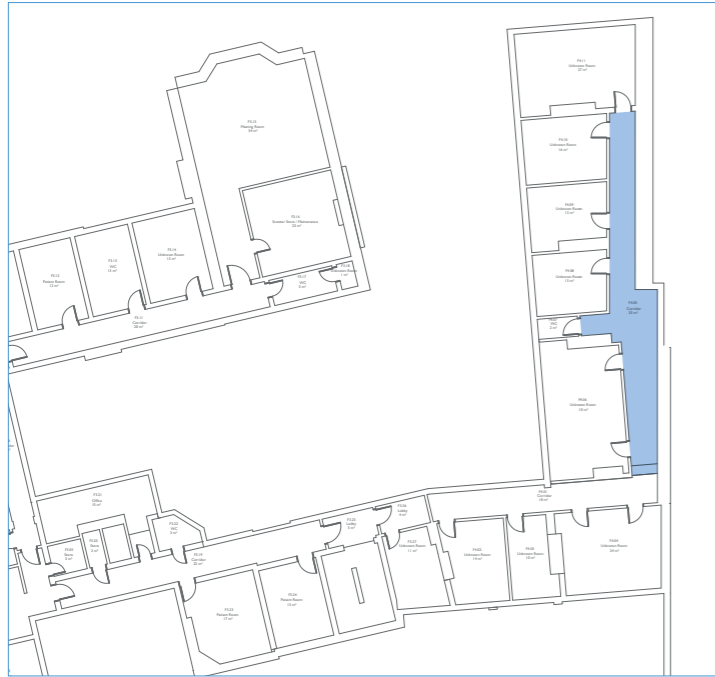
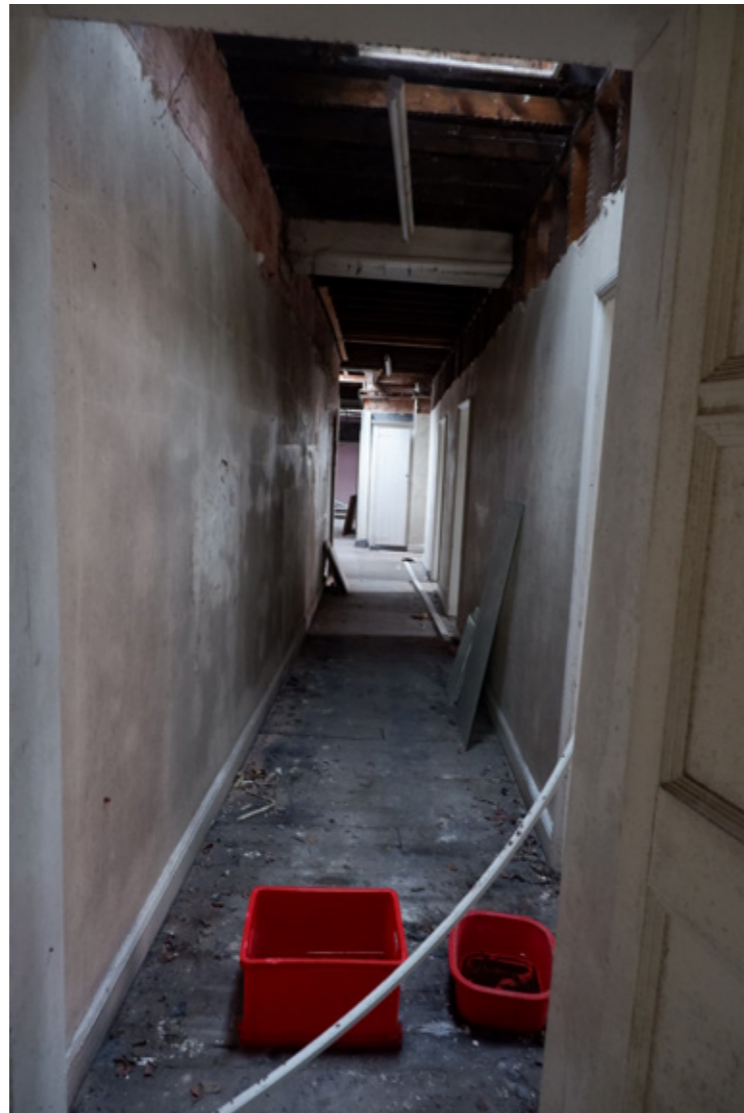
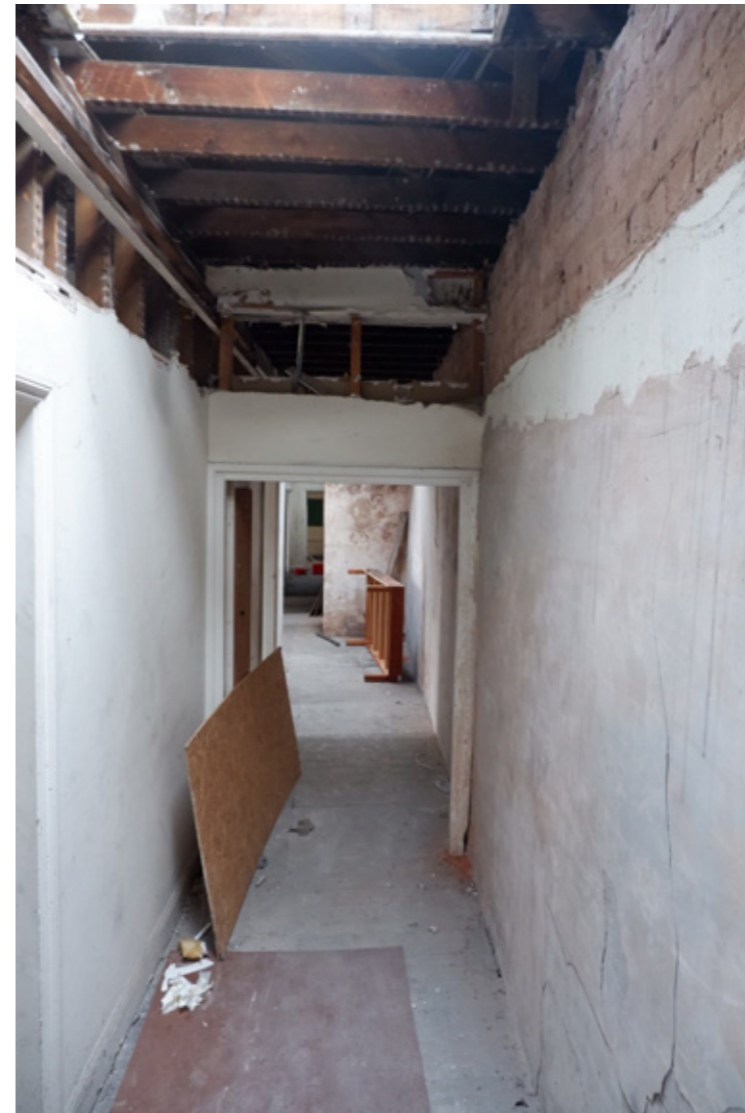
FIRST FLOOR: OFFICE RANGE - F4.05

Room Number:	F4.05
Current Room Use:	Corridor
Historic Room Use:	
Date of Structure:	1848-1893
Date of Fixtures / Fittings:	
Date of Decoration:	Derelict / 20th century
Major Alterations:	Blocked doorway to G5.16 ruin

Overall Significance Level:	Low
Key Historic Features:	None
Detrimental Features:	Modern door
Condition Level:	
Condition Comments:	
Other Comments:

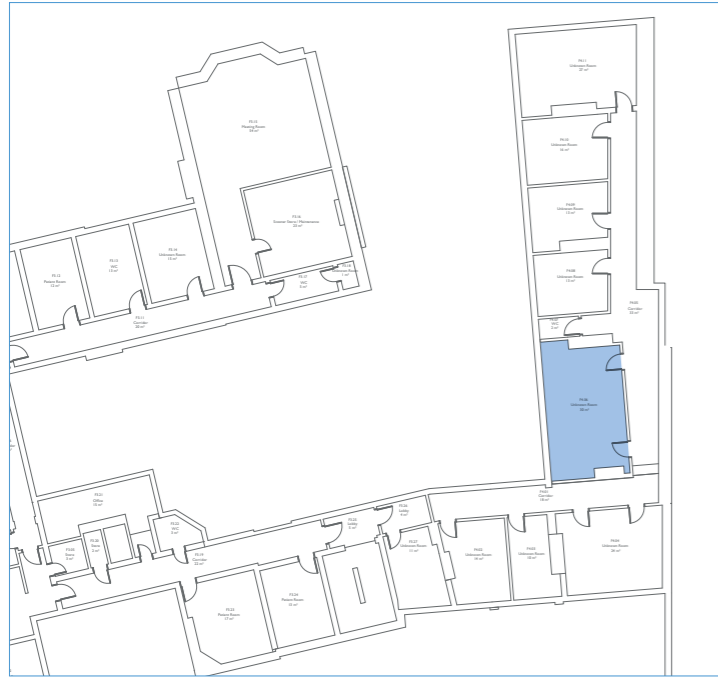
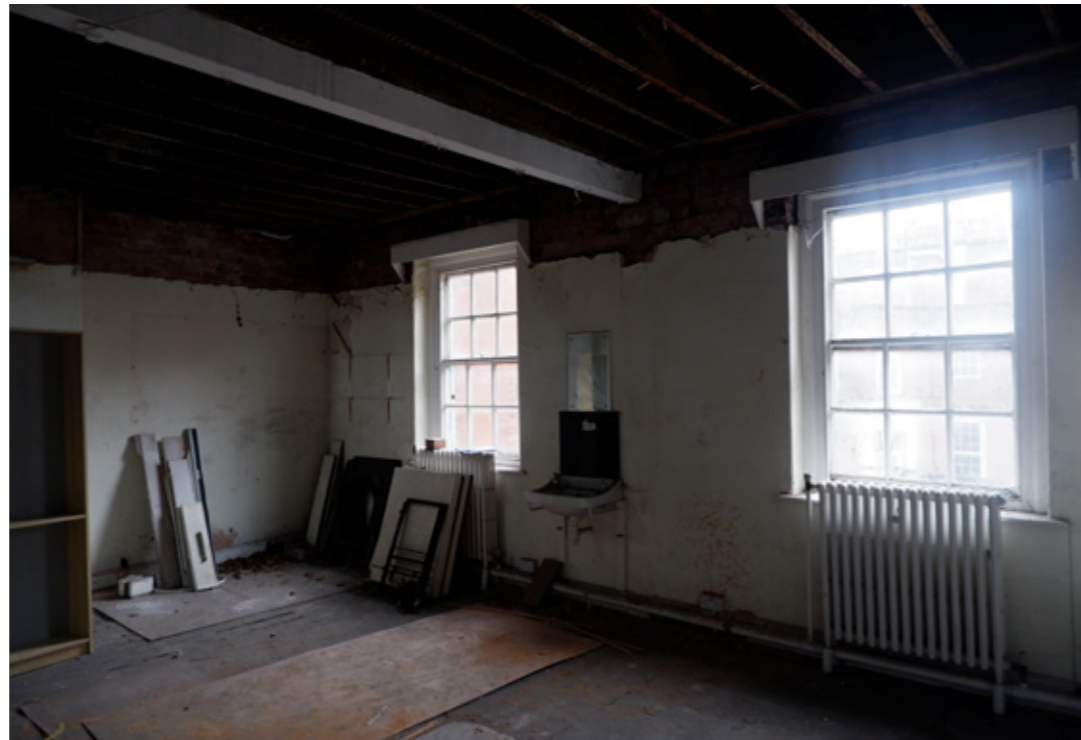
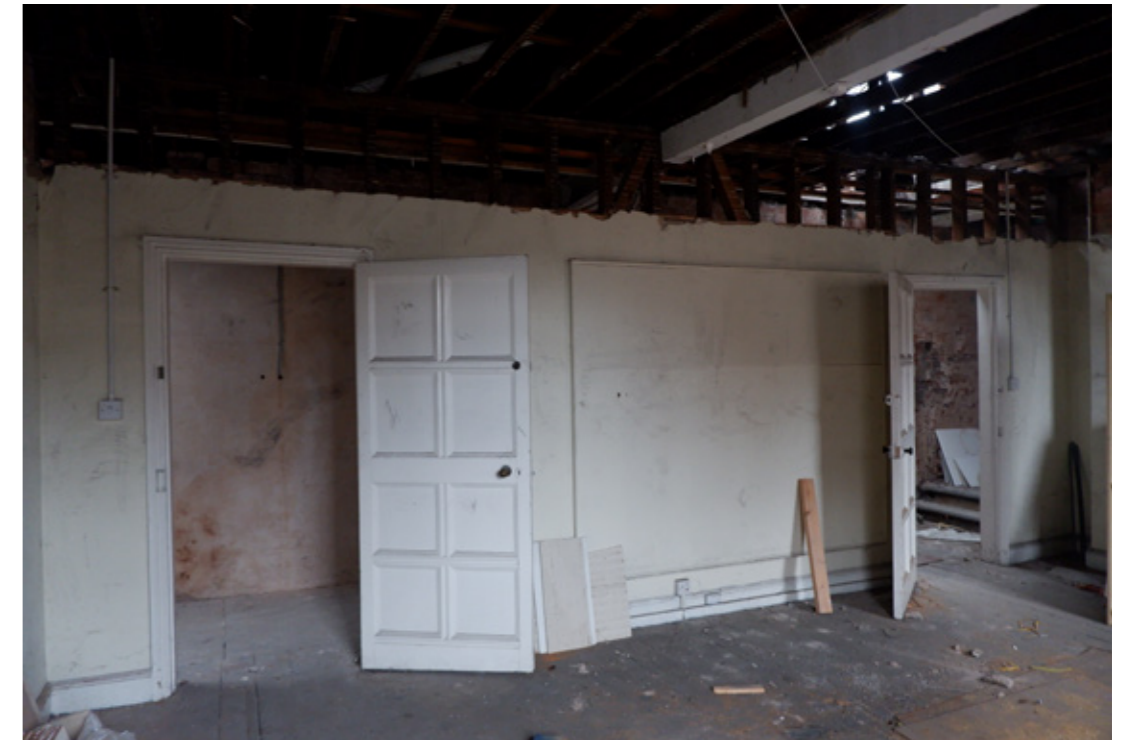
FIRST FLOOR: OFFICE RANGE - F4.06

Room Number:	F4.06
Current Room Use:	Derelict Room
Historic Room Use:	Bedroom
Date of Structure:	1848-1893
Date of Fixtures / Fittings:	
Date of Decoration:	Derelict / 20th century
Major Alterations:

Overall Significance Level:	Low
Key Historic Features:	8 panel doors, joinery, sash windows, fireplace
Detrimental Features:	M&E
Condition Level:	
Condition Comments:	
Other Comments:

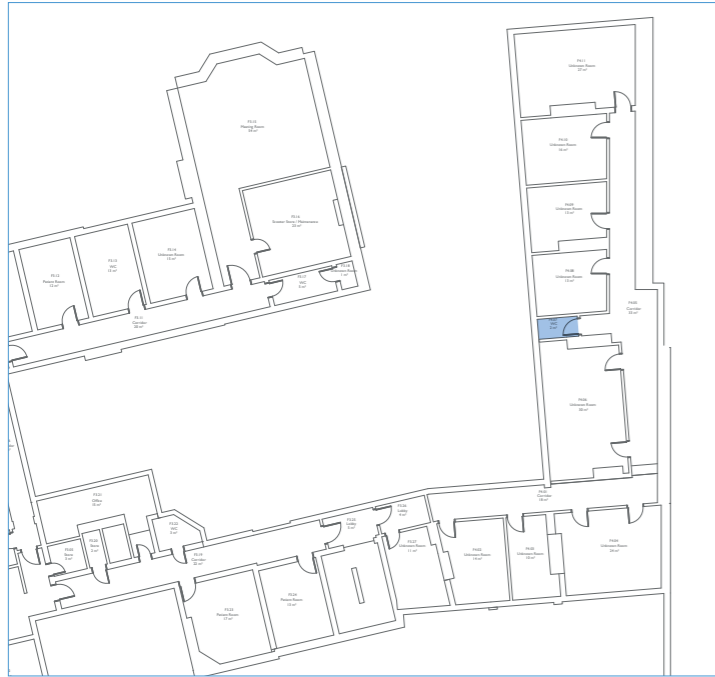
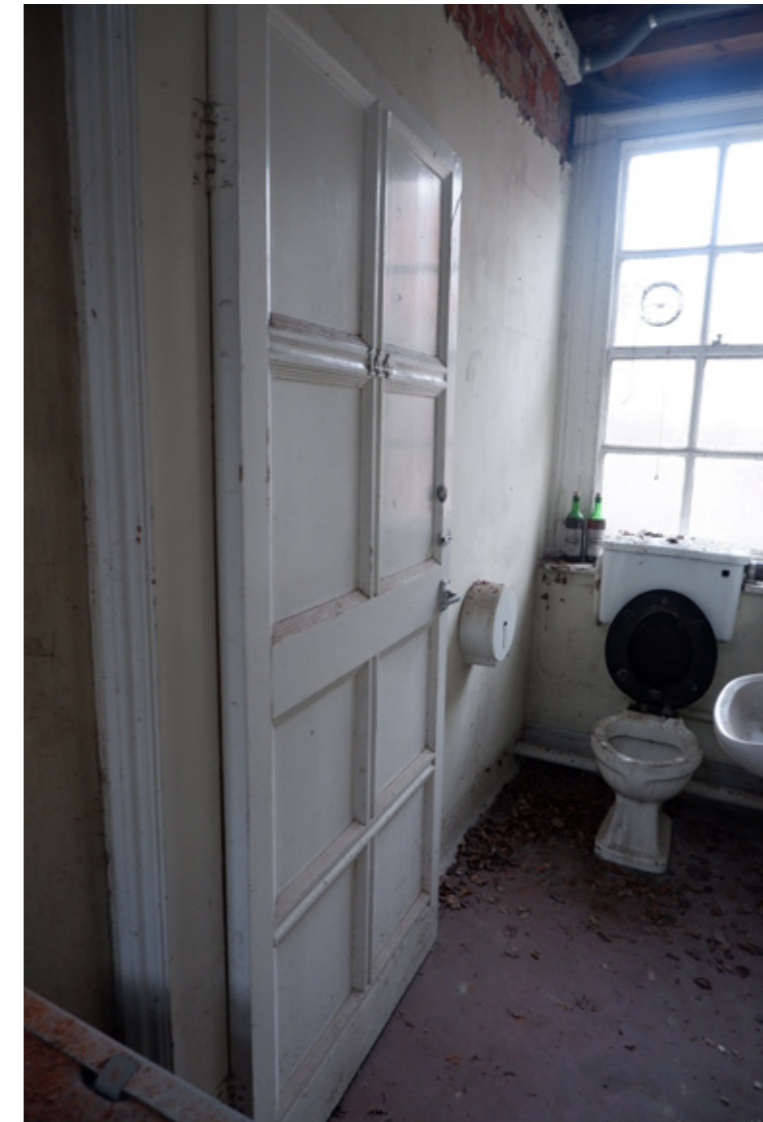
FIRST FLOOR: OFFICE RANGE - F4.07

Room Number:	F4.07
Current Room Use:	WC
Historic Room Use:	
Date of Structure:	1848-1893
Date of Fixtures / Fittings:	
Date of Decoration:	Derelict / 20th century
Major Alterations:	
Overall Significance Level:	Low
Key Historic Features:	8 panel door, sash window
Detrimental Features:	M&E, extractor fan on sash window
Condition Level:	
Condition Comments:	
Other Comments:

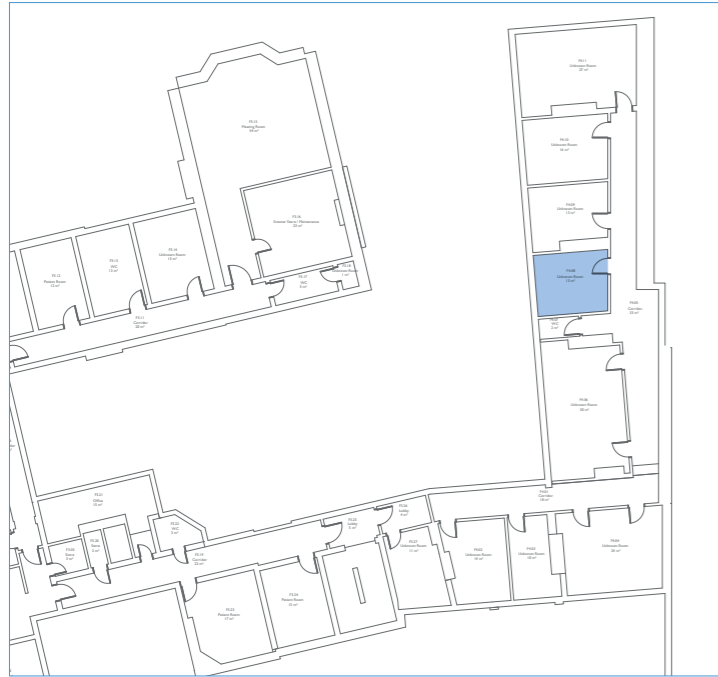
FIRST FLOOR: OFFICE RANGE - F4.08

Room Number:	F4.08
Current Room Use:	Derelict Room
Historic Room Use:	Bedroom
Date of Structure:	1848-1893
Date of Fixtures / Fittings:	
Date of Decoration:	Derelict / 20th century
Major Alterations:

Overall Significance Level:	Low
Key Historic Features:	8 panel door, sash window
Detrimental Features:	M&E
Condition Level:	
Condition Comments:	
Other Comments:
