VOLUME TWO

GAZETTEER

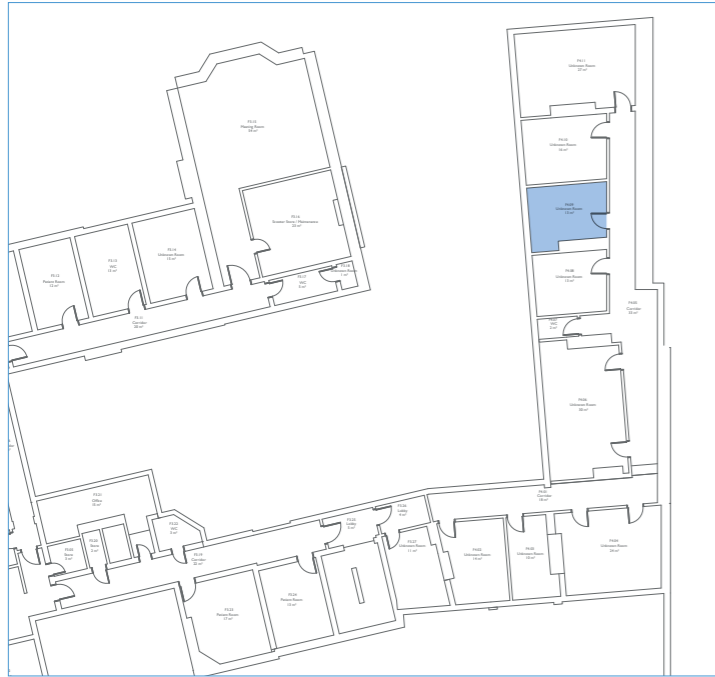
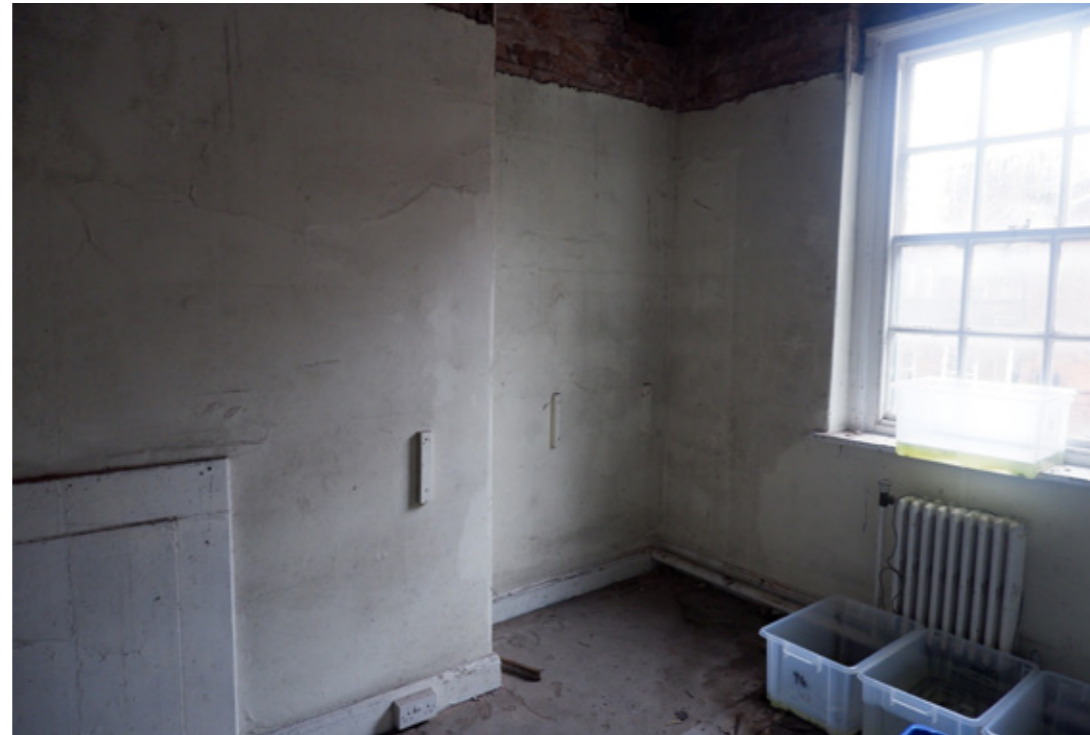
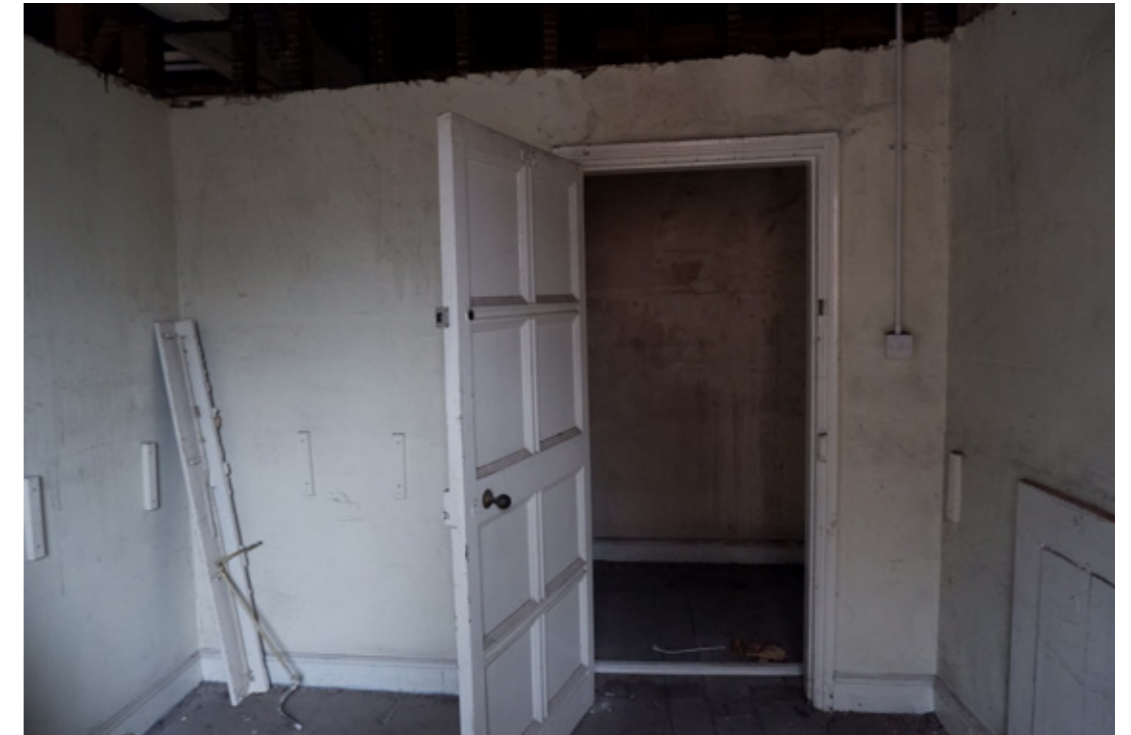
FIRST FLOOR: OFFICE RANGE - F4.09

Room Number:	F4.09
Current Room Use:	Derelict Room
Historic Room Use:	Bedroom
Date of Structure:	1848-1893
Date of Fixtures / Fittings:	
Date of Decoration:	Derelict / 20th century
Major Alterations:

Overall Significance Level:	Low
Key Historic Features:	8 panel door, sash window, blocked fireplace
Detrimental Features:	M&E
Condition Level:	
Condition Comments:	
Other Comments:

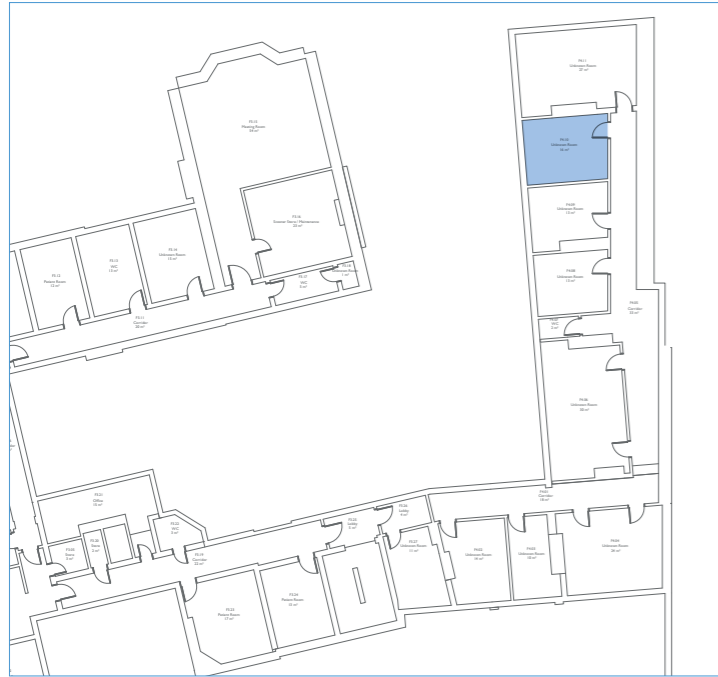
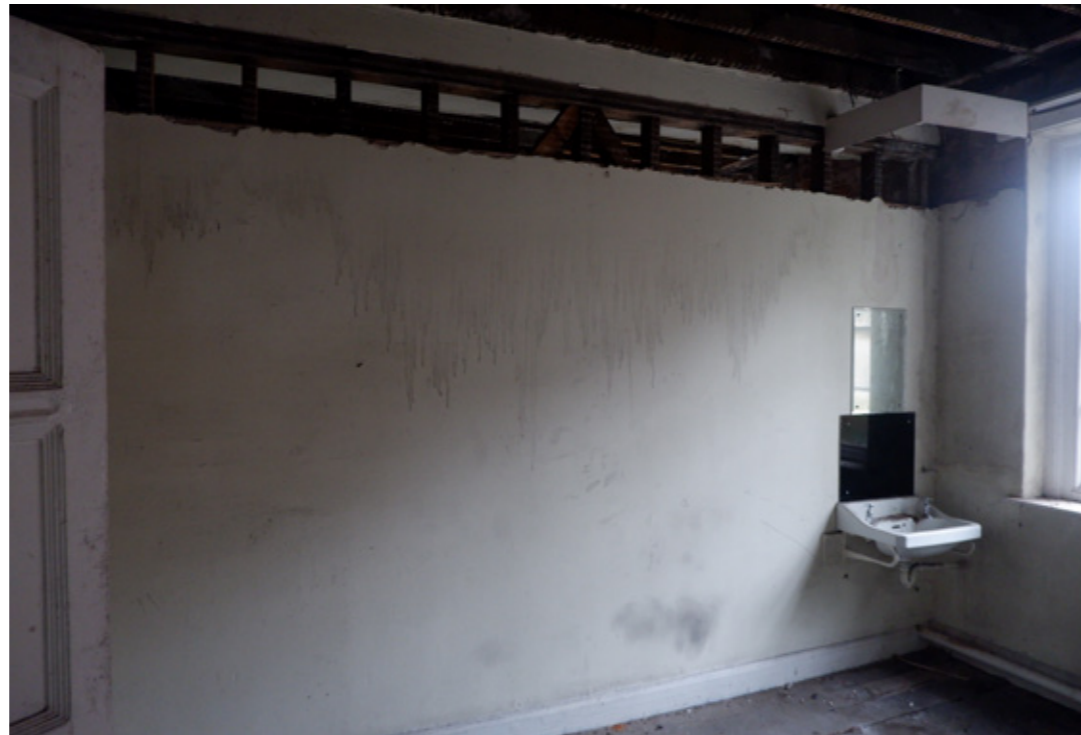
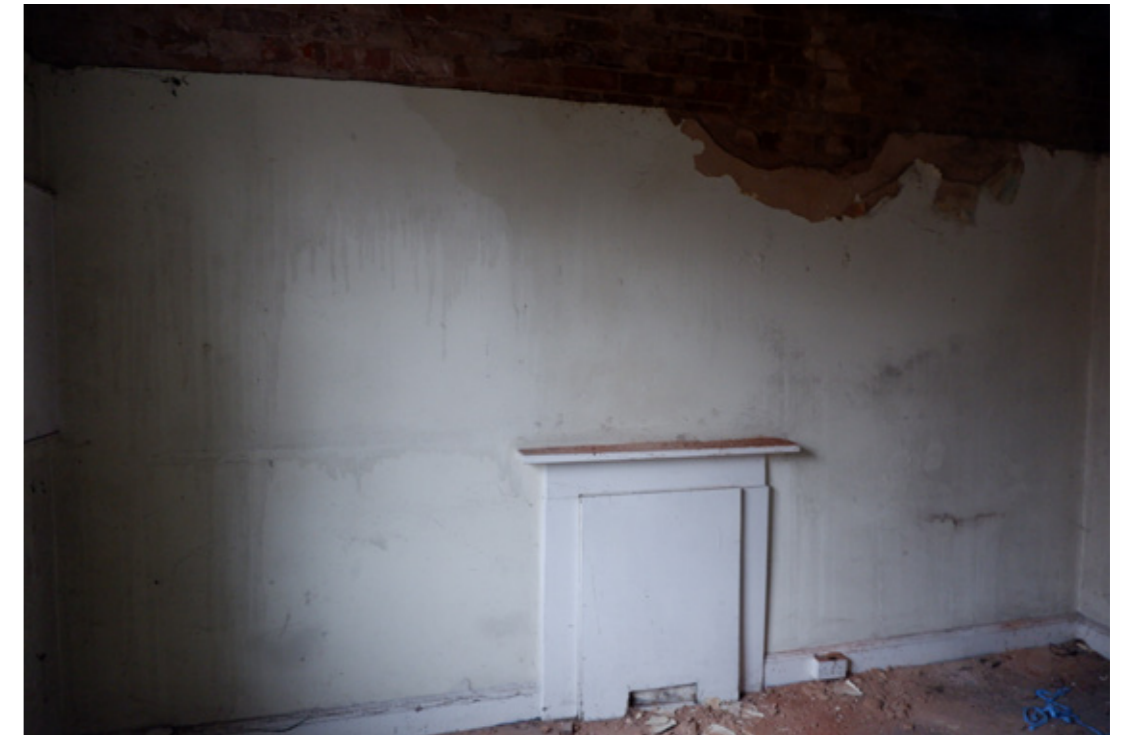
FIRST FLOOR: OFFICE RANGE - F4.10

Room Number:	F4.11
Current Room Use:	Derelict Room
Historic Room Use:	Bedroom
Date of Structure:	1848-1893
Date of Fixtures / Fittings:	
Date of Decoration:	Derelict / 20th century
Major Alterations:

Overall Significance Level:	Low
Key Historic Features:	8 panel door, blocked fireplace, sash windows
Detrimental Features:	M&E, sanitary ware,
Condition Level:	
Condition Comments:	
Other Comments:

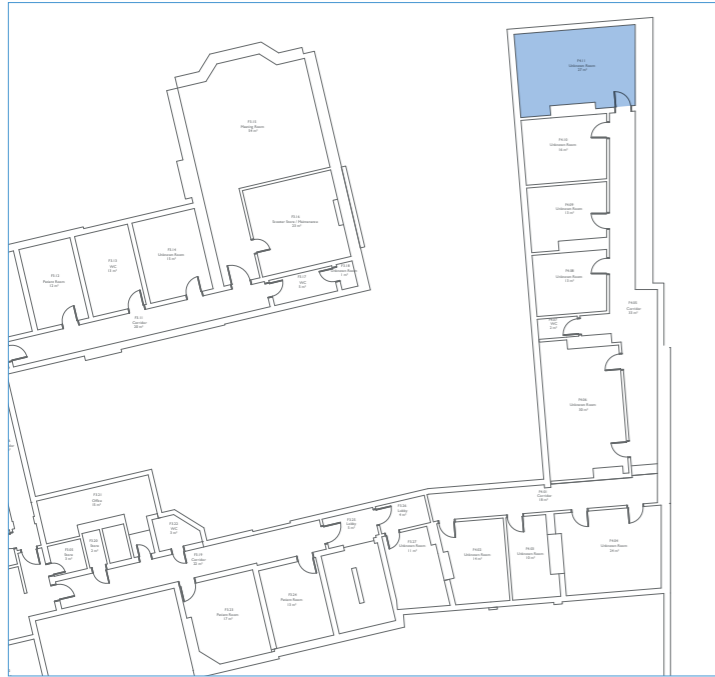
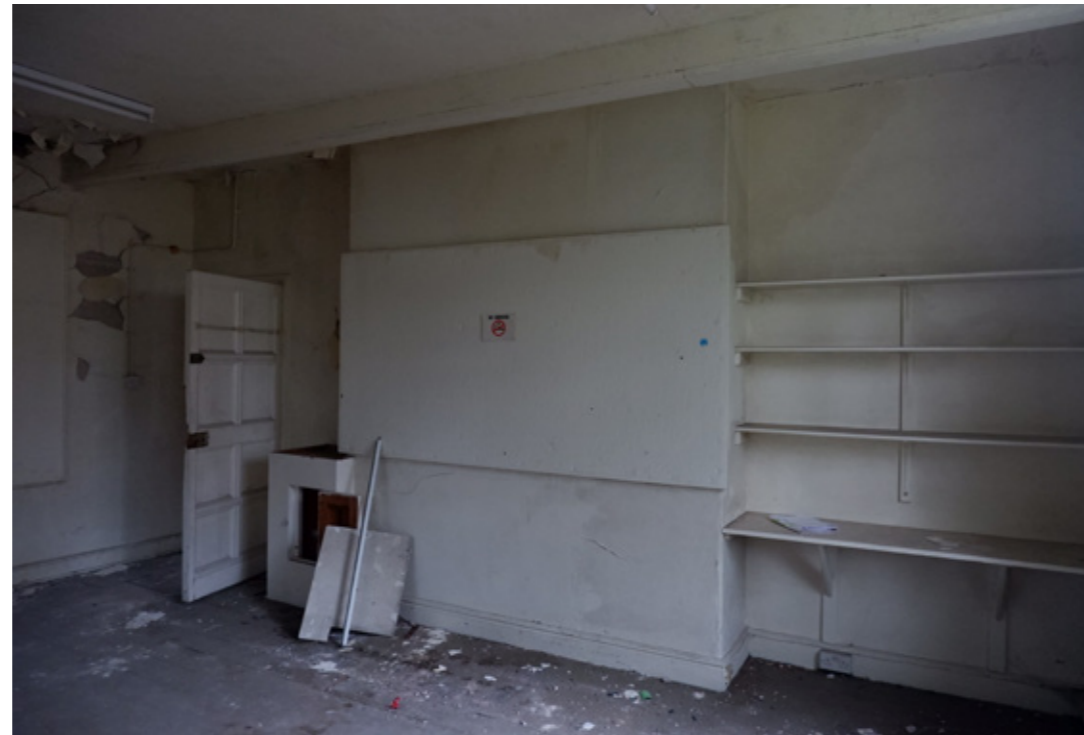
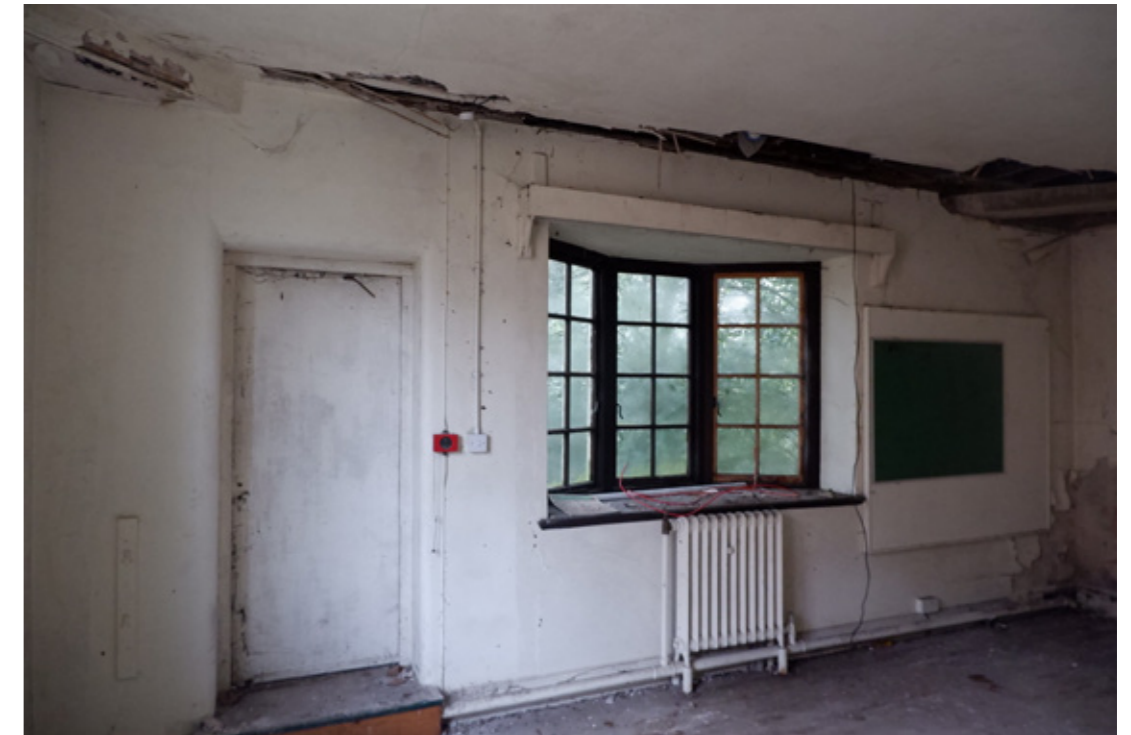
FIRST FLOOR: OFFICE RANGE - F4.11

Room Number:	F4.11
Current Room Use:	Derelict Room
Historic Room Use:	
Date of Structure:	1848-1893
Date of Fixtures / Fittings:	
Date of Decoration:	Derelict / 20th century
Major Alterations:

Overall Significance Level:	Low
Key Historic Features:	8 panel door, canted bay window, sash windows
Detrimental Features:	M&E, modern door
Condition Level:	
Condition Comments:	
Other Comments:
