Cuerden Hall

Landscape Statement  
May 2021

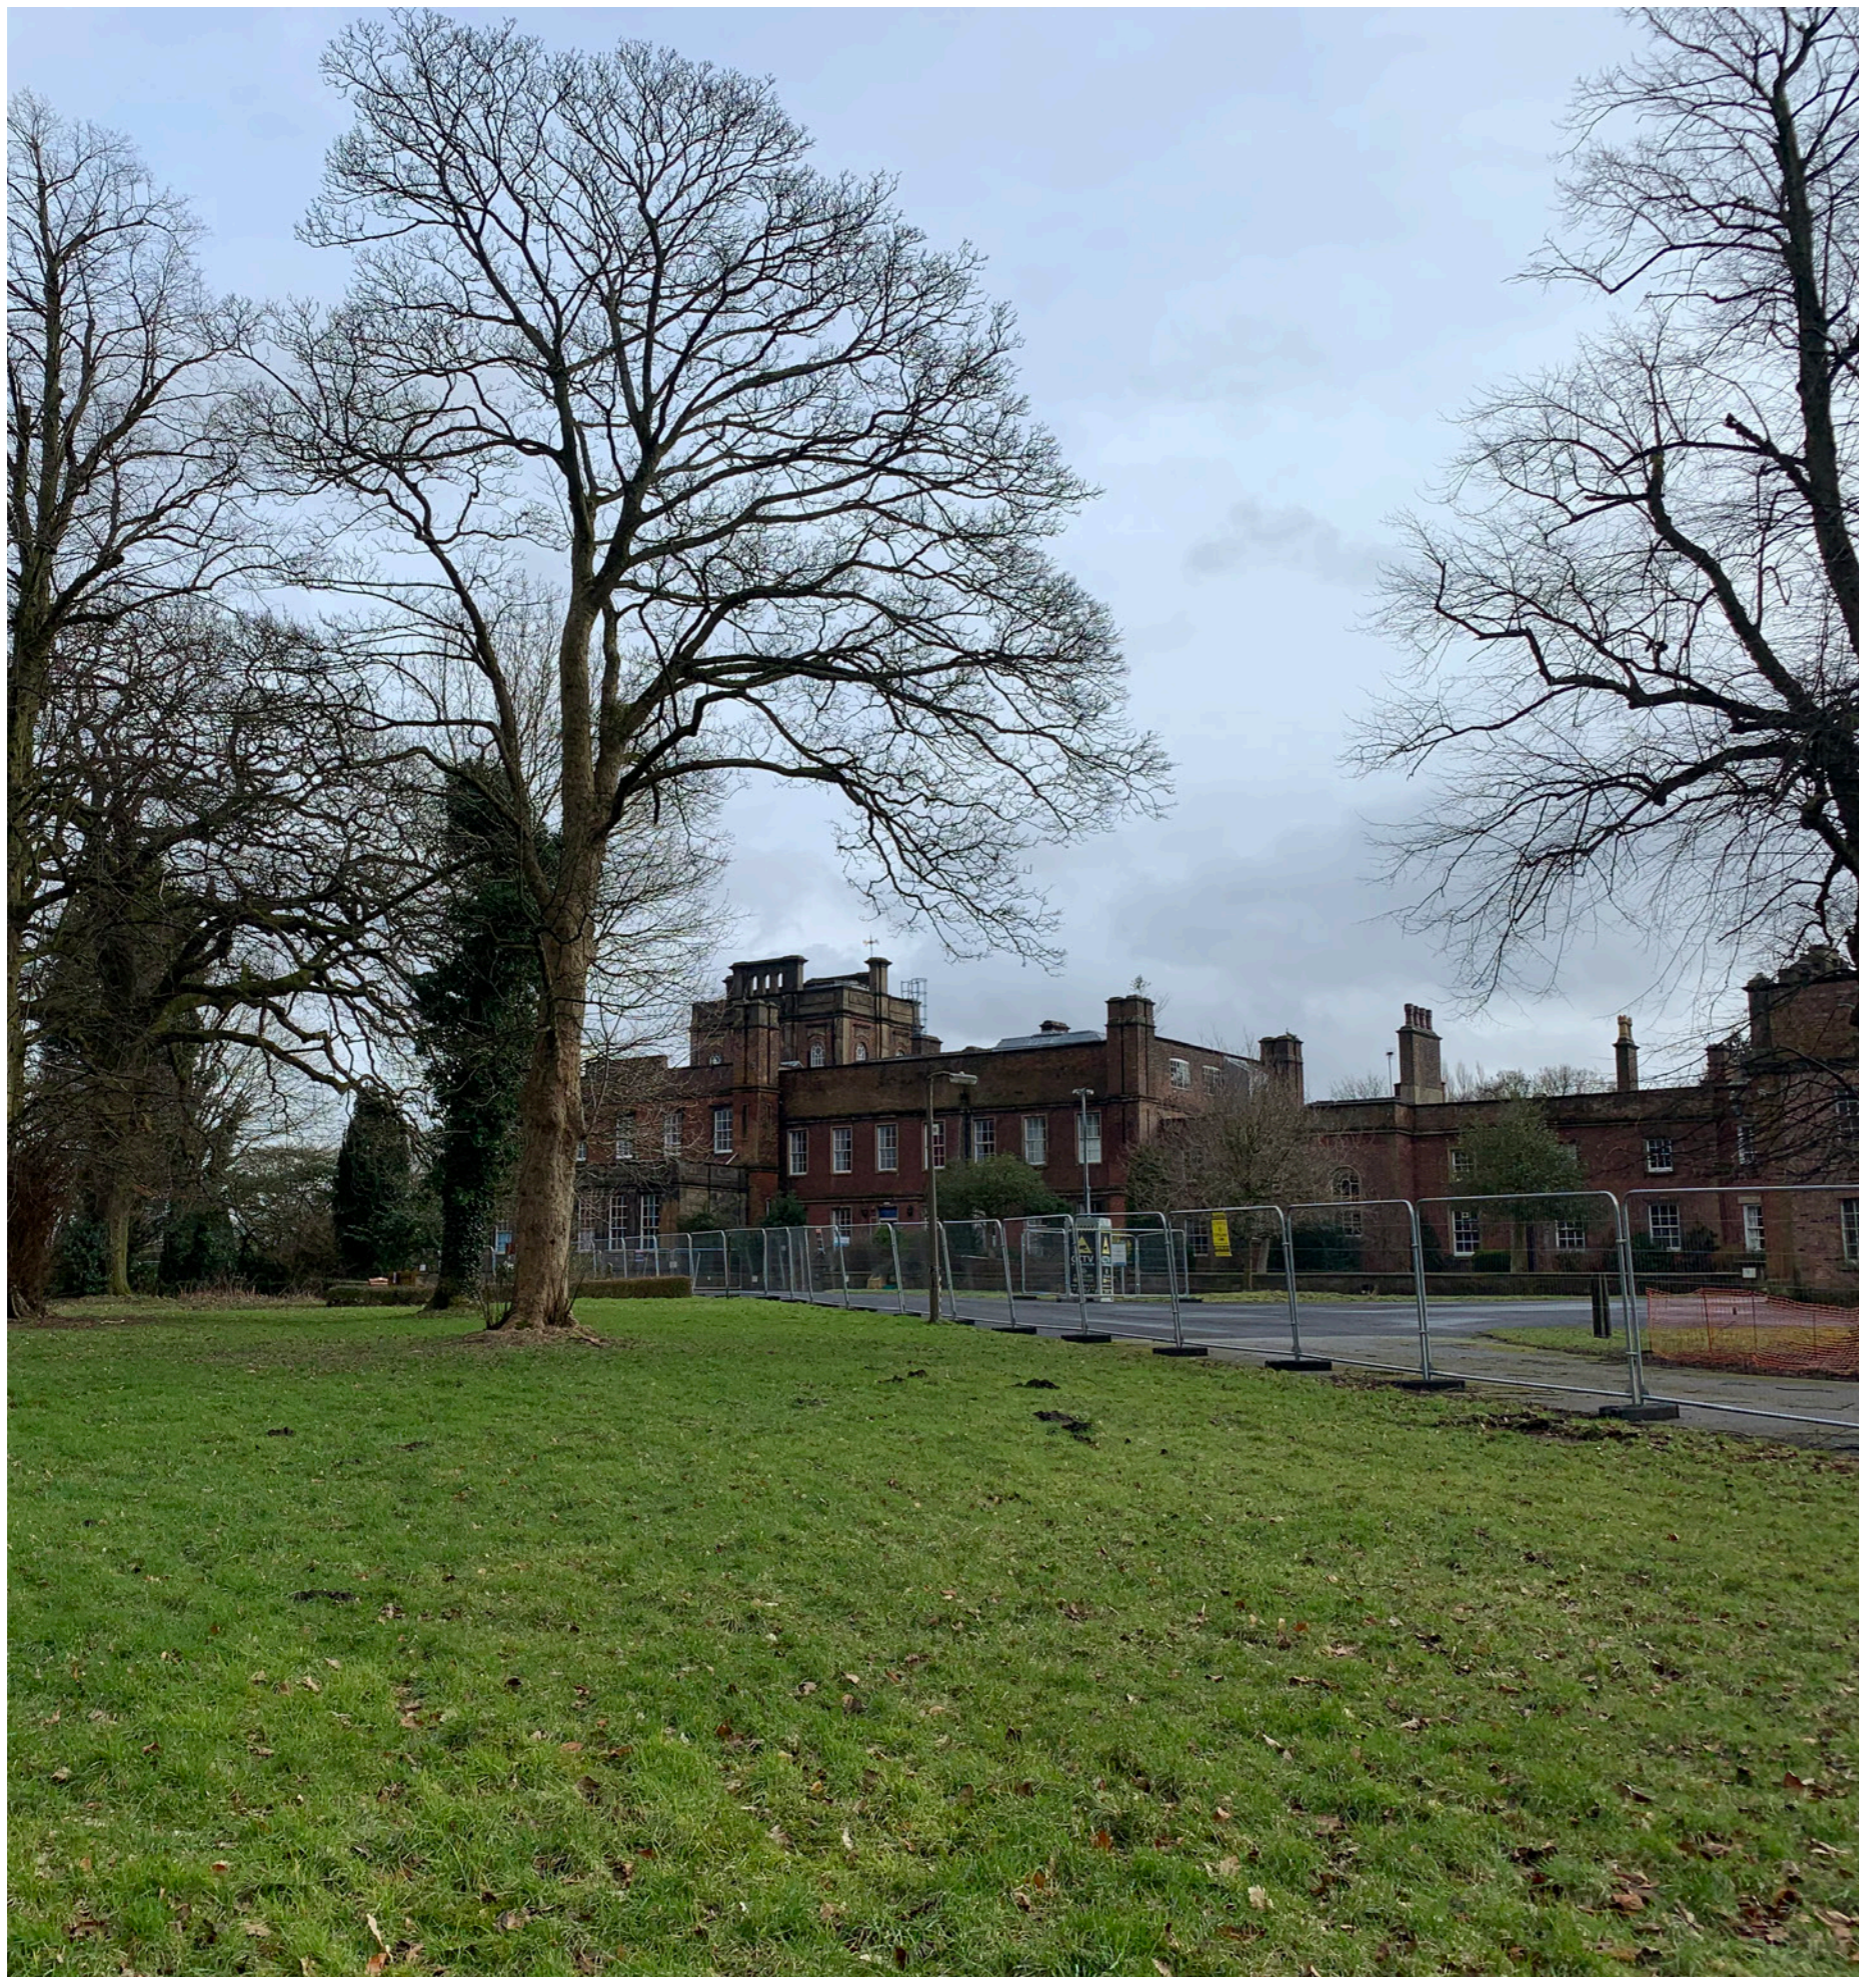
Cuerden Hall - northern facade, 2021

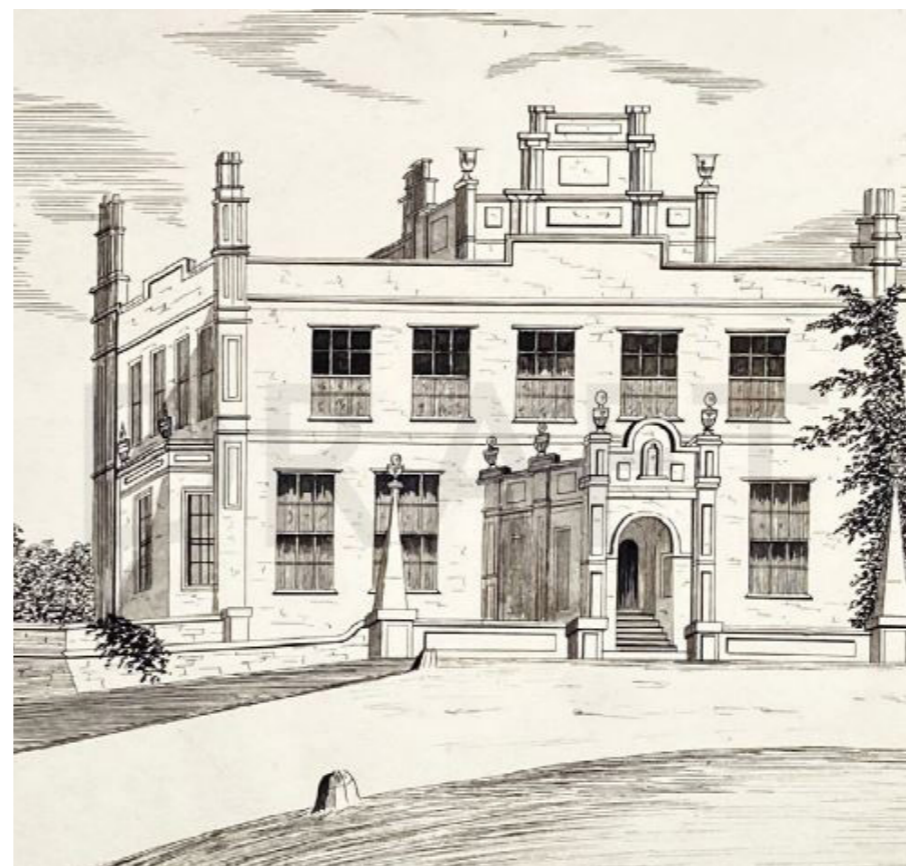
Drawing of Wyatt eastern wing and porch, Cuerden Hall, c. 1819

The original 16th Century house built on the site of the present Cuerden Hall no longer exists. The oldest part of the present house was built between 1717-19 by Robert Banastre. In 1794, Robert Townley Parker inherited Cuerden Hall and commissioned Lewis Wyatt in 1815 to modernise the house and enhance the surrounding parks. Most notably Wyatt added a large 'plain classic' wing to the east side of the 1717 house, which contained the new house's principal rooms.

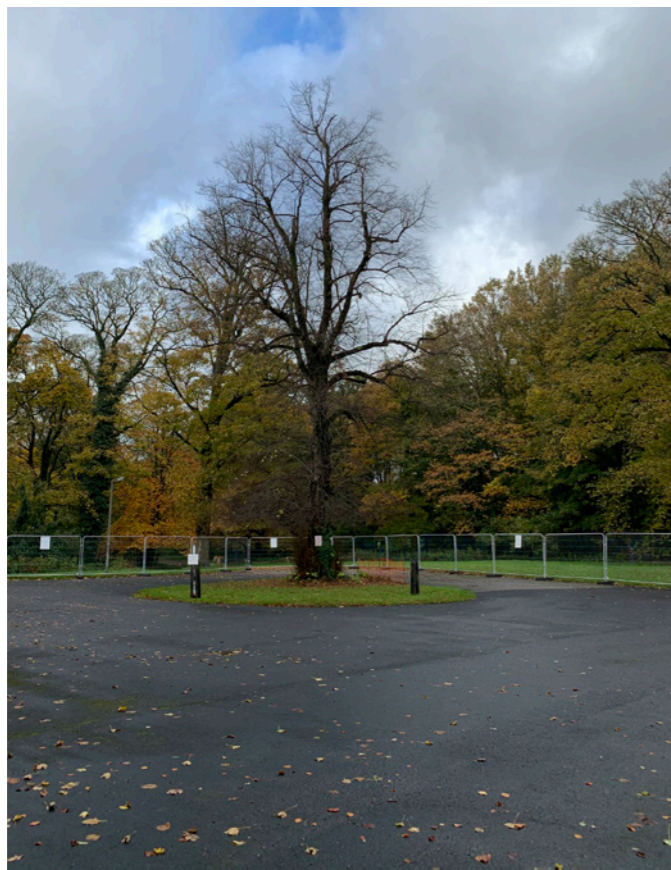
The driveway and main approach to Cuerden Hall is dominated by large expanses of tarmac hard-standing, used as an area for car parking and service access during the property's time as a Sue Ryder care home.

Tarmac driveway

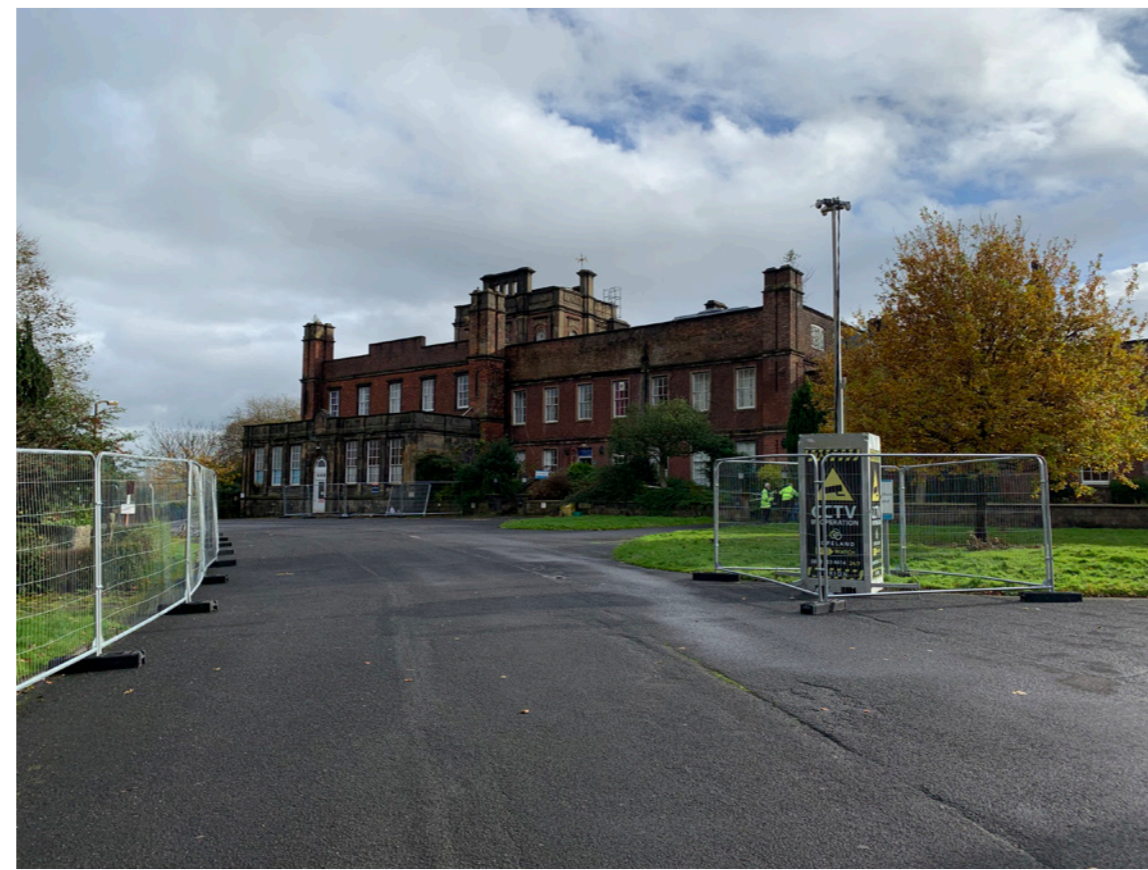
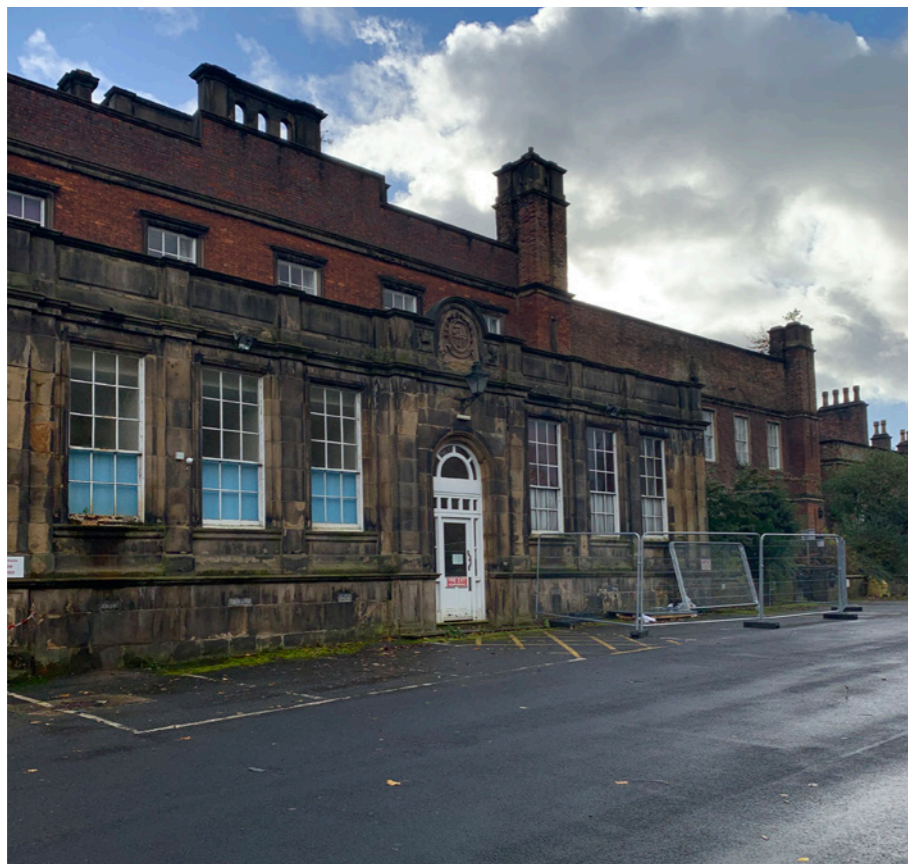
Lewis Wyatt porch extension

The area immediately in front of the Lewis Wyatt porch extension has been used for staff car parking but also as a visitor drop-off area. The levels here had been significantly increased to create more of a level threshold for guests, covering up the original stone steps up to the porch.

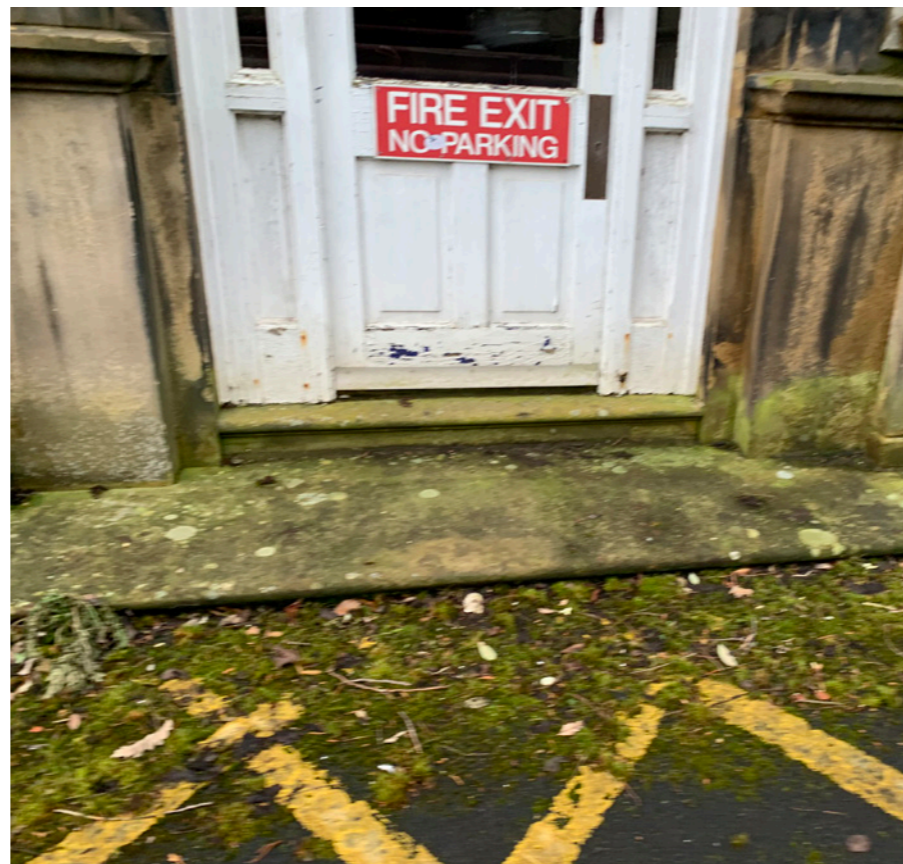
Tarmac covering original porch stone steps

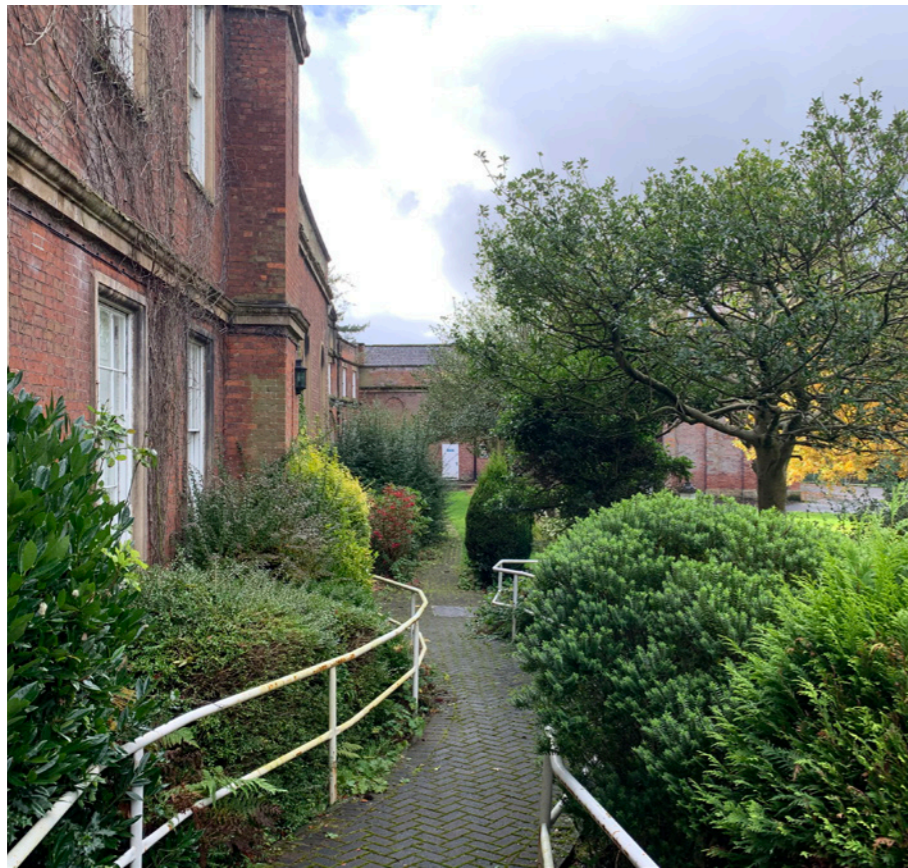
Curved ramp to main entrance

This area includes a curving disabled access ramp with metal balustrades to the main entrance. The levels across this elevation of the building have been drastically changed to accommodate the ramp. Vegetation along this section is very overgrown but the original walls and their copings seem to be in good condition and shouldn't require too much restoration.

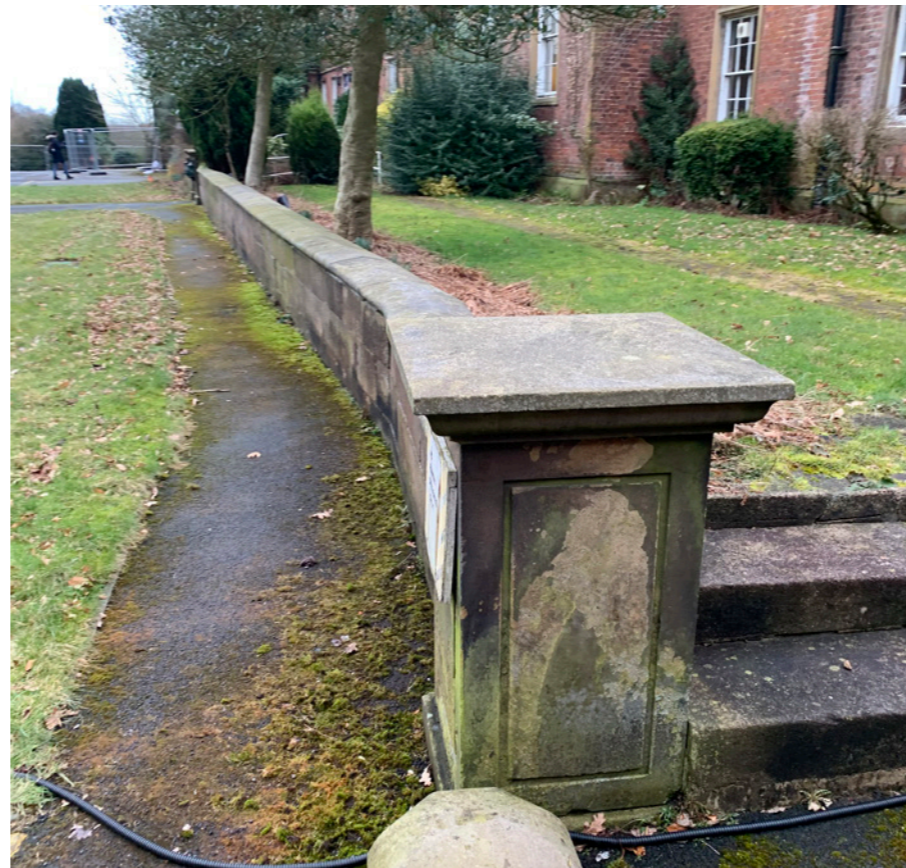
Existing walls along northern elevation

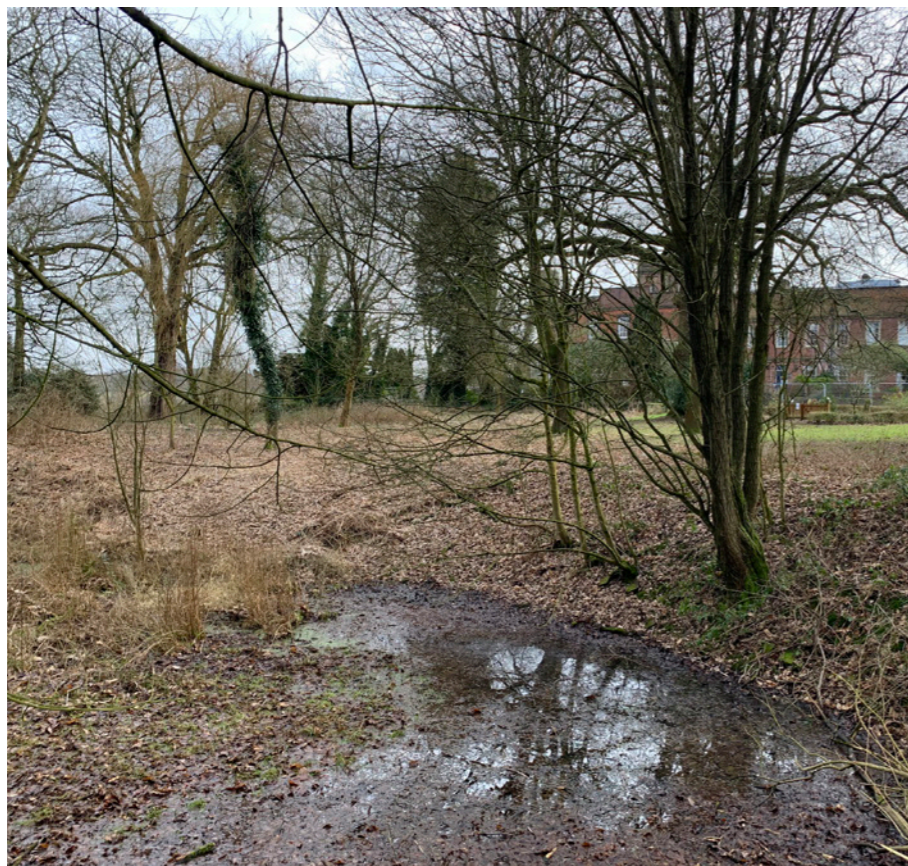
The pond has been unmaintained for, what is estimated to be, half a century and the water level is very low due to either a leak or the quantity of large trees and overgrown vegetation within it.

Pond in disrepair

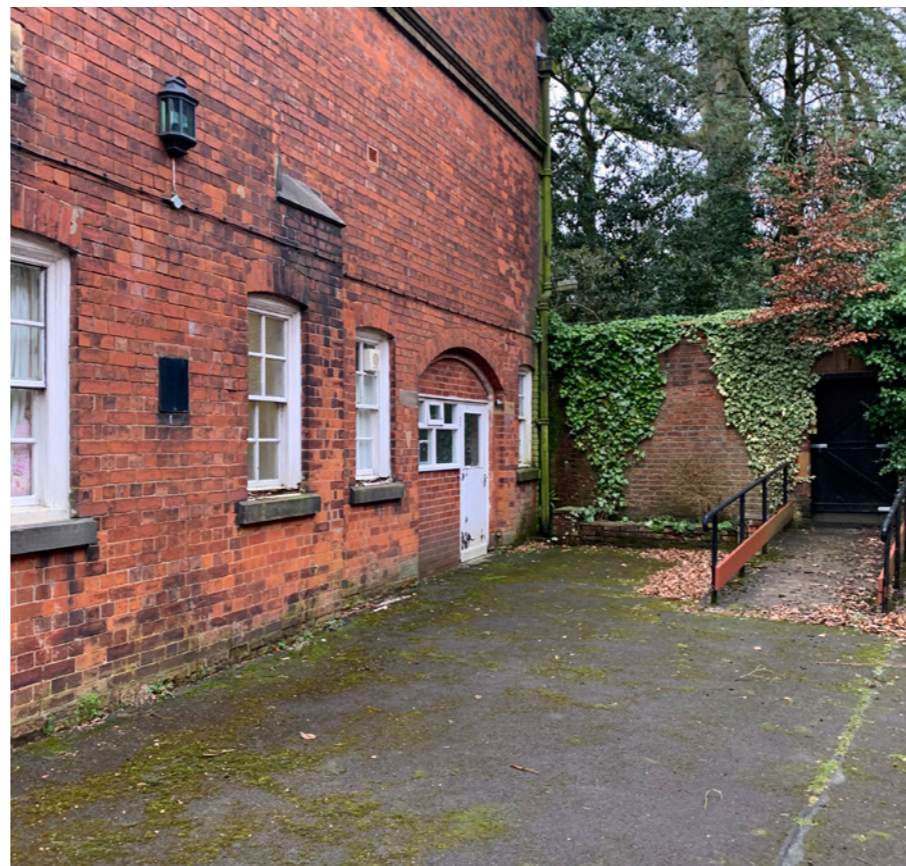
Internal courtyard

The courtyard's surface is entirely tarmac and has gradient of about 1:45 from north to south. There is no planting apart from overgrown ivy and the four cottages that face onto the courtyard all have varying level thresholds. There is a ramped access out through the wall to the rest of the garden.

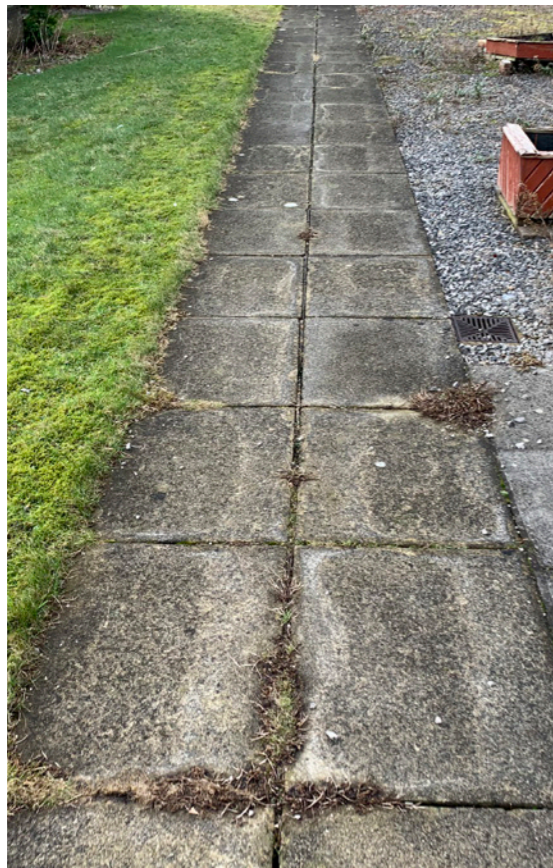
Concrete pavers

Around the house and the lower levels of the southern garden, the main circulatory paths are comprised of concrete pavers and gravel. Many of the pavers are broken and overgrown with weeds and grass.

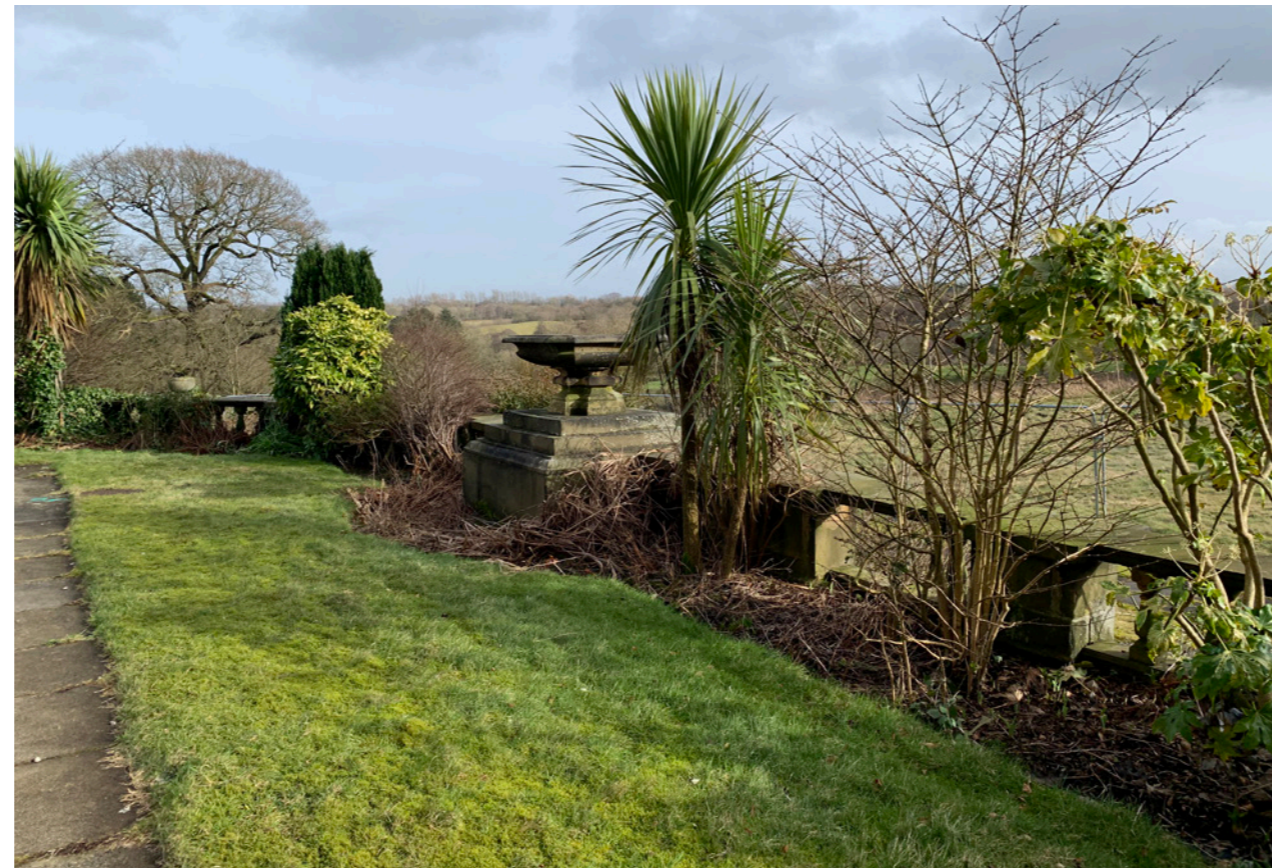
Stone balustrade and urns

The Hall boasts impressive original stone walls, balustrades and an imposing two level set of steps that face east. The structures appear to be sound however there is a significant amount of restoration and replacement of elements to be done.

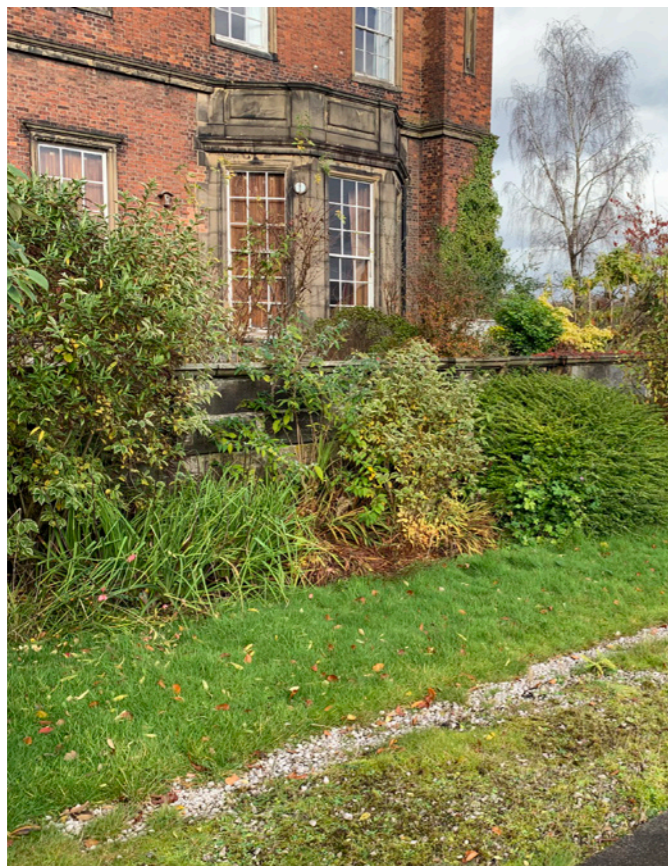
Narrow planting beds

Throughout the site the planting beds are confined to narrow strips along walls and around the Hall. These planting beds are all tired, overgrown and include a mismatched collection of trees, shrubs and perennials that have been accumulated over the 20 years the Hall was used as a care home.

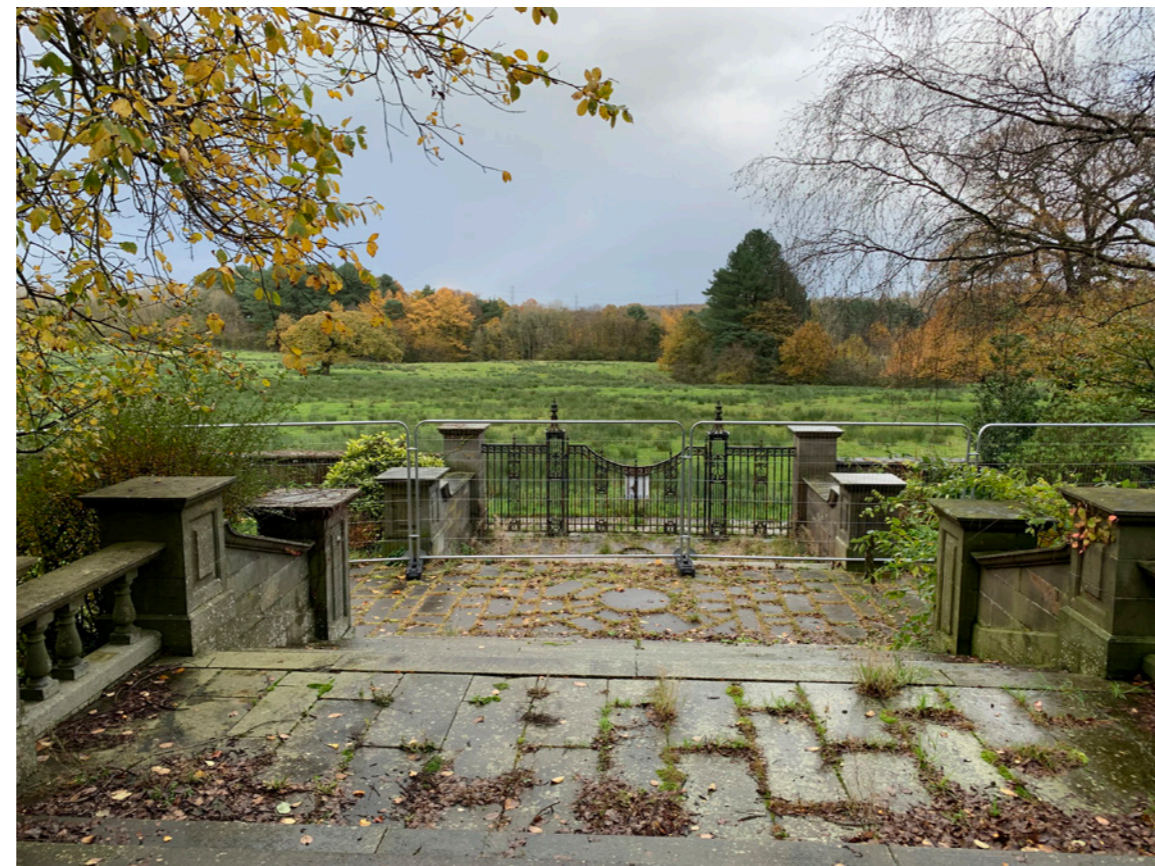
Stone steps and ornate gates

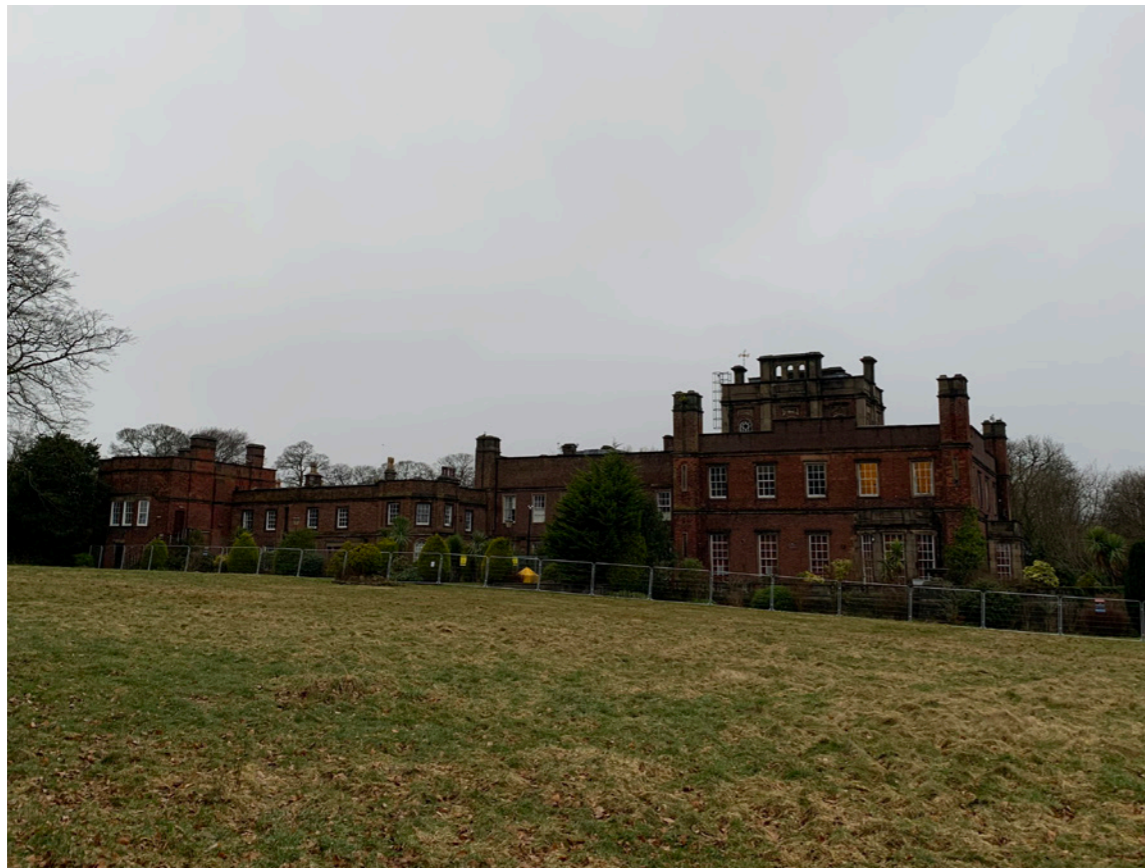
Southern facade of Cuerden Hall and sloping southern lawn

Outside the confines of the existing walls that run around the Hall is a large expanse of sloping lawn, approximately 5,000m<sup>2</sup>. The lawn has a significant level changes from west to east. There are no trees or planting beds within the lawned area. To the south of the lawn is a wooded area of mature deciduous trees. On the west side of the south lawn the tree belt is in poor condition with several over-mature Beech trees.

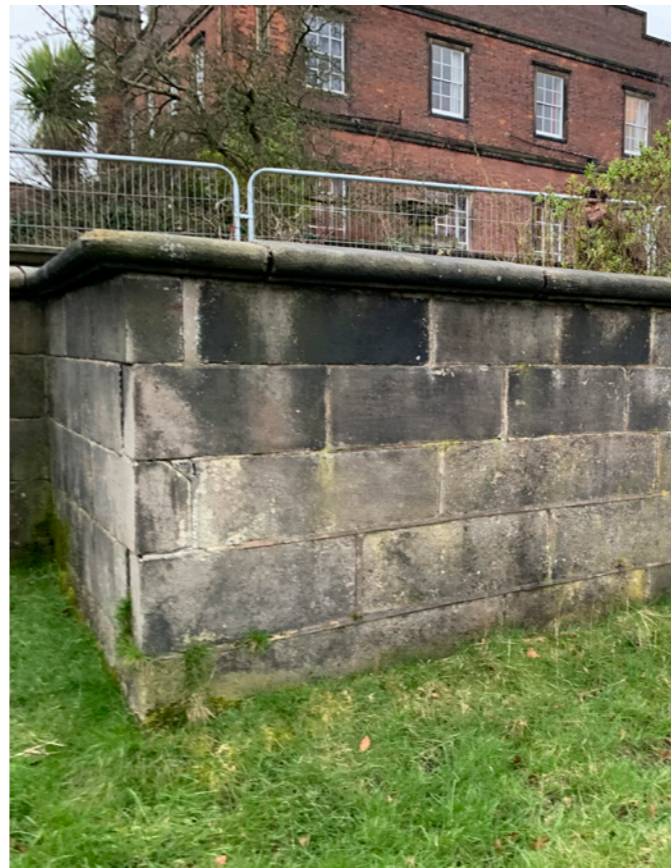
Stone Ha ha

A large stone Ha ha runs along the eastern boundary of the property and is in good condition. The Ha ha separates the property from the surrounding Cuerden Valley Park which can be accessed by the public. There is a public footpath that runs through the park and is visible from the garden.

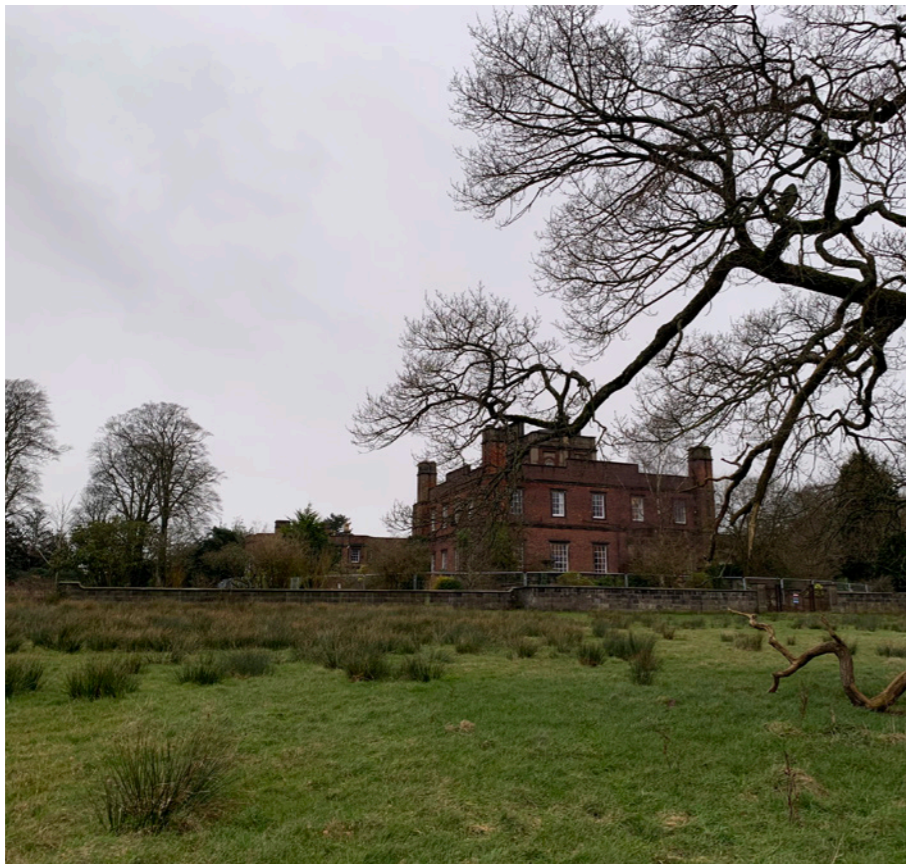
View of the Hall halfway between garden and public footpath

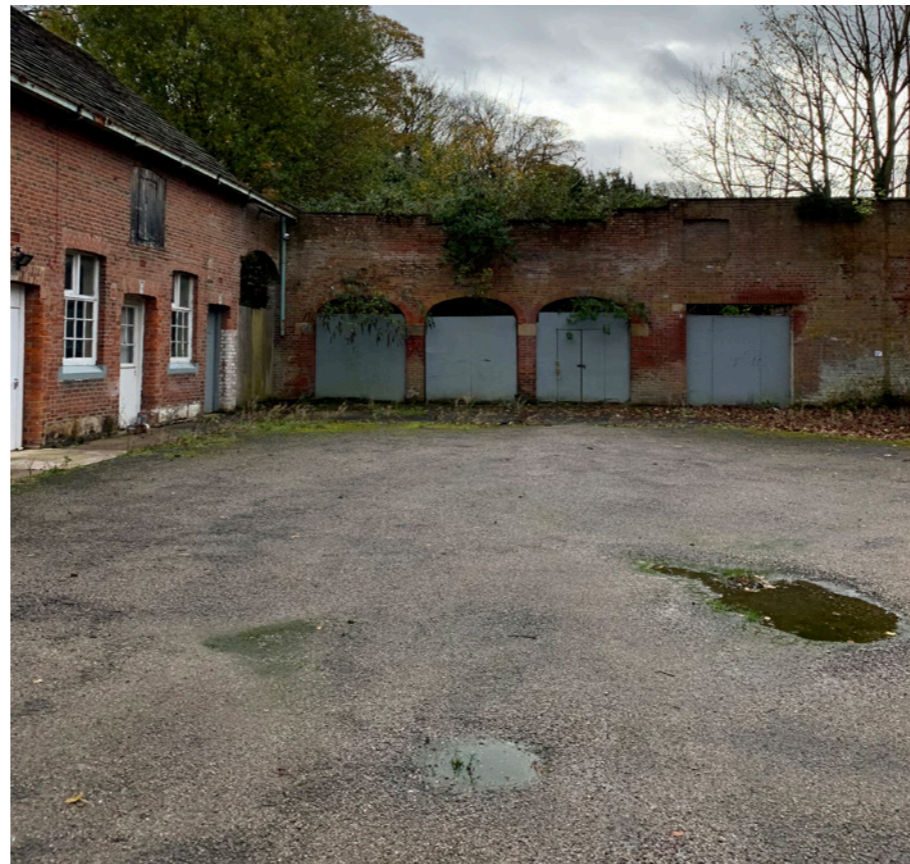
Stable yard

Within the stable yard there is no soft landscaping, the area is surfaced with tarmac which is in a poor condition.
