Shutta Road Retaining Wall & Parapet Safety Proposals Design and Access Statement

Structures Design Group

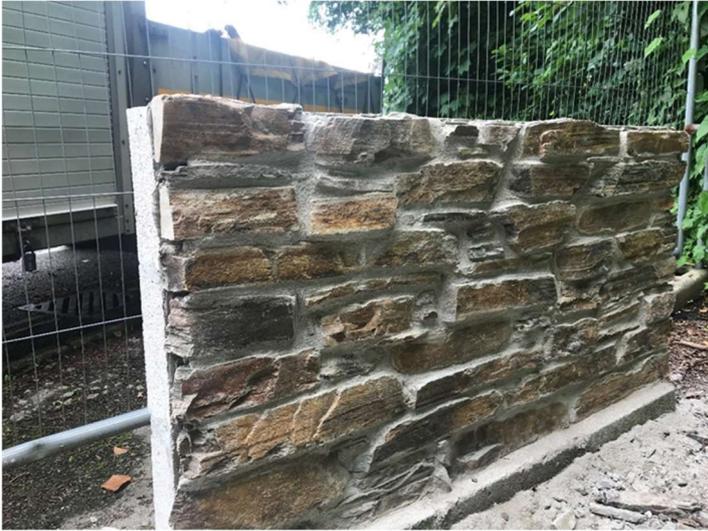
A proposal was developed to use a blockwork inner core using cementitious mortar and then sticking stone panel slips onto the wall to replicate the look of local stone. To this effect, a test panel was erected, and stone slips were placed on the face, this was found to be not as consistent as hoped, not to highways

The test panel.

The colour of the test panel was not considered too bright and was thought to be in keeping with the surroundings. Photographs above show test panel and the adjacent parapet wall (named Shutta Road on the asset list)

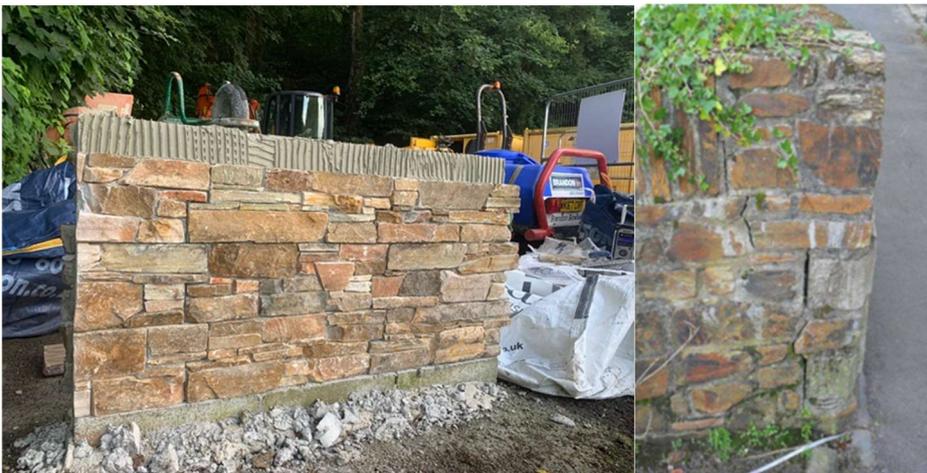
An alternative tile system was proposed, and samples were placed on the test panel shown below.

This gave a consistent surface finish and was considered aesthetically more pleasing than the slip trial.
