**Bat Survey Report for
The Puesdown Inn,
Compton Abdale,
Cheltenham, GL54 4DR**

22nd April 2021 & 12th and 31st May 2021

The Puesdown Inn, Compton Abdale, Cheltenham – Bat Survey Report

Report Number: 3994-CWS-01

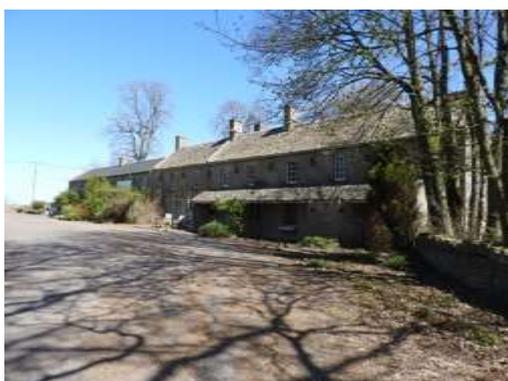
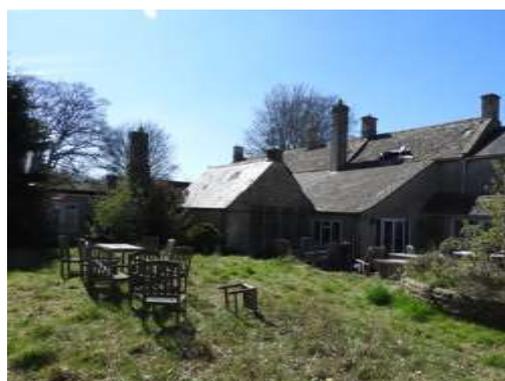
Figs. 1 & 2 Aspects to the front and rear

The survey site comprised a detached pitched roofed building with adjoining mono-pitched, flat roofed and pitched roofed extensions to its rear, and a number of outbuildings (Figs. 1 and 2).

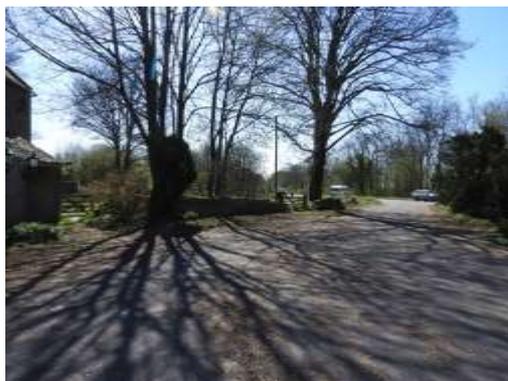
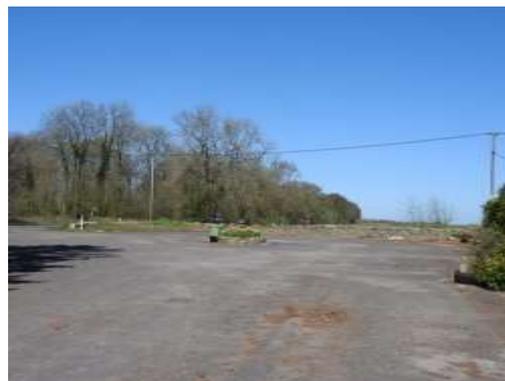
To the front there was a large area of hardstanding with open fields and mature trees beyond (Figs. 3 and 4).

Figs. 3 & 4 View to the front towards the southeast and southwest

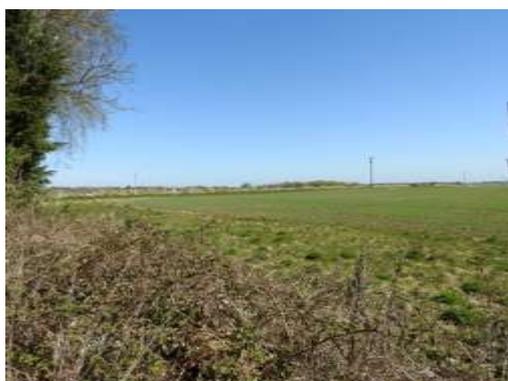
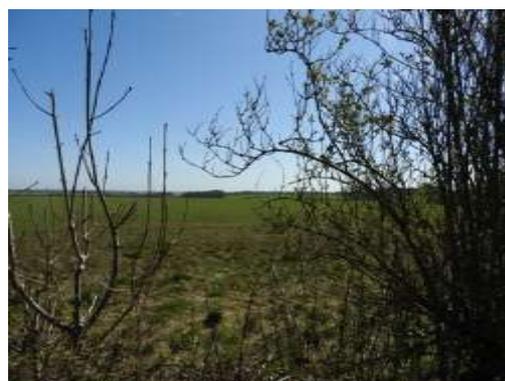
To the rear there was an area of lawn with open fields and mature trees beyond (Figs. 5 and 6).

Figs. 5 & 6 Views to the rear towards the northwest and north

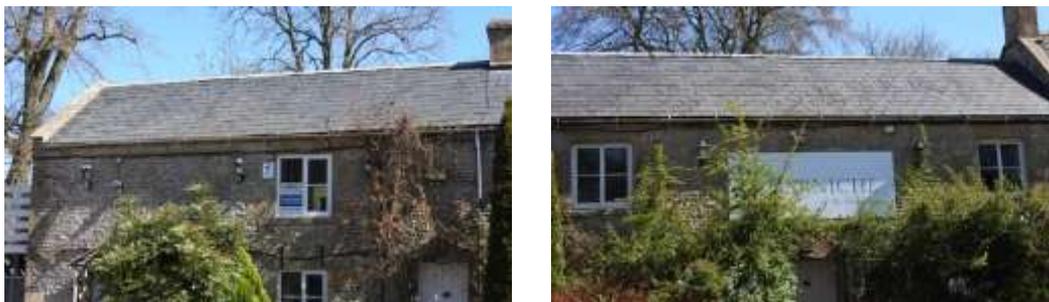
Figs. 7 & 8 Ridge and roof tiles to the front

The ridge was intact and sealed whilst all the roof tiles were tightly overlapping (Figs. 7-10).

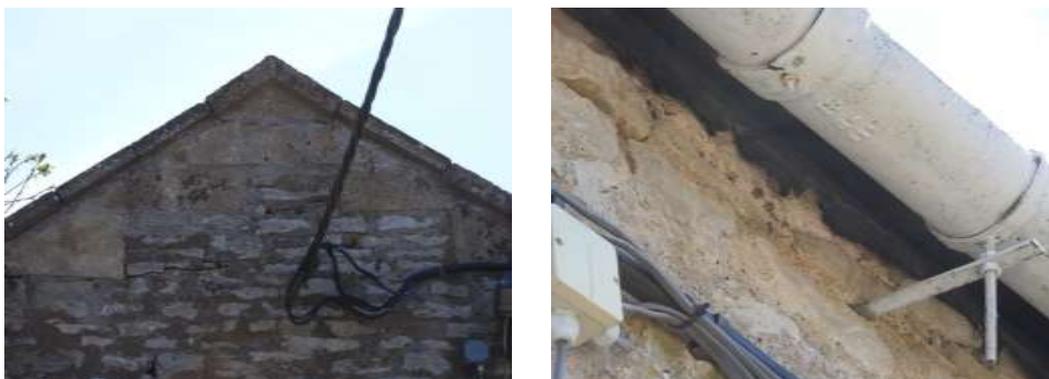
Figs. 11 & 12 Coping stone finished gable wall (L) and sealed eaves (R)

The gable was finished with coping stones (Fig. 11) with the roof verges tightly fitting against the gable wall (Ref. Fig. 7). The clipped eaves were finished with the roof ends tightly fitting against the wall plates (Fig. 12).

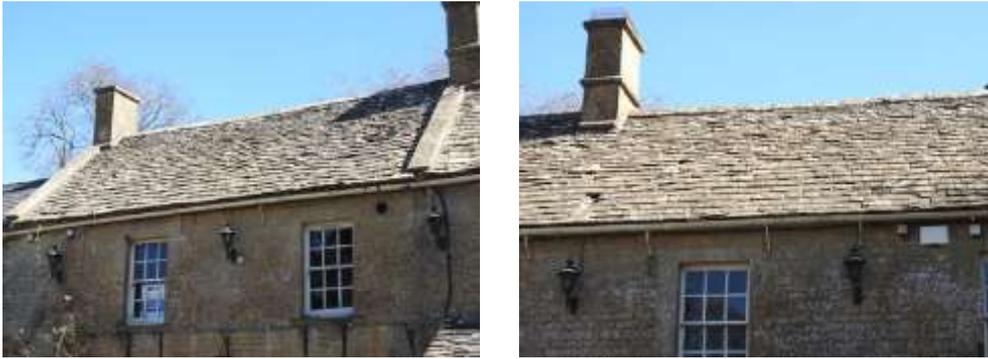
Figs. 13 & 14 Ridge and roof tiles to the front

The ridge was intact and sealed whilst the stone roof tiles were mainly tightly overlapping, although broken, dislodged and missing tiles were observed.

The tiles of the mono-pitched extension were all tightly overlapping (Figs. 13-18).

The suitability for roosting pipistrelles *Pipistrellus sp* was considered to be moderate, as broken, dislodged and missing stone tiles were observed.

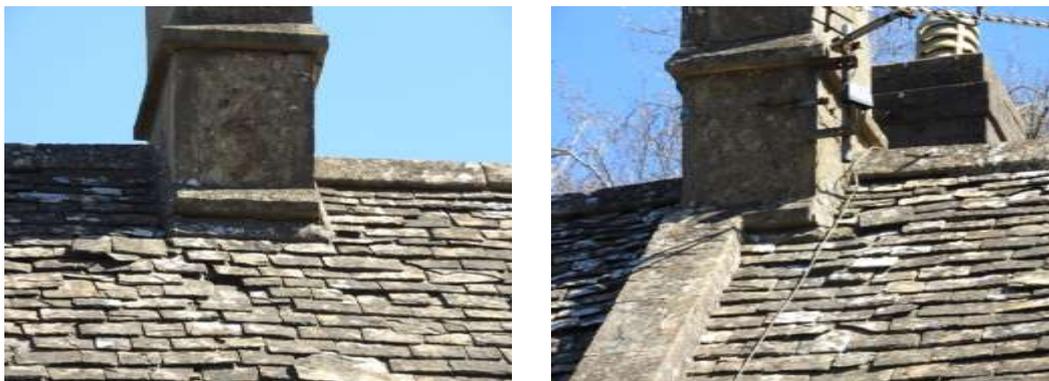
Figs. 19 & 20 Sealed chimney bases

The chimneys were finished with cement tightly moulded around their bases (Figs. 19 and 20).

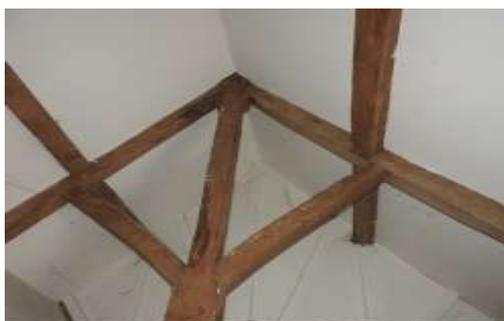
Fig. 23 Vaulted room

Internally the building had several roof voids, with some rooms vaulted (Fig. 23).

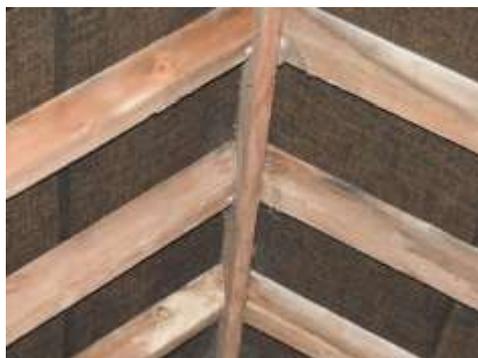
Fig. 24 Cobwebbed ridge

The non-vaulted rooms had roof voids, these measuring approximately 1.8 m high and running the width of the building with varied lengths. The voids were all lined with tarred felt, and all had cobwebs on their ridge boards and gable ends (Figs. 24-26).

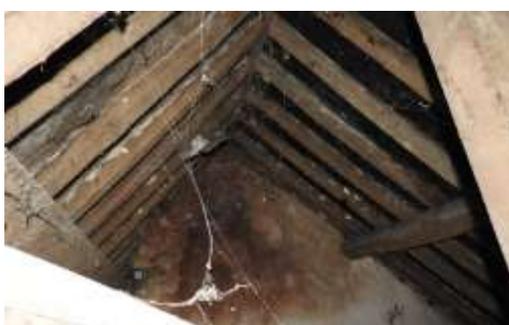
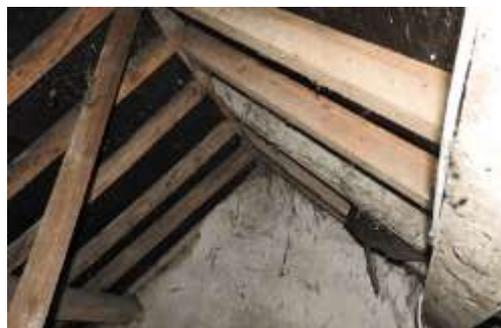
Figs. 25 & 26 Cobwebbed ridge and gable ends

Light penetrated some of the voids, but no evidence of bat occupation was discovered inside the main building.

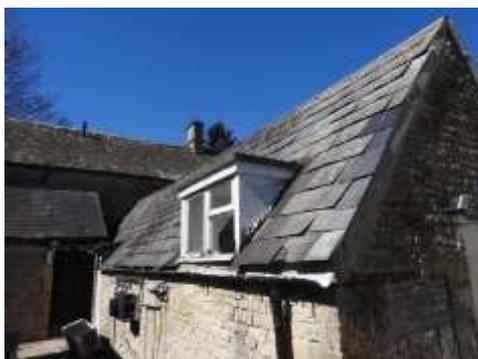
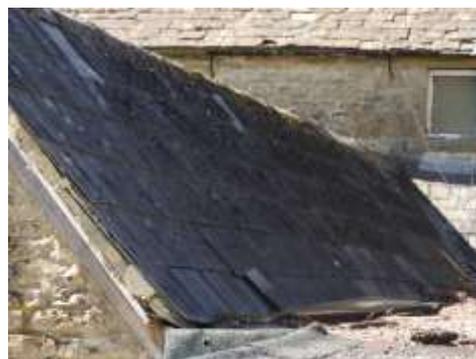
Figs. 27 & 28 Ridges and roof tiles of pitched roofed extension

The ridges of the pitched roofed extensions were intact and sealed, whilst most of the roof tiles were tightly overlapping, with some broken, dislodged and missing tiles noted. The gravel covered tarred felt flat roof was in good condition with no holes or tears, whilst the gables were finished with the roof verges cement sealed to the gable walls (Figs. 27-32).

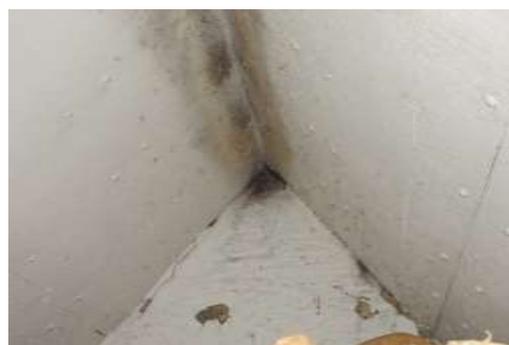
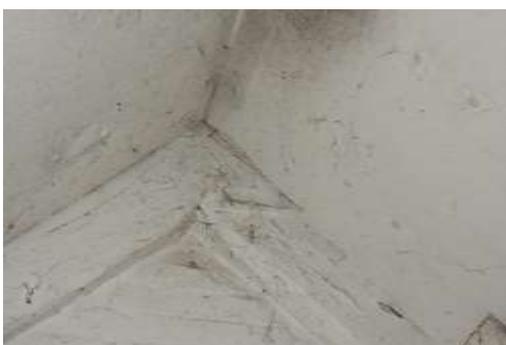
Figs. 33 & 34 Hardboard lined roofs

Internally the pitched roofed extensions had hardboard linings (Figs. 33 and 34). The flat roofed extension was lined on the underside of the joists.

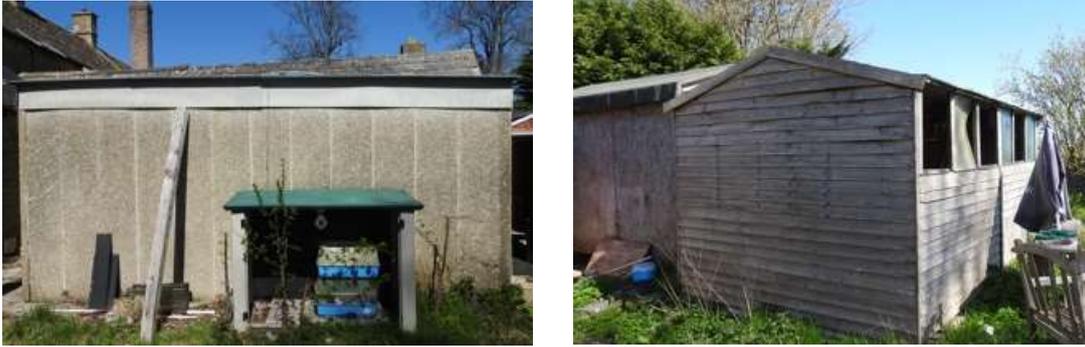
Figs. 35 & 36 Garage (L) and timber sheds (R)

The outbuildings comprised a pre-cast concrete garage and two timber garden sheds (Figs. 35 and 36).

No evidence of bat activity was found inside or outside the outbuildings, and they were unsuitable for bat roosting.

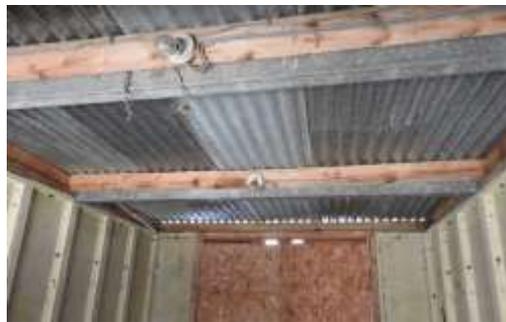
Fig. 37 Corrugated roof of the garage

The garage had a corrugated panelled roof (Fig. 37), whilst the two timber sheds were open to their unlined roofs (Figs. 38 and 39).

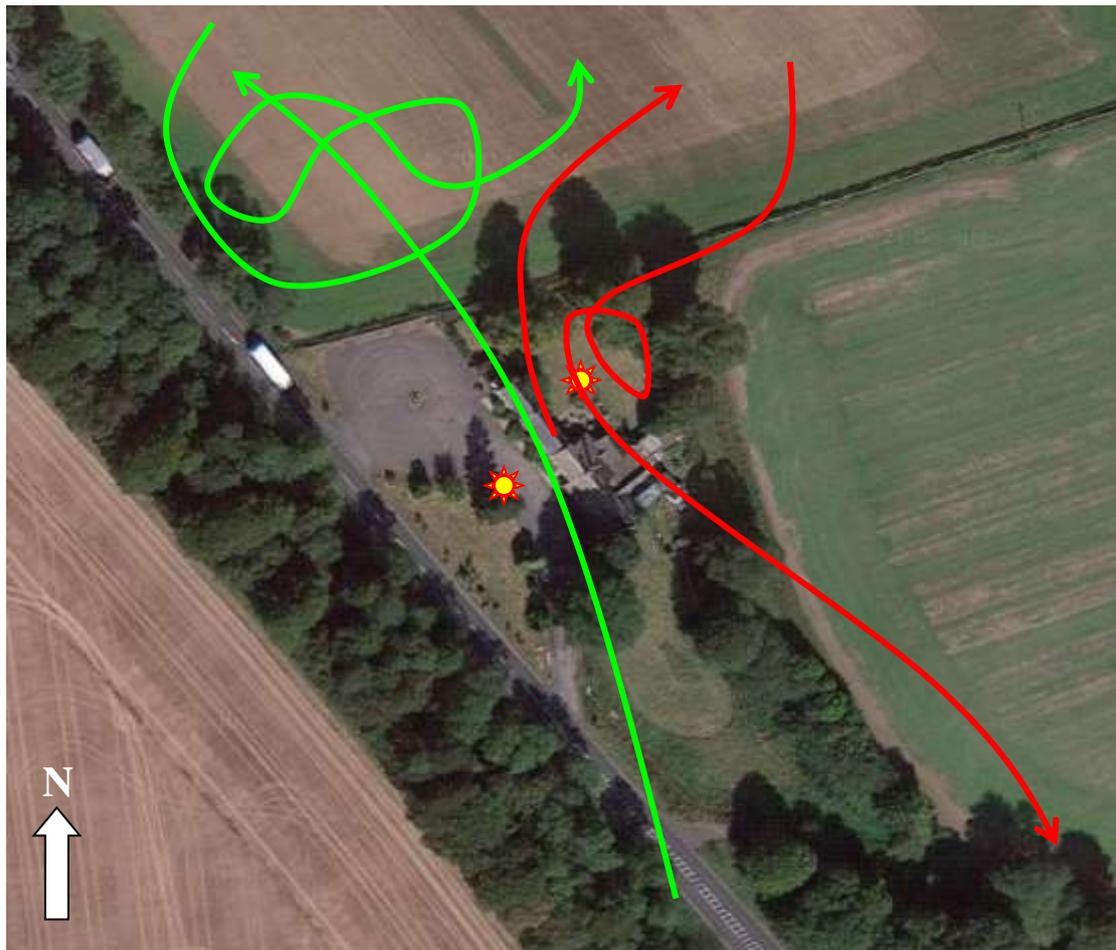
Plan 1 Bat flight paths at emergence on 12th May 2021

A single Common Pipistrelle emerged from under a roof tile, the exact location of which could not be determined. A Noctule Bat was also recorded foraging over the fields to the north, this having emerged elsewhere.

Time	Observation
20:41	Common Pipistrelle emerged from roof (exact location unknown)
21:08	Noctule overhead, heading north
21:09	Common Pipistrelle back to forage in garden
21:11-21:30	Noctule foraging in fields to north
21:12	Common Pipistrelle flew past
21:14	Common Pipistrelle flew past again
21:40	No further detections were made and survey ended

As the roost will be lost with the re-roofing of the buildings, suitable mitigation will be required.

Mitigation measures will include a 'toolbox talk' by a Registered Consultant (RC) to contractors about bats and what to do if one is unexpectedly encountered, a pre-works inspection of the roof by the RC, supervision of the destructive roof works by the RC, the latter undertaken by hand, and the provision of a Schwegler 2F bat box or similar installed on a tree in the grounds in which to relocate a bat if one is discovered before or during works.

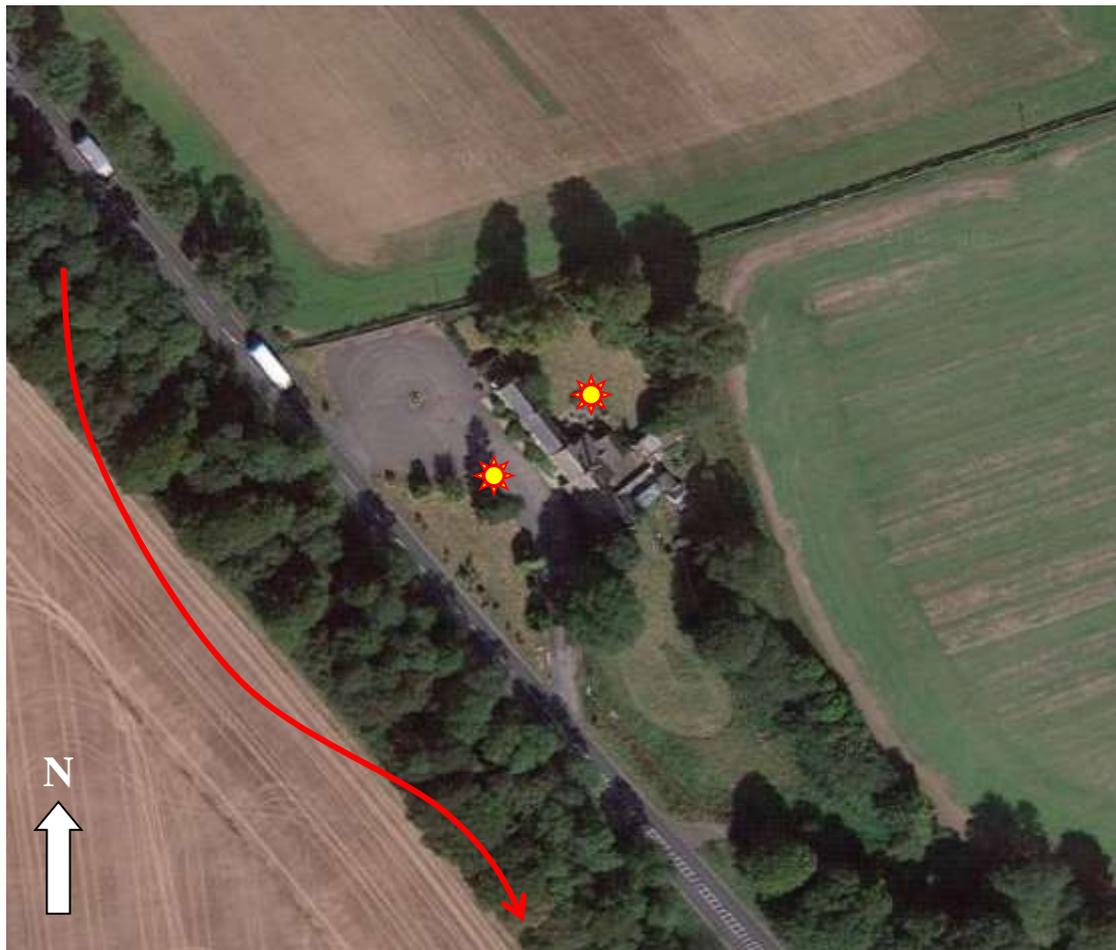
Plan 2 Bat flight paths at emergence on 31st May 2021

No bats emerged from the buildings, and the only bat recorded during the survey was a single Common Pipistrelle flying past in the distance.

Time	Observation
21:53	Common Pipistrelle flew past in distance
22:30	No further detections made and survey ended
