REMEDIATION STRATEGY - DEMOLITION PHASE 4 NORTH

Woodford Aerodrome

PROJECT NO. 70079453

DATE: JUNE 2021

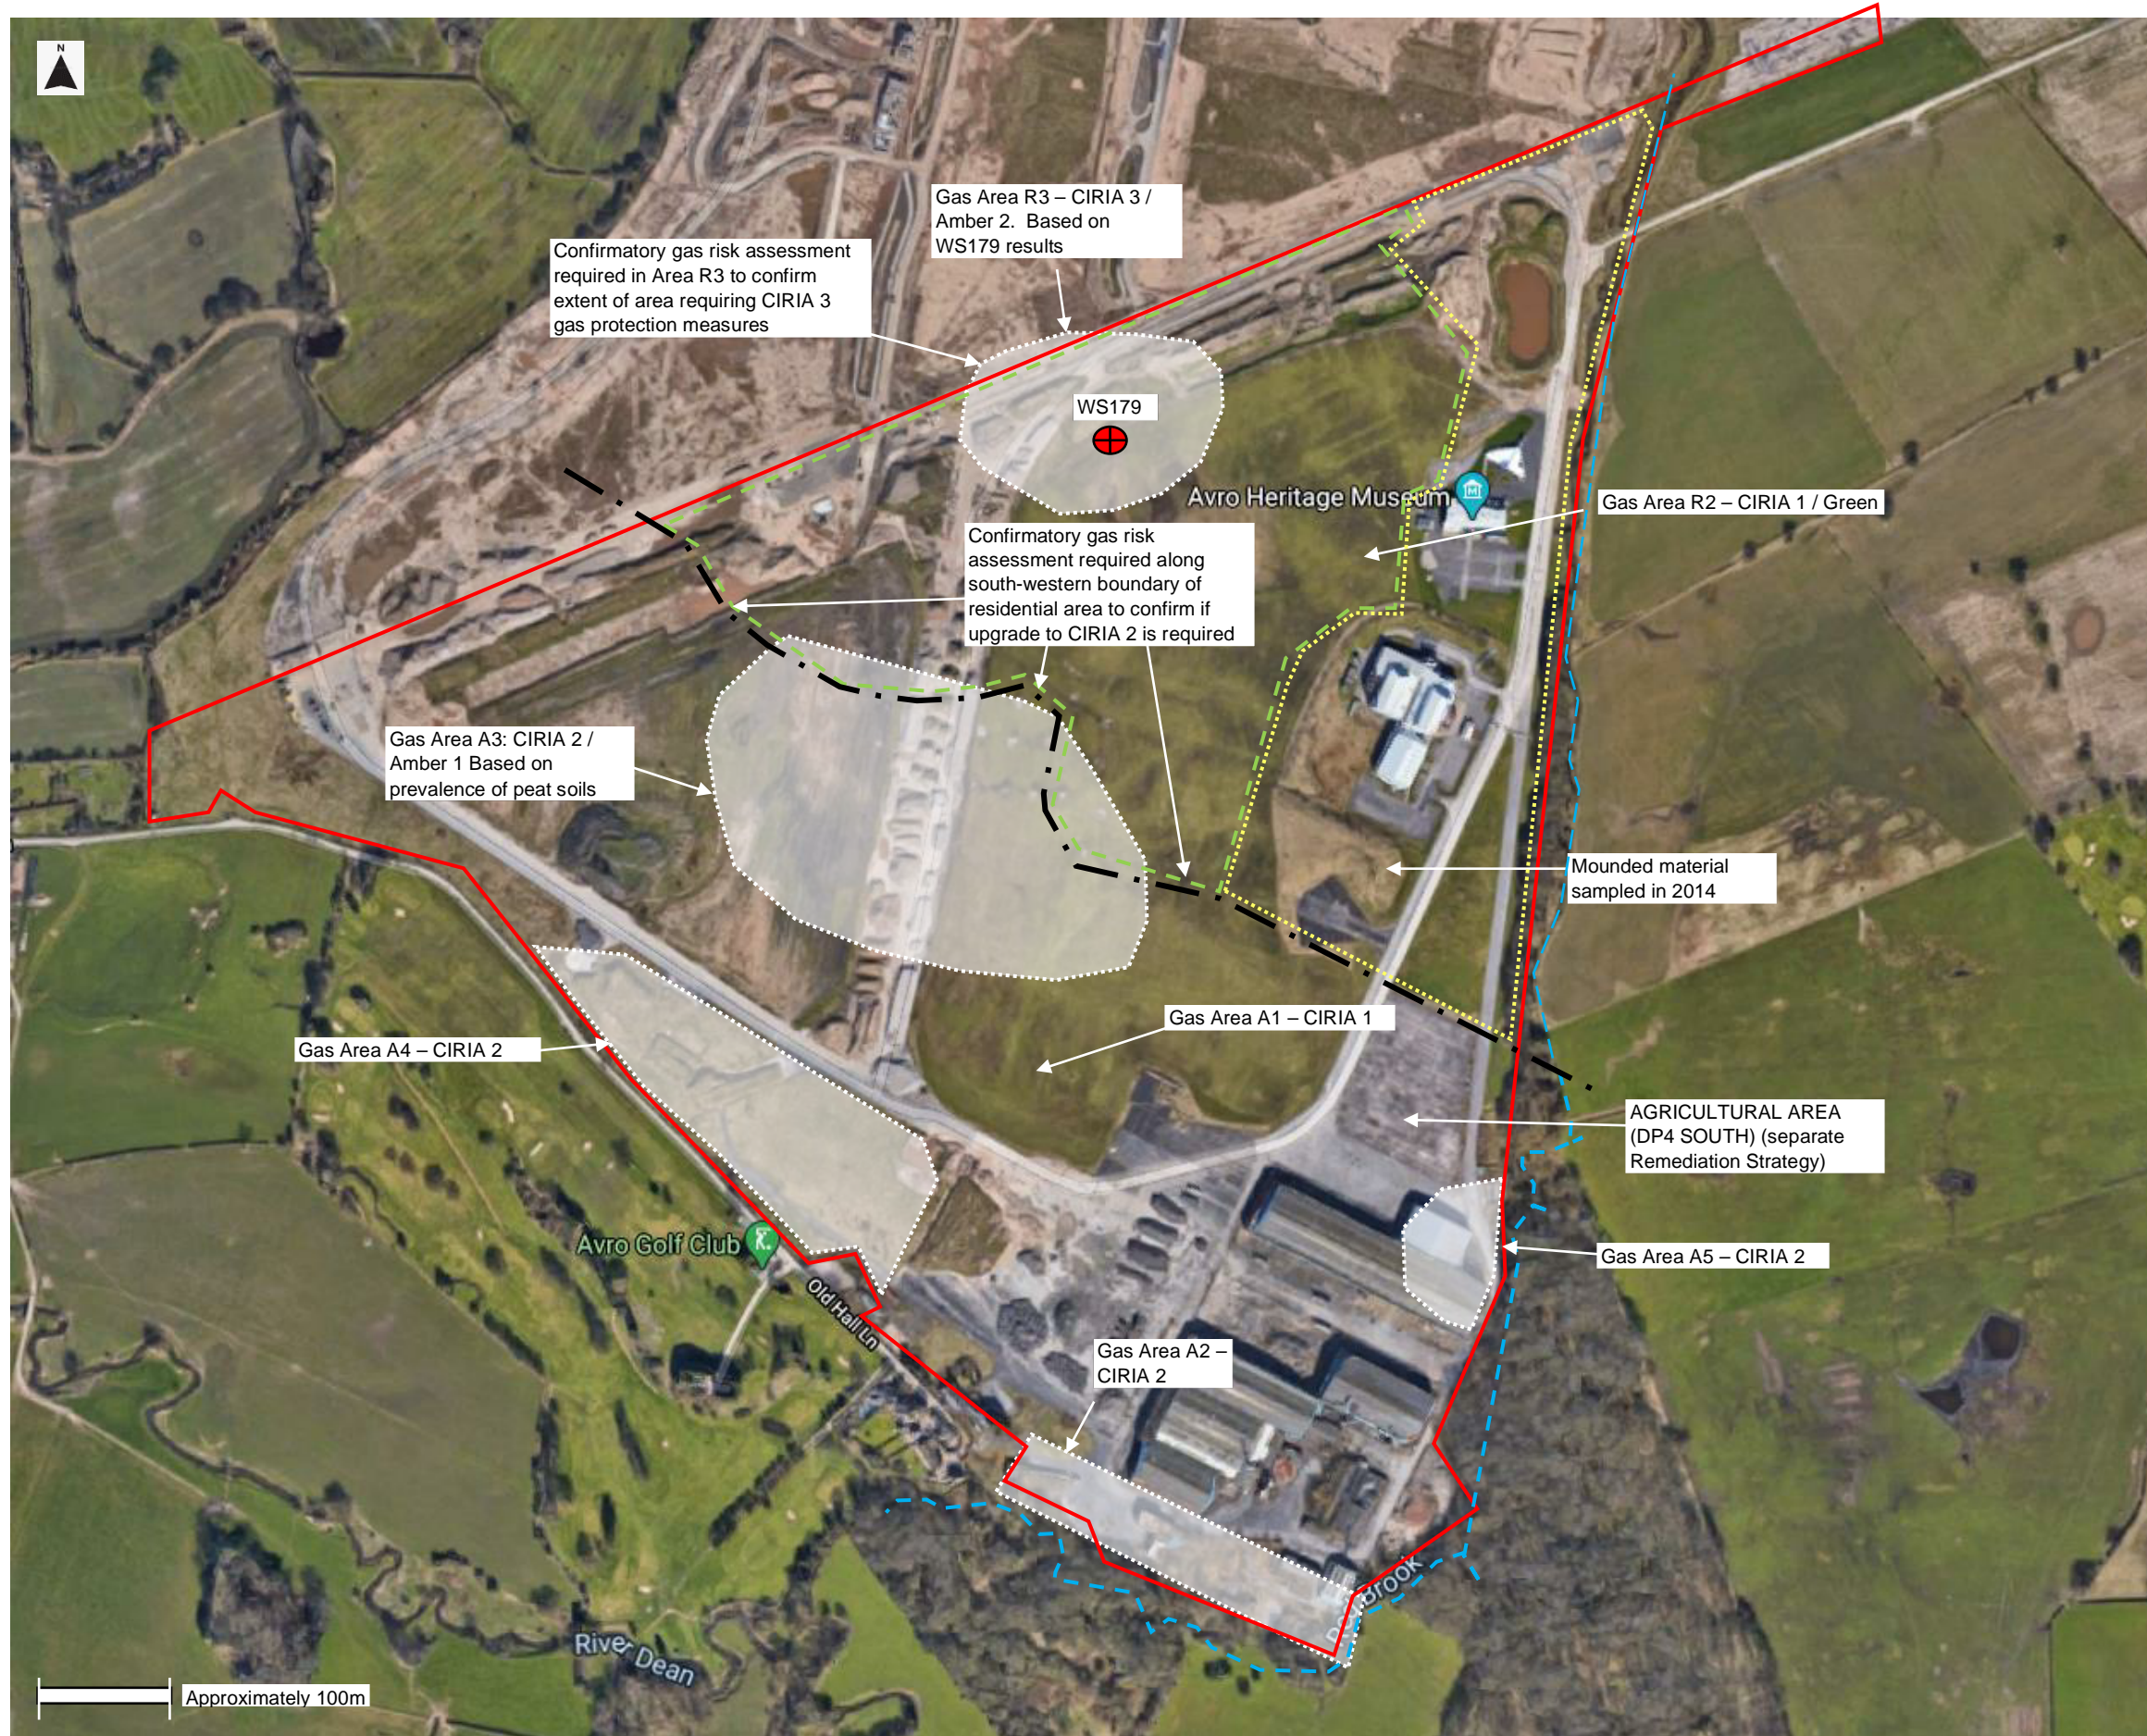
A Remediation Summary Plan showing areas referred to in this section is presented as Figure 3 in Appendix A.

The WSP Gas Report classified this area as Amber 2 / CIRIA Characteristic Situation 3, for which fairly significant gas protection measures are required. The R3 area was defined on the basis of ground gas monitoring results from one monitoring well (WS179) and extrapolation of the data to incorporate the entire area in which peat was encountered. Given the uncertainty associated with the extent of Area R3, it is recommended that supplementary ground gas monitoring and assessment is undertaken by Harrow Estates or the residential developer to provide robust recommendations for gas protection measures in properties in Area R3. The gas risk areas are summarised on Figure 3 in Appendix A.

APC	Location	Reported in 2014 Report			Action Taken After 2014 Report	
		Source	Pathway / Receptor	Recommended Action	Additional Information	Further Work / Remedial Action
No specific APC	Gas Risk Area R3 (see Figure 3 Appendix A)	Hazardous ground gases	Inhalation by construction workers, future site users	Await additional WSP gas monitoring data for confirmation of recommended ground gas protection measures.	WSP Gas Report 2015 confirmed CIRIA Characteristic Situation 3 (for no sub-floor void) or Amber 2 (with clear ventilated sub-floor void) for Area R3. The WSP Gas Report 2015 recommended additional assessment to delineate Area R3; no further works have taken place to date.	Supplementary gas monitoring and risk assessment required for Area R3 and Area A3 to confirm gas mitigation measures– see Section 4.
No specific APC	Gas Risk Area A3 (adjacent to south of Residential Area) (see Figure 3 Appendix A)	Hazardous ground gases (associated with peat soils)	Inhalation (future residents within residential area to north of Area A3)	Await additional WSP gas monitoring data for confirmation of recommended ground gas protection measures	WSP Gas Report 2015 confirmed that a ground gas classification of Characteristic Situation 2 applies to Gas Area A3, which is adjacent to the southern boundary of the Residential Area. Therefore basic gas protection measures are required for properties along the southern boundary of the Residential Area. The WSP Gas Report 2015 recommended additional assessment to delineate Area A3; no further works have taken place to date.

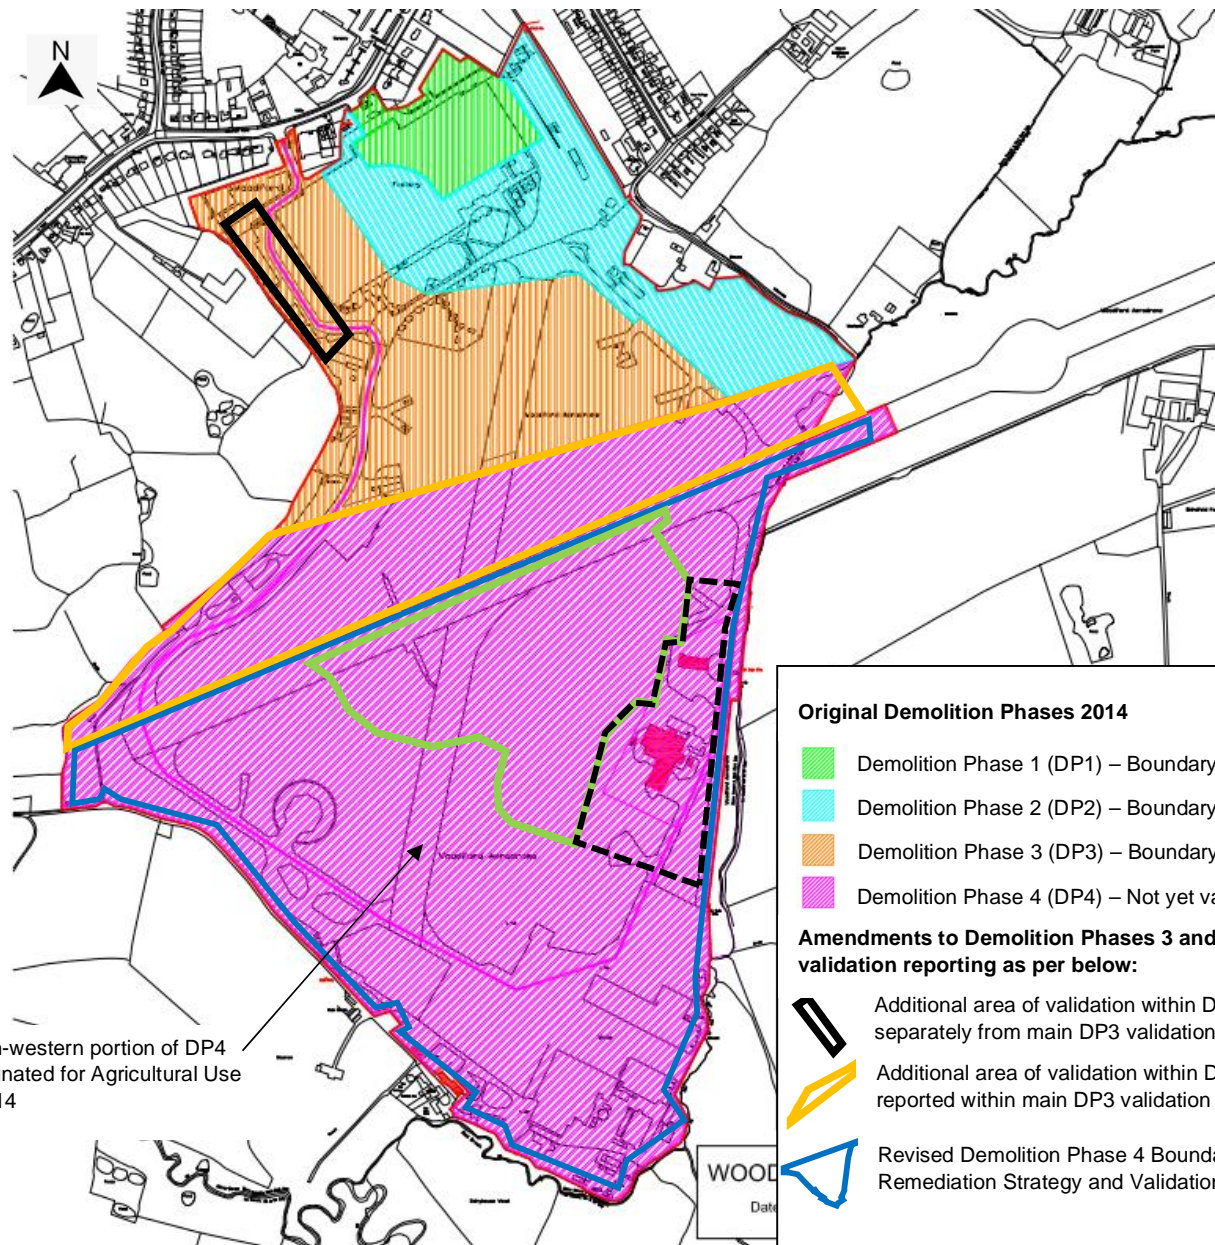
**Woodford Aerodrome – Demolition Phases investigated and validated by WSP
DP4 Remediation Strategy Appendix B**

South-western portion of DP4
Designated for Agricultural Use
in 2014

Original Demolition Phases 2014
