### Greatham Barns, Greatham Manor Farm, Nr Pulborough RH20 2ES

#### A LANDSCAPE CHARACTER AND VISUAL ASSESSMENT

Convert redundant Granary barn and outbuilings buildings to one dwelling

#### February 2018

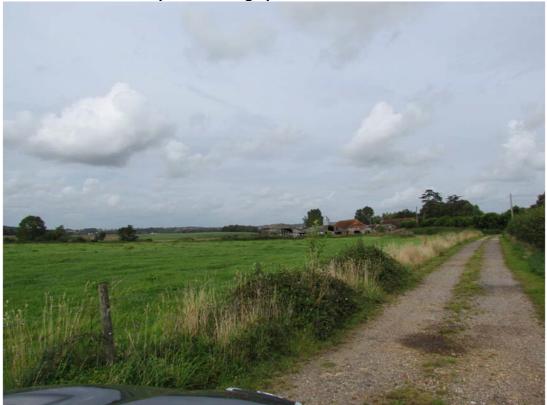
Photograph 1 - Greatham Barns from access road (View Point B)

The closest public view points are from Brook Road, from the access road to the site (Photograph 1/View Point B) and from Footpath 1 (Existing site conditions plan RMA.022.02) (Photograph 2/View Point A). The view from the access road, though only a glimpse if one were driving past, is the most open view and shows clearly the more intrusive modern barns and silo. The view from Footpath 1 shows how the roofs of the barns are visible above the hedgerow where there is a break in the tree line.

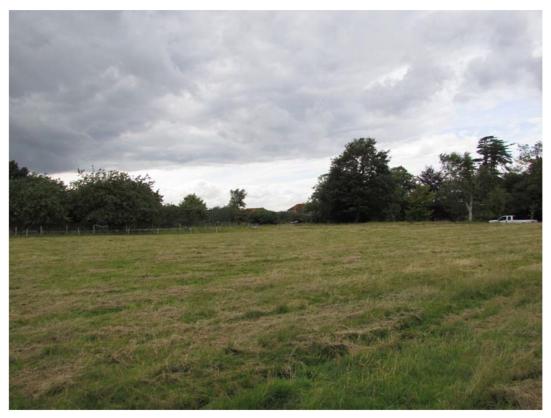
Photograph 2 - View to Greatham Barns from View Point A along Footpath 1

The view from Dora Cottages, situated along Brook Lane (Photograph 9), is similar to the view from View Point A (Photograph 2), where the barn roof lines are visible through a gap in the belt of mature parkland trees which mark the boundary between the site and the Manor House. The proposals are unlikely to alter this view.

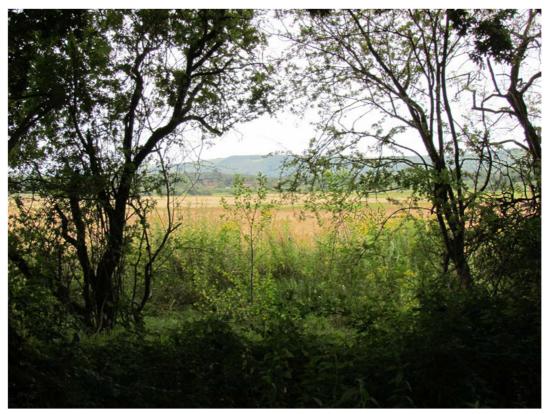
Photograph 3 - View of site from Wey – South path (Footpath 2, View Point J). The site is just visible against the backdrop of woodland.

The main longer distance view is from Public Footpath 2, the Wey-south path near Coldwaltham (Dwg No. RMA.022.01). One or two glimpses (refer Photograph 3 and 4) towards the site are visible through the vegetation which lines the whole length of the footpath. These views are

set against the backdrop of woodland on rising valley slopes. In winter these views would become more open as the vegetation is deciduous. However, the distance is about 1.3km, the proposals involve the removal of the more prominent silo as well as the modern structures, the new stable building may be visible but as the photograph illustrates, though the red tile of the existing barn roofs are visible, the barns are nestled into the landscape with a tree'd backdrop and are not intrusive in nature.

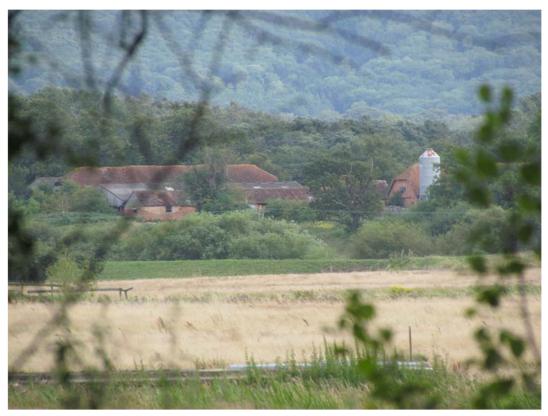
Photograph 4 - View from Wey – South path, zoomed in (Footpath 2, View Point J).

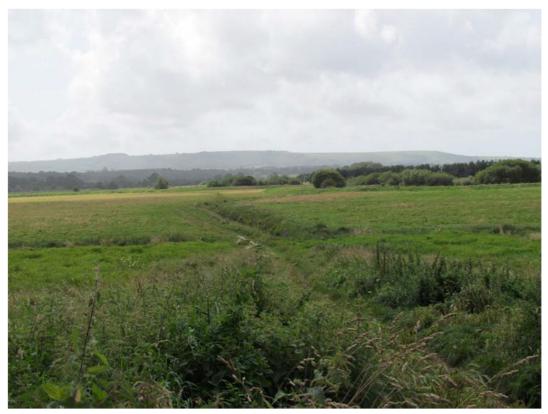
Photograph 5 - View south towards the site from footpath 3 at the edge of Pulborough – site screened from view by the intermediate vegetation.

The third notable view to the site is from Footpath 3 (Dwg no. RMA.022.01, Landscape Planning Constraints Plan), Photographs 5 and 6. The site is not visible from the top section of this footpath as it leaves Pulborough, due to the intervening landform and tree cover. It is only the lower section near View Point N from where the tops of the ornamental trees within the grounds of Greatham Manor are just visible amongst the well tree'd backdrop, however neither the site nor the buildings within it are visible, due to the screening provided by the tree cover.

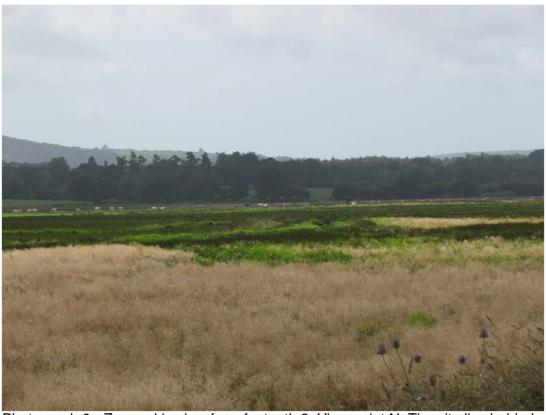
Photograph 6 - Zoomed in view from footpath 3, View point N. The site lies behind the belt of mixed ornamental trees with the grounds of Greatham Manor.

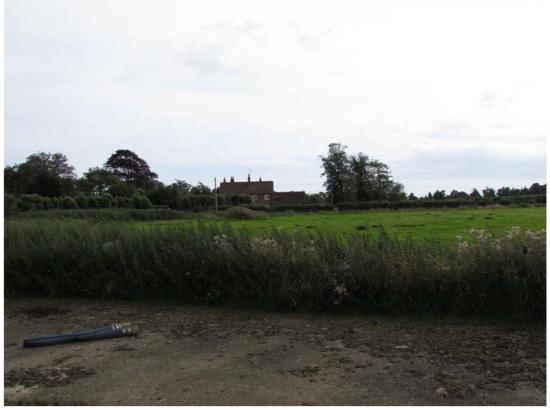
Photograph 7 - View point E Site visible from Manor Farm House

There are views of the site from Manor Farm and Greatham Manor Lodge, both of which are within the Conservation Area. The view is filtered by the presence of the vegetation around the perimeter of the paddock between these dwellings and the farm, including a row of pollarded limes which line the driveway. The view towards the Main Barn dwelling would appear much the same and the view towards the Parlour dwelling would be enhanced due to the removal of the modern structures. How the domestic garden area is delineated needs careful consideration in the landscape proposals.

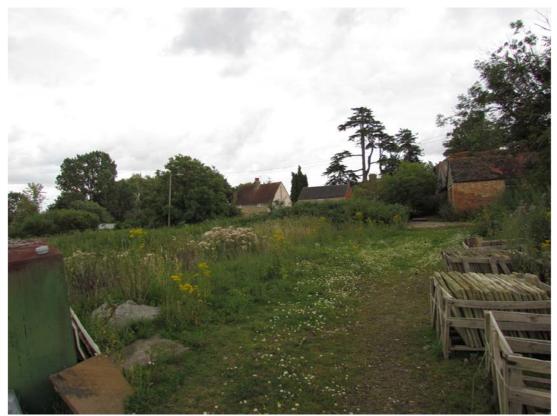
Photograph 8 - View point D showing view from north west corner of site to Manor Cottage

Photograph 8 illustrates how there is inter-visibility between Manor Cottage and the northern elevations of the site. It would be fair to say that the removal of the modern farm building and the sensitive restoration of the existing barns to be retained, together with appropriate structure planting to define the proposed residential curtilage would provide the opportunity to improve the view from Manor Cottage.

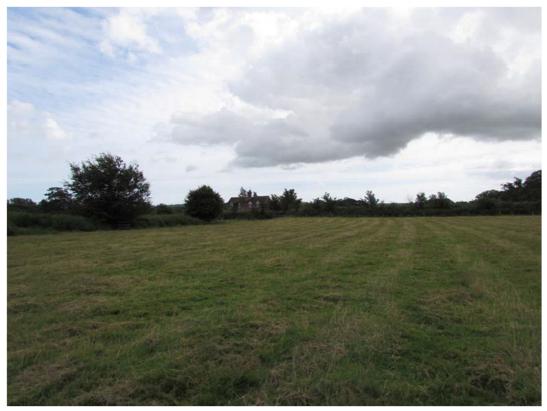
Photograph 9 - View from Dora cottages similar to View point A (see photographs sheet 1)

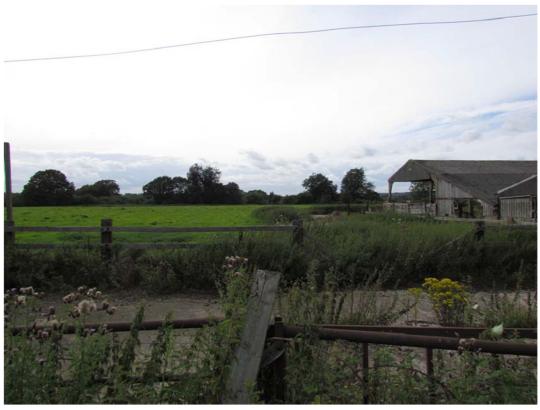
Photograph 11 - View West from View Point H showing vegetation screening views of the site from the West and the direction of Greatham Bridge.

Photographs 10 and 11 illustrate how the landform and the trees to the south and west enclose the visual envelope from these directions and the landscape is in tact and unspoilt and free from signs of built development. The tree belt screens view of the site from the direction Greatham Bridge and Coldwaltham.

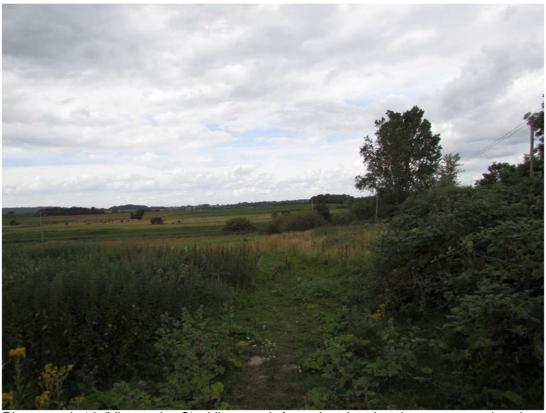
Photograph 12 (View point C) - View north from the site showing open, rural and undeveloped nature of the landscape, with the outskirts of Pulborough just visible on the ridge in the distance.

Photograph 12 shows the view north from the site showing the open, rural and undeveloped nature of the floodplain landscape, with the outskirts of Pulborough just visible on the rising valley slopes in the distance. Other than the view points previously highlighted public access within this riverine landscape is limited, however the landscape treatment of the proposed paddock needs to be respectful of its setting within the conservation area, enclosed for example by a simple wooden post and rail fence. Strategically placed indigenous structure planting in the north-west corner of the paddock would help integrate any new build into this view and the view from the Wey-south path.
