AMBIENT AIR QULITY REPORT

**Bucks Recycling Ltd
Building 214
Westcott Venture Park
Westcott
Aylesbury
Bucks
HP18 0XB**

Report Number :	9328		
Date of Survey :	31st July 2019		
Survey Completed By :	Jon Lowrence Grad IOSH AFOH TFAAM		
Name :	Written By: Trish Kinta	Checked By: Jon Lowrence Grad IOSH AFOH TFAAM	Authorised : Sarah Lowrence Grad IOSH AFOH
Job Title :	Administrator	Consultant	Consultant
Date :			
Signature :

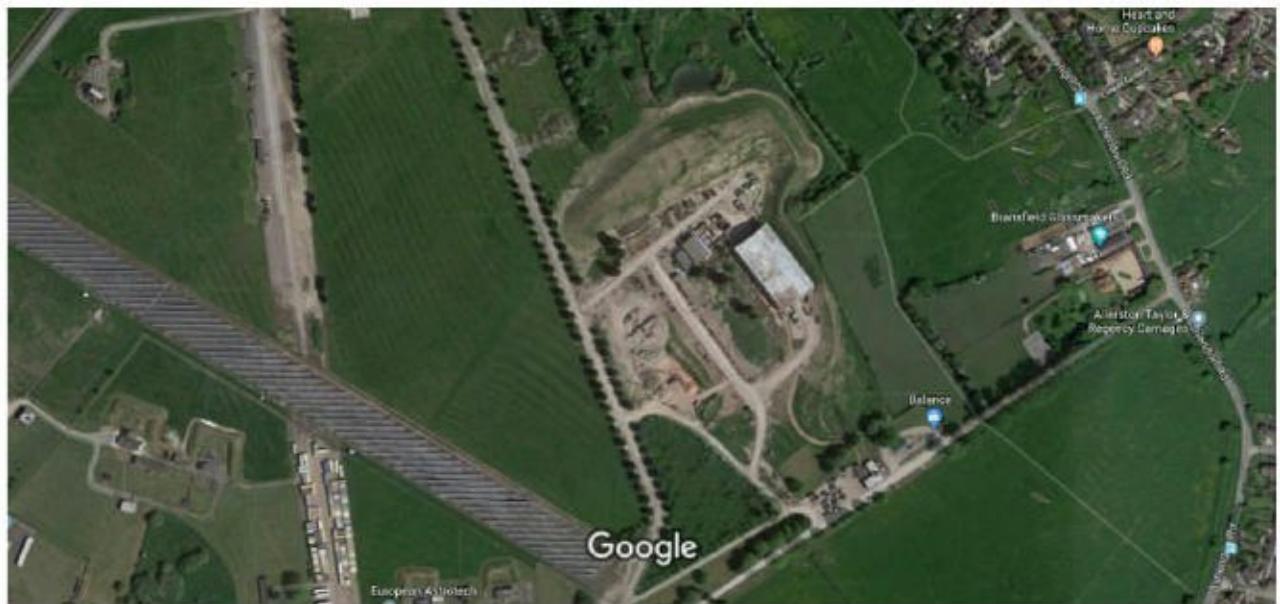
The site is located within the Westcott Venture Business Park in Aylesbury, the site occupies a boundary to the North / East of the site with Ashenden Road, Wescott.

The sites perimeter fence Northern / Eastern boundary, is located next to a field and ~ 100 metres beyond this are residential housing located on Ashenden Road, this housing was identified as Sensitive Receptors.

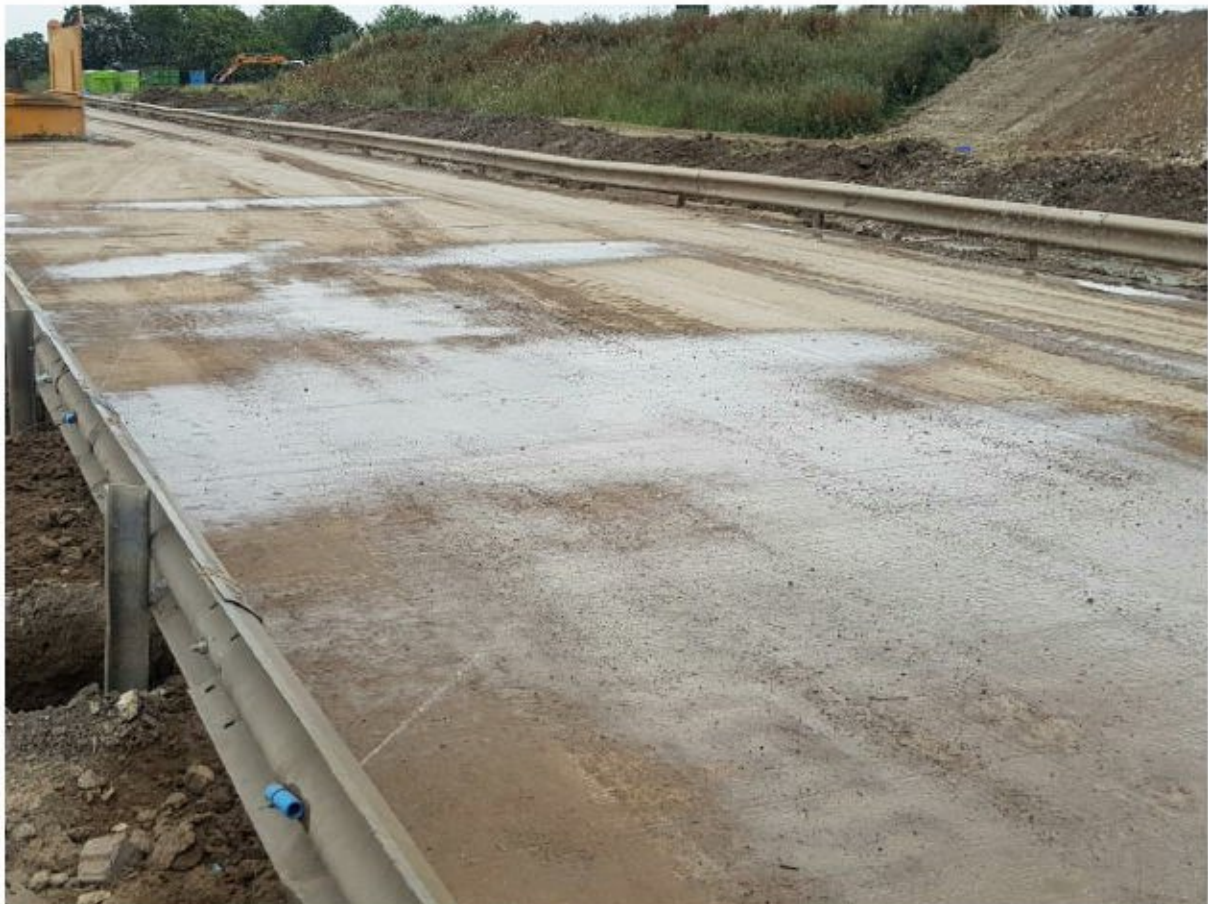
Site roadways sprinkler water system for dust suppression.

- The existing control measures in place are to suppress dusts on the site roadways;
- The use of fixed water sprinkler systems to water the roadways when the site is operational.
 - The use of water bowsers to soak the roadways not served by fixed sprinkler systems.
 - Part containment of dusts within the recycling / processing area, by use of building containment and sorting cabins.
 - Watering of skip tipping / depositing area in dry conditions.
 - Site bund approximately 3 – 4 metres height surround the site towards the Ashenden Road.

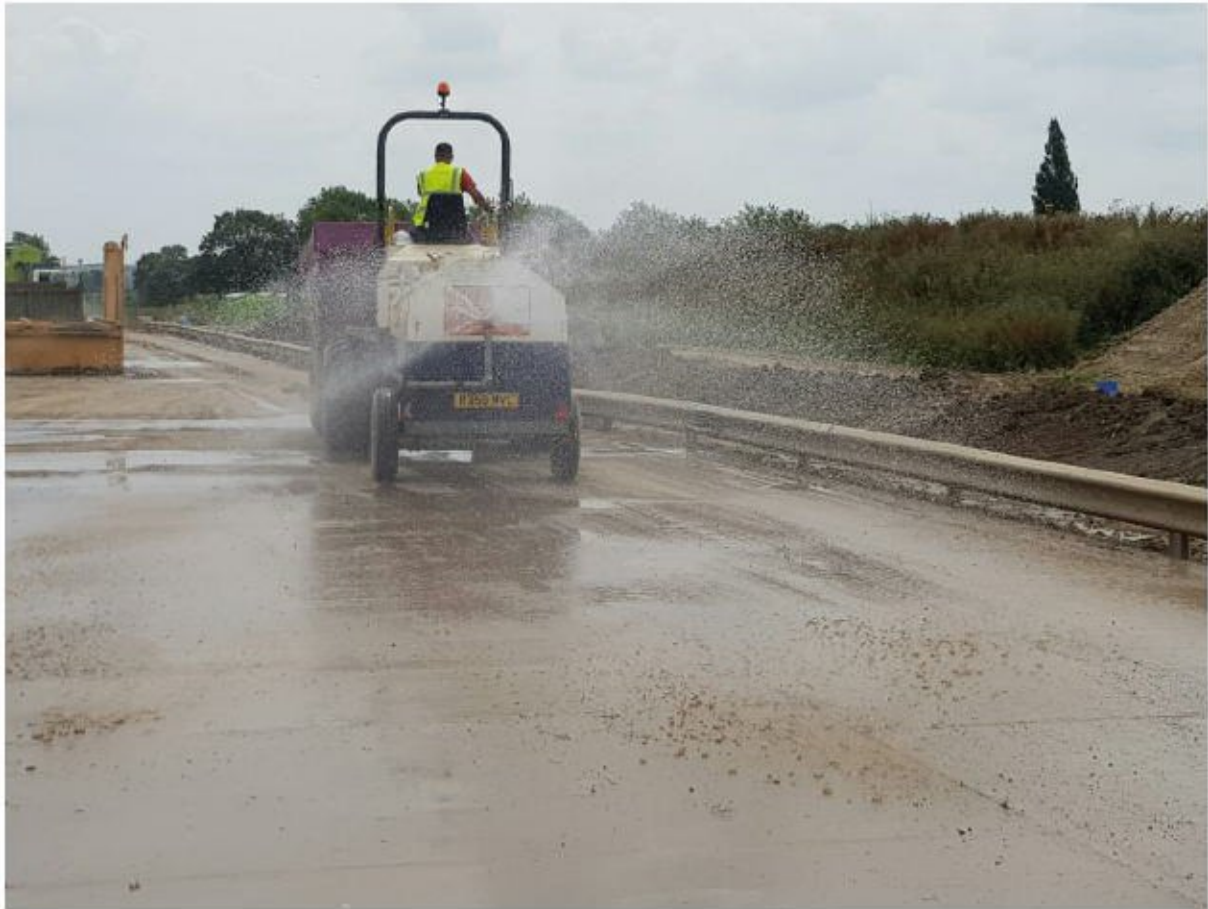
Use of water bowser for dust suppression on site roadways

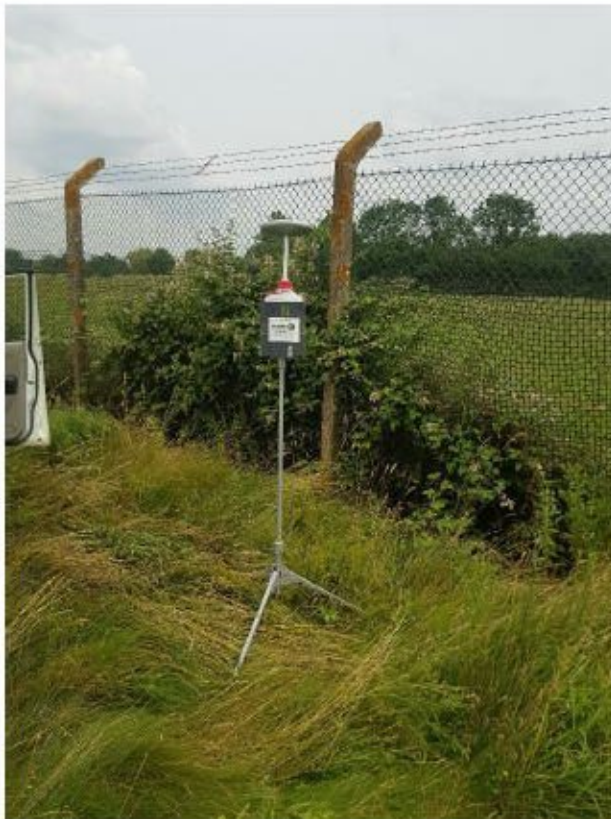
East of the site Frisbee on perimeter fence.

(field with Ashenden Road beyond)

* Dust mass (mg) 15

Deposition ($\text{mg}\cdot\text{m}^{-2}\cdot\text{d}^{-1}$) 27

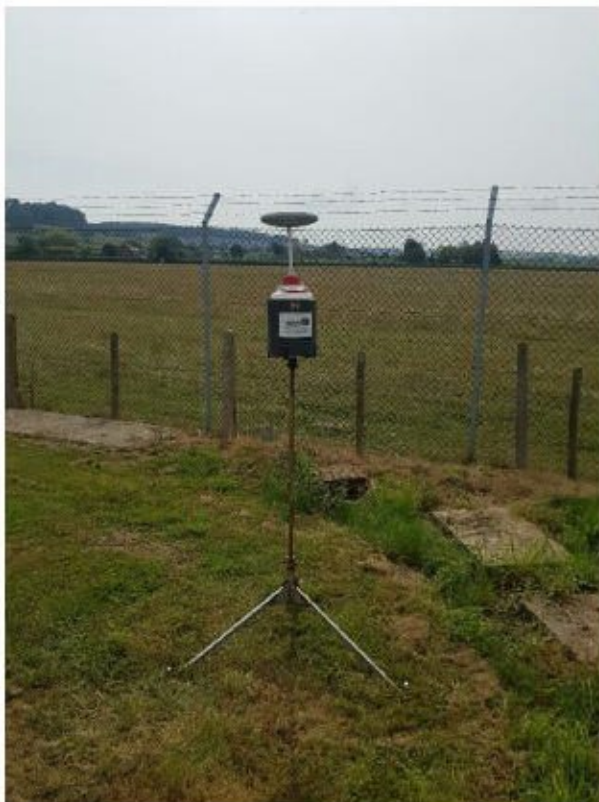
South of the site frisbee, at the perimeter fence (Near to site access roadways).

The results show all samples measured over a 2 week sample period, were all below the control level, the highest result being for the South deposit gauge.

This deposit gauge being nearest the site roadway for access / egress from the site, which as expected produced the highest results, but the results were 41% of the acceptable control level of 200 mg/m² d.

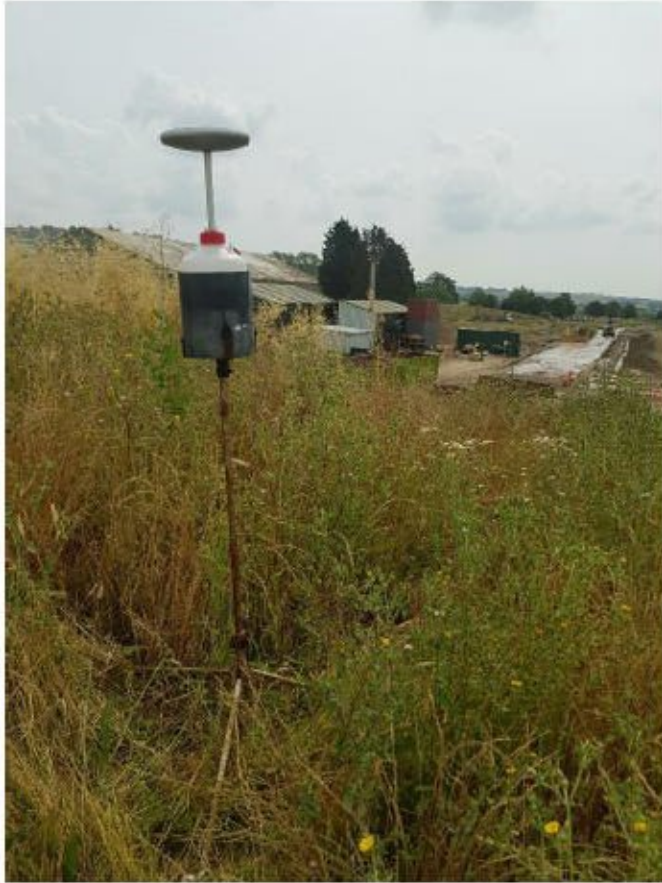
North of the site frisbee
on top of the site bund.

* Dust mass (mg) 31

Deposition ($\text{mg}\cdot\text{m}^{-2}\cdot\text{d}^{-1}$) 56

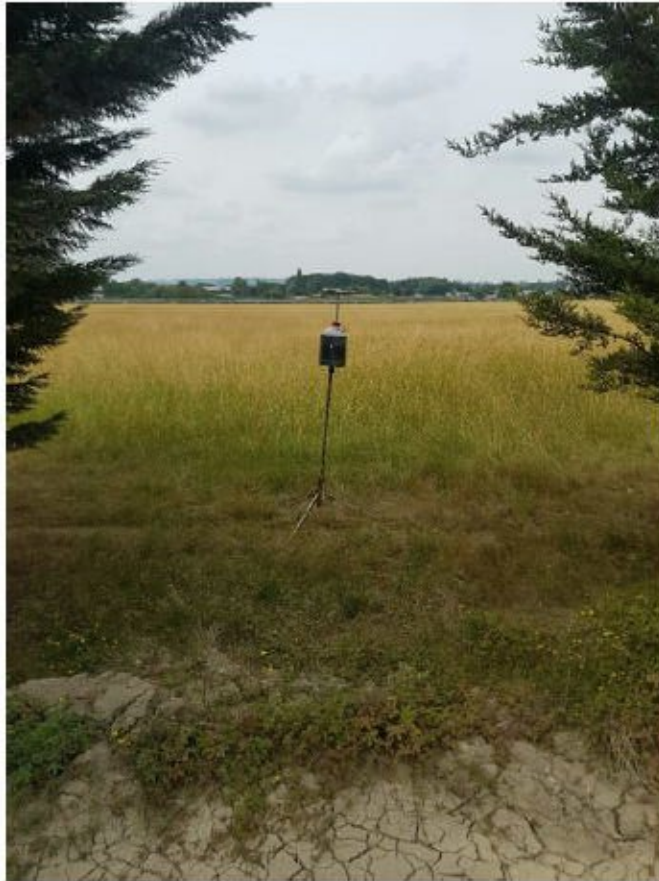
West of the site frisbee
at perimeter boundary

(Prevailing wind enters
from this direction)

* Dust mass (mg) 10

Deposition ($\text{mg}\cdot\text{m}^{-2}\cdot\text{d}^{-1}$) 18
