Our Ref: YE9052

**Ref: Bucks Recycling, Building 214 Westcott Venture Park, Aylesbury,
Buckinghamshire, HP18 0XB**

Soakaway Test

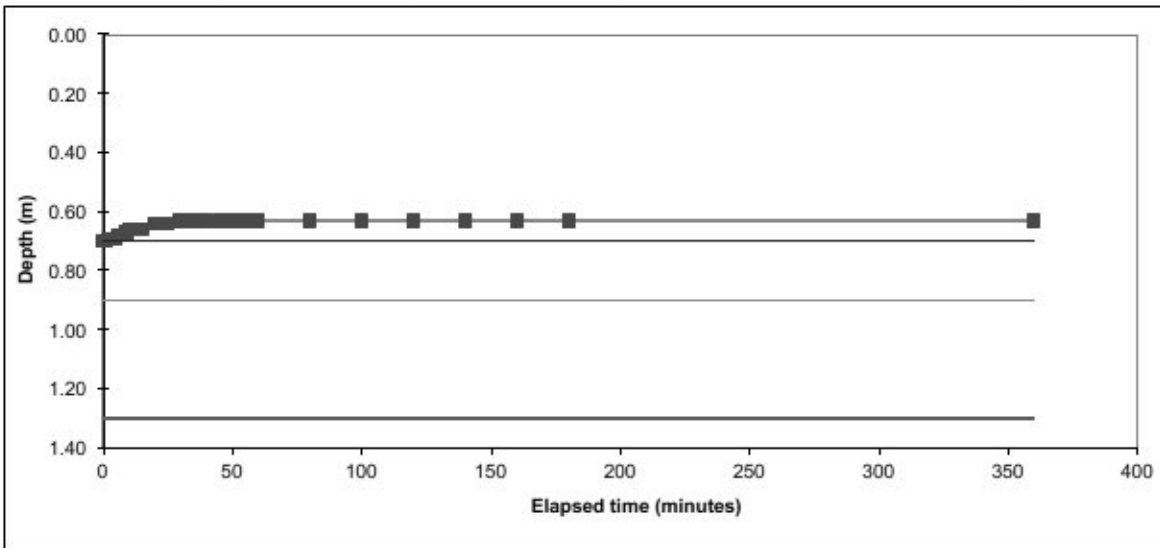
Client:	Bucks Recycling	TP1
Site:	Bucks Recycling, Westcott Venture Park

Trial Pit No:	TP1	Test No:	1	Date:	25/09/2020
Length (m):	1.200	Datum Height:		0.00 m agl	
Width (m):	0.30	Granular infill:	None		
Depth (m):	1.50	Porosity of infill:	1	(assumed)

Start water depth for analysis (mbgl)	0.70	Elapsed time (mins):	#N/A
75% effective depth (mbgl):	0.90		
50% effective depth (mbgl):	1.10	Elapsed time (mins):	#N/A
25% effective depth (mbgl):	1.30		
Base of soakage zone (mbgl):	1.50

Soil infiltration rate (m/s):	Test incomplete as 25% effective depth not achieved. Unable to reliably determine soil infiltration rate.
--------------------------------------	--

WS	Soakage Area Dimensions (m)	Depth (m)	Soil Description (Base of TP)	Infiltration Rate (m/sec)	Drainage Characteristics
TP01 test1	1.20 x 0.30	1.50	Light brown and mottled grey CLAY.	N/A	Practically Impermeable
TP02 test1	1.20 x 0.30	1.75	Grey and mottled orange CLAY.	N/A	Practically Impermeable
TP03 test1	1.30 x 0.30	1.50	Light brown sandy CLAY. Sand is medium - coarse.	N/A	Practically Impermeable

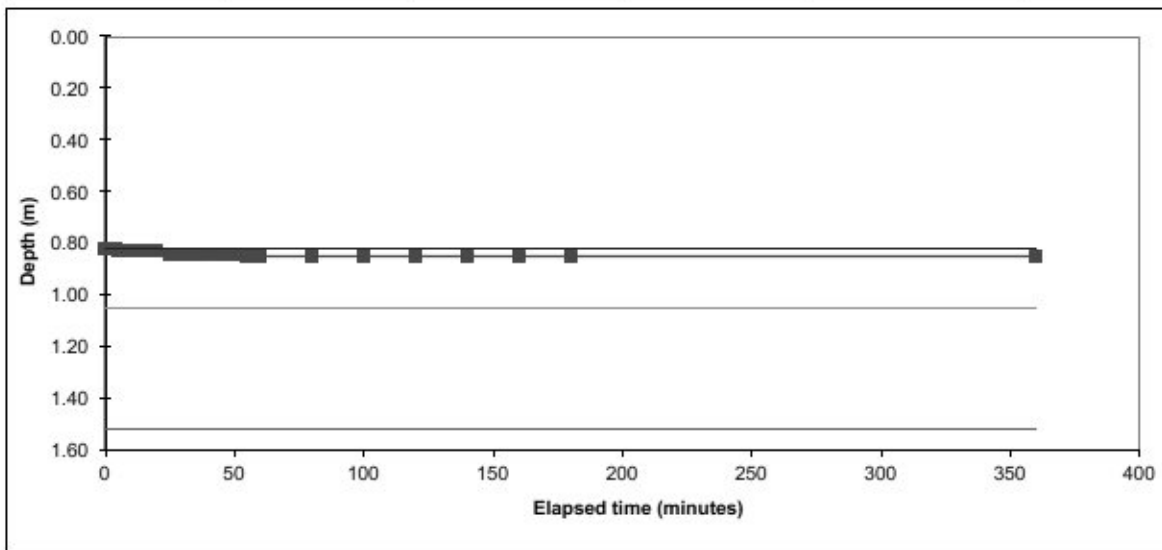
Client:	Bucks Recycling	TP2
Site:	Bucks Recycling, Westcott Venture Park

Trial Pit No:	TP2	Test No:	1	Date:	25/09/2020
Length (m):	1.300	Datum Height:		0.00 m agl	
Width (m):	0.30	Granular infill:	None		
Depth (m):	1.75	Porosity of infill:	1	(assumed)

Start water depth for analysis (mbgl)	0.82	Elapsed time (mins):	#N/A
75% effective depth (mbgl):	1.05		
50% effective depth (mbgl):	1.29		
25% effective depth (mbgl):	1.52	Elapsed time (mins):	#N/A
Base of soakage zone (mbgl):	1.75		
Volume outflow between 75% and 25% effective depth (m ³):			
Mean surface area of outflow (m ²):			1.86
(side area at 50% effective depth + base area)			
Time for outflow between 75% and 25% effective depth (mins):

Soil infiltration rate (m/s):	Test incomplete as 25% effective depth not achieved. Unable to reliably determine soil infiltration rate.
--------------------------------------	--

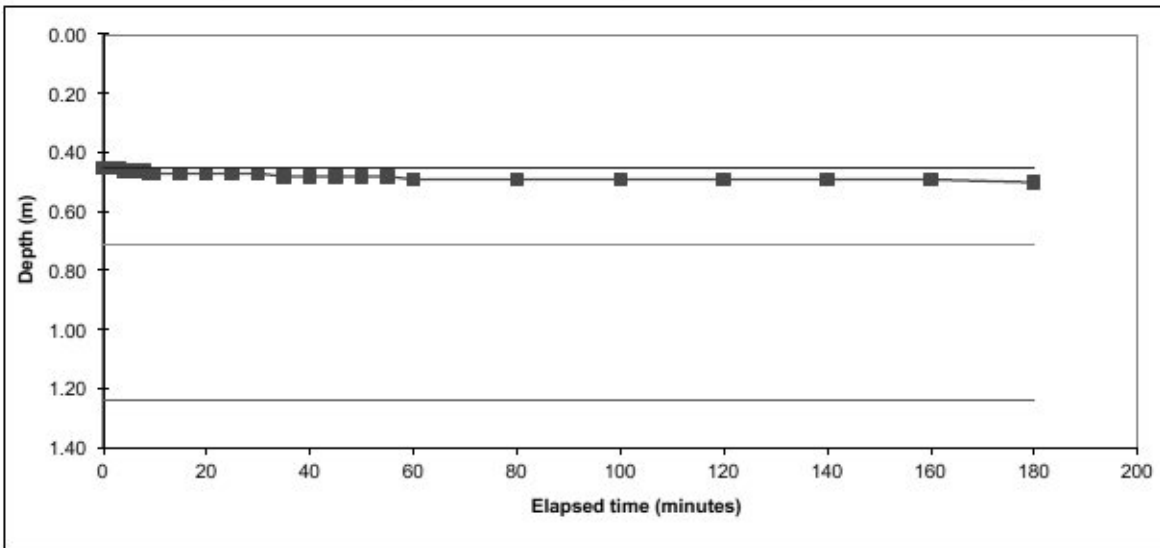
Client:	Bucks Recycling	TP3
Site:	Bucks Recycling, Westcott Venture Park

Trial Pit No:	TP3	Test No:	1	Date:	25/09/2020
Length (m):	1.300	Datum Height:		0.00 m agl	
Width (m):	0.30	Granular infill:	None		
Depth (m):	1.50	Porosity of infill:	1	(assumed)

Start water depth for analysis (mbgl)	0.45	Elapsed time (mins):	#N/A
75% effective depth (mbgl):	0.71		
50% effective depth (mbgl):	0.98		
25% effective depth (mbgl):	1.24	Elapsed time (mins):	#N/A
Base of soakage zone (mbgl):	1.50		
Volume outflow between 75% and 25% effective depth (m ³):			
Mean surface area of outflow (m ²):			2.05
(side area at 50% effective depth + base area)			
Time for outflow between 75% and 25% effective depth (mins):

Soil infiltration rate (m/s):	Test incomplete as 25% effective depth not achieved. Unable to reliably determine soil infiltration rate.
--------------------------------------	--

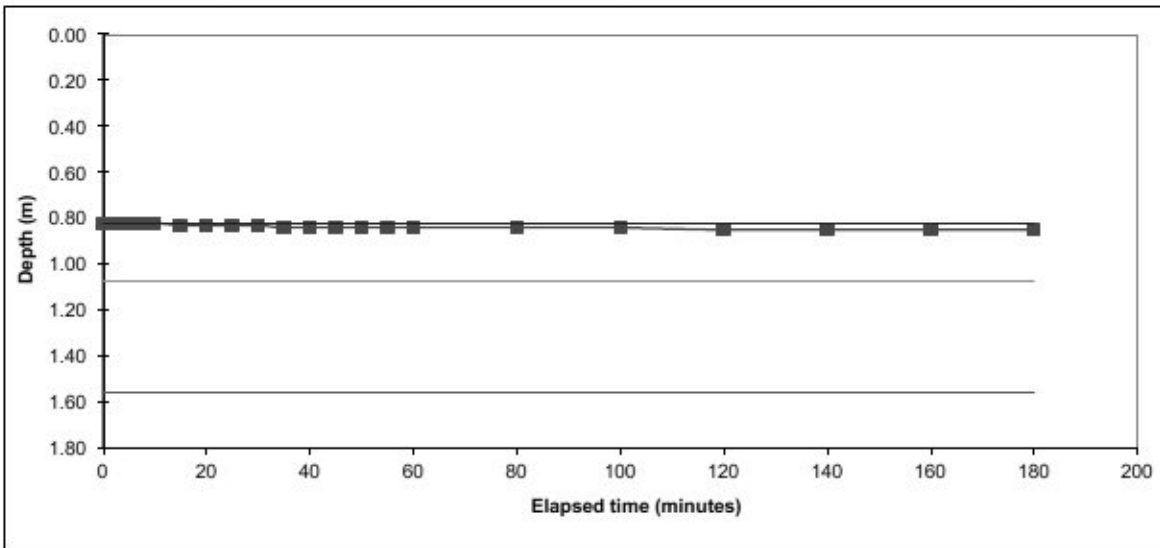
Client:	Bucks Recycling	TP4
Site:	Bucks Recycling, Westcott Venture Park

Trial Pit No:	TP4	Test No:	1	Date:	25/09/2020
Length (m):	1.400	Datum Height:		0.00 m agl	
Width (m):	0.30	Granular infill:	None		
Depth (m):	1.80	Porosity of infill:	1	(assumed)

Start water depth for analysis (mbgl)	0.82	Elapsed time (mins):	#N/A
75% effective depth (mbgl):	1.07	Elapsed time (mins):	#N/A
50% effective depth (mbgl):	1.31	Elapsed time (mins):	#N/A
25% effective depth (mbgl):	1.56	Elapsed time (mins):	#N/A
Base of soakage zone (mbgl):	1.80

Soil infiltration rate (m/s):	Test incomplete as 25% effective depth not achieved. Unable to reliably determine soil infiltration rate.
--------------------------------------	--

TP04 test1	1.40 x 0.30	1.80	Grey and mottled orange CLAY.	N/A	Practically Impermeable
------------	-------------	------	-------------------------------	-----	-------------------------
