## 7 ELVETHAM ROAD, FLEET

### Bat Survey Report

ECO01324  
Bat Survey Report  
Version B  
02 July 2020

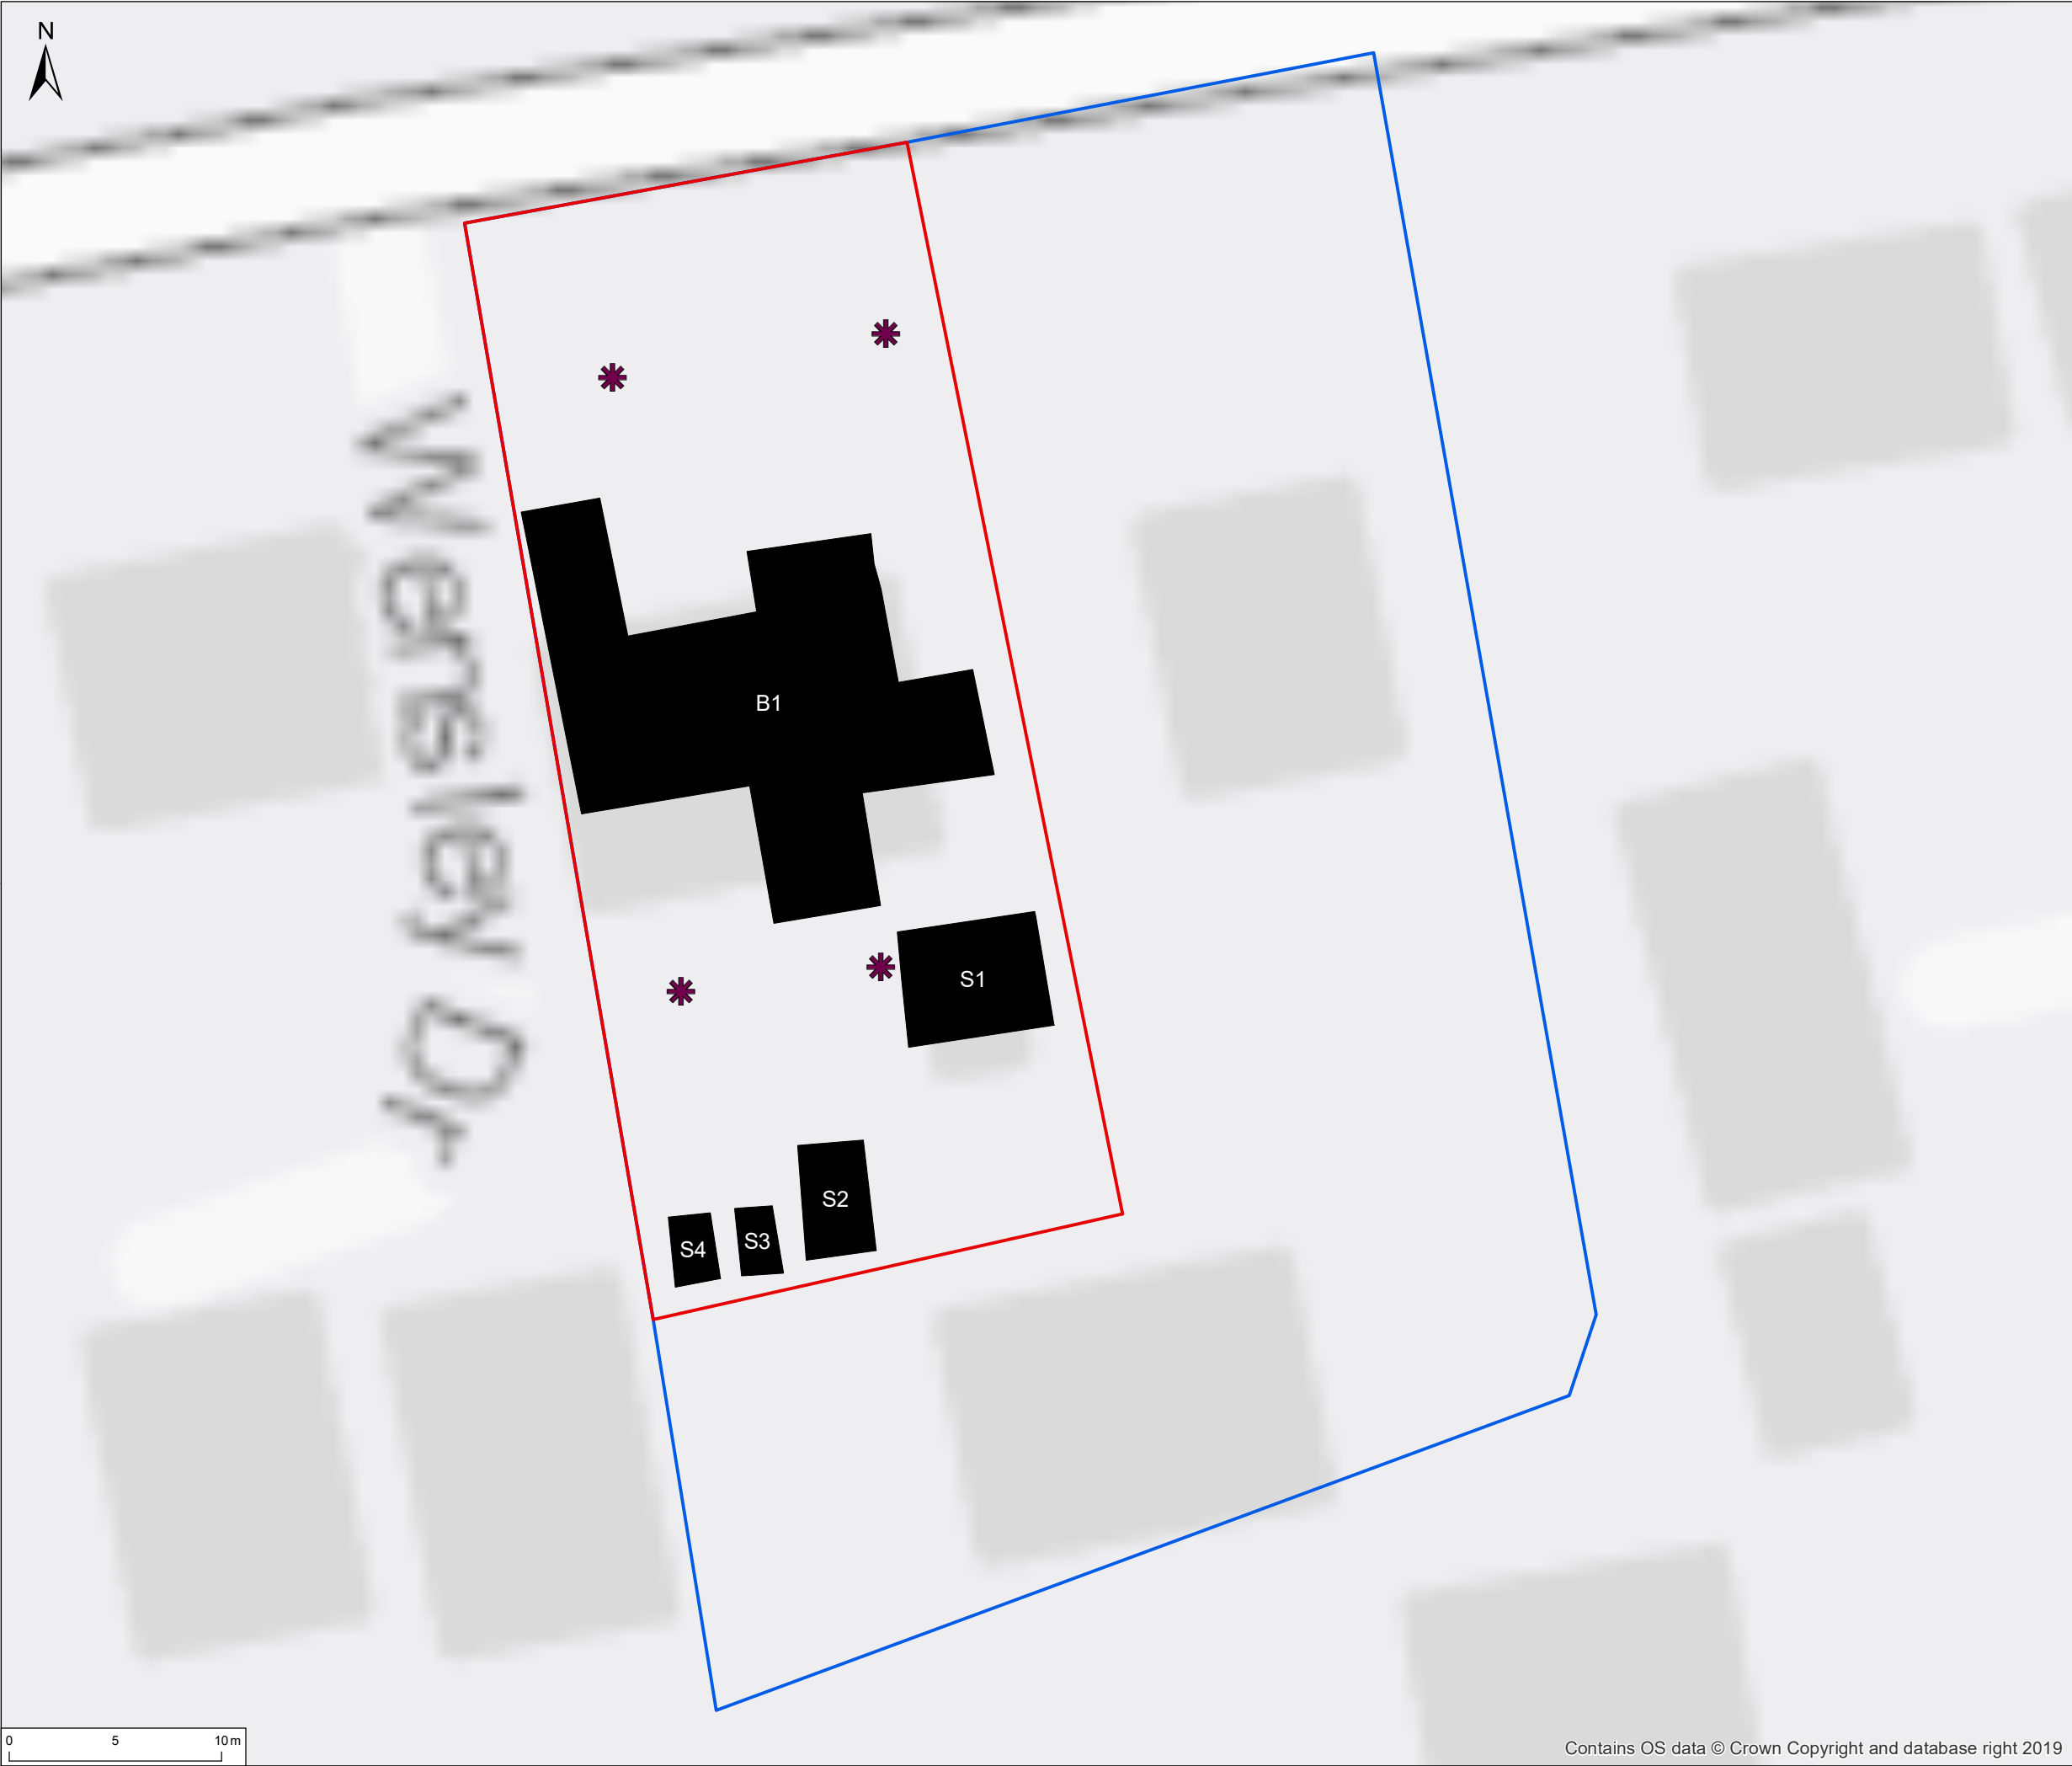
Title      Bat surveyor locations

- 2.1.5 Two experienced bat surveyors, led by Frances Morris, and two infra-red cameras paired with static detectors were positioned in four locations. These locations can be seen in Appendix 1.

- 3.1.4 Bat activity can be strongly dependent on weather conditions. The surveys were therefore only carried out in favourable conditions when bat activity was deemed to be likely (sunset temperature 10°C or above, no rain or strong wind). Surveyor positions were located to view features with potential to support bats on each survey, refer to Appendix 1 for surveyor locations. Table 2 below summarises the survey results.
