**Bat Survey Report for
Mount Farm workshop and stables,
Junction Road, Churchill,
Chipping Norton, OX7 6NP**

Cotswold Wildlife Surveys

13th January, 30th April and 14th & 28th May 2021

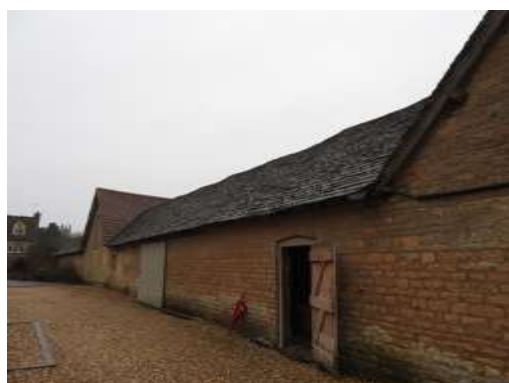
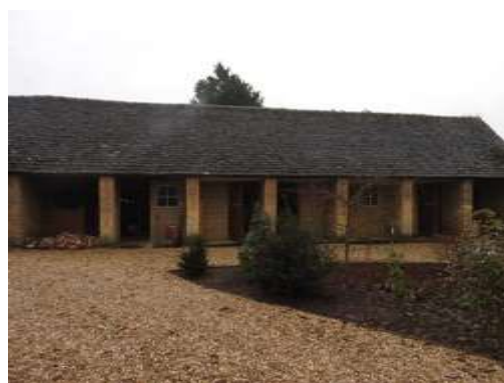
Figs. 1 & 2 Workshop (L) and stable block (R)

The survey site comprised a pitched roofed workshop with an extended gable, and a pitched roofed stable block (Figs. 1 and 2).

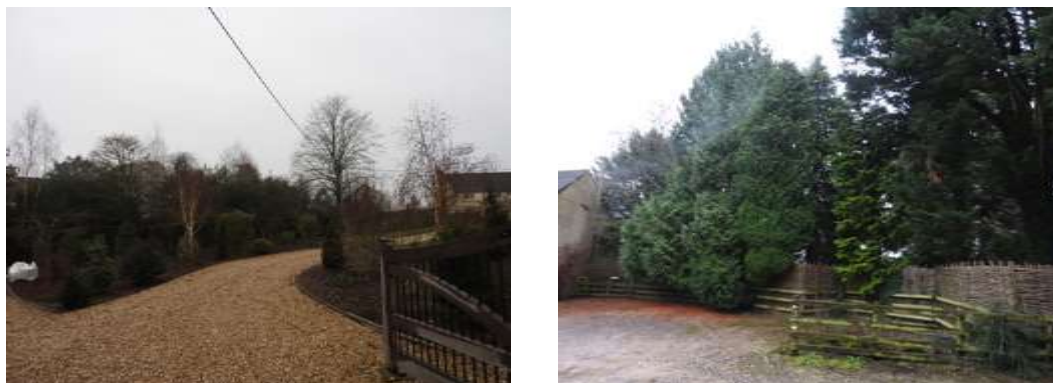
Figs. 3 & 4 Views to the front (L) and rear (R)

To the front of the workshop and stable block was a gravel drive and garden, with dwellings, open fields and mature trees beyond (Fig. 3). To the rear of the workshop and stable block were other adjoining buildings, with mature trees and open fields beyond (Fig. 4).

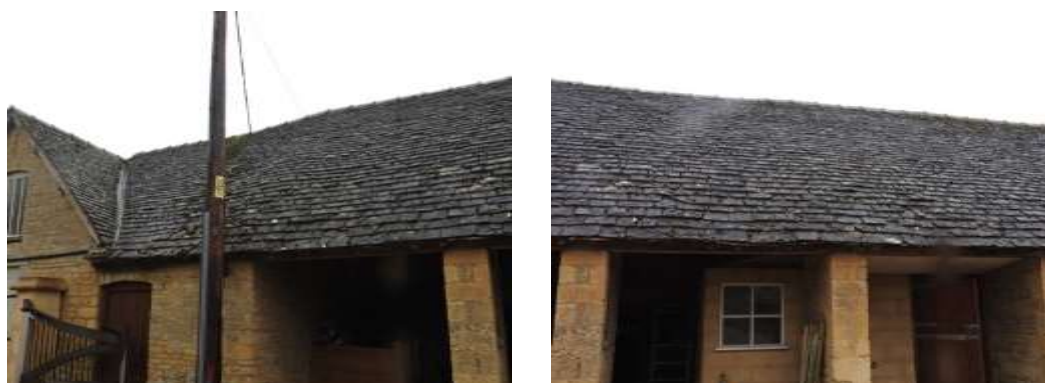
Figs. 5 & 6 Ridges and roof tiles to the front

The ridge was intact and sealed, whilst all the roof tiles were tightly overlapping, with just a small number of broken, dislodged and missing tiles observed (Figs. 5-7).

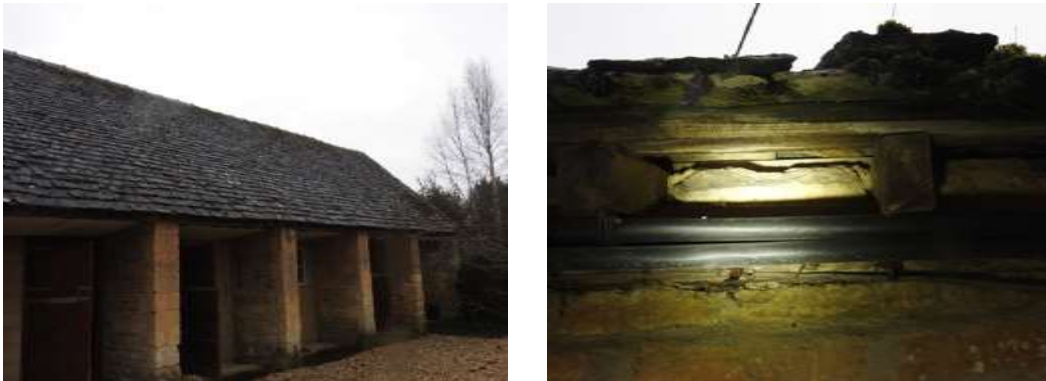
Figs. 7 & 8 Ridges and roof tiles to the front (L) and eaves (R)

The eaves were finished with the roof ends generally tightly fitting against the wall plates, although a small number of gaps were noted (Fig. 8).

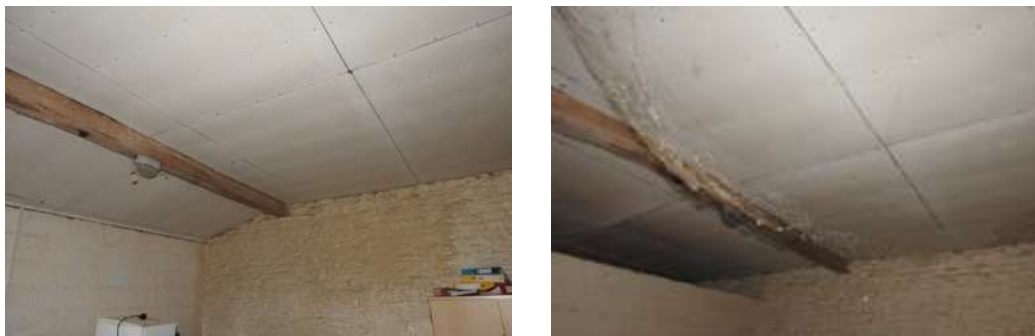
Figs. 9 & 10 Hardboard lined ceiling of the stables

The ground floor stables were open to the hardboard lined ceiling (Figs. 9 and 10), with the west gable open to the roof and lined with tarred felt, this cobwebbed at the gables and along the ridge (Fig. 11).

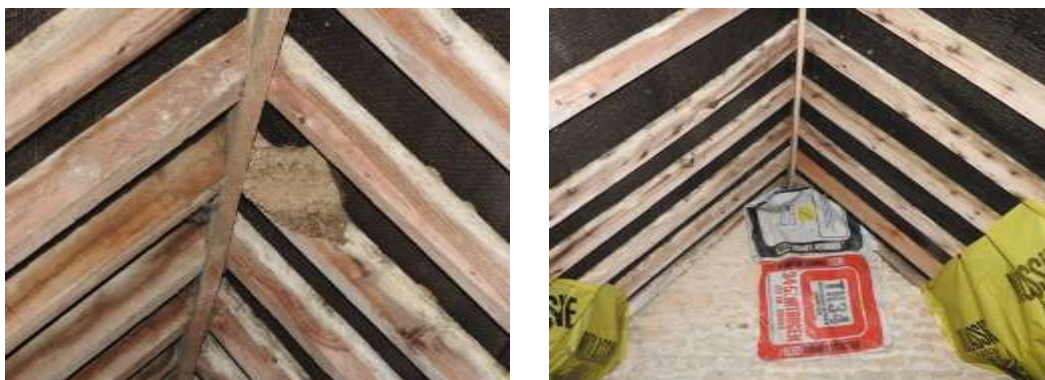
Figs. 12 & 13 Cobwebbed gable and ridge

The roof void above the stables was approximately 2.0 m high, 12 m long and the full width of the building. It was lined with tarred felt in good condition with no holes or tears, whilst the ridge and gable end were cobwebbed (Figs. 12 and 13).

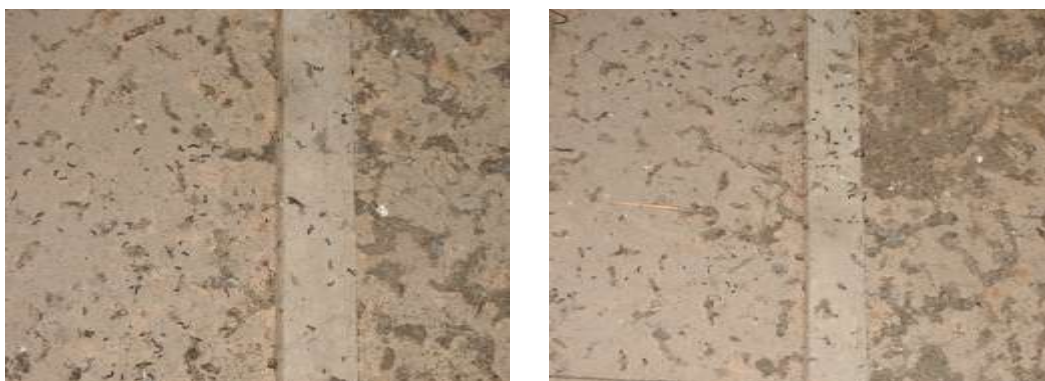
Figs. 14 & 15 Lesser Horseshoe Bat droppings

On the floor of the void close to the west gable, c100 scattered Lesser Horseshoe Bat droppings were found, the species identity confirmed by DNA analysis (Figs. 14 and 15).

No roosting or hibernating bat was present.

Since the roost will be lost with the re-development of the stable block, suitable mitigation is required, along with a development licence from Natural England. As such a new bat loft will be created, this measuring approximately 16 m³ in volume.

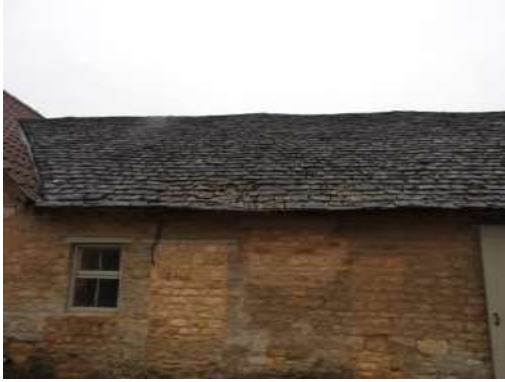
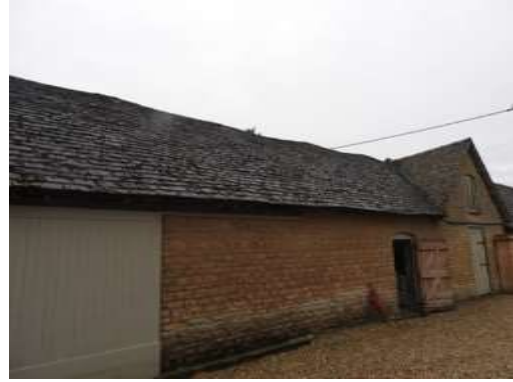
Figs. 16 & 17 Ridges and roof tiles to the front

The ridge was intact and sealed, whilst all the roof tiles were tightly overlapping, with only a small number of broken, dislodged and missing tiles observed (Figs. 16 and 17).

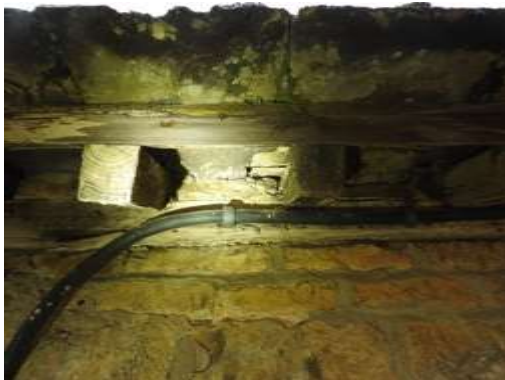
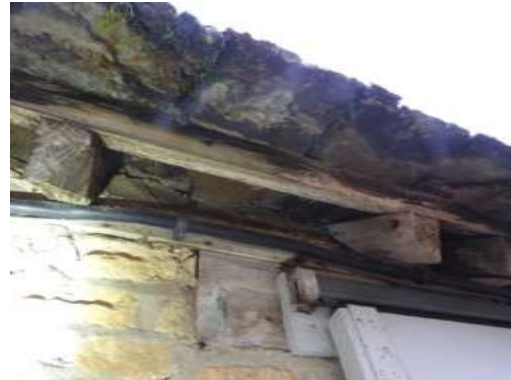
Figs. 18 & 19 Sealed eaves

The eaves were finished with the roof verge tightly fitting against the wall plate (Figs. 18 and 19).

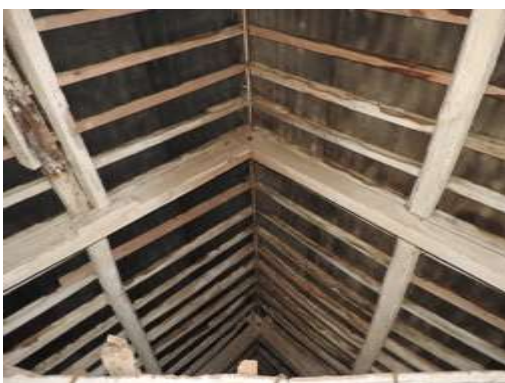
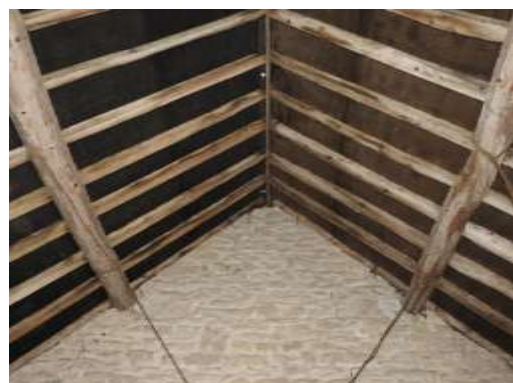
Figs. 20 & 21 Cobwebbed ridge and gable end

Internally the workshop was open to the tarred felt lined roof, some of which had additional hardboard lining, and one section opposite the extended gable had mortar lining. The ridge, plumb cut and gable ends were all cobwebbed (Figs. 20-24).

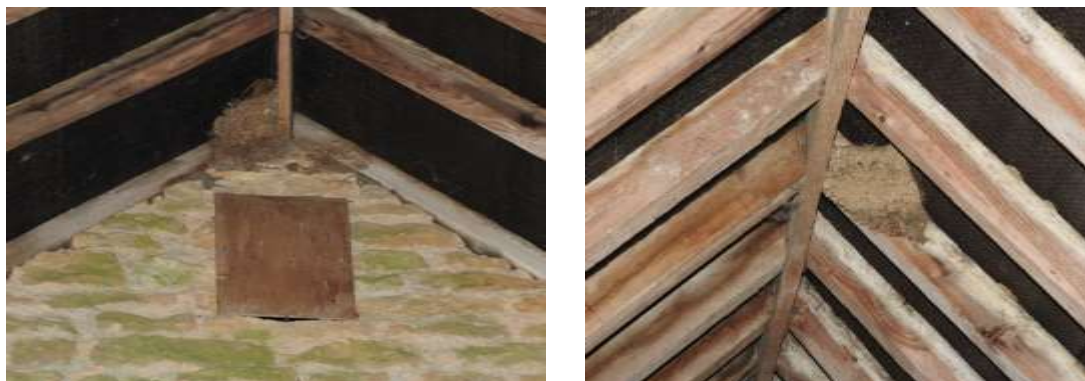
Figs. 25 & 26 Barn Swallow nests

Barn Swallow and Blackbird nests were found in the stable block (Figs. 25-27).

Since all in-use bird's nests and their contents are protected from damage or destruction, any works which affect buildings should ideally be undertaken outside the period March to August inclusive. If this time frame cannot be avoided, a close inspection of the buildings affected will be undertaken prior to clearance. Work will not be carried out in close proximity to any in-use nest, and a minimum buffer of 5.0 metres will be established, although this could be more depending on the sensitivity of the species. Any in-use nest will be allowed to fledge before it is disturbed.

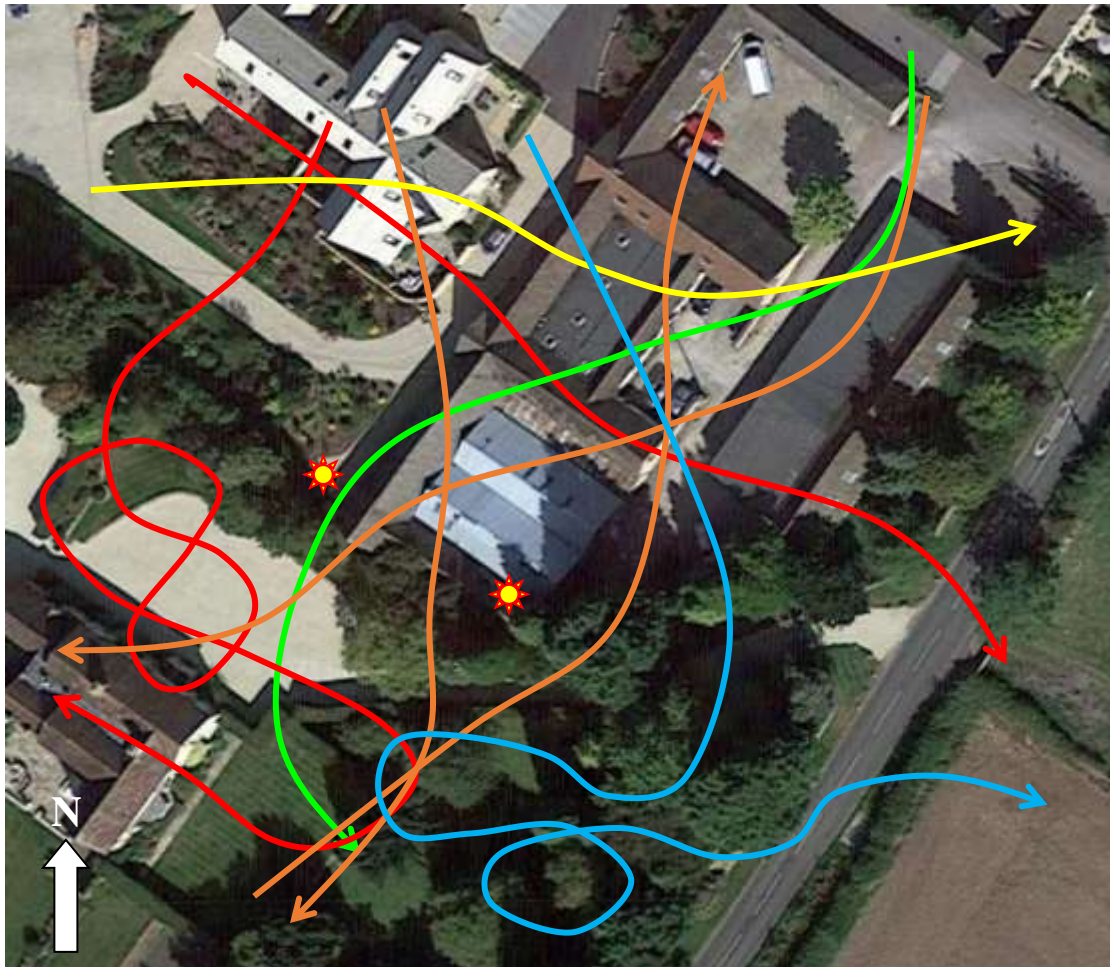
Plan 3 Bat flight paths at emergence on 28th May 2021

On this occasion there was more Common Pipistrelle and Whiskered/Brandt's Bat activity, as well as fly pasts from a Soprano Pipistrelle, a Lesser Horseshoe Bat and a Noctule Bat.

Time	Observation
21:21	Common Pipistrelle flew past
21:22-21:30	Common Pipistrelle foraging nearby
21:33	Soprano Pipistrelle flew past
21:36	Whiskered/Brandt's Bat and Lesser Horseshoe Bat flew past
21:38-21:44	Whiskered/Brandt's Bat foraging nearby
21:51	Noctule overhead
21:52	Lesser Horseshoe Bat flew past again
21:54	Common Pipistrelle flew past
22:01	Lesser Horseshoe Bat flew past
22:08	Lesser Horseshoe Bat flew past
22:45	No further detections were made and survey ended

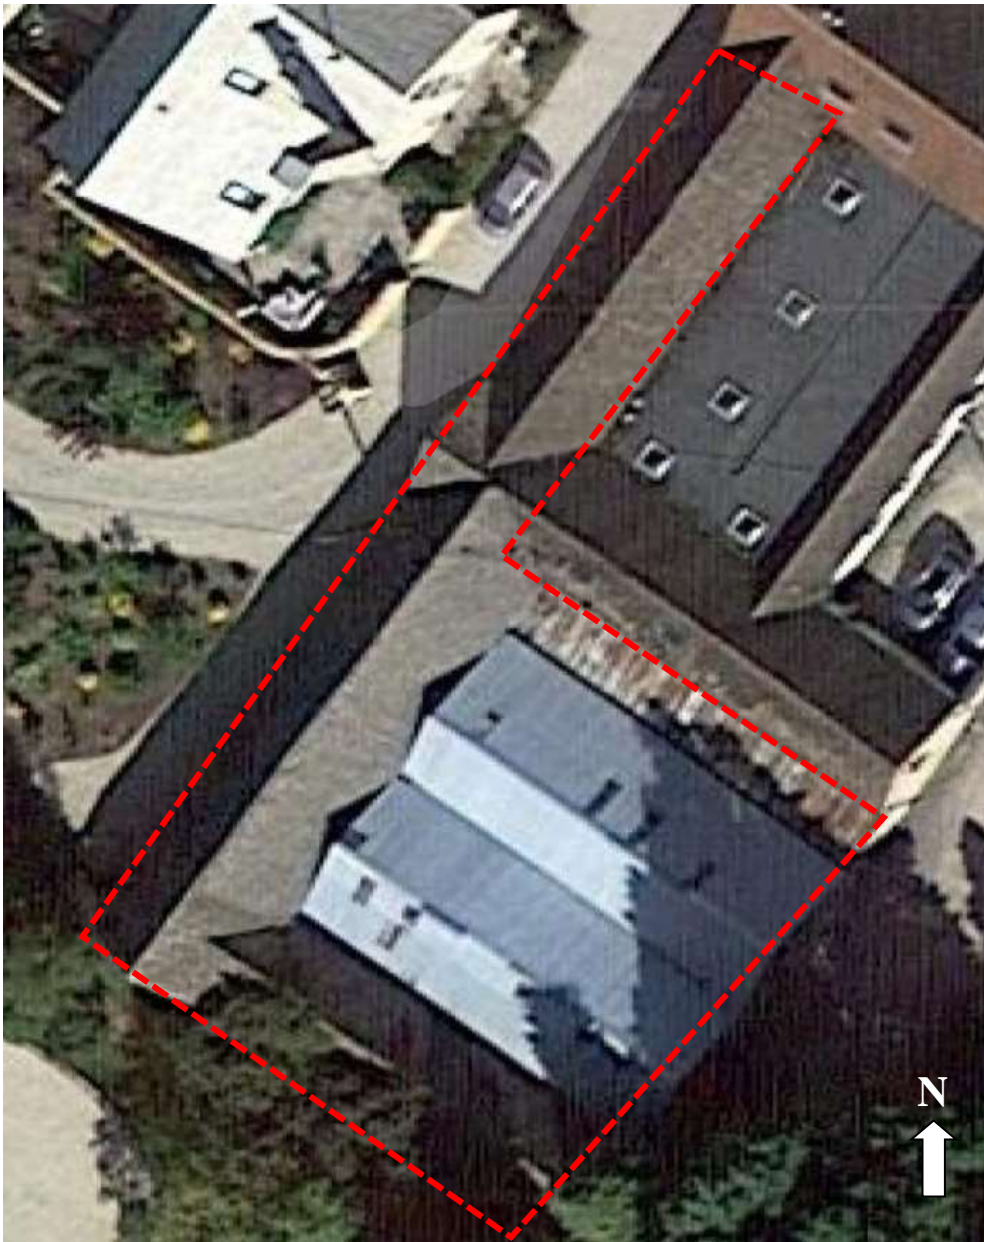
Appendix 2: Site layout

Stables and Workshop

The layout of the site is shown in the aerial photograph in Appendix 2.

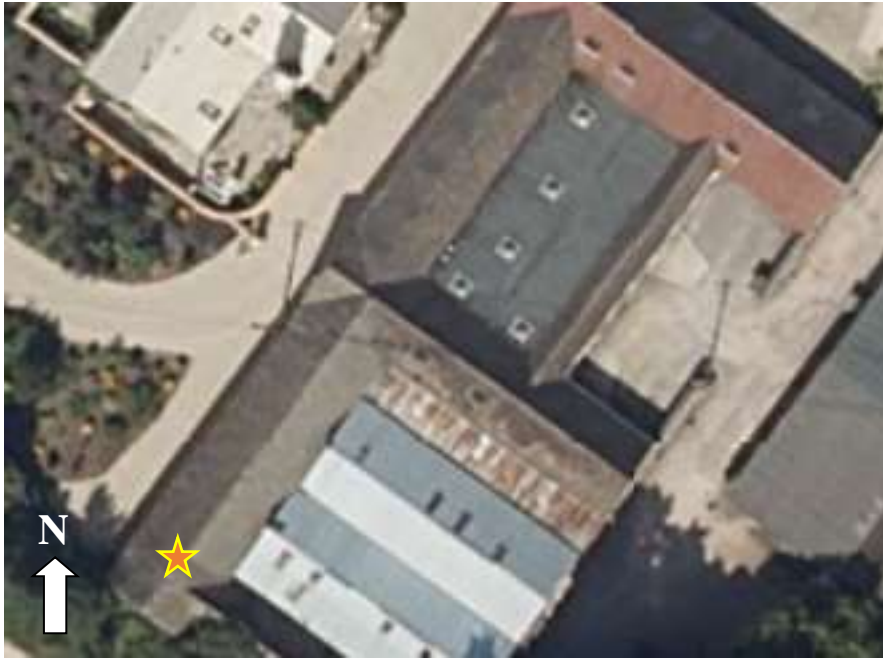
Appendix 3: Location of bat droppings

Lesser Horseshoe Bat droppings ★
