5 East Bight,  
Lincoln

*Assessment of Significance*

*Completed for  
Mr & Mrs Sullivan &  
John Roberts Architects*

AUSTIN HERITAGE  
CONSULTANTS

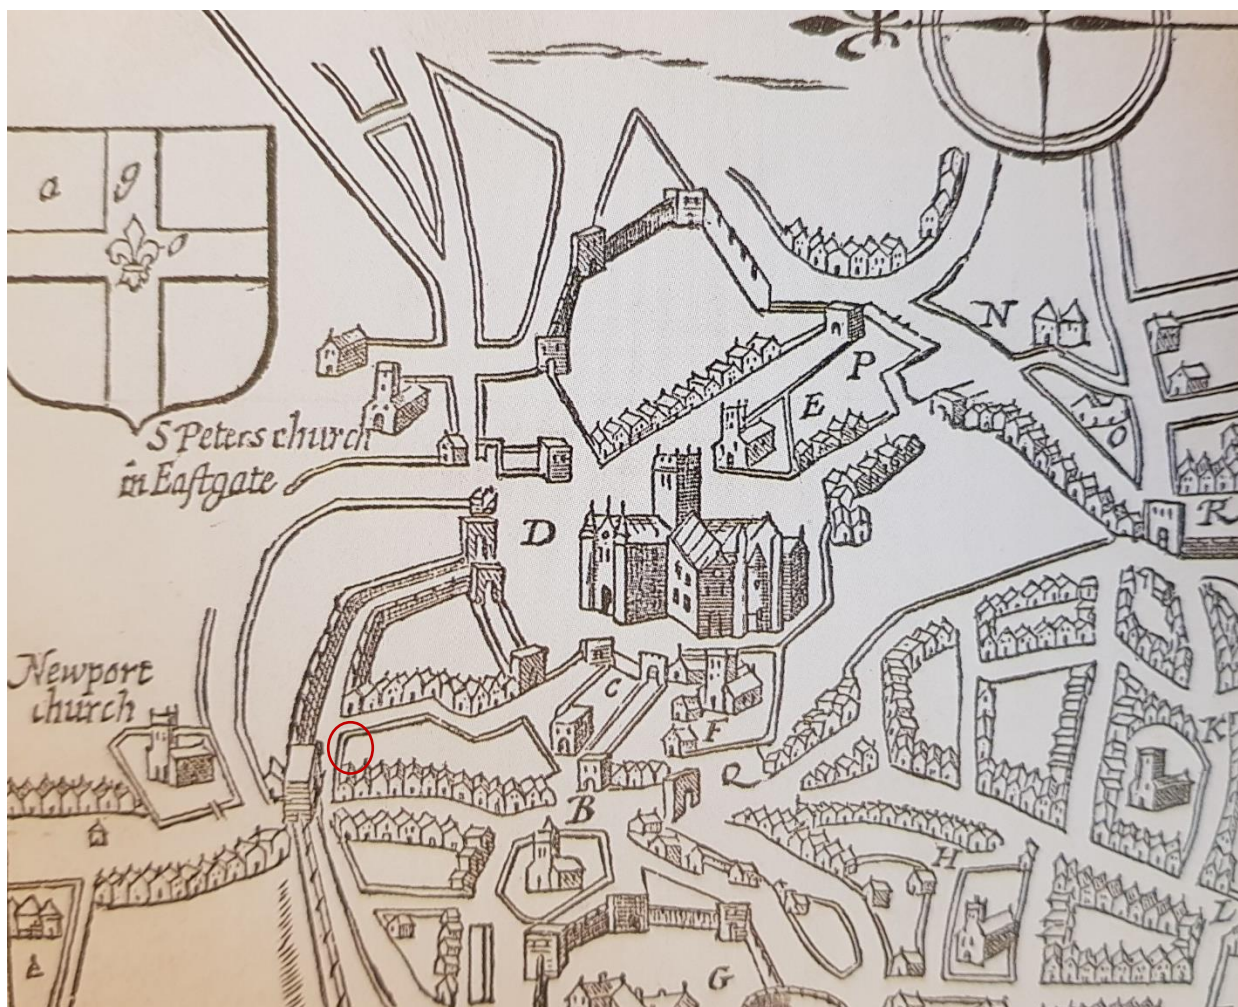
**Figure 3** Extract from a 1610 map of the city of Lincoln with the approximate location of the study area circled.<sup>16</sup> The map is diagrammatic and although it does not suggest any structures in the area, it is designed to show general development of areas and major individual buildings.

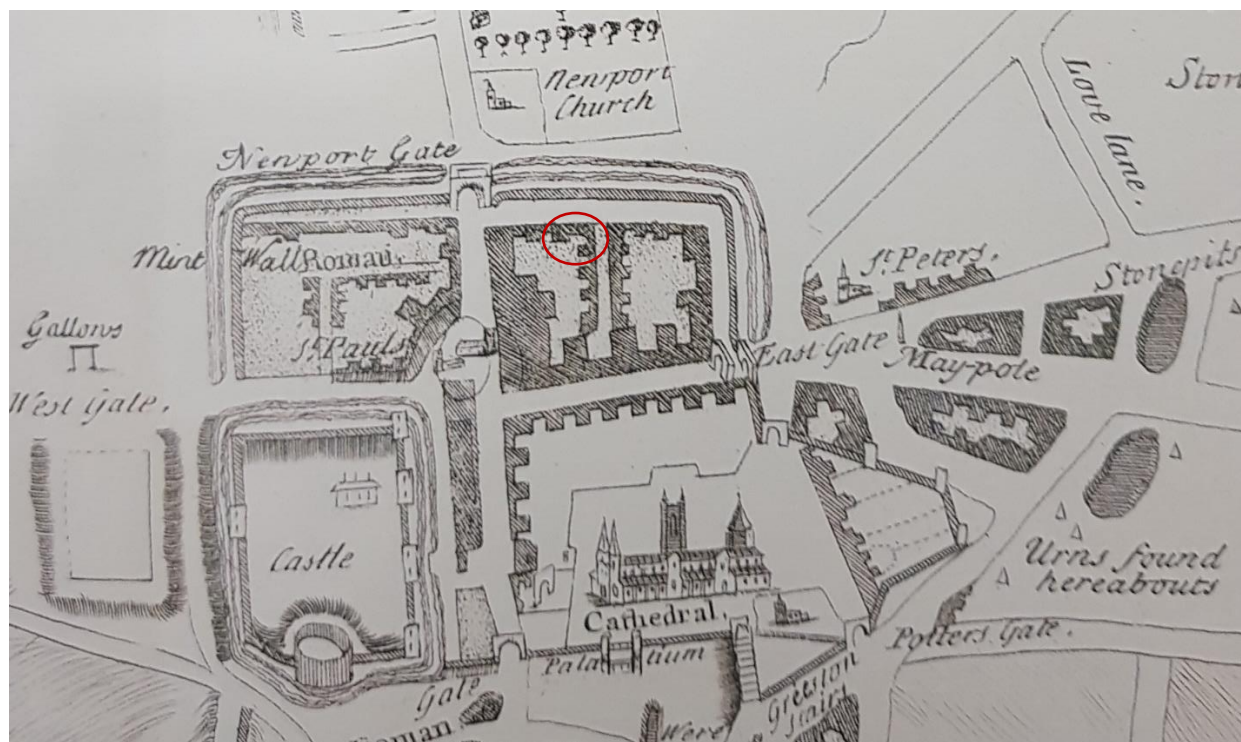
**Figure 4** 4th September 1722 map of Lincoln with the approximate study area circled. Building and wall development is depicted along East Bight and James Street.

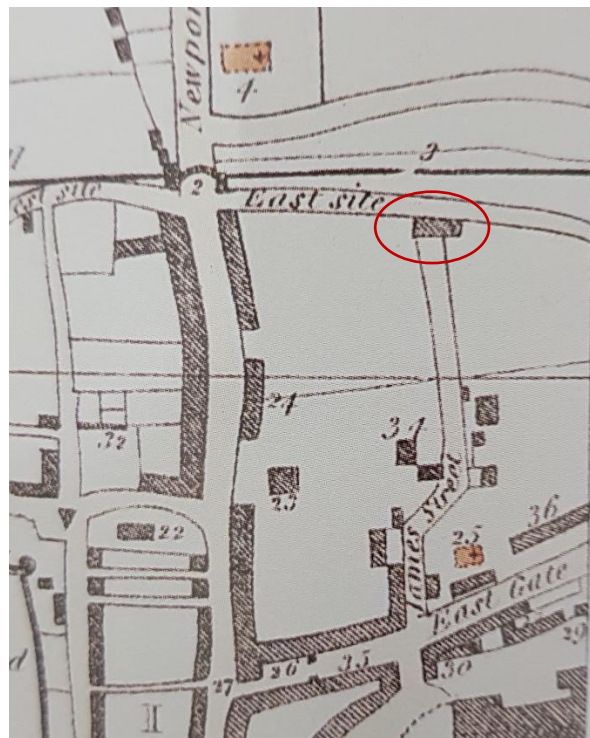
**Figure 5** Extract from an 1817 Map of Lincoln showing a building blocking the north end of James Street<sup>25</sup> – but not in the location of the current building.

An 1817 map (Figure 5) is the first map found to show the location of individual buildings in more detail and it depicts a building blocking the end of James Street where it meets East Bight.

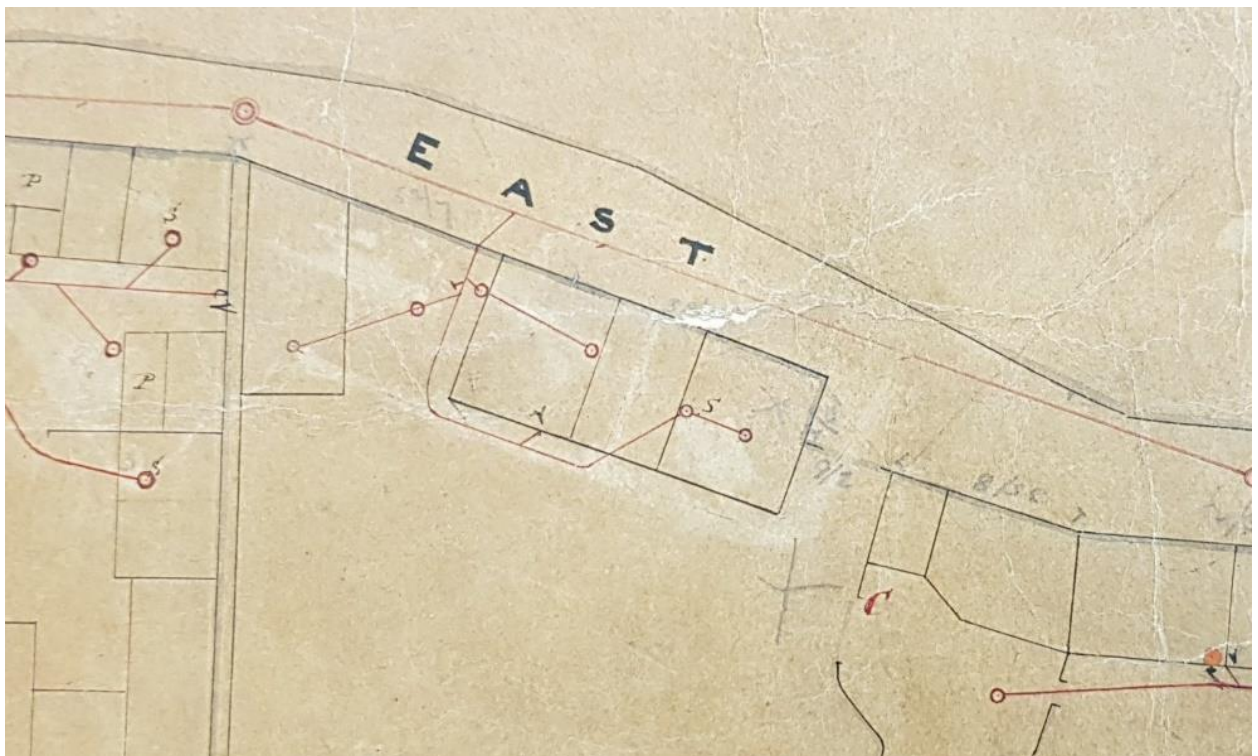
**Figure 11** c.1885 drainage plan showing drainage for the two buildings.<sup>42</sup> The rectangular east building is shown subdivided internally into three parts. The northwest corner building is a footprint different to that shown in 1888 and it is possible that the wall was realigned by 1888 – or is it simply an anomaly on this less refined map?

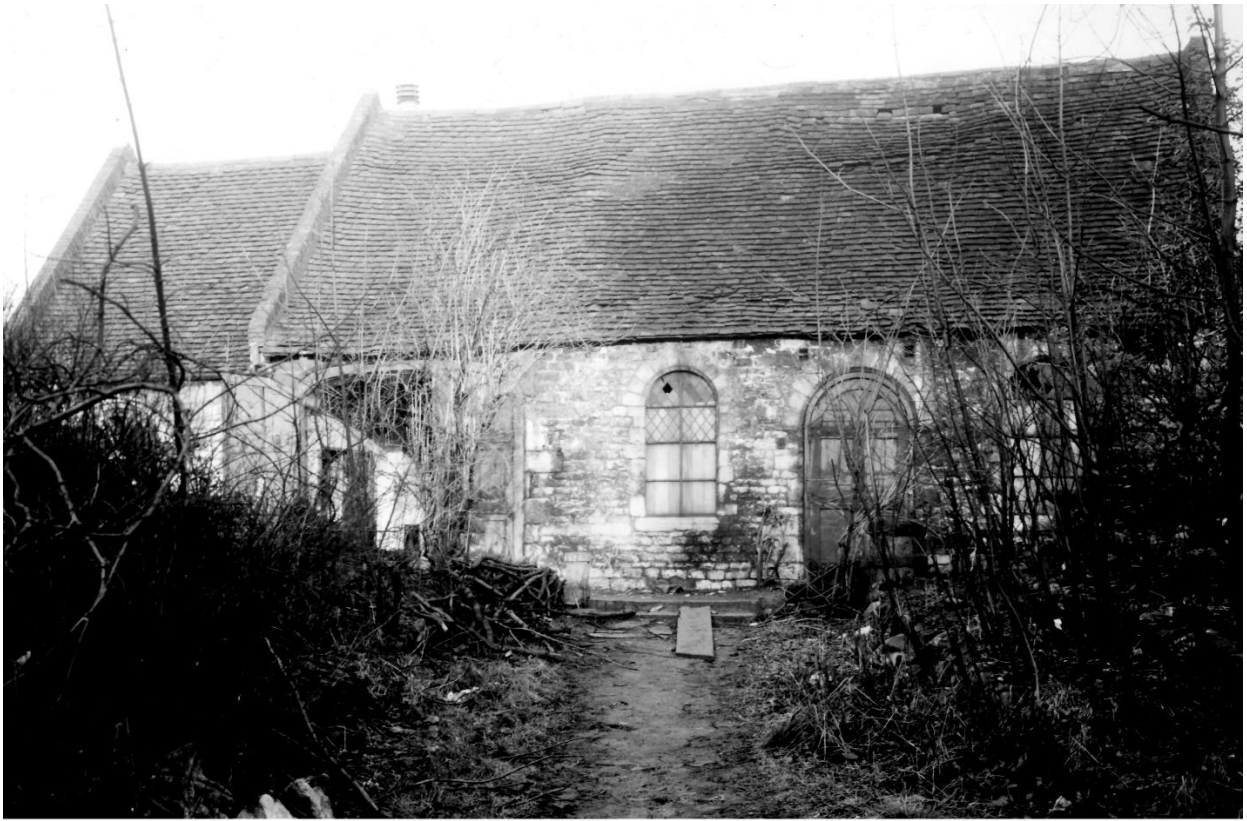
**Figure 14** 1958 image of the south elevation of the stables and coach house prior to conversion for dwelling use.<sup>56</sup>

The images show that the original south elevation in 1958 prior to dwelling conversion comprised (from west to east) the carved stone window at the west end (into the current dining room); a pair of panelled wooden coach house doors with decorative iron strap hinges set into an arched opening; and at the east end, single arched windows flanking a central strapped and panelled door, presumably leading into the stables area. The arched windows were leaded with diamond panes in part with later replacement panes – 8 panes in total for each including the arches. The roof appears to have been clad with flat clay tile, rather than pantile prior to conversion. The northwest corner building on the site is visible to the left of the image at Figure 15 and there was a large opening on the east elevation, the roof was clay-tile and with a pitch sloping down to the east.

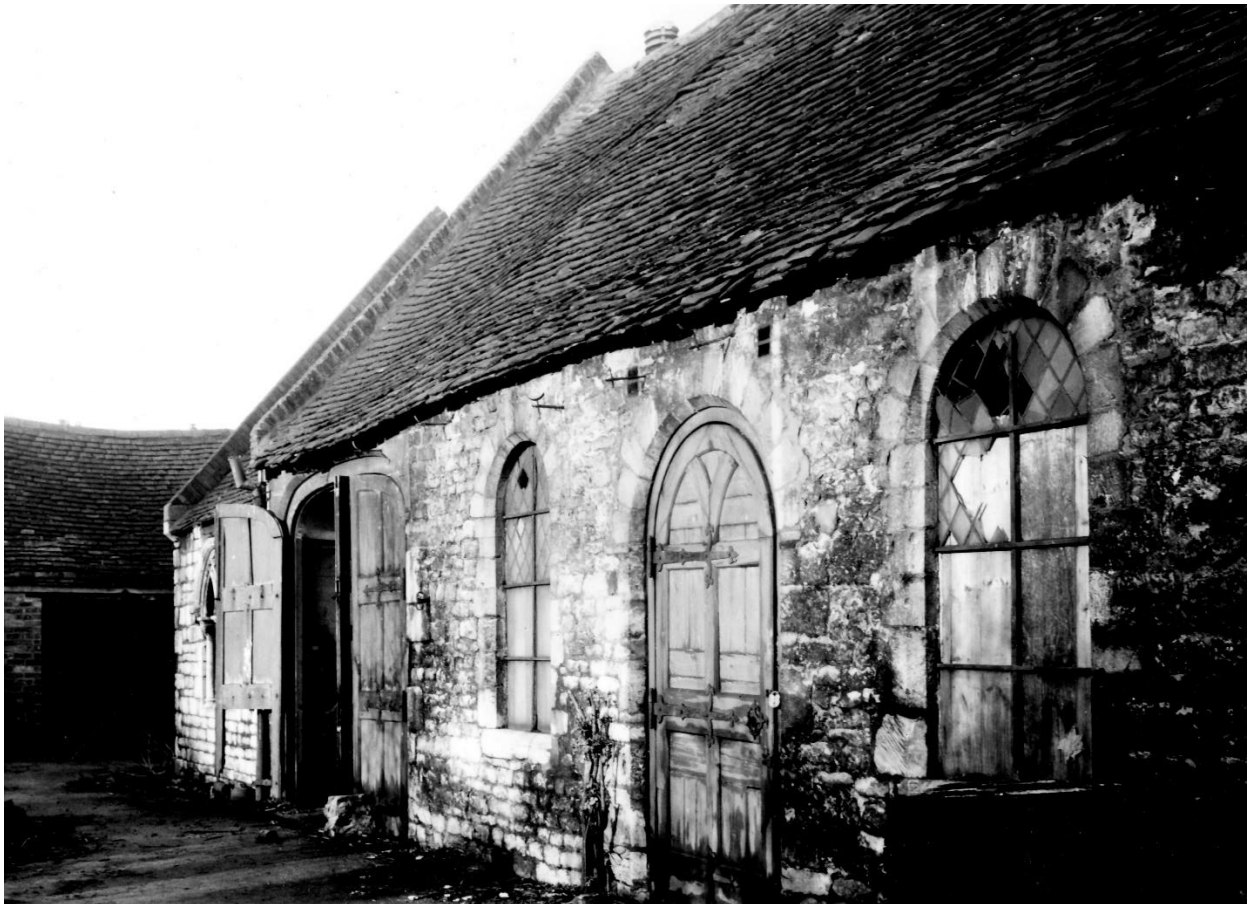
**Figure 15** 1958 image of the building looking northwest to the south elevation and outbuilding beyond, prior to conversion for dwelling use, showing the building presumably referred to as the garage in 1986 to the far left of the image.<sup>57</sup>

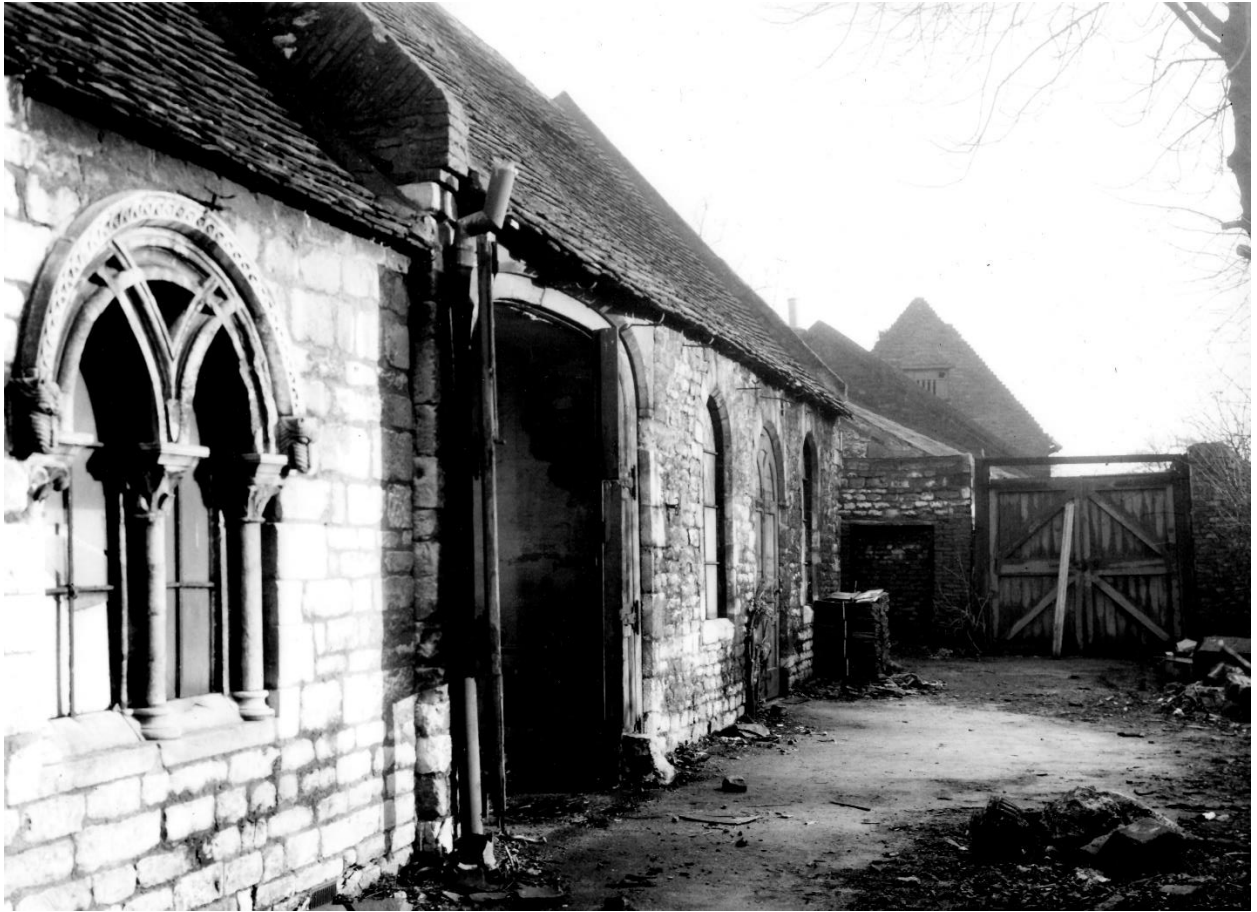
**Figure 16** 1958 image of the south elevation of the former stables and coach house prior to conversion to dwelling use.<sup>58</sup>

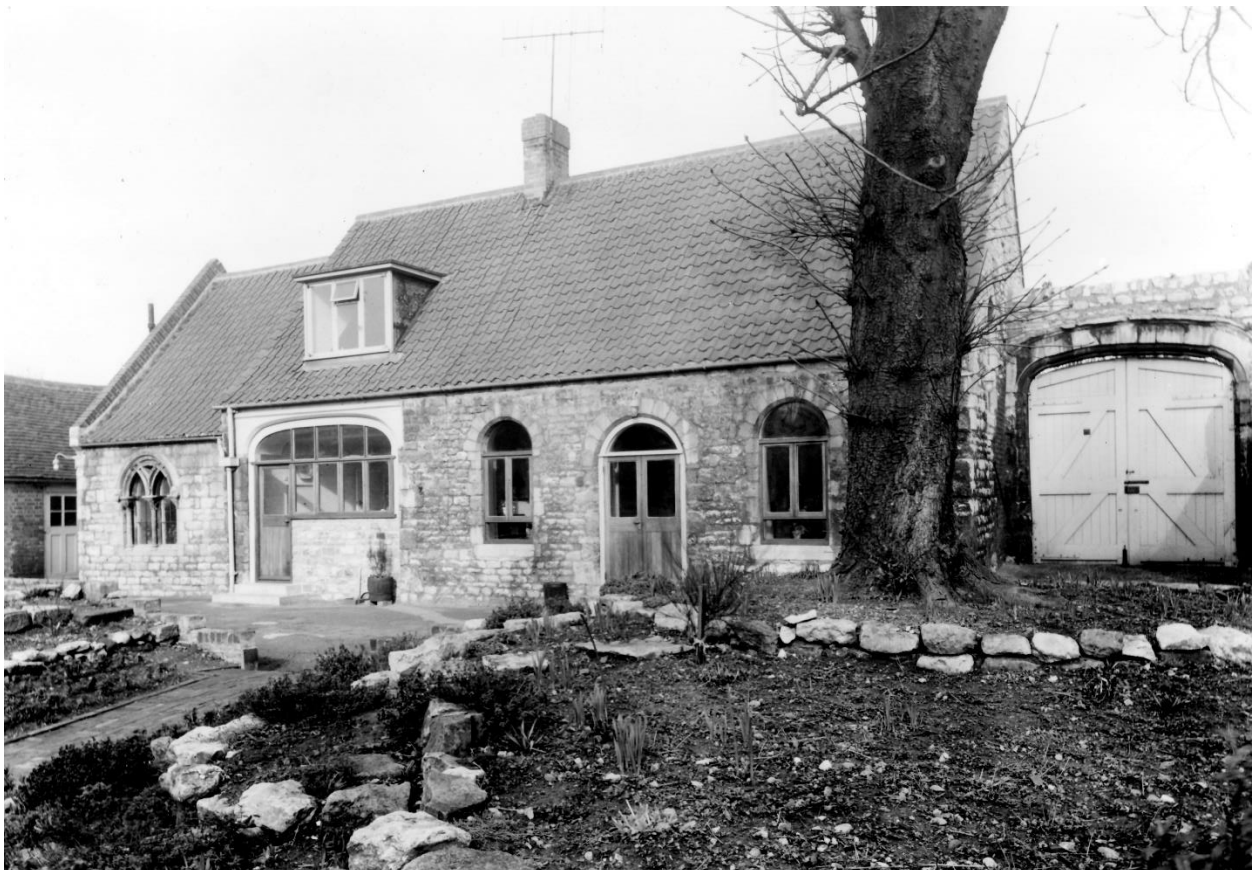
**Figure 17** Photo taken in 1961 following the conversion of the buildings to dwelling use. Note the garage building with door to the left of the image.

Although no drawings were found to show the changes in 1961, the interior of the building does not appear to have been dramatically altered since its original conversion and the image at Figure 17 shows that the changes included a dormer in the south pitch of the roof for the bedroom; retention of the coach house door archway, but infill with stone work, upper glazing and part-glazed door within the west side of the opening; replacement of the multi-pane arched windows and panelled door with new windows and a pair of part-glazed doors; chimney installed in the ridgeline; complete replacement of roofing with pantile (but it would appear that the garage building retained its flat tile roof in 1961).

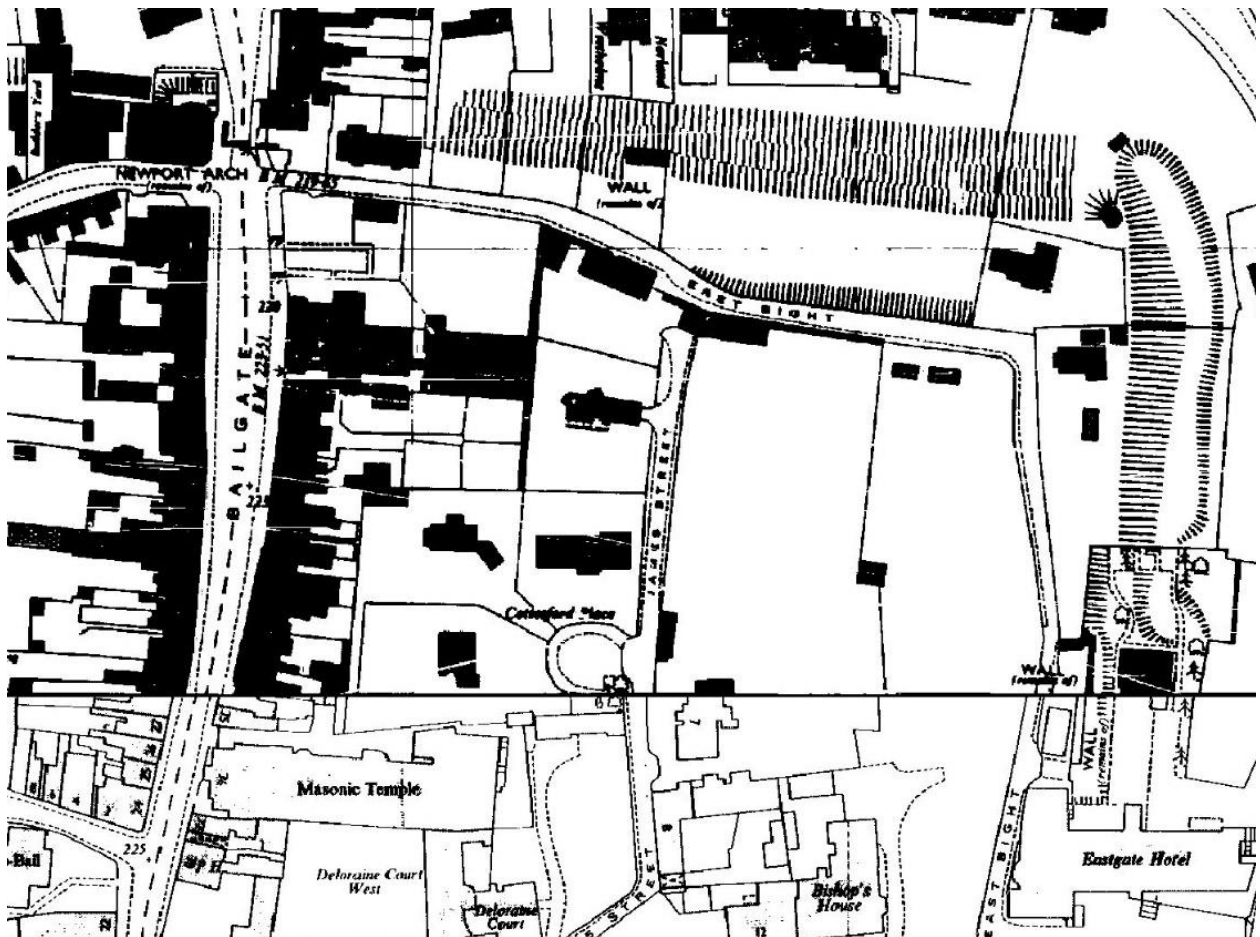
**Figure 18** Extract from the 1967-68 OS Map<sup>59</sup> showing subdivision and redevelopment of the former Cottesford Place gardens for housing by this time.

Between the time of the 1932-38 OS Map and the 1967-68 OS Map at Figure 18 (presumably after the demolition of Cottesford Place in 1956), the original gardens of the house were subdivided for new housing development, with the study area subdivided within its own plot at the north end.

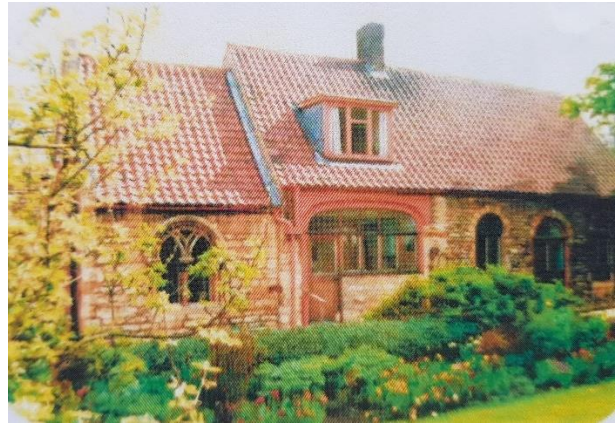
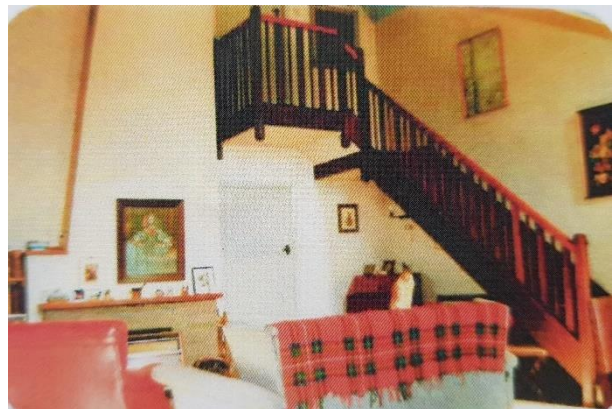
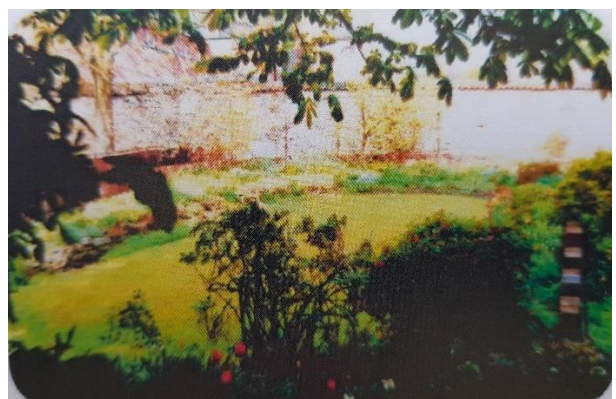
**Figure 20** Images of the south elevation (top); stair to upper floor at east end (centre); and garden (bottom) from 1986 sales particulars.<sup>62</sup>

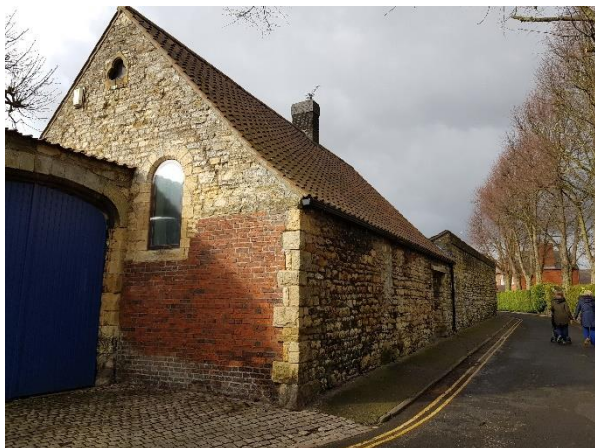
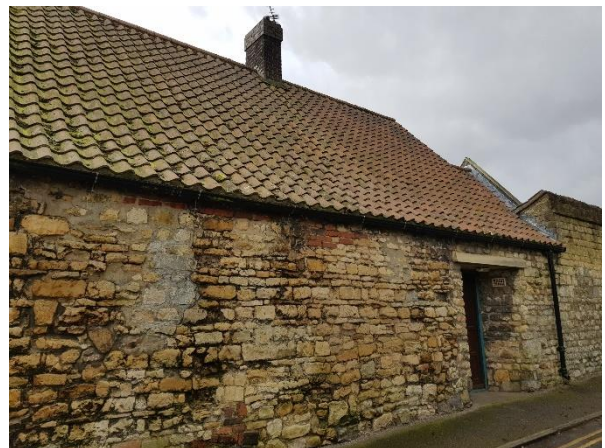
**Figure 24** View looking west along East Bight showing part of the east gable elevation and north elevation of 5 East Bight (L) and a partial view of the north elevation with the early 19th century roof over the wall (reclad in pantile in c.1961)(R).

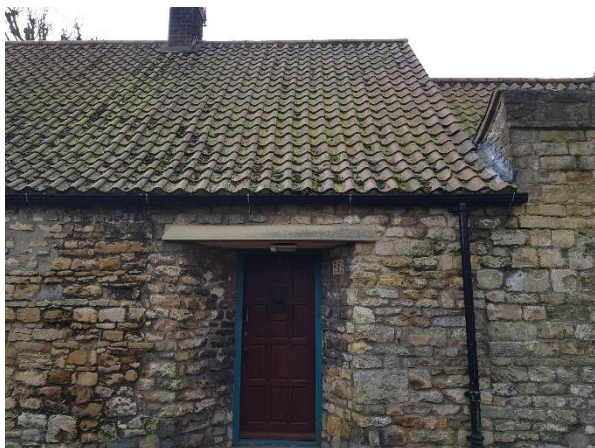
**Figure 25** c.1961 doorway insertion in north elevation as part of the conversion to a dwelling (L) and north close wall continuing west as built by 1327 (and later altered)(R).

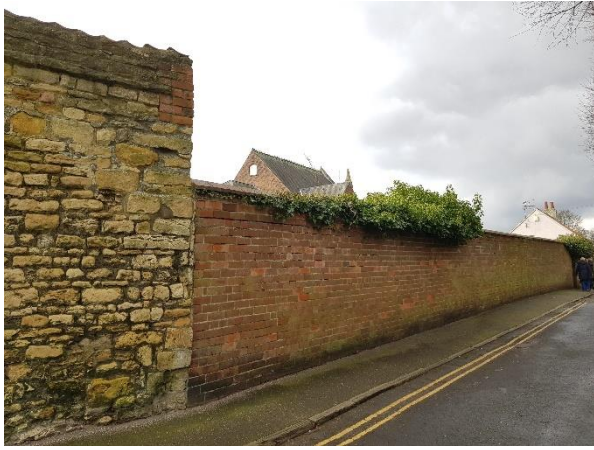
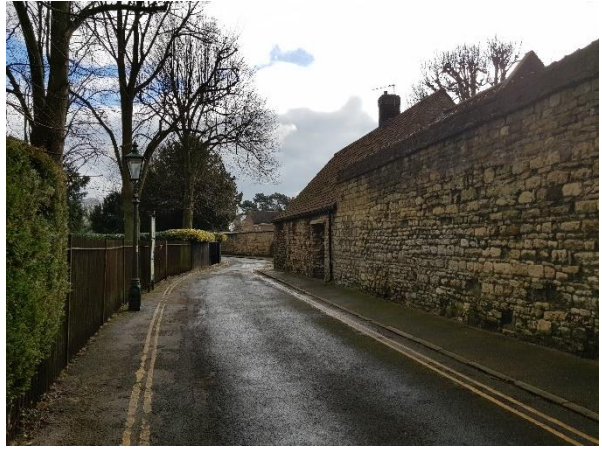
**Figure 26** West end of the north close wall where it abuts the brick wall that continues along East Bight to the west (L) and looking east along East Bight with 5 East Bight to the right of the image integral with the 14<sup>th</sup> century close wall (R).

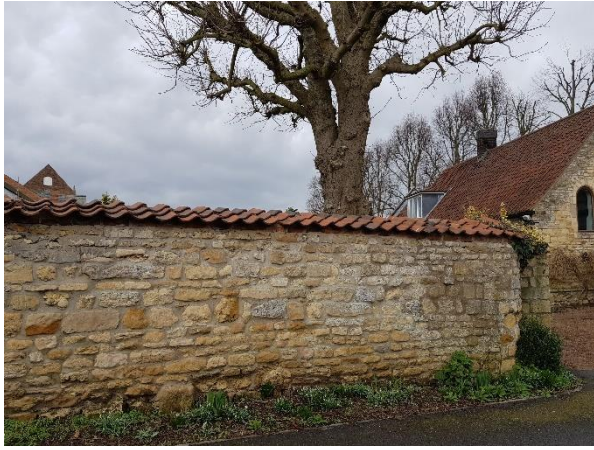
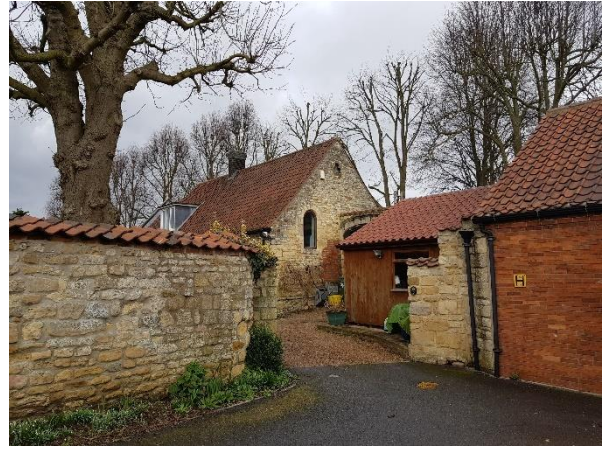
**Figure 29** Wall and gateway entrance to 5 East Bight on the west side of the north end of James Street.

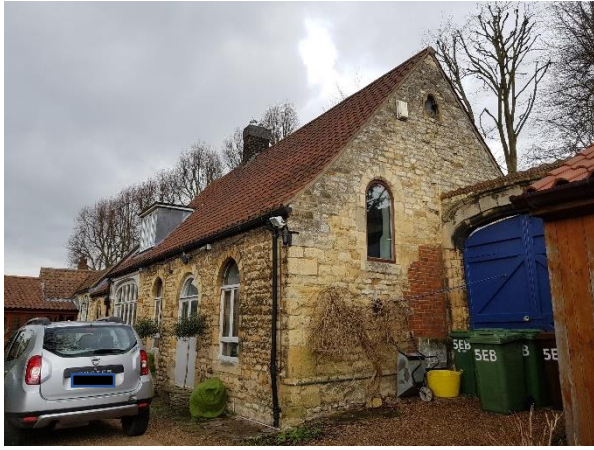
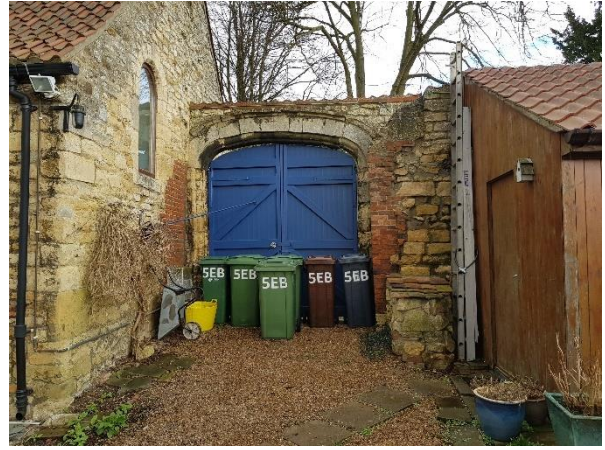
**Figure 32** View looking northwest to the southeast corner of the dwelling showing the east gable end and south elevation (L) and the gates to East Bight looking north (R).

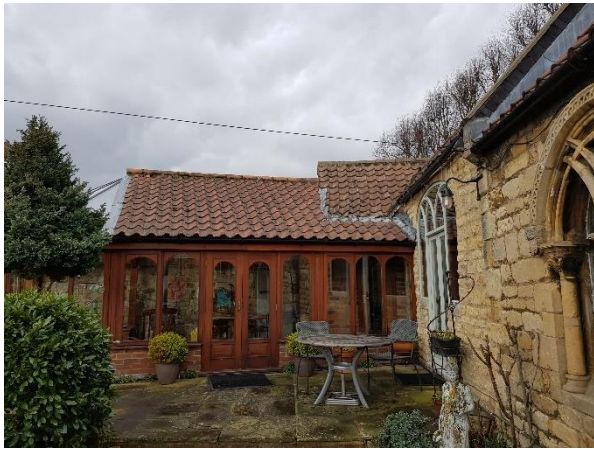
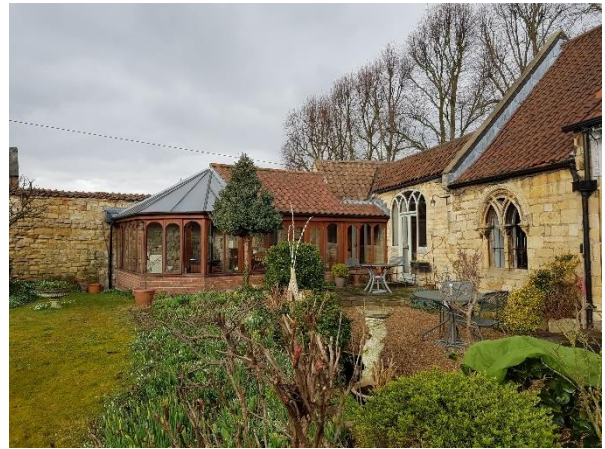
**Figure 33** Looking west to the side of the conservatory constructed in 2001 (L) and looking northwest from the garden to the west end of the dwelling (R).

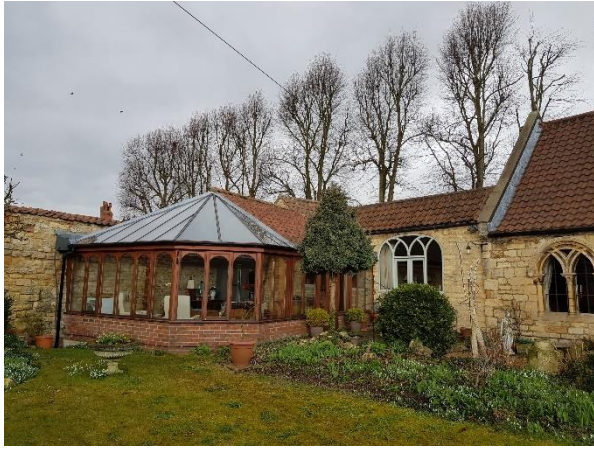
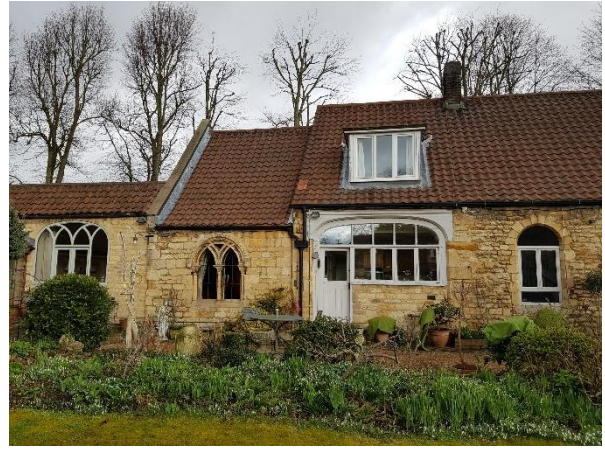
**Figure 35** Looking northwest to the west end of the southern elevation of the dwelling where significant additions have been made in c.1987 and 2001 (L) and looking north to the west end of the 19<sup>th</sup> century former stables and coach house (R).

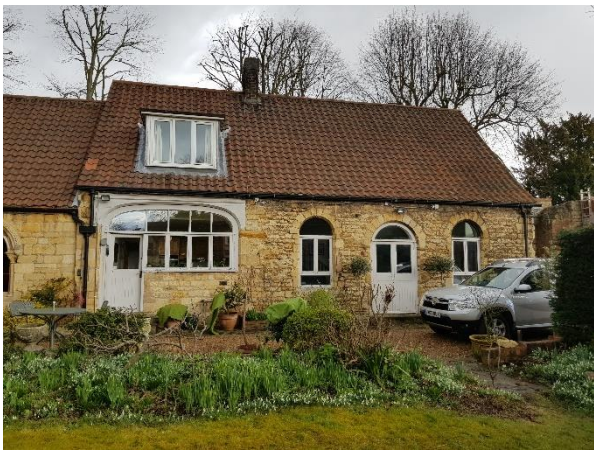
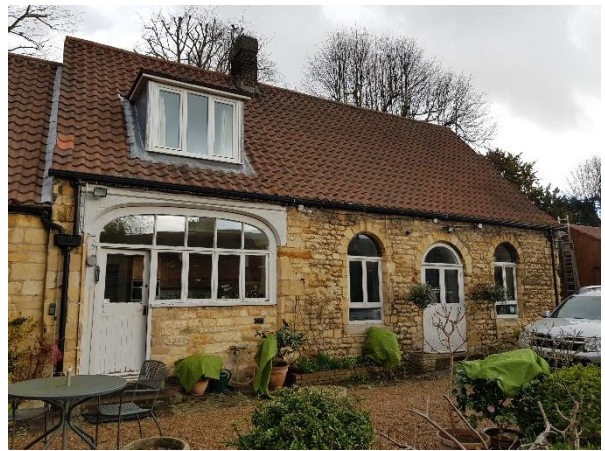
**Figure 36** Views looking north to the east side of the south elevation showing the former coach house opening to left of image and c.1961 dormer insertion.

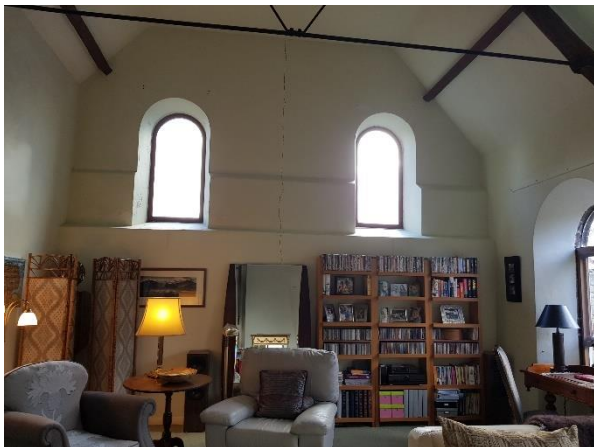
**Figure 37** View looking east (L) and west (R) within the east side 'great hall' showing the c.1961 conversion to a dwelling.

The c.1961 conversion of the building saw significant change to the original building, but as it was the complete conversion of a utilitarian outbuilding to domestic accommodation, this is not unexpected. The inspection noted that there has been little alteration to the fabric of the c.1961 conversion itself and post-1986 additions have altered the former western building 'garage' and absorbed it within an infill for the current sitting room and the large conservatory built in 2001. While the sitting room infill detailing has been approached in a sympathetic manner using stonework and an arched window and door arrangement, the conservatory, while subservient in height, is not a sympathetic addition to the historic building or its original layout. It was noted that there has been considerable change particularly where the west side of the study area.

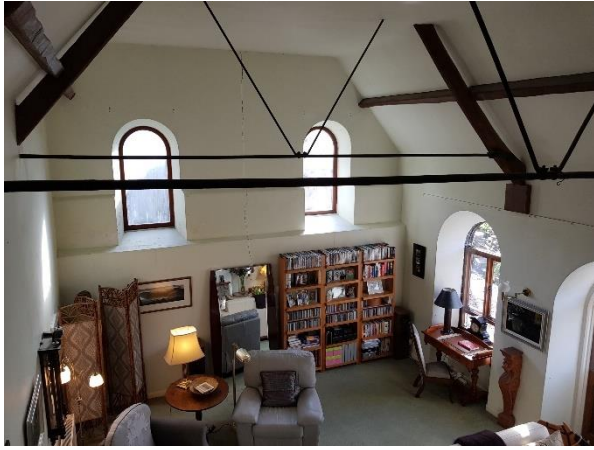
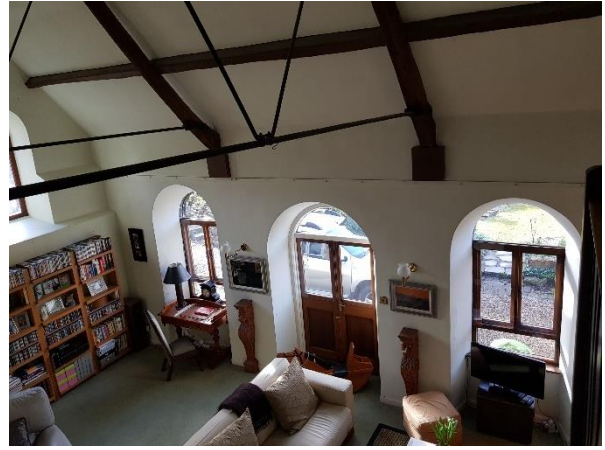
**Figure 38** Views from the upper stair landing looking east (L) and southeast (R) into the 'great hall' space at the east end of the building.

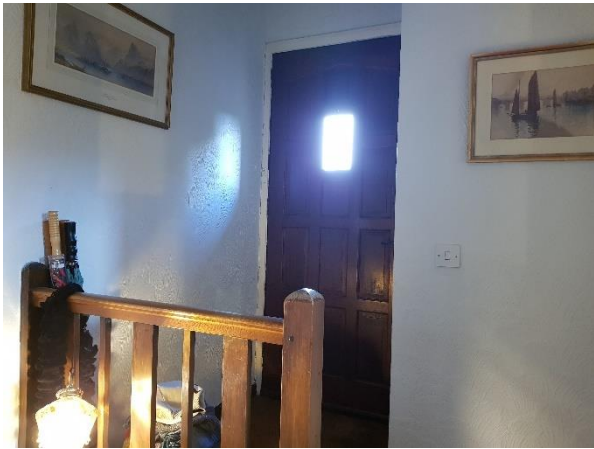
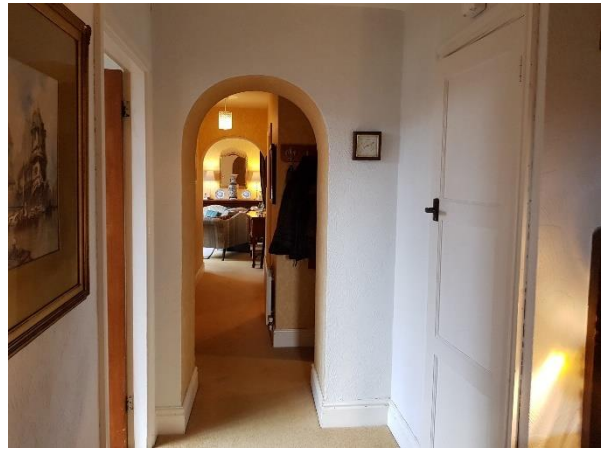
**Figure 39** View looking north to the front door inserted c.1961 (L) and looking west along the central ground floor corridor from the front entrance hall (R).

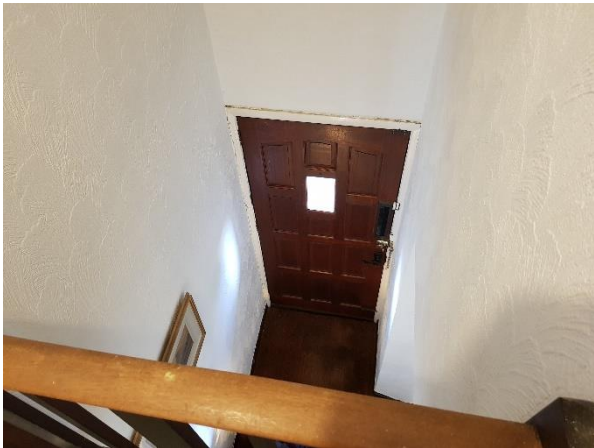
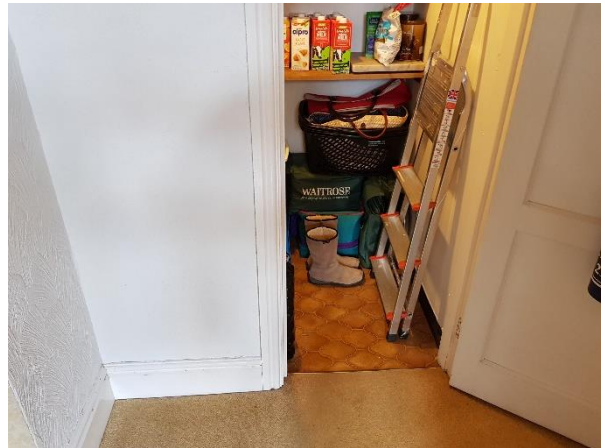
**Figure 40** Looking down from the upper landing to the front door (L) and one of the c.1961 cupboards west of the front door (R).

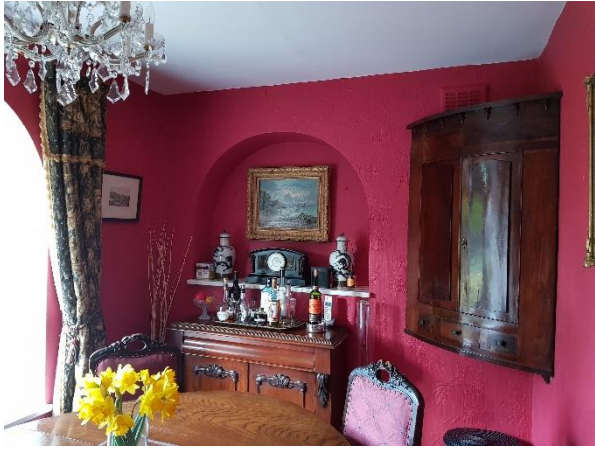
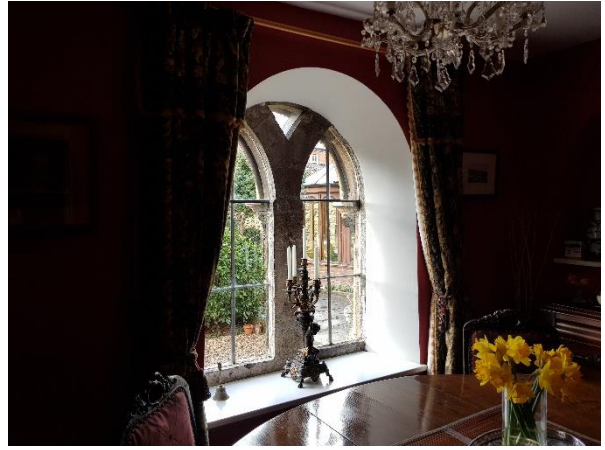
**Figure 41** Views looking west (L) and southwest (R) in the dining room on the south side of the dwelling. This is within a small extension made 1850-1888 that contains a carved 'Norman' style window and iron bars that reputedly is copied from a detail in the Cathedral.

The decorative carved stone neo-Norman window referred to by Pevsner survives within the south elevation of the 1850-1888 extension on the west side of the original building and reputedly reflects a design found within the Cathedral. The original building, as noted in 1958 images was a high-quality building with some fine architectural detailing for what appears to have been a purpose-built stables and coach house located at the very north end of the grounds of Cottesford Place.

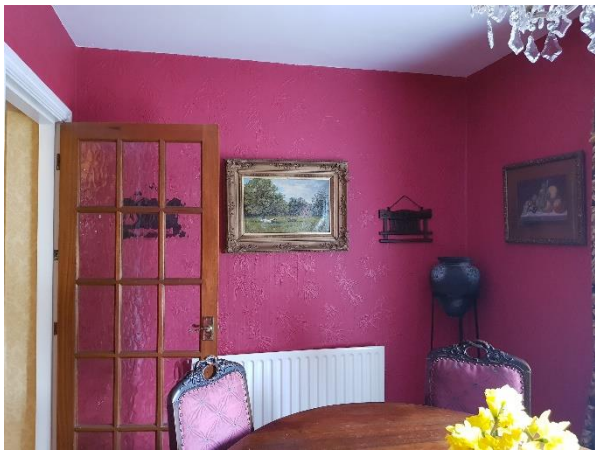
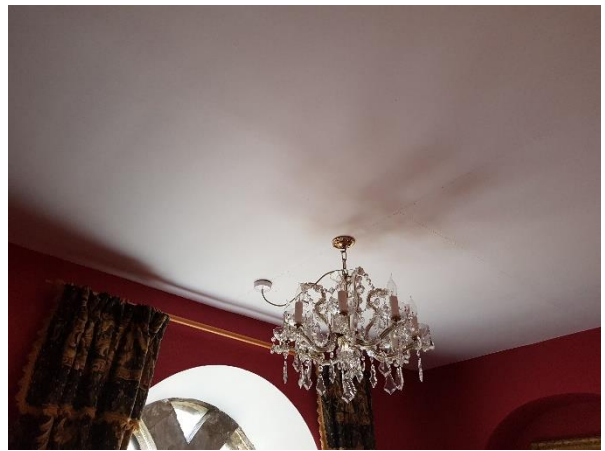
**Figure 42** View looking east within the dining room (L) and ceiling detail (R).

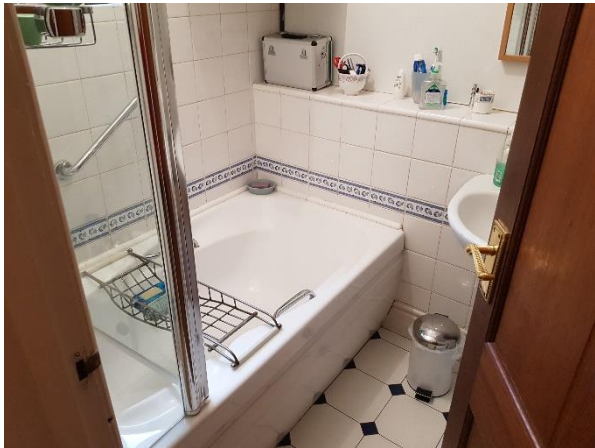
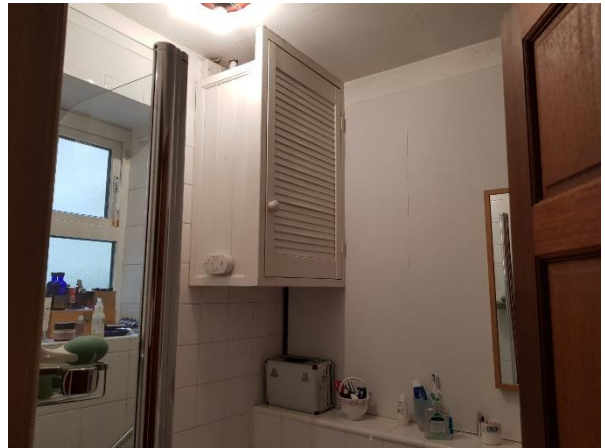
**Figure 43** Modern bathroom insertion on north side of the house with a window into the small courtyard 'area' to the west.

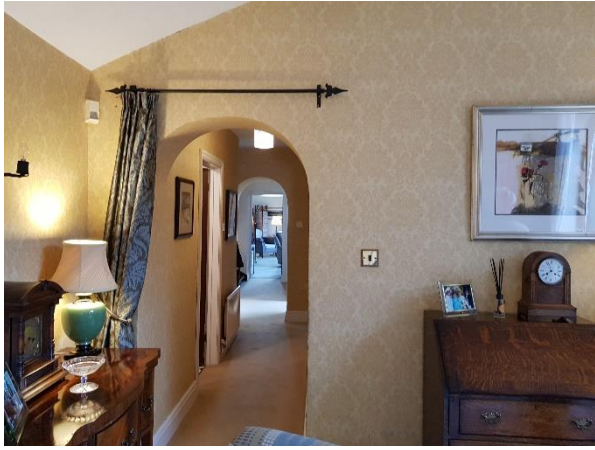
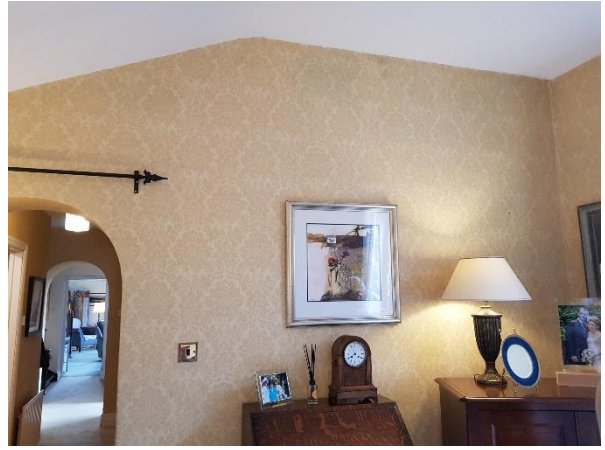
**Figure 44** Views looking east from the post-1986 infill sitting room towards the former external wall of the 1850-1888 extension.

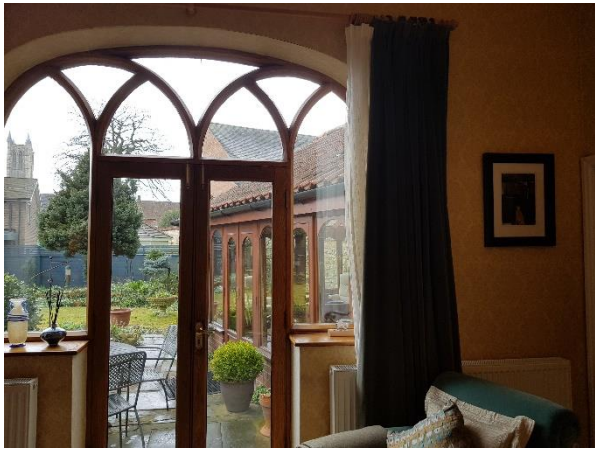
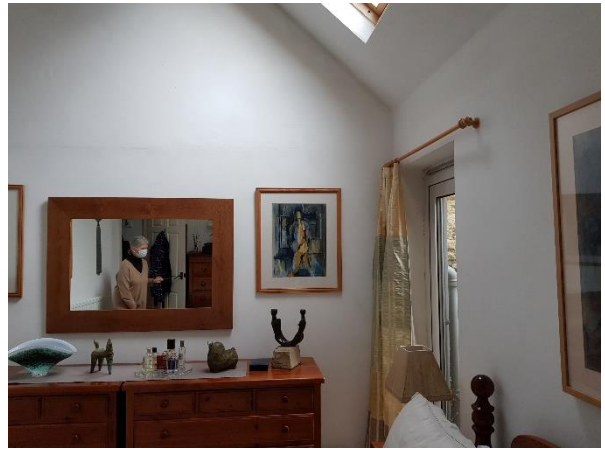
**Figure 45** View looking south from the post-1986 extension sitting room to the garden (L) and looking north within the northwest corner bedroom in the post-1986 extension (R) (within the area of a former outbuilding/later garage).

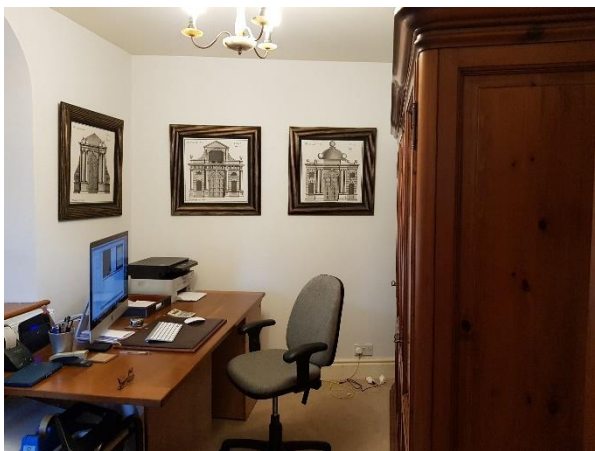
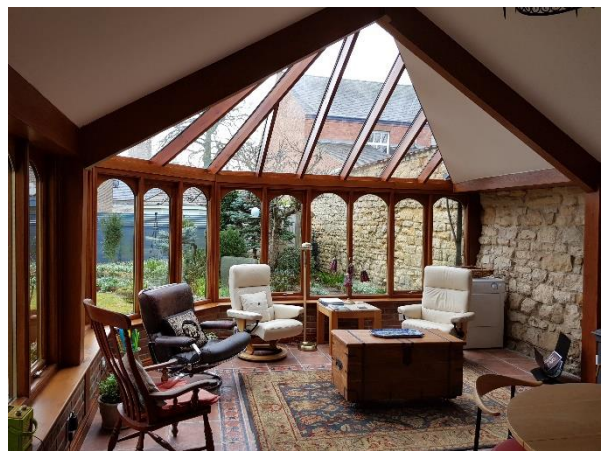
**Figure 48** Looking west within the office on the west side of the dwelling (L) and looking south into the conservatory built in 2001 (R).

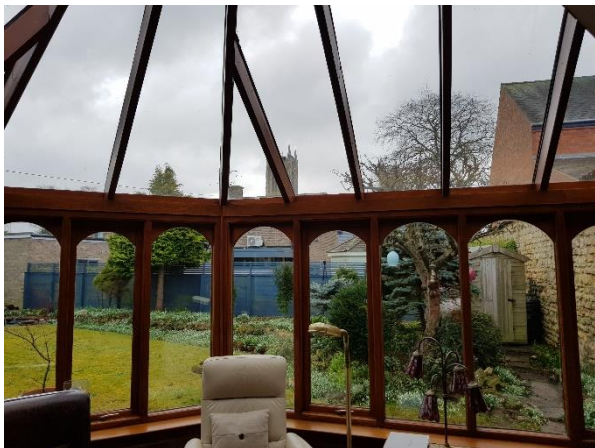
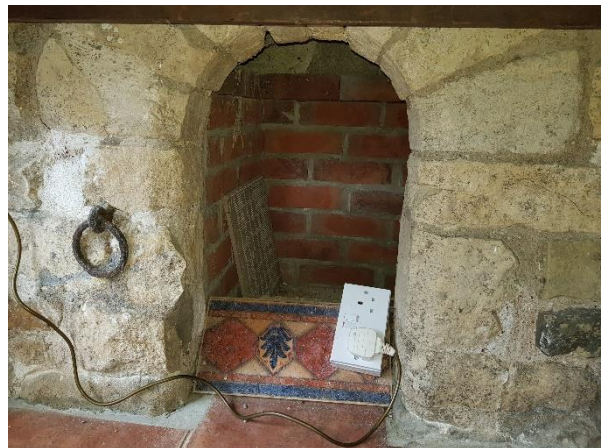
**Figure 49** View towards the Cathedral from the southern end of the conservatory (L) and the stone arched opening in the west close wall within the conservatory (R). Original purpose is not known, but could it have been the location of a source of water? A similar arch was noted in the north wall of the small courtyard area – possibly a culvert or drain?

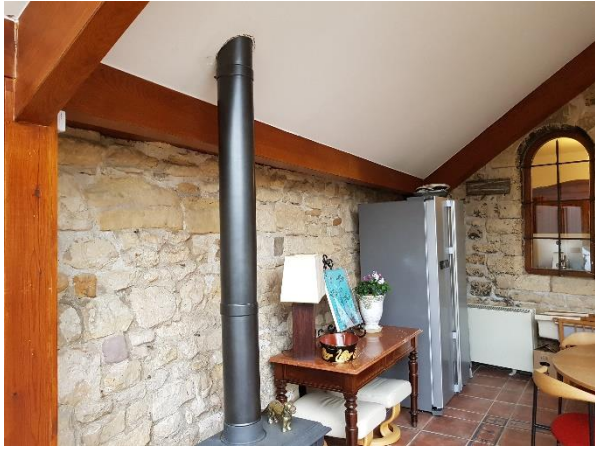
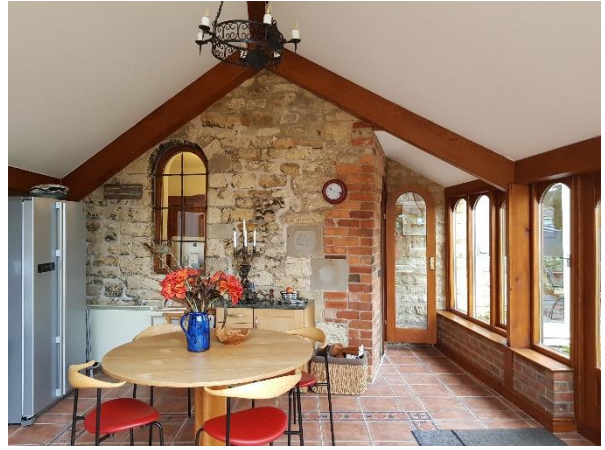
**Figure 50** Views looking north within the conservatory built in 2001 against the western close wall.
