5 East Bight,  
Lincoln

*Assessment of Significance*

*Completed for  
Mr & Mrs Sullivan &  
John Roberts Architects*

AUSTIN HERITAGE  
CONSULTANTS

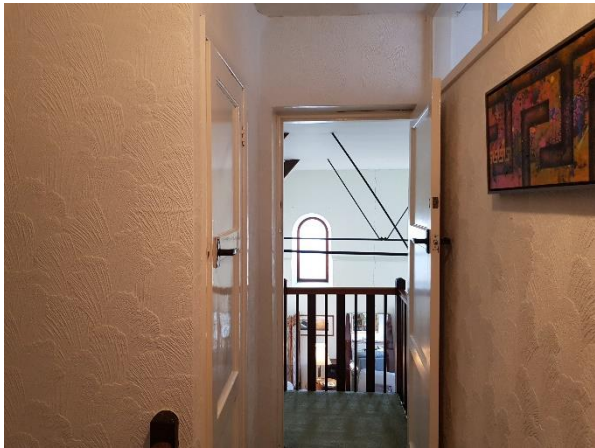
**Figure 51** Looking east along the upper corridor towards the stair landing (L) and looking southeast into the centre first floor bedroom with a dormer window that was inserted in the south roof pitch in c.1961 (R).

Although no drawings were found to show the changes in 1961, the interior of the building does not appear to have been dramatically altered since its original conversion and the image at Figure 17 shows that the changes included a dormer in the south pitch of the roof for the bedroom; retention of the coach house door archway, but infill with stone work, upper glazing and part-glazed door within the west side of the opening; replacement of the multi-pane arched windows and panelled door with new windows and a pair of part-glazed doors; chimney installed in the ridgeline; complete replacement of roofing with pantile (but it would appear that the garage building retained its flat tile roof in 1961).
