A Preliminary Ecological Appraisal & Assessment of The Barn at Windyridge.

Aim: To establish the presence or absence of bats & birds in the building & importance of adjacent habitats.

██████████
Windyridge
Tewkesbury road
Coombe Hill
GL19 4AR

Reference: 1G\Bat & bird's survey.doc
7th May 2021

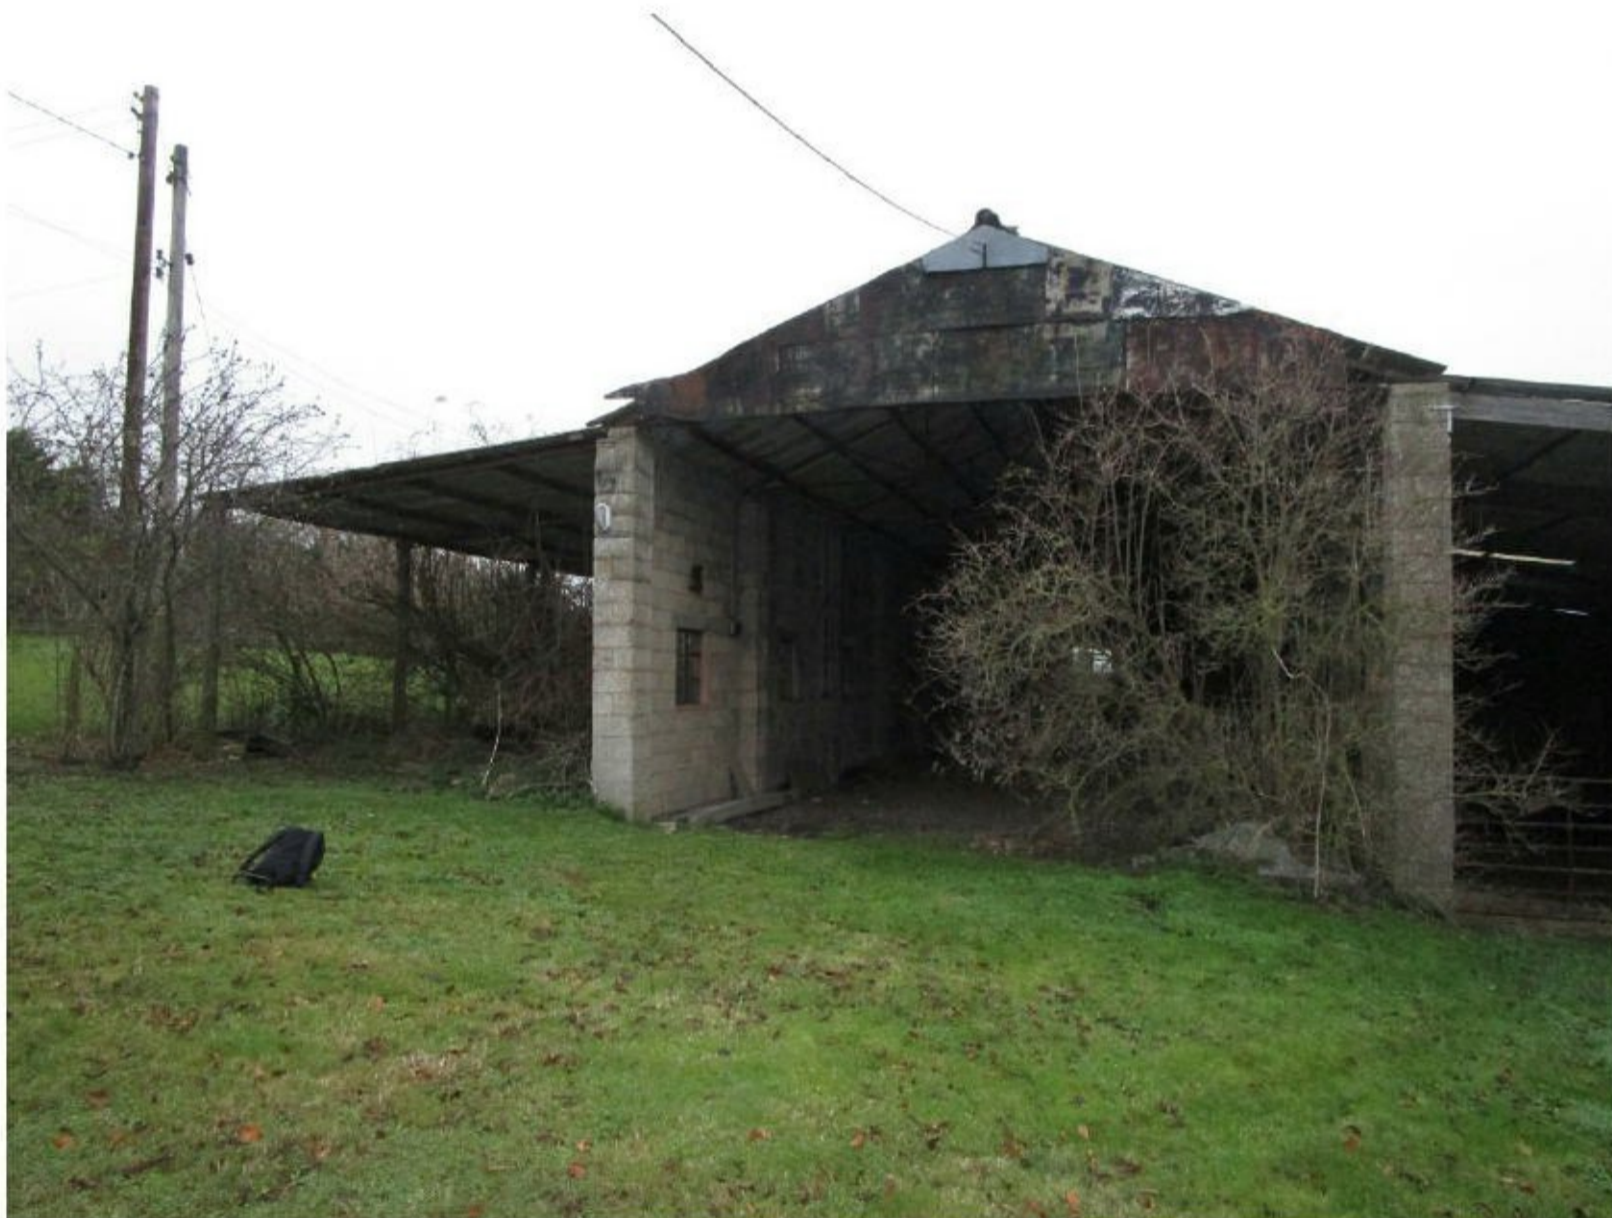
Figure 1: The south western elevation of the first section of the barn and the lean to

The external breeze block walls are exposed but are all well-sealed with no cracks or crevices in them as shown in figure one above. The western side of the first enclosed section of the barn has glazed metal framed windows with an adjacent lean-to section of the building on the south eastern and north western side of the building as shown above in figure one & over the page in figure four.

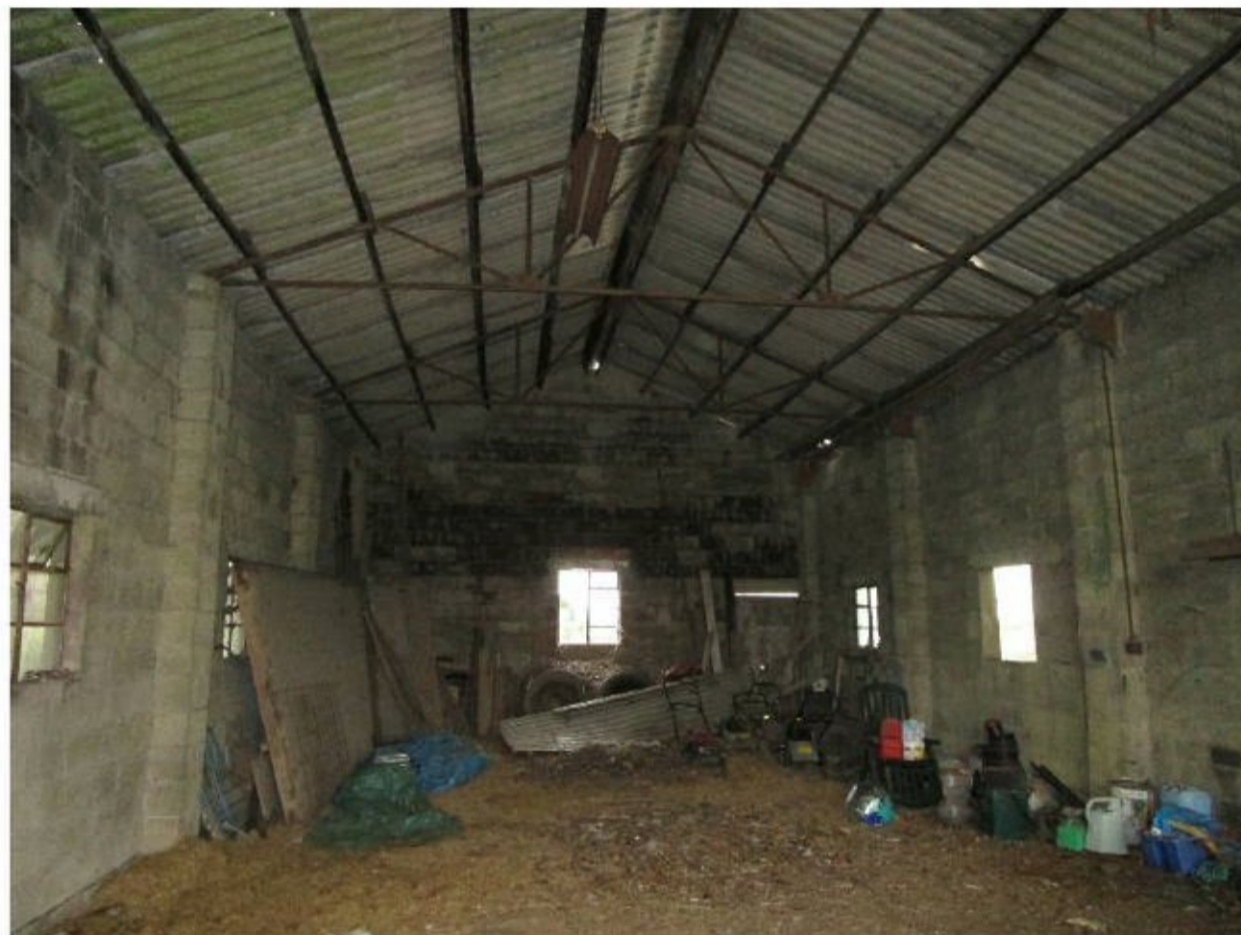
Figure 2 – The northern gable wall and side elevations of section one

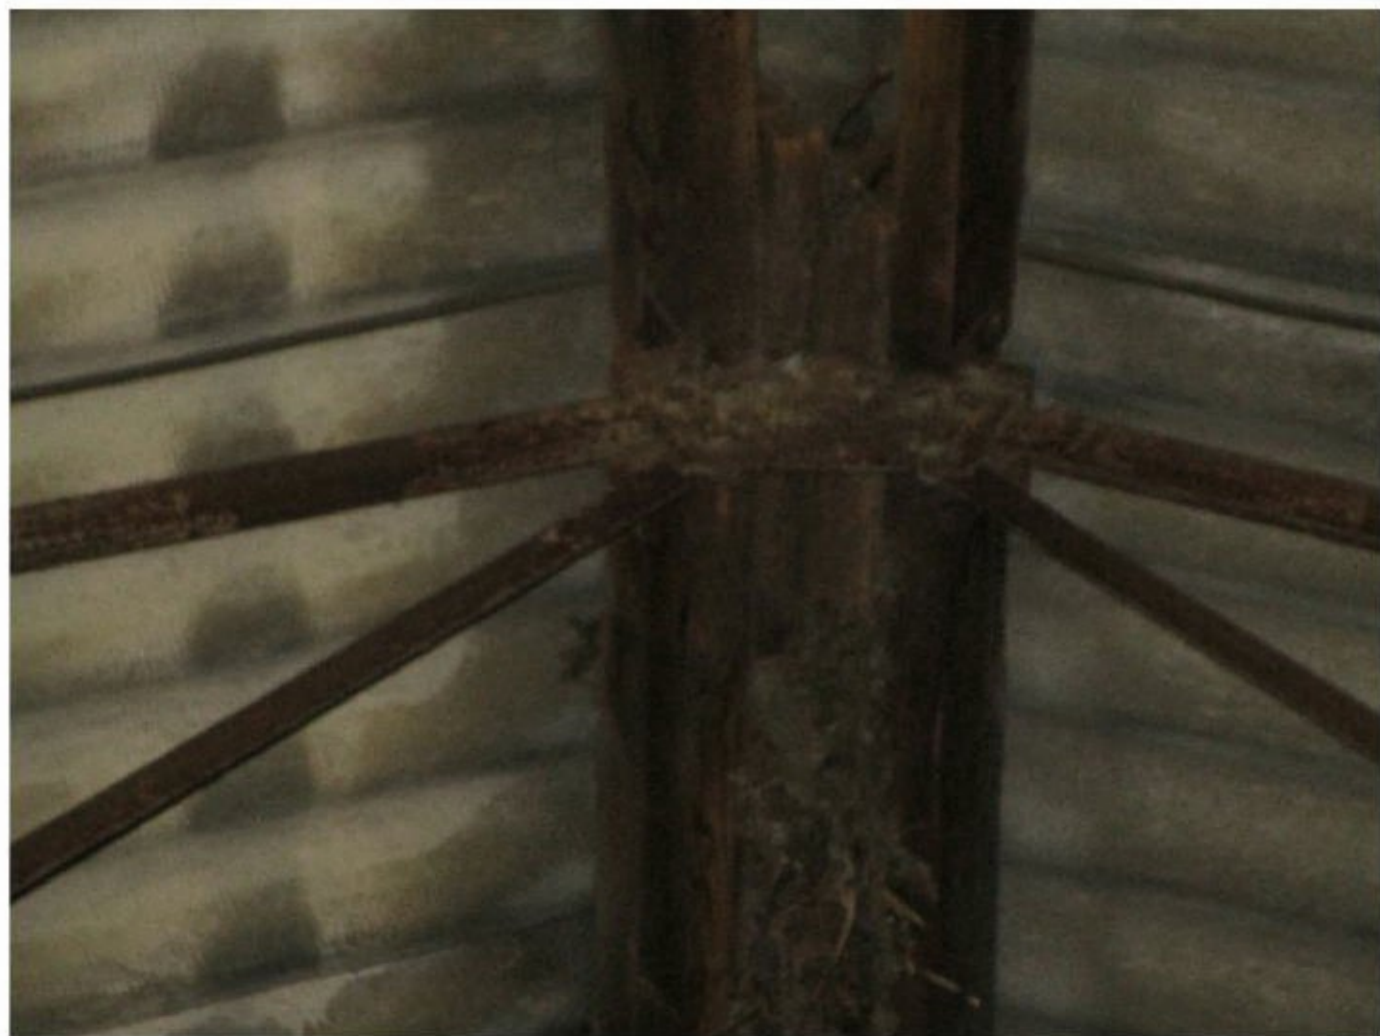
Despite the direct flight access into this area, it offers little roosting potential due to the lack of gaps or crevices in the walls or roof & the large amount of natural light. The corrugated composite roofing sheets are unlined and there are five glazed windows in the internal walls. The metal & timber roof frames are heavily covered in cobwebs. One jackdaw nest was observed within the barn as shown in figure three.

Figure 3 – cobwebs and one Jackdaw nest found

There was evidence of nesting birds within the barn, as such works to the central part of the barn will have to be carried out outside of when the jackdaws are nesting in this part of the barn. The main nesting season is considered to be April to August.

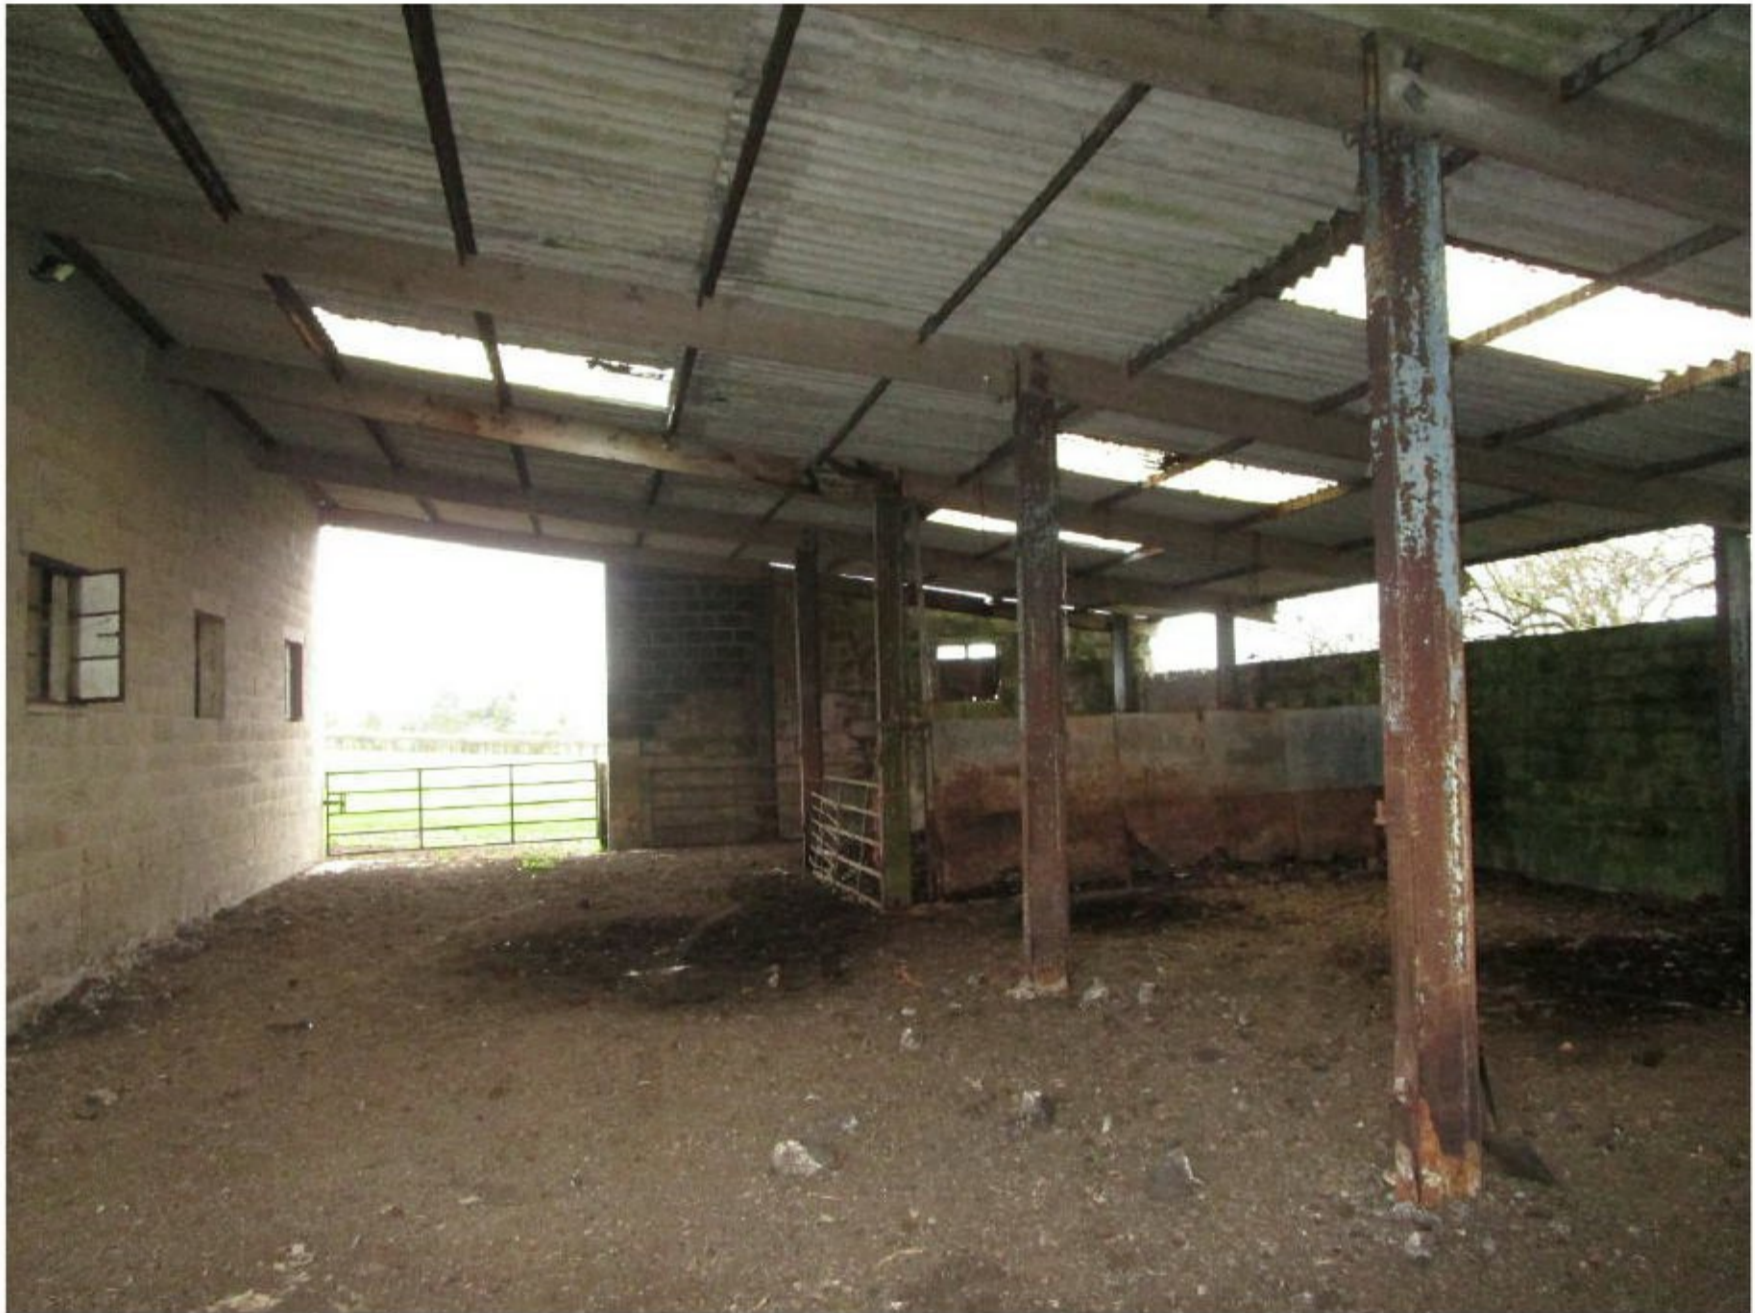
Figure 4 - the interior of the south-eastern lean-to section of the barn

Both sections of the barn are of breeze block construction and have a hard standing floor. In the second section there is a large ivy which has grown through a gap in the south western elevation wall as shown in figure five. At the corner of this large lean-to section there is a cattle pen formed with rusty metal sheets as the walls as shown above in figure four.

This second lean-to section of the barn has metal RSJ from floor to roof holding up large timbers that have considerable rot and water damage as seen in figures four above and in figure five over the page.

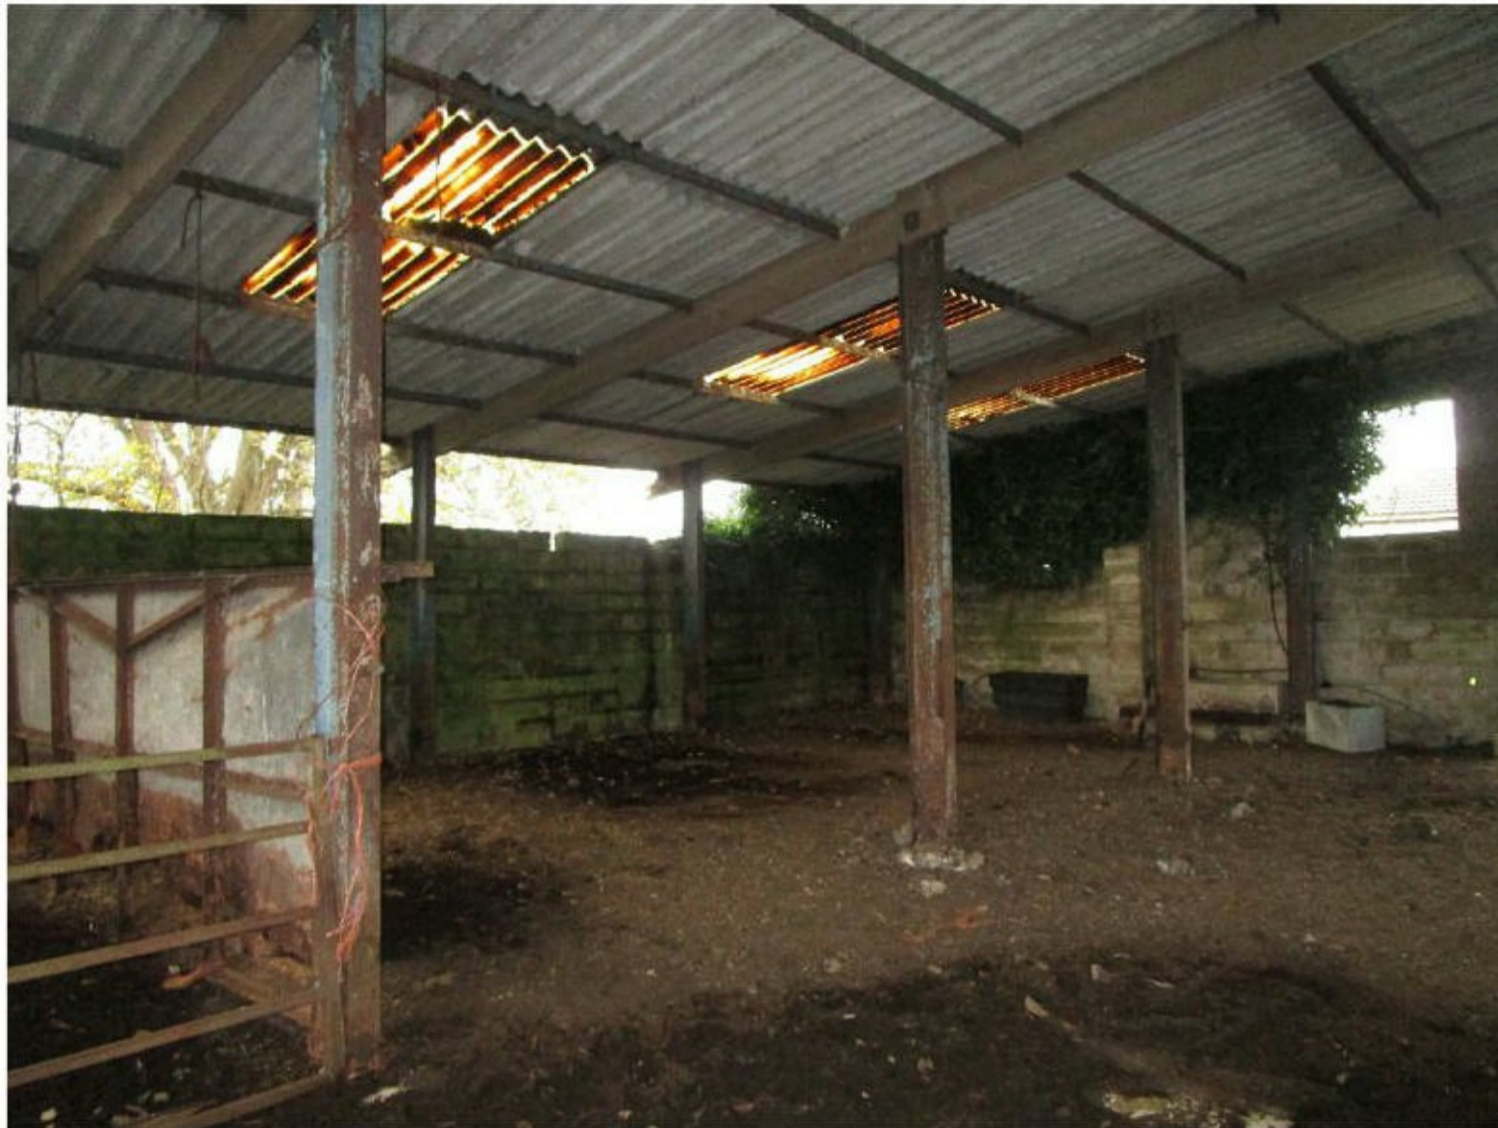
Figure 5 – The internal northern elevation & side wall of the manor

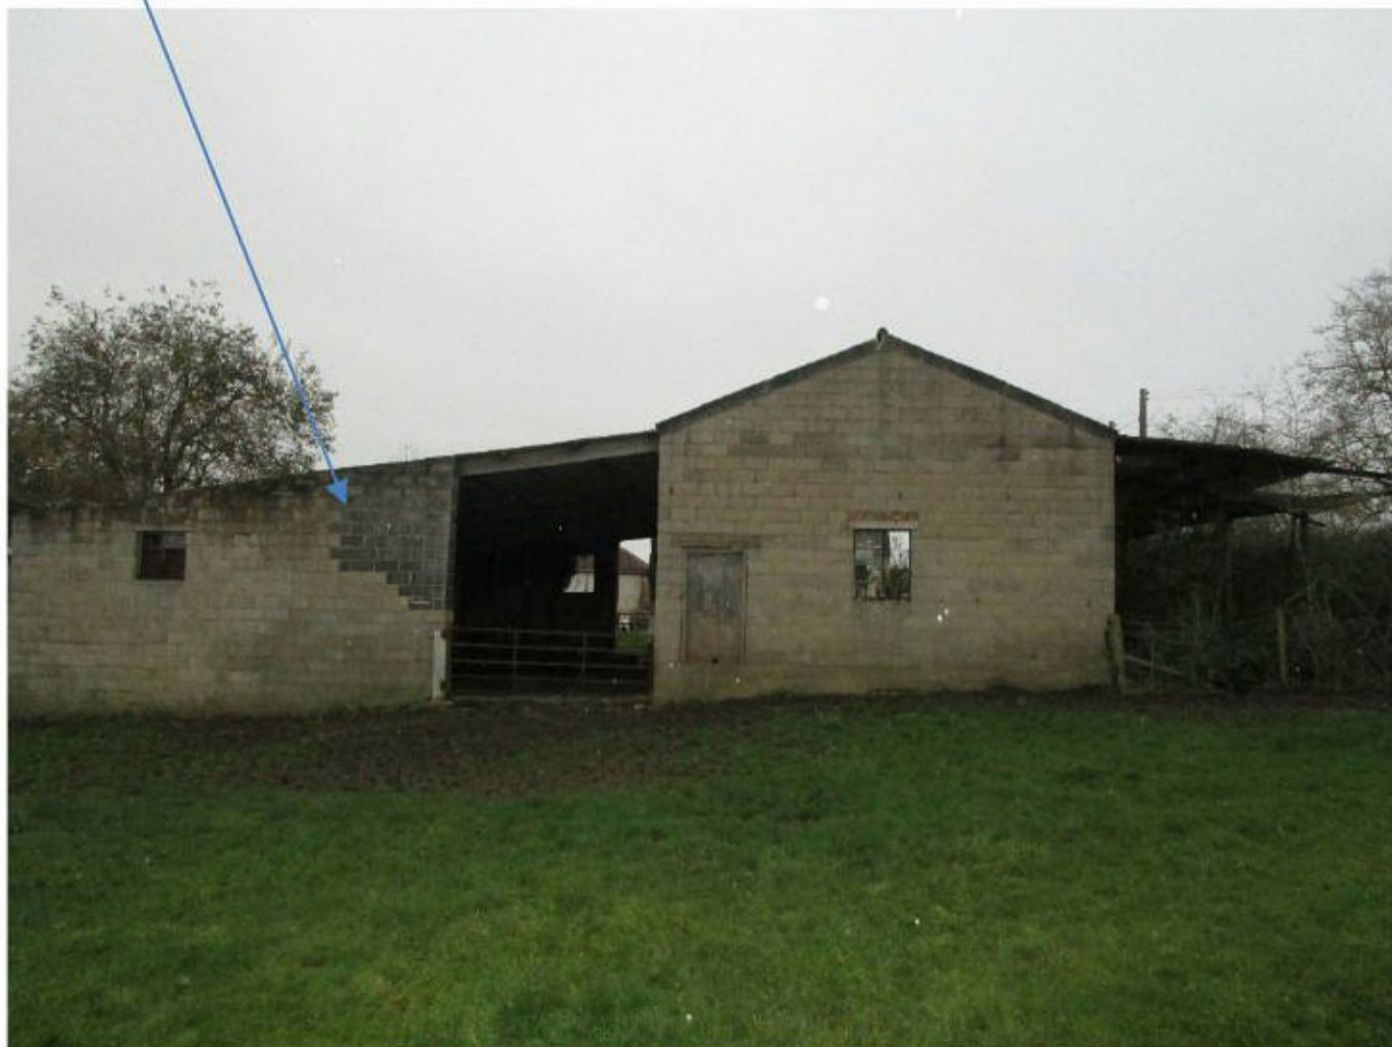
The north eastern elevation wall of the barn as shown below in figure six shows a small timber door on the north eastern gable end of the tallest section of the barn with the two lean to areas coming off this part of the barn & the partly repaired breeze block wall of the lean to.

Figure 6 – the northern elevation

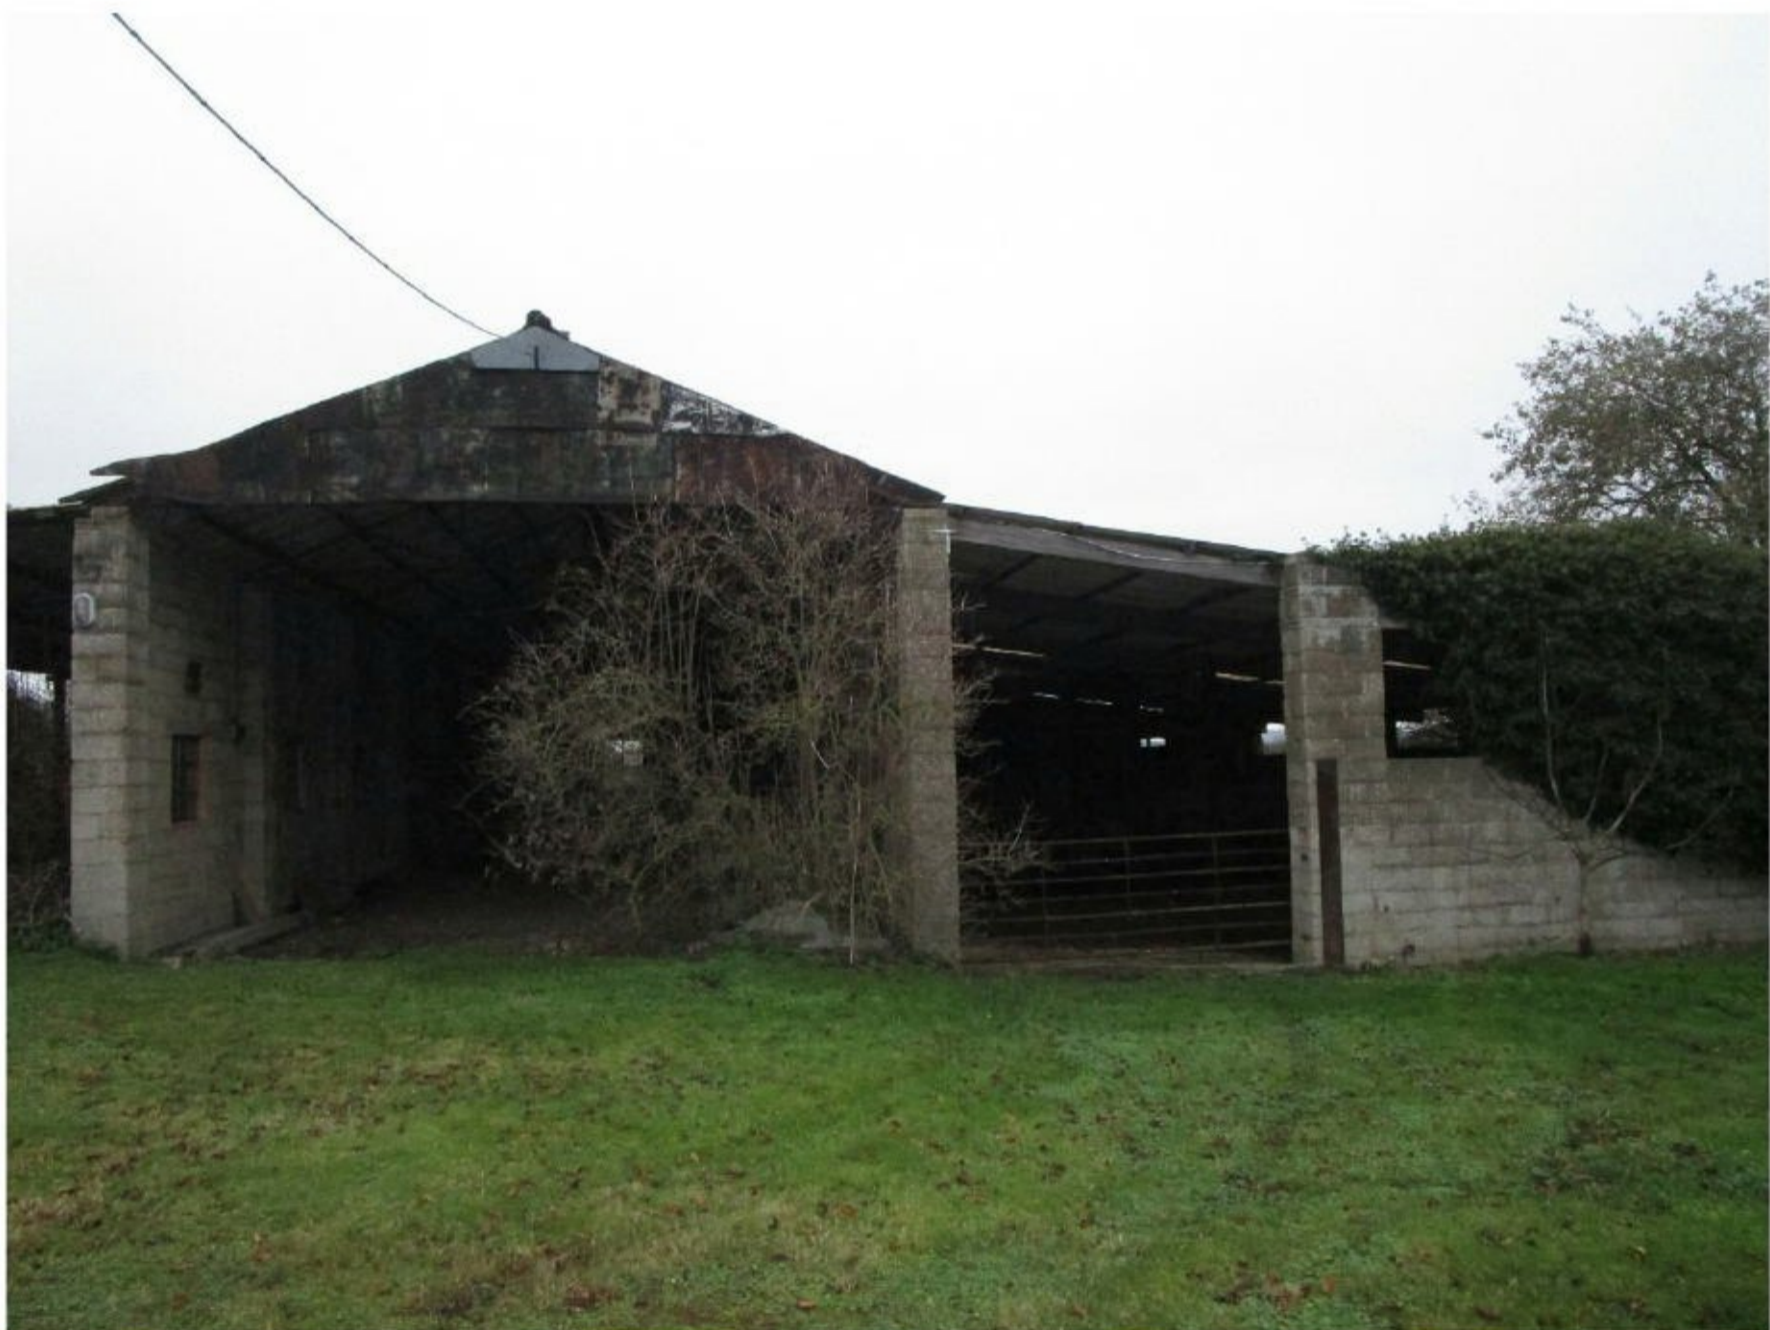
Figure 7 – the southern elevation view of both sections of the barn

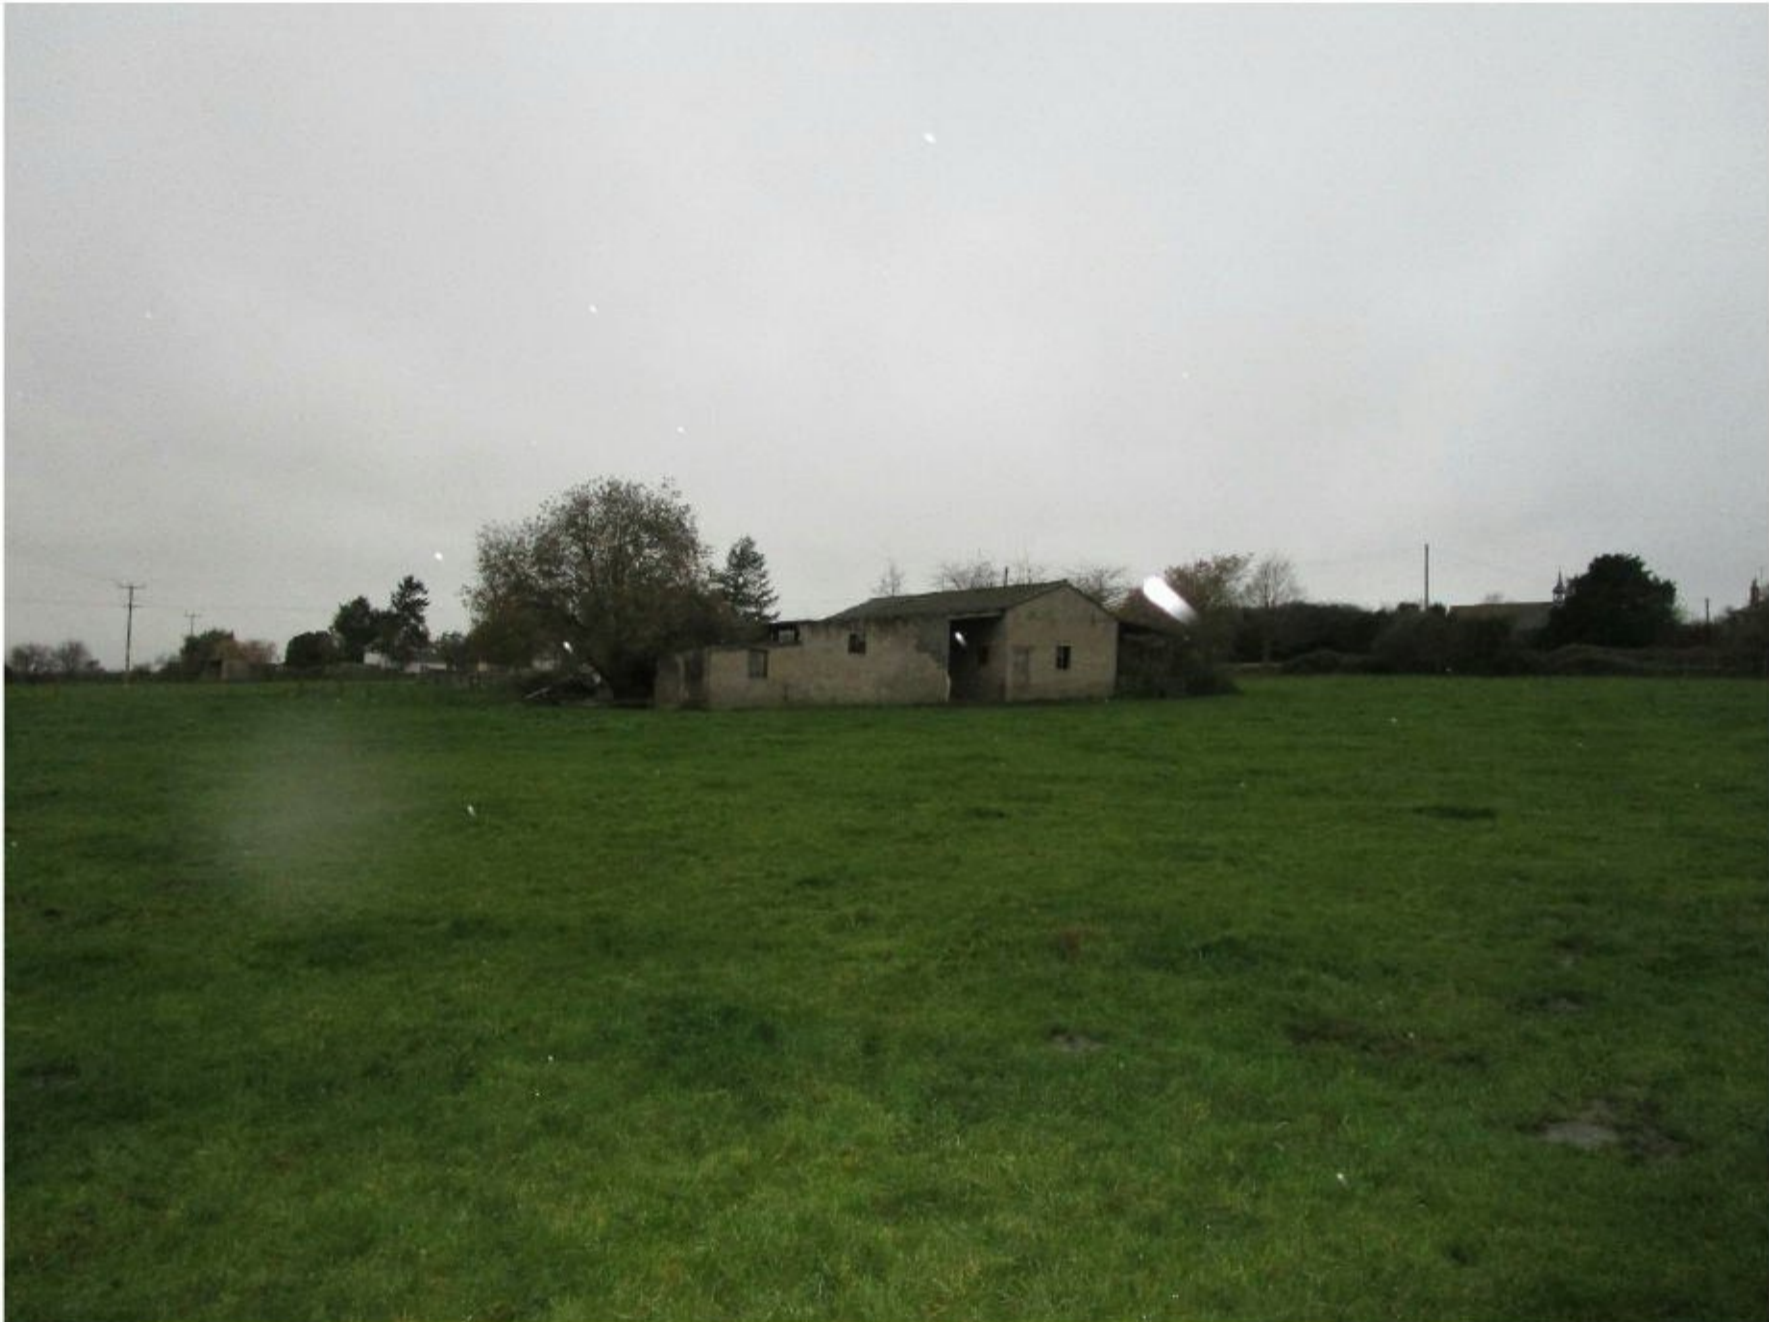
The area adjacent to the building to be affected by this proposal is predominately comprised of hard standing that has some vegetation cover and access drive and parking area. On the rear northern elevation, east and western elevation of the barn there is a permeant grass field comprised of a semi-improved grassland habitat that would be considered to be species poor semi-improved grassland as shown below in figure eight.

Figure 8 – The outside area to the rear of the barn

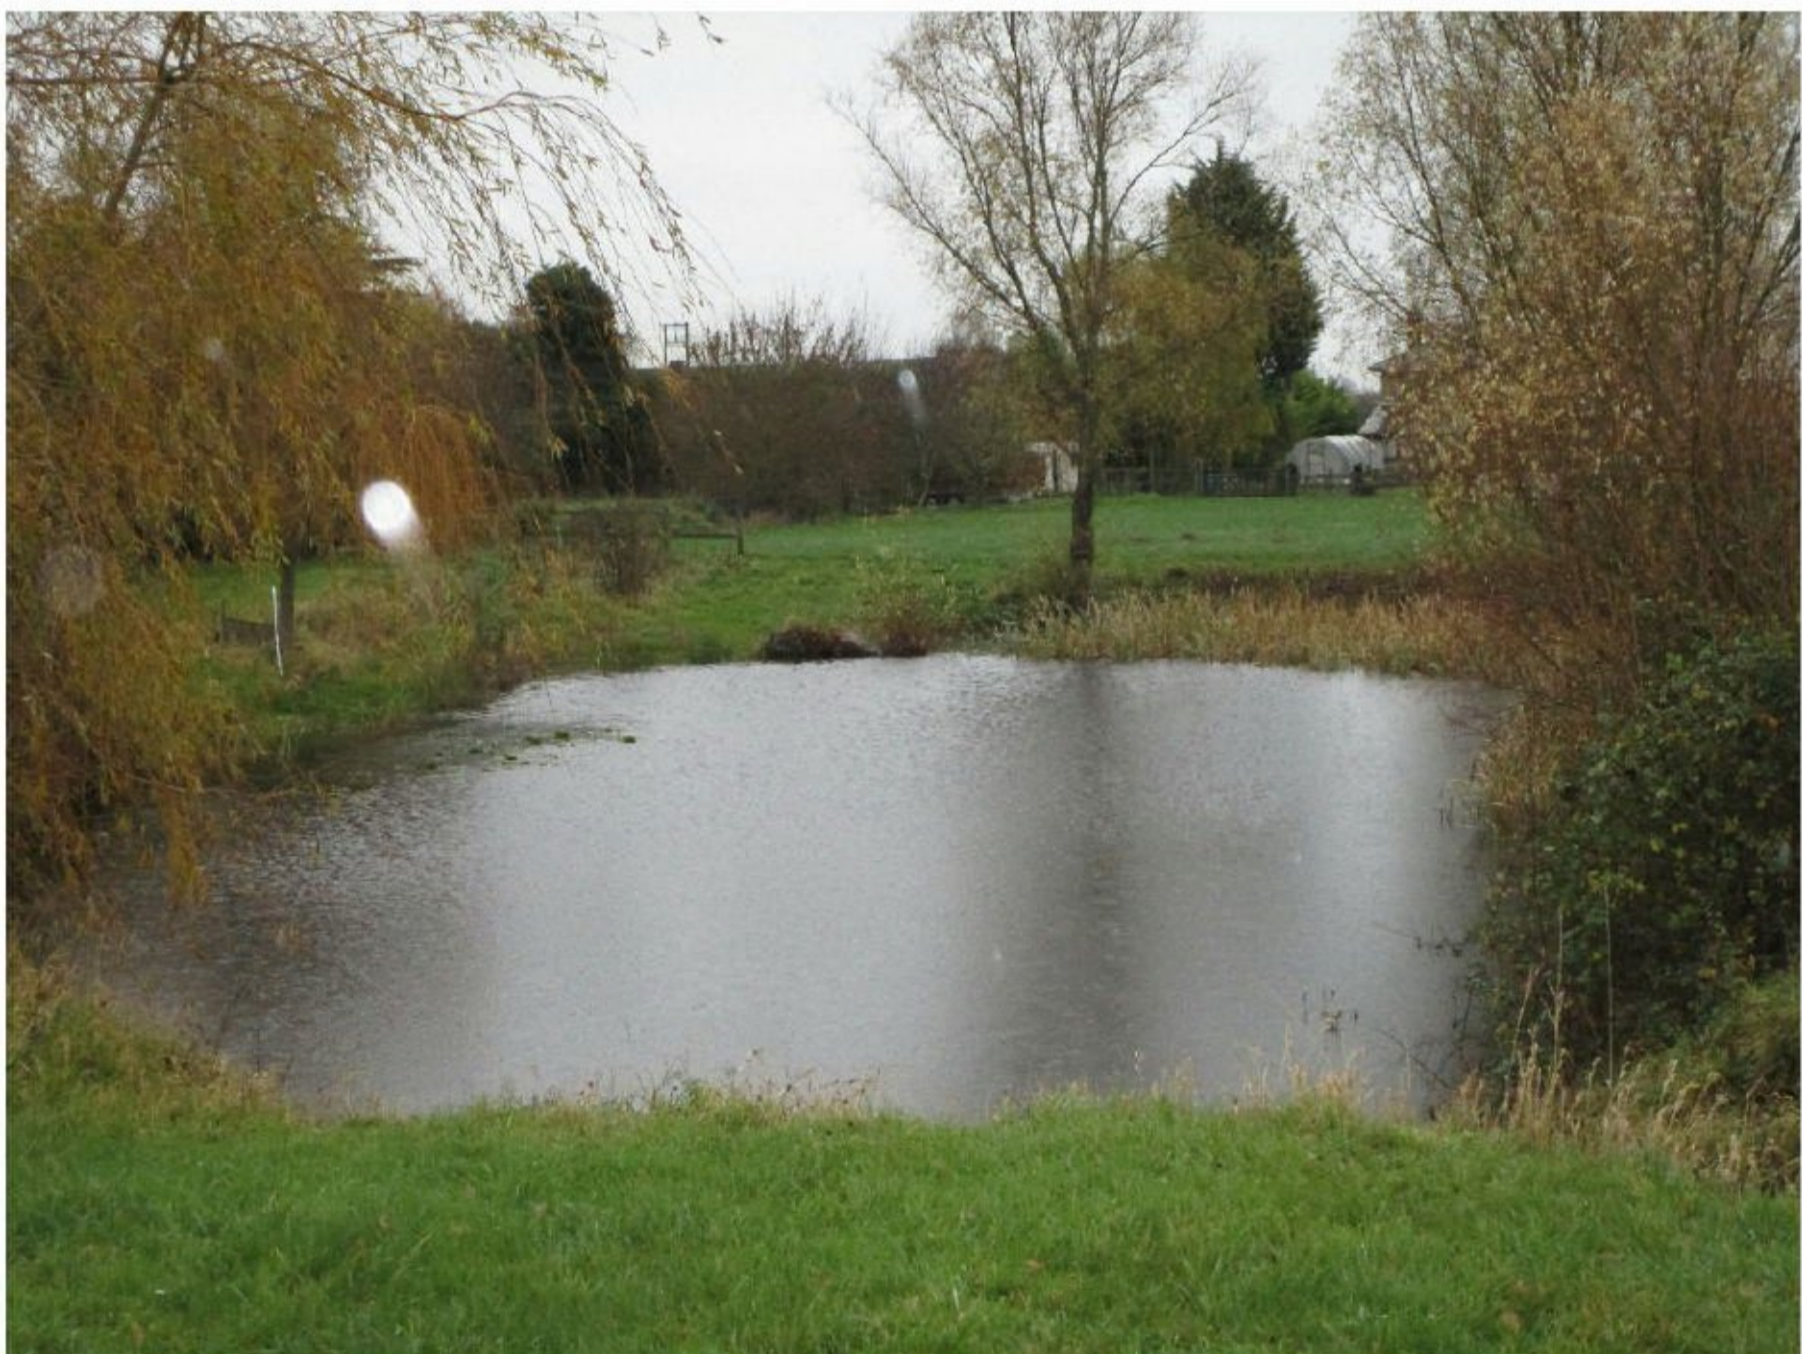
Figure 9 – The pond to the north of the site

The pond is a large pond which appears to be connected to a watercourse & also appeared that local conditions suggest that fish may be present. The limited emergent vegetation & close proximity of a regularly mown residential garden appeared to offer a below average value to Great Crested Newts.

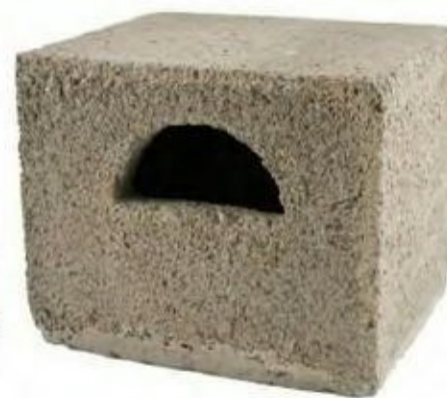
integral soffit bat box

As an enhancement for bats several integral bat boxes such as soffit bat boxes will be included at the edge of the roof of the converted barn to encourage future use of the barn by bats as shown in Appendix five.

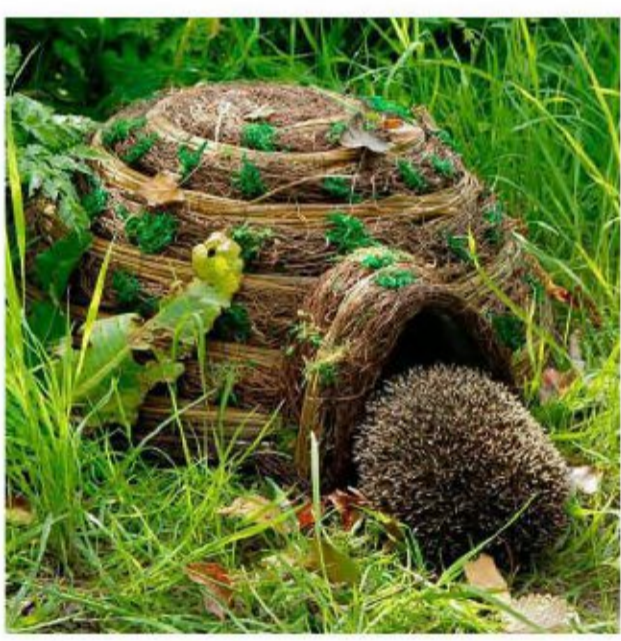
HEDGEHOG HOUSE to be within the new native fruit trees

In addition, an insect house shall be erected on the southern elevation of the converted barn & a hedgehog house positioned at the edge of the gardens of the converted barn by the proposed native fruit tree planting area (an additional enhancement) shown on the plans in appendix five.

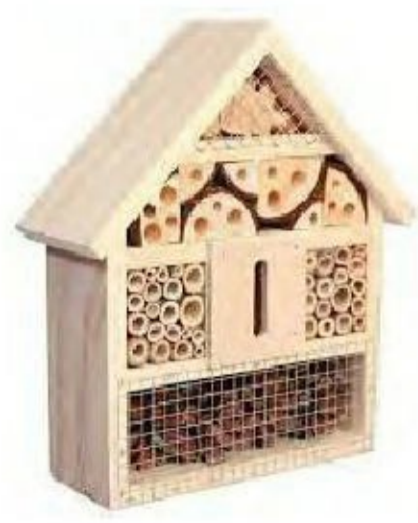
Insect House to be on the wall of the converted barn

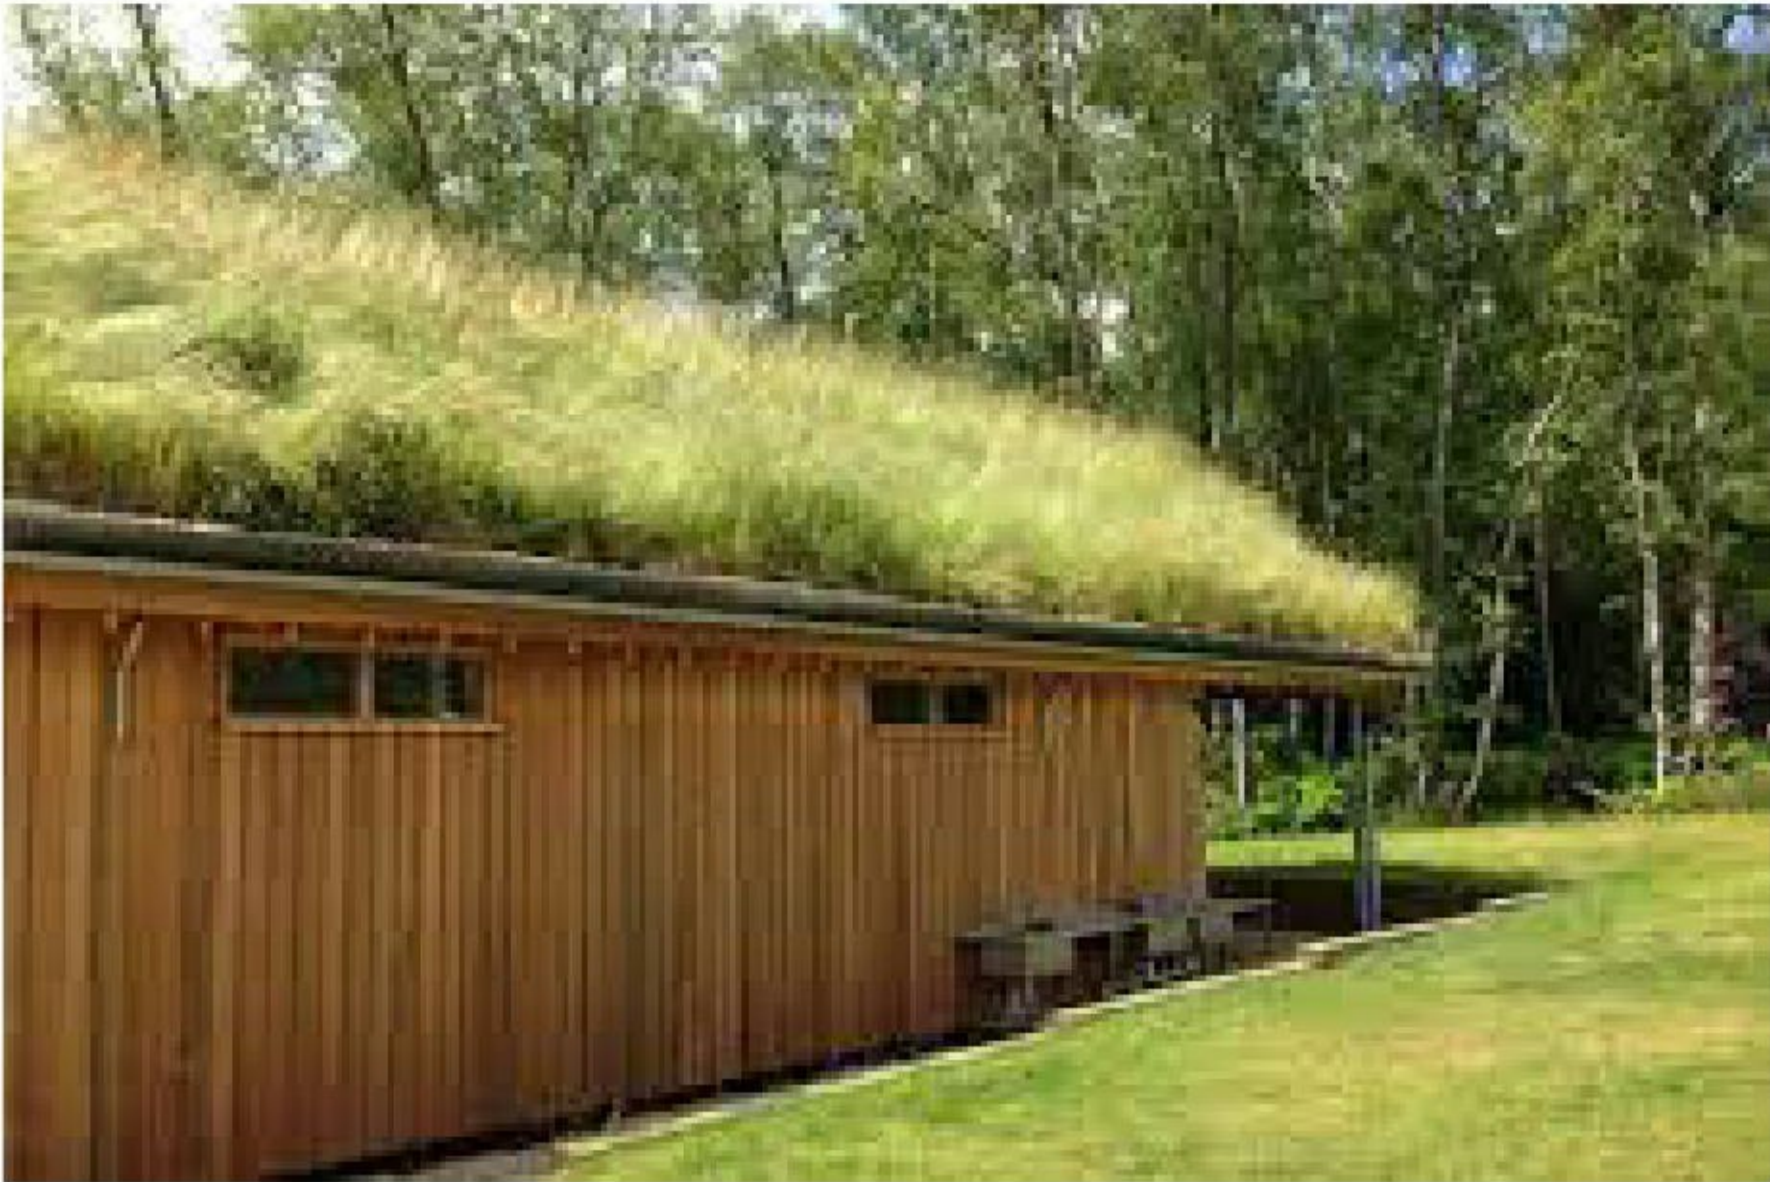
Green roofs from organic.roofs.co.uk suitable for flat or pitched roofs

Ideally any flat roofs included in the design of the converted barn will include green roofs such as the hay base system by the organic roof company to provide further wide-reaching enhancements for wildlife.
