# Wild Service

## The Barn, Gotherington

### Preliminary Ecological Appraisal & Bat Survey Report

Project Ref. EP2020036Av2

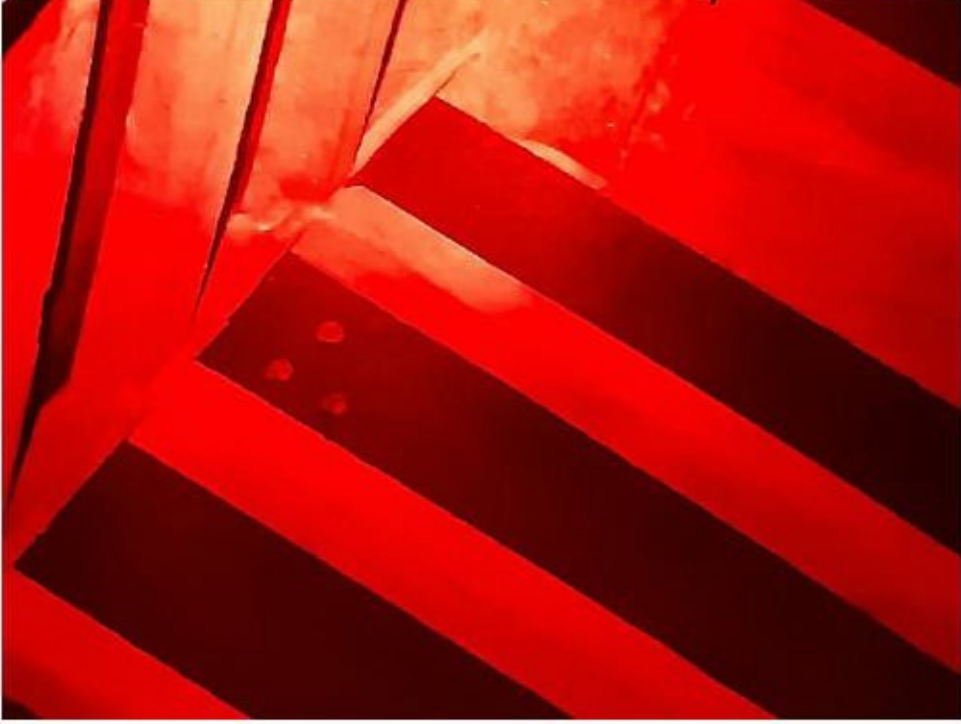
Three lesser horseshoe bats on the ceiling in the barn as seen during Preliminary Roost Assessment.
2

- 4.1.3 Due to the confirmed presence of a summer non-maternity day roost for lesser horseshoe, common pipistrelle bats and a Brandt's bat, and a night roost for lesser horseshoe bats, it will be necessary to apply for a European Protected Species (EPS) mitigation licence from Natural England prior to commencing any works. Details of the mitigation strategy must include plans for the compensation roosts showing the proposed bat roosting opportunities, timetabling of works and other necessary measures to avoid risks to bats. It should be noted that planning permission is required prior to applying for an EPS licence for developments.

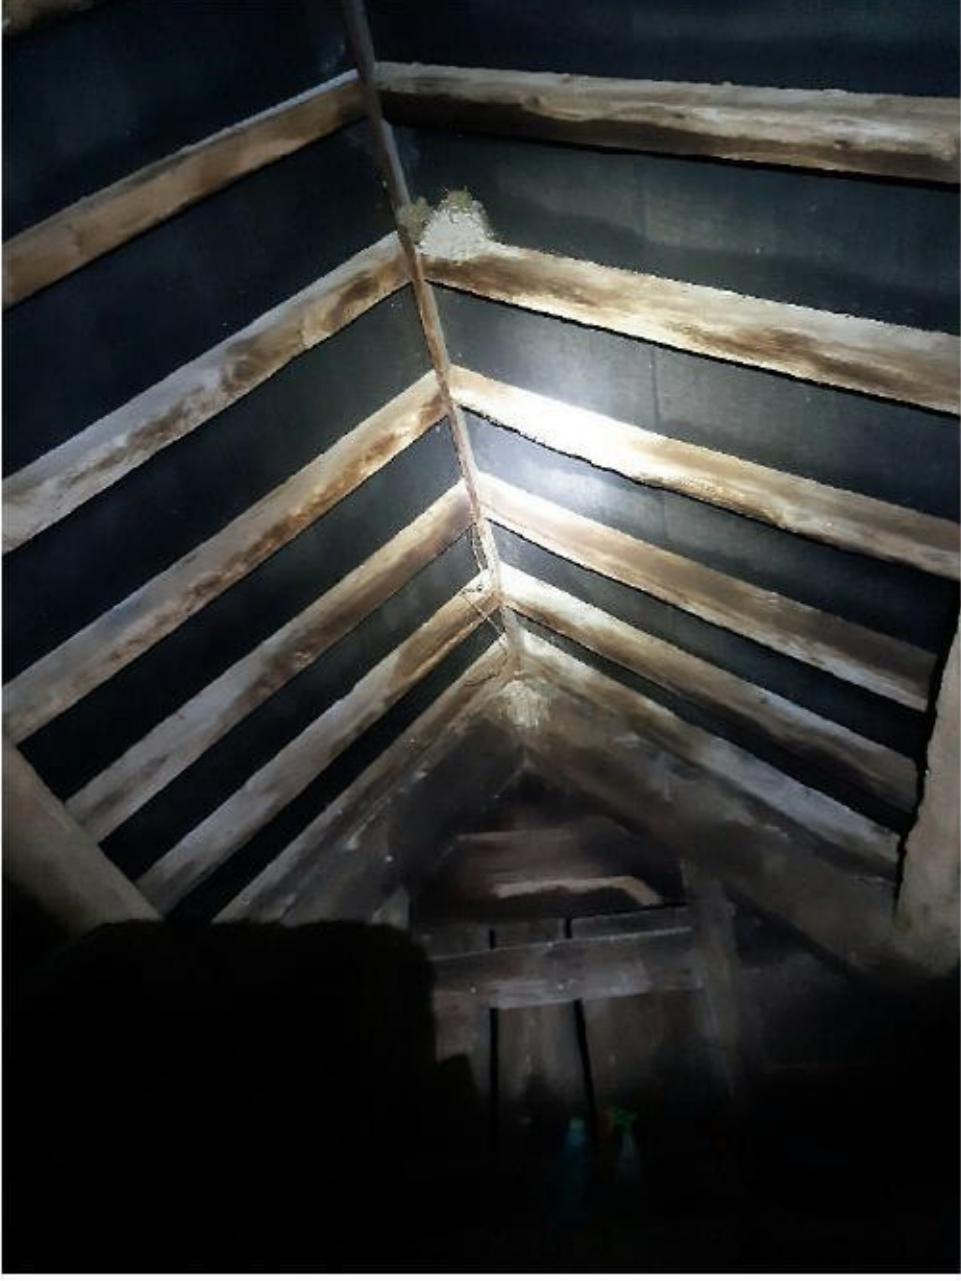
Swallow's nests on the ceiling of the barn.

4.1.11 Three swallow's nests were recorded in the remodelled northern section of the barn and there were no nests in the more enclosed southern section. All birds are protected under Section 1 of the Wildlife and Countryside Act 1981 (as amended). It is therefore generally unlawful to intentionally kill or injure a bird, damage or destroy an occupied nest or take or destroy eggs other than in exceptional prescribed circumstances. Therefore, development operations should take care to avoid the risk of harm to birds and their nests, especially during the nesting season (generally considered to be March to August). Construction works to the northern remodelled section of the barn should be undertaken outside the main nesting season and where this is not possible a suitably qualified ecologist should be engaged to check for nesting birds and to provide advice on the most appropriate way to proceed.

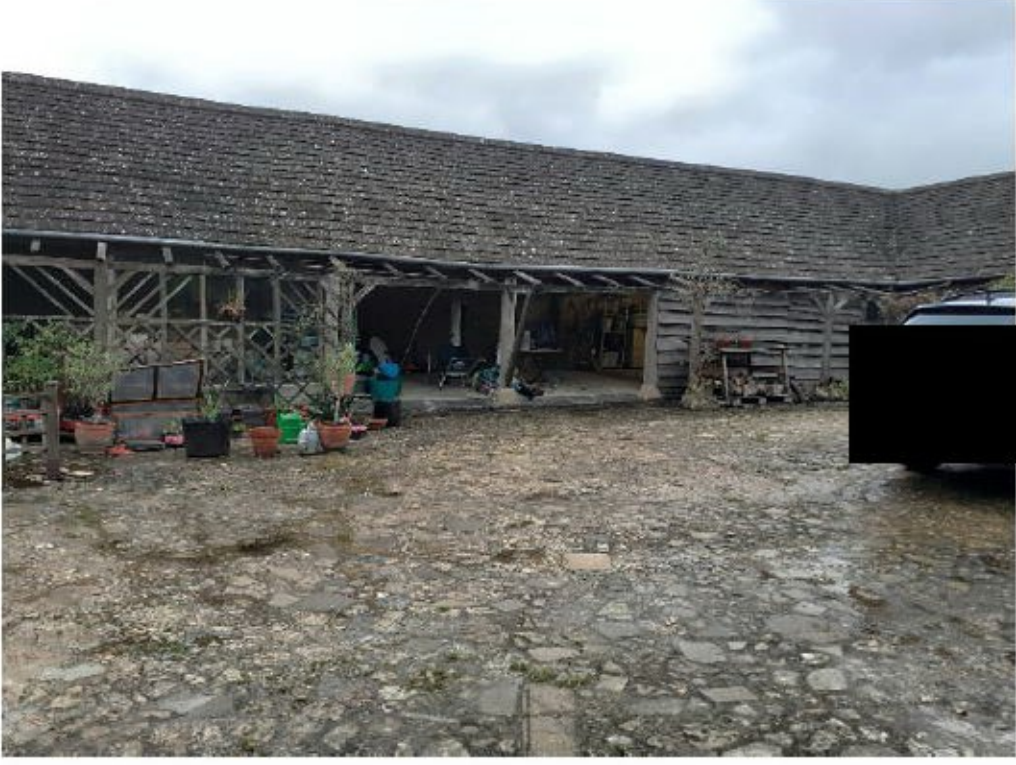
View of northern part of barn.
5

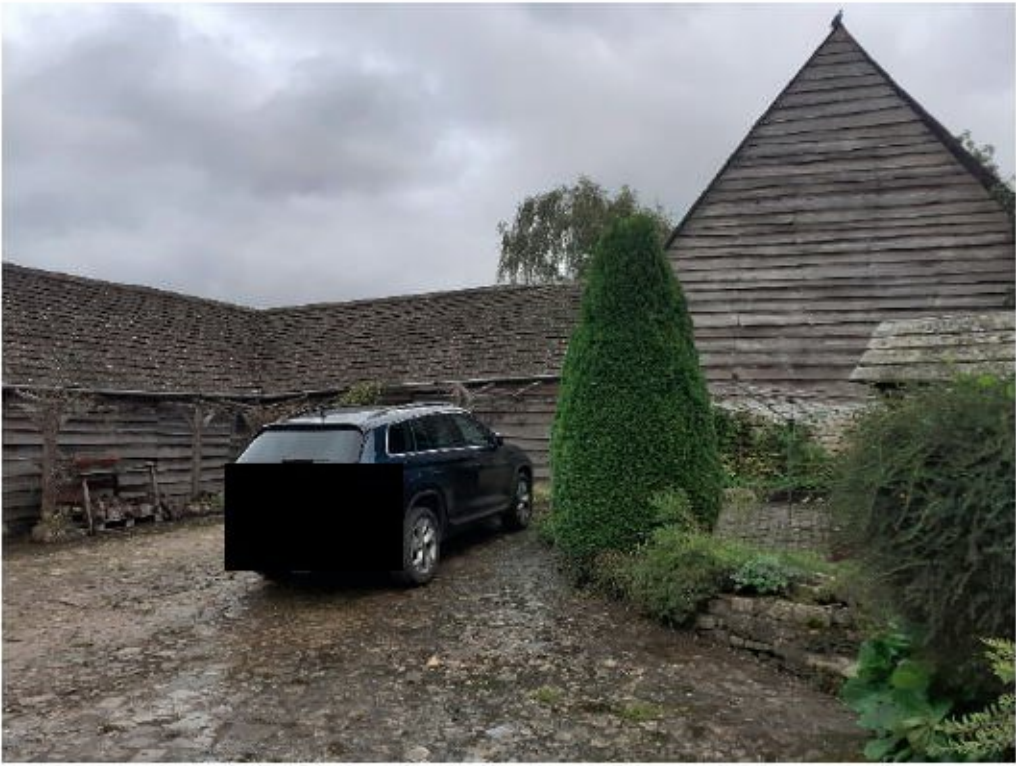
View of southern part of barn and adjoining barn – gable end view (adjoining barn not part of Site).

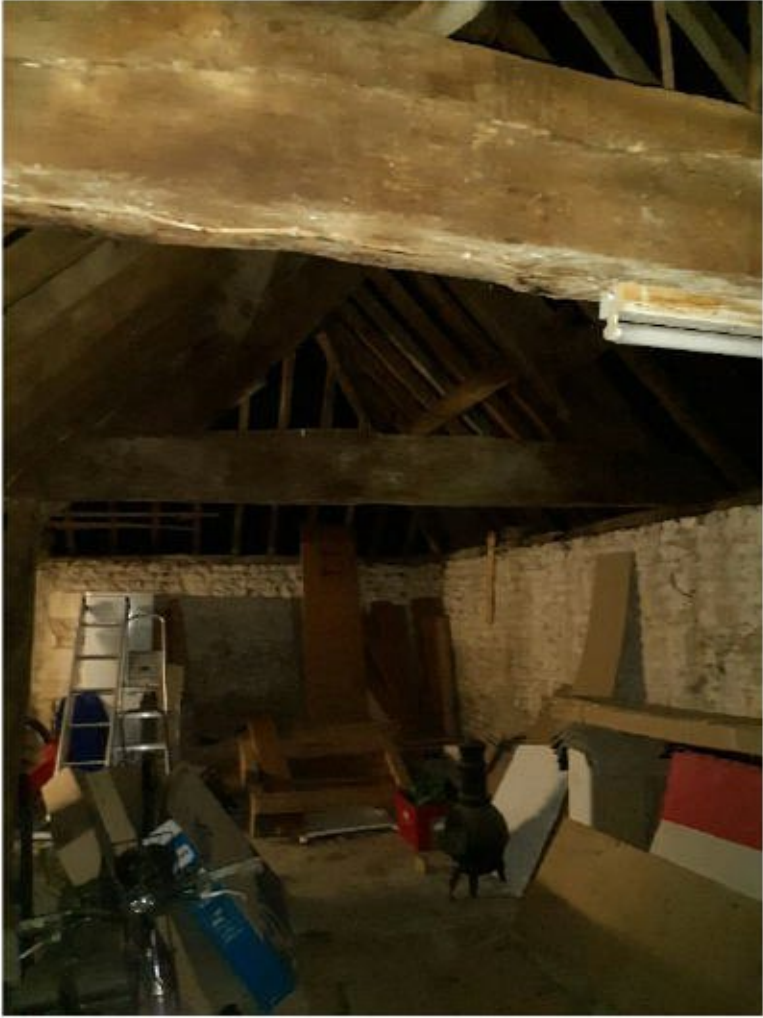
A photograph showing the interior of a barn. The structure features large, dark wooden beams and a gabled roof. The walls are made of light-colored stone or brick. In the foreground, there is a workbench with various tools and equipment, including a ladder and some boxes. The lighting is somewhat dim, highlighting the textures of the wood and stone.	Interior of southern section of barn
11

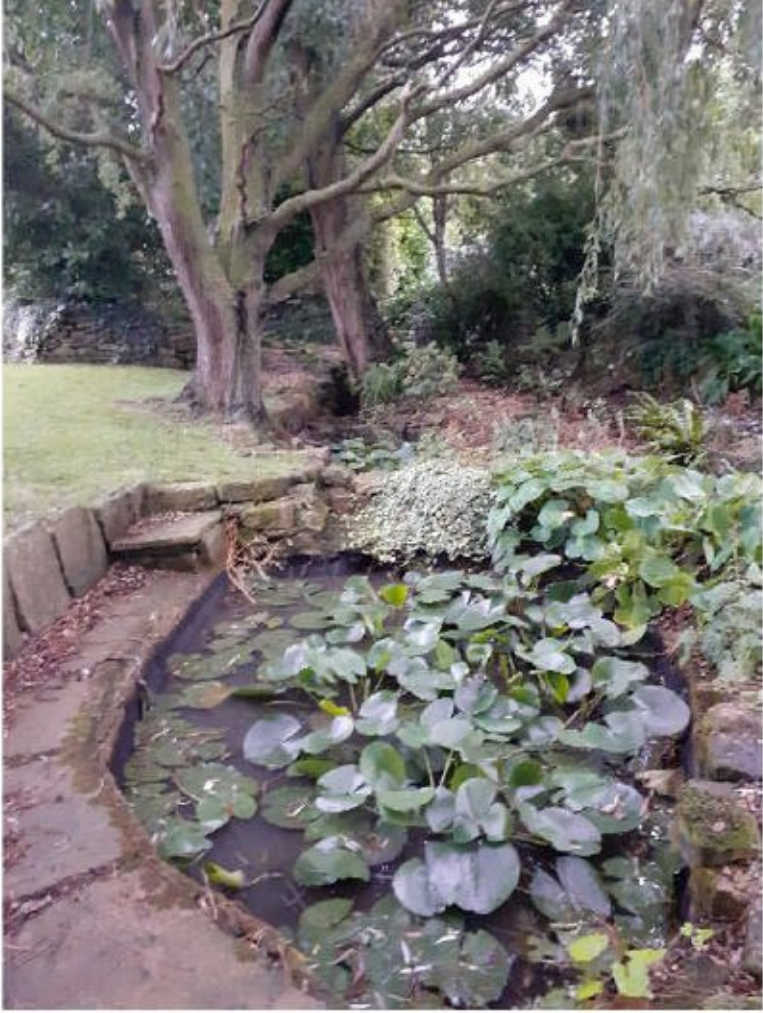
A photograph of a garden pond. The pond is rectangular and filled with water, surrounded by a low stone wall. Large, green, heart-shaped leaves of a water lily or similar plant are growing in the pond. The background shows a lush garden with various trees and shrubs, including a large tree with a thick trunk on the left.	Garden pond 1.

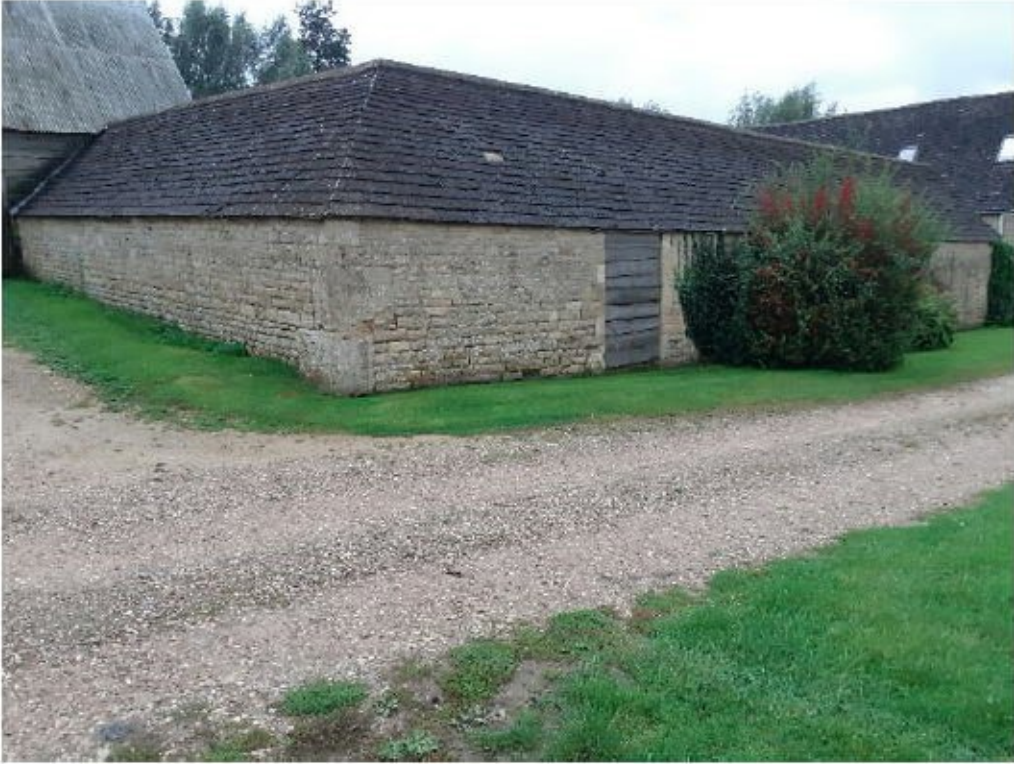
Barn viewed from outside garden.
13

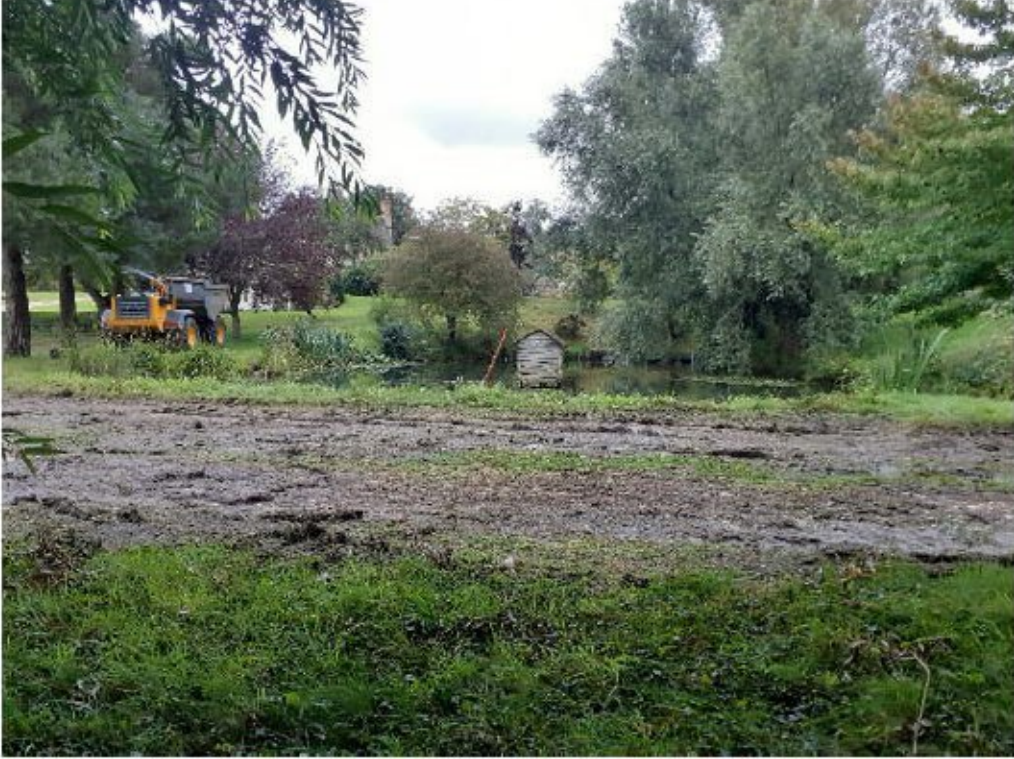
Pond 4 on neighbouring land.
14

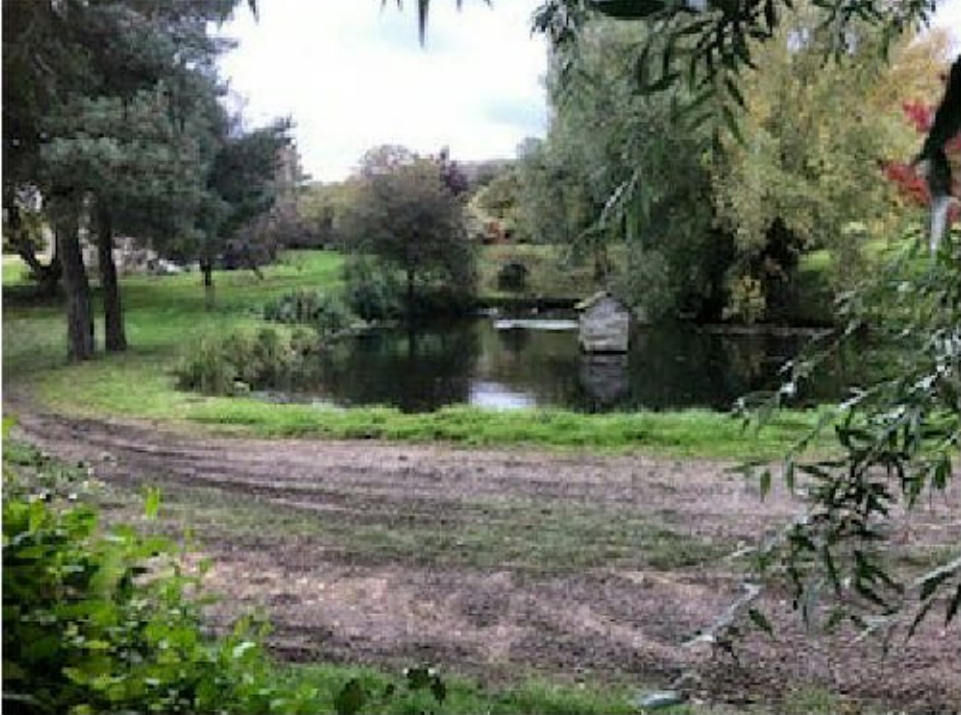
Pond 4.

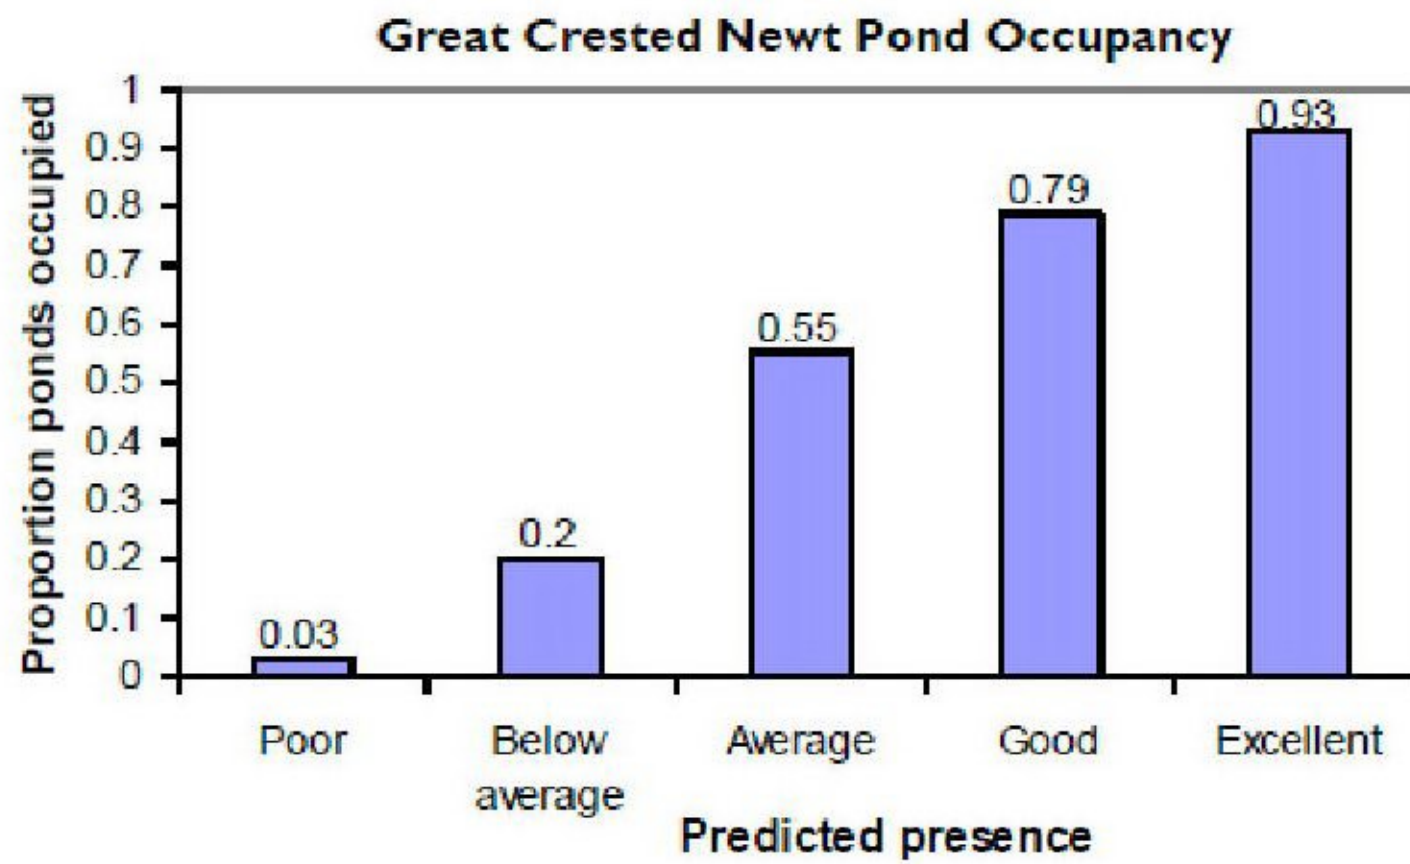
The graph below is reproduced from the ARG-UK Advice Note 5 and shows the predicted presence of great crested newts in relation to the Habitat Suitability Index value.

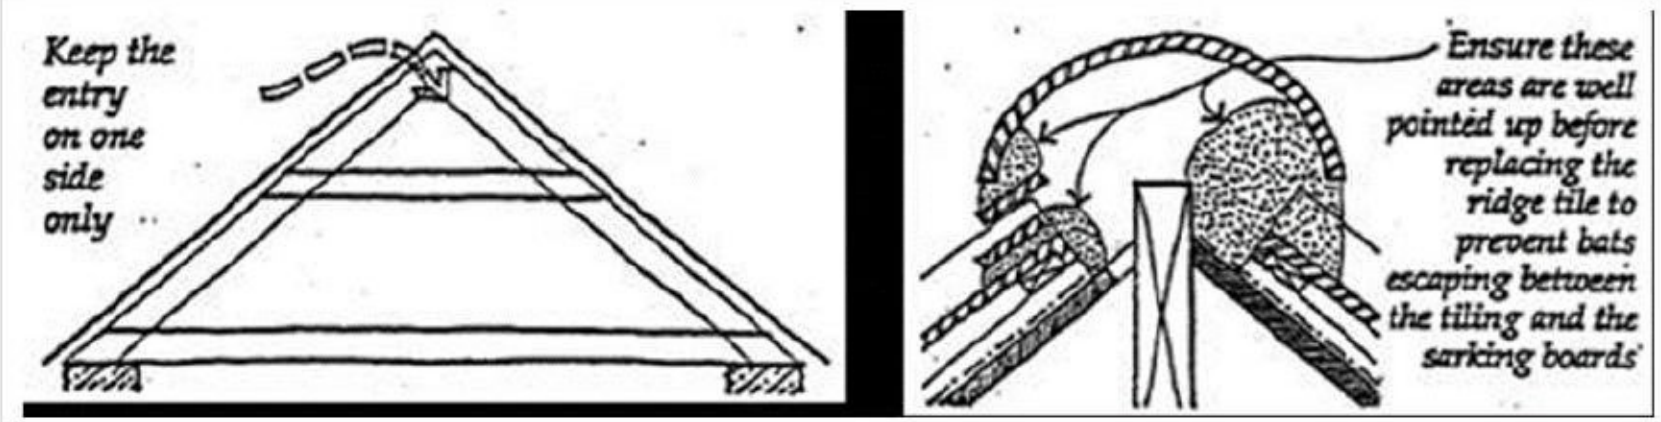
**Diagrammatic view of ridge tile and cross section through ridge tile** showing access point (taken from Scottish Natural Heritage 1996). Bitumastic lining must be used near/on the ridge beam to ensure bats can only have contact with this type of membrane to avoid any possible entanglement with a breathable membrane.
