**Bat and Barn Owl Risk Assessment of house & garden at
5 High Row, Gainford County Durham
5 High Row 16th March 2020**

**Bat and Barn Owl Risk Assessment of house & garden at
5 High Row, Gainford, County Durham
17th March 2020**

Method Statement for works at 5 High Row, Gainford

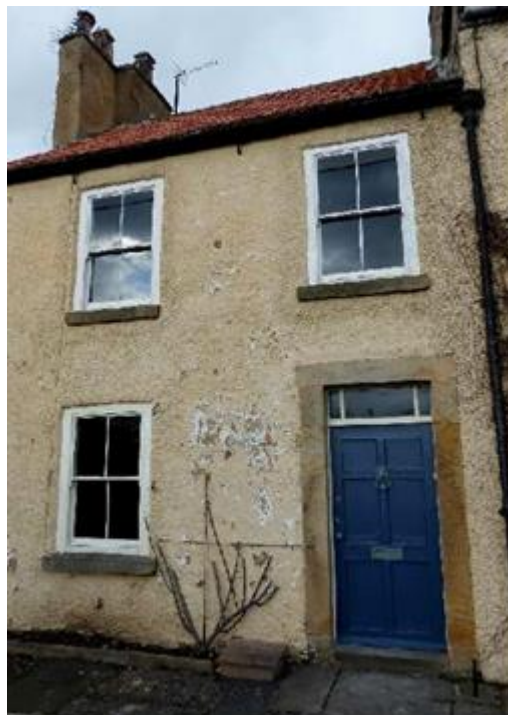
5 High Row is a two-storey Grade 2 listed terraced house situated in the village of Gainford. It is built of a mish-mash of river cobbles, roughly dressed stone with more modern repairs in brick and breeze block.

The exterior has been rendered and much of this remains, particularly at the front of the house. The roof two lower courses of Teesdale slate but above these the roof is covered with modern clay pantiles.

View of the front of 5 High Row, Gainford

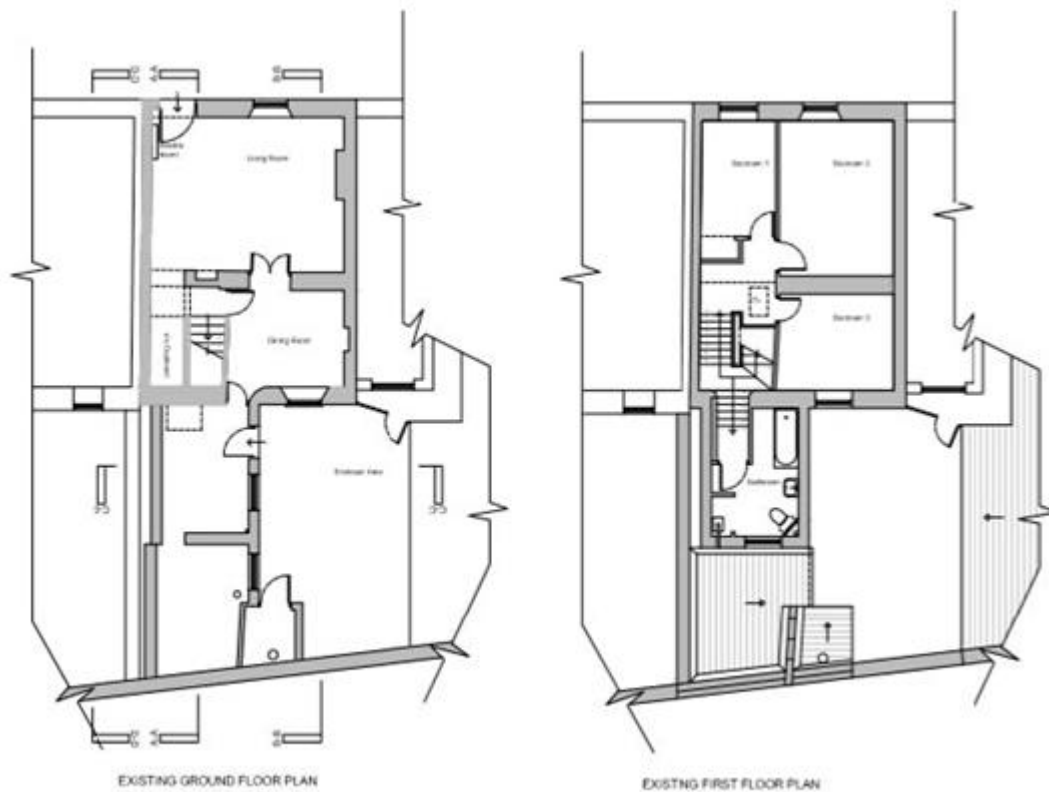
Ground and first floor plans of existing house

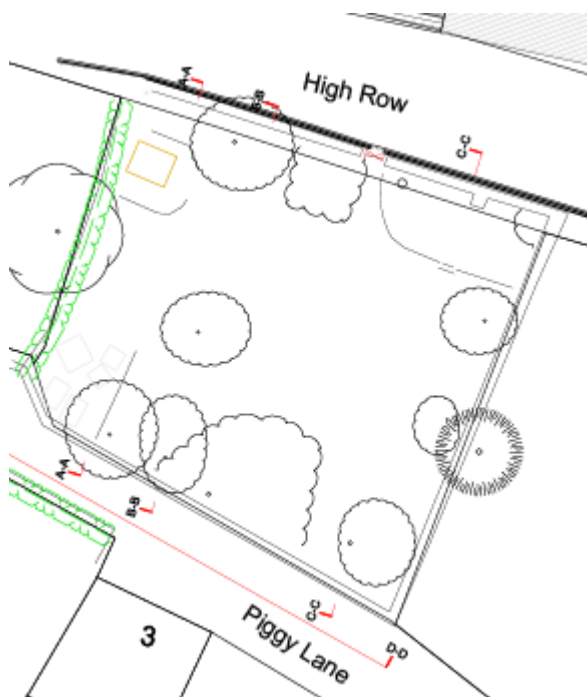
Garden of property to the front of the house

The garden of 5 High Row, Gainford is clear with just a few pruned ornamental shrubs. The only part of possible interest to bats are the perimeter wall on the south, east and north sides. These are made of mortared river boulders and recycled masonry. The workmanship is poor and there are crevices which

could be used by individual bats as roost sites, overnight or over-winter. However, no crevices were found which would support a hibernating colony of bats.

GARDEN: There were no droppings or grease marks found on the garden wall. There were many small cracks that could be used by an individual bat as an overnight roost, but they were all below shoulder height and did not appear to be deep enough to offer the protection needed for hibernation.

To ensure continuity of potential roost sites for bats at 5 High Row, Gainford, crevice roosts will be incorporated into the inside of the garden wall every two or three metres as the wall is rebuilt. These are easy to create and cost nothing.

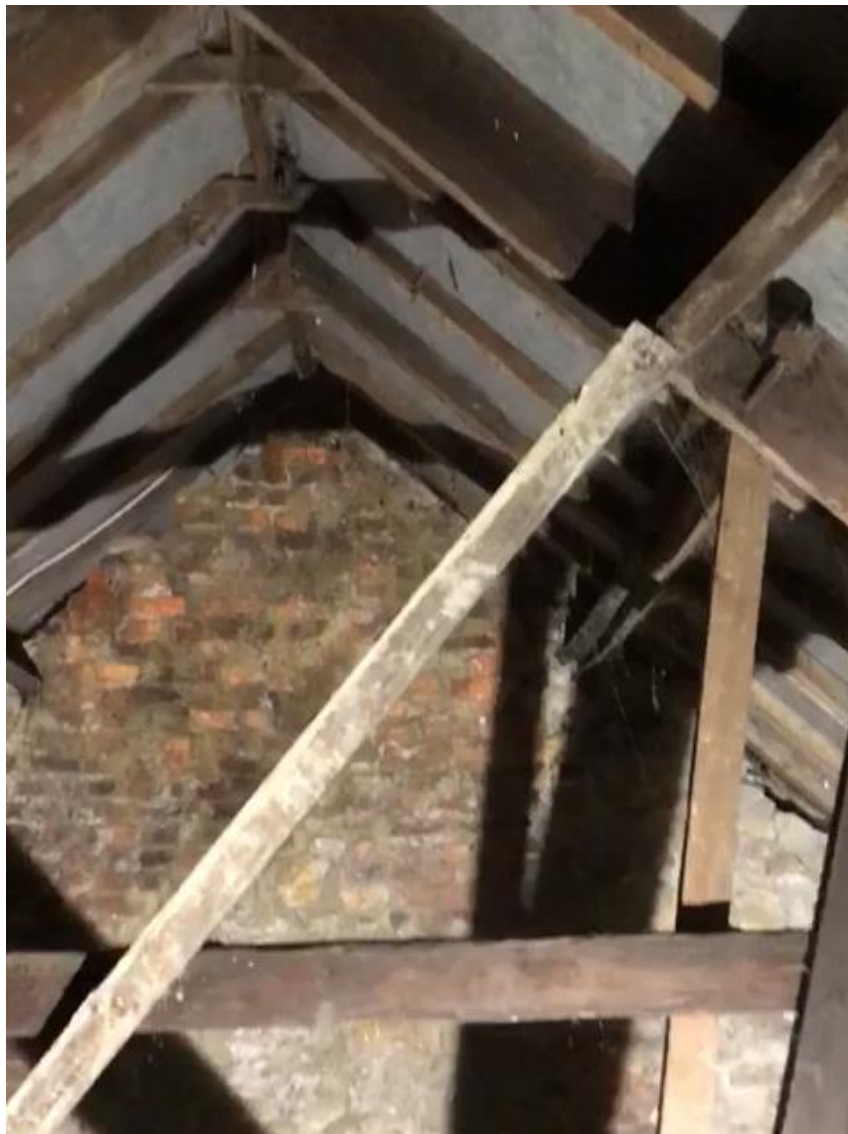
The roof is steeply pitched and covered with pantiles laid on two lower courses of Teesdale slate. The roof is lined with membrane and the roof void is open throughout.

Inside the roof of 5 High Row, Gainford

Some of the roof timbers towards the back of the house were relatively old, adze-hewn with the rounded shape of the original tree trunk still visible. However, most were more modern and machine sawn. The quality of the carpentry was poor and there were no good roost sites around the joints of the kingposts and other main timbers.

The roof was lined with membrane and the only possible roost sites for bats would be round the roof timbers where bats would be visible and exposed.

There were no droppings, lepidopteran wings, scratch marks or grease marks on the floor, walls or on the rafters.

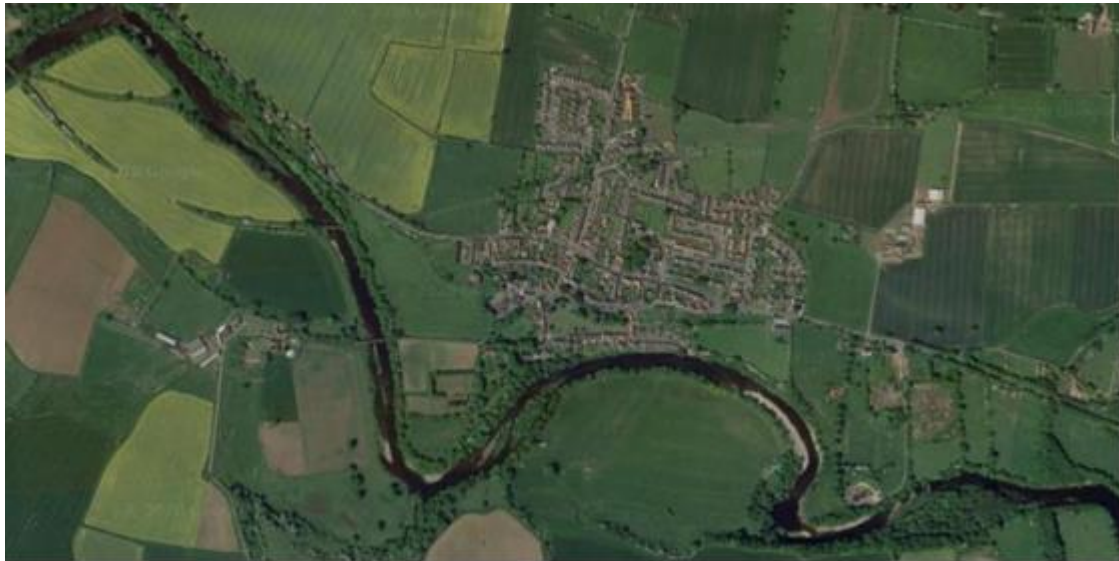
Aerial photograph to show habitats round High Row, Gainford

At Gainford much of the riverine woodland is semi-natural with mature trees that are essential for bats such as Noctules. The Tees valley is probably the most important location for bats in North-east England as the combination of clean water, trees with potential roost holes and trees and plants which are the food source for the insect prey on which all British bats feed.

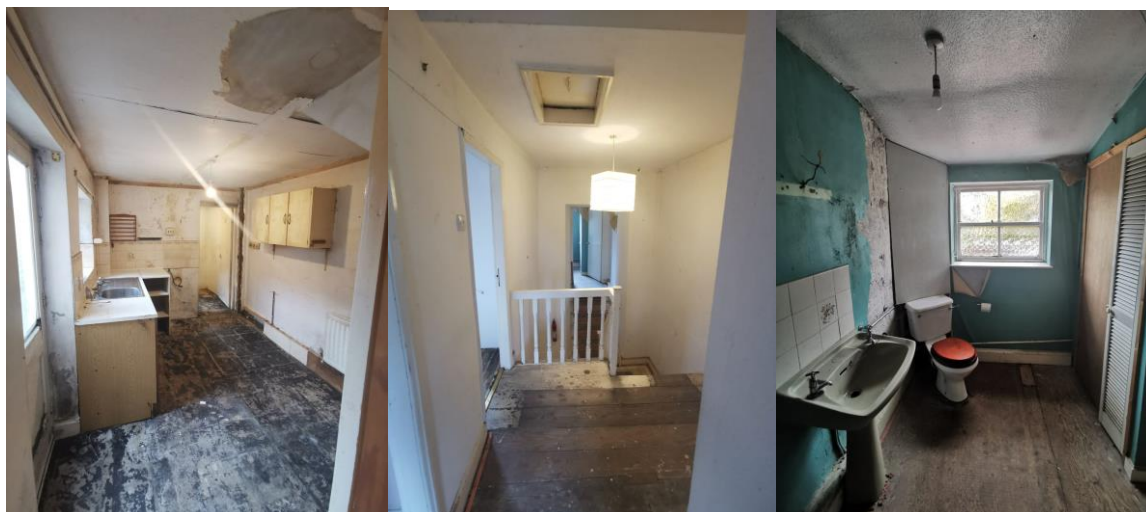
Inside 5 High Row, Gainford

The interior of the main building has few places suitable for roosting bats.

There were no pellets, droppings or any other signs of any use by Barn Owls.

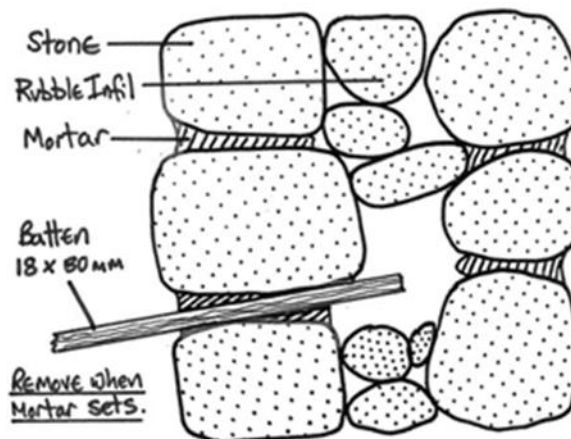
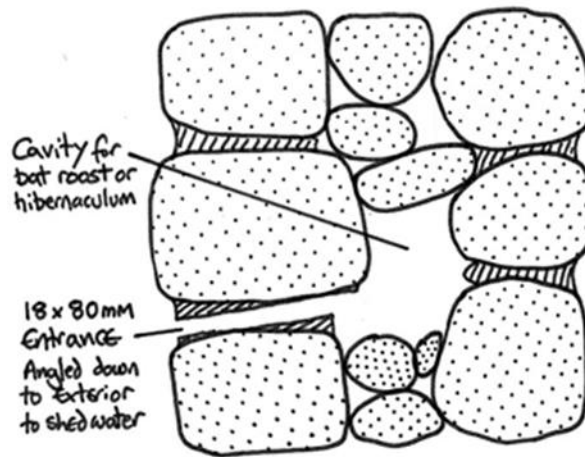
Before

After

Crevices suitable for roosting bats can be created by leaving small gaps in the wall during pointing which give access to the rubble infill. Gaps should slope up slightly to shed water and have a height of 18mm (range 15 -20) and be a minimum of 80mm wide. The height is critical; too small and bats cannot gain access, too big and birds will nest. The roost entrances are best made by placing 18 x 80mm battens into the wall to reach the rubble infill prior to pointing and removing them once the mortar has set. The entrance hole should slope up into the wall to shed water. The cavity inside should be at least 100x100x100mm.

Crevice roosts created on north- and west-facing walls will have relatively cool temperature profiles and more likely to be suitable for hibernacula.

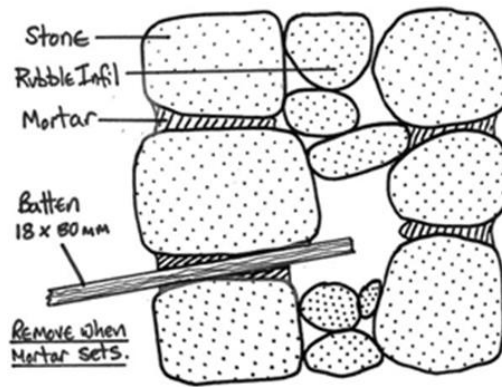
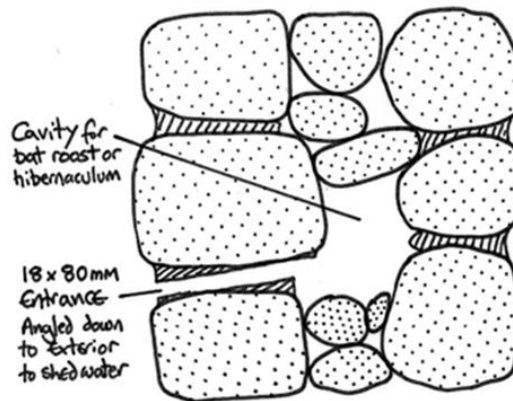
Before

After

To ensure continuity of potential roost sites for bats at 5 High Row, Gainford, crevice roosts will be incorporated into the inside of the garden wall every two or three metres as the wall is rebuilt. These are easy to create and cost nothing.

Crevices suitable for roosting bats can be created by leaving small gaps in the wall during pointing which give access to the rubble infill. Gaps should slope up slightly to shed water and have a height of 18mm (range 15 -20) and be a minimum of 80mm wide. The height is critical; too small and bats cannot gain access, too big and birds will nest. The roost entrances are best made by placing 18 x 80mm battens into the wall to reach the rubble infill prior to pointing and removing them once the mortar has set. The entrance hole should slope up into the wall to shed water. The cavity inside should be at least 100x100x100mm.

Crevice roosts created on north- and west-facing walls will have relatively cool temperature profiles and more likely to be suitable for hibernacula.
