RIBA Stage

1:50@A1 STAGE 3

20-020 P121 -

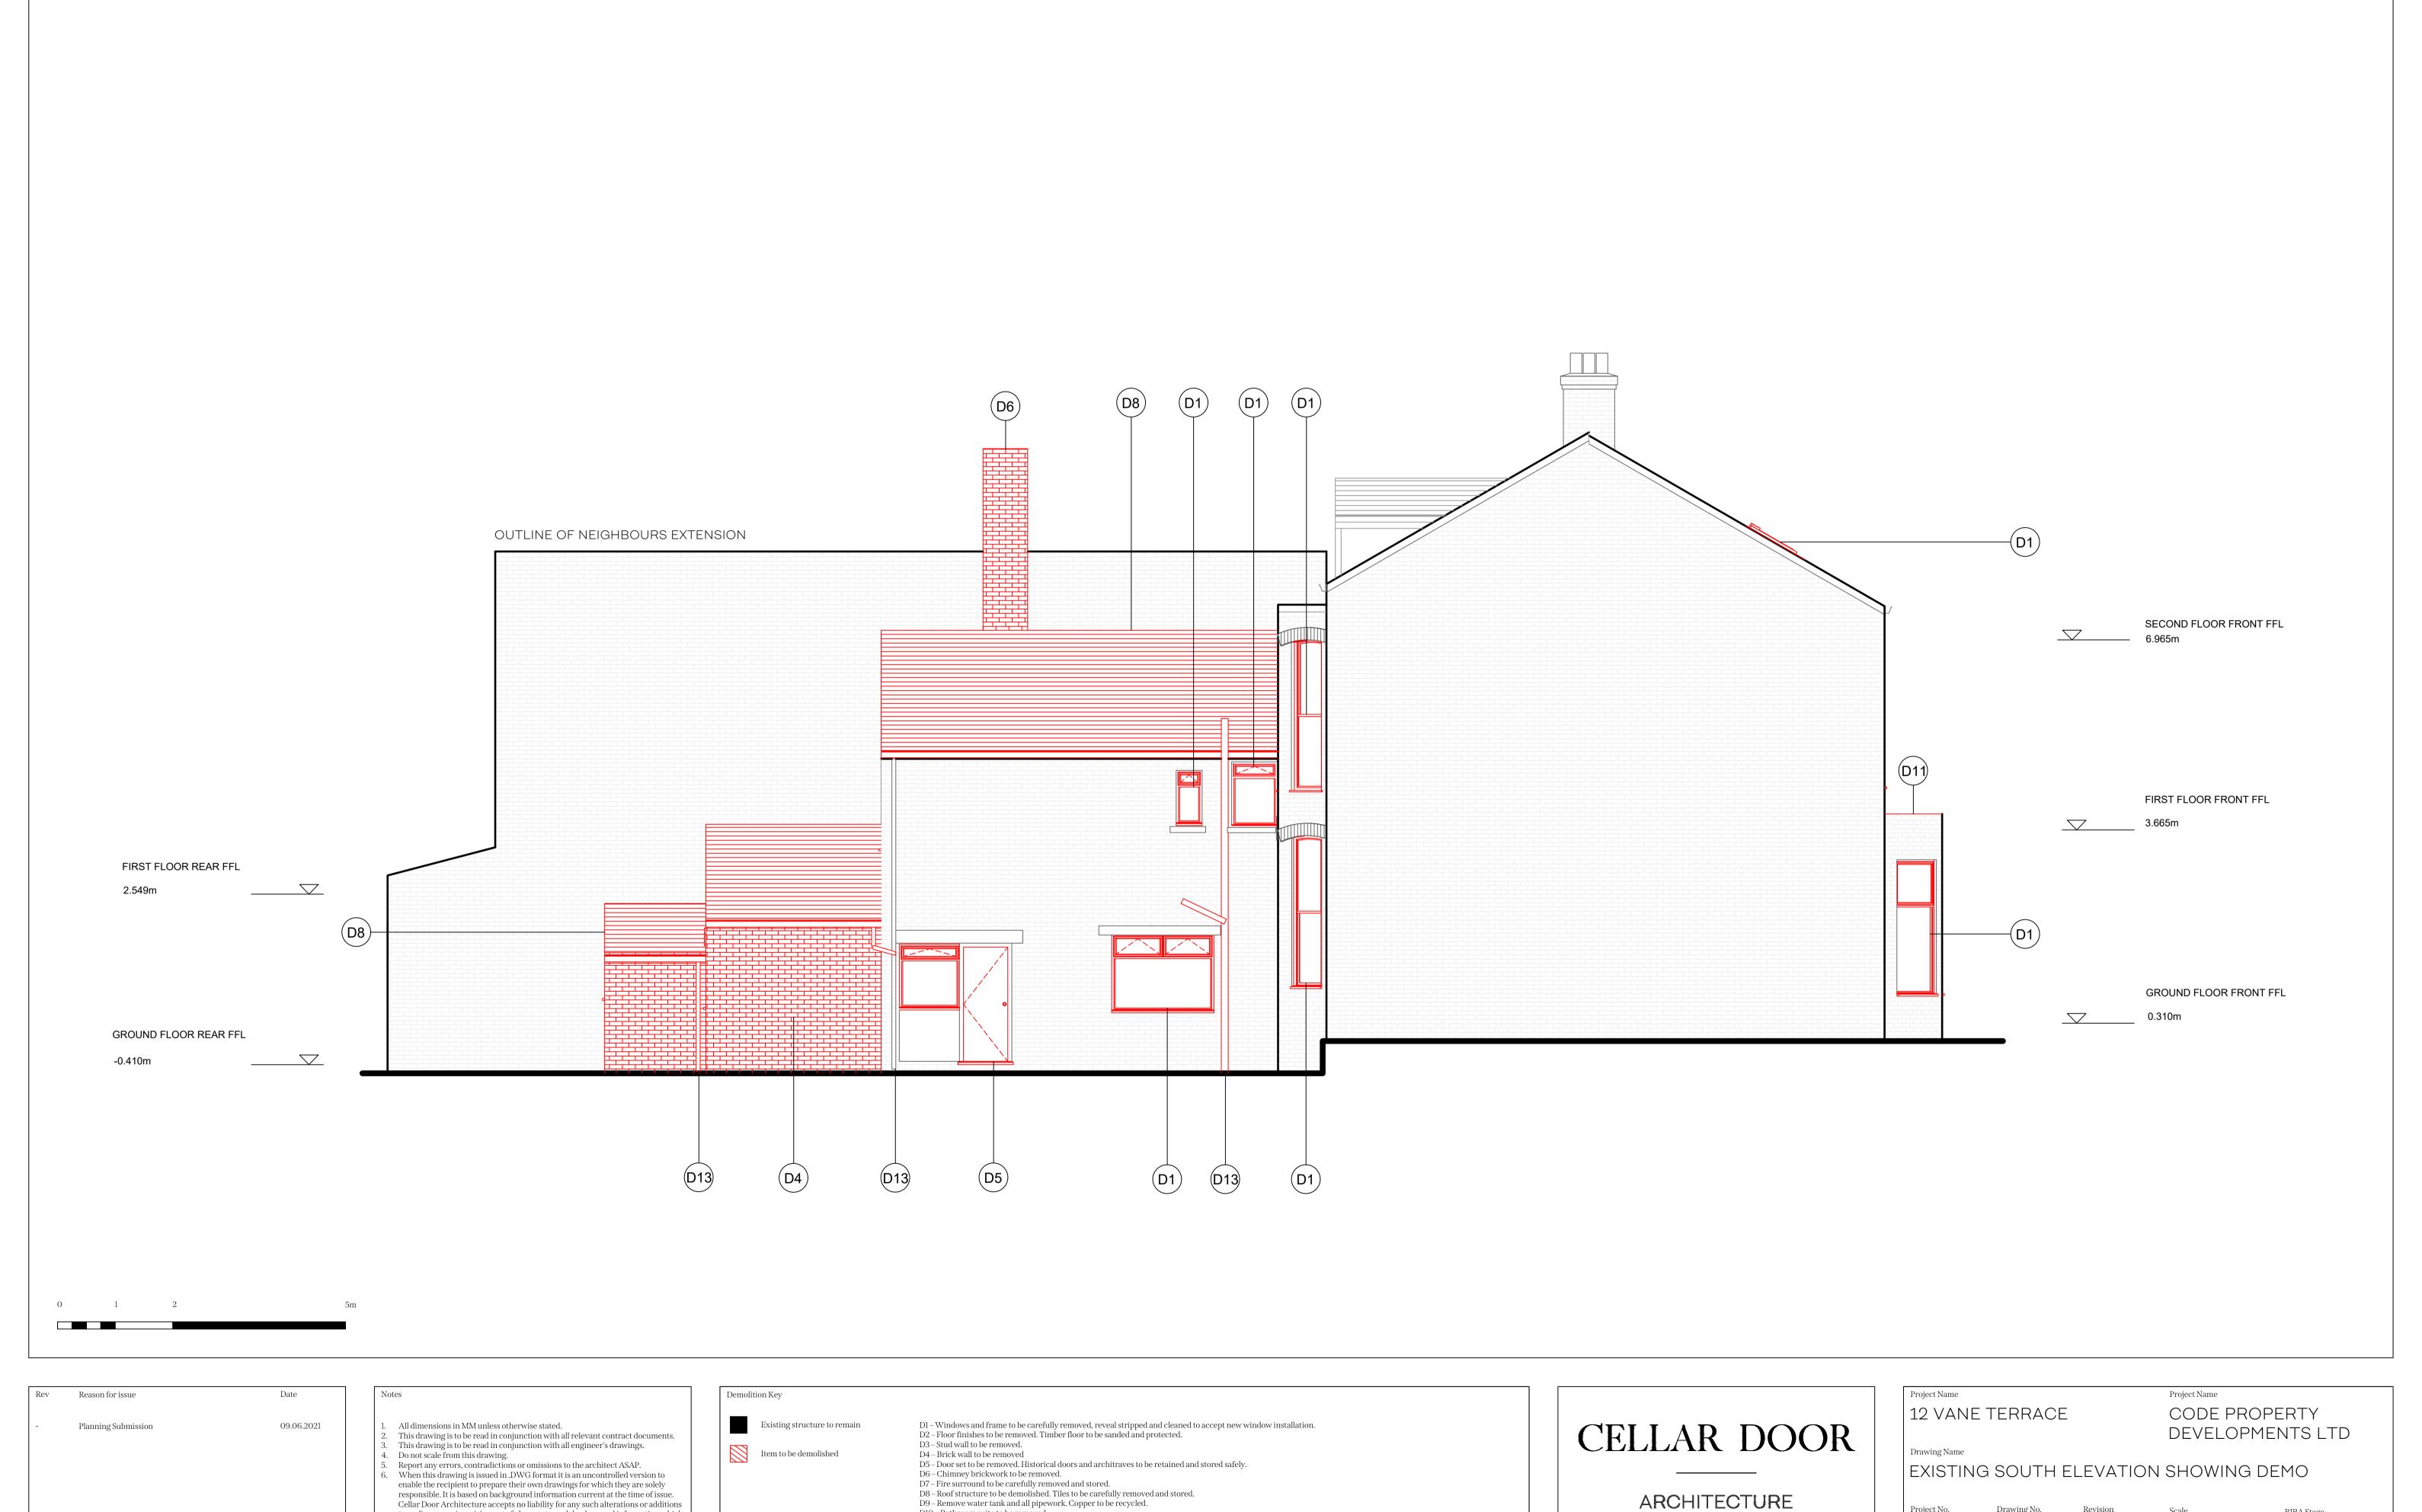
D10 – Bathroom suite to be removed.

D11 – Roof felt over parapet to be removed

D12 – Brown plaster to be removed adjacent to crack.
D13 – RWP to be carefully removed and stored.
