Phase II Ground Investigation

Kilten Cottage, Hugus

Wheal Jane Consultancy

Client	Mr & Mrs Noon
Project Title	Kilten Cottage
Document Title	Phase II Site Investigation
Document No.	SI20077/PH2

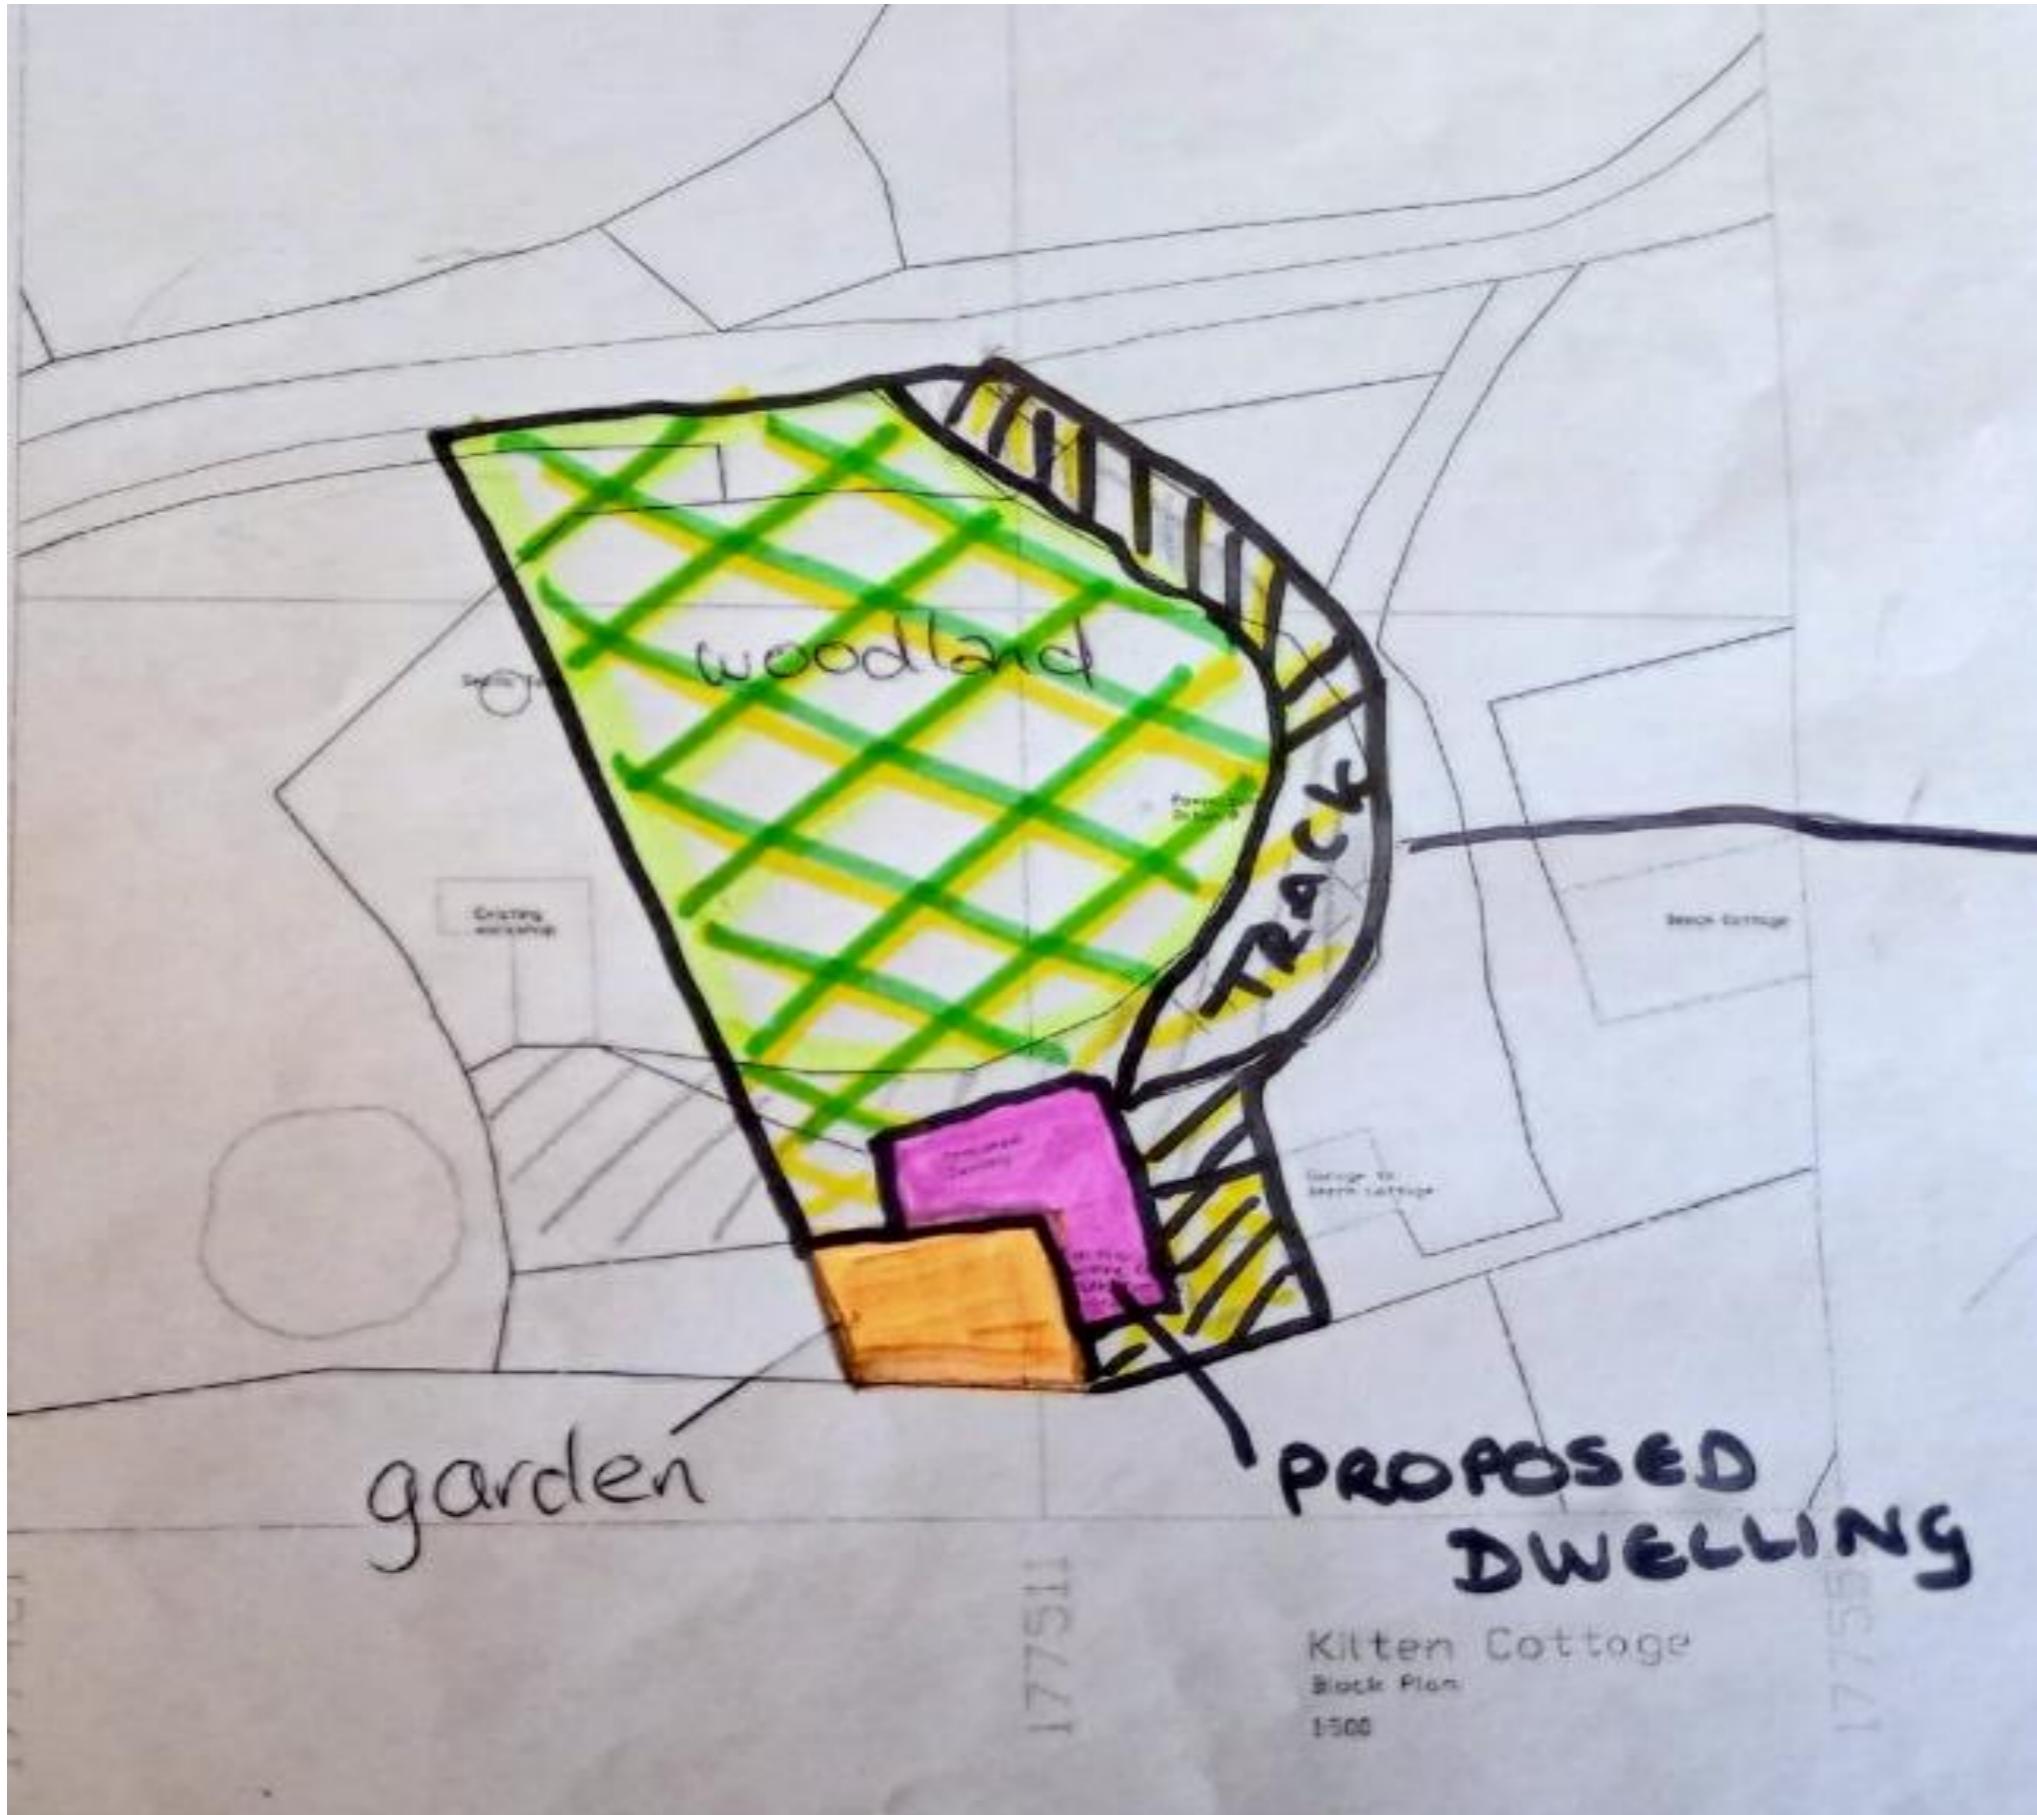
Figure: 2.3

- 2.3.1 It is proposed to construct a single replacement dwelling in the existing garden area. Further information can be found under planning application number PA20/00759.
- 2.3.2 The proposed site plan is contained in Figure 2.3, to the rear of the report.

Proposed Site Layout

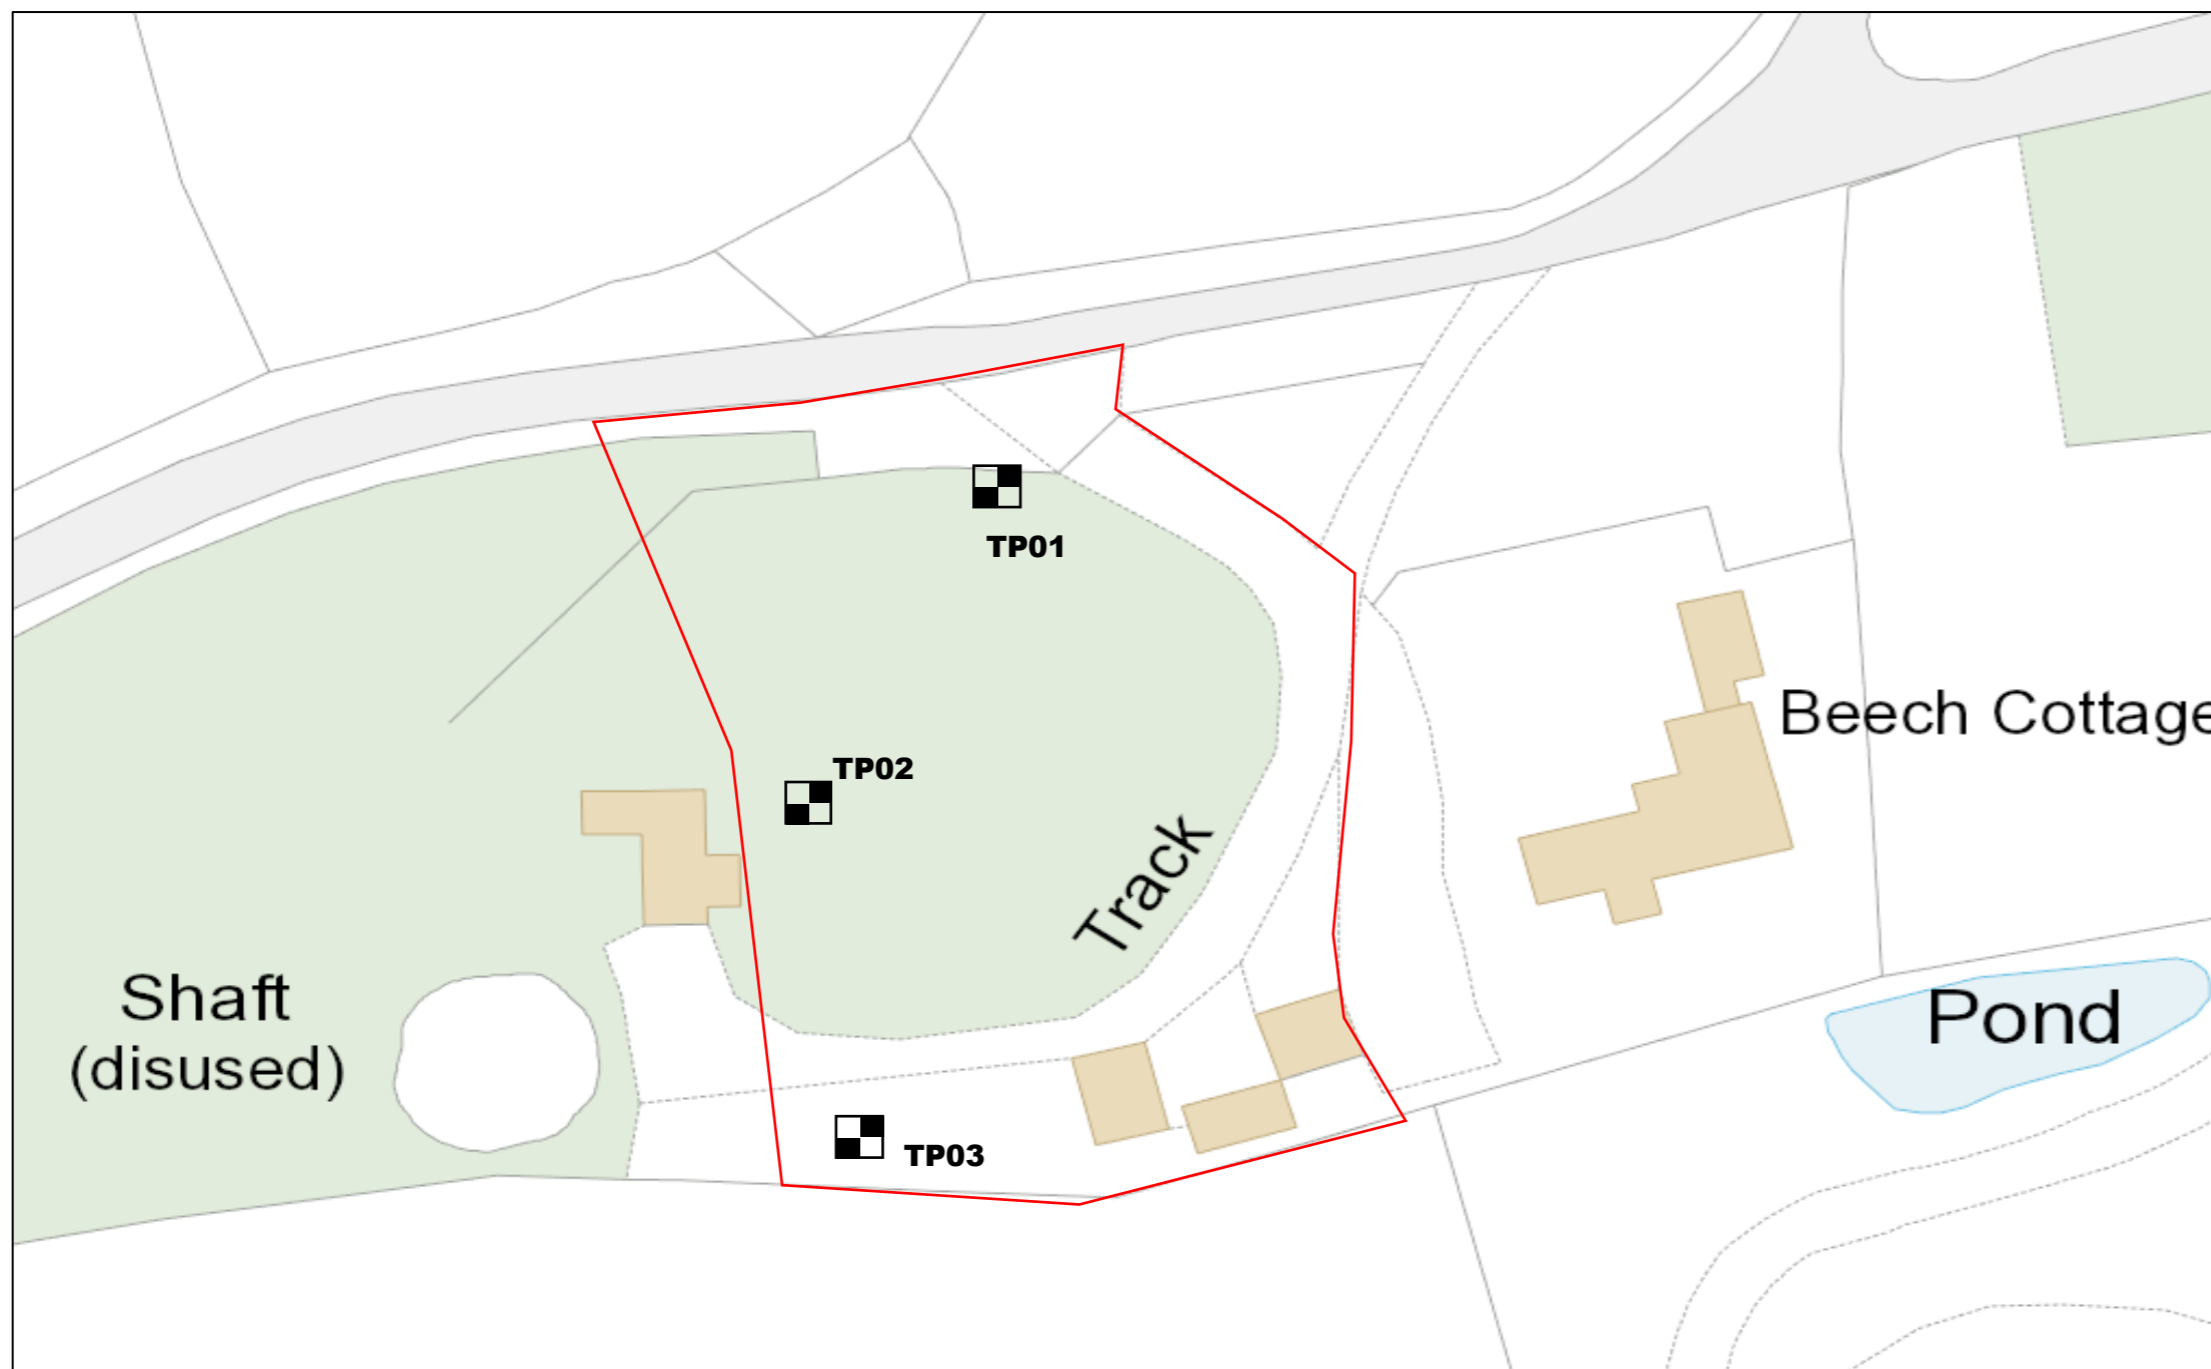
Figure: 3.1

- 3.2.3 Exploratory hole logs are included as Appendix A.
- 3.2.4 A plan showing the location of the exploratory holes is provided as Figure 3.1.

**Hand Pit Location**

Exploratory Hole Location Plan
