Bat Emergence Surveys
Margery Lane, Clearwell, Gloucestershire

Report reference: R-2424-03.2
September 2016

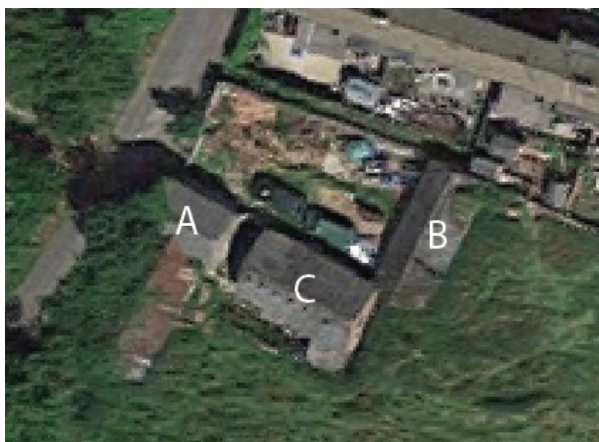
Figure 1

3. There are 3 buildings present on the site.
4. Building A is a two storey former stable with a hayloft, constructed of stone, both limestone and sandstone, with many vertical fissures in the external walls. The roof is pitched and constructed of corrugated asbestos. It is partially covered in dense ivy growth. On the southern wall is a single storey former cattle stall conjoined to building A. It is constructed of brick and stone, with a pitched corrugated metal. During internal inspection of this building in October 2015 a single lesser horseshoe bat was found roosting on the underside of the asbestos roof close to the south eastern gable of the building. This roost was associated with a scattering of droppings on the hayloft floor.

5. Building B is single storey partially open sided building constructed of sandstone, limestone and breezeblock, with glass windows, and a pitched roof of corrugated asbestos.

6. Building C is a relatively modern, double storey, former milking parlour with a pitched roof of corrugated asbestos. The building is constructed of breezeblock and brick, with a small brick built, single storey shed attached to the southern aspect of the building. Old bat droppings have been found in this building.

Buildings

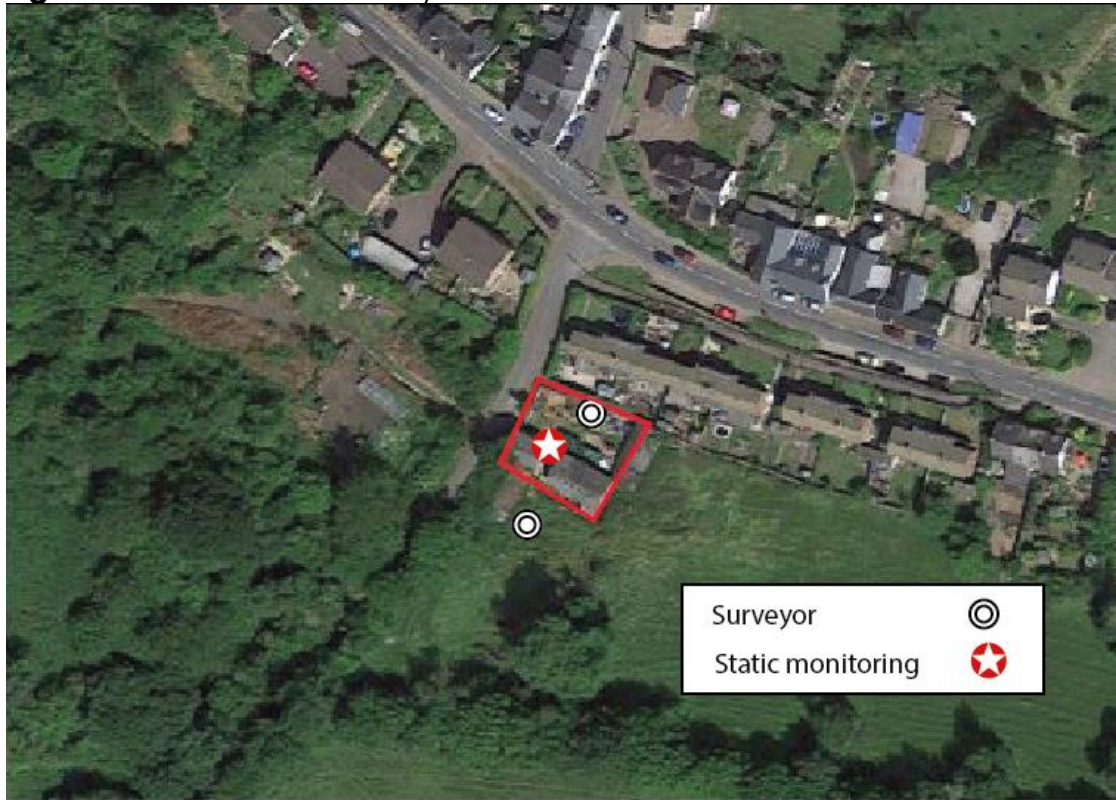
Figure 2 Locations of surveyors and static monitor

10. Figure 2 shows the locations of the surveyors and the static location.

14. Emergence of lesser horseshoe was from the open ground floor stable door of building A. Figure 2 shows this in relation to the roosting bat and droppings found during internal inspection in 2015.

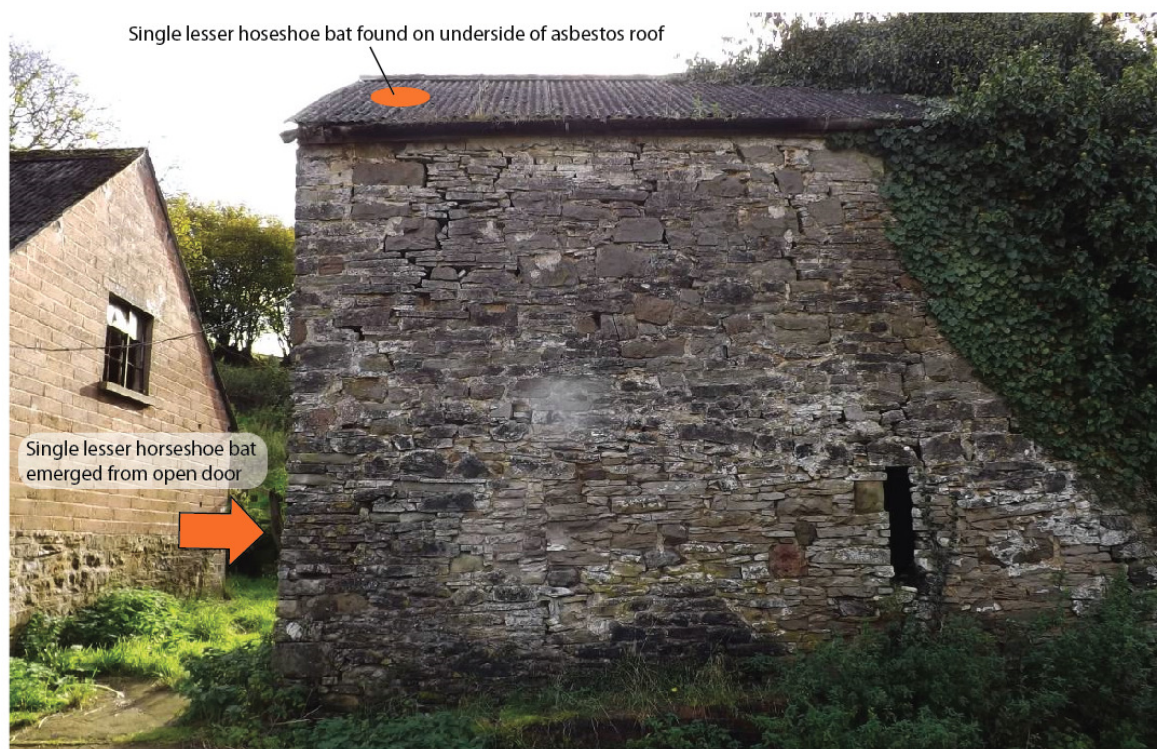
Figure 3 Lesser horseshoe emergence point and roost location

25. The bat roosts on the underside of the asbestos roof and accesses the loft space flying through the stable door and then back over the hayloft floor. The location of droppings within the barn suggests that this bat uses a single roost location and does not move between areas with different conditions within the barn.
