BAT SURVEY 2020
FARM BUILDINGS AT MARGERY LANE
CLEARWELL, GLOUCESTERSHIRE

<u>Version</u>	<u>Purpose</u>	<u>Date</u>
V1.0	Update to bat survey in 2016	4 th October 2020

EXECUTIVE SUMMARY

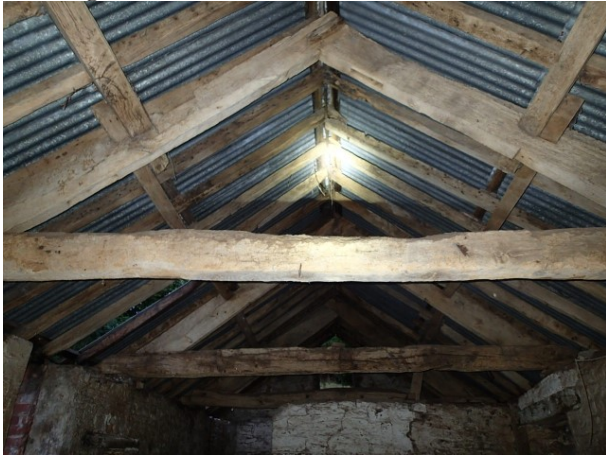
Barn A

Building A – no signs of bats were found. There was a new timber bat box on an external wall – with nothing in it.

- If the prescribed Schwegler 1FQ Bat Boxes are not available (there is a shortage) then Beaumaris Midi Bat Boxes are a suitable replacement. The exact positions of the boxes best are agreed on site with the licence ecologist. The timber boxes recently fitted are not suitable.

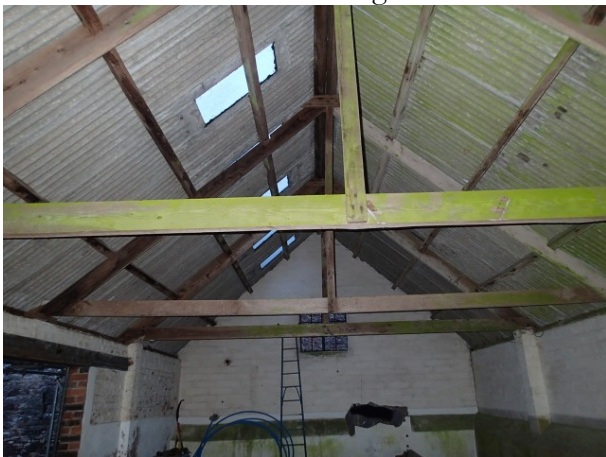
Barn B

Building B – a couple of random lesser horseshoe bat droppings were found on the floor. The droppings were more-likely-than-not from a bat flying around inside the building. There was a new timber bat box on an external wall – with nothing in it.

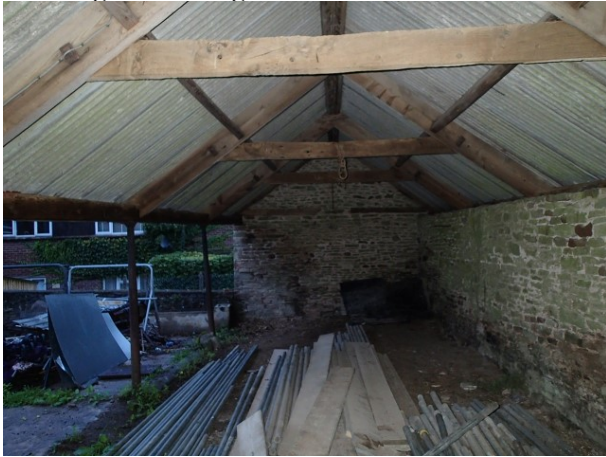
Barn D

Building D – no signs of bats was found.
