Bat and Ecology Survey Report

The Glebe House,
East Marden,
West Sussex,
PO18 9JE

16th June 2021
Project Ref: 17453

**Proposed Replacement Garage/Store at
The Glebe House
East Marden**

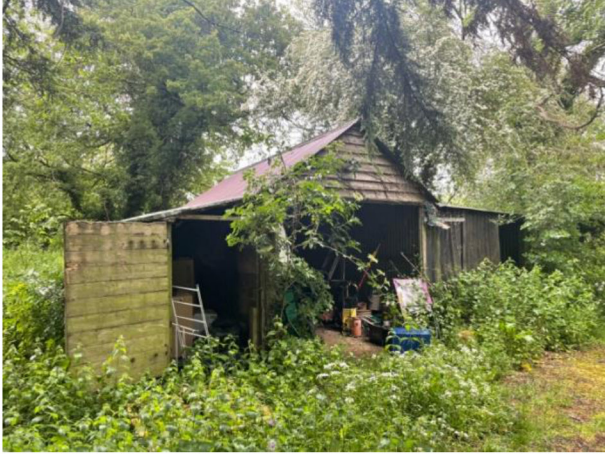
Front (south east) elevation of garage showing weatherboarding, open doors, metal roof and surrounding overgrown vegetation.

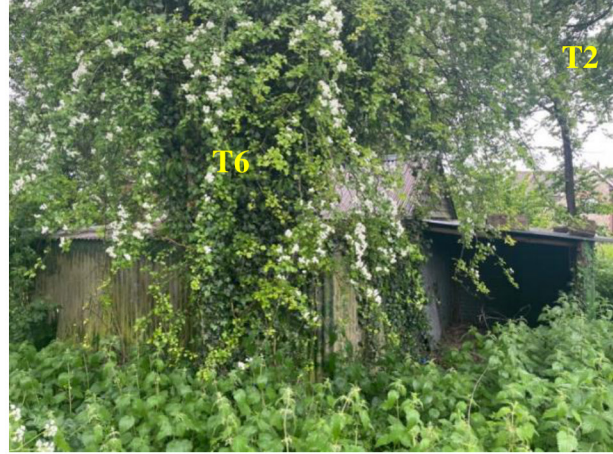
4.2.2. The area immediately surrounding the garage is overgrown with nettle, cow parsley, bramble and ivy with elder and hawthorn shrubs. A Hawthorn T6 and Sycamore T2 are to be removed, neither of which present suitable bat roosting opportunities due to their young age and lack of cavities. There are several mature oaks and conifers which are understood to be retained. This area provides some opportunity for nesting birds and mammals. Although unlikely to present suitable habitat for reptiles as there are no basking opportunities.

Rear (north west) elevation with rear lean to wood store, surrounding overgrown vegetation, T2 Sycamore and T6 Hawthorn to be removed.

- 6.1.1. Any vegetation clearance works must be undertaken outside of the bird breeding season (March to August inclusive). If this is not possible then a pre-works breeding bird inspection must be undertaken, to avoid infringing legislation which protects all nesting birds (WCA 1981). If an active nest is identified, there will be a delay in this area (and an exclusion zone, as recommended by the project ecologist), until all young birds have left the nest.

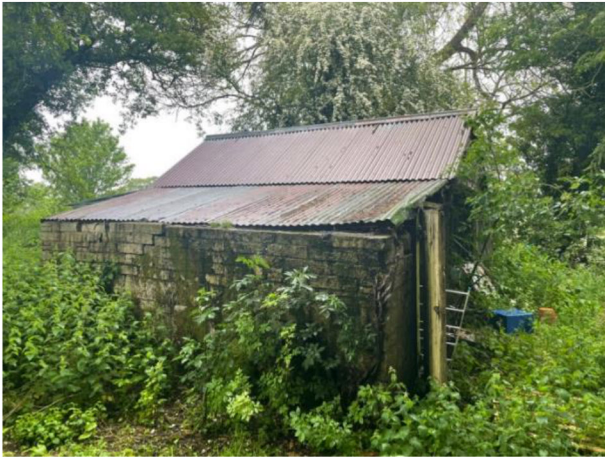
Side (south) elevation with metal sheet roof with brick end wall garage with overgrown vegetation.

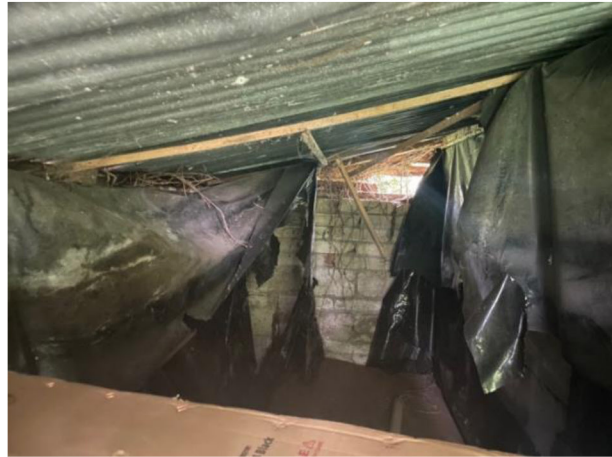
- 4.2.10. The skin timber weatherboarding presents no significant cavity.
- 4.2.11. There is some loose black polythene on the walls and ceiling in the southern section although this does not present suitable roost opportunities for bats due to lack of thermal mass or suitable substrate beneath.

Interior of southern store/shed section with black polythene hung on walls.

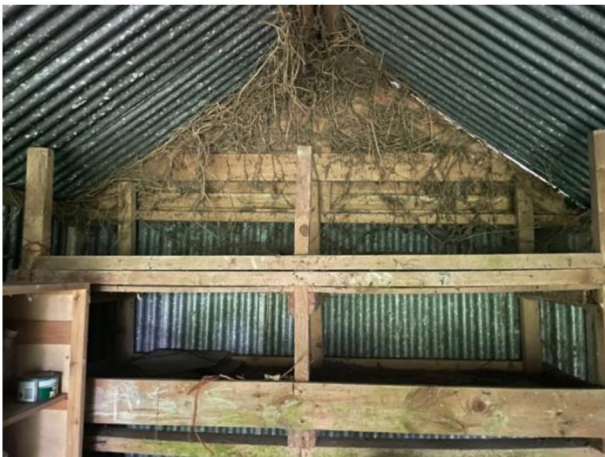
Interior of central garage section.

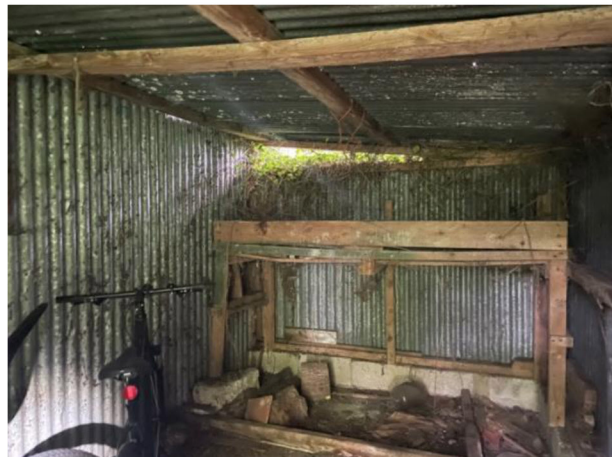
Interior of northern store/shed section.

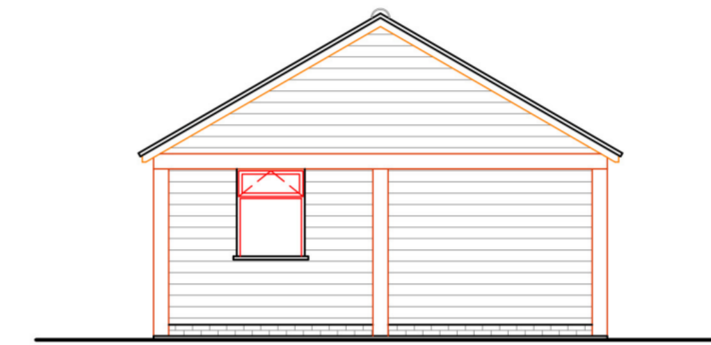
Walls to be finished externally in stained feather edged boarding.

Main framing of building to comprise oak posts, beams and braces.
