## **Listed Building Consent Application**

### **HERITAGE, DESIGN AND ACCESS STATEMENT FOR SAFETY AND ACCESS IMPROVEMENTS TO 9 THE CROFT, HEADINGTON, OXFORD OX3 9BU**

**3 May 2021**

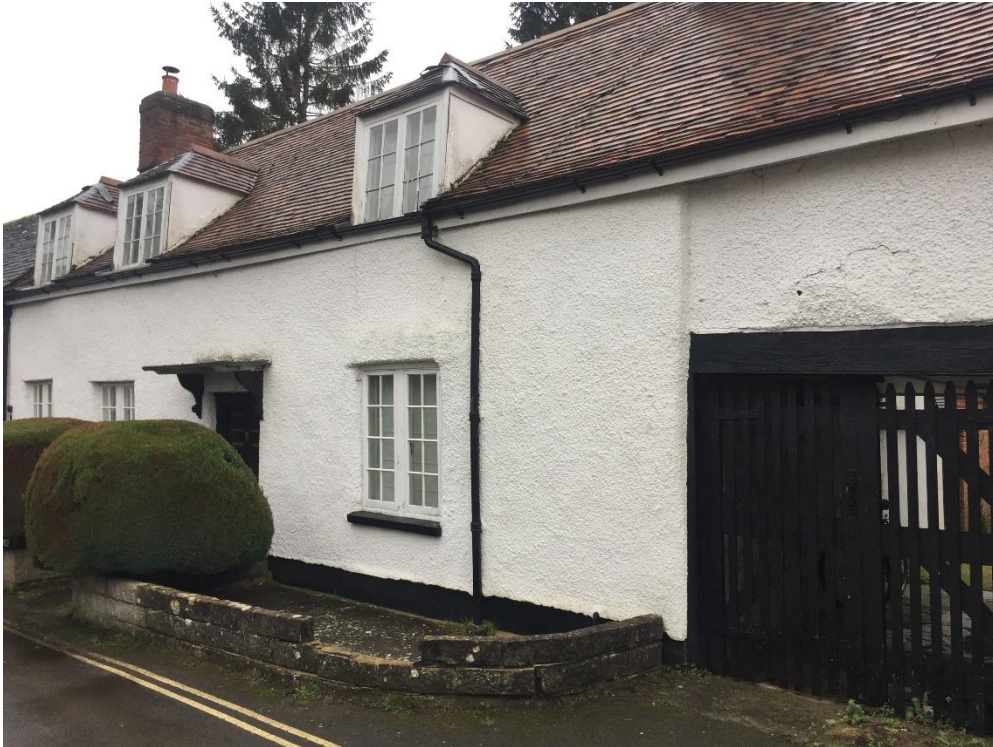
*9 The Croft from the front*

Above the front door is a small porch roof, which can be seen in the first photograph of this application. It is in very poor condition and will be repaired so that the character is maintained. The only parts that will need to be replaced are the modern cover elements (felt and some rotten boards that the felt covers). These will be replaced by new like for like wooden boards, covered in traditional lead rather than felt. The wooden sides and supports will be kept, they will be repaired and re-painted.

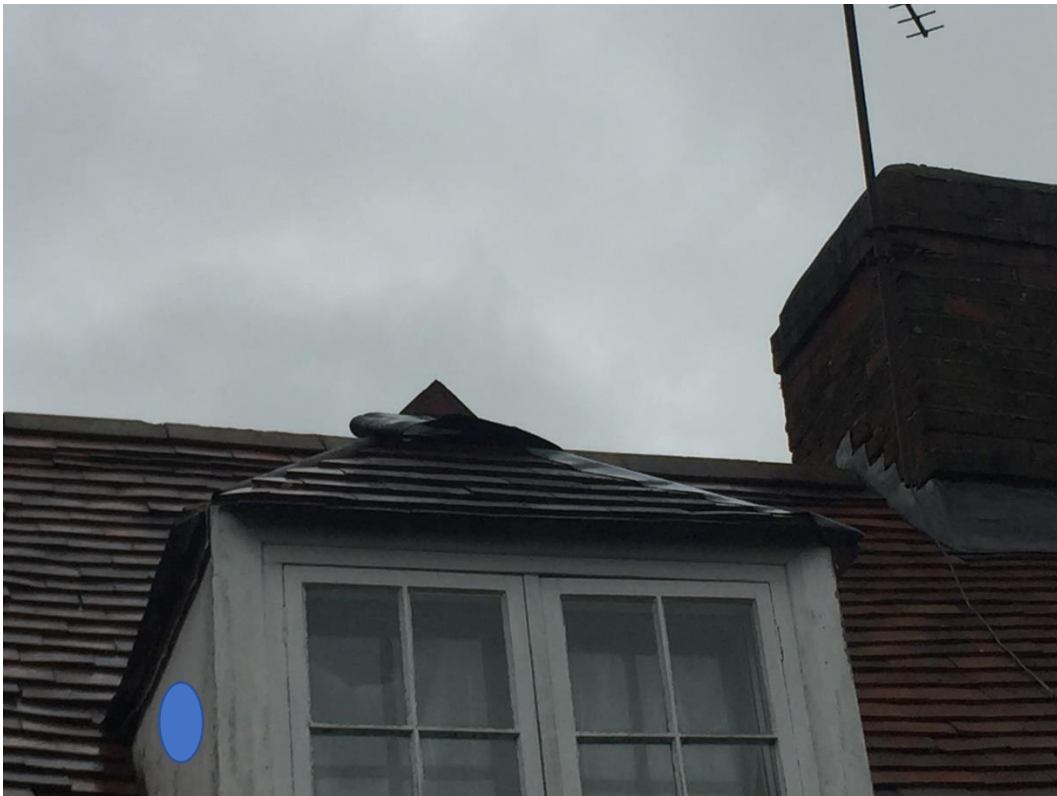
The roof of the main building (traditional clay tiles) was repaired in 2007. This included work on the three dormer roofs as well as the main roof. Unfortunately, the work was done badly. Tiles have blown off and landed in the cul-de-sac street below, and this presents a danger to children who play in the street and pedestrians walking by. As can be seen in the photograph below, the lead flashing on the dormer roofs is also coming off and water has entered (contributing to window and dormer gable damage).

*A dormer*

The roof and dormers will be repaired and re-tiled with the same tiles, replacing any faulty or missing ones with like for like hand-made tiles (we have many spare tiles in the shed). The work will be conducted by a roofing expert with significant experience of Listed buildings (including Old Headington) and churches. The gable ends on the dormers are modern rendered

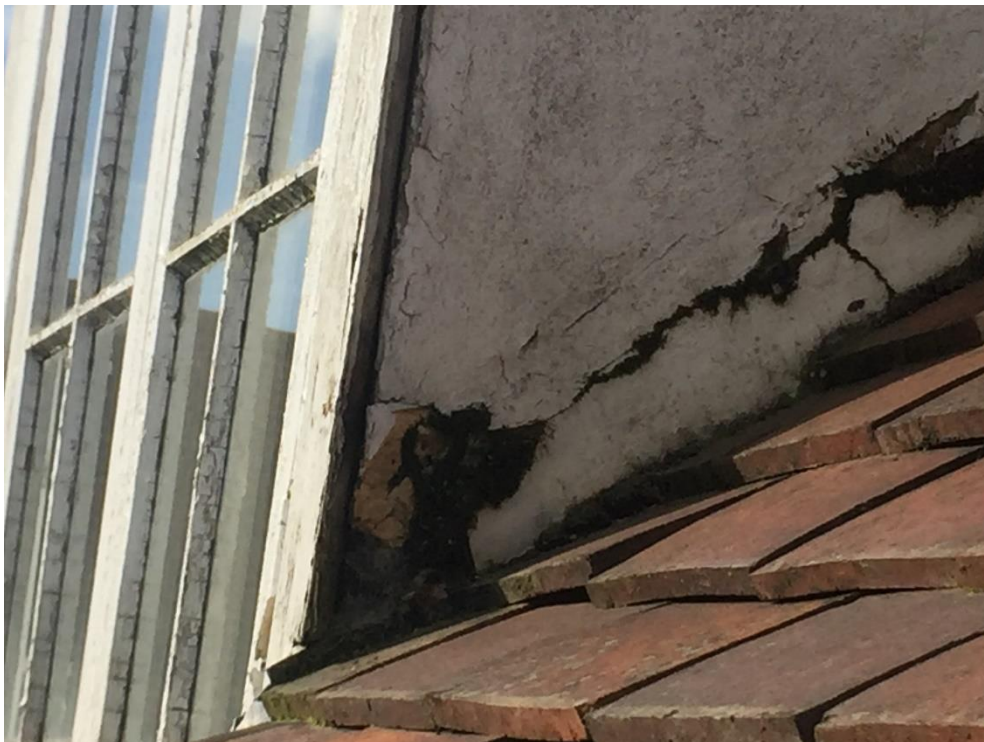
boards which are rotting (see blue oval on photo below); they will be replaced in a like-for-like manner.

*Damaged and rotting gable end*

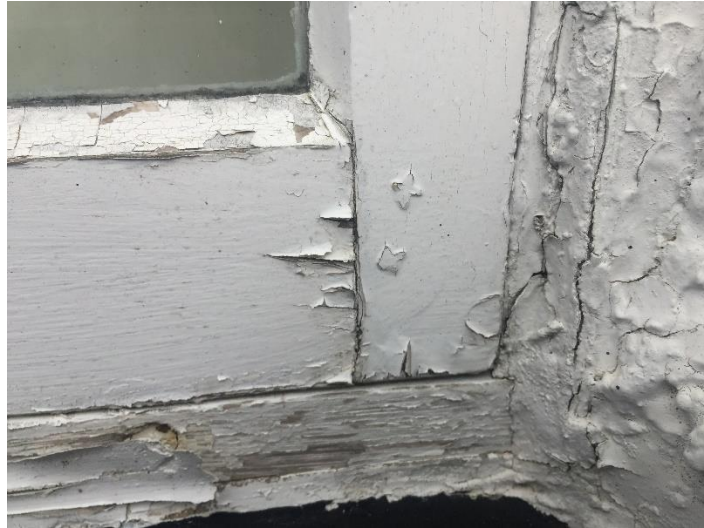
*Deteriorating but relatively modern ground floor window*

Following advice from a local family-run company (Gelders) that makes windows (e.g. for Oxford colleges and Listed buildings – including Old Headington), the three first floor (dormer) window frames and casements are rotten and need replacing. However, the ground floor windows can be saved and will be repaired. The next three images are of the three dormer windows.

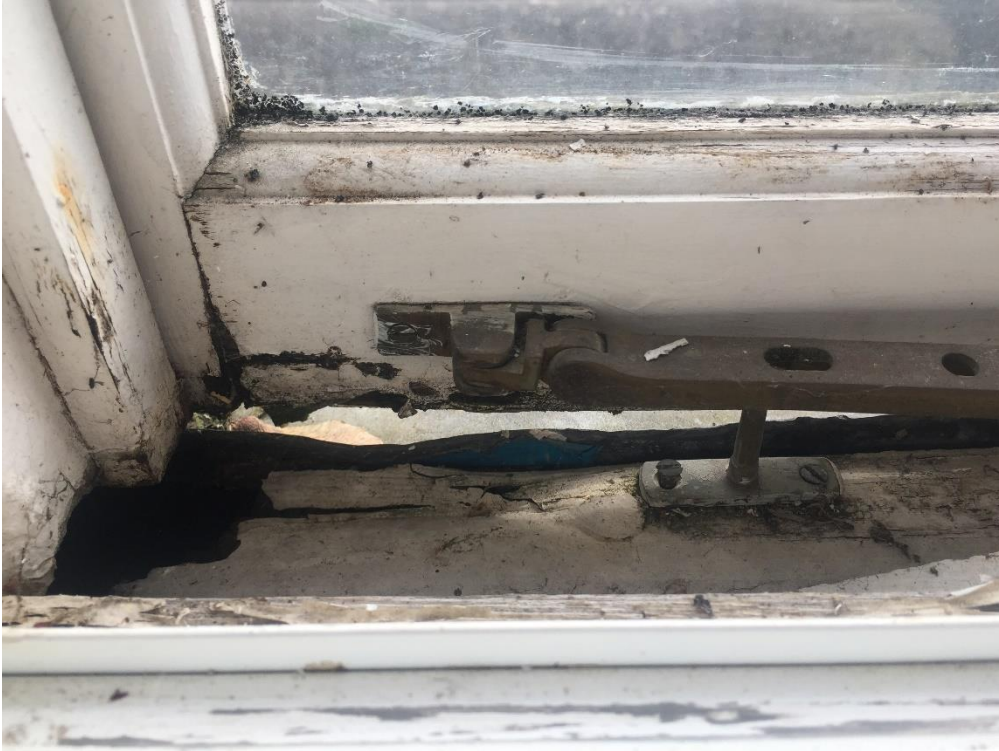
*The bottom edge of the left-hand dormer casement and window have completely rotted away*

Having consulted with our joiner, the dormer casements and frames will be replaced with like for like, hand-made single-glazed wooden casements and frames. Accoya wood will be used as it is the most durable and required to withstand the difficult environmental location. Traditional hand made black ironmongery will be used, replacing the current early 1980s steel ironmongery. The single-glazed dormer casements and frames will be replaced in a like-for-like manner. CAD diagrams for the casements and frames can be supplied by Gelders (an Oxford company with considerable experience of providing joinery to Listed Buildings in Oxford). The windows will be painted in white satin to match the current paint (and to match the windows of neighbouring cottages).

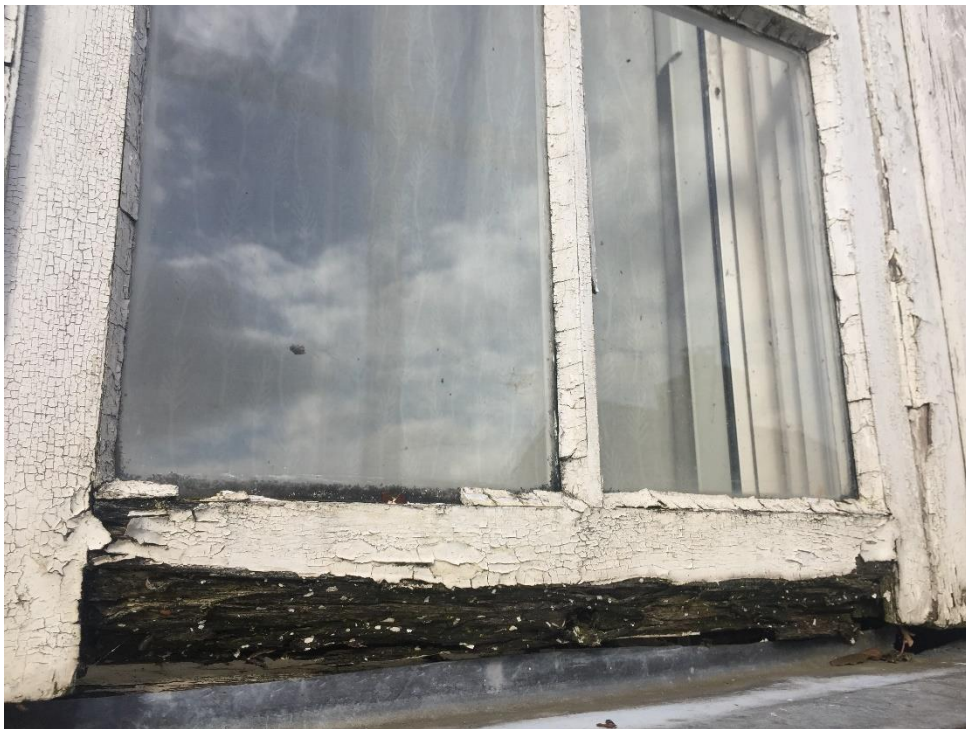
*It would be possible to push a finger through the rotting wood of the middle dormer*

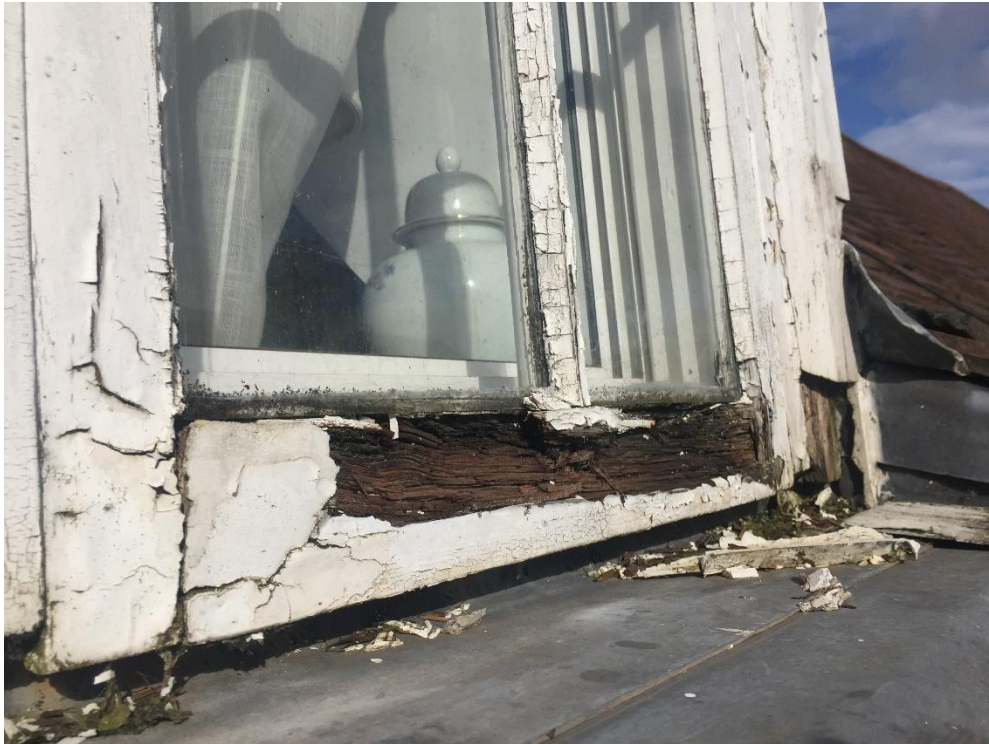
*The right-hand dormer*

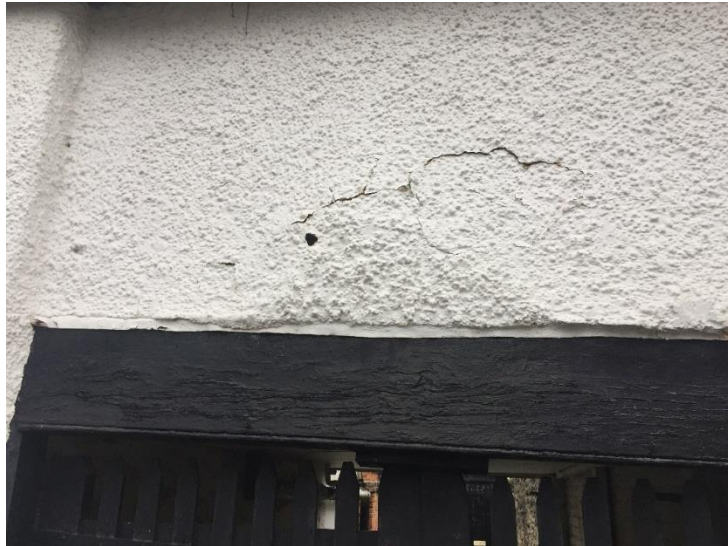
To the front right of the house is a large hole and crack in the render (see photo below). A general builder who has worked on many Listed buildings in the area said it needs removing and investigating. There is a cavity behind it. The render is relatively modern (of a pebble dash type) and it may be that what is behind it is much older and more in character with the cottage. Once the render is removed, OCC Planning will be consulted to determine whether what is behind it presents a better opportunity for enhancing the character of the building or whether it should be re-rendered as before.

*The hole and crack in the render above the gate.*

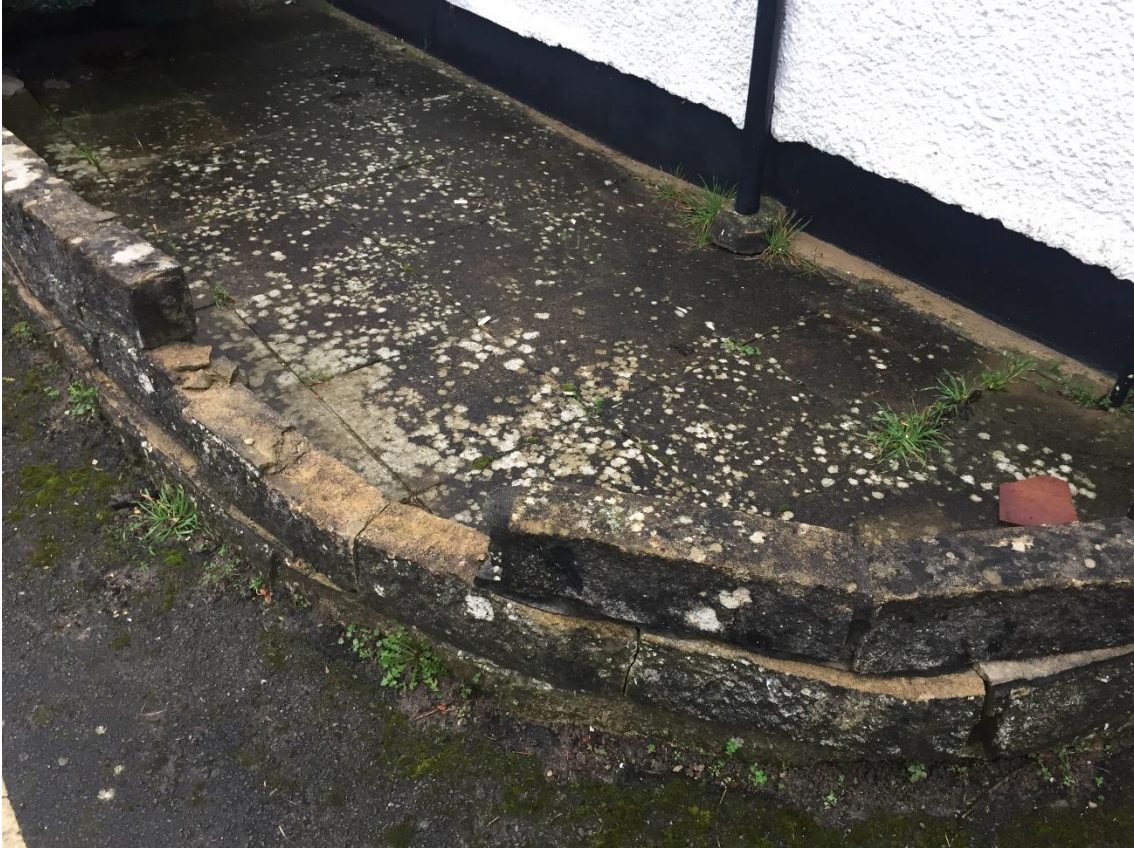
The front garden wall originates from unsympathetic alterations that were made in the early 1980s. As can be seen from the photograph below, it is of poor and ugly construction. Over the years, cars and vans have damaged it while trying to turn in the narrow cul-de-sac. The roots of two hedges are also destroying it. Being only 40cm high, it is also a safety hazard to pedestrians and children – it would be easy to trip and fall on the wall, with the sharp top edges posing a head injury risk. The wall will be removed and replaced with a traditional stone wall using local stone, approximately 60cm high. The stone will come from a quarry near Burford that has provided stone to match Old Headington stone for other Listed Building projects in Old Headington. The stone will match the Listed outbuilding next door (west) which can be seen in an earlier photograph of the cul-de-sac (see 'Heritage' section). The wall will be built by an individual who has built and repaired many stone walls in the Old Headington Conservation Area. It will be capped in a traditional manner in keeping with the stone wall opposite number 9 The Croft (see photograph below).

*Damaged front garden wall at 9 The Croft*

- Repairing a hole in the render at the front of the house.
- Removing a dilapidated, 40cm high single blockwork concrete front garden wall (constructed in the early 1980s) and replacing it with a professionally built 60cm natural stone wall (stone type to match that of the Listed outbuilding next door).

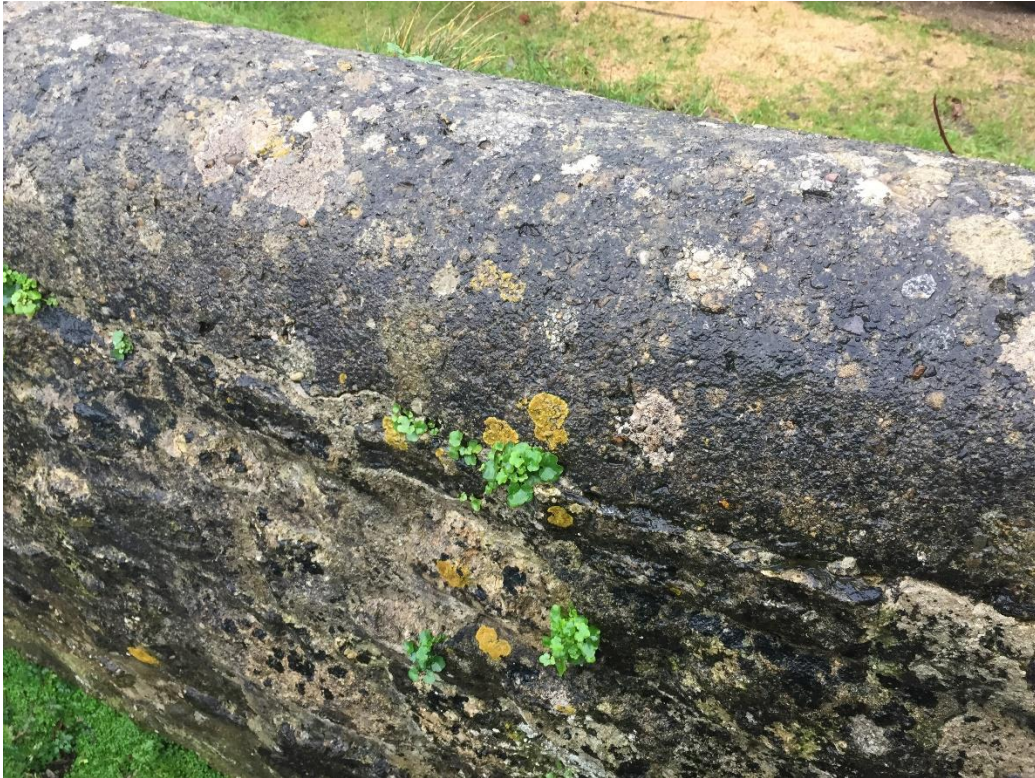
*Wall opposite number 9 The Croft*

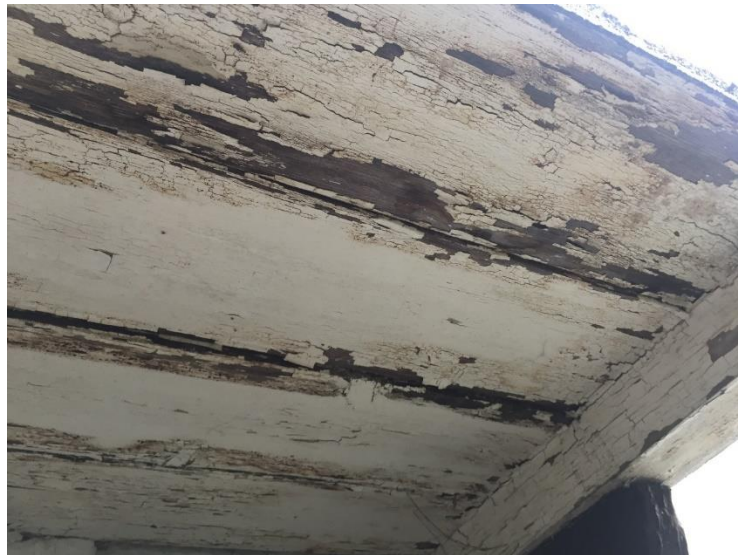
*The underside of the porch cover showing the rotten wooden boards*

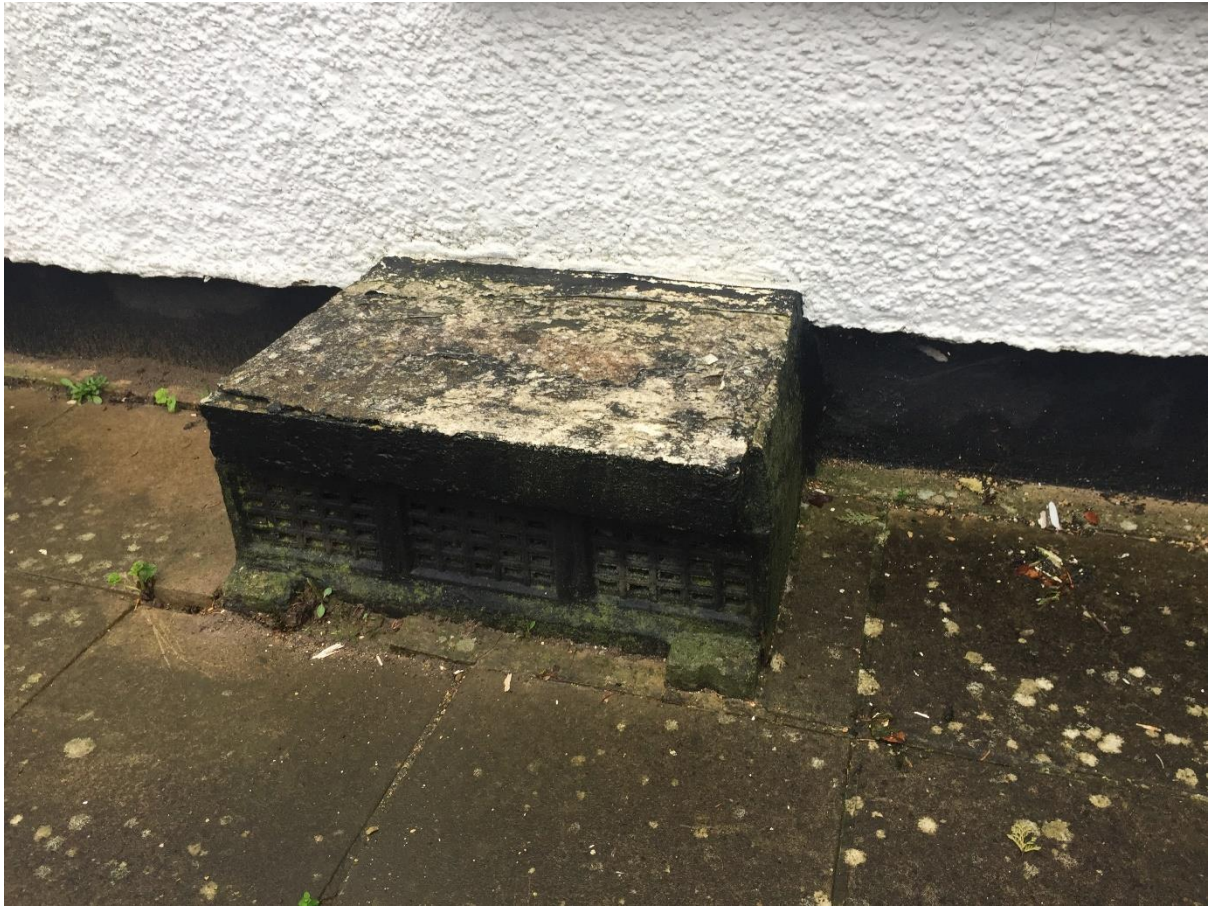
At the front of the house is a concrete cellar ventilation cover which was constructed in the early 1980s. It is ugly and in a poor state of repair. A builder has said it needs replacing. It will be replaced by a more attractive design using reclaimed red bricks and a structural glass cover (to let light into the cellar below). The intent is for a lower profile – one or two red bricks in height – so that it is less of an eyesore than it currently is. The structural glass cover will be made by Gelders.

*The cellar ventilation cover*

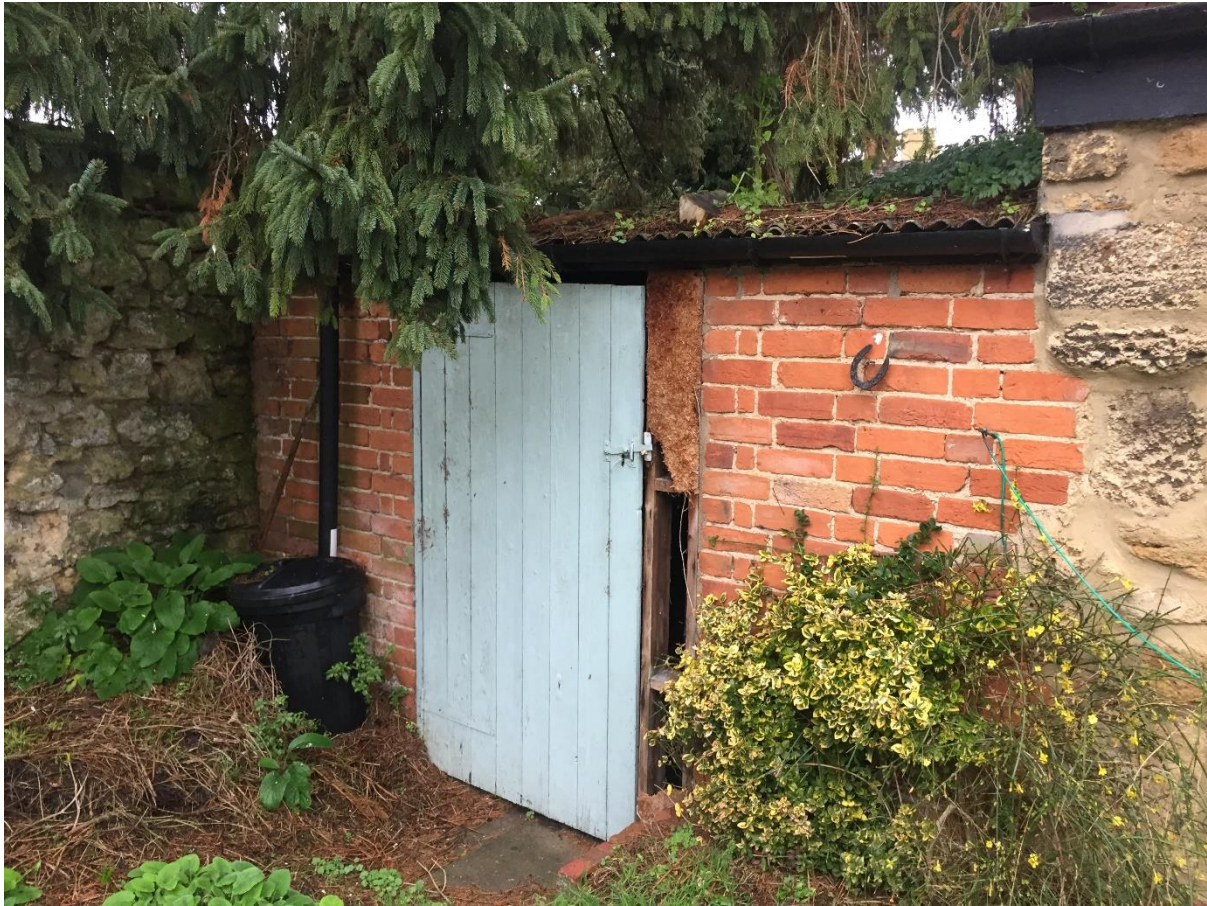
*The shed/outbuilding*

The shed/outbuilding in the small rear garden is falling apart. The asbestos roof will be removed by a specialist company and replaced with a more aesthetically pleasing (and more weatherproof) zinc roof.

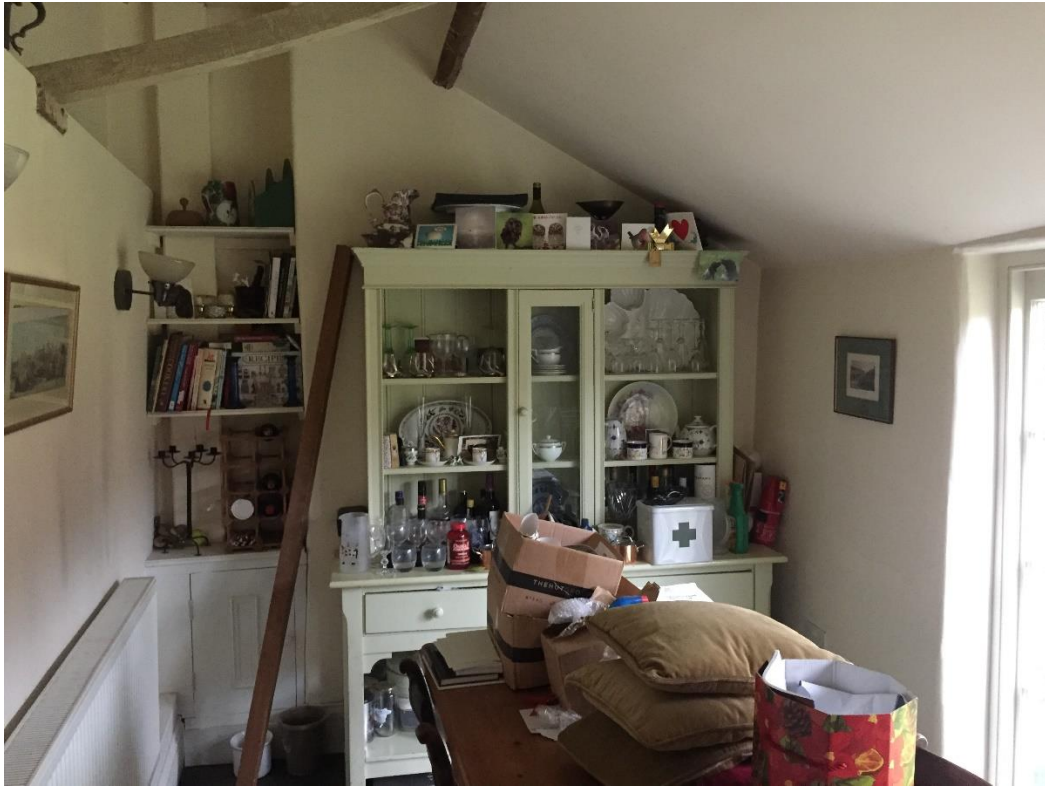
*The interior end of the modern rear extension – looking west*

A small extension was added to the rear of the cottage in the early 1980s. It was renovated in 2007 (see 07/01517/LBC ). There is no toilet on the ground floor and only one toilet in the whole building – on the first floor at the end of a very narrow corridor. This means that an individual with a disability or access difficulties would not be able to use a toilet in the house. Rather than disturb the fabric of the much older ground floor area to the front of the cottage, the plan is to create a small toilet at the end of, and within, the existing rear extension by using a sound-proof partition. The toilet area would be where the light green dresser is in the photograph below, and the partition would end on the right-hand edge of the picture on the right-hand wall. A small window (approximately 45cm wide and 65cm high) would be inserted at the position shown by the blue oval in the second photograph below (corresponding to the area on the left-hand edge of the picture in the first photograph below).

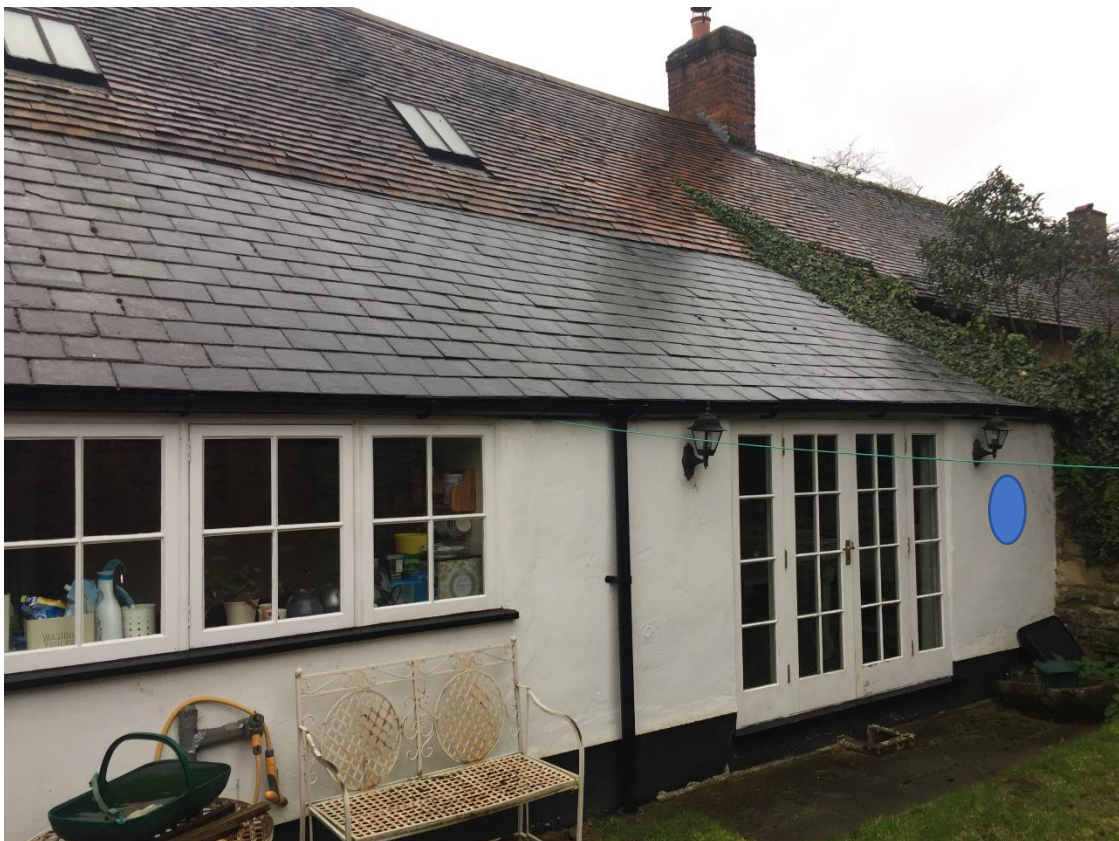
*The rear extension – looking west*
