Bolsover Castle Canopy Structural Appraisal

Curtins Ref: 077684-CUR-00-XX-SC-S-00001-V02

Issue Date: 04 June 2021

Canopy Structural Appraisal

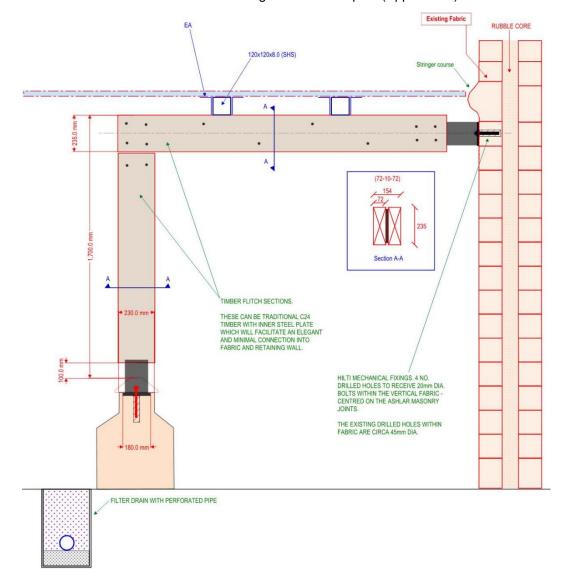
Figure 5 – Elevation of proposed canopy structure and connections

- 4.5 The column baseplate will sit beneath the first course of coping stone, largely hidden from view, with an extruding steel plate extending above the stone. The extruding plate will run up between the timber sections to form the flitch column. Similarly, the steel plate will form connection between column and beam sections.

- 4.6 The canopy sits alongide existing external wall. In avoidance of more complicated and onerous moment connections to the sensitive fabric, the structural connections should sit tight to the underside of stringer course. The raised roof which has been proposed for this design offers the opportunity to maintain a suitable head height and aligns the canopy roof up to the stringer course while avoiding undue stresses to the existing fabric.

- 4.7 The raised roof plate will rest on steel sections running perpendicular to the primary flitch beams, required to reduce deflection of the roof plate. These elements are recessed back from the front of canopy to reduce their visibility. The roof plate itself is designed as a steel plate, which is required for structural integrity but can be covered with the preferred metal to give the desired appearance, such as copper.

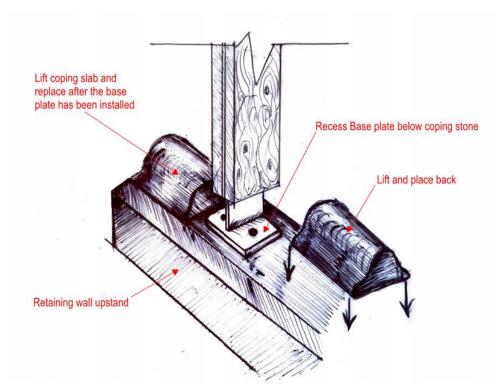
Figure 6 - Proposed connection to existing retaining wall

- 4.4 Proposed connection between structural column and upstand is via discrete baseplate connection, indicated in Figure 6, sitting beneath the existing coping stones. The coping stones across the retaining wall upstand are in poor condition and will require due care when removing, however, the works provide the opportunity to undertake restorative works to the stone in this location.

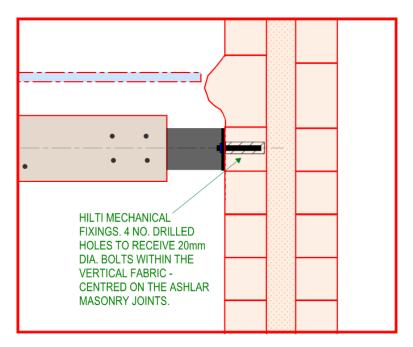
Figure 7 – Proposed connection to existing fabric

- 4.8 Connection between beam and existing fabric face will be steel plate extruding from flitch beam into baseplate at fabric face. The space provided by the extruding steel plate gives breathing space between

- the existing wall and timber. The proposed connections look to utilise a mechanical fastening to reduce intrusive works and the use of chemical adhesives.
- 4.9 Connection plates are to be located along wall face to avoid positioning above window lintels and within stone of suitable condition.
- 4.10 Rainwater from canopy surface will be carried over the long edge and allowed to naturally fall off to surface below. The rainwater will be carried away by the perforated drain running parallel to the long edge of canopy. To ensure that surface water is directed appropriately, gravel within this strip should be brought up to ground level to provide path for water flow and adequate maintenance to confirm the system works as intended. The perforated pipe then feeds back to the drainage system as designed for recent works shown on Curtin's drainage scheme site plan (Appendix A).

- 5.2 The connections will cause a degree of intrusion to the existing fabric, however this has been minimised as far as possible with the adoption of simple connections and reduced connection points along the elevation. The anticipated connection will involve 4 No. drilled holes to receive 20mm diameter bolts within the vertical fabric and centred on the ashlar masonry units.
