**GREEN BANK, STATION ROAD,  
WHITWELL.**

**BAT SURVEY.**

**Ref No: 210467/Rev 1.**

**Date: 22<sup>nd</sup> June 2021.**

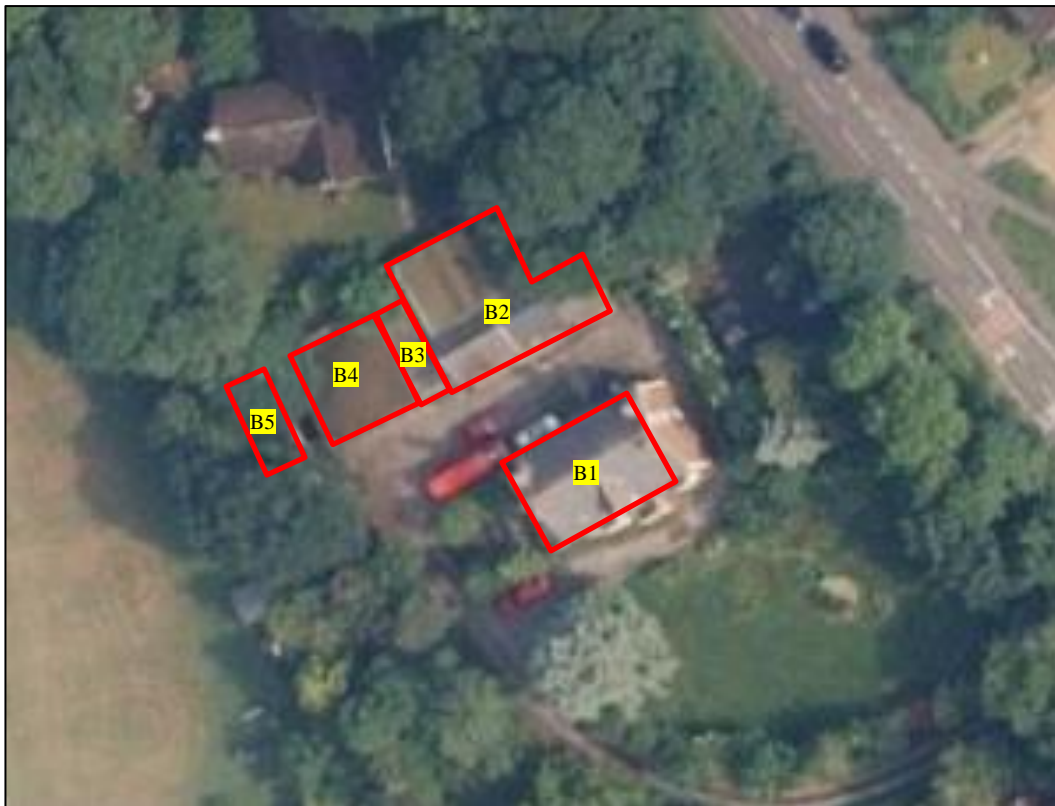
3.2.1. The surveyed area consists of the house at Green Bank, Station Road, Whitwell and the associated outbuildings. The aerial photograph below shows the surveyed area and the buildings, that have been numbered 1 to 5 for the purpose of this report.

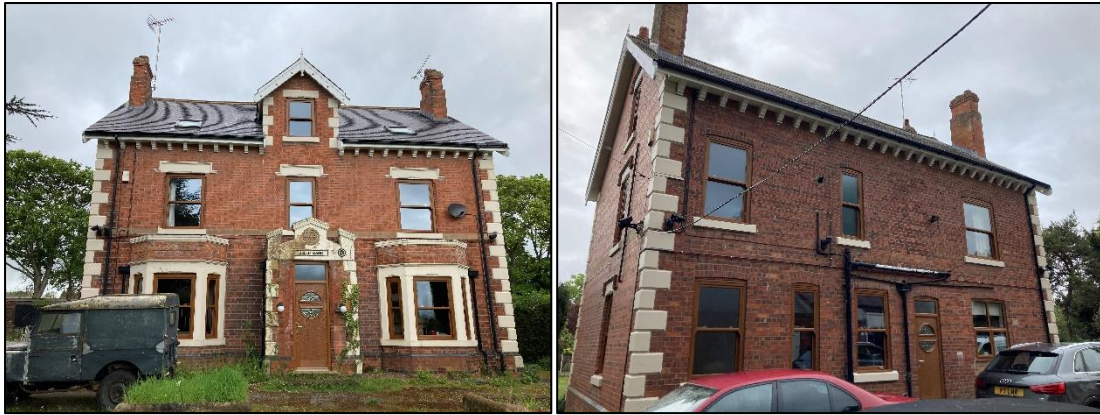
3.3.2.1. Building 1 is the main house of Green Bank and is a three story building constructed with solid brick walls with stone work on each corner of the house and around the ground floor doors and windows on the southern elevation. The walls are in a good state of repair with no gaps, missing bricks, stones or pointing. All the windows and doors are sealed and well fitted with no gaps to the inside. The photographs below show Building 1.

3.3.2.5. No bats or bat field signs such as droppings, feeding remains or staining were identified internally or externally around Building 1 during this survey. However, Building 1 has been assessed to provide **Low** potential for roosting bats in the gaps behind the soffit boards on the northern and southern elevations of the building.

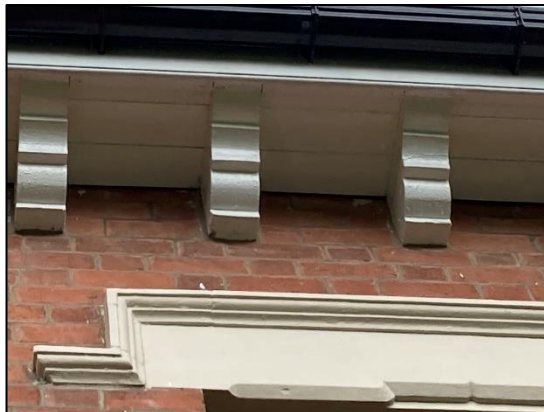
3.3.2.2. The roof of Building 1 is pitched and covered with slate with a dormer window on the southern elevation. The roof is in a good state of repair with all slates in place and all ridge tiles fitted and well pointed. There are timber soffit and fascia boards around the eaves that are well fitted on the eastern and western gable ends. However, there are gaps behind the soffits on the northern and southern elevations. The photograph below shows some of the gaps behind the soffit boards.

4.1. During the daytime survey Building 1 was assessed as providing **low** bat roost potential around the gaps behind the soffit and fascia boards on the eastern and western elevations of the building. Therefore, if any works will affect the areas around the soffit and fascia boards, there may be an impact on roosting bats if they are present.

5.3. If works to Building 1 change and will have any impact on the soffits and fascia boards of the building it is recommended that a further bat dusk emergence survey is carried out on Building 1. If no work will be carried out on the soffit and fascia boards of Building 1, no further surveys of Building 1 will be required.

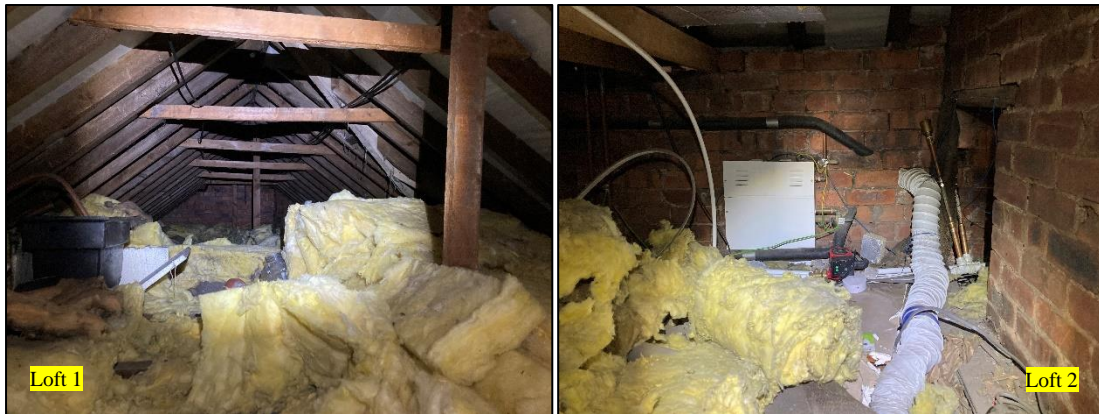
3.3.2.3. Inside the house is still occupied. There are two loft spaces to the house. Loft one spans the length of the house and is supported by a simple timber beam frame and has a plastic membrane liner that is in a good condition. However, light could be seen shining in the loft around the eaves.

3.3.2.4. Loft two is a small loft that is used to house the water tank and has a timber floor and insulation. The loft is lined with a plastic membrane liner that is in a good state of repair. The photographs below show both loft spaces.

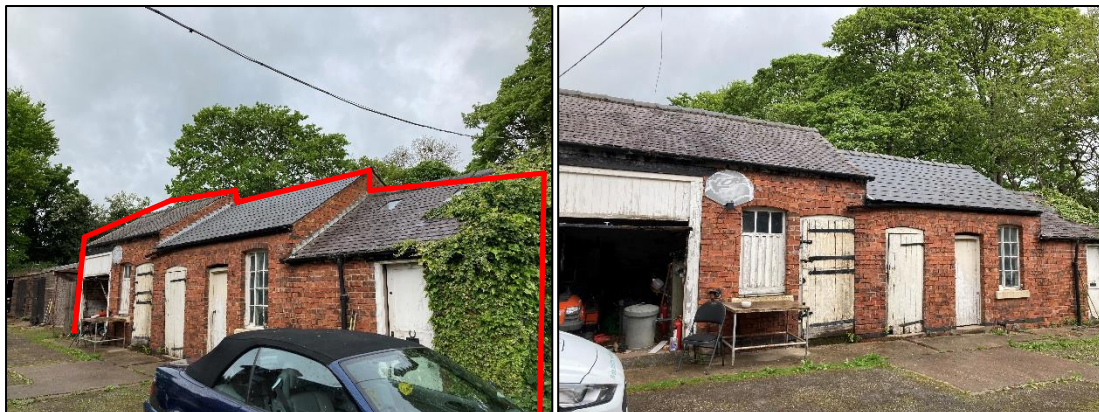
3.3.3.1. Building 2 lies to the north of Building 1. Building 2 comprises five individual rooms. One is a garage, three are small outbuildings and one is a shed/garage that are all separated by brick walls. All the rooms are single story and used for storage. The photographs below show Building 2.

3.3.3.3. The walls of Building 2 are generally in a good state of repair although there are gaps around some of the windows and there are gaps around some of the door frames with the western garage door permanently open.

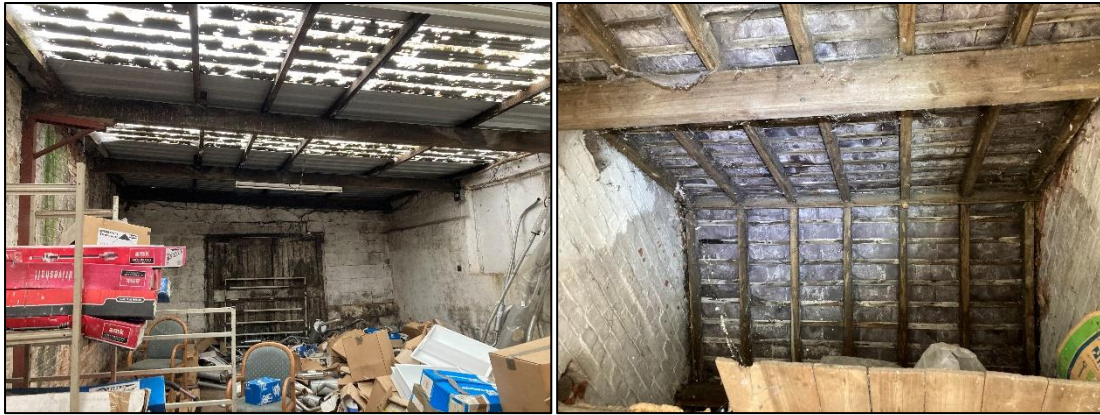
3.3.3.2. Three of the rooms are open to the roof and two have under slung timber and plaster board ceilings with small loft spaces, although the loft spaces could not be accessed during this survey. Two of the rooms have a plastic membrane liner and three are open to the roof. The photographs below show two of the compartments.

3.3.3.4. The roof of Building 2 has three pitches of varying heights that run east to west and are covered with slate. Some of the slates have slipped and there is a hole in the roof at the eastern end. There are also gaps beneath the ridge tiles of the central pitch. The northern room has a flat roof covered with corrugated plastic sheets.

3.3.3.5. No bats or bat field signs were identified internally or externally within any of the rooms of Building 2 during this survey. However, Building 2 provides **Low** roosting bat potential in the slipped tiles of the roof and beneath the gaps in the ridge tiles of the central pitch.

4.2. Building 2 was assessed to provide **low** potential for roosting bats beneath the slipped tiles and gaps beneath the ridge tiles of the roof. Therefore, the proposed works to Building 2 may have an impact on roosting bats if they are present.

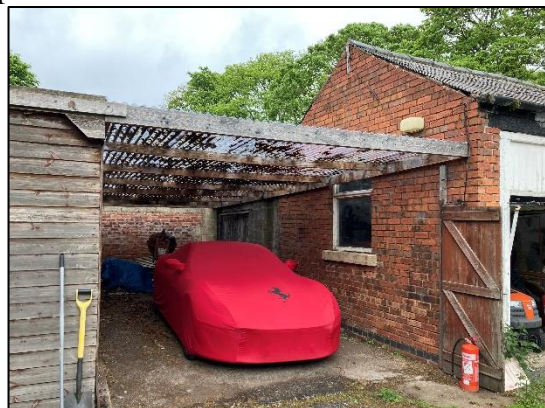
3.3.4.1. Building 3 is a car port that lies between Building 2 and Building 4 and consists of a corrugated plastic roof that is supported by timber beams and is open on the southern elevation and has a brick wall at the northern elevation. The photograph below shows the car port.

3.3.4.2. No bats or bat field signs or any roosting bat potential was identified internally or externally around Building 3 during this survey. Building 3 provides **no** bat roost potential.

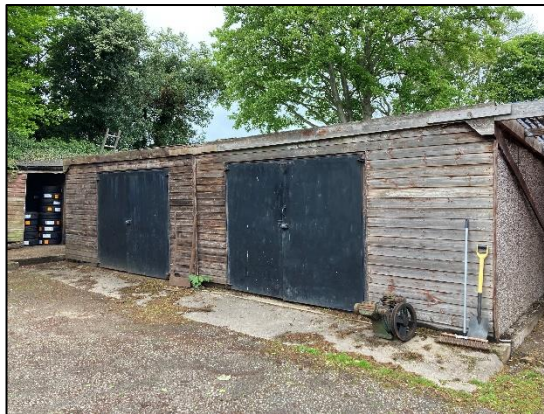
3.3.5.1. Building 4 is a storage shed located to the west of Building 3 and is a single story building constructed with pre-fabricated walls to the eastern and western elevations, brick and breeze block walls to the northern elevation and steel walls with external timber cladding on the southern elevation and has two steel doors. The photograph below shows the southern elevation of Building 4.

3.3.5.2. Internally the shed is used for storage and is open to the roof that has no liner and is supported by a steel frame.

3.3.5.3. The roof of the building is slightly sloping and covered with metal corrugated sheets, that are well fitted.

3.3.5.4. No bats or bat field signs or any roosting bat potential was identified internally or externally around Building 4 during this survey. Building 4 provides **no** bat roost potential.

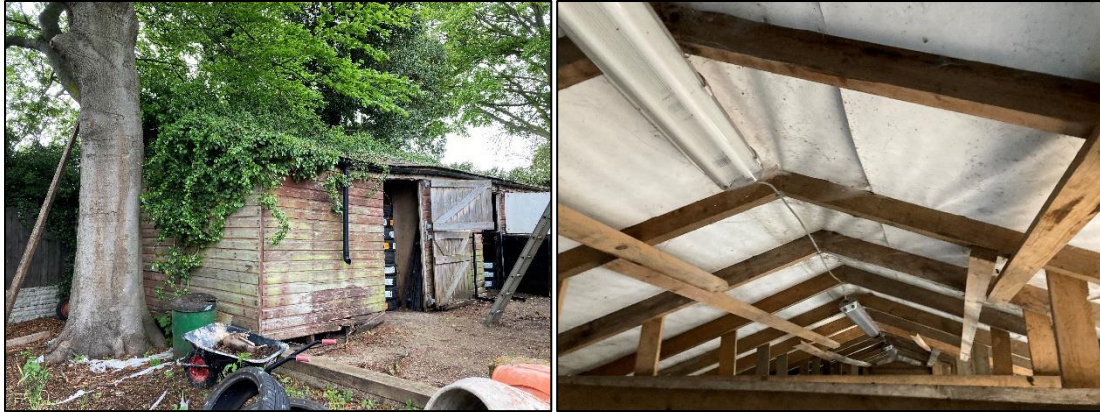
3.3.6.1. Building 5 is located to the west of Building 4 and is a timber shed used for storage that is generally in a good state of repair with all windows and doors well fitted with mesh over the windows. Internally, Building 5 is open to the roof, which is

supported by a timber frame and has a plastic membrane liner. The photograph below shows Building 5 externally and internally.

3.3.6.2. The roof of Building 5 is pitched and covered with slate and is in a good state of repair, although there is dense ivy growing on the roof.

3.3.6.3. No bats or bat field signs or any roosting bat potential was identified internally or externally around Building 5 during this survey. Building 5 provides **no** bat roost potential.

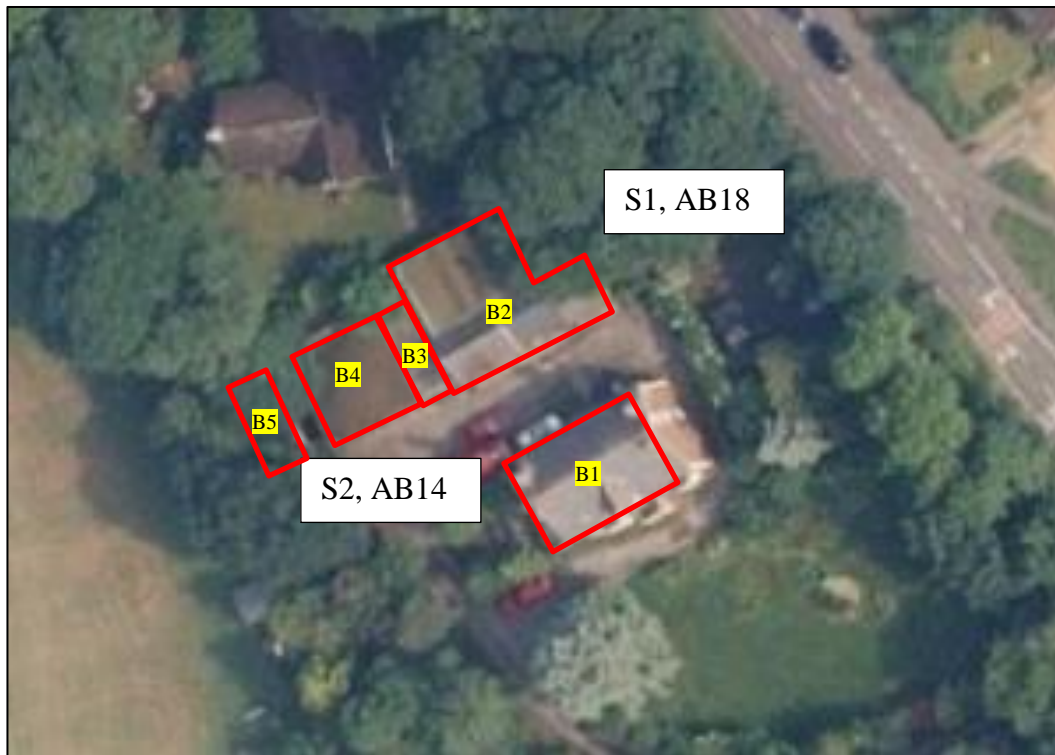
3.4.3. The two surveyors were positioned around Building 2 in order to be able to view all aspects of the building simultaneously. Each surveyor was equipped with a Batbox Duet detector and a two-way radio for communications. In addition, two static Anabat recorders were deployed to record bat activity for subsequent computer analysis using Analook software. The positions of the surveyors (S) and the Anabat recorders (A) were as shown below.
