Old Applecroft Farm
Great Henny, Sudbury

Design & access statement

June 2021

**project
orange**

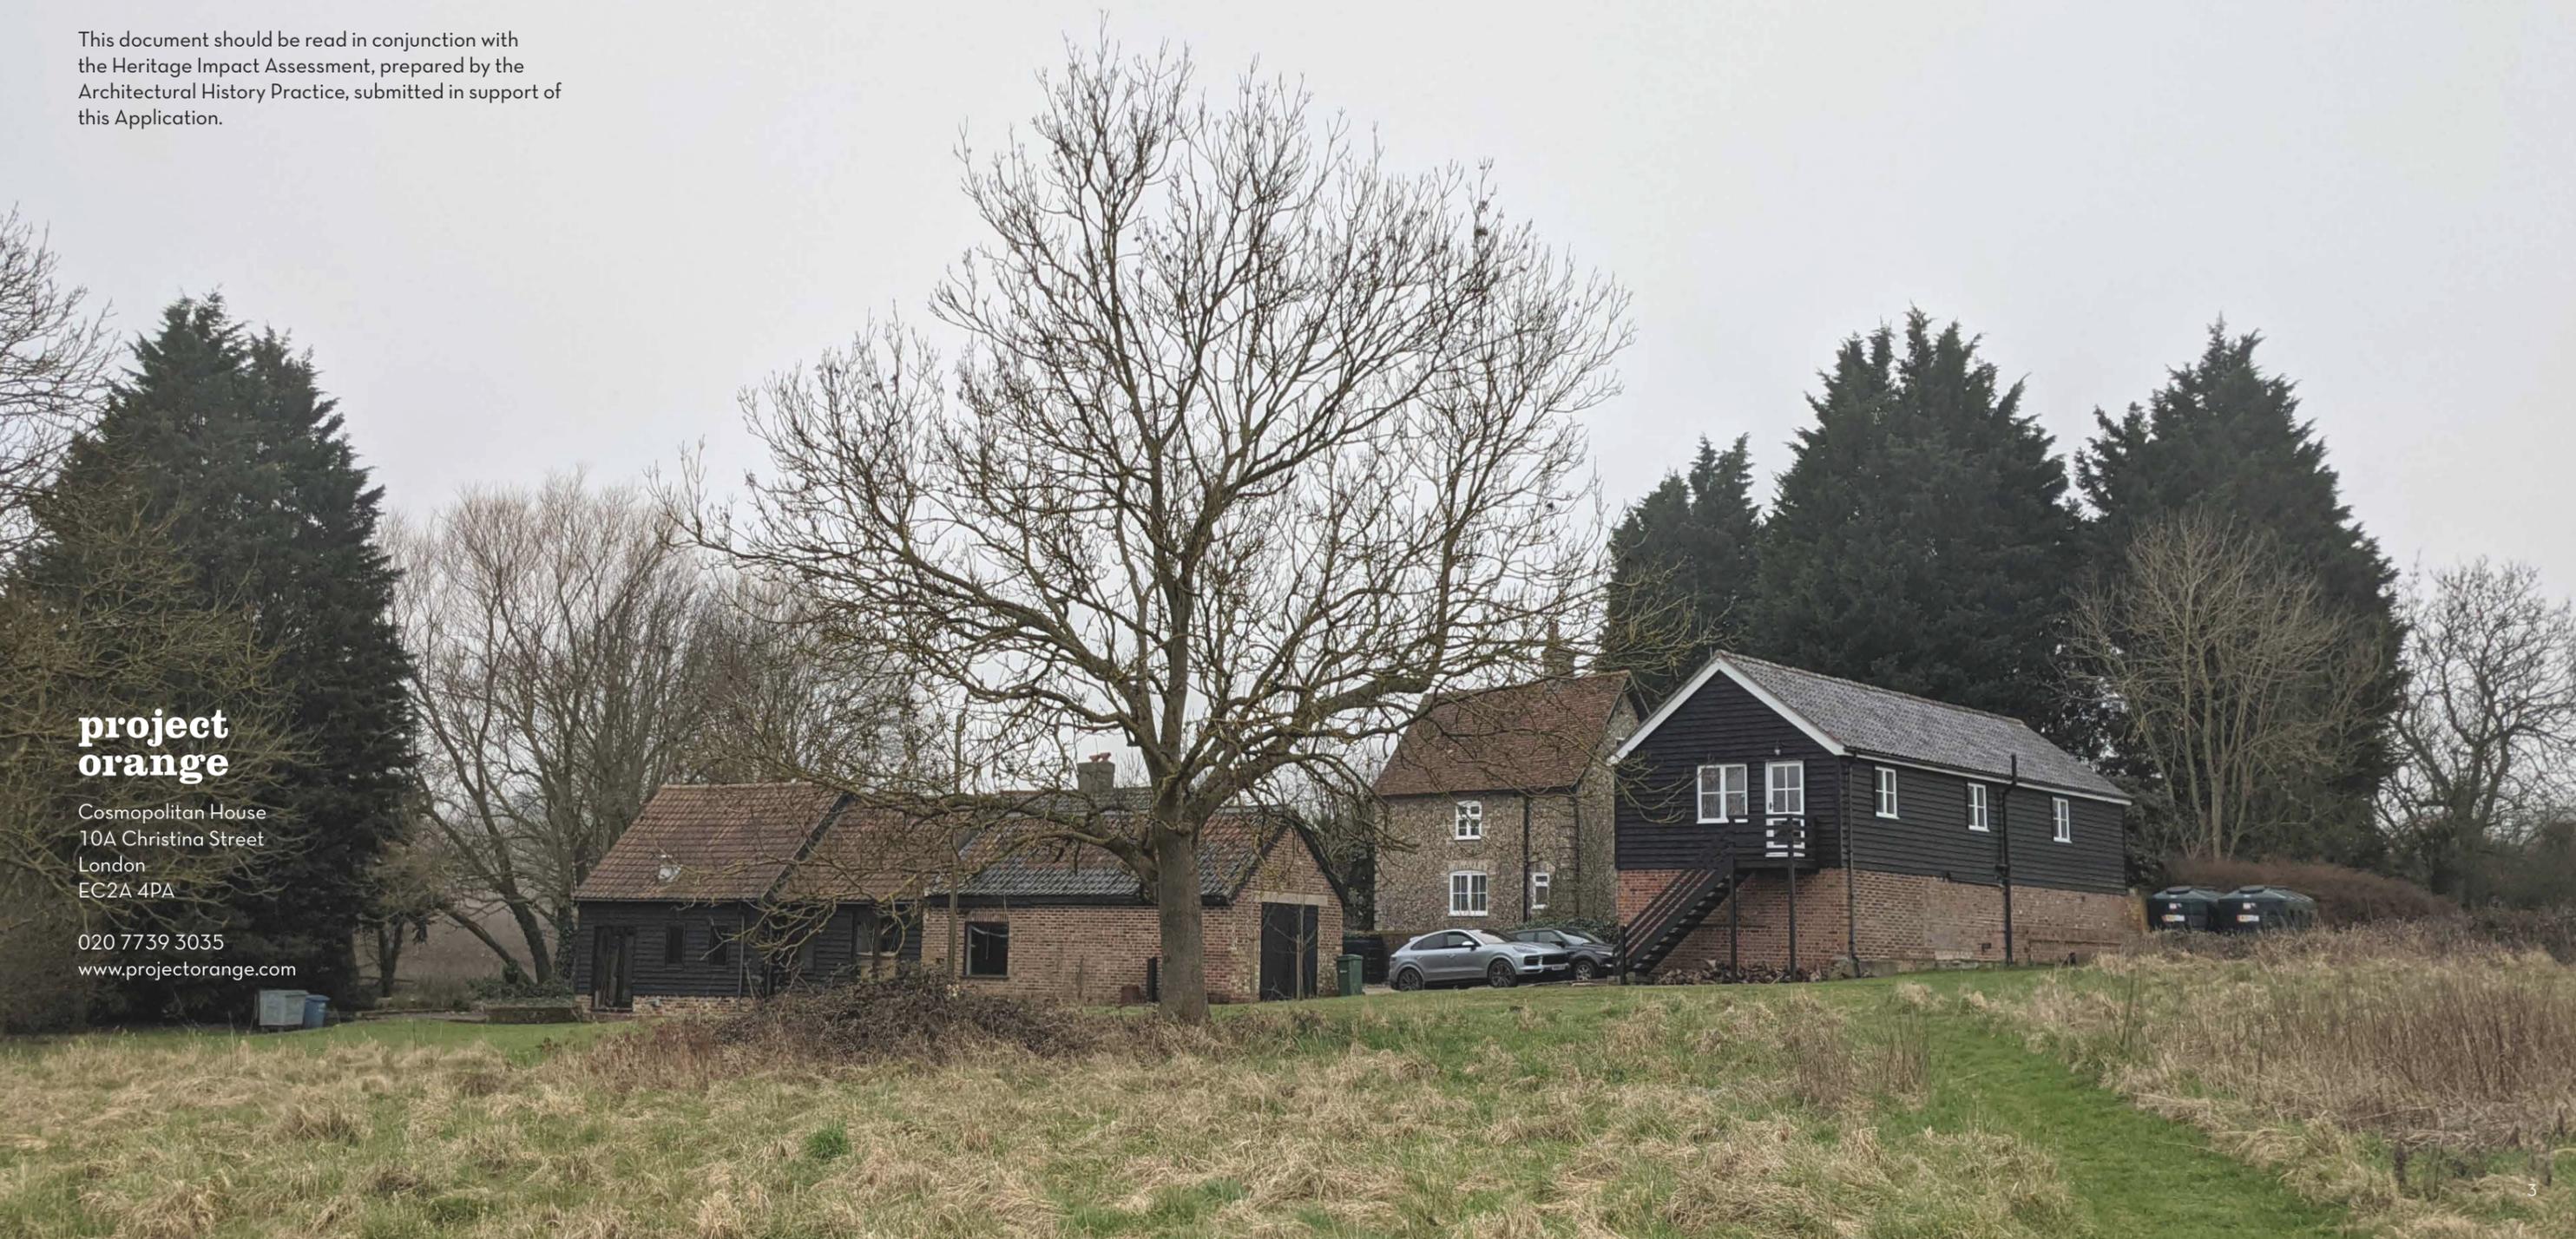
Aerial view

The 5.3 acre site lies in a picturesque dell. There are panoramic views of the surrounding countryside which are most attractive to the north east.

The site is accessed by a private lane from the south and there is a small stream that runs along the southern boundary.

The terrain is a combination of gently undulating grassy levels with a concrete yard at the centre of the complex of buildings.

The site is surrounded by fields and there are no near neighbours. The nearest substantial settlement is Sudbury which is a 10 minute drive north.

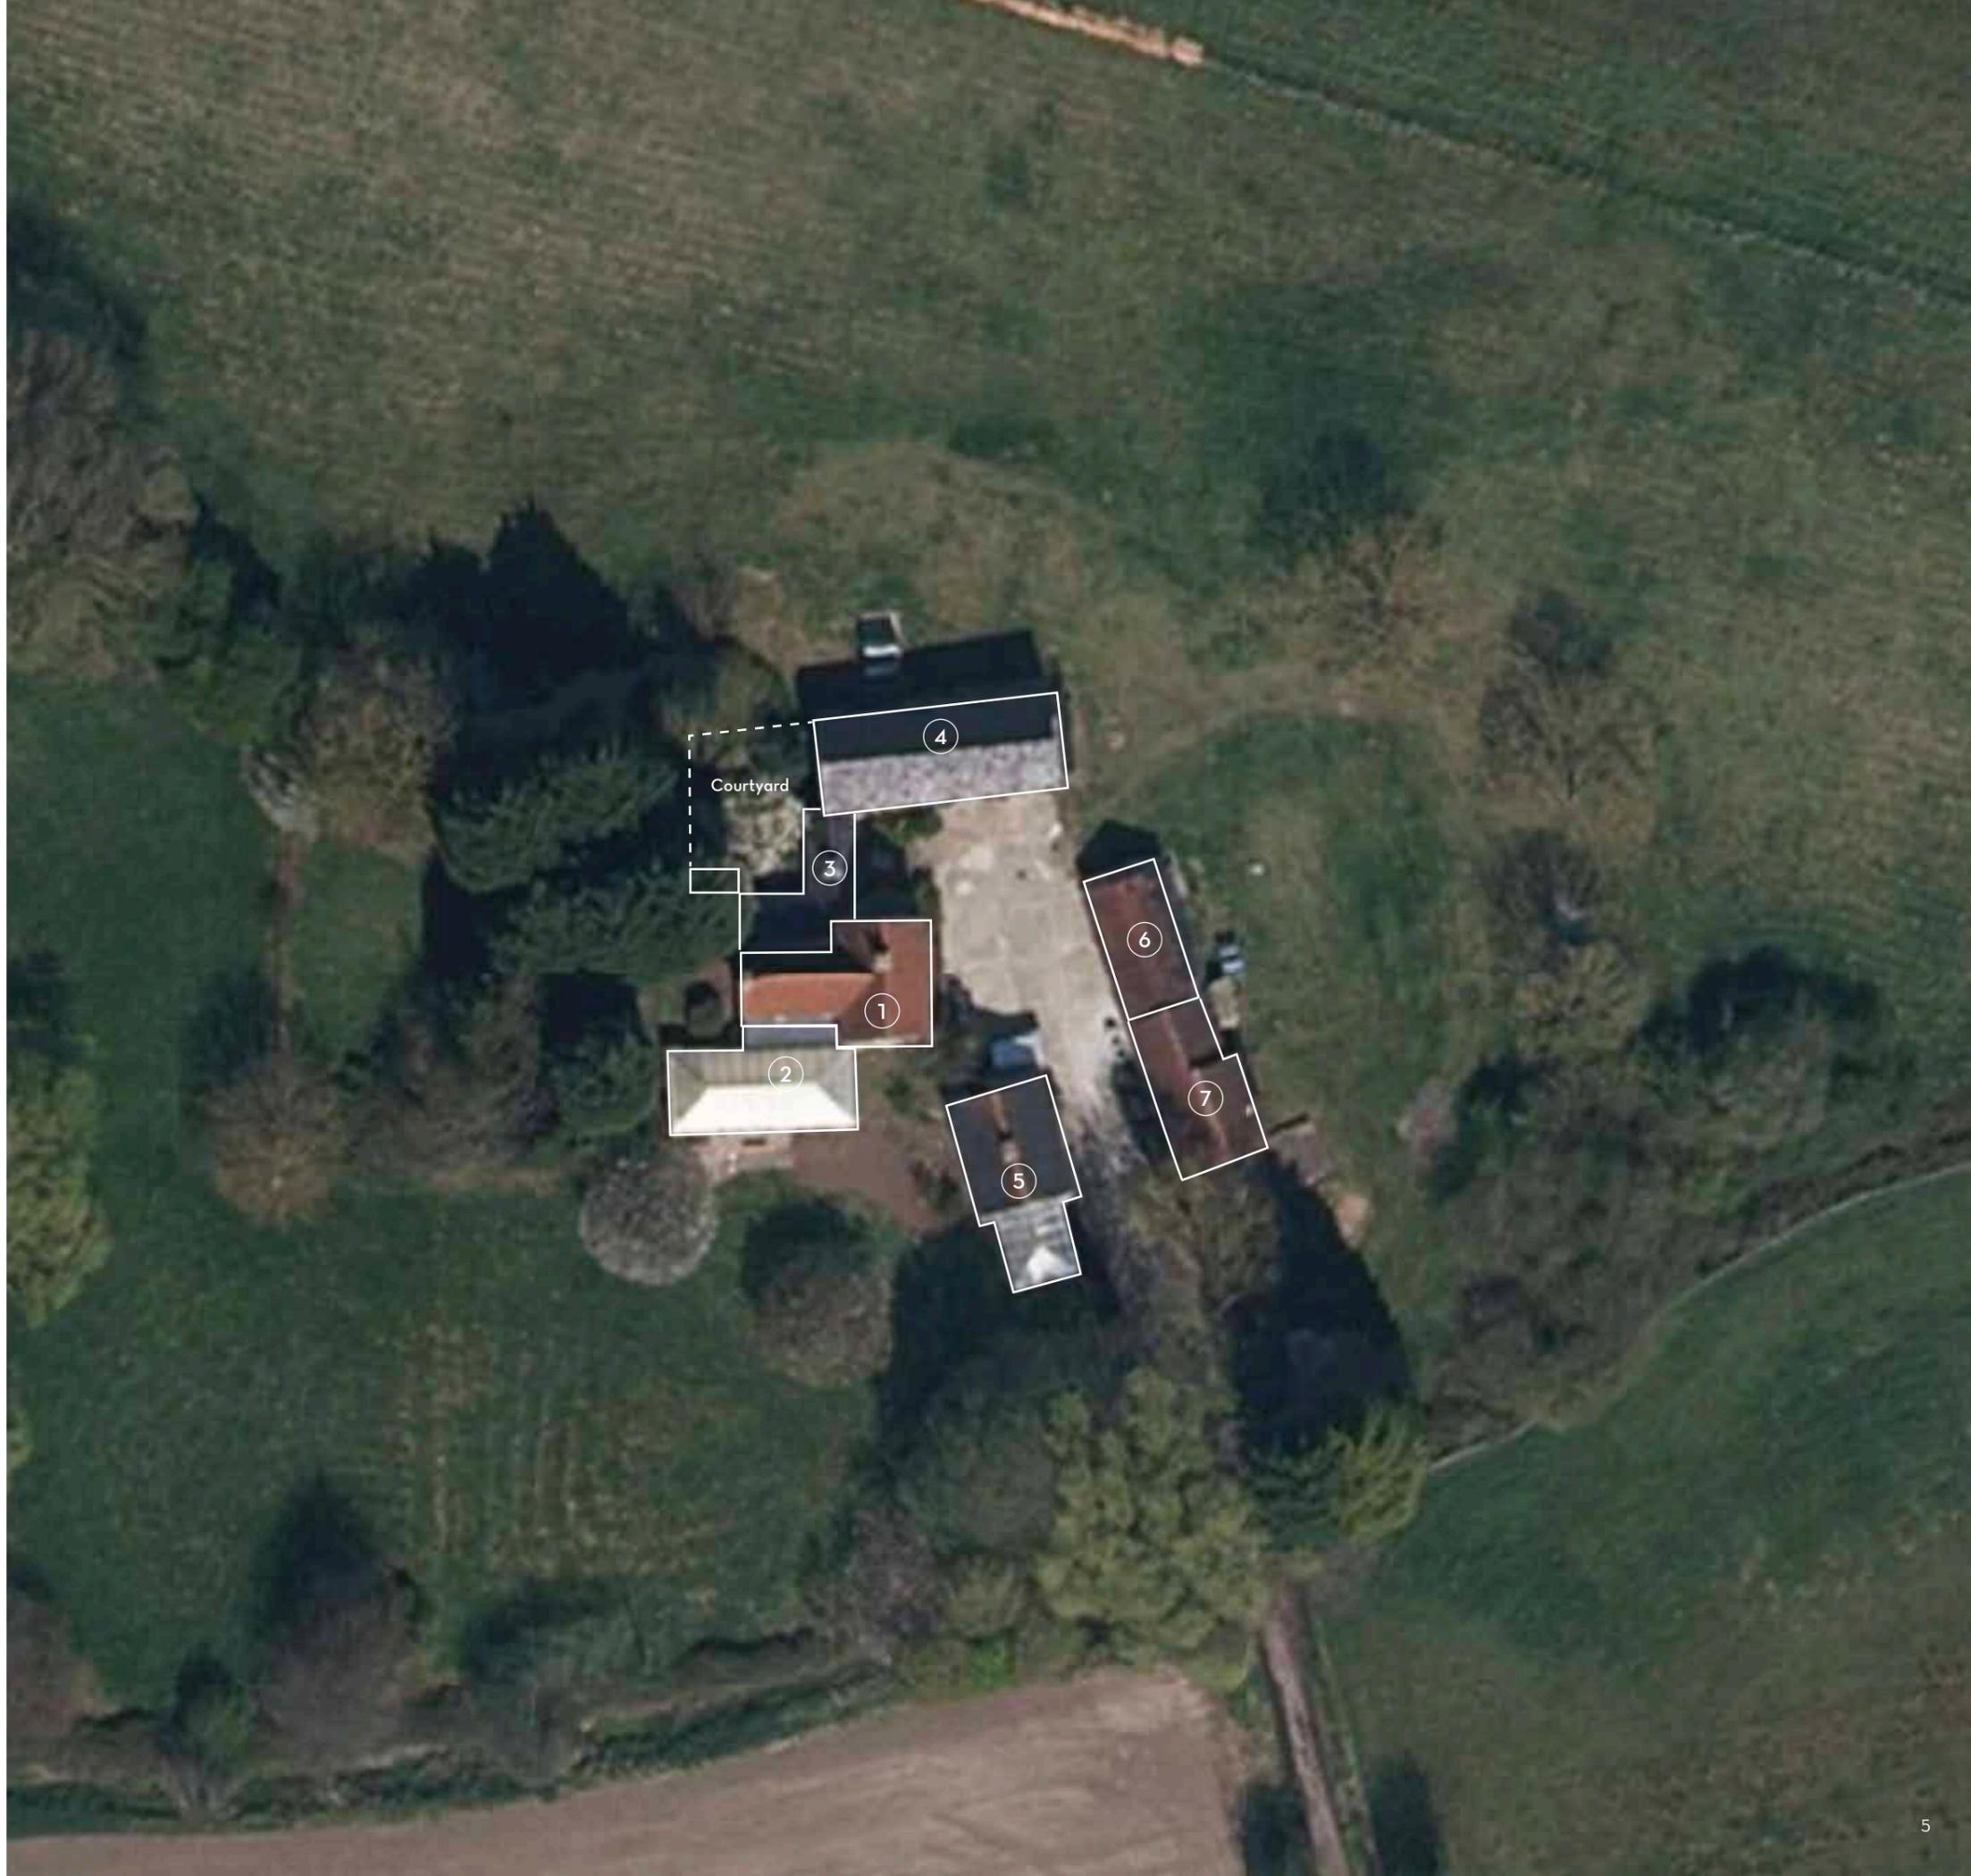
The site contains a tight knit complex of buildings built in various eras and in differing styles. What remains is a relatively modest proportion of a more substantial range of buildings apparent in late 19C maps of the area.

1. Original Farmhouse

The original farmhouse a Grade II listed building, built circa 16th century but re-clad in the 19th century with flint work, brick and quoins. The farmhouse sits elevated above the cottage to the southeast and is relatively tall compared to the other buildings in the complex, which gives it a sense of prominence.

2. Pool hall conservatory

To the south of the farmhouse sits a large conservatory that houses a small redundant swimming pool. It was built in the 1980s and is of no architectural merit. Its scale and form blocks views of and is extremely harmful to the setting of the original farmhouse. Linking the conservatory to the south elevation of the original farmhouse is a non original lean-to brick section. The construction of the lean-to and subsequent conservatory involved the removal of a large section of the southern ground floor facade of the original farmhouse which this application proposes to reinstate.

3. Single storey link

The North block is connected to the original farmhouse by a single storey link building. This link is clad in dark stained horizontal timber boarding and has a black glazed pantile roof. Also, there is a lean-to brick section added to the north elevation of the farmhouse that opens into the link. To the west of the link is a walled courtyard. The link is of negligible architectural merit and provides an inadequate connection from the North range to the farmhouse.

4. North Block

The North block is shown on early maps of the site but has been almost completely rebuilt over the years. It consists of red brick at ground floor level and dark stained horizontal timber boarding at 1st floor. The ground floor contains stores while the 1st floor is bedroom accommodation.

5. Cottage

The cottage is a small 2 storey block with a late 20th century conservatory added to the south. It is partially clad with flint work to the west. The other façades include dark stained horizontal timber boarding and white brick. It has a small porch to the east. It is of negligible architectural merit.

6. Outbuilding 1

This is a single storey red brick building used as a store. It is of negligible architectural merit.

7. Outbuilding 2

This is a single storey red brick building with dark stained horizontal timber boarding and is used as additional accommodation. It has been largely reduced and re clad over the years but retains some original timber framing internally. It is of negligible architectural merit but of modest heritage significance due to the internal timber.

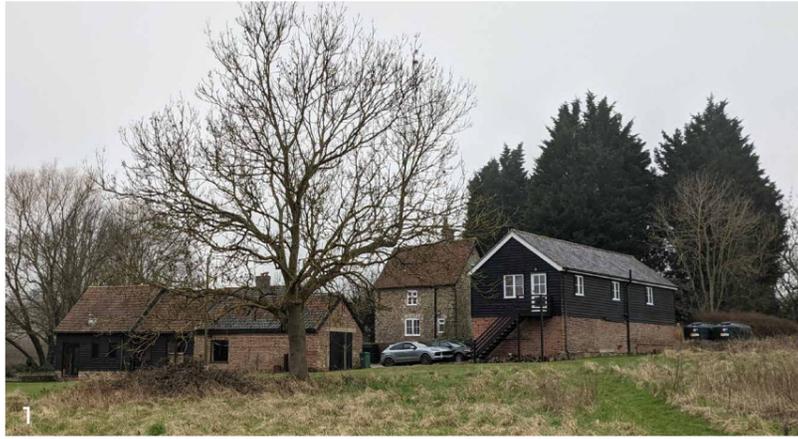
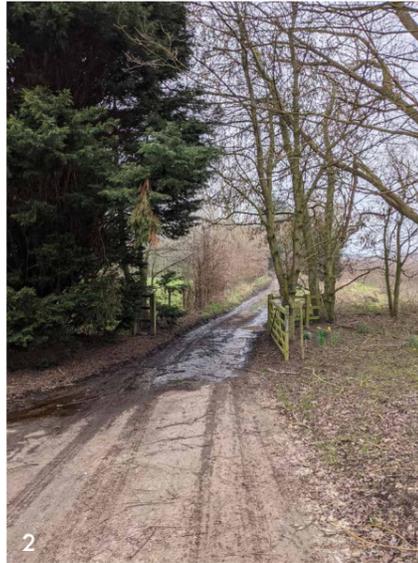
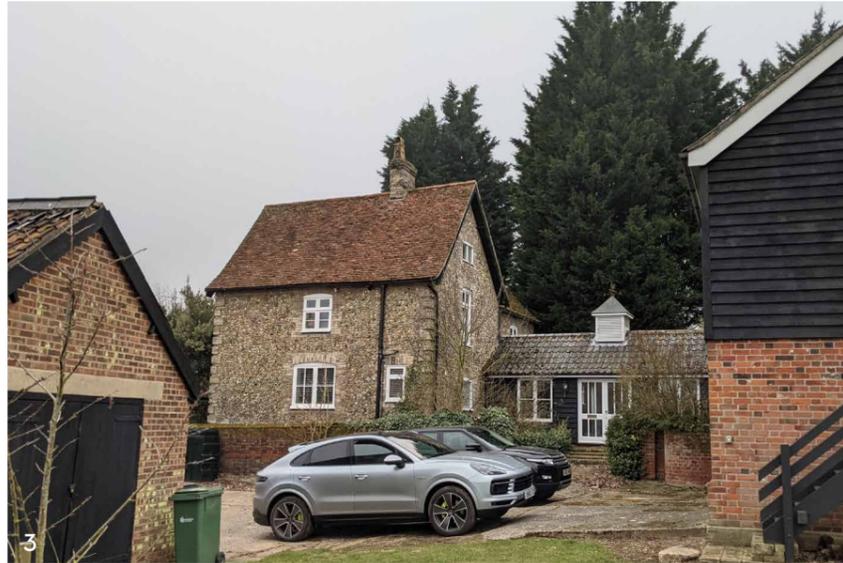
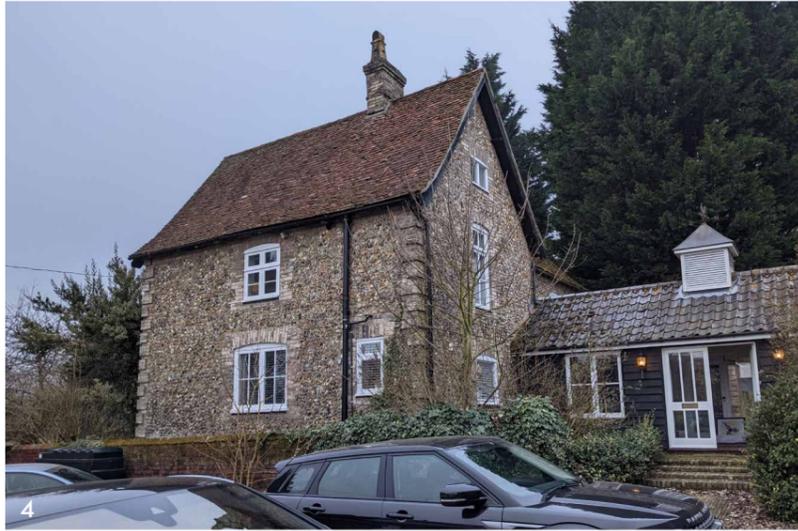
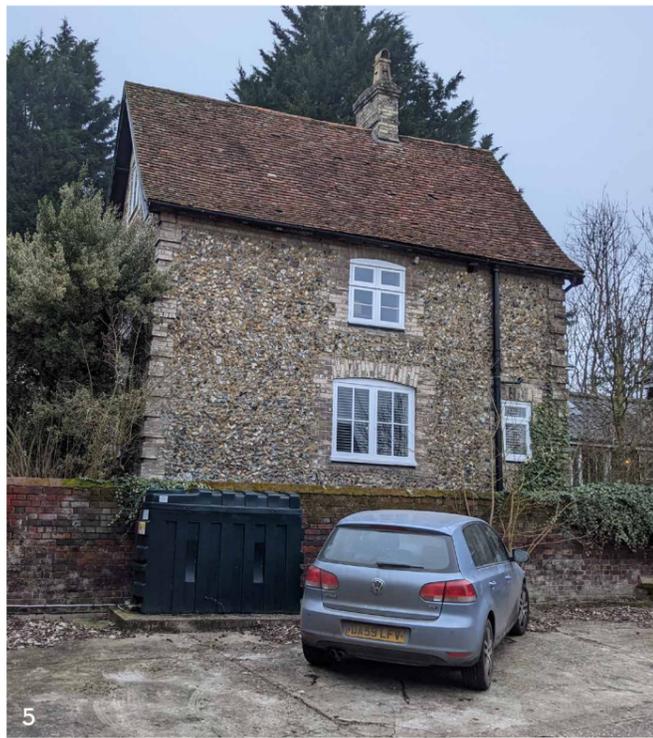
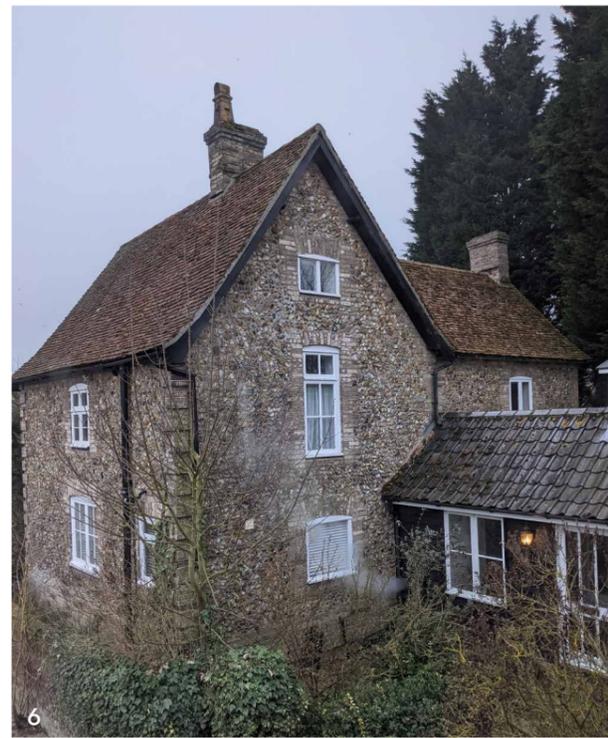
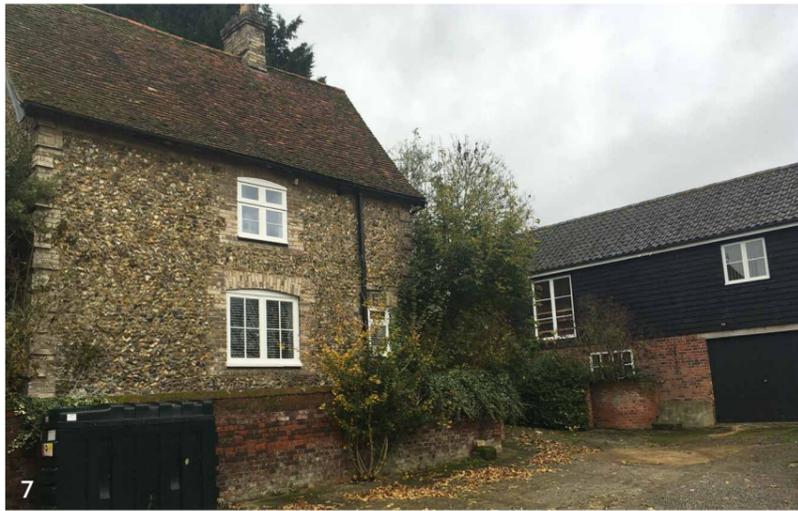
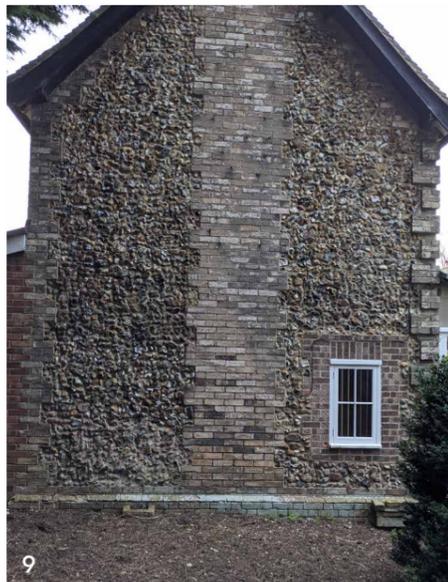
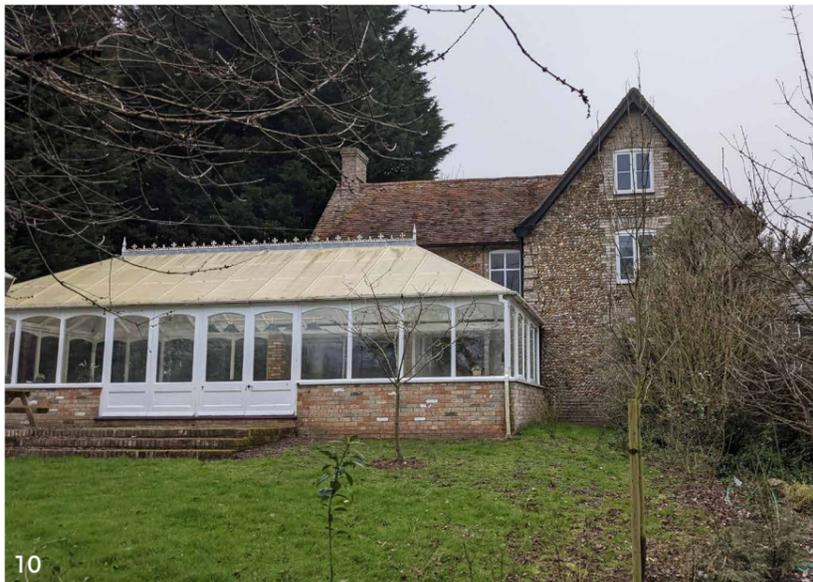
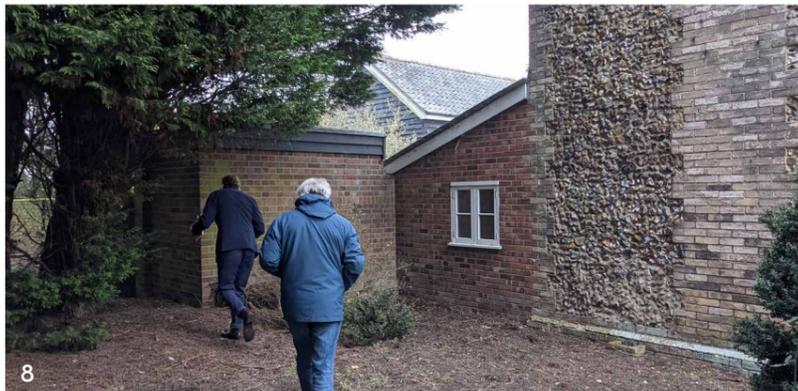
We have included a series of site photos to provide a clear understanding of the existing complex of buildings. We believe this demonstrates that while the listed farmhouse is a modest yet attractive feature, it is shielded from view by the large conservatory to the south which detrimentally detracts from the farmhouse's appearance. This ancillary element, along with other unattractive 20th century features, have damaged the setting of Old Applecroft farm, in particular the settling of the original farmhouse. The current modern link that connects the North block to the farmhouse is inadequate and leaves the dwelling feeling disjointed and outdated to the degree that it does not function as home fitting a property of this size.

1. Full complex from the north east
2. Private entrance lane looking south
3. Original farmhouse, link building and front yard
4. Original farmhouse from the north east
5. Original farmhouse east facade
6. Original farmhouse from north block 1st floor
7. Original farmhouse and north block
8. Original farmhouse west facade and lean-to extension
9. Original farmhouse west facade
10. Original farmhouse and pool conservatory south facade

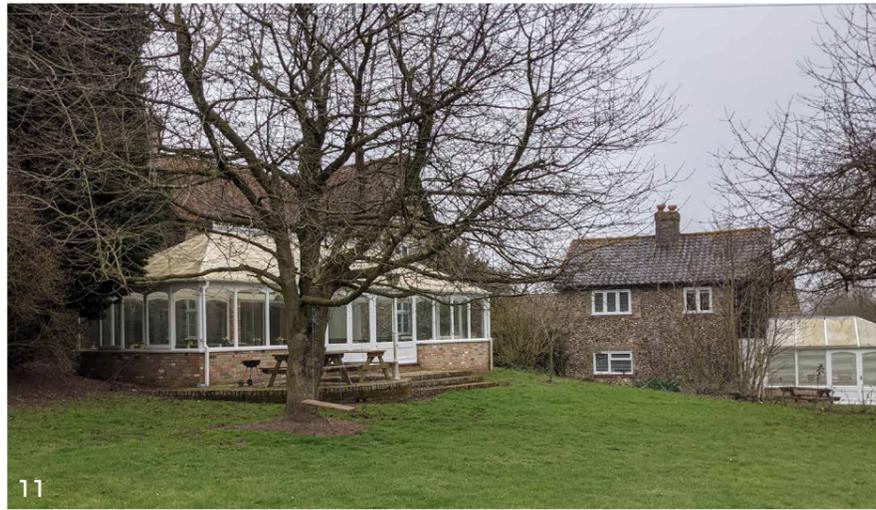
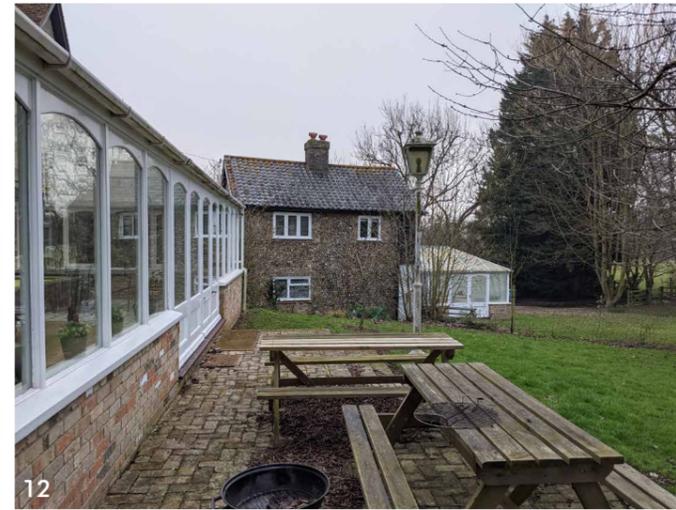
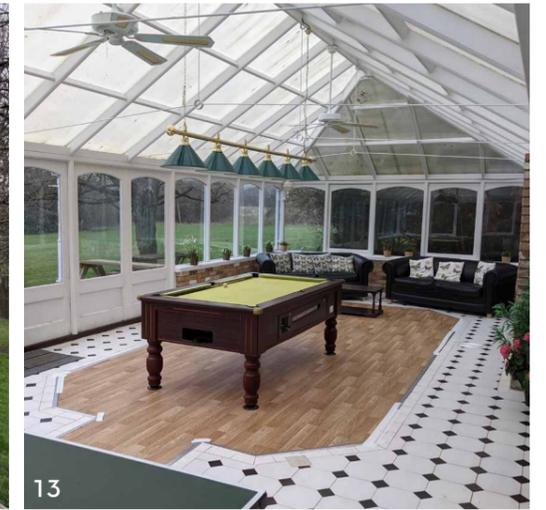
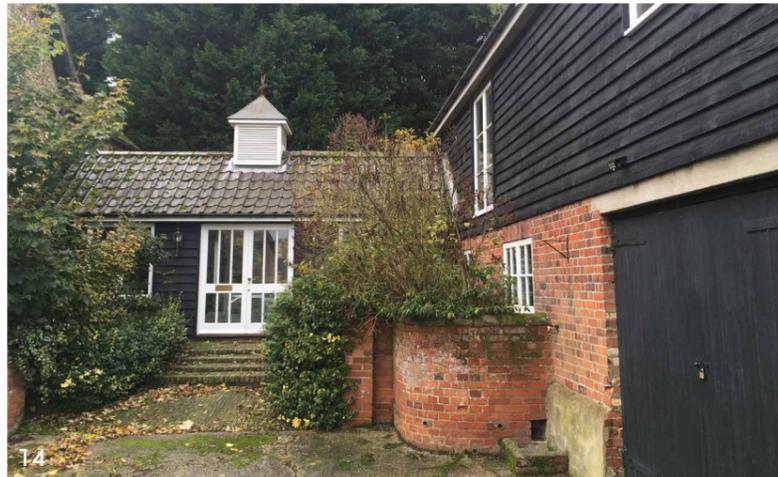
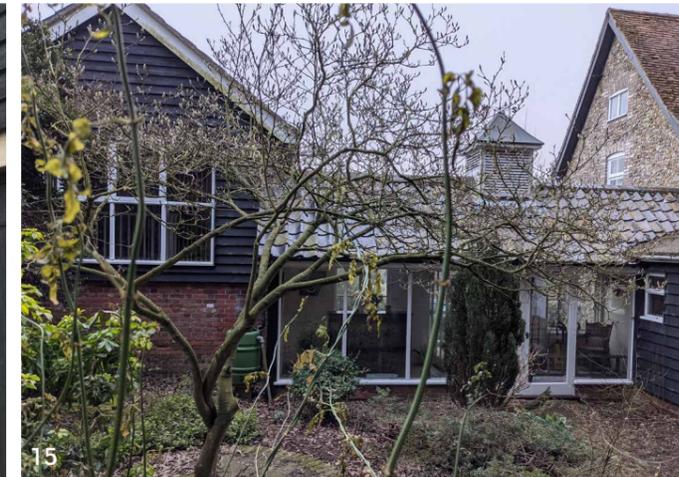
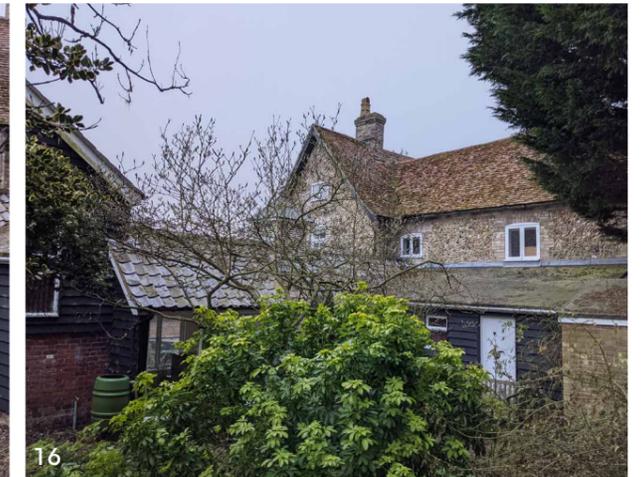
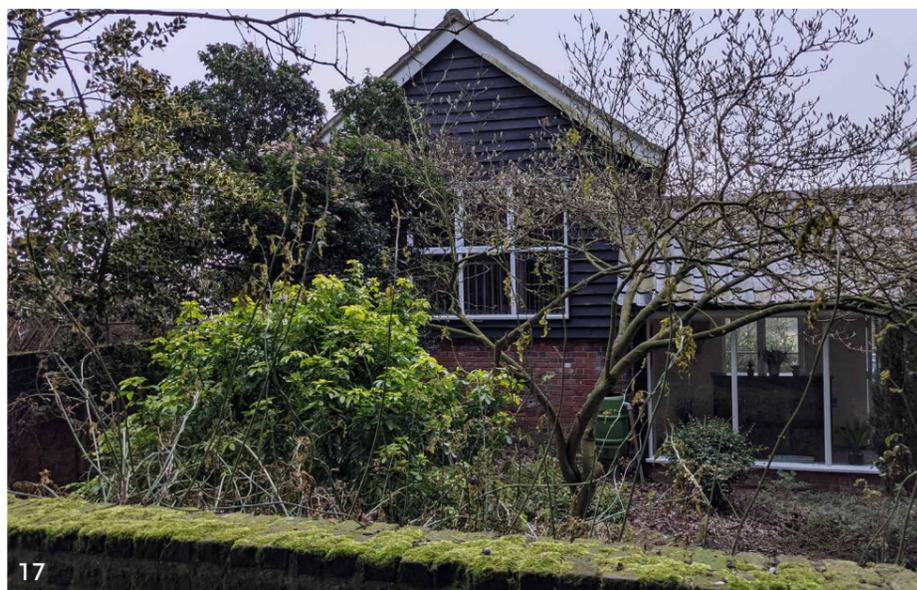
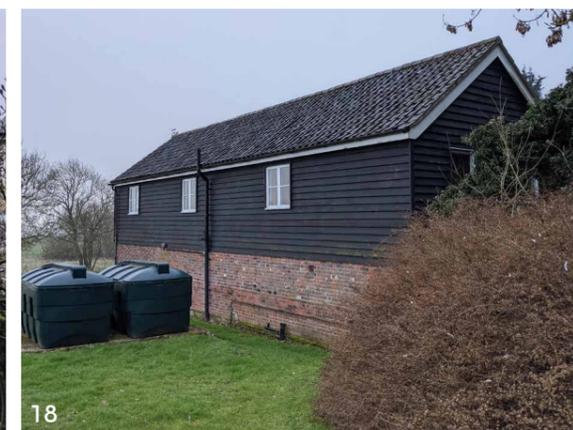
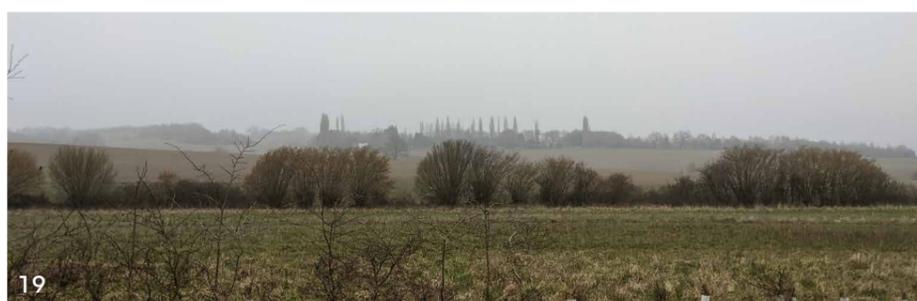
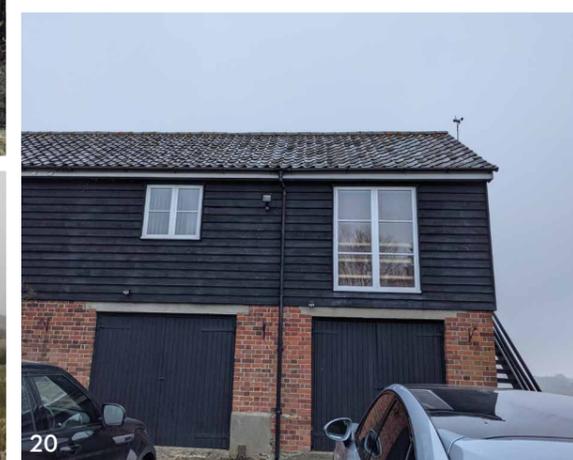
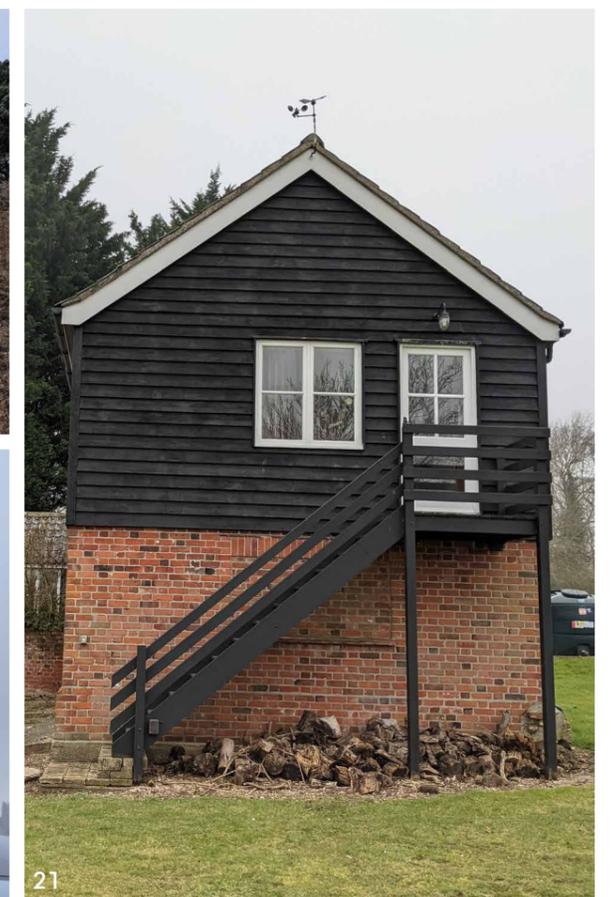
11. Pool conservatory from the south west
12. Pool conservatory patio looking east
13. Pool conservatory interior
14. Link building east facade
15. Link building west facade and walled courtyard
16. Link building and walled courtyard from the north west
17. North block west facade
18. North block from the north west
19. View from the site to the north east
20. Garage entrances on the north block south facade
21. North block east facade with existing staircase

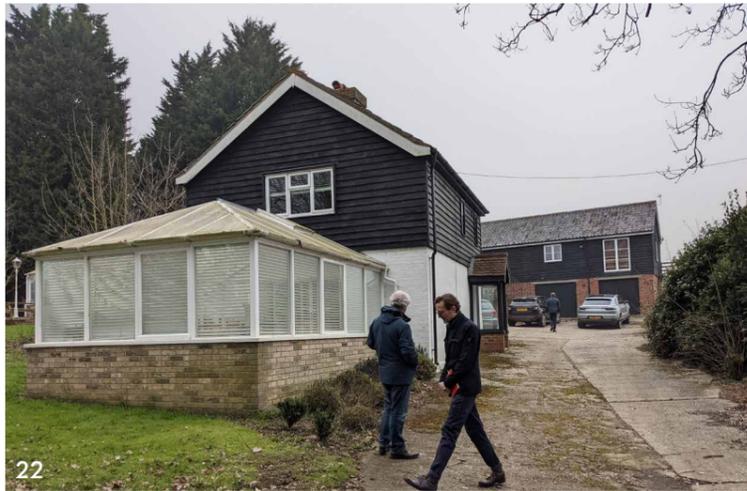
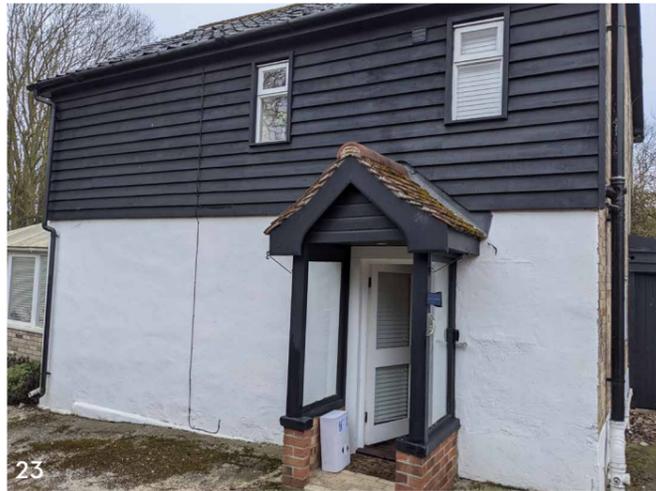
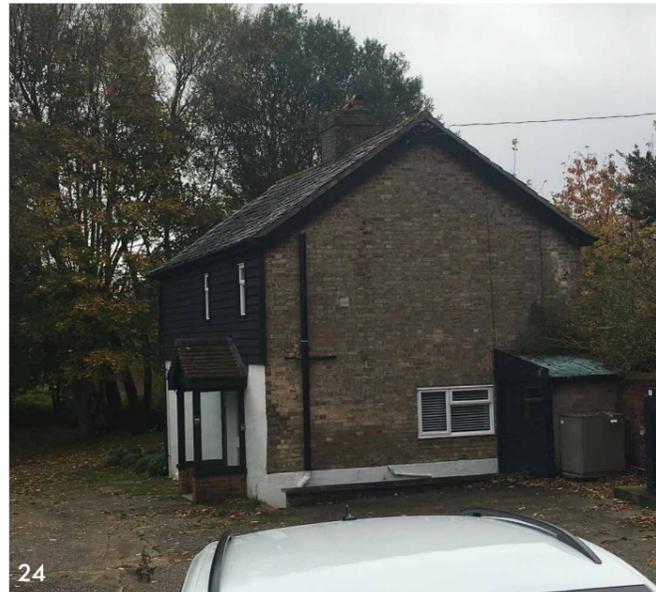
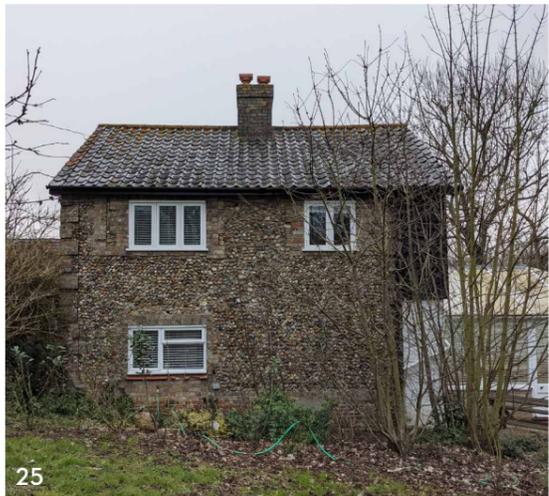
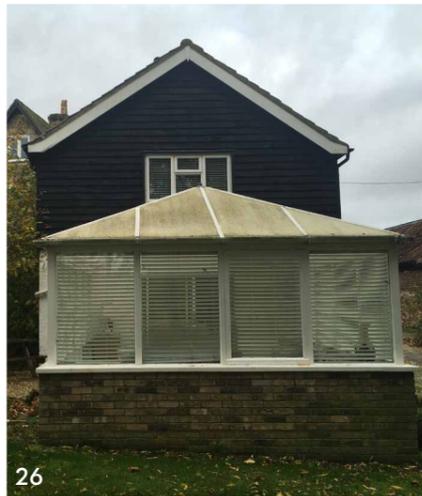
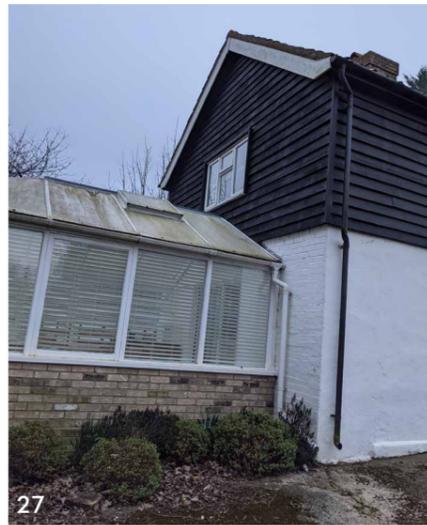
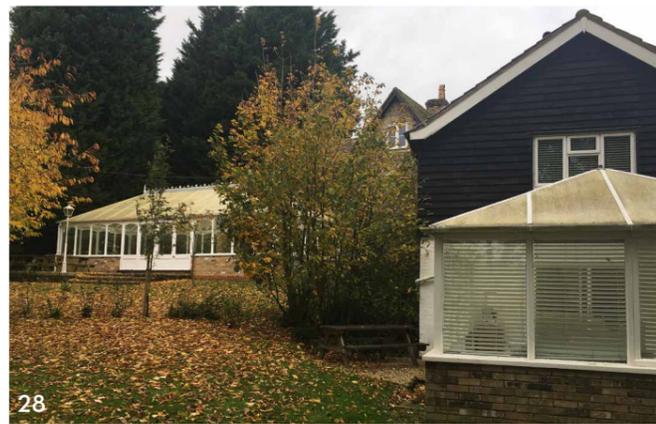
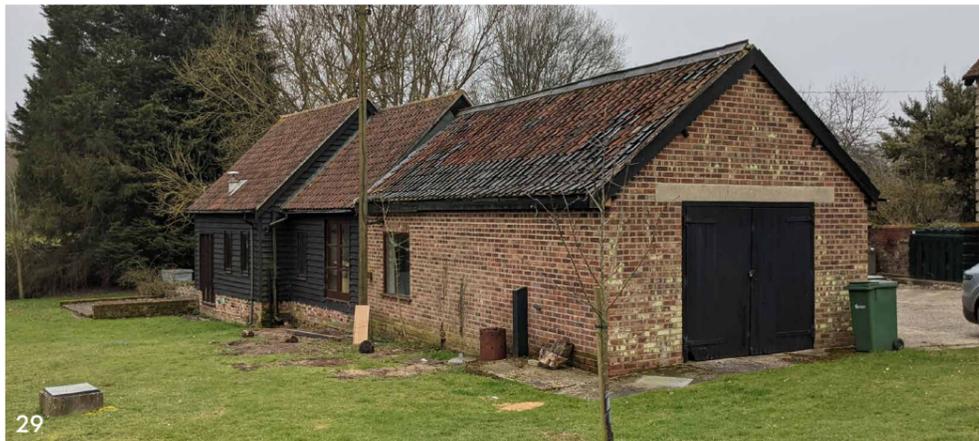
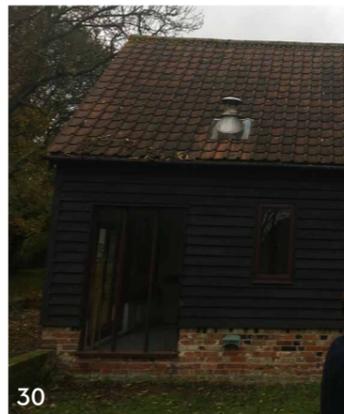
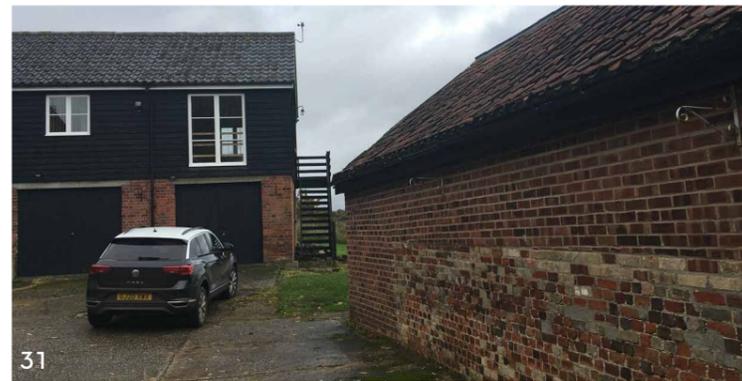
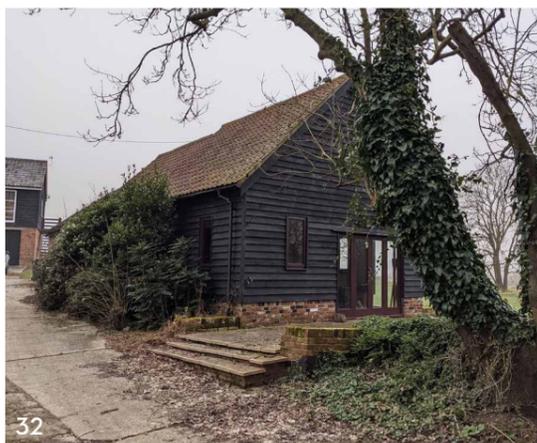
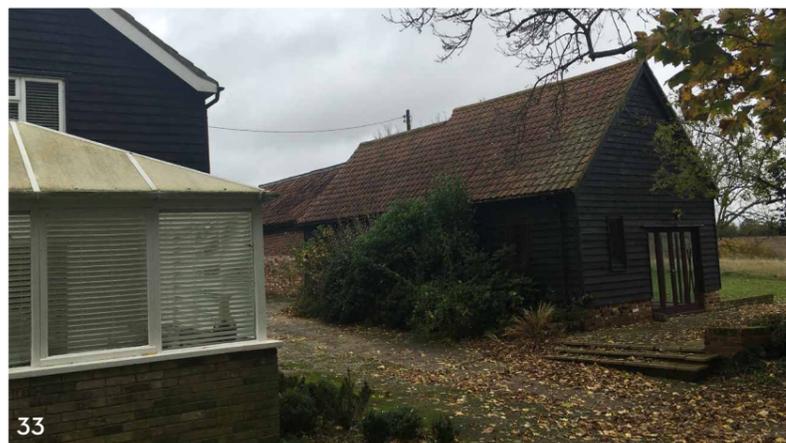
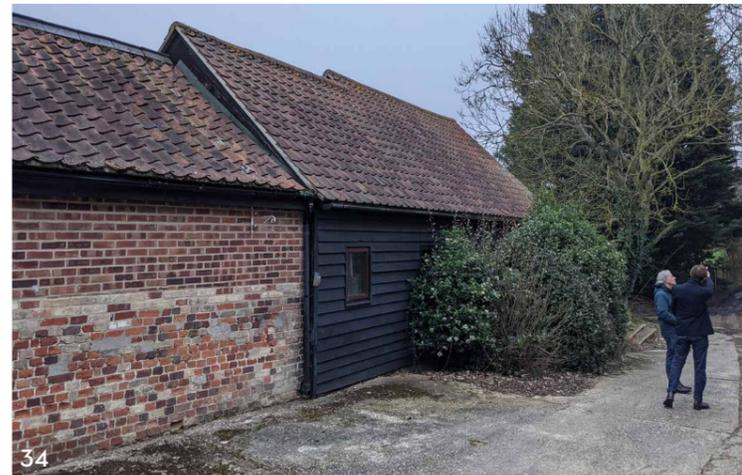
22. Cottage from the south east
23. Cottage east facade
24. Cottage north facade
25. Cottage west facade
26. Cottage south facade
27. Cottage and cottage conservatory junction
28. View of pool conservatory from cottage
29. Outbuildings from the north
30. Outbuilding 2 east facade
31. Outbuilding 1 brick wall to the west
32. Outbuildings from the south
33. Outbuilding 2 from the south west
34. Outbuildings west facade
