Re: Supplementary investigation and assessment of areas of potential made ground – Lower Lane, Coleford.

Following instruction by BDW South Wales, this report presents the results of a supplementary investigation and risk assessment to evaluate the significance to human health of shallow reworked topsoil/made ground at the proposed residential development known as Lower Lane, Coleford – ‘the site’. A site location plan is included in Appendix A.

Project Name
Lower Lane, Coleford

Drawing Title
Supplementary Exploratory Hole
Location Plan
(Possible Made Ground)

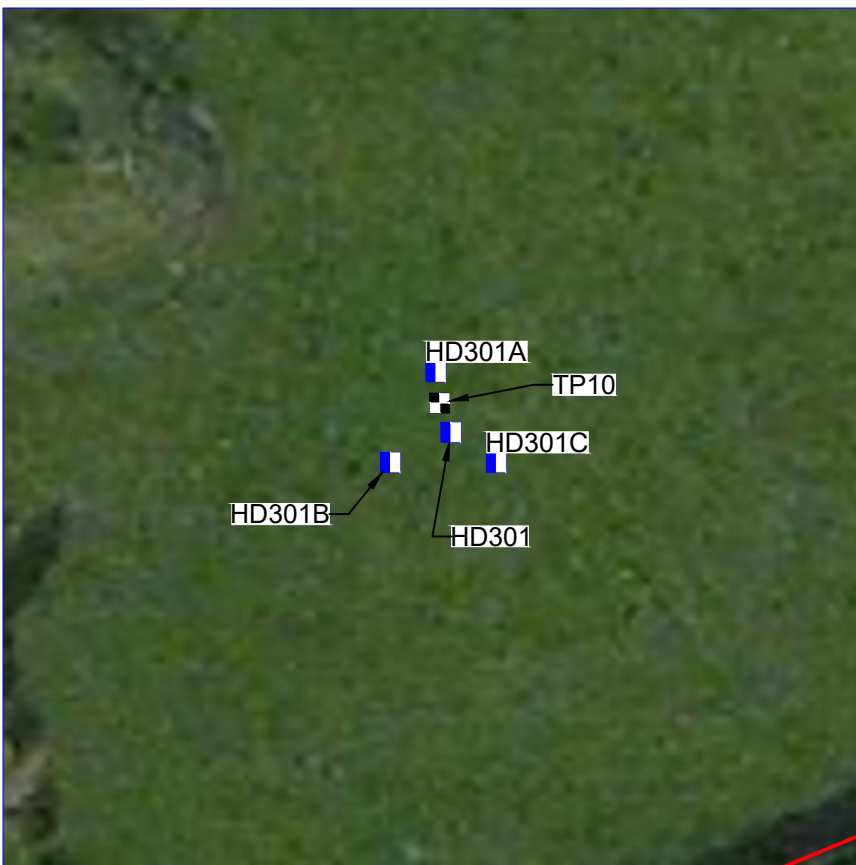
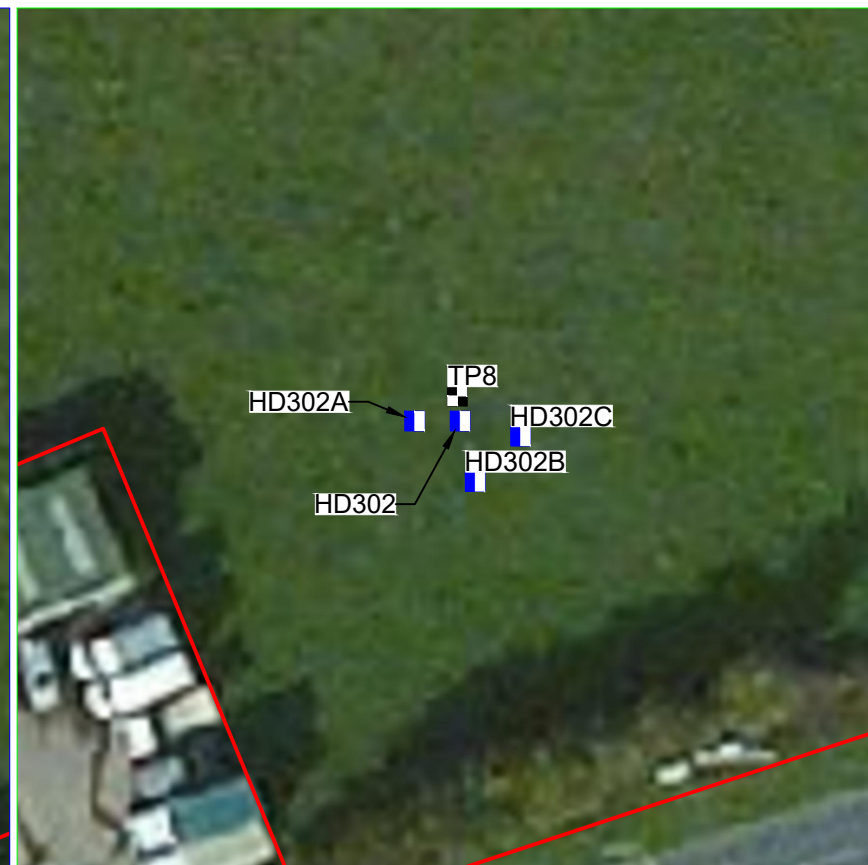
Drawn by AW	Checked by JF	Date 23/01/20	Scale SBAR@A3
Drawing No. MD-500-01-016			Rev. -

A supplementary intrusive ground investigation was undertaken on the 16th January 2020, which comprised the excavation of 12N^o hand excavated trial pits to approximate depths of 0.5mbgl and the recovery of soil samples. The trial pits were located adjacent to the co-ordinates upon the original Opus trial pits logs.

- OPUS Trial Pit Locations (TP6, TP8, TP10)
- Hand Dug Pit Locations (HD301 - HD303)
