# Existing Architectural Features

# Existing ground floor architectural features

Showing existing photos, noted location, condition, and proposed refurbishment works

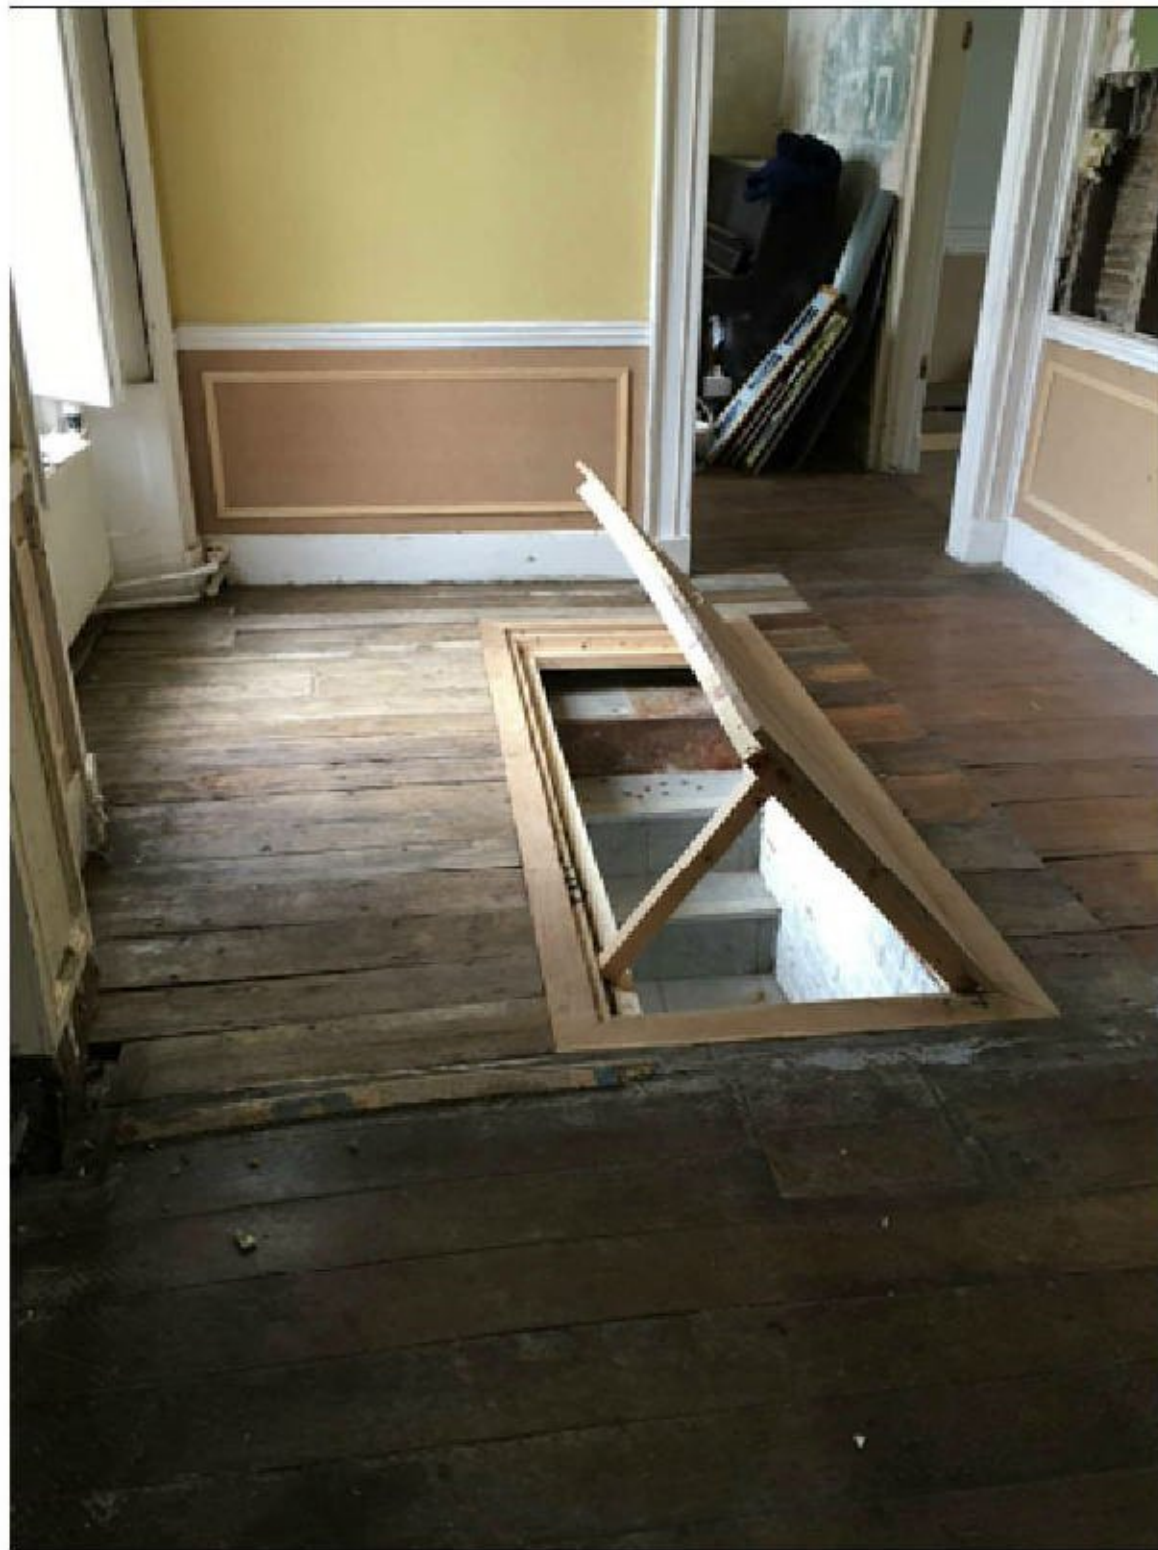
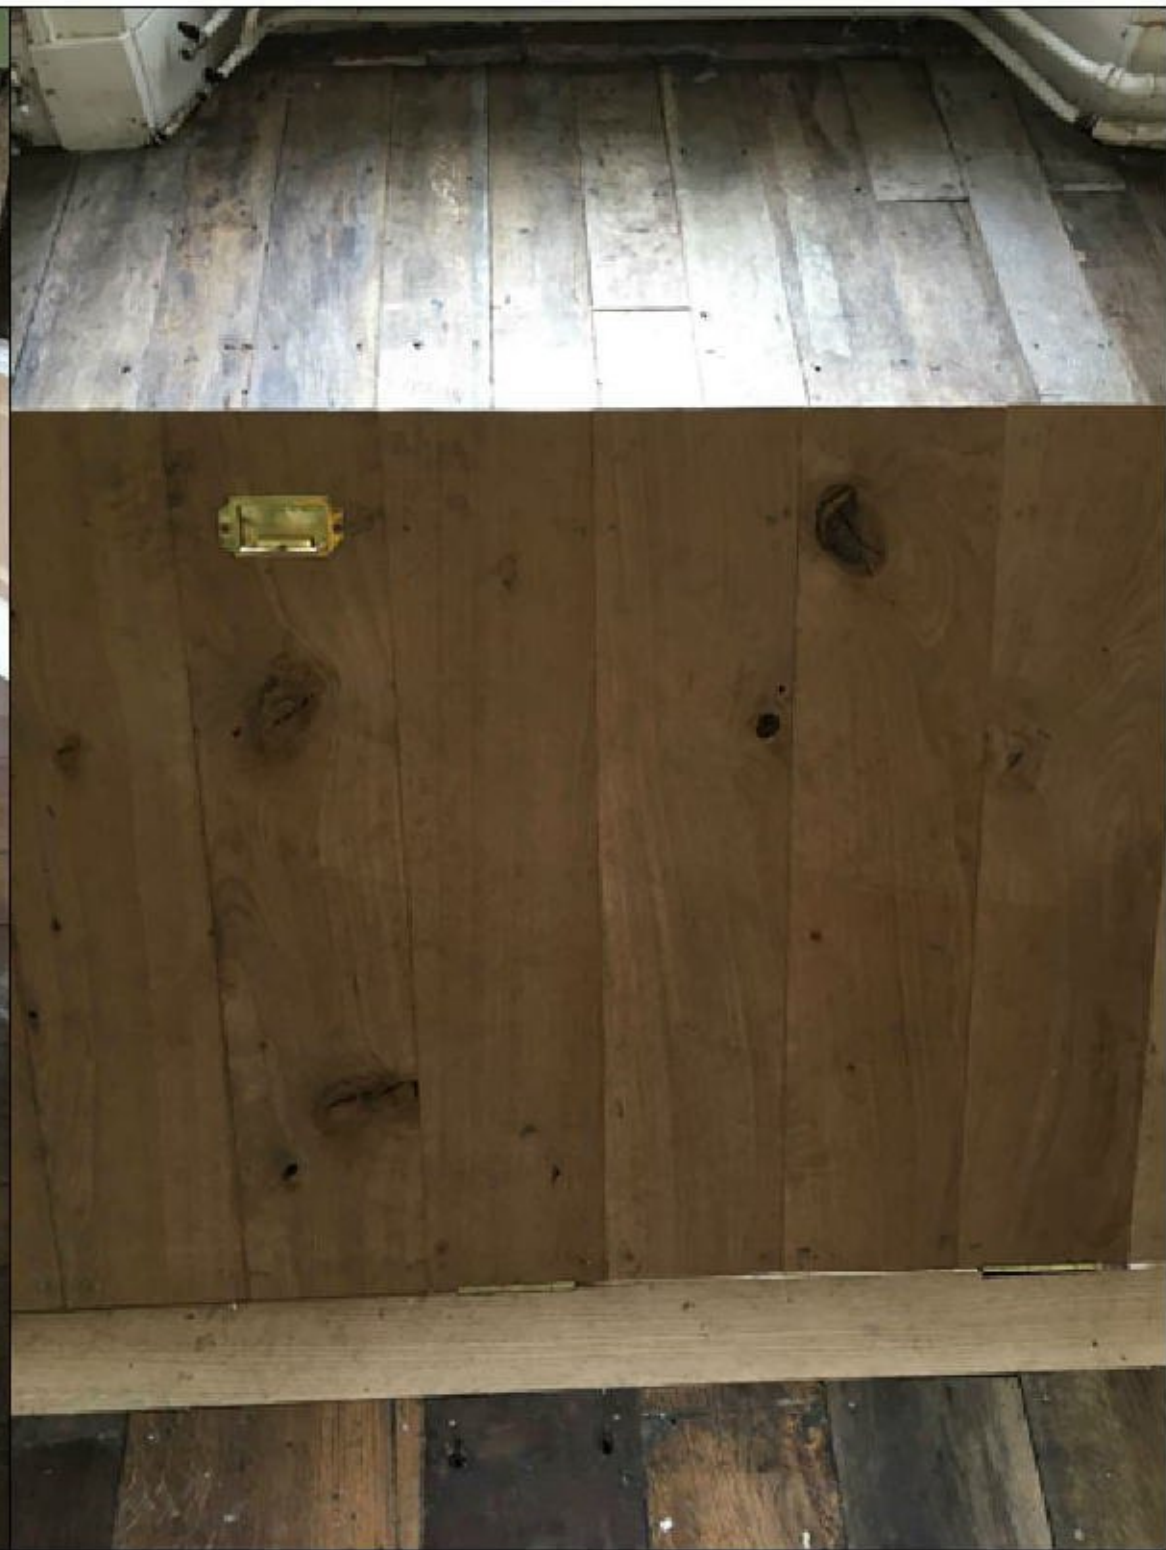
Photo Location - Hall - Photo Number **P01 & P02** - See floor plans for location

Located with 1750's section of the building

Skirting - Presumed original - Retained and re painted

Timber wall paneling - not considered original (possibly 1930's) but is to be retained and re painted

Floor hatch to basement - Original currently missing, some floor boards replaced in the past.

New hatch replaced within the existing opening with grain matched oak

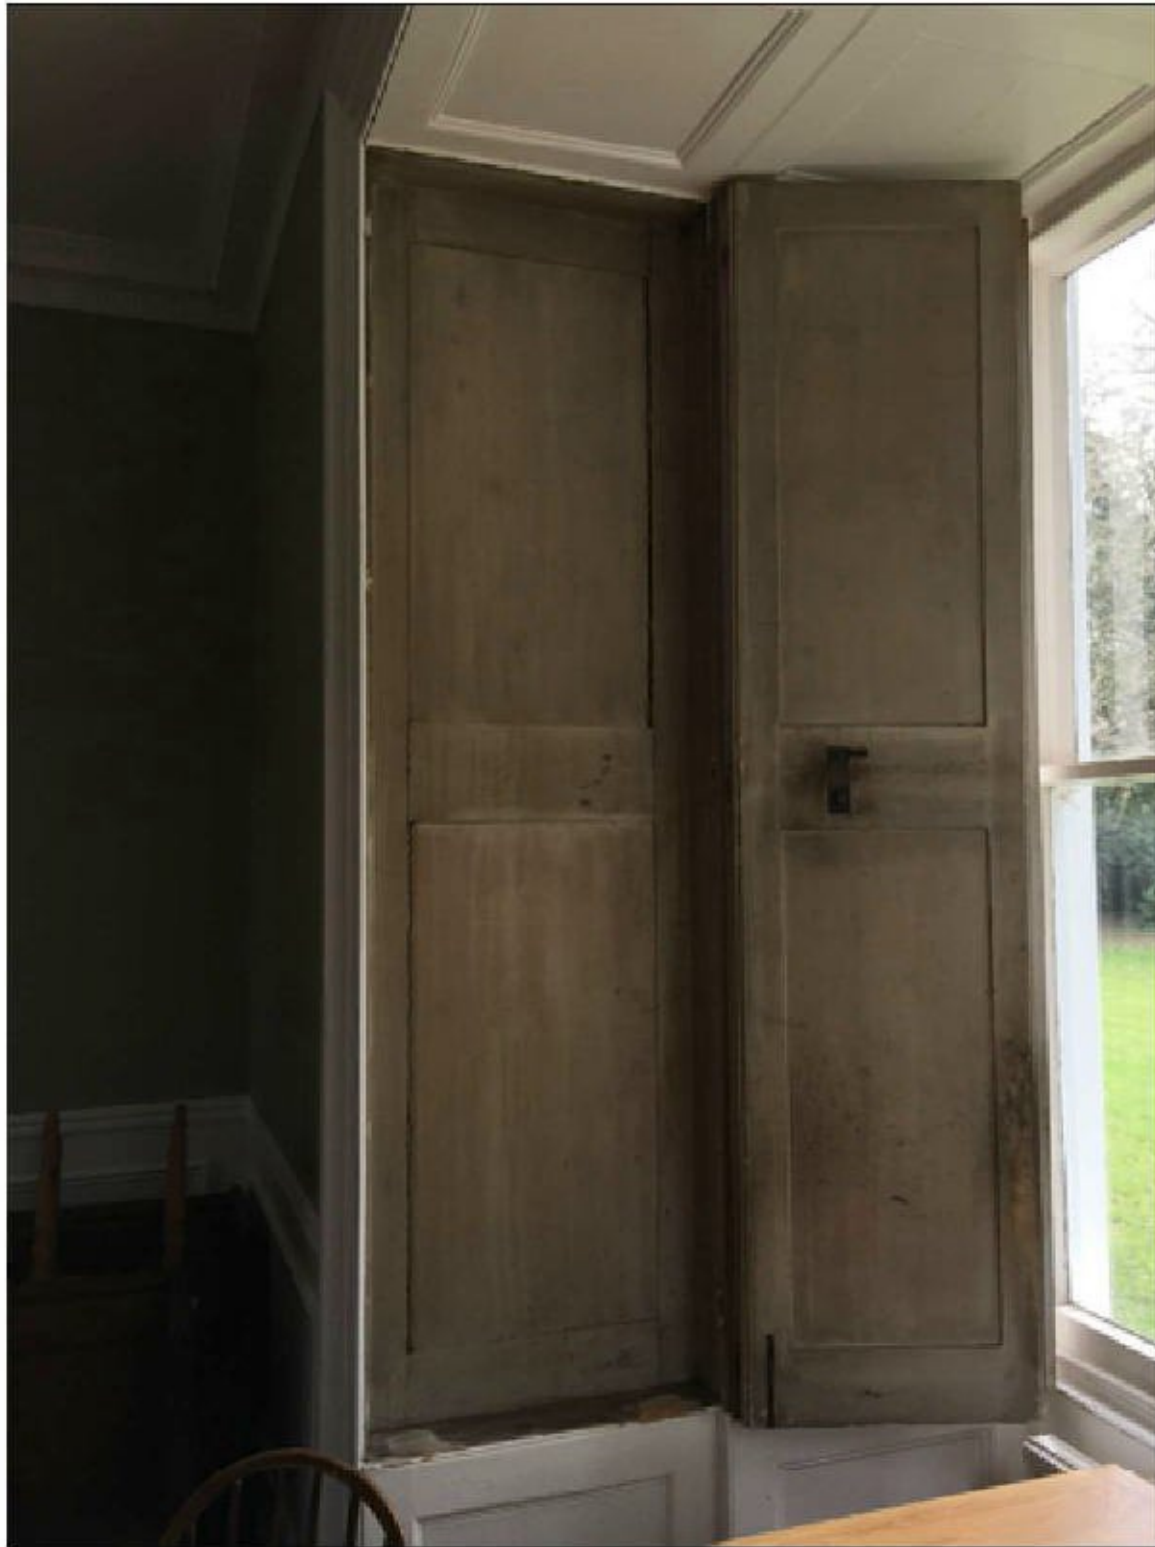
Photo Location - Dining room - Photo Number **P03** - See floor plans for location

Located with 1750's section of the building

Window Shutters - Located in Dining room, lounge, hall and entrance hall.

Good condition, to be restored.

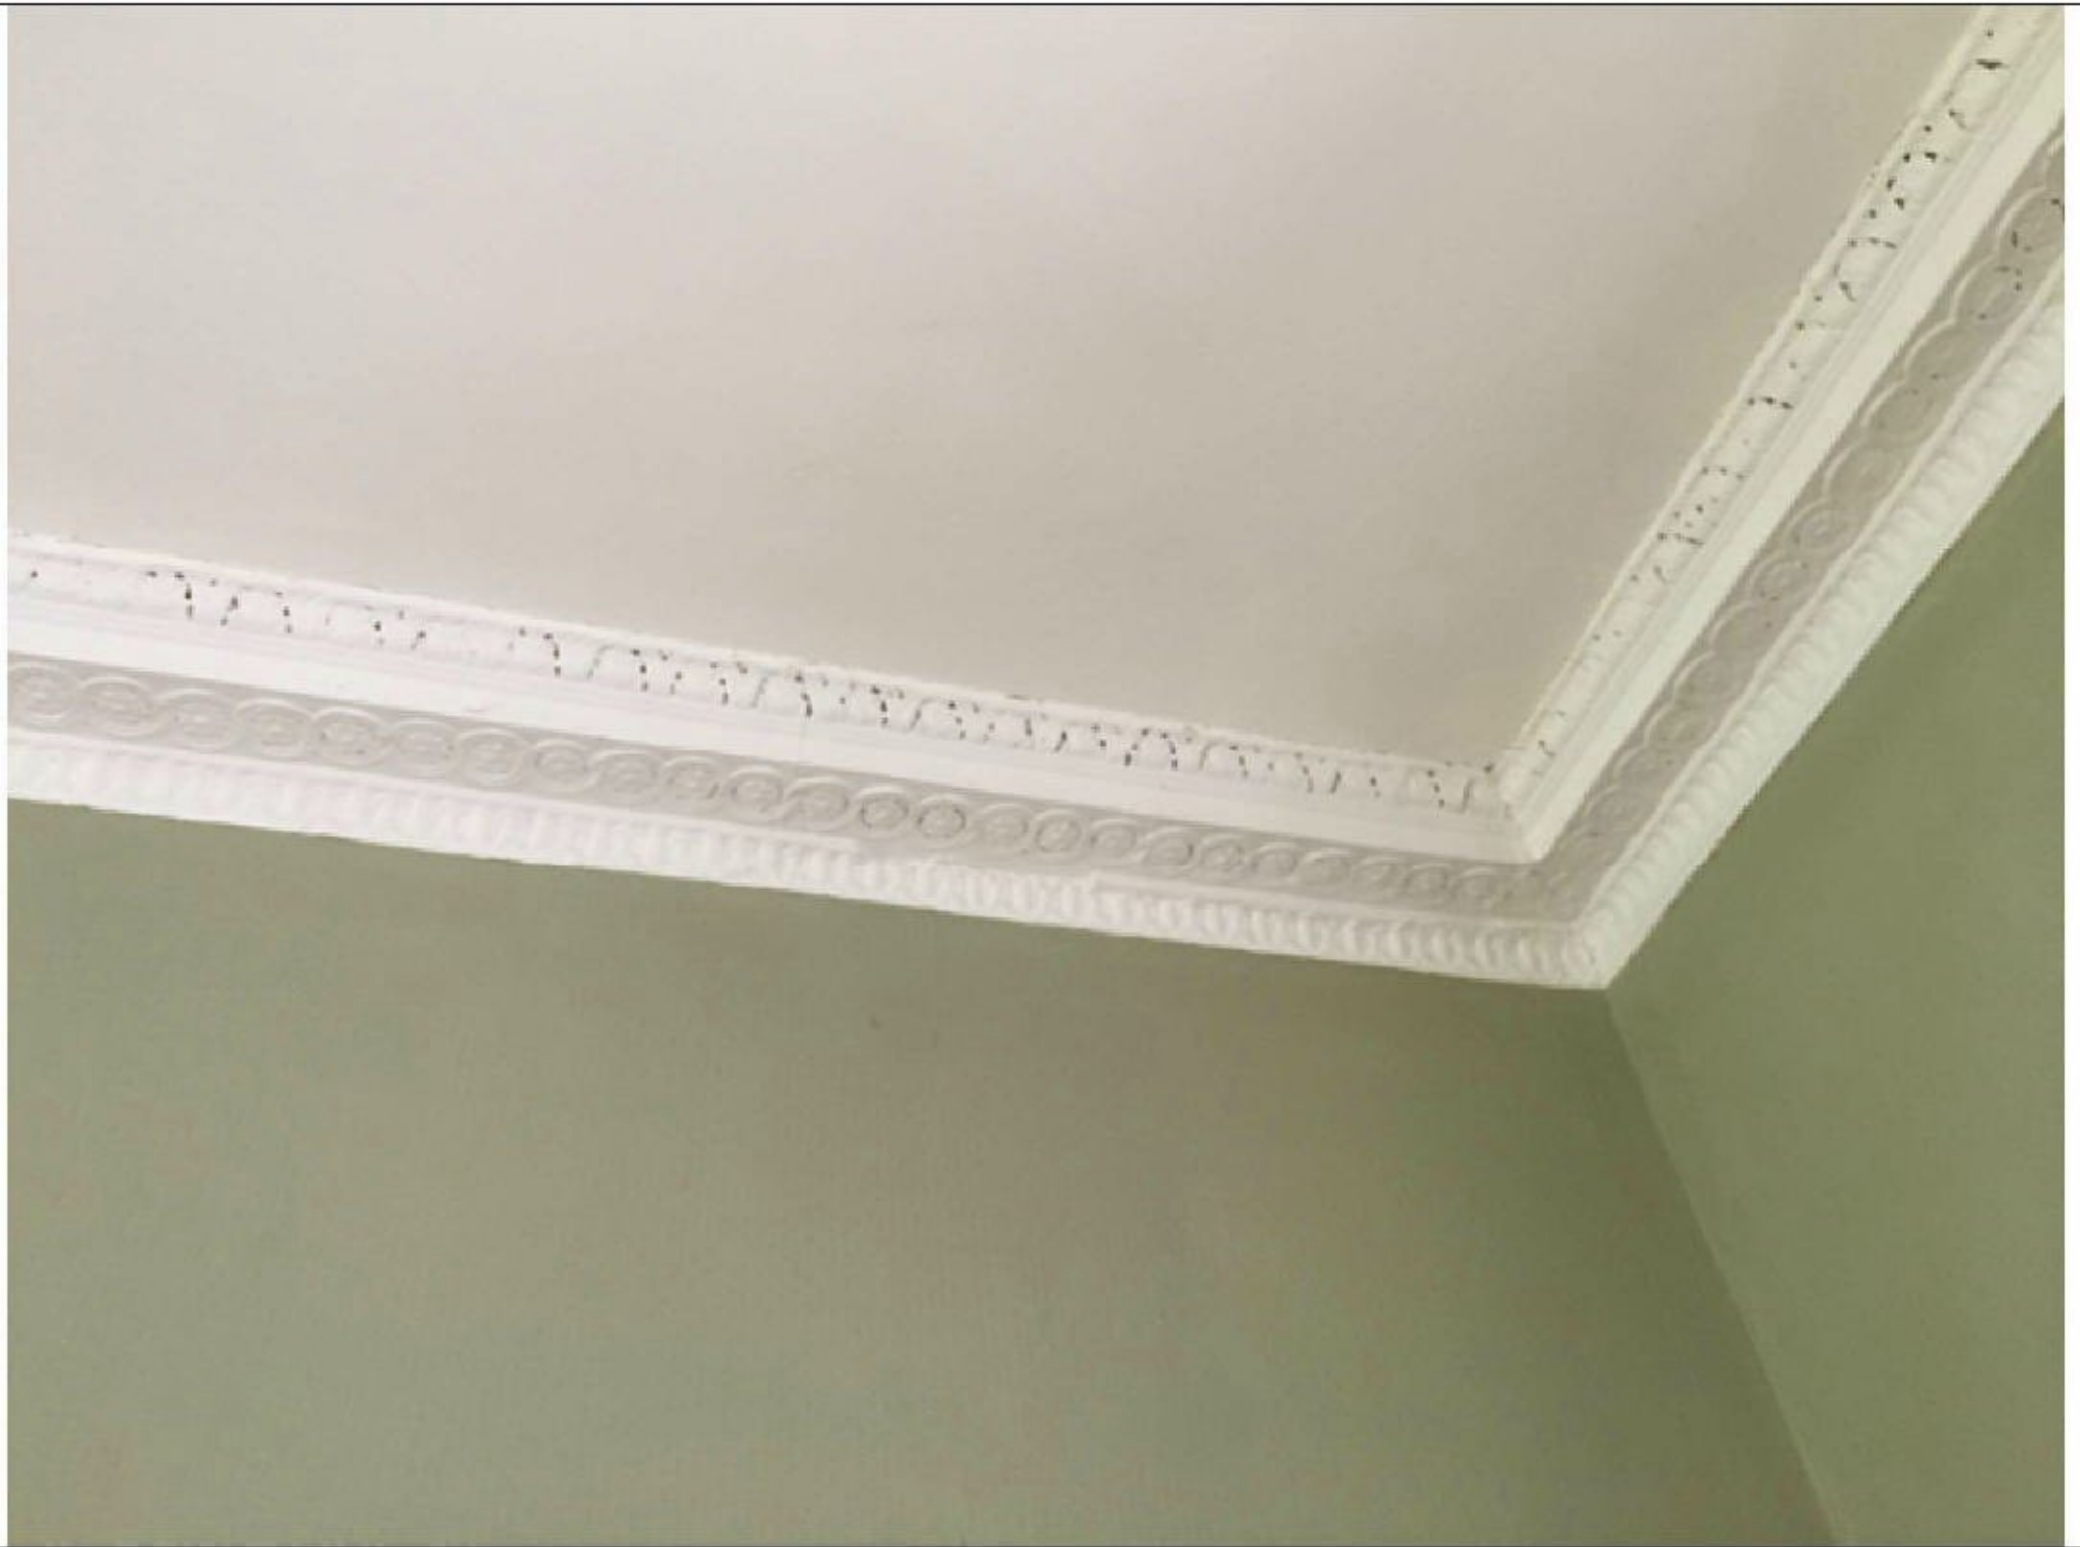
Photo Location - Dinning room - Photo Number **P04** - See floor plans for location

Located with 1750's section of the building

Ceiling plaster coving - Retained no proposed works

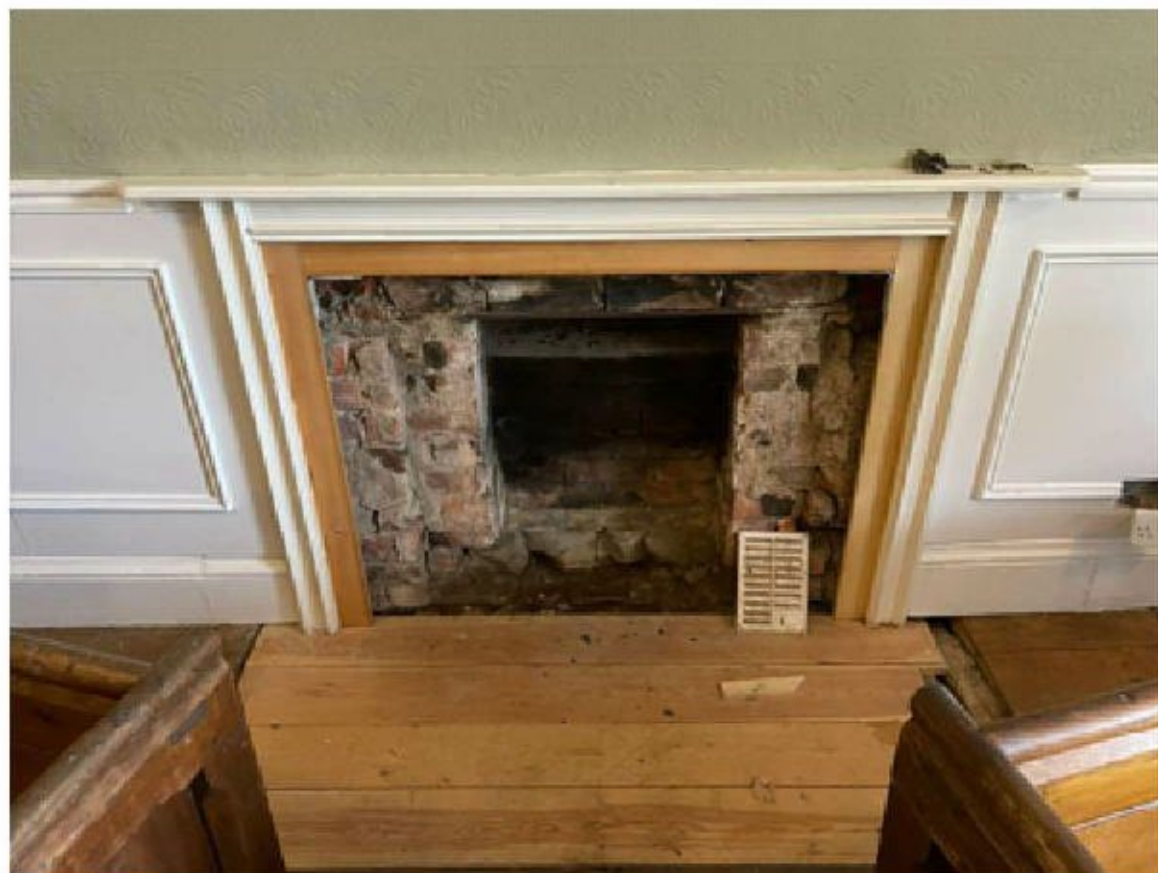
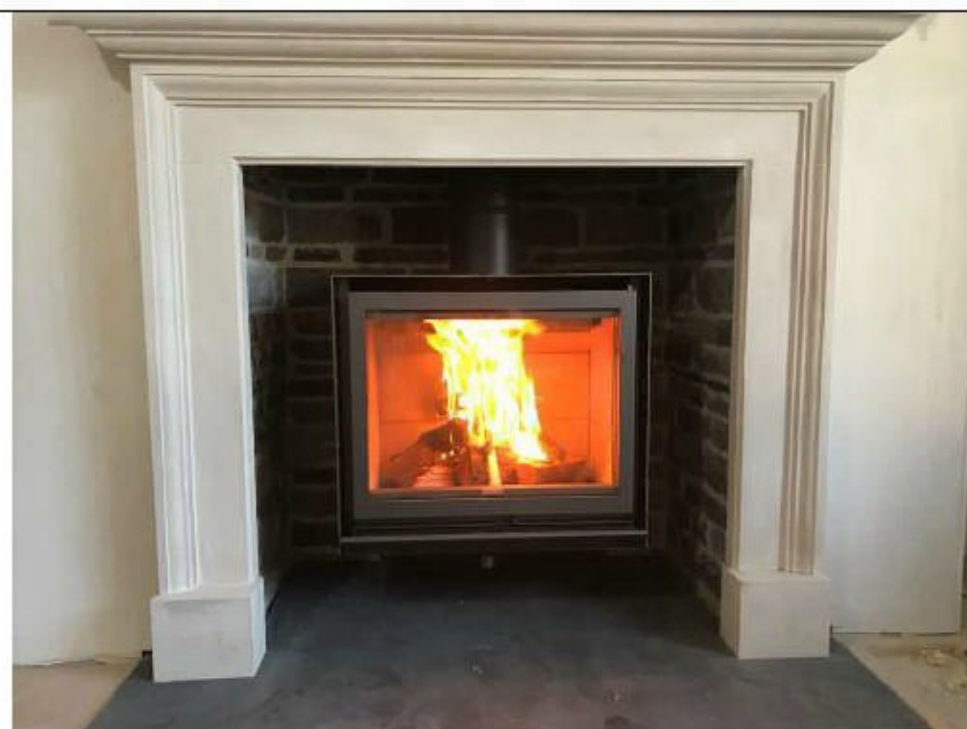
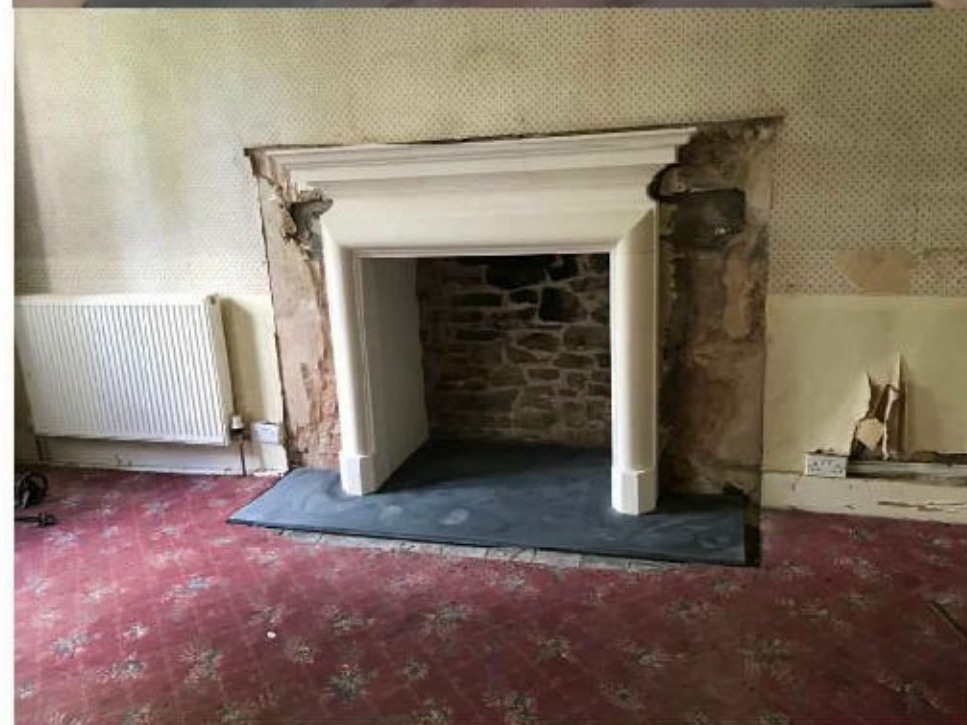
Photo Location - Dining room - Photo Number **P05** - See floor plans for location

Located with 1750's section of the building

Fire place - The original width of the fireplace is presumed to have been the width of the temporary timber floor as shown. The original width of the hearth alongside points towards this.

At some point in the past it is assumed that the fire place width and height has been reduced, possibly in response to fashion or to conserve fuel.

It is proposed to re instate a larger more original fire place in the dining room with a stone hearth and surround, reinstating the original form and style.

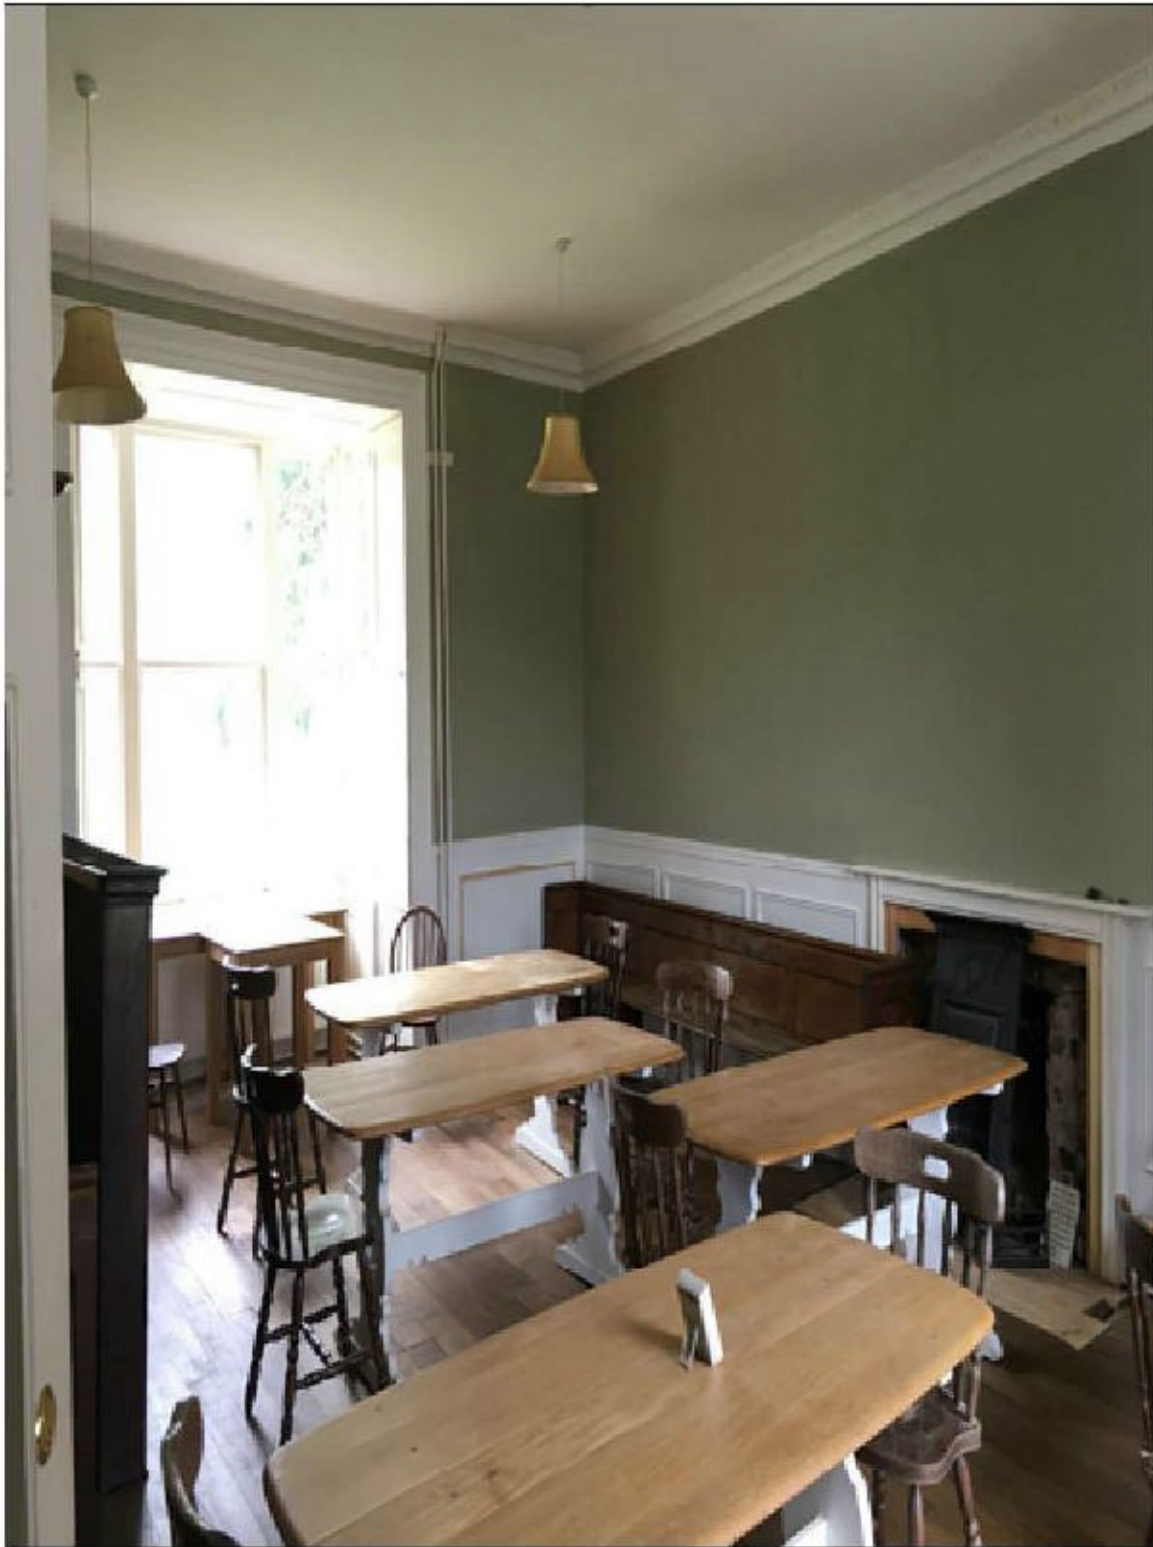
Photo Location - Dining room - Photo Number **P06** - See floor plans for location

Located with 1750's section of the building

Timber wall paneling - not considered original (possibly 1930's) but is to be retained and re painted

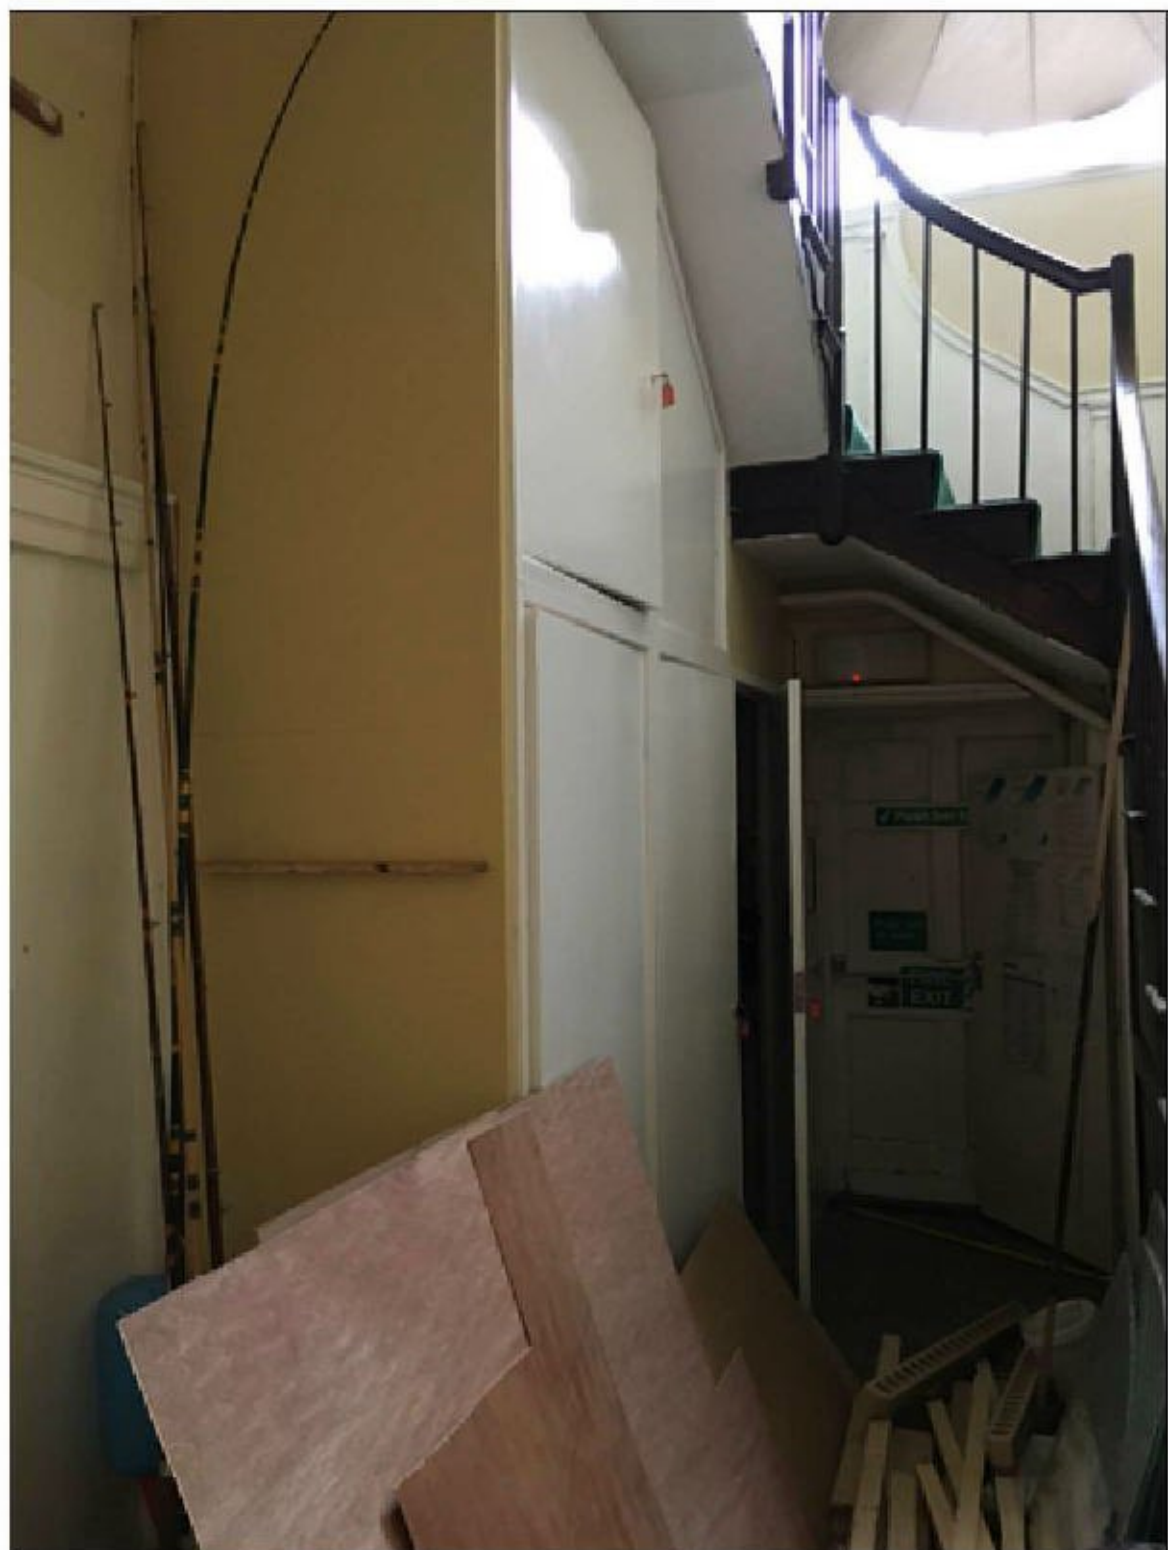
Photo Location - Entrance Hall - Photo Number **P07** - See floor plans for location

Located with 1750's section of the building

Timber cupboard - non original - to be removed to reinstate the hall back to the original layout

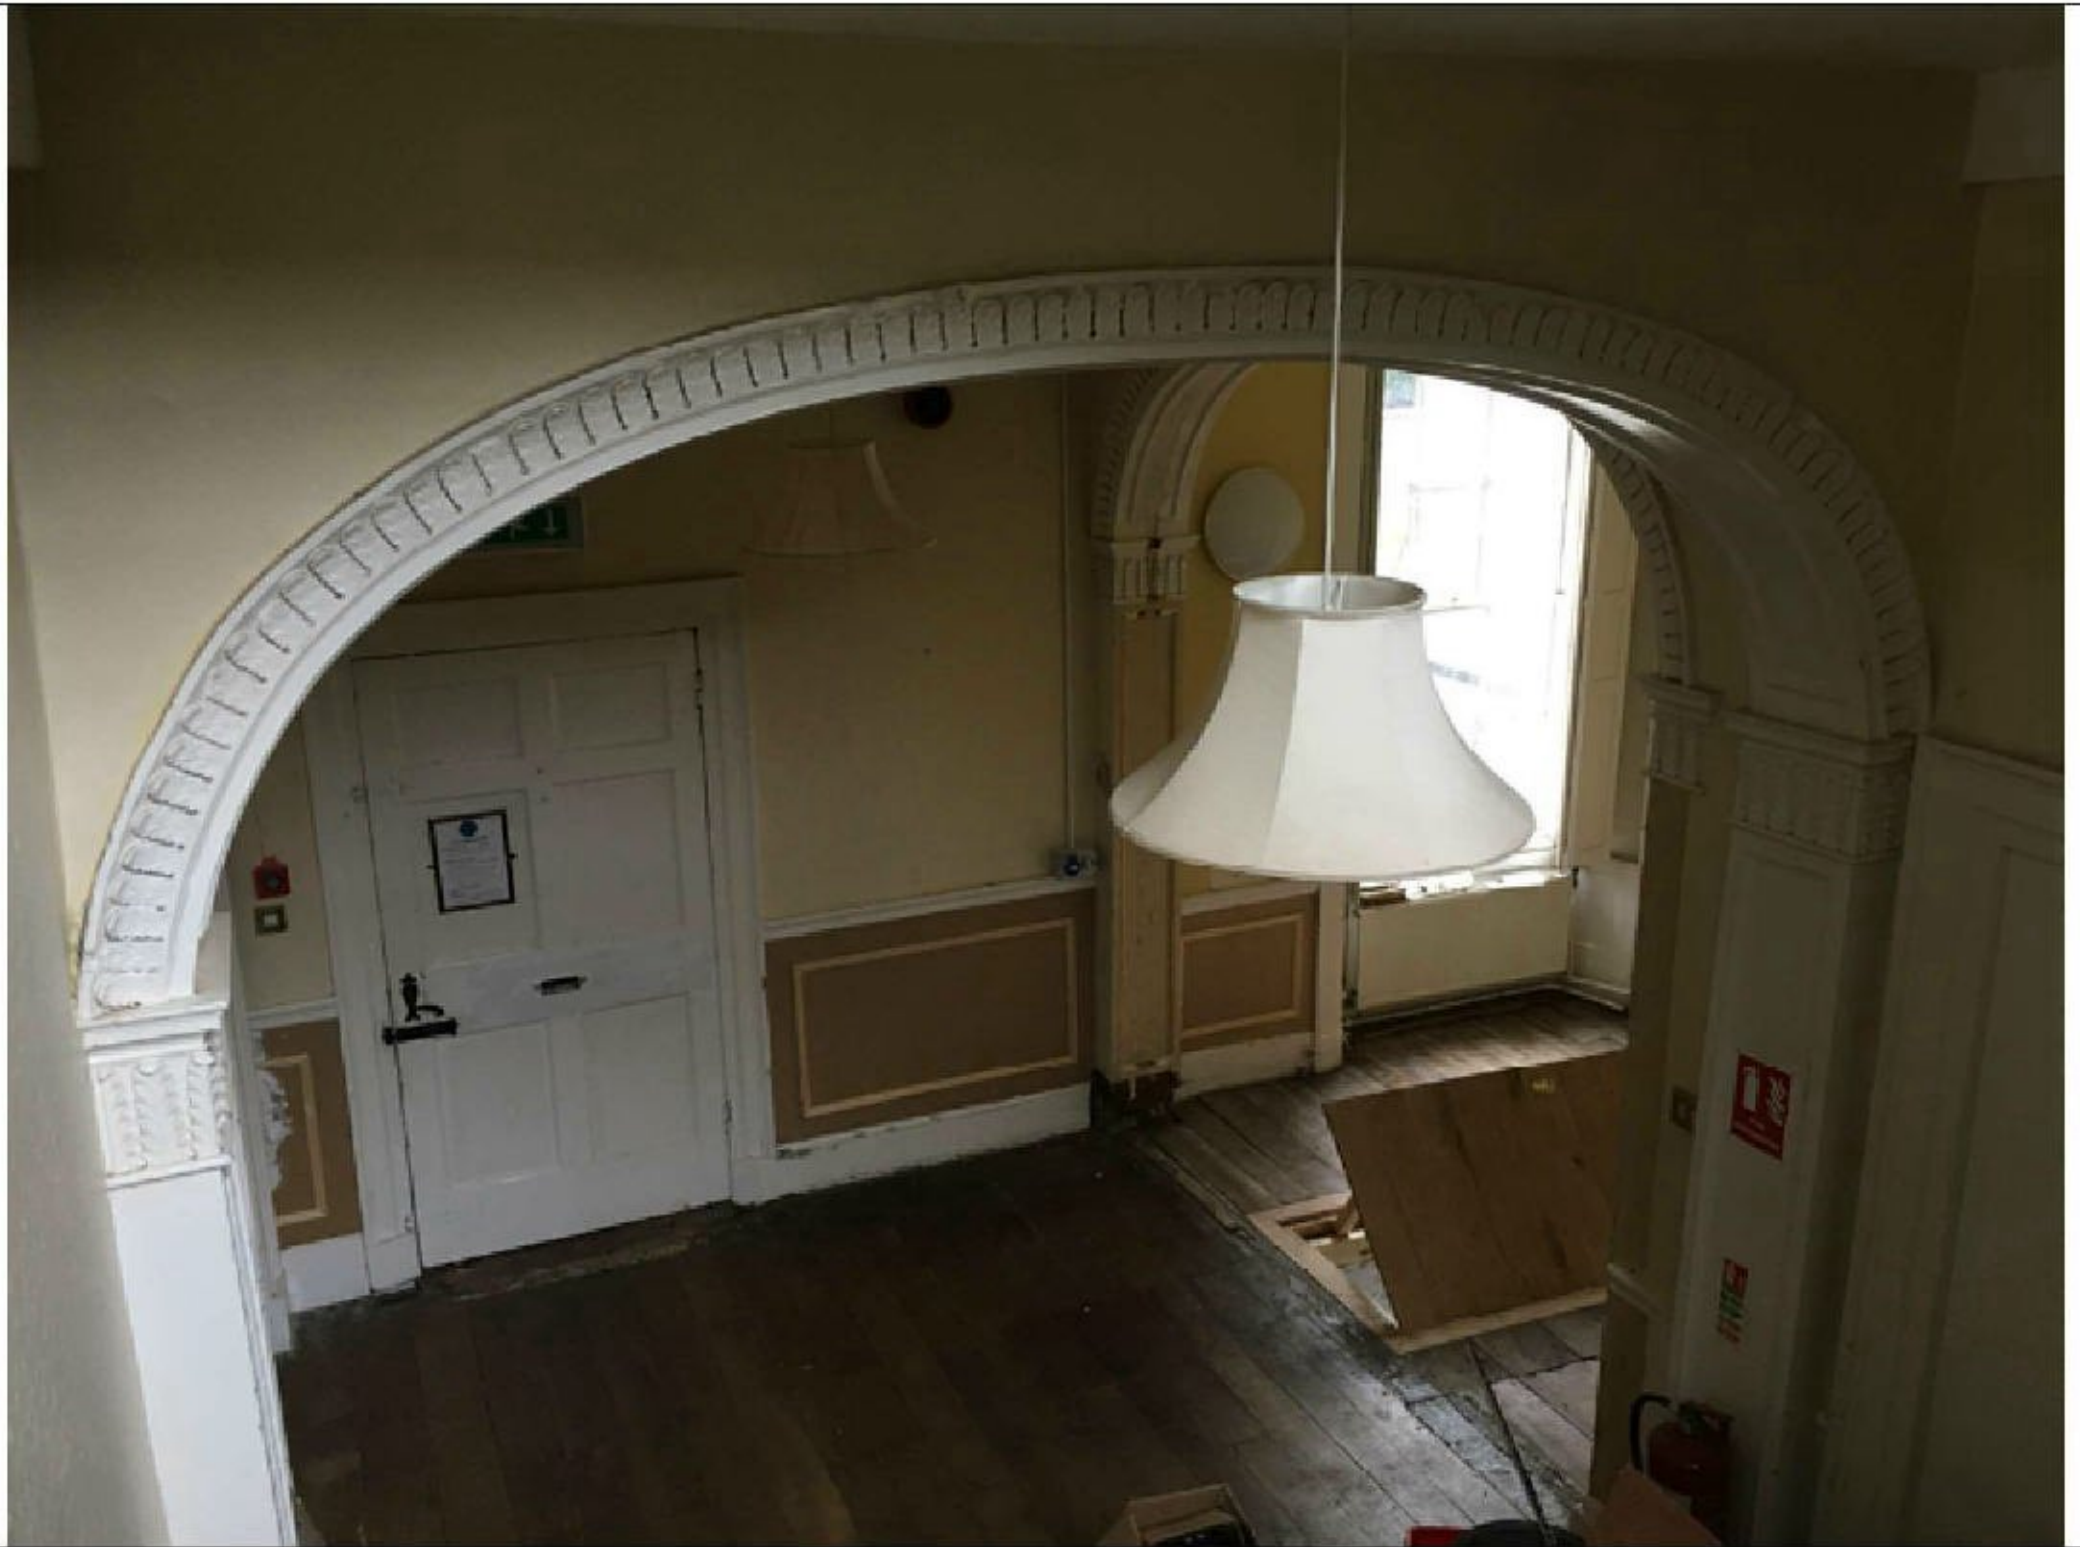
Photo Location - Entrance Hall - Photo Number **P08** - See floor plans for location

Located with 1750's section of the building

Arch plaster coving - Retained no proposed works

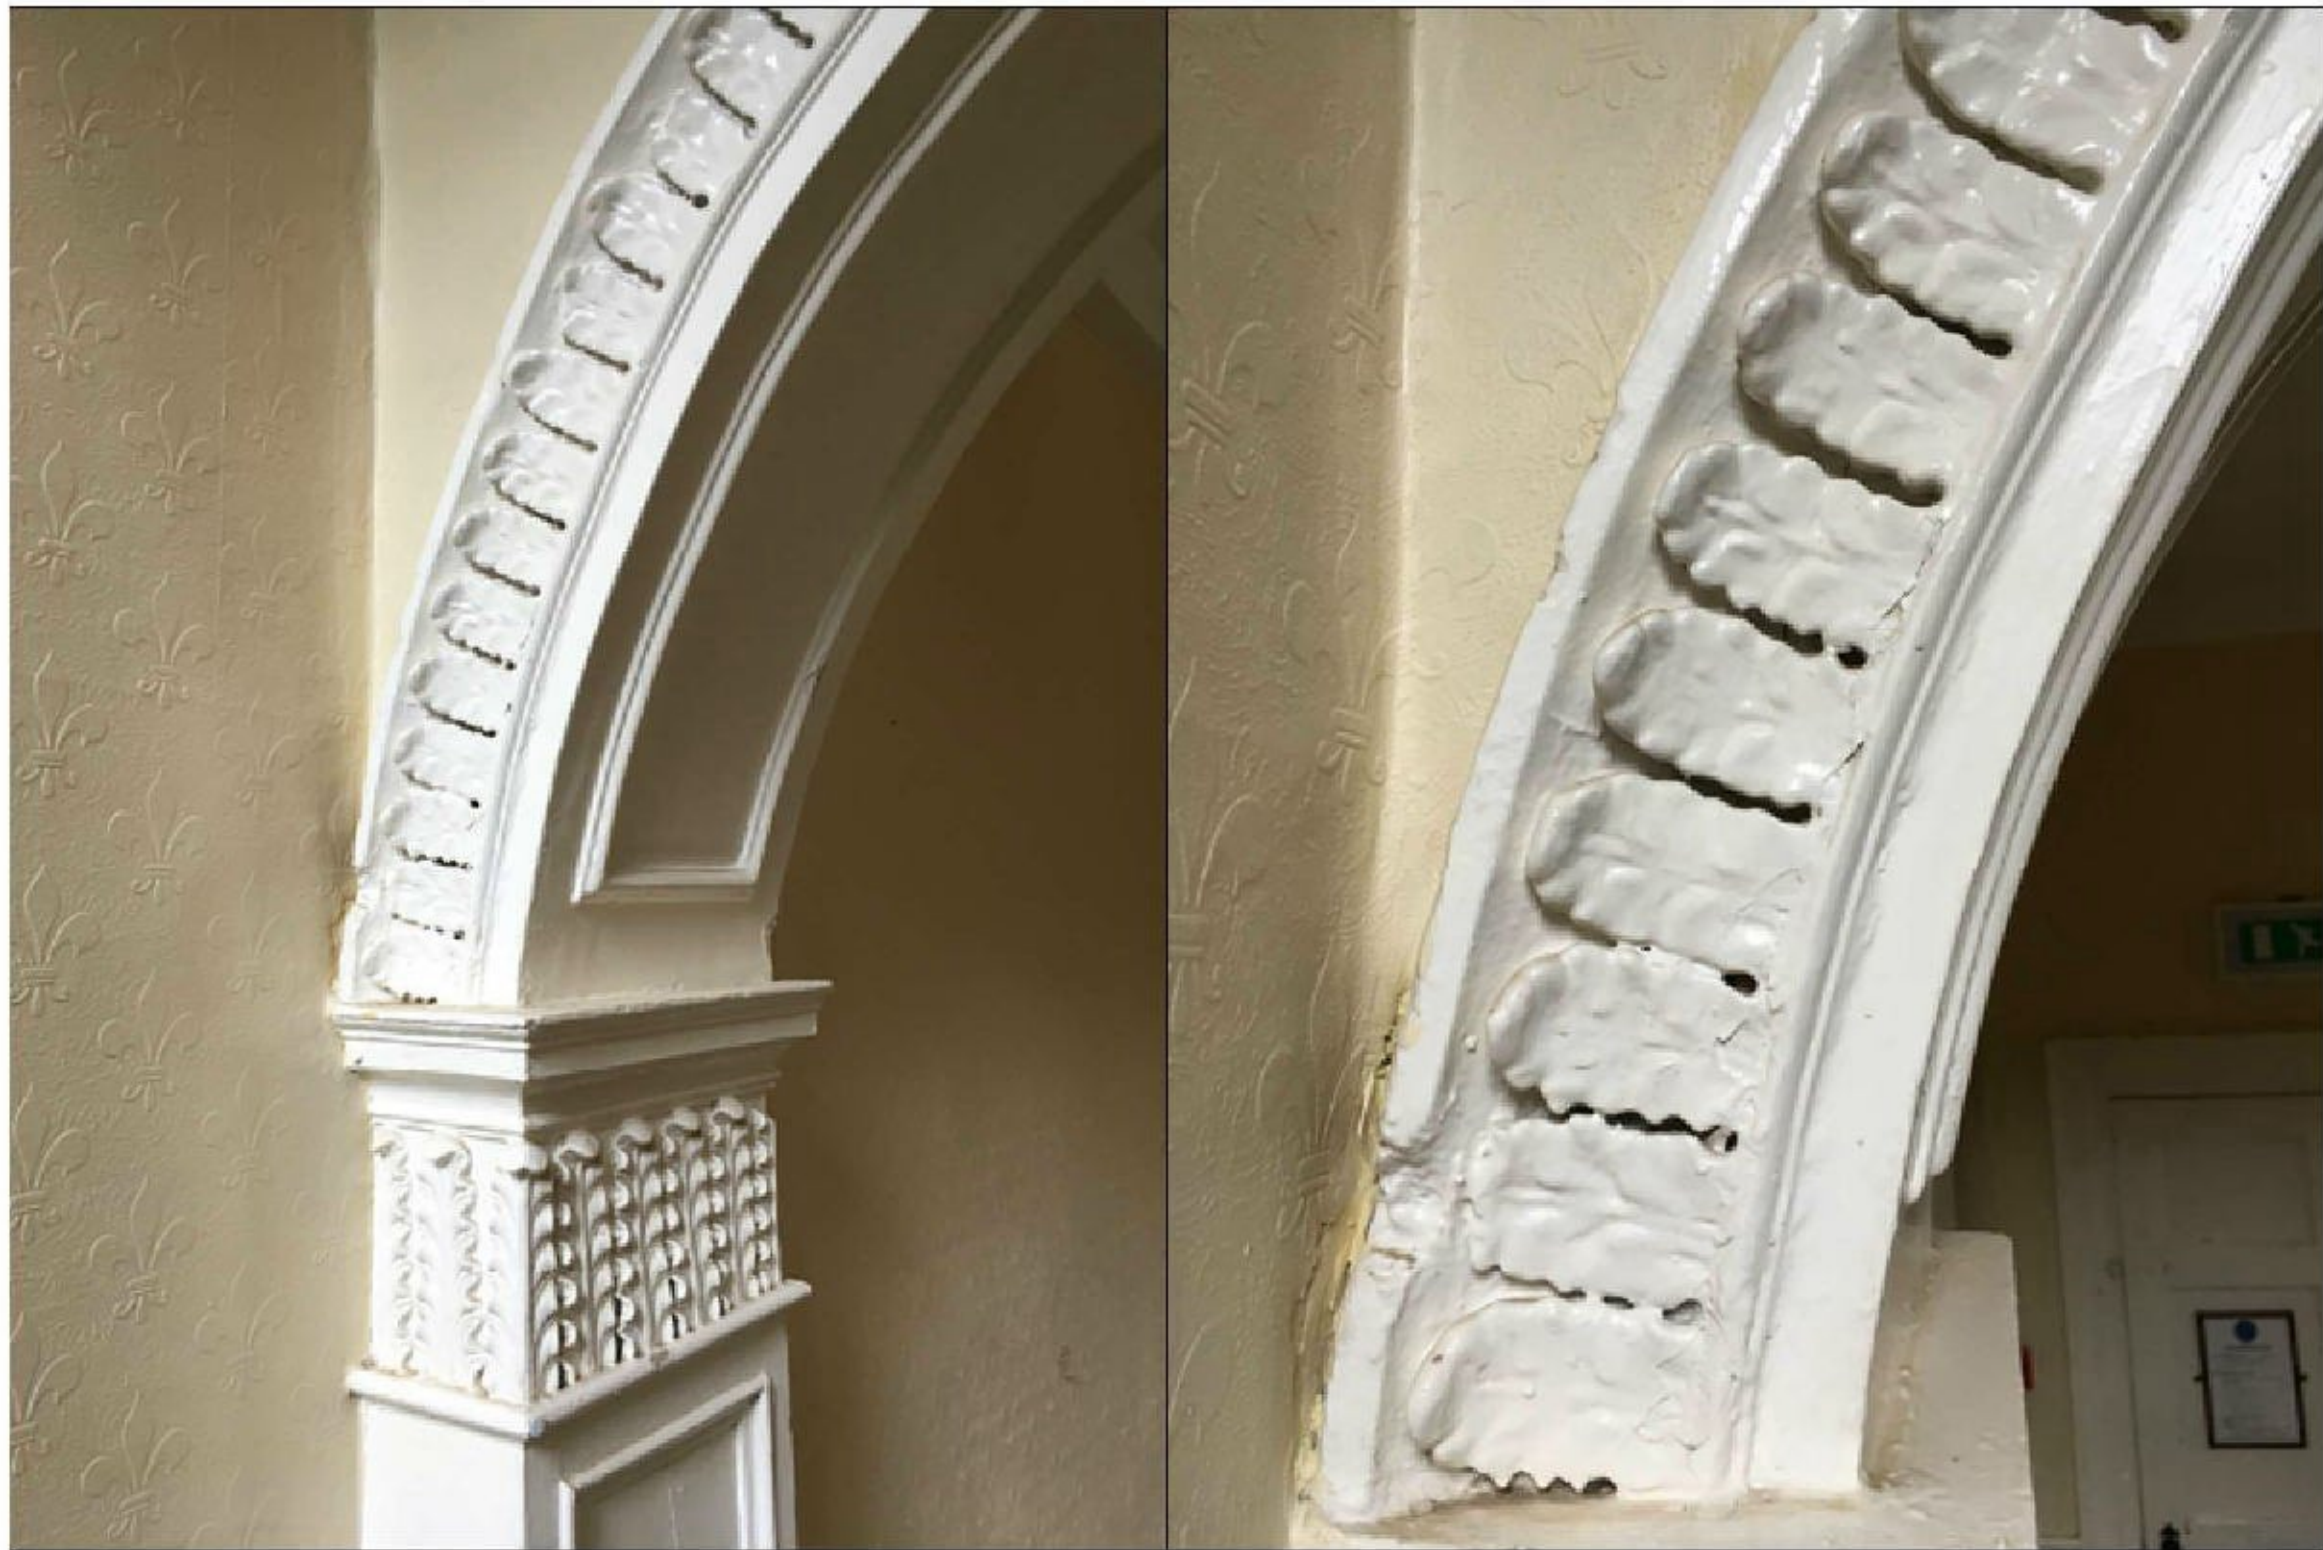
Photo Location - Entrance Hall - Photo Number **P09 & 10** - See floor plans for location

Located with 1750's section of the building

Arch plaster coving - Retained no proposed works
