# Existing Architectural Features

# Existing ground floor architectural features

Showing existing photos, noted location, condition, and proposed refurbishment works

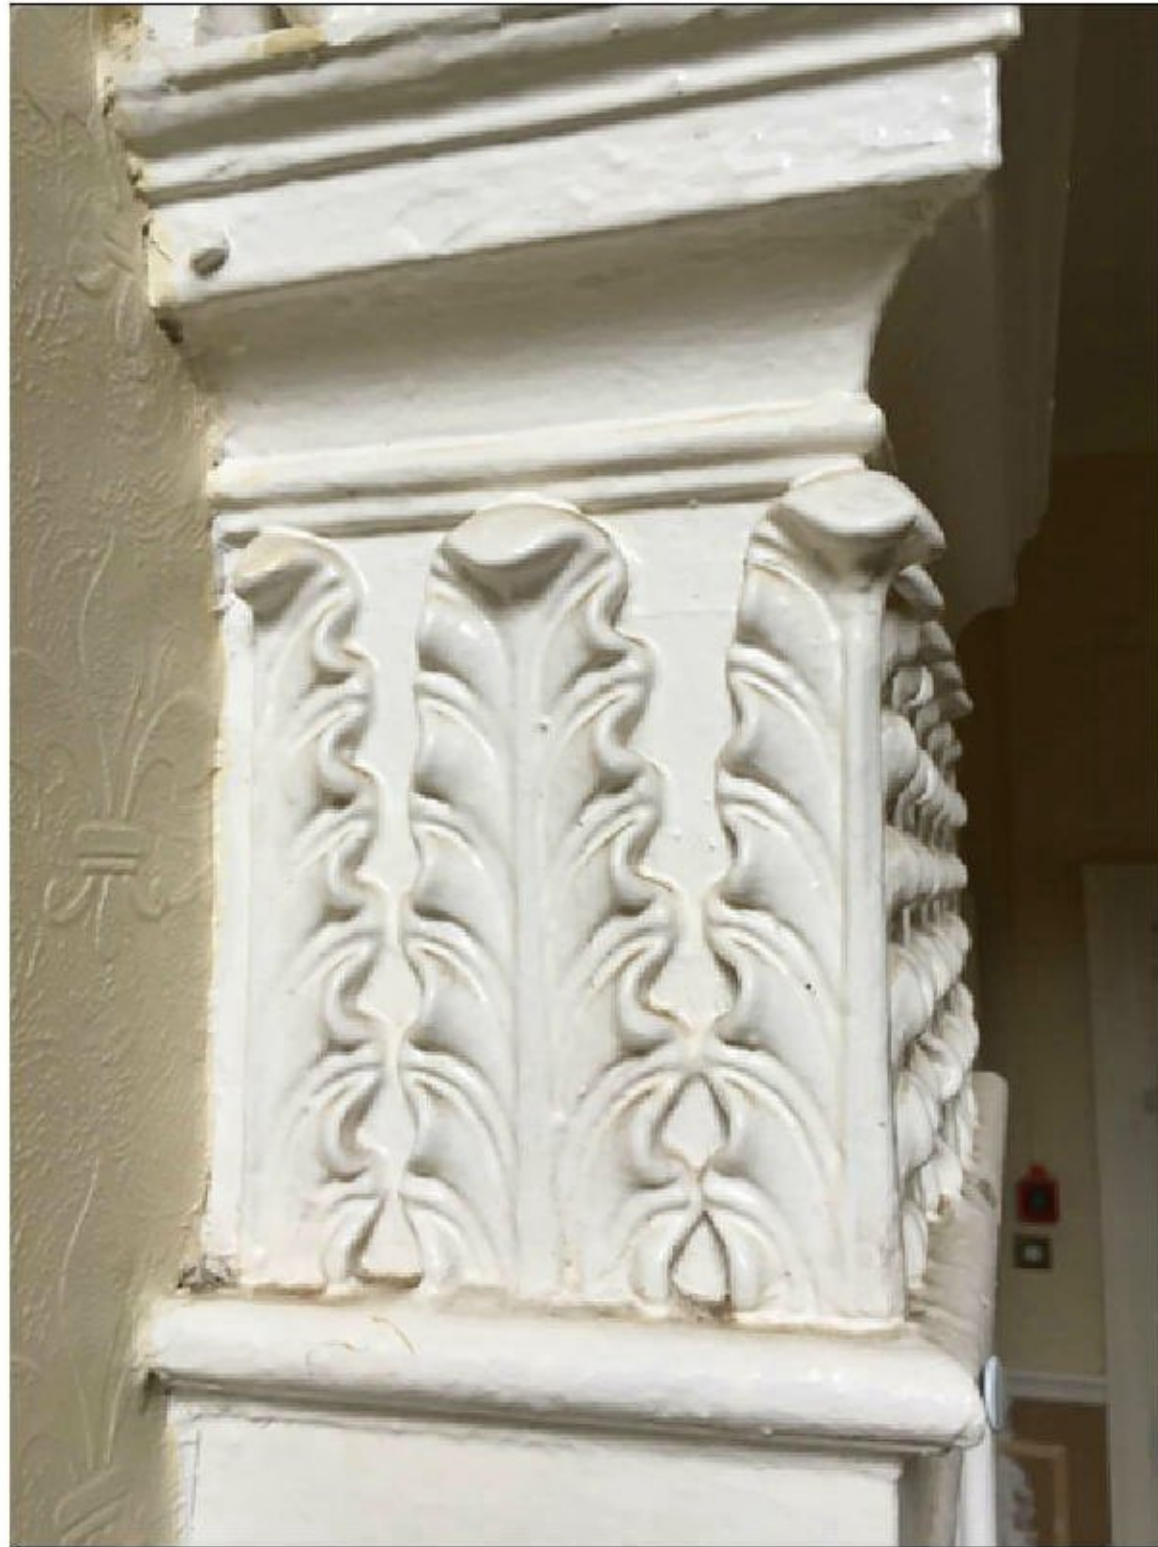
Photo Location - Entrance Hall - Photo Number **P11** - See floor plans for location

Located with 1750's section of the building

Arch plaster coving - Retained no proposed works

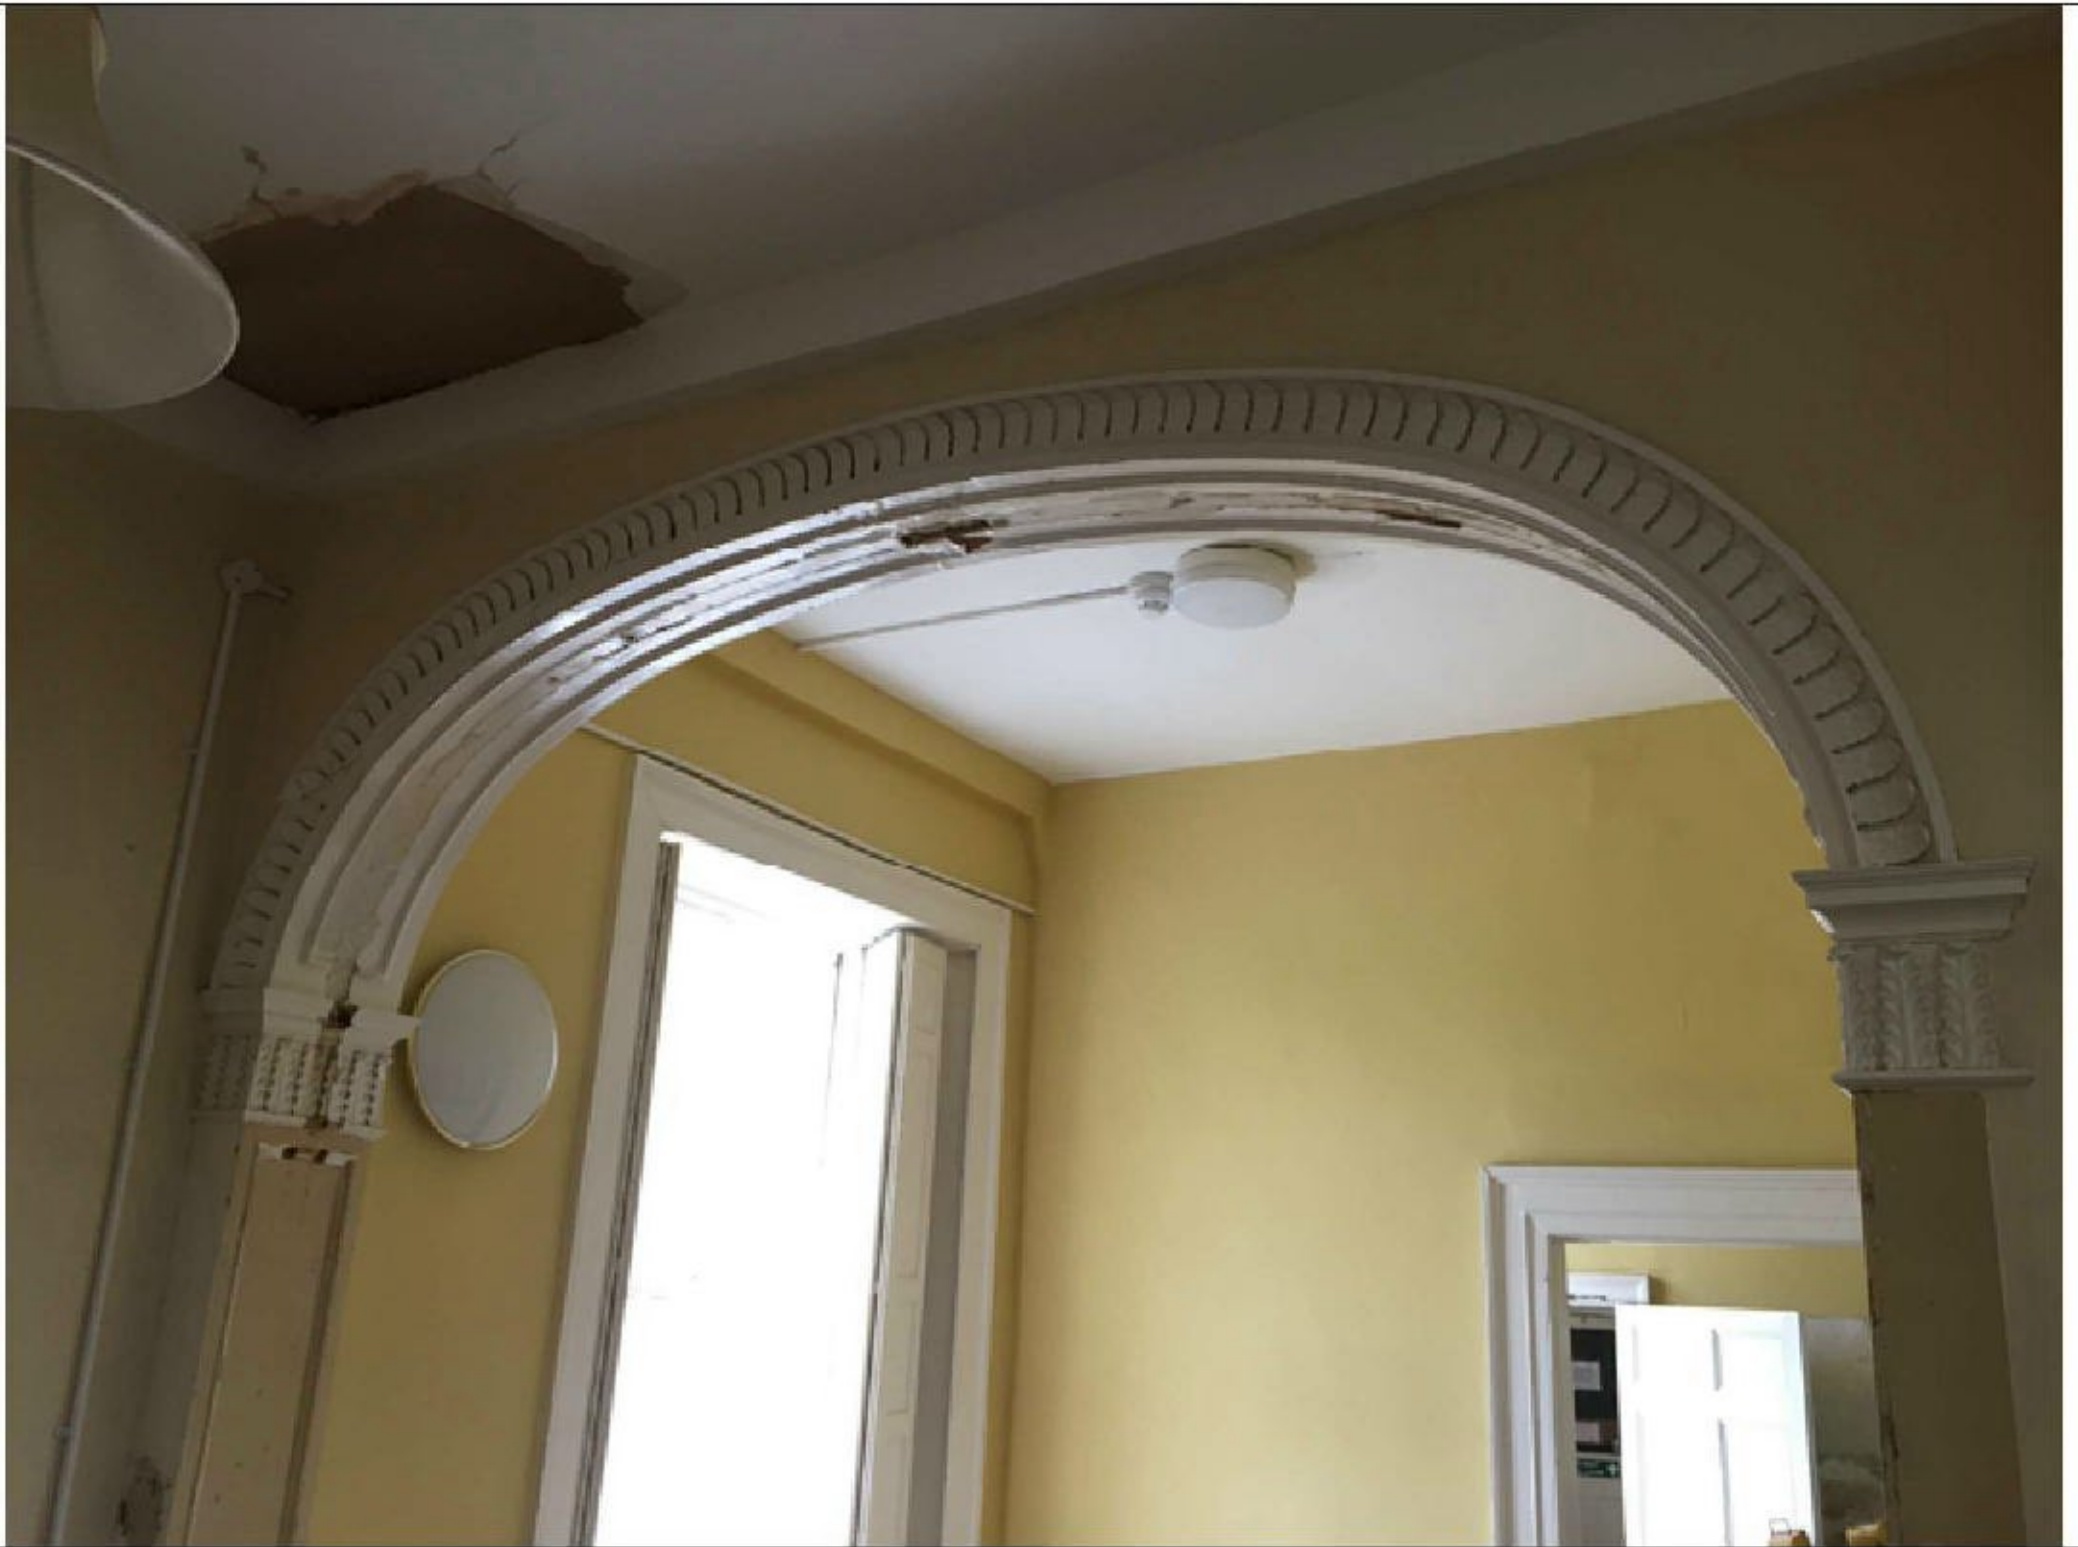
Photo Location - Entrance Hall - Photo Number **P12** - See floor plans for location

Located with 1750's section of the building

Arch plaster coving - Retained no proposed works

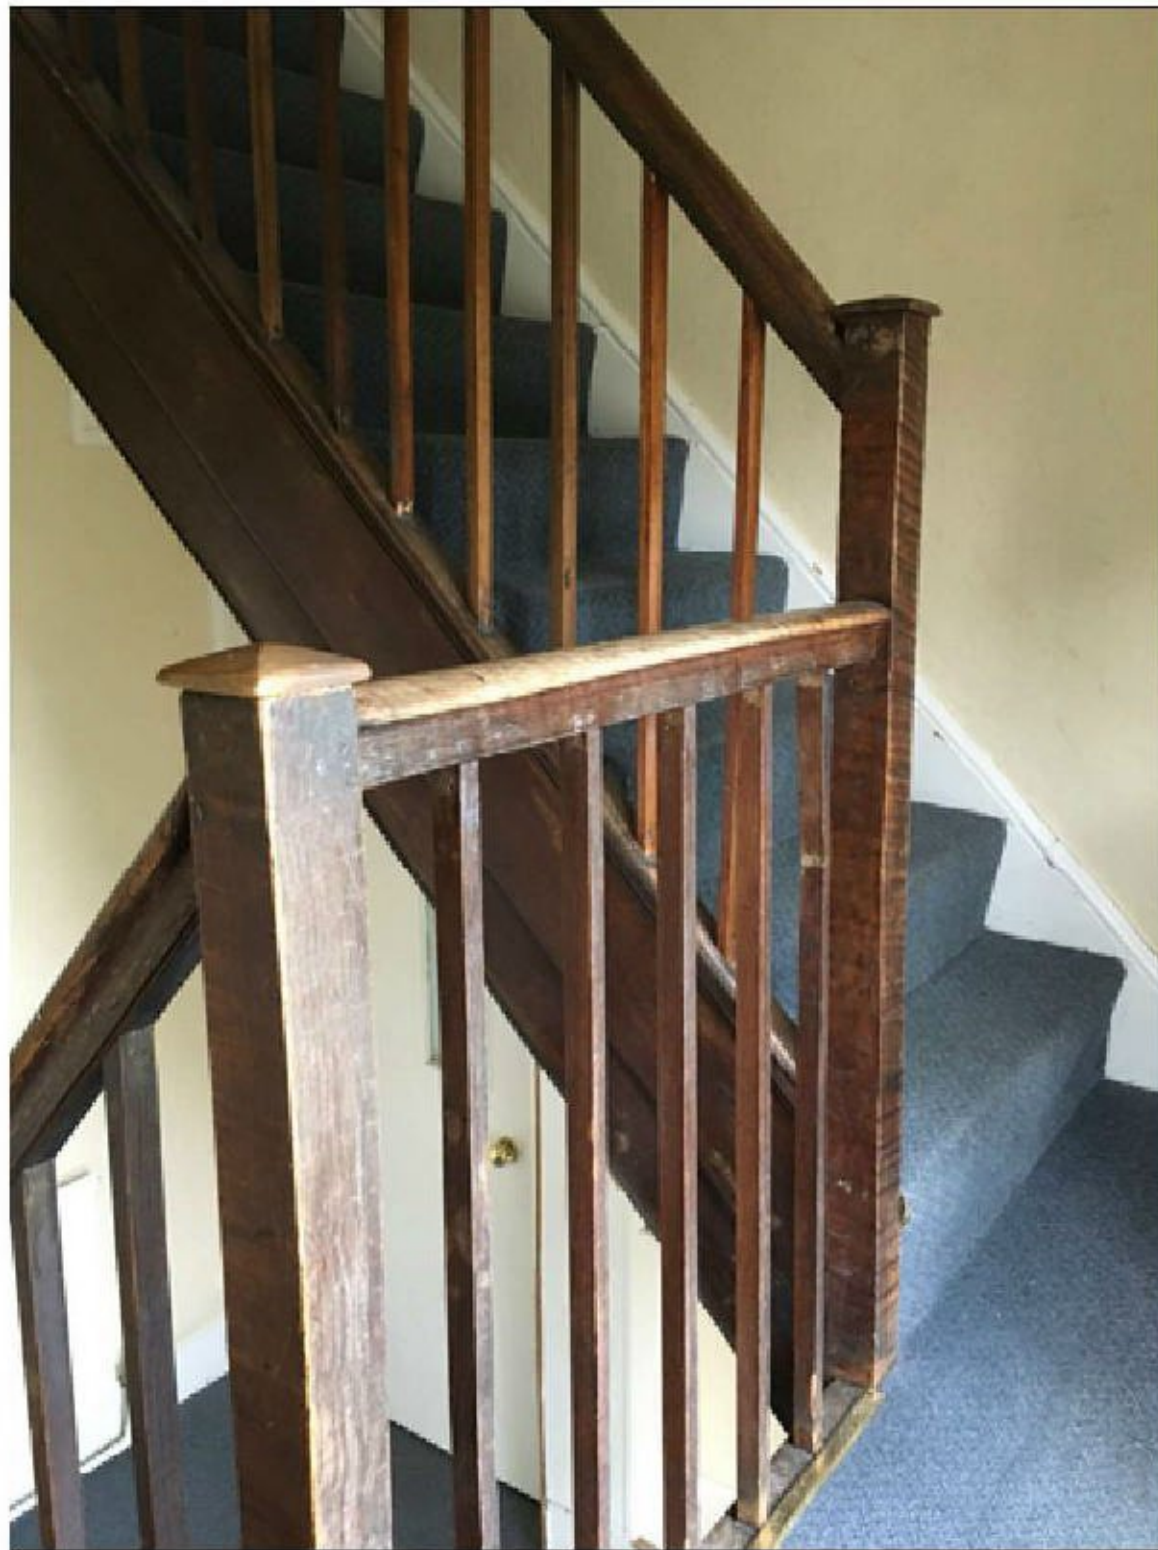
Photo Location - 3rd floor stairs - Photo Number **P14 & 15** - See floor plans for location

Located with 1750's section of the building

Staircase - Retained - refurbished

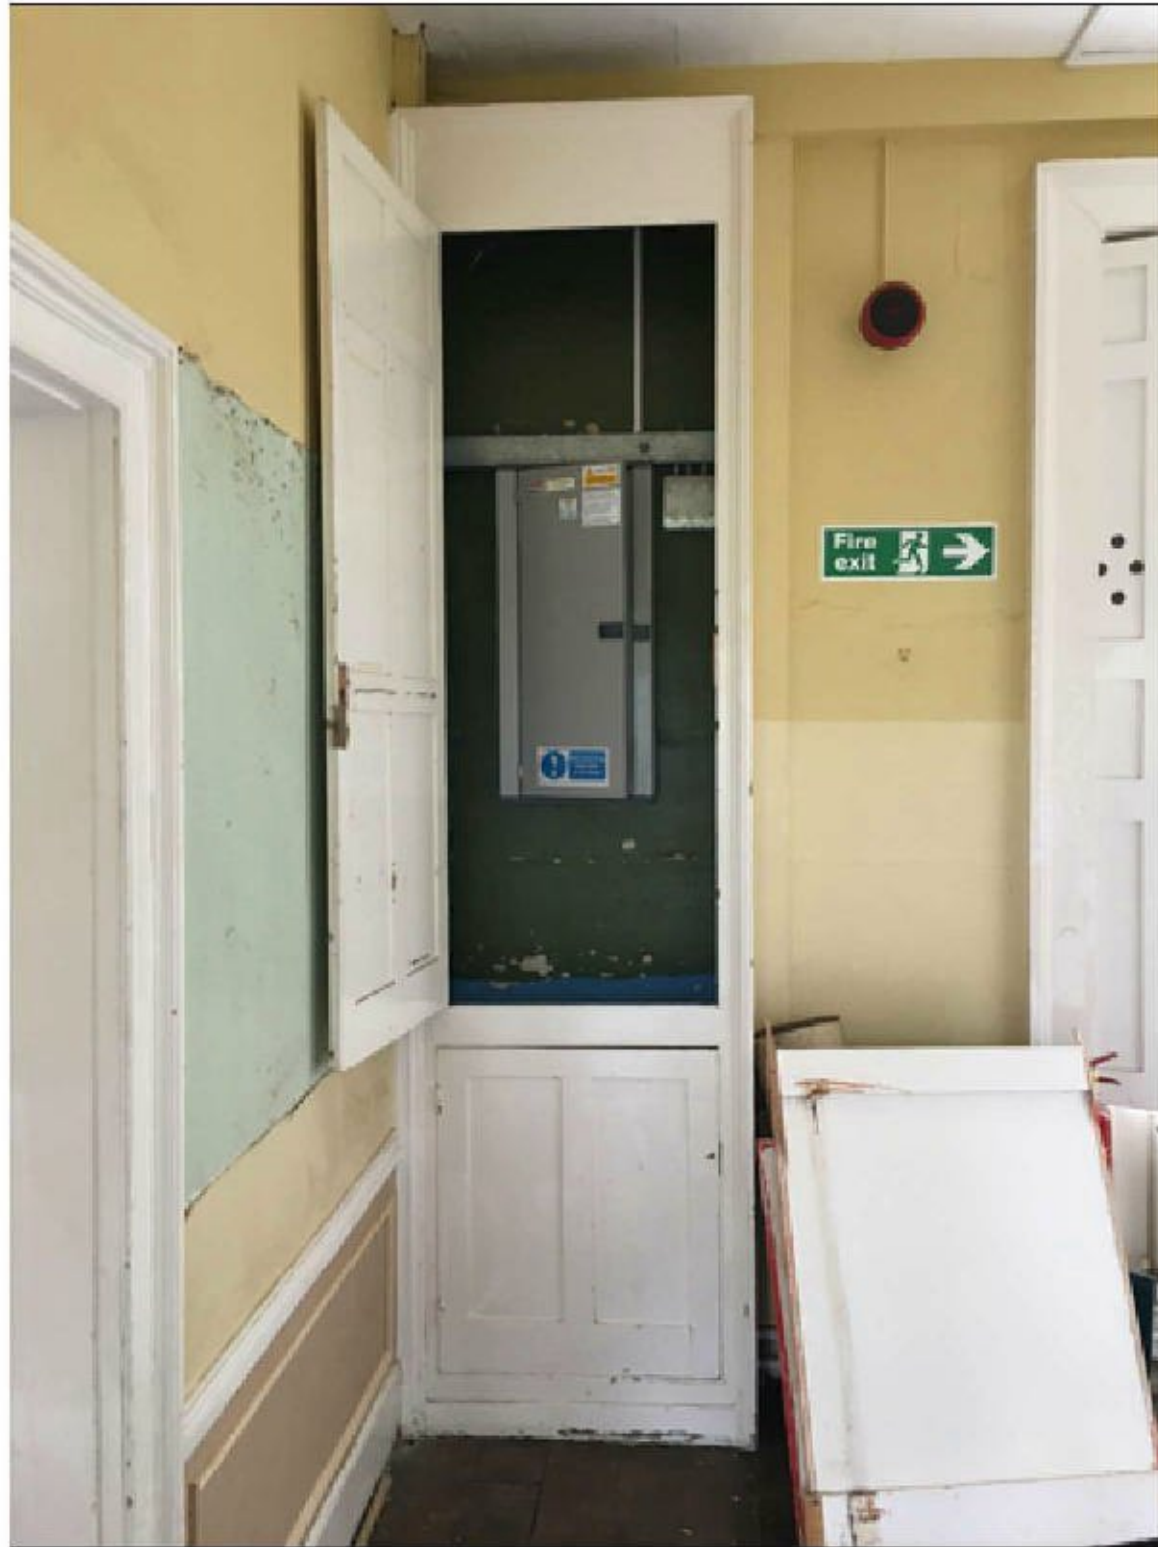
Photo Location - Hall - Photo Number **P16** - See floor plans for location

Located with 1750's section of the building

Created in 1995

Ground floor cupboard - Retained - refurbished

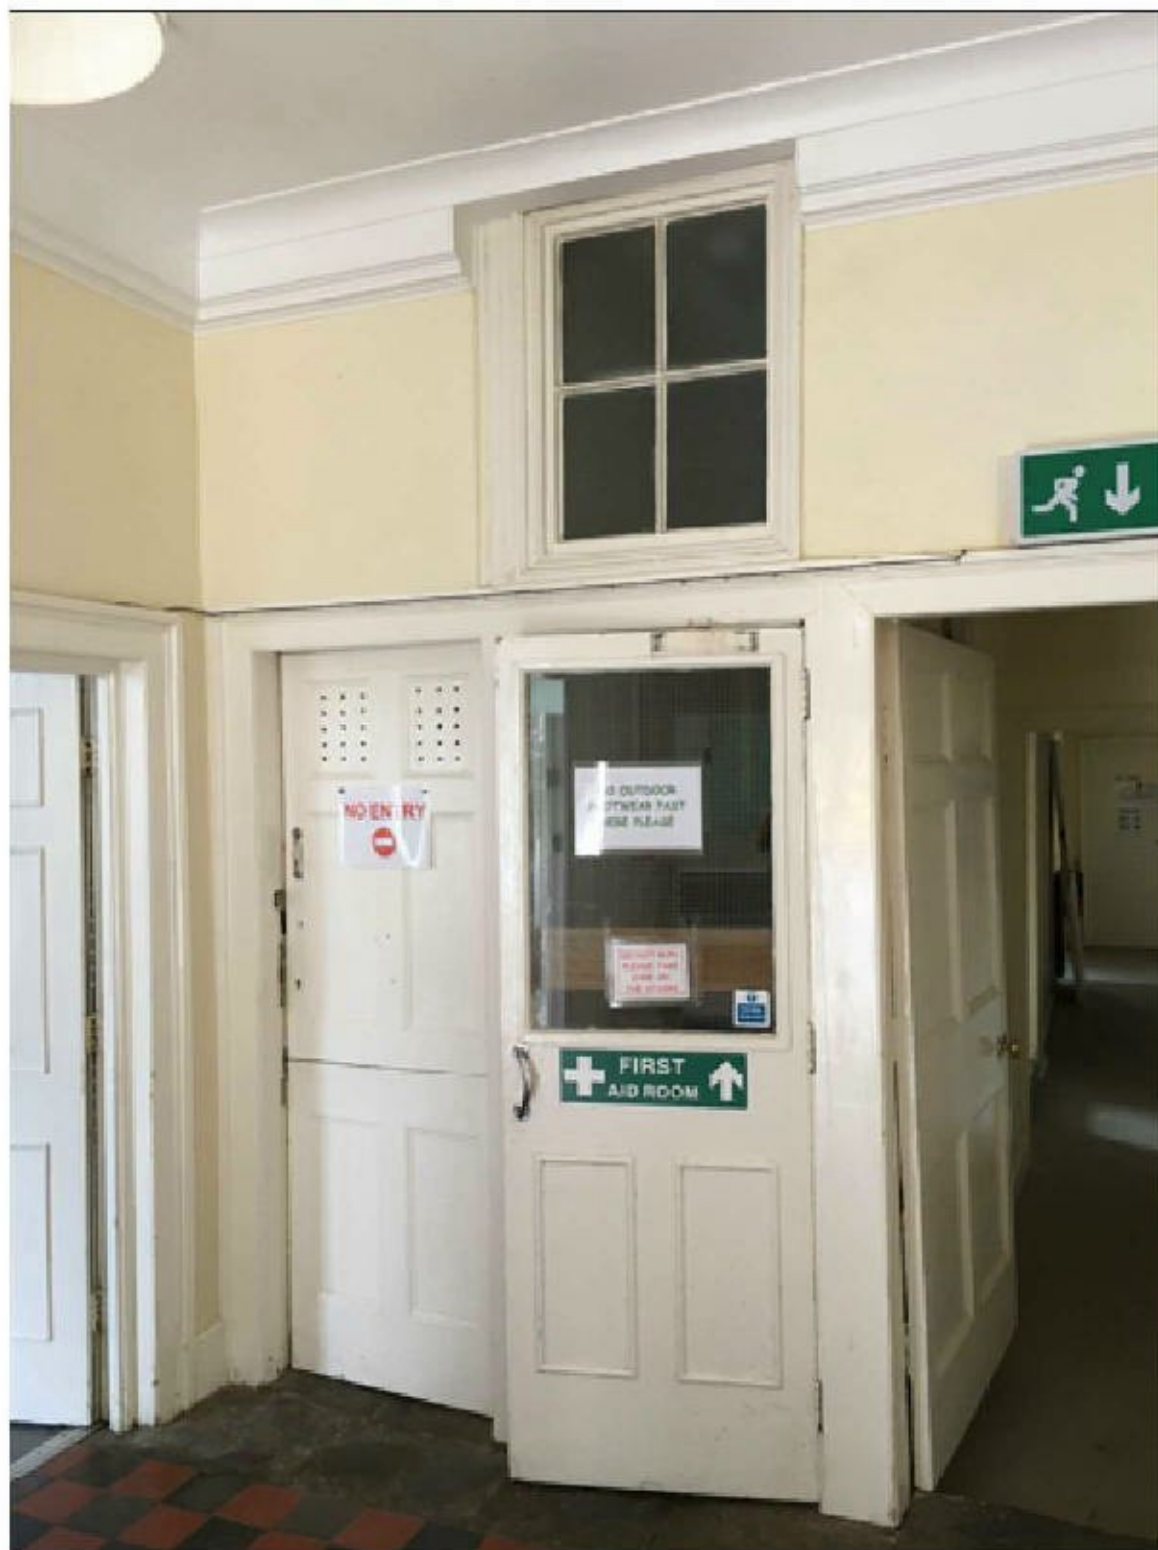
Photo Location - Hall next to kitchen - Photo Number **P17** - See floor plans for location

Located with 1750's section of the building

Timber architrave - Retained - refurbished

Window above and timber work - Retained - refurbished

Ceiling coving - Retained - refurbished

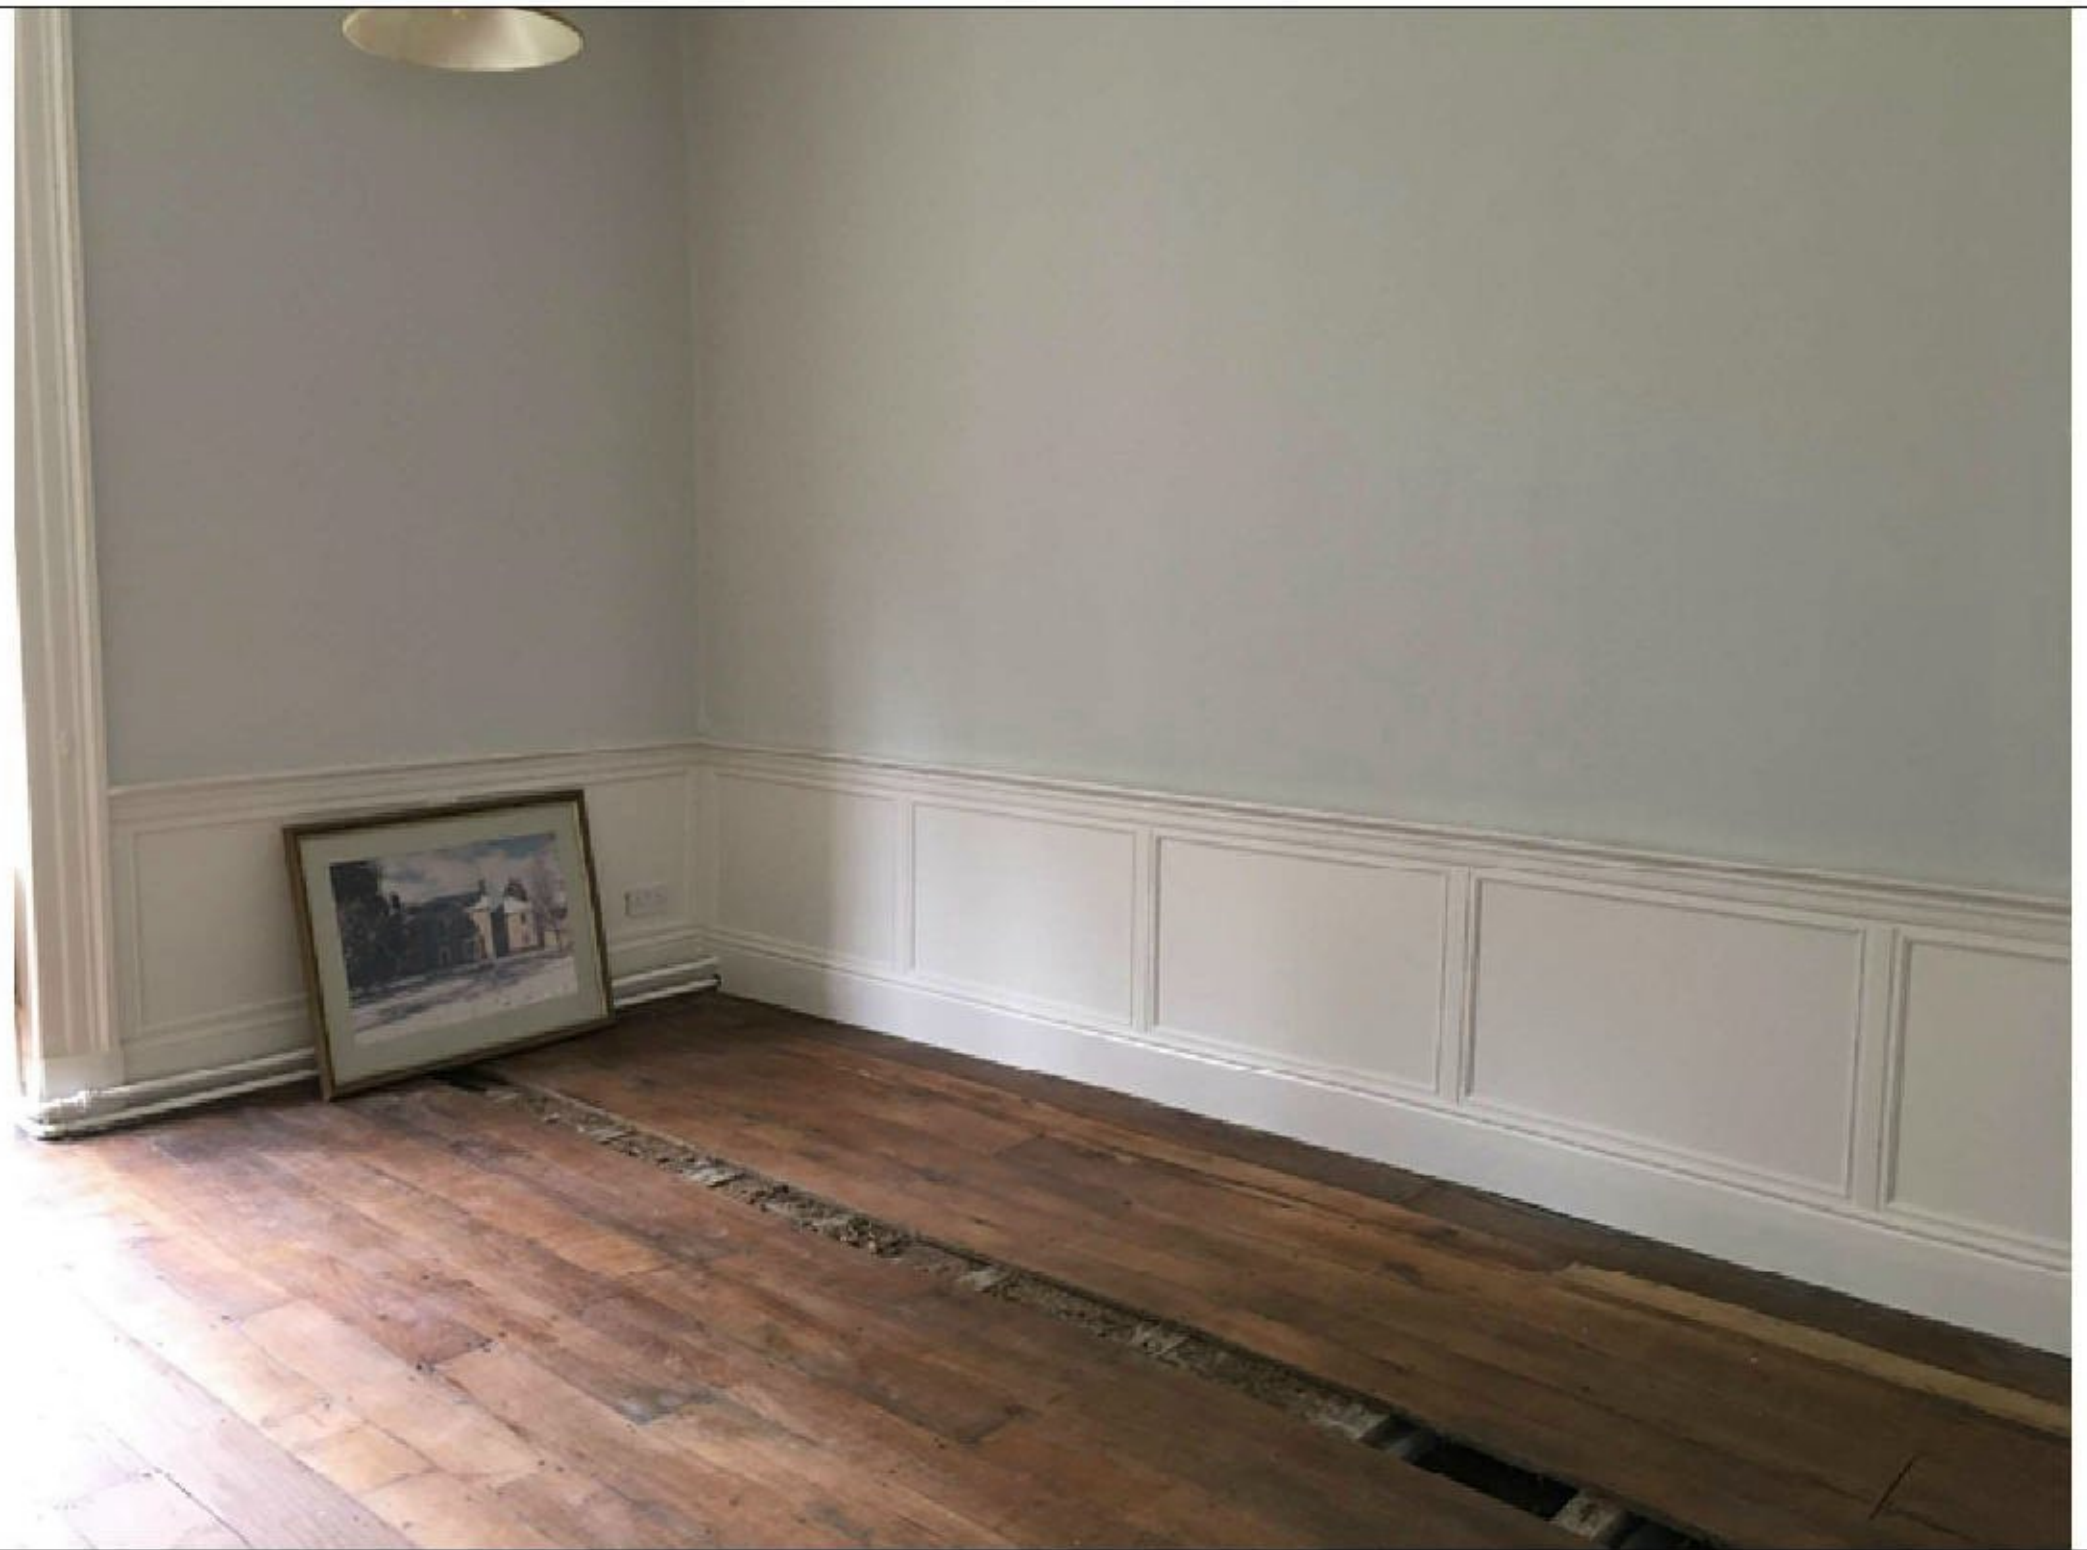
Photo Location - Lounge - Photo Number **P18** - See floor plans for location

Located with 1750's section of the building

Timber Wall paneling - Retained - refurbished

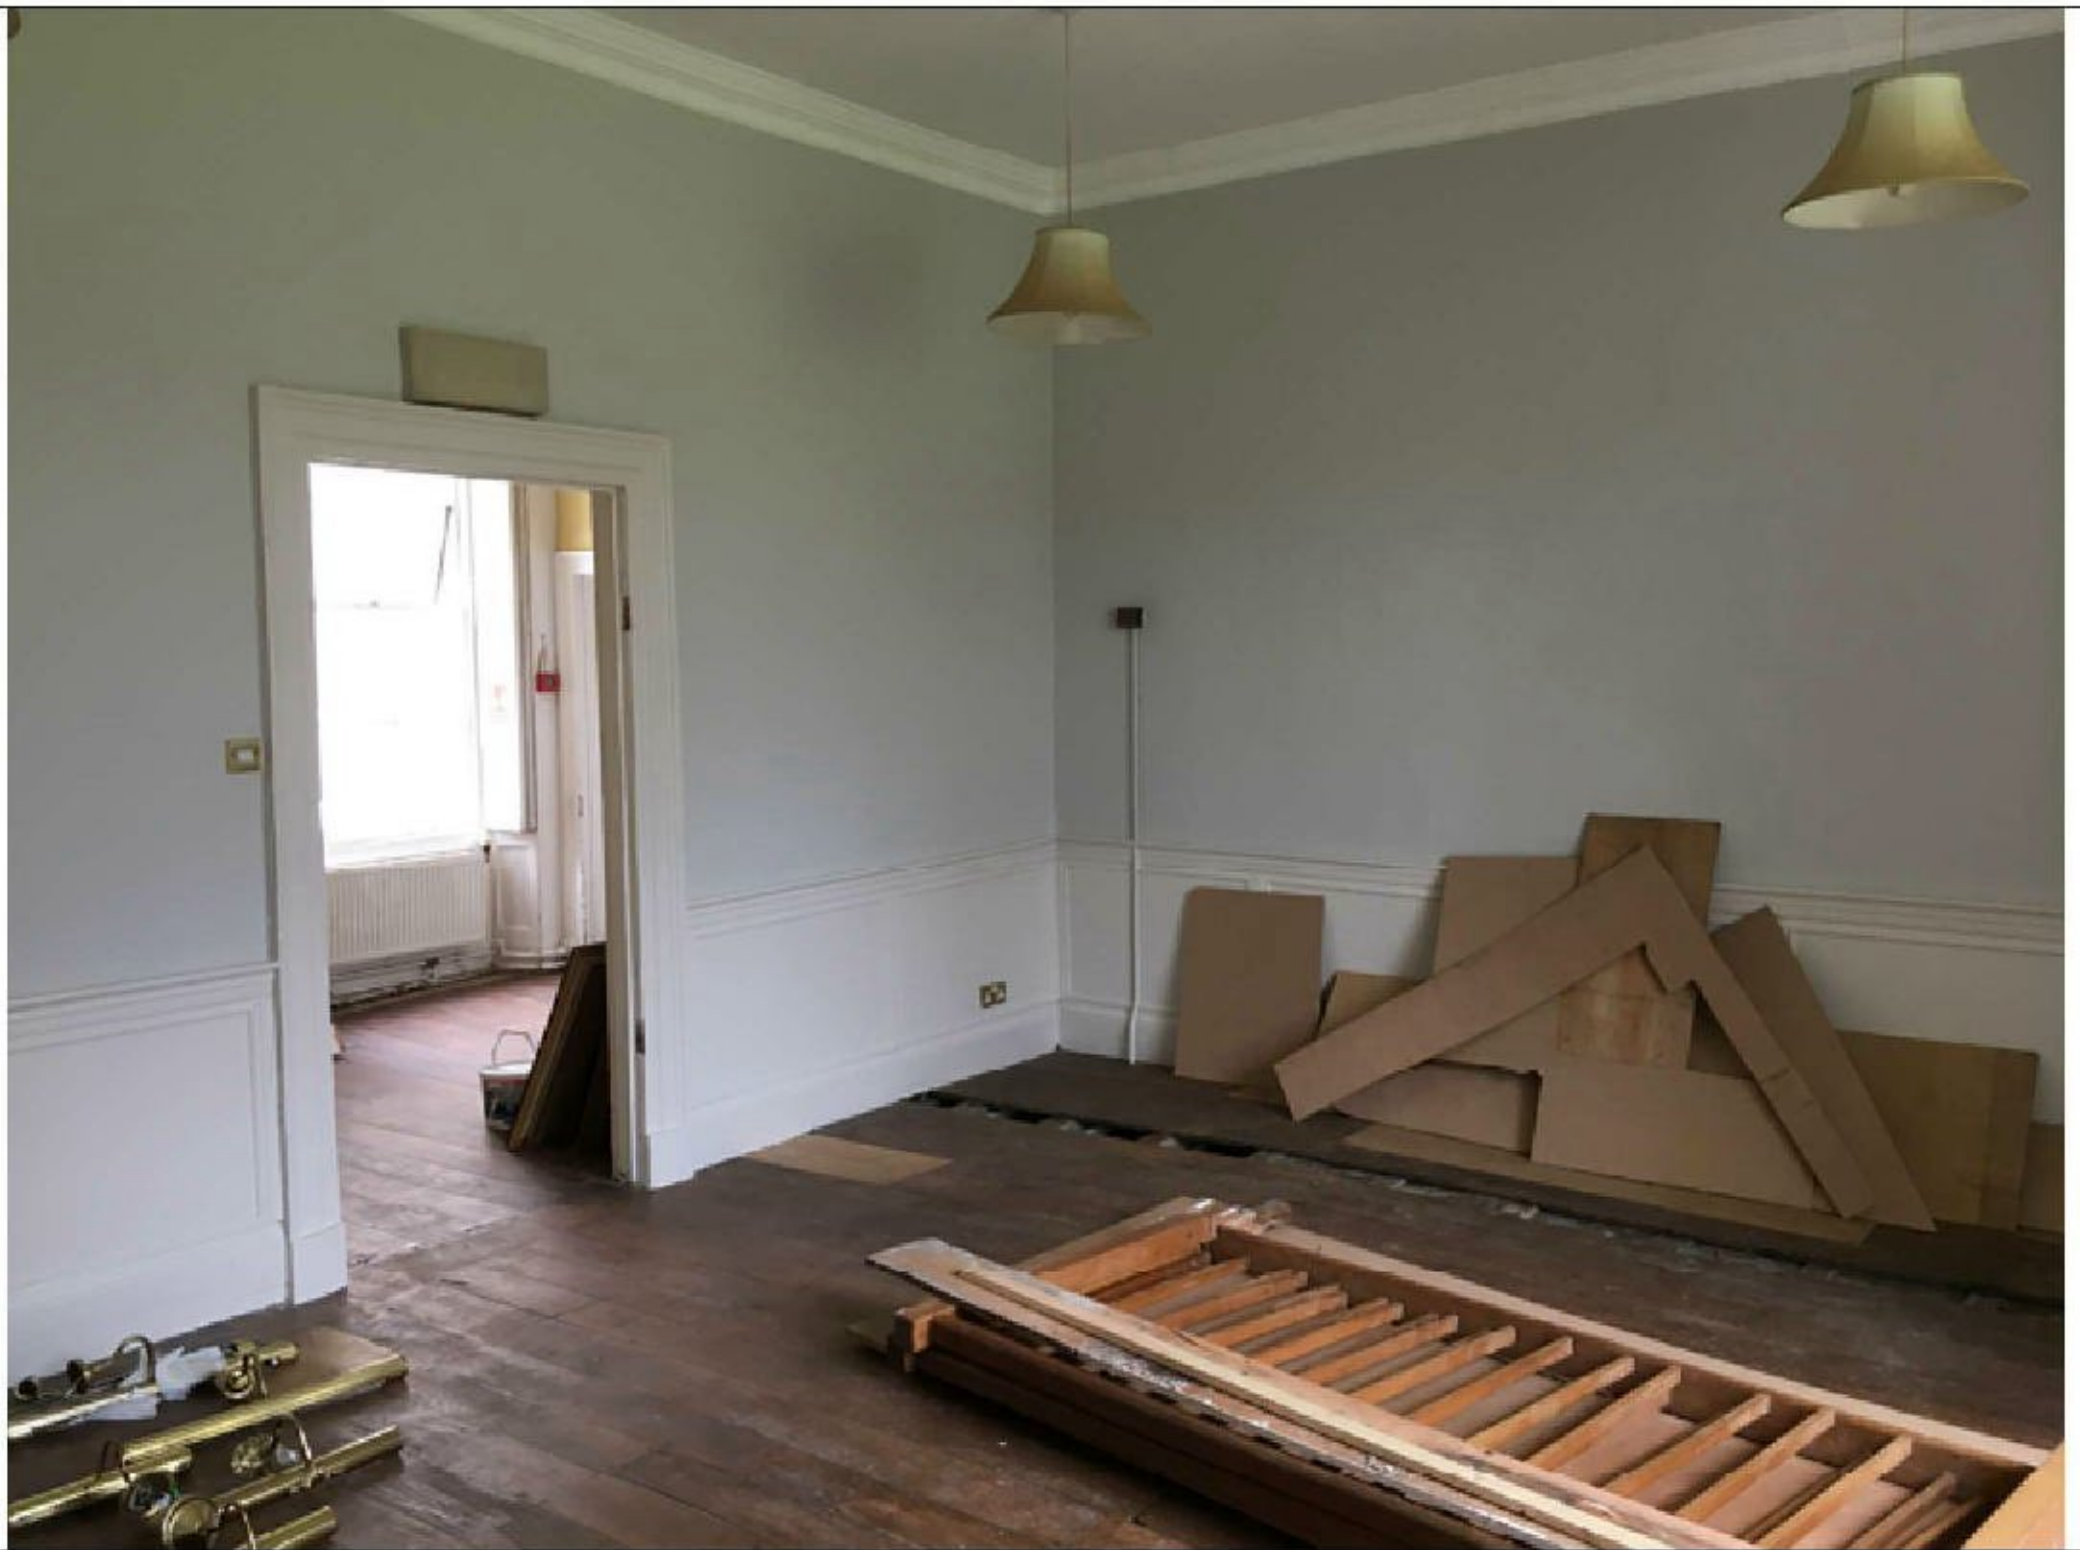
Photo Location - Lounge - Photo Number **P19** - See floor plans for location

Located with 1750's section of the building

Ceiling coving and skirting - Retained - refurbished

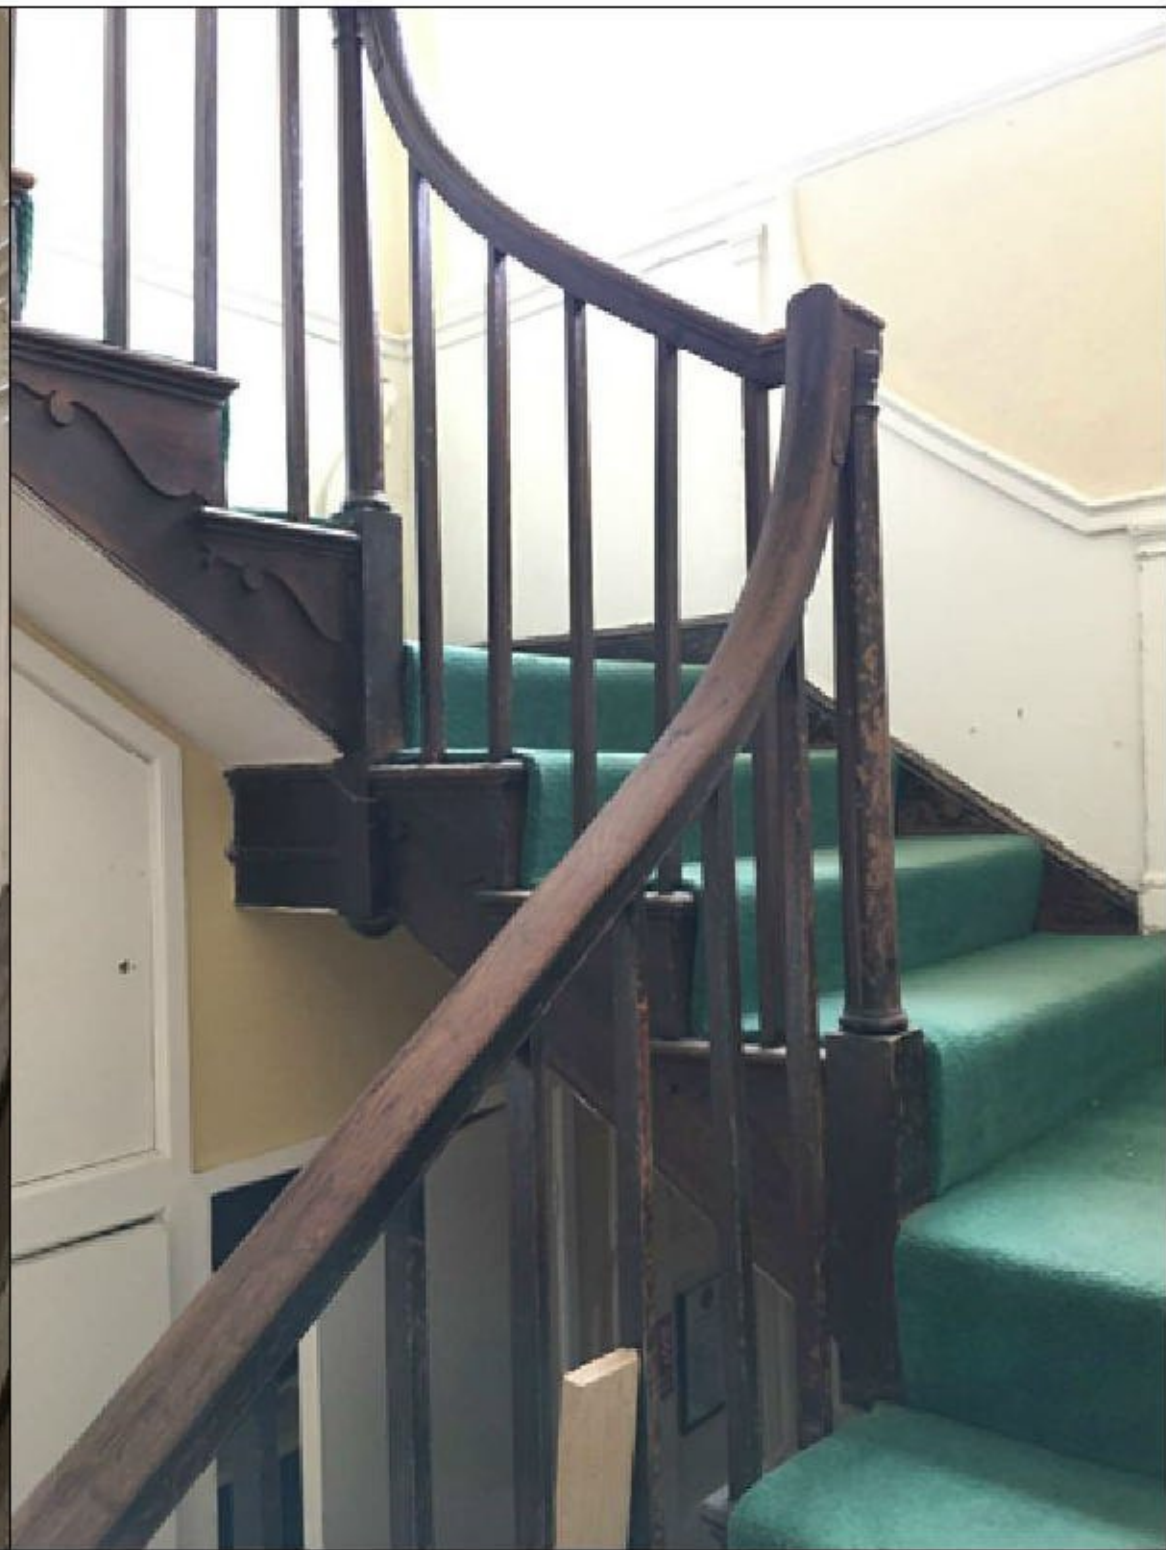
Photo Location - Stairs - Photo Number **P20 & 21** - See floor plans for location

Located with 1750's section of the building

Main Staircase - Retained - refurbished

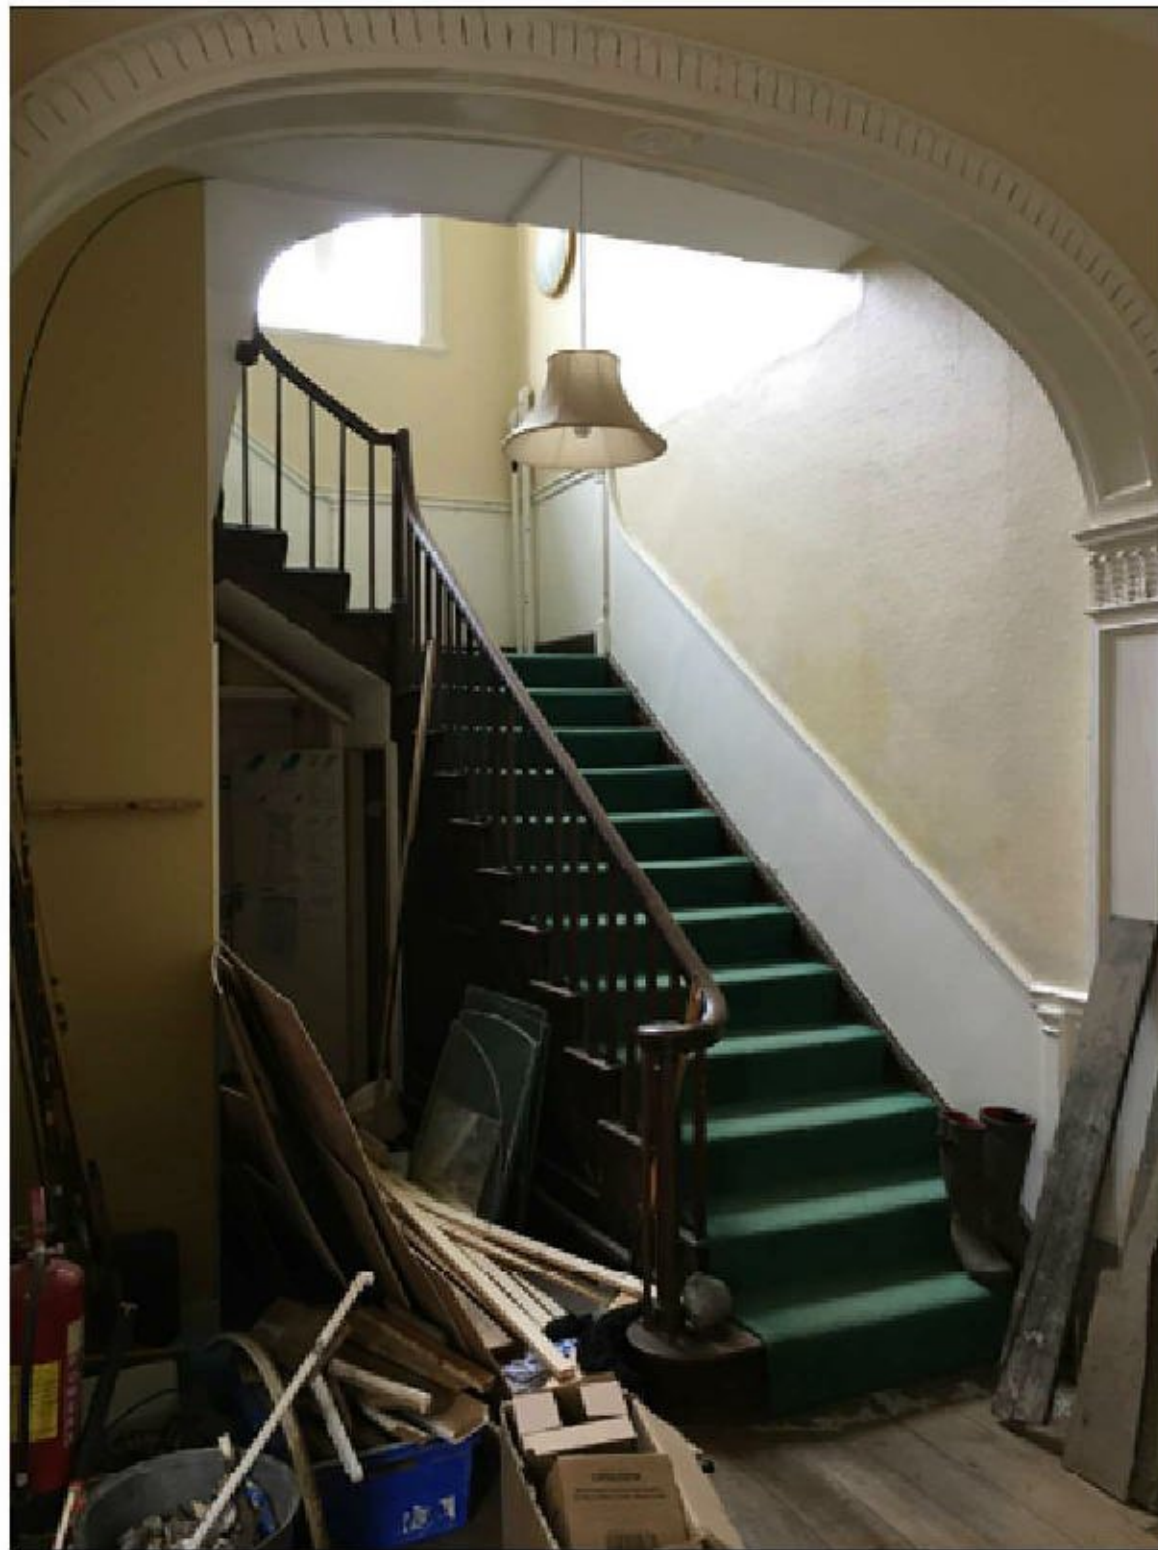
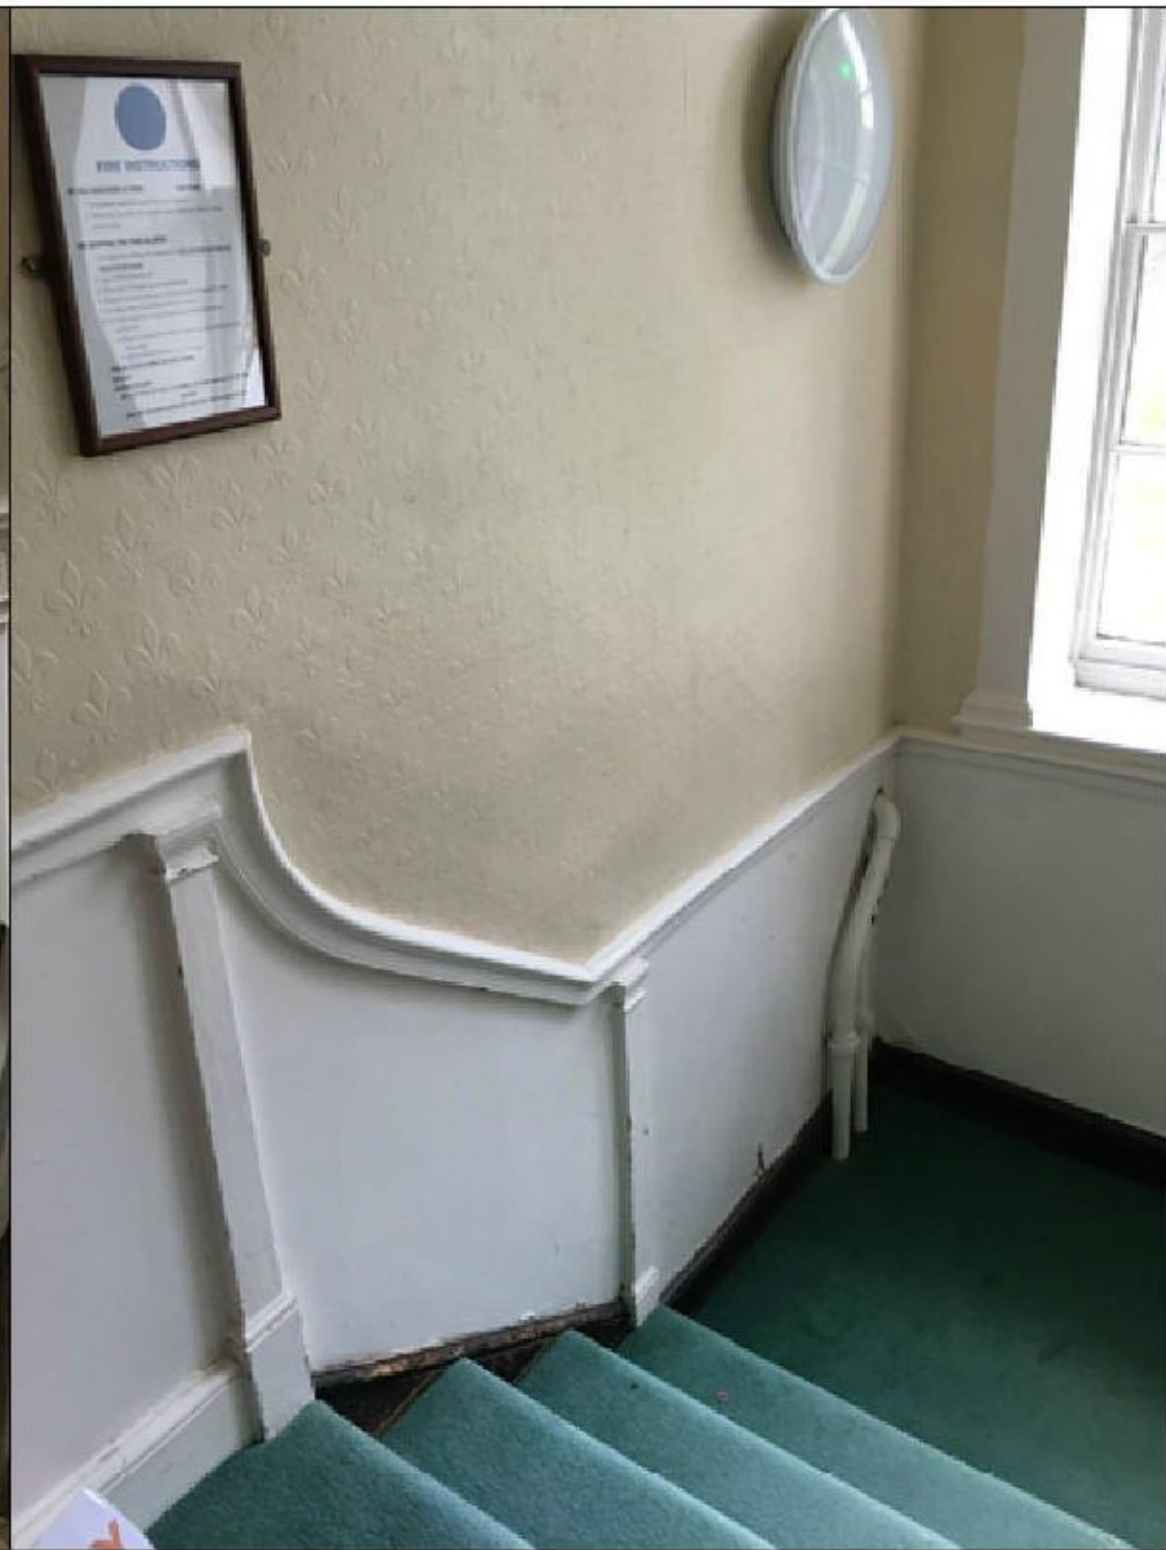
Photo Location - Stairs - Photo Number **P24 & 25** - See floor plans for location

Located with 1750's section of the building

Main Staircase - Retained - refurbished

Staircase timber wall paneling - Retained - refurbished
