# Existing Architectural Features

# Existing ground floor architectural features

Showing existing photos, noted location, condition, and proposed refurbishment works

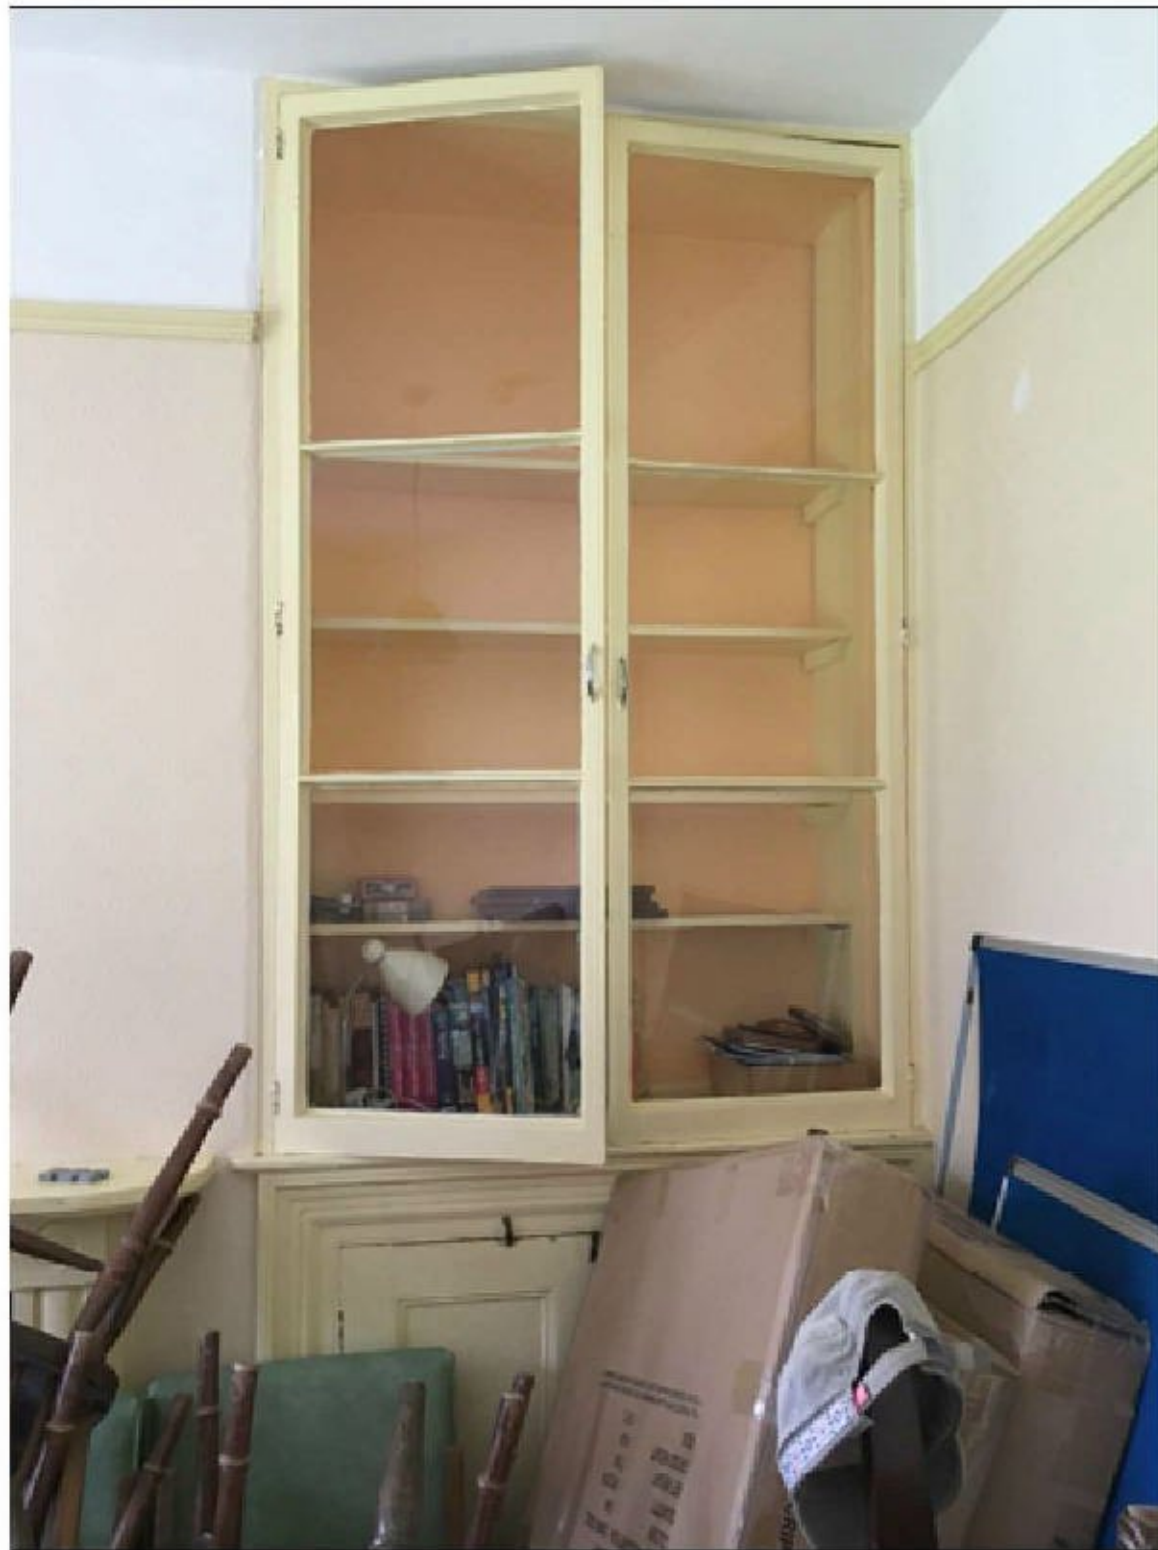
Photo Location - Stairs - Photo Number **P26** - See floor plans for location

Located with 1840's section of the building

Wall cupboard - Presumed 1930's - Retained - refurbished

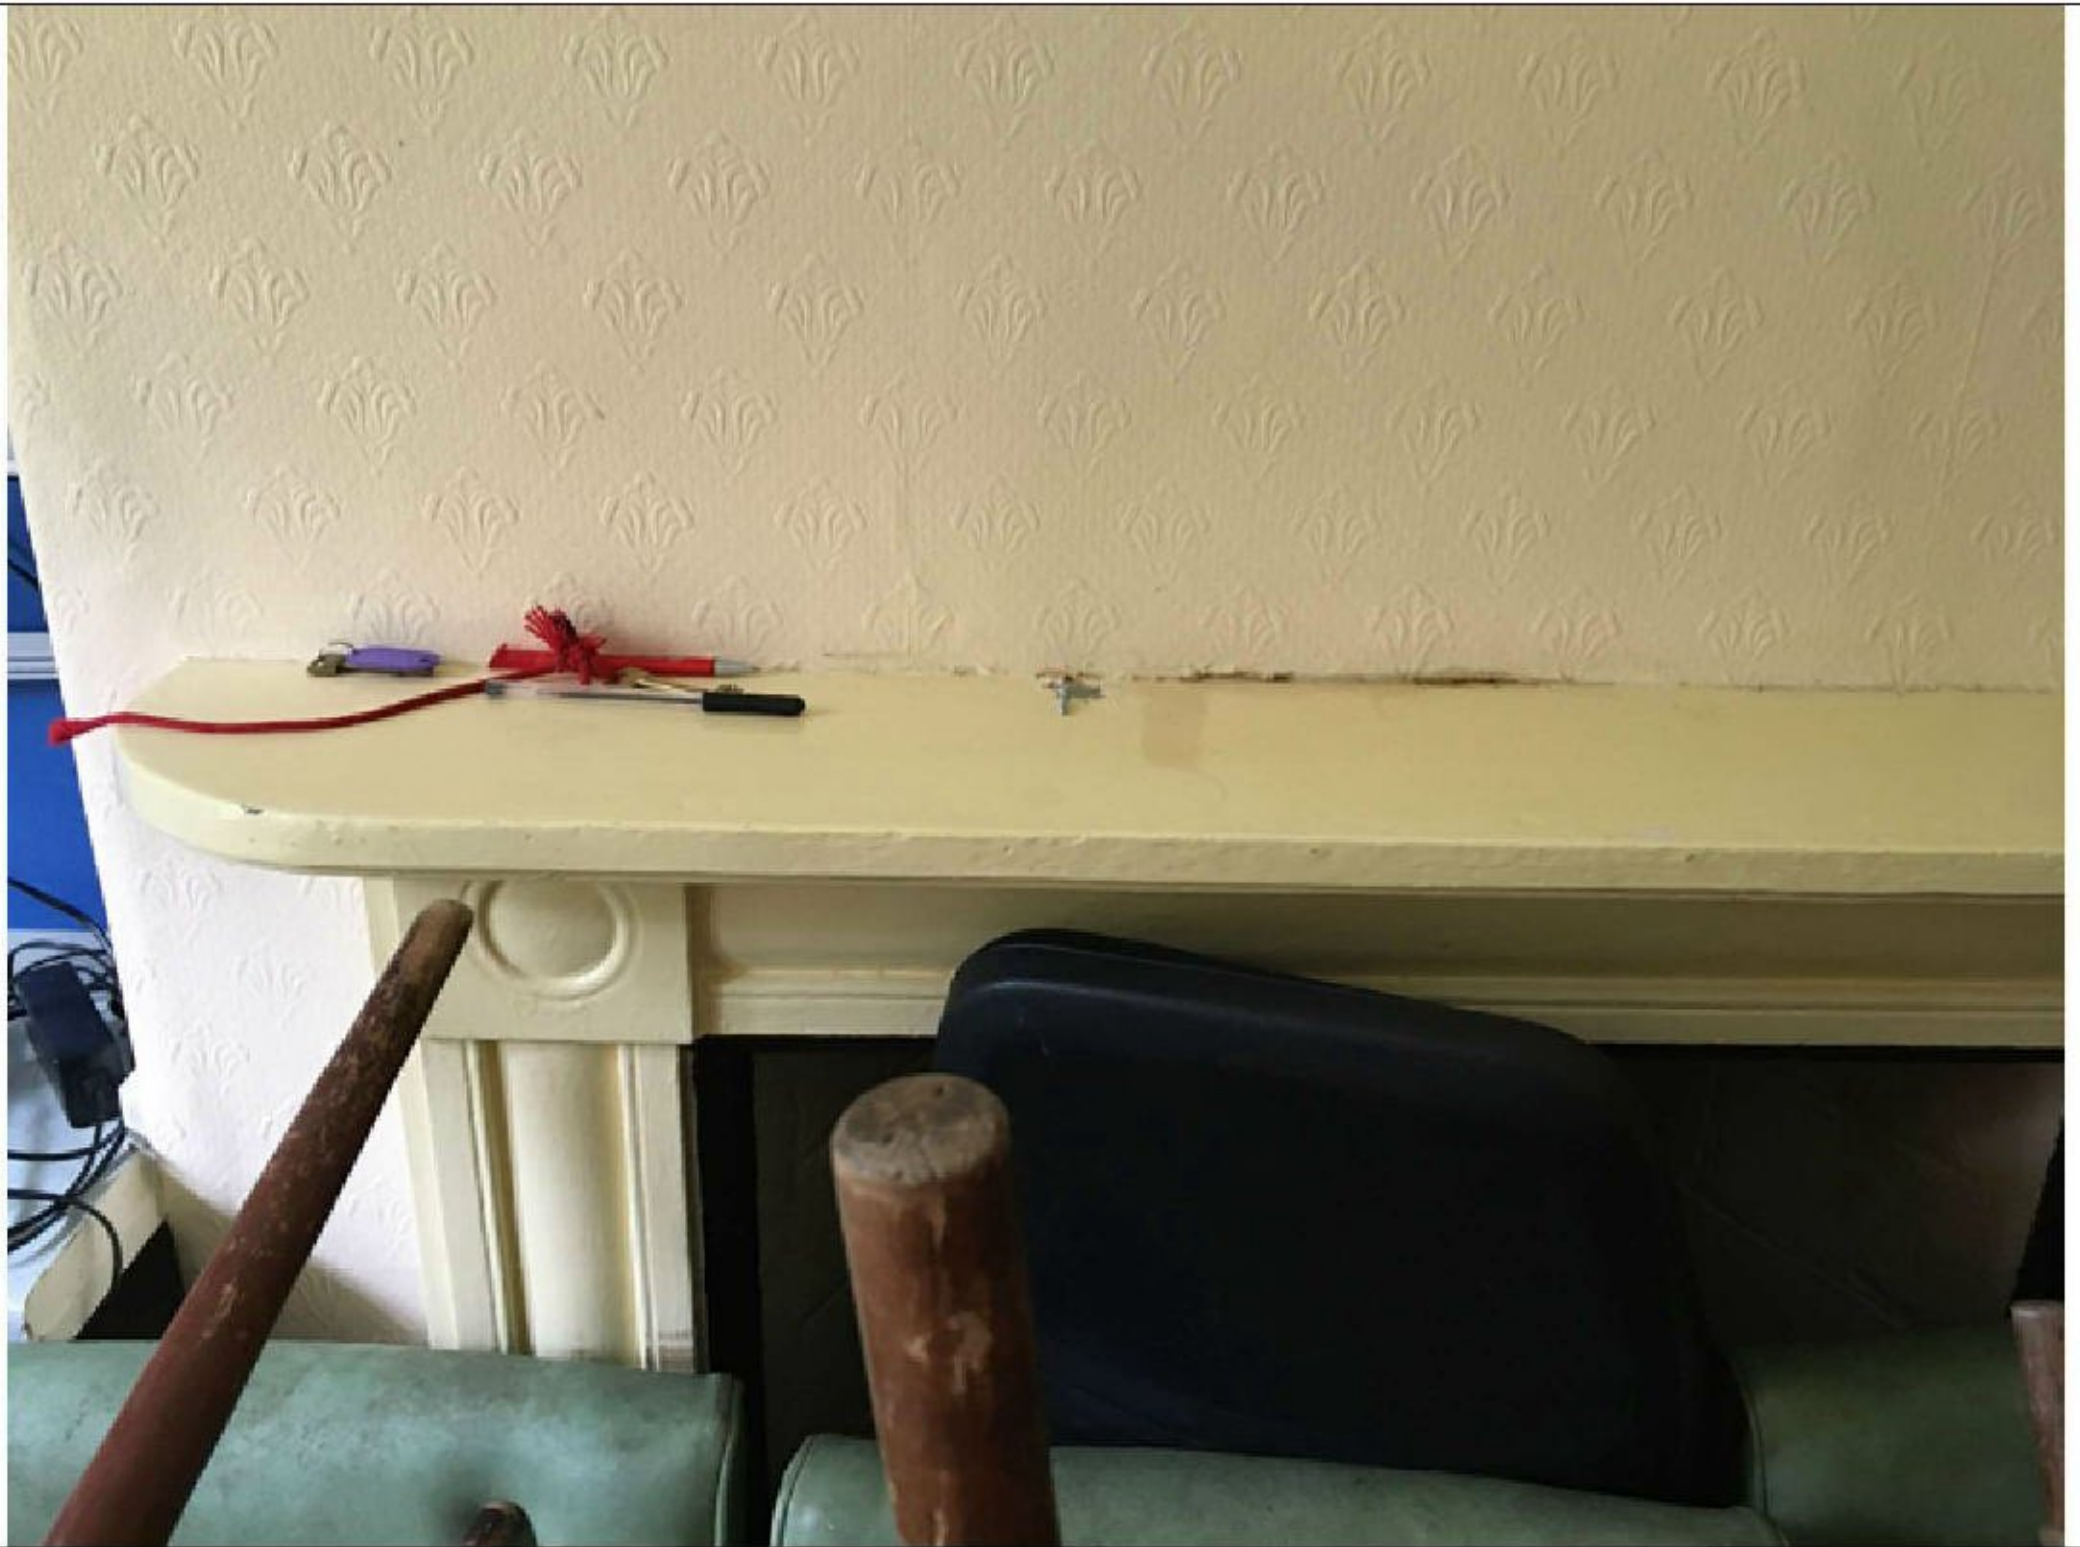
Photo Location - Stairs - Photo Number **P27** - See floor plans for location

Located with 1840's section of the building

Fire place surround - Retained - refurbished

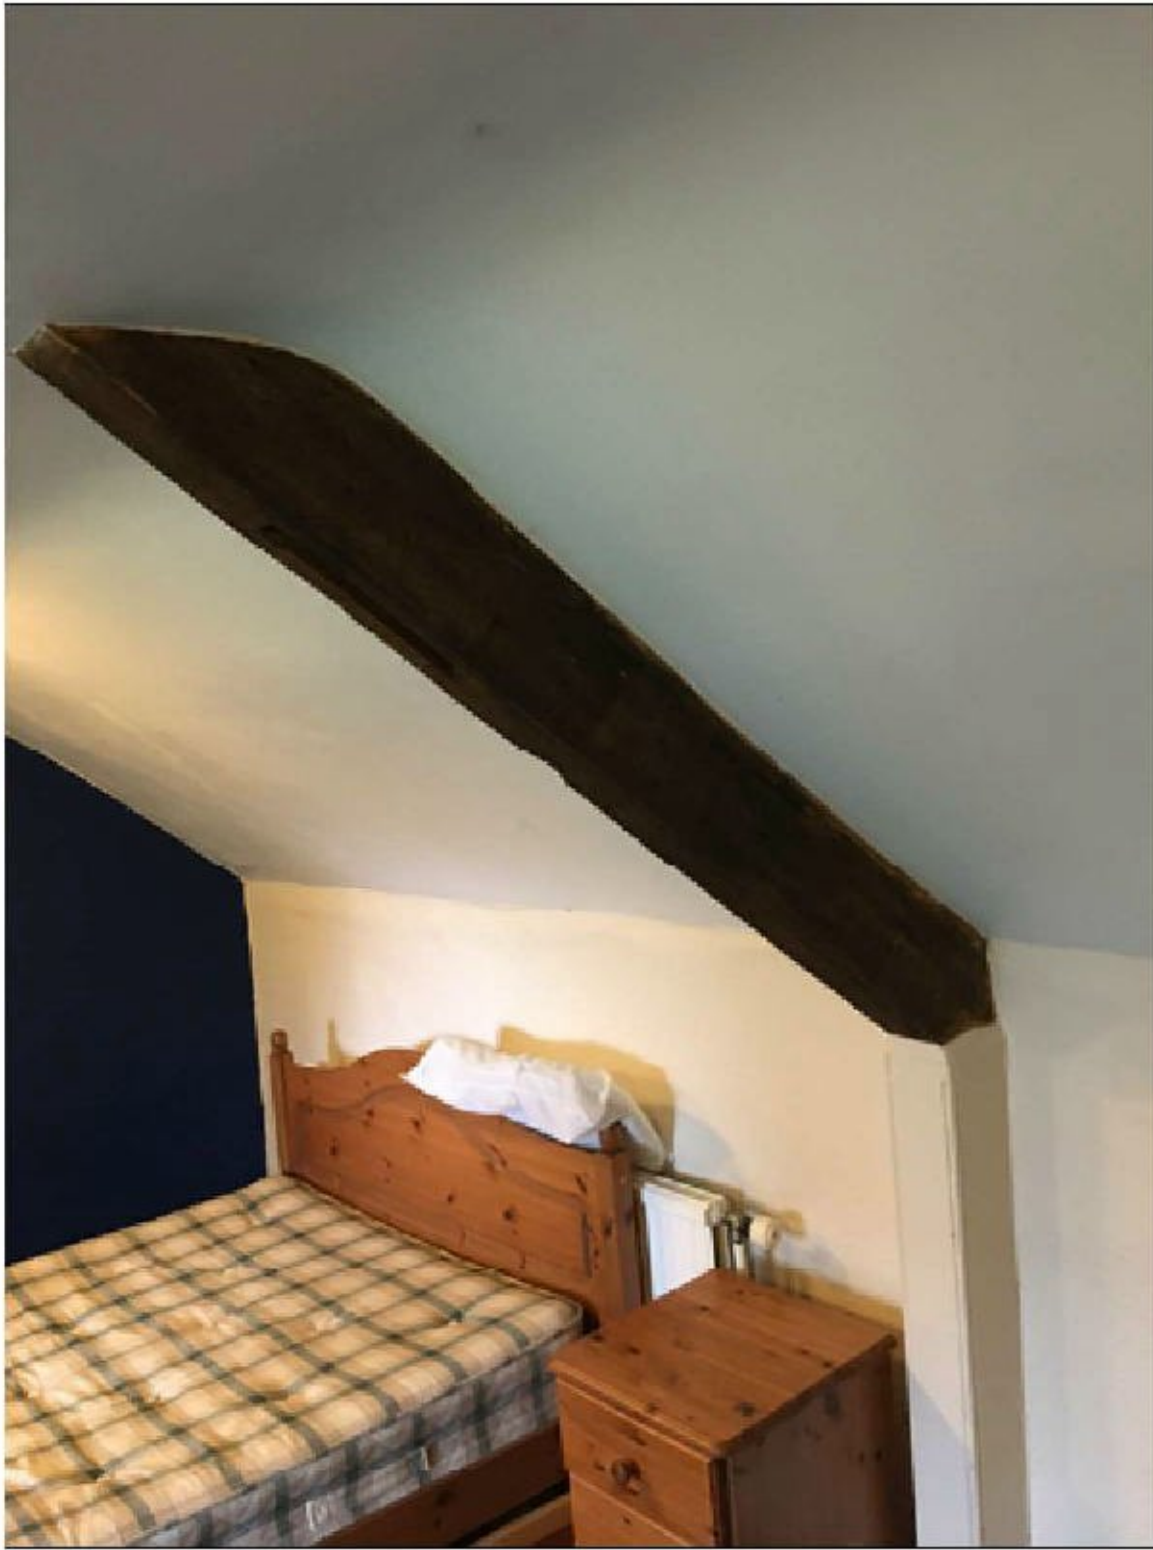
Photo Location - Stairs - Photo Number **P28** - See floor plans for location

Located with 1750's section of the building

Ceiling Timbers - Retained - refurbished
