# KAY PILSBURY THOMAS ARCHITECTS

**HERITAGE, DESIGN AND ACCESS STATEMENT – REV A  
FOR AMENDMENTS TO THE APPROVED APPLICATIONS DC/20/05337 AND DC/20/05338 FOR EXTENSION  
AND ALTERATIONS AT  
SHELLEY HALL,  
SHELLEY,  
IPSWICH,  
IP7 5QX**

**Date:** November 2020

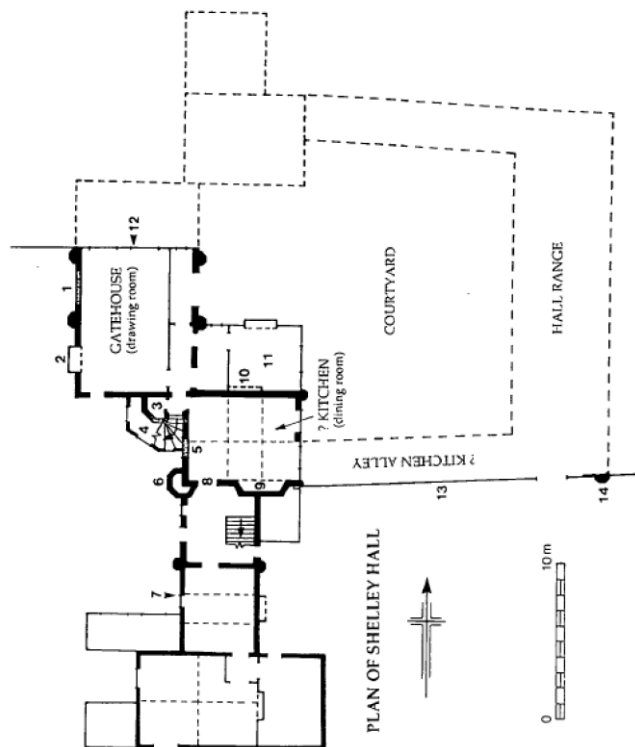
Figure 2: Conjectural Plan of Shelley Hall

The dashed lines around the Courtyard indicate the conjectural outline of the demolished parts of the courtyard house.

Figure 2: Numbers: 1= Block doorsway in gatehouse, 2: C18<sup>th</sup>/19<sup>th</sup> fireplace, 3: Original Stair Turret, 4: C1600 Stair Turret, 5: Blocked Tudor window, 6: Disused service stair turret (no stair/blocked). 7. Brick & Terracotta coat of arms, 8. Doorway with armorial spandrels, 9: Tudor fireplace with two flues, 10 base of Tudor chimney stack, 11: 1813 Range, 12: Stone coat of arms, 13: Brick Garden wall on line of tudor wall, 14: Tudor polygon buttress.

A stone plaque (no.12 Fig 2) with a very fine carving of the Tilney coat-of-arms that is set into the north wall of the house is clearly not in its original position. Armorial carvings by the same hand are in the Tilney Chapel in the church and Farrer (1925) states that this plaque was said to have come from that chapel.

The original brick stair turret (no.3 fig 2), stands adjacent to the South of the Gatehouse but was originally smaller as can be seen externally in the upper part.

The current Dining Room has a large fireplace (no.9, Fig 2) in its South wall, served by a massive chimney stack and it is thought this was the Kitchen fireplace. The wall that runs East off the former Kitchen (now Dining Room) has a polygonal buttress at the end and is thought to have been the South Range of the Courtyard, which had a narrow construction and formed a linking range to the Main Hall Range

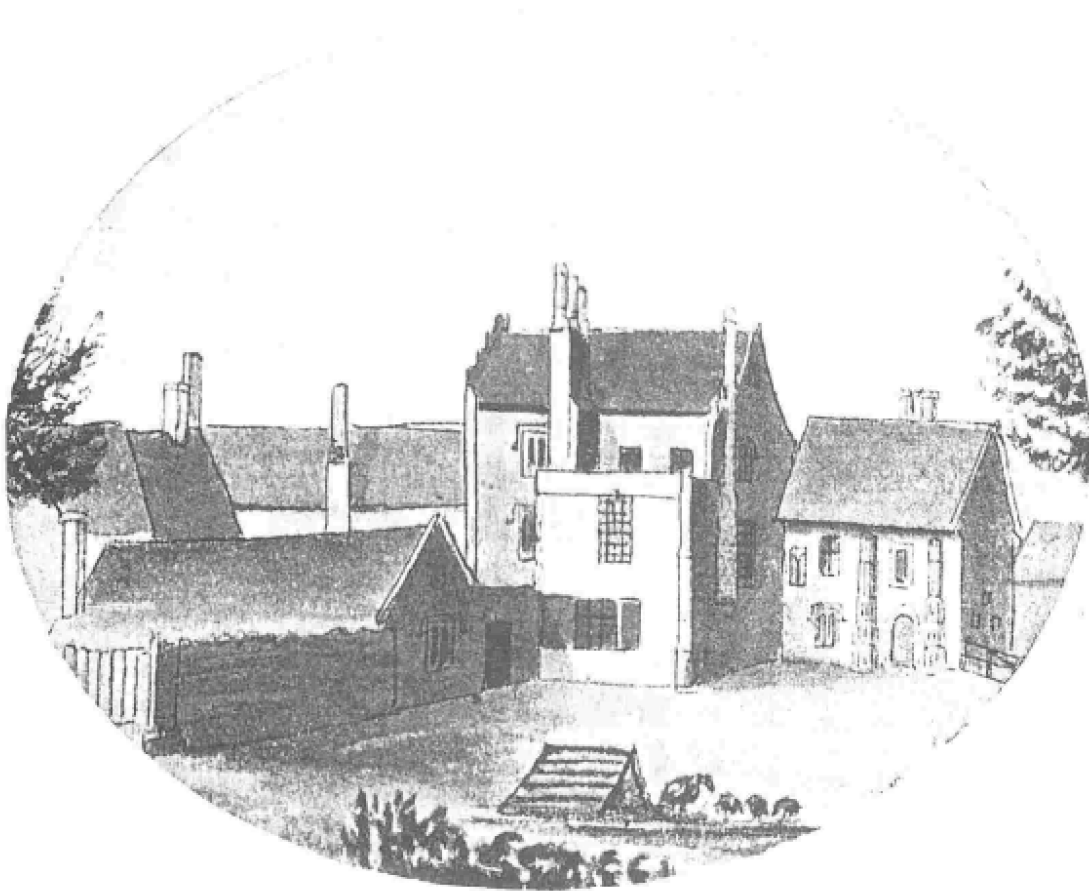
Figure 3: East View of Shelley Hall, copied from an Estate Map of 1786

The Kitchen Range originally had another floor with a crowsfoot stepped gable (fig 3).

Although his son Thomas (d. 1743) is styled 'of Shelley Hall' on his widow's monument in Framlingham church, there are suggestions that the Hall was rented out in his time. It is therefore thought, that sometime in circa 1700 in the early C18th, the Great Hall, North range and South Kitchen link were all demolished. The etching of 1786, certainly show it demolish and house looking more like a farmhouse.

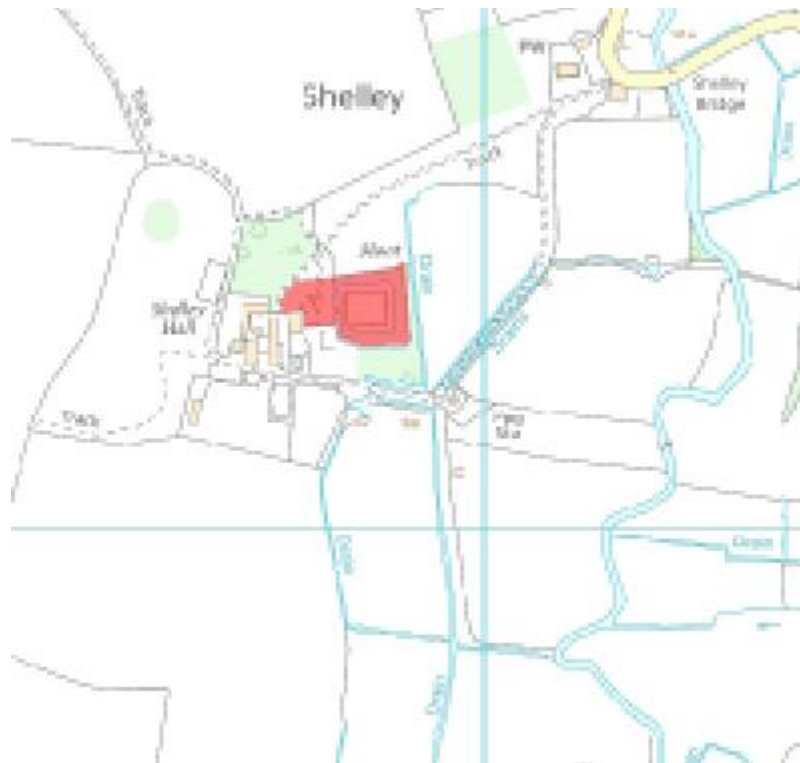
The red hatch denotes the Scheduled Monument area. None of the works within this application are within the scheduled monument site, which is north of the external garden wall onto the Dining Room.

Fig 6: Scheduled monument boundary in red
