1 Cavendish Square

Document 02:
Photographic and Demolition Schedule

1 Cavendish Square,
London,
Westminster,
W1G 0LA

Osel architecture

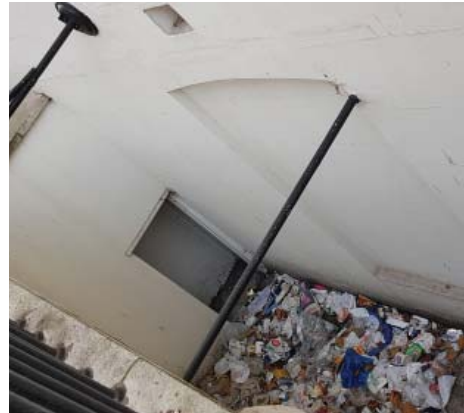
The historic plan shows that these were integral windows to the historic Harcourt house. They were infilled in 1927 in the conversion of the space as a banking vault. It is intended to reinstate the windows to reflect the historic plan and bring in natural light and ventilation to the basement areas.

Photograph of lightwell with infilled arch windows

DEM 1.01 Reinstate historic window openings

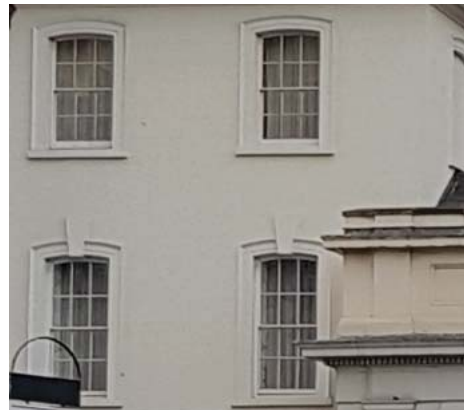
Photograph of existing windows

- 01 White painted render external face of historic house
- 02 White painted render infill (1927) blocking up historic window
- 03 Reinstate historic window opening with timber sliding sash window to match existing in facade.

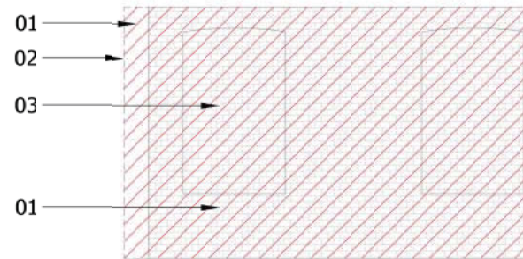
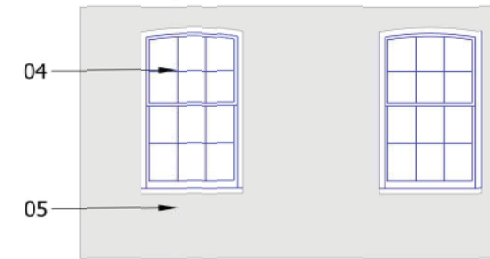
DEM 1.02 Existing

The historic plan was altered with the addition of new 9" and 18" blue brickwork in 1927 in order to alter the basement areas into banking vaults. It is intended to reinstate the original plan.

- 01 Brick lining wall and skim finish added in 1927 as an additional layer to historic walls
- 02 Extent of historic walls
- 03 Position of historic windows beyond, infilled in 1927
- 04 Reinstall historic window opening with timber sliding sash windows to match existing in facade.
- 05 Remove additional build up and reinstall historic room proportions and make good historic walls

DEM 1.02 Remove later addition walls and reinstate historic room proportions and plan of original Harcourt House.

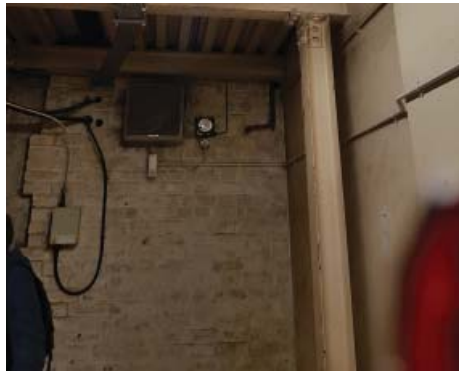
The historic plan shows that the lightwell was blocked up with alterations in 1927. It is intended to reinstate the opening with a traditional style door to open into the external space.

Photograph of brick infill to lightwell

DEM 1.03 Remove infil wall and reinstate historic lightwell opening

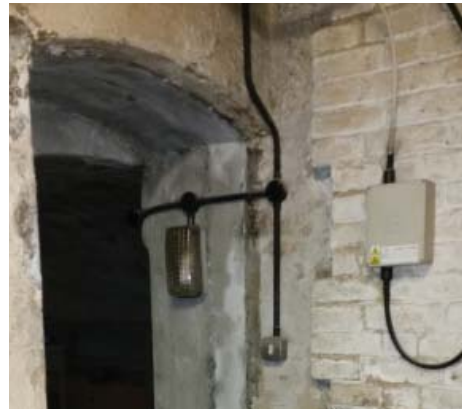
Photograph showing new brick joining to existing vault

- 01 Existing M+E Grille
- 02 Modern brick infill (1927) of lightwell
- 03 White painted render finish to match external facade
- 04 New opening into lightwell, door detail to be conditioned

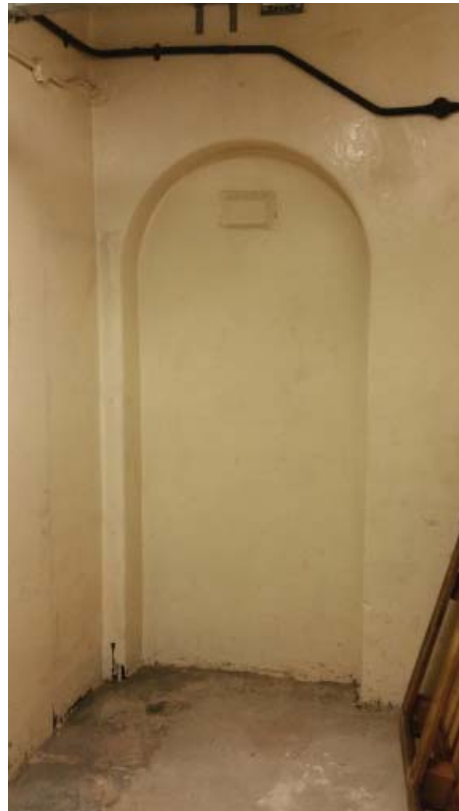
The archived plans show that this was an opening and although not noted on the 1927 drawings has since been filled in.

Photograph showing recessed infill of original opening

It is intended to reinstate this opening to its original parameters, as indicated with an on-site inspection.

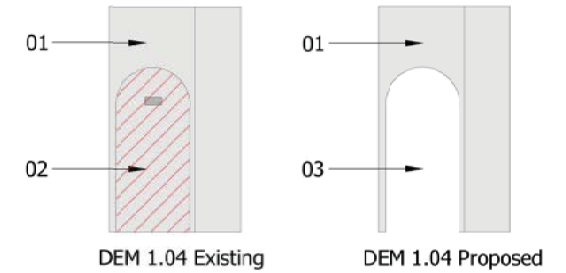
- 01 White painted render finish
- 02 White painted render infill (1950s) of historic opening
- 03 Restored historic opening

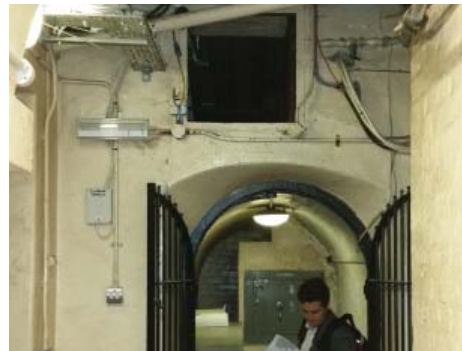
Mechanical void above vault

- 01 Services void
- 02 Vaulted Ceiling
- 03 Redundant Safe
- 04 White painted smooth brick infill beyond
- 05 New M+E services
- 06 New opening to allow adequate circulation and means of escape

DEM 1.05 Reinstatement historic lightwell proportions allowing for suitable circulation space and means of escape for basement areas.

The historic plan shows that this space was likely a lightwell, continuing the form to the historic cellars from the main house. It is intended to reinstate this opening and allow for adequate circulation and means of escape through the basement areas.

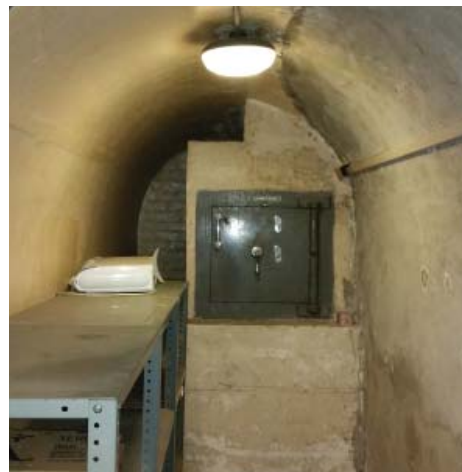
Photograph showing vaulted area.

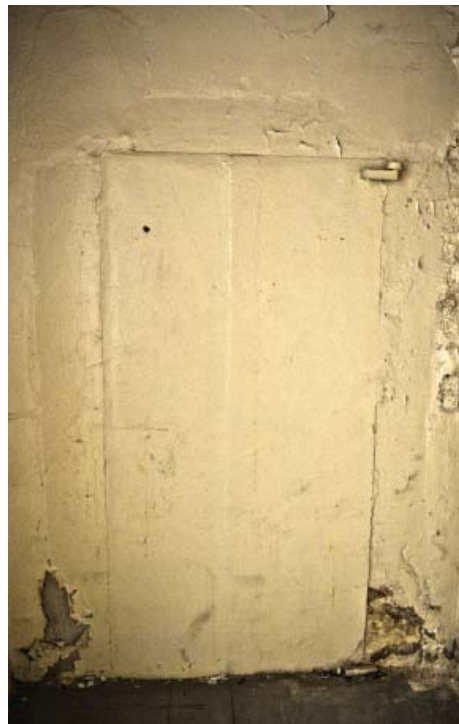
On-site evidence shows a door opening has been fixed shut and painted over. It is unclear from archived plans the reasons for this. The door opening is likely to have formed part of the construction of the main banking hall in 1827. It is required to reinstate this opening for means of escape through the basement areas.

Photograph showing recessed infill of
original opening

**DEM 1.06 Remove fixed shut door and
reinstate historic opening**

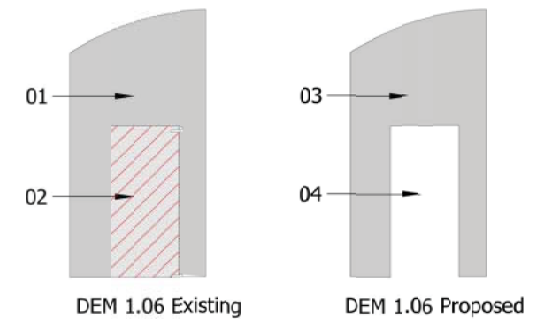
- 01 White painted render
- 02 Door fixed shut and painted over and bricked up to other side
- 03 Strip and repaint white to match
- 04 New opening in historic location

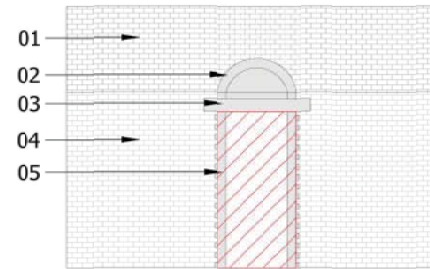
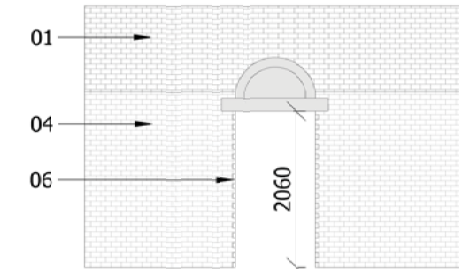
DEM 1.07 Existing

On-site evidence shows that this opening has been made smaller, the extent of which is indicated by a different brick to the historic fabric.

It is likely this was made smaller to enable a particular closing door to the vault areas.

- 01 Vaulted ceiling
- 02 White painted door arch infill
- 03 White painted Lintel
- 04 White painted brick
- 05 White painted smooth brick infill reducing size of historic opening
- 06 Reinstate full width of historic opening and make good

It is intended to reinstate the full proportion of the opening, which would be consistent with other openings in this area of the basement.

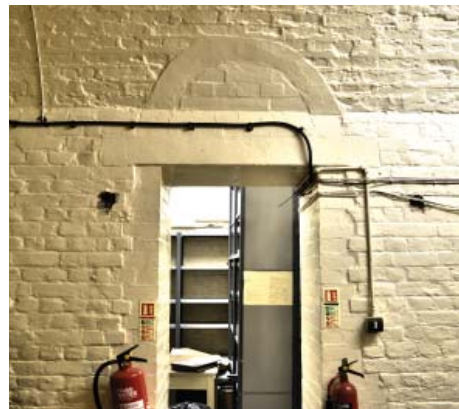
Photograph showing new brick joining to existing vault

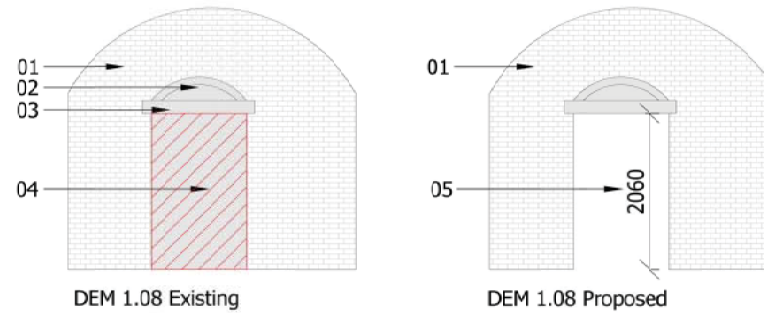
The historic plan shows that this was once an opening, which has been infilled post the 1927 alterations.

On-site evidence shows the extent of the infill section to be removed, which is of a different brick to the historic fabric. For structural integrity and consistency in openings, the lintel will be retained and a rectangular opening formed.

- 01 White painted brick
- 02 White painted door arch infill
- 03 White painted Lintel
- 04 White painted smooth brick infill (1950s) of historic opening
- 05 Restore historic opening

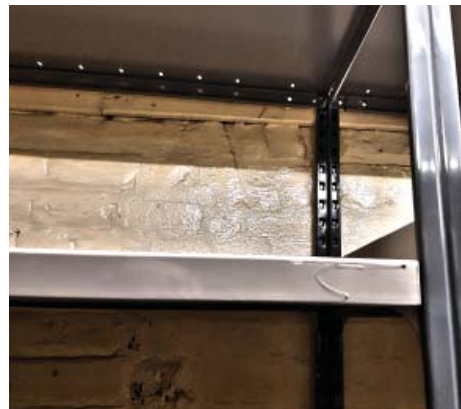
Photograph showing new brick joining to existing vault

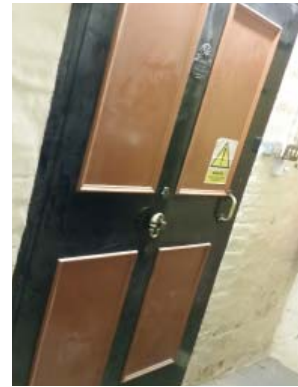
Photograph showing existing door to be relocated within basement

A new feature staircase will continue into the basement areas. The location of the staircase has been carefully chosen to best serve the building and which is less destructive to the historic fabric. It is proposed to increase an existing opening to the full height of the vaulted ceiling, allowing the stair to intersect with the character of the basement vaults. This will also enable the removal of redundant service spaces which are hung from the vault above. The vault door will be relocated within the basement and fixed open.

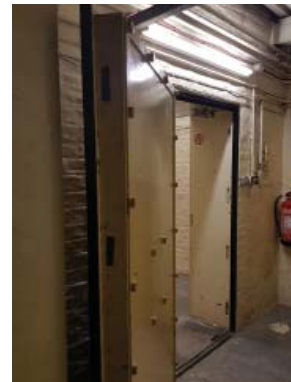
Photograph showing existing opening

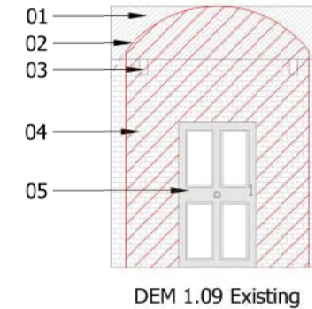
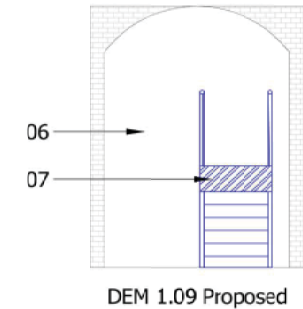
DEM 1.09 Existing

- 01 Services area to be removed
- 02 Line of vaulted ceiling beyond
- 03 Steel beams to be removed
- 04 White painted brick
- 05 Vault Door to be relocated

- 06 Increase opening to meet vaulted space and to allow for new stairs
- 07 New feature stair to basement

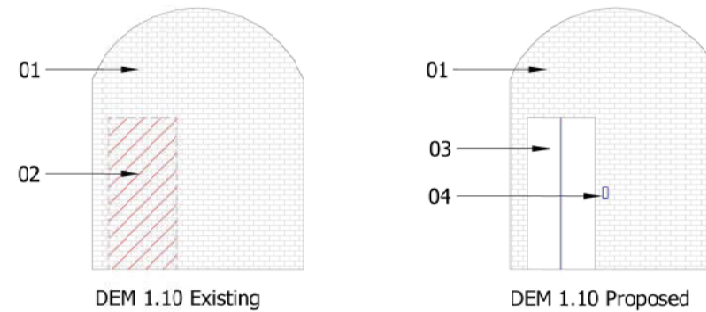
The historic plan shows that this was once an opening.
On-site evidence shows the extent of the infill section to be removed, which is of a different brick to the historic fabric.
The opening will allow for access to the new lift.

- 01 White painted brick
- 02 Position of historic opening
- 03 Reinstate historic opening to accommodate new lift opening
- 04 New lift operating buttons

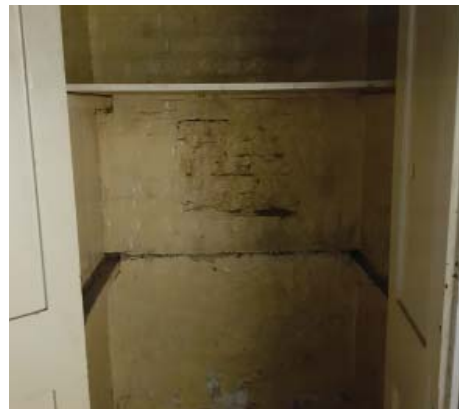
Photograph showing location of existing opening to be reinstated

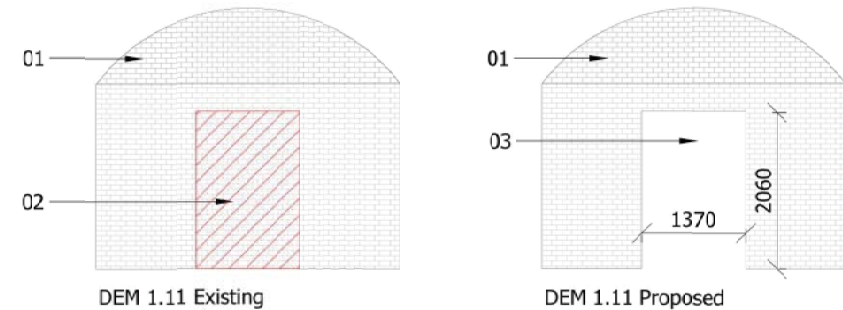
- 01 Vaulted ceiling
- 02 White painted brick
- 03 New opening to match similar openings within vaulted areas

DEM 1.11 Form opening to match width of existing openings in vault space and to be central to the room. New opening will allow necessary circulation through Kitchen areas.

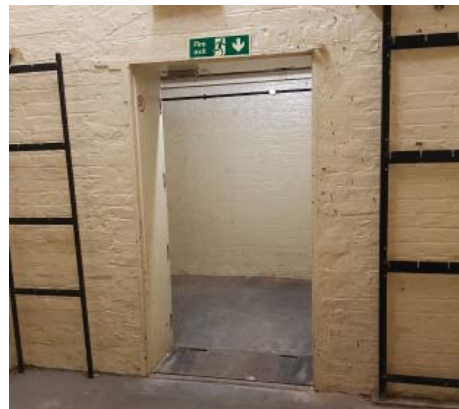
Photograph showing existing proportions of opening to be formed.

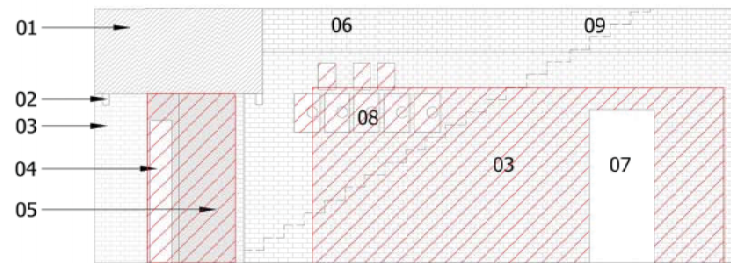
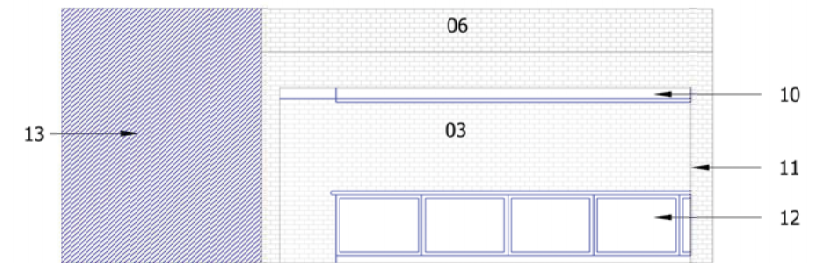
DEM 1.12 Existing

The location of the Kitchen cooking units has been chosen to enable the best extract at high level, without compromising an excessive amount of the historic fabric. The redundant existing stairs (mid/late C20) will be removed and the new cooking units and canopy will be integrated within an increased opening to the stairwell. Service systems and modern partitions will be removed.

- 01 Flat soffit to Services area
- 02 Steel beams
- 03 White painted brick boundary wall
- 04 Opening to stairs
- 05 White painted modern stud partitions
- 06 Vaulted ceiling
- 07 Cupboard opening

- 08 Redundant Electric Meters and high voltage switching gear
- 09 Line of concrete service stairs beyond to be removed
- 10 Integrated cooker canopy
- 11 New opening in wall to allow for cooking equipment
- 12 New cooking equipment
- 13 New Services core to allow for lift, dumbwaiter and mechanical extract

DEM 1.12 Remove redundant services stair and increase existing door opening to allow for Kitchen cooking units and extract system to be discreetly integrated.

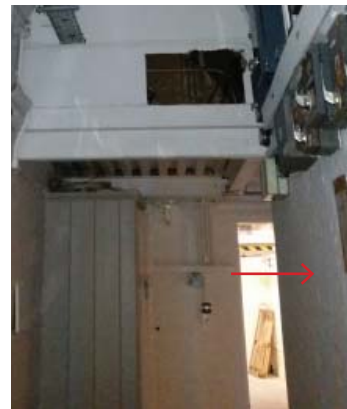
Photograph showing stairwell wall with services to the right.

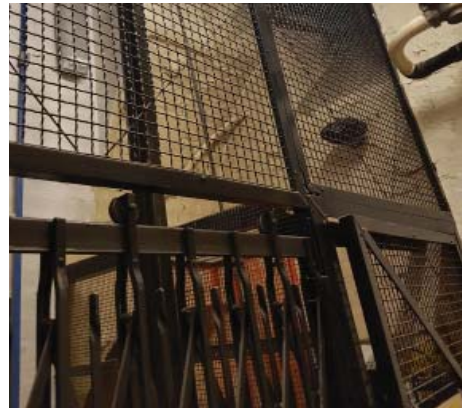
The service lift is redundant and inoperable. It provides no use to the proposed use of the building and will be removed.

Photograph showing service lift caging

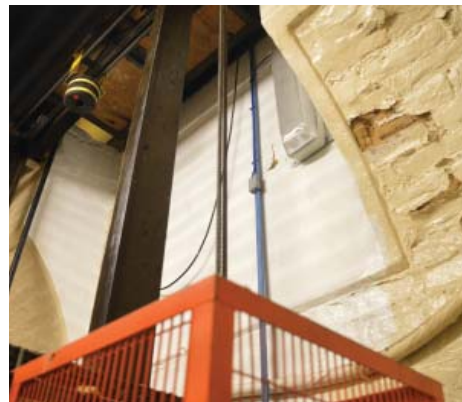
This area has already been cut away and altered with the creation of the service lift void, which has cut at the vaulted areas.

Photograph showing cut in vaults to accommodate service shaft

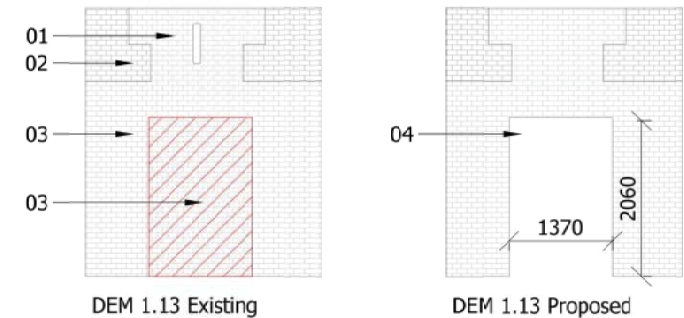
- 01 Vault cut for lift operation (note lift and mechanics not shown for clarity)
- 02 Vaulted ceiling
- 03 White painted brick
- 04 New opening to match size of similar openings in basement

A new opening will be formed to enable effective use of the Kitchen spaces, as per DEM 1.11. The new opening will match those already existing in the basement areas.
