Work of the 1870s

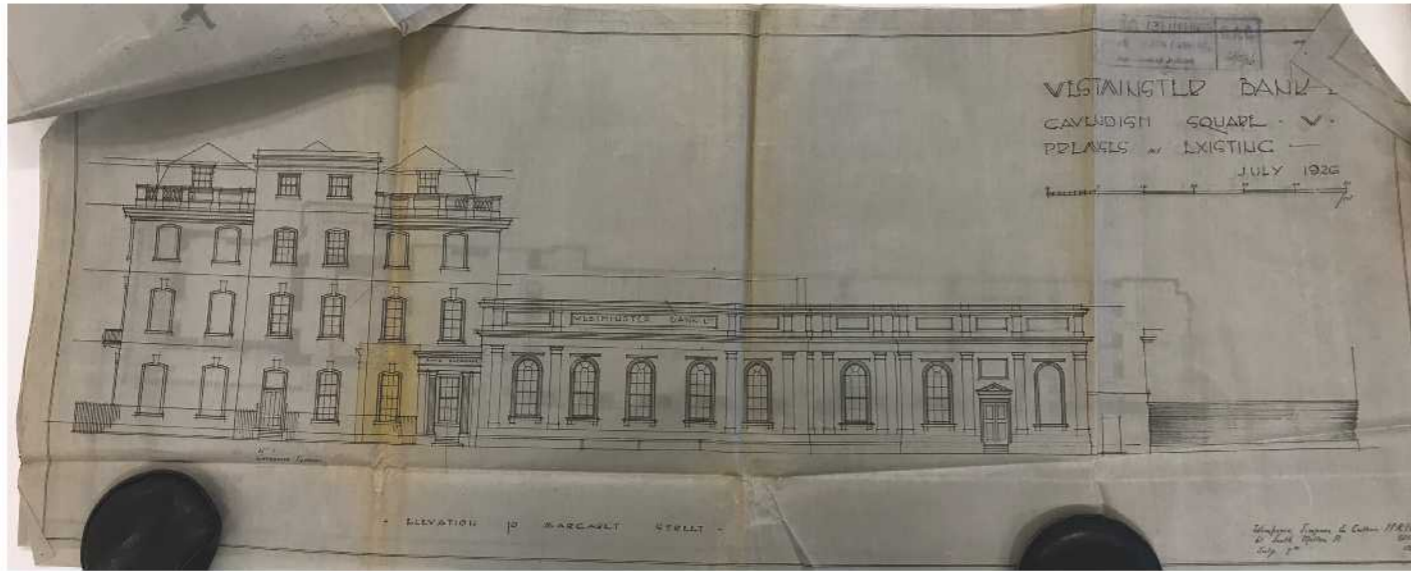
Figure 3.7 Façade as existing, 1927

- 3.21 The as existing elevation of 1927 shows the façade with windows similar to those extant today, but with projecting hoods. The 1870s single bay porch had paired Doric pilasters similar to those on the present porch (they may be reused), with the inner set rounded and fluted, the outer set flat.

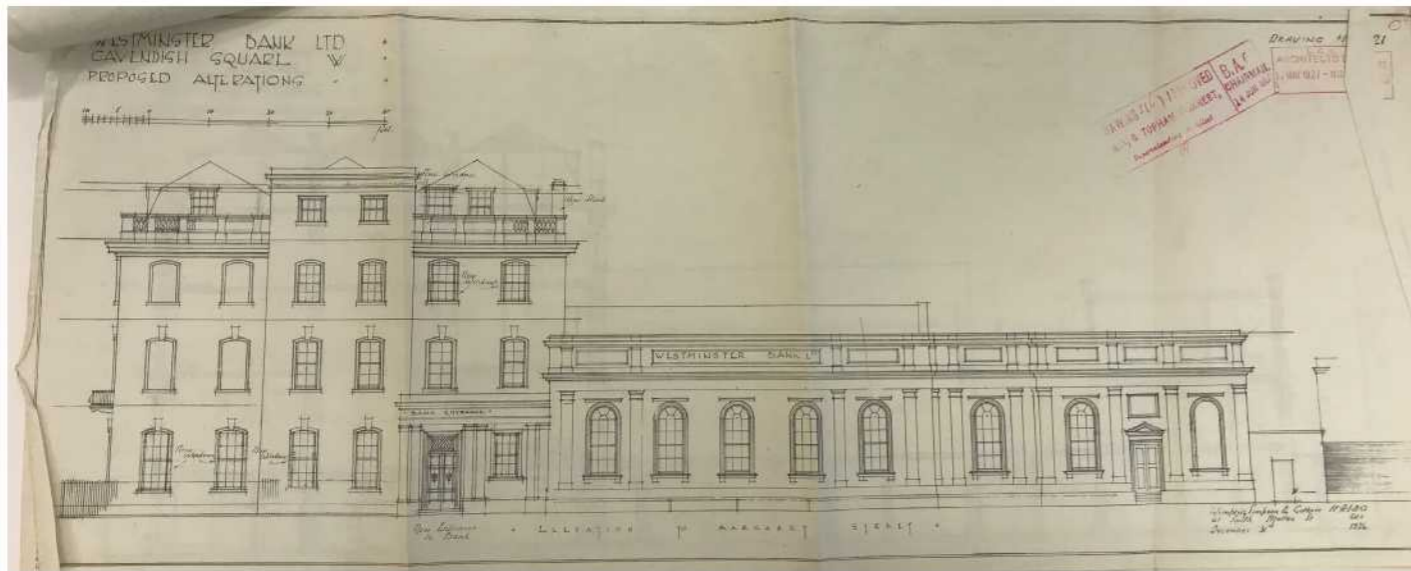
Figure 3.8 Façade as proposed, 1927
