HOP EXCHANGE HERITAGE STATEMENT

Prepared for the Peer Group

19th May 2021

This Heritage Statement has been written in support of proposals for roof extensions and infill development to the rear of the Hop Exchange, Southwark Street, London, a Grade II Listed Building and other improvement work.

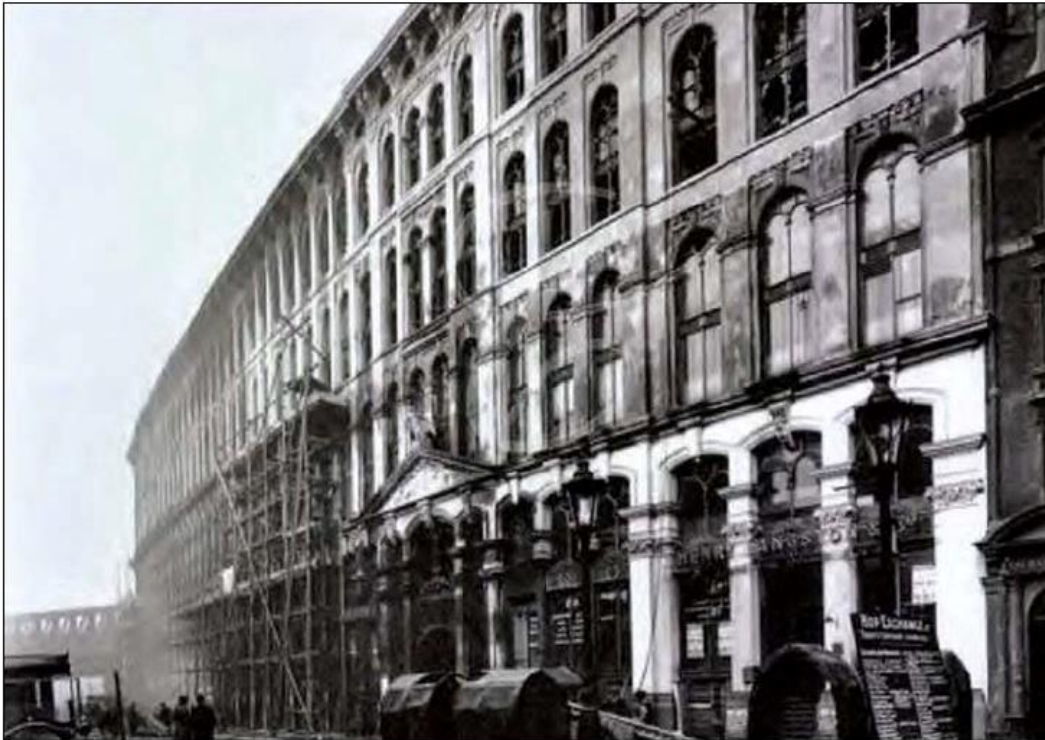
Image 14: Main elevation from eastern end after the fire

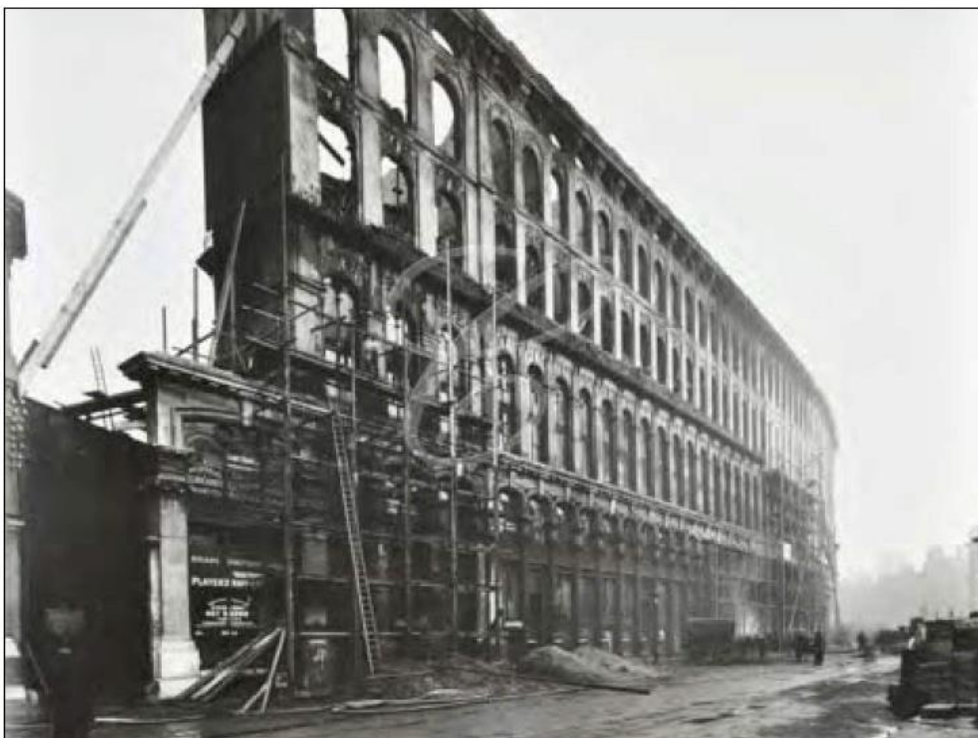
Image 15: Main elevation from western end after the fire

It is understood that the shop on the west end (now the West Wing) was single storey, this explains the thicker end wall which can be seen on the plans.

It is thought that the lower curve of the wall behind the shop front was rebuilt after the fire to join with the original surviving back wall. This vertical joint is evident on the existing elevation with the existence of join in the brick work below the stucco. The window detail can be seen when in these images and much of the original framing appears to survive.

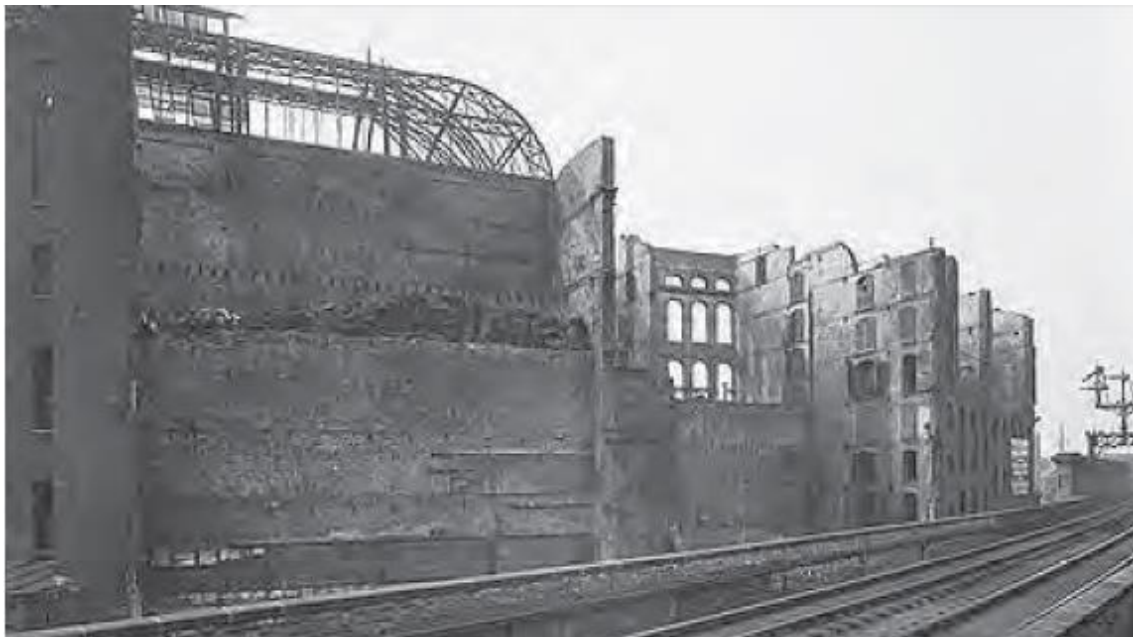
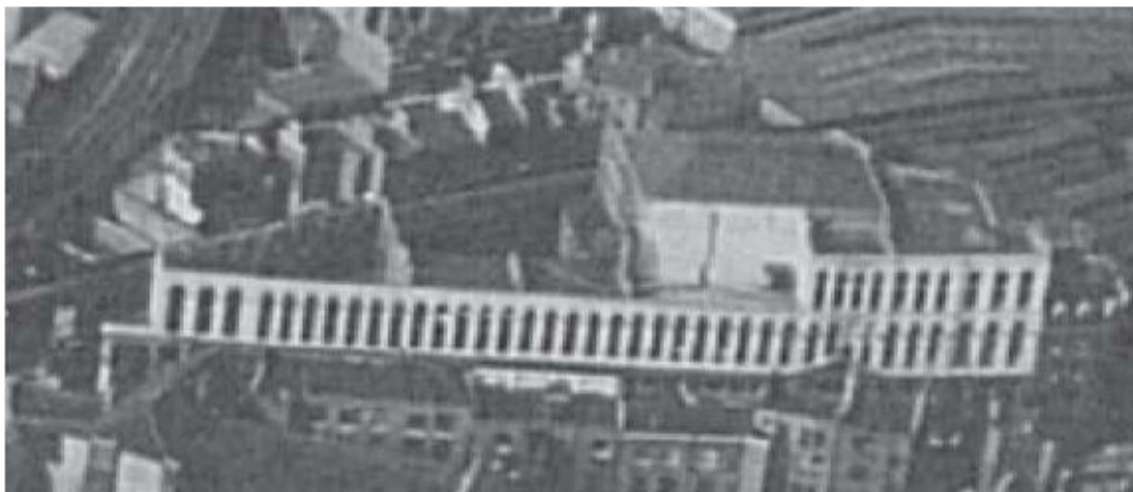
The two images below are the rear elevation immediately after the fire, with the tall warehouse on the left hand side awaiting demolition (this can be seen on a short Pathe Film on YouTube¹¹). By 1937 the west end of the structure had been lowered to two main storeys as can be seen in the lower photograph¹².

Image 16 & 17 below: rear elevation and aerial shot of the building after the fire.

It is thought that the rear wall of the West Wing of the building was retained after the fire from photographs of the rear elevation taken in 1937 (Image 17) . Image 17 also shows a new roof over the atrium which seems to be a single pitched hipped roof with a solid cover¹⁴. The West Wing and current courtyard area seem not to have yet been reconstructed and seem to be open to the elements.

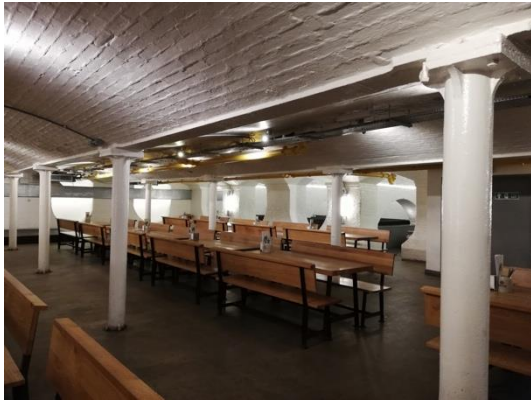
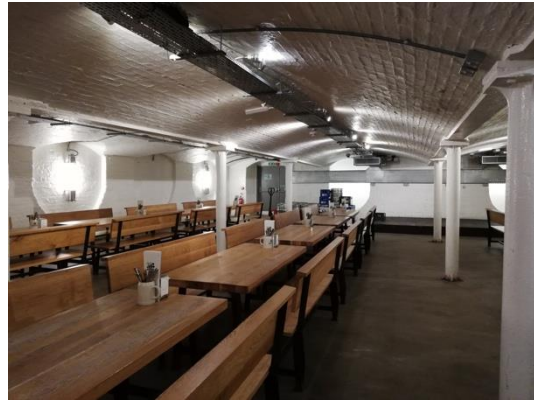
Images 18 & 19 (above) Basement Cellar beneath trading floor with cast iron supports. The cells around the edge lie beneath the trading floor offices.

The majority of the original 1866/7 two storey cellars survive together with their original floor with the exception of the area beneath the Atrium Suite which is modern reinforced concrete joists and breeze block walls.

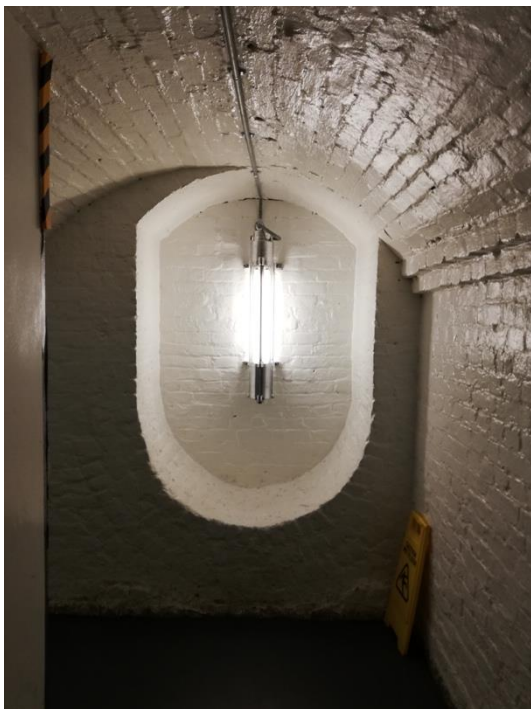
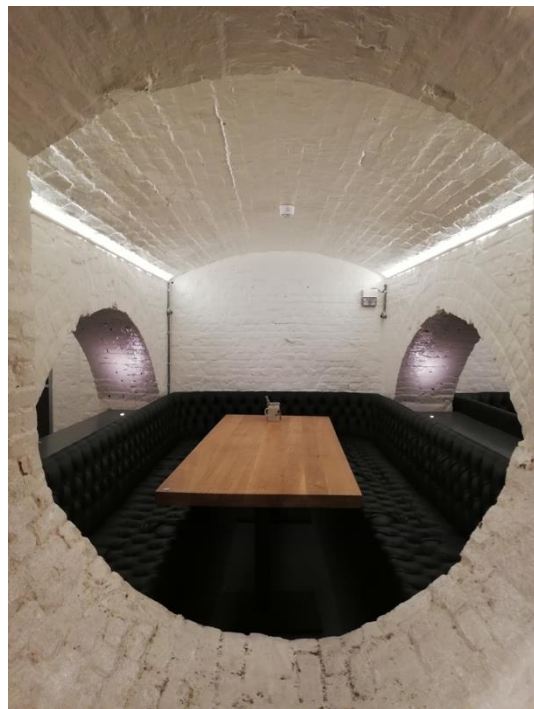
Images 20 & 21 (above): Cellular cellar structures beneath the trading floor offices north and south side

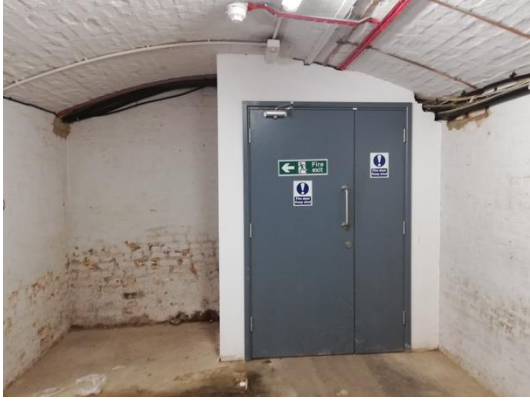
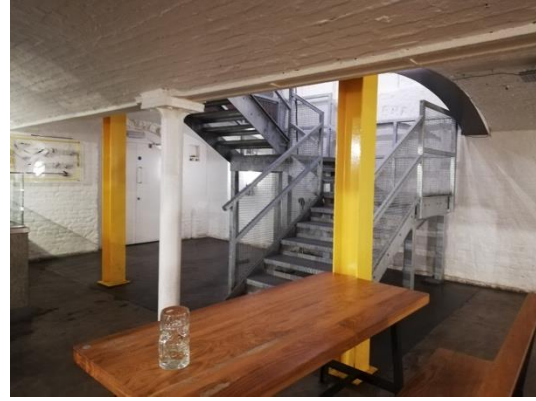
Images 22 & 23 (above): Modern fixtures and services and escape routes within basement

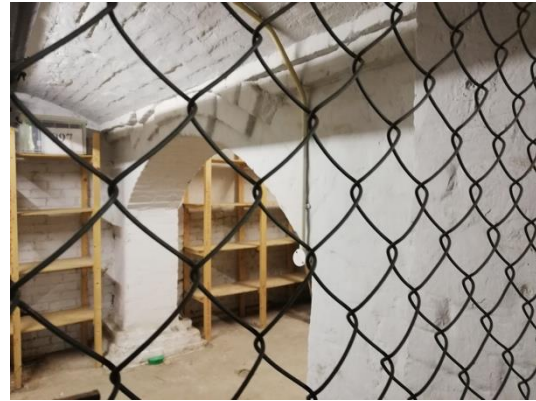
Image 24: Modern cellar structure beneath Atrium Suite

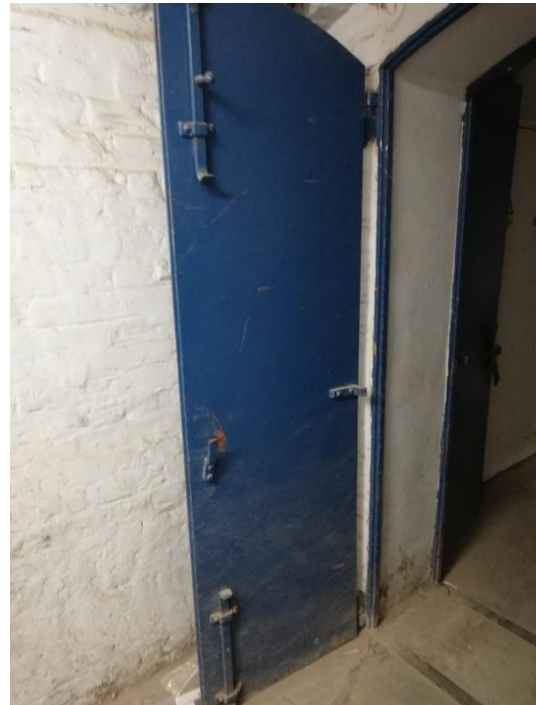
Image 26 (above) and Image 27 (right): Original cast iron doors for security and fireproofing within basement

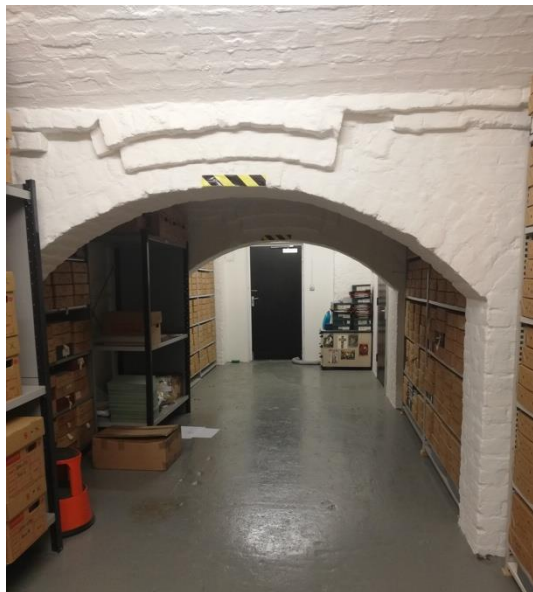
Image 28: Archive with original soft floor forms cellar area beneath north south run off trading floor offices

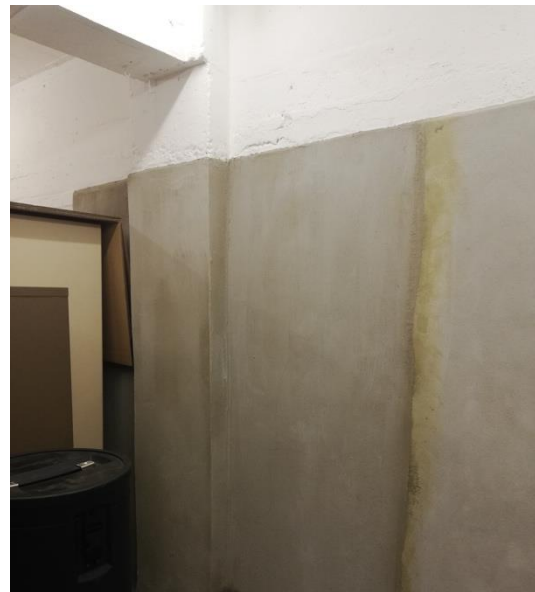
Image 29: Modern area of construction and tanking to north west side of archive and beneath atrium suite

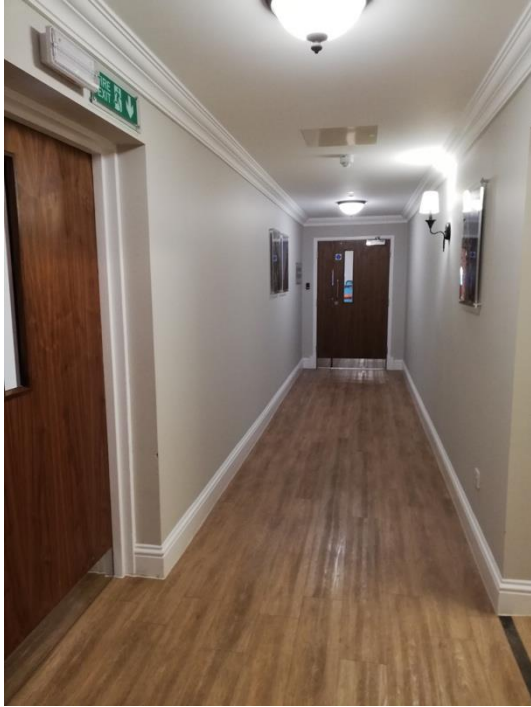
Image 32: Lower Ground floor corridor: modern fit out obscures original structure

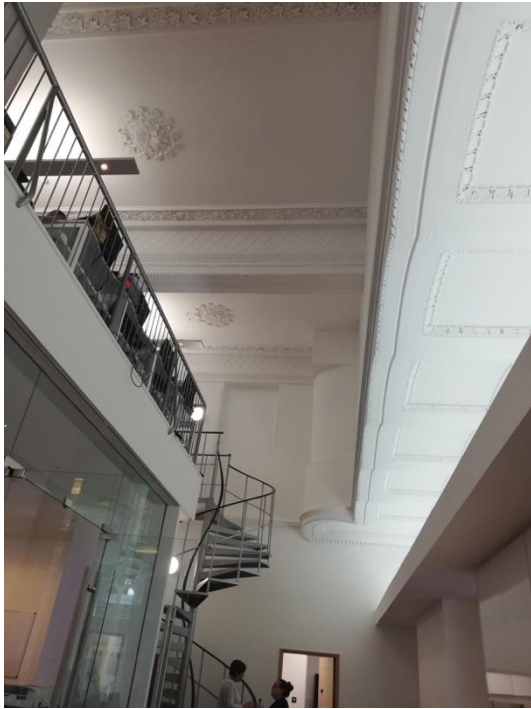
Image 35: Decorative ceilings and cornice in former subscription rooms

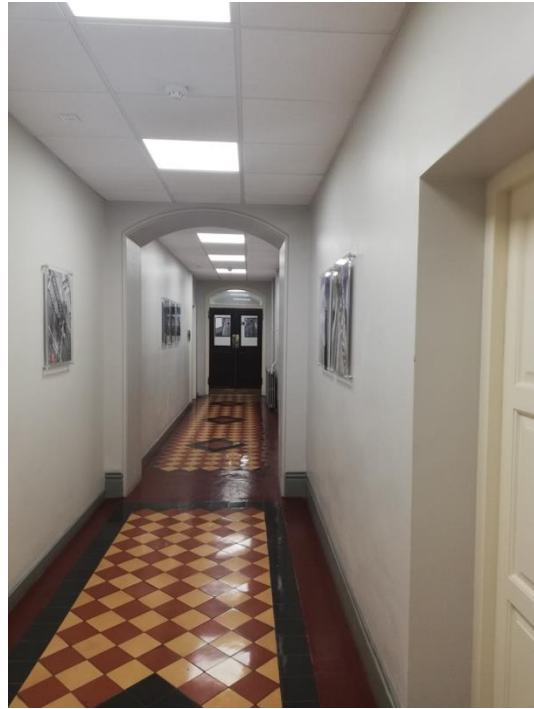
Image 36: Corridor to West Wing with original shape, form and floor but modern ceilings, doors and decoration

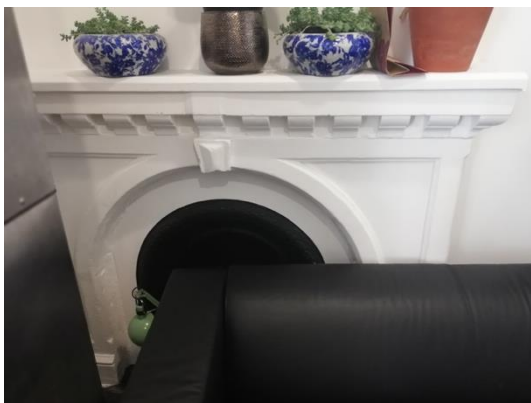
Image 39: Original Fire place – ground floor, this is typical of many that survive throughout the building

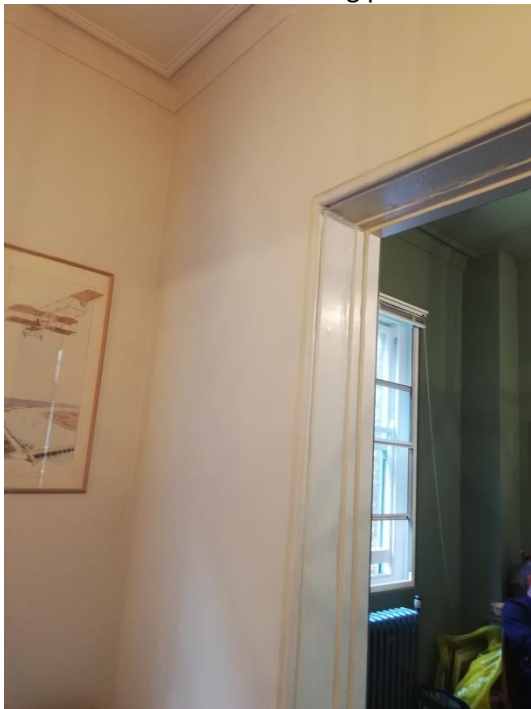
Image 43: Surviving cornice and door moulding in 1st floor trading floor office with post fire C20 sash window

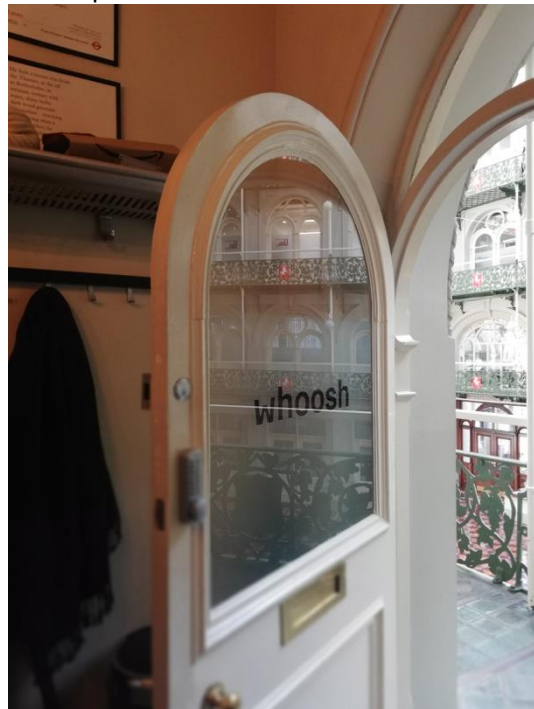
Image 44: Detail of original curved door opening onto 1st floor of atrium

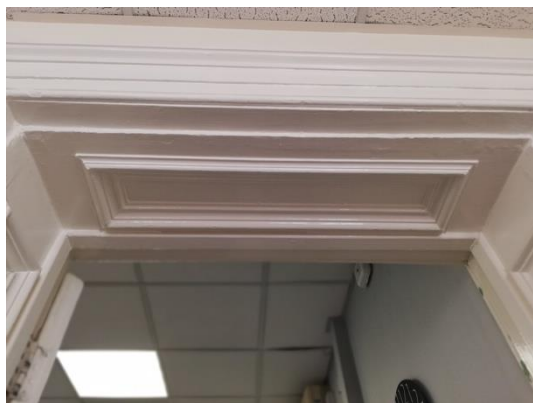
Image 46: Illustrates retention of original detailing despite insertion of suspended ceilings

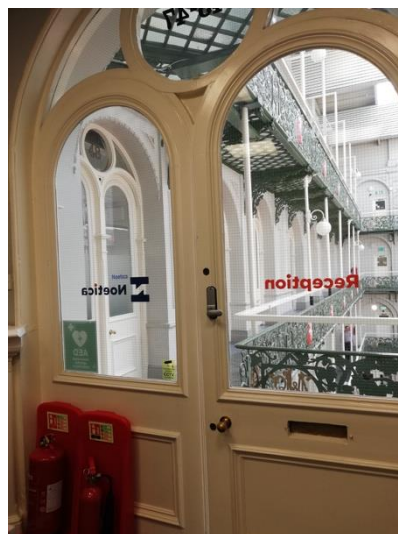
Image 49: Typical door and window opening onto atrium which maximises light from roof into offices.

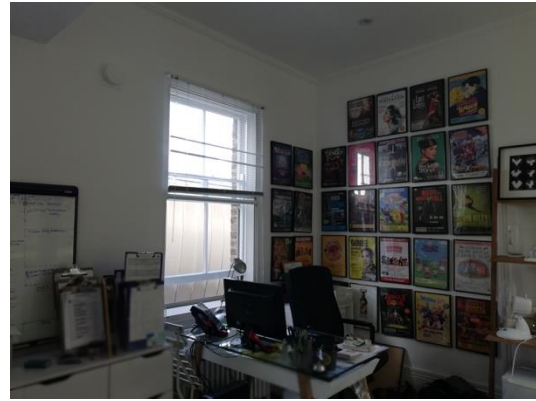
Images 50 & 51 (above): Typical small offices off atrium with door window and light over maximising light into office before sash window (right) was inserted after the fire

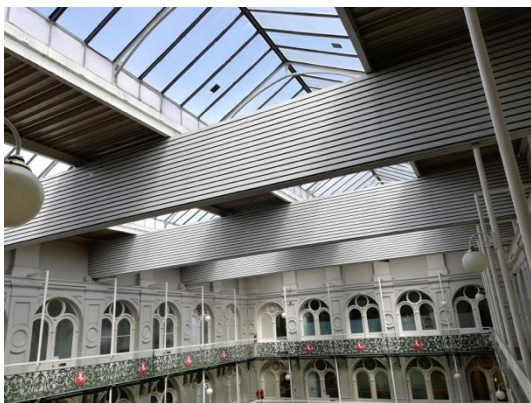
Image 52 (above) & 53 (right): Atrium and modern roof from 3rd floor perspective.

- as with 1st and 2nd floors much of original detailing survives but the heavy nature of the roof trusses detracts from and dominate the character of this space. When these are excluded from the view (right) the character and form of the original building is able to dominate. The additional strengthening and supports to the balconies themselves do not over dominate.
- the base of the pilasters which formed part of the previous 4th and 5th floors survive
- the Peer Group offices have been remodelled to include a stair giving access to the 4th floor offices.

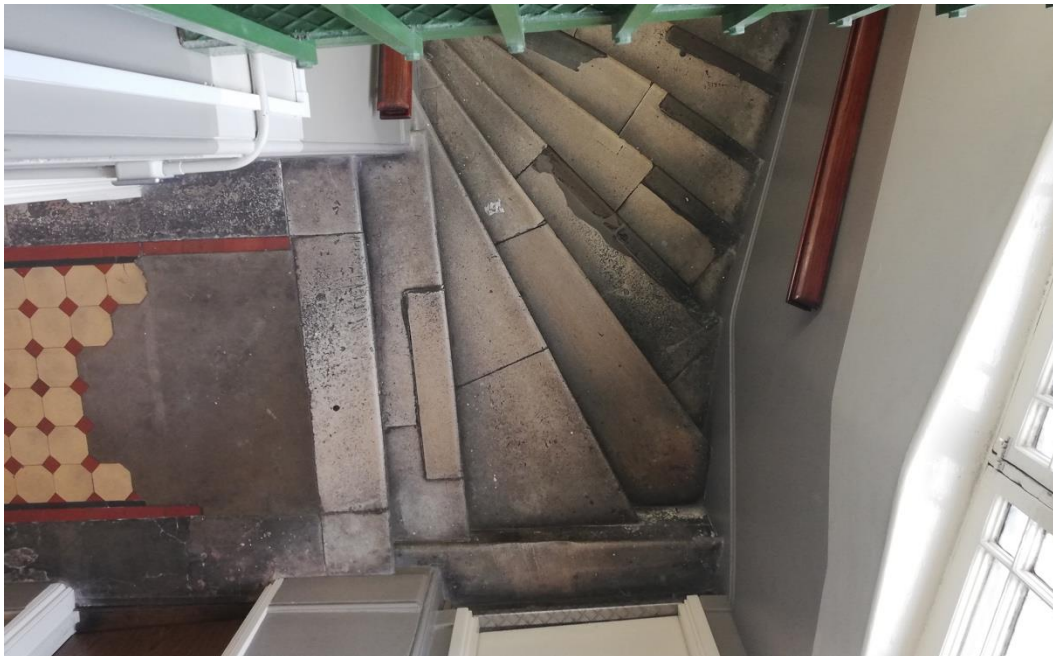
Image 58: View looking down NE stairwell which shows patina and texture formed by wear and tear and careful repairs over 150 years.

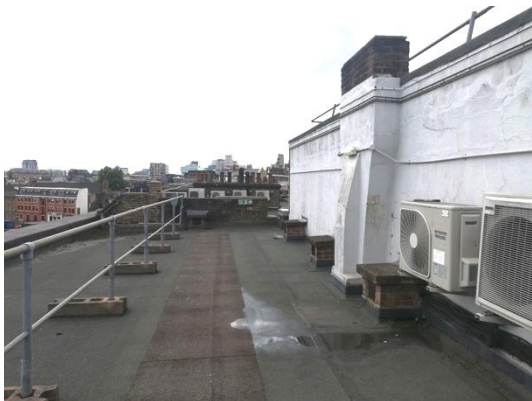
Image 60: South side of roof with higher walls around atrium/trading floor retained. Chimney pots over former internal walls beyond.

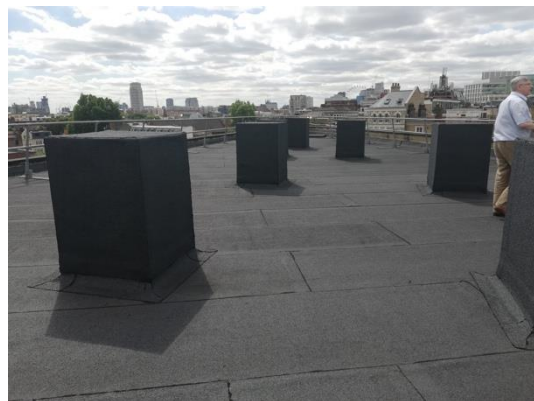
Image 61: Modern Roof over West Wing with structure projecting through roof

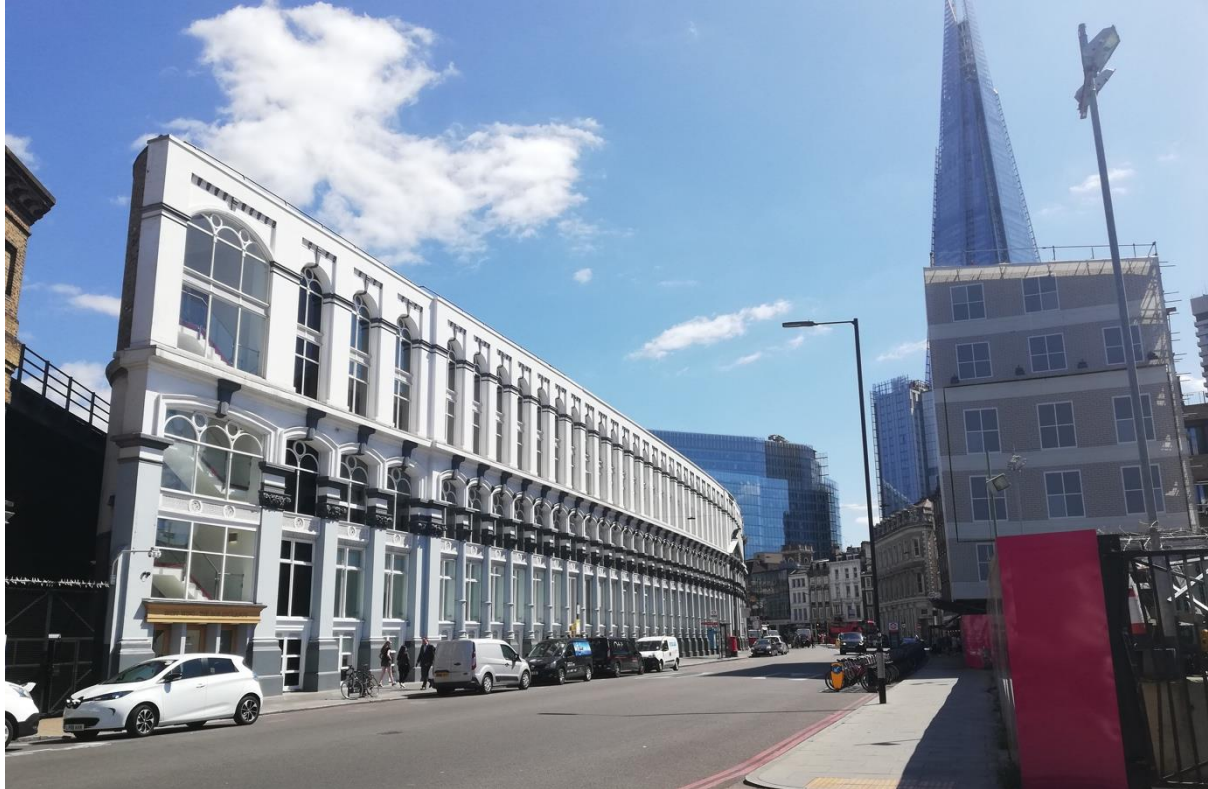
Image 64: Principal Elevation, Southwark Street

Architectural paint research indicates that there have been a number of different schemes of decoration on this principal elevation. Five different phases have been established plus the present modern scheme of today. It should be noted that colours fade and this needs to be born in mind regarding the earlier schemes. The earlier schemes of 1867, 1870 and circa 1874 – 1920 would have all been present when the principal elevation was at a different scale - the building would have been at its full height. That may also be the case for the 1920 – 1940 scheme or at least at its conception, but we can't know for sure.

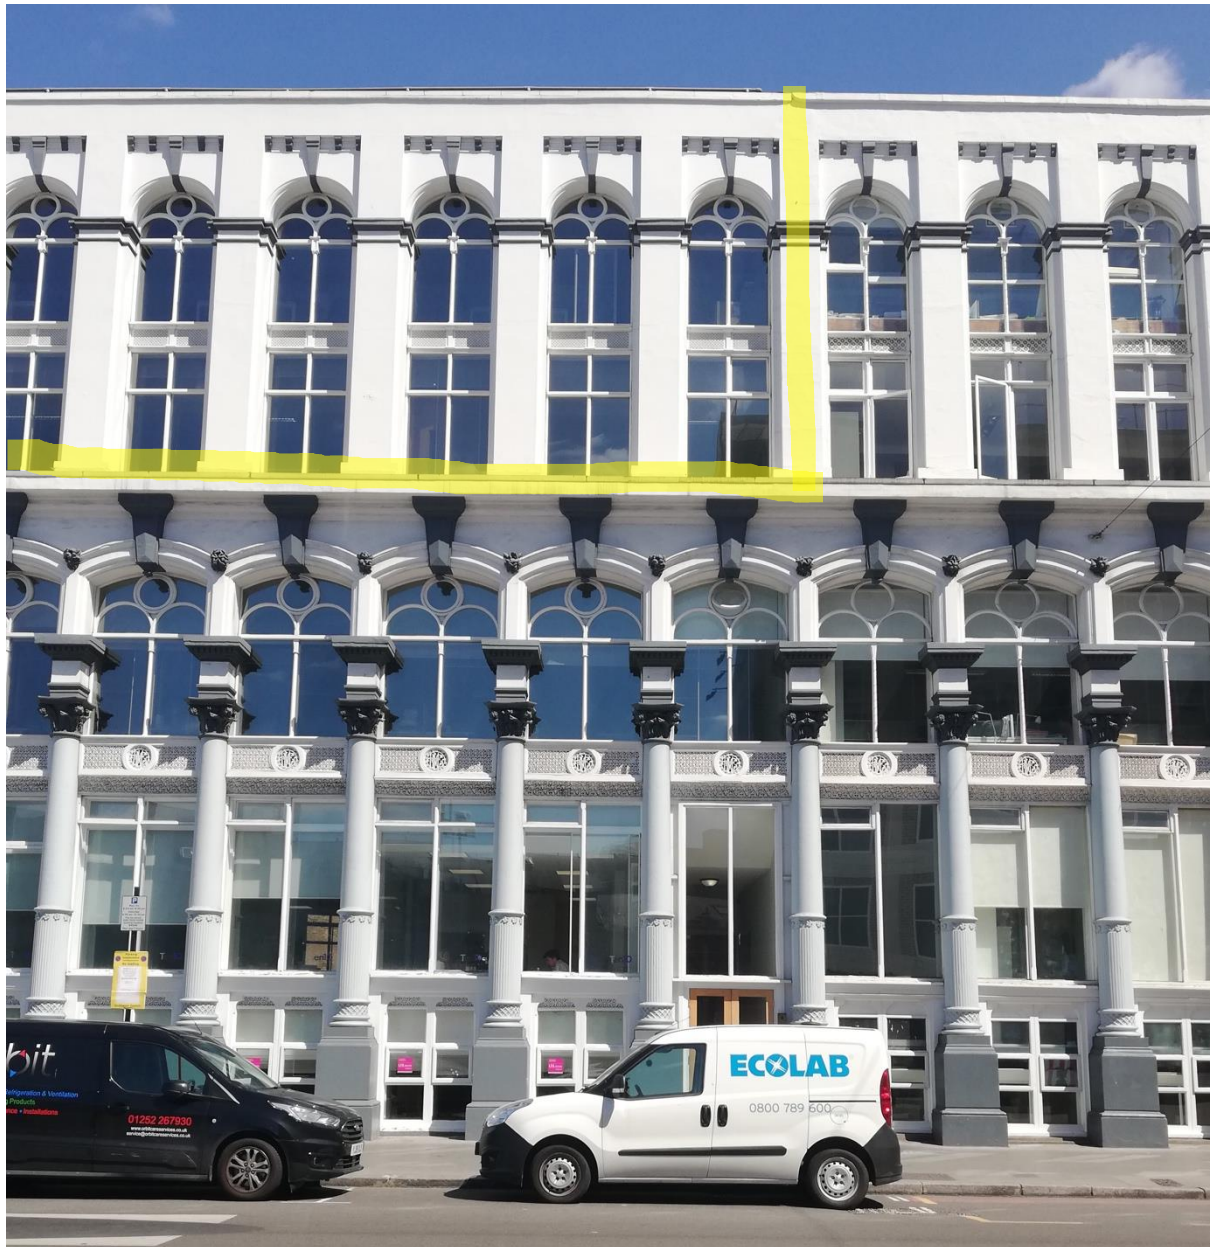
Image 65: West End with areas of new construction above and to the left of highlighted line

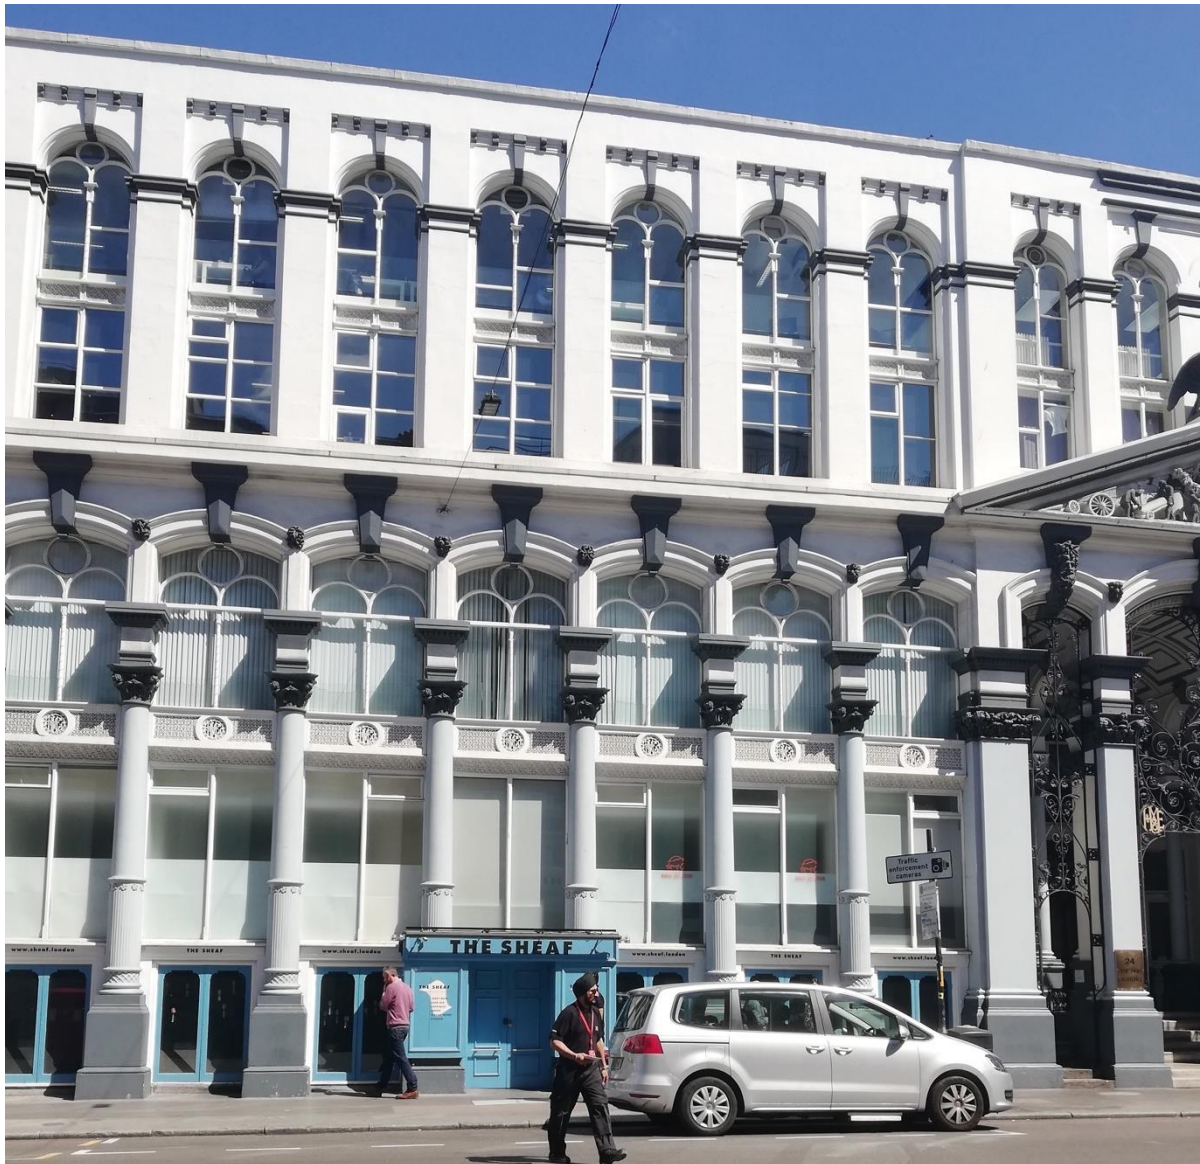
Image 66: Principle Elevation showing subtle changes to windows over 150 years.

Despite the fire and bomb damage and reduction in overall height of the building the main part of the elevation survives remarkably well. The subtle changes in the widths of the window dimensions can be seen on the next page (and originally existed at the west end too).

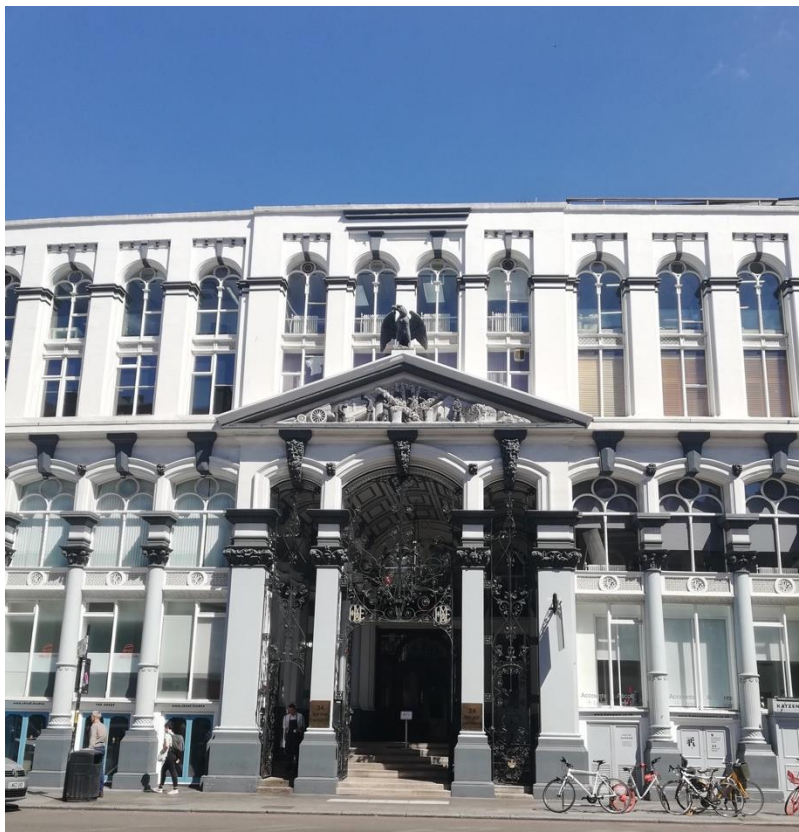
The portico, while painted loses its original polychromatic effect, is in good condition. The friezes on the tympanum, survive in their original form as do the gates and steps.

Image 68 (above): main portico

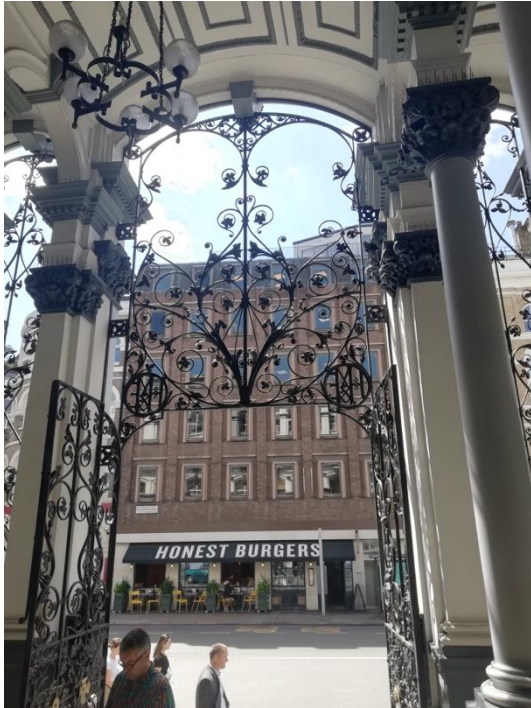
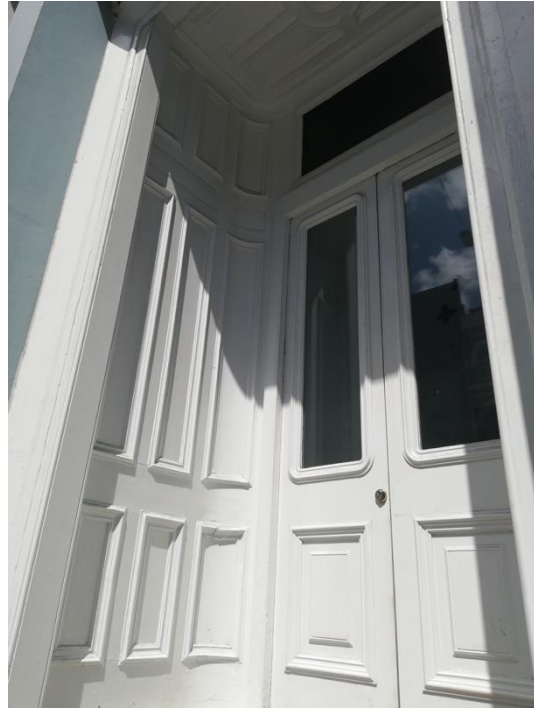
Images 69 (left) & 70 (right): The original ironwork and column details together with the original door surround to the offices at the eastern end of the building are remarkable survivals and demonstrate the quality of the detailing on the original building.

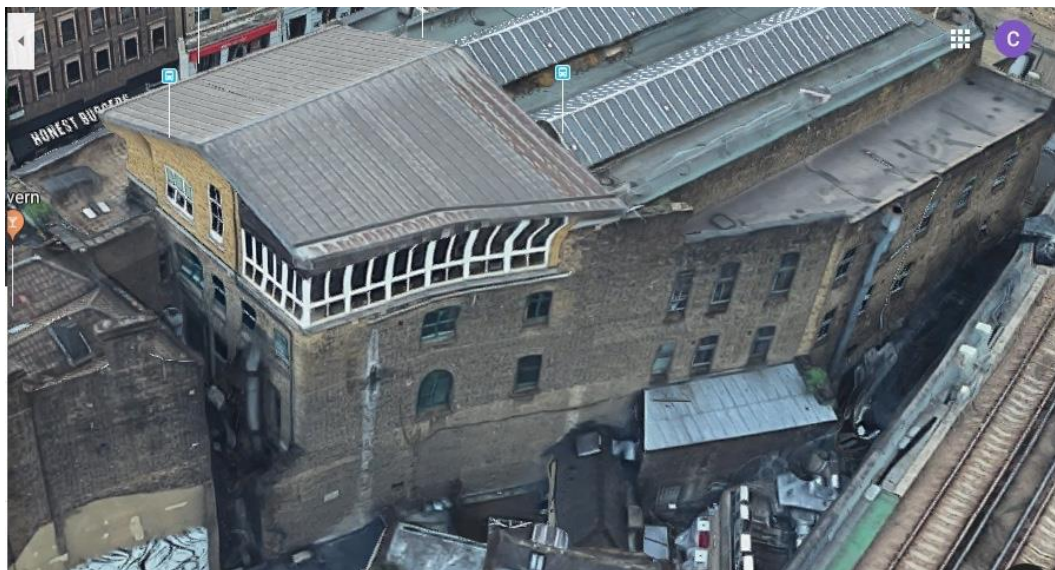
This elevation is the hardest to capture both from ground level and from the streets to the north. The documentary evidence shows us that the ground floor follows the original form. The undrawn but E elevation of the building between the Hop Exchange together with images from GoogleMaps.

Image 71 (above) : Elevations 5 & 6 - rear elevation (source GoogleMaps)

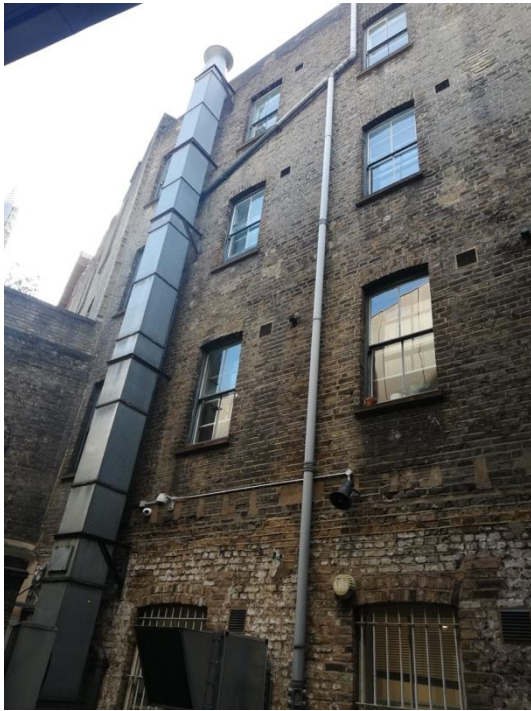
This elevation can be viewed from the roof of the service area to the bars and restaurants. Analysis of the brick work shows how these elevations were originally internal walls, and the sashes inserted after the 1920 fire. There is possible evidence of fire damage at the base of these walls. The lower part of the wall beneath the roof has some original brick openings within it including cellar lights, tall openings with arched heads and access to the archive room.

Image 72: Originally internal walls, these were exposed after demolition of the rear hop warehouse after the 1920 fire, and windows inserted into the original atrium offices.

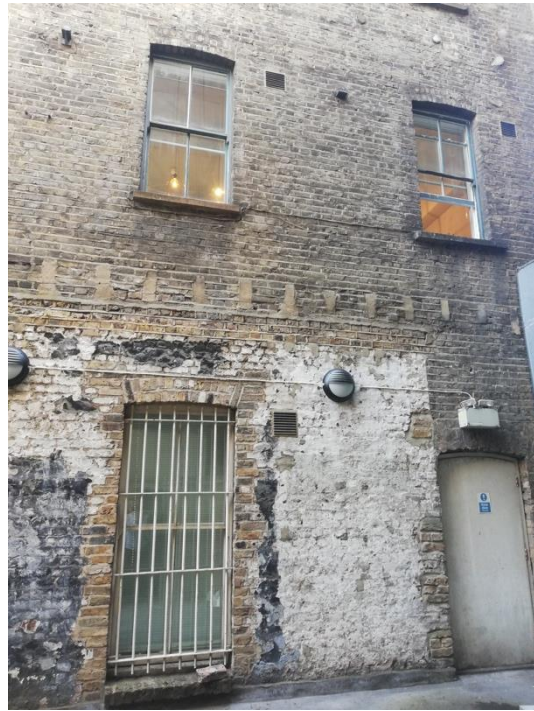
Image 73: This image of the lower part of this wall shows possible fire damage to brickwork, the location of infilled joist holes and the creation of a new opening.

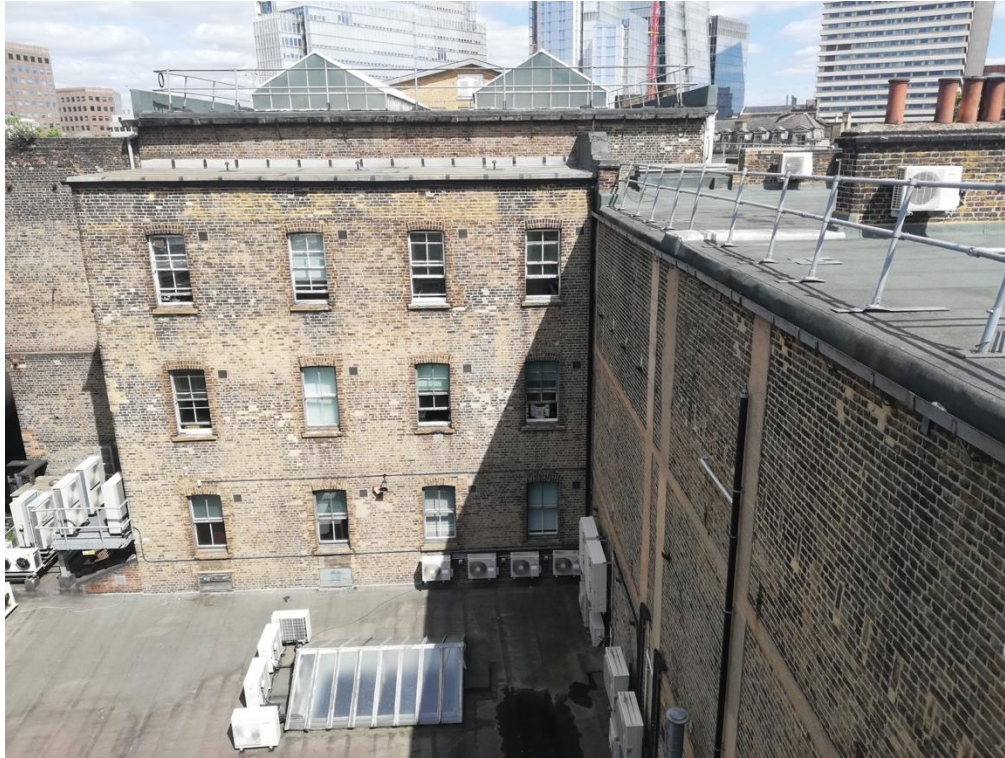
The lower part of this elevation is formed from new work which create the delivery area. The upper parts of the wall, like elevation 7, is formed from what was originally the internal wall to the rear of the west atrium offices which were exposed following the demolition after the fire. The sash windows were inserted at this time.

Image 74: Elevation 8 with sash windows inserted into Trading Floor offices after the 1920s fire

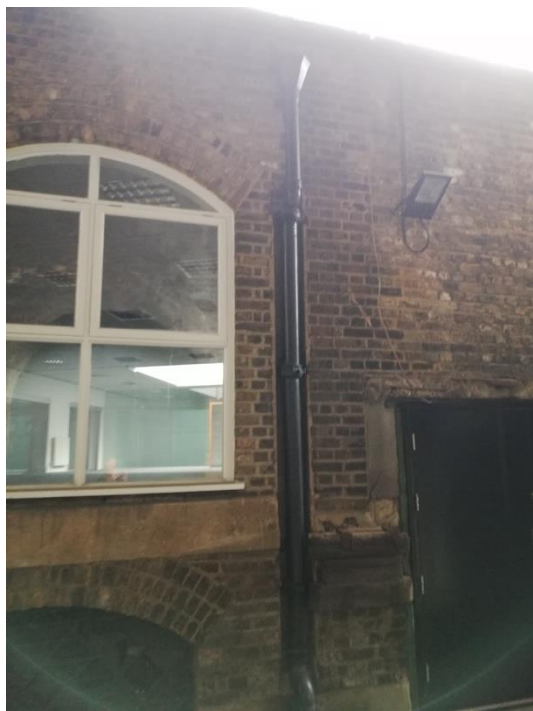
Image 75: Early lower part of wall with Atrium Suite over. Door to lower ground floor archive.

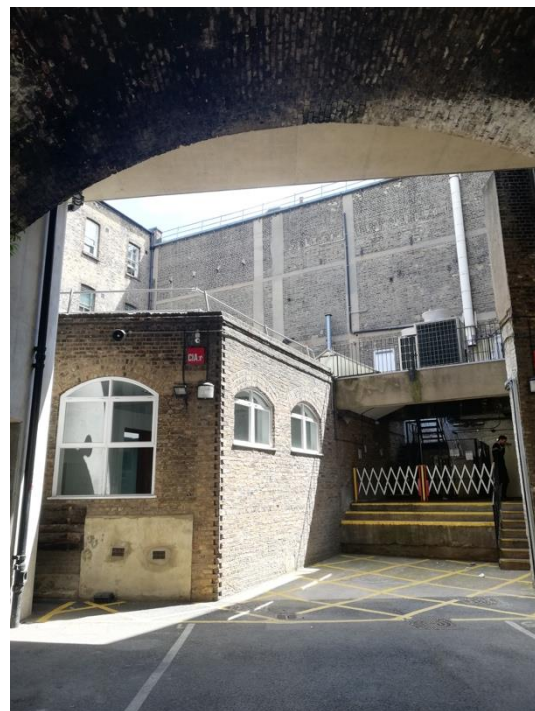
Image 76: New Atrium suite forming east boundary for delivery area.

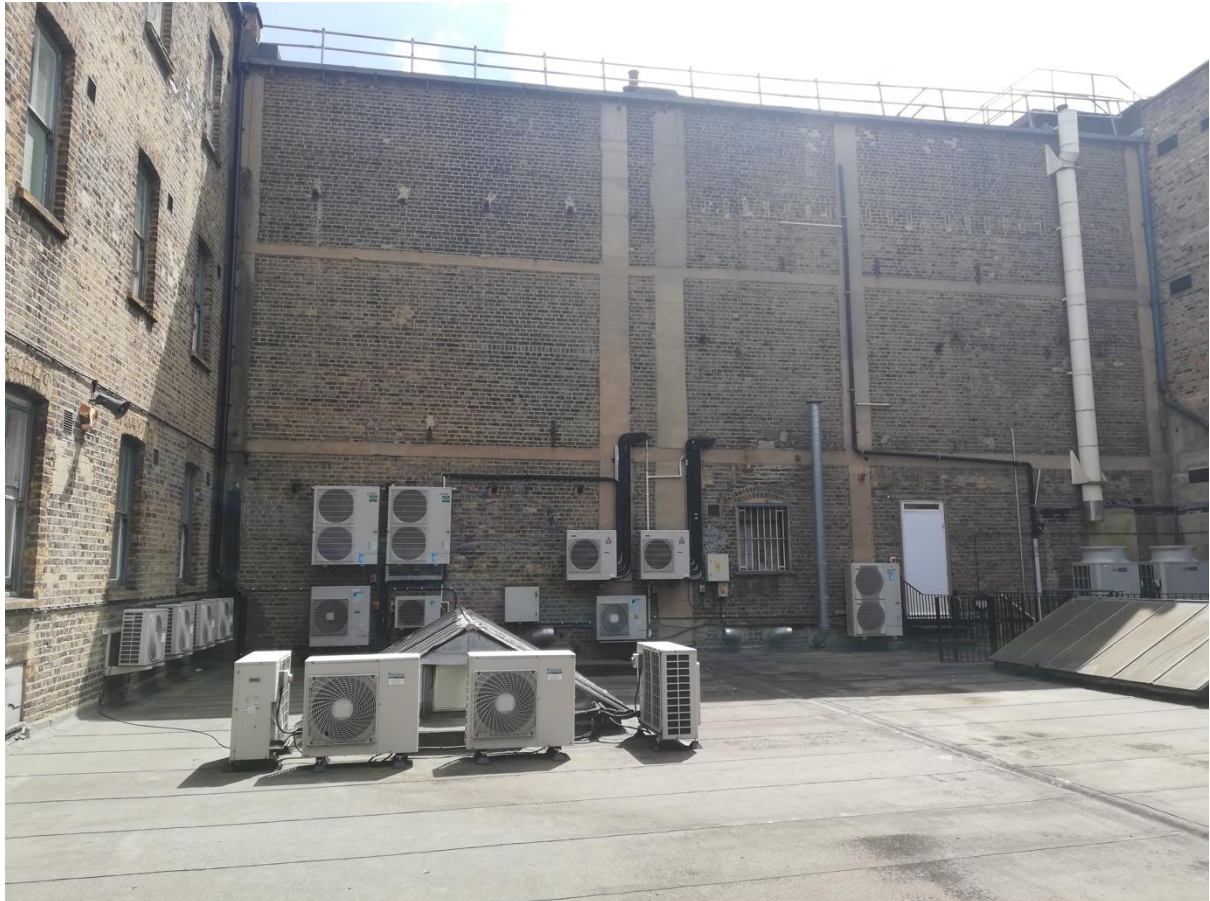
Image 77: Elevation 9

As with elevations 7 & 8 this wall was originally an internal wall with the vertical and horizontal lines demarking the previous internal walls together with some filled joist holes. There is one original opening in the lower area with an arched head. As with elevation 7 this gives this elevation some evidential interest.

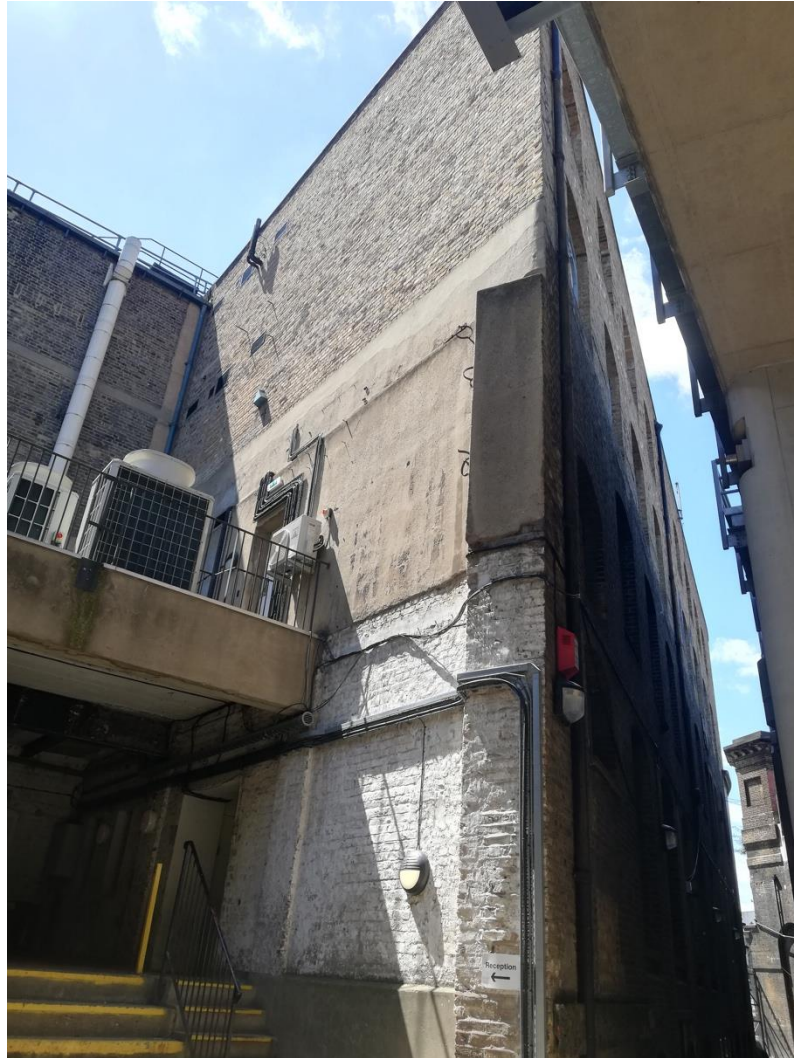
While the lower parts of this wall are original, the upper parts were constructed after 1984. The lower parts of the loading bays, were originally internal walls and have some early openings in them.

Image 78: Elevation 10 showing original parts of surviving walls at base with new brickwork over

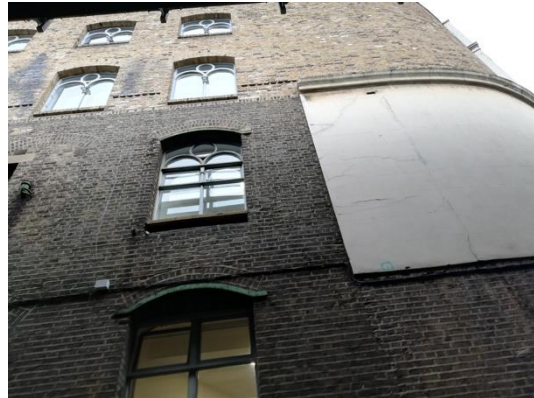
Image 80: Repair / new bricks forming vertical line below stucco

- lower part of main wall known to have survived the 1920s fire
- earlier brick repairs in London stock bricks on the east and west end of this elevation were presumably undertaken after the fire.
- there are some iron supports to window heads, possibly after the 1920 fire
- it is known from photographic and documentary sources that the top two floors were rebuilt after the Peer Group purchase in 1984. The change in brick work is clear together with some reorganisation of the windows to allow for the provision of WCs.
- all the windows were renewed at this time together with rainwater goods. Some vertical recesses in the brick work also appear to have been filled
- the large timber pieces, presumably to protect the wall during deliveries, have character
- part of the original cobbles and kerbstones survive here

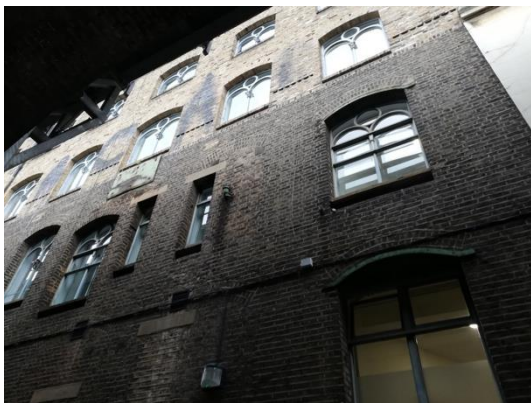
Image 81: Modern windows with new build clearly visible on top two floors with remodelled windows.
