The Hop Exchange London

Structural and Civil Engineering Stage 2 Report

The Hop Exchange 24259 / Stage 2 Report Revision 2

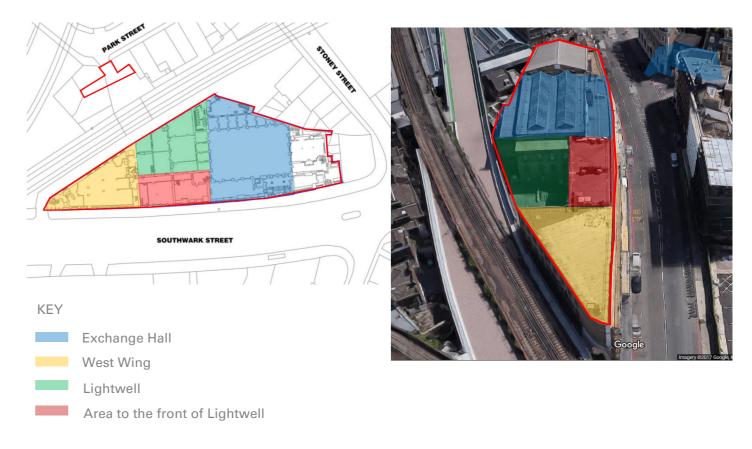
Figure 1: Site Location Plan and 3D (Google Maps)

The site is currently known as The Hop Exchange and is situated in Southwark, London, SE1 1TY. The approximate site boundary for the address is shown in red on the location plan and 3d below in Figure 1.

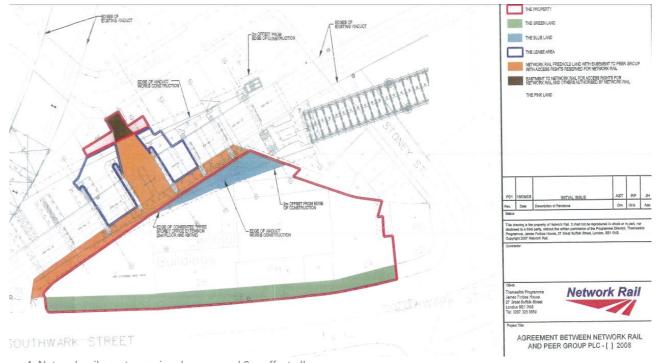
Figure 4: Network rail assets previously approved 2m offset allowance

Figure 4 below shows a plan issued in 2008 by Network Rail as part of an application by Peer Group to obtain permission for a three-storey development to the 'Lightwell'. The plan describes the permitted edge of the consented extension adjacent to the railway. A 2m offset from the railway was permitted and has been used in the initial development of the proposed scheme and assumed construction sequence for this report, however this consent may now have expired.

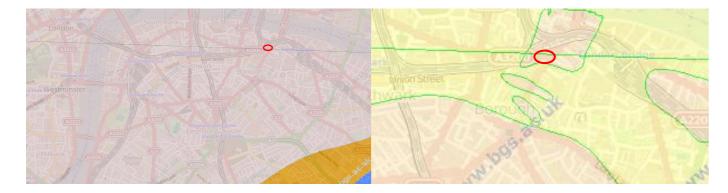
Figure 8: Bedrock surface geology

The site (marked on Figures 8 & 9 in red) sits on "London Clay Formation – Clay, Silt and Sand" and also superficial deposits "Kempton Park Gravel Formation – Sand & Gravel". This geology is typical for the area, although other superficial deposits, of "Alluvium – Clay, Silty, Peaty, Sandy", are also widely found in the surrounding sub-strata.

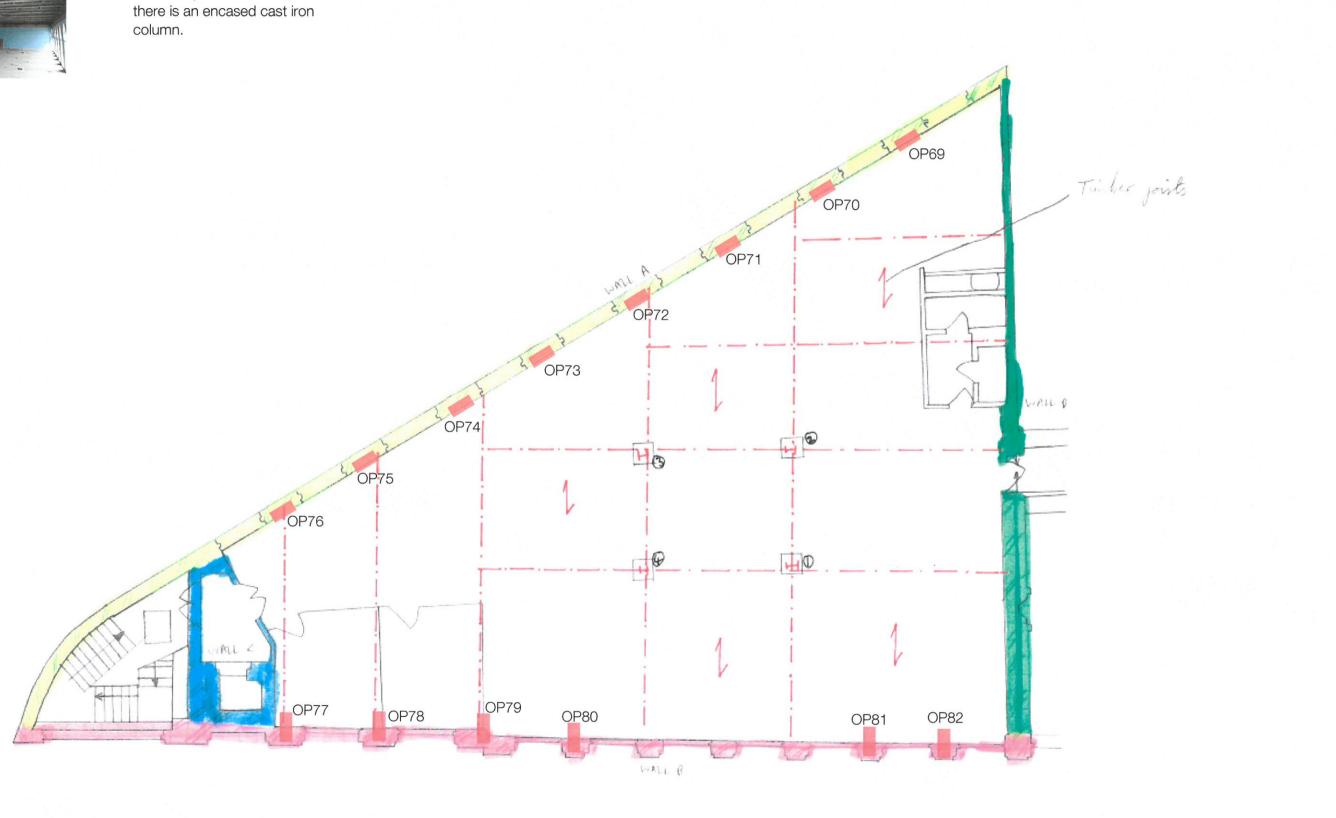
THIRD FLOOR PLAN

OP69-82. Finishes to be removed from piers to establish construction. Hole to be drilled through centre of pier to determine if there is an encased cast iron column.
