# Surface Water Drainage Strategy for Planning

**Our reference:**  
88384-Clyndes-TregoddickFarm-v2.0

**Location:**  
Land at Tregoddick Farm,  
Vingoes Lane,  
Madron  
TR20 8SS

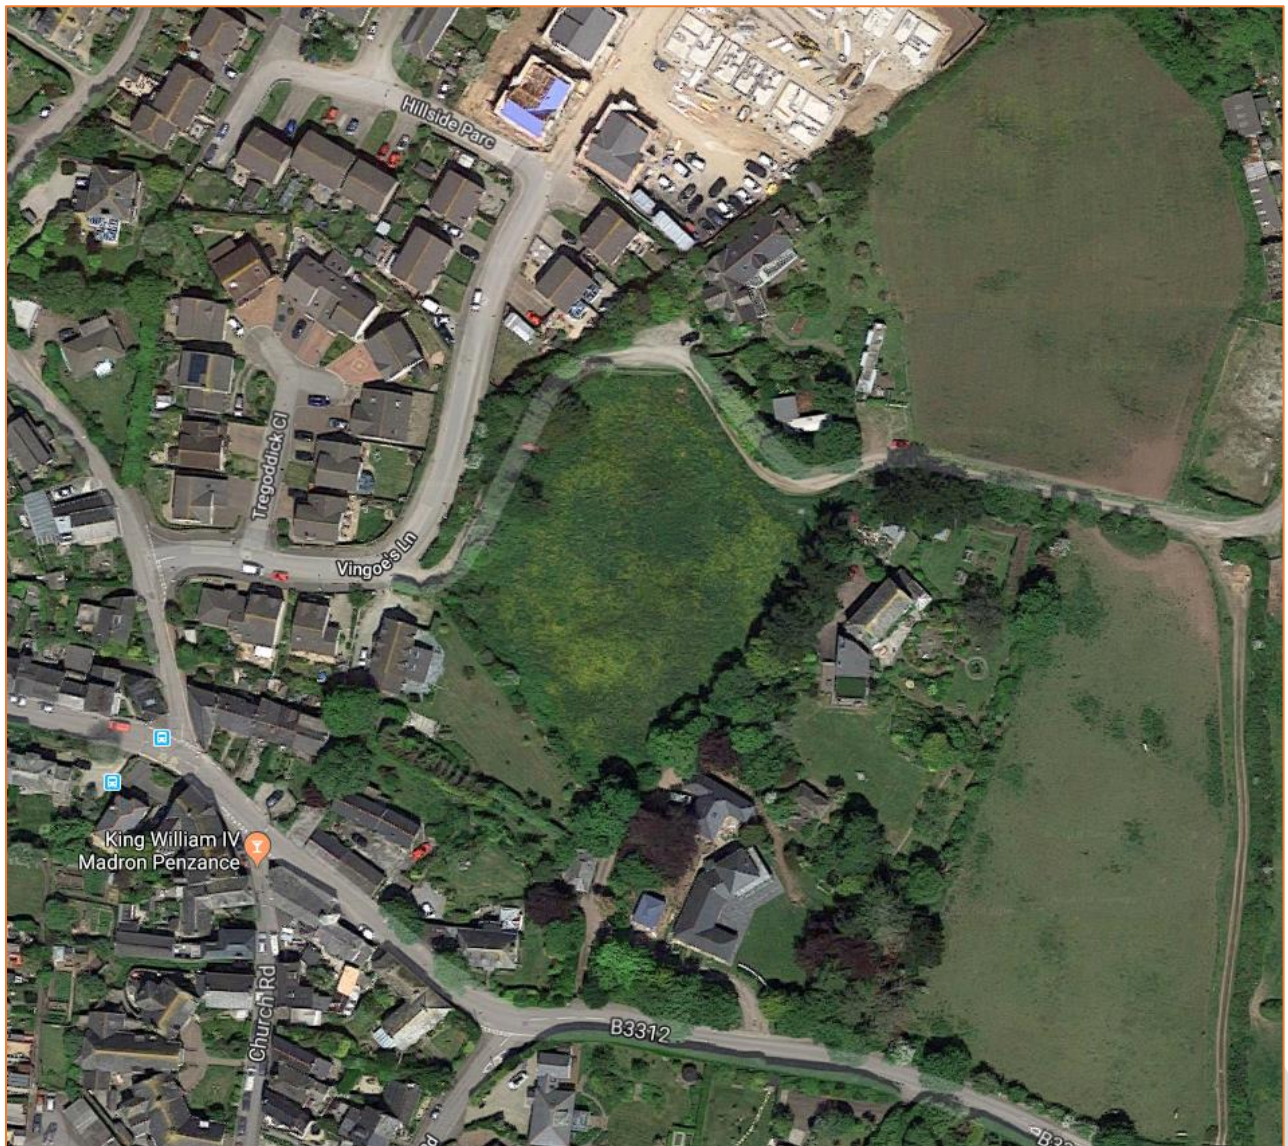
Figure 2: Aerial view of the site (Source: Google)

- 2.1. The proposed development site is approximately 5557m<sup>2</sup> and is currently occupied by a vacant agricultural field, part of the wider Tregoddick Farm. Having reviewed aerial photography the majority of the field appears to be grassland with dense scrub and trees along the north western and south eastern peripheries. A gravel roadway runs through the north of the site connecting Tregoddick Farm House to Vingoe's Lane.

- 2.2. The site is largely surrounded by residential dwellings with Vingoe's Lane forming the western boundary.
- 2.3. A measured topographic survey has not been undertaken at the site however 1.0m horizontal resolution DTM LiDAR data is available. Data suggests that the ground topography on site ranges from approximately 112.90m AOD in the south to 119.20m AOD in the north. The proposed residential dwellings will be situated on land at an elevation of between approximately 113.60m AOD and 118.60m AOD.

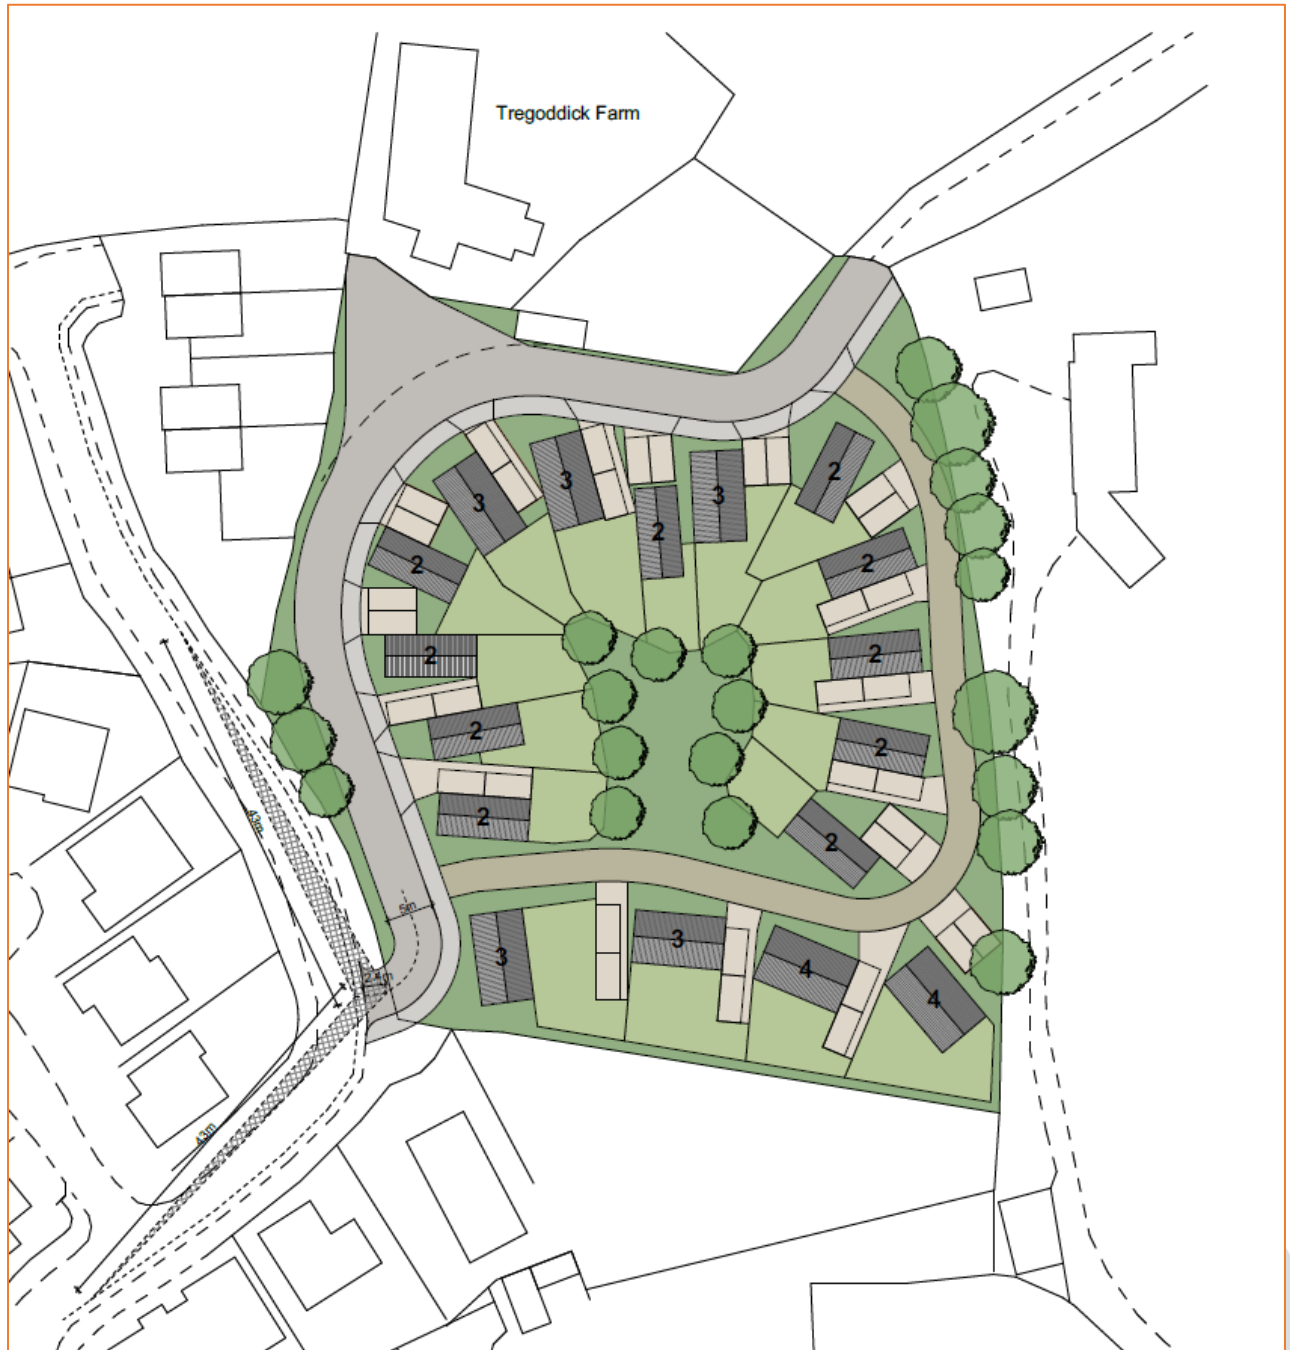
**Figure 5: Proposed Site Layout Plan (Source: Mark Clyndes)**

- 3.1. The proposed planning application is for the development of up to seventeen dwellings on vacant agricultural land. Post development the newly introduced footprint, comprising seventeen houses, new access roads and respective driveways, will cover approximately 2935m<sup>2</sup>.

- 5.12. Surface water runoff from the proposed access roads, driveways and roof areas of the seventeen proposed dwellings will be directed towards permeable paving. Surface water will be collected and stored within permeable paving located beneath all seventeen driveways and the minor road along the south and eastern boundary; amounting to 1040m<sup>2</sup>.
- 5.13. From the permeable paving, runoff will gradually infiltrate into the underlying strata.
- 5.14. The proposed development comprises some 2935m<sup>2</sup> of potentially impermeable surfacing - 1467m<sup>2</sup> of access roads, 641m<sup>2</sup> of residential driveways, and 827m<sup>2</sup> of roof area. In order to comply with CIRIA C753 The SuDS Manual, a 10% allowance will be added

- 5.15. Preliminary calculations indicate that permeable paving with dimensions of 1040m<sup>2</sup> x 0.5m deep x 0.3 (voids) will be sufficient to infiltrate all runoff from 3228.5m<sup>2</sup> of impermeable areas arising from the critical 1:100 year + 40% climate change event. Refer to enclosed calculations and Plan 88384-01 [*Proposed Drainage Layout*].
- 5.16. There will be no off-site discharge. The Permeable Paving SuDS system will be designed to accommodate and dispose of runoff from storms up to the 1:100 year + 40% climate change event, without flooding.
- 5.17. All preliminary surface water drainage calculations have been undertaken using MicroDrainage software. Refer to the Appendix.

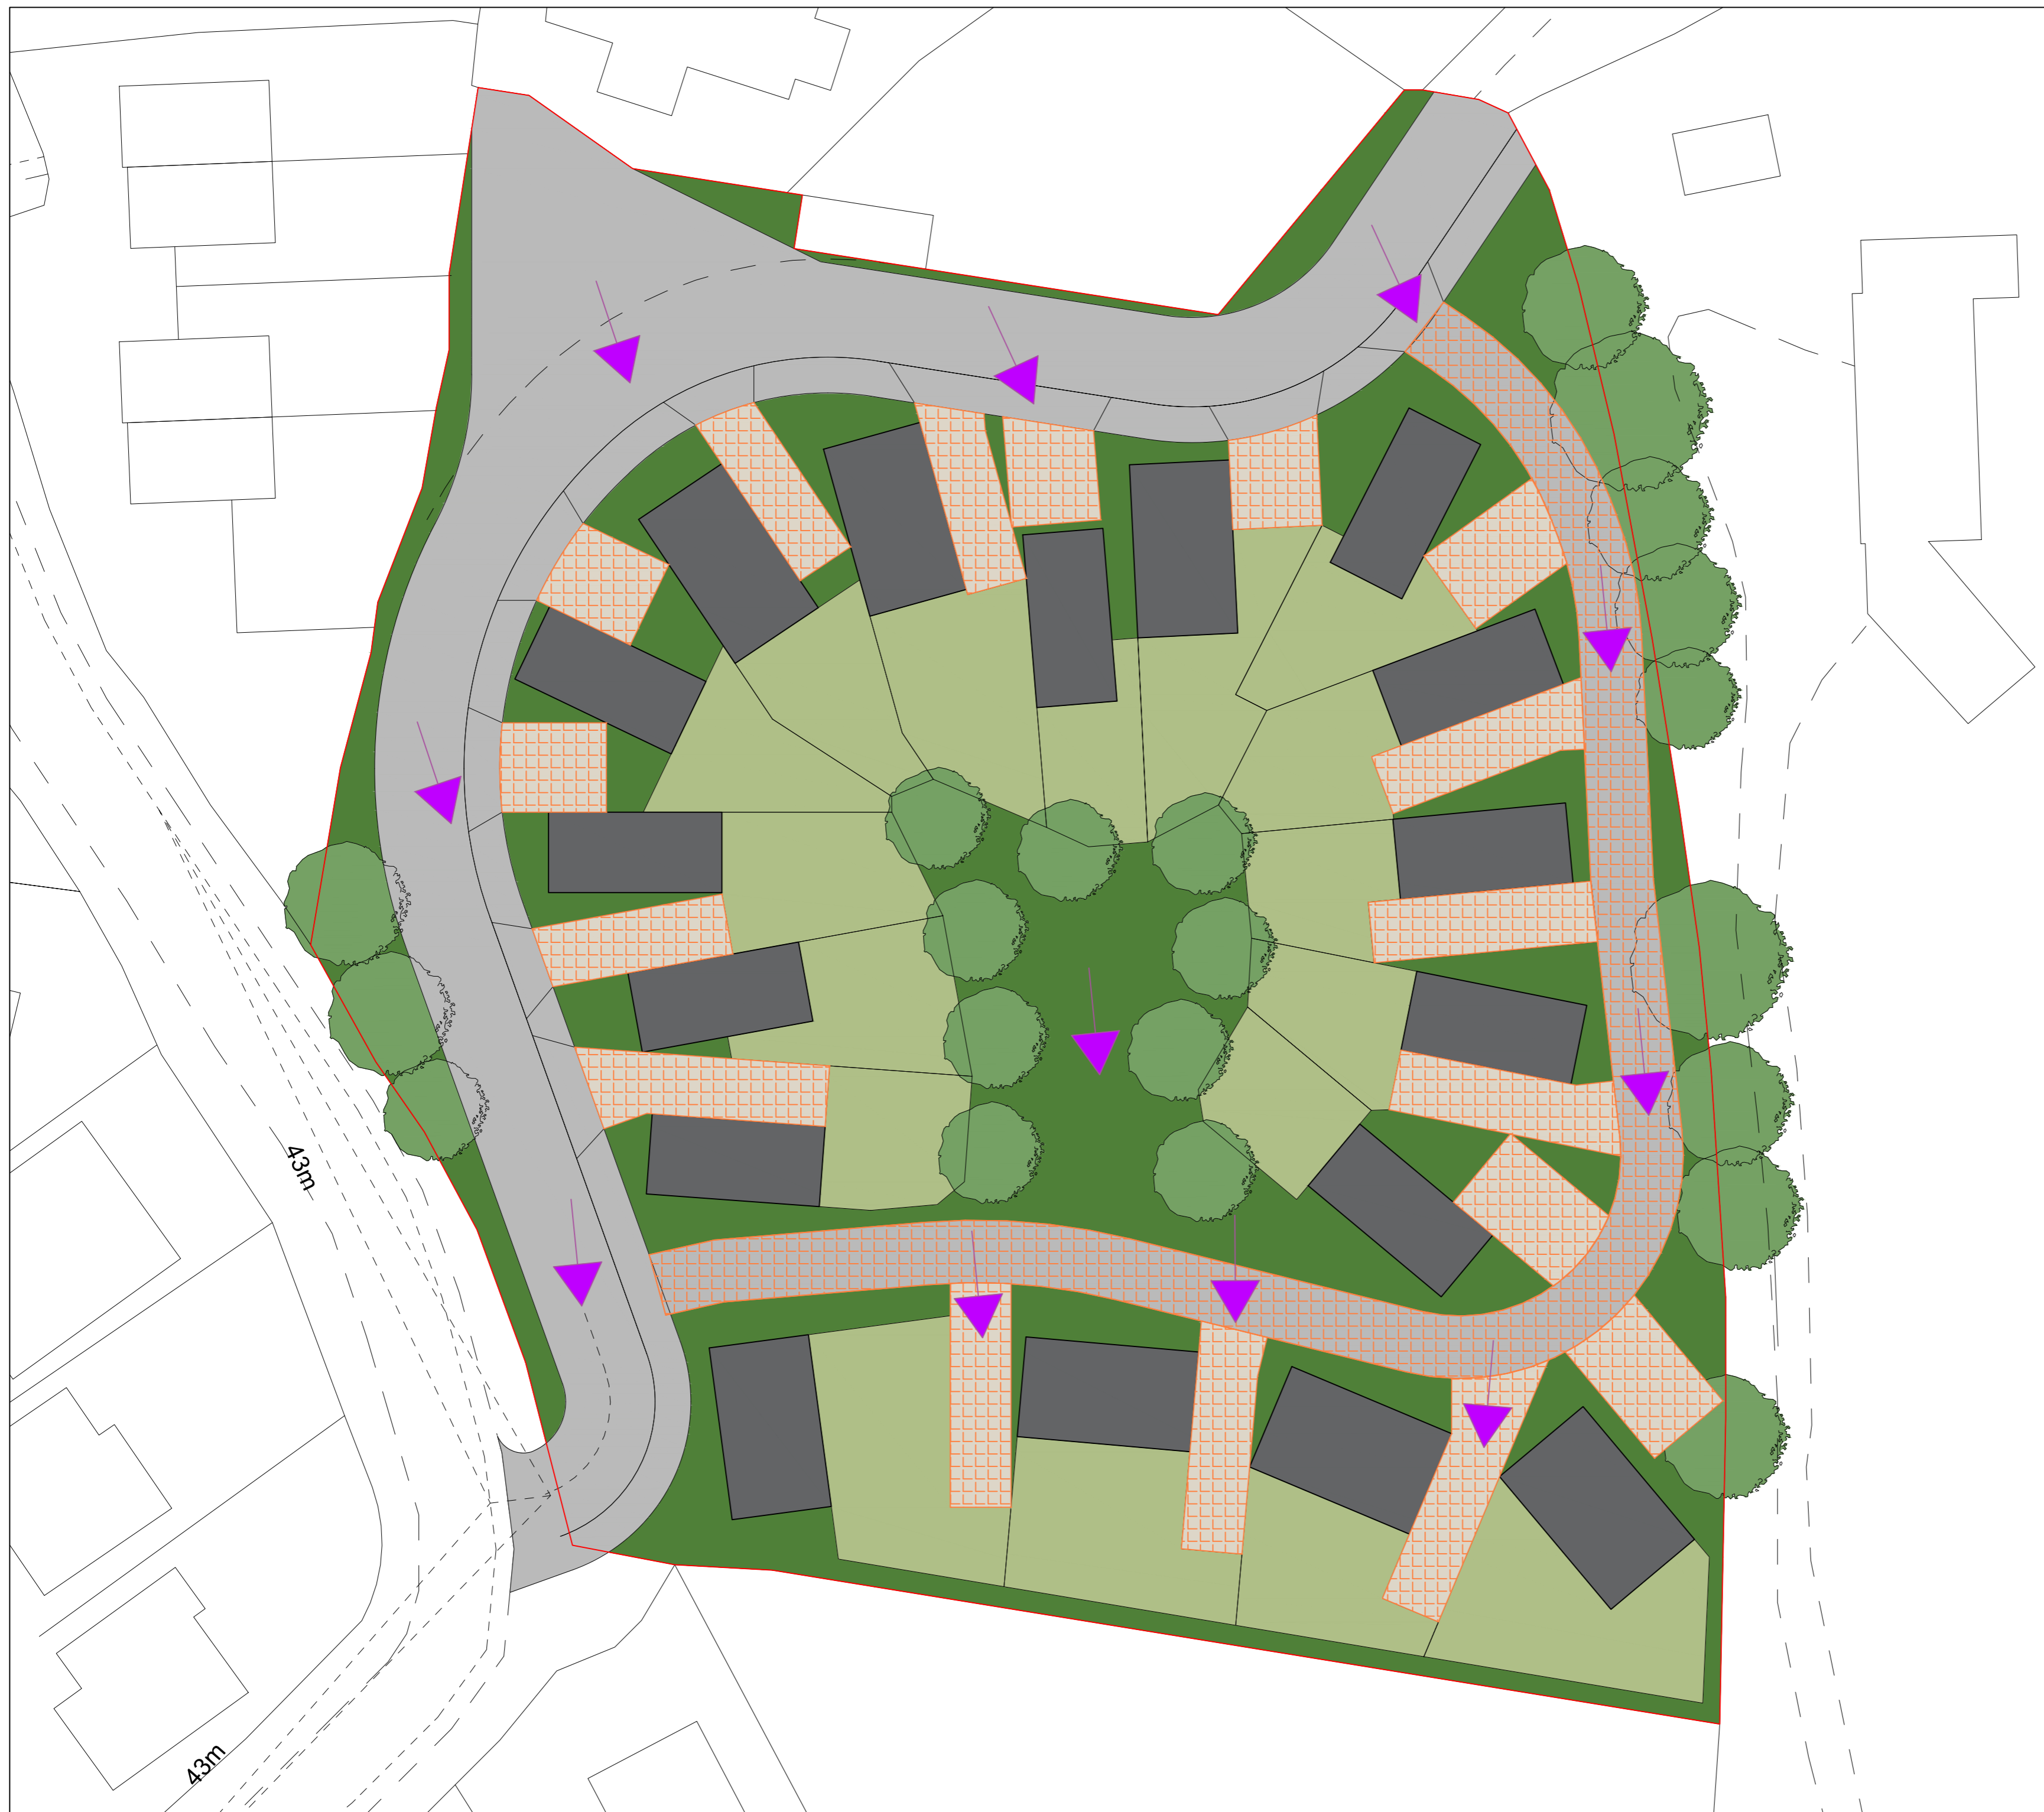
- Site Boundary (5557m<sup>2</sup>)
- Proposed Dwellings (827m<sup>2</sup>)
- Proposed Roads (1467m<sup>2</sup>)
- Proposed Driveways (641m<sup>2</sup>)
- Proposed Permeable Paving (1040m<sup>2</sup>)
- Proposed Soft Landscaping
- Proposed Trees
- Design Exceedance Route

- 7.26. Preliminary calculations indicate that permeable paving with dimensions of 1040m<sup>2</sup> x 0.5m deep x 0.3 (voids) will be sufficient to infiltrate all runoff from 3228.5m<sup>2</sup> of impermeable areas arising from the critical 1:100 year + 40% climate change event. Refer to enclosed calculations and Plan 88384-01 [*Proposed Drainage Layout*].

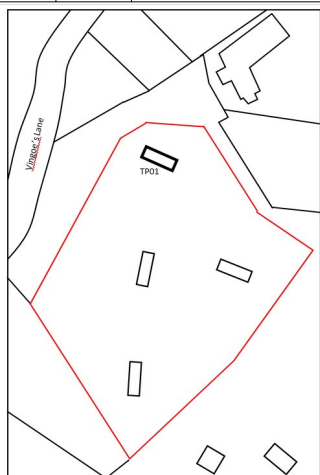
Scale (approx) 1:50	Logged By BH	Figure No. 19570.TP01
------------------------	-----------------	--------------------------

Depth (m)	Sample / Tests	Water Depth (m)	Field Records	Level (mOD)	Depth (m) (Thickness)	Description	Legend	Water
				118.20	0.80	Grass over dark brown clayey, sandy TOPSOIL. Sand is fine to coarse.		
				116.40	1.80	Brown sandy angular to subangular, fine to coarse GRAVEL of granite. Sand is fine to coarse. Rare cobbles and Boulders up to 700mm. [LANDS END INTRUSION]		
				116.20	2.80 (0.20)	Grey sandy angular to subangular, fine to coarse GRAVEL of granite. Sand is fine to coarse. [LANDS END INTRUSION]		
						Complete at 2.80m

**Remarks**  
Sides stable.  
No groundwater encountered.

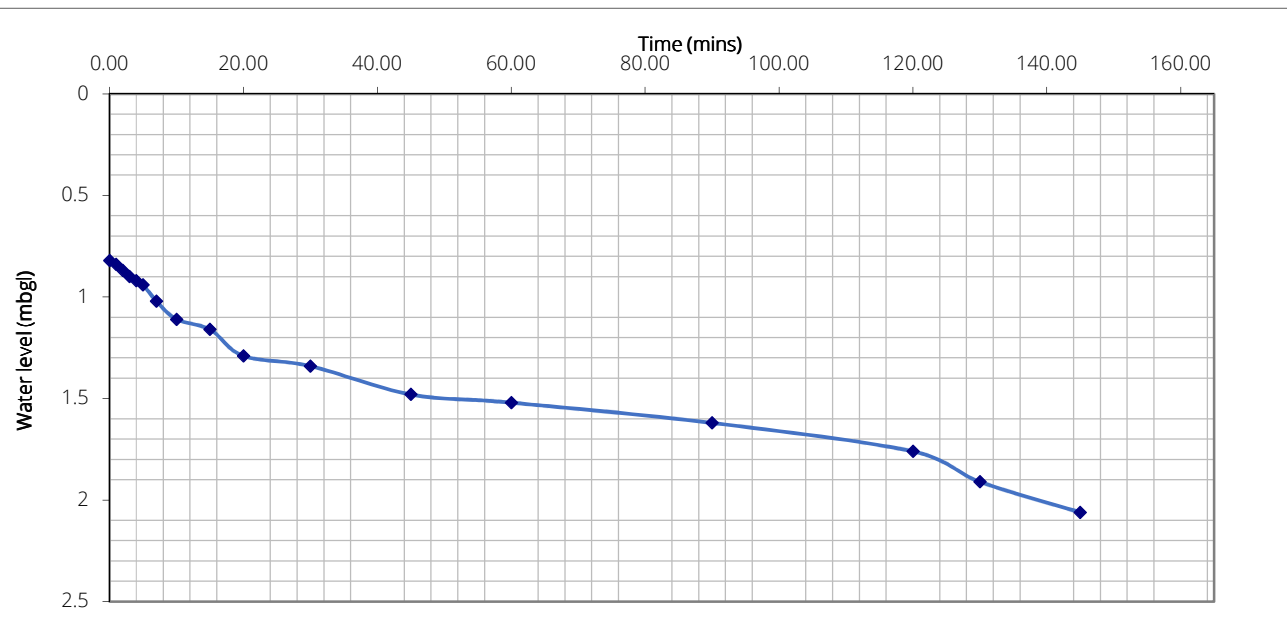
Calculations		
Depth to initial water level	0.82	m
Volume of water between 75% and 25% storage	0.17	m <sup>3</sup>
Water level at 50% storage	1.81	m
Effective height at 50% storage	0.99	m
Effective surface area of hole at 50% storage	1.94	m <sup>2</sup>
Time between 75% and 25% dissipation (from chart)	135	min *

Soil Infiltration Rate ( <i>f</i> )	1.10E-05	m/s
-------------------------------------	----------	-----

- 5.6. Despite slow drainage in TP02, infiltration rates in the remaining three trial pits varied between  $1.10 \times 10^{-5}$  m/s and  $2.65 \times 10^{-5}$  m/s. TP01 had the slowest recorded infiltration rate of  $1.10 \times 10^{-5}$  m/s, in accordance to BRE365. This rate is suitable for infiltration SuDS and has been utilised for the calculations and sizing of the proposed infiltration features. Refer to Appendix.

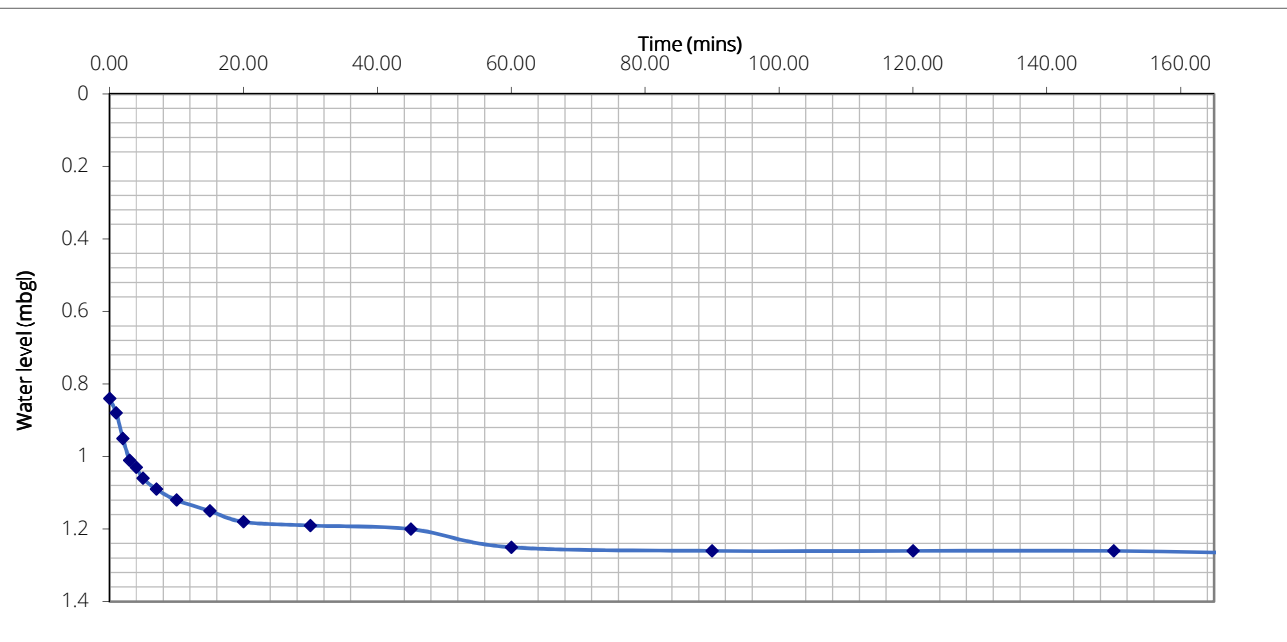
Calculations		
Depth to initial water level	0.84	m
Volume of water between 75% and 25% storage	0.28	m <sup>3</sup>
Water level at 50% storage	1.47	m
Effective height at 50% storage	0.63	m
Effective surface area of hole at 50% storage	2.11	m <sup>2</sup>
Time between 75% and 25% dissipation (from chart)	N/A	min *

Soil Infiltration Rate ( <i>f</i> )	N/A	m/s
-------------------------------------	-----	-----

Sides stable. Pit did not drain to 25% within sufficient time.

- 5.5. Infiltration testing was carried out within four test pits excavated to varying depths, dependent on underlying strata. Three complete test cycles were undertaken in all trial pits, except TP02, in full accordance with BRE365. In TP02, slow infiltration rates dictated that only one test could be completed in the time available.

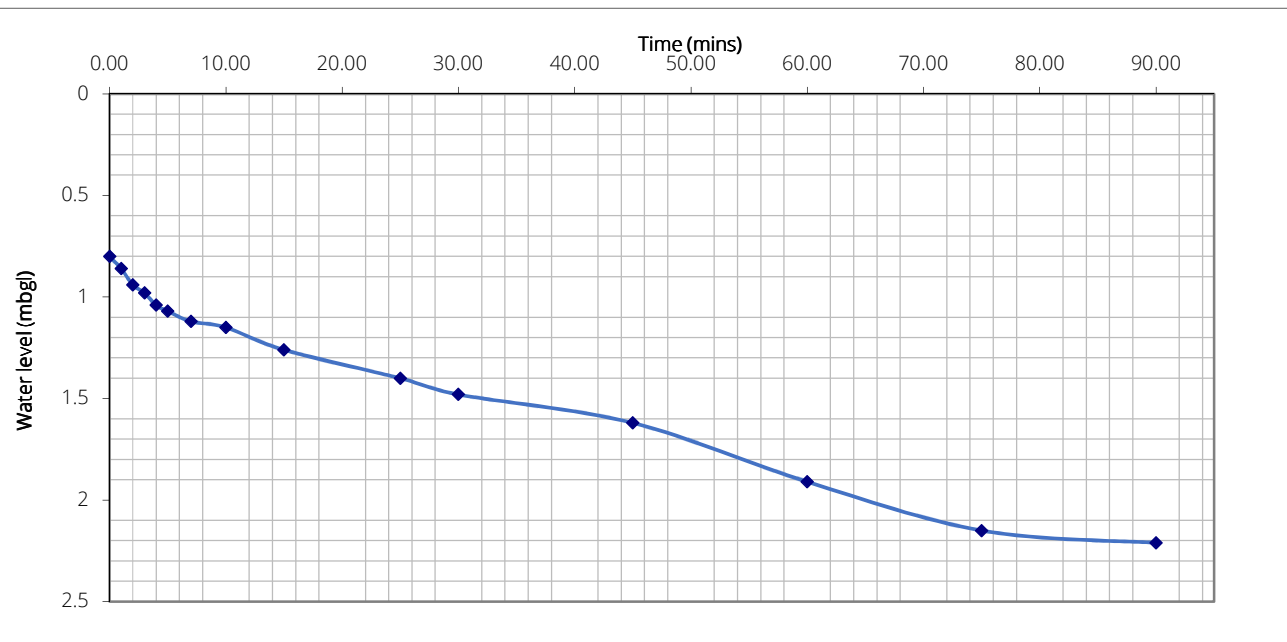
Calculations		
Depth to initial water level	0.80	m
Volume of water between 75% and 25% storage	0.29	m <sup>3</sup>
Water level at 50% storage	1.75	m
Effective height at 50% storage	0.95	m
Effective surface area of hole at 50% storage	2.39	m <sup>2</sup>
Time between 75% and 25% dissipation (from chart)	75	min *

<b>Soil Infiltration Rate ( f )</b>	<b>2.65E-05</b>	<b>m/s</b>
-------------------------------------	-----------------	------------
