Ground Investigation

Tregoddick

Ref: SI19570

Client	Mr M Clyndes
Project Title	Tregoddick
Document Title	Soakaway Testing Investigation
Document No.	S119570

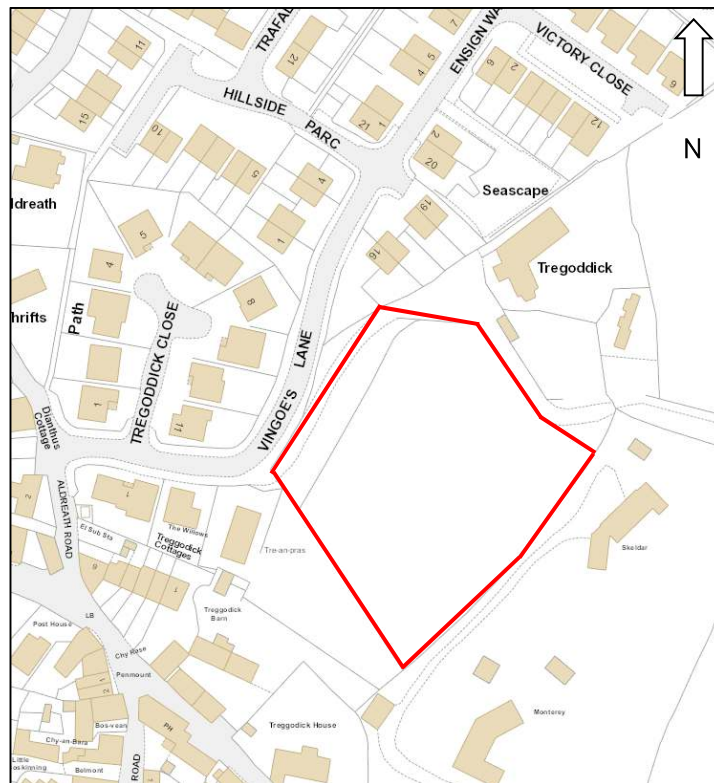
Figure 2.2: Current Site Layout. Plan taken from Cornwall Council Interactive Map.

2.1.2 The site is irregular in shape and covers an area of approximately 0.40ha.

2.1.3 The site layout can be seen in Figure 2.2 below:

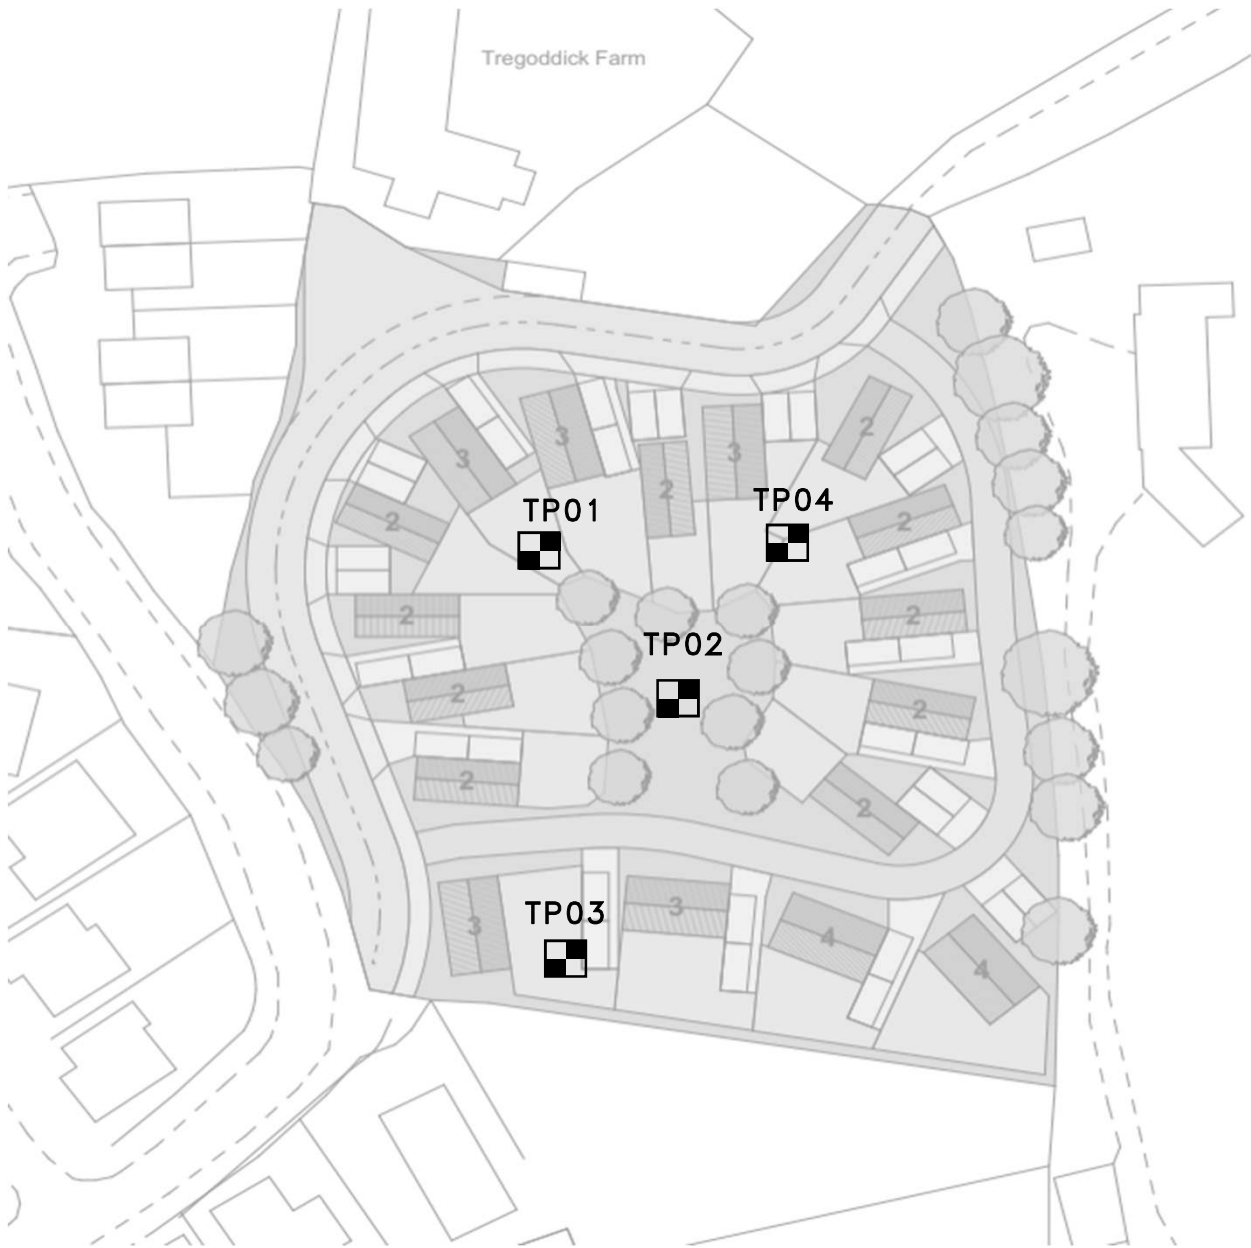
Figure: 3.1

3.1.1 A BRE 365 Soakaway Testing Investigation was conducted on Tuesday 13th November 2018. The investigation was overseen by a geotechnical engineer from Wheal Jane Consultancy. An exploratory hole location plan is presented as Figure 3.1.

Title: Exploratory Hole Location Plan

Exploratory Hole Type	Exploratory Hole ID	Hole Depths (mBGL)	Comments
Trial Pit	TP01 – TP04	2.10 – 2.80	Soakaway test completed at all locations.

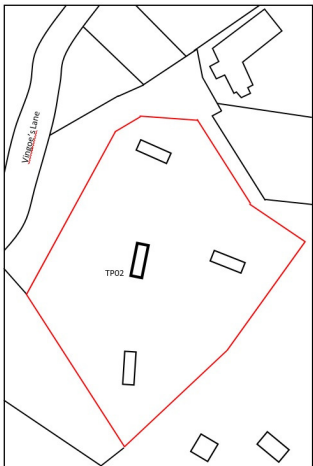
Scale (approx) 1:50	Logged By BH	Figure No. 19570.TP02
------------------------	-----------------	--------------------------

Depth (m)	Sample / Tests	Water Depth (m)	Field Records	Level (mOD)	Depth (m) (Thickness)	Description	Legend	Water
				117.20	0.80	Grass over dark brown clayey, sandy TOPSOIL. Sand is fine to coarse.

115.90	2.10	Brown clayey angular to subangular, medium to coarse GRAVEL of granite. Frequent cobbles and boulders up to 800mm. [LANDS END INTRUSION]

Remarks
Sides stable
No groundwater encountered.

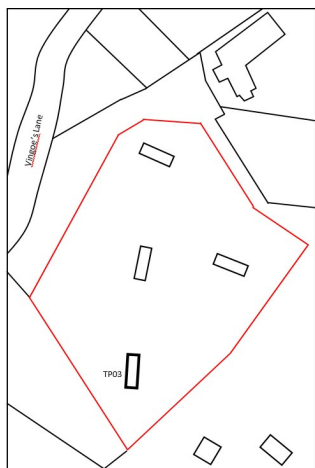
Scale (approx) 1:50	Logged By BH	Figure No. 19570.TP03
------------------------	-----------------	--------------------------

Depth (m)	Sample / Tests	Water Depth (m)	Field Records	Level (mOD)	Depth (m) (Thickness)	Description	Legend	Water
				115.20	0.80	Grass over dark brown clayey, sandy TOPSOIL. Sand is fine to coarse.

113.20	2.80	Brown clayey angular to subangular, medium to coarse GRAVEL of granite. Frequent cobbles and boulders up to 600mm. [LANDS END INTRUSION]

No groundwater encountered.
Sides stable.

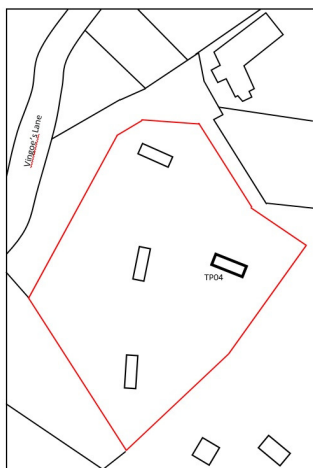
Scale (approx) 1:50	Logged By BH	Figure No. 19570.TP04
------------------------	-----------------	--------------------------

Depth (m)	Sample / Tests	Water Depth (m)	Field Records	Level (mOD)	Depth (m) (Thickness)	Description	Legend	Water
				115.40	0.60	Grass over dark brown clayey, sandy TOPSOIL. Sand is fine to coarse.

113.30	2.70	Brown sandy angular to subangular, fine to coarse GRAVEL of granite. Sand is fine to coarse. [LANDS END INTRUSION]

No groundwater encountered.
Sides stable.

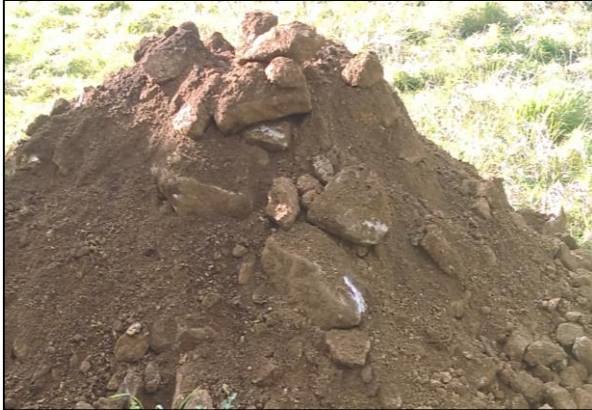
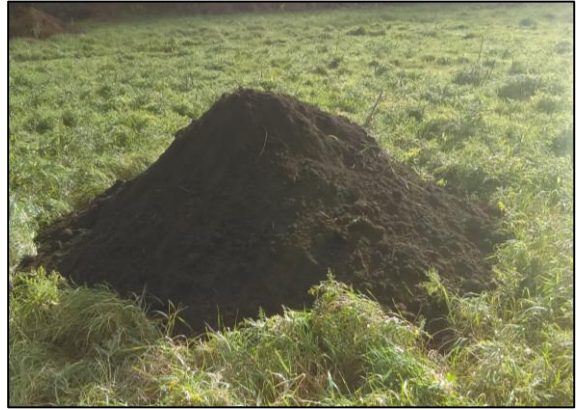
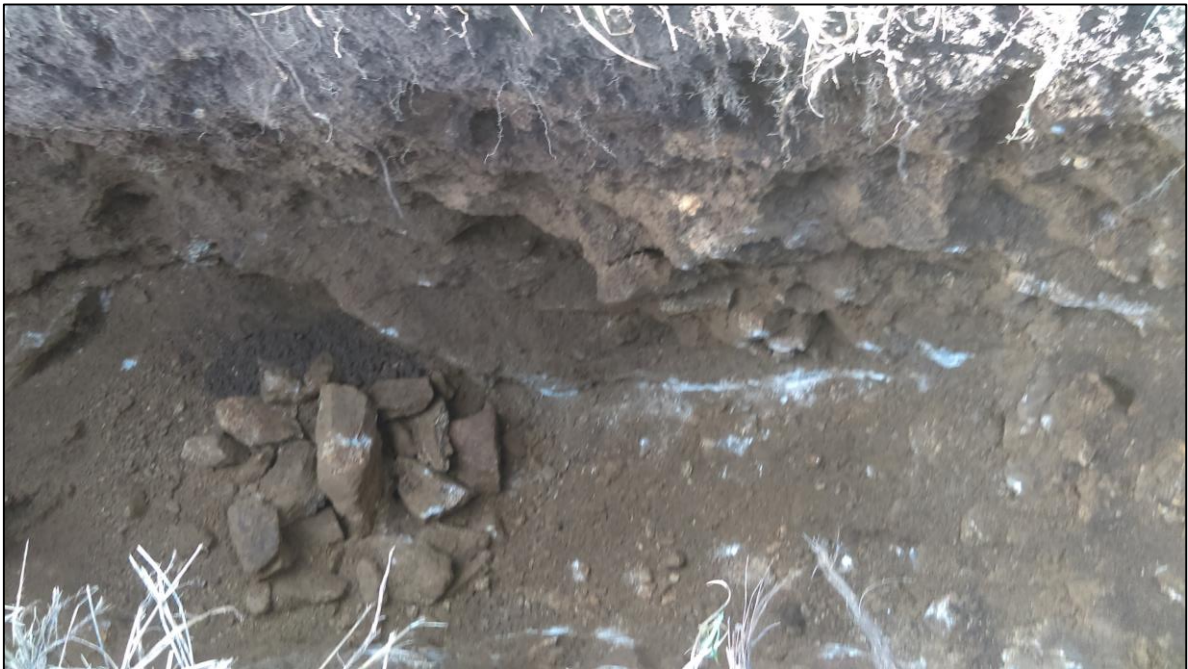
- Infiltration rates varied between 1.10E-05m/s and 2.65E-05m/s across the site.
 - The fastest infiltration rates were encountered in TP04 in the east.
 - Slow soakage was encountered in TP02 in the centre of the site and as a result only one test was undertaken.
-

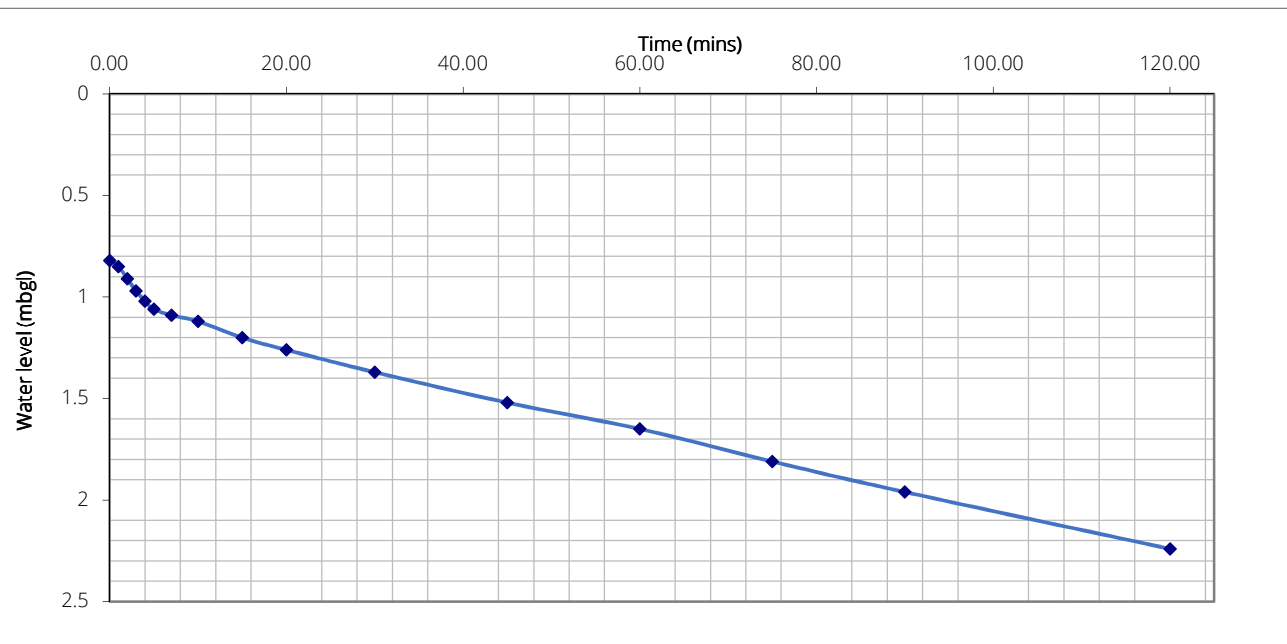
Job Name:	Tregoddick	Trial Pit:	TP01
Job Number:	19570	Test No:	1
Client:	Mr M Clydes	Engineer:	Wheal Jane Consultancy
		Date:	13/11/2018

Elapsed Time (mins)	Water Level (m)
0.00	0.82
1.00	0.85
2.00	0.91
3.00	0.97
4.00	1.02
5.00	1.06
7.00	1.09
10.00	1.12
15.00	1.2
20.00	1.26
30.00	1.37
45.00	1.52
60.00	1.65
75.00	1.81
90.00	1.96
120.00	2.24
150.00	
180.00	
210.00	
240.00

Calculations		
Depth to initial water level	0.82	m
Volume of water between 75% and 25% storage	0.17	m ³
Water level at 50% storage	1.81	m
Effective height at 50% storage	0.99	m
Effective surface area of hole at 50% storage	1.94	m ²
Time between 75% and 25% dissipation (from chart)	100	min *

Soil Infiltration Rate (<i>f</i>)	1.48E-05	m/s
-------------------------------------	----------	-----

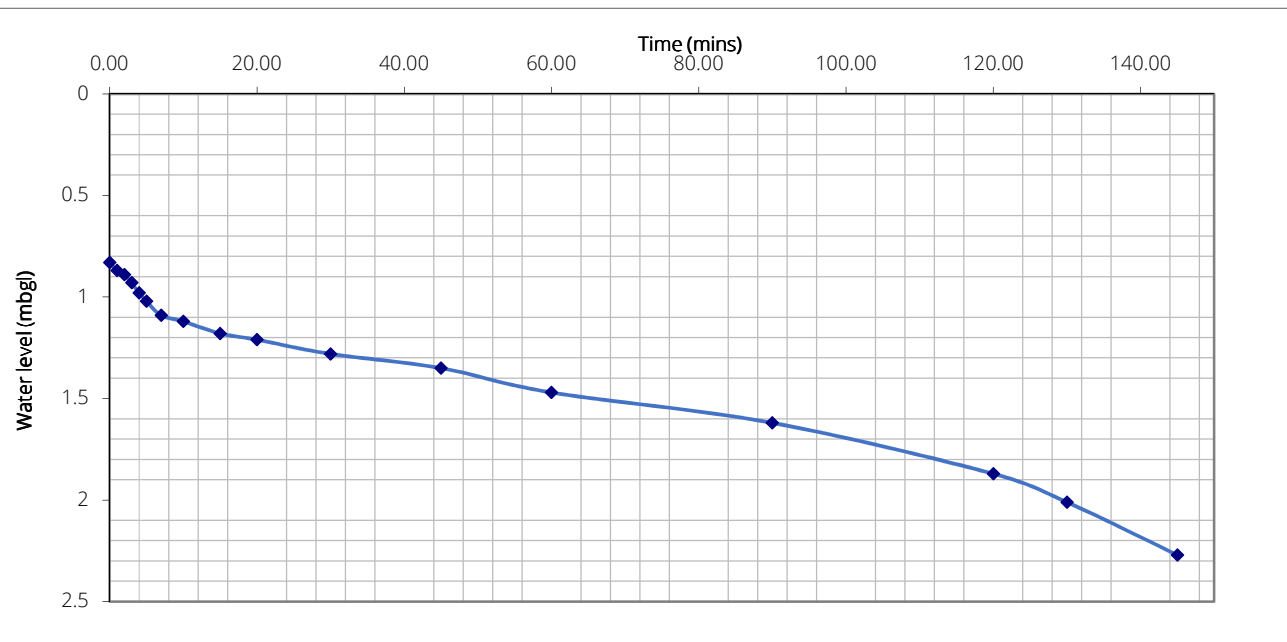
Job Name:	Tregoddick	Trial Pit:	TP01
Job Number:	19570	Test No:	2
Client:	Mr M Clydes	Engineer:	Wheal Jane Consultancy
		Date:	13/11/2018

Elapsed Time (mins)	Water Level (m)
0.00	0.83
1.00	0.87
2.00	0.89
3.00	0.93
4.00	0.98
5.00	1.02
7.00	1.09
10.00	1.12
15.00	1.18
20.00	1.21
30.00	1.28
45.00	1.35
60.00	1.47
90.00	1.62
120.00	1.87
130.00	2.01
145.00	2.27
150.00	
180.00	
210.00

Calculations		
Depth to initial water level	0.83	m
Volume of water between 75% and 25% storage	0.17	m ³
Water level at 50% storage	1.82	m
Effective height at 50% storage	0.99	m
Effective surface area of hole at 50% storage	1.91	m ²
Time between 75% and 25% dissipation (from chart)	110	min *

Soil Infiltration Rate (<i>f</i>)	1.33E-05	m/s
-------------------------------------	----------	-----

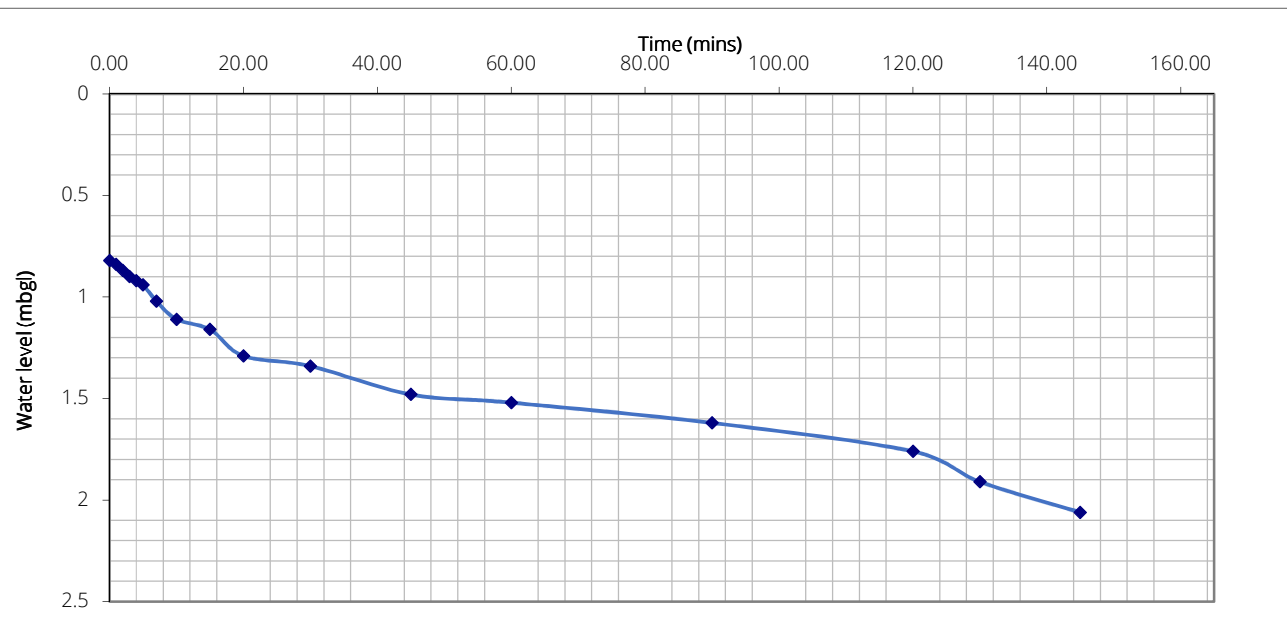
Job Name:	Tregoddick	Trial Pit:	TP01
Job Number:	19570	Test No:	3
Client:	Mr M Clydes	Engineer:	Wheal Jane Consultancy
		Date:	13/11/2018

Elapsed Time (mins)	Water Level (m)
0.00	0.82
1.00	0.84
2.00	0.87
3.00	0.9
4.00	0.92
5.00	0.94
7.00	1.02
10.00	1.11
15.00	1.16
20.00	1.29
30.00	1.34
45.00	1.48
60.00	1.52
90.00	1.62
120.00	1.76
130.00	1.91
145.00	2.06
160.00	2.28
190.00	
220.00

Calculations		
Depth to initial water level	0.82	m
Volume of water between 75% and 25% storage	0.17	m ³
Water level at 50% storage	1.81	m
Effective height at 50% storage	0.99	m
Effective surface area of hole at 50% storage	1.94	m ²
Time between 75% and 25% dissipation (from chart)	135	min *

Soil Infiltration Rate (<i>f</i>)	1.10E-05	m/s
-------------------------------------	----------	-----

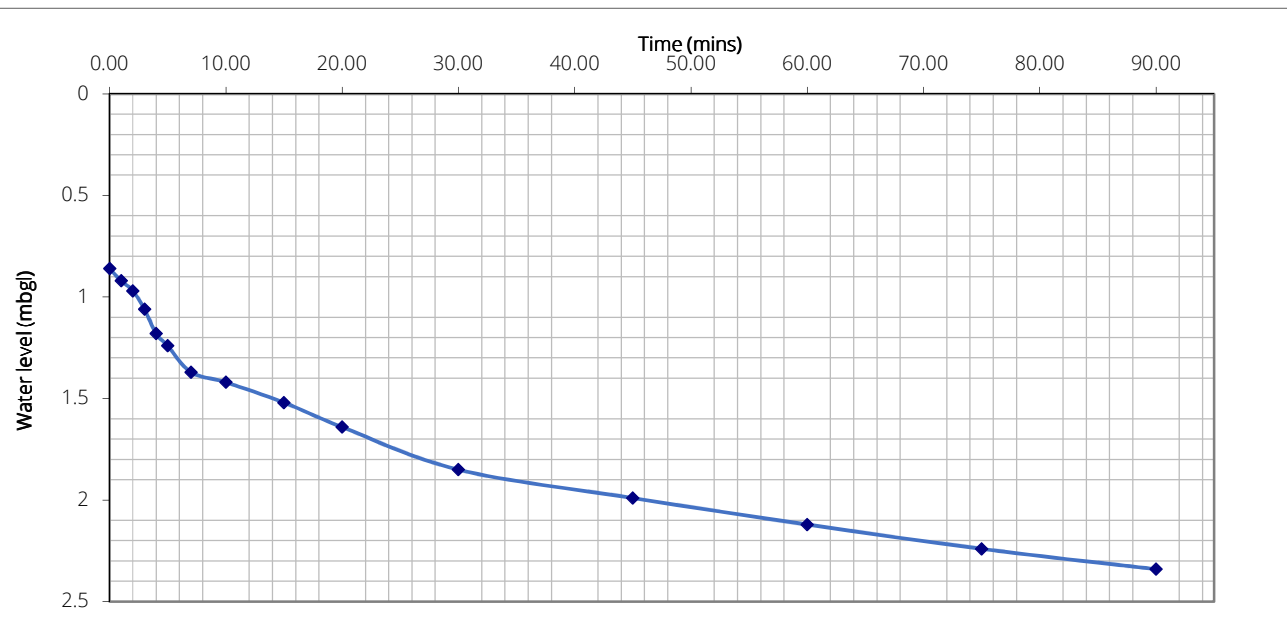
Job Name:	Tregoddick	Trial Pit:	TP03
Job Number:	19570	Test No:	1
Client:	Mr M Clydes	Engineer:	Wheal Jane Consultancy
		Date:	13/11/2018

Elapsed Time (mins)	Water Level (m)
0.00	0.86
1.00	0.92
2.00	0.97
3.00	1.06
4.00	1.18
5.00	1.24
7.00	1.37
10.00	1.42
15.00	1.52
20.00	1.64
30.00	1.85
45.00	1.99
60.00	2.12
75.00	2.24
90.00	2.34
120.00	
150.00	
180.00	
210.00	
240.00

Calculations		
Depth to initial water level	0.86	m
Volume of water between 75% and 25% storage	0.22	m ³
Water level at 50% storage	1.83	m
Effective height at 50% storage	0.97	m
Effective surface area of hole at 50% storage	2.10	m ²
Time between 75% and 25% dissipation (from chart)	76	min *

Soil Infiltration Rate (<i>f</i>)	2.24E-05	m/s
-------------------------------------	----------	-----

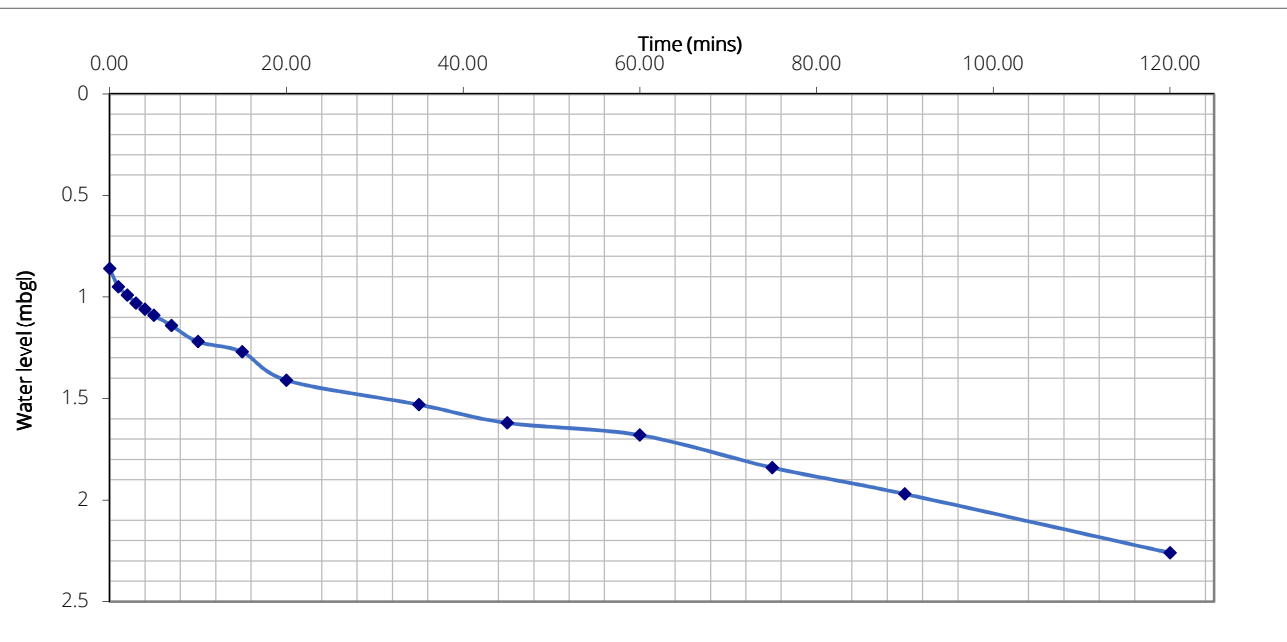
Job Name:	Tregoddick	Trial Pit:	TP03
Job Number:	19570	Test No:	2
Client:	Mr M Clydes	Engineer:	Wheal Jane Consultancy
		Date:	13/11/2018

Elapsed Time (mins)	Water Level (m)
0.00	0.86
1.00	0.95
2.00	0.99
3.00	1.03
4.00	1.06
5.00	1.09
7.00	1.14
10.00	1.22
15.00	1.27
20.00	1.41
35.00	1.53
45.00	1.62
60.00	1.68
75.00	1.84
90.00	1.97
120.00	2.26
150.00	
180.00	
210.00	
240.00

Calculations		
Depth to initial water level	0.86	m
Volume of water between 75% and 25% storage	0.22	m ³
Water level at 50% storage	1.83	m
Effective height at 50% storage	0.97	m
Effective surface area of hole at 50% storage	2.10	m ²
Time between 75% and 25% dissipation (from chart)	108	min *

Soil Infiltration Rate (<i>f</i>)	1.58E-05	m/s
-------------------------------------	----------	-----

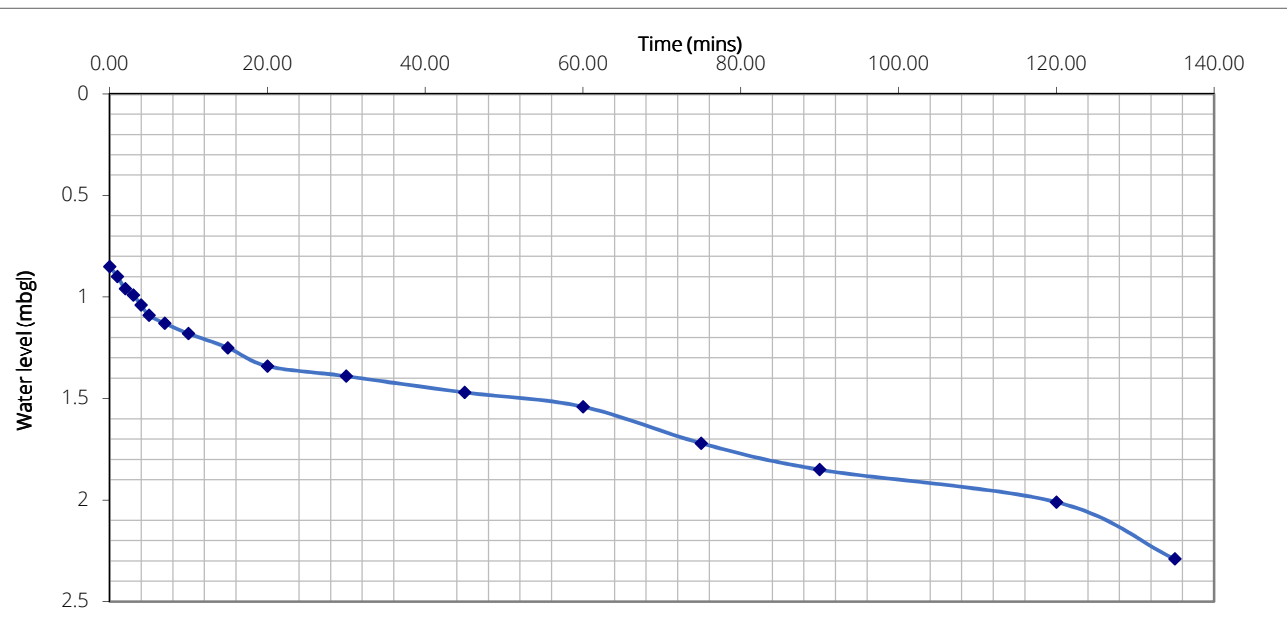
Job Name:	Tregoddick	Trial Pit:	TP03
Job Number:	19570	Test No:	3
Client:	Mr M Clydes	Engineer:	Wheal Jane Consultancy
		Date:	13/11/2018

Elapsed Time (mins)	Water Level (m)
0.00	0.85
1.00	0.9
2.00	0.96
3.00	0.99
4.00	1.04
5.00	1.09
7.00	1.13
10.00	1.18
15.00	1.25
20.00	1.34
30.00	1.39
45.00	1.47
60.00	1.54
75.00	1.72
90.00	1.85
120.00	2.01
135.00	2.29
180.00	
210.00	
240.00

Calculations		
Depth to initial water level	0.85	m
Volume of water between 75% and 25% storage	0.22	m ³
Water level at 50% storage	1.83	m
Effective height at 50% storage	0.98	m
Effective surface area of hole at 50% storage	2.13	m ²
Time between 75% and 25% dissipation (from chart)	127	min *

Soil Infiltration Rate (<i>f</i>)	1.35E-05	m/s
-------------------------------------	----------	-----

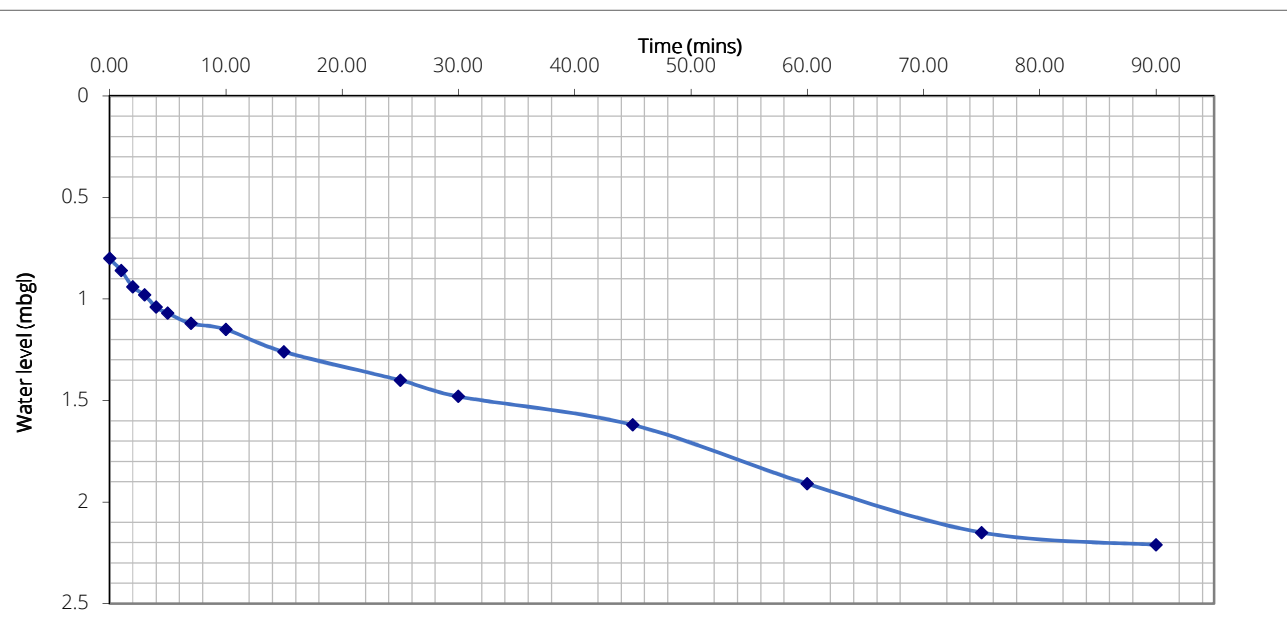
Job Name:	Tregoddick	Trial Pit:	TP04
Job Number:	19570	Test No:	1
Client:	Mr M Clydes	Engineer:	Wheal Jane Consultancy
		Date:	13/11/2018

Elapsed Time (mins)	Water Level (m)
0.00	0.8
1.00	0.86
2.00	0.94
3.00	0.98
4.00	1.04
5.00	1.07
7.00	1.12
10.00	1.15
15.00	1.26
25.00	1.4
30.00	1.48
45.00	1.62
60.00	1.91
75.00	2.15
90.00	2.21
120.00	
150.00	
180.00	
210.00	
240.00

Calculations		
Depth to initial water level	0.80	m
Volume of water between 75% and 25% storage	0.29	m ³
Water level at 50% storage	1.75	m
Effective height at 50% storage	0.95	m
Effective surface area of hole at 50% storage	2.39	m ²
Time between 75% and 25% dissipation (from chart)	75	min *

Soil Infiltration Rate (f)	2.65E-05	m/s
-------------------------------------	-----------------	------------

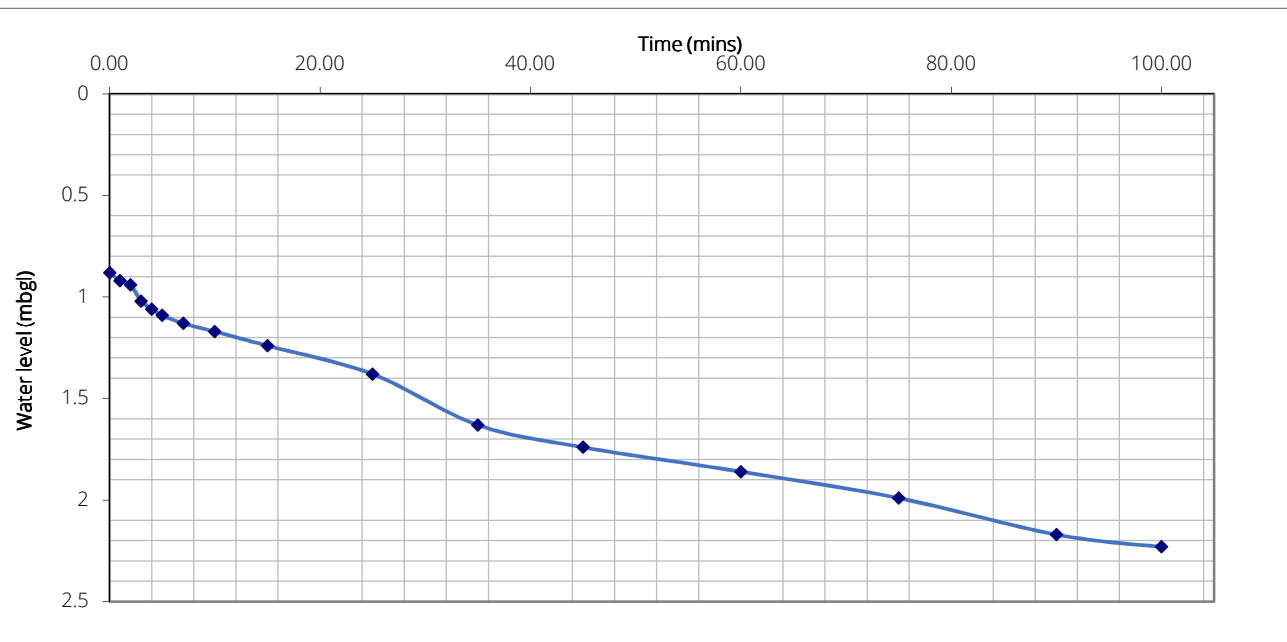
Job Name:	Tregoddick	Trial Pit:	TP04
Job Number:	19570	Test No:	2
Client:	Mr M Clydes	Engineer:	Wheal Jane Consultancy
		Date:	13/11/2018

Elapsed Time (mins)	Water Level (m)
0.00	0.88
1.00	0.92
2.00	0.94
3.00	1.02
4.00	1.06
5.00	1.09
7.00	1.13
10.00	1.17
15.00	1.24
25.00	1.38
35.00	1.63
45.00	1.74
60.00	1.86
75.00	1.99
90.00	2.17
100.00	2.23
130.00	
160.00	
190.00	
220.00

Calculations		
Depth to initial water level	0.88	m
Volume of water between 75% and 25% storage	0.25	m ³
Water level at 50% storage	1.79	m
Effective height at 50% storage	0.91	m
Effective surface area of hole at 50% storage	2.21	m ²
Time between 75% and 25% dissipation (from chart)	80	min *

Soil Infiltration Rate (<i>f</i>)	2.37E-05	m/s
-------------------------------------	----------	-----

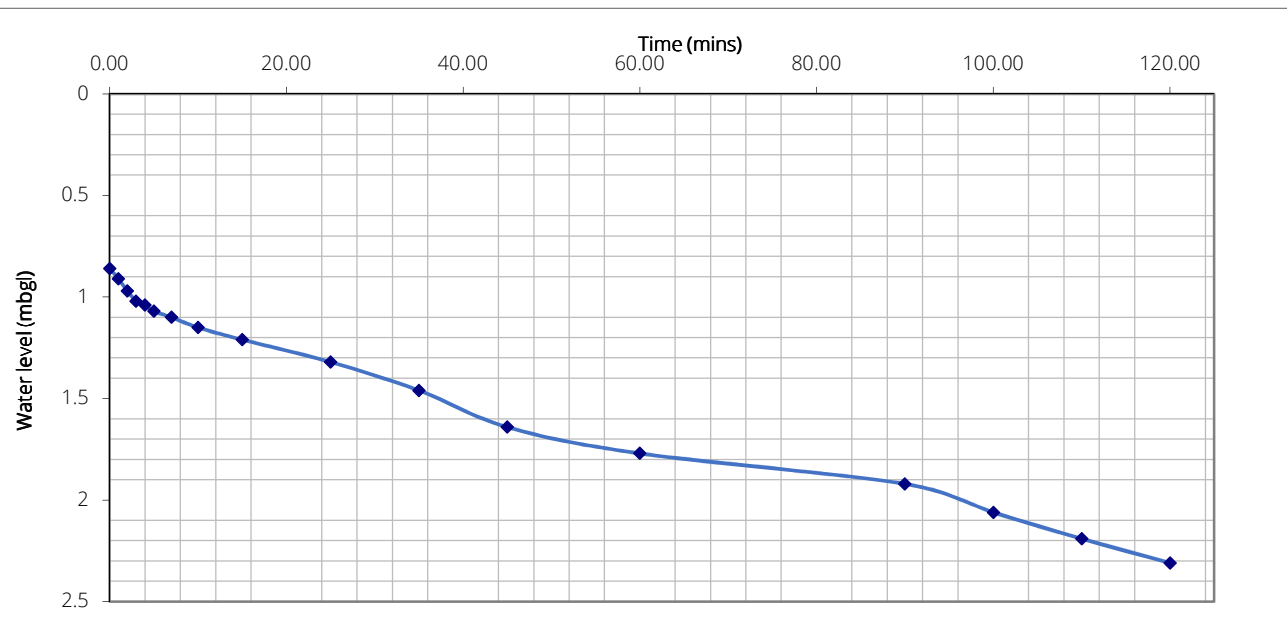
Job Name:	Tregoddick	Trial Pit:	TP04
Job Number:	19570	Test No:	3
Client:	Mr M Clydes	Engineer:	Wheal Jane Consultancy
		Date:	13/11/2018

Elapsed Time (mins)	Water Level (m)
0.00	0.86
1.00	0.91
2.00	0.97
3.00	1.02
4.00	1.04
5.00	1.07
7.00	1.1
10.00	1.15
15.00	1.21
25.00	1.32
35.00	1.46
45.00	1.64
60.00	1.77
90.00	1.92
100.00	2.06
110.00	2.19
120.00	2.31
150.00	
180.00	
210.00

Calculations		
Depth to initial water level	0.86	m
Volume of water between 75% and 25% storage	0.26	m ³
Water level at 50% storage	1.78	m
Effective height at 50% storage	0.92	m
Effective surface area of hole at 50% storage	2.25	m ²
Time between 75% and 25% dissipation (from chart)	90	min *

Soil Infiltration Rate (<i>f</i>)	2.13E-05	m/s
-------------------------------------	----------	-----
