**Bat and Bird Survey for,  
Ann Burford.  
Buildings at,  
37 Stockhay Lane,  
Hammerwich,  
BURNTWOOD,  
Staffordshire,  
WS7 0JE.**

**Map Ref SK 0699 0838  
15<sup>th</sup> March 2021.**

**S. Christopher Smith MRICS MSc CEnv.  
The Hayloft,  
Farm Lane,  
Grendon,  
ATHERSTONE,  
Warwickshire.  
CV9 3DR  
01827 713324**

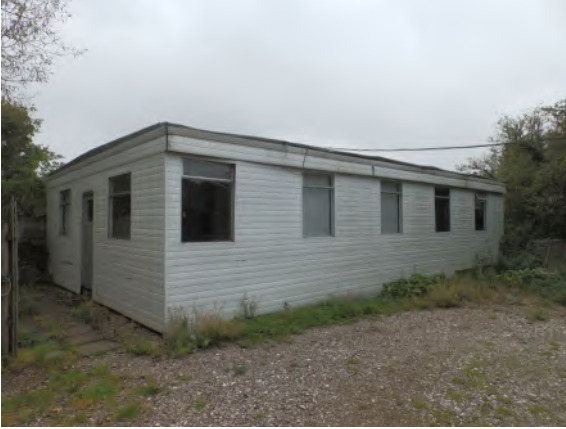
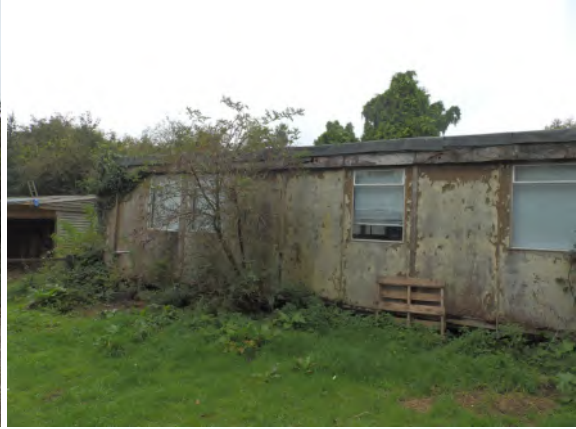
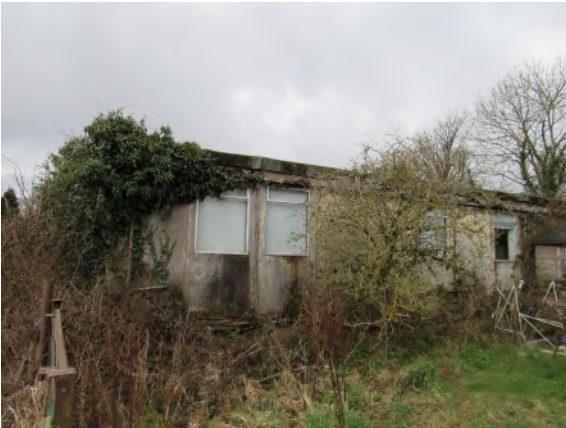
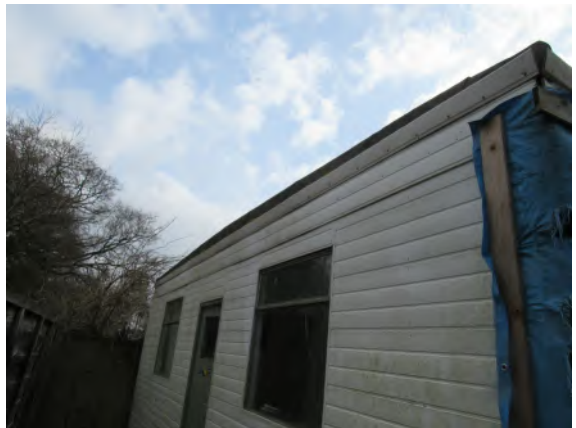
This is a metal framed portable building with a shallow pitched roof.

The walls were clad in timber with a waterproof paint finish when the building was new. Water penetration of the original structure has occurred and this has resulted in the roof being over clad with a new mineral felt roof covering and areas of uPVC cladding fixed to the timber.

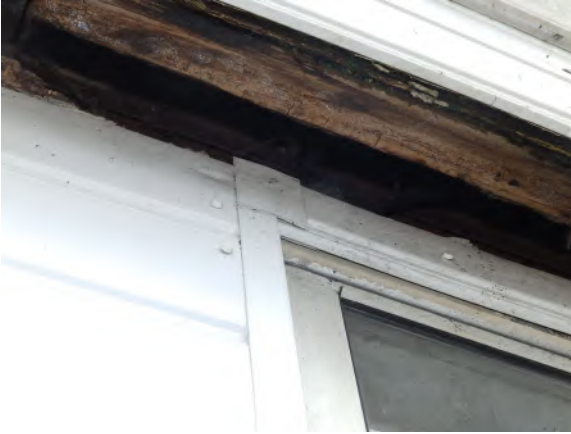
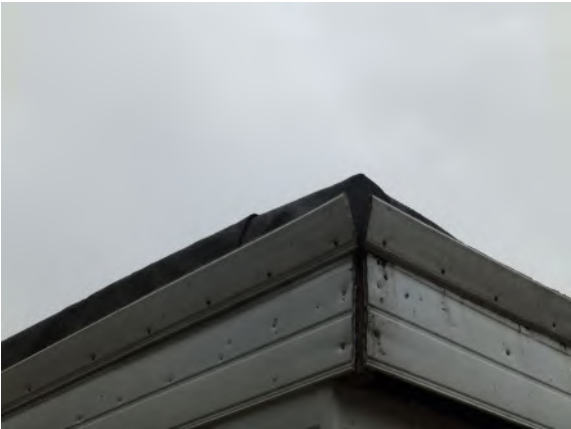
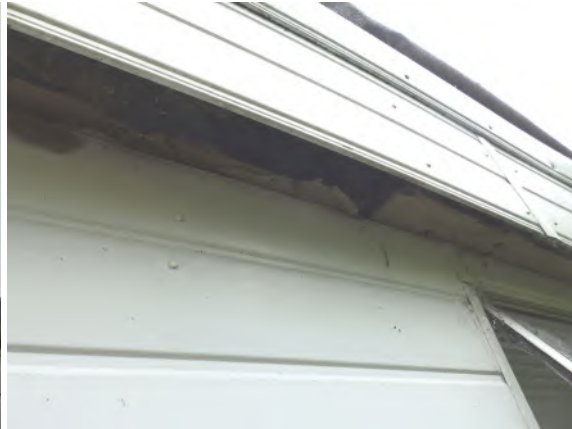
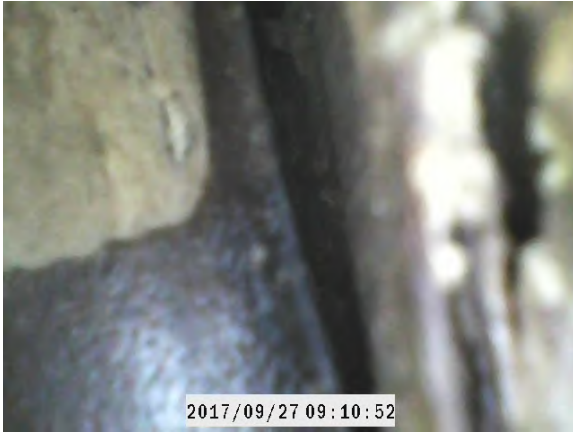
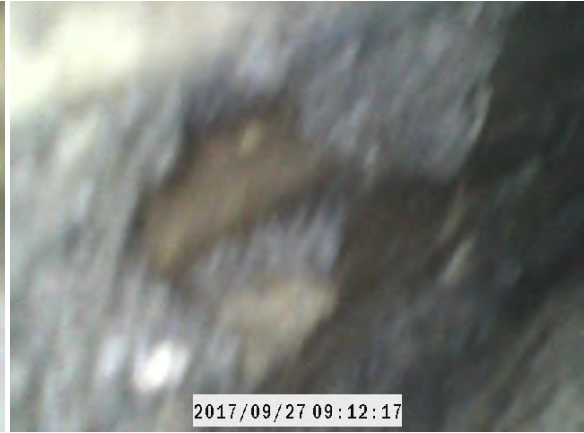
Water penetration has continued with the timber of the soffits beginning to collapse.

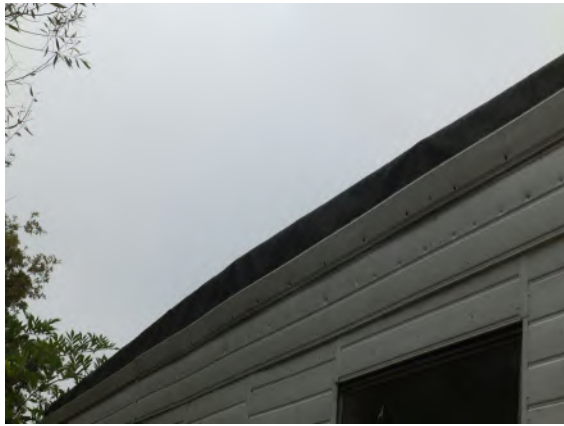
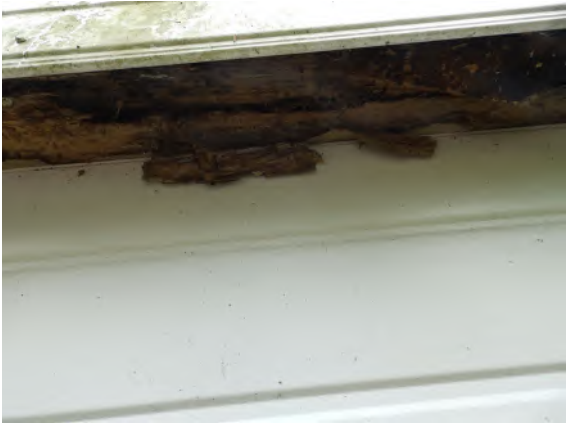
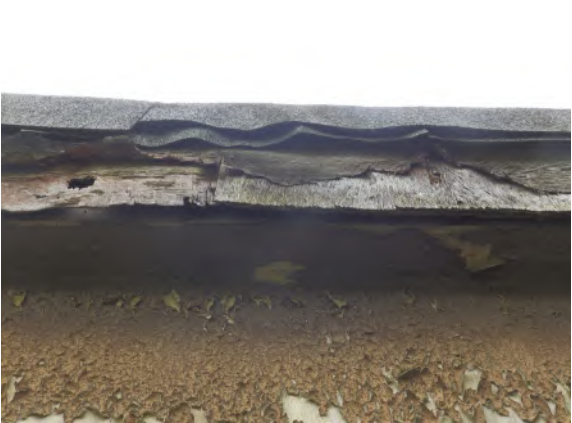
This has created a temporary place of shelter for individual bats but there is no access to the roof space of the original building which is seen with the endoscope beneath the new roof covering.

There are temporary roosting opportunities for bats in the soffit of the portacabin where wet rot has caused the soffit to collapse. This area is small, exposed to weather and water penetration and would only be used by individual bats during periods of warm and dry weather. The bat consultant believes the likelihood of this space being used is very small and does not require emergence surveys to be undertaken.

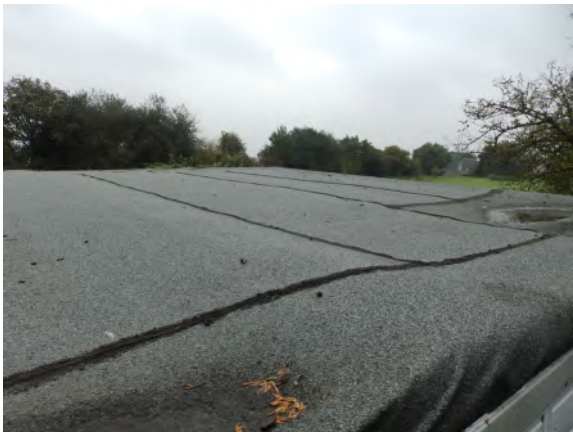
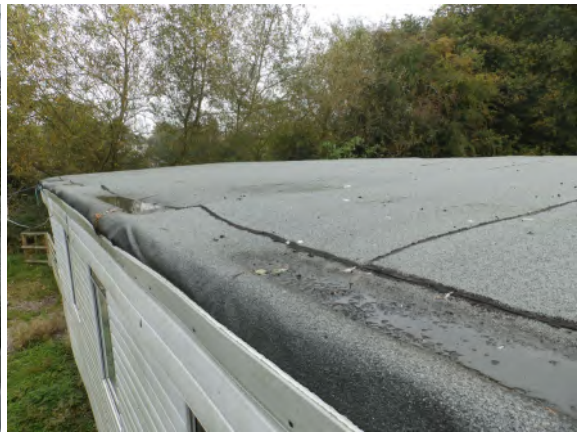
This temporary place of shelter could only be used in periods of warm and dry weather by individual bats but the surveyor believes this use is highly unlikely.

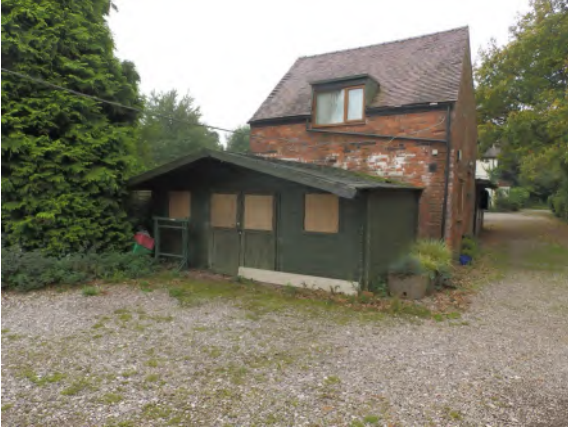
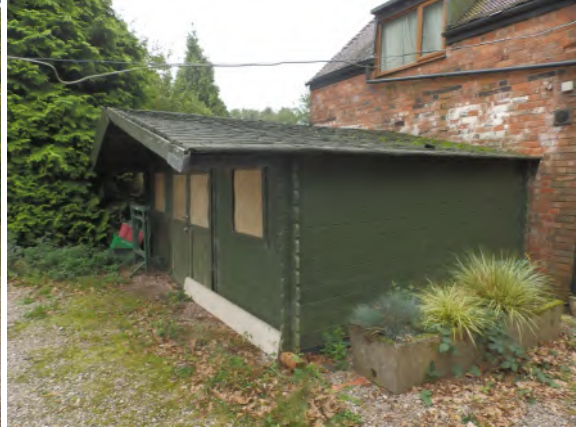
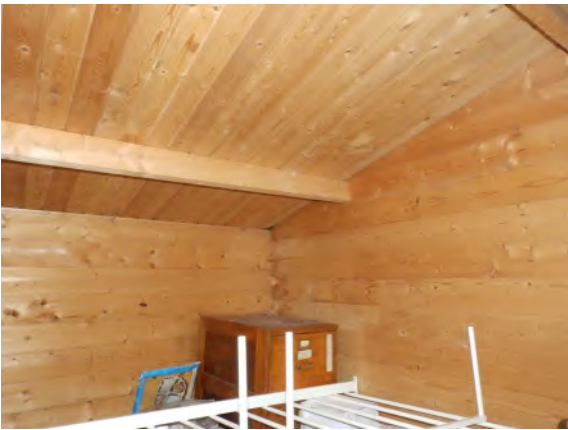
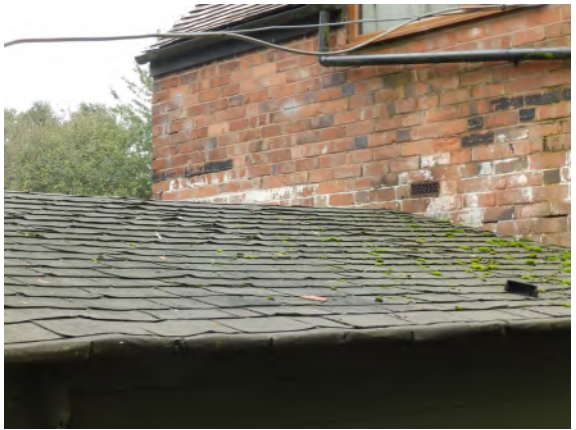
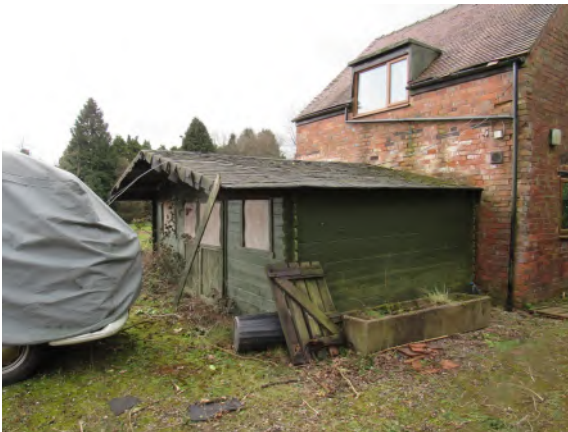
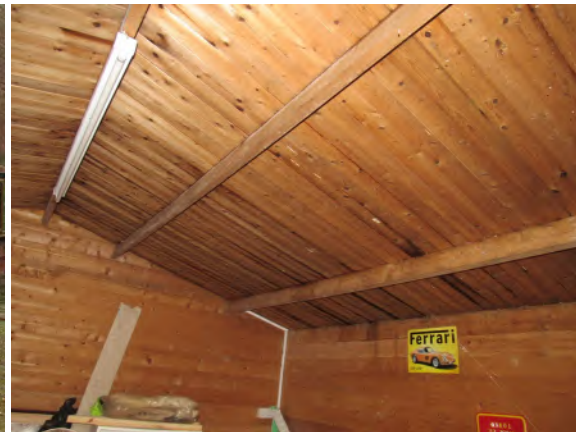
This is a timber framed building with timber plank sides and bitumous roofing membrane shingles on top of a timber plank roof.

The building offers no places of shelter for bats.

There are no birds nesting in the building.

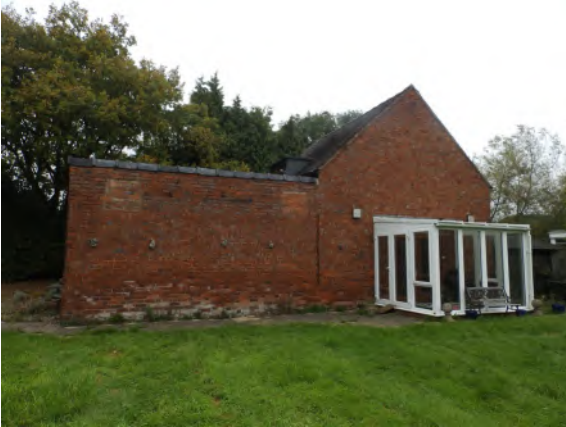
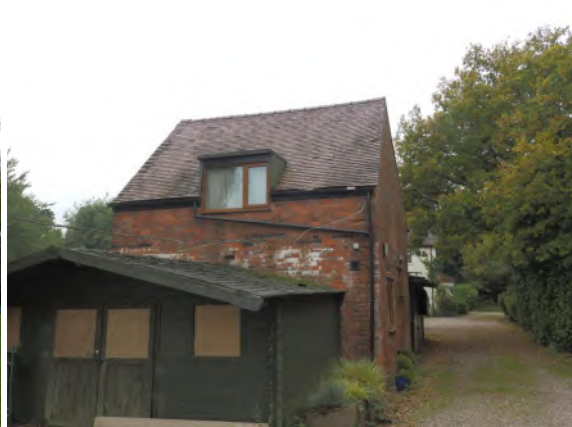
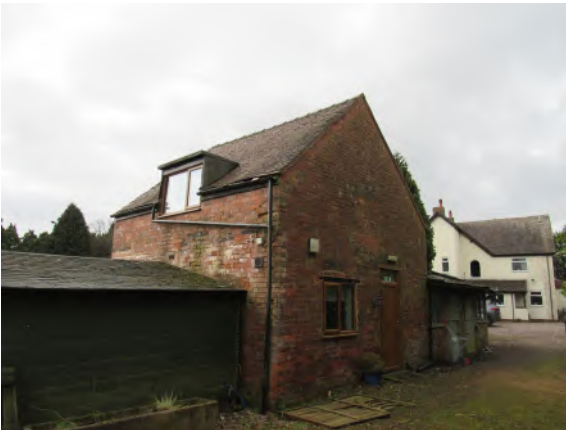
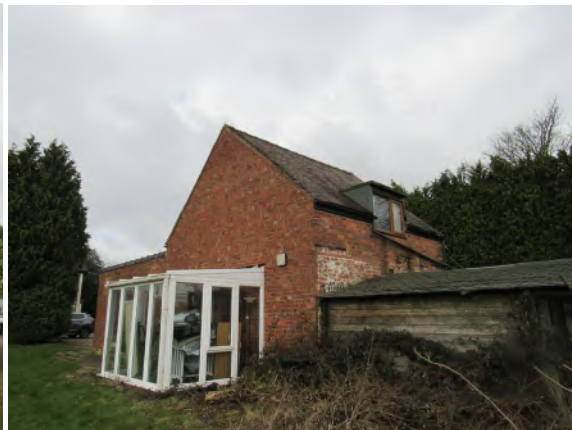
This is a two storey brick barn that is currently used as ancillary accommodation to the dwelling.

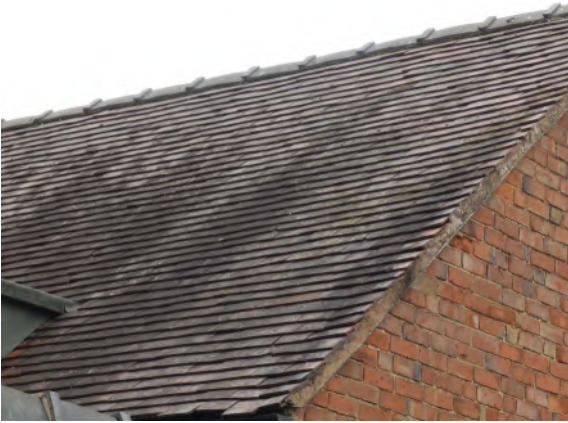
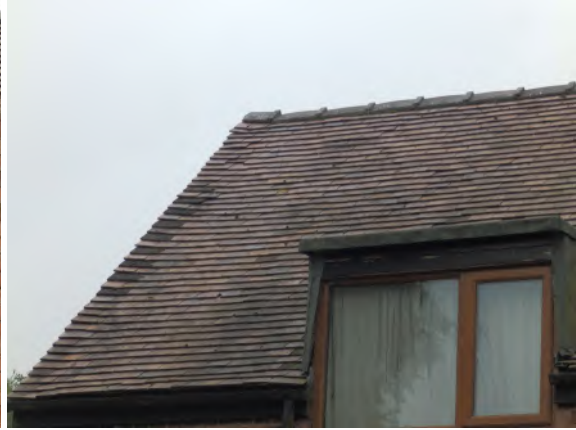
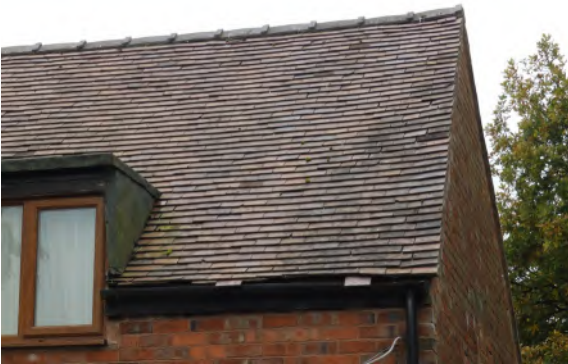
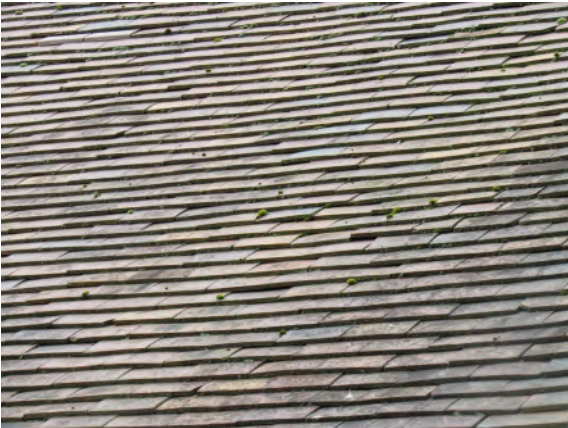
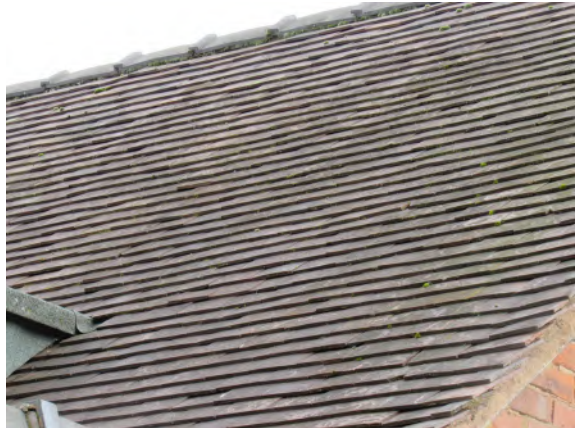
The buildings has solid brickwork with a pitched roof supported on timber rafters. The roof space of the building has been fully incorporated into the living space. There are plain tiles on the roof above a bituminous underfelt.

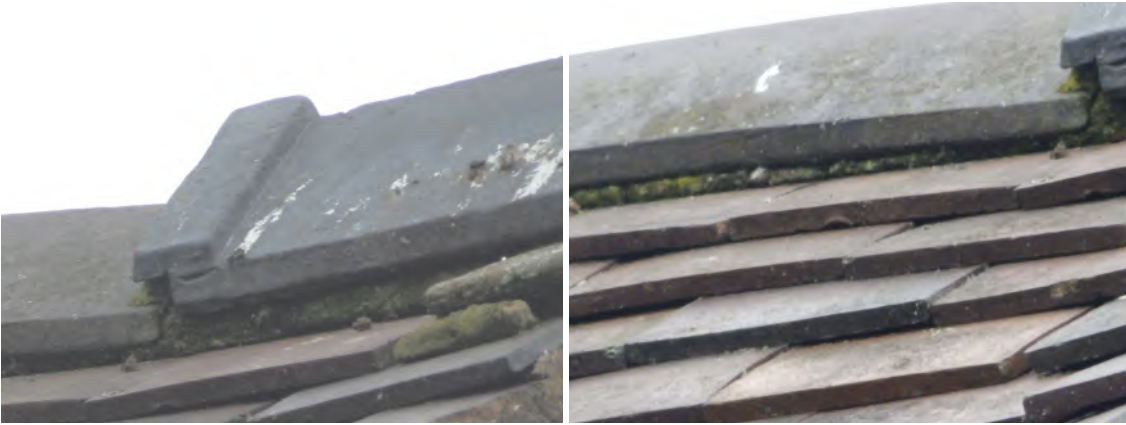
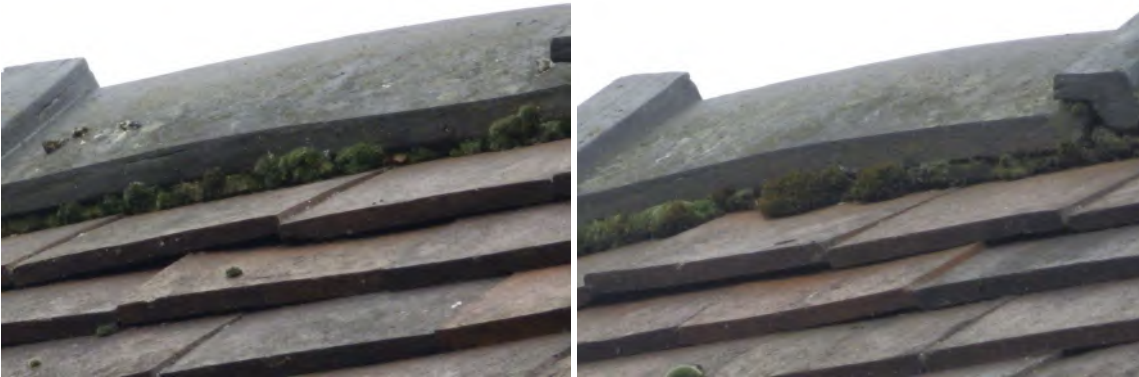
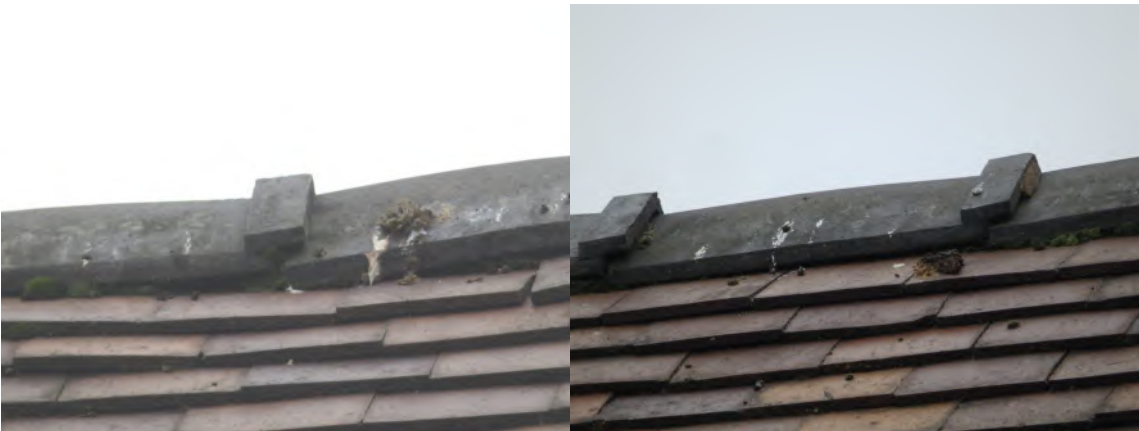
2017.

There is no access under the plain tiles and there are few gaps under the ridge tiles that give access for bats to the rear of the ridge tiles. The accesses are partially filled with mortar and may not extend under the ridge tiles.

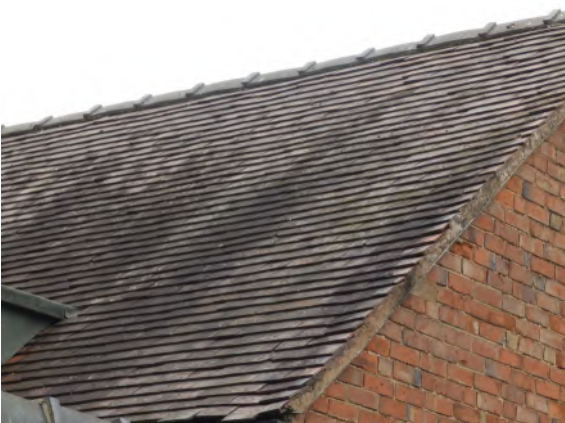
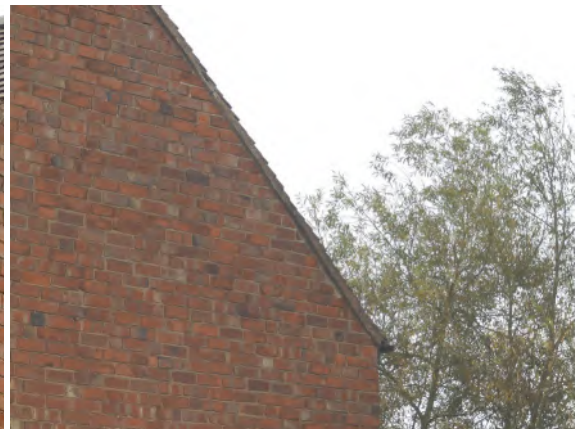
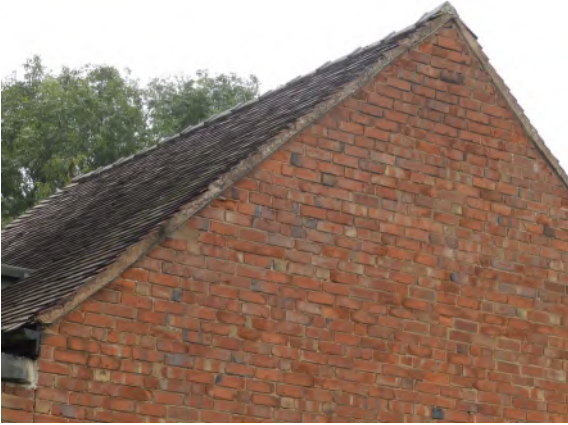
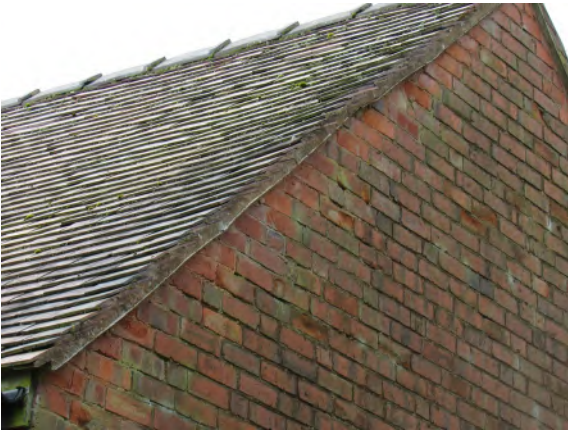
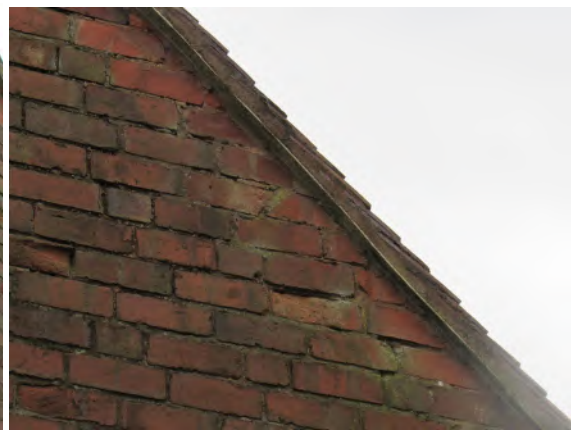
There is no access at the verges.

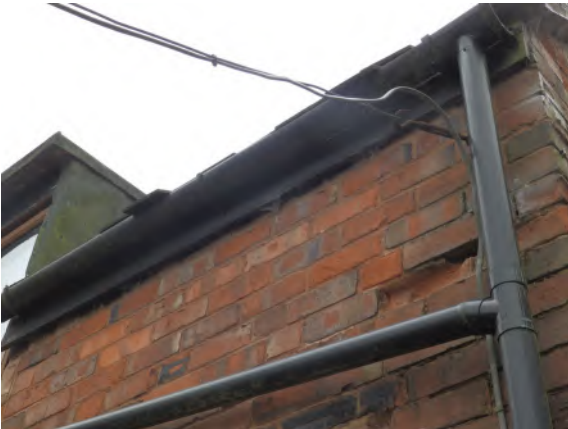
The eaves are closed with a timber fascia board and there is no access for bats.

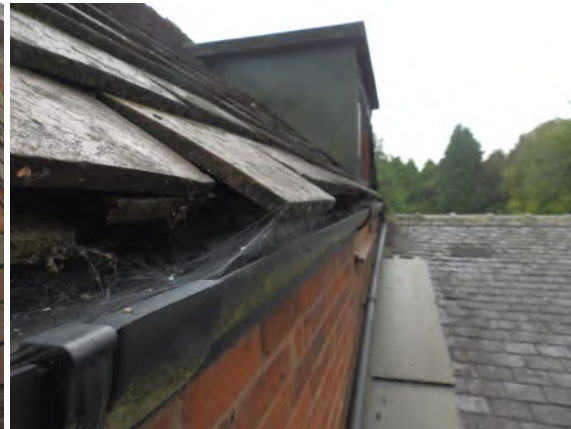
**2017.**

There has been warping of the fascia board which now creates a temporary place of shelter for crevice dwelling bats.

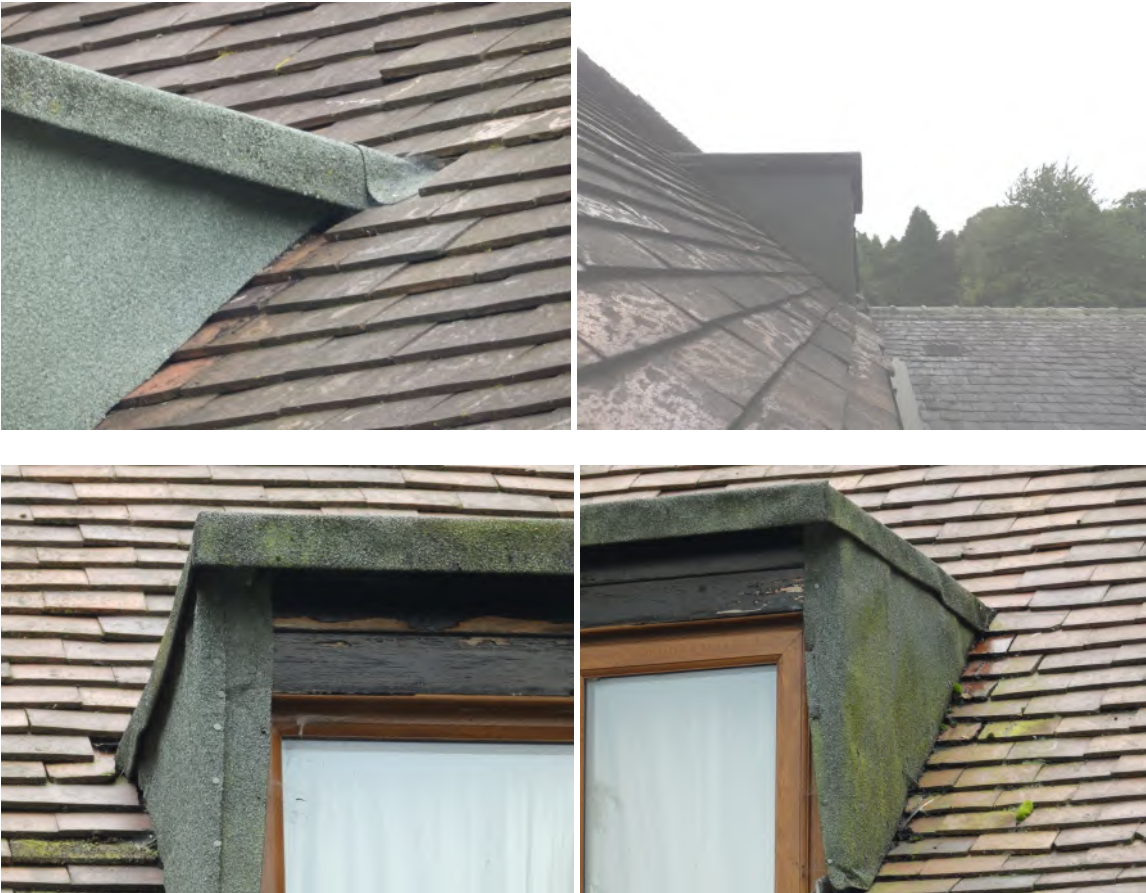
**2017.**

There are two dormer windows with bituminous mineral felt sides and roof. There is no access for bats.

The bituminous felt that covers the sides of the dormer windows is coming loose on the eastern elevation dormer. This provides a temporary place of shelter for individual bats but there is no access to the roof space and this area is open to weather penetration.

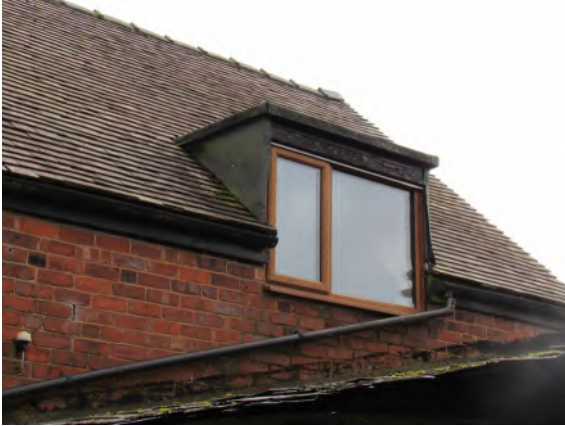
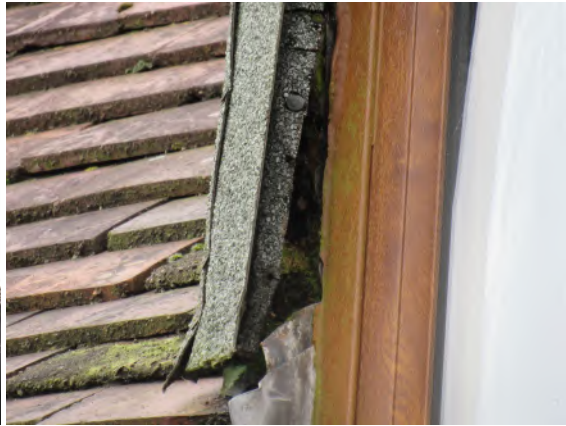
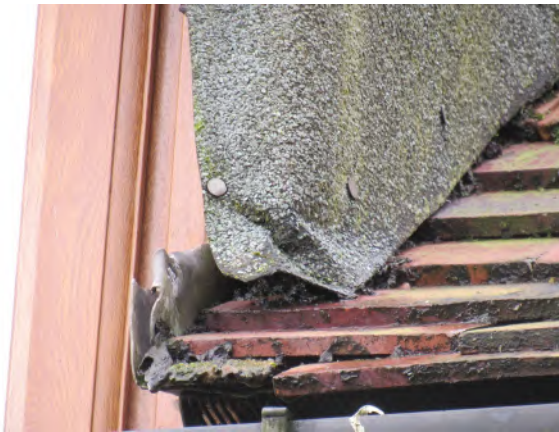
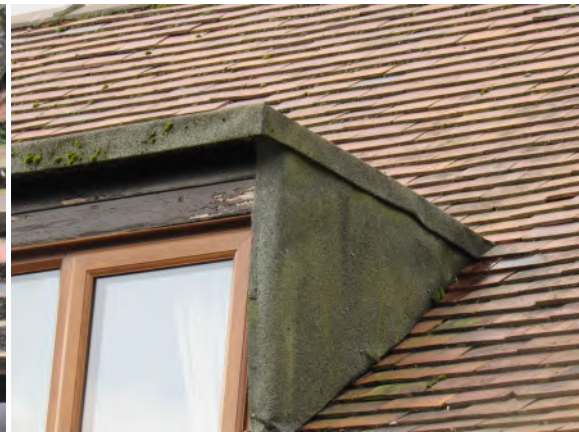
The building offers only poor places of shelter for bats.

There are no birds nesting in the building and no opportunities for birds to nest.

There had been no increase in the bat roosting opportunities for bats when the site was visited in March 2021.

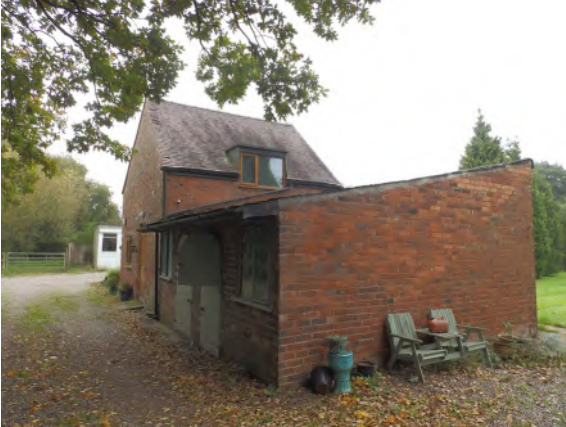
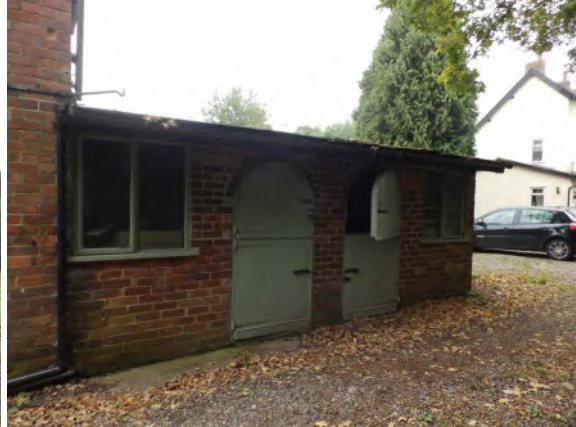
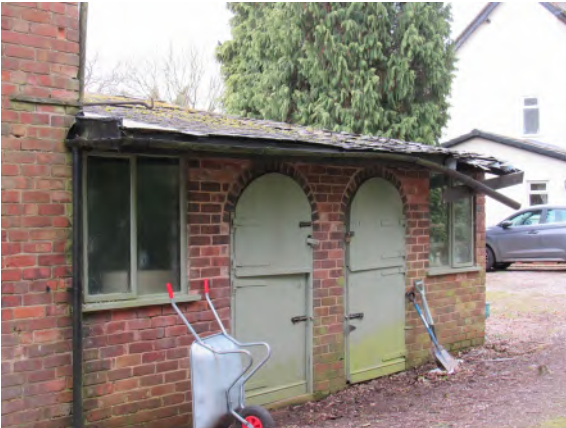
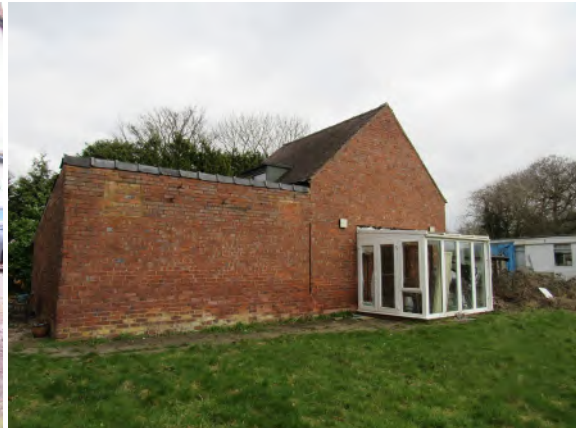
These are a single storey solid brick building with a mono pitch roof.

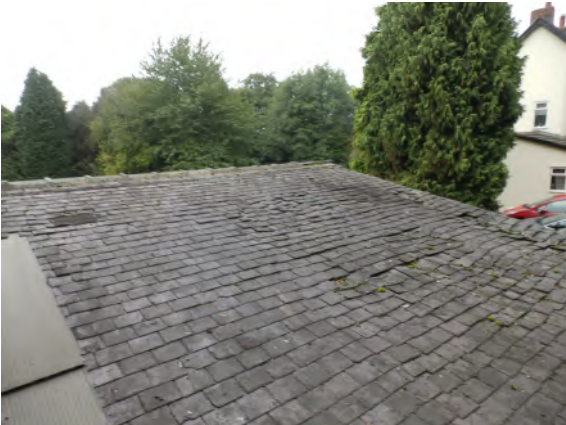
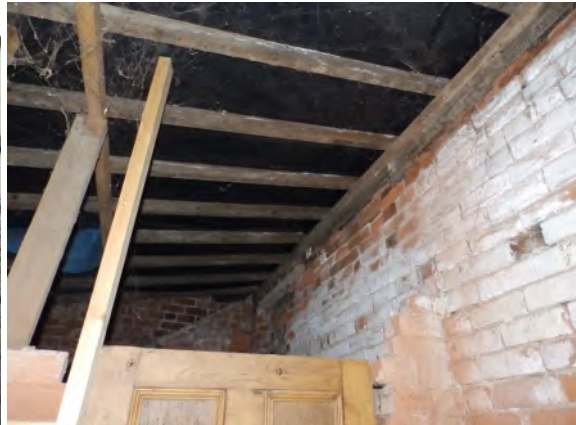
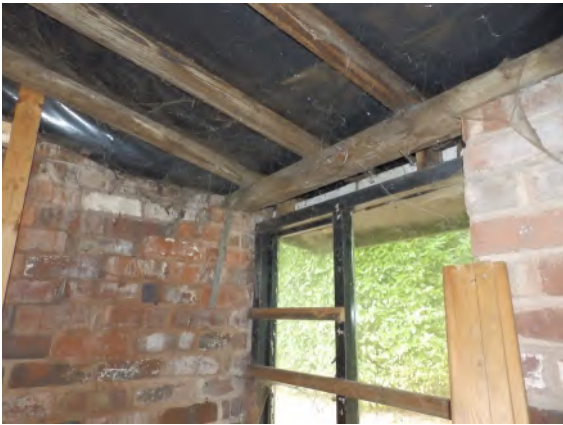
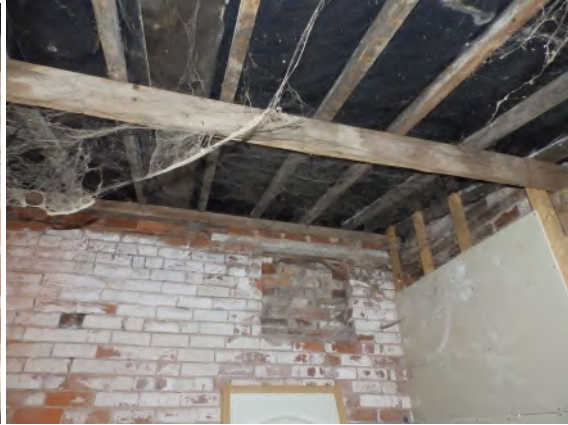
**2017.**

The roof is supported on timber rafters with a heavy duty polythene sheet roofing membrane. There are slates on the roof.

The slates have slipped in the centre where the timber beneath is broken. This allows bat access to the rear of the slates but the polythene roofing membrane makes this area unusable by bats because of their inability to crawl across the smooth surface.

There are cobwebs in the roof space indicating no use of the inside of the building by bats.

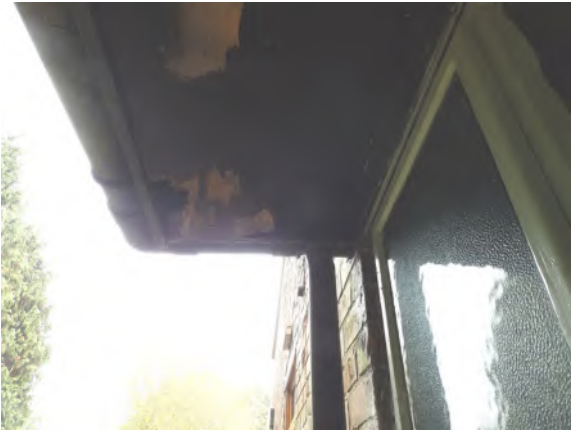
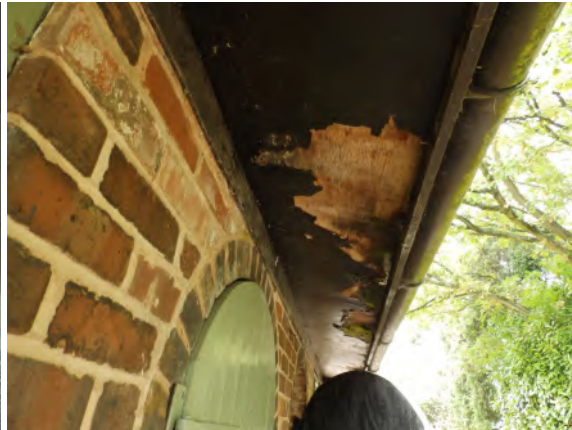
**2017.**

There is a timber soffit at the front of the building with no access for bats. There is no access for bats at the verge.

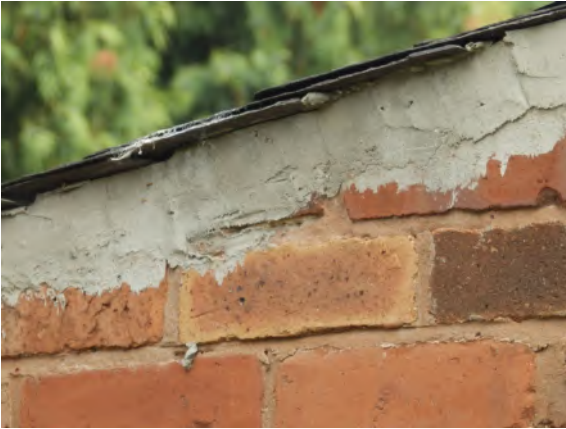
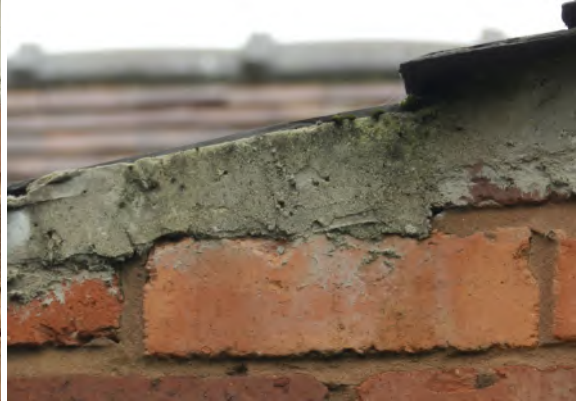
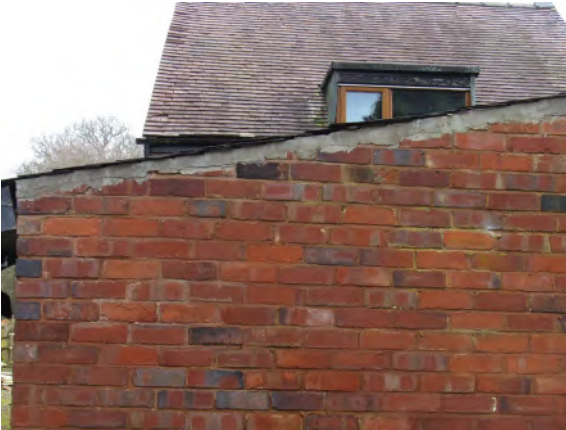
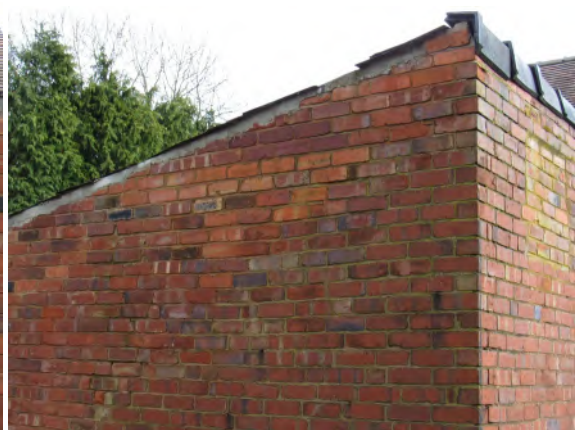
The ridge of the mono pitch roof is closed by a ridge tile placed at an angle over the timber wall plate. There is a cavity beneath the ridge tile and this has been used by bats with three small elongated bat droppings being visible when the area was search with an endoscope in 2017.

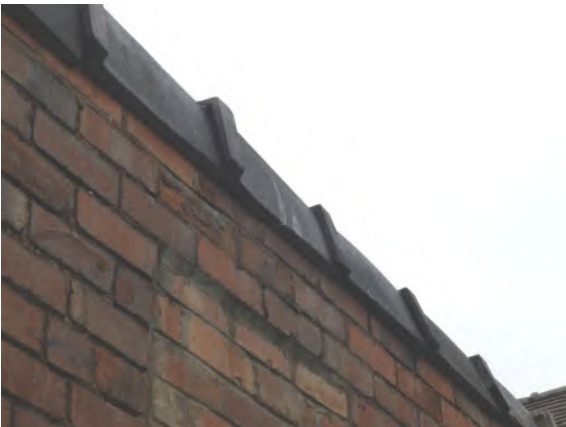
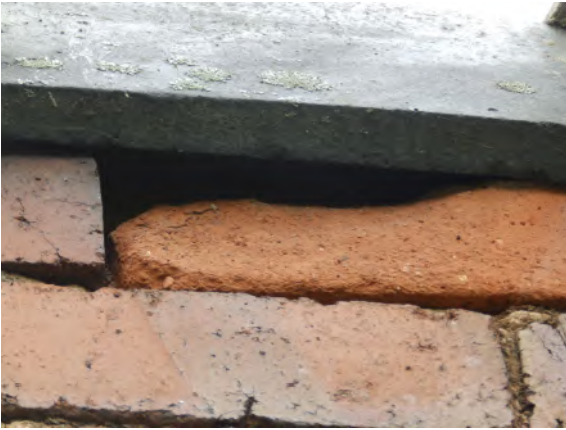
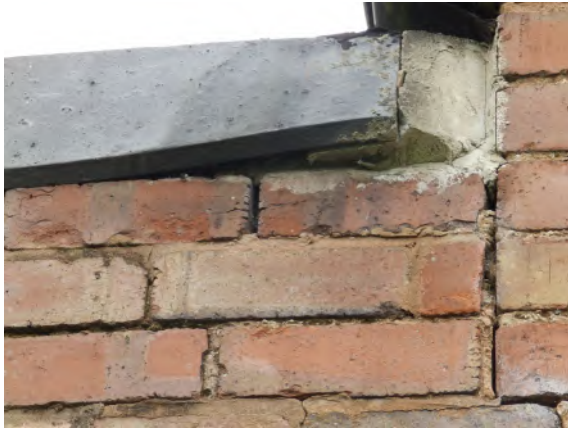
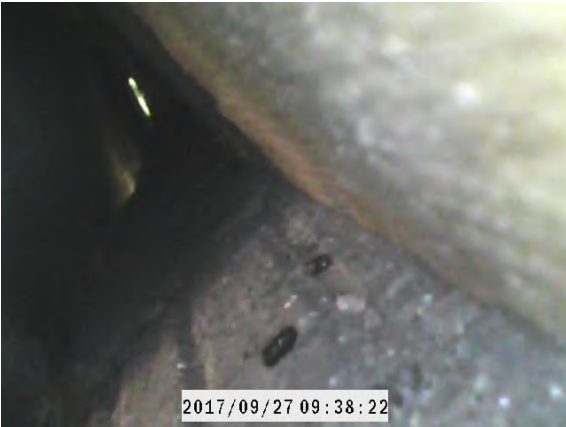
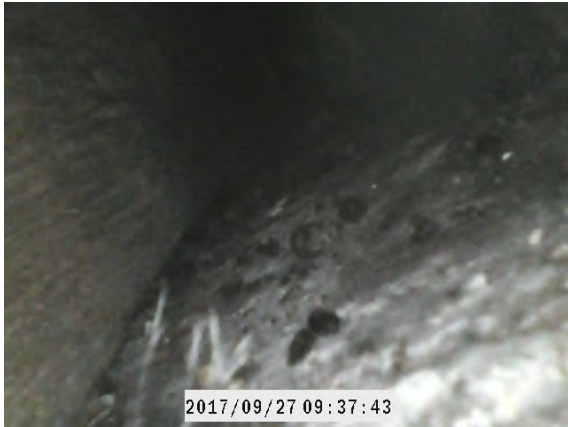
**2017.**

The droppings could be from mice but the slightly nobby texture make this unlikely, mouse droppings being more torpedo shaped and smoother surfaced.

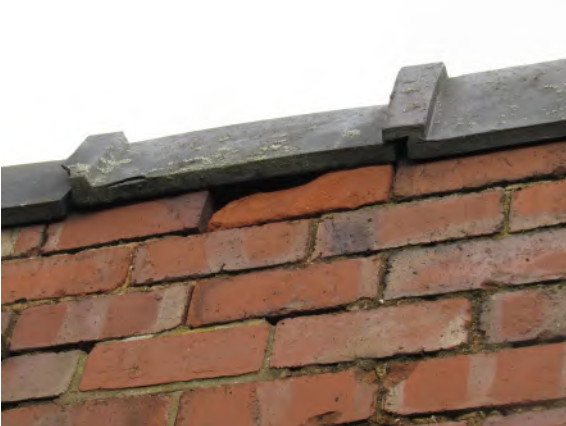
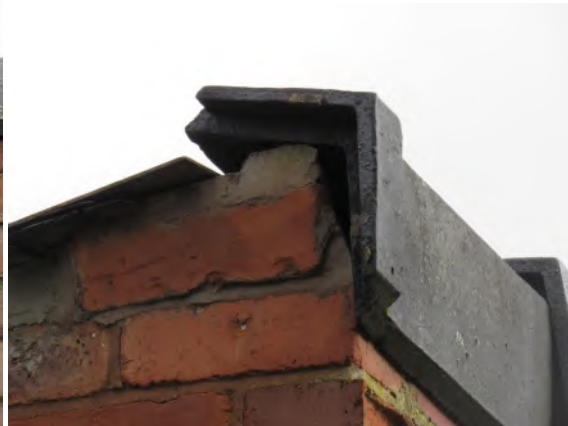
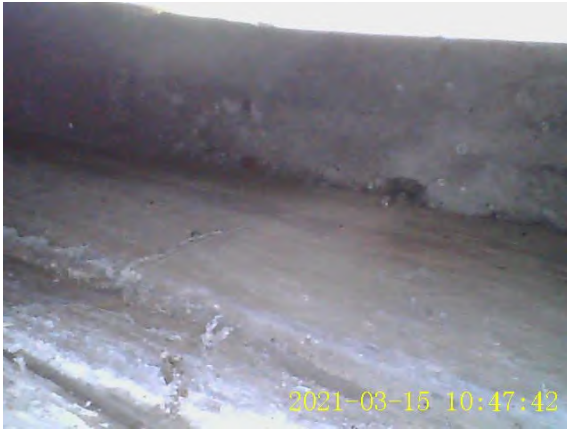
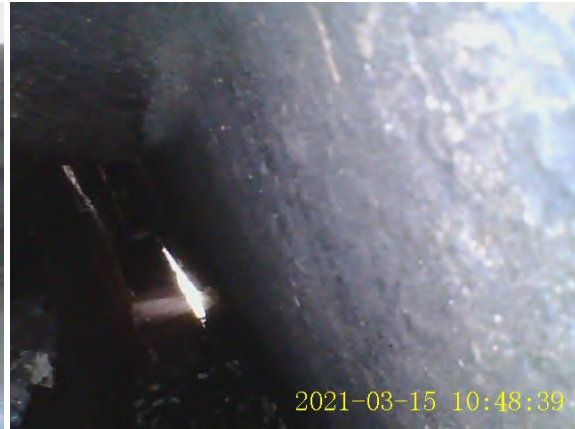
**2021.**

No bat droppings were found in 2021.

There is access to the rear of the ridge tile for birds but there was no evidence of nesting.

**Bat roosting potential; Definite.**

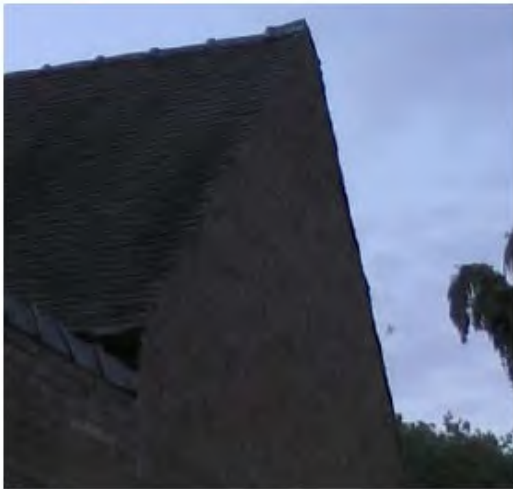
Time.	Direction.	Activity.	Species.	Notes.
21:21	1a	E?	NH	From roof of 2 storey barn (see video 15:34 and screen shot below)
21:23	1b	C	Pip	From tree in garden on RHS of surveyor– same bat?
21:38	2	C	CP	From house towards barn – to back of barn – around trees then to garden then back to house
21:39	1b	C	CP	from tree in garden on RHS of surveyor to house.

From the emergence surveys it has been seen that individual Common pipistrelle bats are using the accesses under the ridge tiles and roof tiles of the two storey barn as a place of shelter, and the ridge tiles of the stables as a place of shelter.

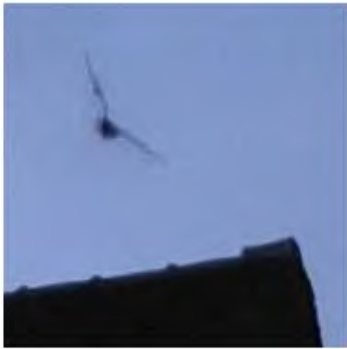
over barn roof

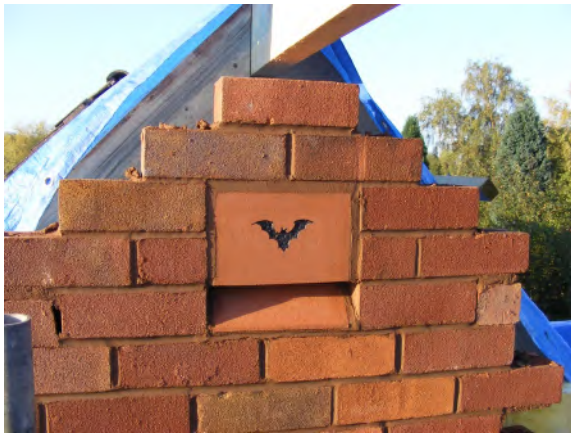
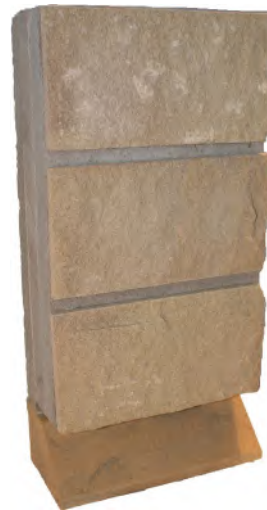
A brick built bat box can be installed at the gable apex of one elevation on each of the new dwellings, should planning permission be granted. These are constructed from brick or concrete blocks and are built into the outer leaf of brickwork. They can have facing bricks or be rendered. They provide no access to the cavity wall.
