Bat & Protected Species Survey,
Bat Emergence Survey & Bat Activity Survey

Great Trill Farm
Pudleylake Road
Musbury
Devon
EX13 8TU

Planning Reference:		Report Reference:	201207 rev00
Client/s:	Roland De Hauke		
Architect/Agent:	Martin Blake Associates Ltd.		
Survey Date/s:	8 th January, 10 th May & 7 th June 2021		
Report Date:	July 2021	OS Grid Refs:	SY 29093 95635 SY 29076 95680
Report Author:	William Corbett BSc (Hons), MRes		
Approved By:	Andrew Charles BSc (Hons), MSc, MCIEEM		
Surveyor/s & Licence N°:	James Baker	Bats: 2015-12067-CLS-CLS (WML-A34 – Level 2)	
Additional Surveyor/s:	William Corbett, Andrew Charles, Dominic Sheldon, George Greenshields, Ian Crowe, Adrian Bayley, Andrew Baker, Megan Hobbs, Andrew Hobbs, Ruth Cooper & Will Robinson

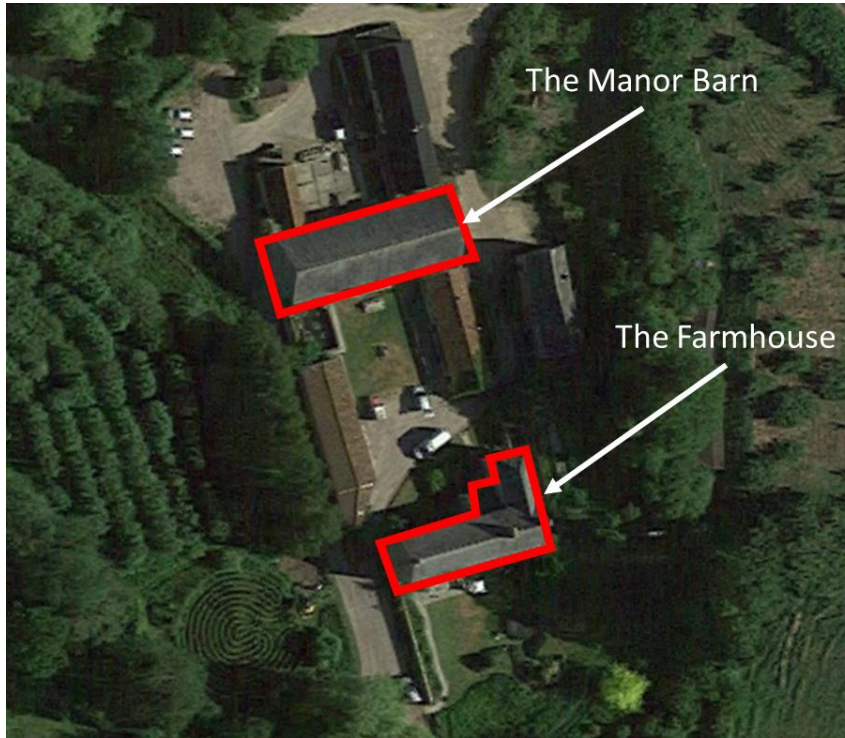
Figure 1. The Farmhouse and Manor Barn at Great Trill Farm

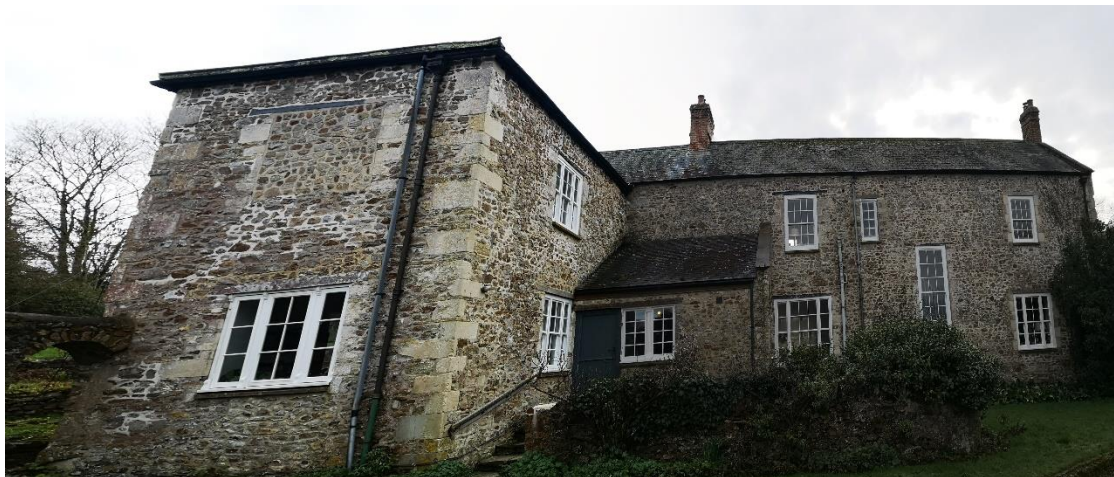
Figure 2. The northern and western elevations of the Farmhouse

The traditional farmhouse is an L-shaped two-storey building with a modern porch extension on the northern elevation (Figures 2 & 3). The main pitched roofs are constructed of original timbers and have a covering of slate tiles, no underlining is present. The attached porch has a covering of slates and has an underlining of bitumen roofing felt. The walls are constructed predominantly of stone which is partially rendered, with some brick and concrete block.

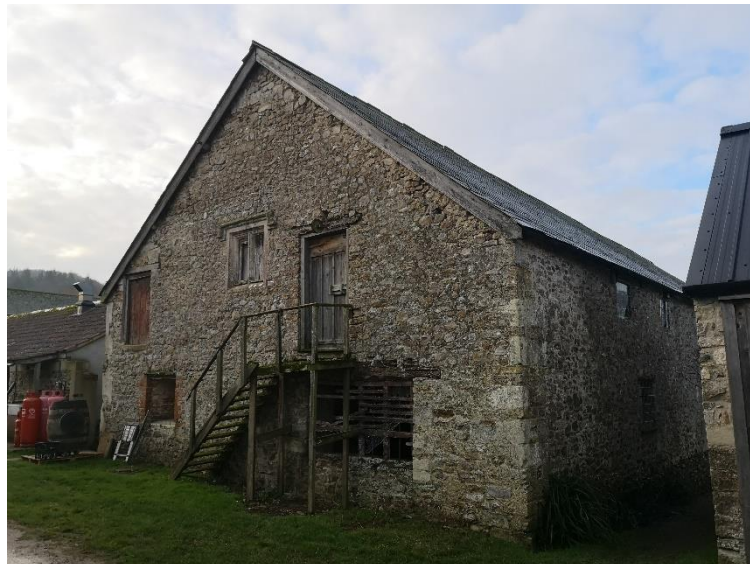
Figure 4. The eastern gable and northern elevation of the Manor Barn

The Manor Barn is a large, pitched roof barn with a separate building attached on the northern elevation (Figures 4 & 5). The pitched roof is constructed of original timbers with a covering of slates and clay ridge tiles, no underlining is present. There are wooden fascias and barge boards present. The walls are constructed primarily of stone, with an extent of brick reveals and arches and concrete block repairs. The eastern extent has two floors, the western extent of the barn is a large open space to the roof.

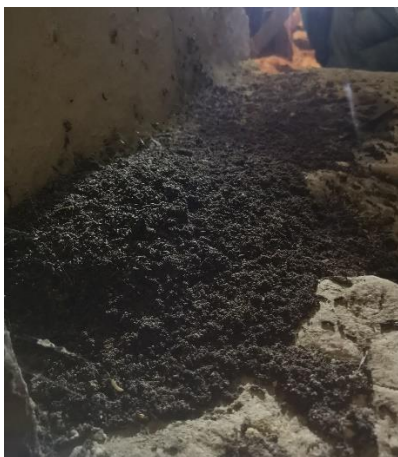
Actual field signs of bats included ~10,000s of predominantly lesser horseshoe bat droppings within the loft void of the Farmhouse (Figure 6). A myotis species bat was observed hibernating within a stone crevice within the loft void.

Figure 6. A concentration of the 1,000s of lesser horseshoe bat droppings within the loft void of the Farmhouse

- Within the Farmhouse, it is understood following completion of the works the loft void will be re-instated including retention of the 'free-flight' access point for lesser horseshoe bats on the eastern elevation. Combined crevice positions within the loft void in the form of four wooden bat boxes will also need to be provided. Re-instatement of the three 'crevice' bat access points on the roof and ridge will also be required (see Appendix 2);

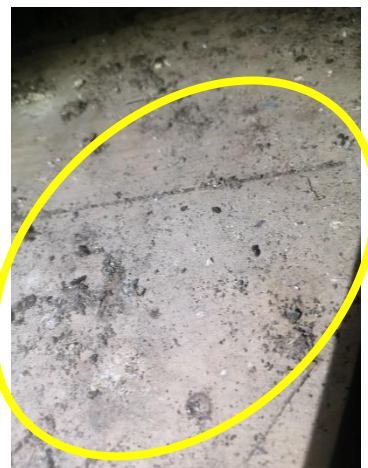
Actual field signs of bats included a brown long-eared bat hibernating within a ceiling joist on the ground floor of the eastern extent of the barn. The mezzanine floor within the eastern section of the barn included approximately 200 medium-sized droppings which DNA analysis revealed to be from a Natterer’s bat (Figure 7). A large concentration (~1000s) of lesser horseshoe droppings was observed within a grain hopper at the eastern extent of the barn. A scattering of long-eared droppings was observed within the western extent of the barn.

Figure 7. A scattering of Natterer's bat droppings on the mezzanine floor within the eastern extent of the Manor Barn

- Within the Manor Barn, it is understood that the loft void at the eastern extent of the barn will be retained for bats. Combined crevice positions within the loft void in the form of six wooden bat boxes will also need to be provided. A 'free flight' access point measuring 400 mm x 300 mm is recommended to be installed on the eastern elevation/aspect of the barn into the loft void (see Appendix 3). On the western extent of the loft void it is recommended a 400 x 300 mm gap is created allowing bats to access the unconverted western extent of the barn. Installation of 'crevice' bat accesses in the form of four ridge tile accesses and four access slates on the roof of the barn will also be required (see Appendix 2);

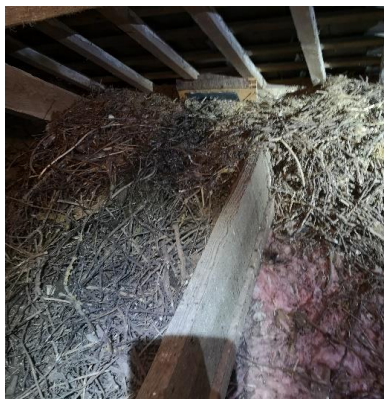
Two corvid nests were observed within the loft space of the Farmhouse (Figure 8).

Figure 8. A corvid nest within the loft void of the Farmhouse

Ideally building works and any vegetation removal should be scheduled to commence outside of the bird-nesting season (March to August inclusive), removing any potential for undue delay/s caused by nesting birds. Alternatively, if works are to be commenced during the bird nesting season, a nesting bird check would be required to confirm the presence or absence of active bird nests, with any active nests protected accordingly.

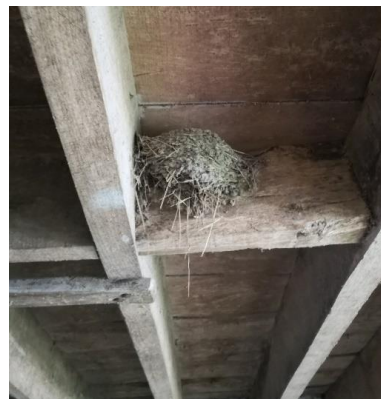
Multiple corvid, swallow (Figure 9), small passerine and robin/wren nests were observed throughout the barn.

Figure 9. One of the many swallow nests observed within the Manor Barn

- Two sparrow terrace nesting provisions – positioned within external walls of the on-site buildings (see Appendix 4);
- A dedicated swallow roosting area incorporated into the Manor Barn (unconverted western extent, eaves overhang box) or alternative structure. The swallow nesting area is to be supplemented by five nesting cups to encourage use by swallows (see Appendix 4);

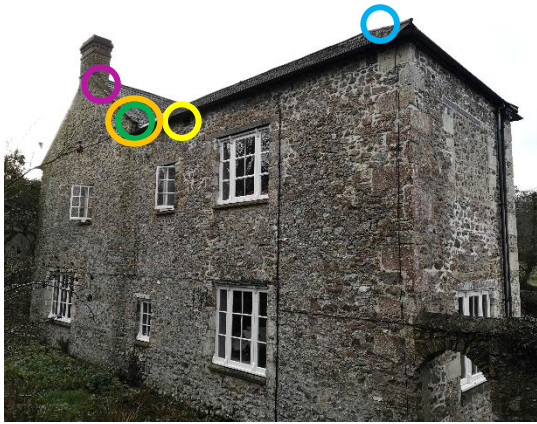
At the start of the survey, 12 lesser horseshoes were observed roosting within the loft void of the farmhouse. Eight lesser horseshoe bats were subsequently recorded emerging from the 'free flight' access point on the eastern elevation of the Farmhouse between 20:51 & 21:20 (see Figure 10). A number of these bats were observed light sampling and hanging up within the 'bovey' kiln to the north of the building.

A long-eared bat was recorded emerging from the roof join on the eastern elevation of the Farmhouse at 20:55 (Figure 10).

Ten lesser horseshoe bats were recorded emerging from the 'free flight' access point on the eastern elevation of the Farmhouse between 21:39 & 21:55 (Figure 10). A number of these bats were observed light sampling before emerging fully.

Figure 10. Locations of the emerging lesser horseshoe bats (yellow), long-eared bat (green), whiskered bat (purple), soprano pipistrelle (blue) and barbastelle (orange) from the northern and eastern elevations of the Farmhouse

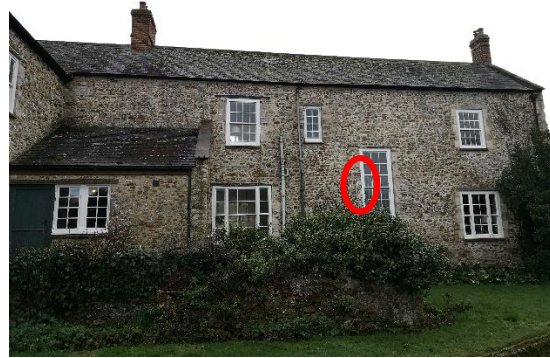
A common pipistrelle bat emerged at 21:12 from a gap beside a window frame on the northern elevation of the Farmhouse (Figure 11).

Figure 11. Locations of the emerging common pipistrelle bats (red) from the northern elevation of the Farmhouse

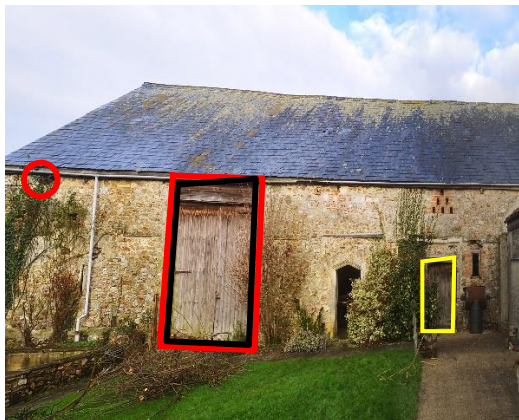
Two common pipistrelle bats were recorded emerging from the eaves on the southern elevation of the barn at 20:54 and 21:01 (Figure 12). A further two common pipistrelle bats were recorded emerging from the large opening on the southern elevation of the barn (Figure 12). Two common pipistrelles emerged from above the barn door on the eastern elevation of the Barn at 21:10 and 21:20 (Figure 13).

A lesser horseshoe bat was recorded light sampling within the barn at 21:12. A lesser horseshoe was later observed emerging from a door opening on the southern elevation of the barn (Figure 12). At 21:22 two lesser horseshoe bats were observed roosting/remaining within the barn.

Figure 12. Locations of the emerging common pipistrelle bats (red), serotines (black) and lesser horseshoe (yellow) from the southern elevation of the barn

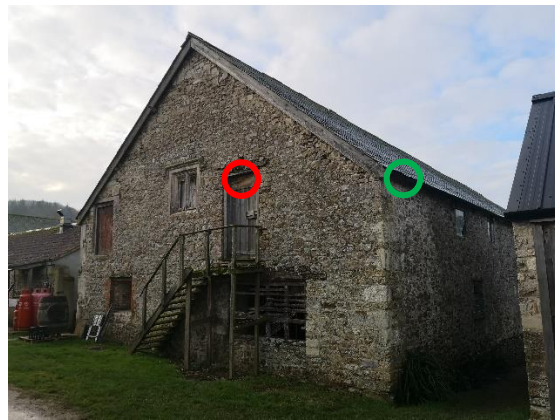
A Natterer's bat emerged from the eaves of the barn on the northern elevation at 21:15 (Figure 13).

Figure 13. Location of the emerging common pipistrelle bats (red) and Natterer's bat (green) from the eastern and northern elevation of the barn

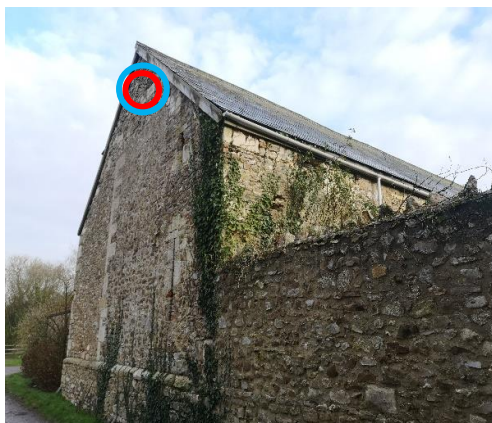
Figure 14. Locations of the emerging common pipistrelle bat (red) and soprano pipistrelle bat (blue) from the western elevation of the barn

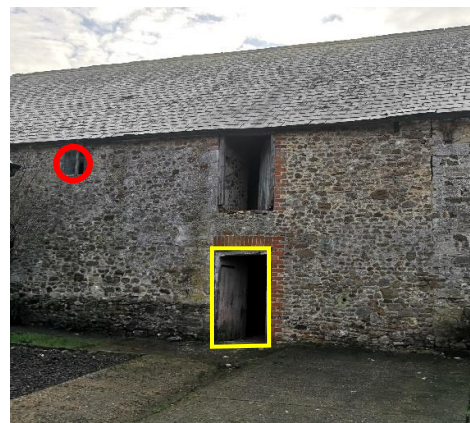
Figure 15. Location of the emerging common pipistrelle bat (red) and lesser horseshoe bat (yellow) from the northern elevation of the barn

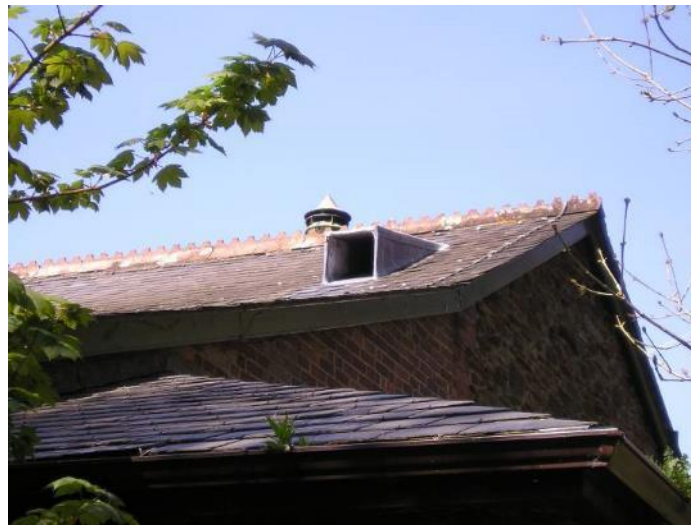
Dormer type entrance suitable for horseshoe bats

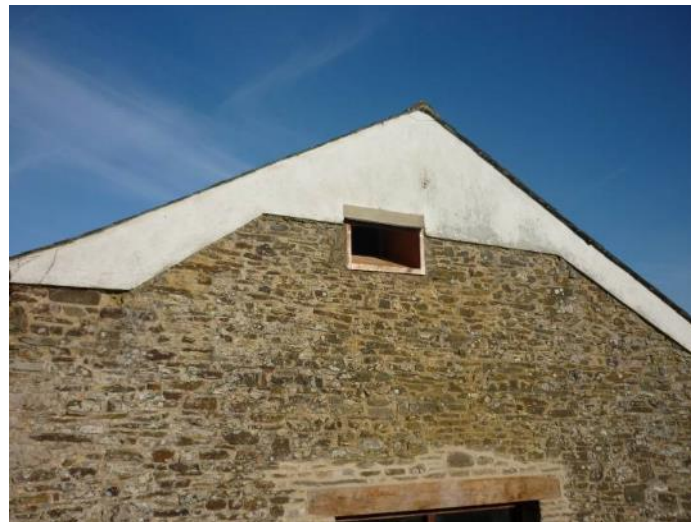
Letter box type entrance suitable for horseshoe bats

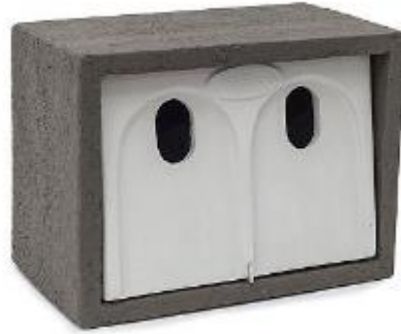
Woodstone Sparrow Terrace

Suitable for: House sparrows and individual blue & great tits
 Material: Woodcrete
 Height: 220 mm
 Width: 290 mm
 Depth: 165 mm
 Weight: 7 kg

Position: At a height of at least 2 m within external wall

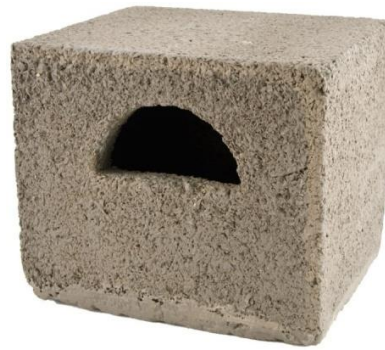
**WoodStone Build in Open Nest Box**

Suitable for: robins, wrens and blackbirds.
 Material: Woodstone
 Height: 180 mm
 Width: 220 mm
 Depth: 180 mm
 Weight: 4.2 kg

Position: Within external walls, at a height of 2 m or above.

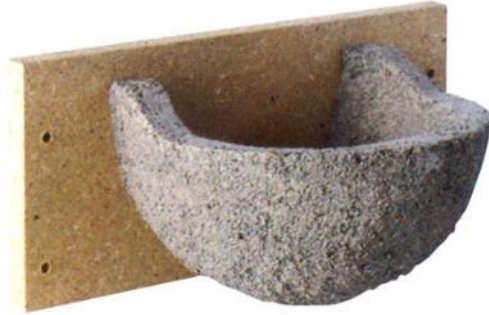
Suitable for: Common swallow
Material: Woodcrete with water resistant glued chipboard mounting panel which can be painted
Height: 110 mm
Width: 250 mm
Depth: 140 mm
Weight: 0.9 kg

Positioning: Inside of buildings or larger covered areas ensuring clear flight path in and out of the structure

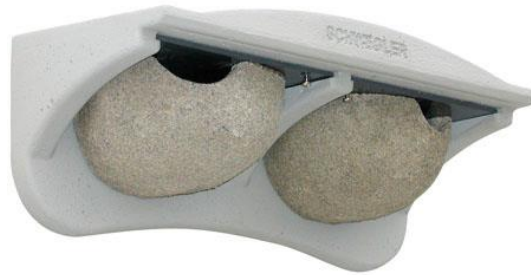
Schwegler House Martin Nesting Cups

Suitable for: House martins
Material: Woodcrete with stainless steel fittings
Height: 175 mm
Width: 430 mm
Depth: 175 mm
Weight: 5.5 kg

Positioning: On unobstructed walls directly beneath eaves, at a height of 2 m or above

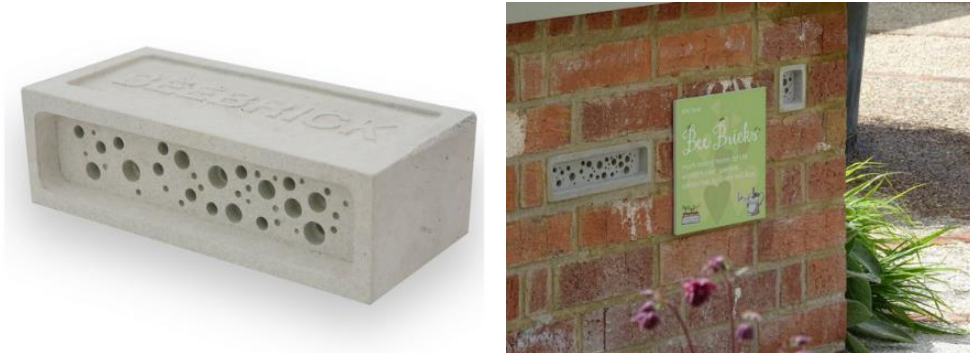
Each bee brick includes nesting compartments for solitary nesting bees, including for egg laying and hibernation.

Bee bricks to be positioned within southerly elevations, which includes part or full sun, between 1 m to 2 m above ground level, and ideally facing garden or boundary habitats.

Bee Brick - case in concrete: 215 mm x 105 mm x 65 mm
<http://greenandbluebuild.co.uk/product/bee-brick/>

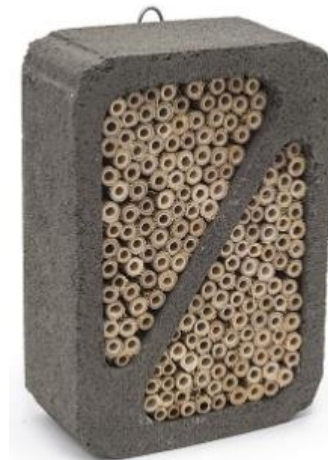
Woodstone Insect Block

Position: Place the insect block preferably in a sunny spot, ideally next to areas with flowers close by. The front where possible aimed at the south. Hang the insect block up at least 2 metres high.

The insect block can also be directly built into a façade or wall.
