**Earslwood Barn,
Moss Lane, Wrightington,
Wigan, Lancashire.
WN6 9PF**

**Survey & Assessment in Respect of Bat Species
and Nesting Birds (including Barn Owl).**

2nd December 2020

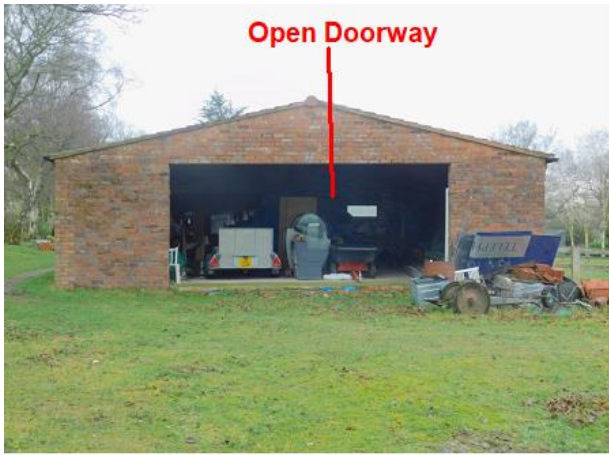
PHOTO 1
Southern Elevation

- The large garage doors within the southern elevation had been removed at some point in the past, resulting in a very large open opening. A careful search around the doorway, on the internal floor and other features, found neither bat droppings, urine or fur staining, nor prey remains, and therefore the former garage was deemed to have not been used by roosting bats, (refer to **fig 3** and **4**, and **photo 1**).

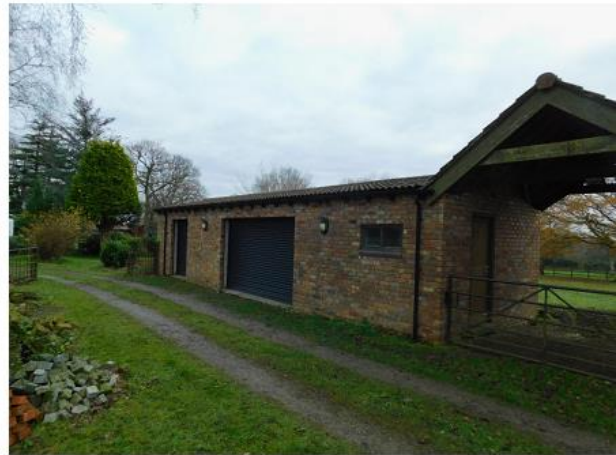
PHOTO 5
Western View of Archway

Attached externally to the northern elevation of the stable block and to the southern elevation of the northern part was a tall archway, constructed from timber, and covered in concrete tiles, underlined in roofing felt. The arch was open at both the western and eastern ends, but the remainder of the arch was fairly sound, (refer to **fig 3 and 4**, and **photos 5, 6, 11 to 13, 21 and 22**).

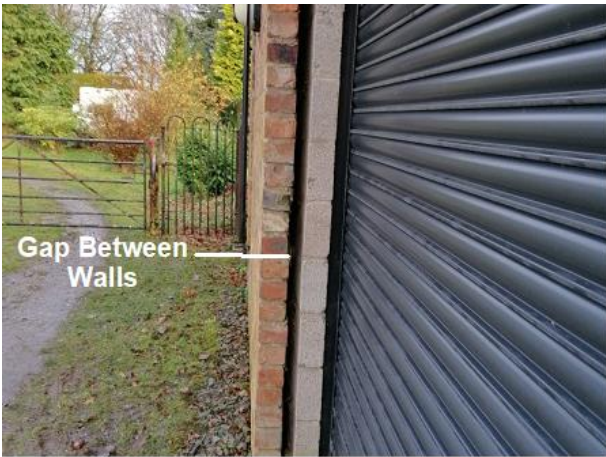
PHOTO 7
View of Wall Cavity Gap

- There was a large gap between the doorframe and the outer brick wall adjacent to a door in the western elevation, however, close inspection of the gap using the endoscope, found parts of the gap to be cobwebbed, and the remainder to be devoid of any signs of bat roosting, (refer to **fig 3 and 4**, and **photo 7**).

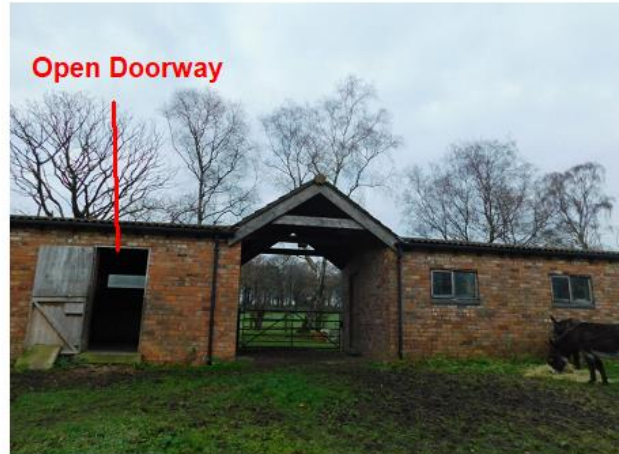
PHOTO 12
Eastern View of Archway

- Positioned part way along the western elevation, was a large opening left by the removal of a large door, however, a careful search around the doorway and on the internal floor, found neither bat droppings, urine or fur staining, nor prey remains, and therefore this part of the complex was deemed to have not been used by roosting bats, (refer to **fig 3 and 4**, and **photos 2 to 4**).
- The door in the entrance to the donkey stable at the north-eastern corner of the building was left open most of the time, but again an internal search found no evidence to suggest that bats use the interior of the stables for any type of roosting behaviour, (refer to **figs 3 and 4**, and **photos 12 to 14**).

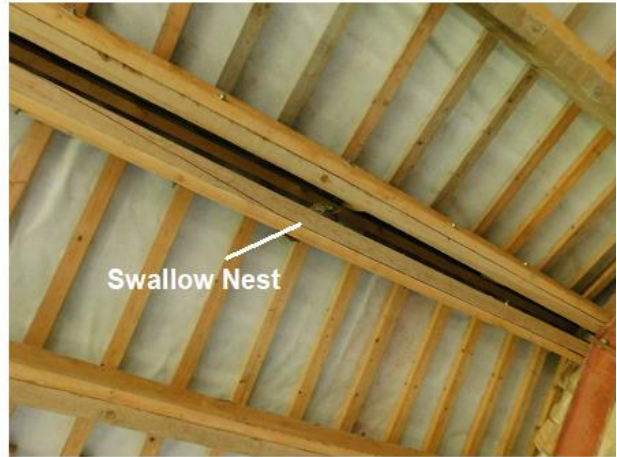
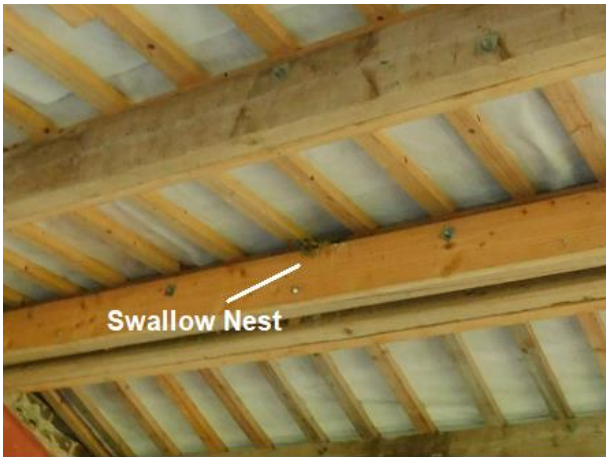
PHOTO 18
View of Swallows Nest

- Attached to roof beams at two locations were the remains of swallow nests, (*Hirundo rustica*), and although both nests looked as though they hadn't been used recently, it was thought that these nesting opportunities would be lost, should the development go ahead, (refer to **figs 3 and 4**, and **photos 18 and 19**).

5.8 This is particularly important in relation to the two currently inactive swallow's nests within the interior of the garage, both found during the surveys on 25th November 2020. As these future nesting opportunities will be lost during the planned schedule for site modernisation, It is recommended that some Schwegler No 10 woodcrete swallow nests be put up, to mitigate for potential loss of swallow nesting opportunities, during, and after the development. This type of nesting box is widely available, and should be erected as soon as possible, to mitigate for potential loss of nesting opportunities, during, and after the development, to encourage and enhance future colonisation and nesting by these species, (refer to **Appendix 7** for details).

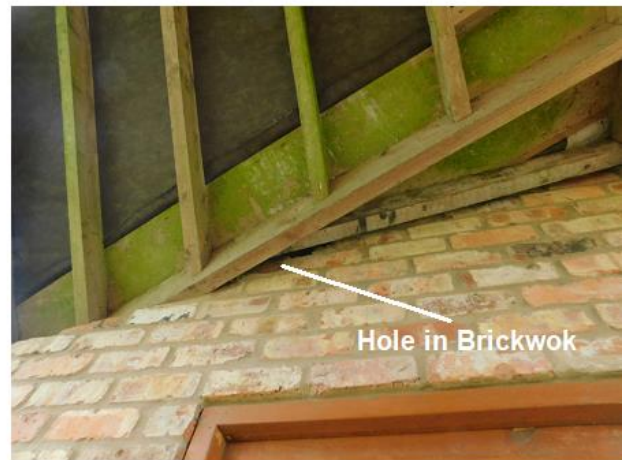
PHOTO 22
View of Part Archway Roof

- There was a small hole at the junction between the top of the wall and where it meets the roofing felt, however, a close inspection internally using an endoscope, found the hole to be of insufficient depth to offer any bat roosting potential, (refer to **fig 3 and 4**, and **photo 21**).
- Two small areas of the roofing felt had peeled back beneath the arch roof, leaving small gaps, but an inspection of the gaps and the floor and walls beneath them, found neither staining, prey remains or droppings, (refer to **fig 3 and 4**, and **photo 22**).

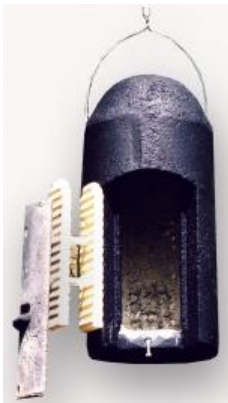
Schwegler 1FD Bat Box

This Schwegler 1FD bat box has been developed specifically for smaller bats. The interior and the type and size of the entrance hole match the requirements of smaller species. It features a special layout inside the domed roof, an increased interior height, and two grooved internal wooden front panels with precise spacing between them.

- Ideally, erect the boxes facing so they face in different directions, to provide a range of temperature conditions. For example, boxes facing from south-east to south-west allow the sun to fall on each box for part of the day. During very hot days a south-facing box may overheat, but the other boxes should have some shade during the day.
- Bat boxes should be located close to a linear vegetation feature such as a tree line or hedgerow or to lines of buildings. Some bat species use these features for navigation between their roosting site and feeding ground and to avoid flying in open and exposed areas.
- Ensure that tree branches or other items will not impede the bats’ approach to the box – clear away underneath the box so the bats can land easily before crawling into the box.
- Boxes should be erected at a height of approximately 4m above ground level

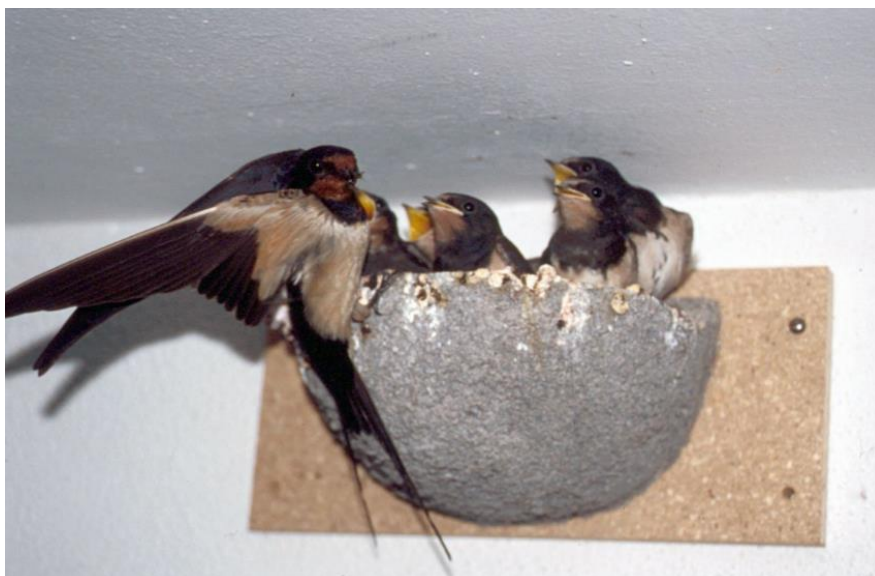
Schwegler No 10 Swallow Nest.

The Swallow Nest should ideally be placed inside outbuildings such as sheds, barns or stables, however, there should always be unrestrictive access for the birds through an open window or skylight. Swallows are sociable birds, but multiple nests should not be placed at less than 1m intervals.

These Woodcrete nest boxes are famous for their durability - lasting for at least 20-25 years. Woodcrete is a blend of wood, concrete and clay which will not rot, leak, crack or warp. They are backed by leading ornithologists, nature conservation organisations, government agencies and forestry experts. Schwegler boxes have the highest occupation rates of all nest boxes and are carefully designed to mimic natural nest sites and provide a stable environment for chick rearing and winter roosting.
