**A Heritage Assessment
Rapid Building Appraisal
Broniarth Farm
Guilsfield
Powys**

ABRS Report No 2021-BFGP

May 2021

A Heritage Assessment, Rapid Building Appraisal of Broniarth Farm (Former Farmhouse only), Guilsfield, Powys (NGR SJ 21096 13506).

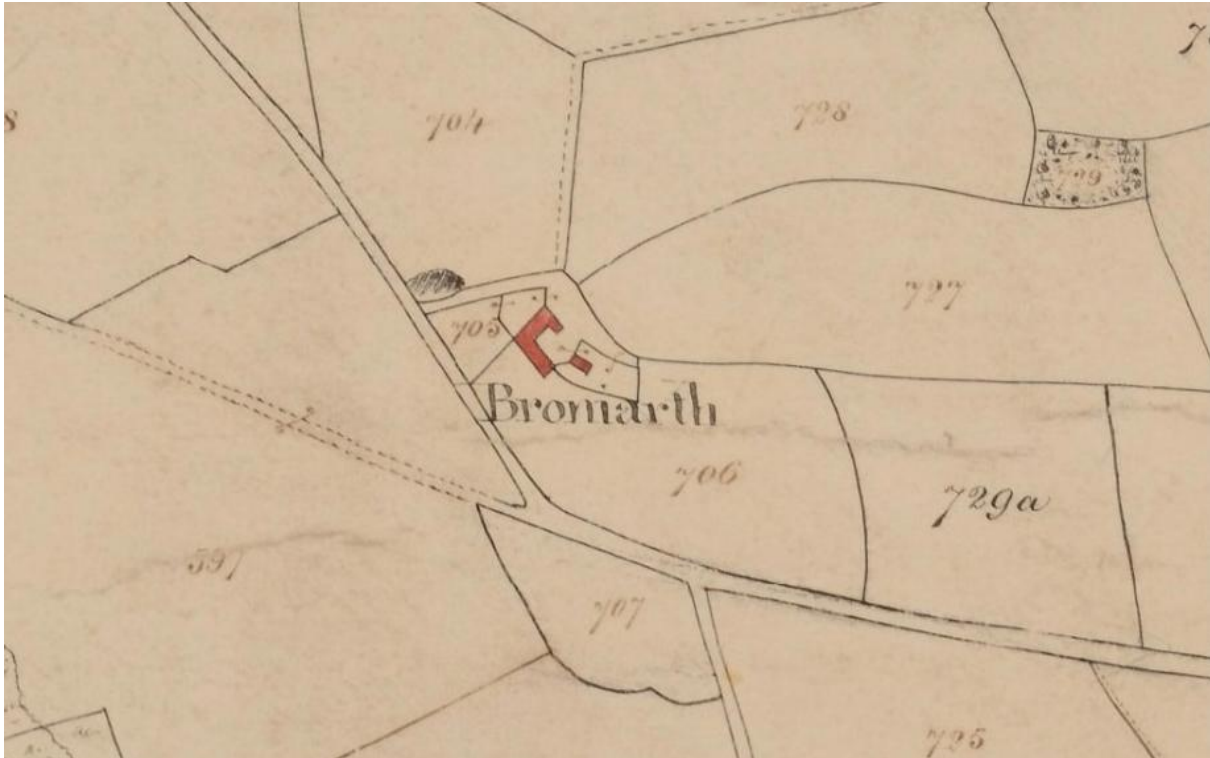
Figure 3

Broniarth Farm is located approximately 2kms north – north west of the village, the *Map of the townships of Upper and Lower Broniarth in the parish of Guildsfield and County of Montgomery* published in 1845 is the earliest available reference to the proposed development area. The map (*Figure 3*) records and identifies the proposed development area

as Broniarth, it consists of a “J”-shaped range of buildings with a smaller building to the south east occupying a similar footprint as the current Broniarth. Interestingly, the accompanying Apportionment lists it as Ty Coch – House, Building, Garden etc occupied by William Rogers and owned by William Ormsby-Gore. It is possible that the farmstead had recently changed its name; Broniarth was once a lordship held by the Princes of Powys.

Map of the townships of Upper and Lower Broniarth in the parish of Guilsfield and County of Montgomery (1845)

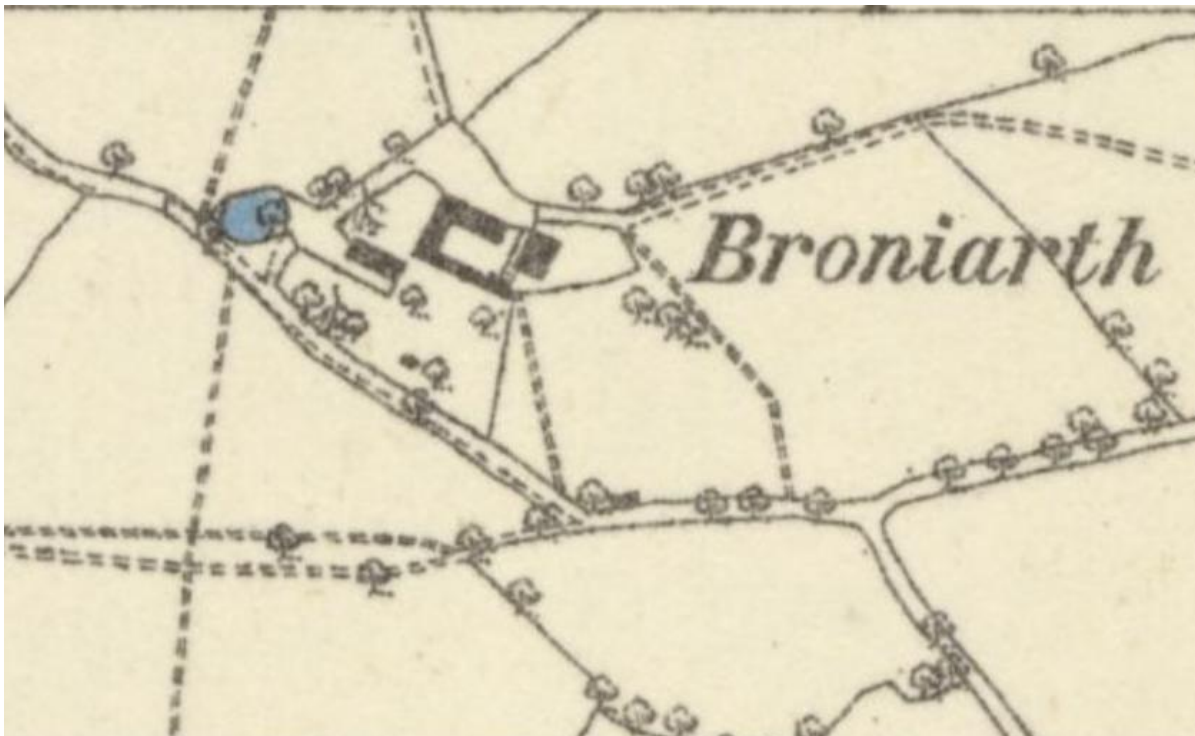
The 1884 Ordnance Survey (XV.SE (*Figure 4*)) records a similar arrangement of buildings as the tithe map, however the building to the south east of the farmyard is much larger and occupying a nearly identical footprint to the present Broniarth Farm. This would appear to suggest that the farmhouse had been rebuilt during the later 19th century, potentially utilising parts of the previous building at the southern end. Slater's *Directory of North & Mid Wales* published in 1895 lists Edward Jones, a farmer of Broniarth, confirming the name.

Figure 4
1884 Ordnance Survey.
(Montgomeryshire Sheet XV.SE)

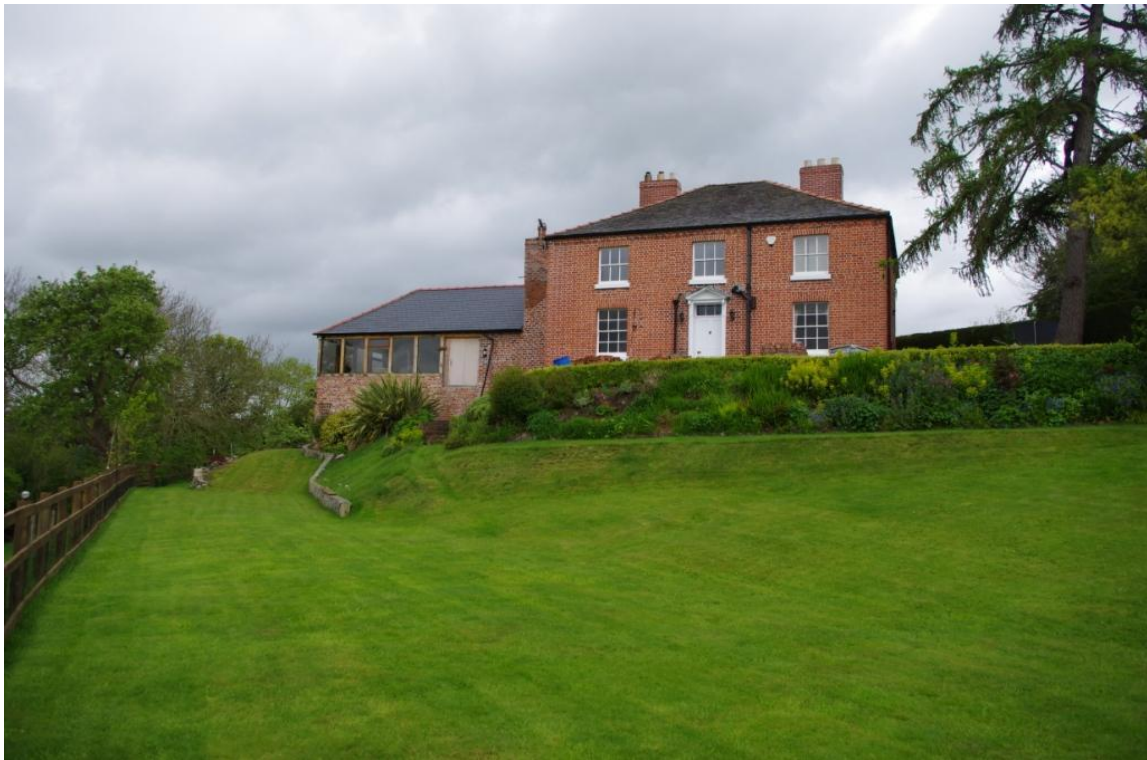
Briefly, Broniarth Farmhouse is a two storey, double pile, brick-built house under a hipped (on all four sides) roof in Welsh slate, believed to date to the mid 19th century; initial cartographic sources appear to support this. The three bay principal elevation (*Figure 5*) houses a tall central doorway with original four panelled door with overlight within an open

pedimented timber doorcase, potentially original six over six sash windows survive on the ground and three over three on the first floor, all finished with segmental brick heads and stone sills. There are brick dentilled eaves on each elevation. The rear elevation (*Figure 6*) has a much more “cottage” appearance with three light casement windows under flat cambered brick arches.

Figure 5
Principal Elevation (Looking West – North West).

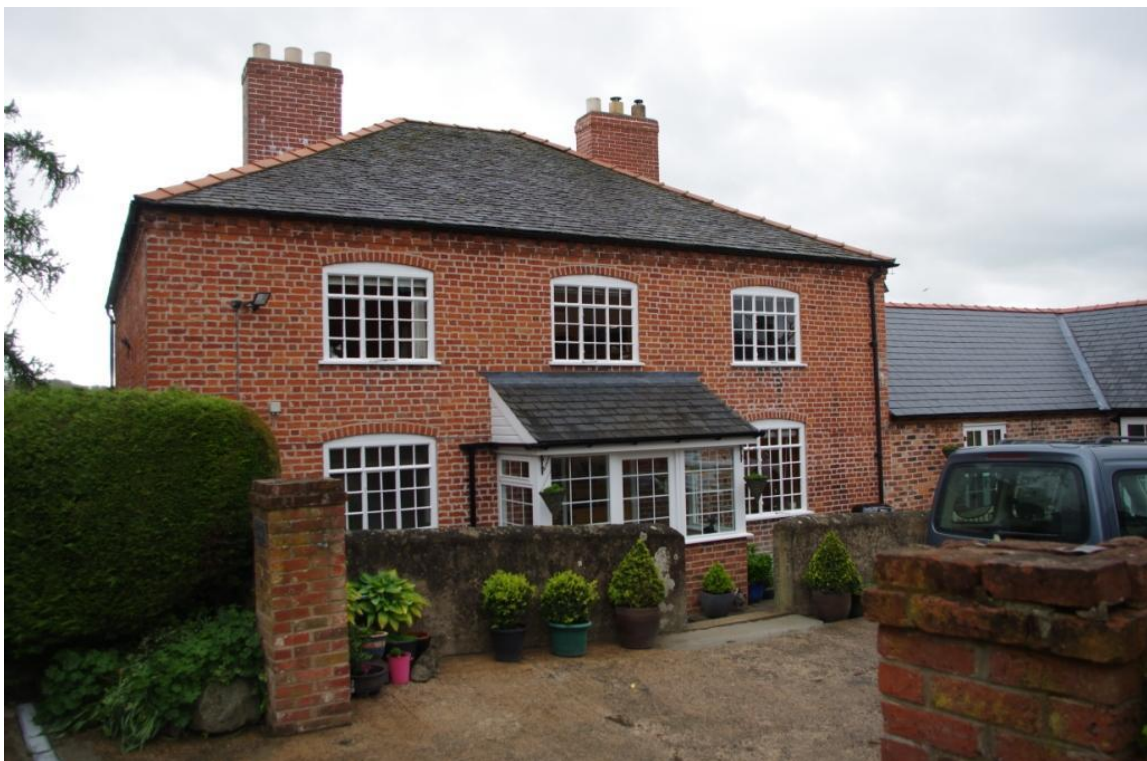
Figure 6
Rear Elevation (Looking South East).

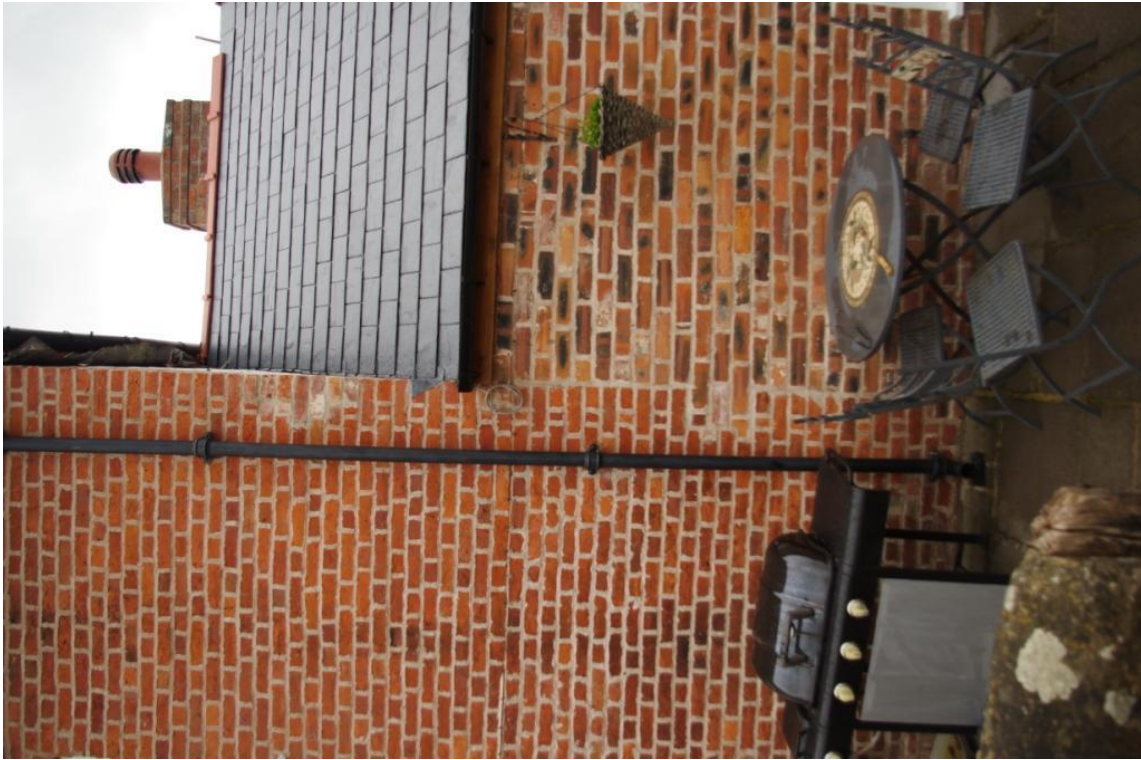
There are two brick stacks on a central cross wall. On the south facing gable is a later lean to extension under a slate roof. The lean to is believed to date to the early 20th century, the straight joint (*Figure 7*) on both elevations confirms the lean to is later. On the main house is a stone-built plinth and a cellar window. The ground floor window is identical to those on the principal elevation. The north facing gable is blank, with the exception of a single ground floor window, it is similar in appearance to those of the rear elevation, but appears to be a later frame.

Figure 7
Straight Joint Between Main House
(Left) and Lean To (Right) on Rear
Elevation (Looking East – South East).

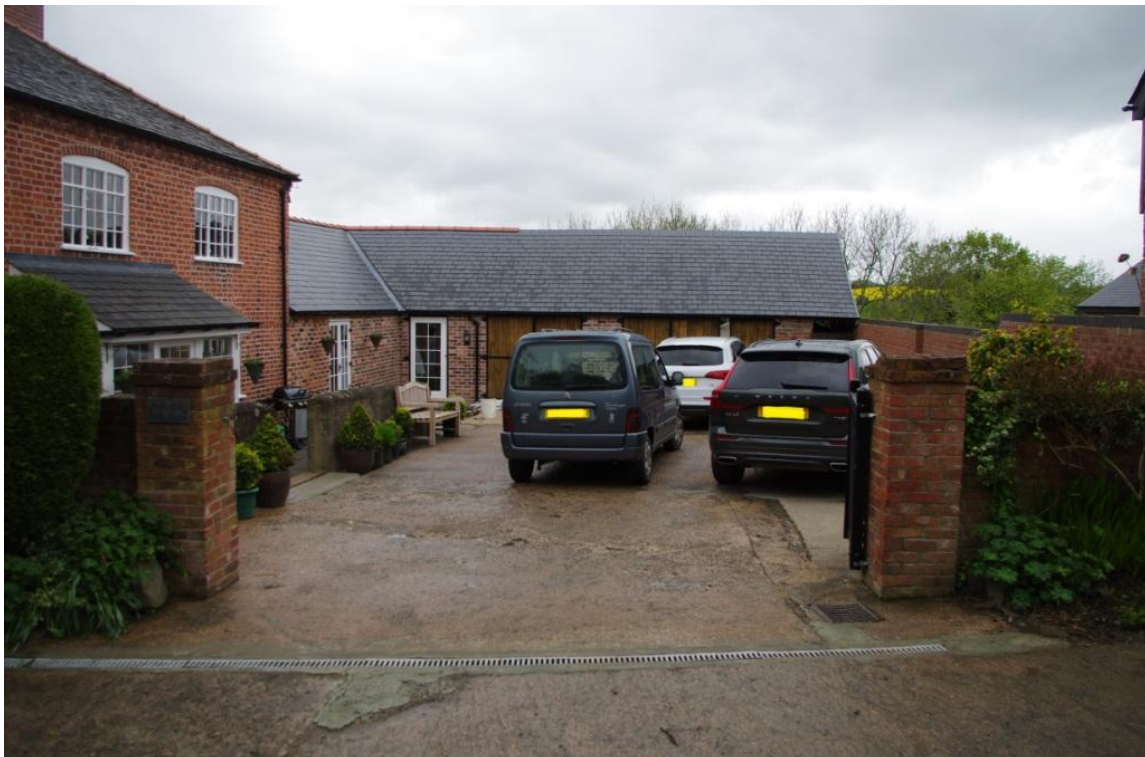
The outbuilding to the south of the house is again brick-built under a pitched slate roof (*Figure 8*). The three bay building was originally stabling and was until recently in a near derelict condition (D. Turner pers comm). The outbuilding is constructed on a steep south facing slope and the rear (south facing) elevation is partly stone built (*Figure 9*).

Figure 8
Outbuilding (Looking South West).

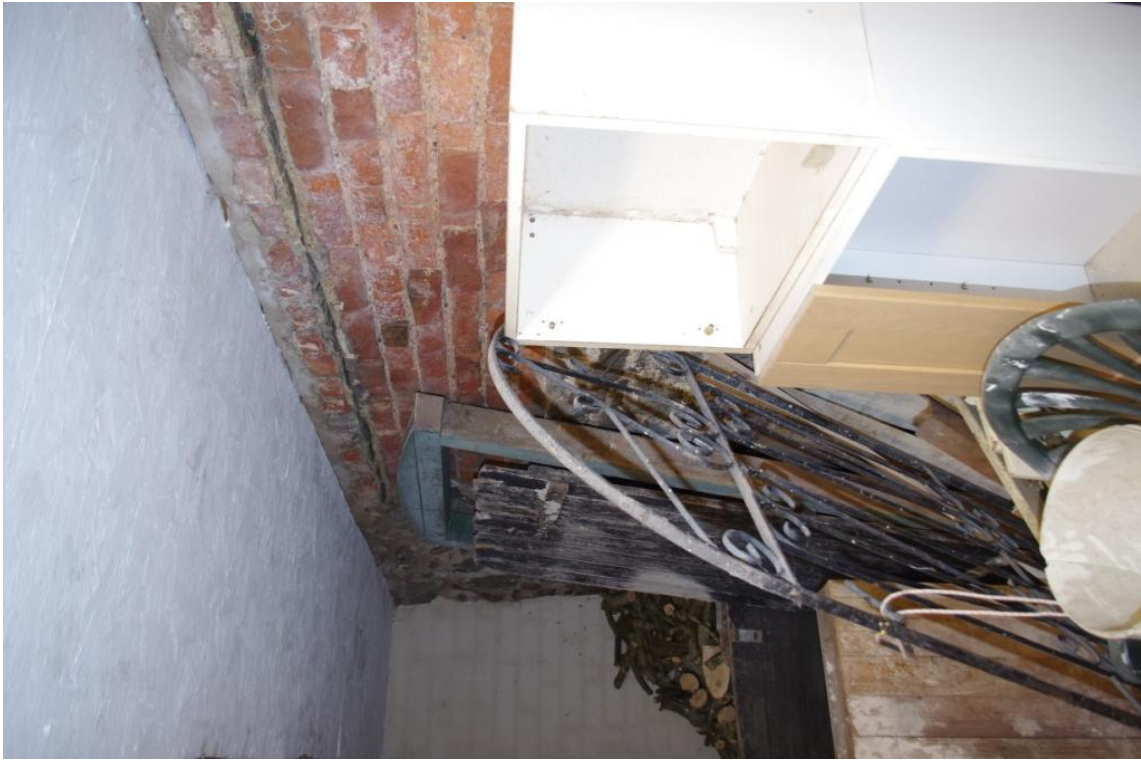
Figure 9
Original South Facing Wall of
Outbuilding (Looking North West).

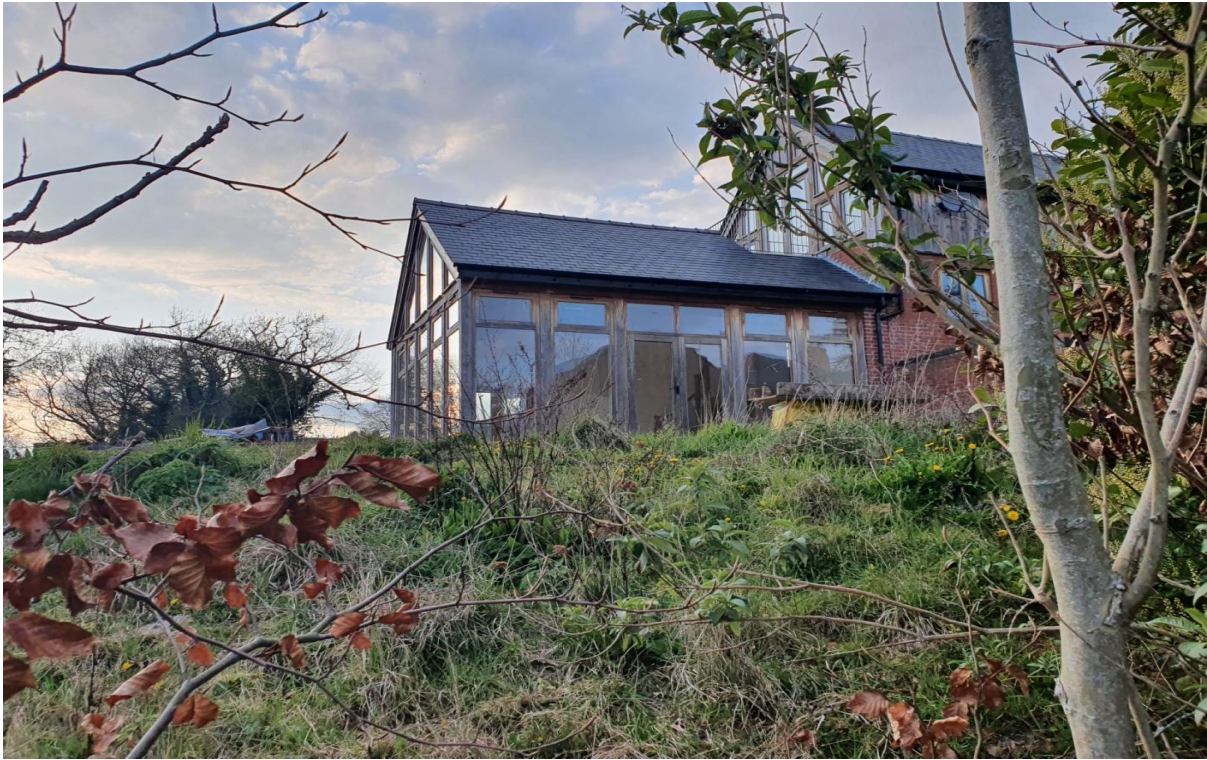
The principle of the proposed works have been agreed in previous, approved planning applications (Powys County Council PA Ref. No: M/2007/0320). The current proposals are a variation of these previously approved works and should therefore be supported. The only significant change is the inclusion of the panoramic windows in the south east angle. These windows will result in some harm to the historic asset. The windows are oak framed and located within the proposed extension, the use of simple rectangular panels will emphasise the windows as clearly modern, albeit influenced by the box timber framing tradition seen in the locality and not attempt to emulate the existing 19th century windows, there are a number of examples of glazed box framing in the locality (*Figures 13 & 14*).

Figure 13
Adjacent Curtilage Listed Building with Similar Windows as the Proposed Panoramic Windows.
(Image Supplied By Client)

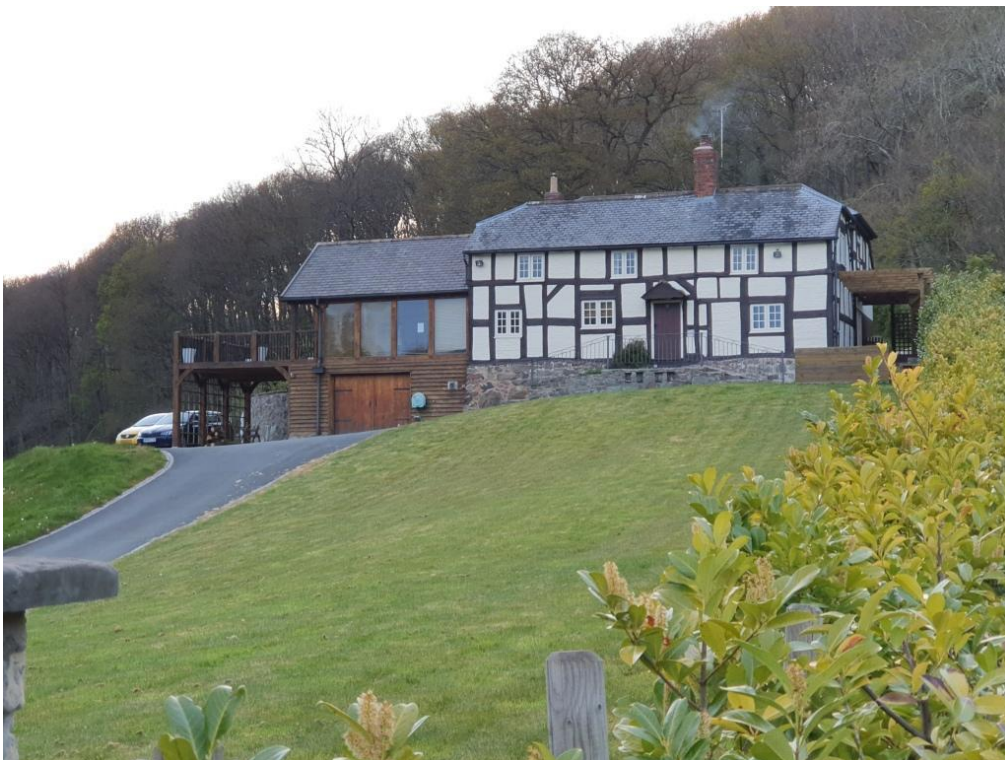
Figure 14
Gaer Fawr Holding, S.E of Broniarth Farmhouse with Similar Windows as the Proposed Panoramic Windows.
(Image Supplied By Client)

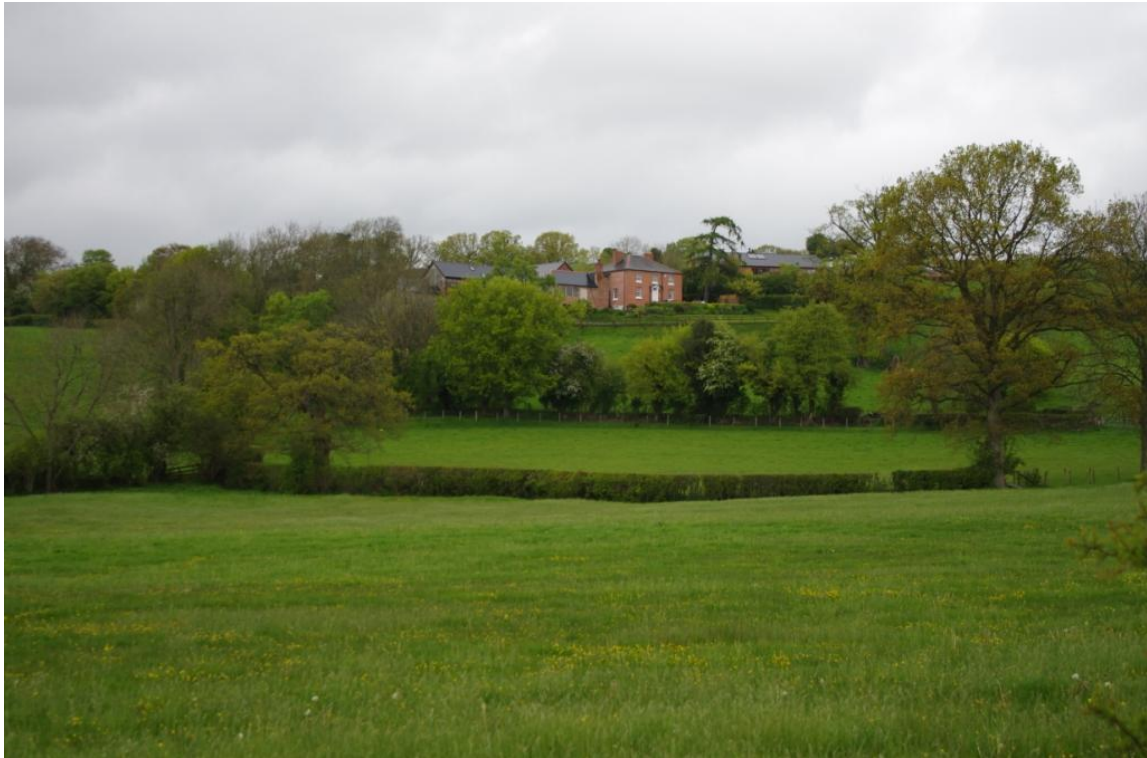
The impact of these windows upon the historic asset will be further diminished through soft landscaping (*Figure 15*) and weathering of modern pointing.

Figure 15
Broniarth Farmhouse, from the South East Showing Limited Impact of Proposed Panoramic Windows (Looking North – North West).

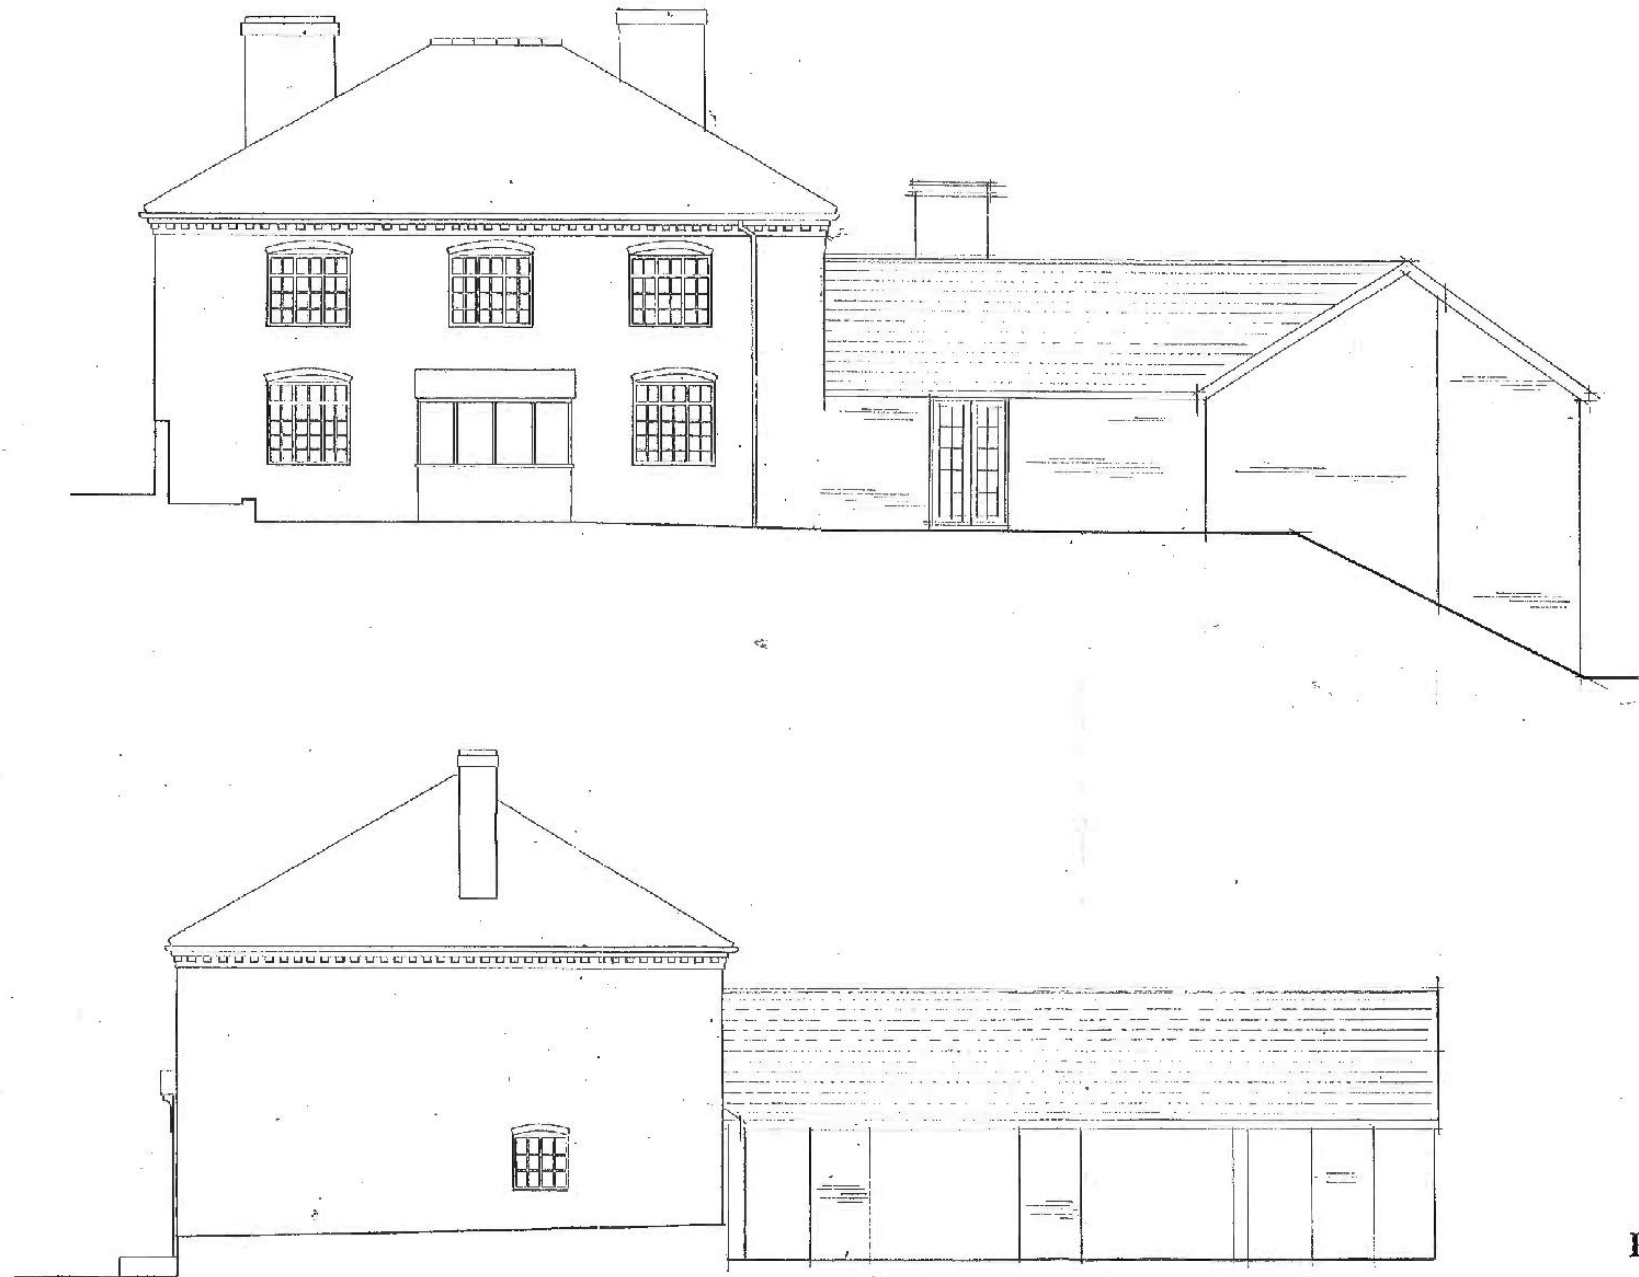
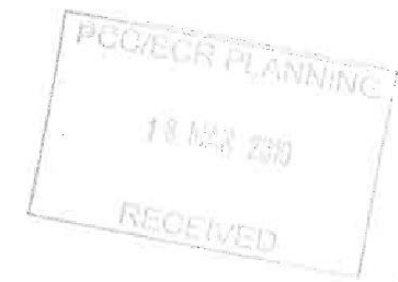
Figure 19
Elevations – As Proposed (As of May
2021 Not to Scale).

The proposed development consists of the conservation of the outbuilding and internal remodelling and a link extension between the outbuilding and the main house (*Figures 17, 18 & 19*). The outbuilding and lean to will be joined with a link extension under a pitched roof which will be hipped at the south east angle. Panoramic windows are to be included in the south east angle of the proposed link, these will be modern in appearance to emphasise this as a modern addition to the building.

Proposed Elevations
