**BARN AT GREEN FARM,
DOWNHEAD, SOMERSET**

**PROTECTED SPECIES SURVEY
&
MITIGATION STRATEGY**

Final Report

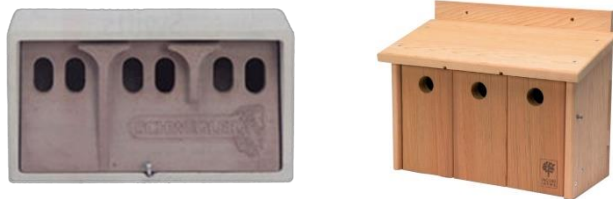
Alternative bird boxes can be viewed on-line (e.g. www.nhbs.com or www.wildcareshop.co.uk), with an example of an integrated and bolt-on sparrow terrace box shown here.

To provide new habitat for nesting birds, it is recommended that one sparrow (*Passer domesticus*) nest-box be included on the new dwelling. Bird boxes can either be integrated into the fabric of a wall (preferable) or bolted onto a wall as far above the ground as possible near to the roof apex of the north-facing elevation of the building, which provides shelter from direct sunlight.

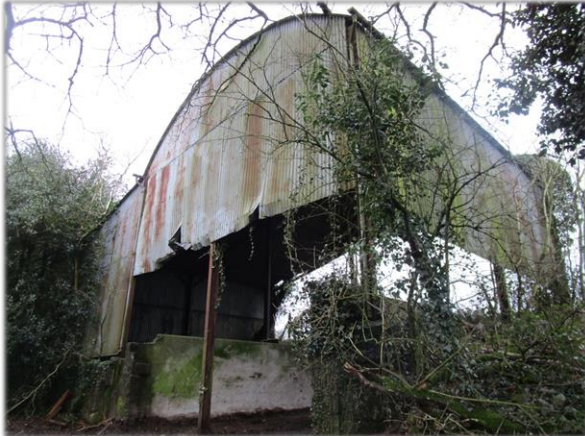
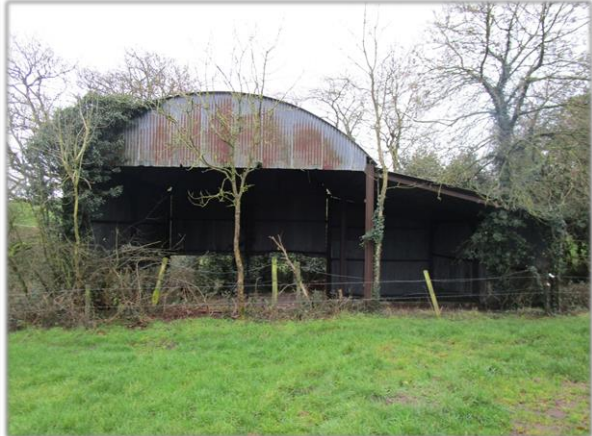
The barn is constructed with a metal frame and is open or has large openings on three sides. Walls comprise low (maximum 2m high) concrete blockwork, which are sealed on the sides and top leaving no gaps. The upper walls are single-skin corrugated metal that attach directly to the metal frame and are unlined.

The roof is rounded with a mono-pitched lean-to section, and both are clad in single-skin corrugated metal sheets that attach directly to the metal frame and are un-lined. There are no roof timbers and no ridge board. The building is open to the roof structure, and the floor is split into three levels being lined with concrete or earth.

Barn exterior showing south-facing elevation (left) and north-facing elevation (right)

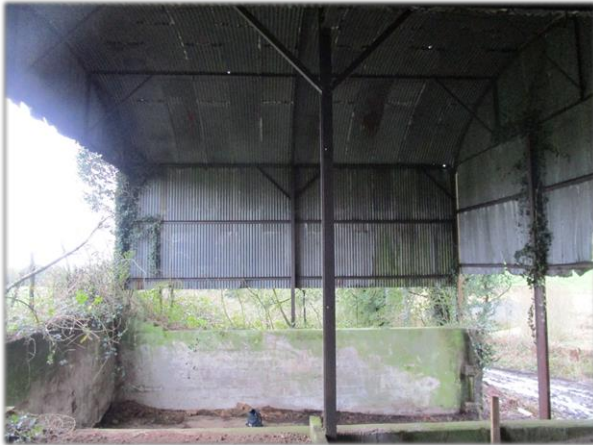
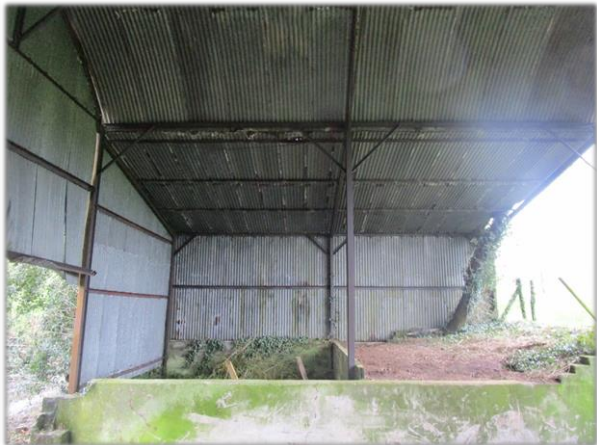
There are no external or internal gaps/crevices or hidden voids or exposed roof timbers associated with this building. The building is very open, light, draughty (thermally unstable) as well as being enclosed or shaded by mature hedgerow that will keep much of the building interior cold, all of which significantly reduces its suitability for roosting bats.

There are no potential bat roosting features associated with the barn as there are no gaps, hidden voids or exposed roof timbers. The barn provides totally unsuitable environmental conditions for roosting bats being very open, light, draughty and shrouded by vegetation. There is no evidence to suggest that the building is being, or has ever been, used by roosting bats or by bats seeking a place of rest. No bats were present, no bat droppings were found anywhere either on the floor, surfaces or caught in webs on the walls/corners etc., and the inspection found no other evidence of the presence of bats. The barn is classed as Category 1 (not a roost) and is deemed to have no potential to support roosting bats in the future.

Barn interior showing main Dutch-style section (left) and lean-to (right)
